SMALL PUBLIC WATER SYSTEMS ASSESSMENT
WESTERN REGION

BEAVER CREEK RCMP
RESIDENCE BUILDING # M0133
SITE LOCATION DIAGRAM
WELL ID: M0133

SMALL PUBLIC WATER SYSTEM ASSESSMENT

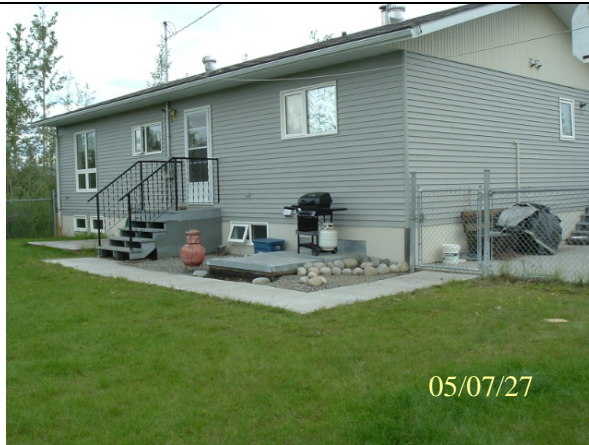
Photo 0545: M0133 Beaver Creek RCMP Residence from rear, wellhead enclosure (front centre)

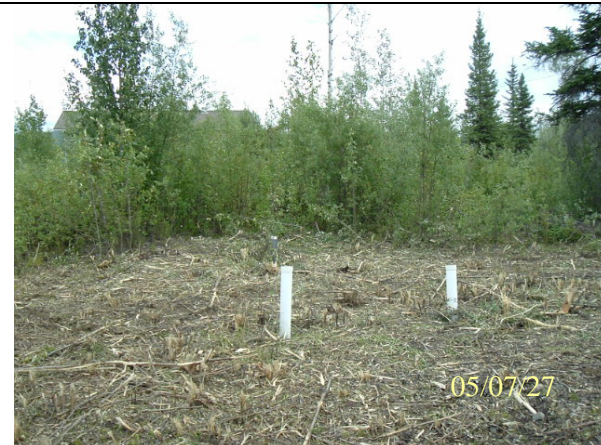
Photo 0544: M0133 Septic field

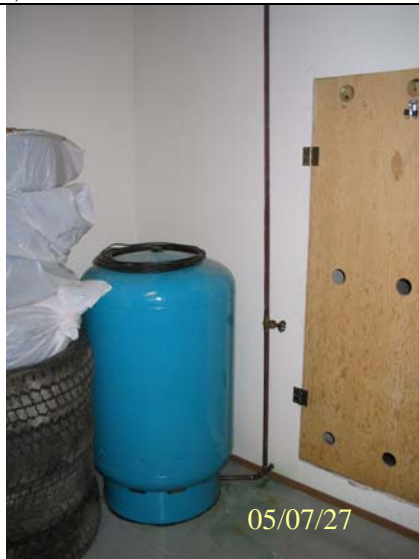
Photo 0089: M0133 Pressure tank

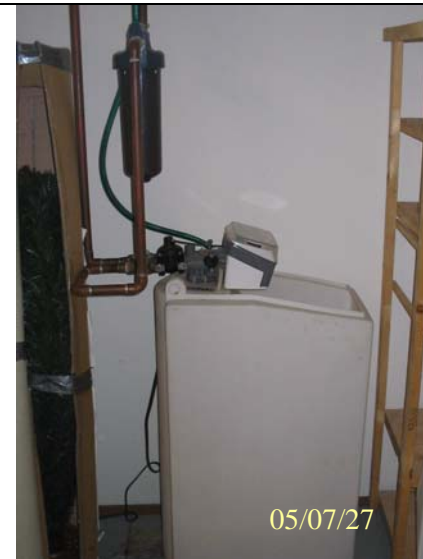
THE PIPING AT WELL HEAD IS UNPROFESSIONAL.
THE WATER SOFTENER IS NOT OPERATIONAL
AND THE INLINE FILTER IS IN NEED OF
CHANGING.
THE SOFTENER DRAIN IS NOT TO CODE.

Photo 0090: M0133 In-line filter and water softener

REPAIR WATER SOFTENER AS NECESSARY IN
PUT BACK INTO SERVICE. CHANGE INLINE
FILTER. REPIPE SOFTENER DRAIN TO CODE.
BRING WELL HEAD PIPING TO CODE.
