SMALL PUBLIC WATER SYSTEMS ASSESSMENT WESTERN REGION	
GOVERNMENT OF YUKON HIGHWAYS & PUBLIC WORKS	
BEAVER CREEK RCMP RESIDENCE BUILDING # M0134 SITE LOCATION DIAGRAM WELL ID: M0134	REVISION ISSUE 0
FIGURE NO. FIGURE M0134-A

## SMALL PUBLIC WATER SYSTEM ASSESSMENT

### PART A: EBA Site Inspection

WELL ID #	Owner	Location Description
M0134	RCMP	Beaver Creek RCMP Residence (South)

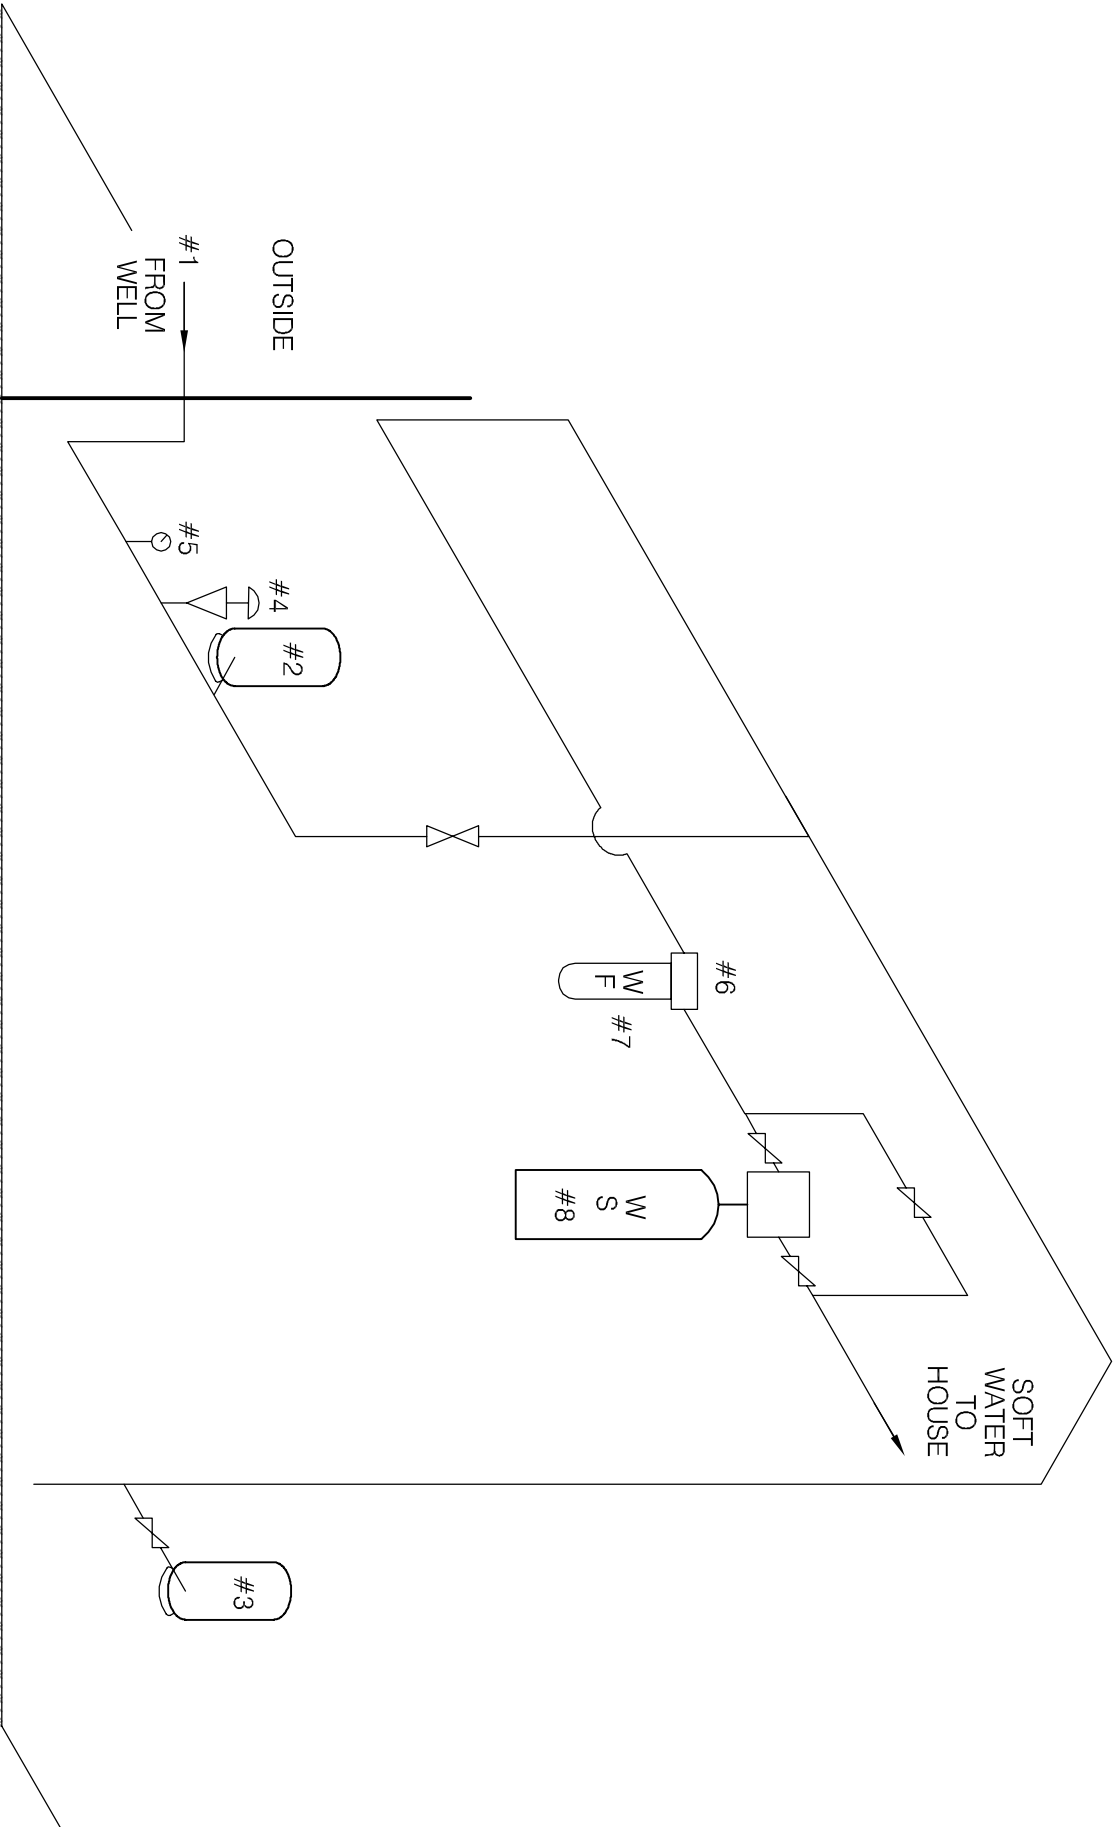
FIGURE M0134-B

INSIDE INSTALLATION IS OF GOOD QUALITY.  
INLINE FILTER AND WATER SOFTENER IS IN  
VERY BAD CONDITION.  
SOFTENER DRAIN NOT TO CODE.

REPAIR SOFTENER & INLINE FILTER AS  
NECESSARY TO PROVIDE PRETREAT FOR UV  
SYSTEM. INSTALL UV SYSTEM FOR  
APPROPRIATE FLOW.  
INSTITUTE BI-ANNUAL WELL MAINTENANCE  
PROGRAM. MAINTAIN TREATMENT SYSTEM  
IN WORKING ORDER.

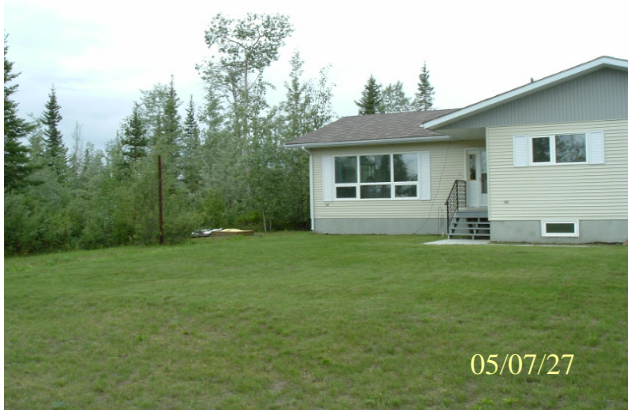
Unauthorized access by humans? ☐ Yes ☒ No  
unlocked enclosure

Entrance by animals? ☐ Yes ☒ No  
Access possible

**Photo 0549:** M0134 Beaver Creek RCMP Residence (right), wellhead enclosure (left)

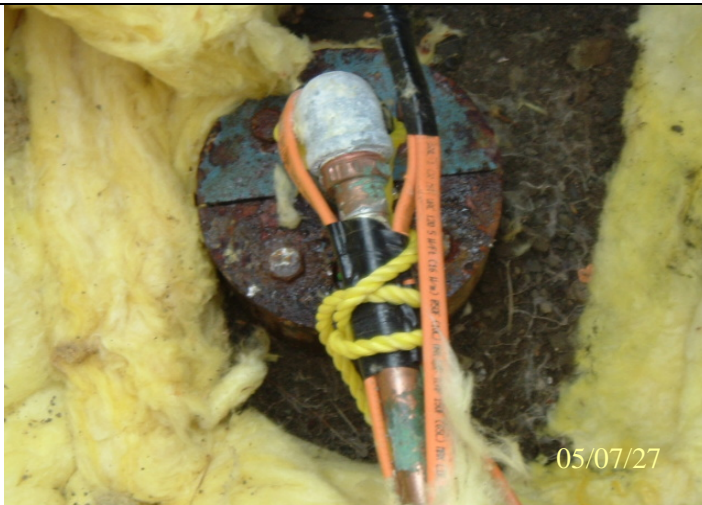
p. Is well site subject to flooding? ☒ Yes ☐ No  
Dampness in pit

- i. Is the well head below grade? describe in detail ~ 1.05 m below grade
- ii. Are there signs of ponding on the enclosure(e.g. water stains, etc.)? ☒ Yes ☐ No
- iii. Is the wellhead enclosed by fiberglass insulations? ☒ Yes ☐ No
- iv. Any evidence of rodents? Specify Yes,
- v. Does the well casing have a proper seal cap? ☒ Yes ☐ No
- If no, describe condition split gasket cap

**Photo 0550:** M0134 Wellhead in pit

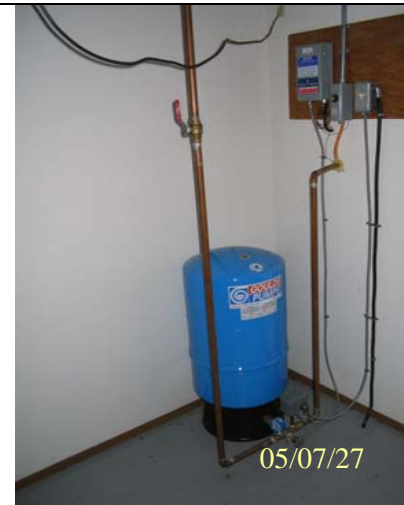
**Photo 0094:** M0134 pressure tank and pump controls
