<b>EBA Engineering Consultants Ltd.</b></div>			PROJECT SMALL PUBLIC WATER SYSTEMS ASSESSMENT WESTERN REGION		
<div>

<b>Yukon</b> Highways and Public Works Property Management Branch</div>			TITLE WATER SYSTEM DISTRIBUTION/TREATMENT SCHEMATIC SYSTEM ID.: 3100 BESSIE JOHN SCHOOL - BEAVER CREEK		
DATE	SEPT. 2005	DWN.	JSB	CHKD.	FMN
FILE NO.	1260002.003				DWG.: FIGURE 3100-B

## SMALL PUBLIC WATER SYSTEM ASSESSMENT

### PART A: EBA Site Inspection

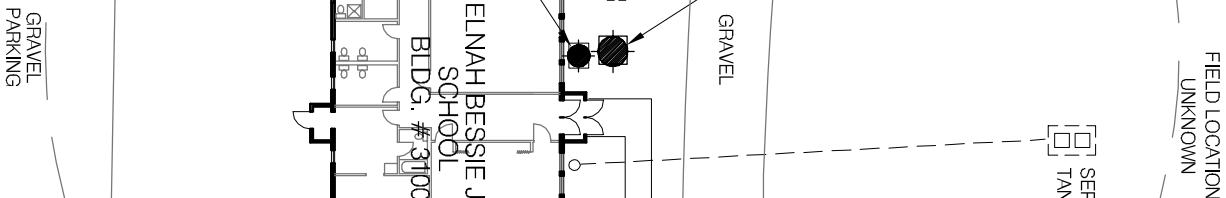
30 m RADIUS FROM WATER WELL FOR CONSIDERATION OF PROXIMITY TO POTENTIAL CONTAMINANT SOURCES.

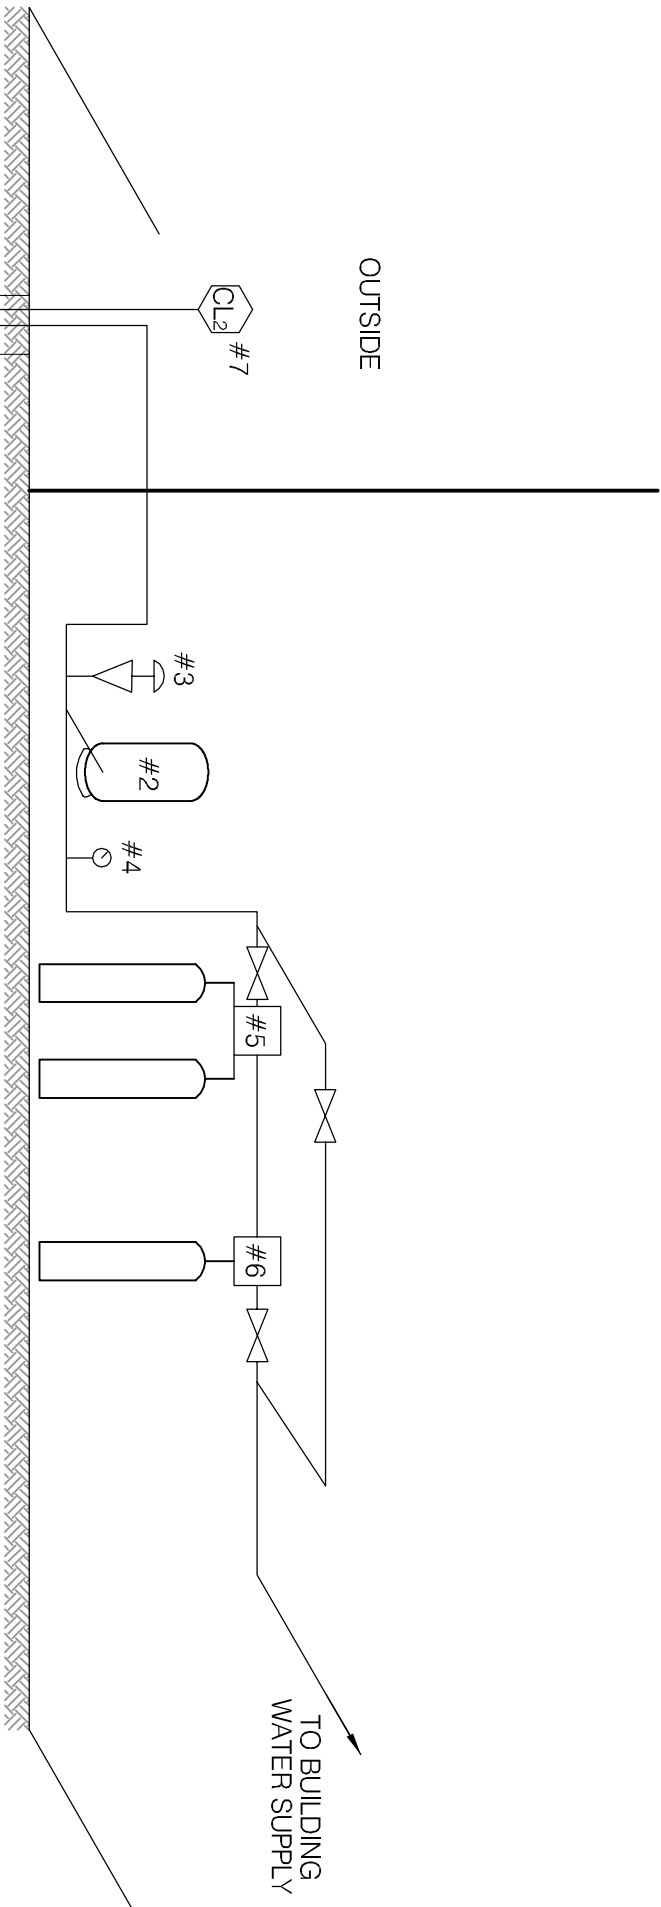
SCHEMATIC PRODUCED BY BERT ALBISSEER OF AQUATECH SUPPLIES AND SERVICES LTD.

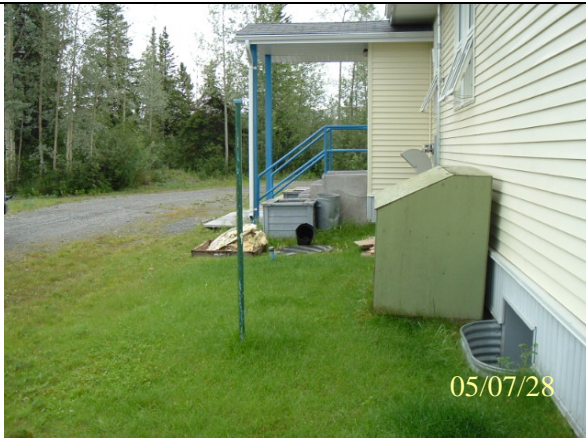
r. Is there a buried fuel tank on the property? ☒ Yes ☐ No

Distance from the well to known buried tank 1 m

**Photo 0567:** 3100 Wellhead in pit (back centre), underground fuel storage tank (front centre), school (right)

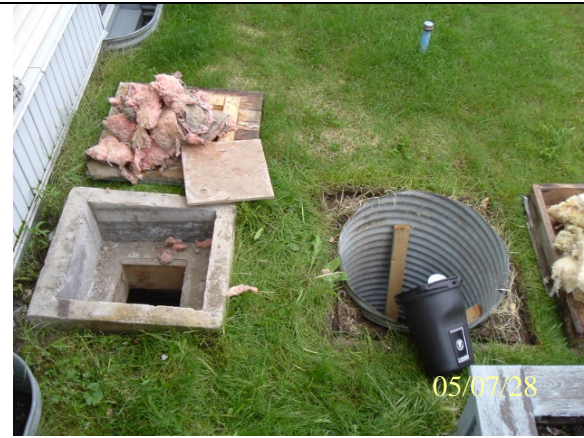
Unauthorized access by humans? ☐ Yes ☒ No Entrance by animals? ☐ Yes ☒ No  
unlocked enclosure Access possible

**Photo 0570:** 3100 Wellhead in pit (right), access enclosure (left)

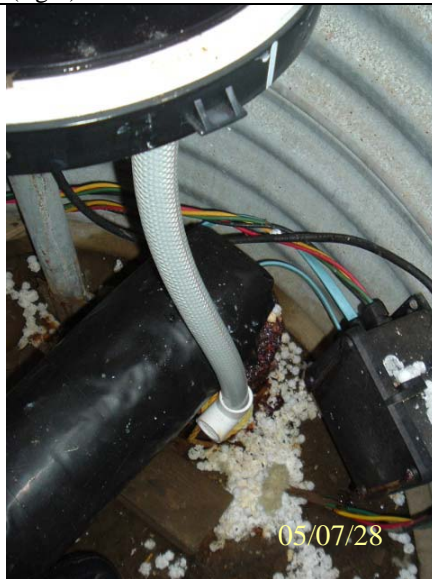
If no, describe condition but heavy rust/corrosion

THIS IS A REASONABLY GOOD INSTALLATION.  
HOWEVER THE CONFIGURATION DOES NOT  
MEET THE NEW REGULATION AND THE  
PELLET CHLORINATORS HAVE PROVEN  
TROUBLESOME FOR MAINTENANCE AND RUSTING  
OUT THE CASING.  
HEAT TAPES INSTALLATION IS NOT TO CODE.

**Photo 0572:** 3100 Wellhead and pellet chlorinator. Note pellets in bottom of pit.

REPLACE THE PELLET CHLORINATOR WITH  
PROPORTIONAL FEED CHLORINATION AND  
CHANGE CHARCOAL FILTER TO MULTI-MEDIA  
CONFIGURATION.  
CONVERSELY PREFILTRATION AND UV AFTER  
THE EXISTING TREATMENT IS AN OPTION.  
INSTALL NEW HEAT TRACES TO CODE.

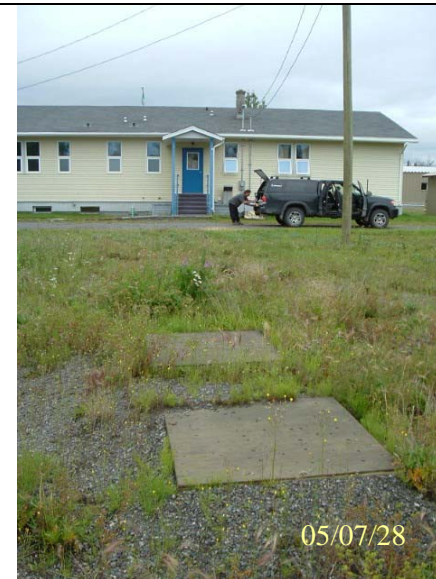
j. Distance from well to nearest point of known field: septic tank + field @ 22m

**Photo 0569:** 3100 Septic tank (front), school (rear)

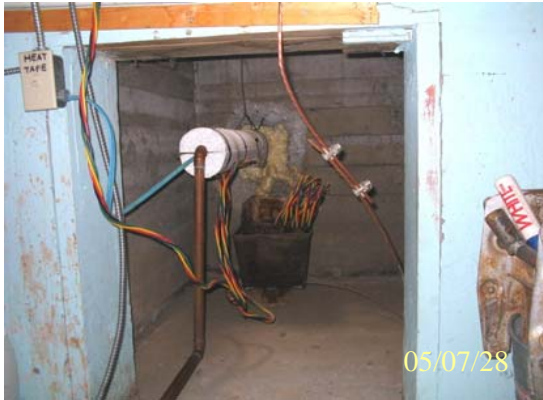
There is also an abandoned well in an enclosure off from  
the basement of the school. Drilled April 1961, depth: 48 ft.  
Abandoned well is open w/ no cap. Static water level  
(measured) 13.22 m below grade.

**Photo 0101:** 3100 Point of entry from well (top), abandoned well under box (bottom)
