SMALL PUBLIC WATER SYSTEMS ASSESSMENT
 WHITEHORSE REGION

HOOTALINQUA FIRE HALL
 BUILDING 1391
 SITE LOCATION DIAGRAM
 WELL ID: 1391

PART A: EBA Site Inspection

WELL ID #	Owner	Location Description
1391	YTG	Hootalingua Firehall

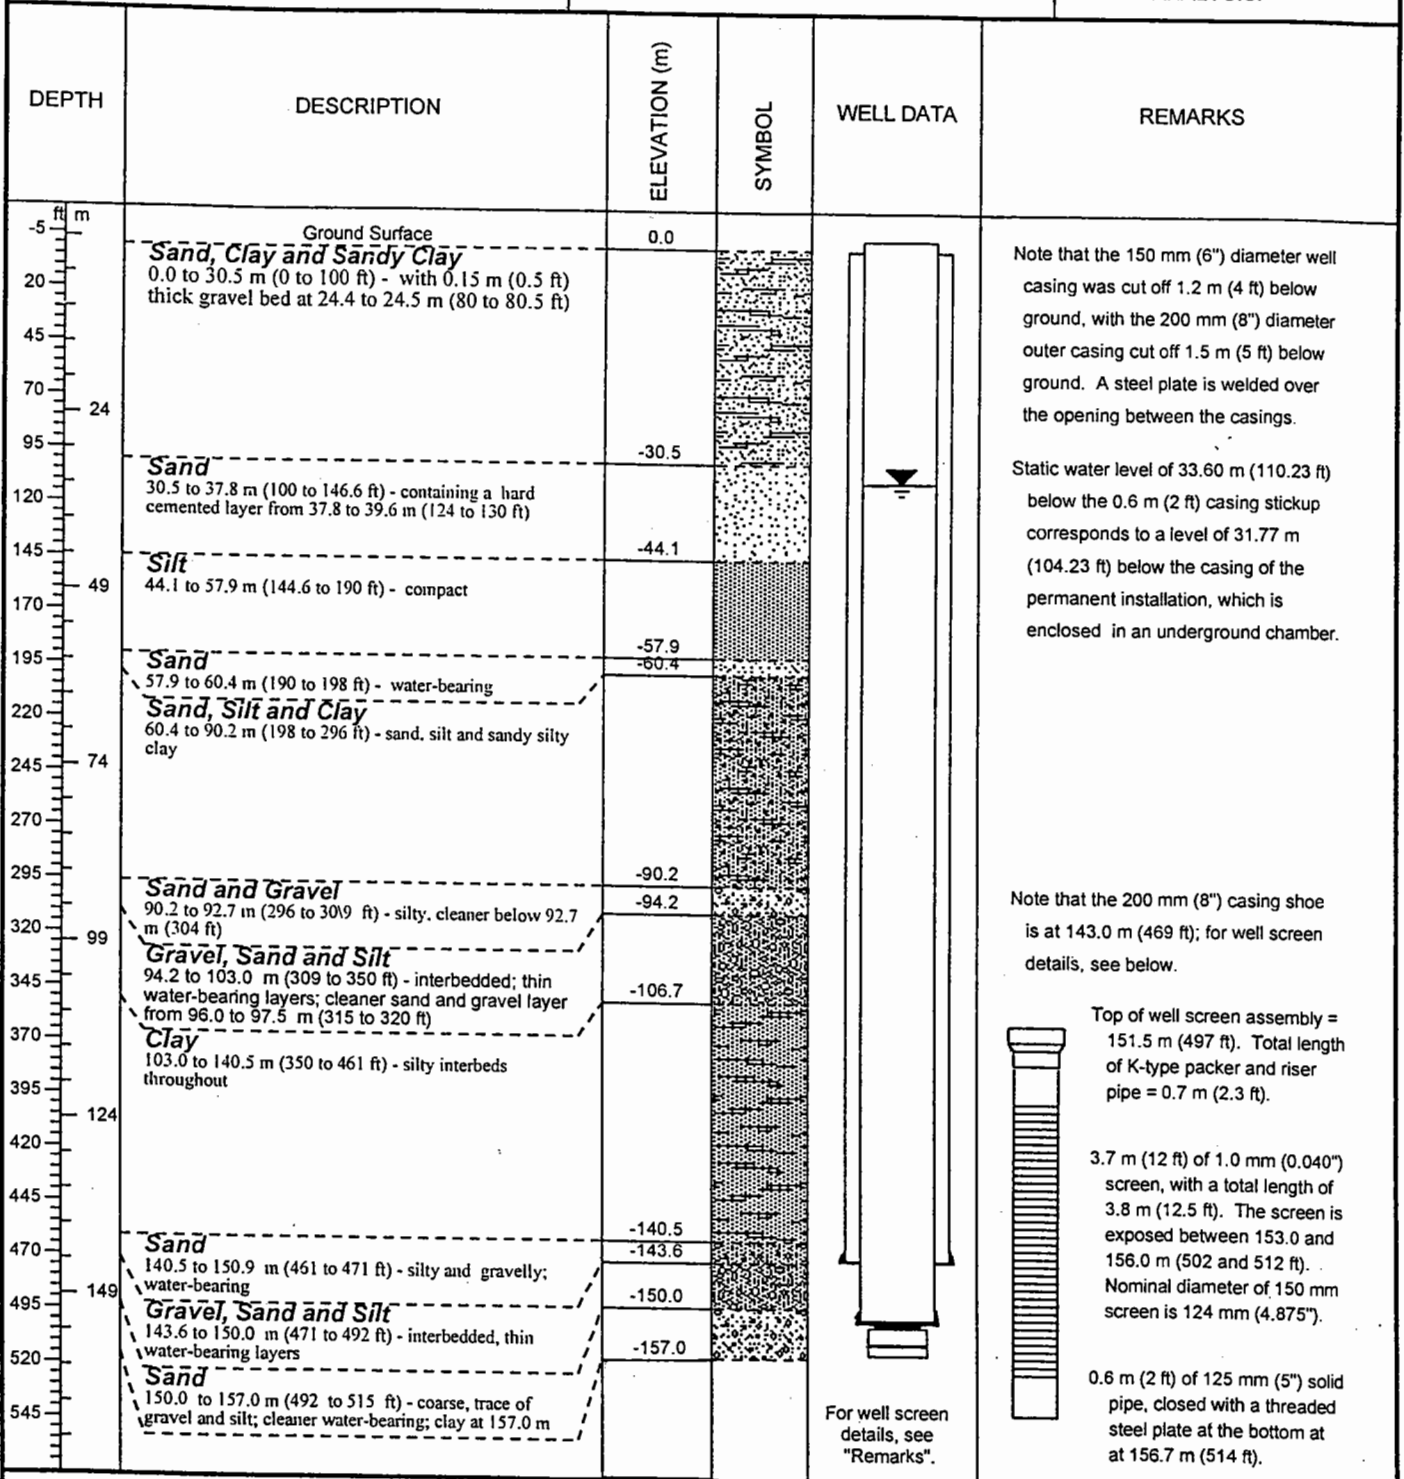
PROJECT: YTG - Hootalinqua Firehall Well	CASING STICKUP: 0.6 m (2 ft)	WELL NO: 1-02
PHCL PROJECT NO: C730101	STATIC WATER LEVEL: 33.0 m (108.23 ft) bgs	PUMPING TEST: Yes
LOCATION: North of Whitehorse	COMPLETION DEPTH: 156.7 m (514 ft)	WATER ANALYSIS: Yes

CONTRACTOR: Cathway Water Resources	DATE: Mar-Aug/2002	PACIFIC HYDROLOGY CONSULTANTS LTD. Consulting Hydrogeologists Suite 201, 1537 West 8th Avenue VANCOUVER, B.C. Canada V6J 1T5 Telephone: (604) 730-6990
DRILLING METHOD: Cable Tool	BY: rt	
PAGE: 1 of 2	FIGURE: 3

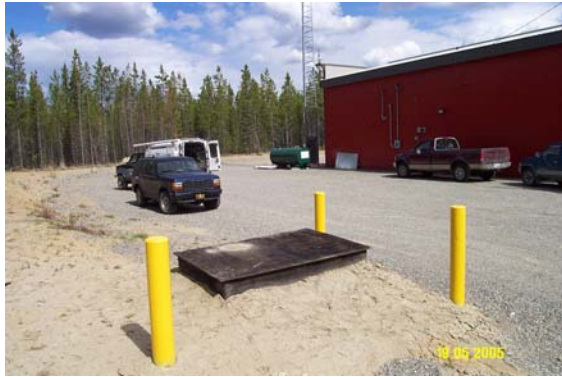
Potential Source 1: AST; Distance from well to Potential Source 1: 24m

Photo 0188: 1391 Well Head Enclosure (front), Hootalinqua Firehall and Above Ground Fuel Storage Tank (back)

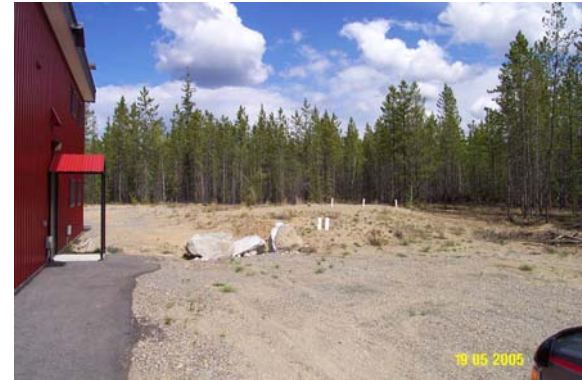
Septic tank 36m away, field greater than that

Photo 0189: 1391 Septic Field

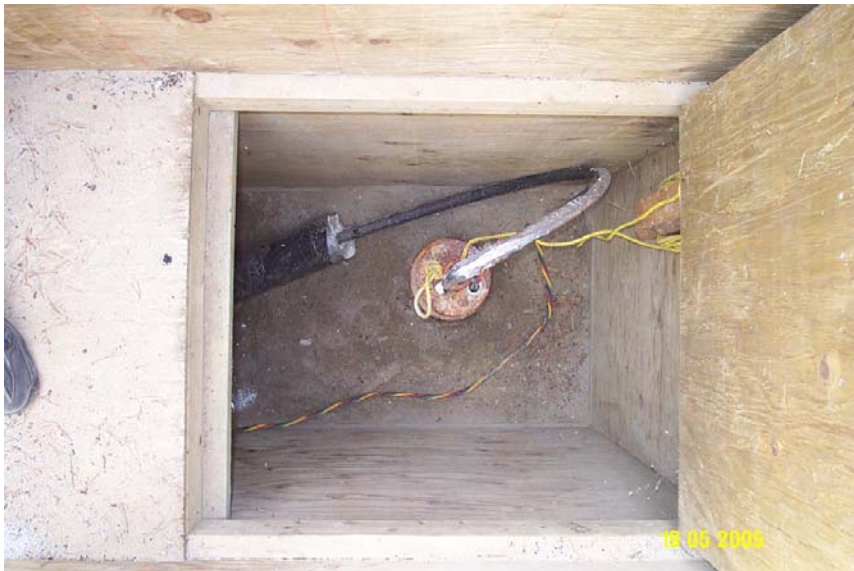
Unauthorized access by humans? Yes No
There are no locks and neither the lid or the hatch are fastened on

Entrance by animals? Yes No
Cobwebs, ants, evidence of mice

There appears to be no water staining or dampness but for the rust on the well head

Photo 0190: 1391 Well Head

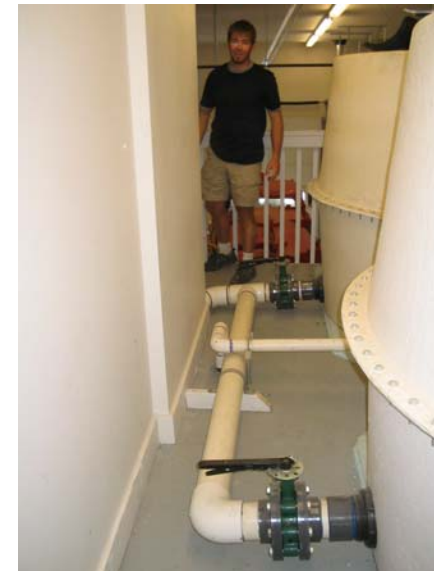
Is there any odour associated with the water or tank? YES NO CHLORINATED WITH PUCKS

Photo 0013: 1391 Water Storage Tanks

INSTALL COMMERCIAL SIZE FILTER ON
WATER LINE BETWEEN SAND TRAP &
PRESSURE TANK. INSTALL CHLORINATOR
AFTER INLINE FILTER
