DATE October 2, 2009**PROJECT No.** 07-1413-0077/7400

Doc. No. 123

TO Mr. Jonathan Clegg
Western Copper Corporation**CC** John Hull, Fiona Esford**FROM** Javier Ubilla**EMAIL** jubilla@golder.com**EROSION AND SEDIMENT CONTROL MEASURES, SEPTEMBER 2009, CARMACKS COPPER PROJECT,
YUKON TERRITORY**

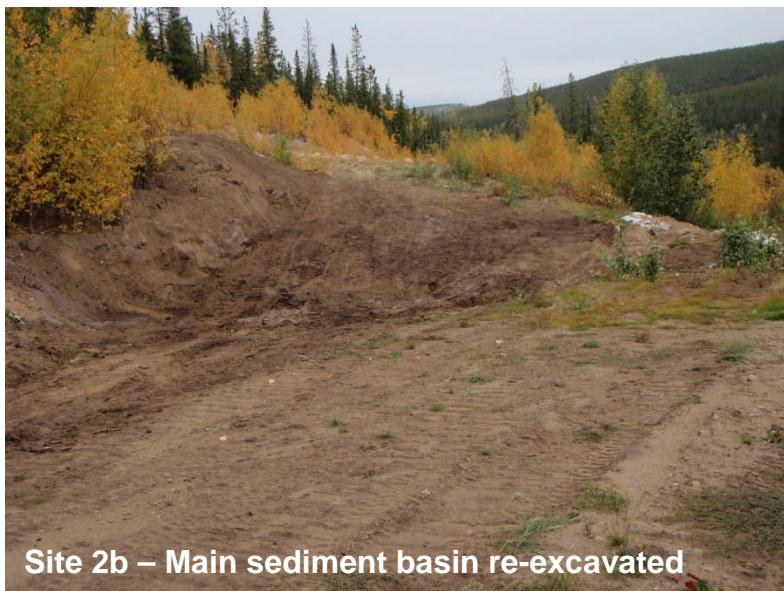
Figure 2 shows photographs of the sediment basins at Sites 2b and 4d. The basins were re-excavated to restore the initial storage capacity. These two sites together with Site 5g (sediment basin and berm, Figure 3) are considered the final features in the sediment plan program to retain sediments from being transported from the heap area towards Williams Creek (Figure 1). Sediment basins 2b, 4d and 5g were re-excavated to restore the storage capacity they had after the 2008 work. Sediment control elements in roads 4, 5, 6 and 7 also help to reduce the amount of sediments being mobilized.

Site 2b – Main sediment basin re-excavated

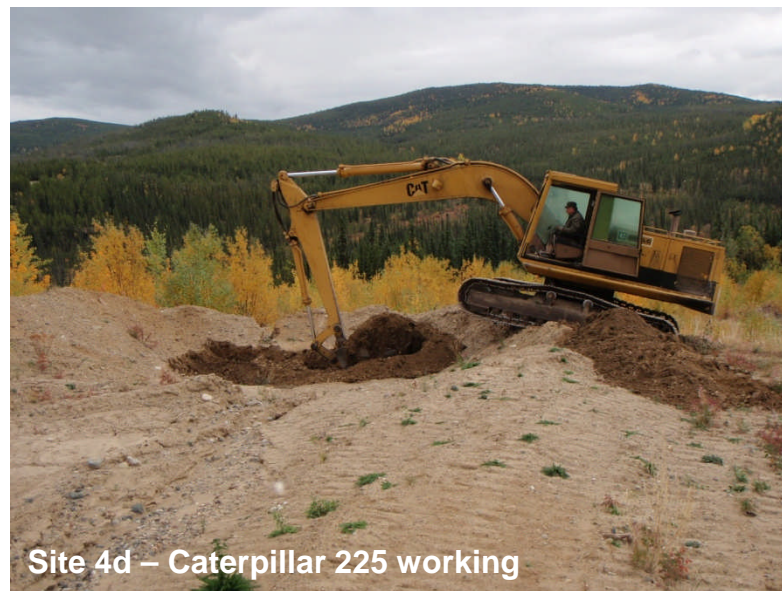
Site 4d – Caterpillar 225 working

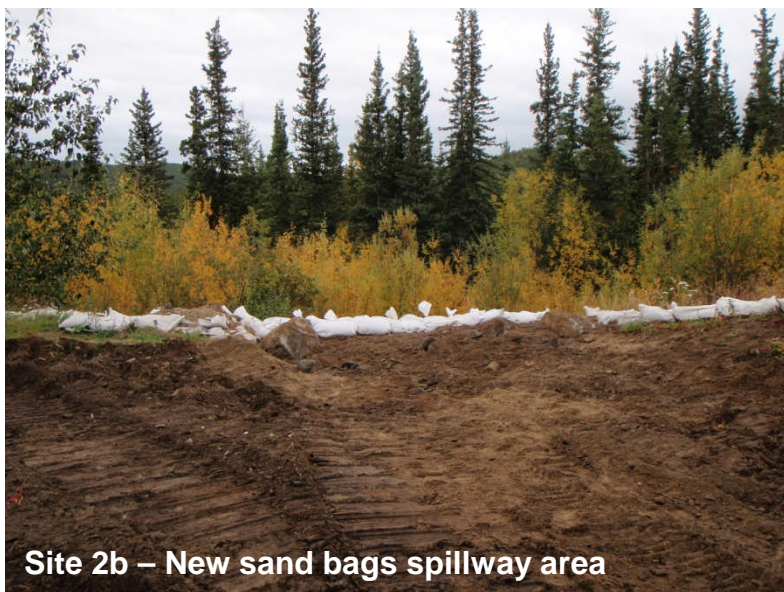
Site 2b – New sand bags spillway area

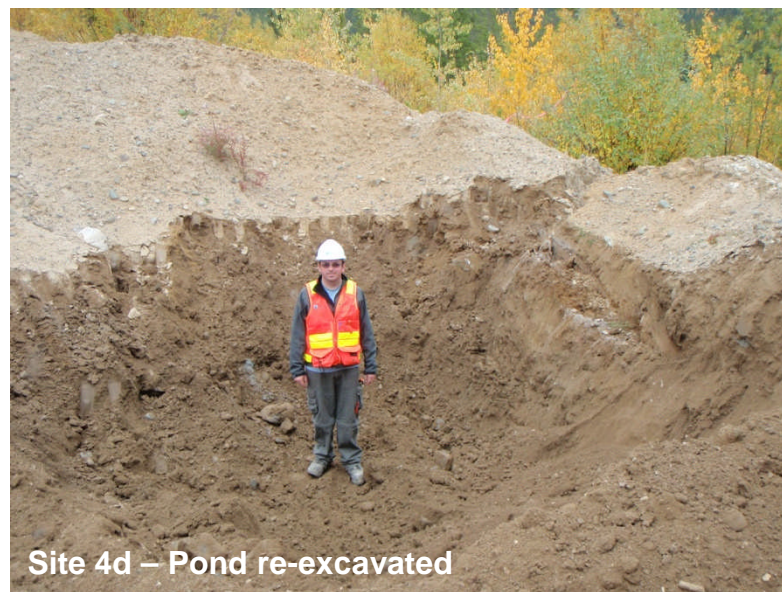
Site 4d – Pond re-excavated

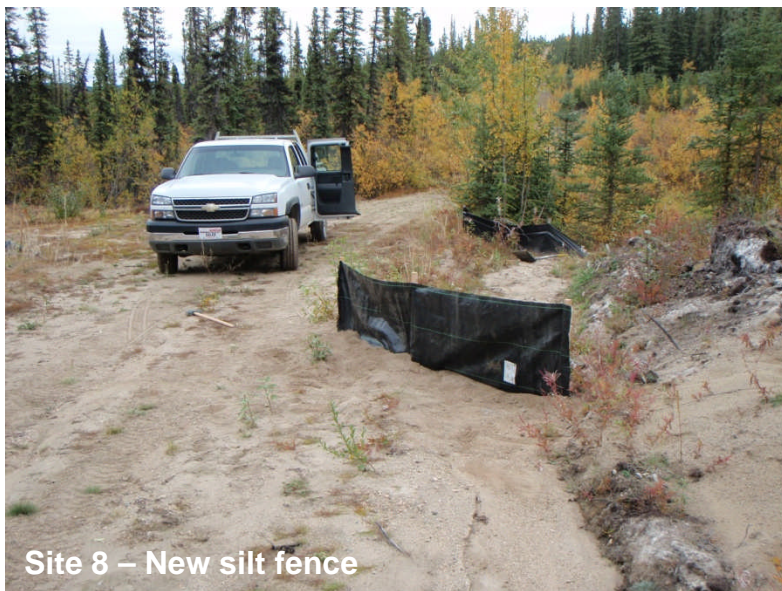
Figure 4 shows the silt fences that were replaced or repaired, particularly in Sites 2a, 2c and Site 8.

Site 8 – New silt fence

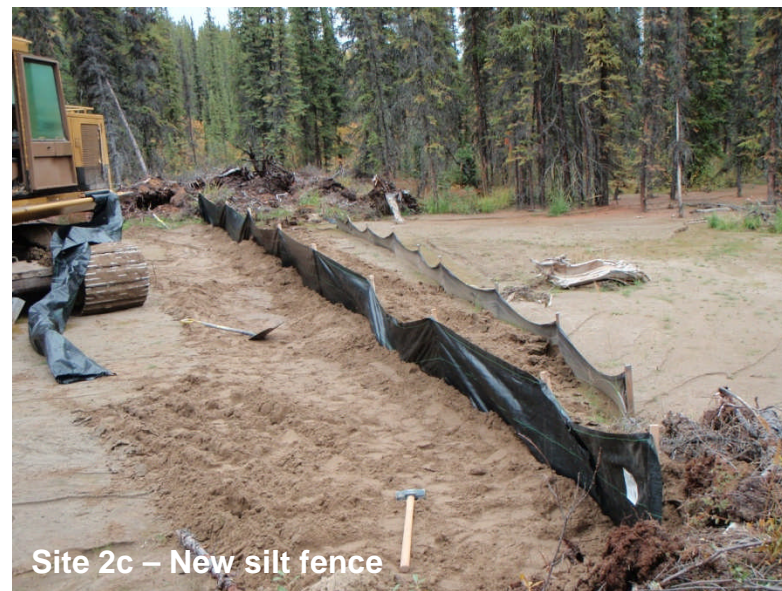
Site 2c – New silt fence

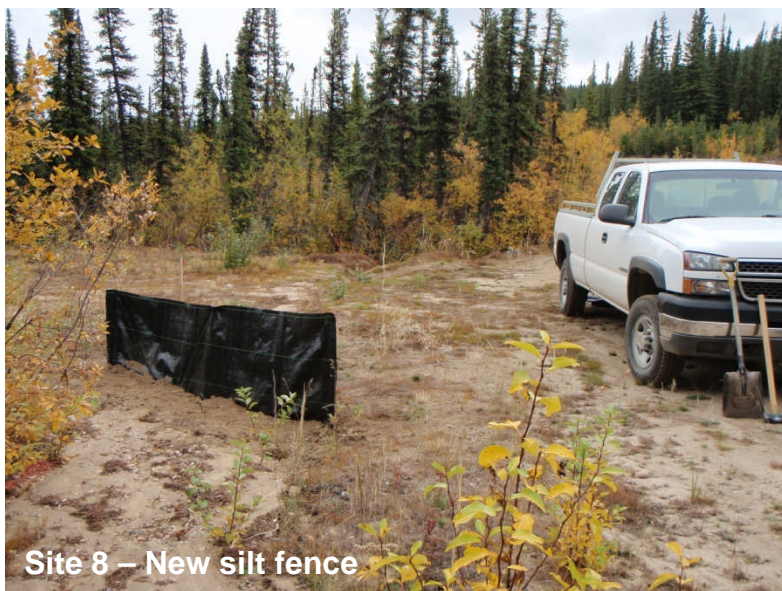
Site 8 – New silt fence

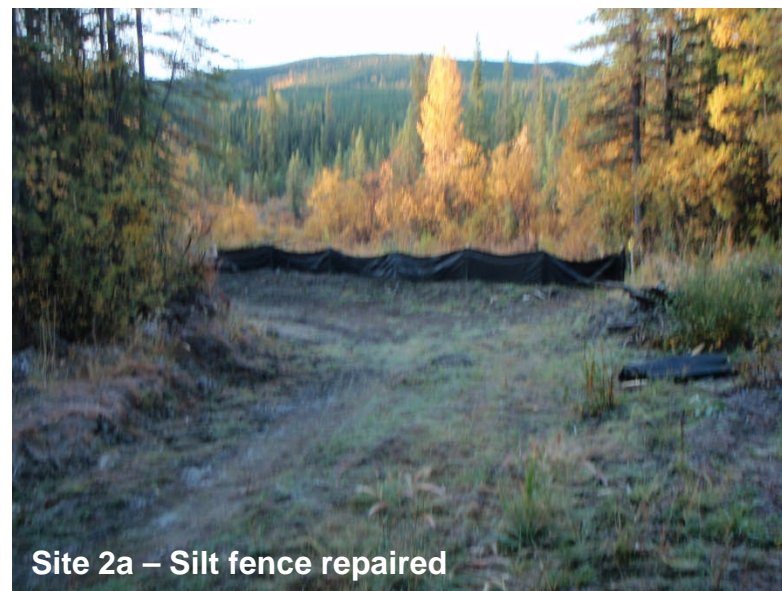
Site 2a – Silt fence repaired

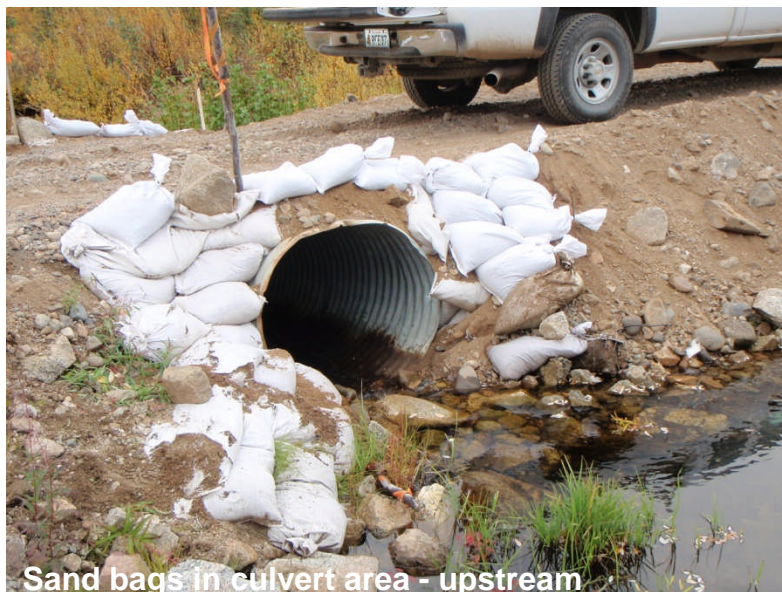
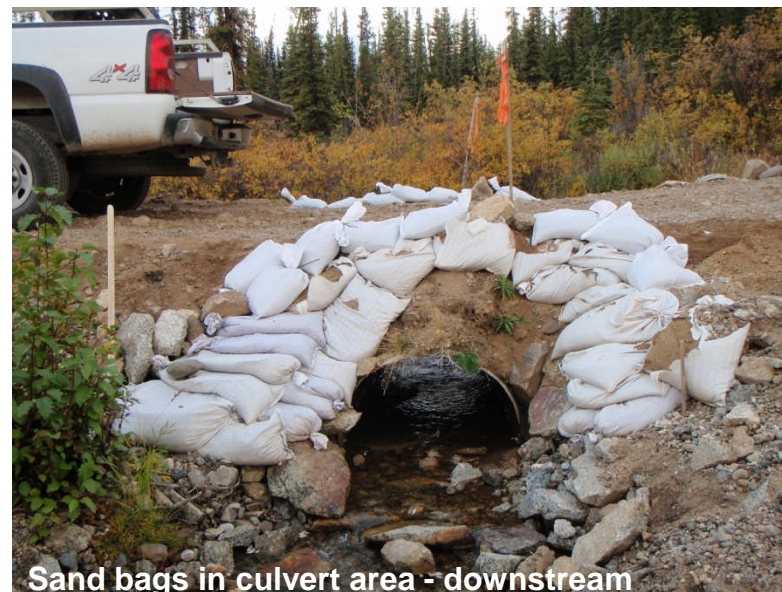
CARMACKS COPPER PROJECT	
		Sand Bags Culvert Area	
Drawn: JU	App'd:	Date: September 25, 2009	Figure: 5
Project No.: 000-0000		Revision No.:

Figure 5 presents the upstream and downstream ends of the culvert area in Road 1. Due to the limited supply of sand bags, the sand bags were installed only to replace the most damaged sand bags. It was also observed that sand bags are not performing effectively in the long term. Due to environmental exposure most of the sand bags were ripped and, in general, the sand bags were not providing the desired level of protection of the soils at the culvert. It is recommended that if the development of the operation is delayed, a more effective longer term solution, for example the installation of light rip-rap, should be considered to replace the sand bags and minimize the sediment load entering Williams Creek in this area.

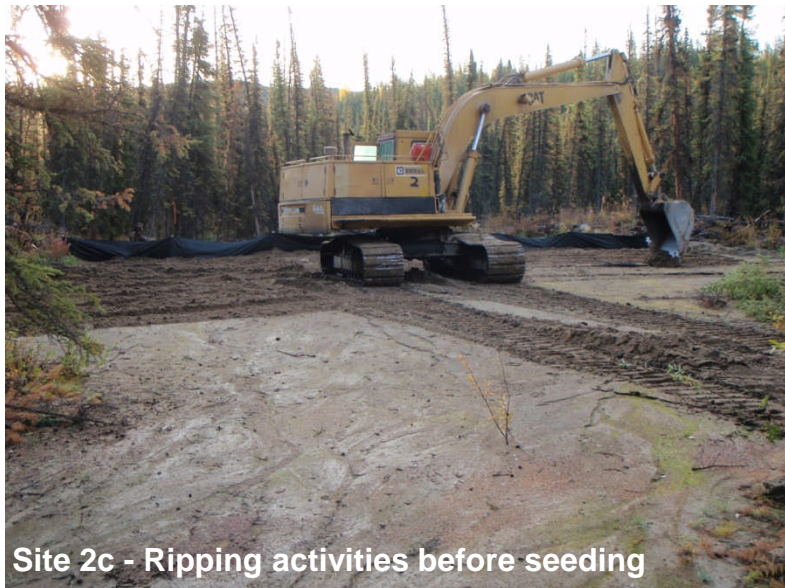
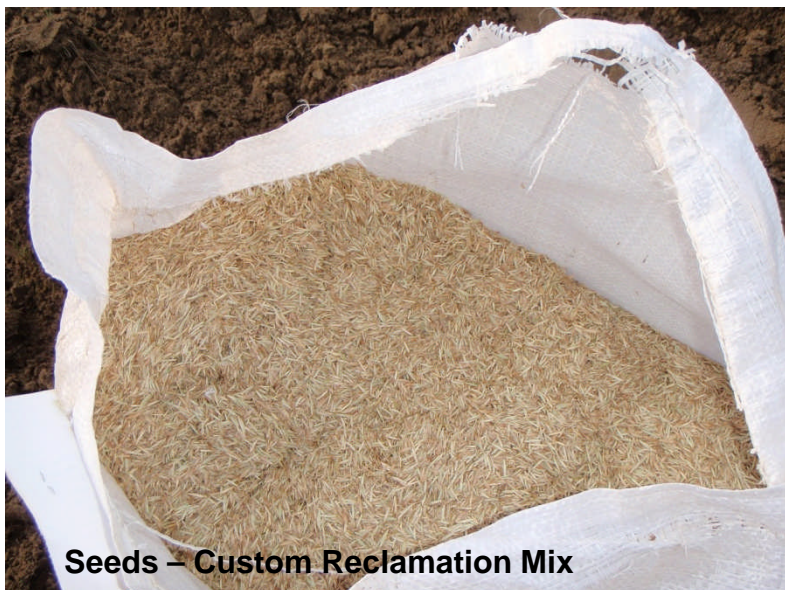
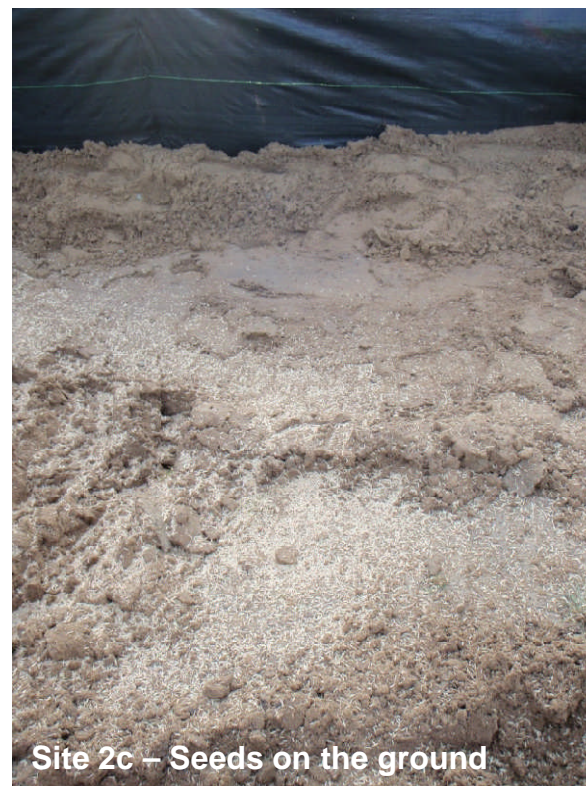
CARMACKS COPPER PROJECT Seeding	
Drawn: JU	App'd:	Date: September 25, 2009	Figure: 6

Figure 6 presents photographs of the seeding activities, including ripping the surface in Site 2c before sowing the seeds. Seeds were spread from about 3 m behind the silt fence shown in the photographs all the way to the road next to site 2f (Figure 1). It is anticipated that the vegetation will help to stabilize the sediments in this area. The same type of seed mixture was spread on Site 2b on the sediments excavated from the sediment basin and upstream the sediment basin (See Figure 2).

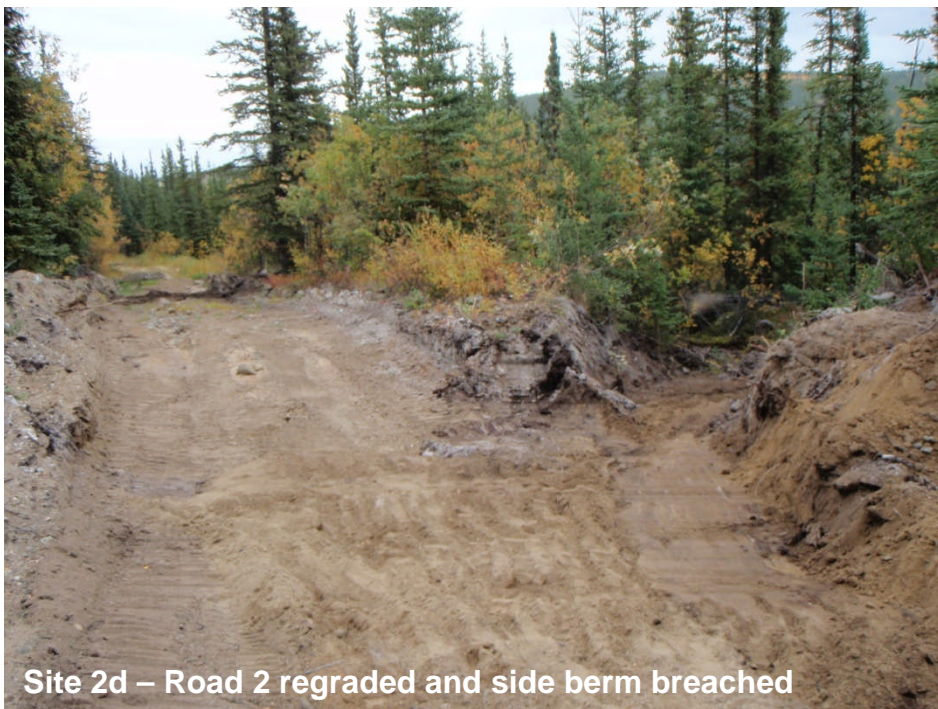
Sites 2d and 2e are also new features developed this year to minimize ongoing erosion. At the time of site visit the Road 2 was in good condition however, according to Al Serafinchon, (a personal communication), this road had significant erosion which he repaired during June, 2009. The source of this erosion was water over flowing from sediment basin 2b and reaching Road 2, then moving eastward and eventually reaching the Site 2c (Figure 1). Based on this information, Road 2 was regraded at two points as shown in Figure 7. This provides an exit point and diverts the water and sediments running through Road 2 to vegetated areas before reaching Site 2c.

Site 2d – Road 2 regraded and side berm breached

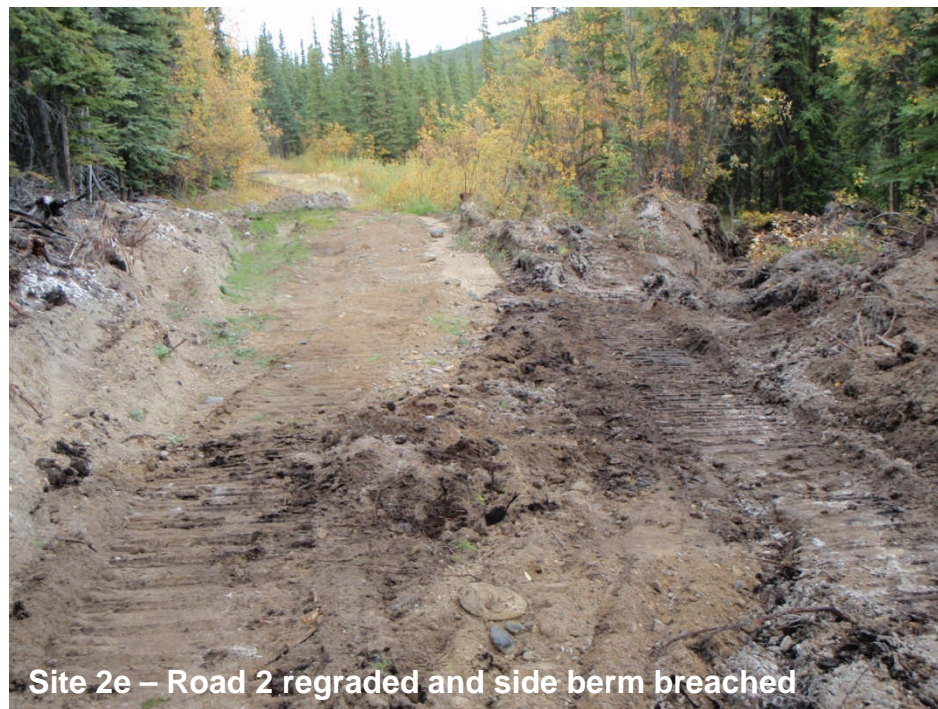
Site 2e – Road 2 regraded and side berm breached

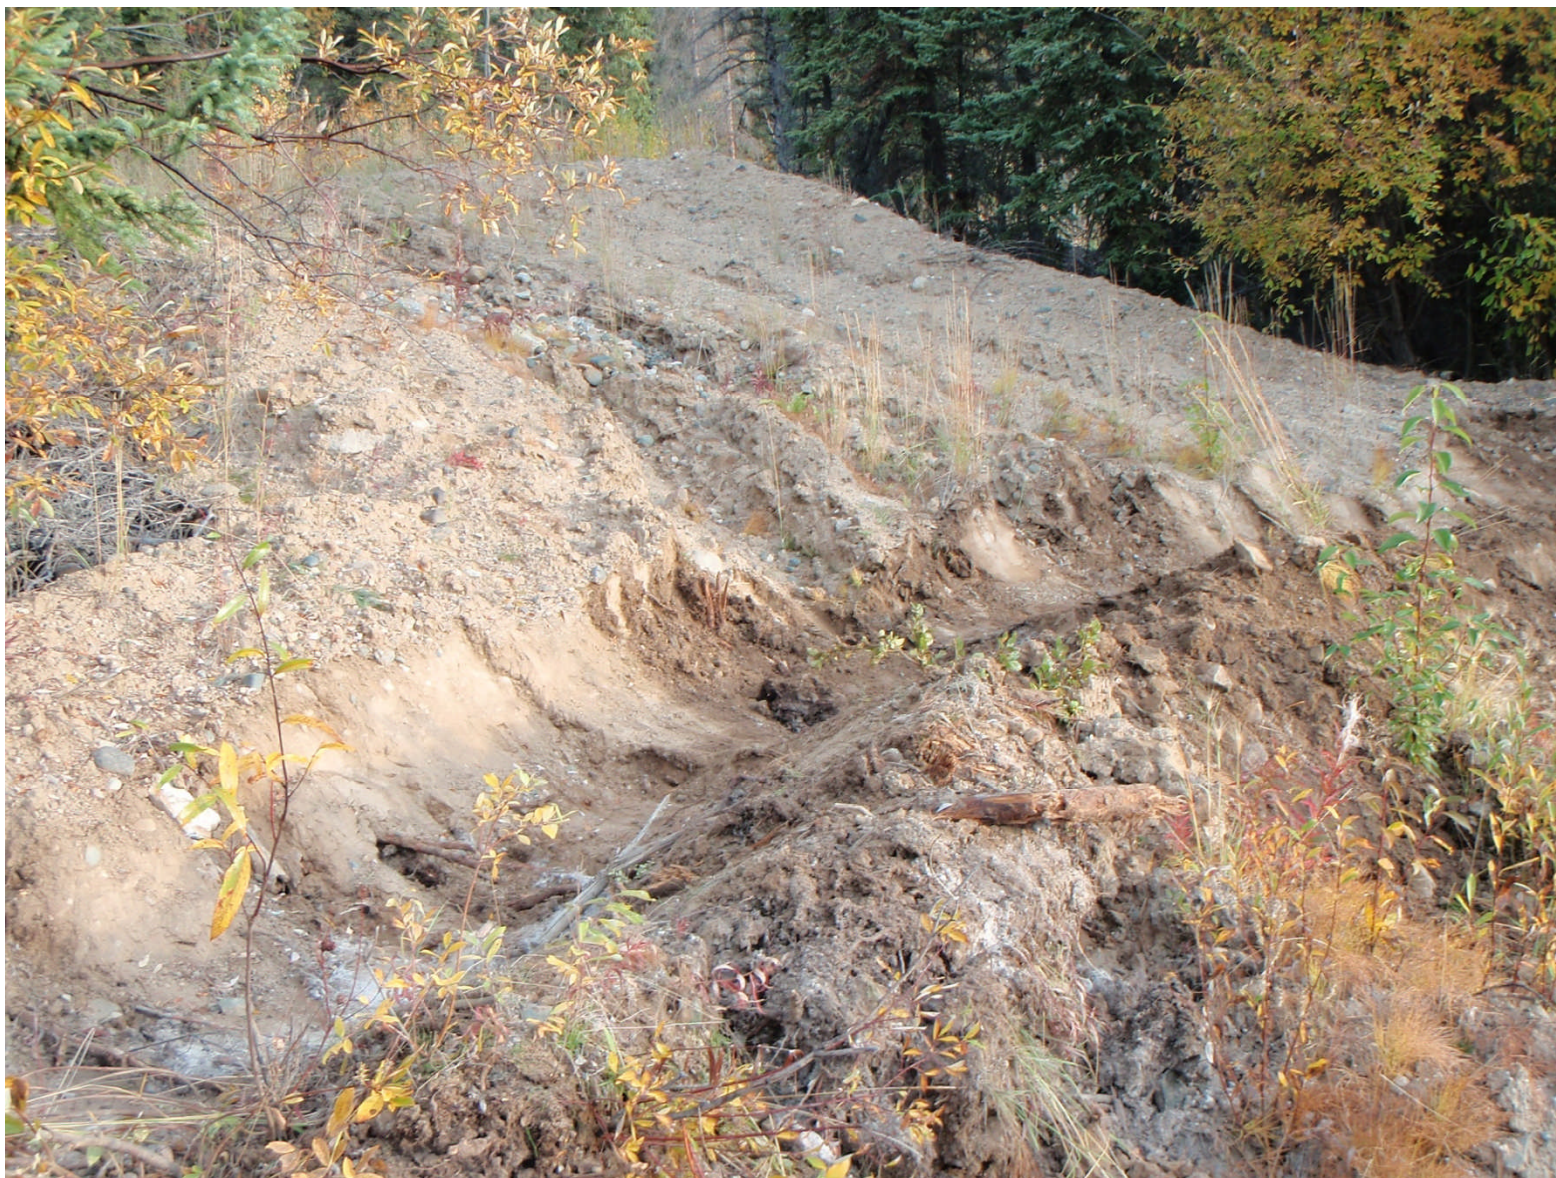
Site 2f – New Berm

The area of Site 2f is shown in Figure 8. It is a zone located just upstream of Site 2c with significant gradient and shows evidence of erosion. Even though the material on the slope appeared stable and no further sediment movement was expected, it could be a source of water reaching Site 2c that may cause erosion. For this reason a berm was built with the intention of reducing the energy of water crossing Road 2 and reaching Site 2c.
