August 23, 2011

Project No. 07-1413-0077  
Doc. No. 162 Rev. 0

**ANNUAL INSPECTION, JUNE 29, 2011  
CARMACKS COPPER PROJECT, CARMACKS, YUKON**

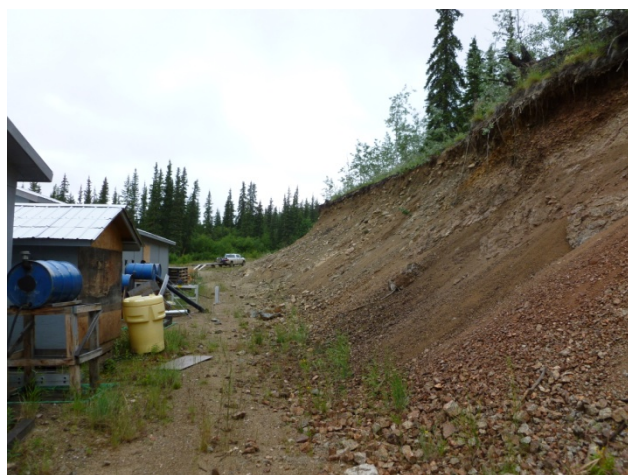
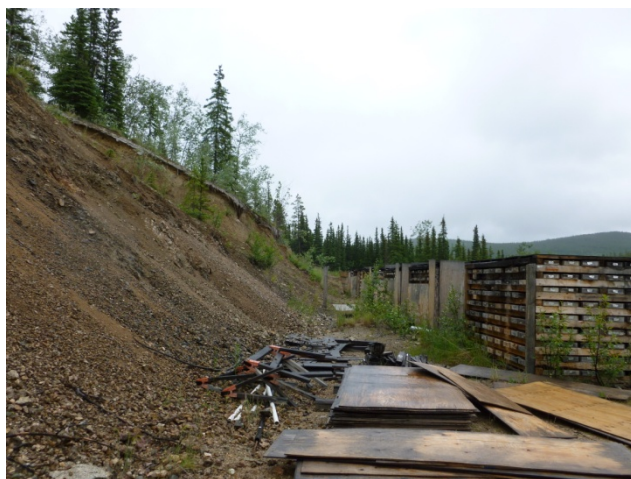
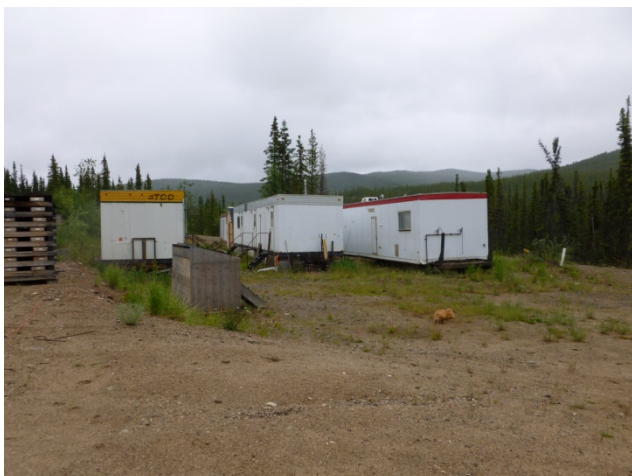
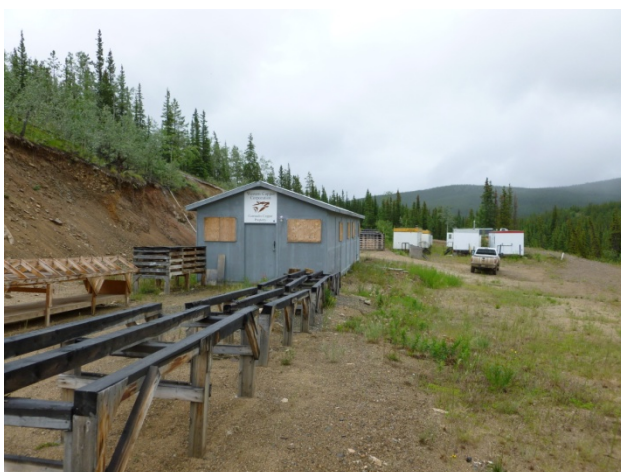
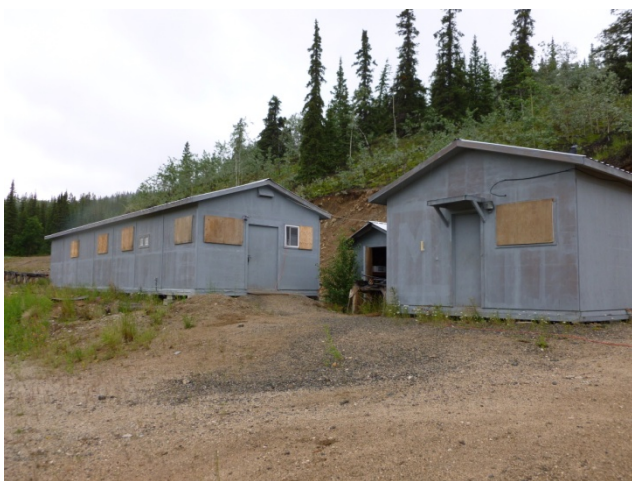
The inspection of the camp area indicated the camp is well maintained and there is no erosion of sediments from the pad area into the surrounding natural area. The slope behind or west of the camp is stable and is not impacting or causing any safety issues with the camp structures or operations. There is minor slumping of small

sections of the slope, but these are not impacting camp safety nor would they represent an issue to workers on the project.

*Photographs 1 - 5: Carmacks Exploration Camp Infrastructure, which includes an office, core shack, equipment shed, temporary trailers for accommodations and kitchen facilities, and drill core storage area.*

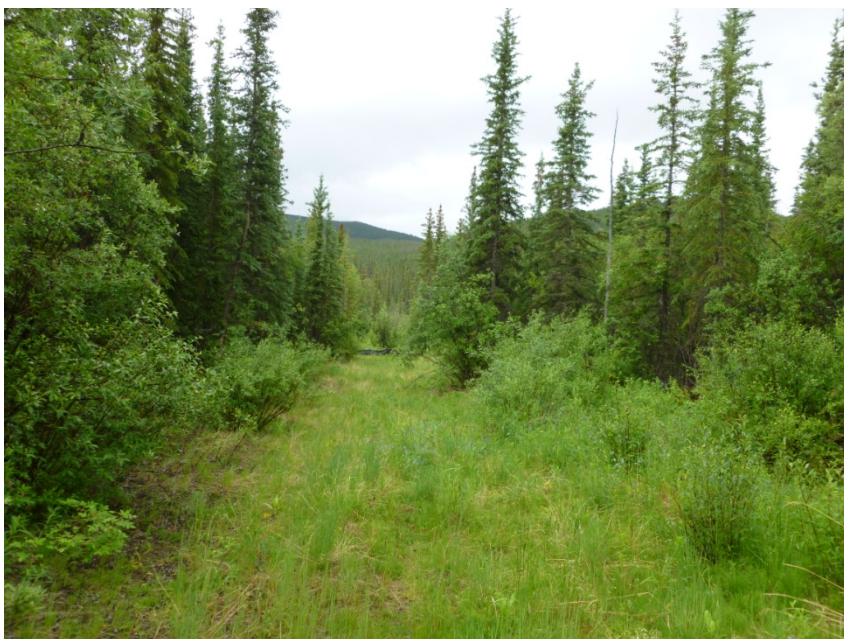
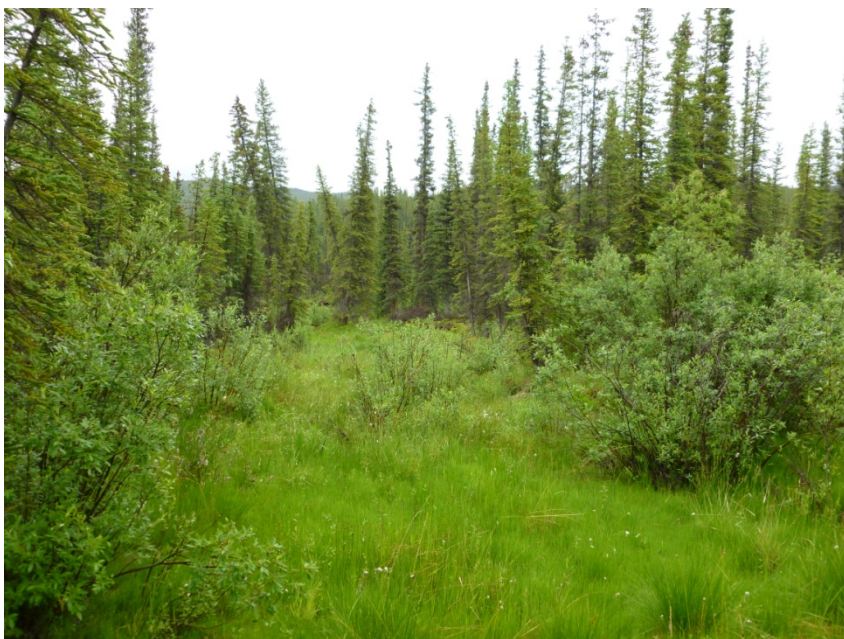
*Photographs 6 - 7: Drill pad access road located north of Williams Creek and downstream of the area of the proposed heap leach facility sediment pond. Photographs show vegetation re-growth which has occurred and is assisting in stabilizing previously transported sediments.*

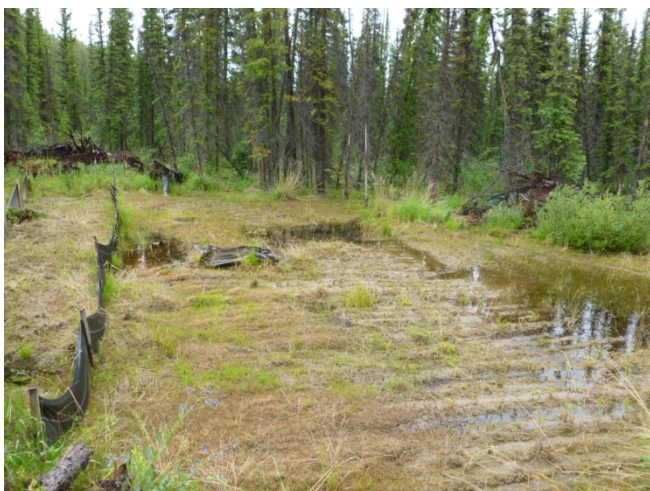
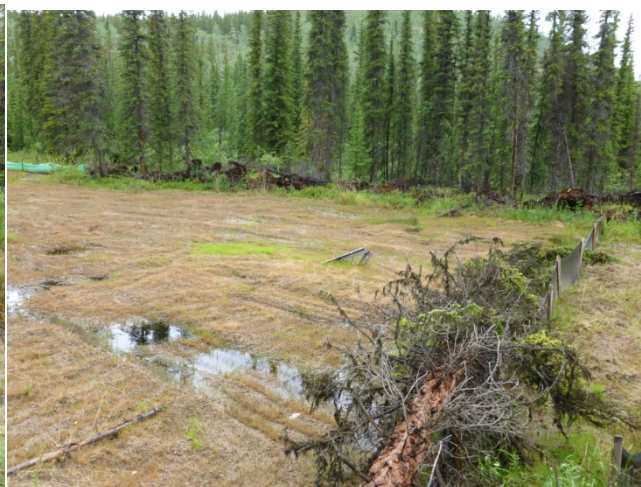
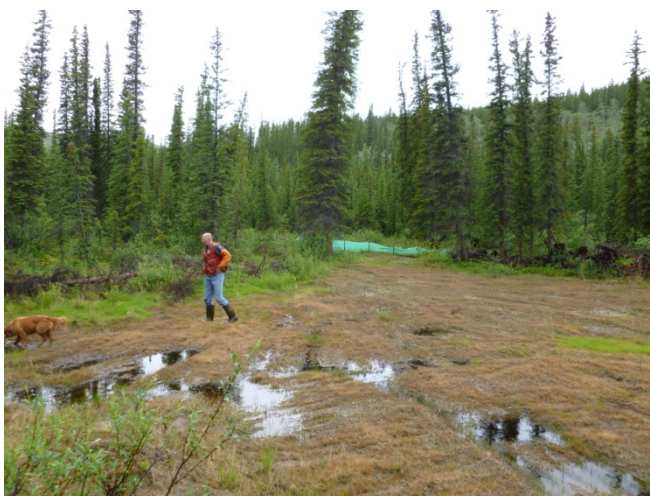
Further down slope of the proposed HLF sediment pond, and within the floodplain of Williams Creek, a series of silt fences have been installed and the area seeded, where sediment from previous site erosion has accumulated. At the time of the inspection, it was observed that the silt fencing surrounding these areas is working effectively and there is no evidence of recent sediment movement. Grass seed used in 2009 to promote the re-establishment of vegetation and further stabilize the sediment has generally been effective. However, re-growth in one particular area has not progressed well as it seems water is periodically pooling thereby impacting growth. It is recommended that either small ditches be made to promote drainage from the area into other vegetated areas, or alternatively, the area is re-vegetated with woody plants (e.g. willow cuttings) that are better able to tolerate saturated soil conditions. No movement of sediment beyond the existing silt fences was observed, nor does it appear that sediment has entered Williams Creek. These erosion control measures are of a temporary nature that should be inspected annually and ongoing minor maintenance activities should be anticipated.

*Photographs 8 - 10: Silt fences located between the area of the proposed heap leach facility sediment pond and Williams Creek and area re-vegetated area. Re-establishment of grass vegetation in this area appears to be hampered by the periodic pooling of water. Therefore planting of woody vegetation (e.g. willow cuttings) which are more tolerant to saturated soil conditions is recommended.*

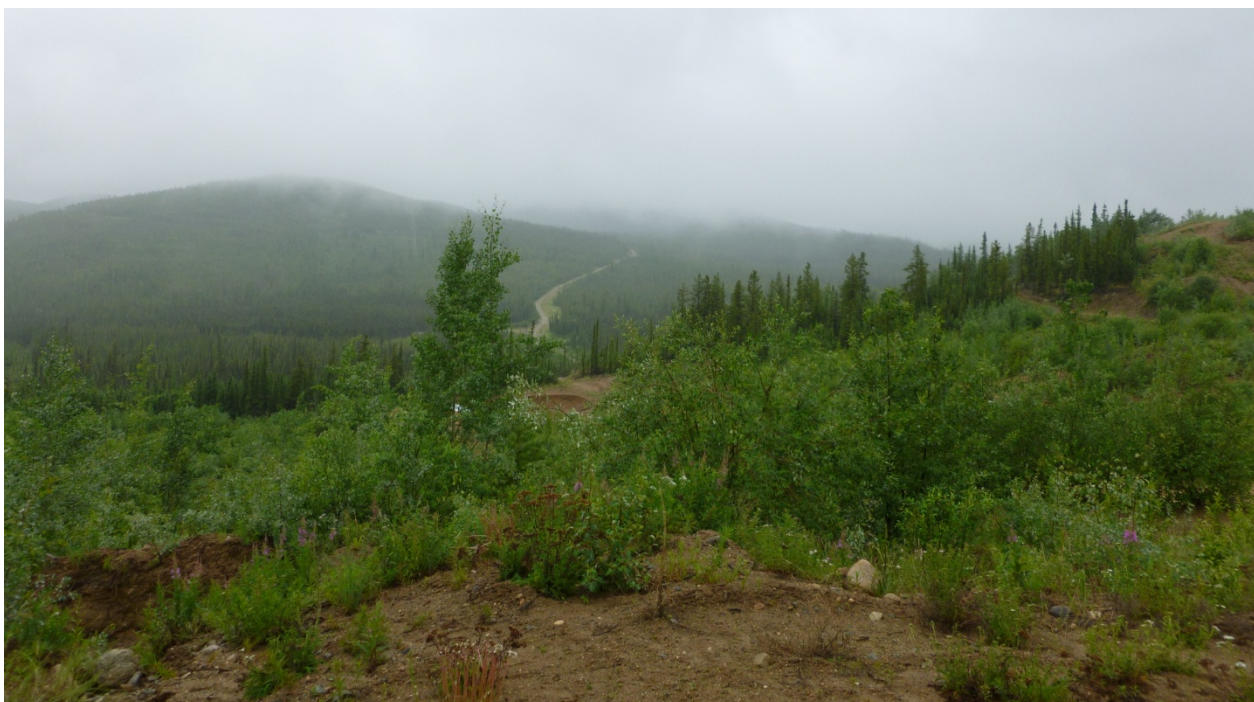
*Photograph 11: View of proposed heap leach facility and plant site area, taken from area of proposed open pit, looking southwest.*

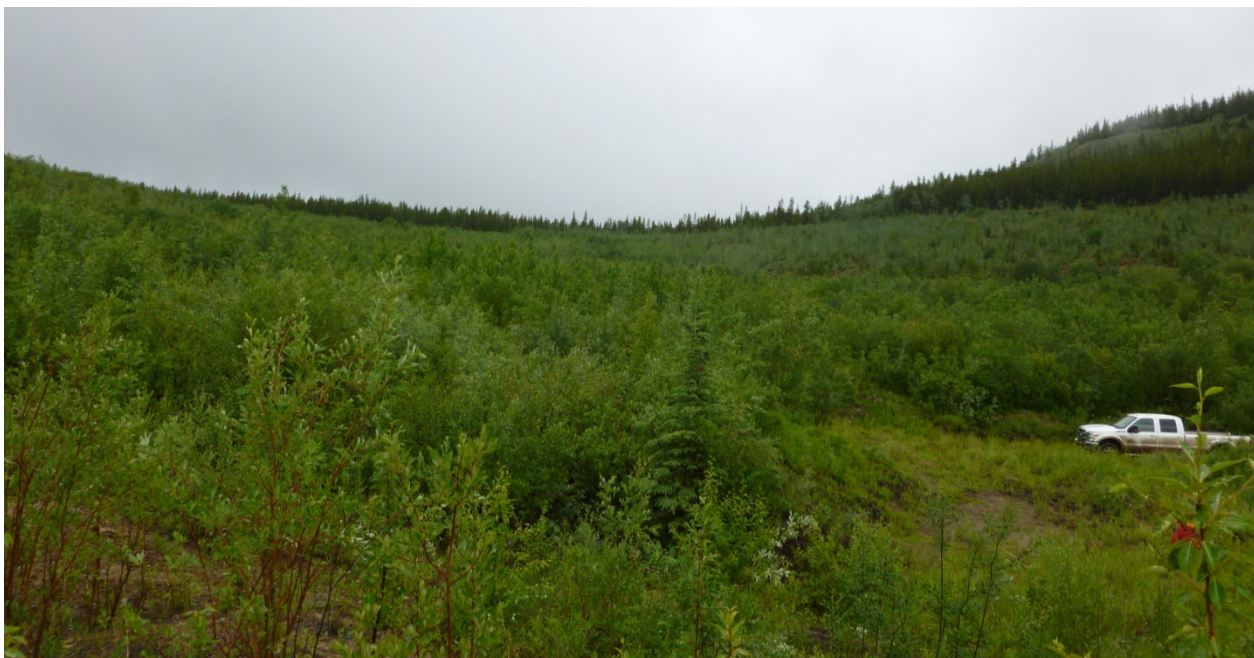
*Photograph 12: View of proposed heap leach facility area taken from near the proposed plant area.*

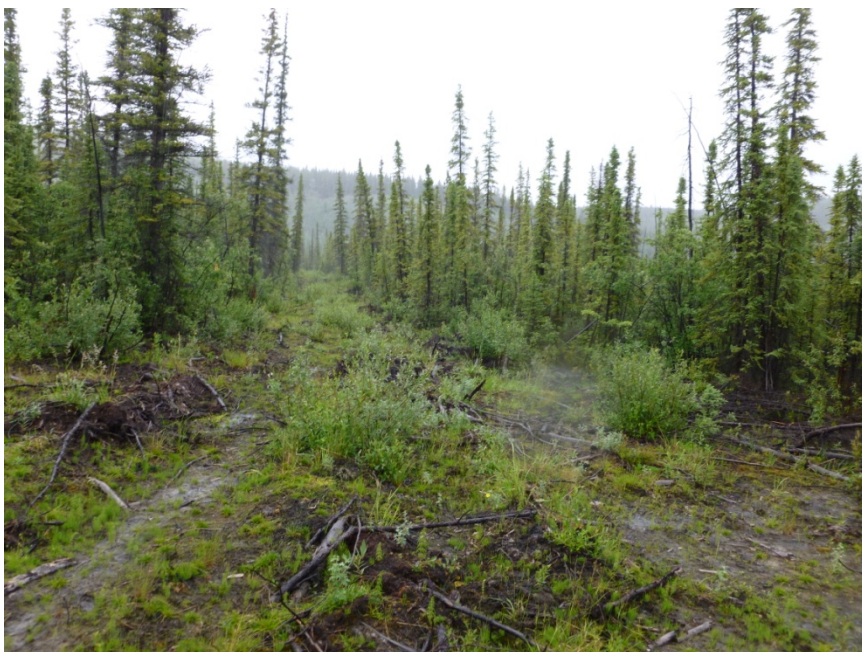
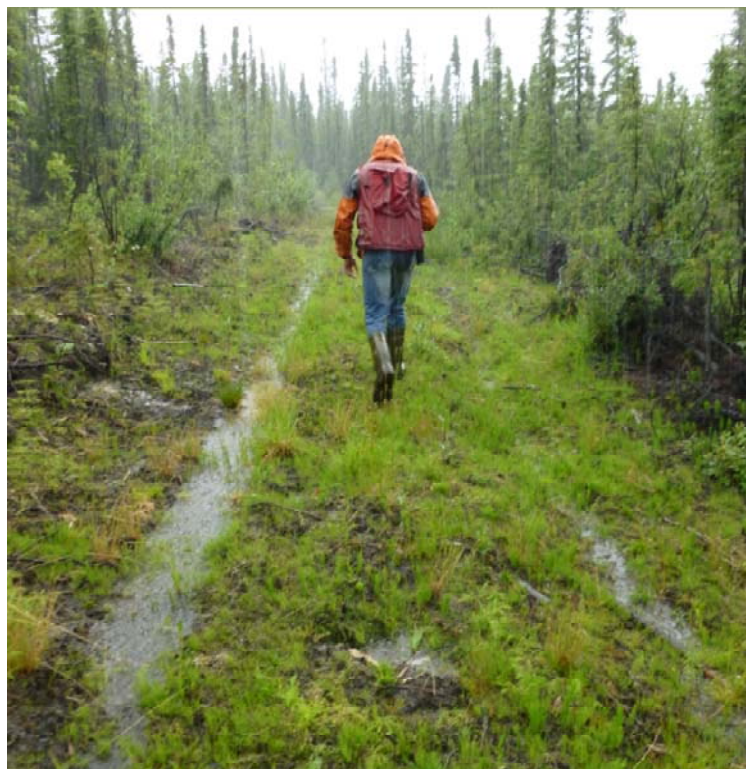
The area of the proposed waste rock storage area and the present access road crossing at North Williams Creek was inspected. The waste rock storage area is still tree covered and the drill pads in the area of the proposed waste rock storage area did not have any signs of sediment movement into the surrounding area. The small sediment catch basins at the drill pads still have capacity to manage more sediment, if required. Small erosion of the access road which crosses the waste rock storage area was observed. Sediment from the access road is being naturally diverted to adjacent vegetated areas as a result of road grades and was not observed to be entering any waterways.

*Photographs 13 - 14: Access roads within the proposed waste rock storage area.*

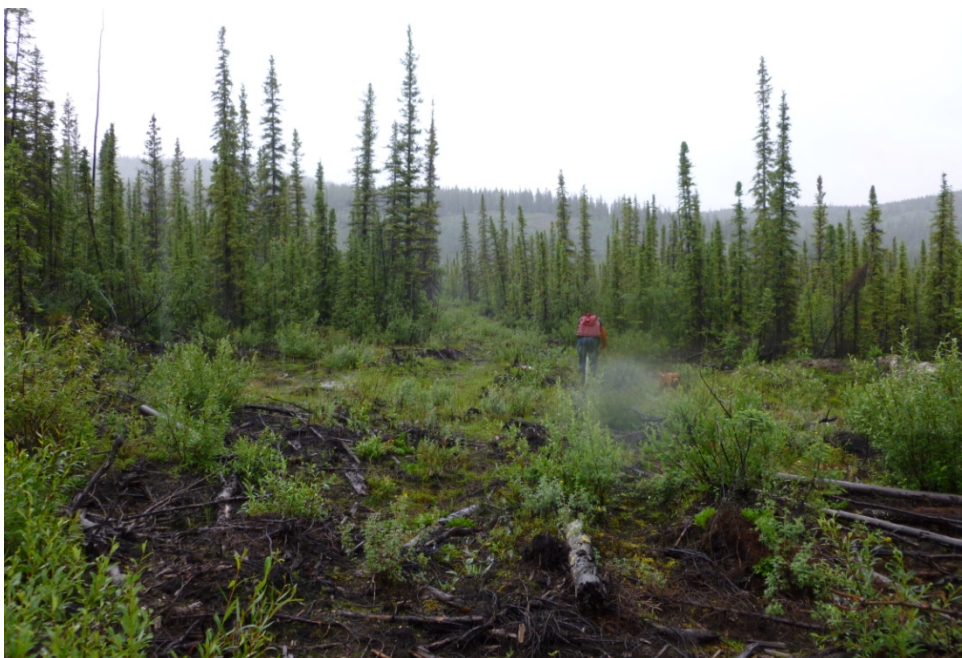
*Photograph 15 (top):* Access road within the proposed waste rock storage area.

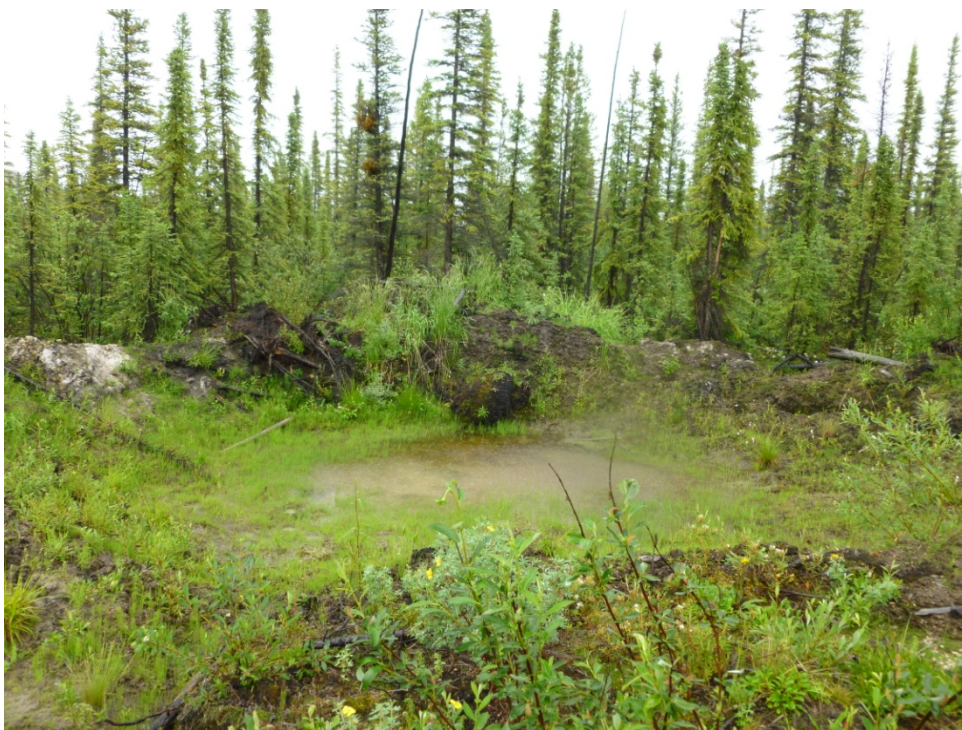
*Photograph 16 (bottom):* Sediment basin trap near drill pad in proposed waste rock storage area.

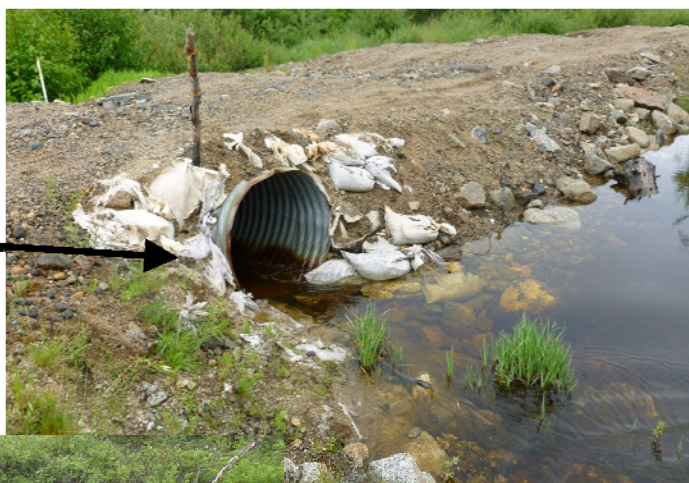
Upstream view of culvert

The site access road crossing of Williams Creek has a single culvert. The sand bags that were previously placed surrounding the culvert entrance and exit have now deteriorated. We would recommend re-establishing the support of the fill material adjacent to the culvert. In addition, it appears that flow has passed over two segments of the road near the crossing. It is anticipated that this was a temporary condition, which likely occurred at the beginning of the freshet, potentially when the culvert was still frozen/blocked by snow. Some erosion of the roadbed material has occurred. At some point in the future if additional activities are to occur at the site, then upgrading the crossing would be recommended. In the interim, given the lack of activity at the site, it is recommended to re-establish the bank protection on the upstream and downstream side of the culvert and extend the protection to the location where flow has occurred across the access road. Further, a coarse gravel material should be placed across the road at the low points (where erosion occurred) so that future flows across the road do not result in new erosion of the road embankment.

Photographs 17 - 19: View of culvert and access road crossing Williams Creek. Note sand bags used for embankment support on upstream and downstream side of the culvert which have deteriorated.

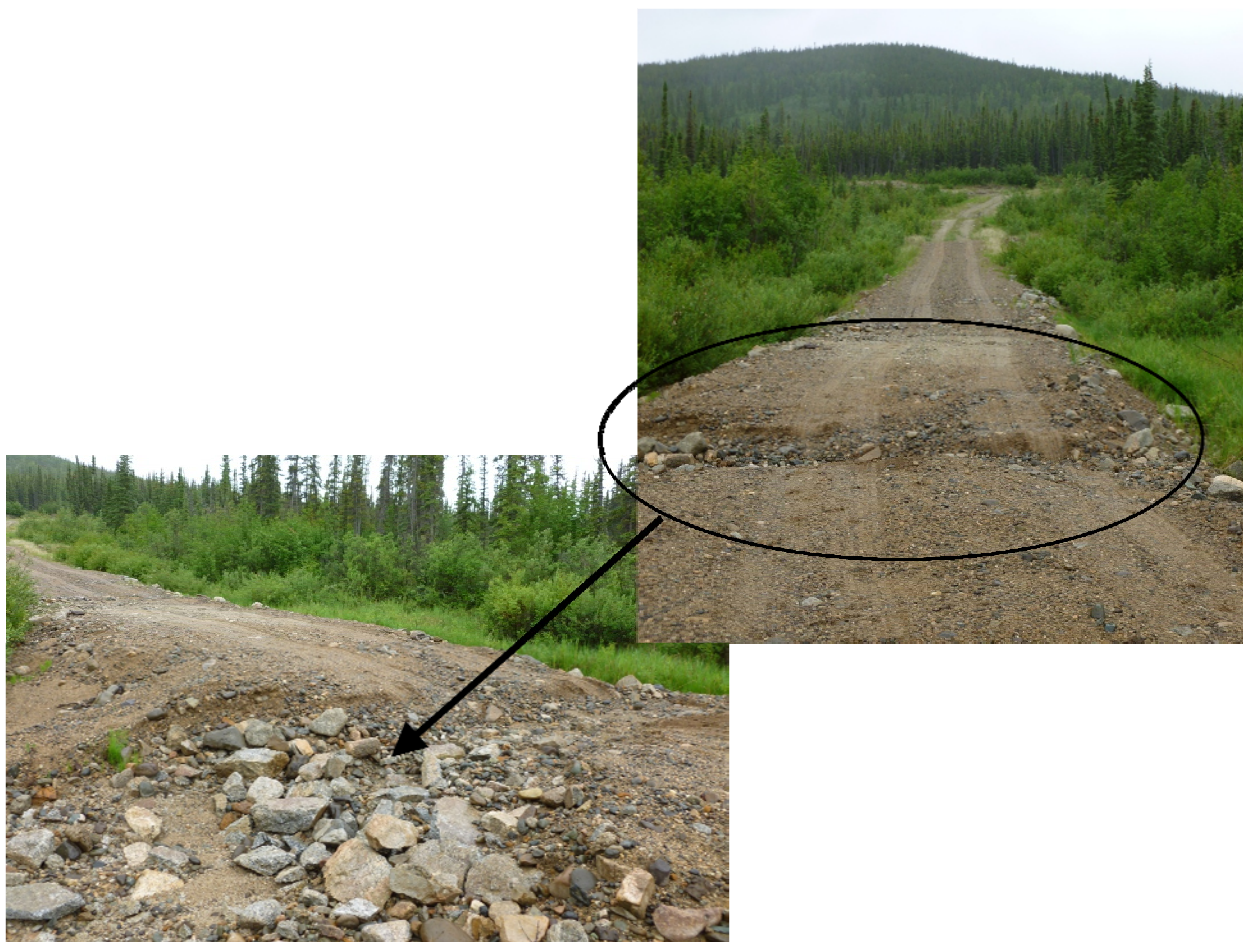
*Photographs 20 - 21: Access road near Williams Creek crossing where water appears to have flowed across and where some road bed material has eroded.*
