Project No. 07-1413-0077
Doc. No. 191 Rev. 0

**ANNUAL INSPECTION, JULY 10, 2012
CARMACKS COPPER PROJECT, CARMACKS, YUKON**

Carmacks Copper Project Annual Inspection

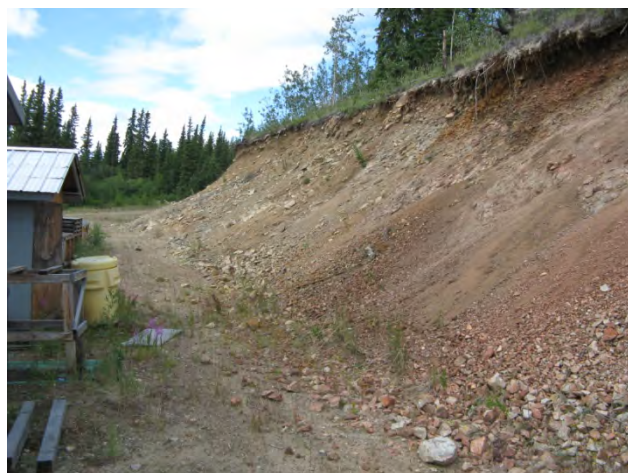
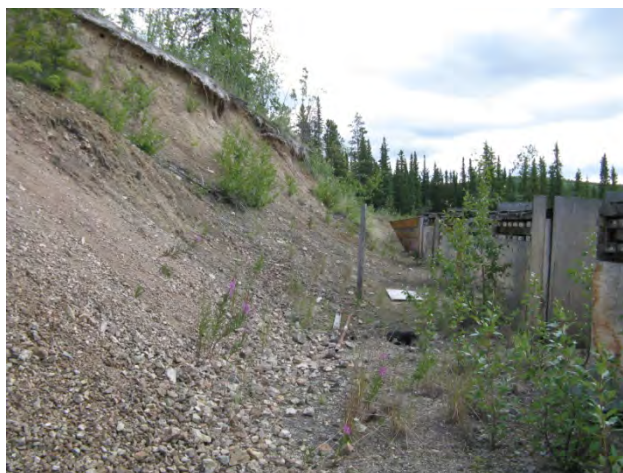
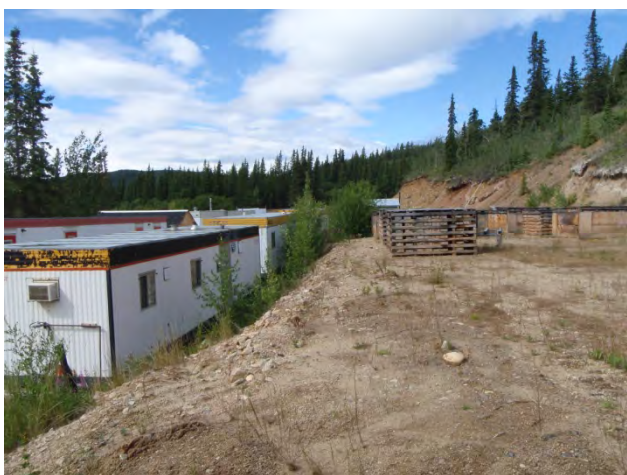
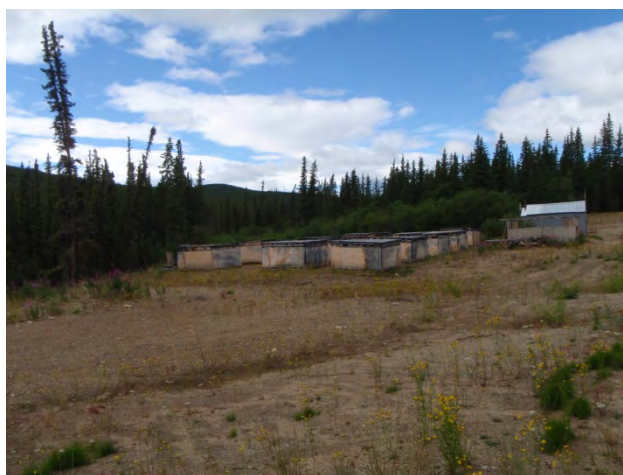
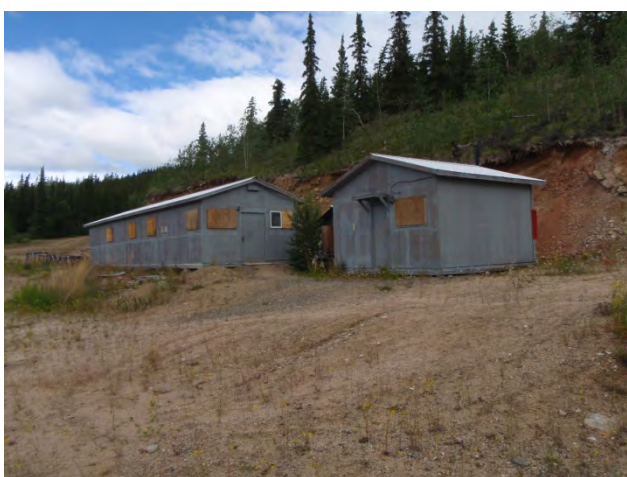
The inspection of the camp area indicated there is no erosion of sediments from the pad area into the surrounding natural area. The slope behind or west of the camp is stable and is not impacting or causing any

safety issues with the camp structures or operations. There is minor slumping and ravelling of small sections of the slope, but these are not impacting camp safety nor would they represent an issue to workers on the project. Some re-growth of vegetation was observed in the camp area.

Photographs 1 - 5: Carmacks Exploration Camp slope - north of camp, exploration camp trailers, core box storage and logging shacks.

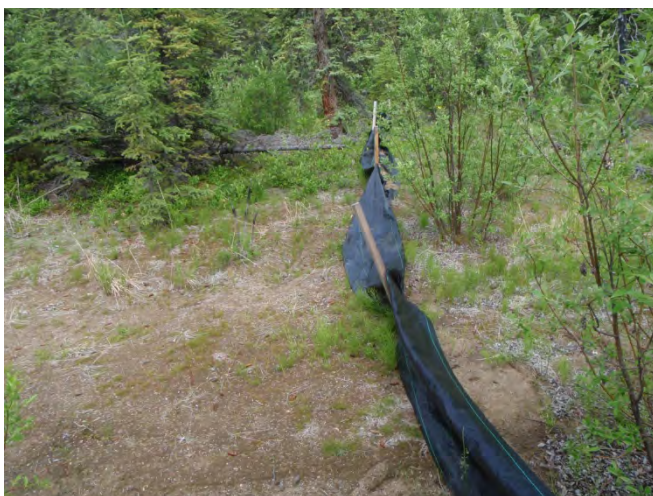
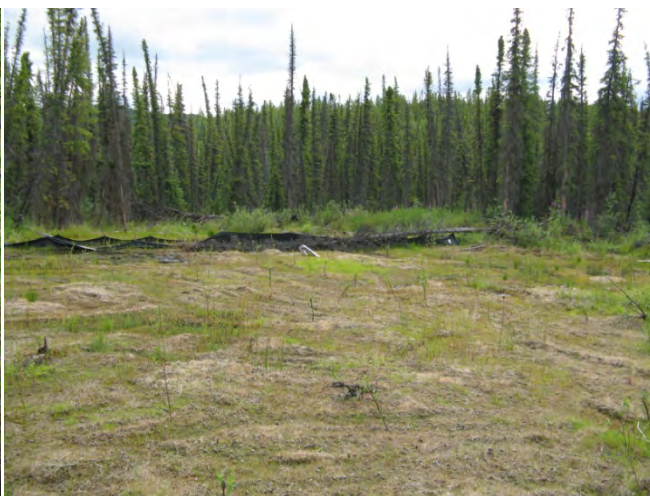
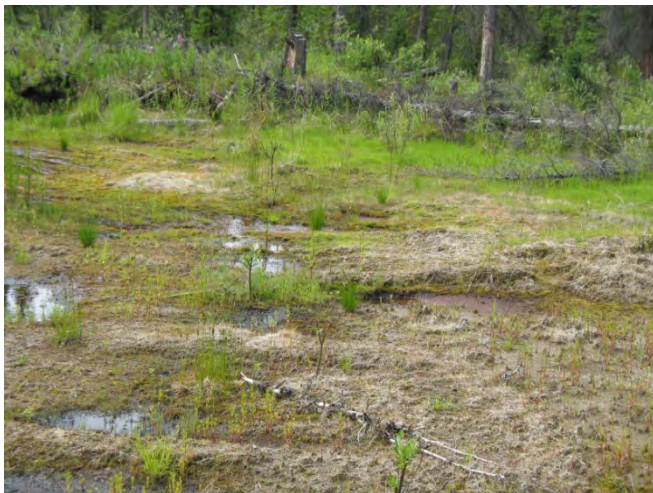
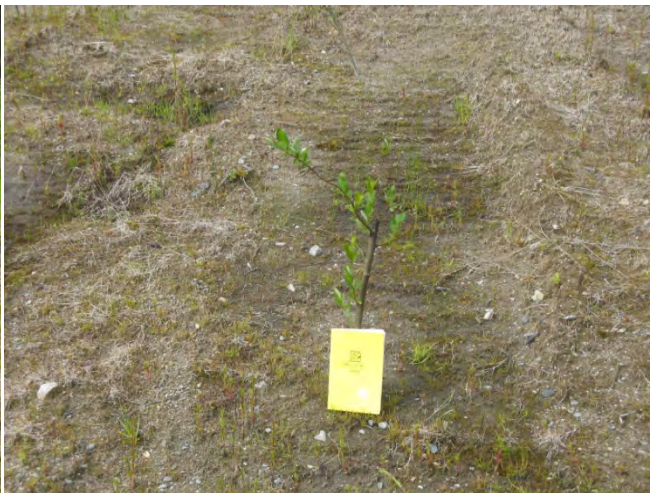
Further down slope of the proposed HLF sediment pond, and within the floodplain of Williams Creek, a series of silt fences have been installed and the area seeded, where sediment from previous site erosion has accumulated. At the time of the inspection, it was observed that the silt fencing surrounding these areas is working effectively and there is no evidence of recent sediment movement. Grass seed was used in 2009 to promote the re-establishment of vegetation and further stabilize the sediment. The approach was noted to be generally effective in 2011, but with limited re-growth in one particular area attributed to periodically pooling of water. The area was re-vegetated with woody plants (willow cuttings), and volunteer species appear to be tolerating saturated soil conditions. No movement of sediment beyond the existing silt fences was observed, nor does it appear that sediment has entered Williams Creek. These erosion control measures are of a temporary nature that should be inspected annually and ongoing minor maintenance activities should be anticipated.

Photographs 6 - 9: Silt fences located between the area of the proposed heap leach facility sediment pond and Williams Creek and re-vegetated area. Re-establishment of grass vegetation in this area appears to be hampered by the periodic pooling of water. Willow cuttings planted in 2011 appear to be taking hold.

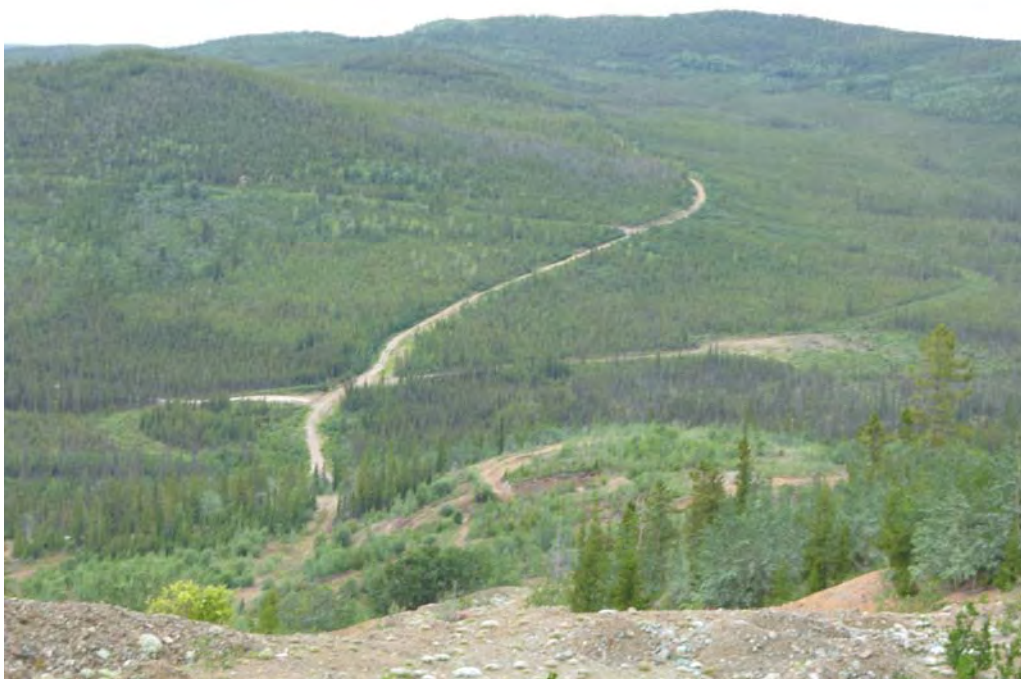
Photograph 10: View of proposed heap leach facility taken from proposed pit area, looking south west.

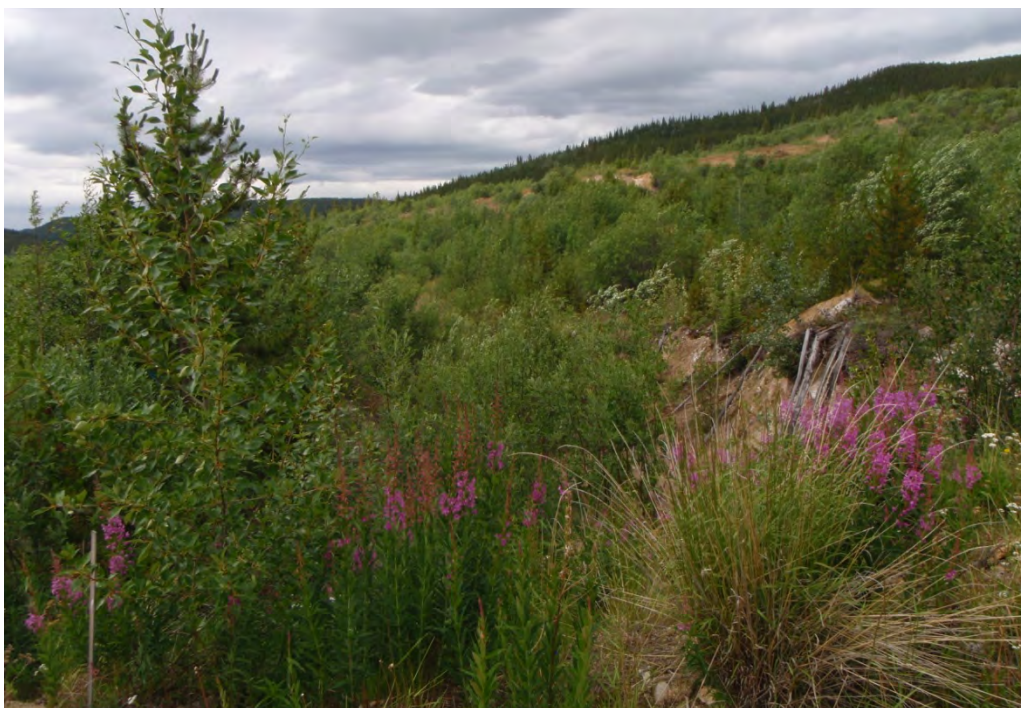
Photograph 11: View of proposed heap leach facility area from near the proposed events pond, looking north west.

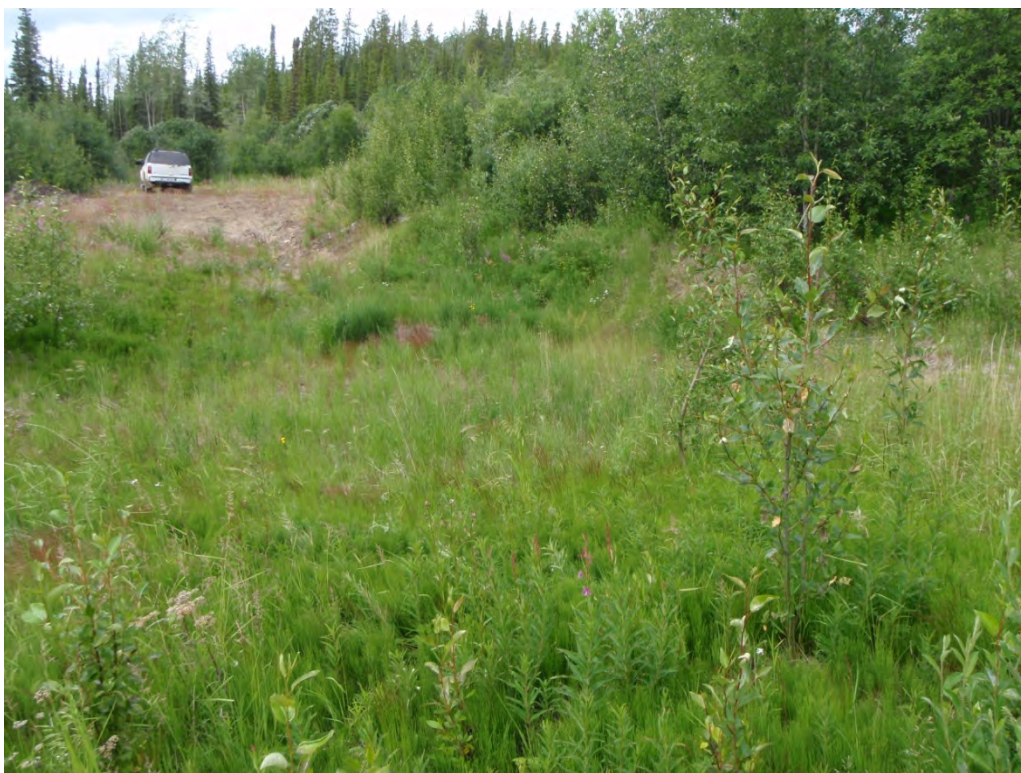
Photograph 13: Re-vegetation on drill access road in the events pond area.

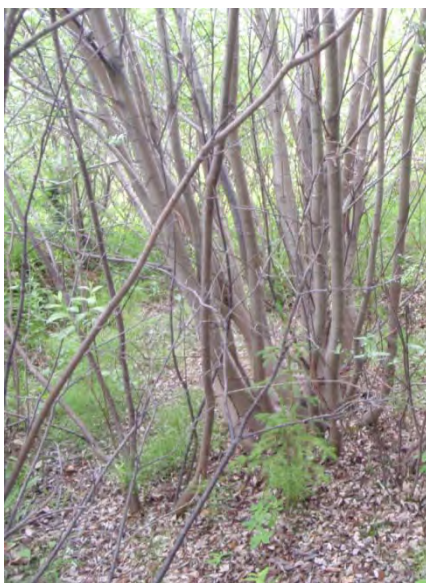
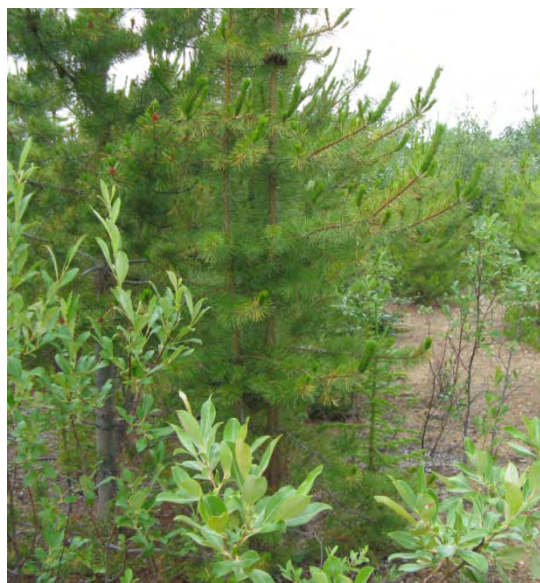
Photographs 14 - 15: Re-vegetation in the heap leach facility area.

It is recommended that vegetation in the lower footprint area of the HLF and confining embankment be re-cleared of vegetation in 2012 or 2013 to promote thaw of permafrost ground prior to development of the area. Vegetation may promote re-establishment of permafrost and ground ice and should therefore be cleared to allow thaw over the warmer months.

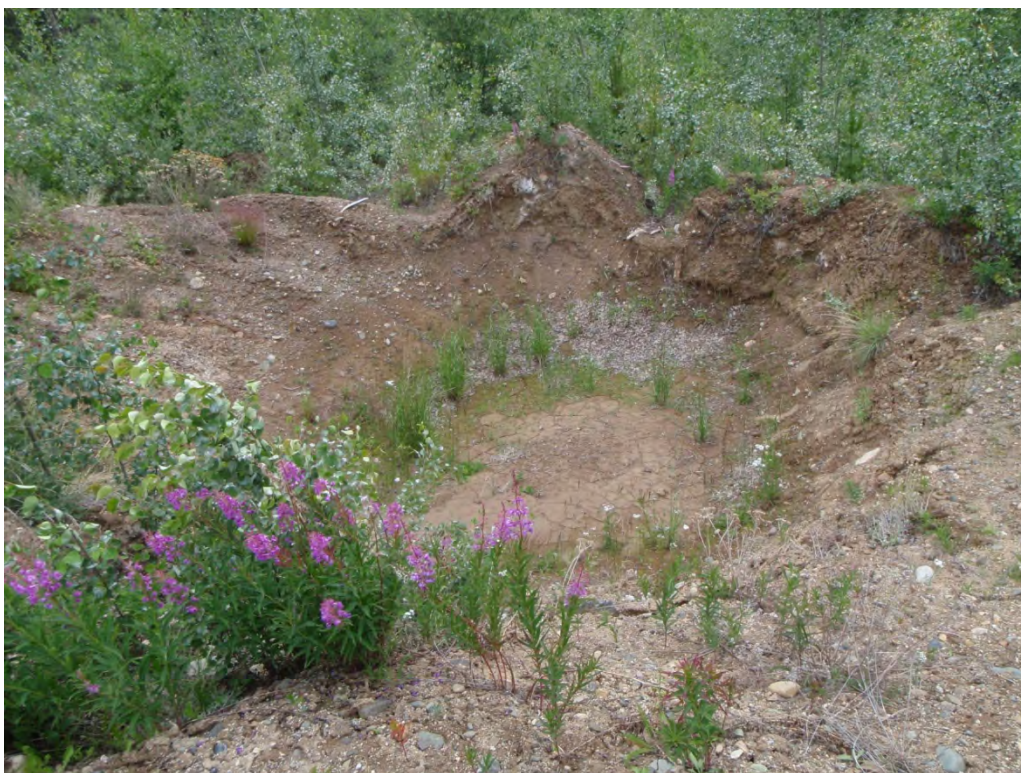
Photograph 16: Drill pad sediment basin trap near the proposed events pond.

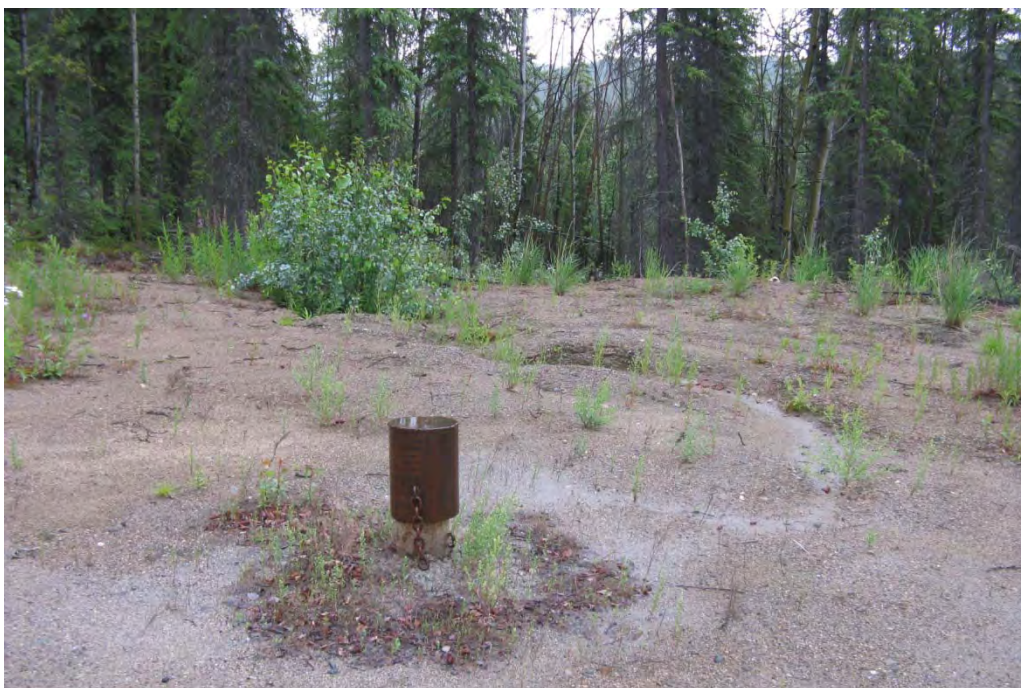
The new camp site was inspected and it is still tree covered. The site adjacent to the camp where the new water wells were installed was also inspected and there is no apparent movement of sediment beyond the work pads around the wells.

Photograph 17: Water supply well and pad near proposed camp site.

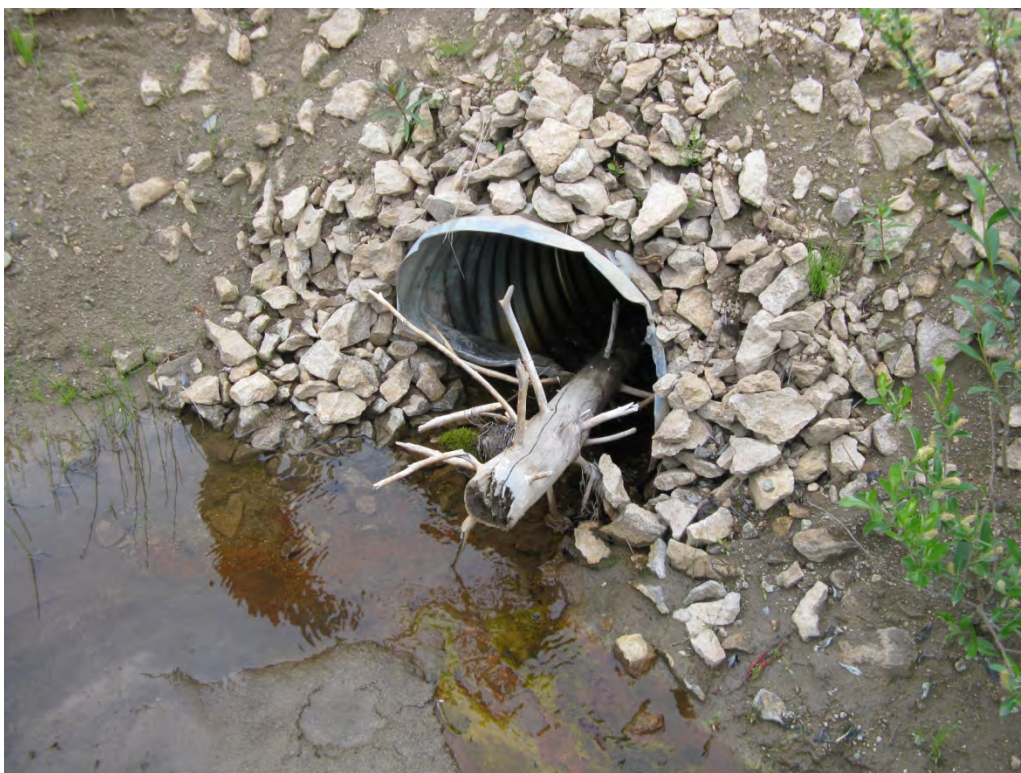
Local erosion was observed on the main access road to the north of the WRSF, in the area of the North Williams creek crossing. The local erosion is attributed to reduced flow in the culvert leading to temporary overtopping of the road from the ponded area adjacent the road. The invert of the culvert inlet was observed to be bent upward and was partly blocked by woody debris. The woody debris was removed. It is recommended that the culvert mouth be restored to allow full flow. It is recommended that the area of local erosion on the road be filled with coarse gravel to level the grade.

Photograph 18: Inlet of culvert on crossing of North Williams Creek.

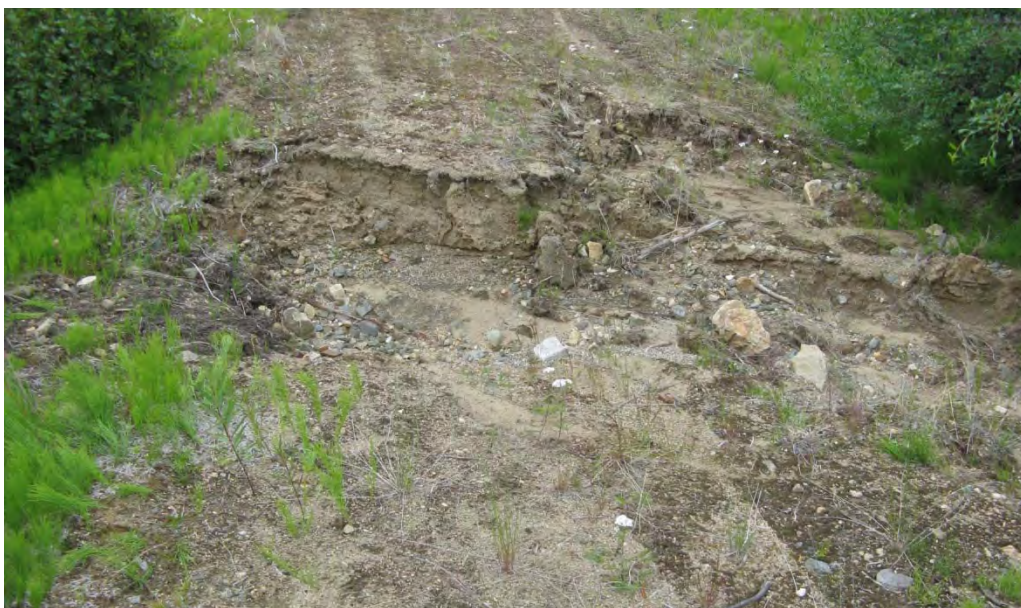
Photograph 19: Erosion on road immediately north of North Williams Creek crossing.

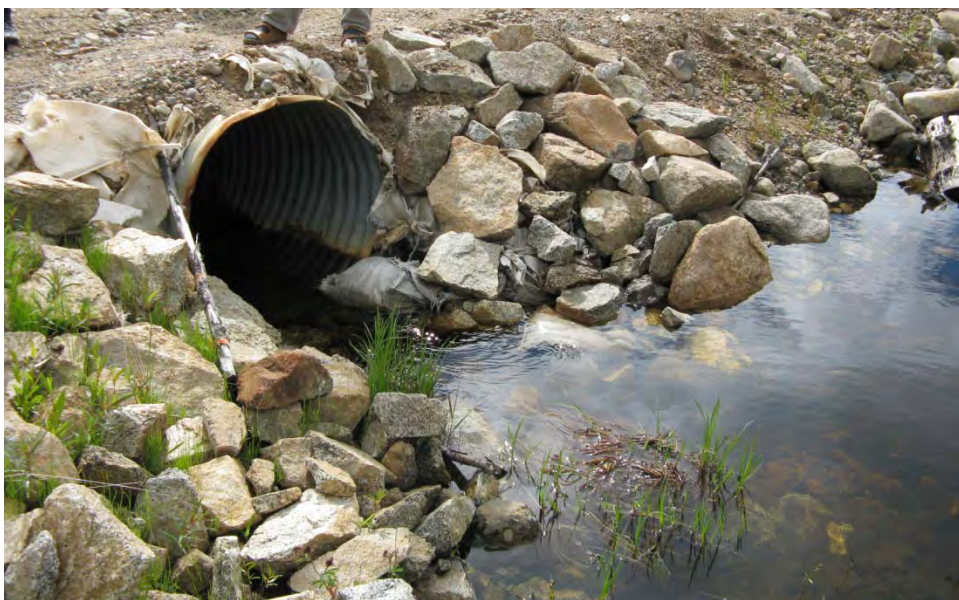
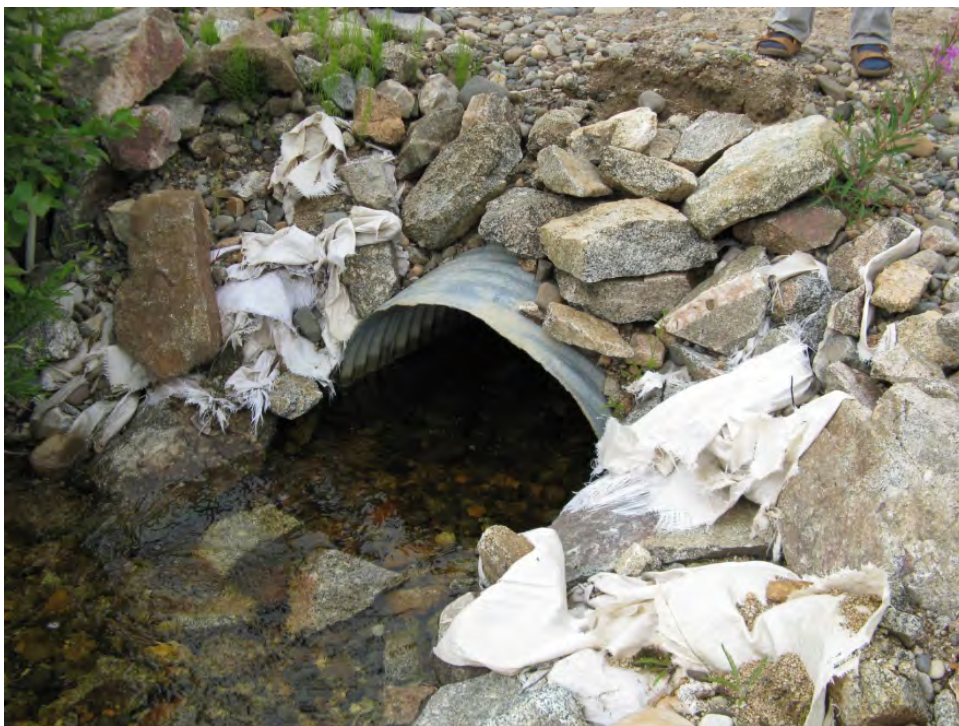
The site access road crossing of Williams Creek has a single culvert. As noted in 2011, the sand bags that were previously placed surrounding the culvert entrance and exit are deteriorated. In 2012, the exit of the culvert was observed to be partly in filled by granular material. In addition, it appears that further flow has passed over two segments of the road near the crossing. It is anticipated that this was again a temporary condition, which likely occurred at the beginning of the freshet, potentially when the culvert was still frozen/blocked by snow. Some erosion of the roadbed material has occurred. It is recommended to excavate the material out of the exit of the culvert, re-establishing the support of the fill materials adjacent to the culvert inlet and outlet, re-establish the bank protection on the upstream and downstream side of the culvert and extend the protection to the location where flow has occurred across the access road. Further, a coarse gravel material should be placed across the road at the low points (where erosion occurred) so that future flows across the road do not result in new erosion of the road embankment.

Photographs 20 - 21: View of culvert inlet (top) and outlet (bottom) at access road crossing of Williams Creek. Note sand bags used for embankment support on upstream and downstream side of the culvert which have deteriorated.

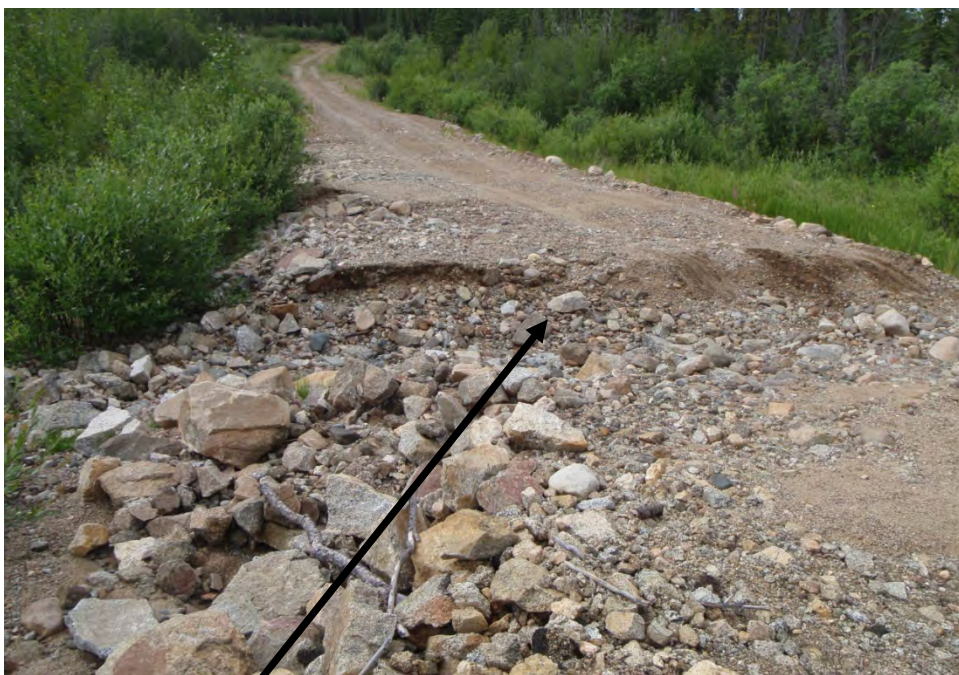
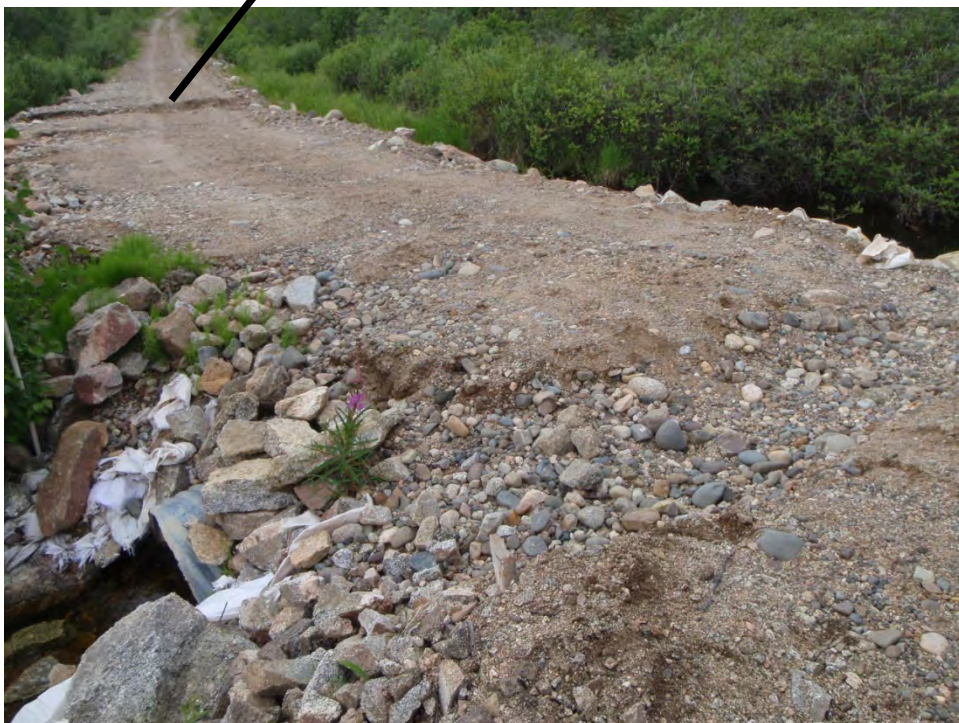
Photographs 22 - 23: Erosion on access road near Williams Creek crossing where water appears to have flowed across and where some road bed material has eroded.

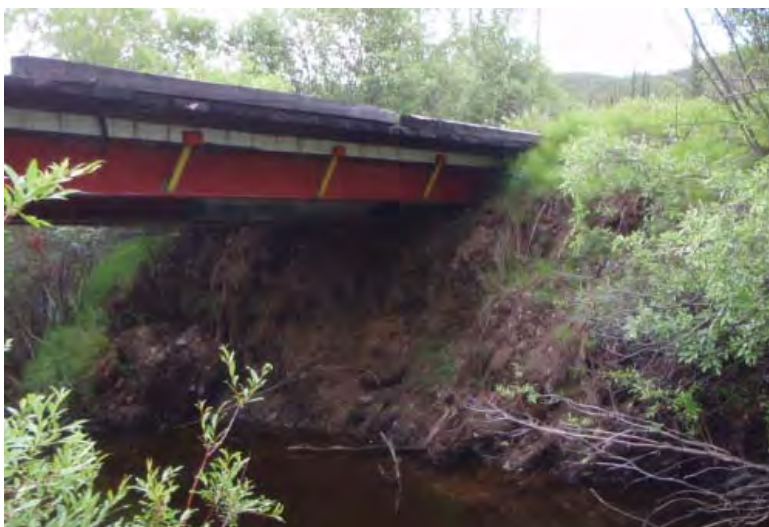
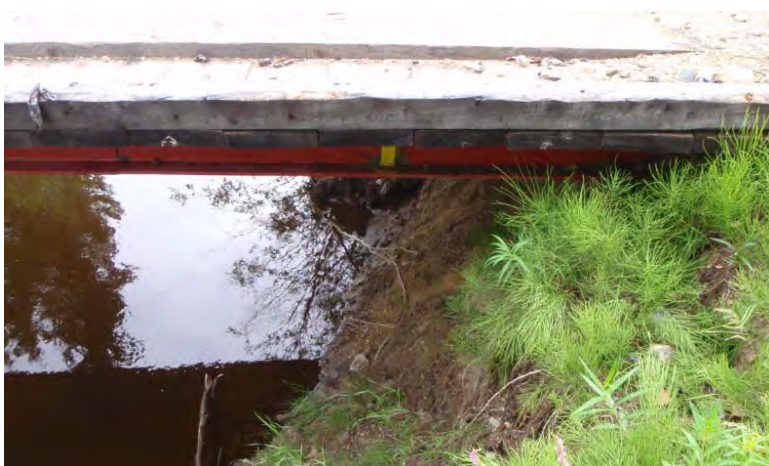
Photographs 24 - 25: Erosion on near bridge abutment at Maurice Creek (near side to the Village of Carmacks).

The access road crossing at Merrice Creek includes a single span bridge set on grade. No steelwork or abutment foundations were observed, and the creek banks were being eroded and under cut at the crossing location. The bridge should be re-set or the abutments protected against further erosion. This work should be completed in 2012 if possible, or if not possible then it will be critical to fixed and re-inspected in 2013.
