Reference No. 1314270077-222-L-Rev0-1000

**ANNUAL INSPECTION, JULY 16, 2013
CARMACKS COPPER PROJECT, CARMACKS, YUKON**

Carmacks Copper Project Annual Inspection

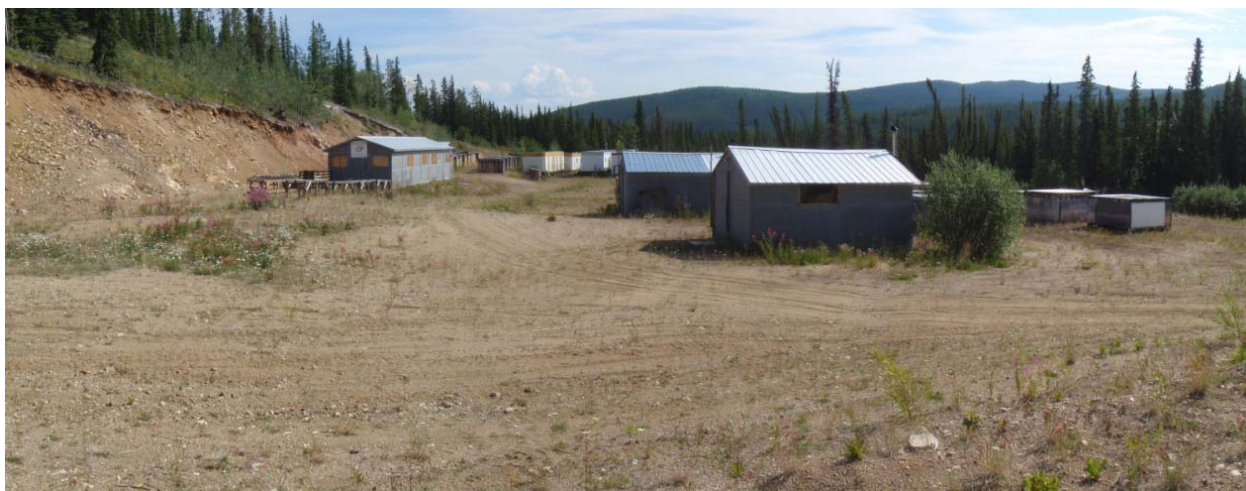
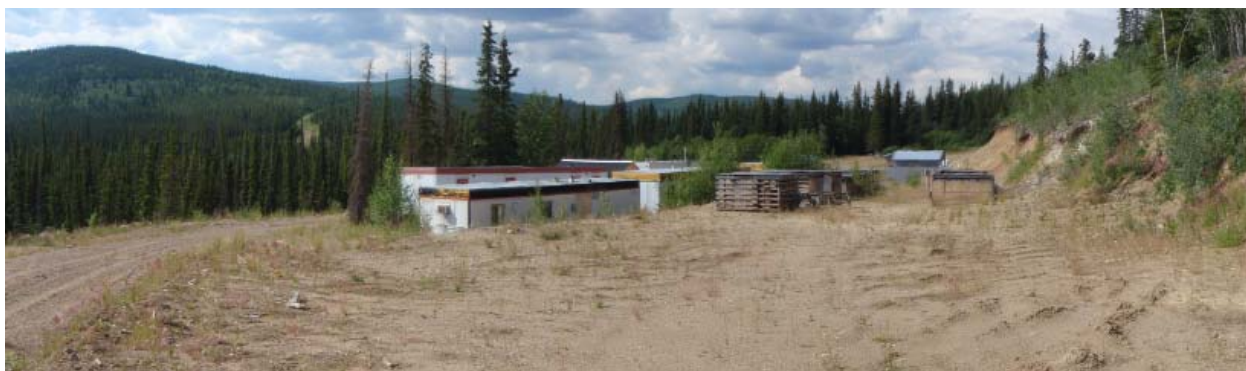
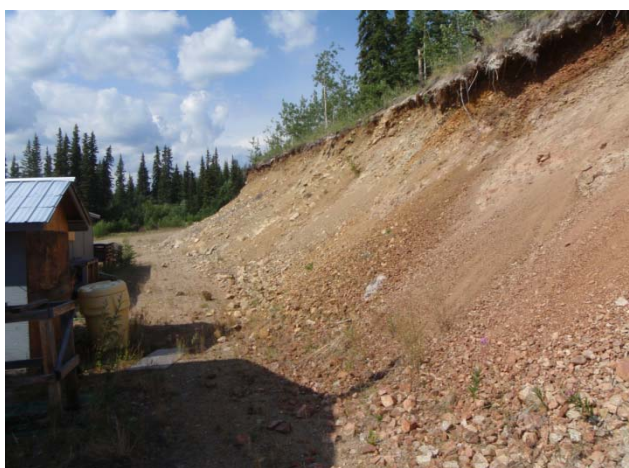
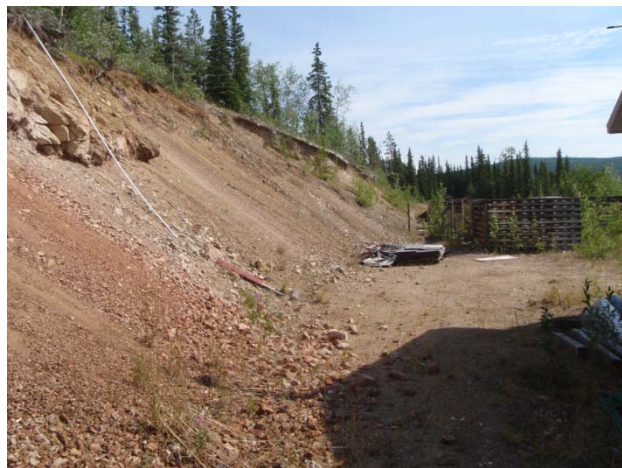
The inspection of the camp area indicated there is no erosion of sediments from the pad area into the surrounding natural area. The slope behind the camp is stable and is not impacting or causing any safety issues with the camp structures or operations. There is minor slumping and ravelling of small sections of the slope, but these are not impacting camp safety nor would they represent an issue to workers on the project. Some re-growth of vegetation was observed in the camp area. In addition, there was some cracking observed along the south edge of the pad (lower limit of pad), some 3 to 4 m from the pad edge.

Photographs 1 - 5: Carmacks exploration camp – views looking east to camp (top), looking west to camp (middle), slope immediately north of camp looking west (bottom left) and east (bottom right)

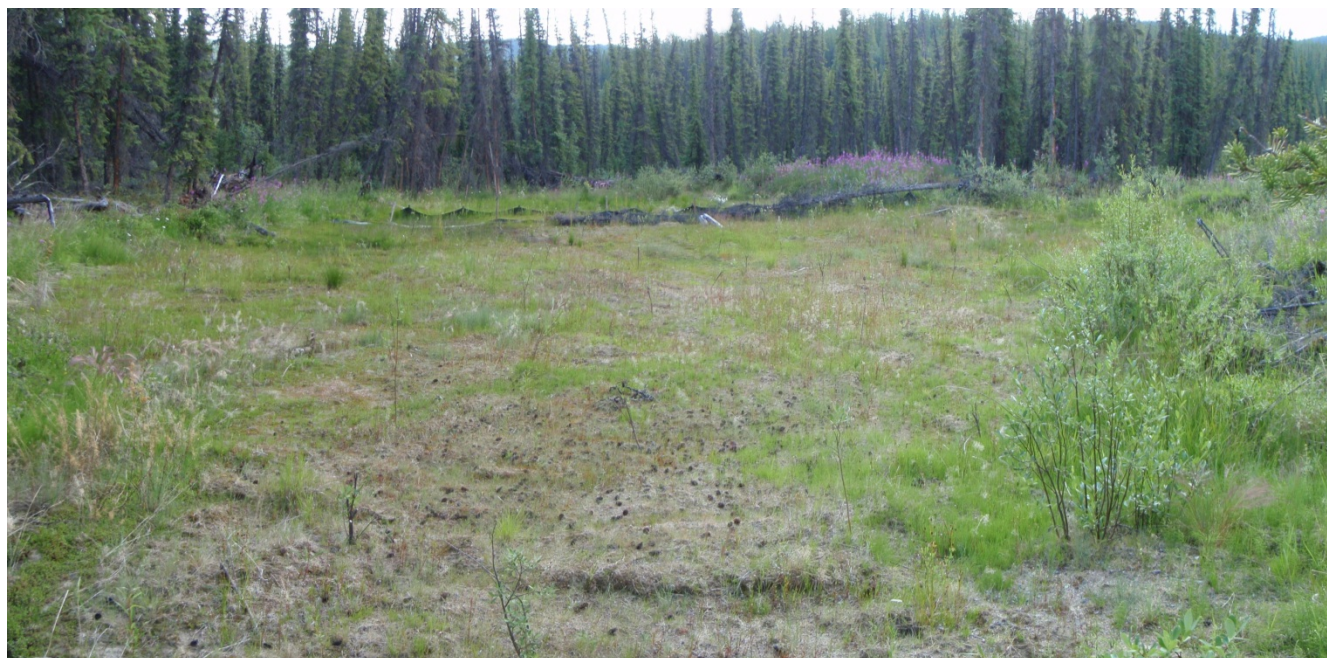
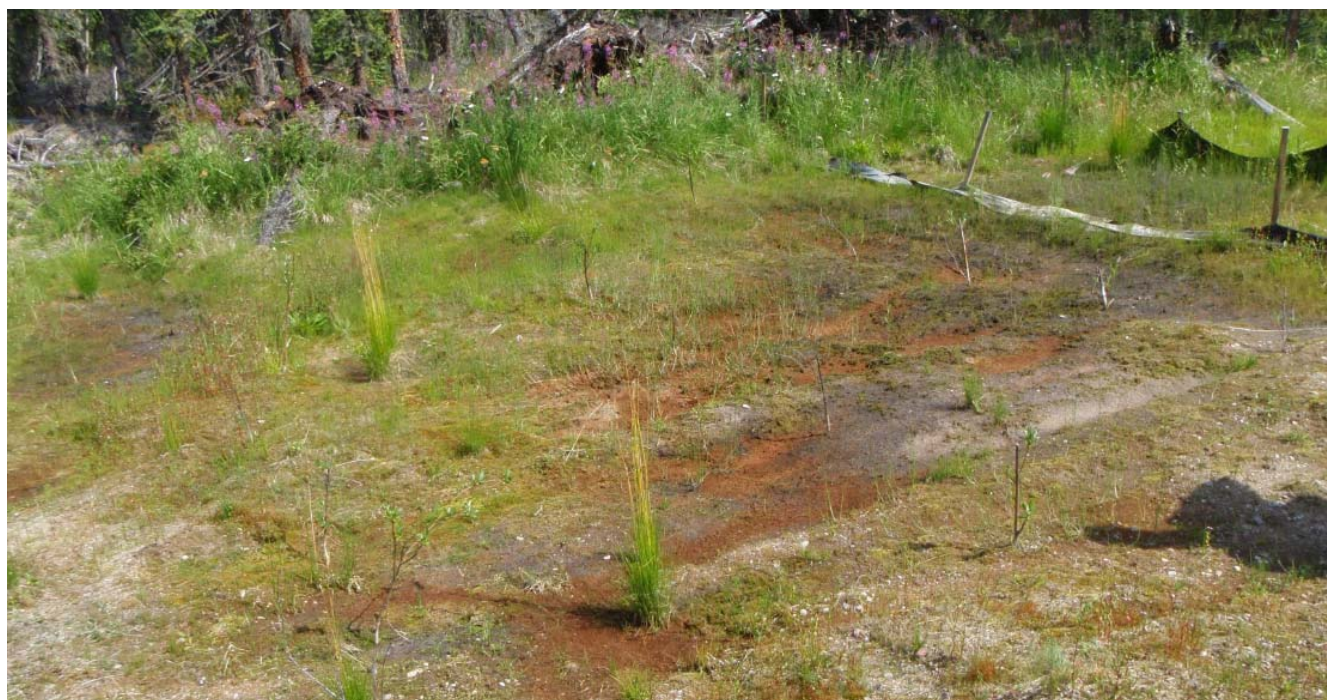
Further down slope of the proposed Heap Leach Facility Sediment Pond, and within the floodplain of Williams Creek, a series of silt fences have been installed and the area seeded where sediment from previous site erosion has accumulated. At the time of the inspection, it was observed that the silt fencing surrounding these areas is working effectively and there is no evidence of recent sediment movement. Grass seed was used in 2009 to promote the re-establishment of vegetation and further stabilize the sediment. The approach was noted to be generally effective in 2011 and 2012, but with limited re-growth attributed to periodic pooling of water. The area was re-vegetated with woody plants (willow cuttings), and plants appear to be tolerating saturated soil conditions. Conditions in 2013 were similar to 2012, with limited growth of the willow cuttings. No movement of sediment beyond the existing silt fences was observed, nor does it appear that sediment has entered Williams Creek. These erosion control measures are of a temporary nature that should be inspected annually and ongoing minor maintenance activities should be anticipated.

Photographs 6 - 7: Silt fences located between the area of the proposed Heap Leach Facility Sediment Pond and Williams Creek and re-vegetated area. Re-establishment of grass vegetation in this area appears to be hampered by the periodic pooling of water. Willow cuttings planted in 2011 had taken hold with limited new growth visible in 2013.

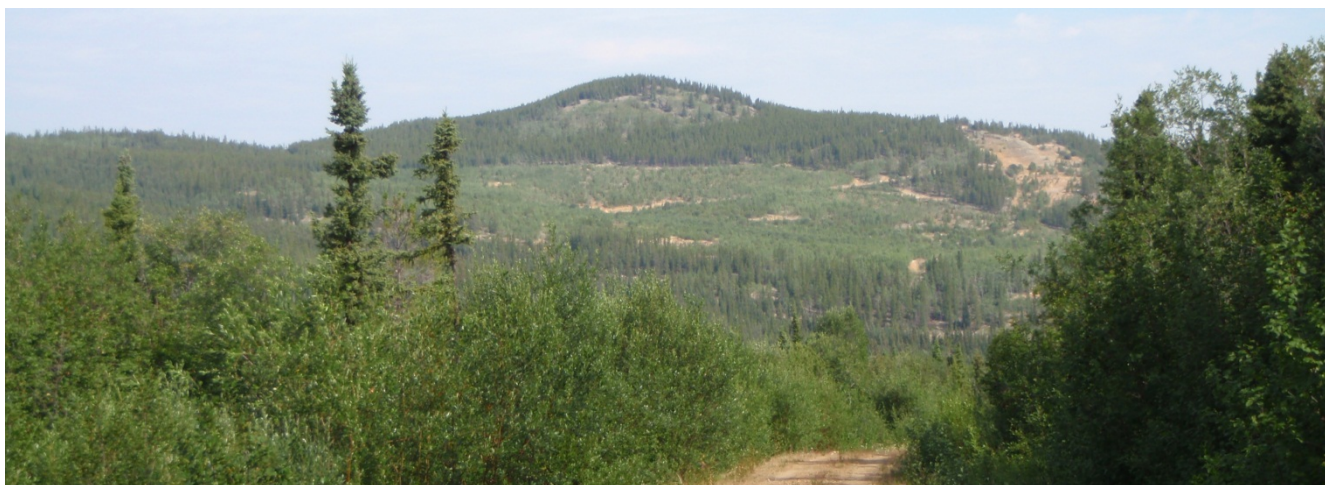
Photograph 8: View of proposed Heap Leach Facility and open pit areas (far slope) from site access road, looking north.

It is recommended that vegetation in the lower footprint area of the Heap Leach Facility and Confining Embankment be re-cleared of vegetation in 2013 or 2014 to promote thaw of permafrost ground prior to development of the area. Vegetation may allow re-establishment of permafrost and ground ice and should therefore the vegetation should be cleared to allow the ground to thaw over the warmer months.

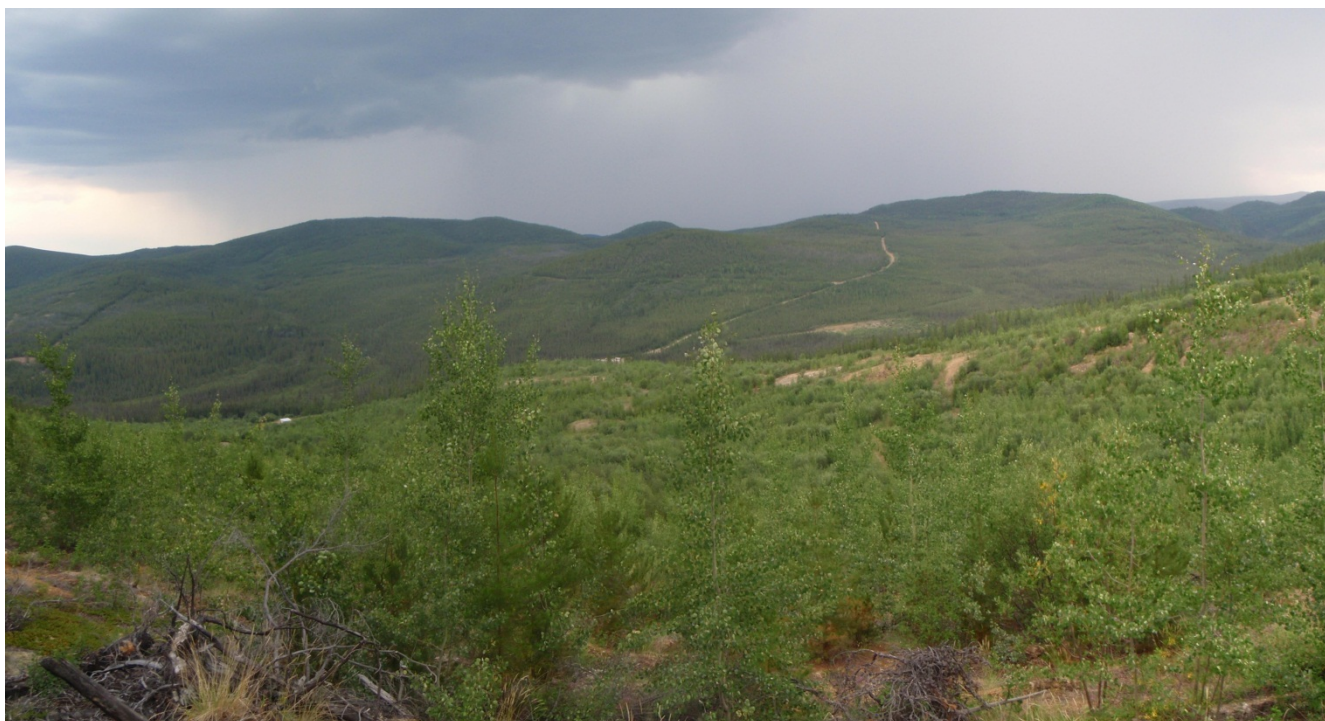
Photograph 9: View of proposed Heap Leach Facility (foreground) looking south west.

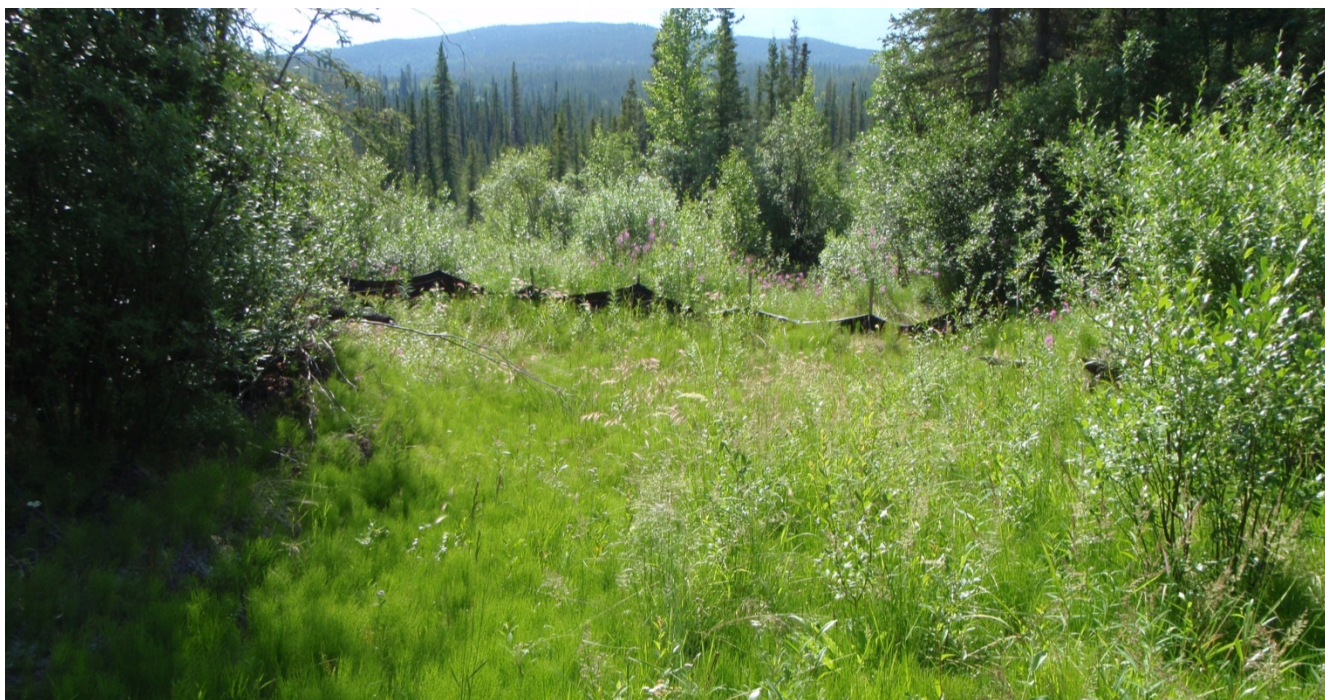
Photograph 10: Re-vegetation on drill access road in the Events Pond area.

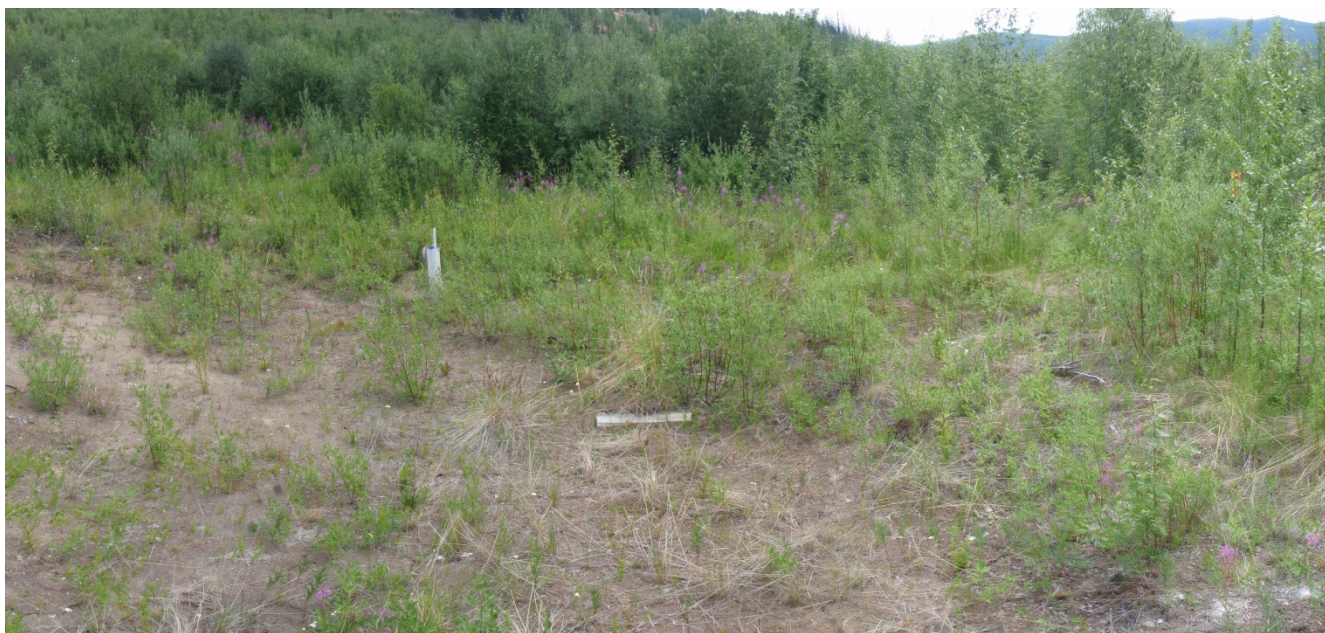
Photograph 11: Re-vegetation at BH17-07 drill pad in the Heap Leach Facility area.

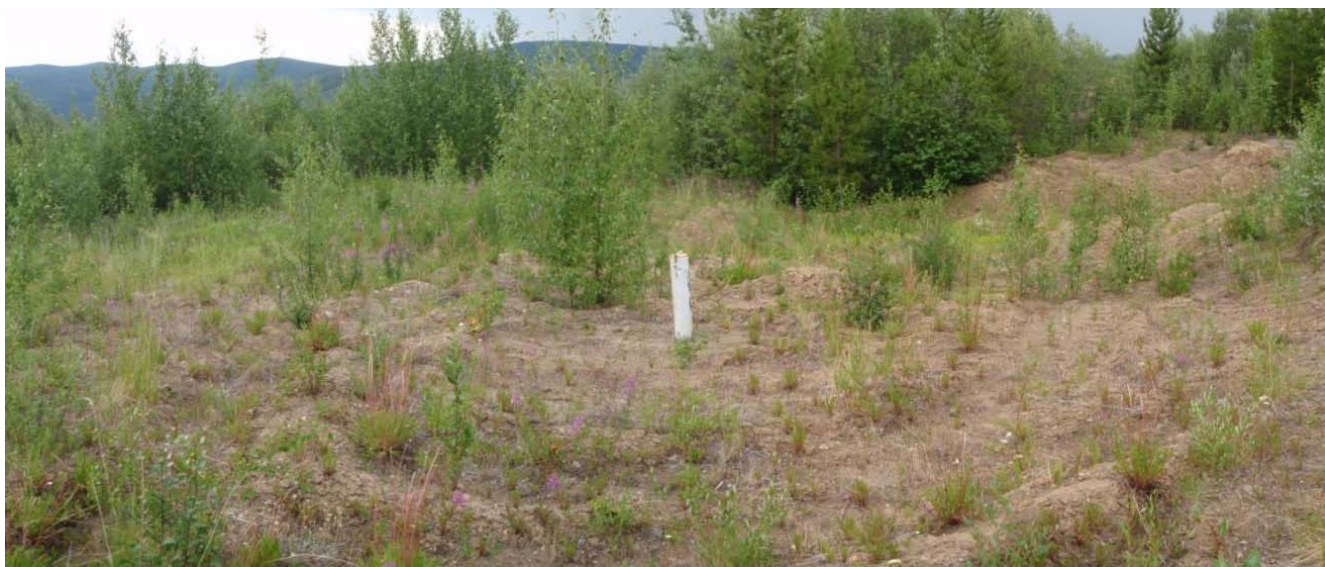
Photograph 12: Re-vegetation on BH-26-07 drill pad in the Heap Leach Facility area.

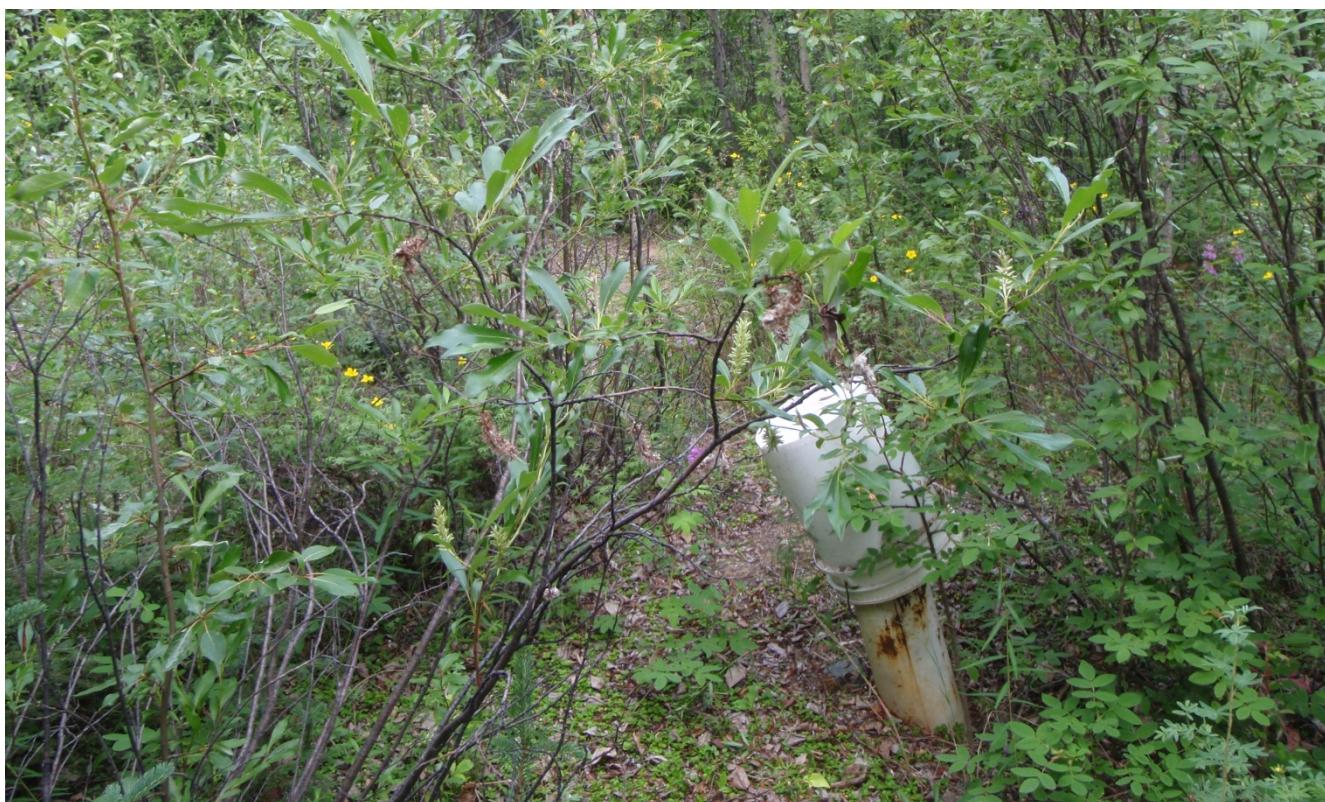
Photograph 13: Re-vegetation at DH95-H drill pad in the Heap Leach Facility area.

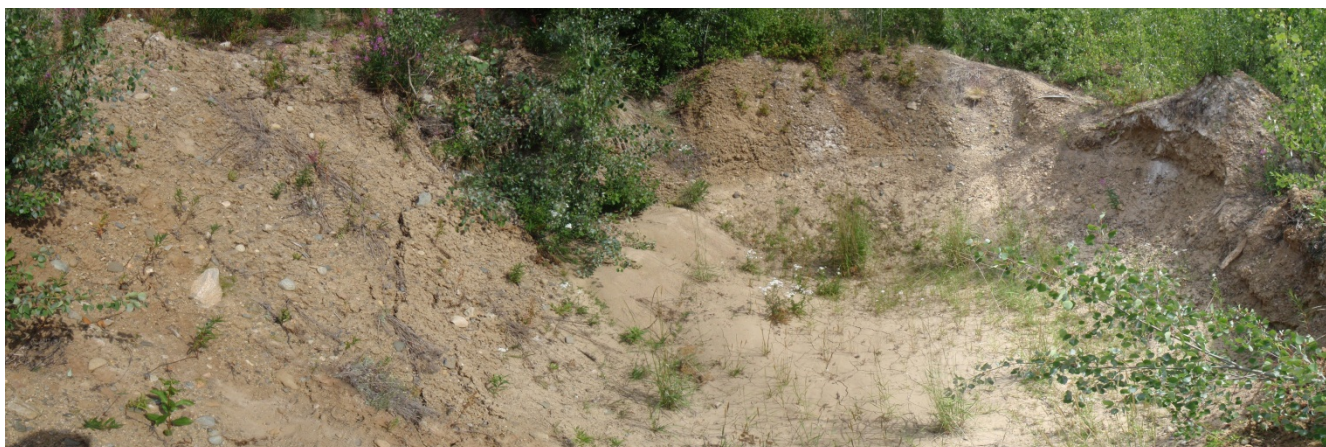
The area of the proposed Waste Rock Storage Area and the present access road crossing at North Williams Creek was inspected. The Waste Rock Storage Area is still tree covered and the drill pads and access roads in the area are re-vegetating by volunteer species. The small sediment catch basins at the drill pads still have capacity to manage more sediment, if required.

Photograph 14: Drill pad sediment basin trap near the proposed Events Pond.

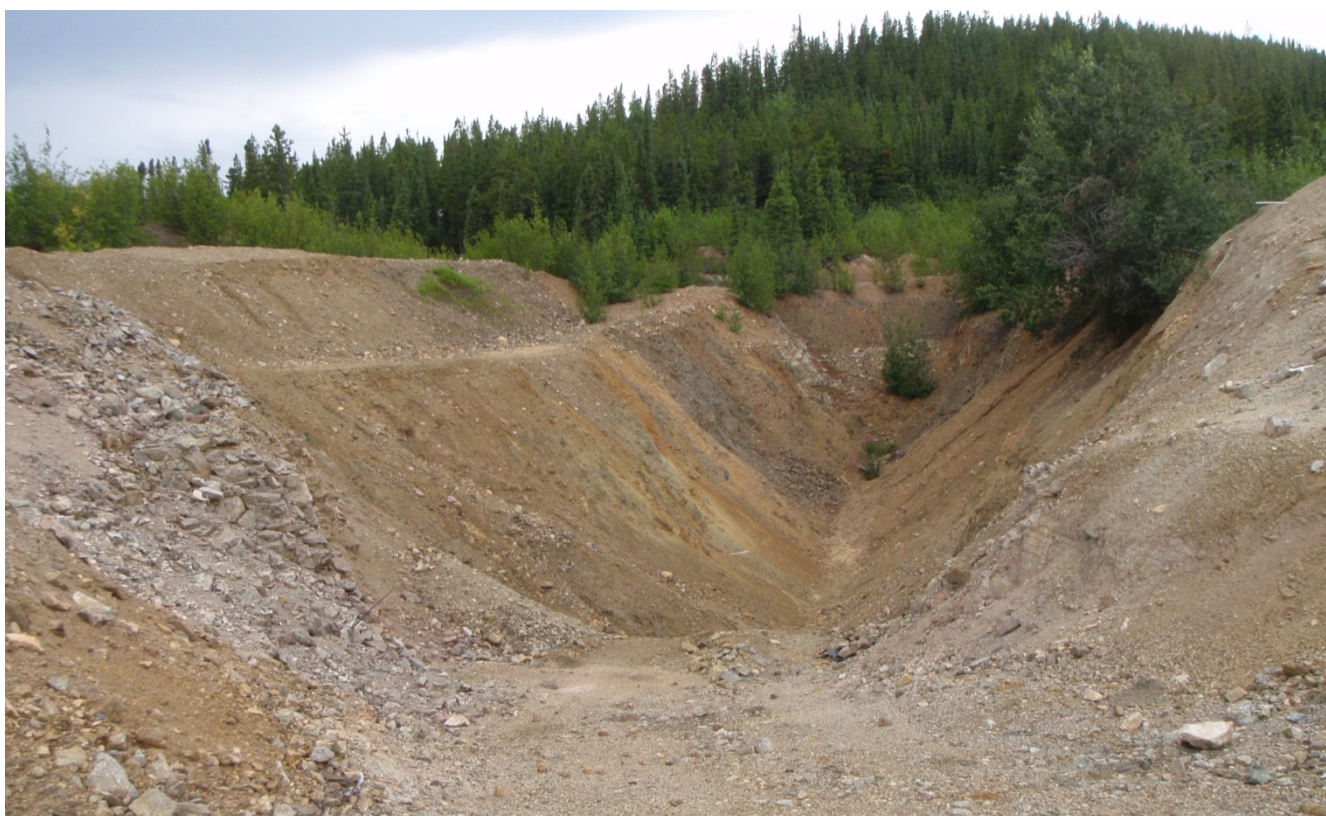
The area where the open pit is to be developed was inspected. The excavation slopes of the trenches developed as part of the effort to obtain bulk samples during exploration activities were observed to be in reasonable condition and there was no observed slumping or failures of these slopes. The leached ore pile from the off-site test pad adjacent the trench was observed to be stable and there was no erosion or slope movement of the material. Several of the closed drill pads were inspected and there did not appear to be any erosion noted from these areas that require attention.

Photograph 16: Bulk sample excavation site.

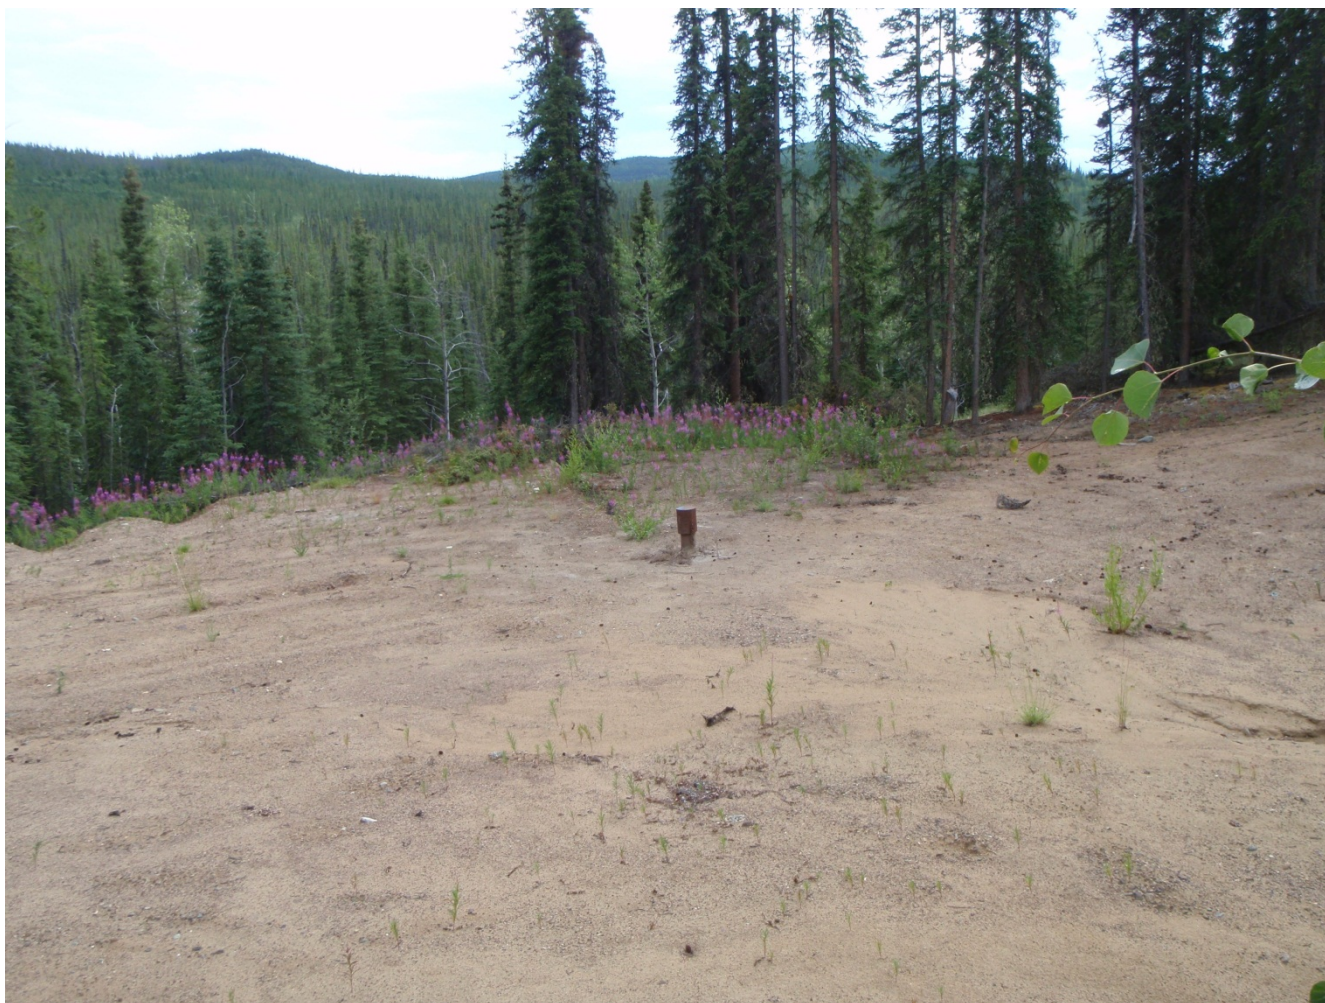
The proposed camp site was inspected and it is still tree covered. The site adjacent to the camp with two water wells was also inspected and there is no apparent movement of sediment beyond the work pads around the wells.

Photograph 17: Water supply well and pad near proposed camp site.

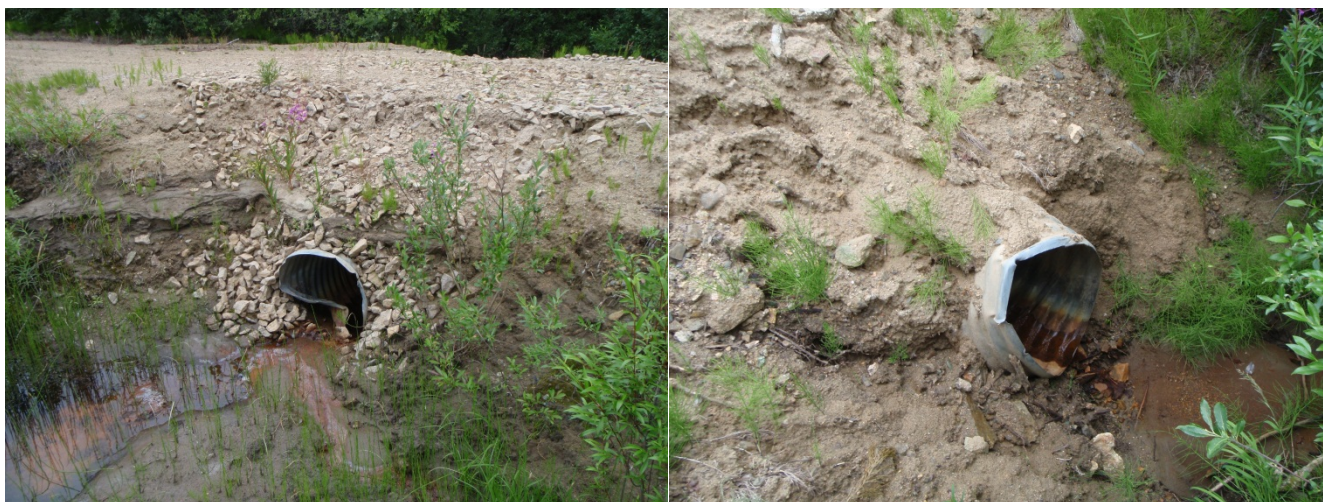
Local erosion on the main access road to the north of the Waste Rock Storage Area continues. The shoulders of the road at the culvert on North Williams Creek have eroded, reducing the road crest width at the culvert location. The road is washed out approximately 30 m past the culvert. A ponded area adjacent the road is anticipated to have temporarily flowed over and eroded the road fill due to reduced flow in the culvert near this location. The inlet of the culvert was observed to be bent. It is recommended that the culvert mouth be reshaped or opened to allow flow at capacity. The eroded area on the road should be filled with gravel to level the grade and re-establish the road.

Photographs 18 and 19: Inlet (left) and outlet (right) of culvert on main access road crossing of North Williams Creek located north of the Waste Rock Storage Area.

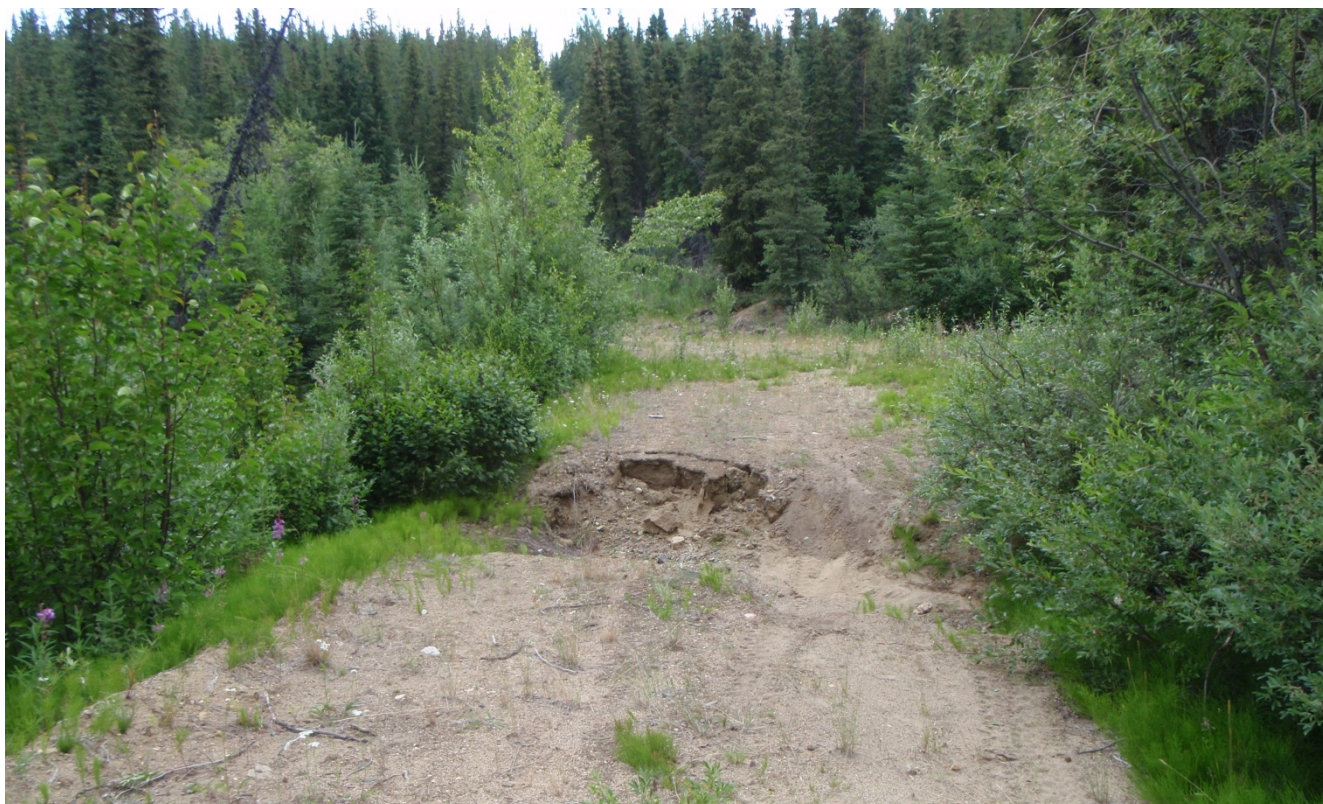
Photograph 20: Erosion on road near North Williams Creek crossing.

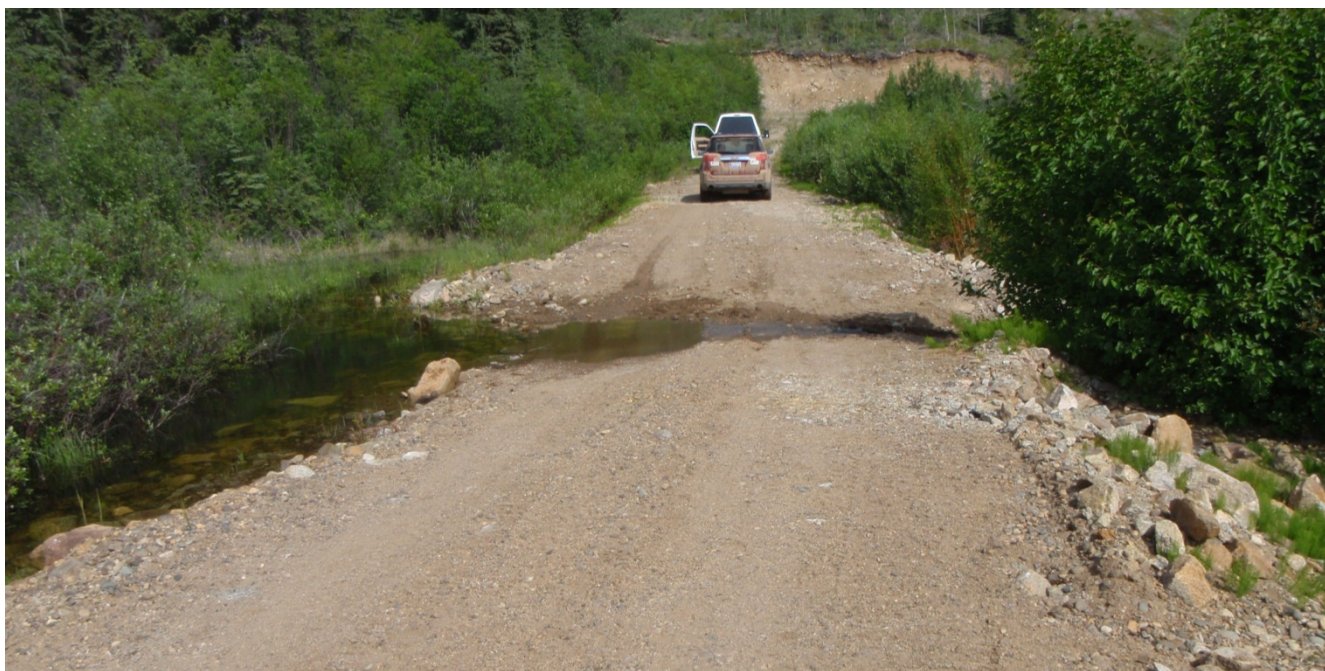
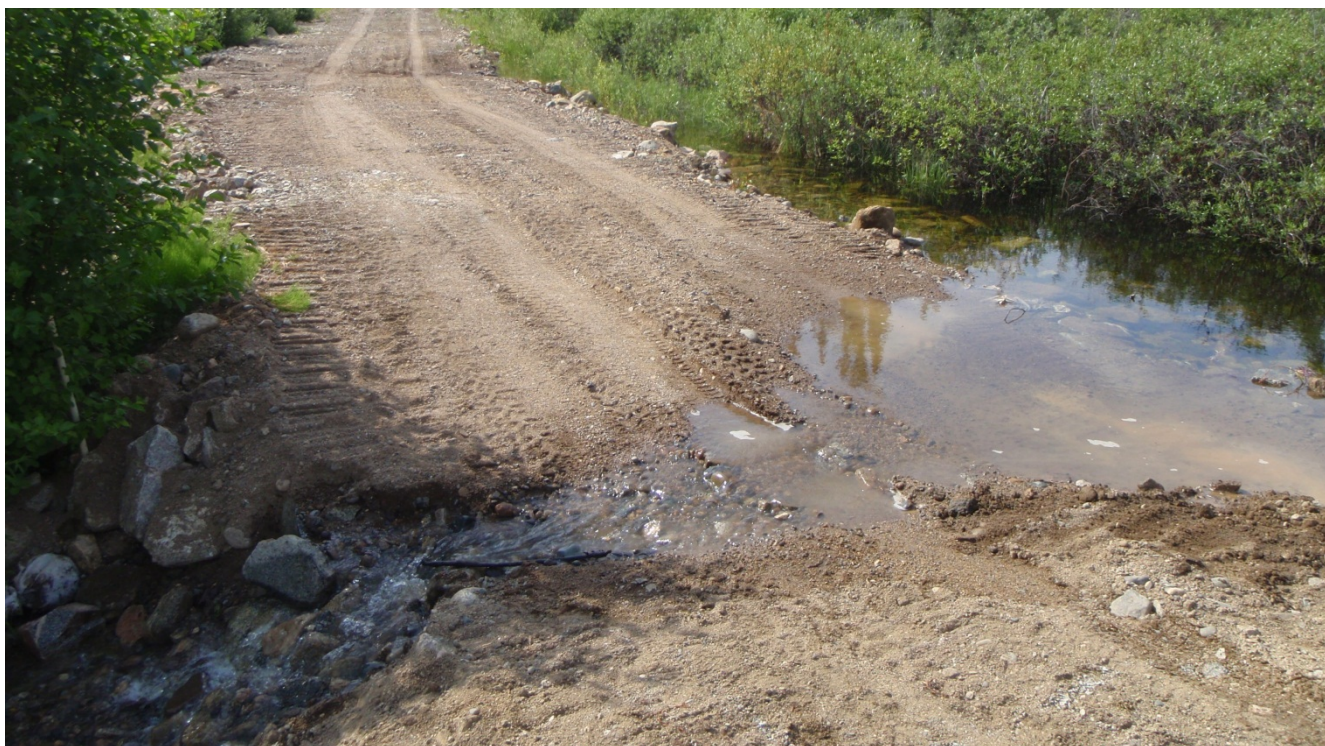
The culvert in the site access road which allowed Williams Creek to flow by the road was recently removed. The crossing is now a 'ford' with the road bed depressed over a length of 10 m to a maximum depth of 0.8 m below the adjacent road grade or crest elevation. Ponded water was observed on the upstream side of the road, with flow across the road. Scott Casselman reported that the culvert was angled upwards with the inlet in the air, and the culvert was therefore removed and the depression regarded as observed on July 10, 2013.

Photographs 21 - 22: View of access road crossing of Williams Creek looking north (top) and south (bottom).

Without further erosion protection, it is anticipated that the general fill of the roadbed at Williams Creek will erode at the crossing location during high flow events. The culvert should therefore be replaced and armoured or the 'ford' should be upgraded to operate through next spring.

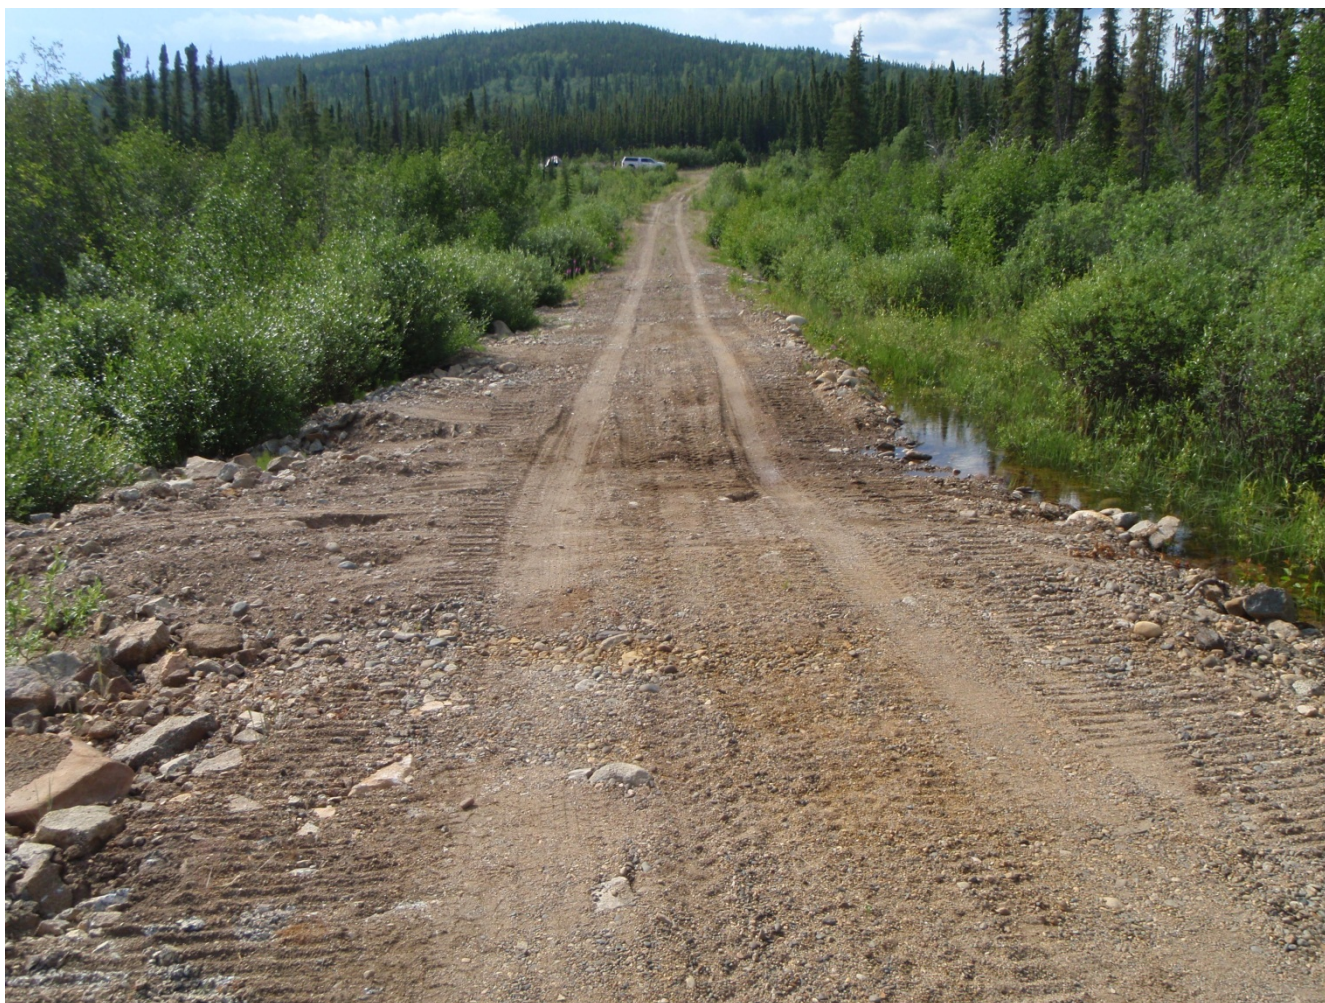
Some erosion noted during the 2012 inspection, indicated that flow had previously appeared to pass over an additional segment of the road near the Williams Creek crossing, eroding the road bed some 18 m south of the culvert location. It is anticipated that this was a temporary condition, which likely occurred at the beginning of the freshet, potentially when the culvert was still frozen/blocked by snow and ice. This southern eroded area was observed to have been repaired. Scott Casselman reported that the eroded area was repaired on July 10, 2013.

Photograph 23: View of access road repair just south of Williams Creek, looking south.

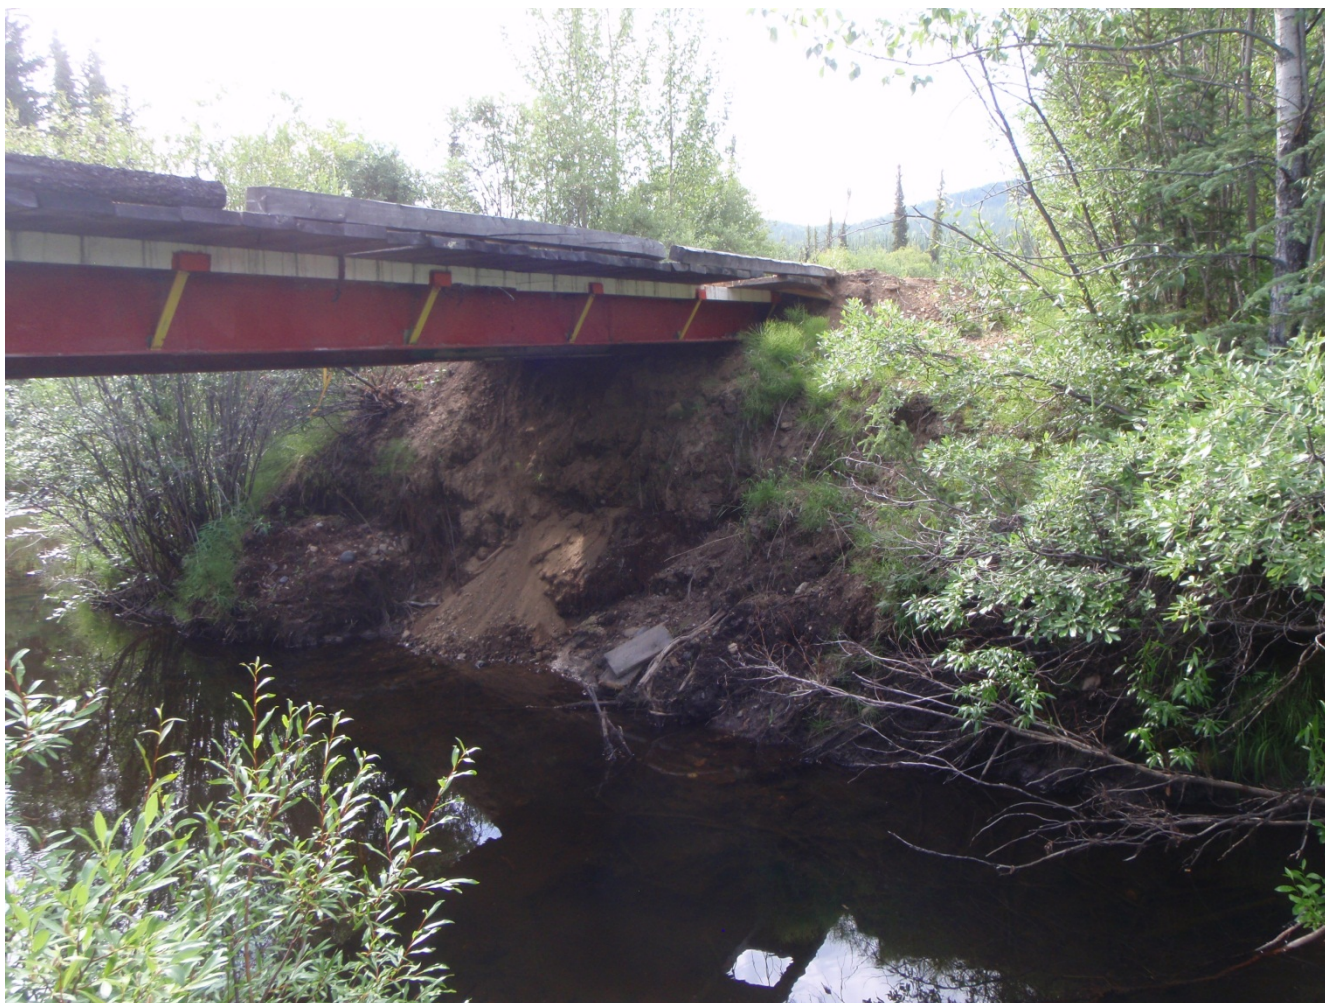
The access road crossing at Merrice Creek includes a single span bridge set on grade. No steelwork or abutment foundations were observed. In July 2012 the creek banks were being eroded and under cut at the crossing location. Scott Casselman reported that the bridge span was re-set on July 10, 2013, following recommendations in the July 2012 inspection memorandum. The abutment on the Village of Carmacks side of the bridge was reportedly leveled, or cut down, and then the span dragged back and re-set. During the July 2013 inspection the length of span seated on the Village side abutment was 0.5 to 0.75. The slope of the ground at the abutment immediately under the span at this location was observed to be over-steepened, approximately 1 horizontal to 2 vertical. The measures to stabilize the span therefore appear temporary and it is anticipated that the bridge will have to be re-set again in 2014 or in 2015.

Photograph 24: Site access road crossing of Merrice Creek, view of bridge abutment nearest to the Village of Carmacks.
