August 28, 2014

Reference No. 1314270077-227-L-Rev0-7000

**ANNUAL INSPECTION, JULY 17, 2014
CARMACKS COPPER PROJECT, CARMACKS, YUKON**

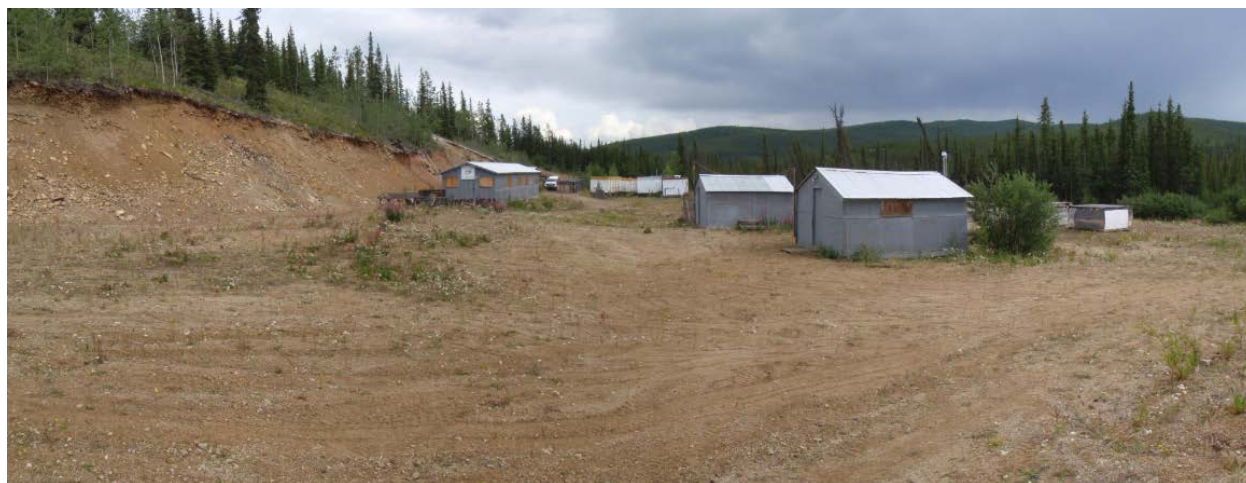
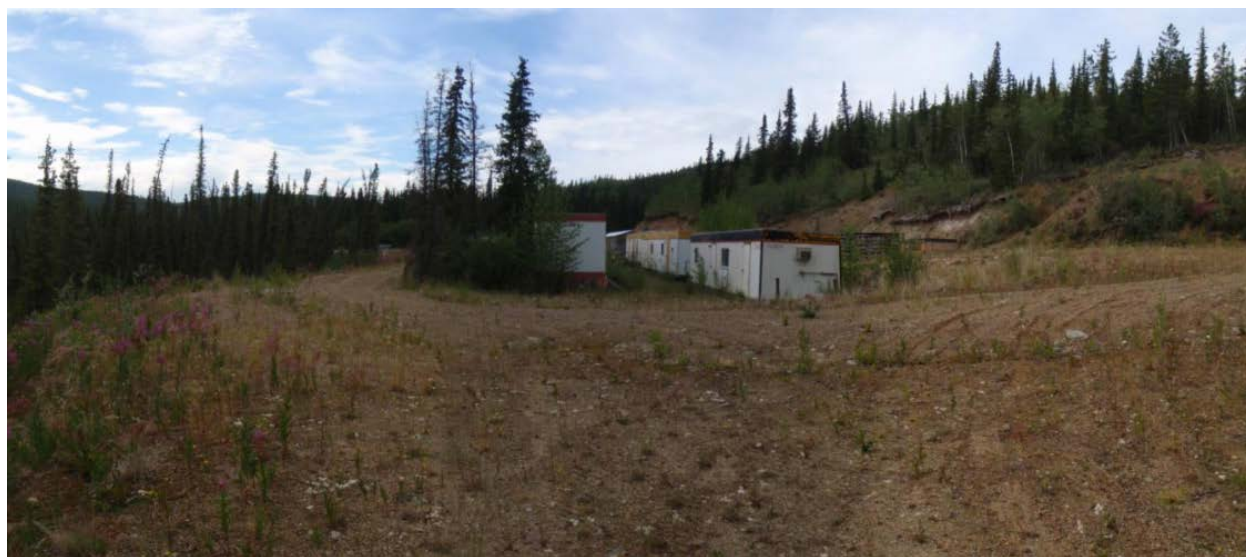
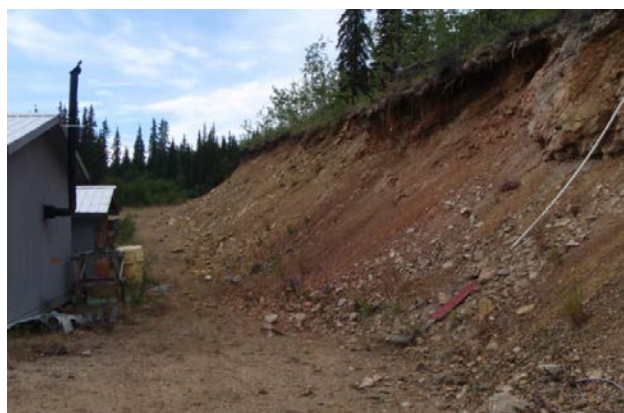
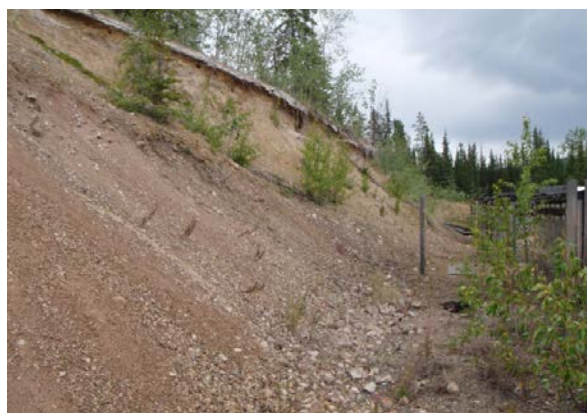
The inspection of the camp area indicated there is some thaw related settlement on the pad, which should be monitored as core storage cribs may be impacted. The inspection did not indicate erosion of sediments from the pad area into the surrounding natural area. There was some cracking observed along the south edge of the pad (lower limit of pad), some 3 to 4 m from the pad edge observed in 2013. New additional cracking was observed on the pad to the west, below the area of core storage, which is likely related to thaw related settlement in the core storage area. The slope behind the camp is stable and is not impacting or causing any safety issues with the camp structures or operations. There is minor slumping and ravelling of small sections of the slope, but these are not impacting camp safety nor would they represent an issue to workers on the project. Some re-growth of vegetation was observed in the camp area.

Photographs 1 - 5: Carmacks exploration camp – views looking east to camp (top), looking west to camp (middle), slope immediately north of camp looking west (bottom left) and east (bottom right)

- Monitoring of thaw of the camp pad and south west core storage area for settlement. Movement of the core may be required should the pad continue to degrade.

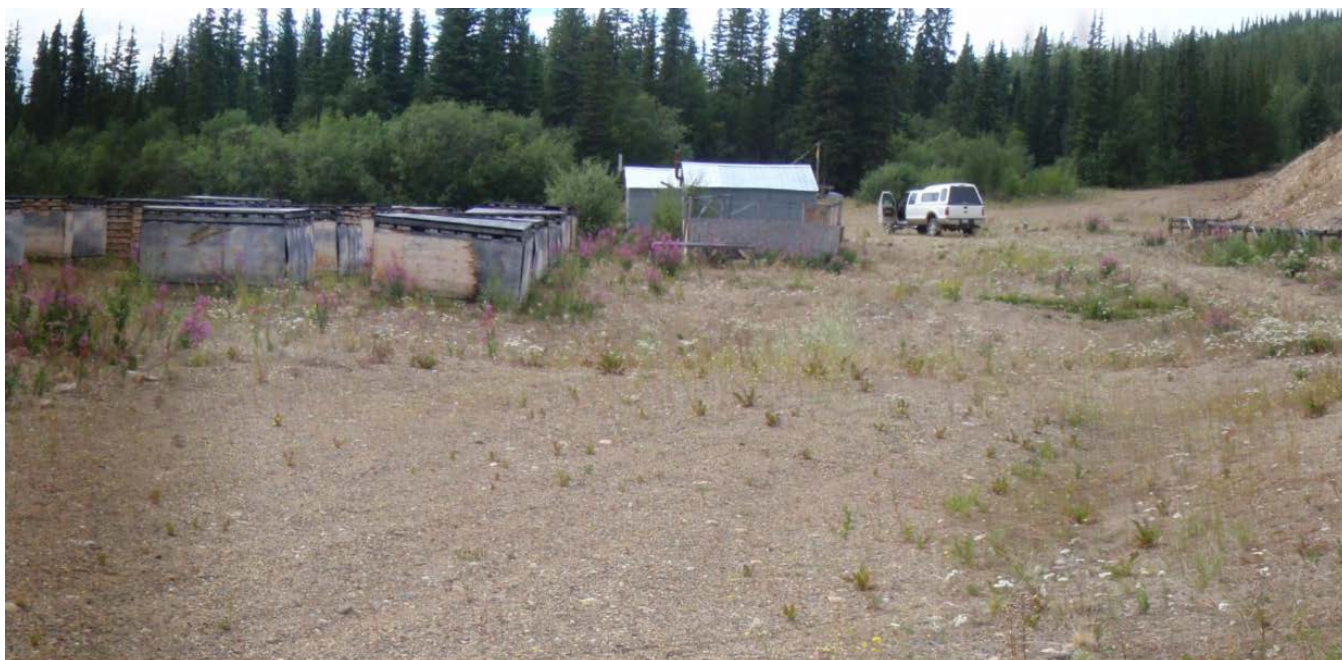
Photograph 6: View of southwest end of camp pad with core storage, looking west, note settlement of pad to right (north) of core boxes and related drop in corner of foremost core storage crib.

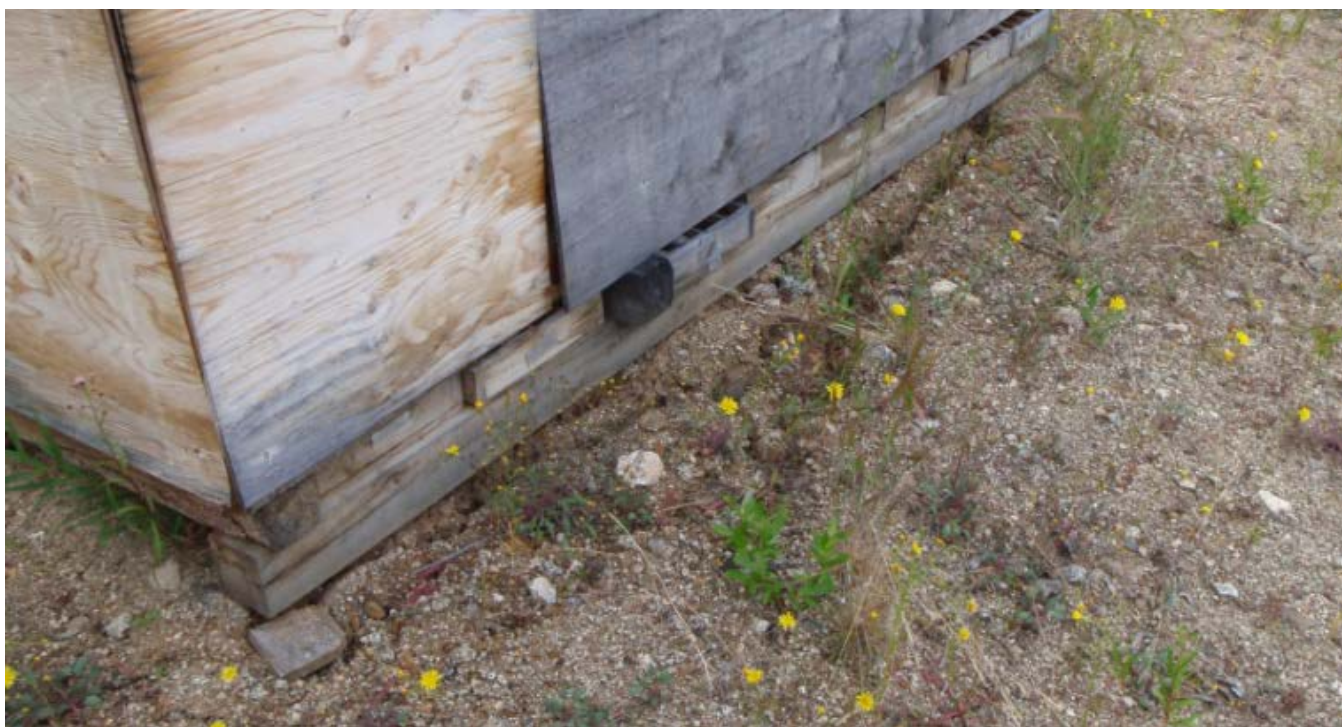
Photograph 7: Cracking in camp pad at southwest core storage area, second row from edge of pad.

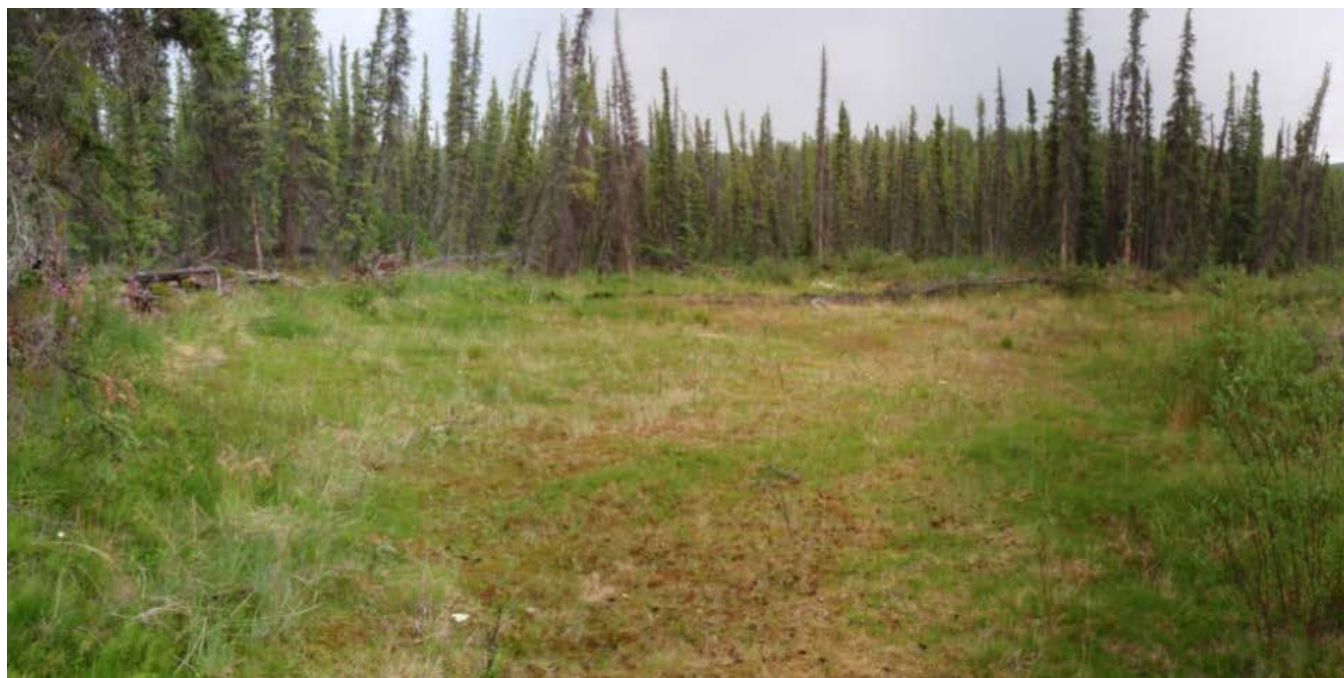
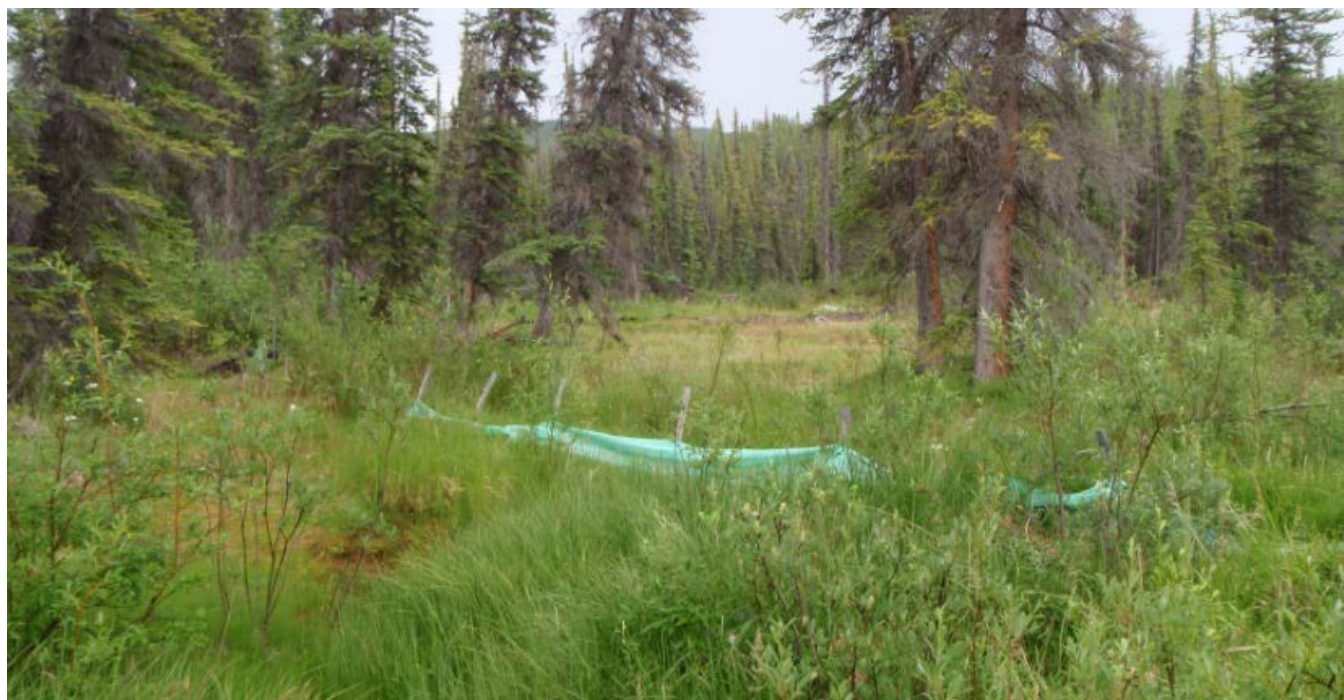
Further down slope of the proposed Heap Leach Facility Sediment Pond, and within the floodplain of Williams Creek, a series of silt fences have been installed and the area seeded where sediment from previous site erosion has accumulated. At the time of the inspection, it was observed that the silt fencing surrounding these areas is working effectively – the fences are overgrown, with no evidence of recent sediment movement. Grass seed was used in 2009 to promote the re-establishment of vegetation and further stabilize the sediment. The approach was noted to be generally effective in 2011 and 2012, but with limited re-growth attributed to periodic pooling of water. The area was re-vegetated with woody plants (willow cuttings), and plants appear to be tolerating saturated soil conditions. Conditions in 2014 were similar to 2013, with limited growth of the willow cuttings. However, no movement of sediment beyond the existing silt fences was observed, nor does it appear that sediment has entered Williams Creek. These erosion control measures are of a temporary nature that should be inspected annually and ongoing minor maintenance activities should be anticipated.

Photographs 8 - 9: Re-vegetated area and silt fence located between the area of the proposed Heap Leach Facility Sediment Pond and Williams Creek. Willow cuttings planted in 2011 had taken hold with limited new growth visible in 2014. Silt fence nearer to camp was overgrown, with no bare earth visible.

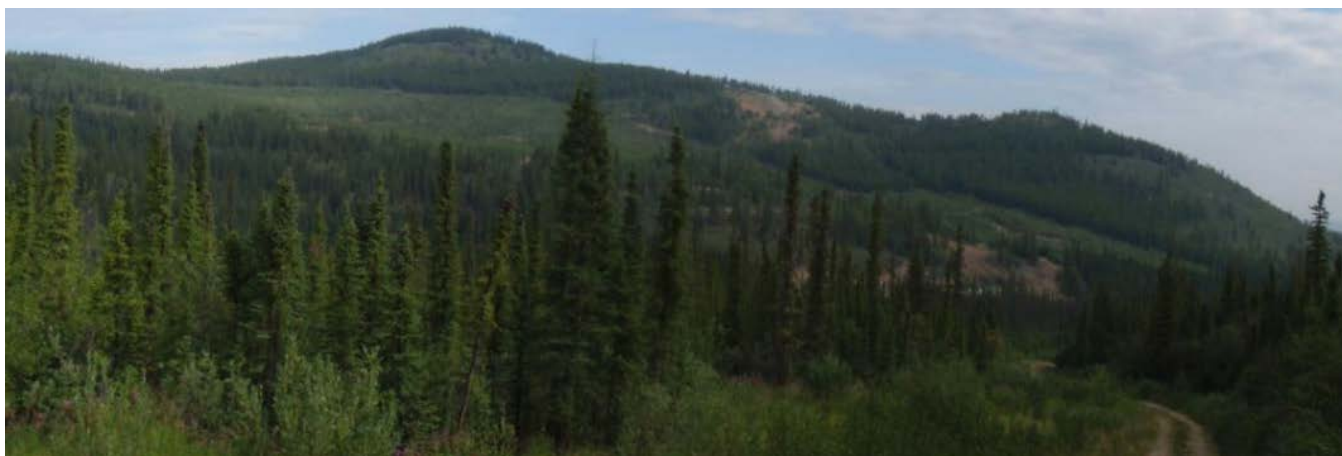
Photograph 10: View of proposed Heap Leach Facility and open pit areas (far slope) from site access road, looking north.

It is recommended that vegetation in the lower footprint area of the Heap Leach Facility and Confining Embankment be re-cleared in 2014 or 2015 to promote thaw of permafrost ground prior to development of the area. Vegetation may allow re-establishment of permafrost and ground ice and therefore the vegetation should be cleared to allow the ground to thaw over the warmer months.

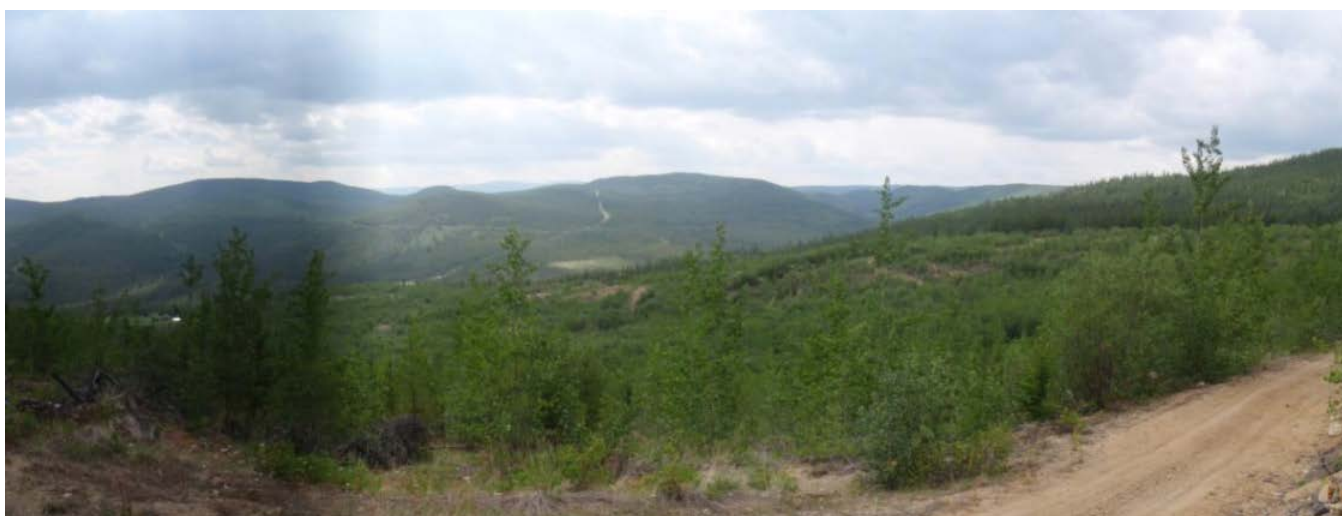
Photograph 11: View of proposed Heap Leach Facility (foreground) looking south west.

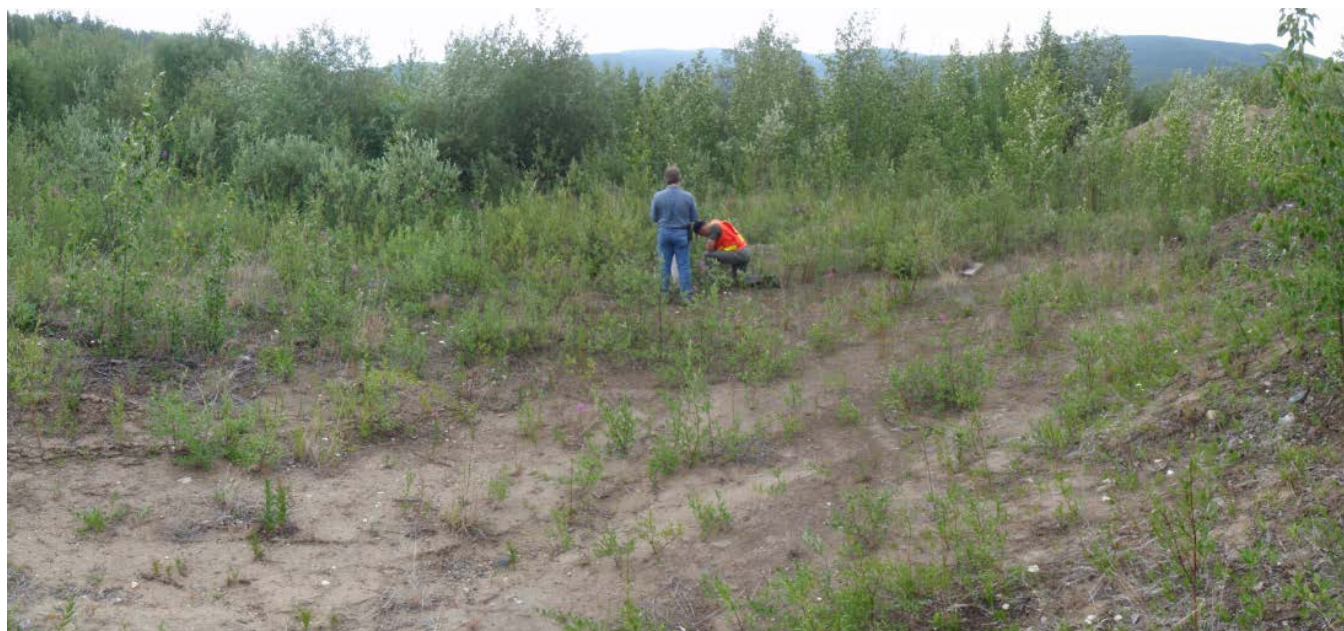
Photograph 12: Re-vegetation at BH17-07 drill pad in the Heap Leach Facility area.

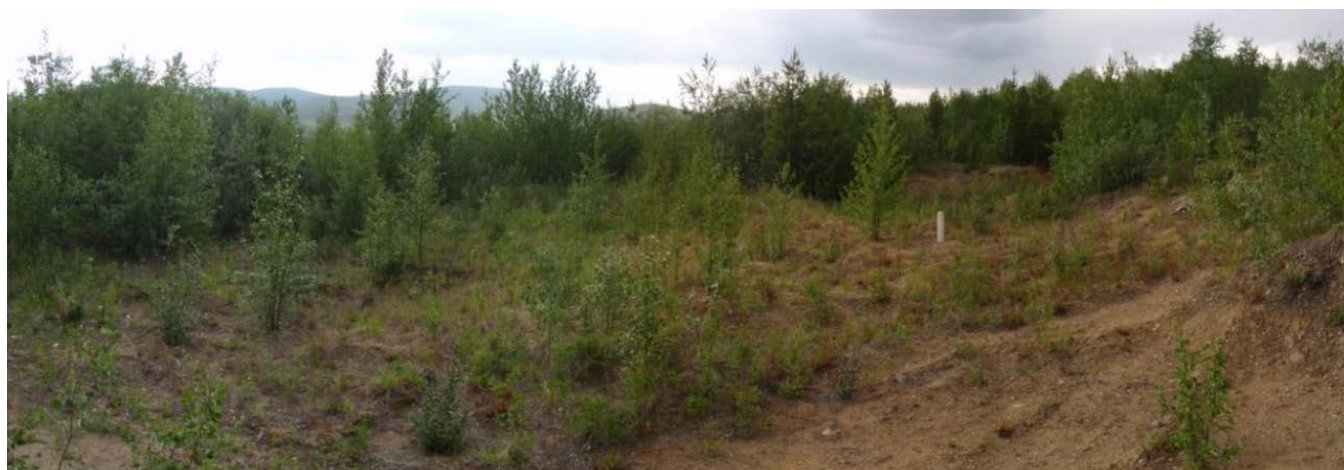
Photograph 13: Re-vegetation on BH-26-07 drill pad in the Heap Leach Facility area.

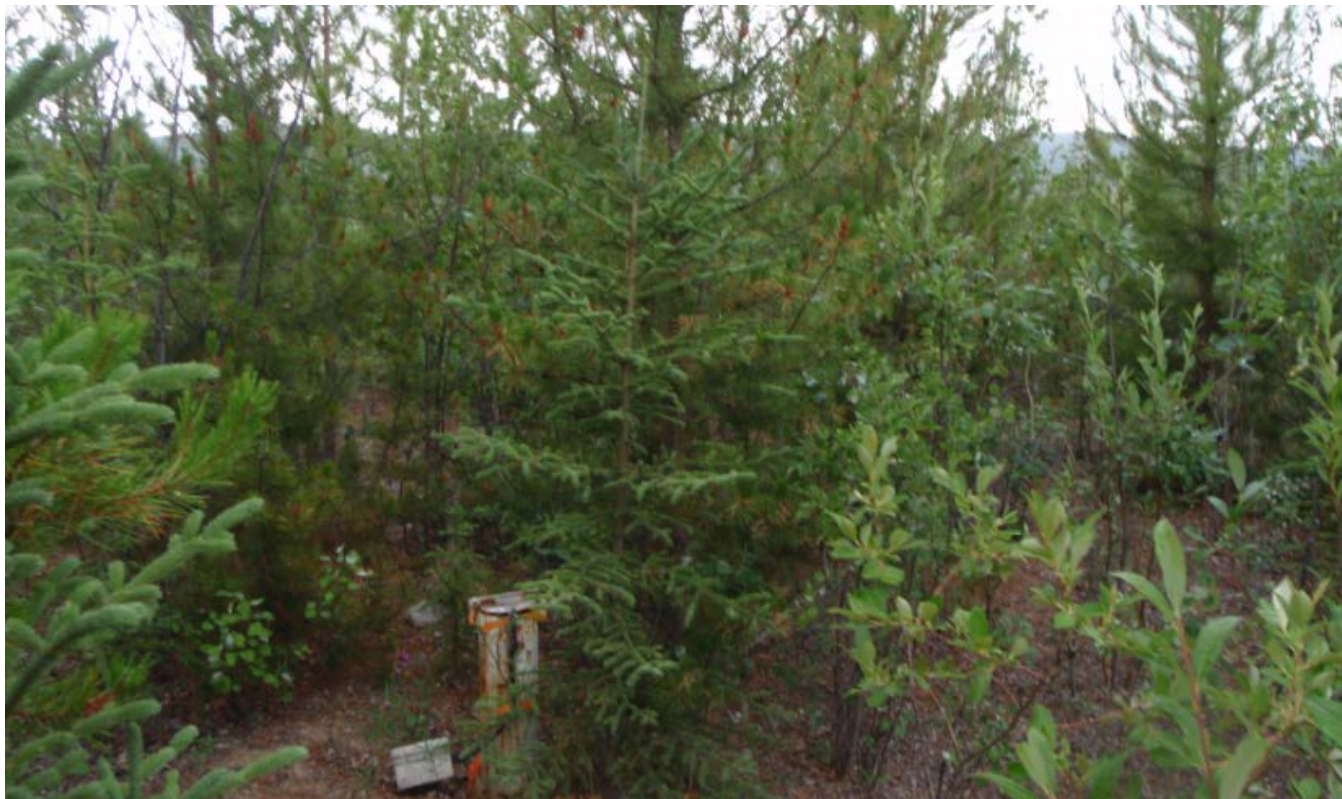
Photograph 14: Re-vegetation on DH96-16 drill pad in the Heap Leach Facility area.

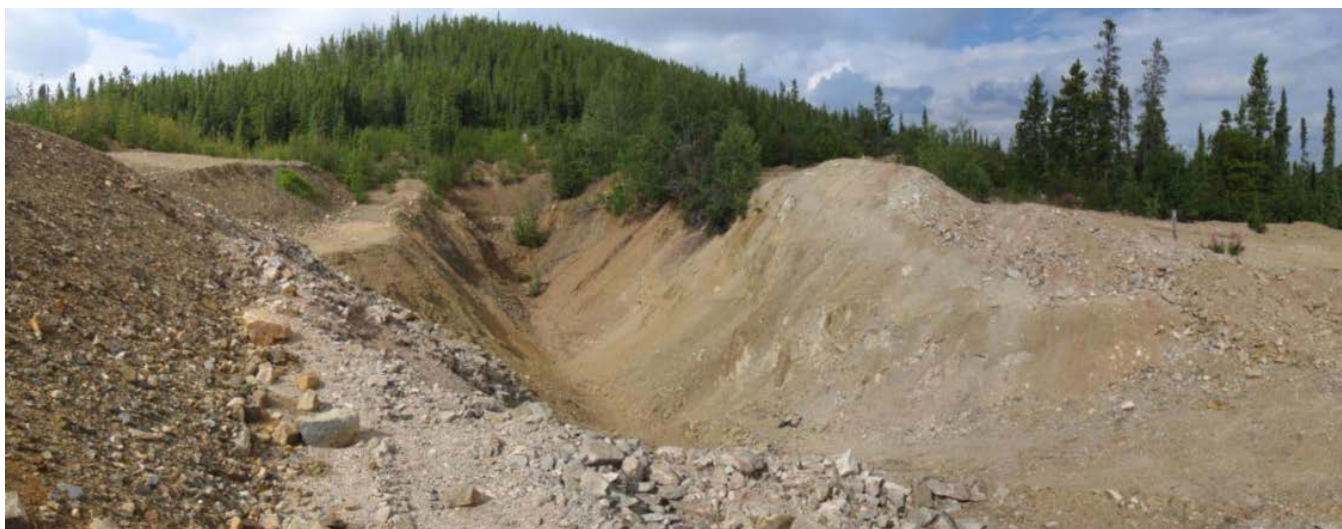
The proposed open pit area was inspected. The excavation slopes of the trenches developed as part of the effort to obtain bulk samples during exploration activities were observed to be in reasonable condition and there was no observed slumping or failures of these slopes. The leached ore pile from the off-site test pad adjacent the trench was observed to be stable and there was no erosion or slope movement of the material. Several of the closed drill pads were inspected and there did not appear to be any erosion noted from these areas that require attention.

Photograph 15: Bulk sample excavation site.

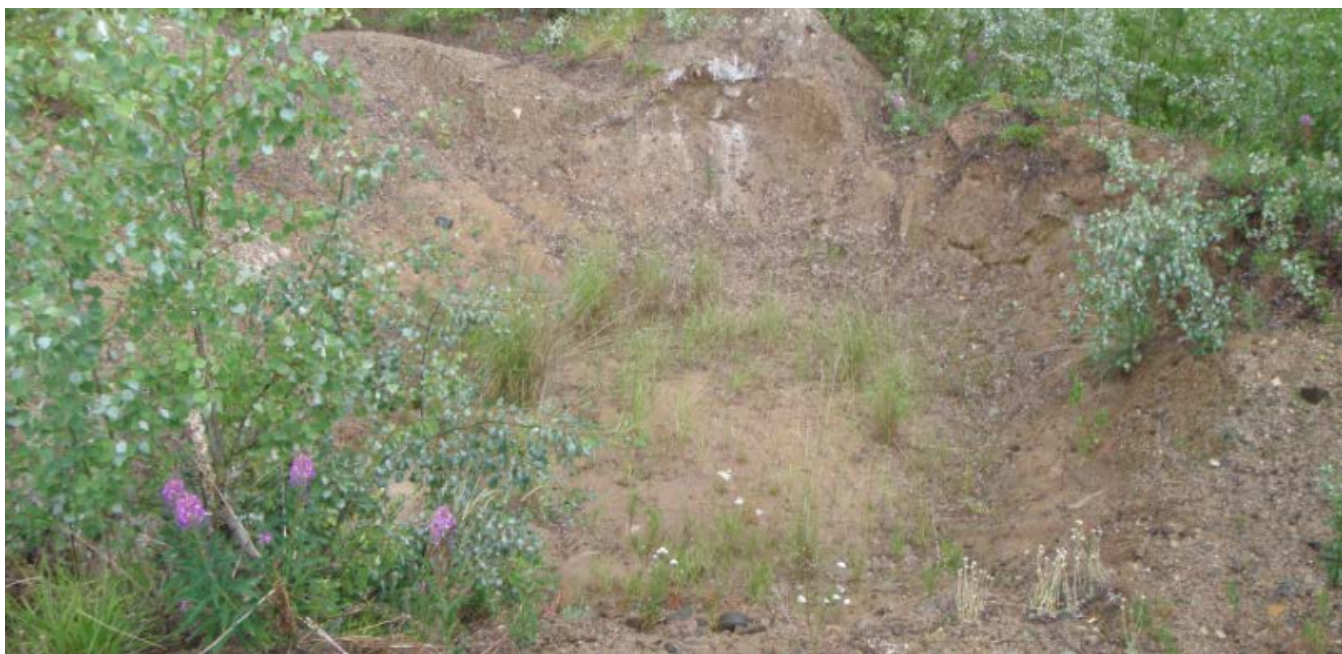
Photograph 16: Drill pad sediment basin trap at BH13-07, near the proposed Events Pond.

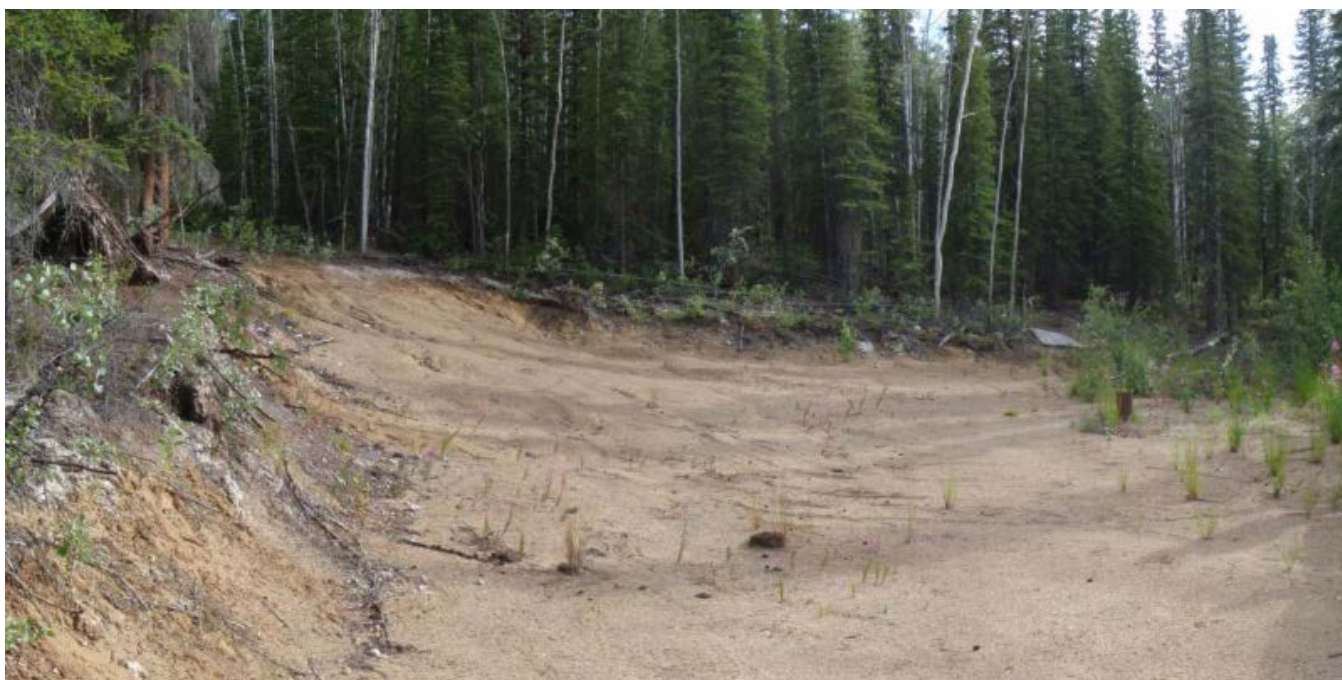
The proposed camp site was inspected and it is still tree covered. The site adjacent to the camp with two water wells was also inspected and there is no apparent movement of sediment beyond the work pads around the wells.

Photograph 17: Water supply well (right side of photo) and pad near proposed camp site.

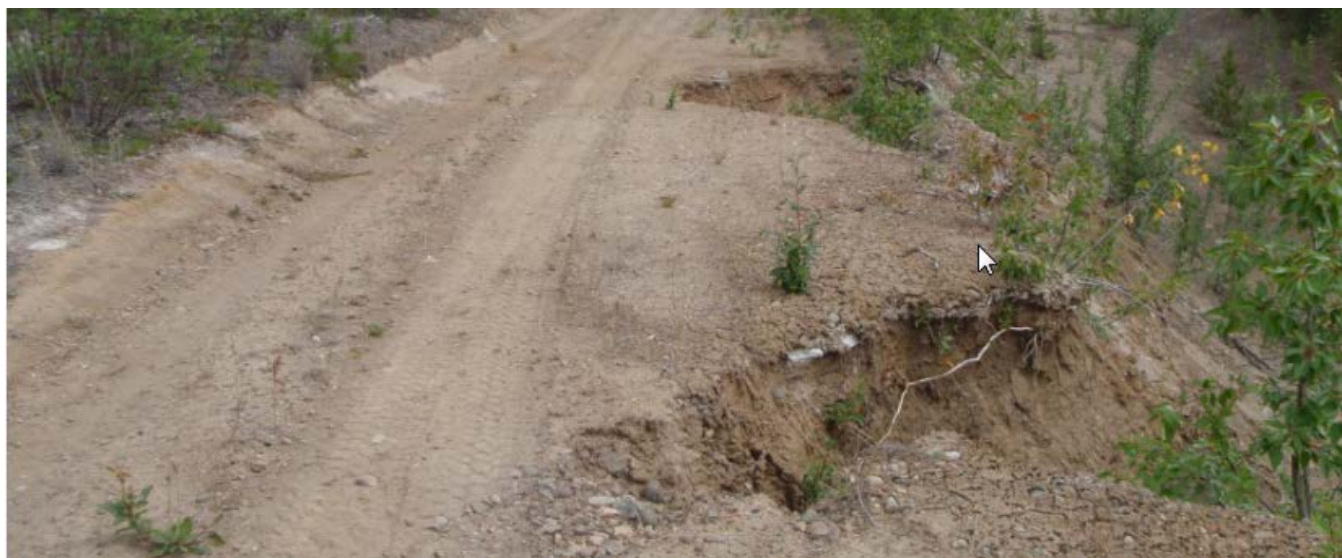
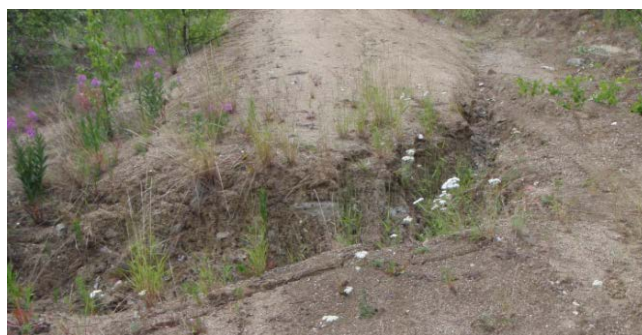
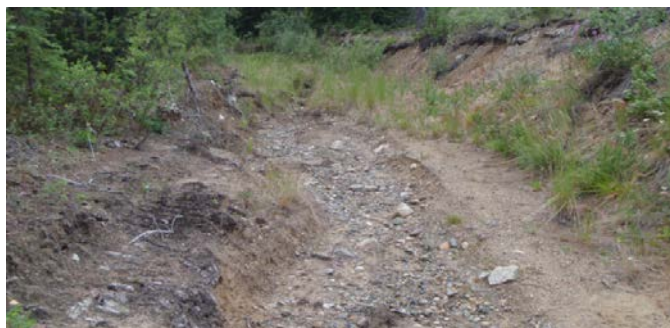
Erosion on roads due to run-off continues, developing gullies of approximately 30 cm depth in the roads to the east and west of the existing camp, and on the access roads in the areas of the Heap Leach Facility and the Waste Rock Storage Area. Larger eroded areas or wash-outs to approximately 60 cm depth were observed on access roads near the area of the Heap Leach Facility, near North Williams Creek, and near Williams Creek.

Photographs 18 to 20: Erosion on site drill pad access roads, in footprint of proposed locations of HLF (top), near HLF confining embankment (bottom left), and near HLF sediment pond (bottom right).

- Maintenance of the culvert on the main access road immediately north of the proposed Waste Rock Storage Facility.
- Filling and grading of the washouts on access roads in the Heap Leach Facility and Waste Rock Storage Facility areas.

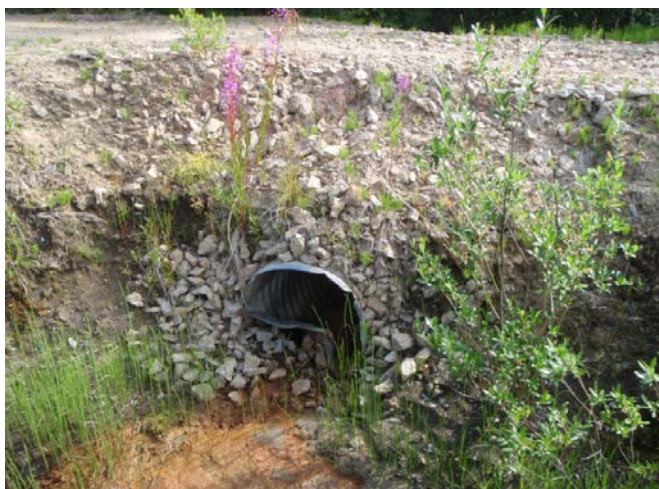
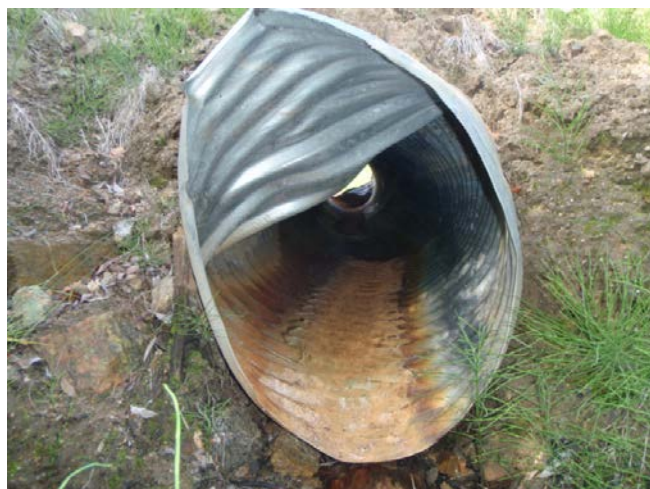
The present access road crossing at North Williams Creek was also inspected. Local erosion on the main access road to the north of the Waste Rock Storage Area continues. The shoulders of the road at the culvert on North Williams Creek have eroded, reducing the road crest width at the culvert location. The road is washed out approximately 30 m past the culvert, and recent flow has further developed the wash-out. A ponded area adjacent to the road is anticipated to have temporarily flowed over and eroded the road fill due to reduced flow in the culvert near this location. The inlet and outlet of the culvert were observed to be bent. It is recommended that the culvert mouth be reshaped or opened to allow flow at capacity. The eroded area on the road should be filled with gravel to level the grade and re-establish the road.

Photographs 21 and 22: Inlet (left) and outlet (right) of culvert on main access road crossing of North Williams Creek located north of the Waste Rock Storage Area.

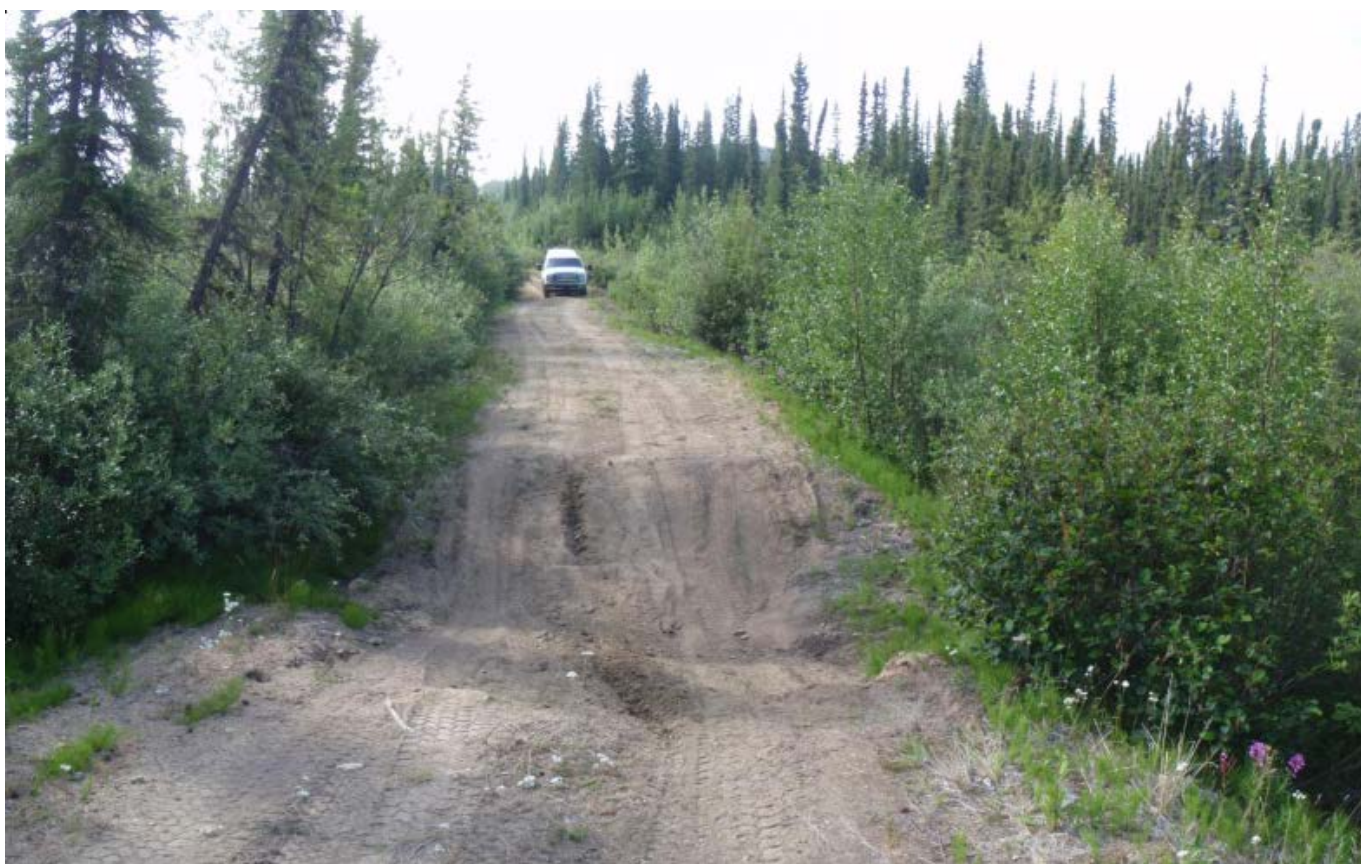
Photograph 23: North Williams Creek crossing – erosion to east of culvert location.

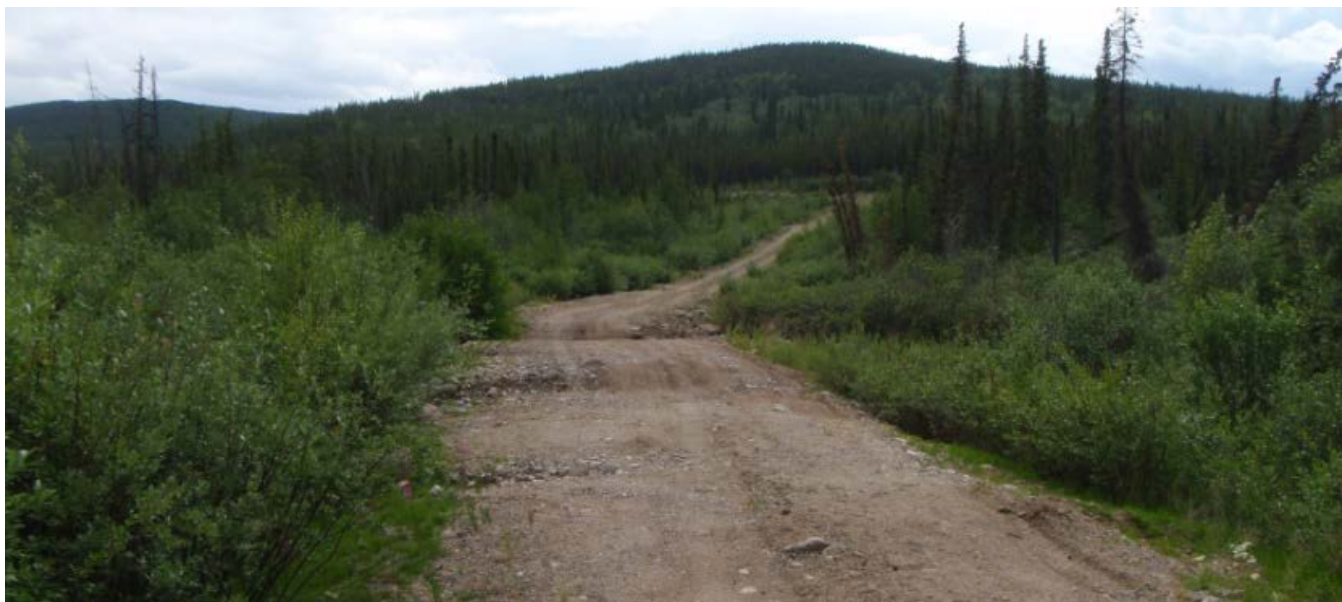
The culvert in the site access road which allowed Williams Creek to flow under the road was recently removed. The crossing is now a 'ford' with the road bed depressed over a length of 10 m to a maximum depth of 0.8 m below the adjacent road grade or crest elevation. Flow has eroded the road in several locations adjacent the constructed ford, and the rockfill in the ford has been flushed of finer materials. Ponded water was observed on the upstream side of the road, with flow across the road.

Photograph 24: View of access road crossing of Williams Creek looking south.

- Re-installation of the culvert or addition of rip rap to restore the site access road crossing of Williams Creek. The road embankment should be armored against erosion at the crossing location.

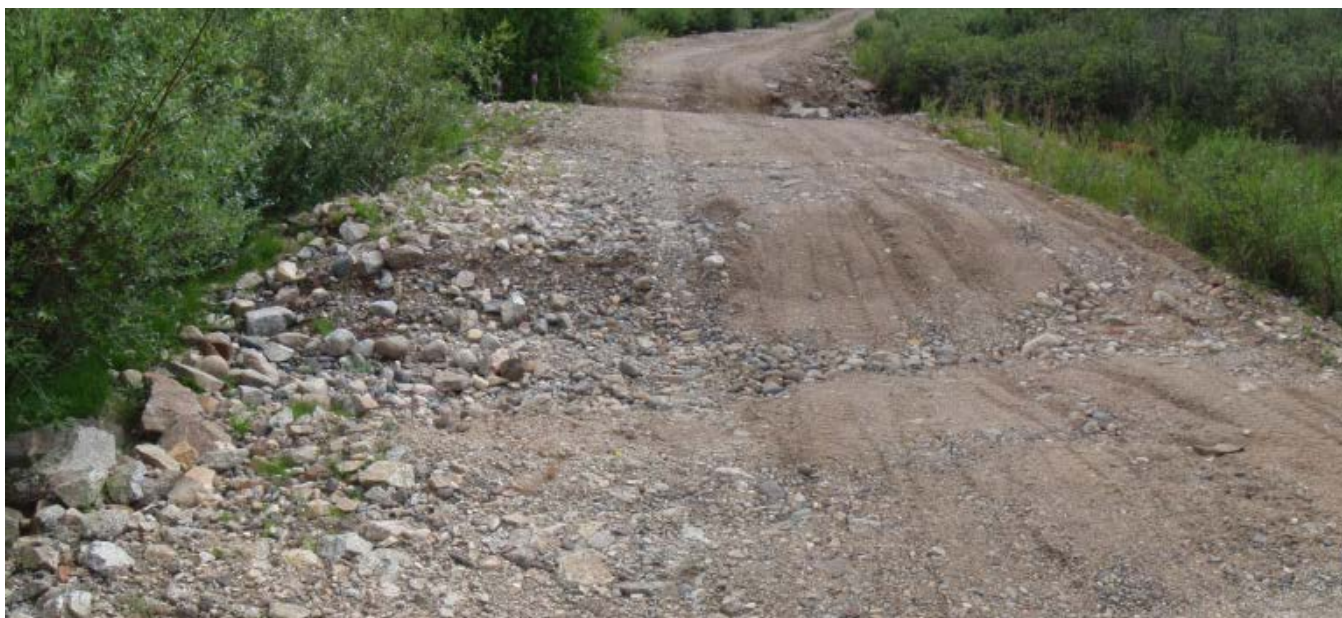
Without further erosion protection, it is anticipated that the general fill of the roadbed at Williams Creek will erode at the crossing location during high flow events. The 'ford' should be upgraded to operate through next spring.

Photographs 25: View of erosion on access road crossing of Williams Creek, north of constructed ford, looking south.

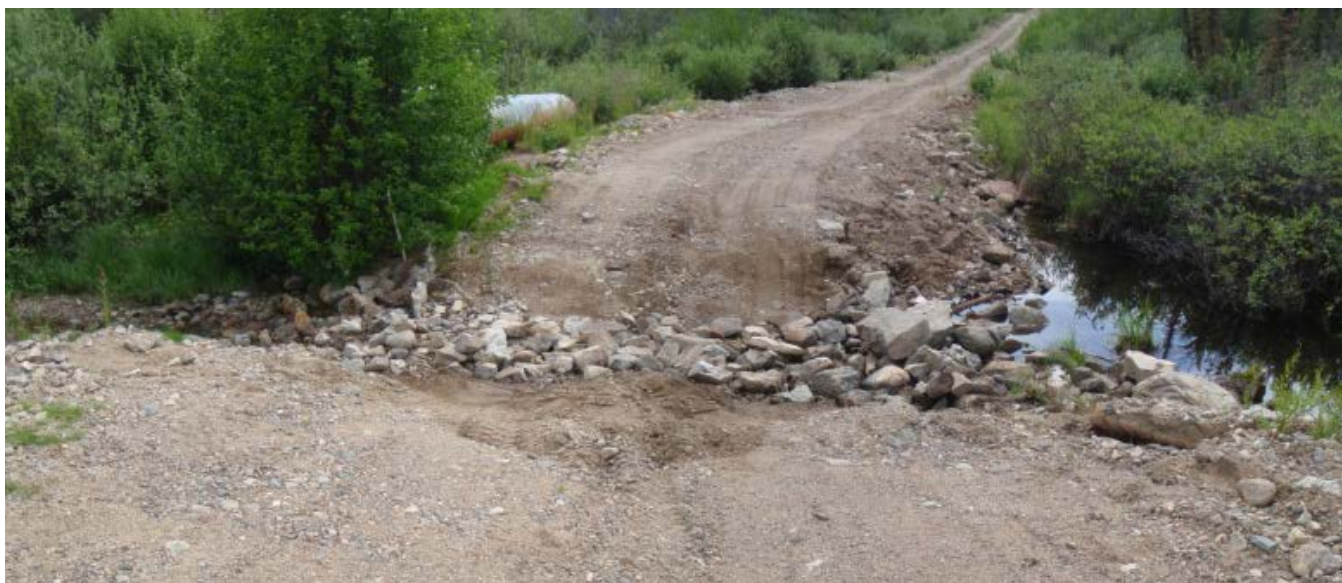
Photograph 26: View of constructed ford on access road at Williams Creek, looking south.

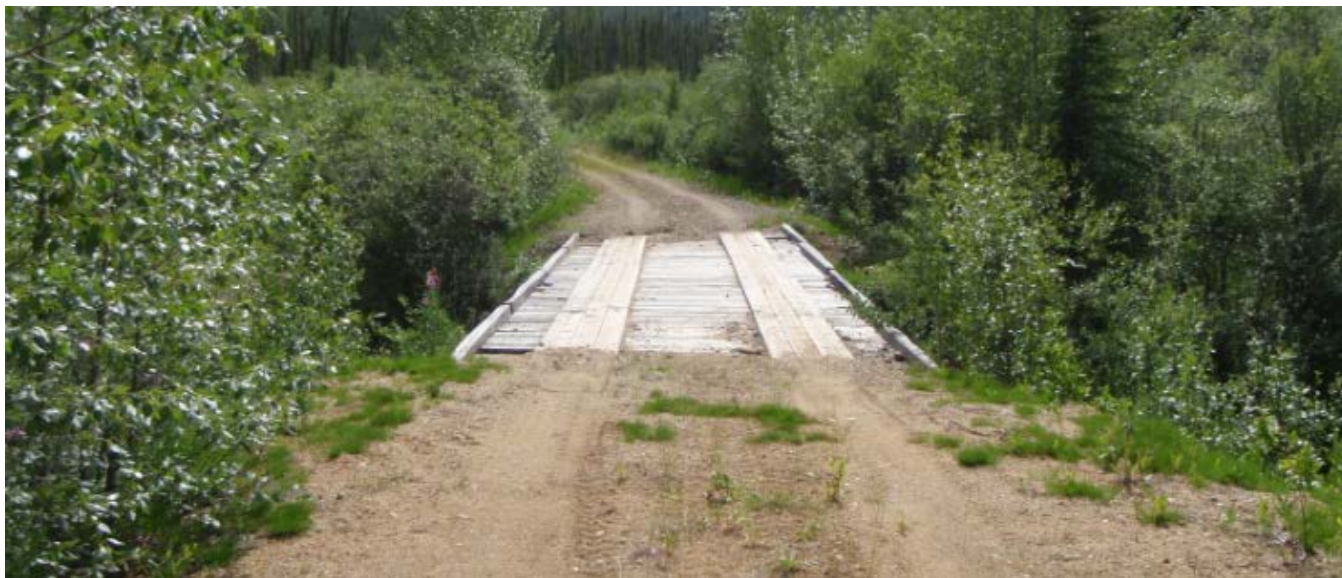
The access road crossing at Merrice Creek includes a single span bridge set on grade. No steelwork or abutment foundations were observed. In July 2012, the creek banks were being eroded and under cut at the crossing location. Scott Casselman reported that the bridge span was re-set on July 10, 2013, following recommendations in the July 2012 inspection memorandum. The abutment on the Village of Carmacks side of the bridge was reportedly leveled, or cut down, and then the span dragged back and re-set. During the July 2013 inspection the length of span seated on the Village side abutment was 0.5 to 0.75. The slope of the ground at the abutment immediately under the span at this location was observed to be over-steepened, approximately 1 horizontal to 2 vertical. The measures to stabilize the span therefore appear temporary and it is anticipated that the bridge will have to be re-set again in 2014 or in 2015. During the July 2014 inspection the decking on the bridge had been broken through, and the bridge was marked and flagged to warn motorists against use of the bridge.

Photograph 27: Site access road crossing of Merrice Creek, view in direction of the Village of Carmacks.

- Repair of the bridge crossing at Merrice Creek. The bridge should be removed from service until the abutment on the Village of Carmacks side can be restored and armoured against further erosion, the deck repaired, and the bridge reset. Alternatively, the bridge could be replaced with a longer span.

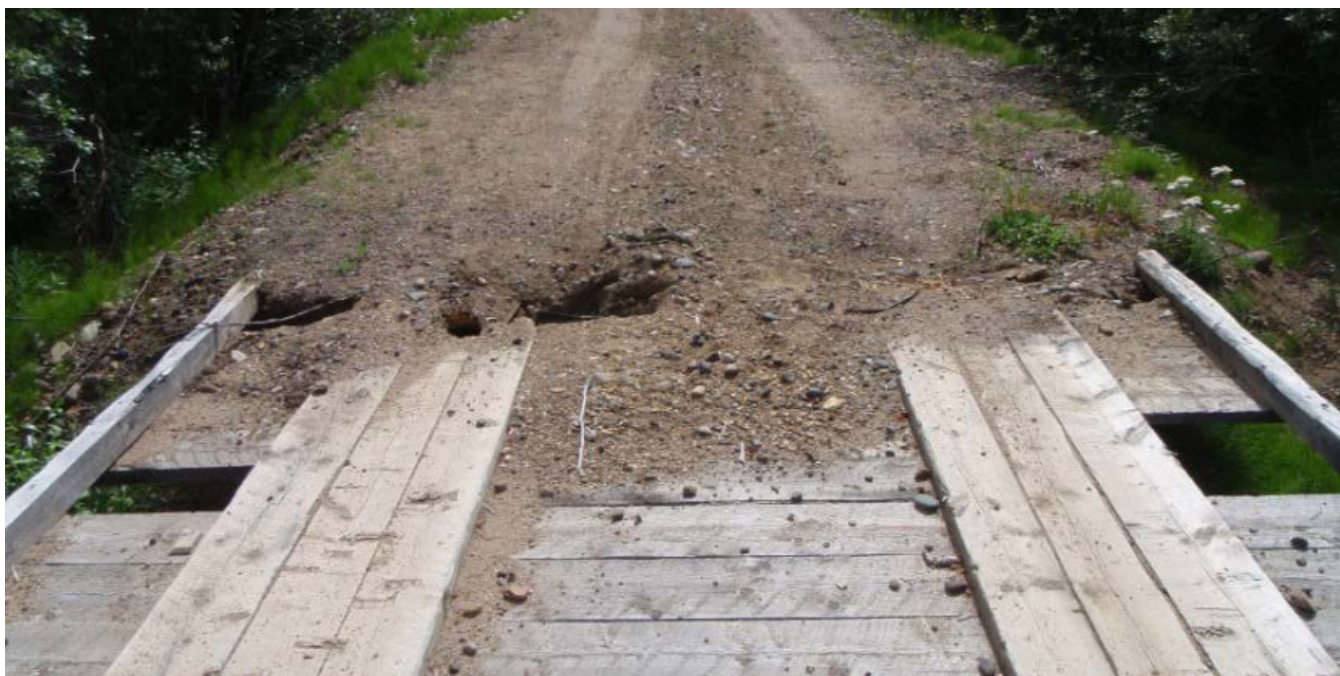
Photograph 28: Site access road crossing of Merrice Creek, view of bridge deck at abutment nearest to the Village of Carmacks.

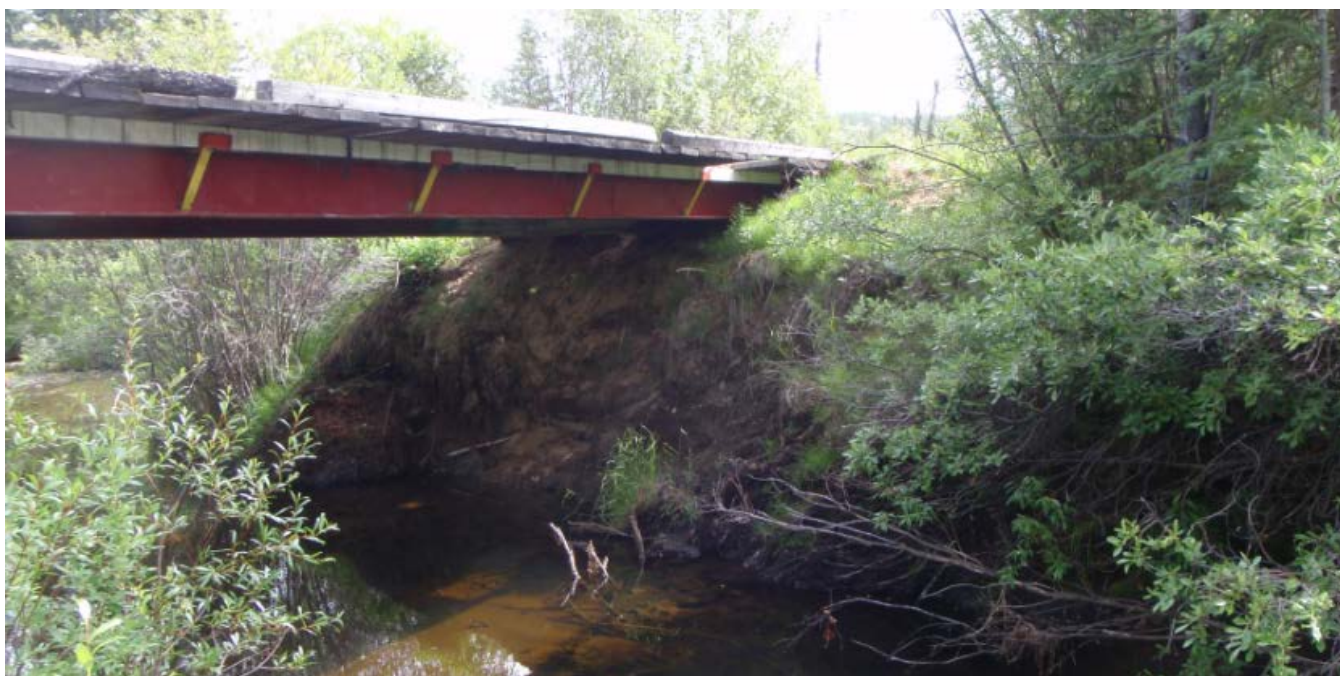
Photograph 29: Site access road crossing of Merrice Creek, view of bridge abutment nearest to the Village of Carmacks.
