October 27, 2017

Project No. 1786033_LT0001_Rev0

2017 ANNUAL INSPECTION OF THE CARMACKS COPPER PROJECT, CARMACKS, YUKON

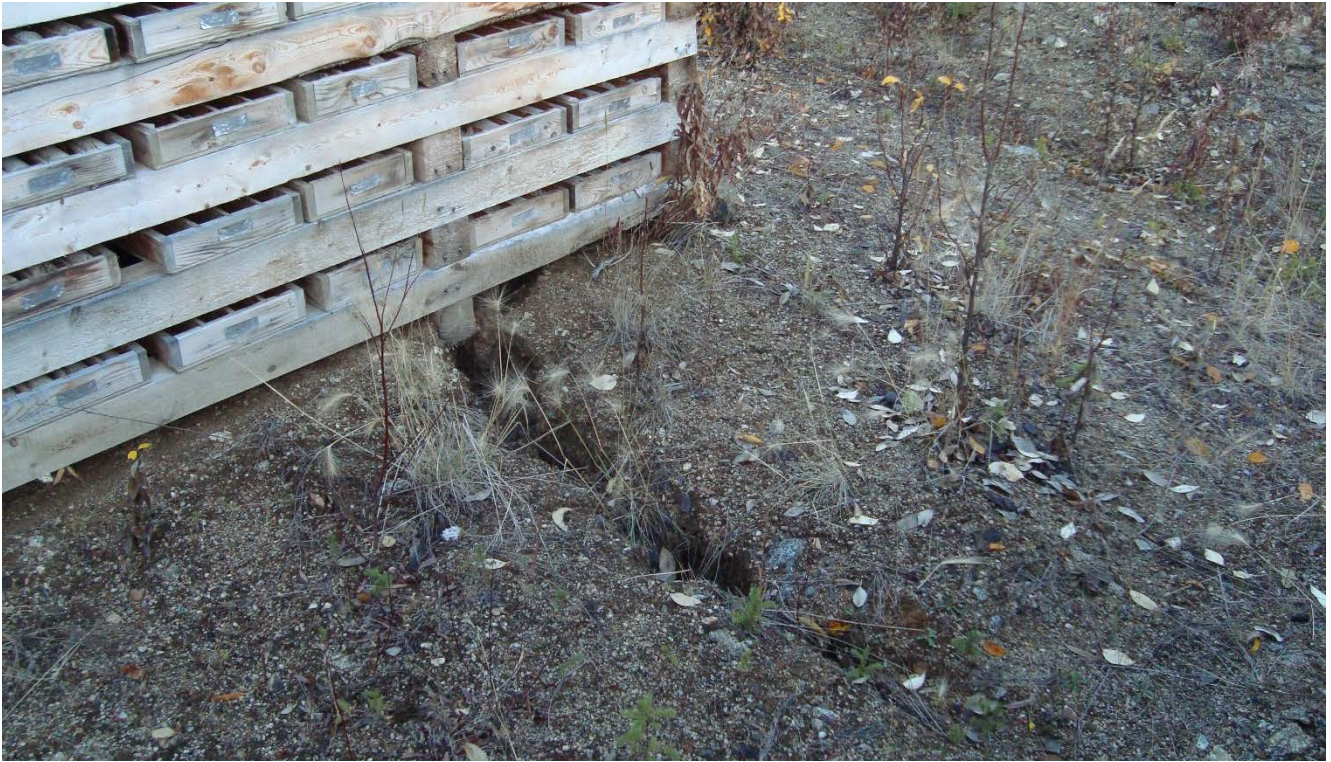
In previous years, inspections of the camp area have noted the presence of cracking, most likely resulting from thaw induced settlement beneath and adjacent to core storage racks. During the current inspection, only one crack was observed in the vicinity of the core storage racks (Photograph 1). In general, the appearance of cracks in the core storage rack area was consistent with the 2016 inspection. There appears to have been some infilling of cracks observed during previous inspections. The area is also characterised by the regrowth of vegetation around the core racks and a general decrease in the magnitude of settlements occurring with time. As in previous years, settlement in this area does not represent a safety concern and the inspection did not indicate erosion of sediments from the pad area into the surrounding natural area. Two new core racks have been constructed in 2017 and one was under construction at the time of the inspection (Photograph 2).

Photograph 1: Crack beneath core storage rack

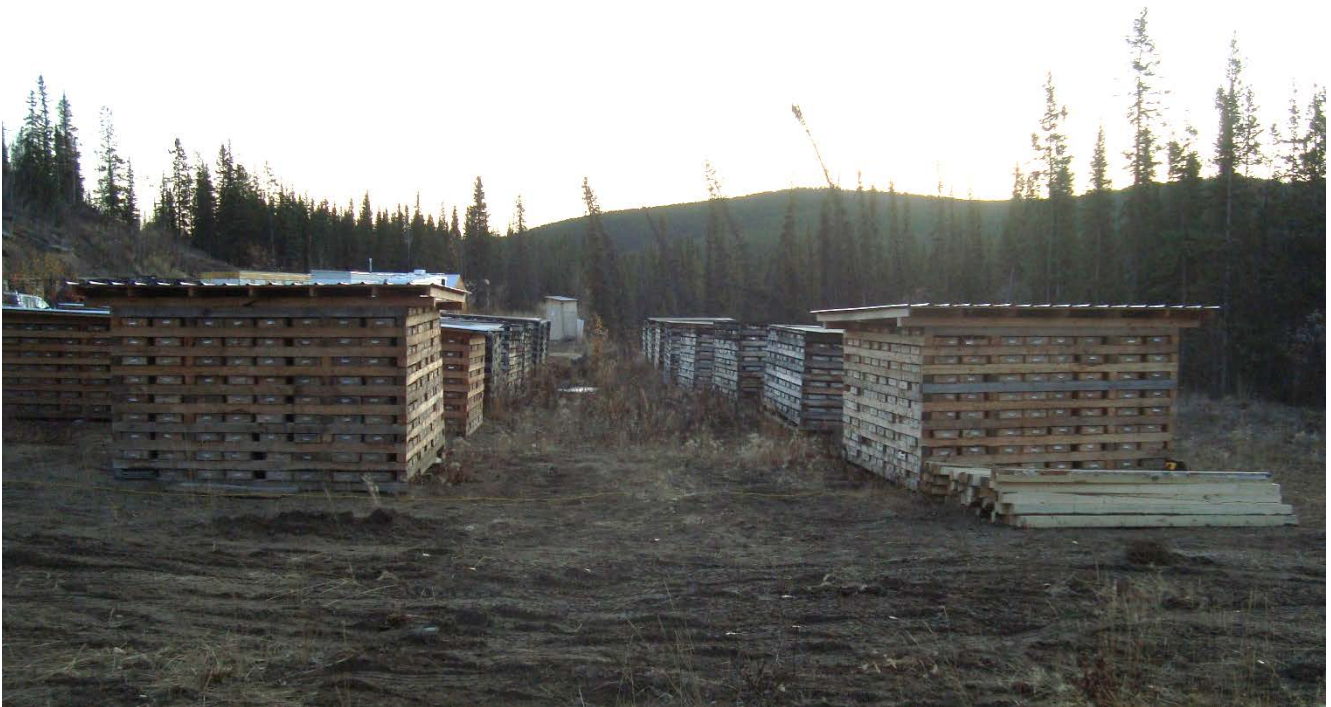
Photograph 2: Core storage racks

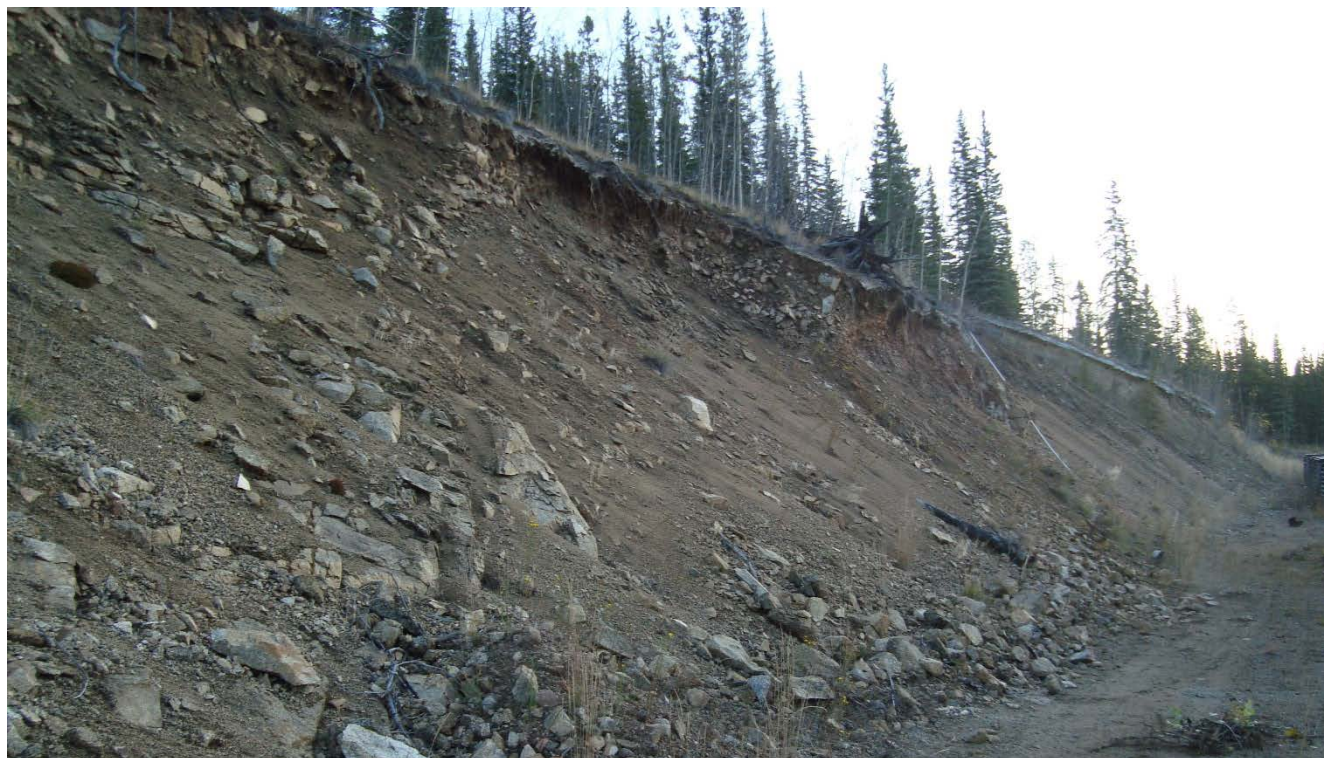
The slope behind the camp (Photograph 3) is stable and does not pose a safety concern for the camp structures or current operations. There is minor ravelling of small sections of the slope, but these are not impacting camp safety nor would they represent a risk for workers on the project. Some regrowth of vegetation was observed in the camp area.

Photograph 3: Cut-slope behind camp

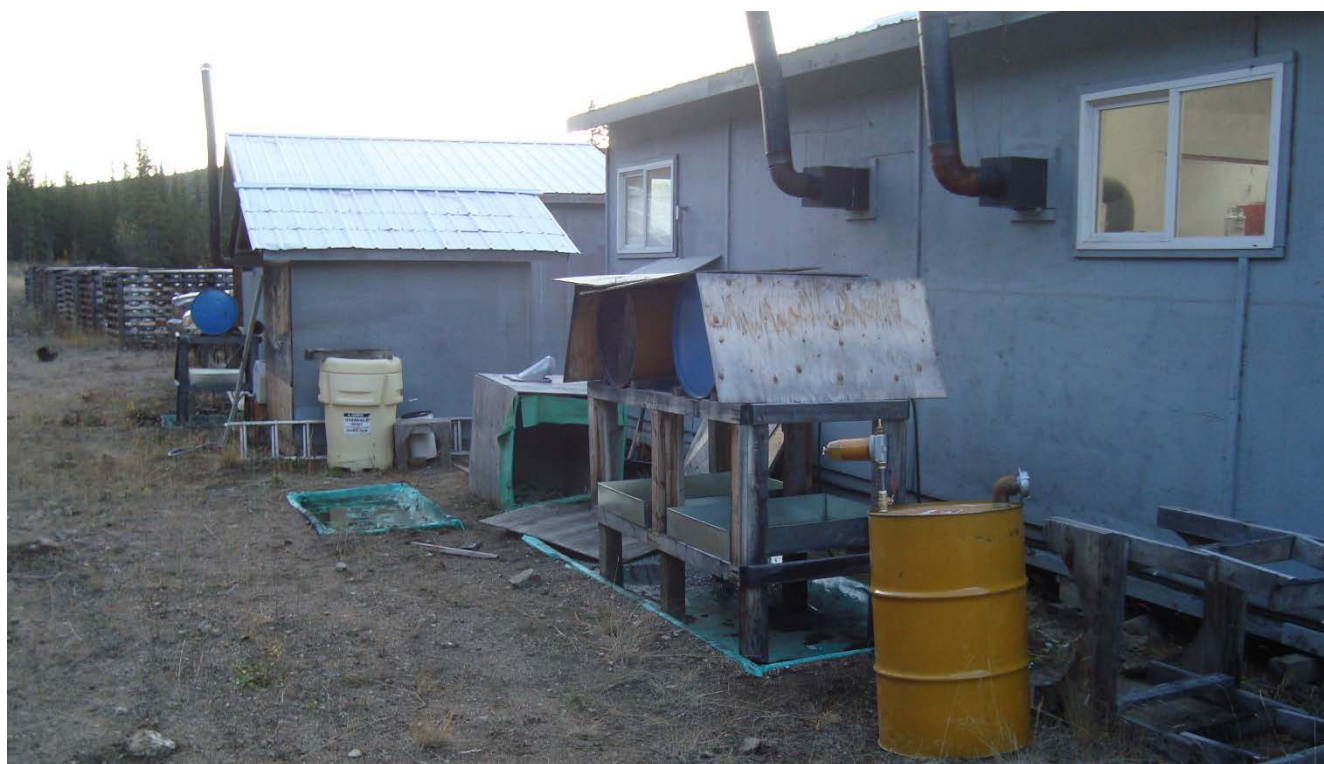
There are two heated buildings, the core shack (foreground) and geology office (background), located adjacent to the core storage racks (Photograph 4). The tanks, valves and hosing were in a satisfactory condition at the time of inspection. Liners have been placed beneath each tank to act as secondary containment for potential leaks and were in a satisfactory condition.

Photograph 4: Core logging shacks

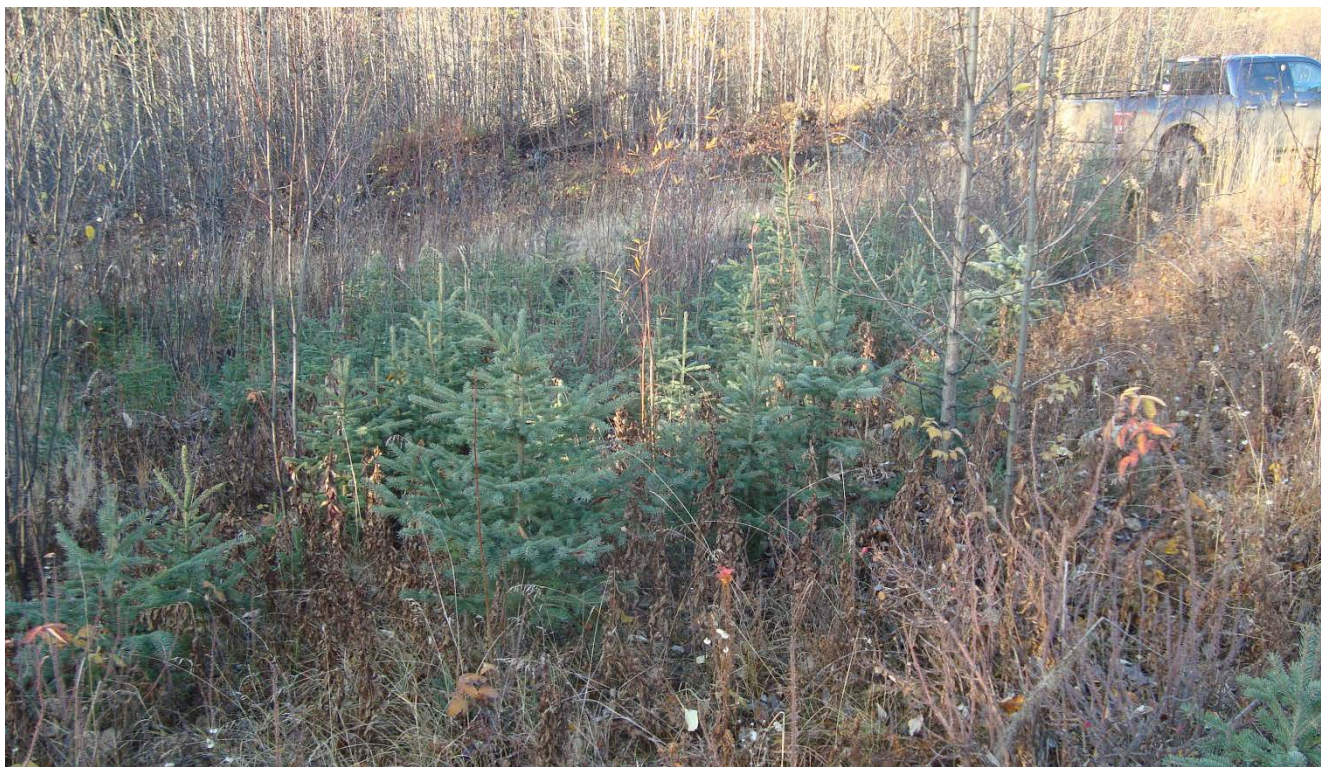
Since the initial clearing in 1997 and 1998, regrowth of vegetation has been occurring in the area. Small coniferous trees, approximately 1 m in height, are established throughout this area (Photograph 5). Erosion and sediment control measures in this area were initially installed in September 2008 and further maintained in September 2009 and August 2010. The sediment control measures include ditches and berms to divert water into sediment catch basins, silt fences, and vegetated areas to break up flow and reduce the potential for erosion. There continues to be some minor erosion of sediments along the access roads, however, this appears to be attenuating as vegetation growth on the access roads increases (Photographs 6 and 7). Sediment basins and controls are functioning adequately in areas that have seen no new activity.

Photograph 5: Vegetation regrowth in area of proposed heap leach pad facility

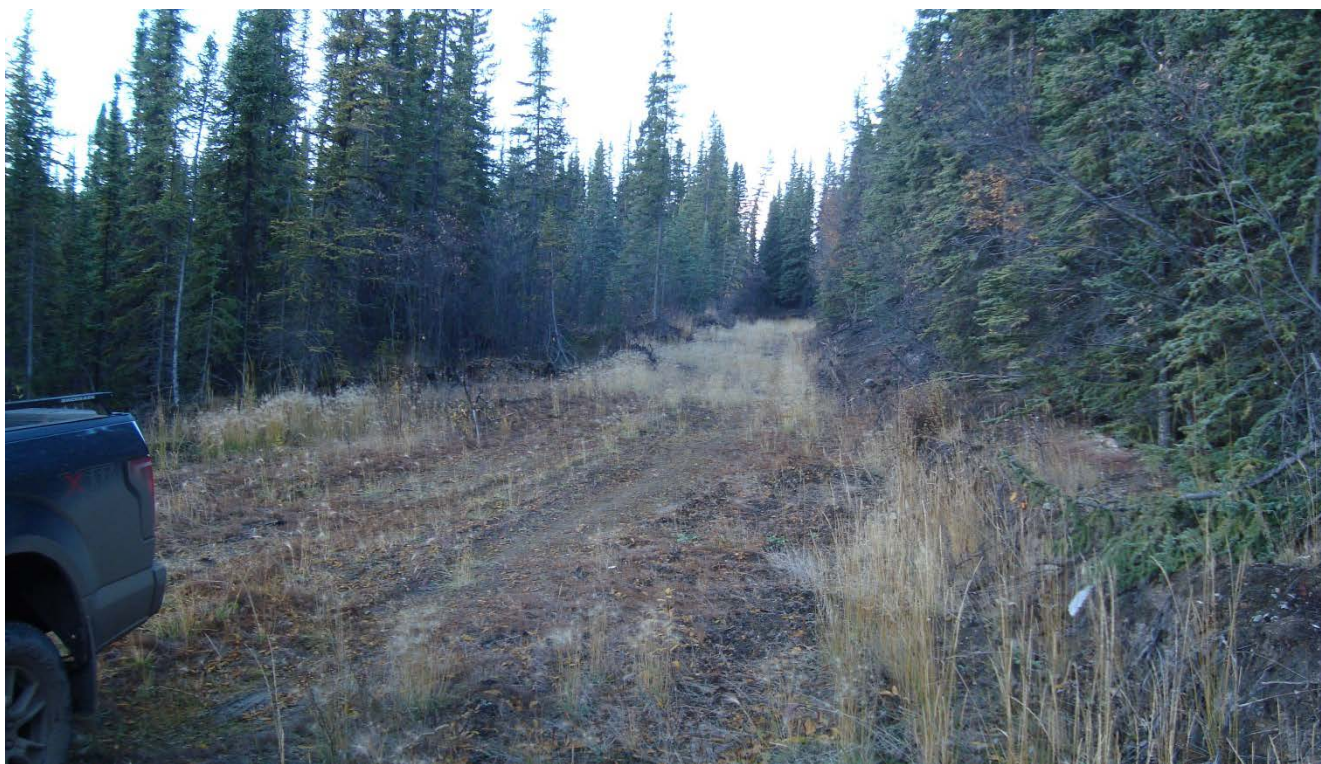
Photograph 6: Vegetation regrowth on access roads

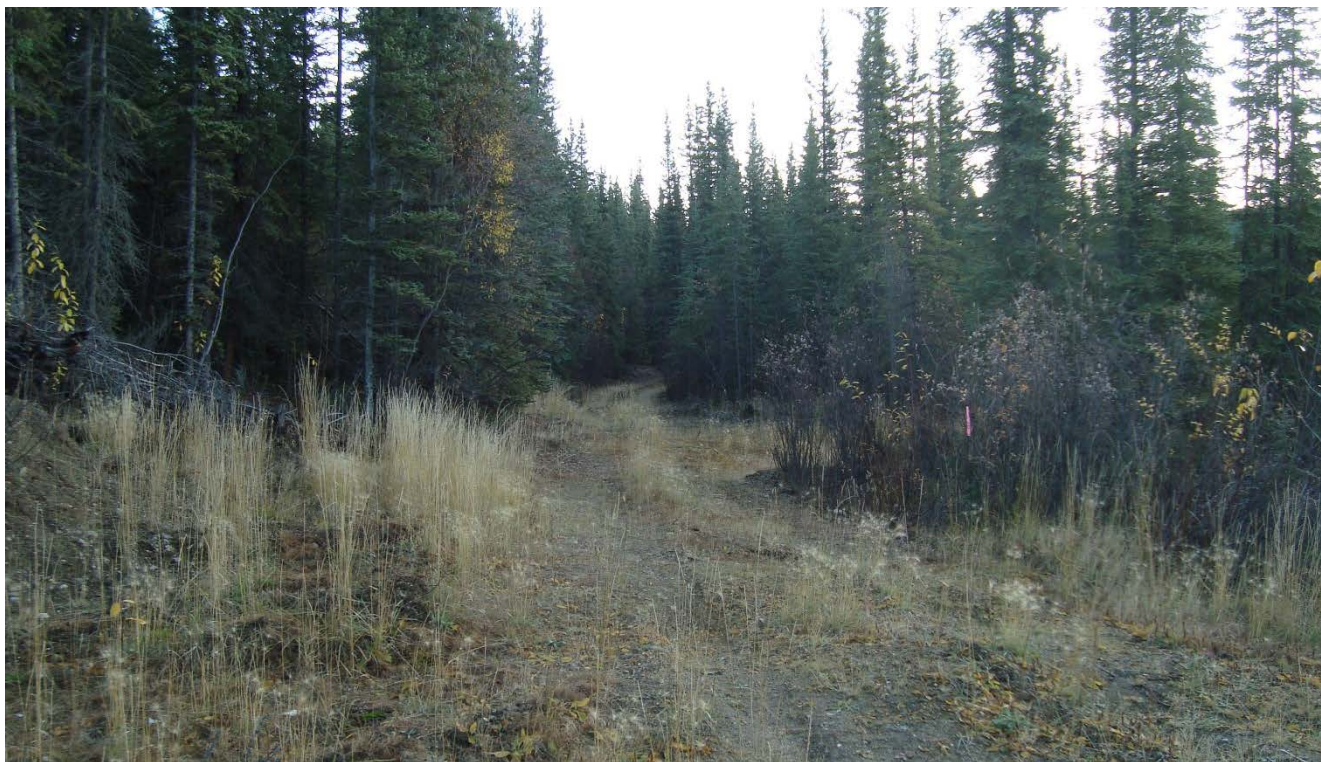
Photograph 7: Vegetation regrowth on access roads

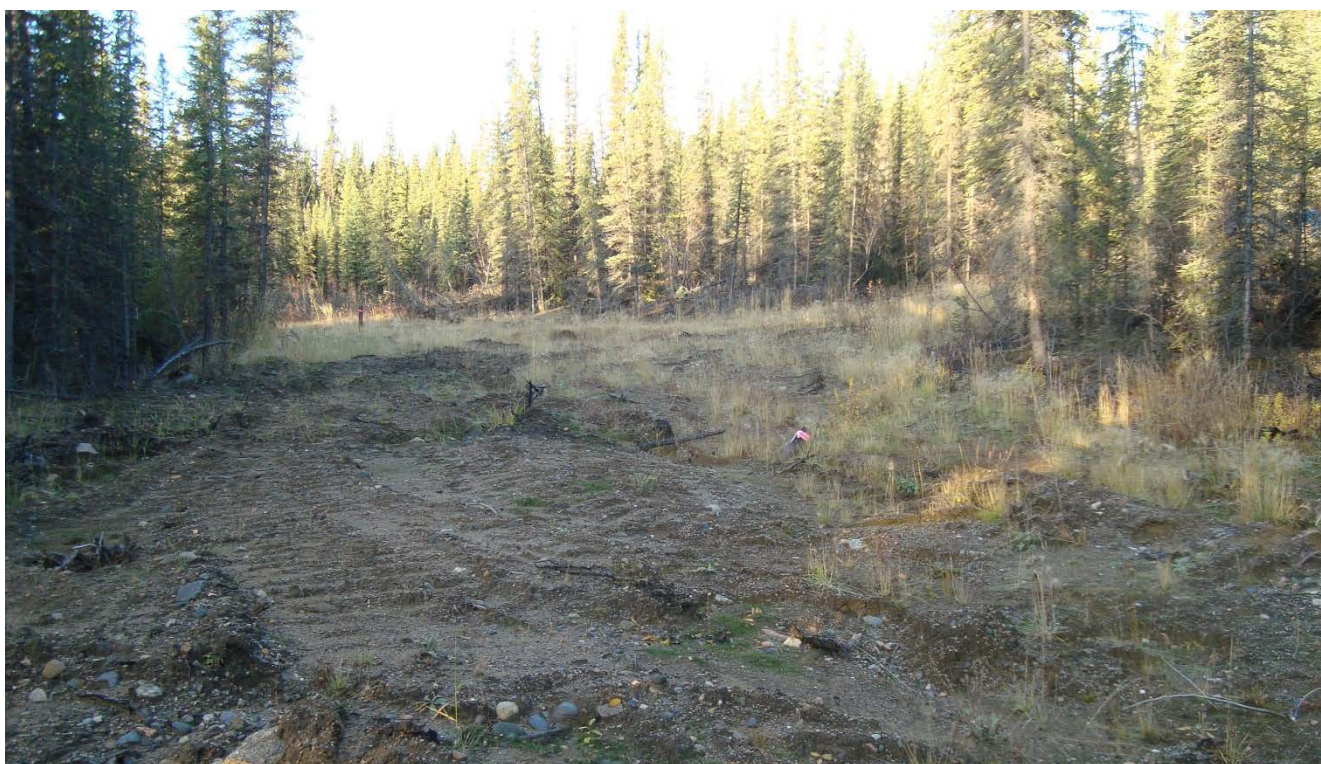
Clearing and drilling activities were carried out in 2015 and 2016 at a location down slope of the proposed heap leach facility, near the proposed water management pond (Photograph 8). Regrowth of vegetation, primarily volunteer species of grass, has mitigated loss of sediment from the former drill pads and is suitably rehabilitating.

Photograph 8: Vegetation regrowth on former drill pad

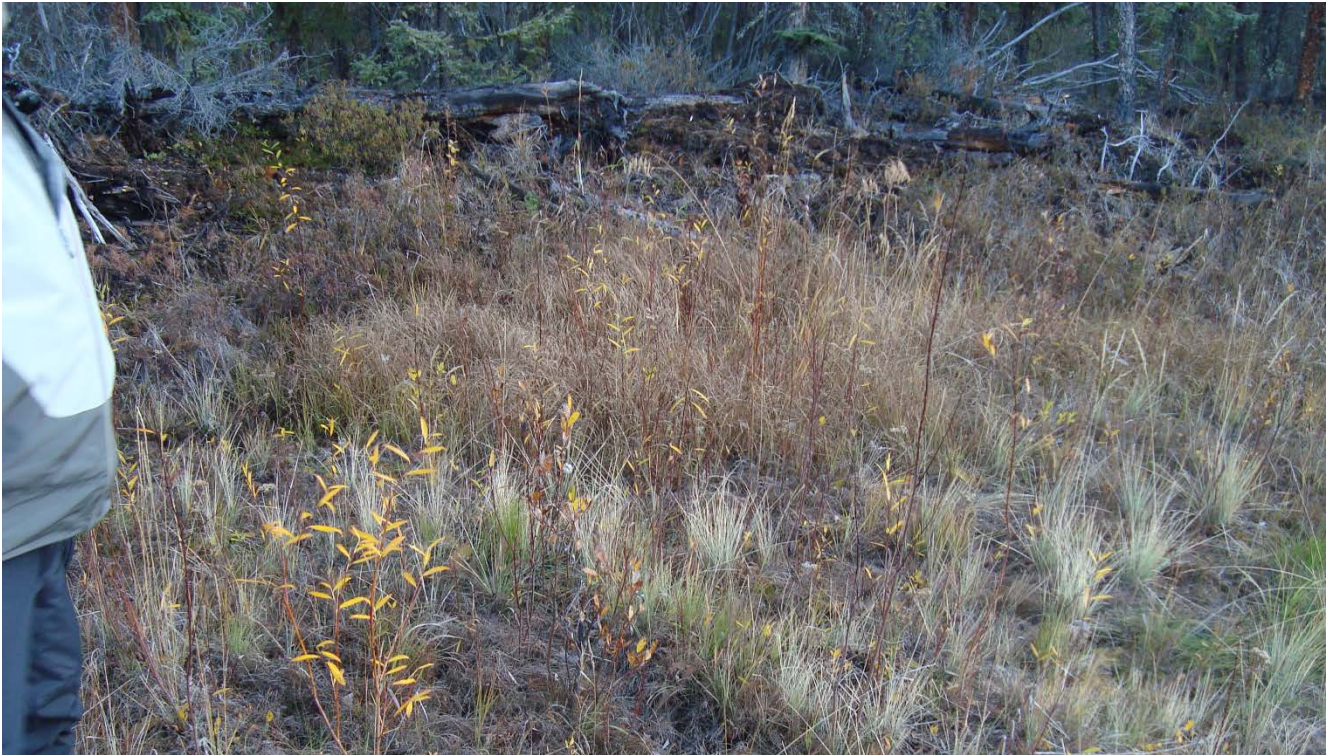
Further downstream, within the floodplain of Williams Creek, silt fences have been installed and the area seeded where sediment from previous site erosion accumulated (Photographs 9 and 10). Grass seed was applied in 2009 to promote the re-establishment of vegetation and to further stabilize sediment. The approach was noted to be generally effective in 2011 and 2012, but with limited regrowth attributed to periodic pooling of water. The area was also re-vegetated with woody plants (willow cuttings), and these plants are now well established. Volunteer species of grass and woody plants are performing very well. There was no evidence of sediment movement, indicating that re-vegetation has been effective in minimizing erosion. Silt fencing surrounding these areas is now overgrown and there is no evidence of sediment movement through the area. Silt fences are typically a temporary measure and could be removed if no further disturbance is expected upstream.

Photograph 9: Vegetation regrowth in Williams Creek floodplain

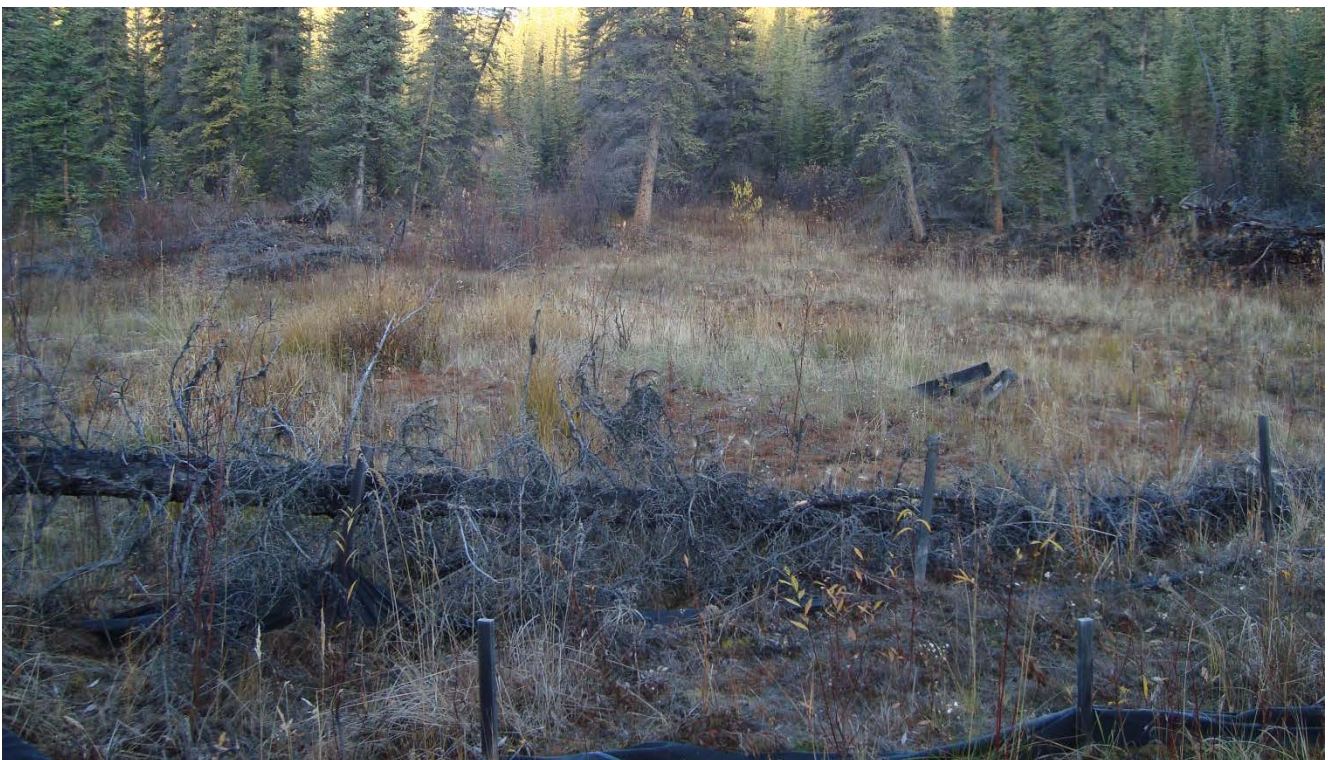
Photograph 10: Vegetation growth around sediment fencing

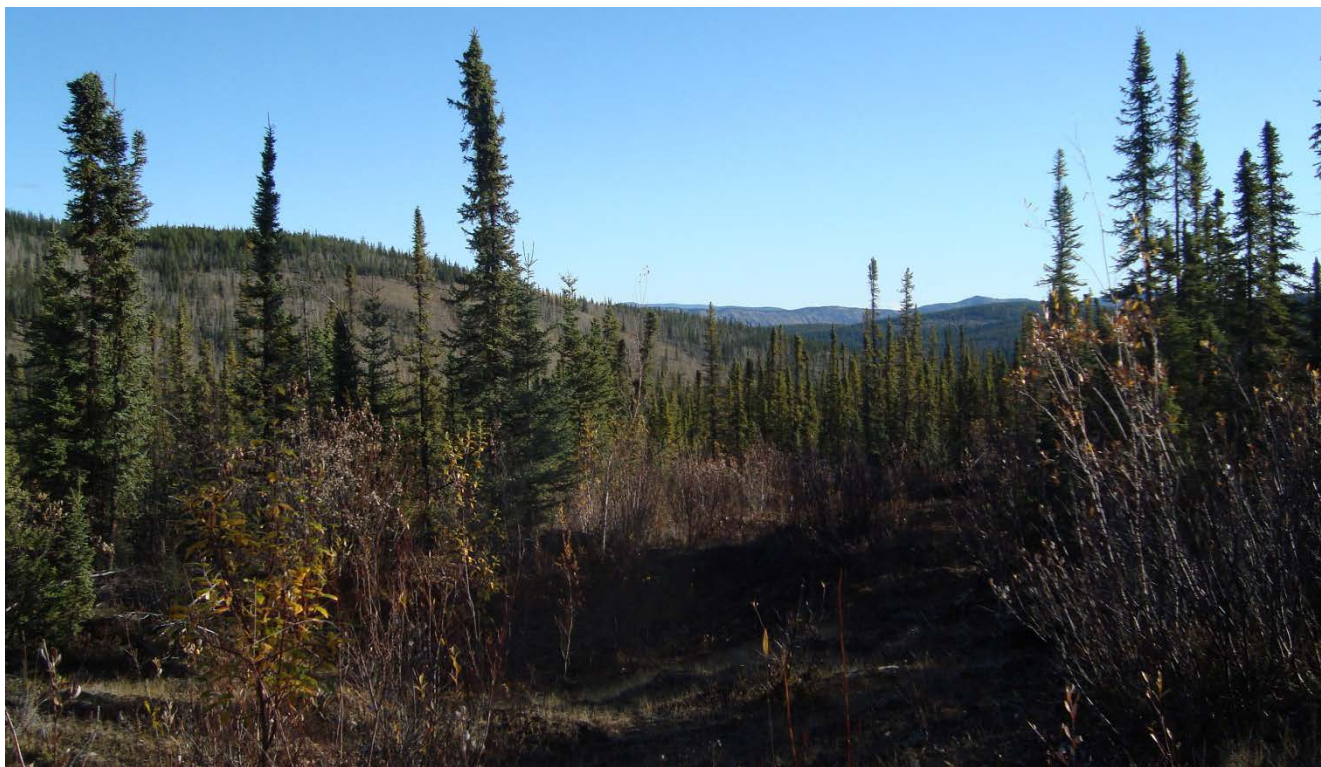
The proposed waste rock storage area was inspected. The waste rock storage area is tree covered and the drill pads and access roads in the area are re-vegetating by volunteer species to the extent that access on foot is now difficult (Photograph 11).

Photograph 11: Vegetation regrowth on access road in proposed waste rock storage area

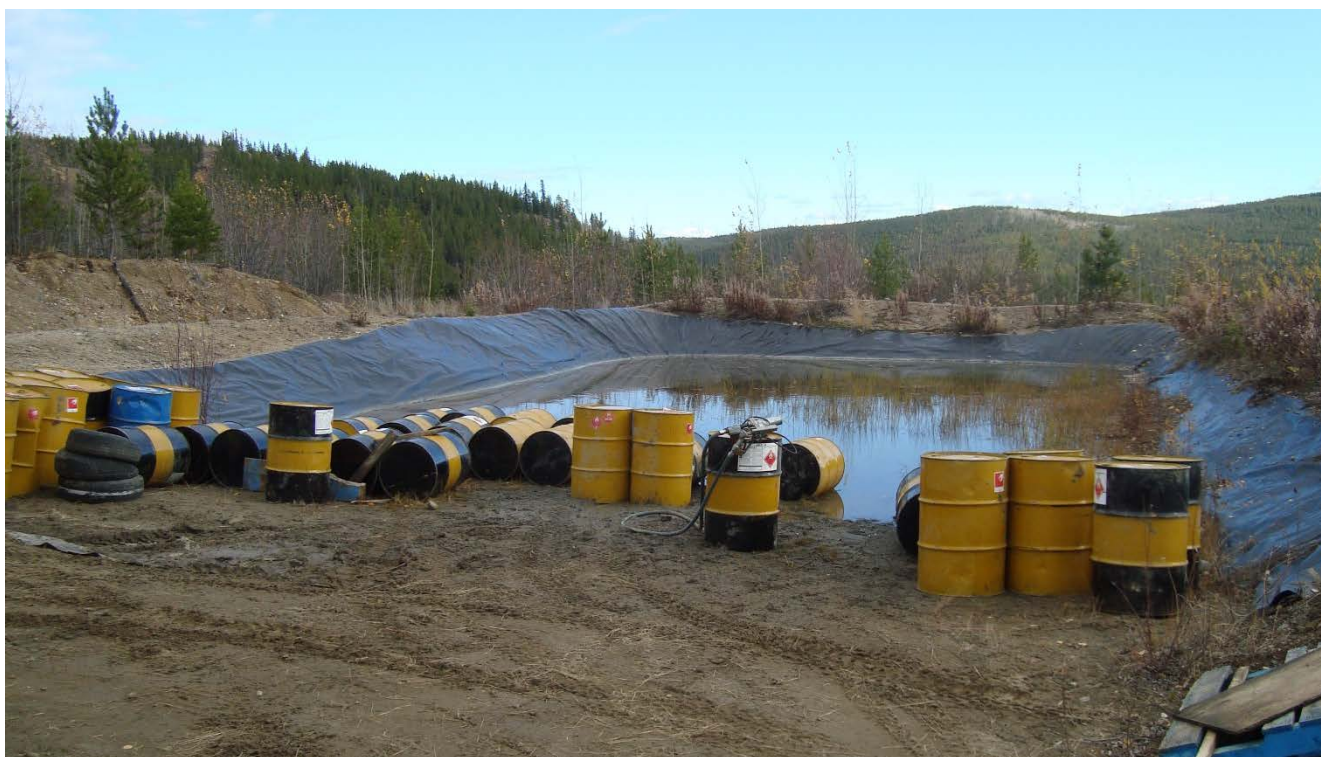
The fuel storage area was inspected. The fuel storage area comprises a bunded and lined basin constructed to contain any spilled fuel and currently a few dozen drums of diesel fuel. After several days of rain prior to the inspection, approximately 0.3 m of water had accumulated in the basin (Photograph 12). The bund is less than 3 m in height and the basin capacity is less than 10,000 m³; therefore, the fuel storage area is appropriately permitted under the QML without need for a water license (Yukon Environment Dam Guide).

Photograph 12: Lined basin at fuel storage area

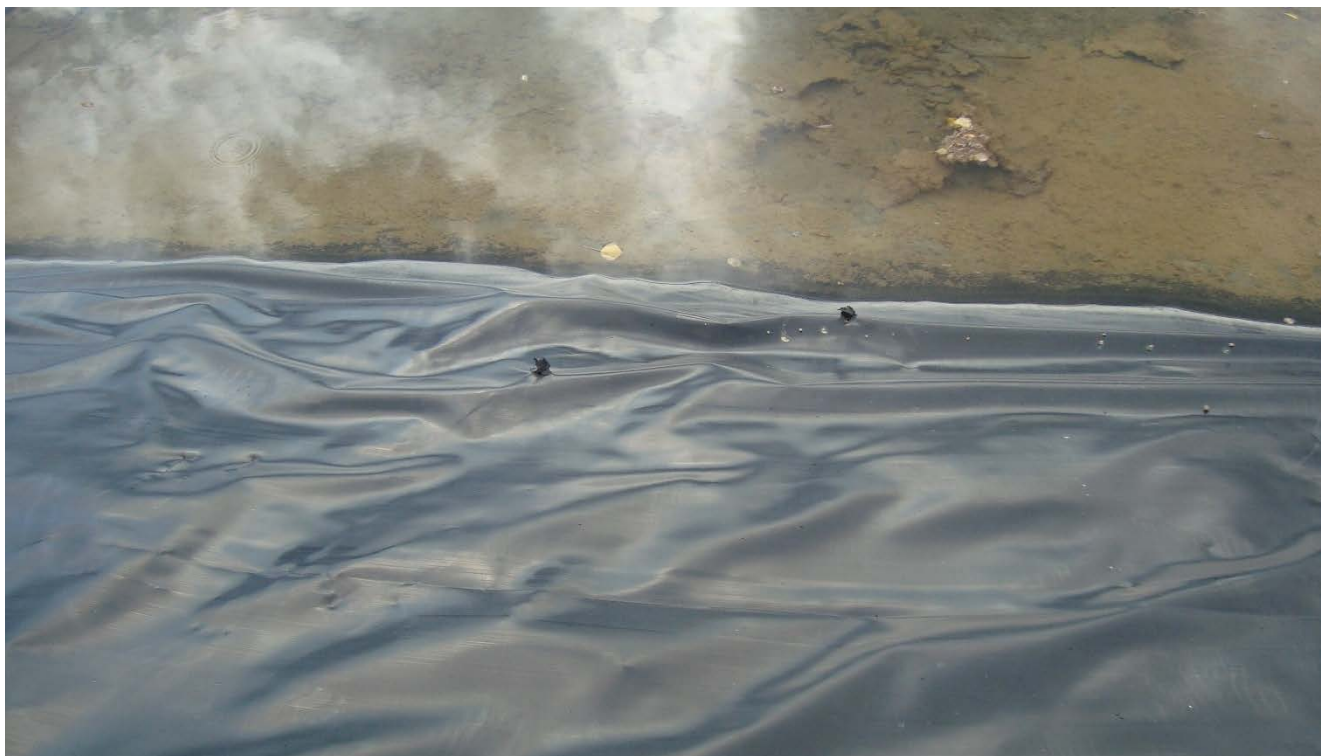
There was evidence that an animal had entered and exited the basin. The animal damaged the liner in a few locations (Photograph 13). The damage to the liner should be repaired. The fuel drums should be organized in a manner to allow wildlife egress from the basin.

Photograph 13: Liner damage at fuel storage area

- Water crossings, including the bridge abutments at Merrice Creek, should continue to be inspected annually and following major rainfall events. Minor maintenance should be carried out, as required to maintain the functionality and safety of these crossings.
- Controls should be implemented to manage runoff and sediment from the area of heavy traffic located in the area of North Williams Creek. The high traffic area should be regraded and repaired.
- The damage to the liner at the fuel storage area should be repaired. The fuel drums should be organized in a manner to allow access and egress for wildlife.

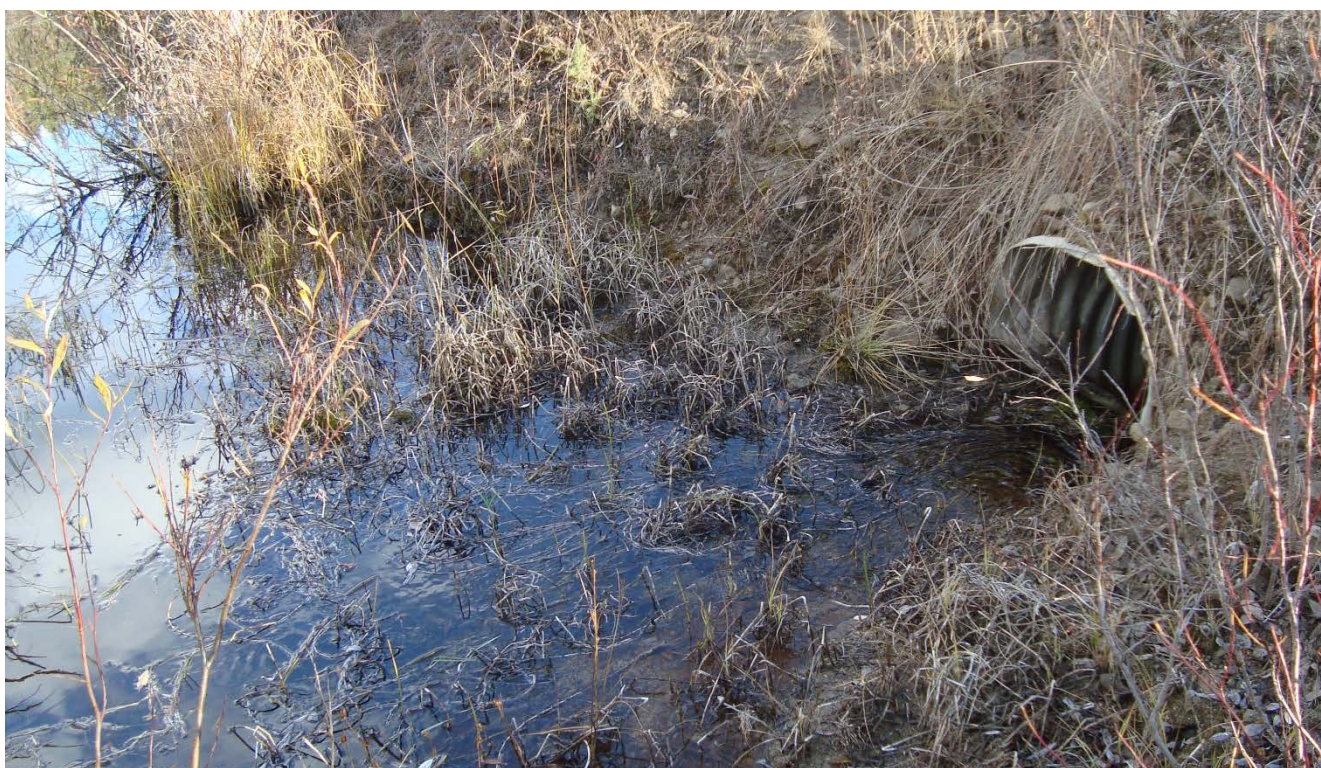
The main access road to the north of the waste rock storage area was observed to be in good condition with only minor erosion observed. Minor erosion of the road shoulders was observed near at the culvert on North Williams Creek. The culvert has undergone some crushing and has accumulated some sediment (Photograph 14). However, the culvert remains more than adequate to accommodate the relatively minor flows at this location. The access road should be inspected annually and ongoing maintenance of drainage features and erosion should be anticipated. The combination of recent rain and high traffic due to current drilling activities have resulted in a rutted, muddy area at the low point in the road near North Williams Creek (Photographs 15 and 16). The road in this area should be regraded and gravel placed, as required to improve trafficability at this location.

Photograph 14: Culvert beneath road at North Williams Creek

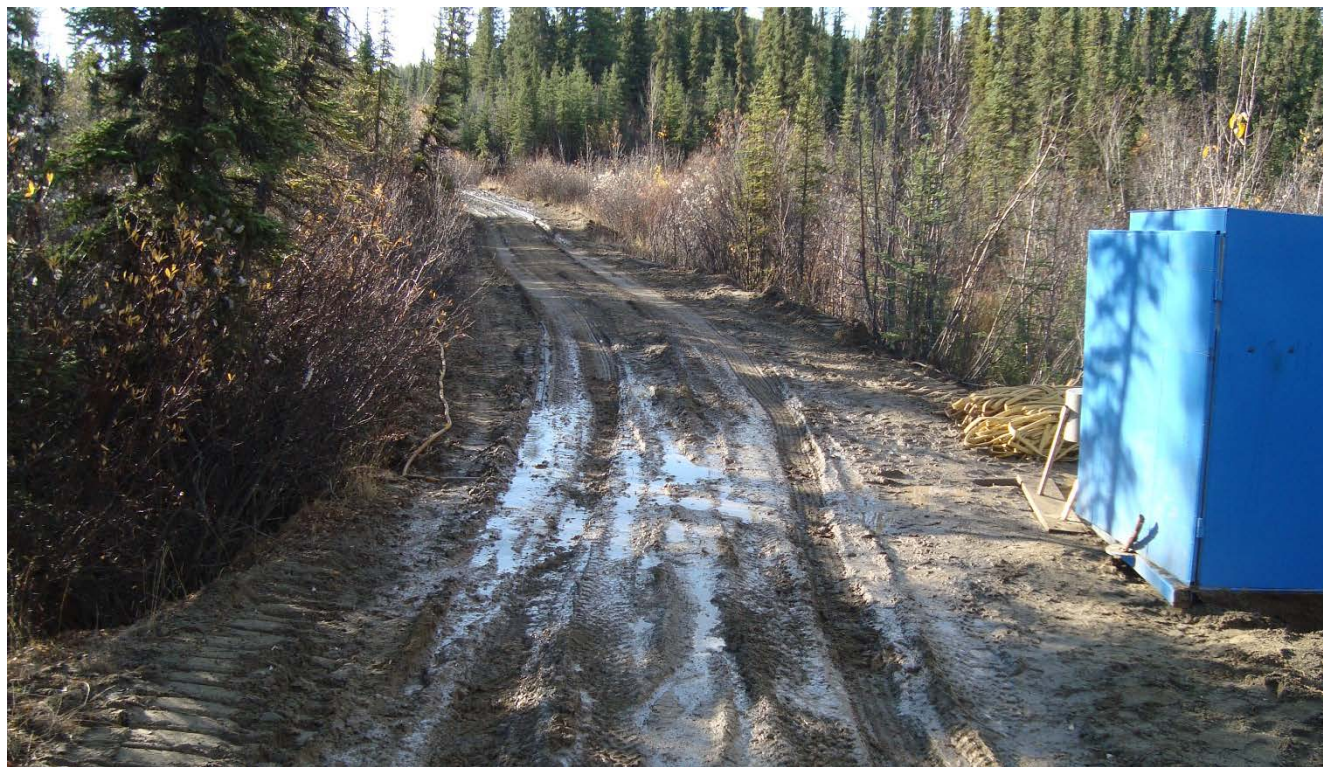
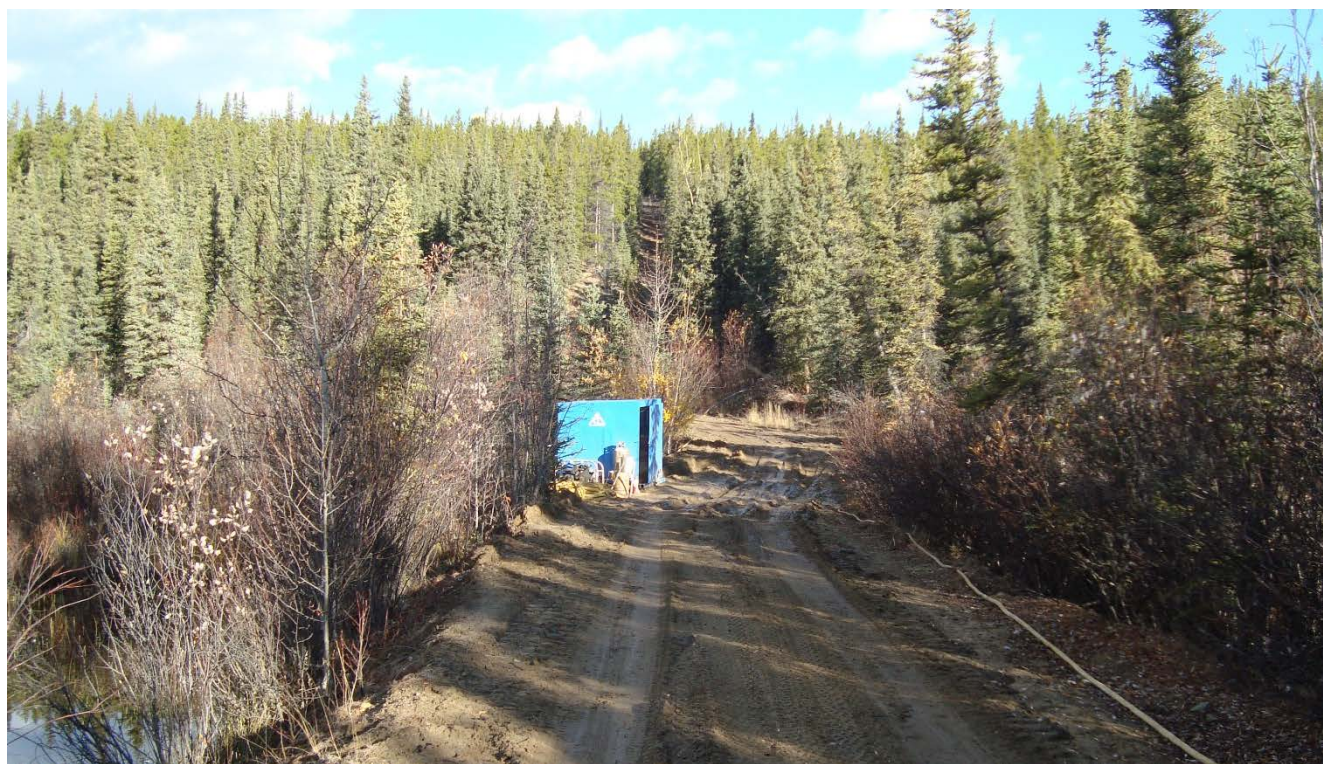
Photograph 15: High traffic area at North Williams Creek

Photograph 16: High traffic area at North Williams Creek

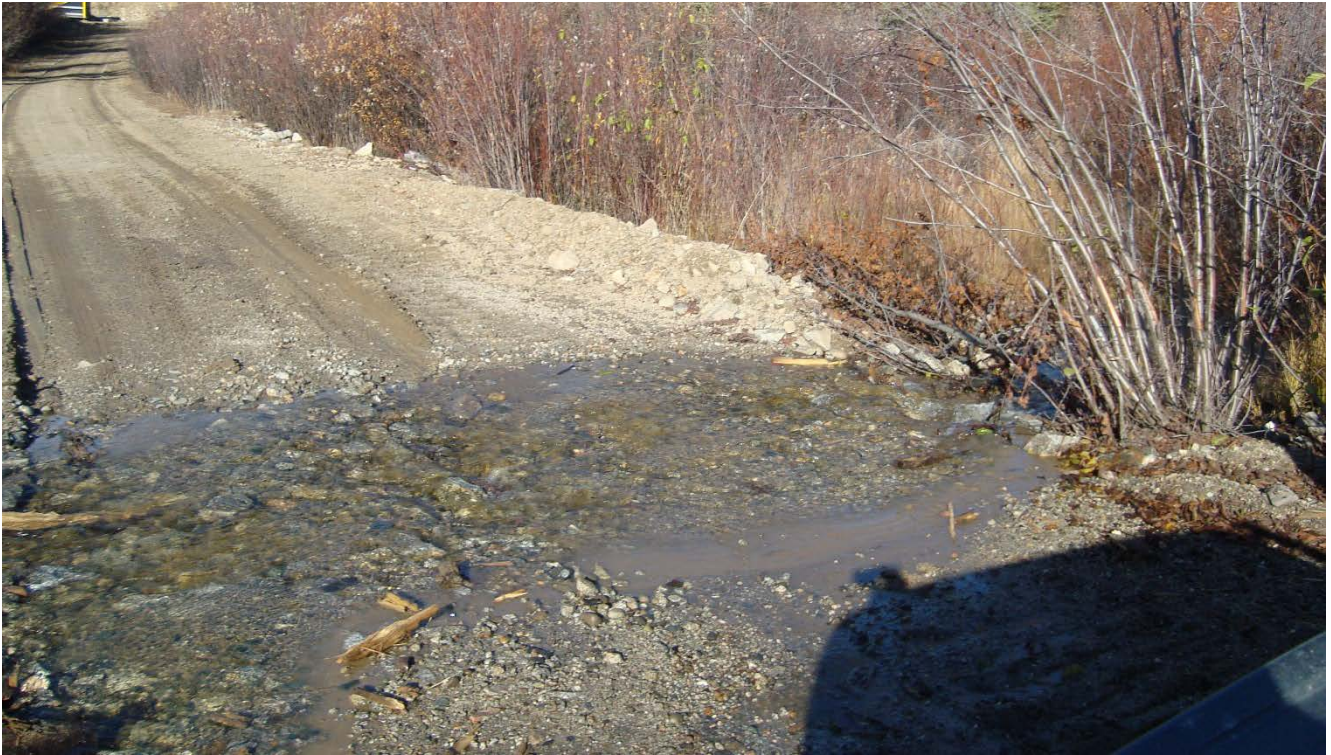
The ford road crossing installed at Williams Creek in 2013 continues to function as intended (Photograph 17). The rockfill in the ford is well-graded and there is no indication of movement of finer materials. Ponded water was observed on the upstream side of the road, with flow across the road. It is possible that a large rainfall event could result in erosion. We therefore recommended that the ford continue to be inspected annually and maintenance be carried out, if required. The ford is appropriate for the current status of the project. However, prior to site development, it is recommended that the culvert at the Williams Creek crossing is replaced and the access road armored against erosion at this location.

Photograph 17: Williams Creek crossing

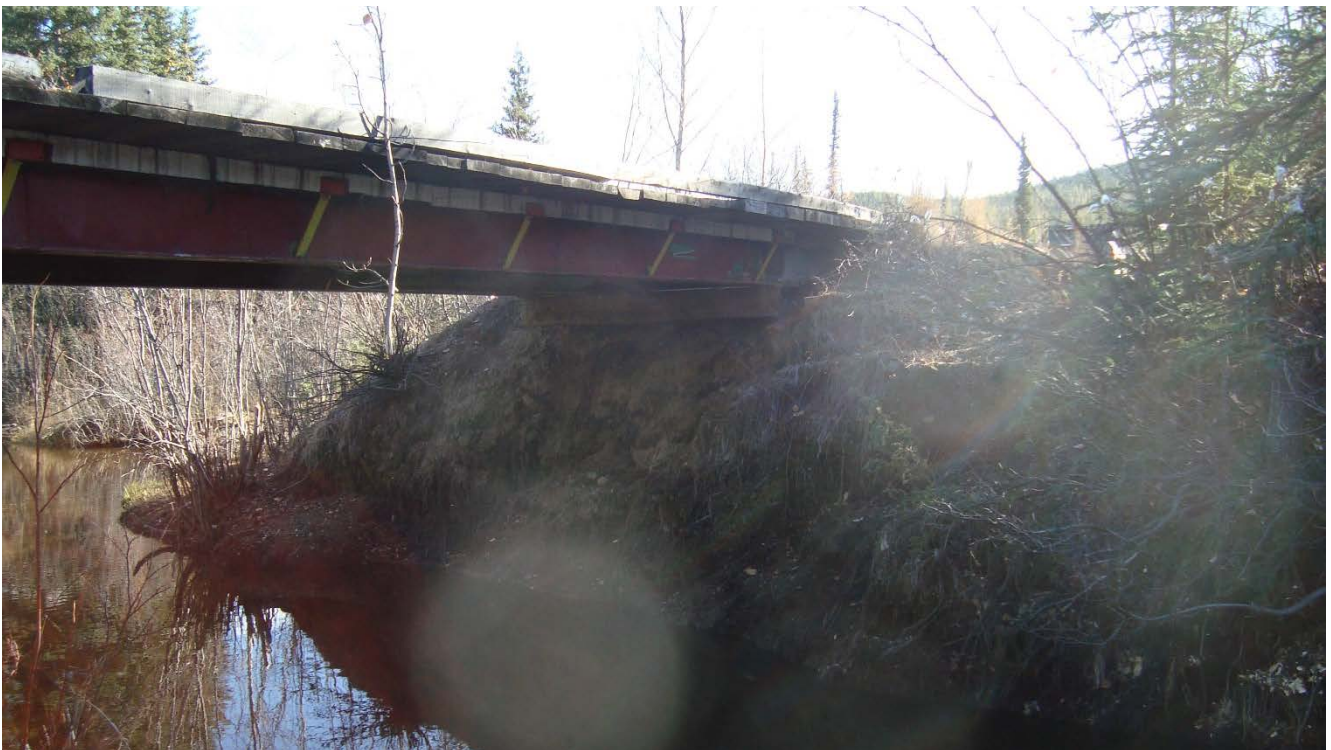
The access road crossing at Merrice Creek includes a single-span bridge set on grade (Photograph 18). Following recommendations in the July 2014 inspection memorandum, the bridge was extended by approximately 3 m and seated 1 to 2 m on the abutments. Approximately 3 m of steel was welded to the existing span, bridge decking was replaced and extended, and the approaches were re-graded to the bridge deck elevation.

The bridge was observed to be in a satisfactory condition and is securely anchored at each of the abutments. The right (or southern) abutment is steep sided and there is evidence that erosion may be continuing to occur at this location under high-flow conditions. The bridge should be monitored annually and following large rainfall events. In the event that erosion begins to compromise the stability of the abutment, consideration should be given to the installation of erosion protection at this location.

Photograph 18: Bridge crossing at Merrice Creek
