TECHNICAL MEMORANDUM

Reference No. 22538861-002-TM-Rev0-30000

2022 CARMACKS COPPER ANNUAL INSPECTION

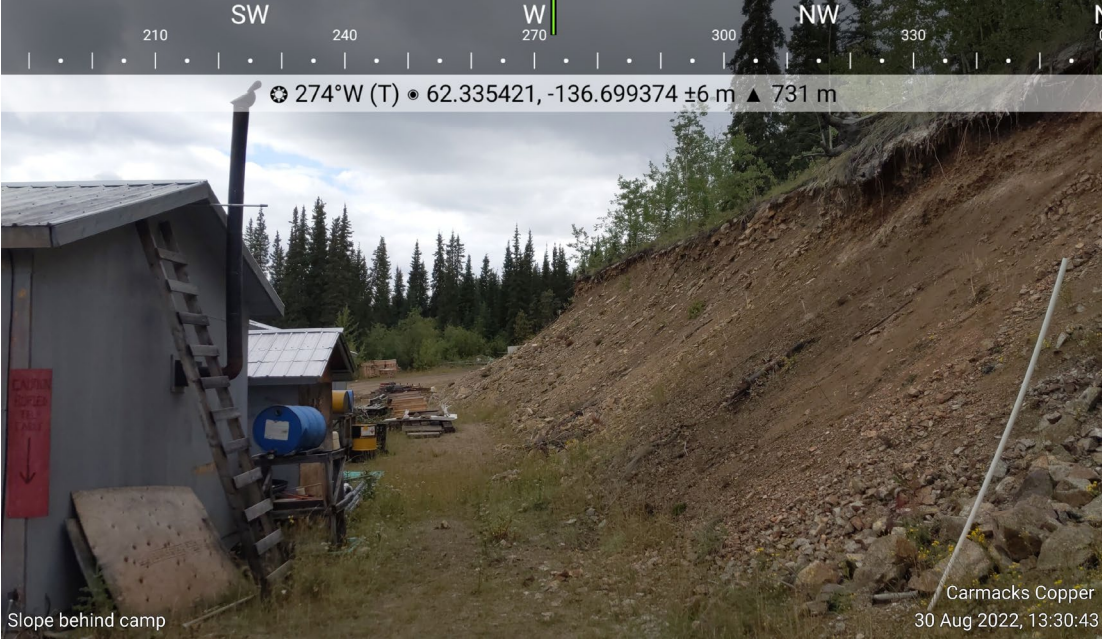
The slope behind the camp (Photos 1 and 2) is stable and does not pose a safety concern for the camp structures or current operations. There is minor raveling of small sections of the slope, but these are not impacting camp safety, nor would they represent a risk for workers on the project. Some regrowth of vegetation was observed in the camp area.

Photo 1: Slope behind camp – slope is in satisfactory condition

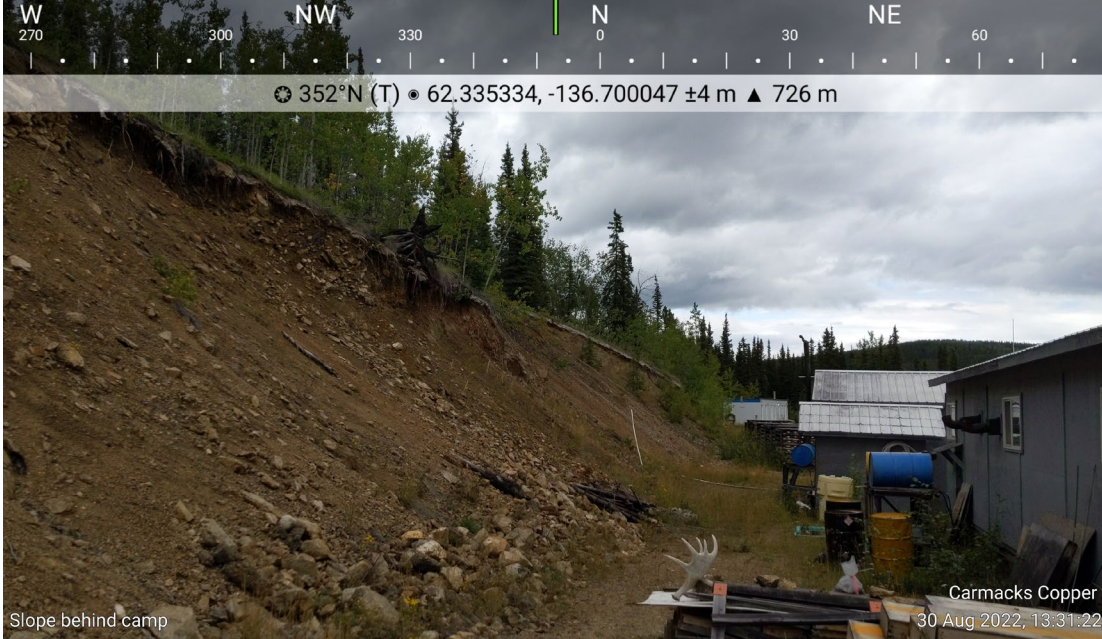
Photo 2: Slope behind camp – slope is in satisfactory condition

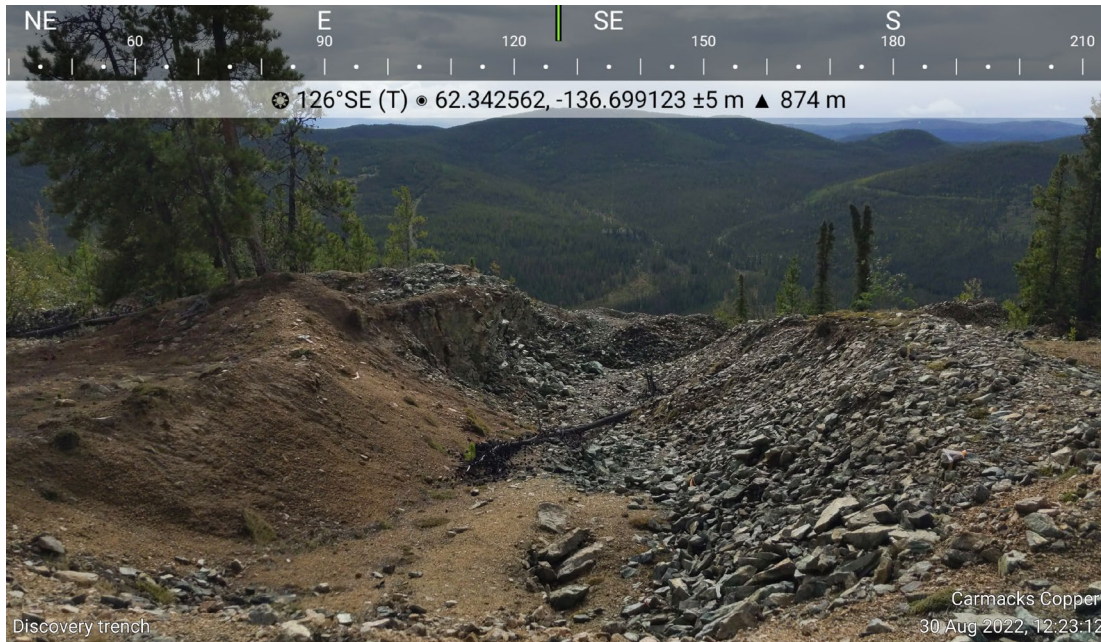
The area proposed for the open pit mine was inspected. The slopes of the trenches excavated as part of the effort to obtain bulk samples during exploration activities were observed to be in satisfactory condition (Photos 3 to 8). There was no observed slumping or failures of the trenches and the slopes facilitate egress for wildlife. Several of the drill pads were inspected and there did not appear to be any erosion noted from these areas that would require attention.

Photo 3: Discovery trench – sides of trench are sloped, trench is in satisfactory condition

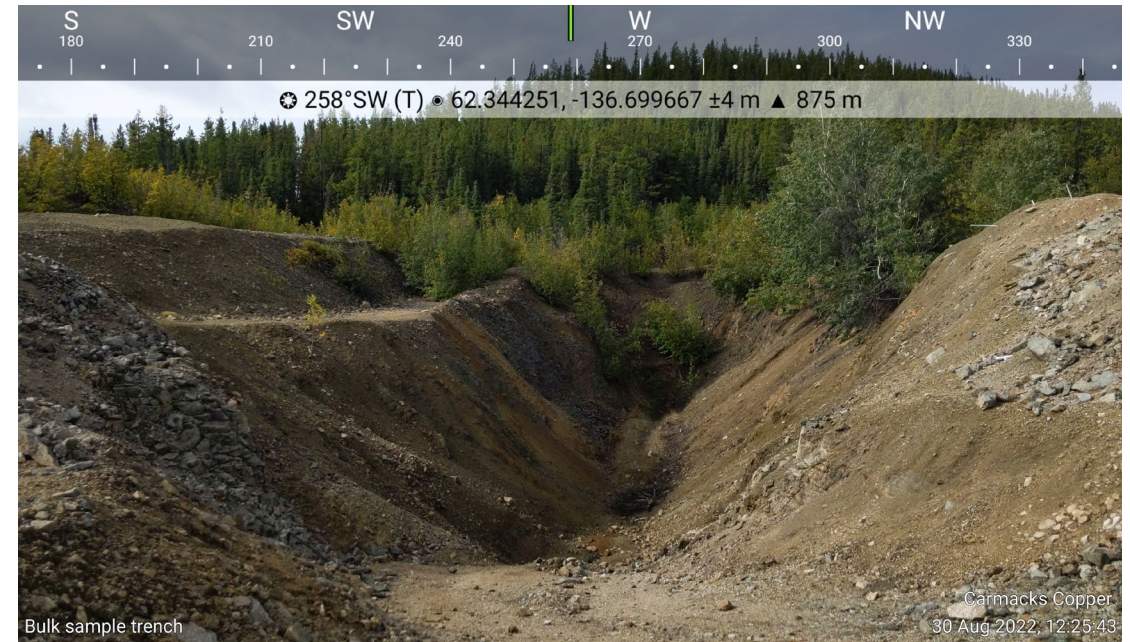
Photo 4: Bulk sample trench – sides of trench are sloped and benched, trench is in satisfactory condition

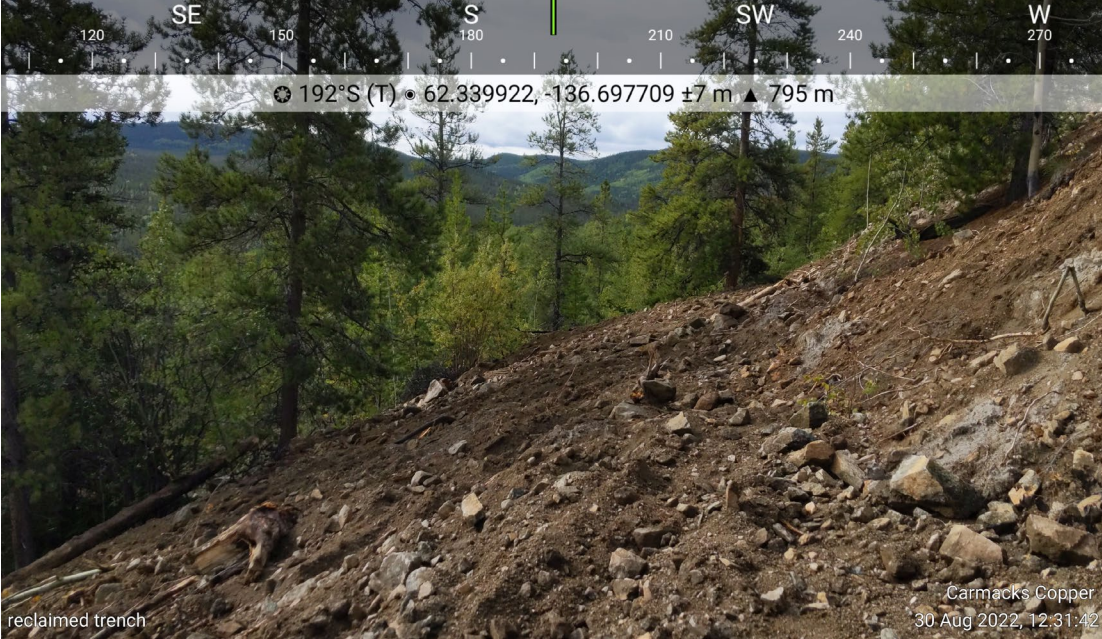
Photo 5: Reclaimed exploration trench

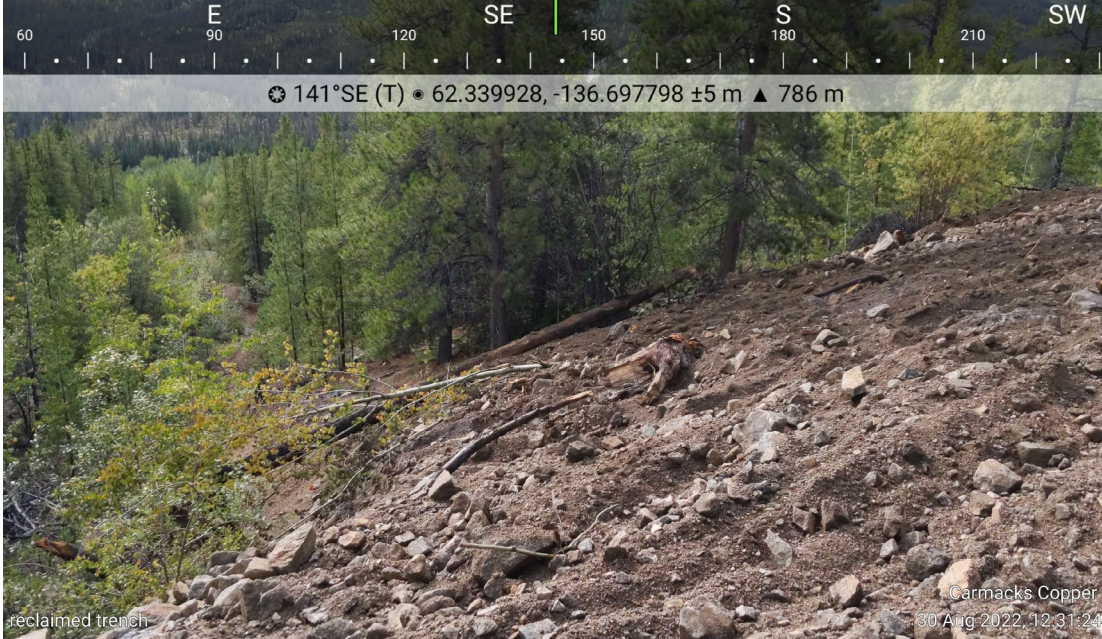
Photo 6: Reclaimed exploration trench

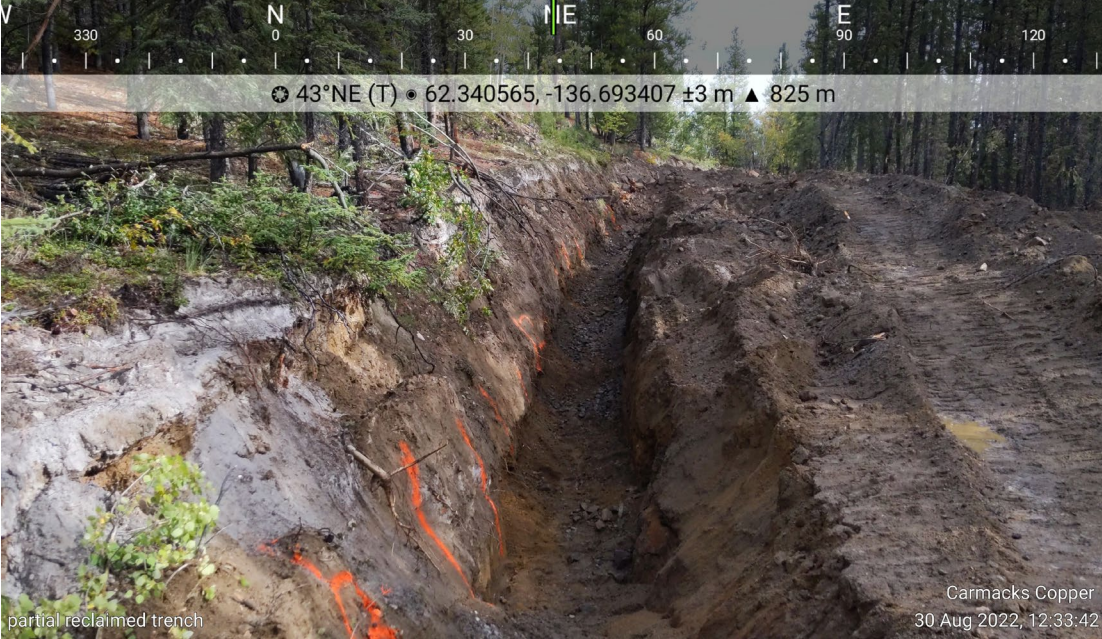
Photo 7: Exploration trench – trench is currently in use

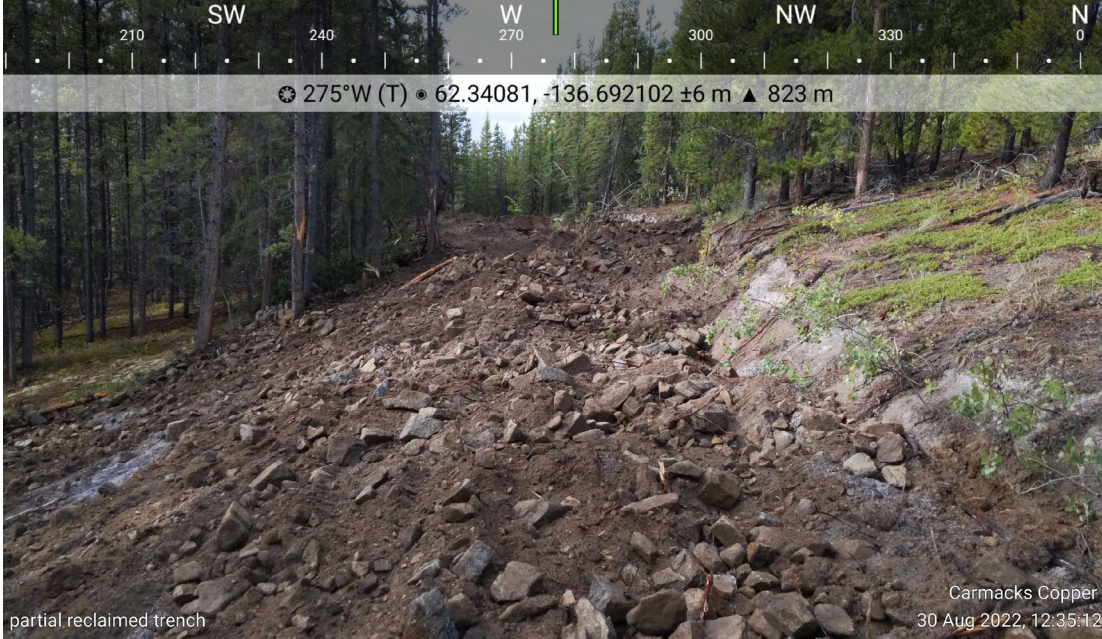
Photo 8: Exploration trench – trench is partially reclaimed

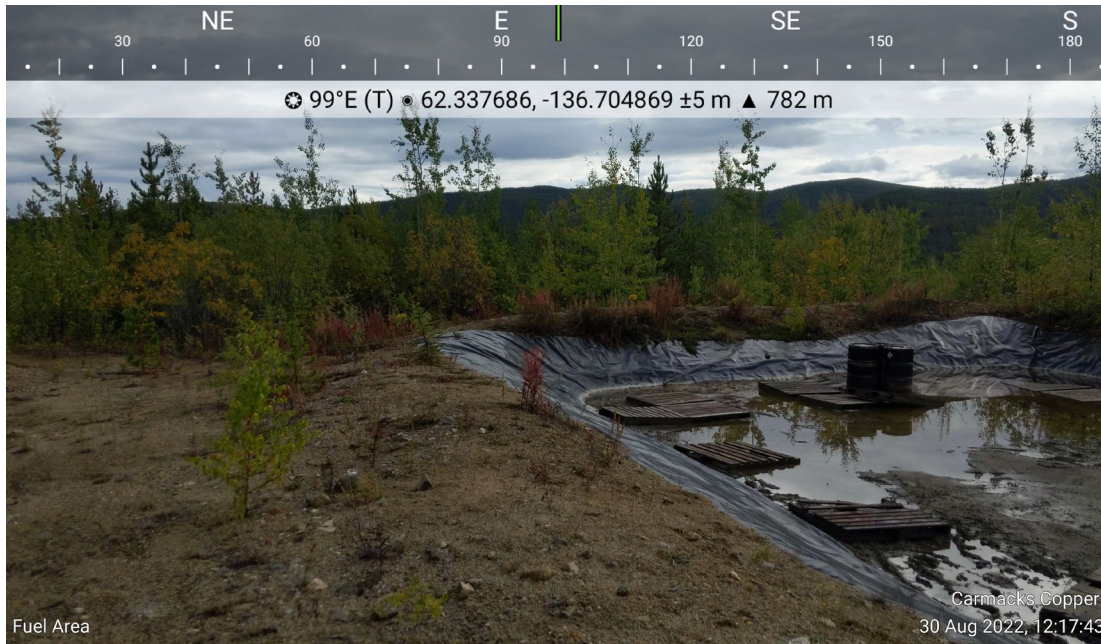
The existing fuel storage area was inspected. It comprises a bunded and lined basin constructed to contain any spilled fuel and currently contains a few dozen drums of diesel fuel. Approximately 0.2 m of water has accumulated in the basin (Photos 9 and 10). The bund is less than 3 m in height and the basin capacity is less than 10,000 m³; therefore, the fuel storage area is appropriately permitted under the QML without need for a water license (Yukon Environment Dam Guide).

Photo 9: Water accumulation in fuel bund

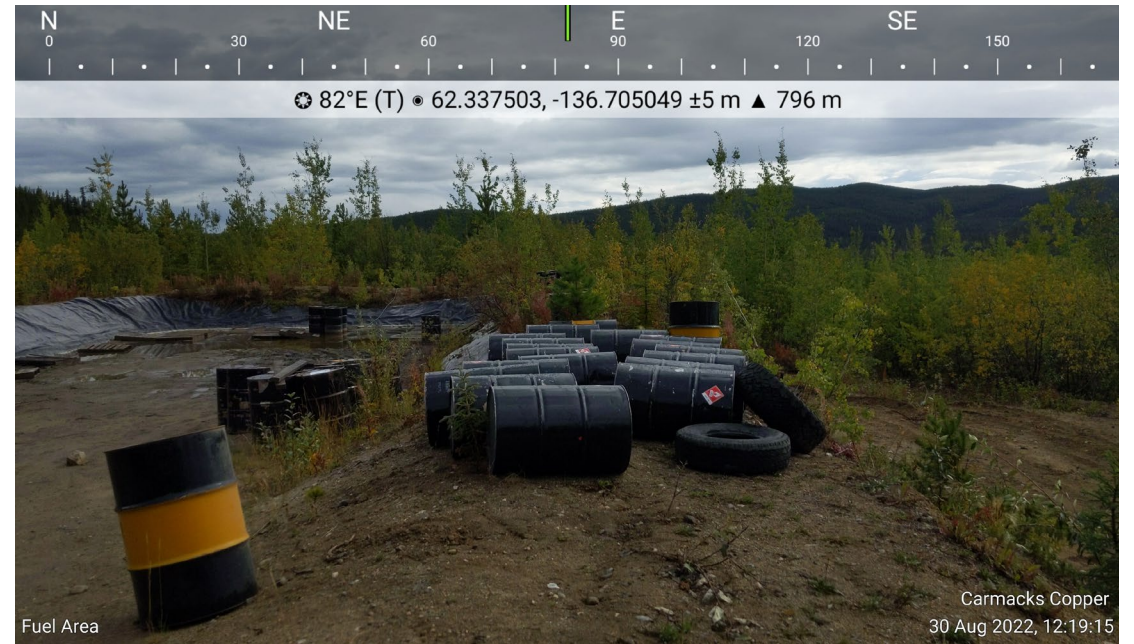
Photo 10: Fuel bund vegetation

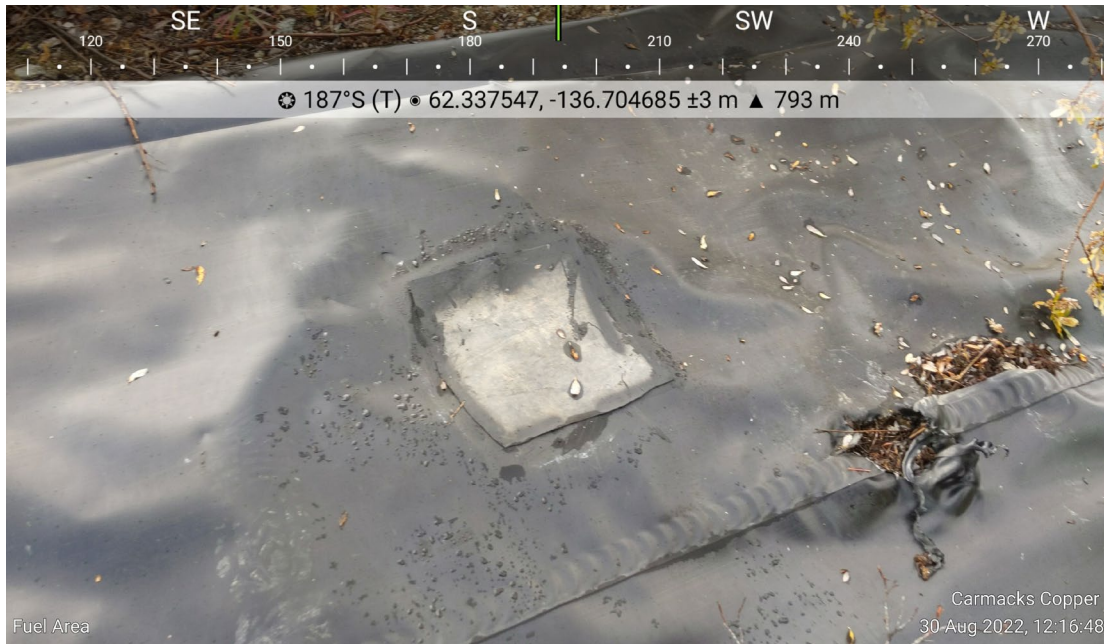
Some of the previously reported damage to the liner has been repaired. However, the areas with larger holes remain unrepaired. These areas will require HDPE welding in order to patch the liner (Photos 11 and 12). The fuel drums have since been organized in a manner to allow wildlife egress from the basin. There is some vegetation growth along the top of the containment berms and within the lined basin. There is the potential that the roots of willows and other shrubs could penetrate through the liner.

Photo 11: Patch in fuel bund liner

- Drainage repairs and upgrades, such as constructing ditches, is required along the access road between Freegold Road and Merrice Creek.
- The damage to the liner at the fuel storage area should be repaired. This may require engaging a specialist contractor to weld HDPE patches over the damaged areas. At the time when repairs to the liner are made, the vegetation within the bermed area should be removed, the area inspected and repaired, if required. Alternatively, the project may want to consider decommissioning and replacing the existing fuel bund with one or more double walled fuel tanks. The surrounding soils should be assessed for hydrocarbon contamination if the existing fuel bund is decommissioned. If necessary, remediation of the surrounding soil should be conducted. These efforts may include on-site soil farming.

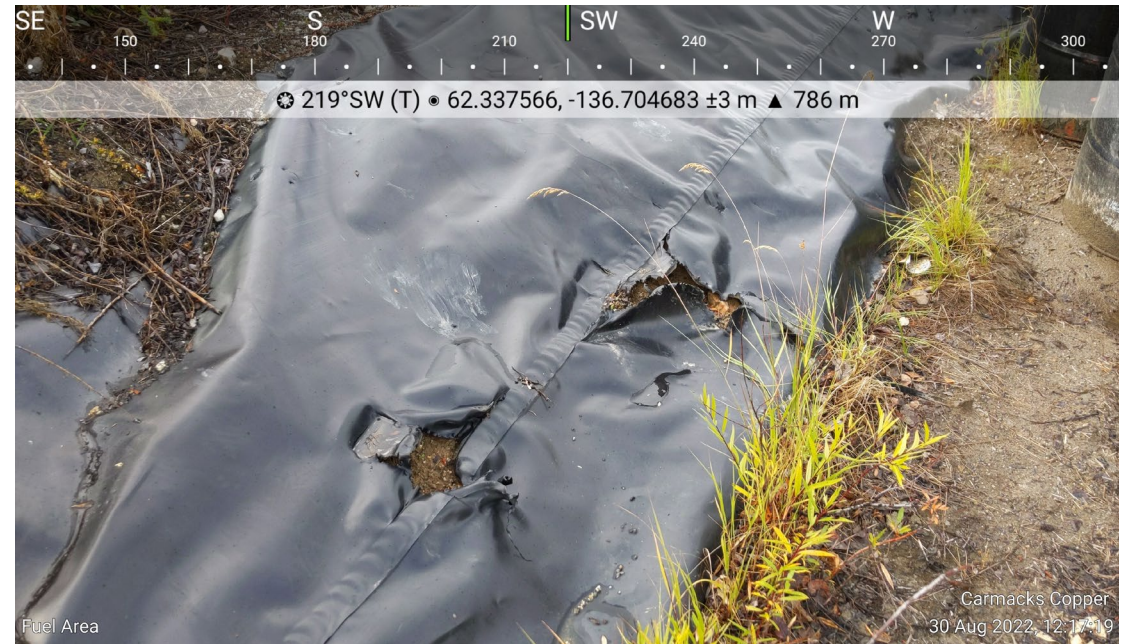
Photo 12: Hole in fuel bund liner

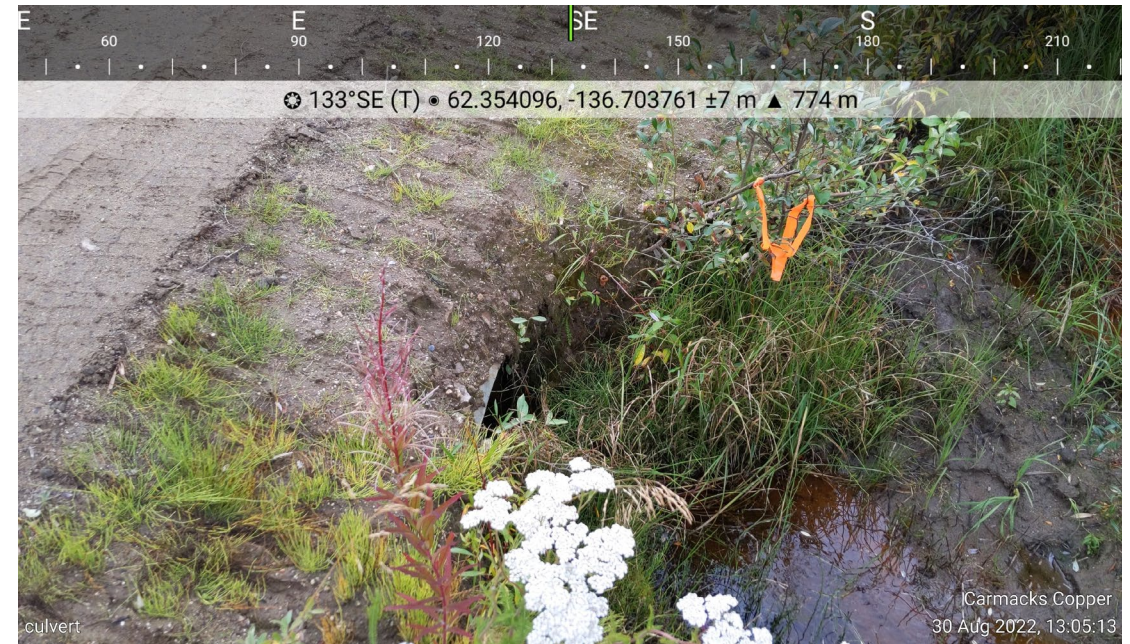
The access road to the north of the proposed waste rock storage area was observed to be in good condition with only minor erosion observed. The North Williams Creek culvert has undergone some crushing and has accumulated some sediment (Photo 14). However, the culvert remains adequate to accommodate the relatively minor flows observed at the time of the inspection. There is no visual evidence to indicate that erosion is occurring near the culvert. The access road should be inspected annually, and periodic maintenance of drainage features and erosion management should be anticipated.

Photo 14: Culvert under road

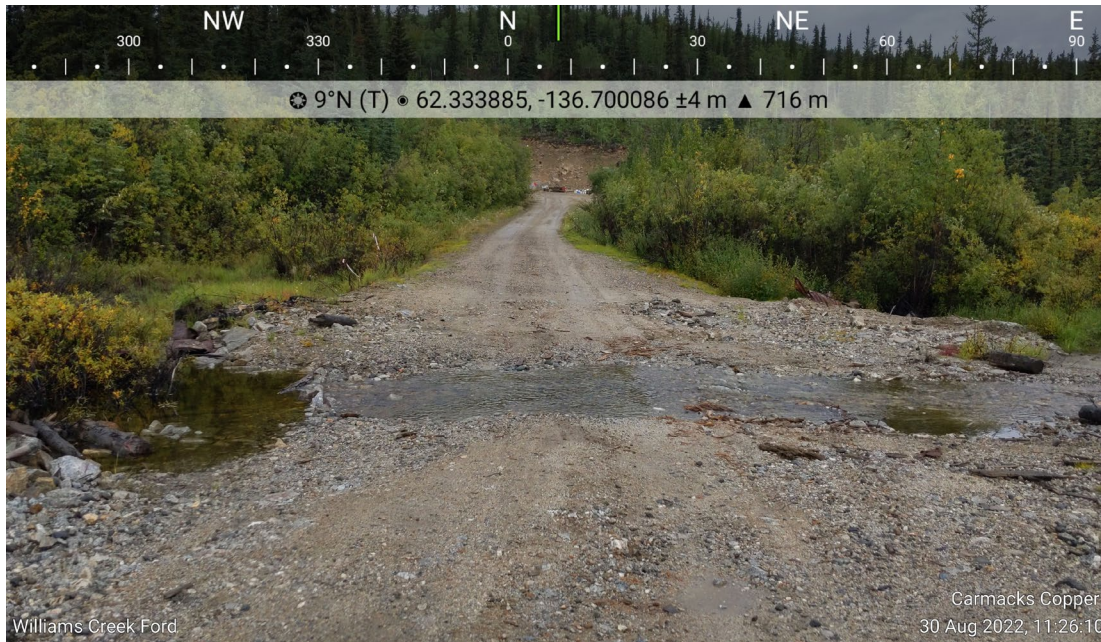
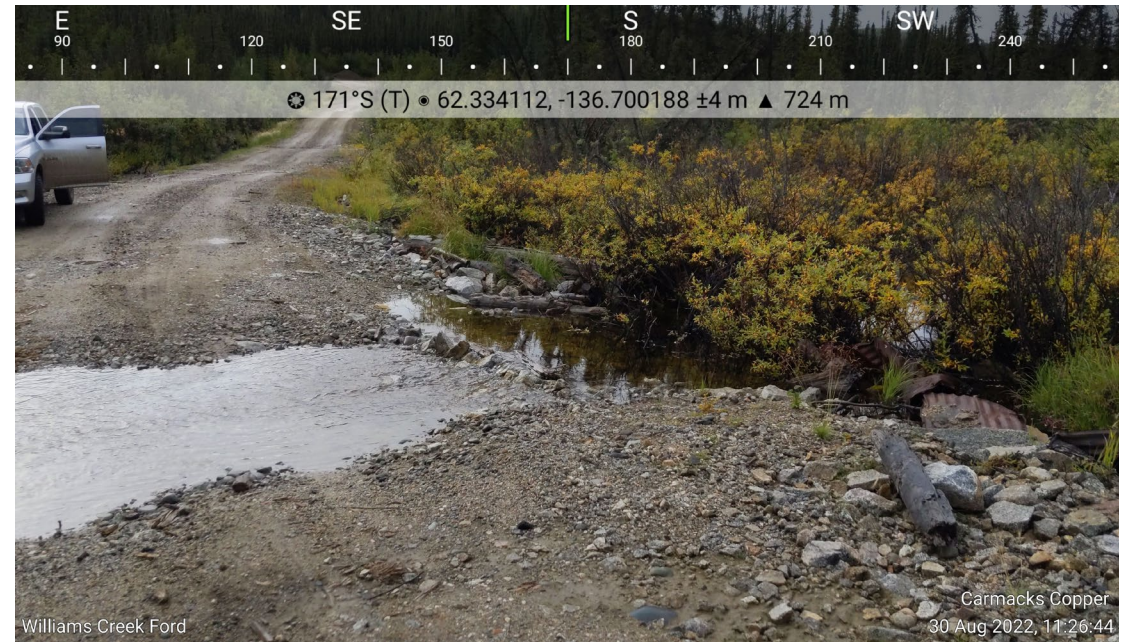
The ford road crossing installed at Williams Creek in 2013 continues to function as intended (Photos 15 and 16). The rockfill in the ford is well-graded and there is no indication of movement of finer materials. Pondered water was observed on the upstream side of the road, with flow across the road. It is possible that a large rainfall event could result in erosion. We therefore recommended that the ford continue to be inspected annually and maintenance be carried out, if required. The ford is appropriate for the current status of the project. However, prior to site development, it is recommended that the crossing is upgraded.

Photo 15: Ford crossing

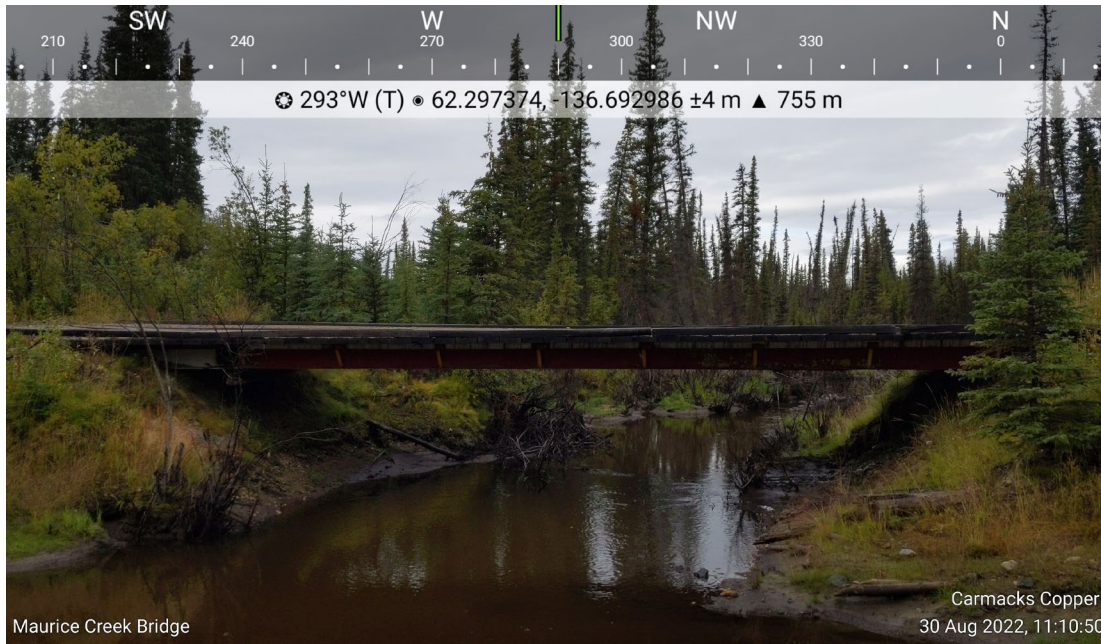
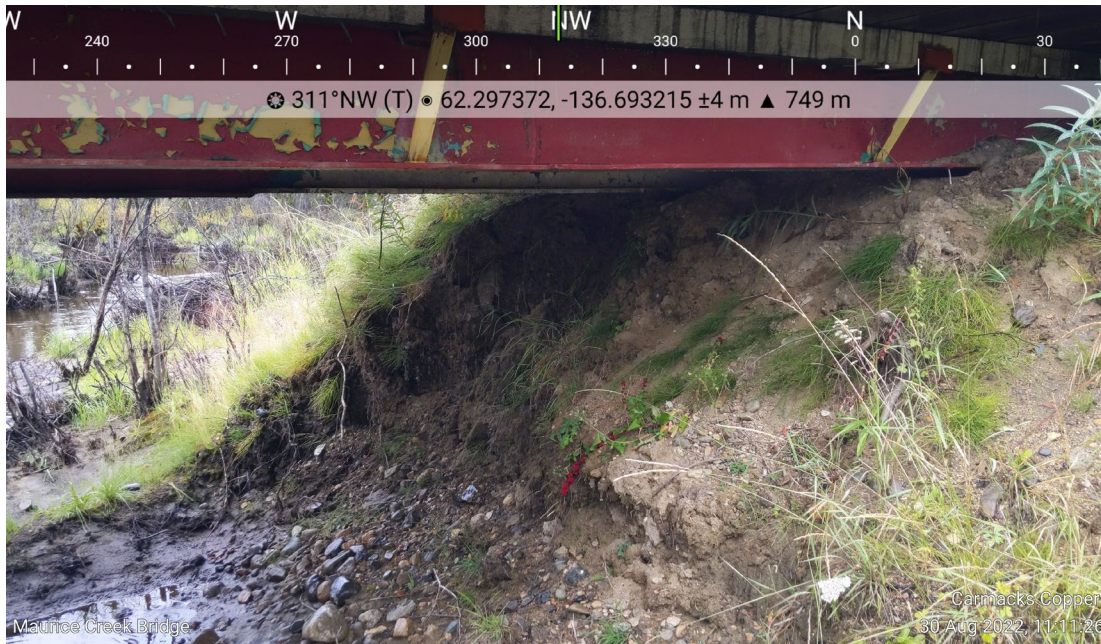
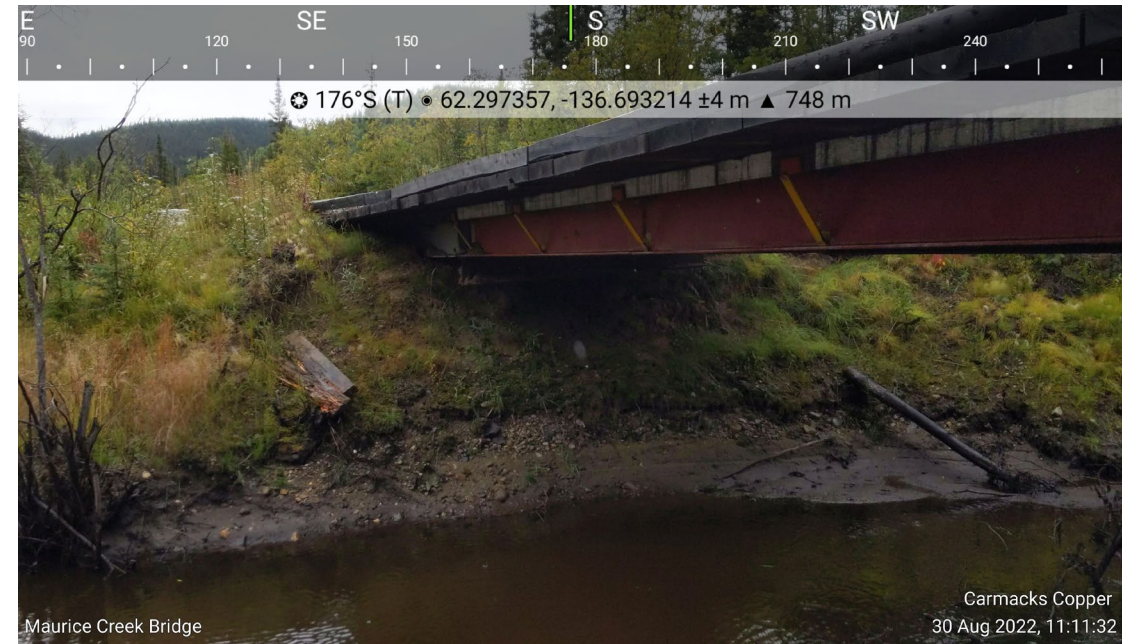
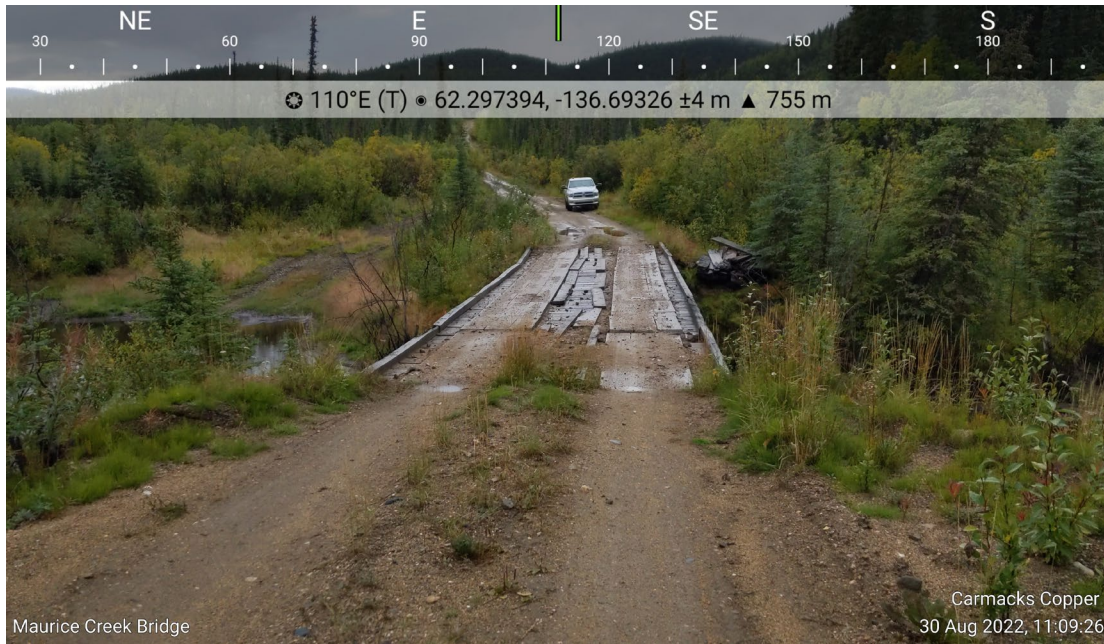
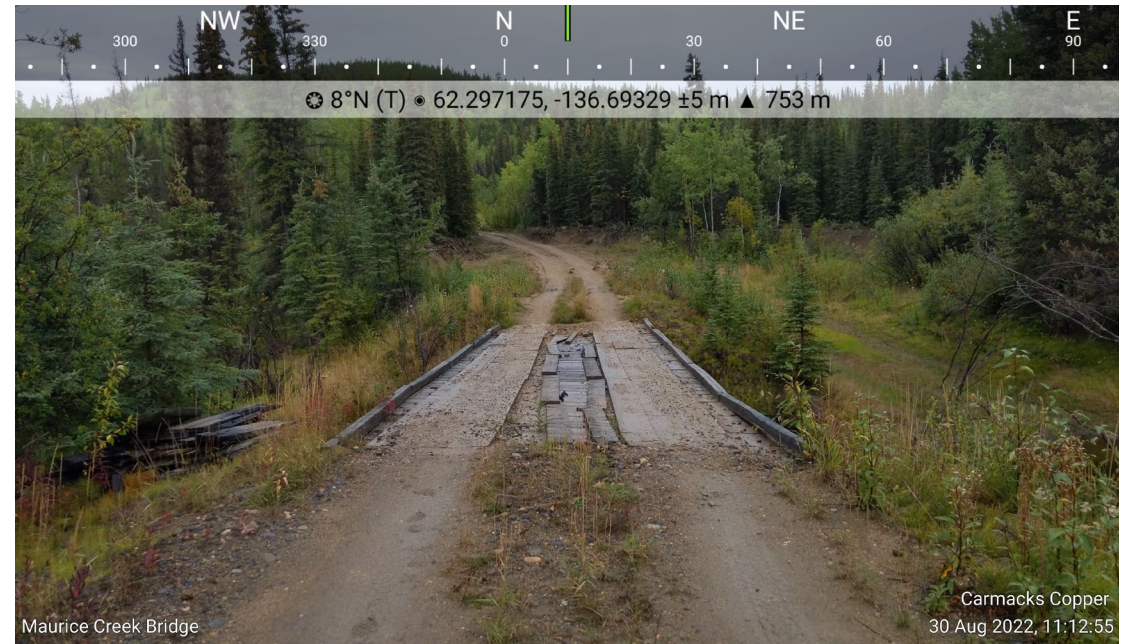
The access road crossing at Merrice Creek includes a single-span bridge (Photos 17 to 22). The wood decking on the bridge is beginning to show signs of wear and side rails have started to separate from the deck (Photograph 18). The structure of the bridge was observed to be in a satisfactory condition and is securely anchored at each of the abutments. The right (or southern) abutment is steep sided and there is evidence that erosion may be continuing to occur at this location under high-flow conditions. The bridge should be monitored annually and following large rainfall events. In the event that erosion begins to compromise the stability of the abutment, consideration should be given to the installation of erosion protection at this location.

- Water crossings, including the bridge abutments at Merrice Creek, should continue to be inspected annually and following major rainfall events. Maintenance should be carried out, as required to maintain the functionality and safety of these crossings.

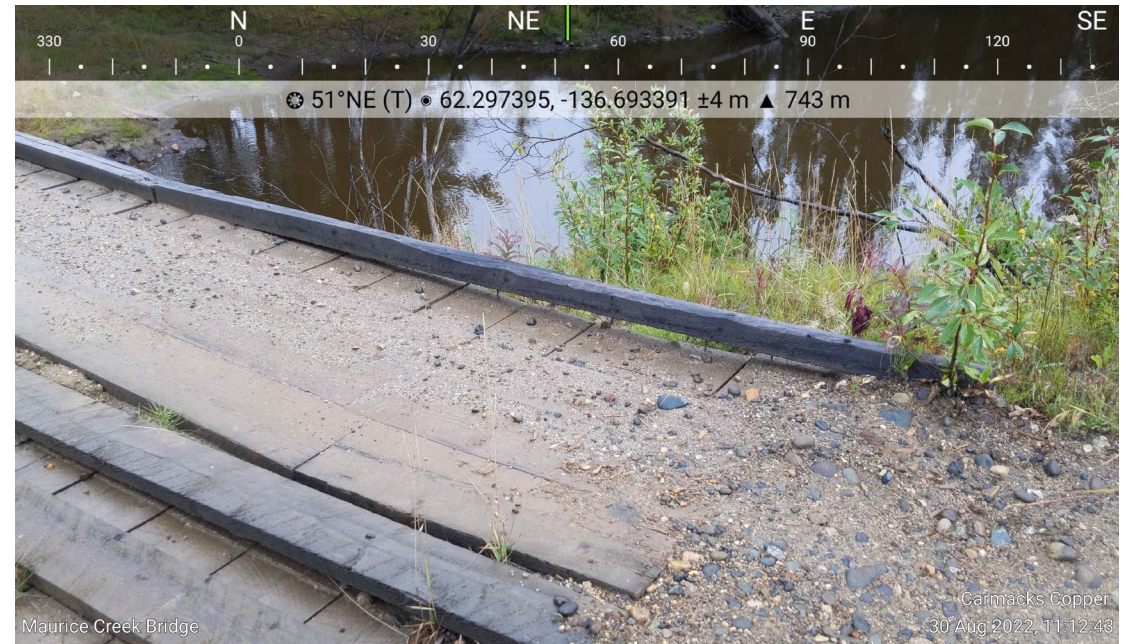
Photo 18: Damaged bridge rail – rail should be reattached to the bridge deck

- The wood side rails on the Merrice Creek bridge have separated from the wood decking. The wood rails should be repaired and reattached to the bridge deck.
