December 5, 2023
File: AM2.ENG01023
Issued for Use

TruePoint Exploration
409 Granville St, Suite 904
Vancouver, BC V6C 1T2

2023 Carmacks Copper Annual Inspection – Carmacks, YT

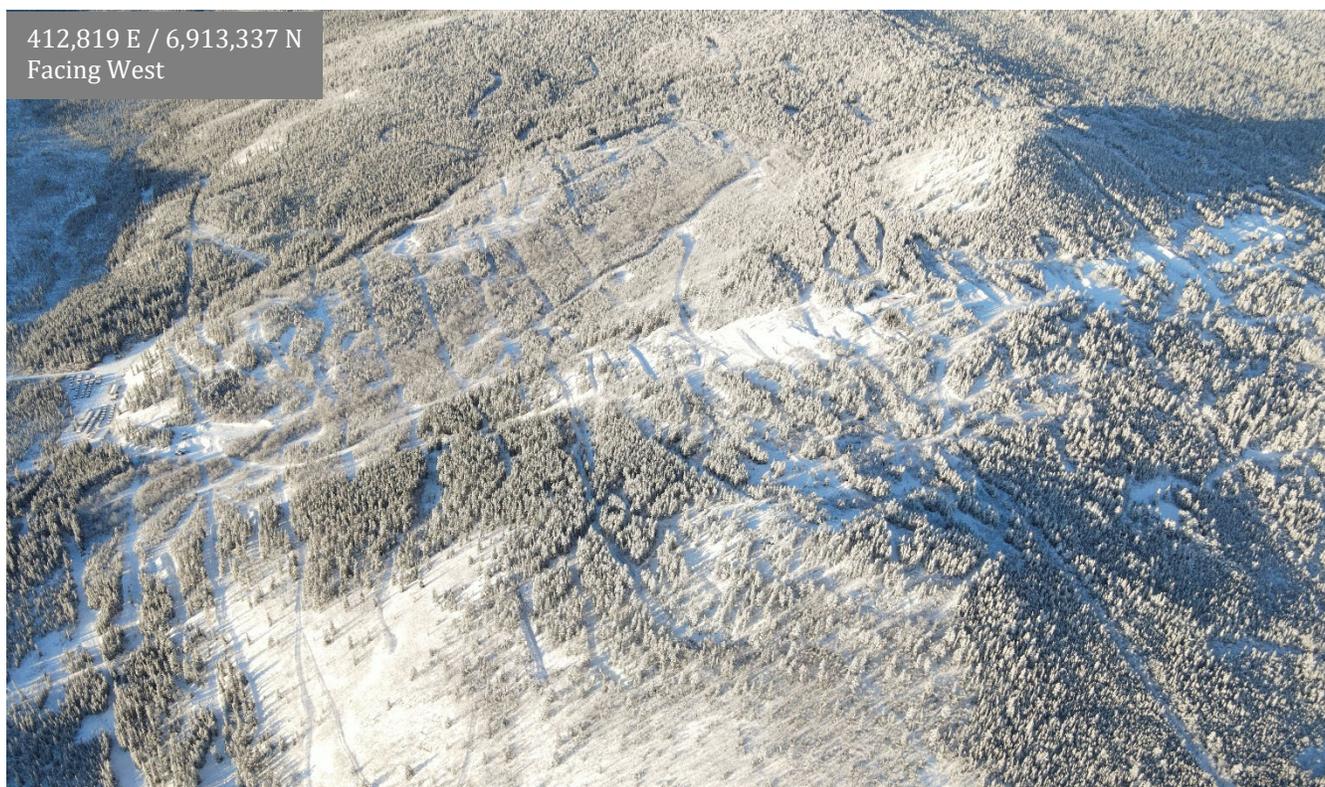
All photos referenced below are in Section 4 of this report. Photos 1 through 3 provide aerial overviews of the CCP.

Photo 1: Overall view of exploration camp, proposed heap leach site, and proposed open pit area

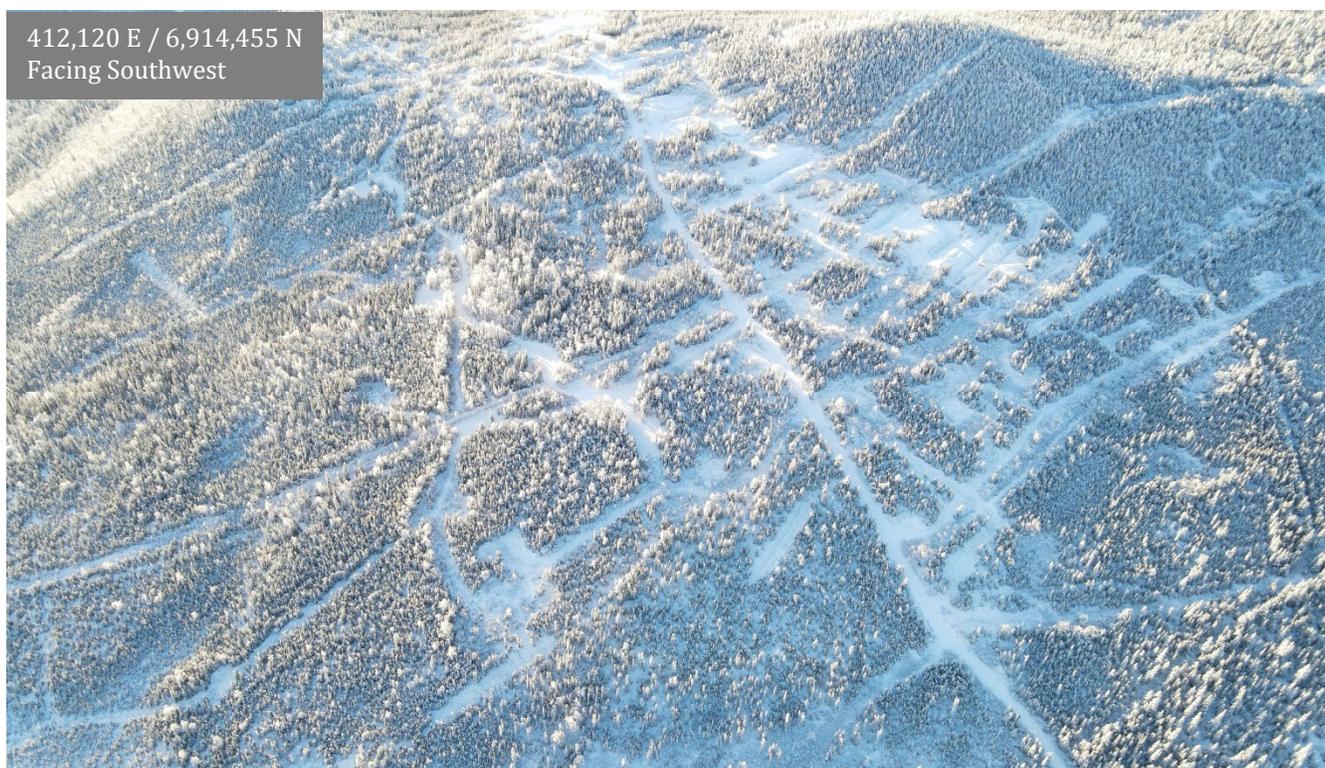
411,830 E / 6,913,958 N
Facing West

Photo 2: Overall view of proposed open pit area and waste rock storage area

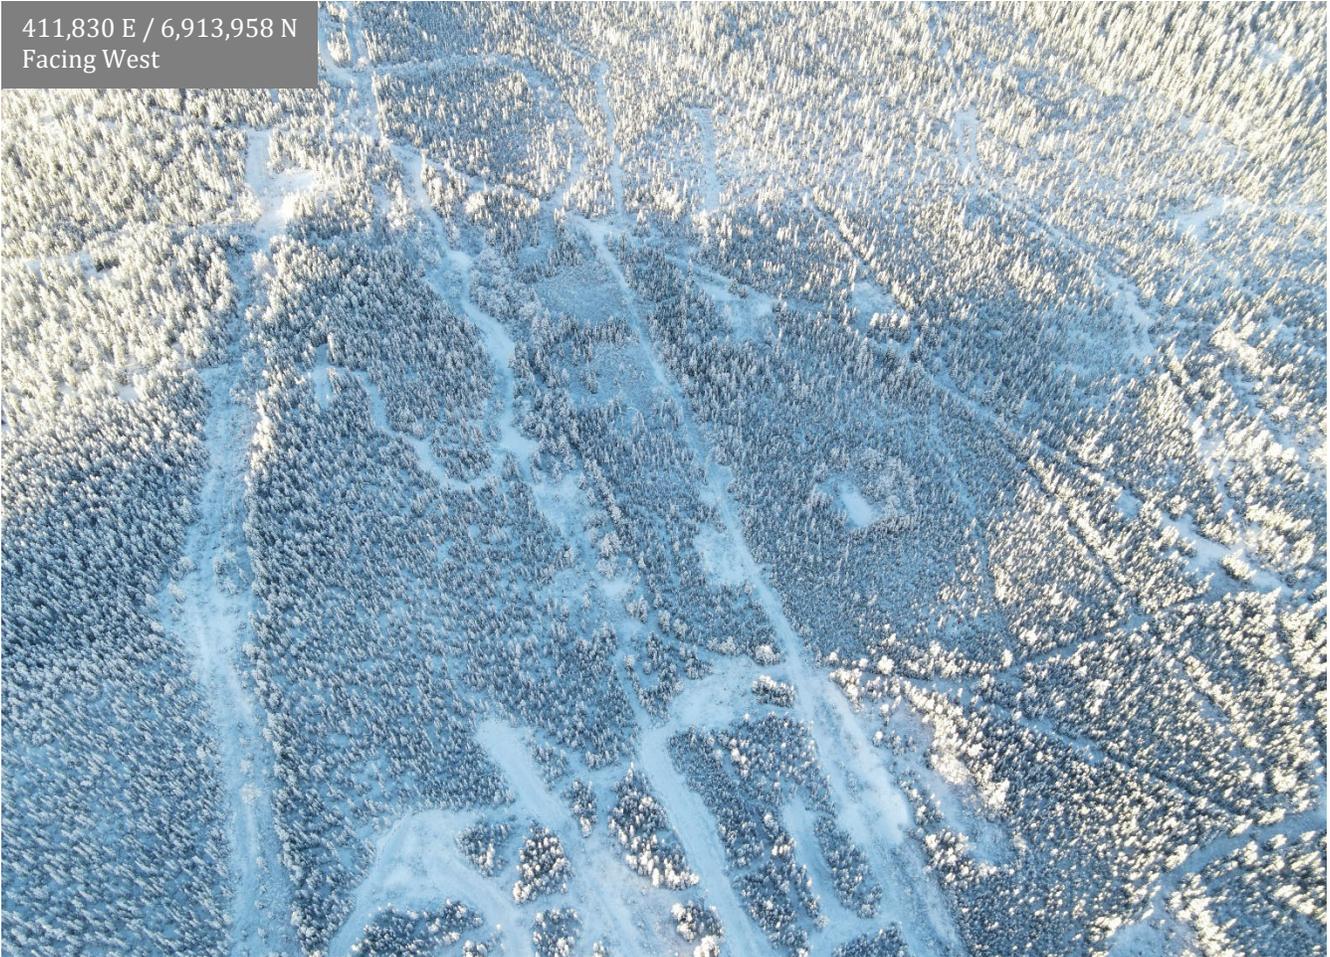
411,955 E / 6,912,611 N
Facing North

Photo 3: Overall view of proposed tailings management area

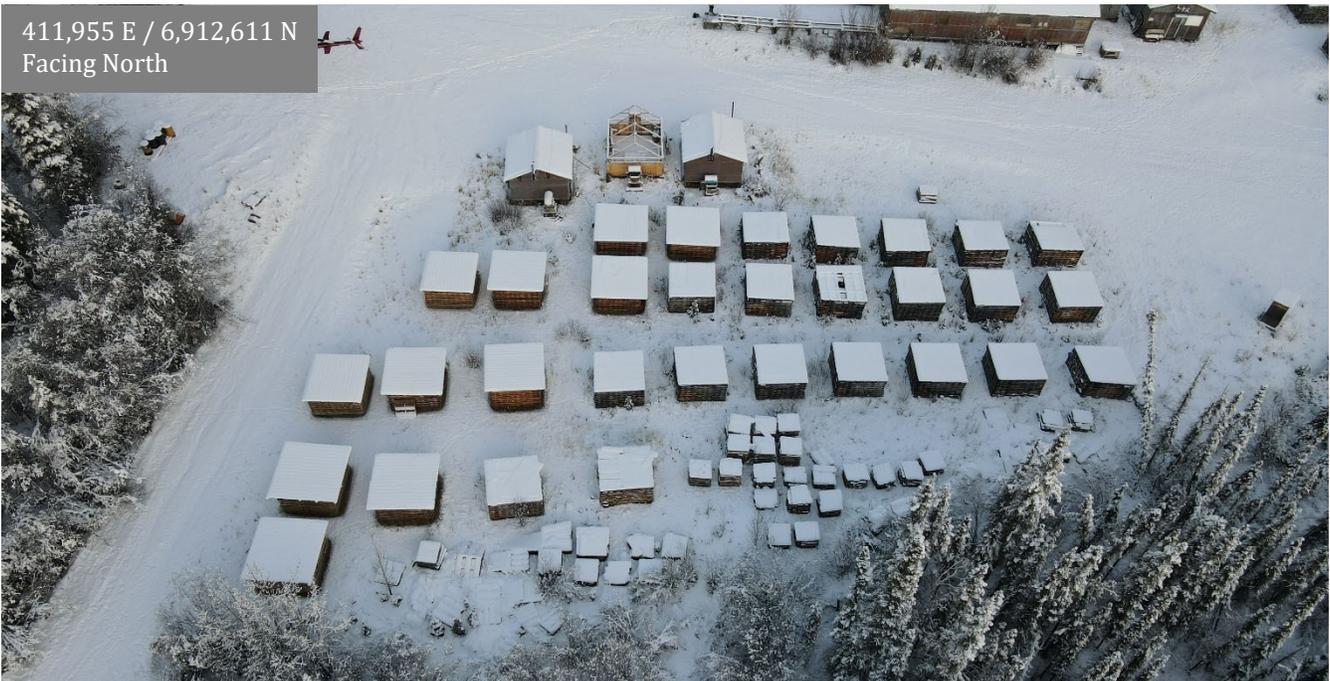
The 2022 inspection noted that cracking around the core storage racks has been observed in the past, likely from thaw-induced settlement. However, WSP stated that settlement in the area does not represent a safety concern. AM2 walked around the core storage area but could not see evidence of cracking due to snow cover. Photo 4 shows the core storage area.

Photo 4: Core storage area

- Annual inspections should continue as required by the QMS. However, there are no current concerns, and inspections would look to identify any emerging issues.
- TruePoint should inspect the fuel containment areas for heating fuel tanks at camp buildings in 2024 on the first trip to the site to confirm that no leaks have occurred.

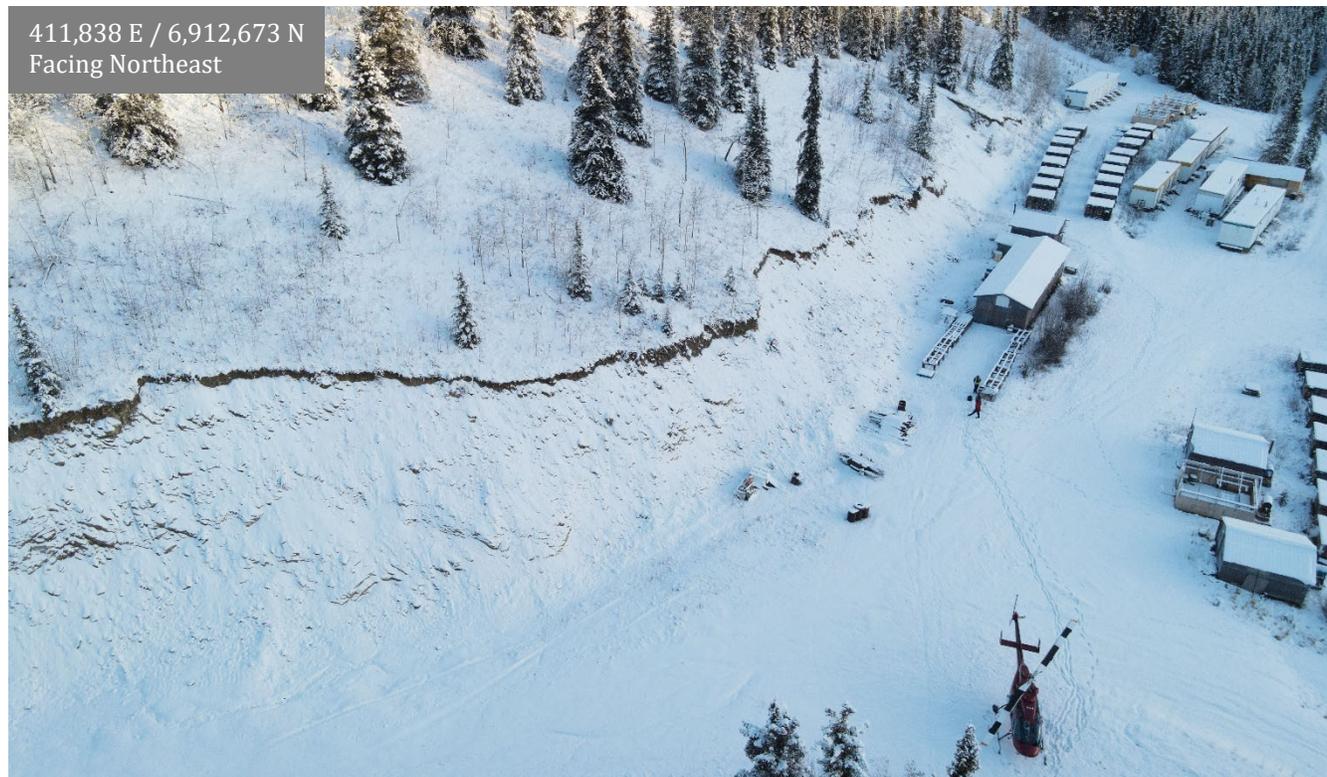
The slope behind the camp showed no evidence of instability and remains in a similar condition as observed in 2022. Minor ravelling continues but does not impact camp facilities. Photo 5 shows the slope behind the camp.

Photo 5: Embankment slope behind exploration camp

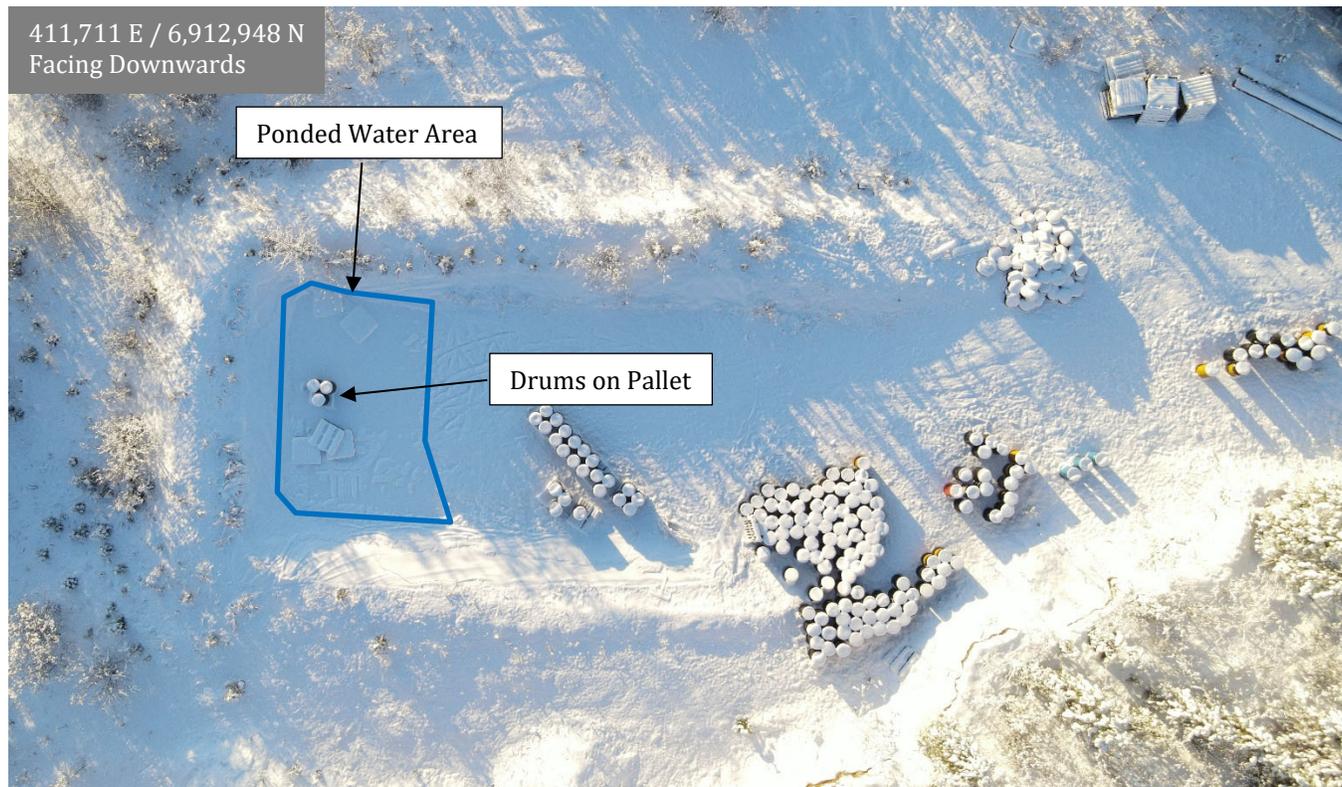
411,622 E / 6,913,412 N
Facing South

The fuel storage area is on the slope above the exploration camp and is a bunded and lined basin to contain spilled fuel. Fuel drums in and around the fuel storage area are stood up, which reduces the possibility of leakage compared to lying on their side. Fuel drums are not stored in a manner that would limit wildlife egress from the basin.

Water has accumulated in the corner of the basin, which is evident by a smoother snow surface. There are three drums on a pallet where water has collected, but the pallet is visible, suggesting that the depth of the water is less than 0.2 m. The 2022 inspection noted that the bund is less than 3 m in height and the basin capacity less than 10,000 m³, meaning the storage area is appropriately permitted under the QML without a water license. Photo 6 shows the fuel storage area, indicating the ponded water area and the drums on a pallet within it.

No site activities in 2022 mean that the liner should be in the same state as the 2022 inspection, where some previously reported damage had been repaired, but larger holes remain unrepaired. The liner could not be assessed due to snow cover to determine if wildlife or people not associated with the project had created any new holes. However, the Yukon Government inspected the fuel storage area in July 2023 and observed evidence of spilled fuel and the holes in the liner. TruePoint said that they have everything to repair the liner sitting in Whitehorse but did not make it to the site in 2023 to make repairs. The berms have vegetation growing along the top and side slopes that were present in 2022, and WSP noted that there is potential for roots to penetrate the liner.

Photo 6: Aerial view of fuel storage area

- A qualified professional should fully repair the liner in the fuel storage area to reduce the risk of leakage outside of the containment if a spill occurs, and the soil beneath the holes should be inspected to determine if fuel has breached the liner through the holes.
- Trees and shrubs should be cut and removed to limit the continued growth of roots. If the roots are removed, they should be carefully excavated by hand in case they have penetrated the liner, and the liner should be repaired as needed. Removal of vegetation should occur while someone is on-site to repair the liner in case added repairs are required.

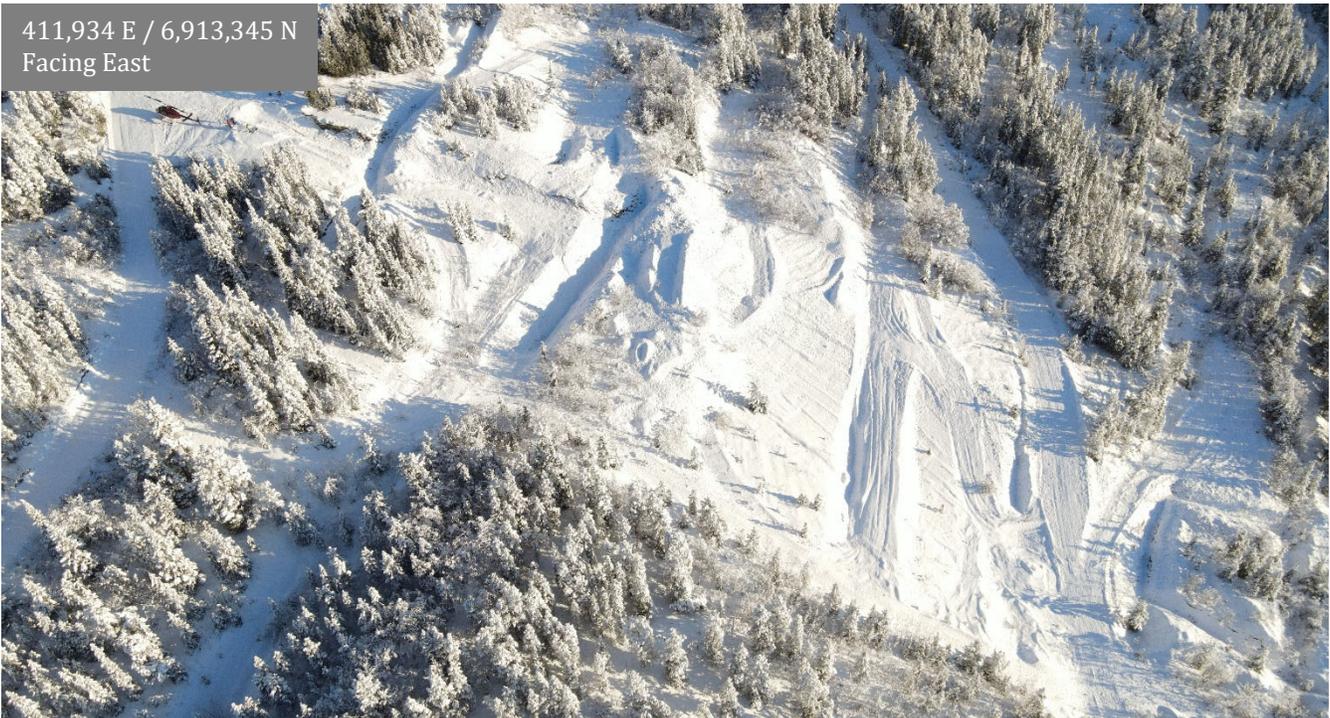
On-site access roads appeared in good shape while flying over them with the helicopter and subsequent drone flights. Again, the snow cover limited the ability to inspect access roads. AM2 did not observe any significant erosional features that required further inspection. However, some areas with wheel rutting could lead to a concentration of surface water flow and excessive erosion if ditches do not capture runoff. Photos 7 and 8 provide examples of the on-site access roads.

Photo 8: Site access roads at the southern point of the proposed open pit

- The North Williams Creek culvert should be reassessed to confirm that degradation or excessive erosion has not occurred since the 2022 inspection and repaired as necessary.
- The access roads should continue to be inspected annually, and TruePoint should conduct maintenance as required, including ditches. If wheel ruts lead to excessive erosion, they should be graded smooth, and surface water runoff should be directed into ditches.

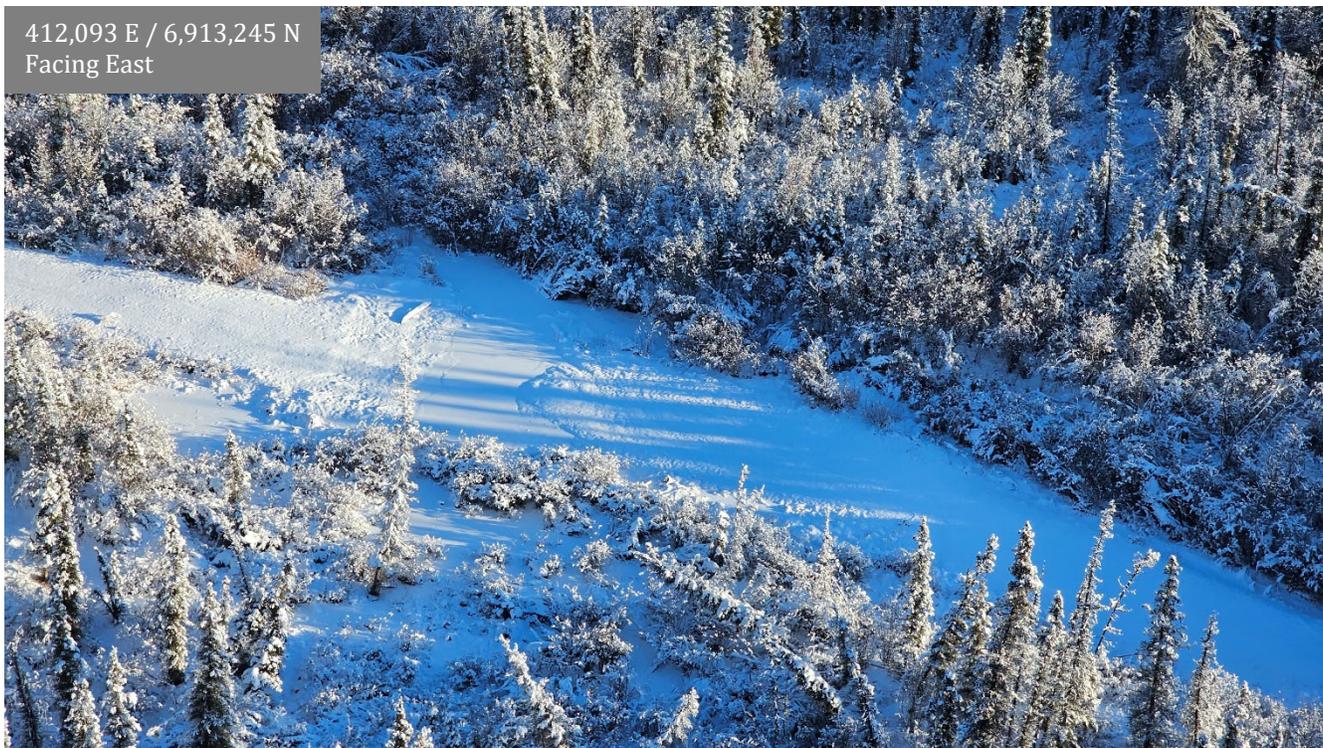
The ford road crossing at Williams Creek could not be inspected due to snow cover, but the crossing had ponded water before freezing, as evidenced by a smooth snow surface. The 2022 inspection noted that the ford consists of a well-graded rockfill that was in satisfactory condition when inspected. Photo 9 shows the state of the ford at the time of the inspection.

Photo 9: Williams Creek ford crossing showing no evidence of significant erosion

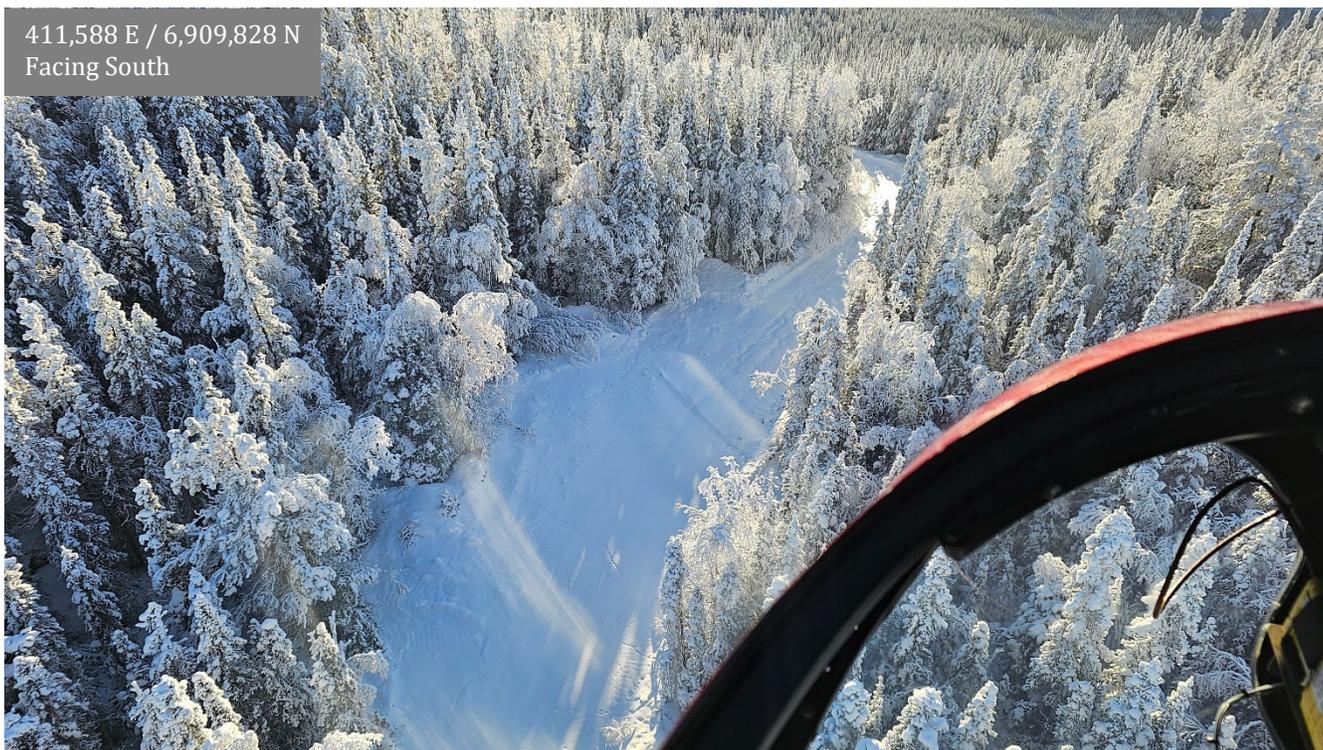
The helicopter flew along the access road between the Freegold Road and the CCP site, allowing AM2 to inspect the road surface visually. Due to surface water management, rutted sections are present along the access road, allowing runoff to flow along the road surface and create erosion channels along wheel ruts. An inspection without snow cover and from the ground is required to assess the impact on the access road properly and determine how to mitigate erosion of the roadway surface. Photo 10 shows a typical example of the erosion.

Photo 10: Typical erosion on the access road to the CCP site

- The main access road should have a more comprehensive inspection to determine the extent of the erosion and repairs made to mitigate runoff flowing on the road surface. Repairs could be regrading the road surface, installing additional culverts, or constructing/reconstructing ditches.
 - The portion of the access road in the Merrice Creek Valley may have to be repaired before vehicles can access the CCP, but the site should remain accessible if off road vehicles are used.

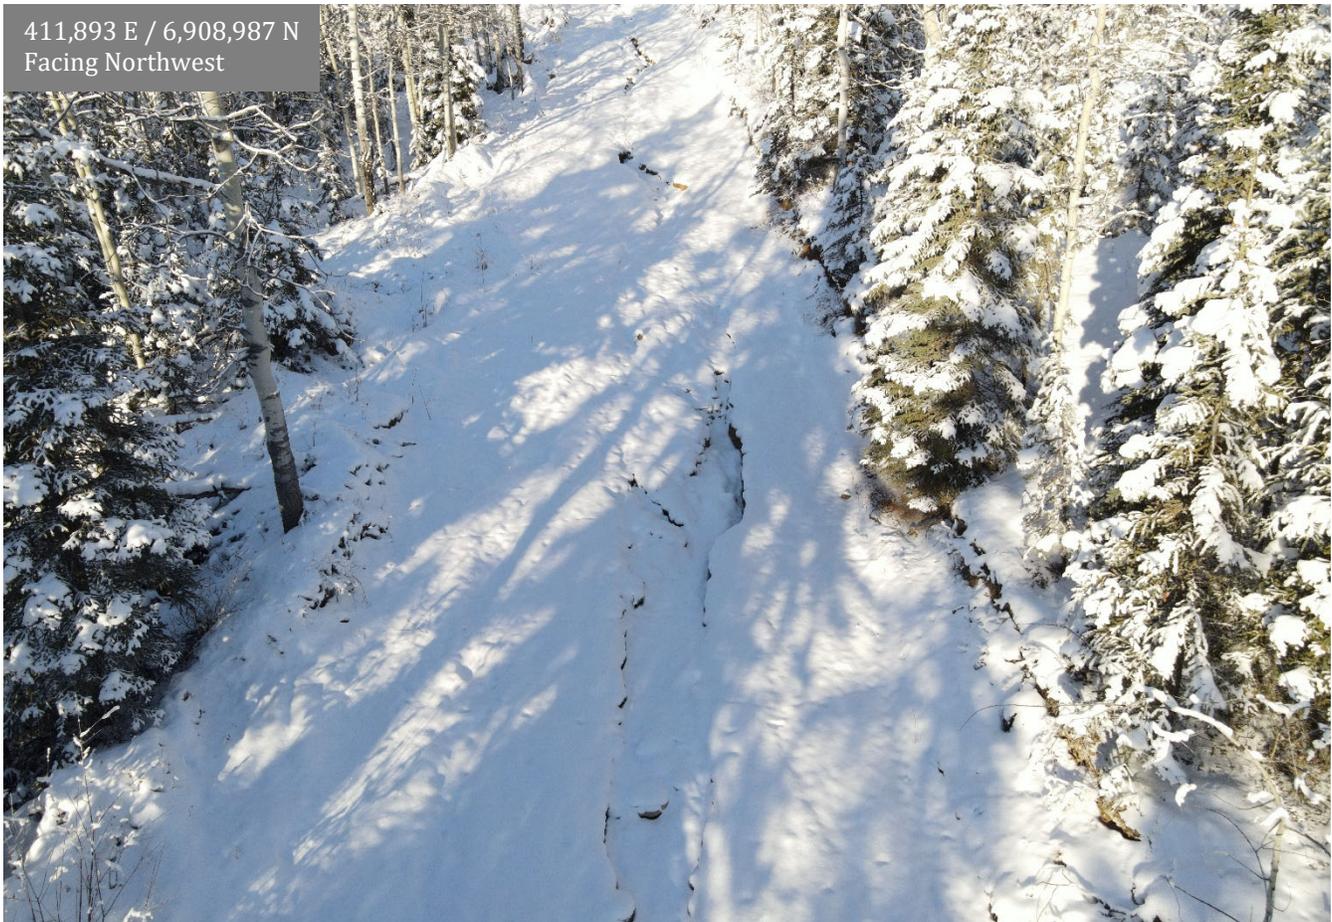
The portion of the access road leading into and out of the Merrice Creek Valley had significant erosion of the access road, making it difficult for a vehicle to traverse and gain access to the CCP. Deterioration of the road surface has occurred on the hills leading to Merrice Creek on both sides of the bridge, with an estimated depth of up to 0.5 m and 1 m wide in places. Much of the erosion is longitudinal with the road alignment but crosses the road at some locations. Photos 11 and 12 show examples of significant erosion.

Photo 11: Significant erosion on north Merrice Creek hill

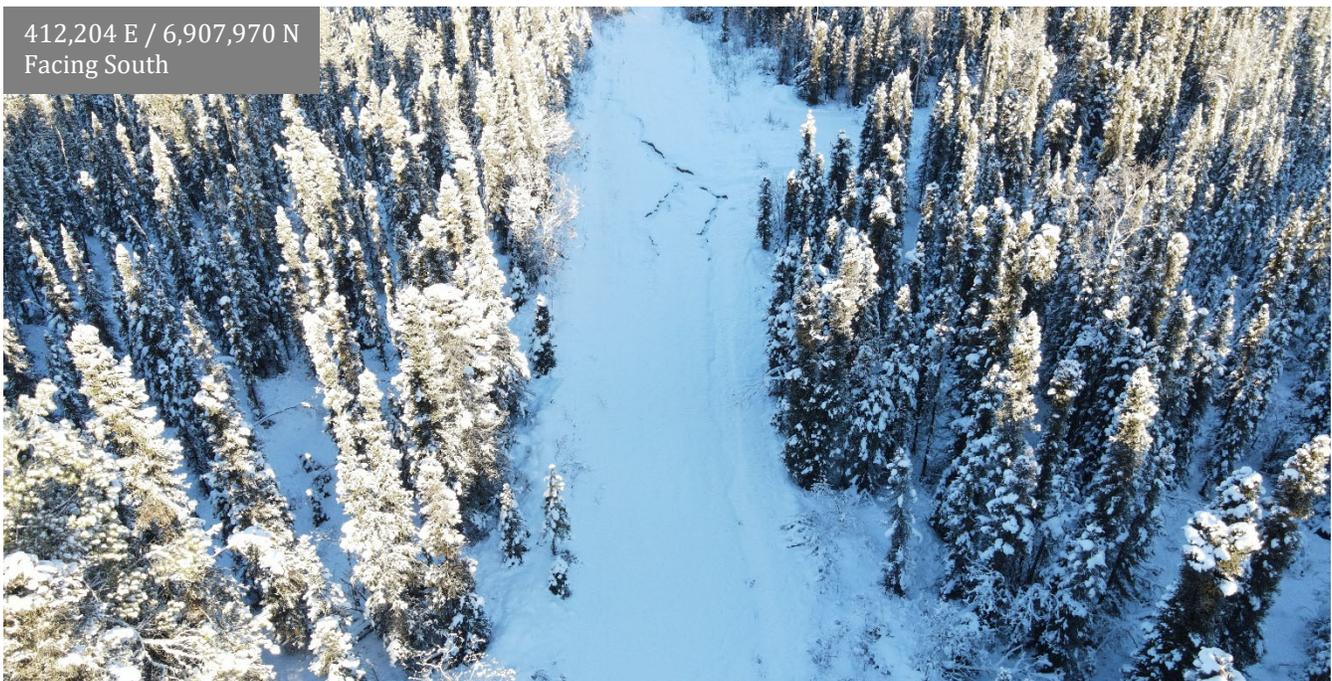
Photo 12: Significant erosion on south Merrice Creek hill

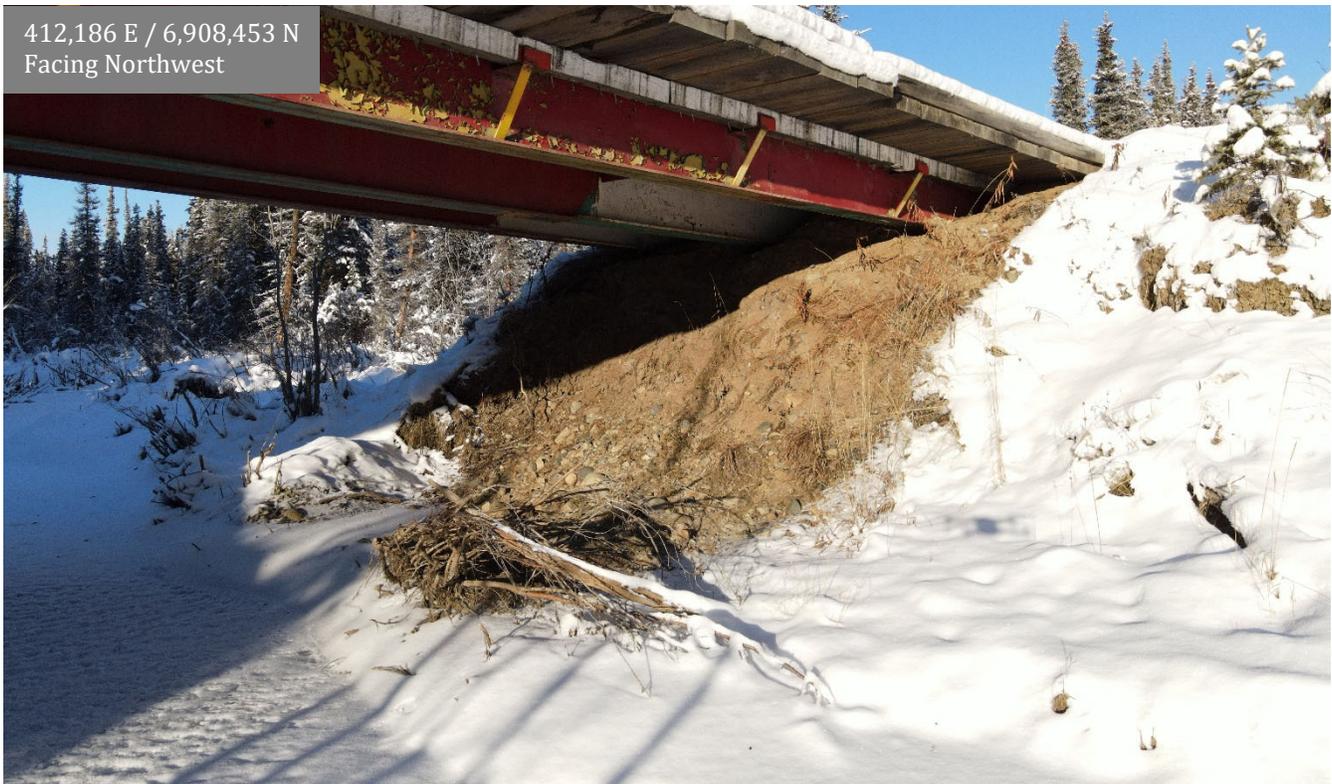
AM2 reviewed WSP's pictures of the north and south abutments of the Merrice Creek bridge to determine if additional erosion in 2023 occurred. The north abutment had a trim line from erosion in 2022 that is not evident in 2023, suggesting that further erosion has occurred or soil slumped, removing the trim line. The erosion or slumping has not appeared to have resulted in less soil supporting the bridge at the top of the abutment. The south abutment also has a less distinguishable trim line between inspections but appears to be from the soil slumping rather than erosion during a high-water event. Photos 13 and 14 show the two abutments.

Photo 13: Merrice Creek bridge north abutment

- The Merrice Creek bridge should continue to be monitored annually, with inspections occurring after freshet and significant rainfall events to determine how much erosion of the abutments occurred and if it puts the bridge at risk.
 - Routine maintenance should continue to reduce the degradation of the bridge deck and side rails repaired for the safety of road users.
 - If excessive erosion threatens the abutments' integrity, TruePoint should seek recommendations for erosion protection using rip rap or concrete lock blocks.

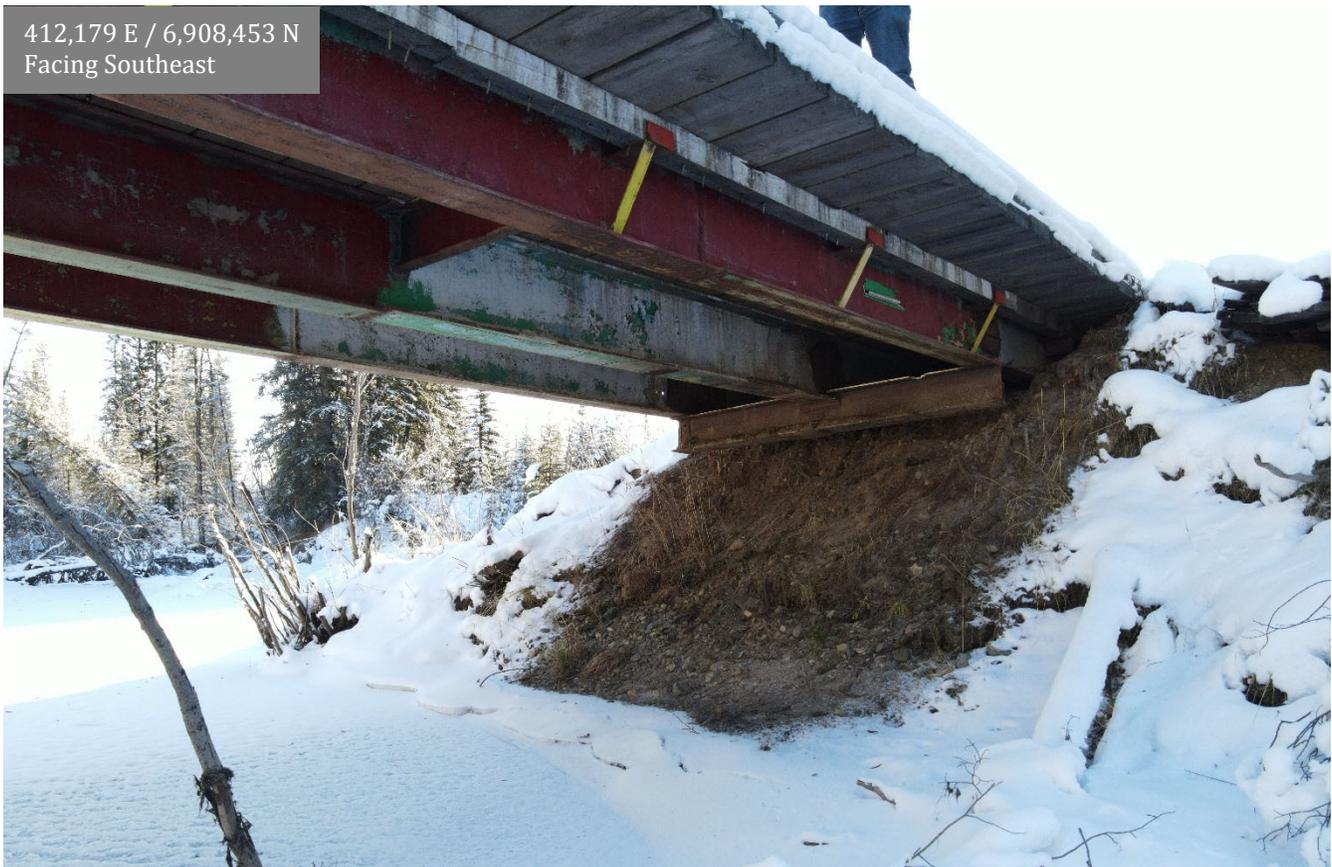
Photo 14: Merrice Creek bridge south abutment

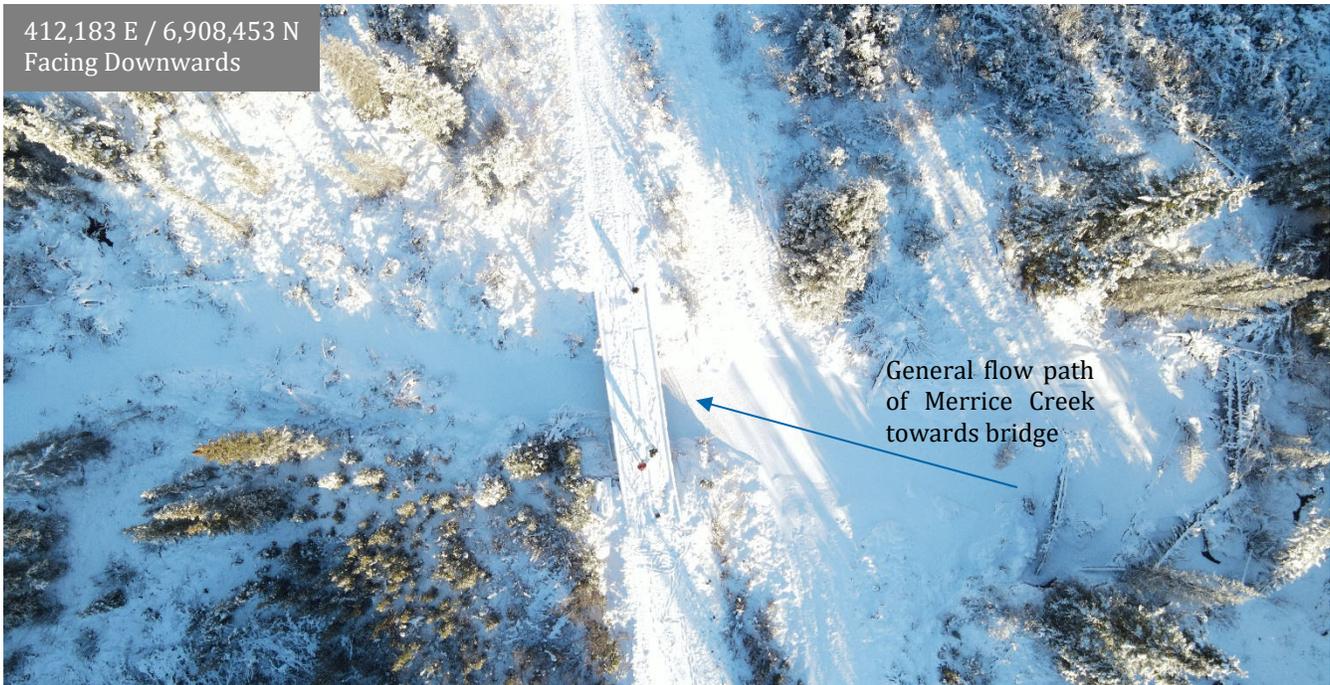
An aerial view of the bridge suggests that the north abutment is more susceptible to continued erosion during high-water events than the south abutment. The south abutment is partially protected by soil on the upstream side, but the north abutment has limited protection to redirect water flow around the slope. Photo 15 shows an aerial view of the bridge with an arrow indicating general flow towards the bridge, specifically towards the north abutment.

Photo 15: Aerial view of Merrice Creek bridge

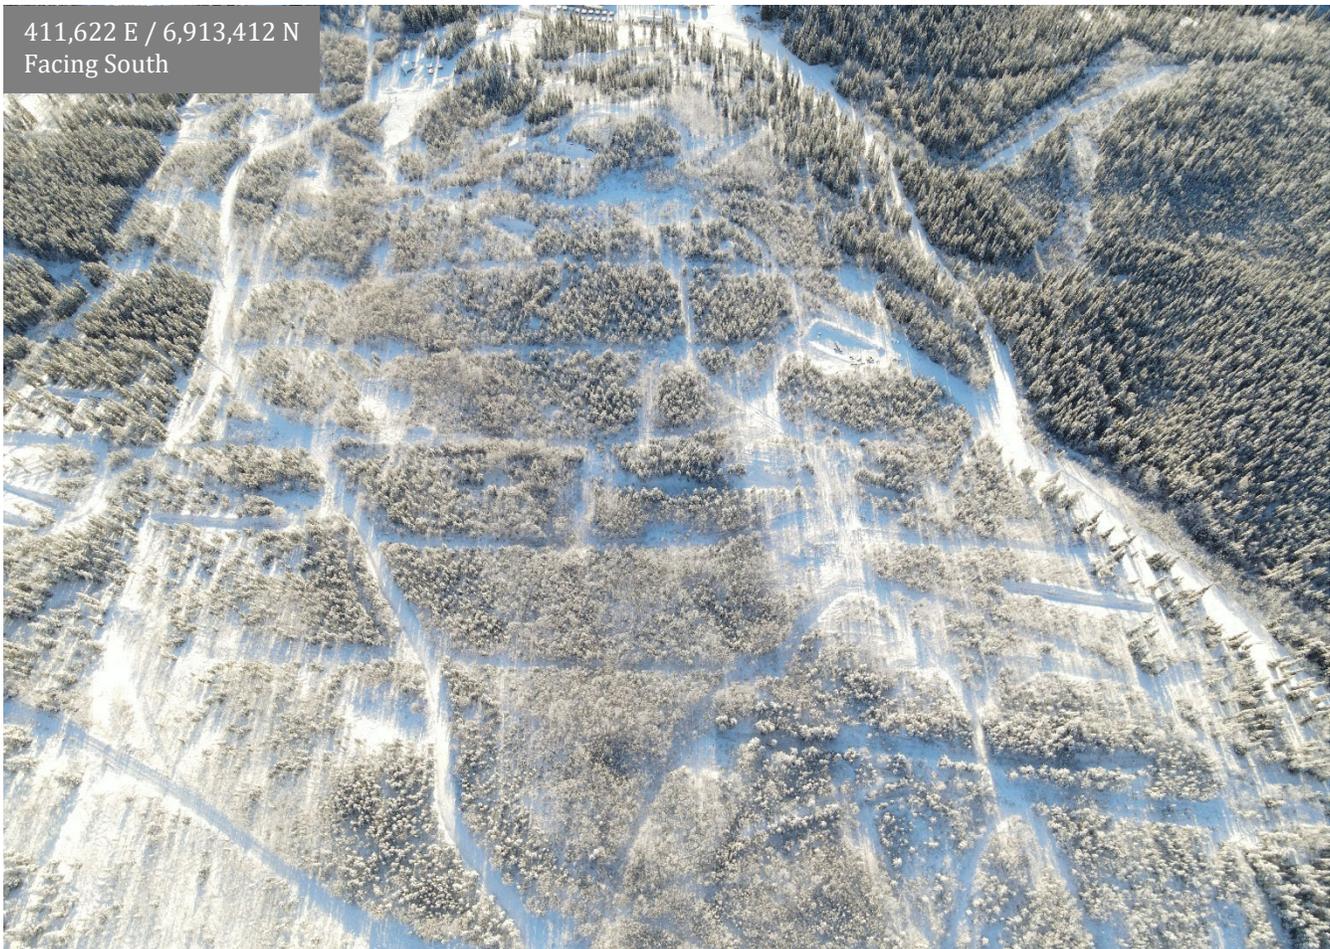
Photos 16 and 17 show the previously proposed heap leach site and the current proposed site, respectively.

Photo 16: Proposed heap leach area

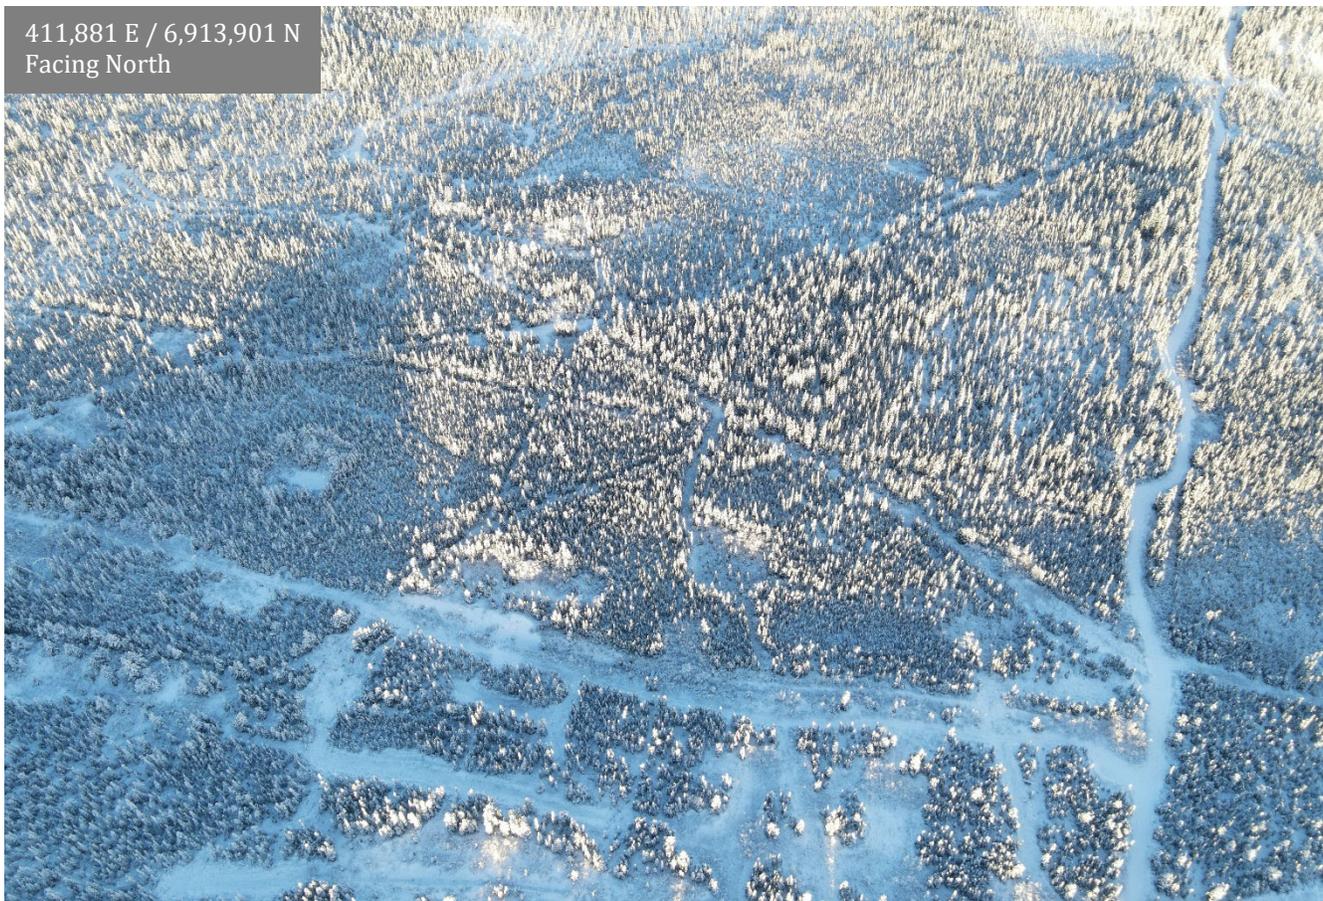
Photo 17: Proposed tailings management area and part of waste rock storage area

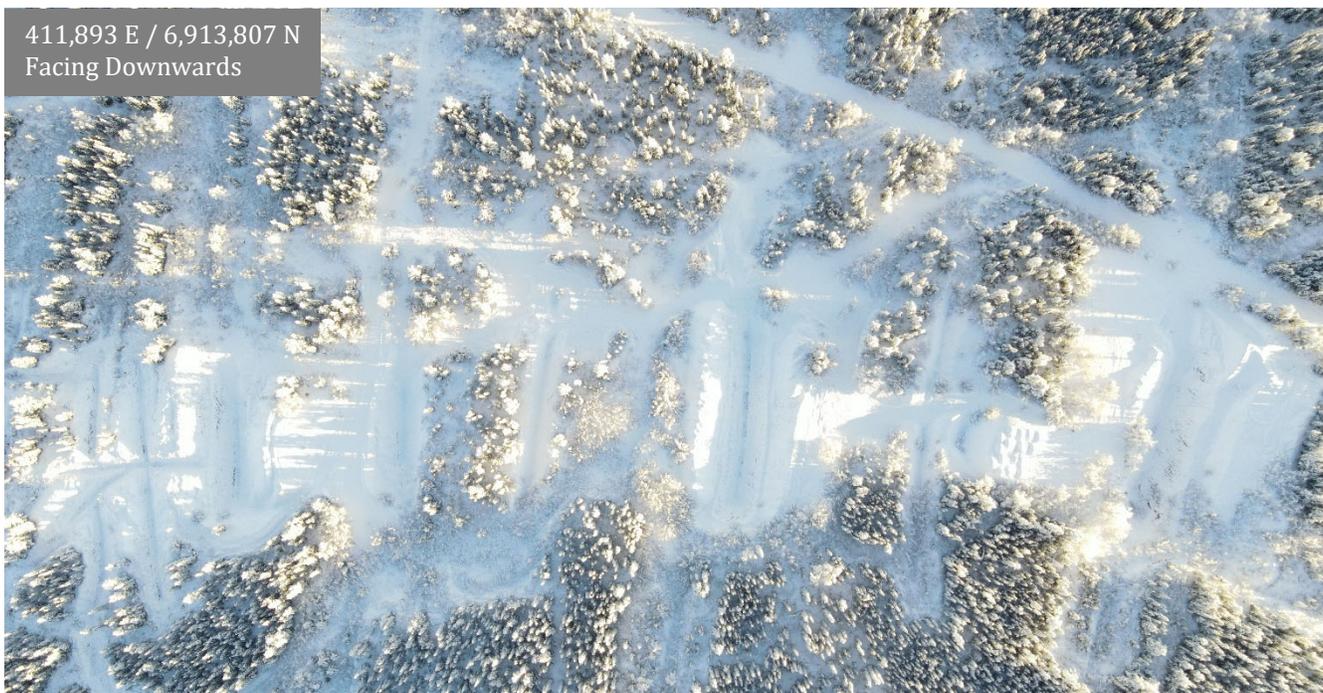
The open pit area comprises trenches excavated to collect bulk samples during exploration activities and drill pads. AM2 inspected the site, and trench slopes remain stable with no slumping or failures, and the trenches still facilitate egress for wildlife. Drill pads did not appear to have any significant erosion that could be observed through the snow cover. Photos 18, 19, and 20 show the exploration trenches in the proposed open pit area.

Photo 18: Aerial view of exploration trenches in the northern portion of the proposed open pit area

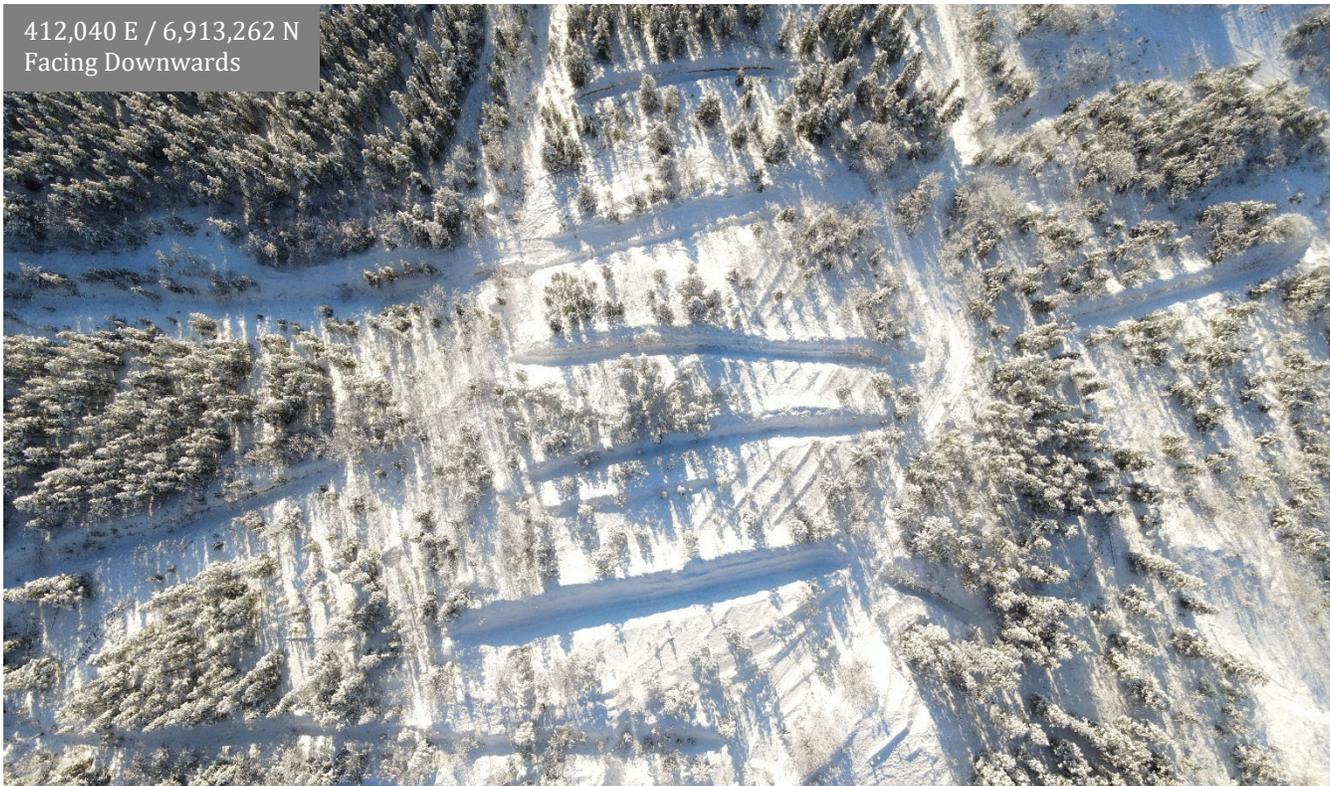
Photo 19: Aerial view of exploration trenches in the southern portion of the proposed open pit area

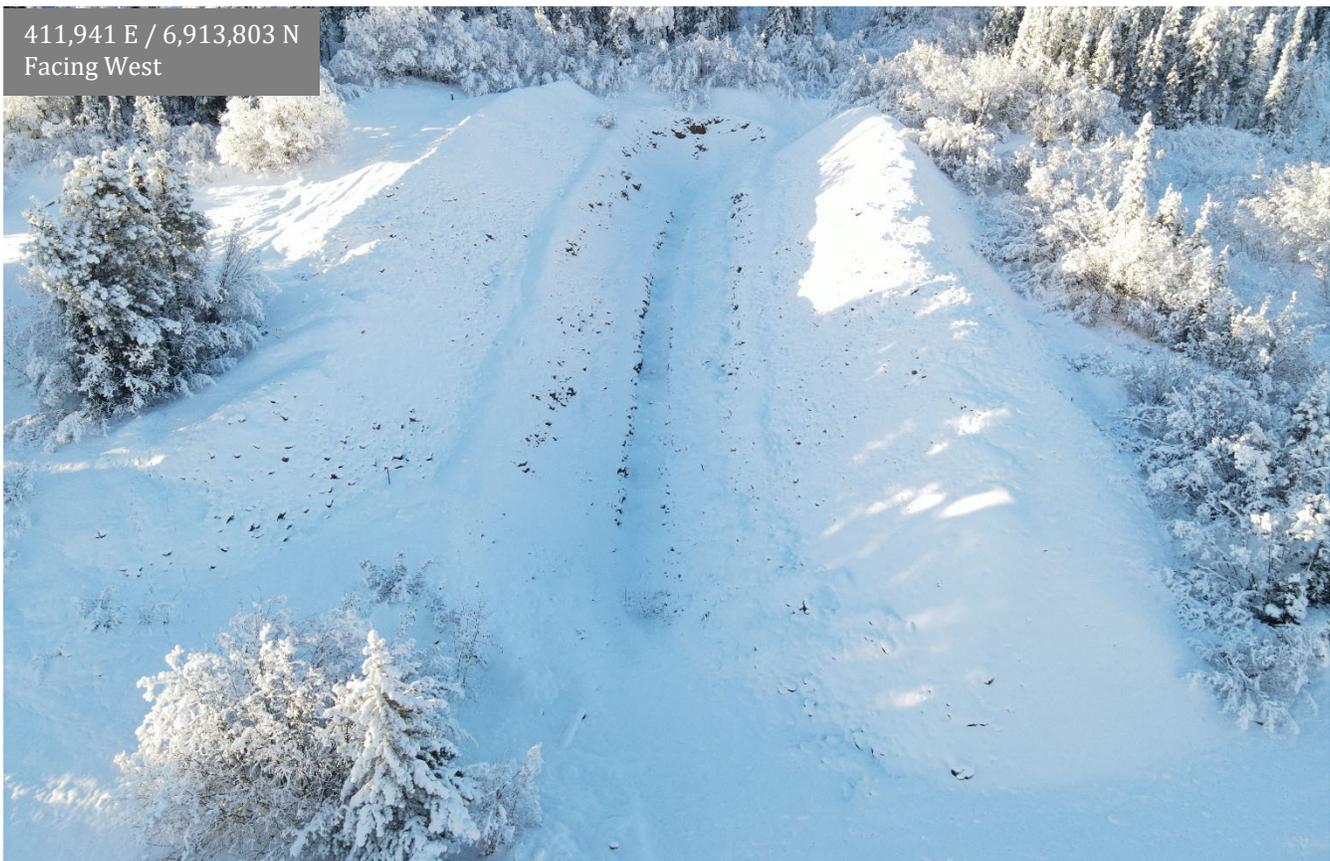
Photo 20: Typical exploration trench in the proposed open pit area
