November 6, 2015

Reference No. 1417183-006-L-Rev0-1000

**ANNUAL INSPECTION, OCTOBER 14, 2015
CARMACKS COPPER PROJECT, CARMACKS, YUKON**

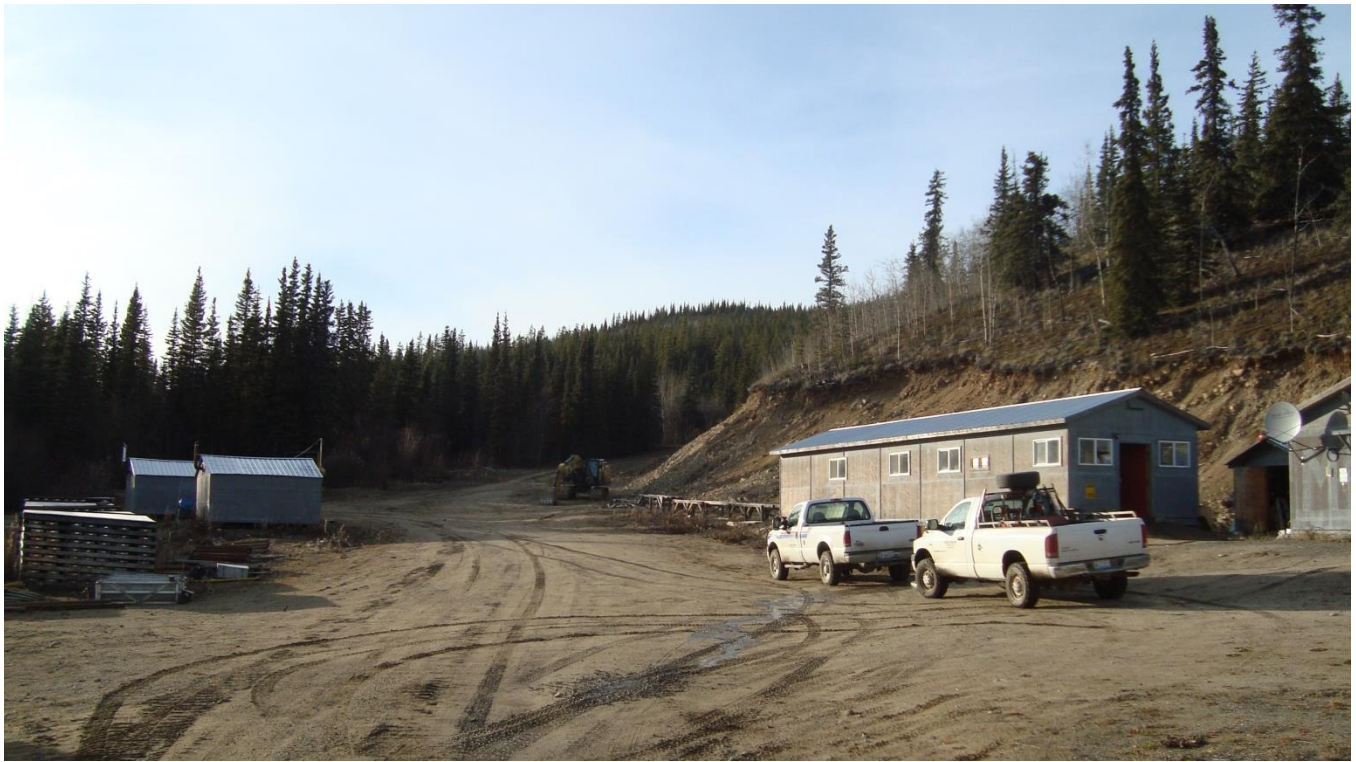
The inspection of the camp area (Photographs 1 and 2) indicated there is some thaw related settlement on the pad, which should be monitored as core storage racks may be affected. The inspection did not indicate erosion of sediments from the pad area into the surrounding natural area. There was some cracking observed in 2013 along the south edge of the pad (lower limited of pad), approximately 3 to 4 m from the pad edge. Additional cracking was observed in 2014 on the west edge of the pad, which is likely the result of thaw related settlement in the core storage area.

Photograph 1: View looking west to exploration camp

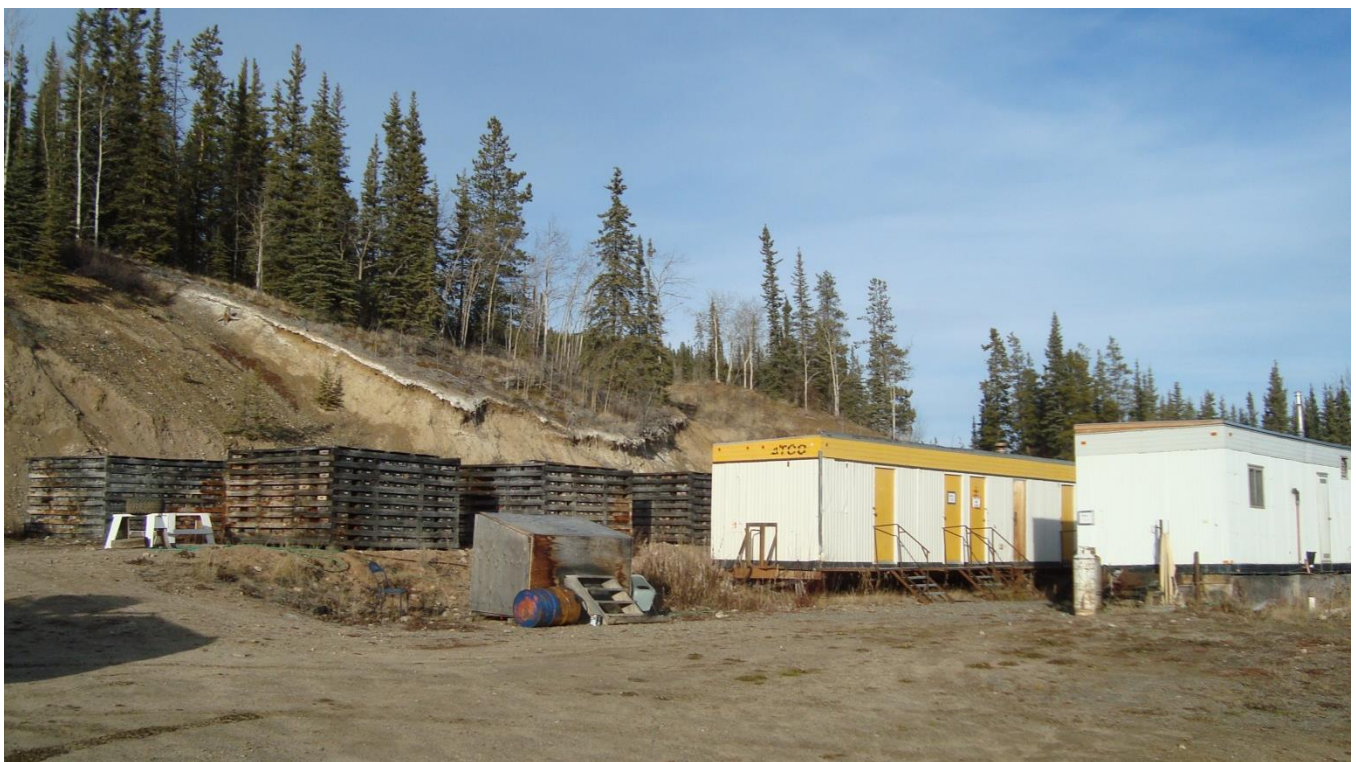
Photograph 2: View looking northeast exploration camp

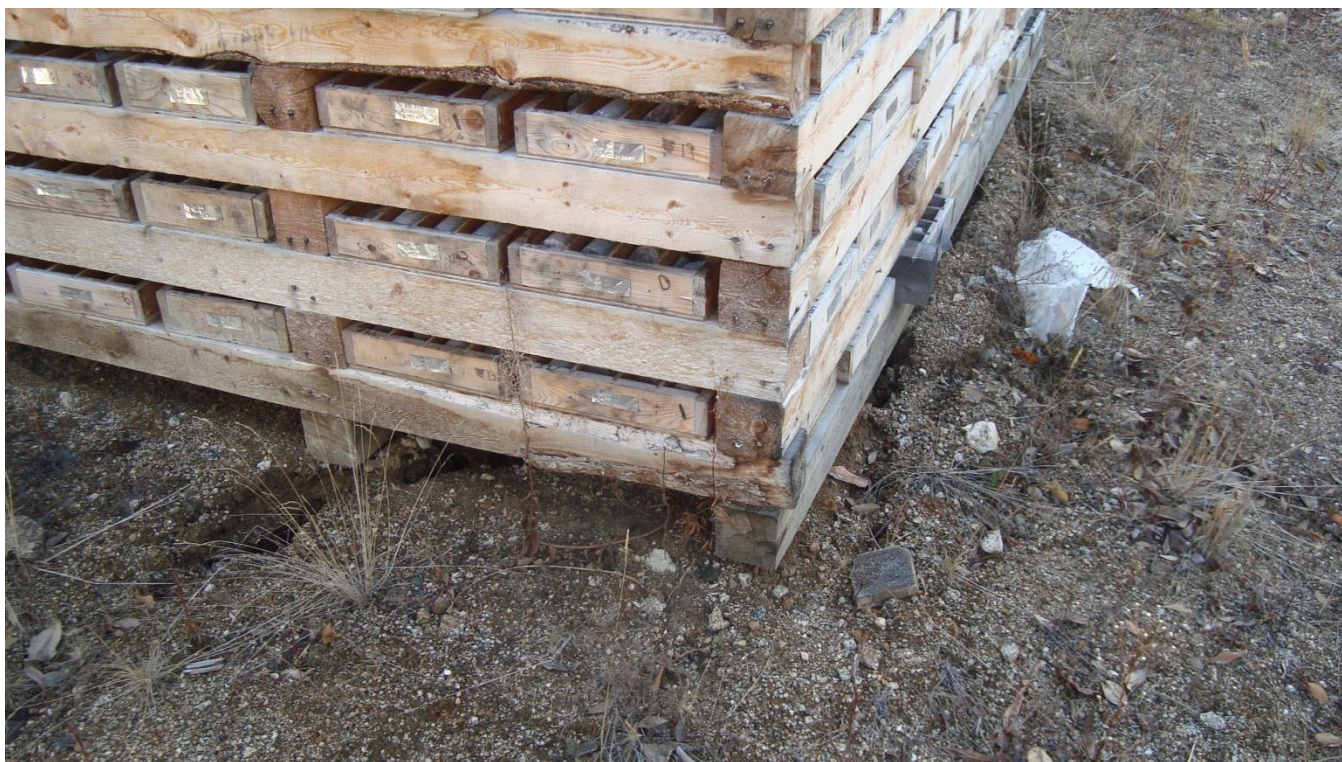
In 2015, new cracking was observed to the north of the southern row of core racks (Photographs 3 and 4). There is a trough, approximately 0.2 m deep located between the core racks, which is likely the result of thaw related settlement and does not pose an immediate safety concern.

Photograph 3: Cracking in pad at southwest core rack area

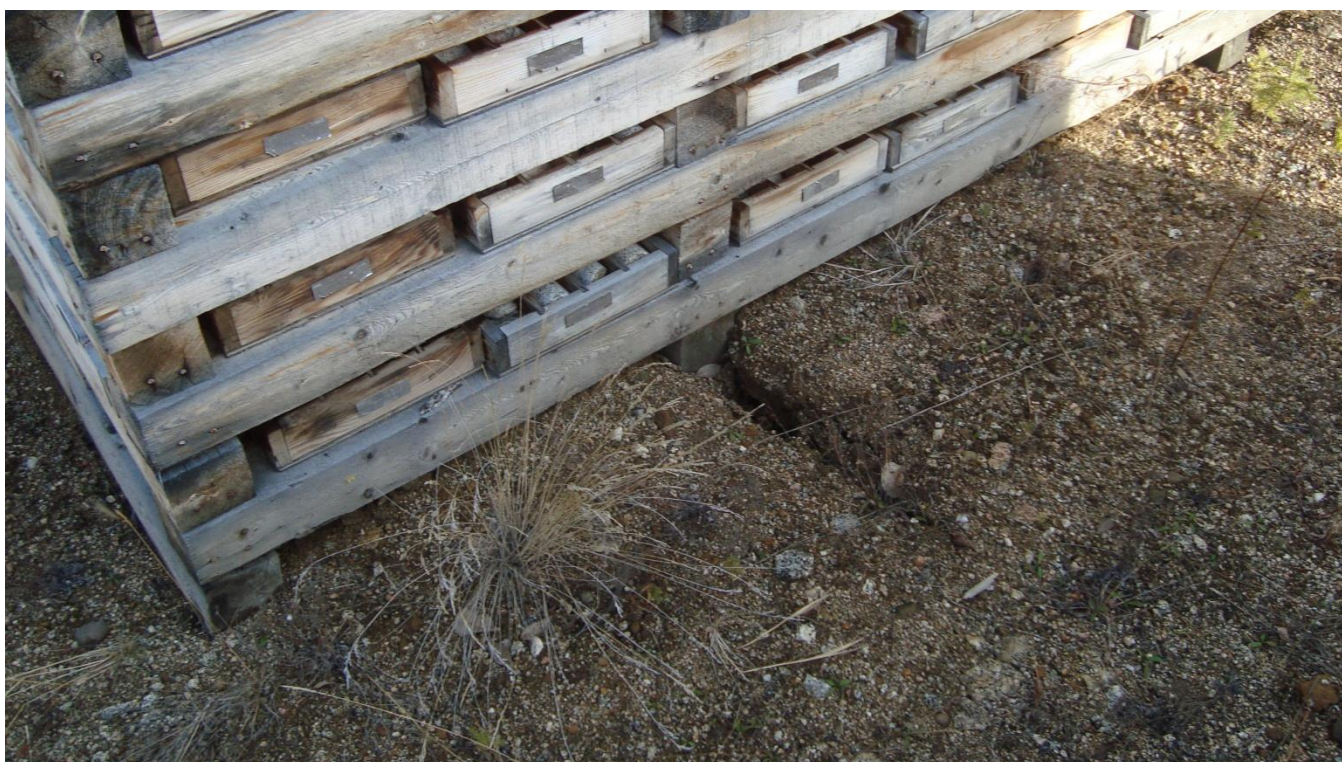
Photograph 4: Cracking in pad at southwest core rack area

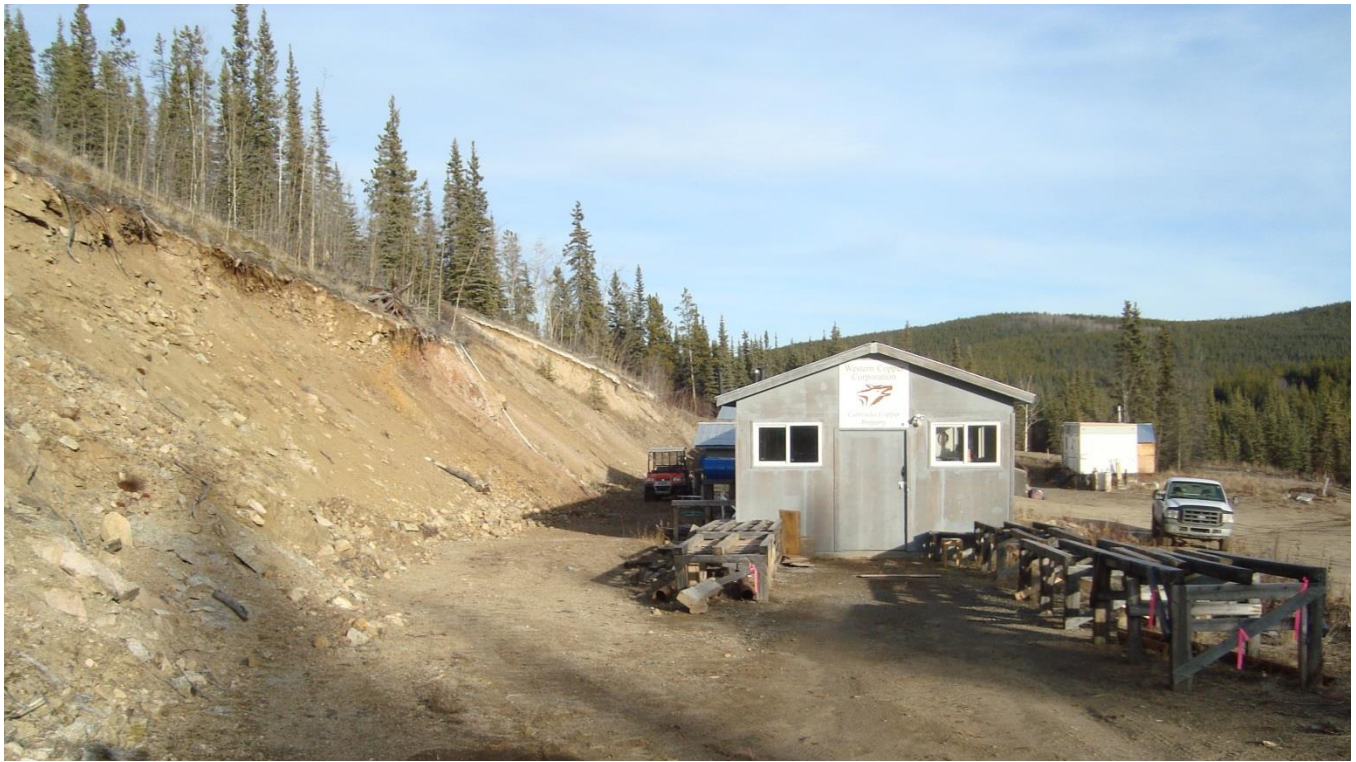
The slope behind the camp (Photographs 5 and 6) is stable and does not pose a safety concern for the camp structures or current operations. There is minor ravelling of small sections of the slope, but these are not impacting camp safety nor would they represent an issue to workers on the project. Some regrowth of vegetation was observed in the camp area.

Photograph 5: View looking east to slope immediately north of exploration camp

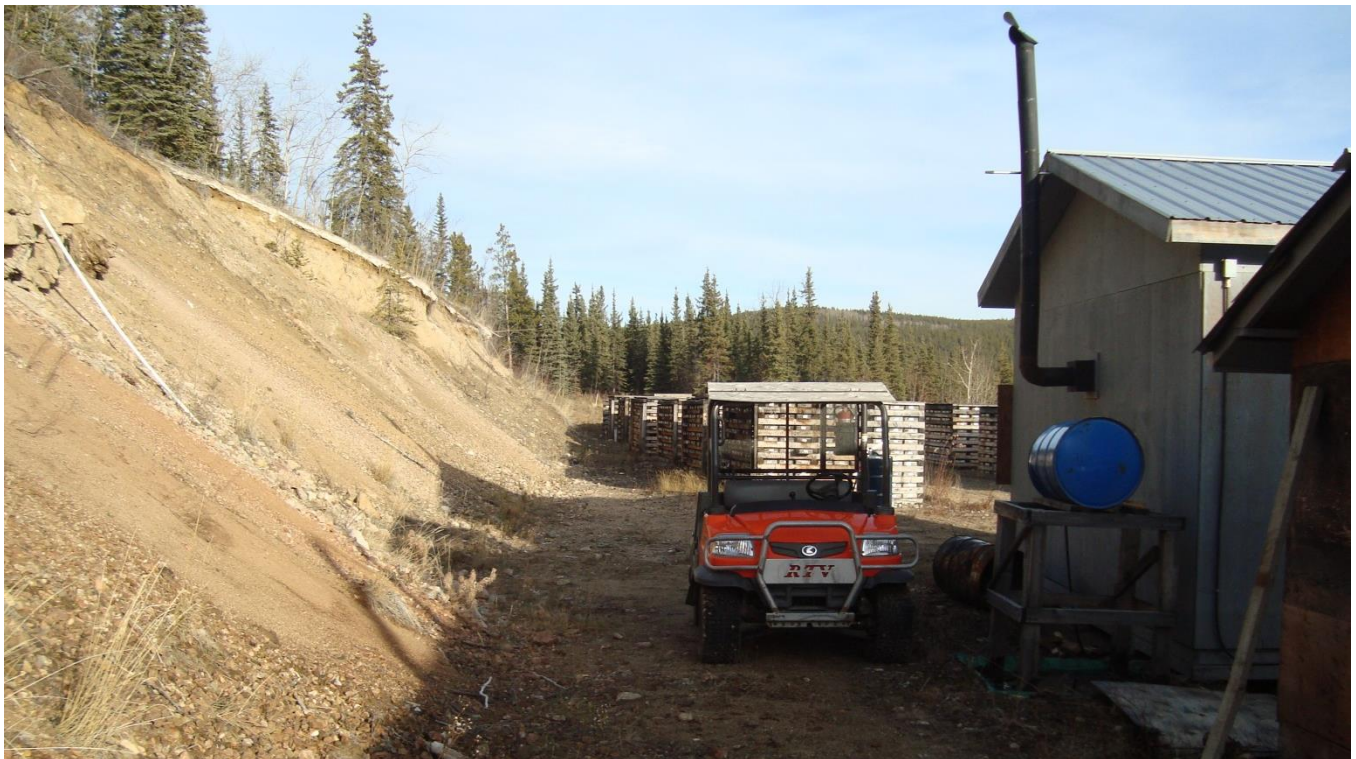
Photograph 6: View looking east to slope immediately north of exploration camp

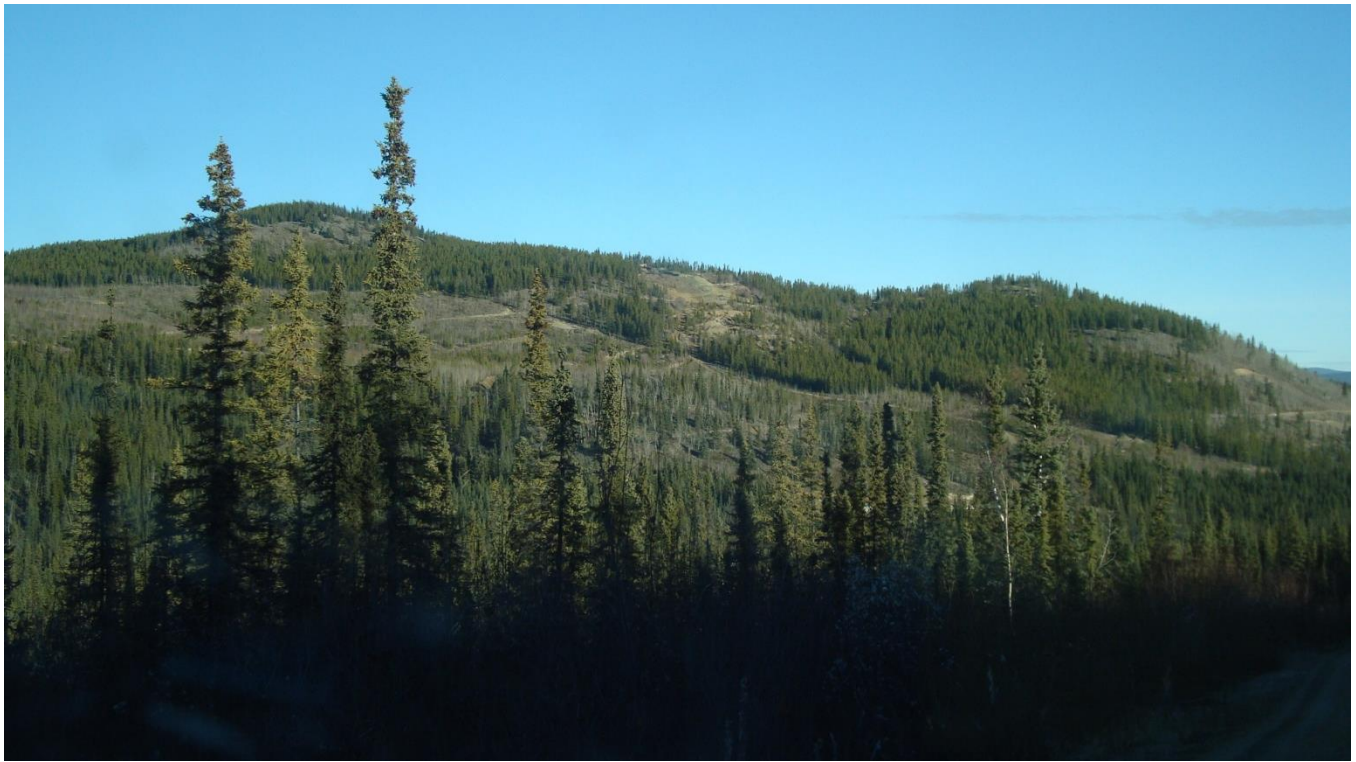
In addition to the camp, the inspection included the area proposed for the heap leach facility (Photograph 7), and water management pond. Site preparation in these areas has been limited to the clearing of trees and organic soils. This portion of the site also includes several access roads and drilling platforms previously used for exploration/investigation activities.

Photograph 7: View looking north to area proposed for the heap leach facility and open pit area

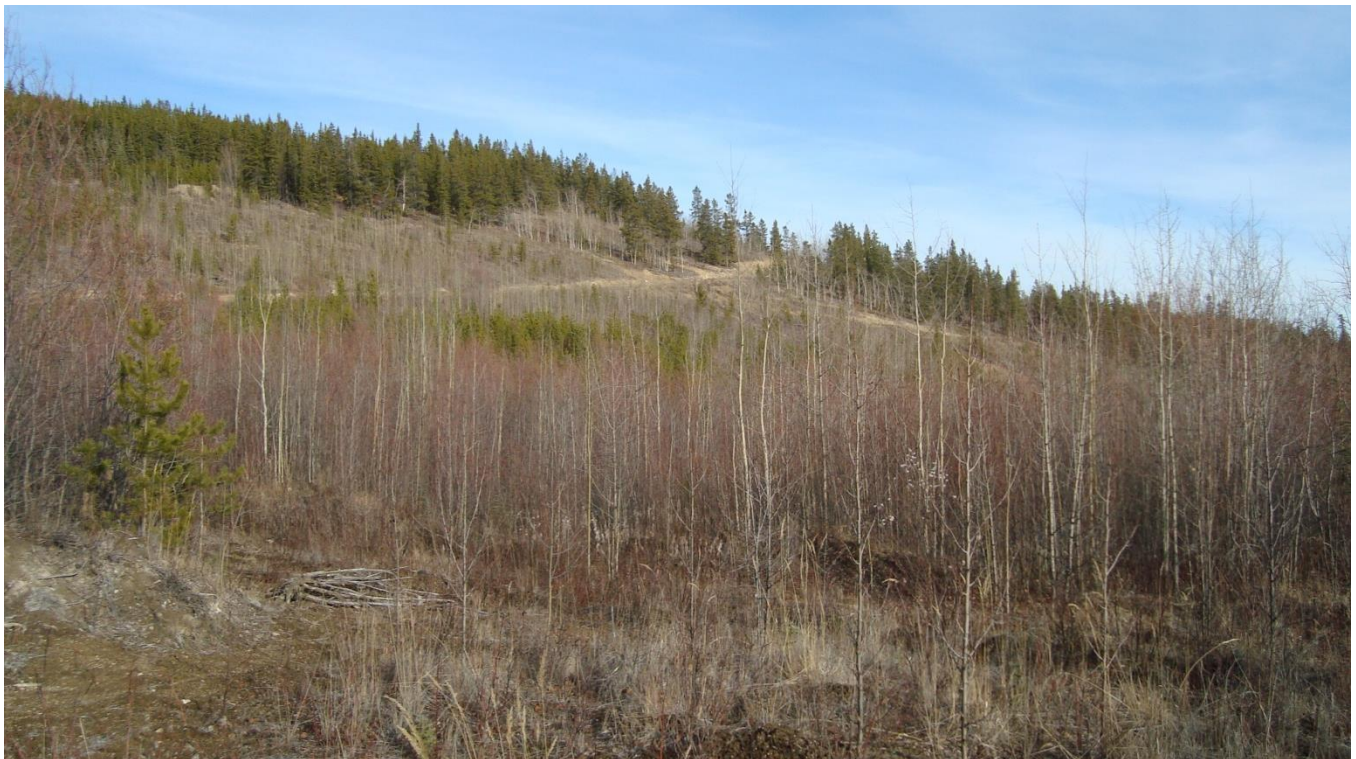
Since the initial clearing in 1997 and 1998, regrowth of vegetation has been occurring in the area (Photograph 8 and 9). Erosion and sediment control measures in this area were initially installed in September 2008 and further maintained in September 2009 and August 2010. The sediment control measures include ditches and berms to divert water into sediment catch basins, silt fences, and vegetated areas to break up flow and reduce the potential for erosion. The inspection indicated that there has been some erosion of sediments along the access roads and that the sediment basins are trapping and containing the sediment adequately.

Photograph 8: Re-vegetation of area proposed for the heap leach facility

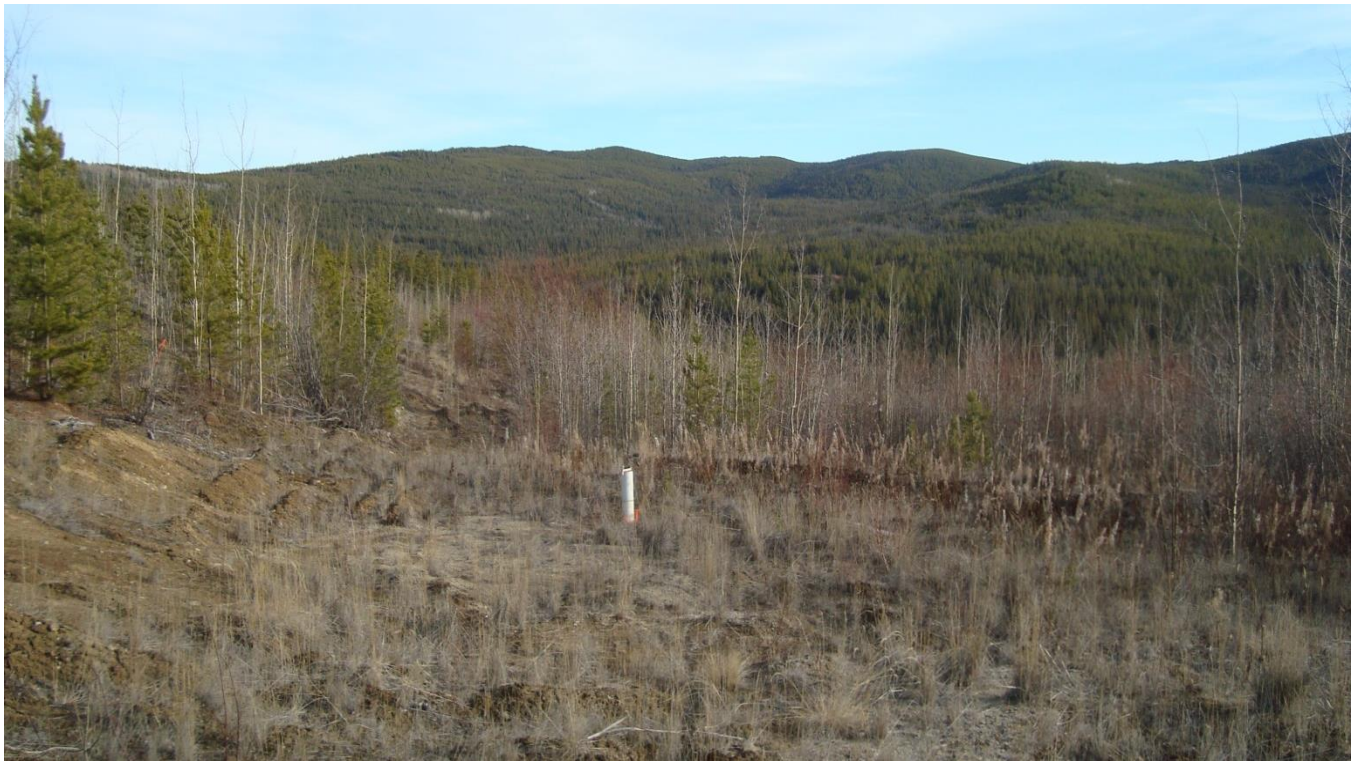
Photograph 9: View looking east of re-vegetated drill pad in the area proposed for the heap leach facility

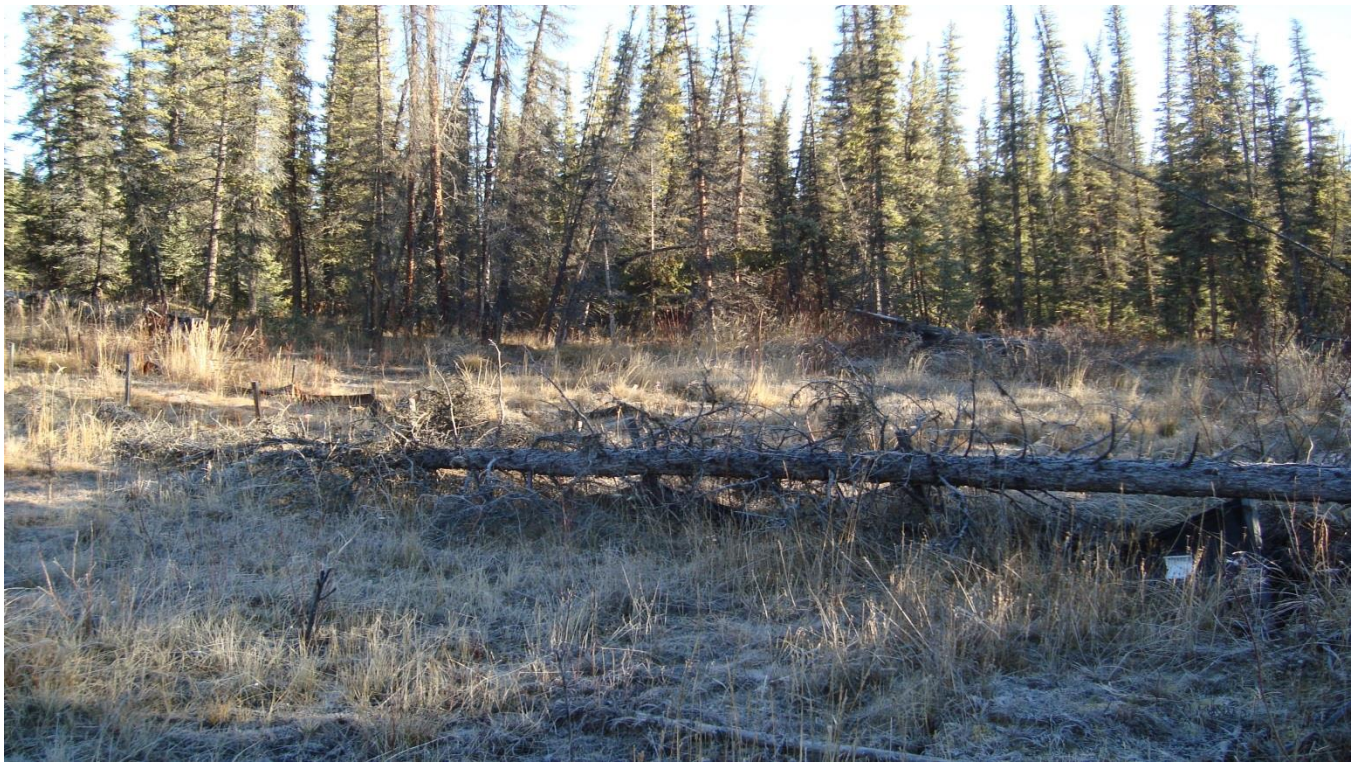
Further down slope of the proposed heap leach facility sediment pond, and within the floodplain of Williams Creek, silt fences have been installed and the area seeded where sediment from previous site erosion accumulated (Photographs 10 and 11). Grass seed was applied in 2009 to promote the re-establishment of vegetation and to further stabilize sediment. The approach was noted to be generally effective in 2011 and 2012, but with limited regrowth attributed to periodic pooling of water. The area was also re-vegetated with woody plants (willow cuttings), and plants appear to be tolerating saturated soil conditions. There was no evidence of sediment movement, indicating that re-vegetation has been effective in minimizing erosion.

At the time of the inspection, it was observed that the silt fencing surrounding these areas is working effectively; the fences are overgrown. No evidence of movement of sediment beyond the existing silt fences was observed, nor does it appear that sediment has entered Williams Creek. Limited growth of willow cuttings was observed. Silt fences are of a temporary nature that should be inspected annually and ongoing minor maintenance activities should be anticipated.

Photograph 10: Re-vegetation and silt fence between area proposed for the heap leach facility and Williams Creek

- Ongoing minor maintenance, as required, of access roads with regards to erosion and washouts potentially resulting in movement of sediment into local waterways, and
- Ongoing minor maintenance on the silt fences and sediment traps in the area between the proposed heap leach facility area and Williams Creek.

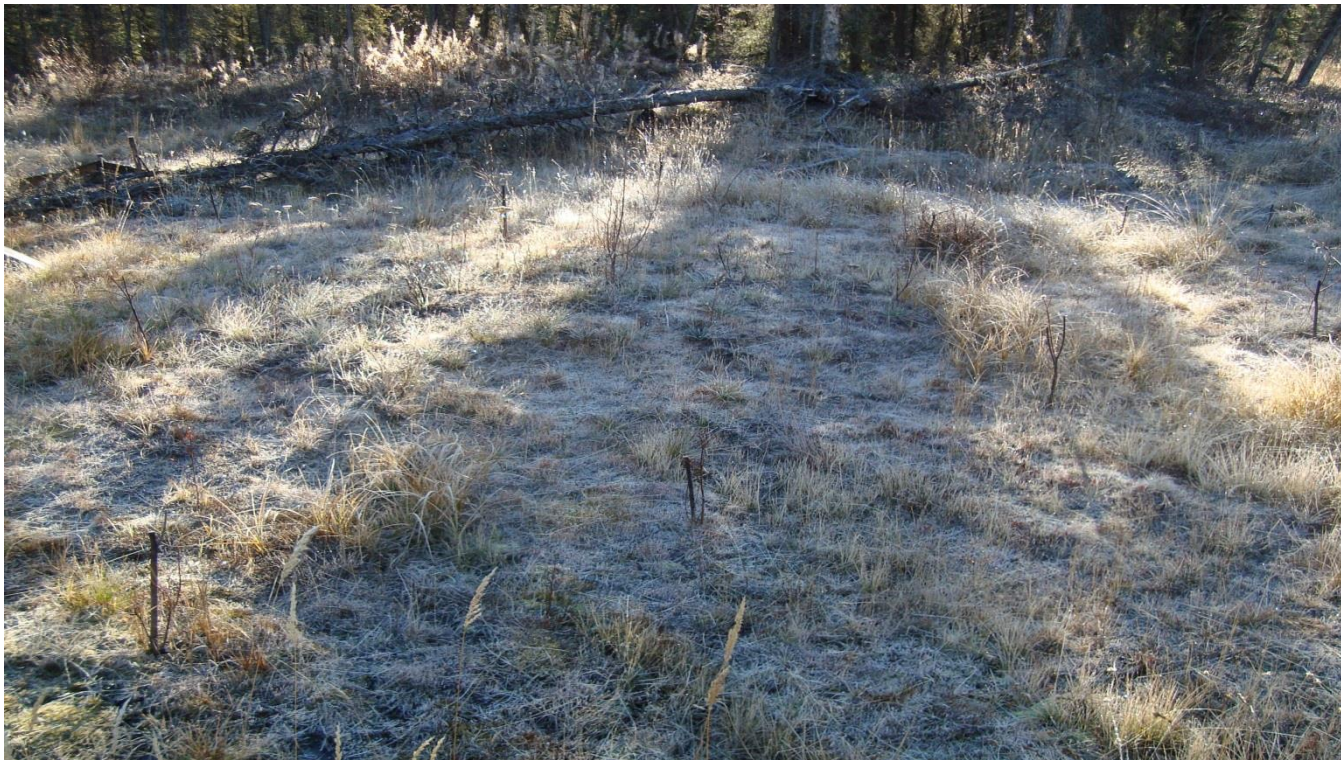
Photograph 11: Re-vegetated area with willow cuttings between area proposed for heap leach facility and Williams Creek

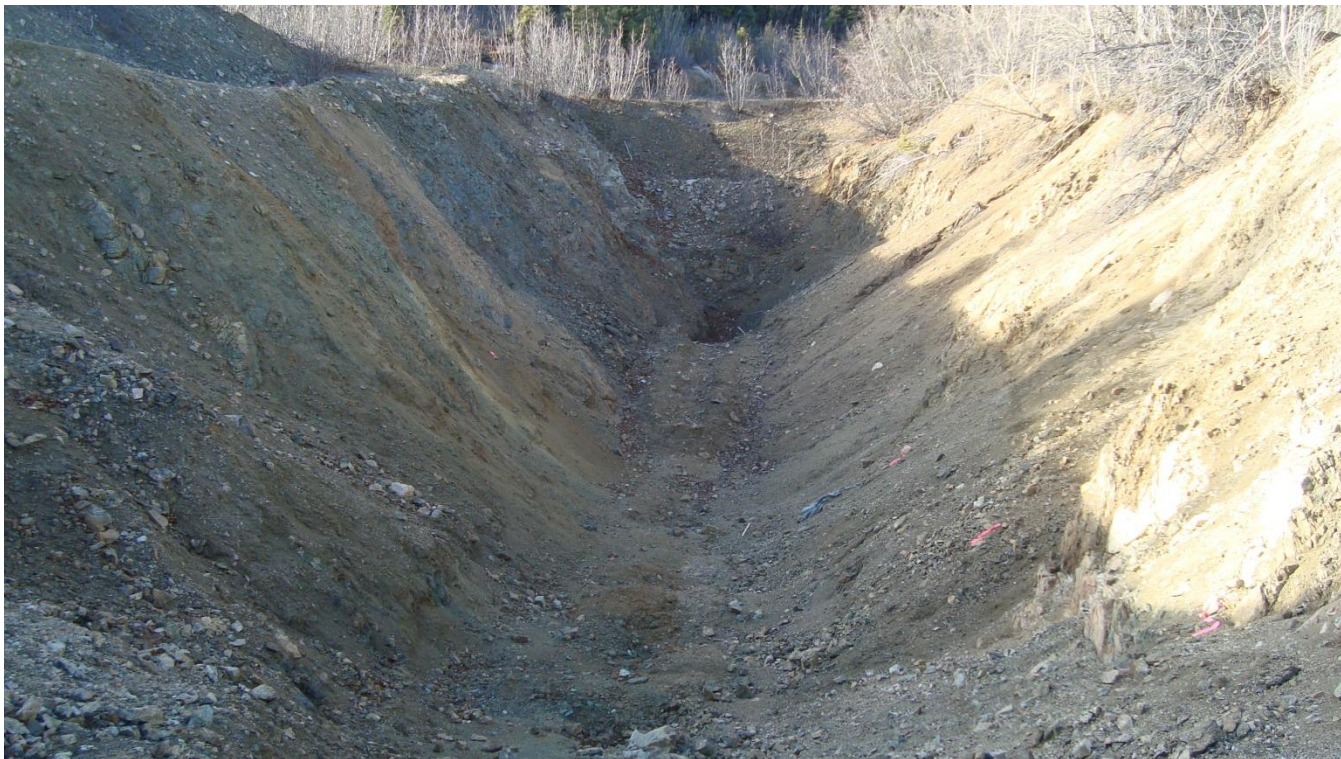
The area proposed for the open pit mine was inspected (Photographs 12 and 13). The slopes of the trenches excavated as part of the effort to obtain bulk samples during exploration activities were observed to be in reasonable condition and there was no observed slumping or failures of these slopes. The leached ore pile from the off-site test pad adjacent to the trench was observed to be stable and there was no erosion or slope movement of the material. Several of the closed drill pads were inspected and there did not appear to be any erosion noted from these areas that would require attention.

Photograph 12: View looking northwest of bulk sample excavation site in the proposed open pit area

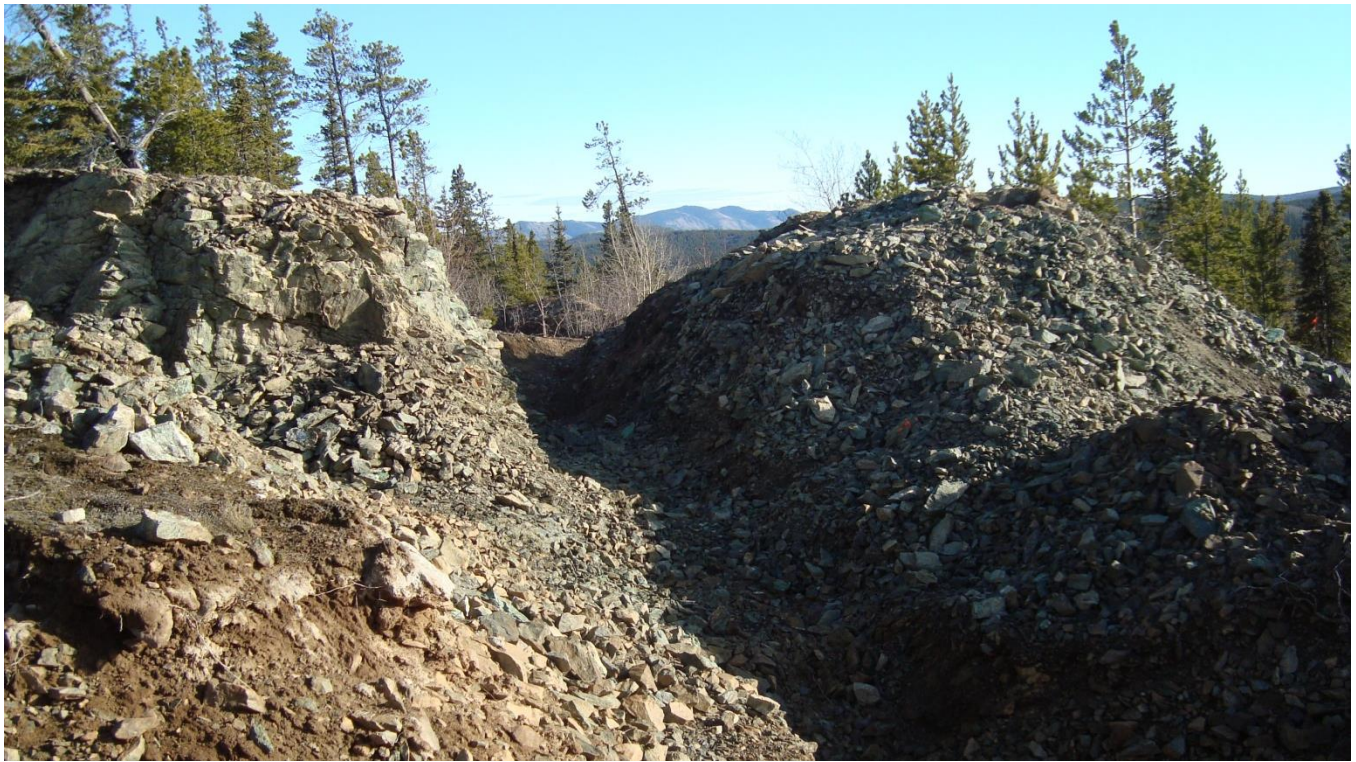
Photograph 13: View looking east of bulk sample excavation site in the proposed open pit area

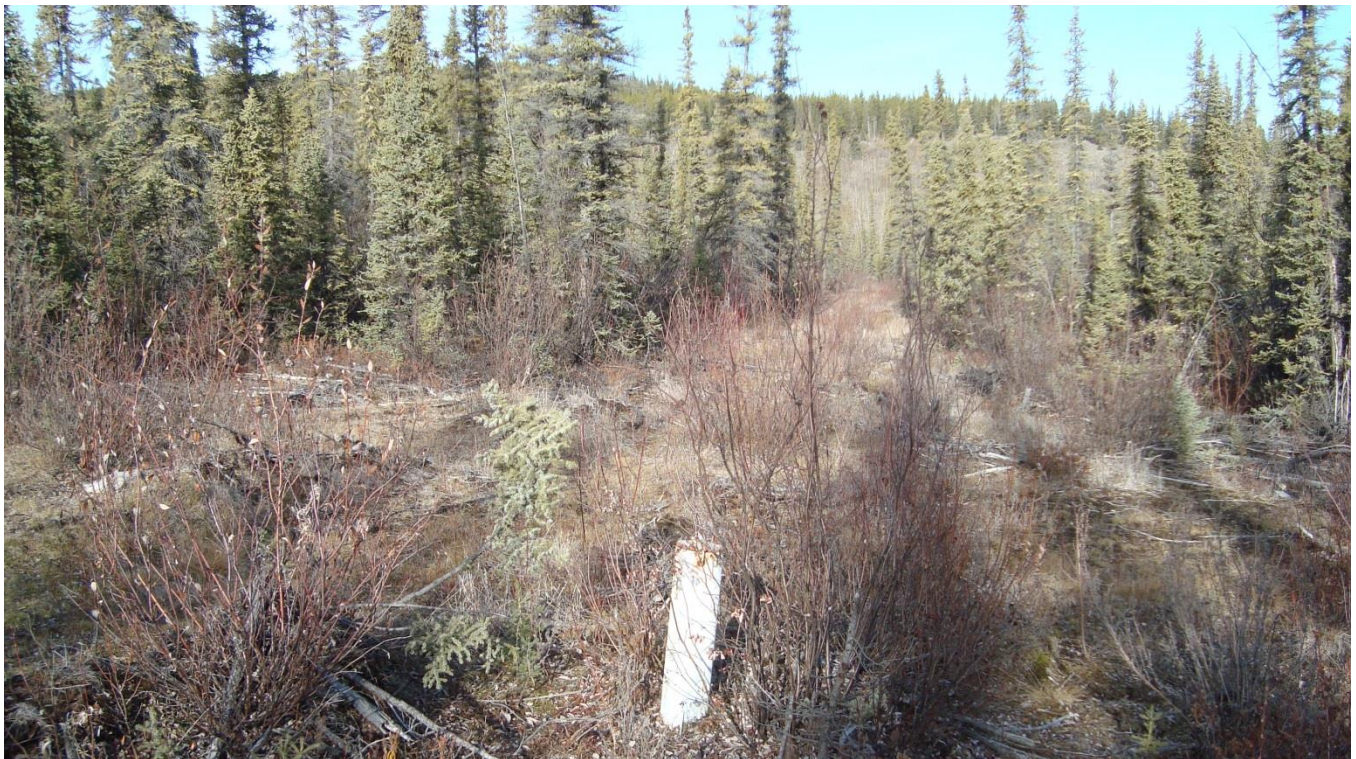
The proposed waste rock storage area was inspected. The waste rock storage area is still tree covered and the drill pads and access roads in the area are re-vegetating by volunteer species (Photograph 14). The small sediment catch basins at the drill pads still have capacity to manage additional sediment, if required.

Photograph 14: View looking east of re-vegetated drill pad in the proposed waste rock storage area

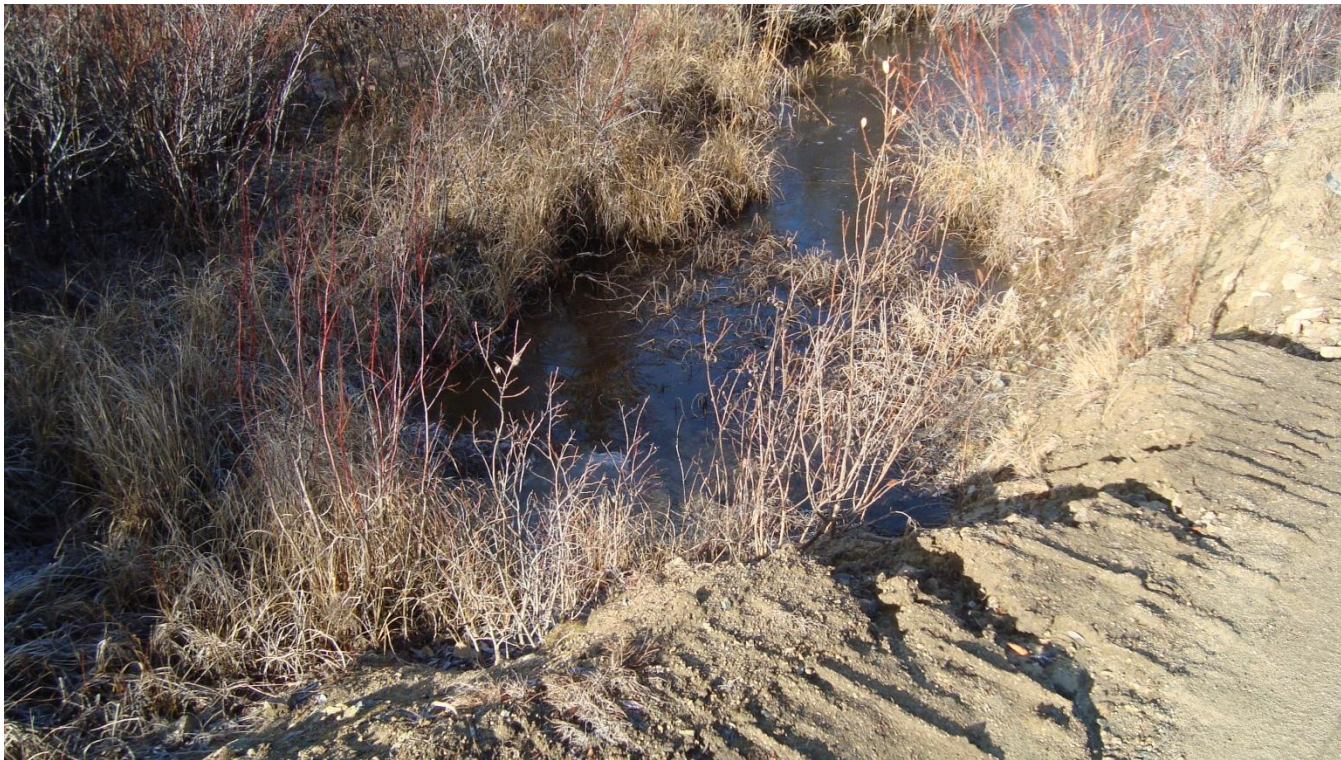
Local erosion on the main access road to the north of the waste rock storage area continues. The shoulders of the road at the culvert on North Williams Creek have eroded (Photograph 15 and 16). The access road should be inspected annually and ongoing maintenance of local erosion features should be anticipated.

Photograph 15: View looking north of ponded water and erosion above culvert on access road at North Williams Creek

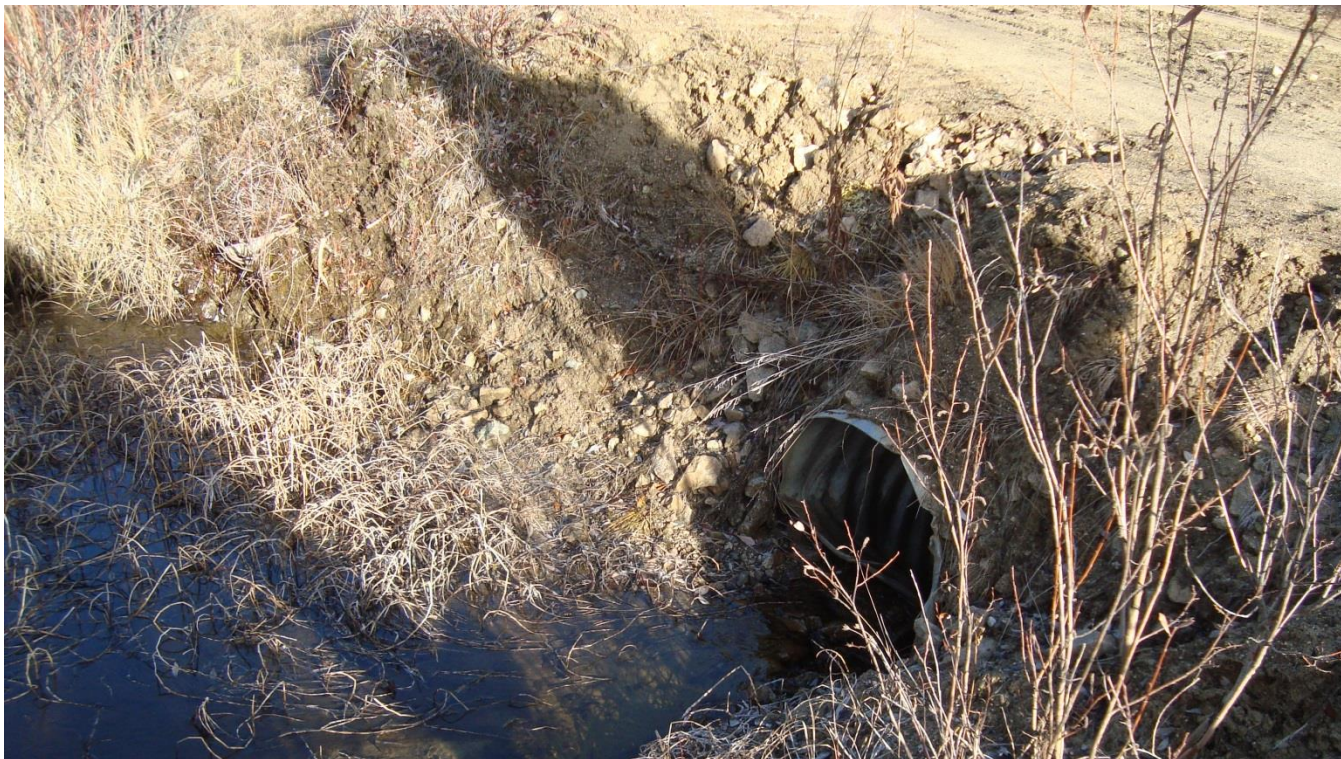
Photograph 16: View looking east of erosion above culvert on access road at North Williams Creek

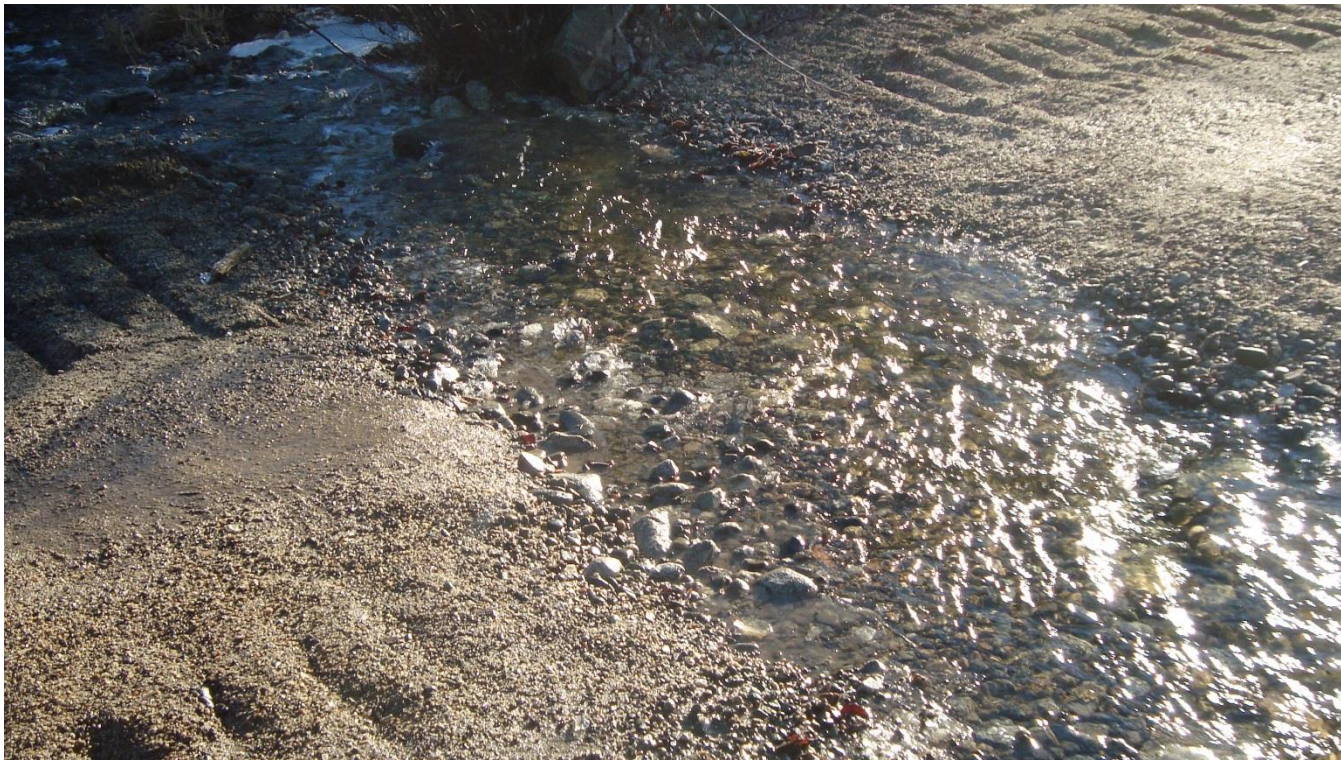
The culvert in the site access road, which allowed Williams Creek to flow under the road was previously removed in 2013. The crossing is now a 'ford' with the road bed depressed over a length of 10 m to a maximum depth of 0.4 m below the adjacent road grade or crest elevation (Photograph 17). The rockfill in the ford is well-graded and there is no indication of movement of finer materials. Pounded water was observed on the upstream side of the road, with flow across the road (Photograph 18).

Photograph 17: View looking north of constructed 'ford' on access road at Williams Creek crossing

The rockfill of the ford appears to be stable. It is recommended that the ford is inspected annually and monitored for erosion of finer materials, particularly following large rainfall events, and maintained as required. The ford is appropriate for the current status of the project. However, prior to site development, it is recommended that the culvert at the Williams Creek crossing is replaced and the access road armored against erosion at this location.

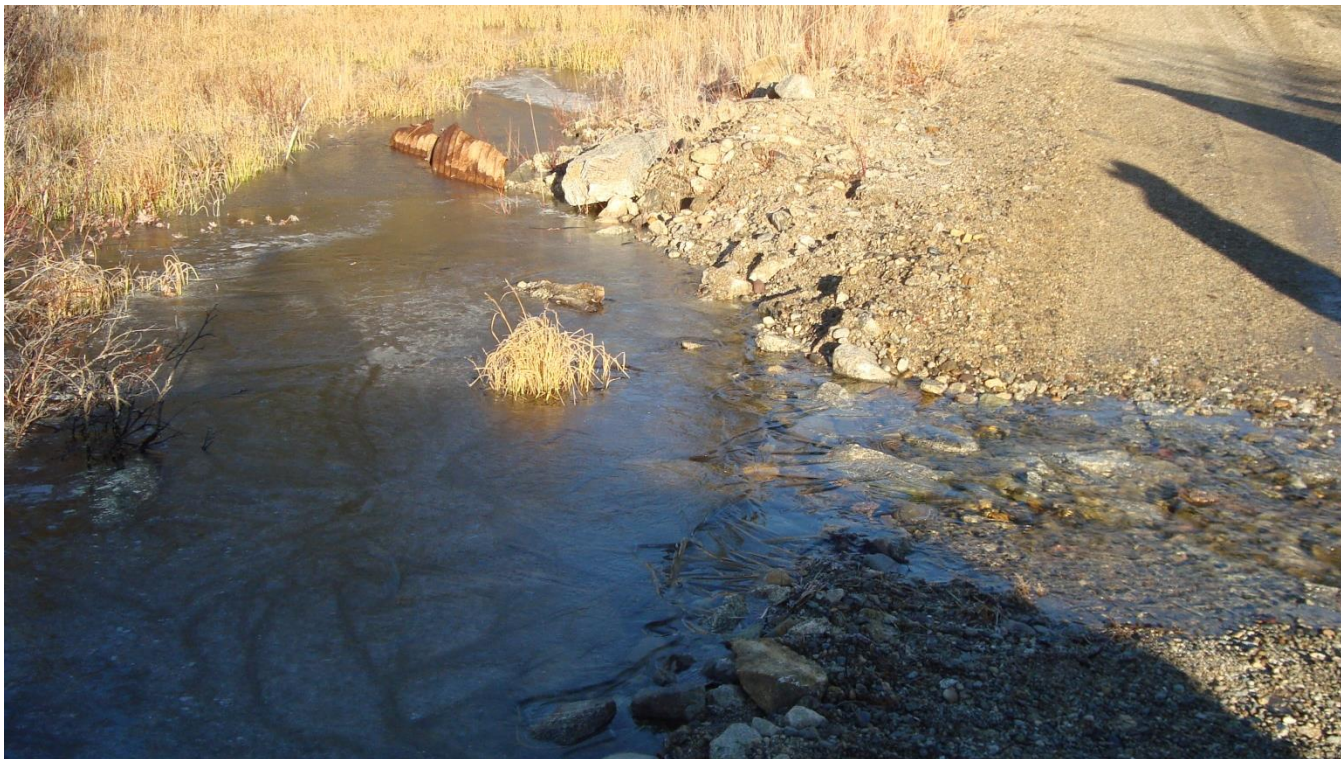
Photograph 18: View looking north of ponded water behind 'ford' on access road at Williams Creek crossing

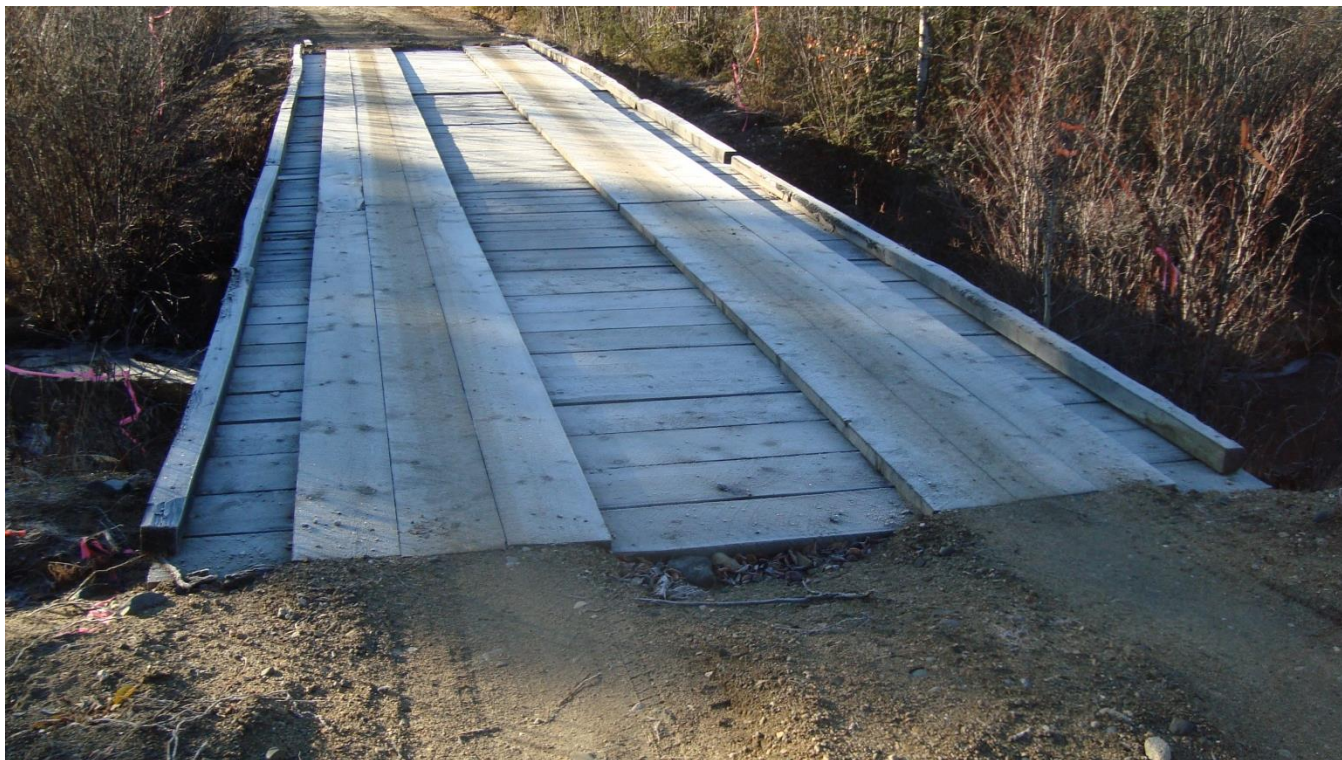
The access road crossing at Merrice Creek includes a single-span bridge set on grade. Following recommendations in the July 2014 inspection memorandum, the bridge was extended by approximately 3 m and seated 1 to 2 m on the abutments. Approximately 3 m of steel was welded to the existing span, bridge decking was replaced and extended, and the approaches were re-graded to the bridge deck elevation (Photographs 19 and 20). Further work is not required as the bridge seems appropriate for the current status of the project.

Photograph 19: Site access road crossing Merrice Creek, view in direction of Carmacks

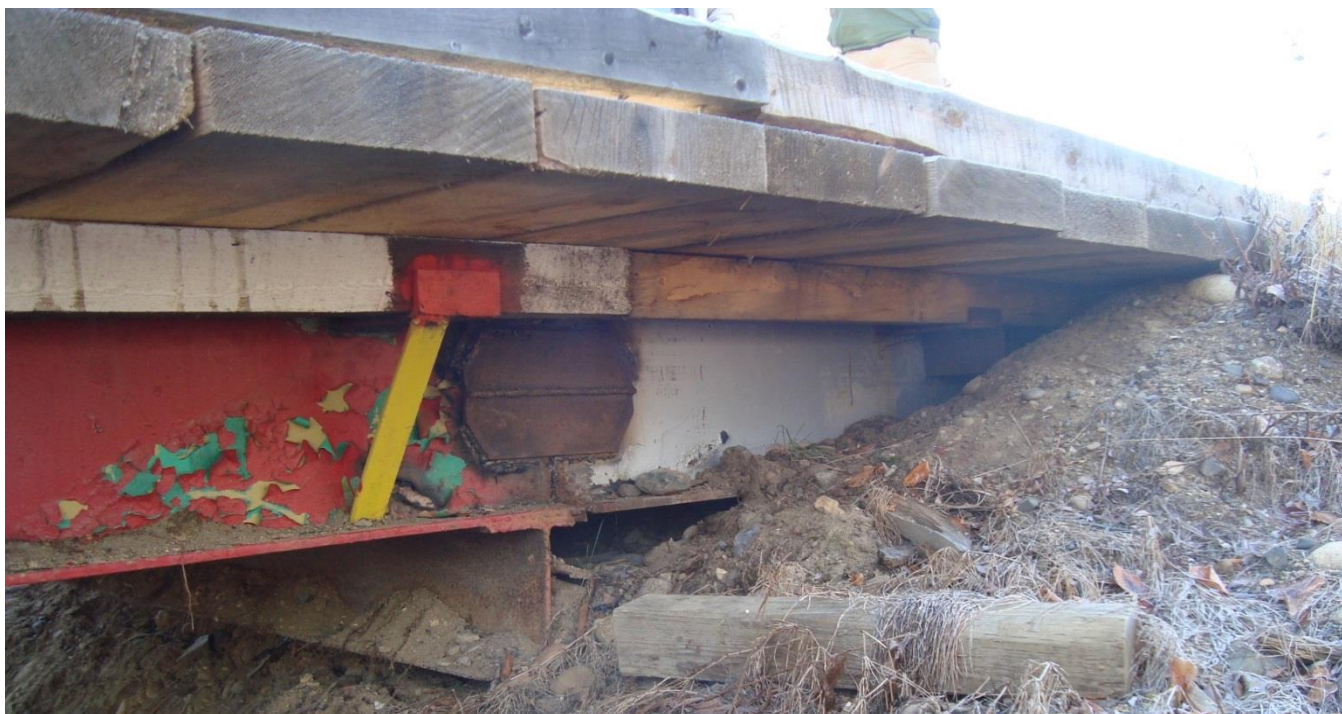
Photograph 20: Site access road crossing Merrice Creek, view of extension and bridge abutment nearest to Carmacks
