## **2015 ANNUAL QUARTZ MINING LICENCE REPORT**

**Submitted to Yukon Government, Energy Mines and Resources  
Yukon Quartz Mining Licence QML-0007**

**March 2016**

**Carmacks Copper Project, Yukon Territory**

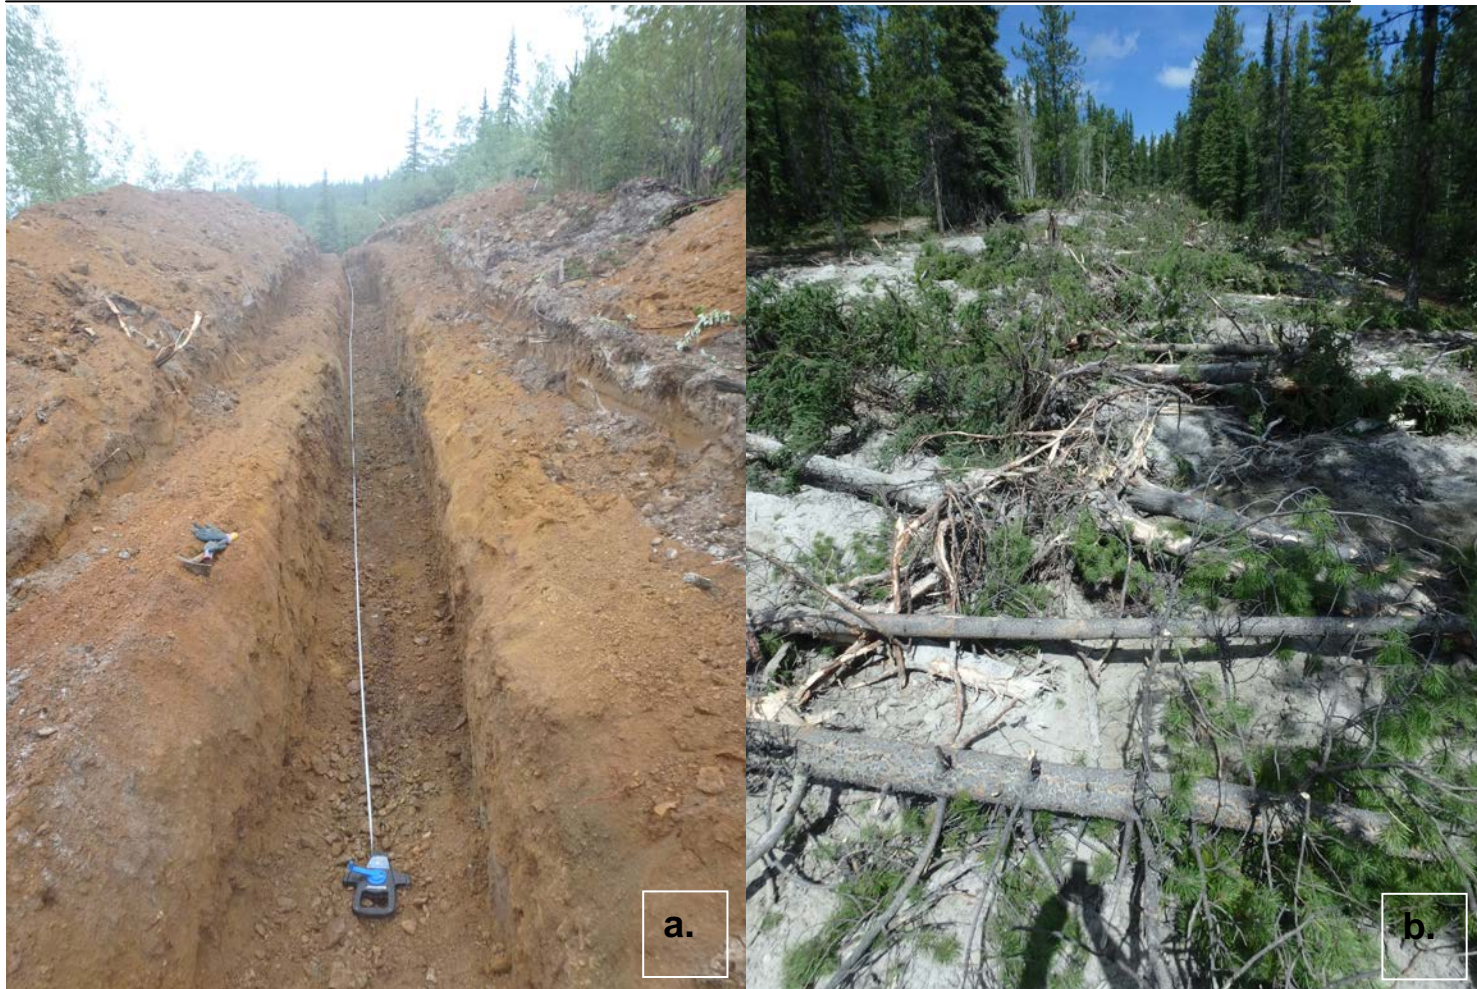
All drill pads developed in 2015 were reclaimed. All trenches developed in 2015 not required for further sampling were reclaimed, as listed in Table 1. Typical before and after trench reclamation is shown in Figures 2a and 2b.

**Figure 2. Typical trench conditions before (a. Trench TR-15-32A) and after (b. Trench TR16-26) reclamation.**
