Allnorth Information		VICTORIA GOLD CORP.	
Project #:	18-VA-0109	Client Project #:	
Document #:	181003	Client Document #:	
Document Rev. #:	0	Client Doc. Rev.#:	
Prepared By:	Rod Keetch, P. Eng. James Garner, EIT	Client Contact:	Stephen Wilbur, Hugh Coyle

Annual Physical Stability Assessment Report – Victoria Gold – Eagle Gold Project

Visual inspection of the following structures; Lower Dublin South Pond, Secondary Crusher – cut slopes, fill slopes and MSE wall, Primary Crusher – cut slopes and fill slopes, 90 Day Stockpile, Stockpile A, Stockpile B, Adsorption, Desorption and Recovery Plant – cut slopes, fill slopes and stockpile, Heap Leach Facility, Event Pond.

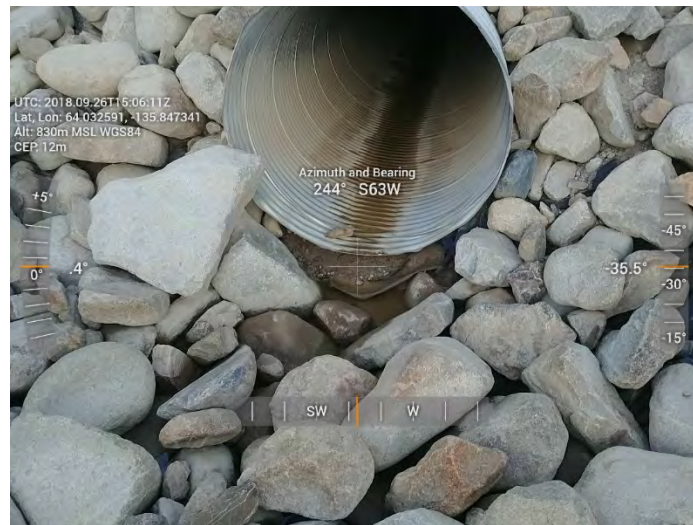
1. At the inlet of the 1500mm spillway culvert that crosses under the process plant service road there is a depression with exposed soil. Water is pooling in the depression. Additionally, a very small amount of moving water is flowing from ditching adjacent to the camp road to the spillway. The flow is below the riprap, but above the geotextile. This water is not passing through the 1500mm culvert, therefore it is likely that the low volume flow is passing through the granular subgrade of the culvert.

Figure 1: LDSP - 1500mm Culvert with depression and pooling at inlet.

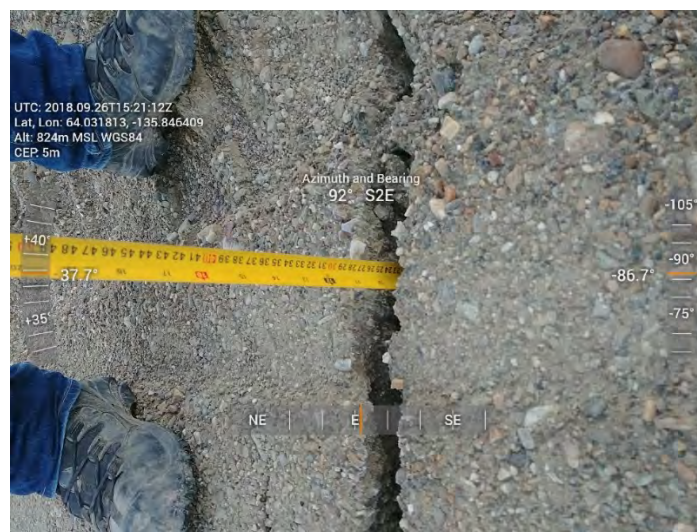
1. Tension cracking, 0.3m deep by 5.0m long, is present on the Lower Dublin South Dam possibly associated with the settlement of new construction.

Figure 2: LDSP - Tension cracking on south dam.

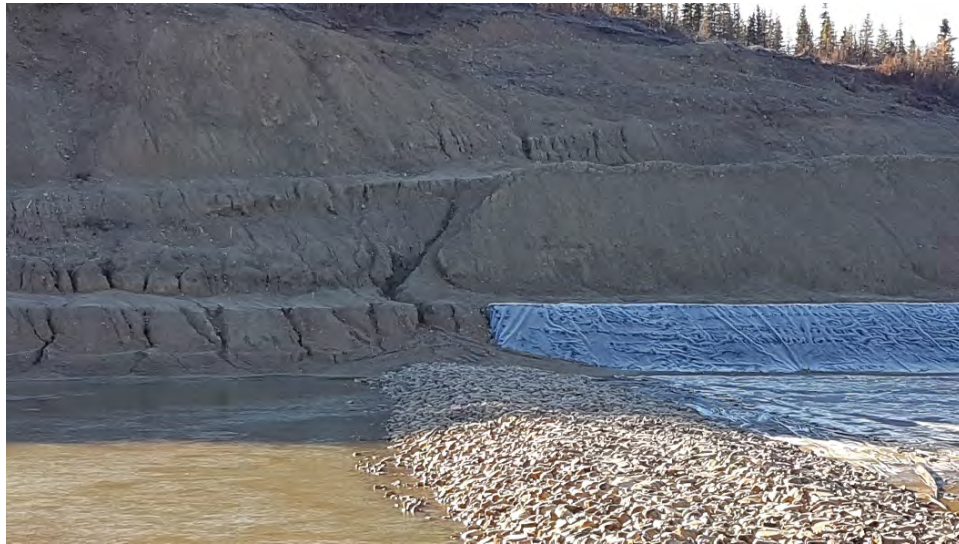
1. A significant amount of water and sediment is entering the collection pond and fore bay from the southern side. Some of the water and sediment is not intercepted by the fore bay prior to entering the collection pond. The water appears to be directed from a berm at a higher elevation. Erosion can be seen at the edge of the collection pond liner, in the cut slopes above the pond and fore bay, and in the bench. Comments on site indicate that a plan is already in place to address drainage in the area.

Figure 3: LDSP - Erosion at the southern side near the fore bay berm.

1. Extend the existing berm along the south side of the pond further to the east to direct water into the fore bay / siltation pond, where there is no liner to disturb and where the facility is designed to capture eroded material.

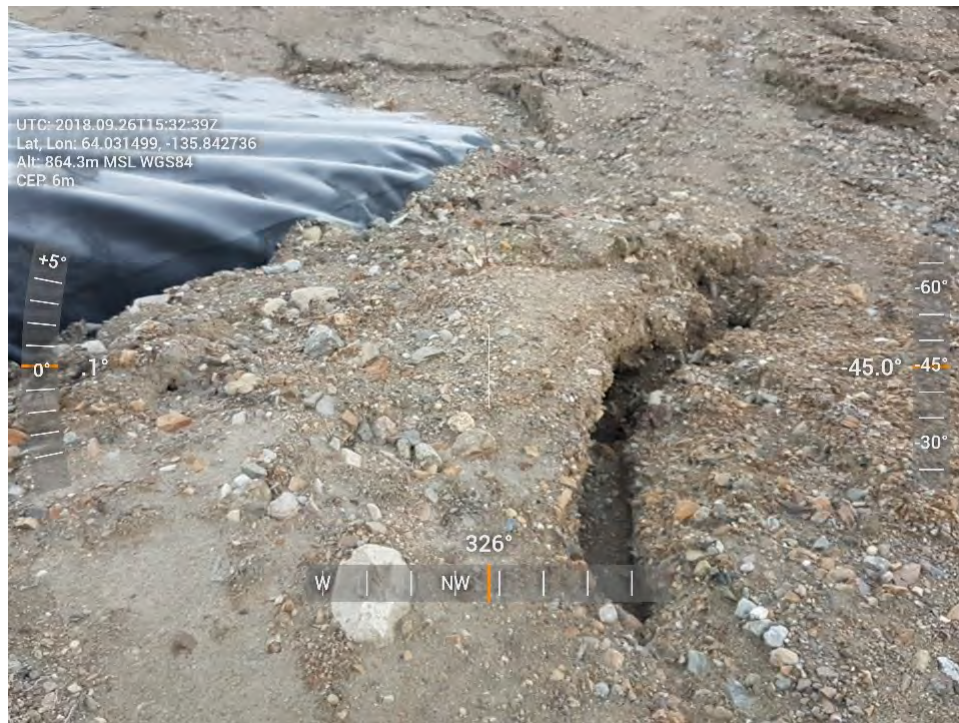
Figure 4: LDPS - Erosion at liner.

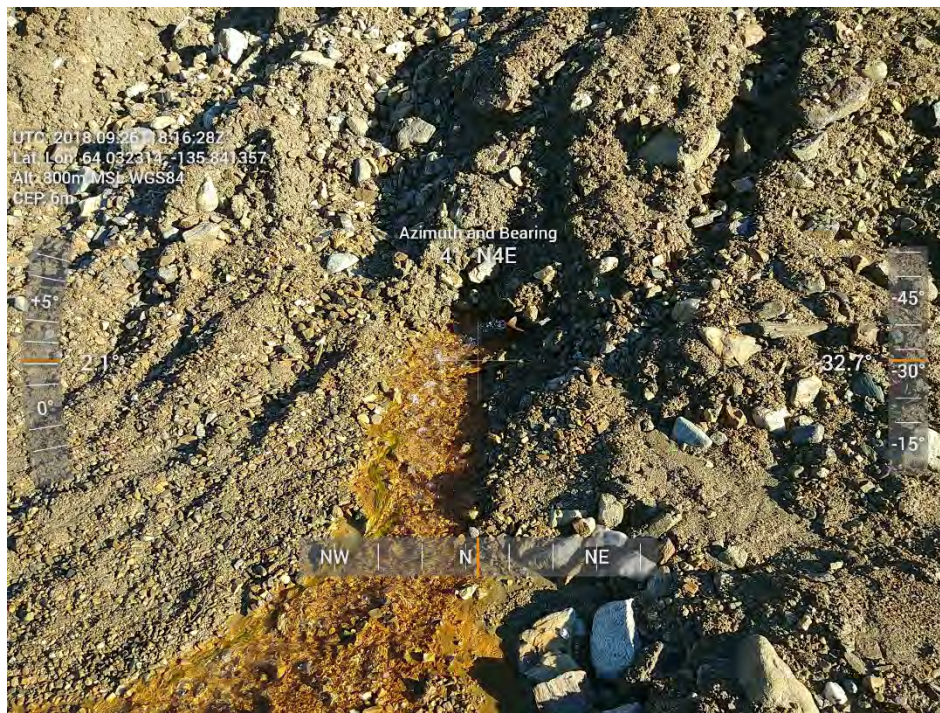
- On the northeast corner of the pond water is flowing out of a culvert of unknown size. VGC staff have indicated that the culvert was uncovered during construction and is a relic from historic placer mining. The outlet is damaged, and the flow is currently captured by a diversion ditch.

Figure 5: LDSP – Water flow from damaged culvert on northeast corner of pond.

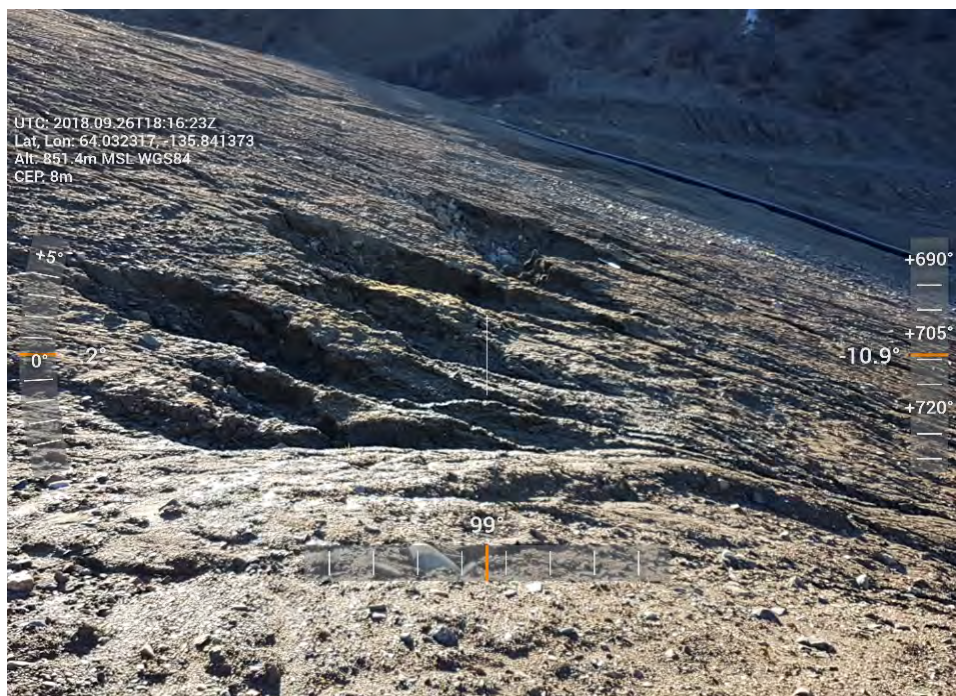
- Groundwater with unknown origin has previously caused erosion on the West slope of the fore bay. No ground water flows were observed at the time of inspection.

Figure 6: LDSP - Erosion on west slope of fore bay.

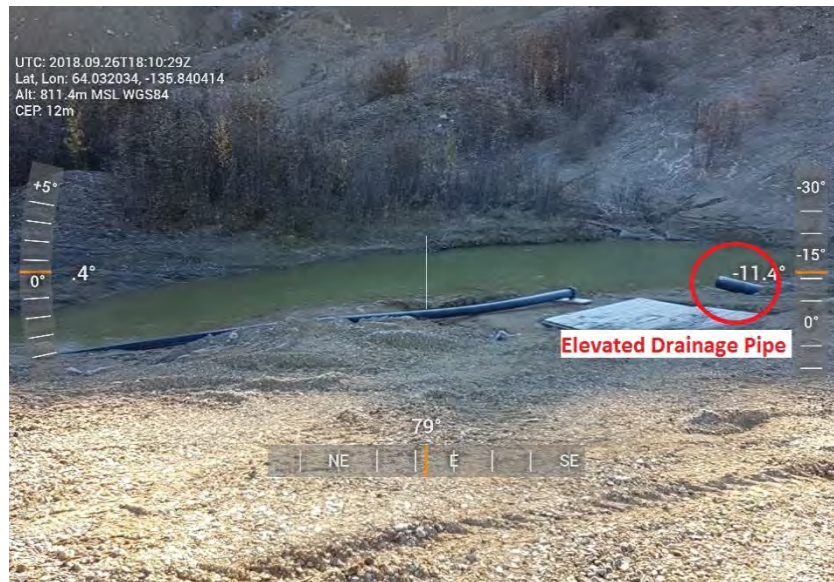
4. A small elevated pond above the East slope of the fore bay has trapped some water. A PVC pipe is in place to drain the pond, however, the elevation of the PVC pipe is too high to fully drain the pond. Leaving perched water storage above a soil structure is non-typical. VGC staff have indicated that the pond was created to mitigate erosion of the east fore bay slope and that the pond is periodically pumped to the exfiltration sump when threshold levels in the pond are reached.

Figure 7: LDSP - Elevated Pond above Eastern side of fore bay

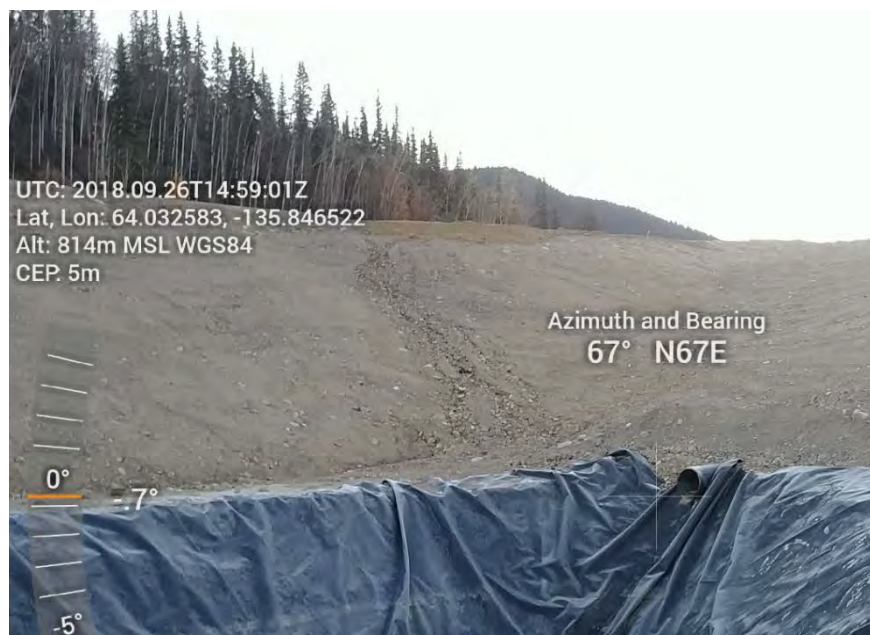
1. In the pond outlet area, surface water from the roadway is flowing down slope causing minor erosion. The exclusion ditching appears inadequate around pond above the v-notch weir to avoid further erosion.

Figure 8: LDSP - Erosion at low level outlet pond.

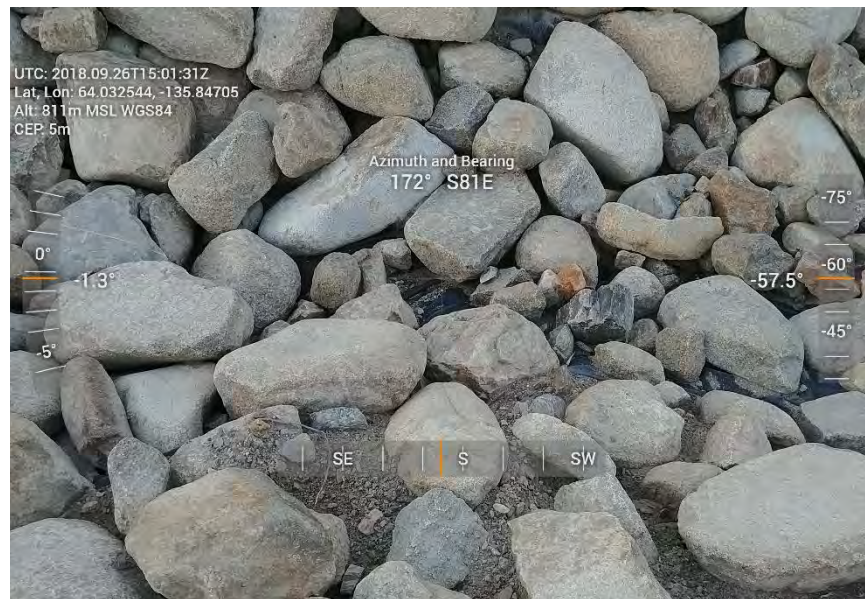
- The channel has appropriately sized riprap, but the armour does not meet typical minimum thickness in many locations.

Figure 9: LDSP - Exposed liner in low level outlet channel.

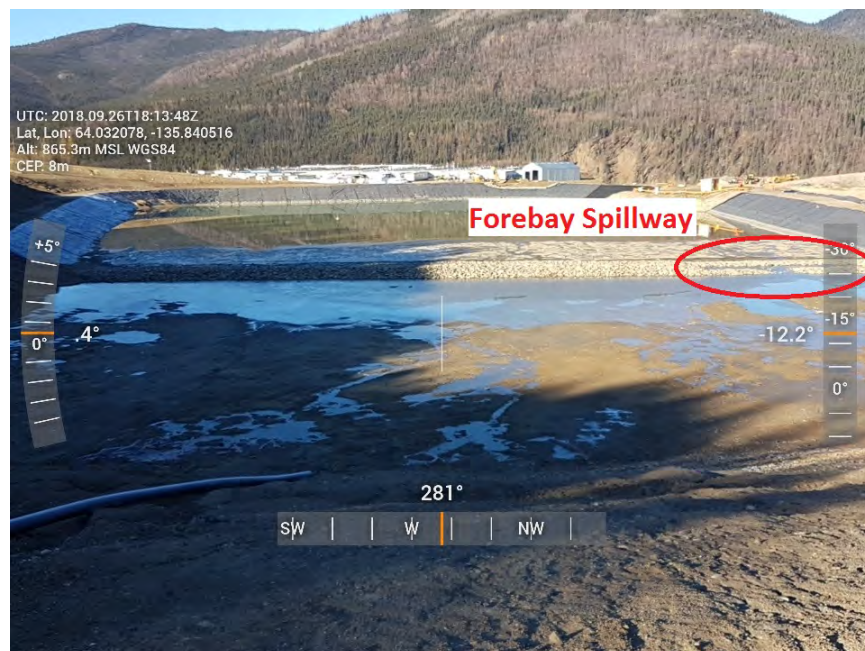
- The fore bay has a reduced capacity due to large quantities of material entering the pond from the South and West slopes. VGC staff have indicated that plans are currently in place to excavate the sedimentation pond and restore additional capacity.

Figure 10: LDSP - Sediment Nearing the top of the fore bay spillway.

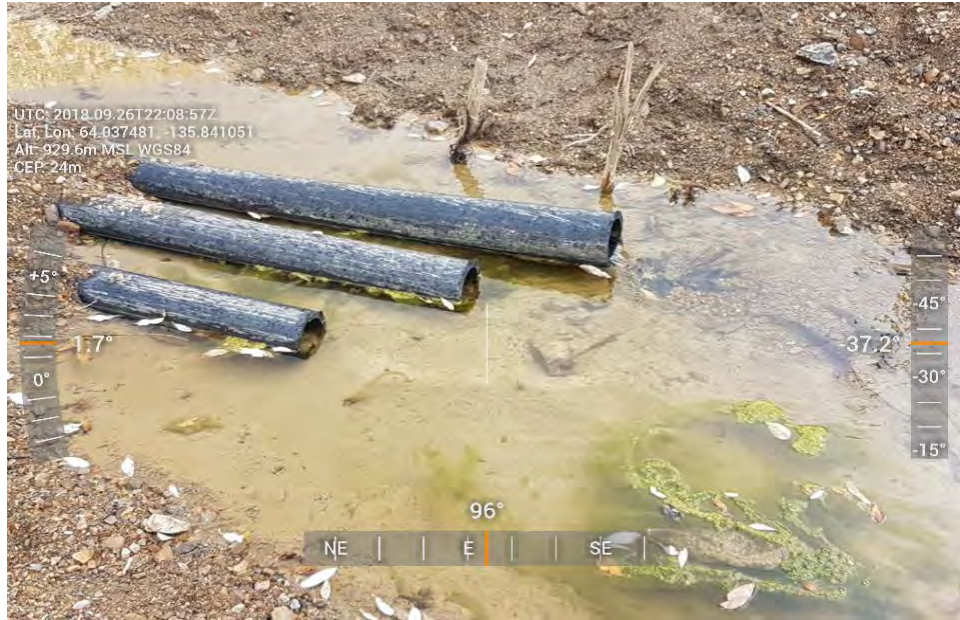
1. The under drains below the LDSP storage appear to be operating as planned. There is water at the outlet, and outlet flow has stayed fairly constant since their install, according to site staff.

Figure 11: LDSP - Low level outlet pond.

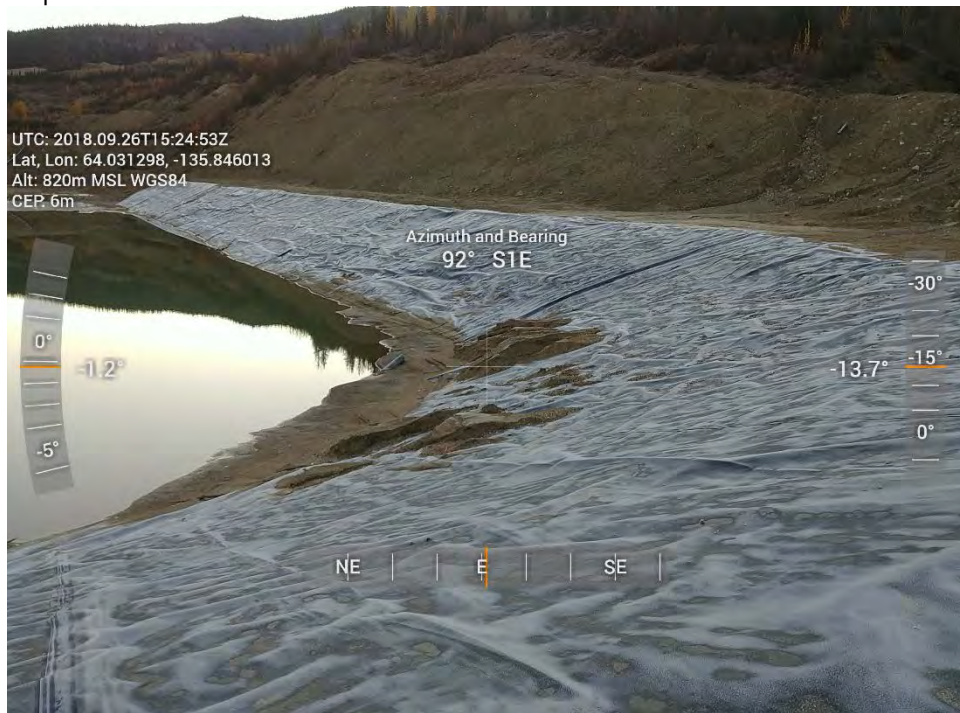
2. Water and sediment has been carried into the pond and onto the liner at the southwest corner of the pond.

Figure 12: Sediment carried onto collection pond liner.

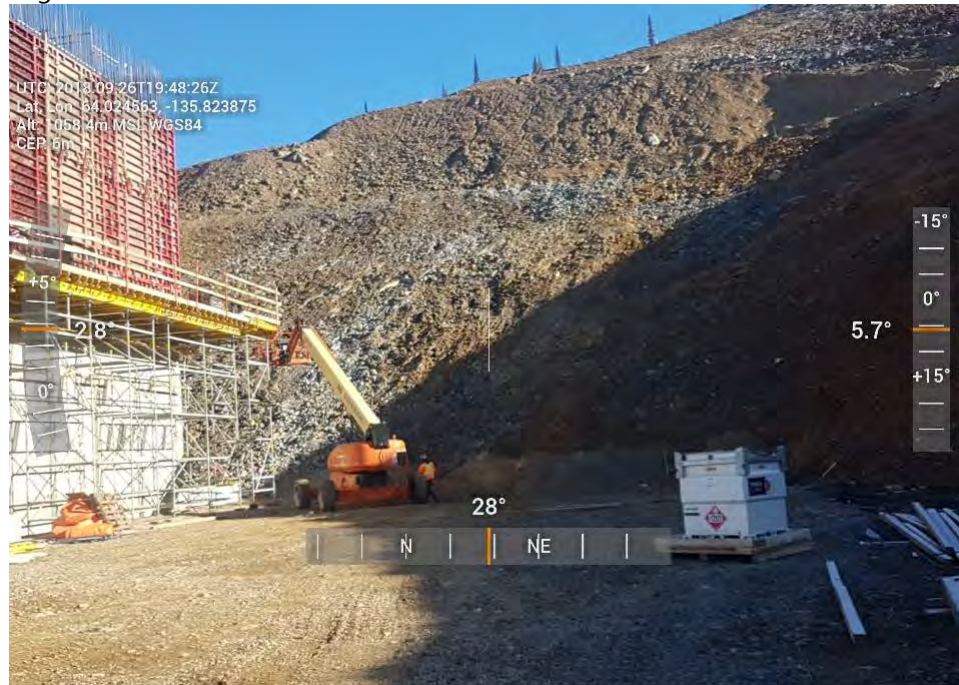
1. The support slope for the Primary Crusher access road is over steepened at 50%, however, this appears to be for a temporary access. (No Photo).
2. The slope immediately behind the primary crusher is rip-able rock with knobs of rock that would require blasting. Measurements taken on site indicates slopes here meet recommendations and range between 50% and 64%.

Figure 13: Slope behind primary crusher.

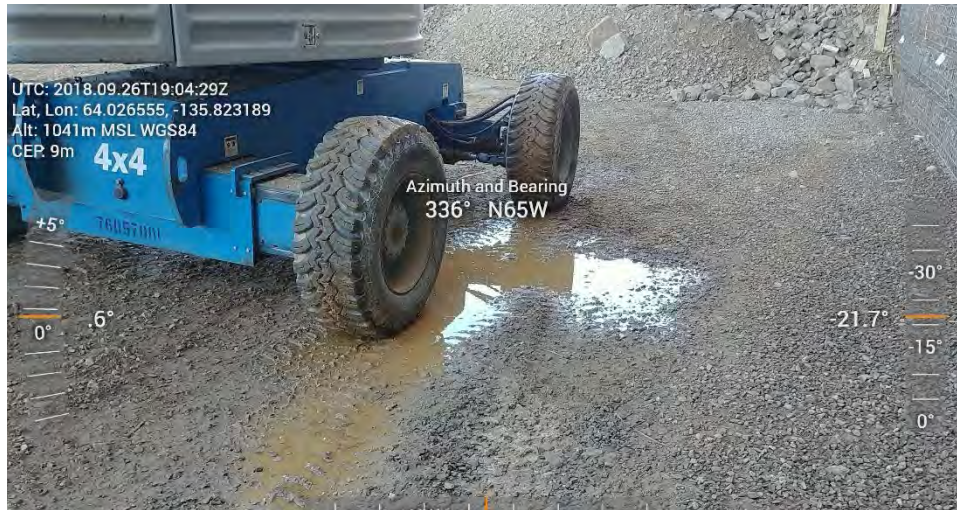
1. Very minor ponding is present at the base of the MSE wall due to inadequate grading in some sections.

Figure 14: SC MSE - Minor ponding at base of MSE wall.

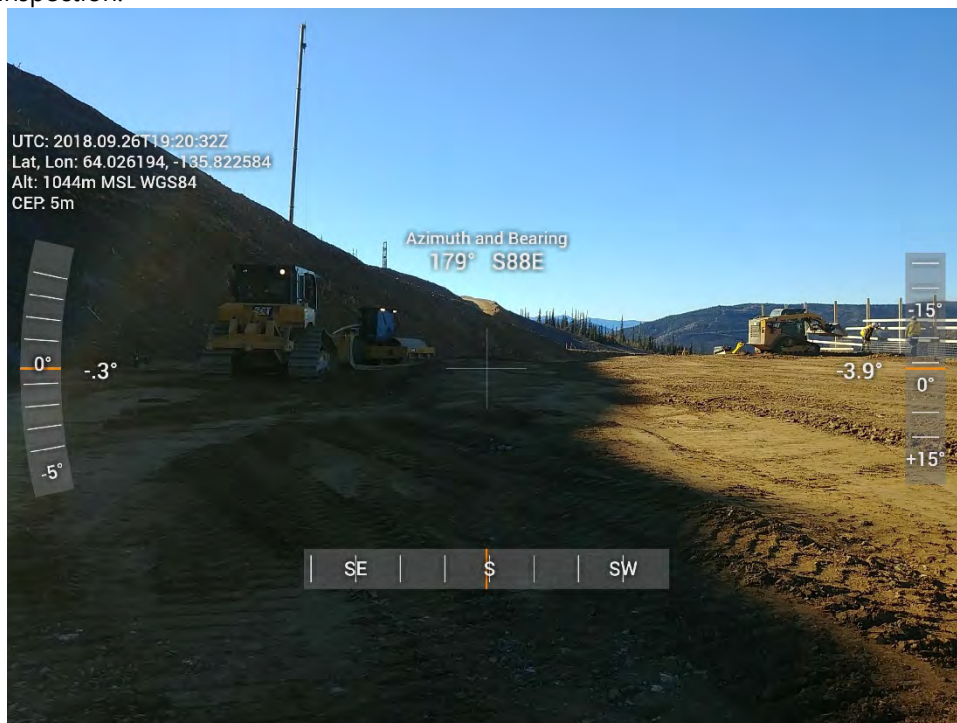
2. Drain outlets for the MSE wall are not visible at the face. Site staff have indicated the drain system is in place, installation has been recorded in as-built records and will be day lighted as part of the final site grading. (No Photo).
3. Construction on the MSE wall is ongoing and appears to be well compacted and placed during our inspection.

Figure 15: SC MSE - Equipment used for MSE wall construction.

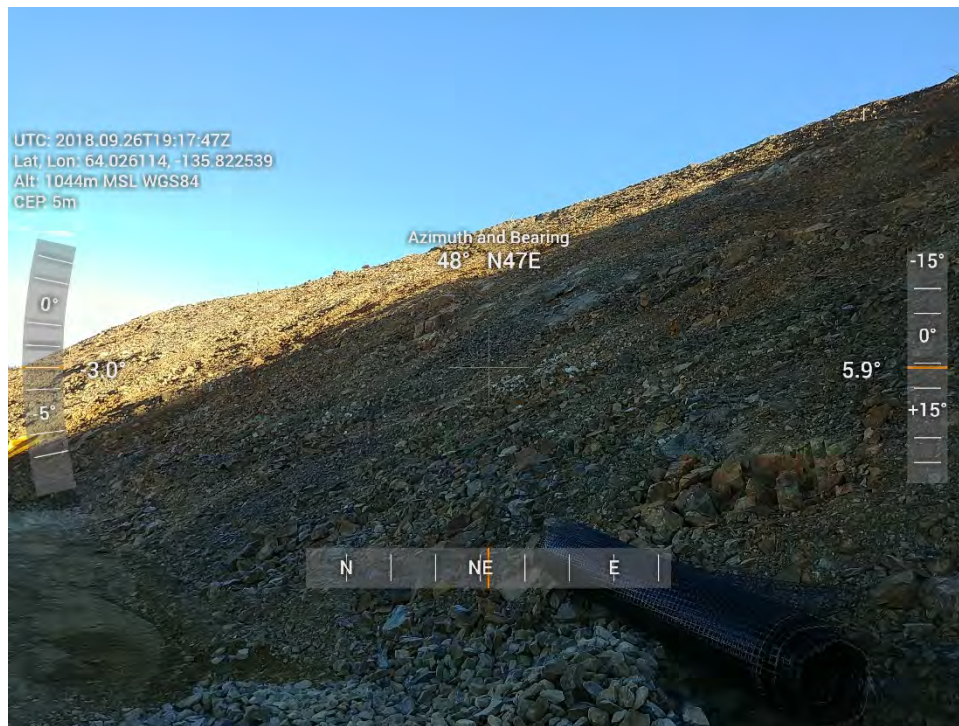
- Backfill behind the MSE wall varies to a maximum recorded angle of 64% and appears to be type 2 rock and blastable rock.

Figure 16: SC MSE - Slope behind secondary crusher MSE wall.

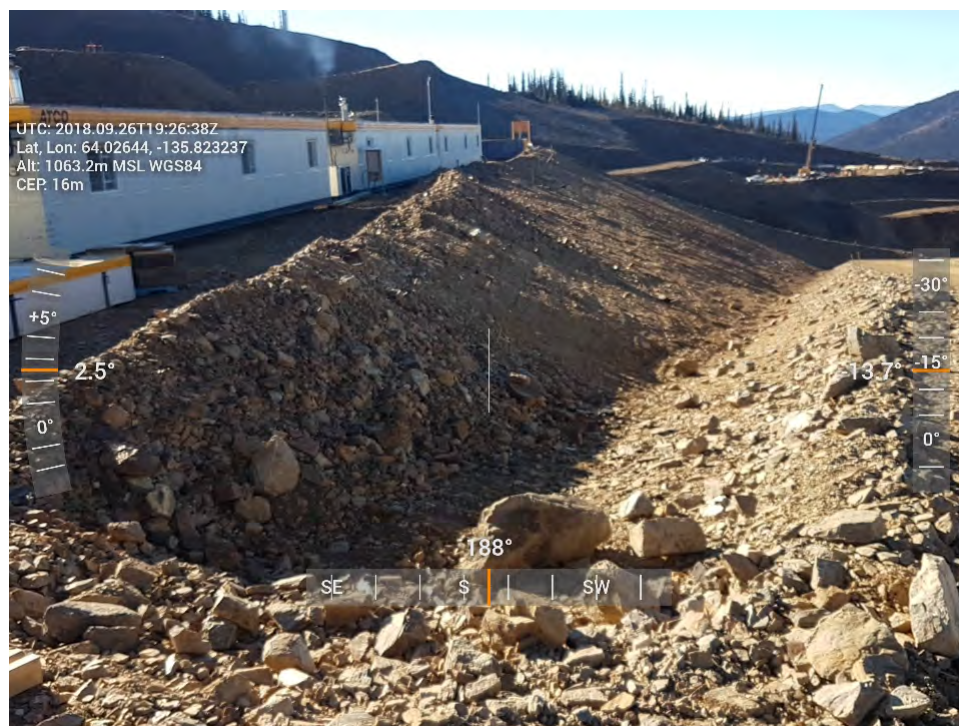
- The slope below the MSE wall is well offset from both the wall and the Secondary Crusher foundations. The slope was measured at 22%-25%.

Figure 17: SC MSE - Slope below secondary crusher pad.

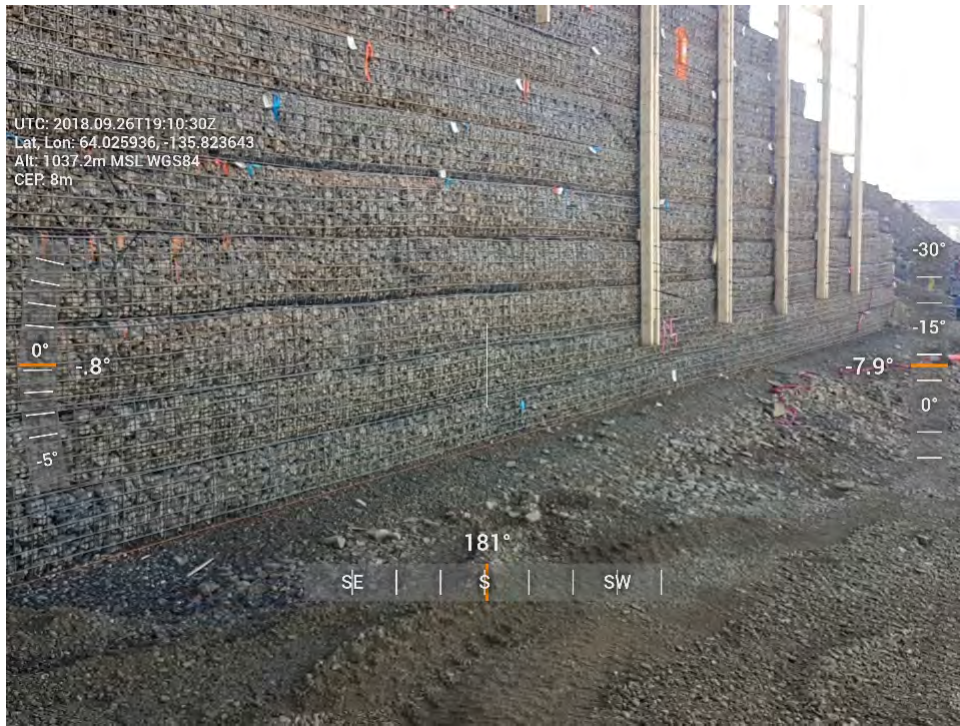
6. The MSE wall has inadequate set back and uneven layers at the bottom of the wall. This has been addressed by the owner and the wall manufacturer according to site personnel.

Figure 18: SC MSE - Secondary crusher MSE wall.

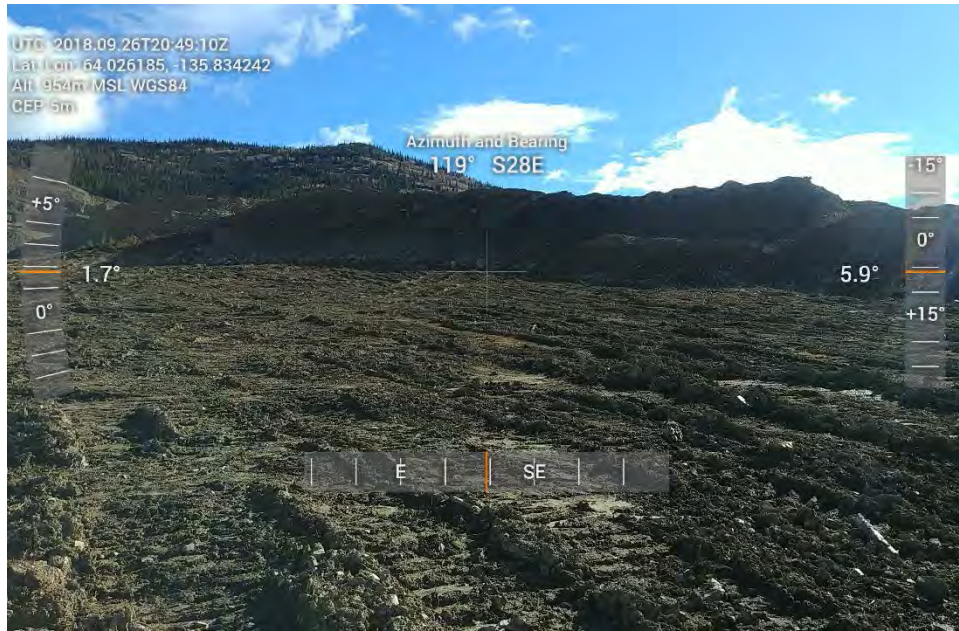
Figure 19: 90 Day Stockpile - Ungraded material.

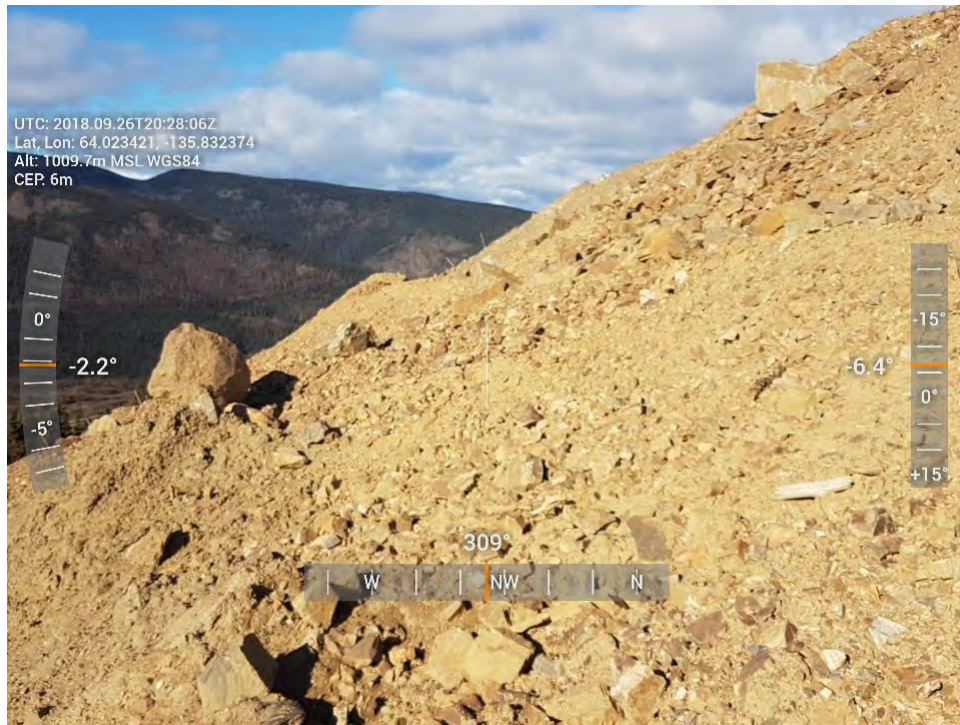
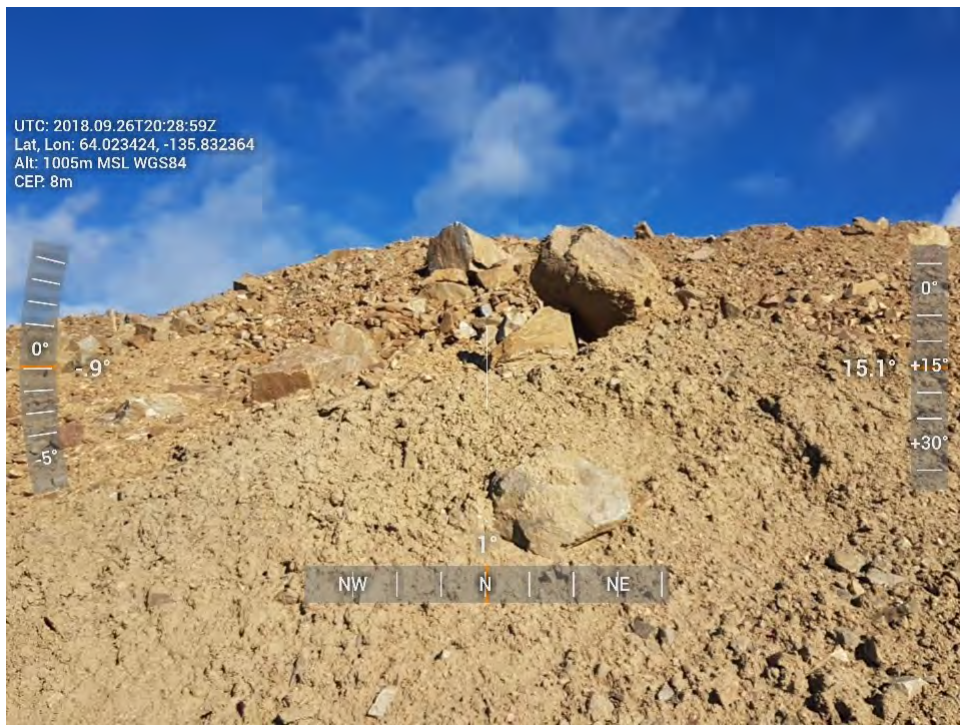
- 4. There are perched boulders on the fill above an access road on the south east corner of the stockpile, only a relatively narrow band of vegetation and trees separates the toe of the stockpile from the road.

Figure 20: 90 Day Stockpile - perched boulders.

Figure 21: 90 Day Stockpile - perched boulders.

1. Mitigate risks associated with perched rocks throughout the slope. Boulders should be removed in a controlled manner, or have a machine press (or bury) the boulders into the existing fill so they have a more stable base, and are less likely to become dislodged. Care should be taken during this work to ensure that critical infrastructure, workers and equipment are restricted from the fallout path, or other appropriate mitigation measures are put in place.

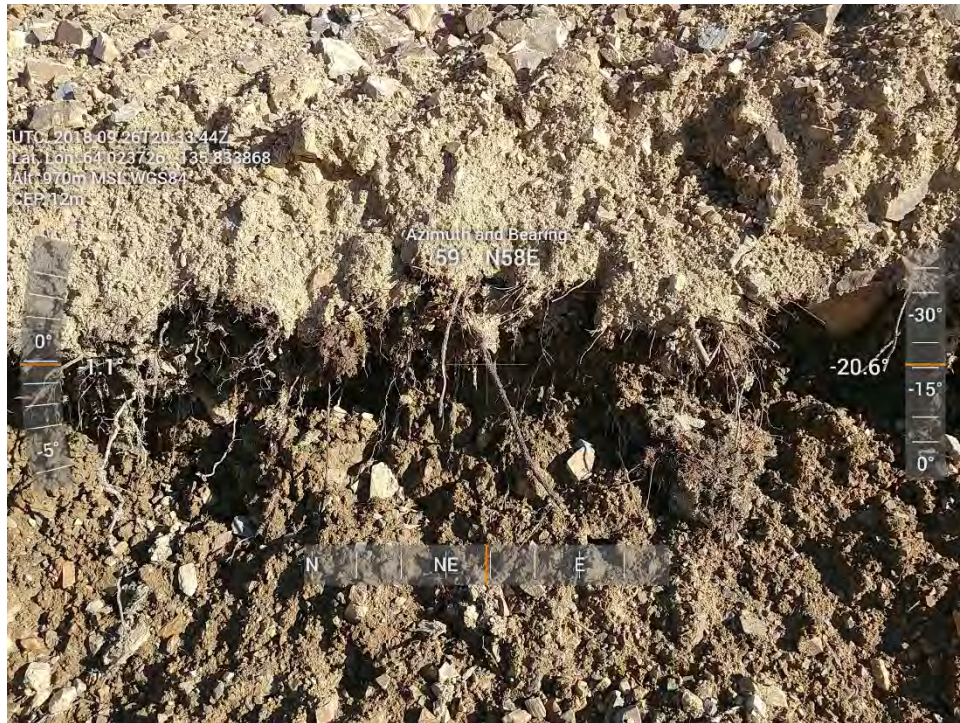
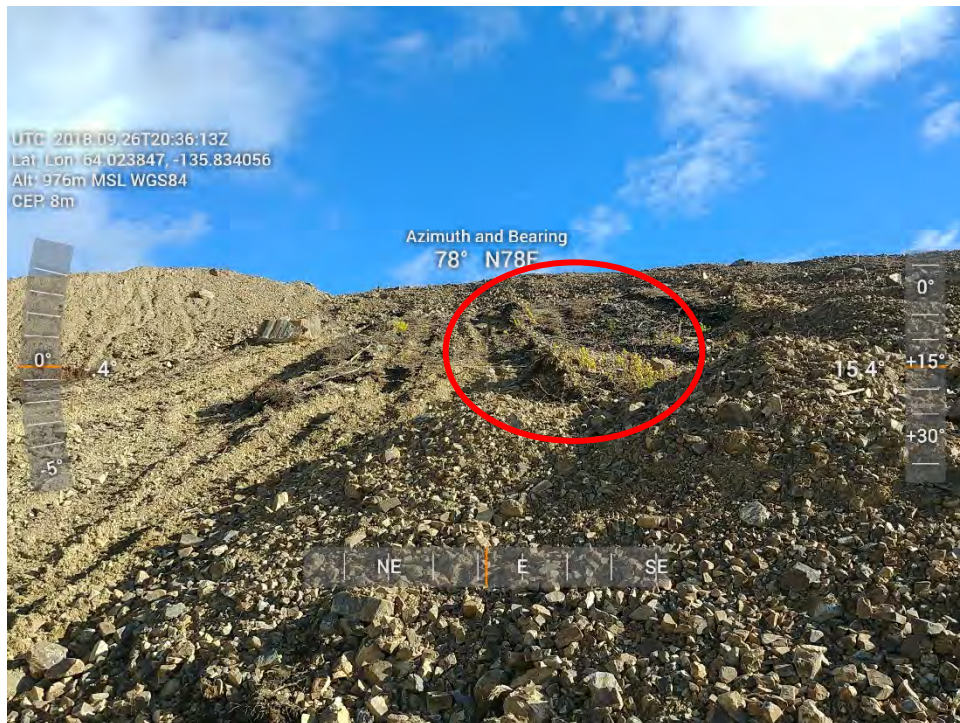
- 5. Portions of the 90 Day Stockpile footprint have not yet had complete stripping of the organics, and there appears to be limited locations where the new placement is being completed on some built up organics near the west edge. It is unclear if this is an acceptable part of the foundation of the stockpile, or if the stripping program is complete at this time.

Figure 22: 90 Day Stockpile – Organic layer near west edge.

Figure 23: 90 Day Stockpile - Organics in phase 2 foundation (typical).

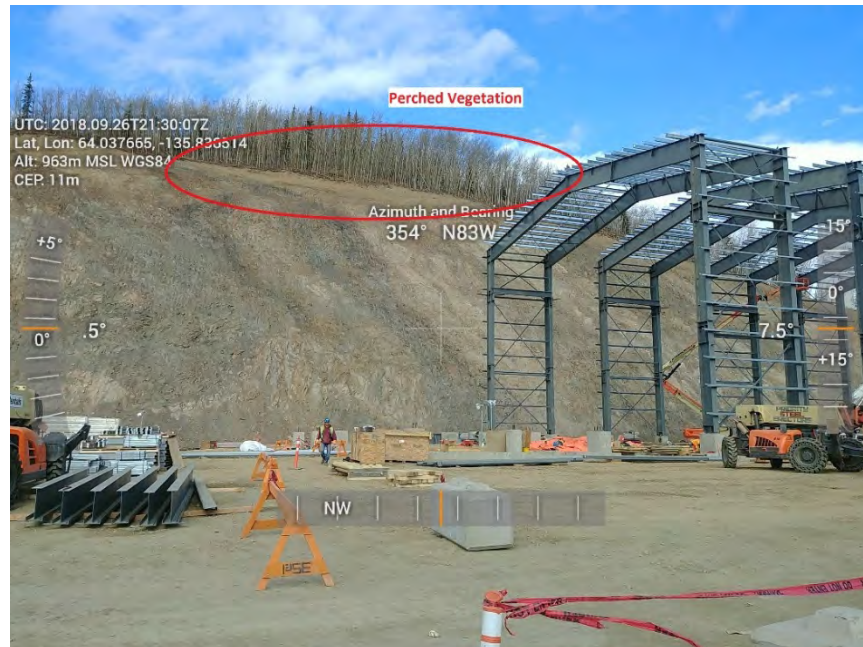
1. Vegetation is perched near to the top of the ADR Slope, though an explicit measurement was not possible due to access considerations. There is adequate space at the base of the slope to accommodate any materials that may fall, though during construction some of that space is being used as a laydown.

Figure 24: ADR - Perched vegetation.

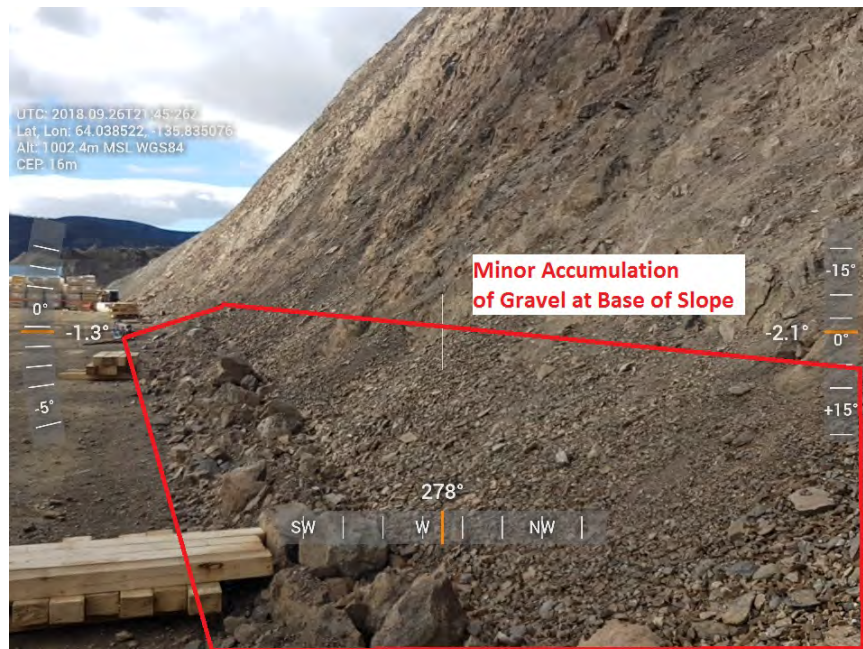
2. The established slope behind the ADR building appears stable and well constructed on the face with only minor accumulation at the toe of small rock and gravels.

Figure 25: ADR - Minor accumulation of gravel at base of cut slope.

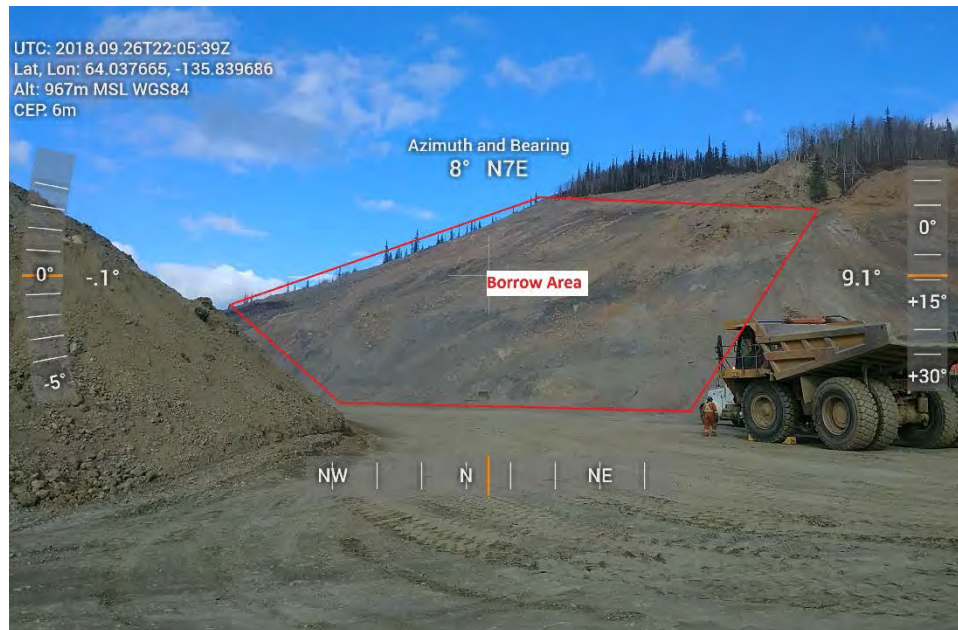
- There is additional borrow happening around the corner from the ADR facility. The slope is under construction/excavation, and there does not appear to be any adverse affects to the already constructed slope above the ADR building. The final excavation should be reviewed to ensure that any altered drainage isn't directed onto critical infrastructure, or the slopes above them, or is accounted for.

Figure 26: ADR – Borrow area.

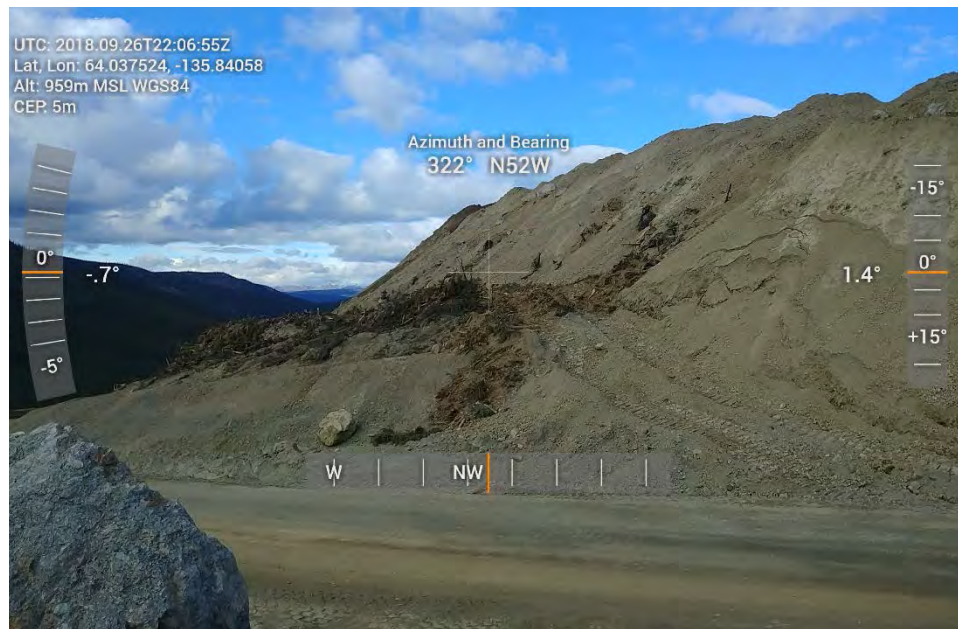
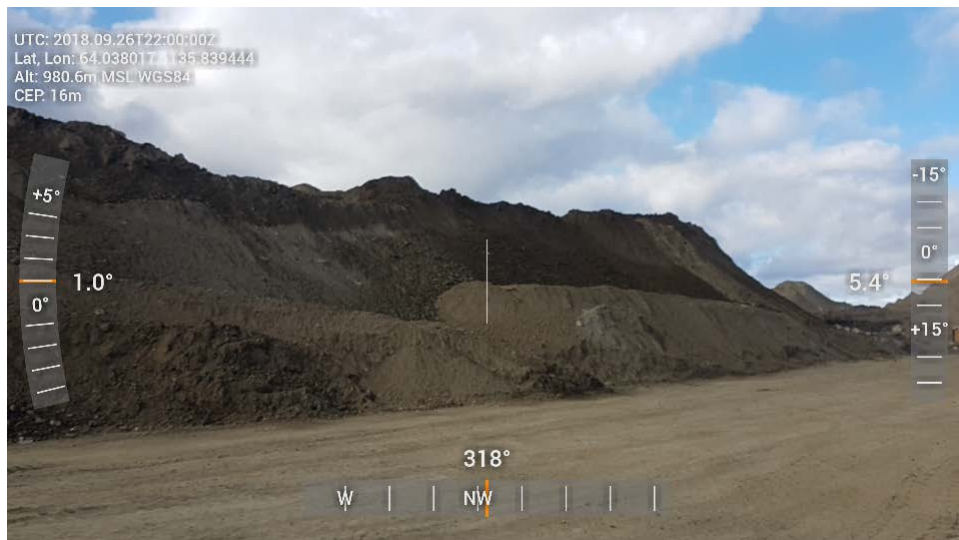
- There is a temporary stockpile perched on the outside of slope on this area. The stockpile exceeds the recommended slopes for long term stability for a common fill material. The stockpile should be shaped to meet requirements if it is a long term storage solution.

Figure 27: ADR - Common material stockpile with over steepened slopes.

Figure 28: ADR - Common material stockpile with over steepened slopes.

1. Reduce the outside slope of material in the stockpile above the ADR Access Road. The stockpile West Northwest of the ADR Building is composed of a mix of several materials with unknown compaction and possibly over steepened outside slopes. It is recommended that the stockpile be shaped within geotechnical design specifications, or that the location of the pile is adjusted so that there is a bench between the crest of the adjacent slope, and the toe of the stockpile. If the stockpile is to remain long term, the structure should have a design completed by a qualified professional.

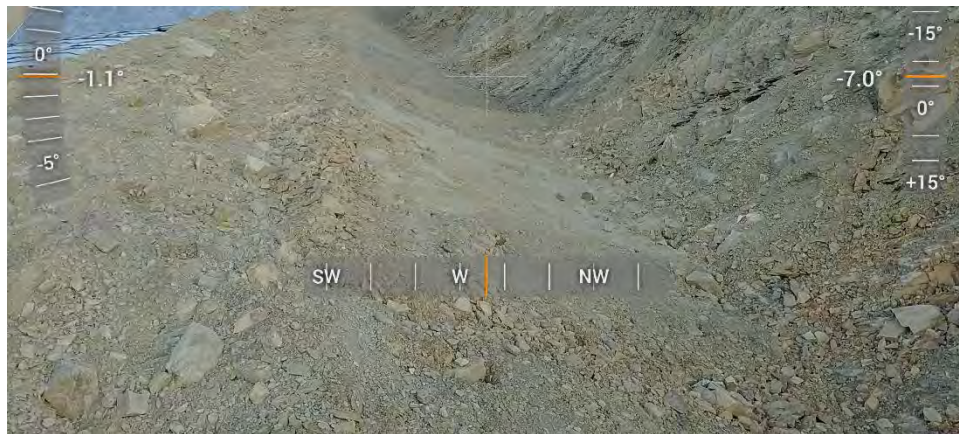
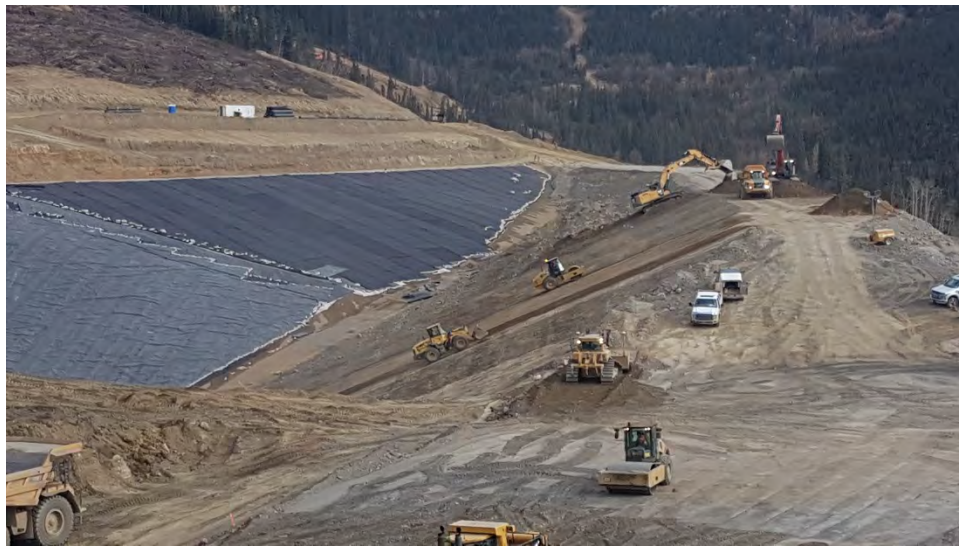
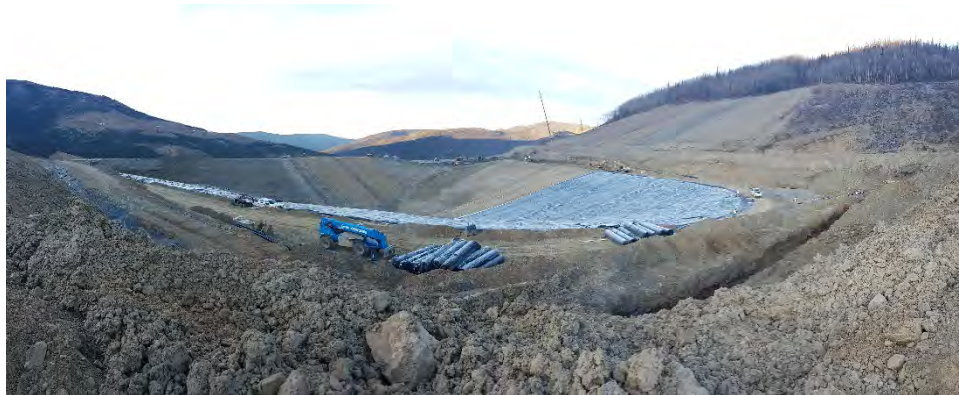
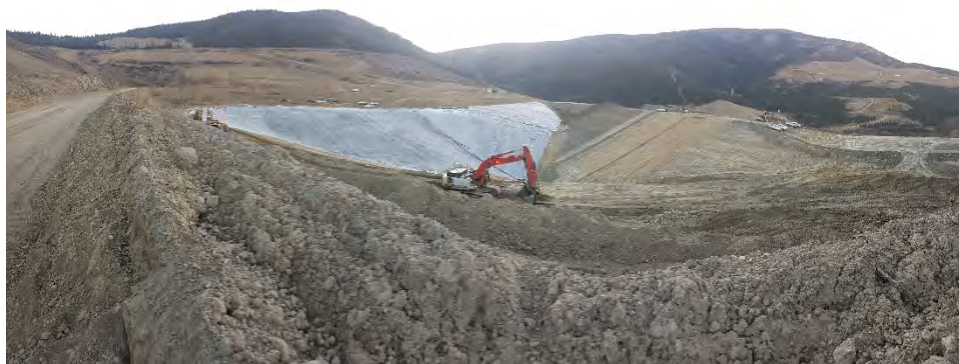
1. Phase 1 of the HLF is under construction. The confining embankment is nearly complete, and the liner is being installed. A drainage collection ditch has been constructed above current liner and is approximately 1m deep by 3m wide at the top. The measured faces of the constructed slopes were measured at an acceptable 38% grade.

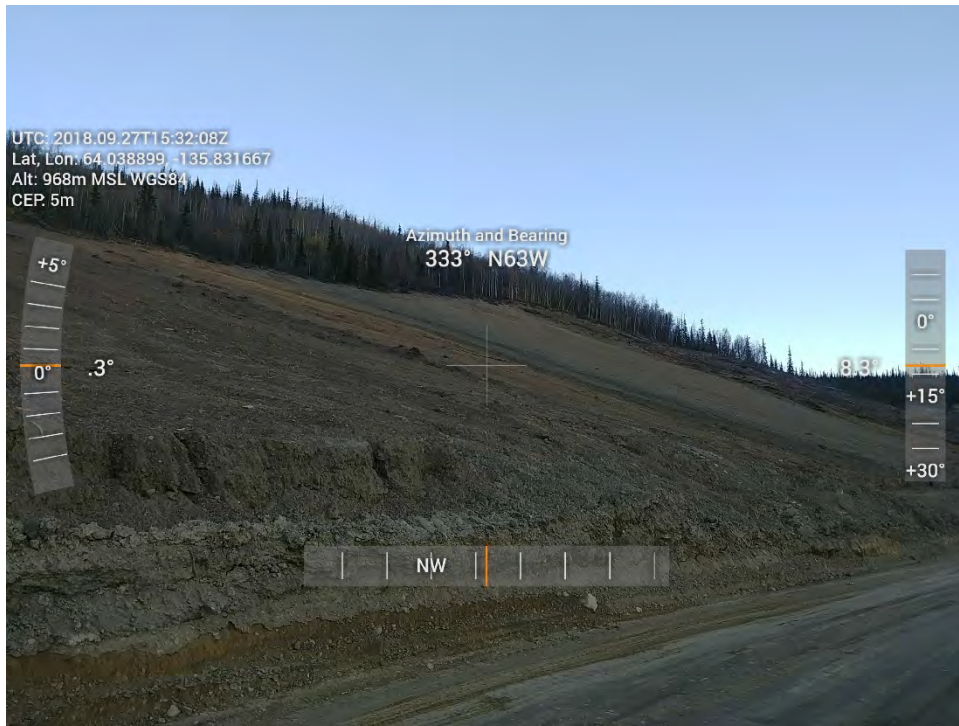
2. Clearing and stripping has begun for the phase 1B areas. Slopes have been graded to approximately 33%.

Figure 33: HLF - Phase 1B northwest slope.
