Allnorth Information		VICTORIA GOLD CORP.	
Project #:	18-VA-0109	Client Project #:	
Document #:	181003	Client Document #:	
Document Rev. #:	0	Client Doc. Rev.#:	
Prepared By:	Rod Keetch, P. Eng. James Garner, EIT	Client Contact:	Stephen Wilbur, Hugh Coyle

Annual Physical Stability Assessment Report – Victoria Gold – Eagle Gold Project

Visual inspection of the following structures; Lower Dublin South Pond, Secondary Crusher – cut slopes, fill slopes and MSE wall, Primary Crusher – cut slopes and fill slopes, 90 Day Stockpile, Stockpile A, Stockpile B, Adsorption, Desorption and Recovery Plant – cut slopes, fill slopes and stockpile, Heap Leach Facility, Event Pond.

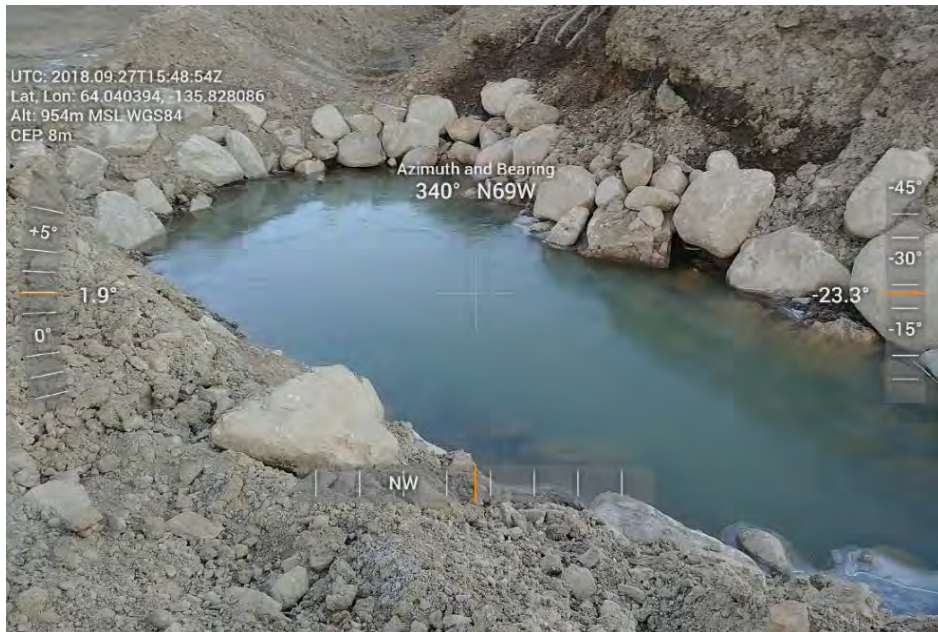
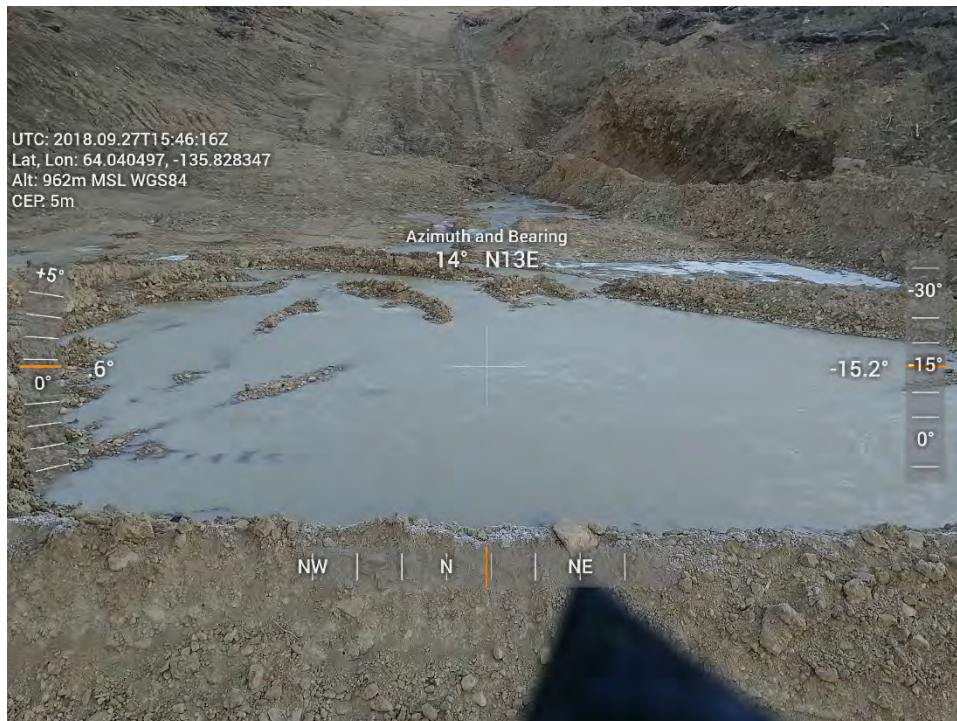
- 3. A small amount of water has ponded above the collection ditch. VGC staff have indicated that this will be eliminated as construction of the HLF proceeds.

Figure 34: HLF - Ponded water above collection ditch.

Figure 35: HLF - Pooling above collection ditch.

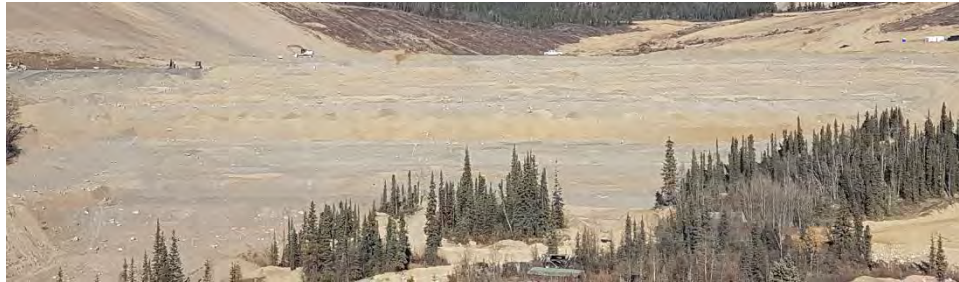
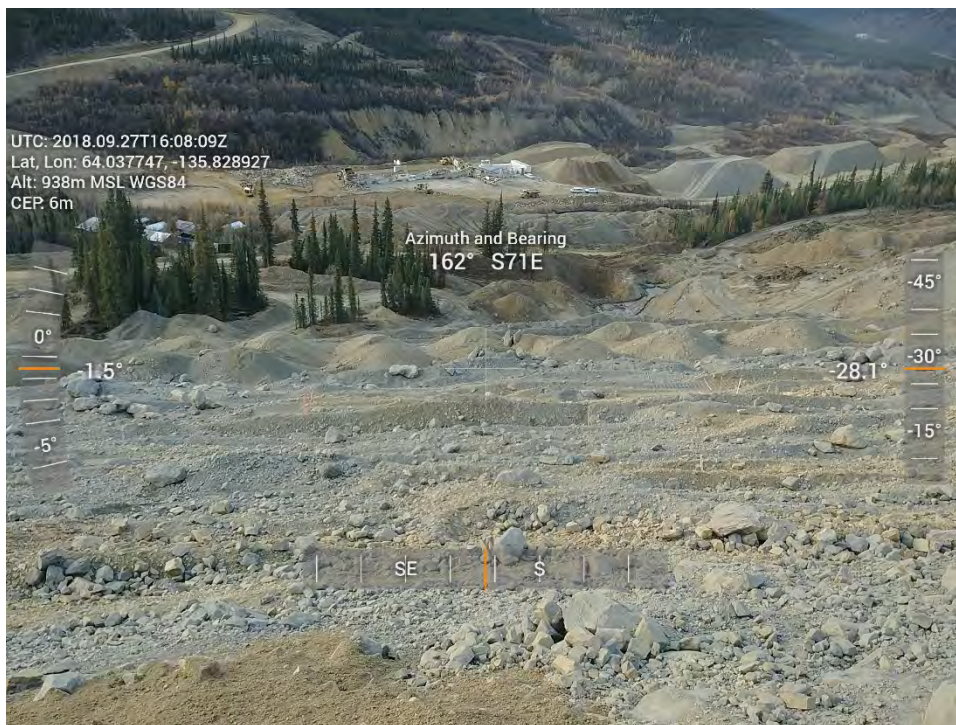
4. The free face of the HLF confining embankment is benched with some heaped material and perched rock. Typically these exposed faces are smoothed and sealed to help prevent erosion of the face once in operation, it is not clear if that is part of the final design. Perched rock does not appear to be located above any construction, infrastructure, or roadways at the time of inspection.

Figure 36: HLF - Free face with heaped material and perched rock.

Figure 37: HLF - Free face with heaped material and perched rock.

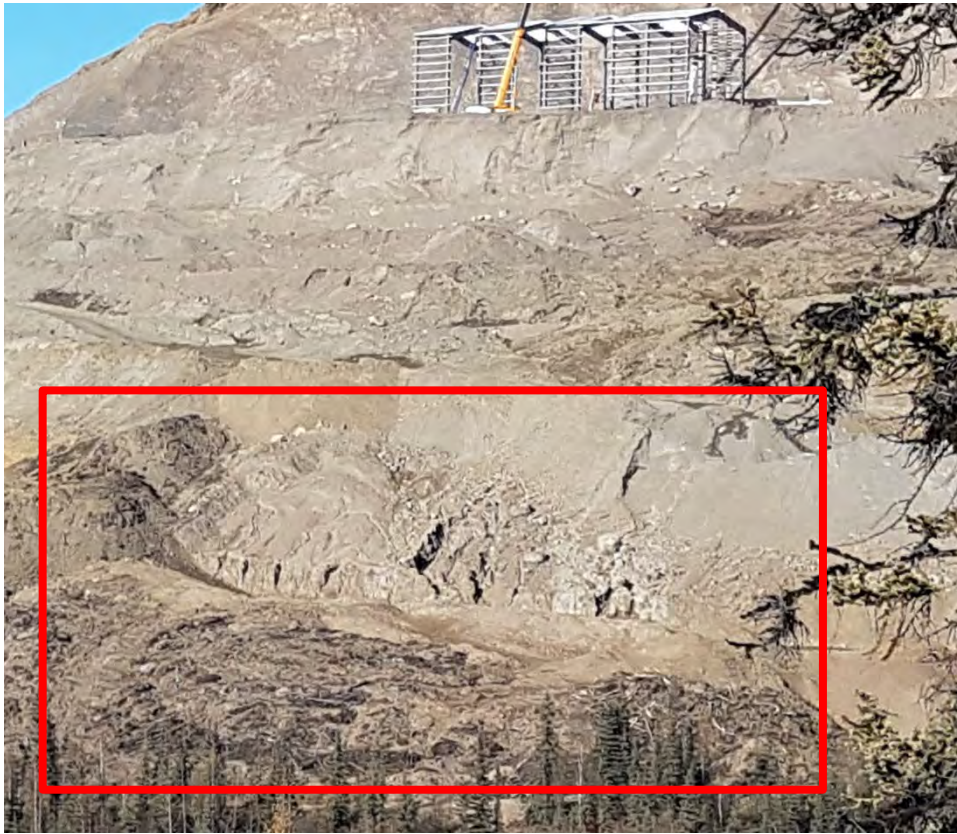
5. There is some water directed near, but not onto the HLF construction. This is west of the structure, but there does not appear to be any management plan in place for the concentration of water directed by a terminated haul road.

Figure 38: HLF - Erosion and material flows west of confining embankment.

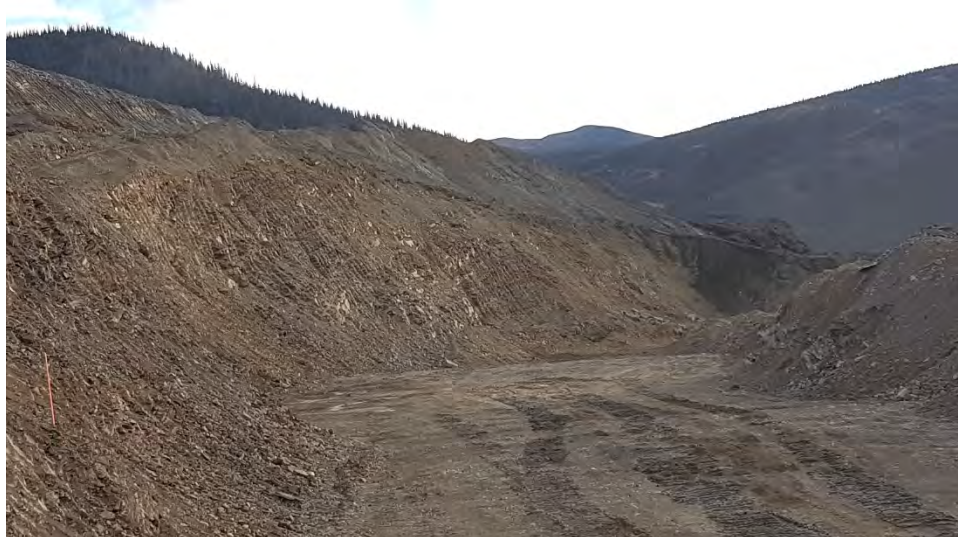
1. This area is under construction. Temporary excavations in rock meet the suggested slopes as laid out by the specifications provided, and determined by the geotechnical consultants in mine planning.

Figure 39: Event pond (facing east) – rock cuts.

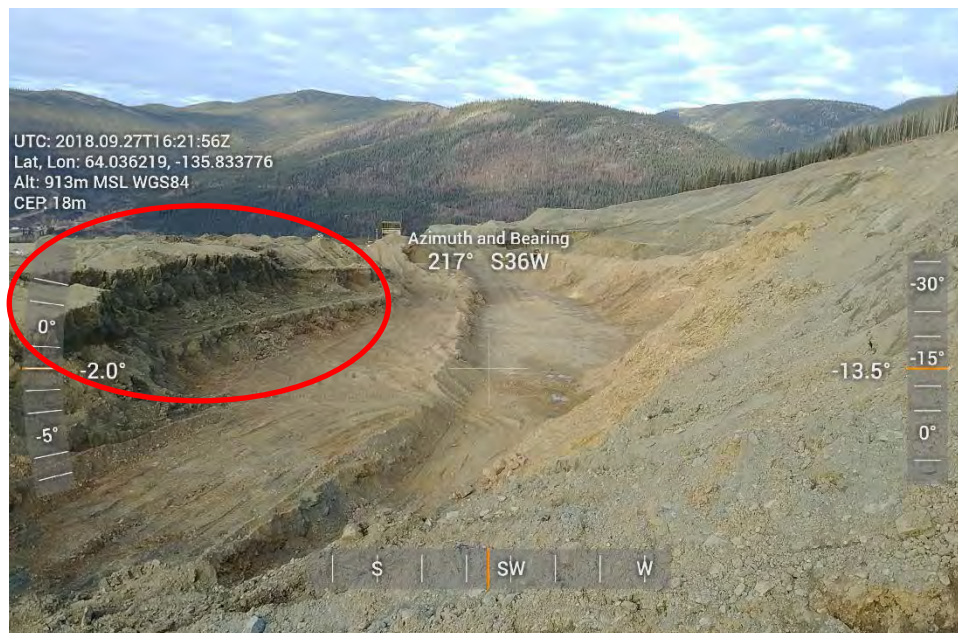
2. There are some small over steepened stockpile material above the rock cuts, but there is no equipment or active work below the face.

Figure 40: Event pond (facing west) – over steepened material.

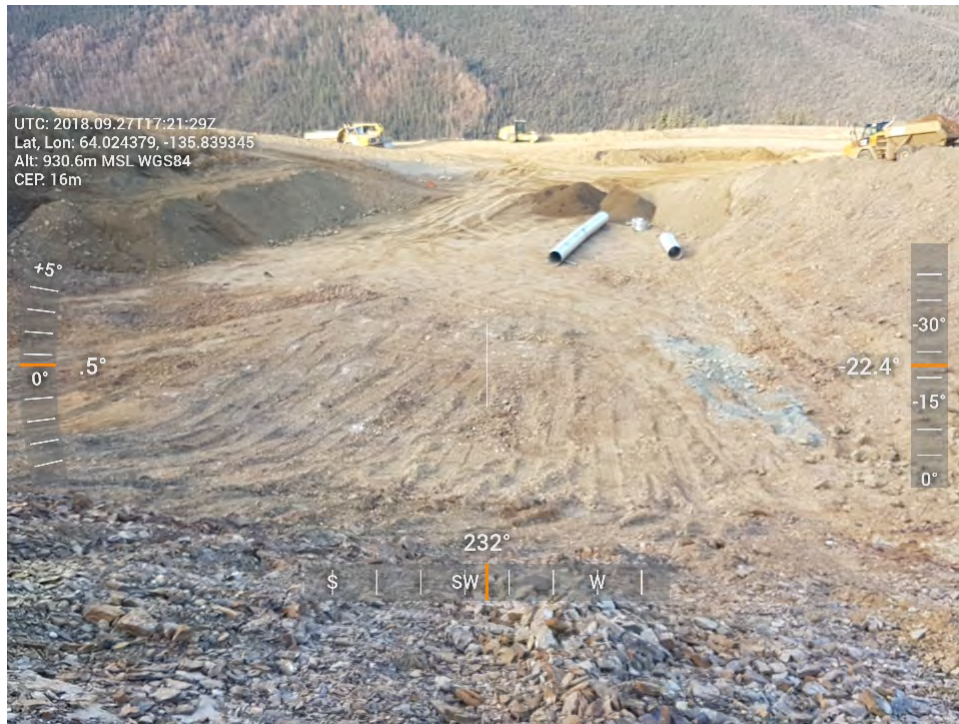
1. The Stockpile is currently being excavated with the material being used for road fill in a culvert installation on the road adjacent. There is very little stockpiled material present at the time of inspection.

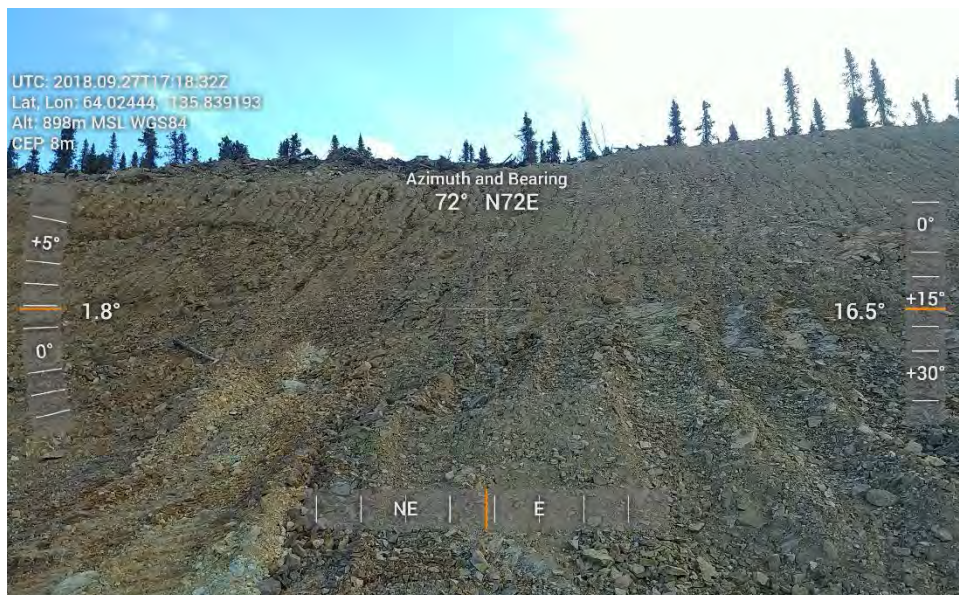
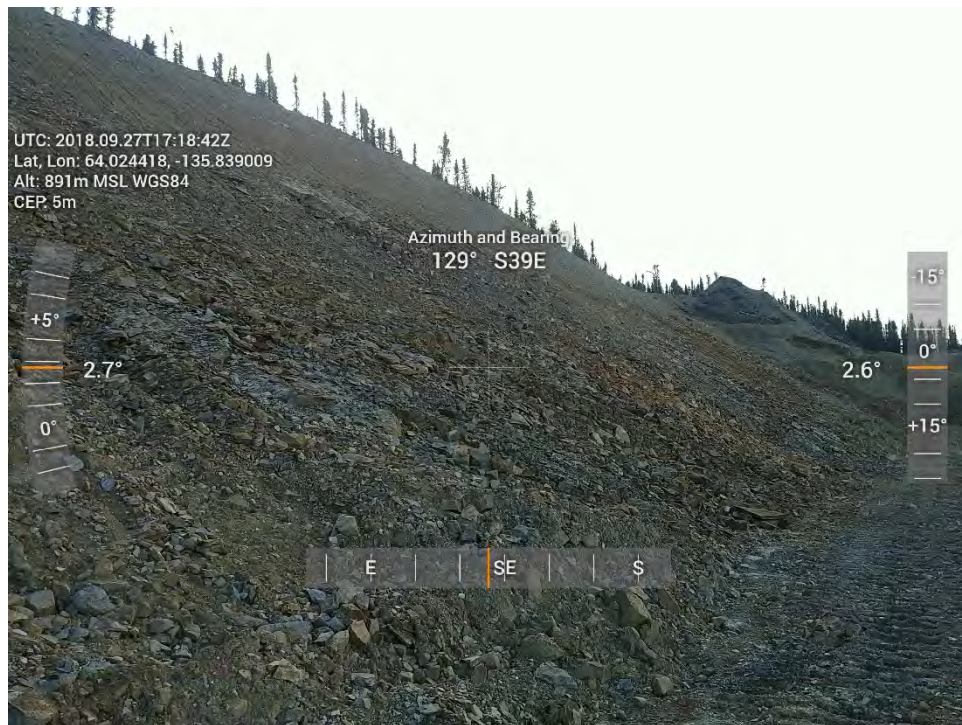
2. The rear slopes of the stockpile area are composed of placed rock and engineered fill at 50% below a bench and a rock face above the bench at 65%.

Figure 42: Stockpile A - upper slope.

Figure 43: Stockpile A - upper slope.

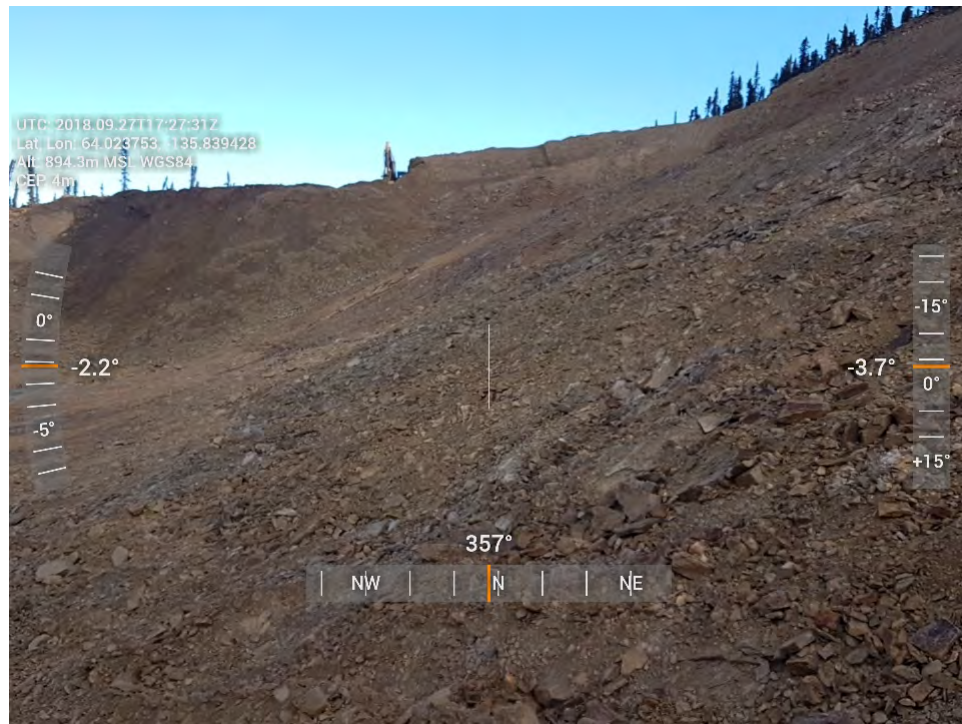
3. The temporary faces of the remaining stockpile material are well supported and set at 50% when benching setbacks are included.

Figure 44: Stockpile A - lower slopes.

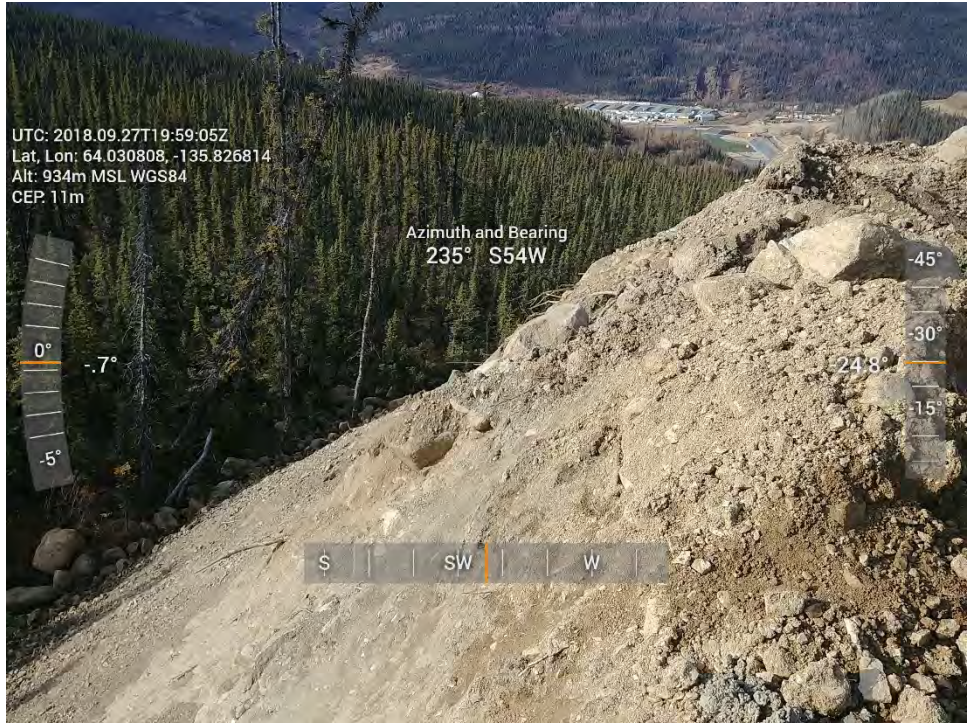
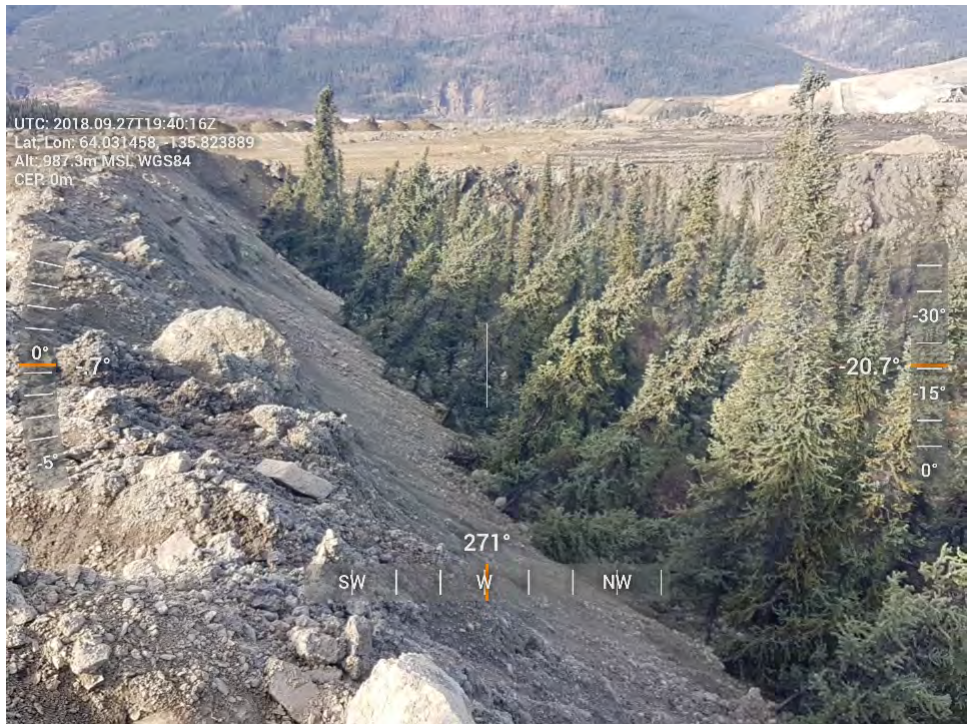
- 1. Edges of the stockpile are extending past stripping, this could be an issue if there is a required base/foundation preparations for future loading.

Figure 45: Stockpile B - Toe of slope encroaching on organics.

Figure 46: Stockpile B - Toe of slope encroaching on organics.

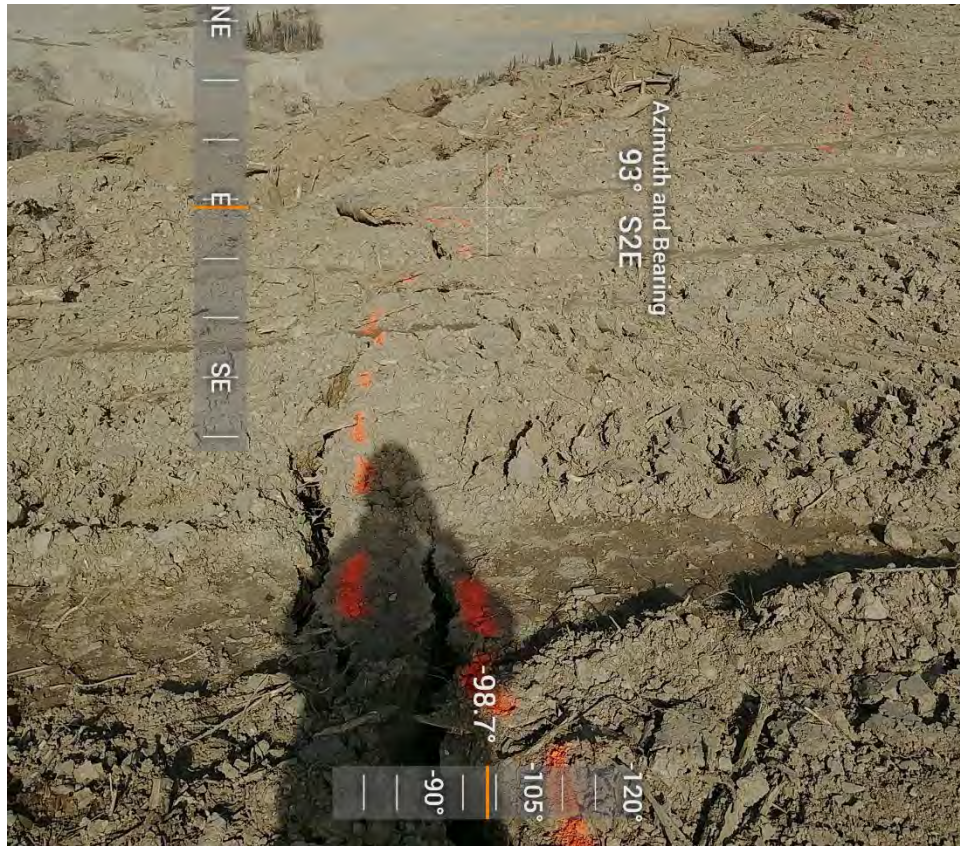
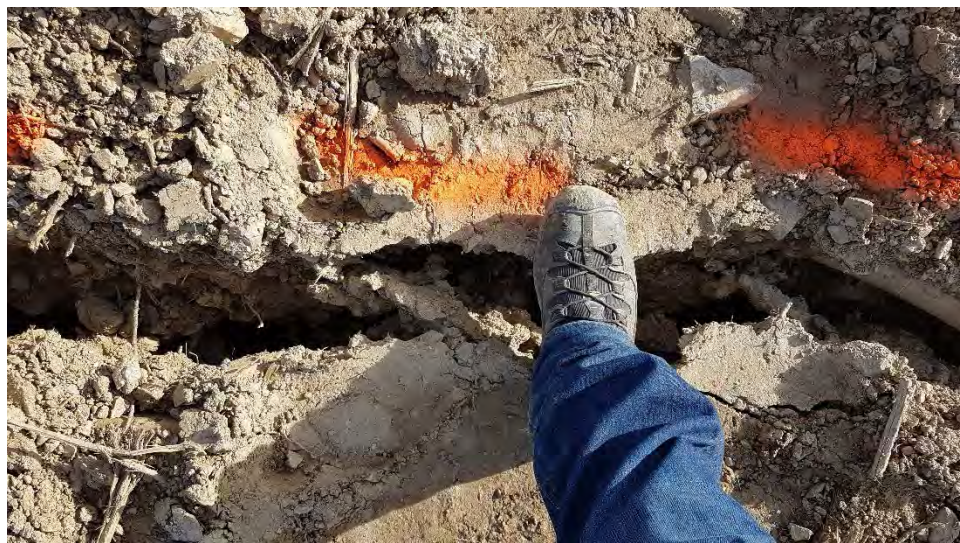
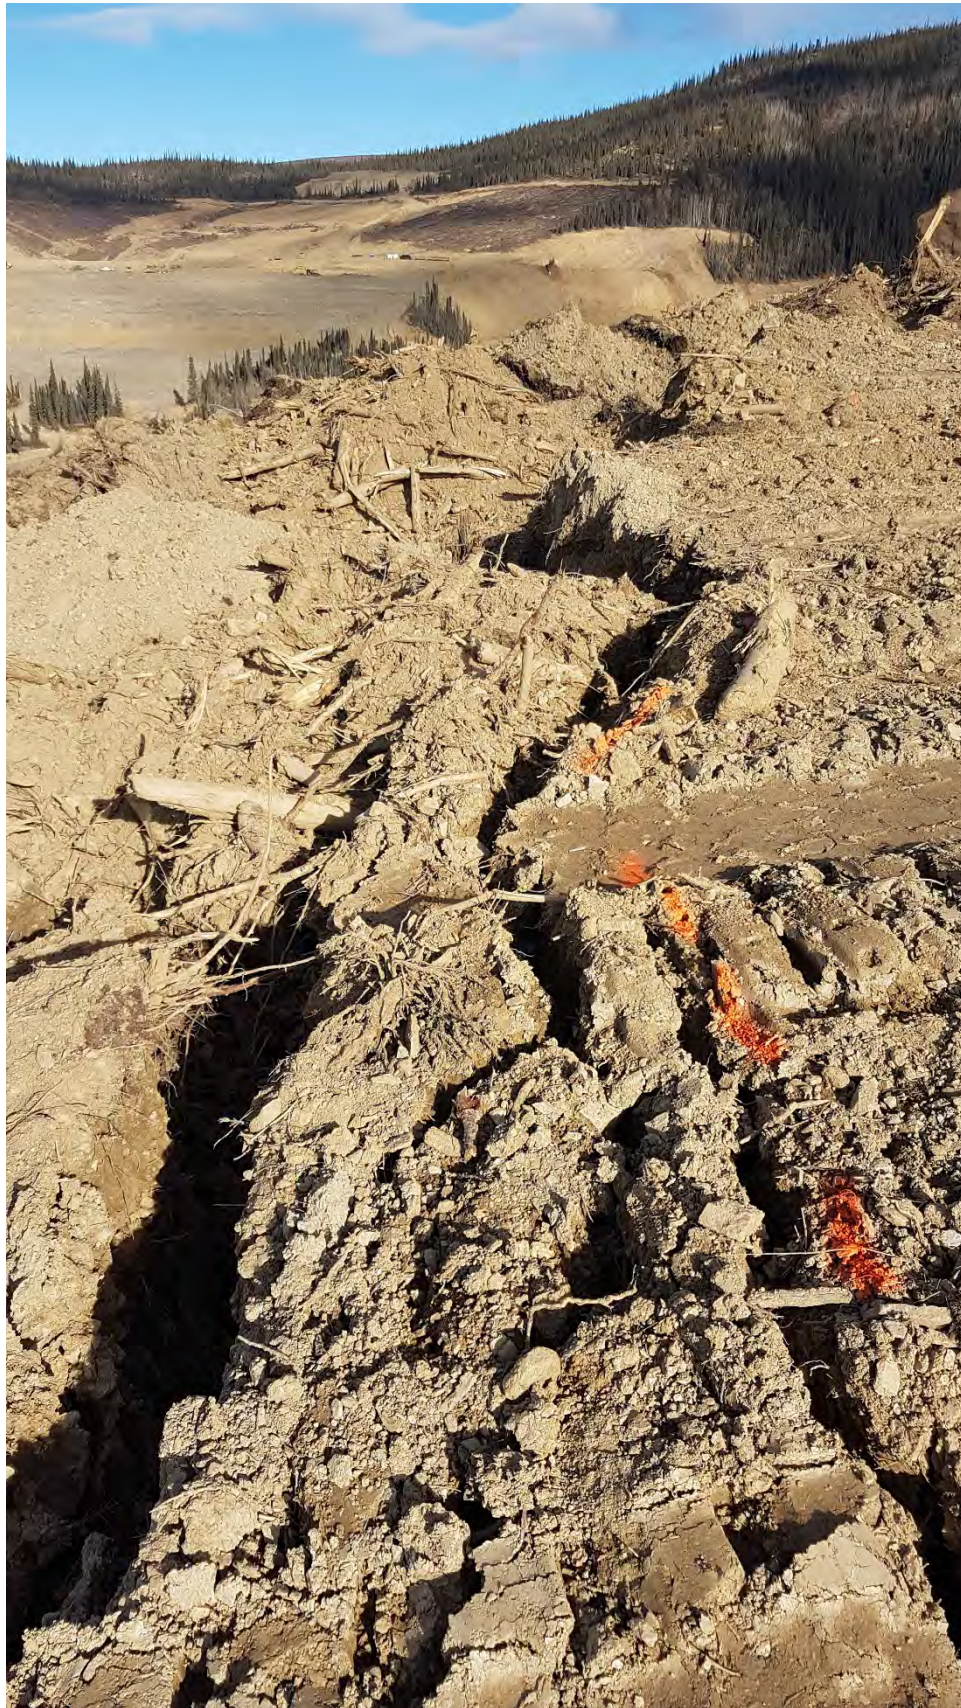
- The west portion of the stockpile is primarily organics and topsoil. Tension cracking up to 1m deep and 30m long was found on the west edge behind some slowly failing material caving off in sloughing block sections. There is no infrastructure or active work nearby, therefore, if a small failure were to occur the consequences would be very low.

Figure 47: Stockpile B - West end tension cracking.

Figure 48: Stockpile B - West end tension cracking.

Figure 49: Stockpile B - West end tension cracking.

1. This stockpile should be graded on top to eliminate or seal tension cracking.
2. The extent (volume and location) of ice and other frozen materials in the stockpile should be determined based on site records and information from site staff available. A record of the resulting instability should be noted.
3. Have a qualified professional determine if ice and other frozen materials are an acceptable material for construction of a mass earth structure, and if they are, how they should be placed or incorporated in an overall stockpile design to ensure that there are no localized failures as a result.

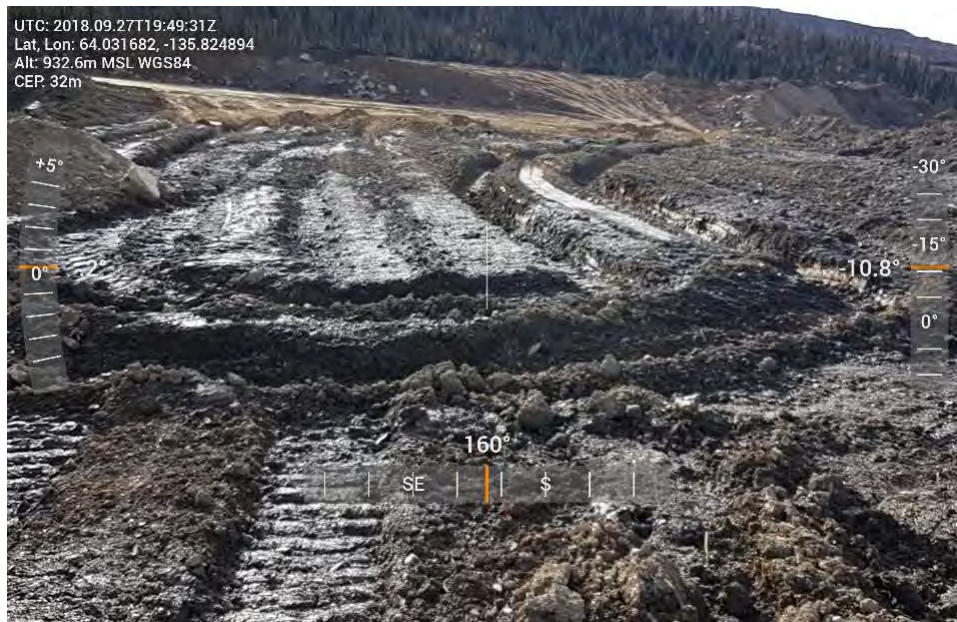
- The new material being moved to the stockpile varies significantly in material composition and moisture content. The north edge of the dump has significantly saturated soils at the time of inspection.

Figure 50: Stockpile B - North side saturated soils

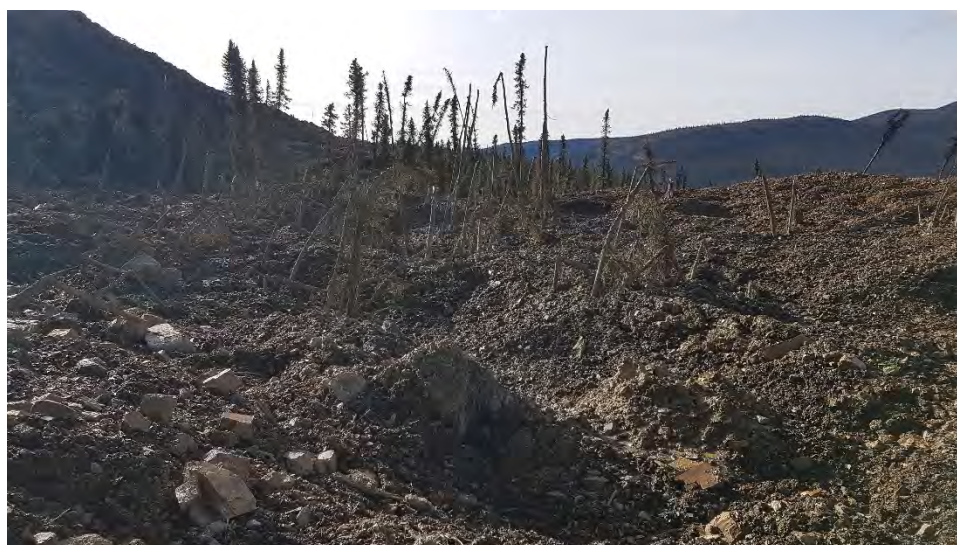
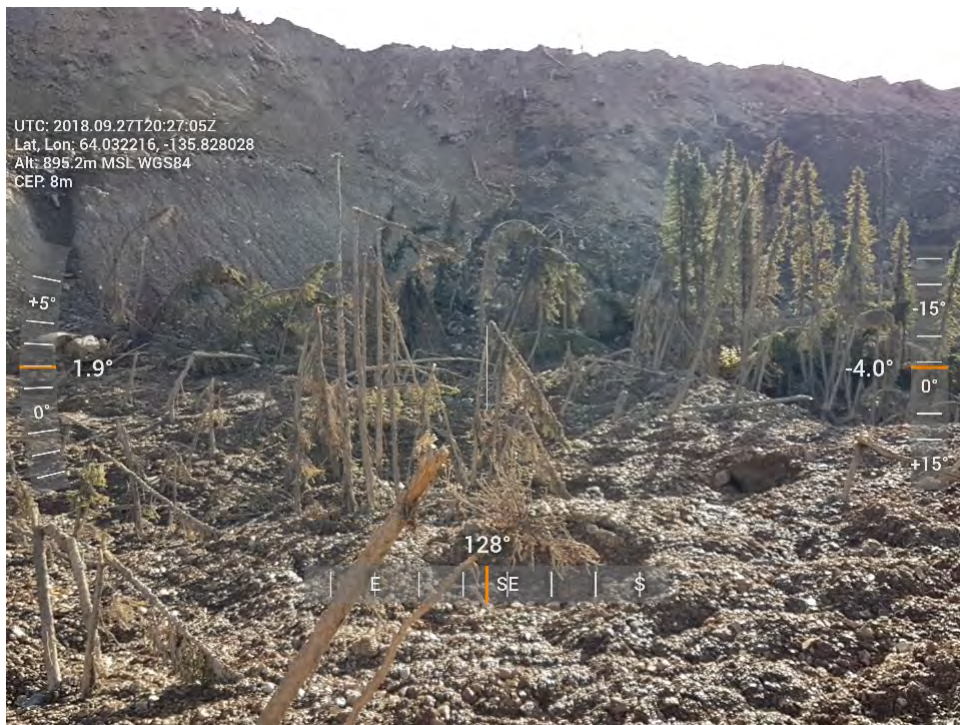
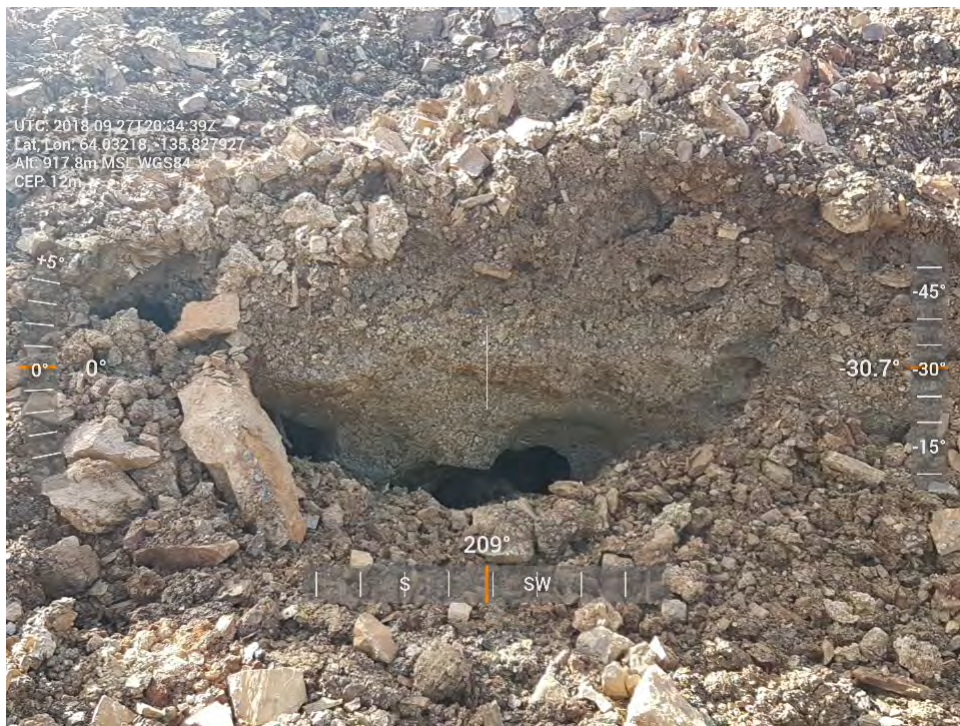
- There is a small failure at the north west edge of the stockpile. While the mechanism is not completely clear, it appears to be linked to a stockpile deposit of mixed ice and earth that was excavated for other works. The material failed in a flow mechanism, and the run out does not extend more than 20m past the toe of the existing stockpile. The toe of the flow is composed of ice chunks and fractured rock mixed with fines. Work is not taking place below the stockpile, but there is an active haul road accessing the stockpile adjacent to the failure path. It is unclear if any ice remains in the stockpile.

Figure 51: Stockpile B - Northwest material flow.

Figure 52: Stockpile B - Northwest material flow.

Figure 53: Stockpile B - Ice found in Northwest material flow.

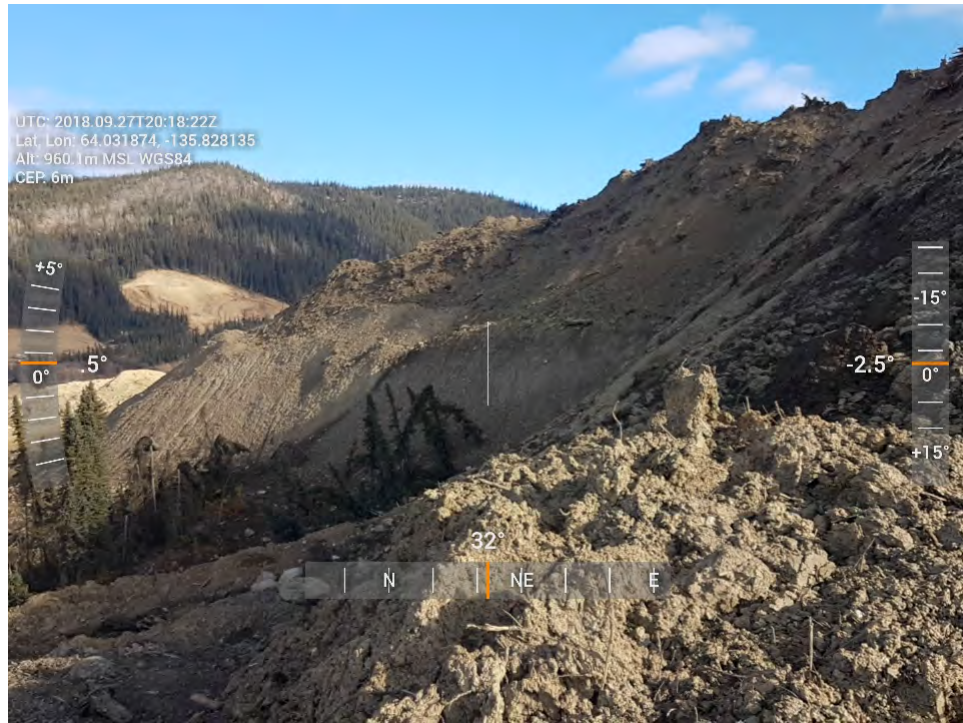
- Sloping of the outside faces of the stockpile was found to be supported at 90% to 100%.

Figure 54: Stockpile B - Outside slope (Typical).
