Allnorth Information		VICTORIA GOLD CORP.	
Project #:	<b>19-PG-0305</b>	Client Project #:	
Document #:	<b>191029</b>	Client Document #:	
Document Rev. #:	<b>0</b>	Client Doc. Rev.#:	
Prepared By:	Jordan Smith, EIT	Client Contact:	Richard Tuohey
Reviewed By:	Don Williams, P.Eng.

Annual Physical Stability Assessment Report – Victoria Gold – Eagle Gold Project

Visual inspection of the following structures: Open Pit, Platinum Gulch Dump, Lower Dublin South (Control) Pond, Secondary Crusher, Primary Crusher, 90 Day Stockpile, Adsorption, Desorption and Recovery Plant, Heap Leach Facility, Event Pond, Ditch A, B, and C, Former Nuway Crusher Pad, Orica Laydown, Various Un-named Stockpiles.

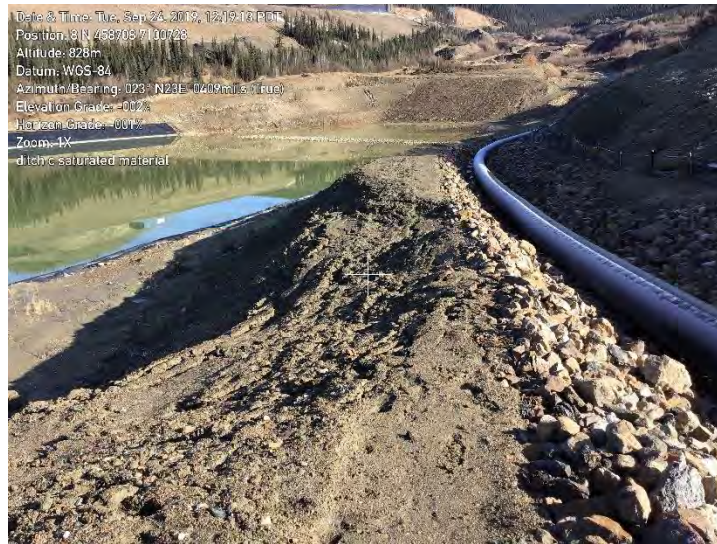
1. Some saturated material and erosion was noted on the slope of the southwest corner of the Control Pond over the width of the narrow access road (Figure 5). Water flowing down Ditch A may be leaking into the fill in this area. There was some flow into this area from a culvert crossing a former construction access road.

**Figure 5: LDSP – Erosion on the Southwest slope**

**Figure 6: LDPS – Some flow from adjacent culvert**

1. Address erosion occurring on the southwest slope of the pond. This is likely due to water infiltration from Ditch A or the adjacent culvert outlet. This section of ditch may require further armoring or installation of a liner to properly direct water away from the Control Pond slope.

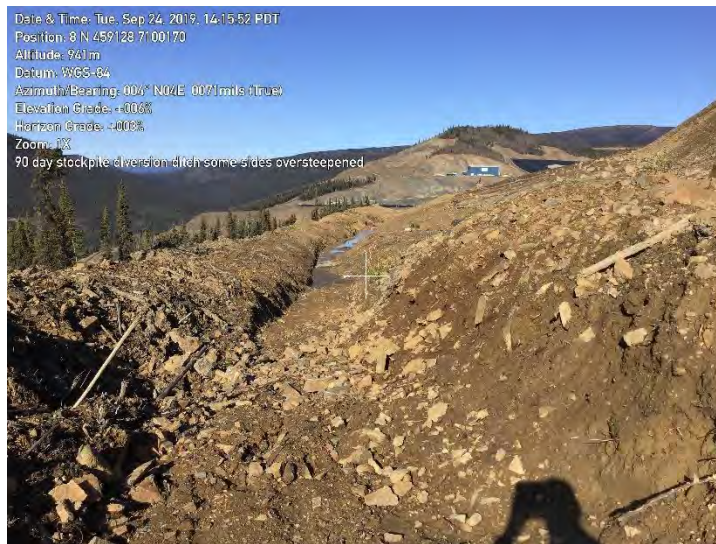
1. A perimeter interception ditch extends around the downhill toe of the 90 Day Stockpile area (Figure 8 and Figure 9). The construction of this ditch is not yet complete, as it is currently unlined with no rock armoring, and is founded on native soils, and over-steepened and sloughing in places.

**Figure 8: Perimeter Ditching**

**Figure 9: Perimeter Ditching**

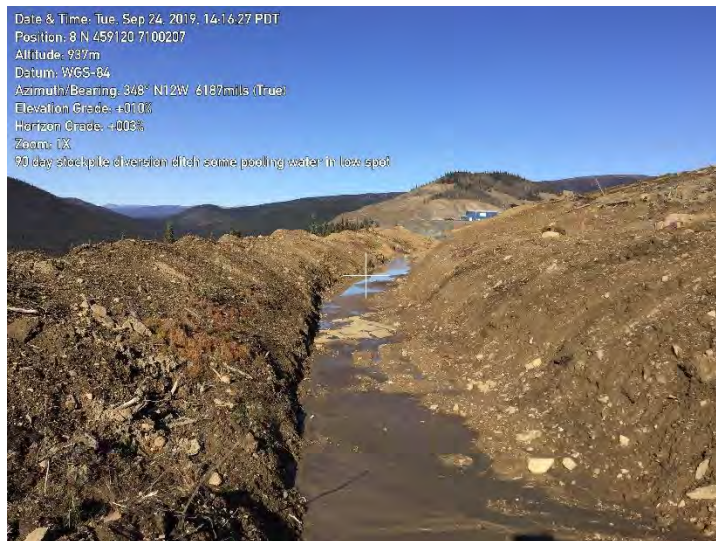
2. In one location some pooling of water has occurred as it appears that the final grade has not been completed (Figure 10).

**Figure 10: Pooling water in perimeter ditch**

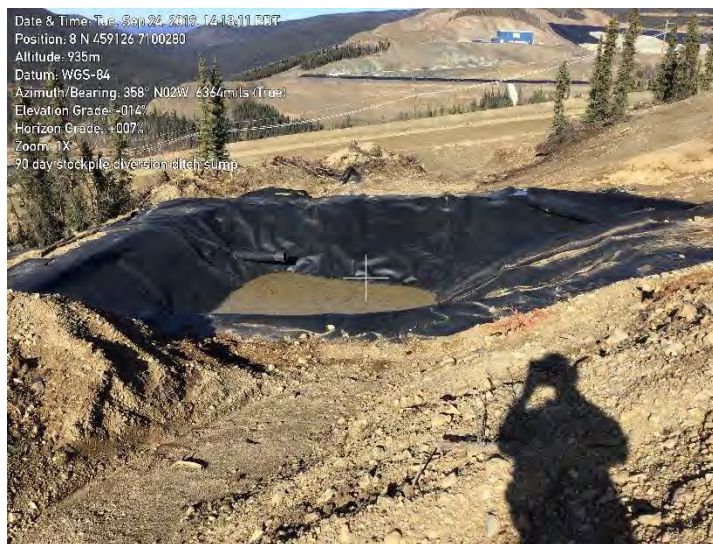
**Figure 11: Collection Sump**

3. The outlet of one side of the perimeter ditch does not currently tie into the collection sump (Figure 11), such that a large flow of runoff could be directed down towards the access road until the tie in is completed. Site representatives indicated that this ditch will eventually be tied into the collection sump.

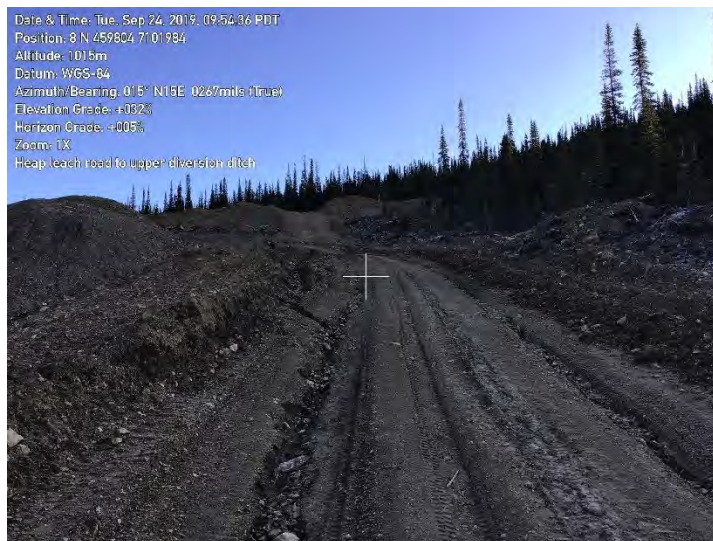
1. Scouring associated with rainfall runoff was noted on the access road that leads to the upper overburden stockpile and interception ditch (Figure 16).

**Figure 16: Scour on access road**

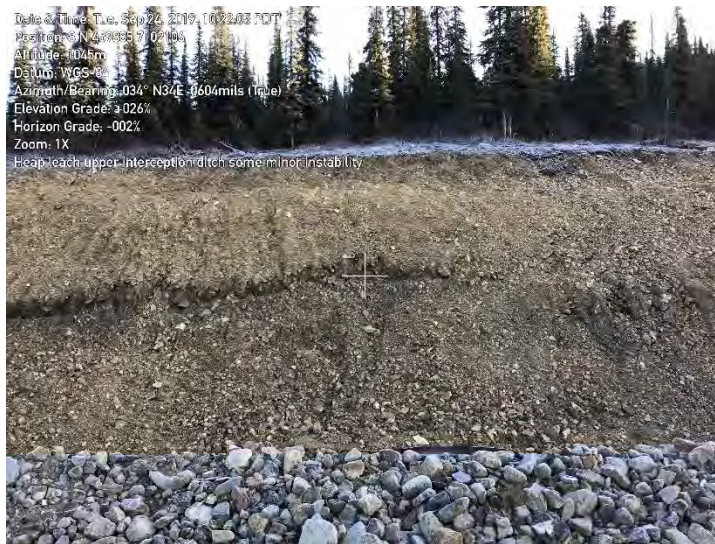
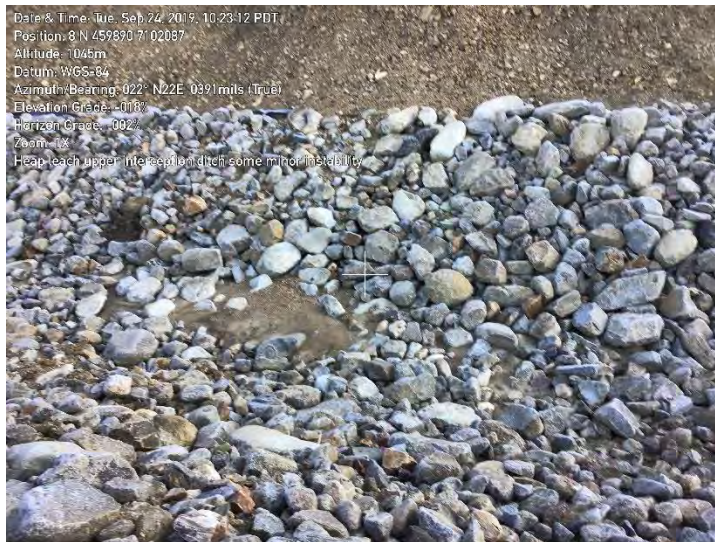
3. Some minor scour and slope instability was noted on the uphill cut slope adjacent to the ditch (Figure 21). Some material has been deposited into the ditch (Figure 22).

**Figure 21: Sloughing slope**

**Figure 22: Material deposited into ditch**

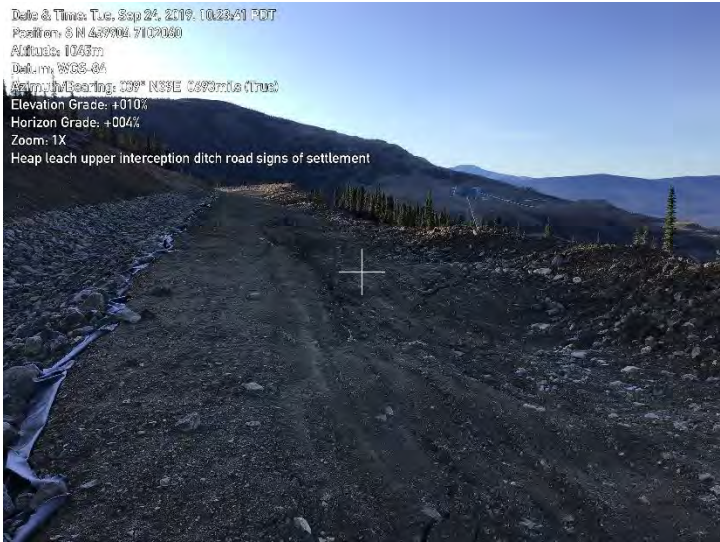
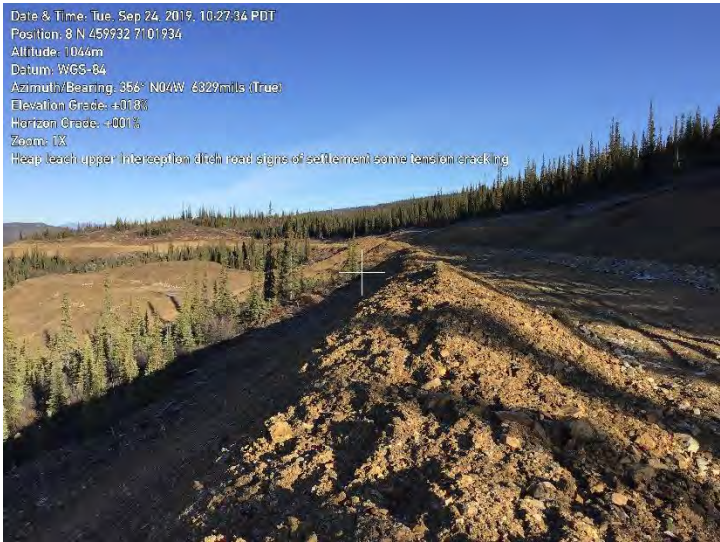
4. Settlement and movement was noted in one section of the temporary access road, which extends along the south and down gradient side of the ditch (approximate 0+650 along the ditch alignment) (Figure 23). Tension cracking in the soil is present. This is likely due to settlement after road construction, which occurred during winter and likely incorporated snow/ice when building up the fill section. Movement or failure of the fill section could impact the functionality of the interception ditch, however, fill slopes were measured to be less than 50%, and the consequences of further movement are likely low, as there is moderate setback from the toe of the downhill slope to the closest access road (Figure 24). This deteriorated temporary road only accesses a short section of the interception ditch.

**Figure 23: Road settlement along temporary access road**

**Figure 24: Downhill slope from road settlement**

4. Review requirements of the Phase 1 Interception ditch outfall. Currently the ditch terminates at the top of an un-vegetated slope, and would be more stable with an armored exfiltration outfall/sediment sump.
5. Monitor road settlement around 0+650 of the interceptor ditch alignment. Currently this section requires some additional fill to facilitate truck traffic. Additional settlement could impact the functionality of the interception ditch. Additional settlement or failure is unlikely to impact other infrastructure, due to adequate setback from the toe of the slope.

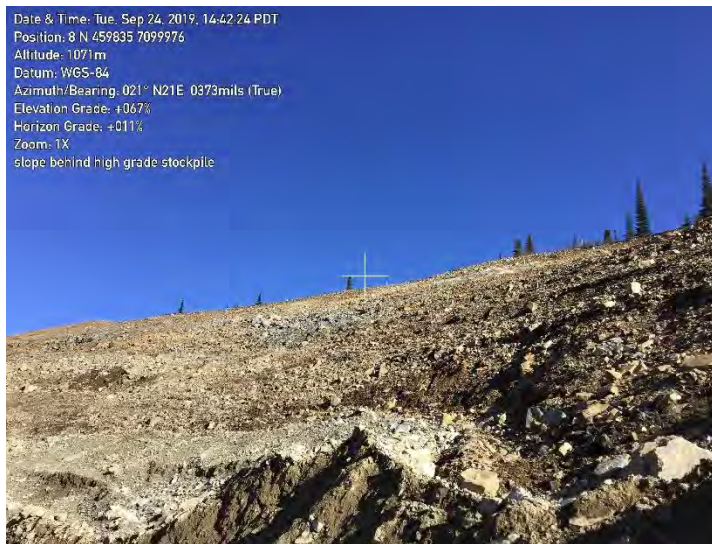
2. Cut slopes behind the Primary Crusher were measured to be approximately 50%, and within recommended guidelines (Figure 33). A small ore stockpile is located in this area.

**Figure 33: Cut slope and small ore stockpile behind primary crusher**

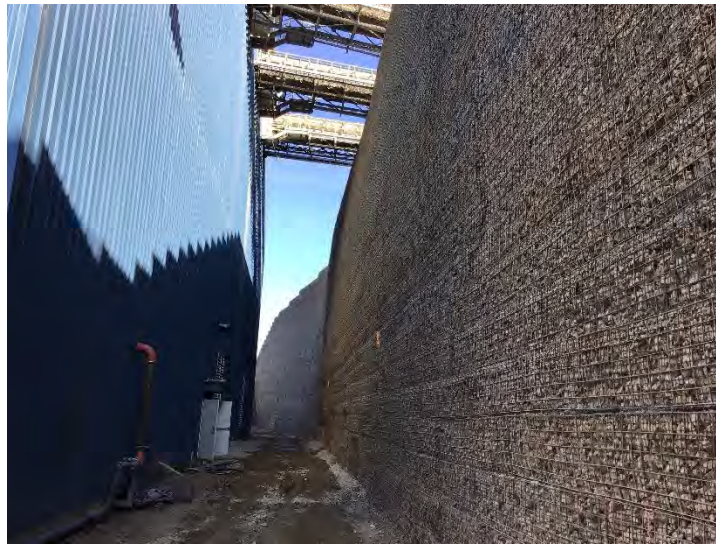
1. No apparent damage or deterioration was noted during the inspection (Figure 34). Much of the construction in this area has been completed since the previous inspection in 2018, and little baseline data is available for comparison. The structure is complete and operational. Survey benchmarks were present on the face of the wall (Figure 35).

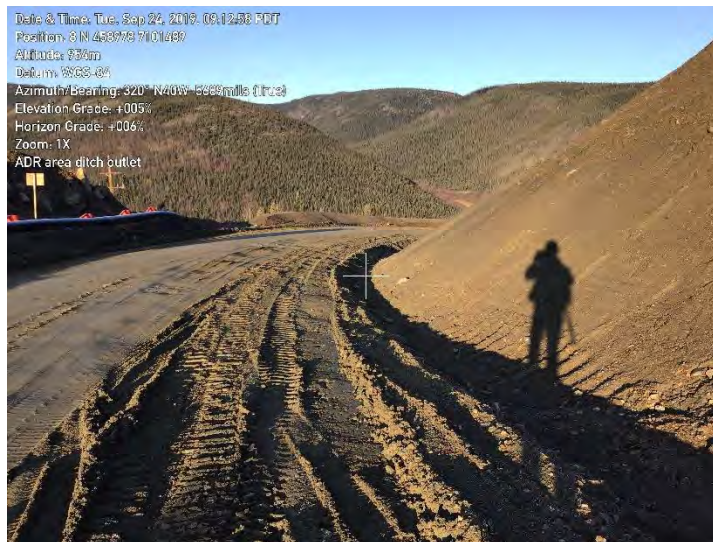
2. Currently the north toe ditch is directed through the culvert and into a smaller roadside ditch, which runs along the uphill side of the ADR access road (Figure 39). This ditch is also not armored and contains loose gravel and fines.

**Figure 39: Flow into roadside ditch**

1. Review engineering requirements for the North Toe Ditch to confirm ditch size, and need for rock armoring. Toe ditch is currently tied into the roadside ditch, which should also be reviewed for engineering requirements. Recommend reviewing hydraulic design of both ditches to determine what is necessary.

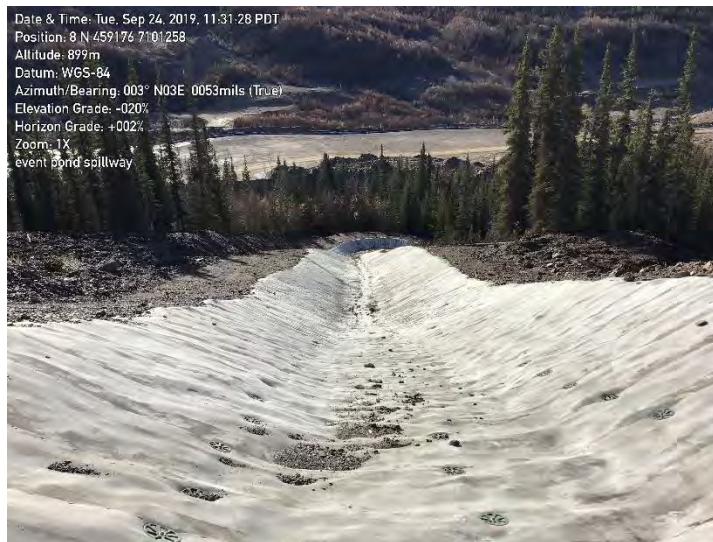
- The emergency spillway is in place, constructed of similar material as the HLF spillway, and appears stable (Figure 45). The spillway is directed downslope towards Dublin Gulch. No concerns at this time.

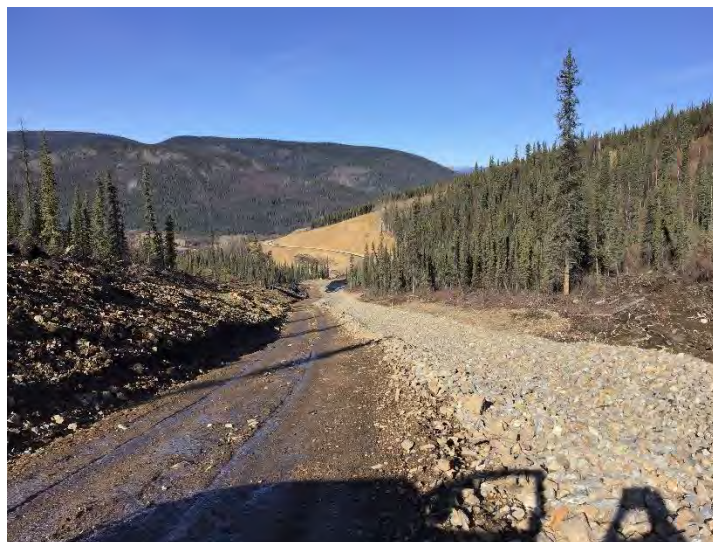
1. Ditch A carries flow from Platinum Gulch down to the Control Pond. The ditch is armored with approximately 50kg rock, and appears to be un-lined for the majority of it's length. The ditch flows into a lined collection sump several hundred meters down from it's initial point of collection (Figure 46 and Figure 47). Water collects in the sump and flows through a 36" HDPE pipe for the remainder of it's length. An overflow weir is present at the sump over the collection pipe, which would direct flow into the ditch during higher water level events. During the time of inspection, the ditch was mostly dry downstream from the collection sump, with all of the visible flow handled by the 36" HDPE pipe.

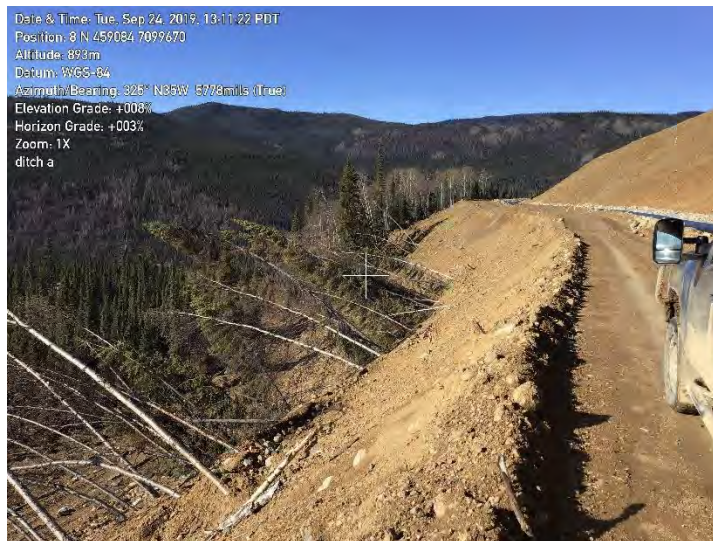
- Fill along portions of the access road adjacent to Ditch A appears to have been pushed onto trees and debris in the subgrade (Figure 49).

**Figure 49: Trees in fill subgrade**

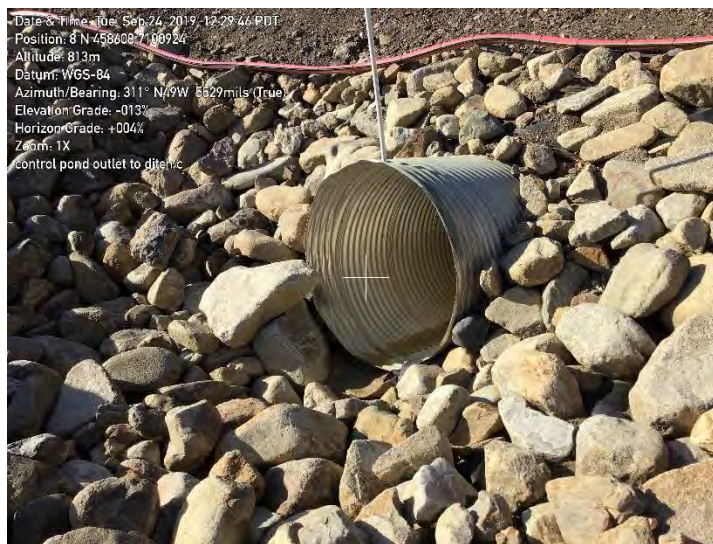
1. Diversion ditch C begins at the 1500mm outlet culvert for the Control Pond (Figure 52), and terminates in Haggart Creek (Figure 53 and Figure 54). This ditch acts as both an emergency spillway if the Control Pond is filled over capacity or a conveyance channel for water released from the control pond through the low level outlet. The ditch is armored with approximately class 10kg rock, and liner is visible in several locations. The ditch has several road crossings which are spanned by culverts. No issues identified at the time of inspection.

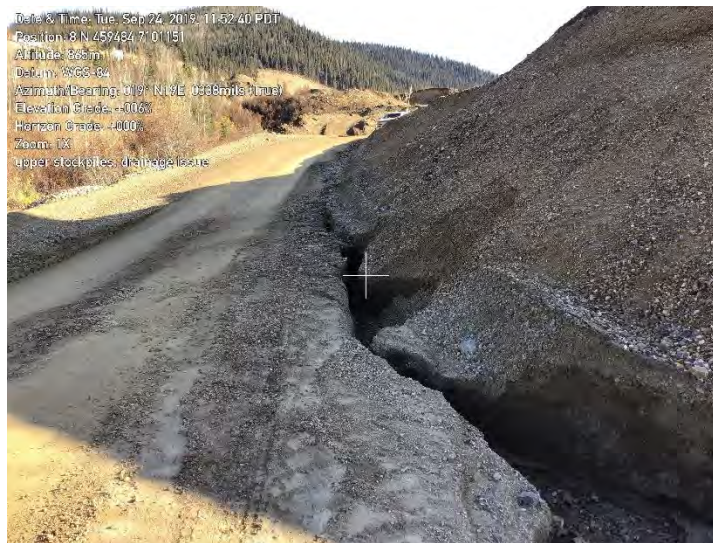
**Figure 59: Scouring and gully forming adjacent to stockpiles**
