Allnorth Information		VICTORIA GOLD CORP.	
Project #:	2002684	Client Project #:	
Document #:	201215	Client Document #:	
Document Rev. #:	1	Client Doc. Rev.#:	
Prepared By:	Spencer Bergin, EIT	Client Contact:	Richard Tuohey
Reviewed By:	Don Williams, P.Eng.

Document Description
Annual Physical Stability Assessment Report – Victoria Gold – Eagle Gold Project
<p>Project Description:</p> <p>Visual inspection of the following structures: Open Pit, Platinum Gulch Dump, Lower Dublin South (Control) Pond, Secondary Crusher, Primary Crusher, Secondary Stockpile, Adsorption, Desorption and Recovery Plant, Heap Leach Facility, Events Pond, Ditches A, B, and C, Former Nuway Crusher Pad, Orica Laydown, Various Un-named Stockpiles.</p>

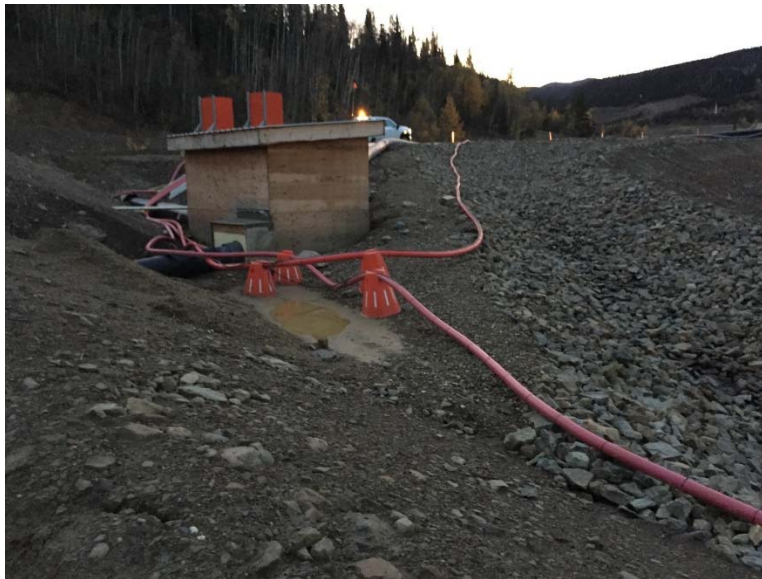
Some minor pooling of water was noticed at the shed which houses the junction of pipes and is adjacent to the rip-rapped groundwater diversion ditch (Figure 1), no other items noted. Site noted that there was above average rainfall throughout the summer and leading up to the site visit which may have lead to this and other instances of pooling water on site. There is an outlet sump and weir which were constructed between the 2018 and 2019 inspections; no issues noted (Figure 2).

Figure 1: LDSP – Pooling adjacent to Shed and Diversion Ditch

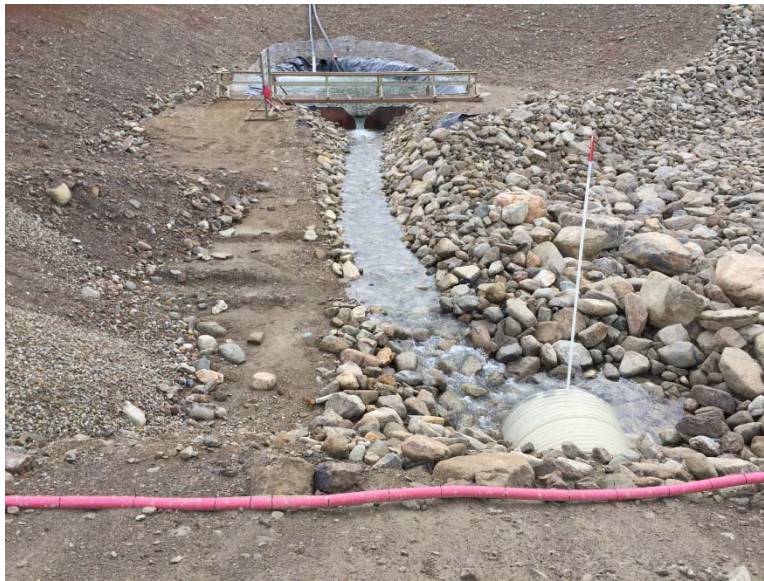
Figure 2: LDSP – Outlet Sump and Weir

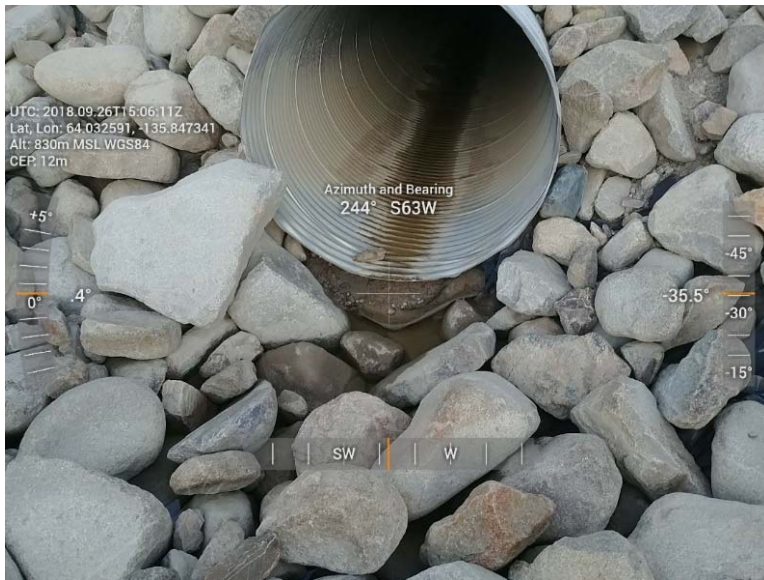
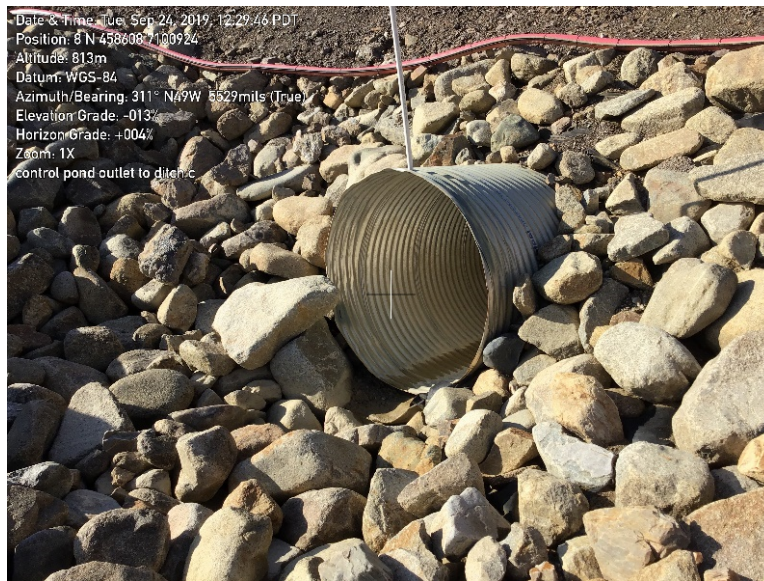
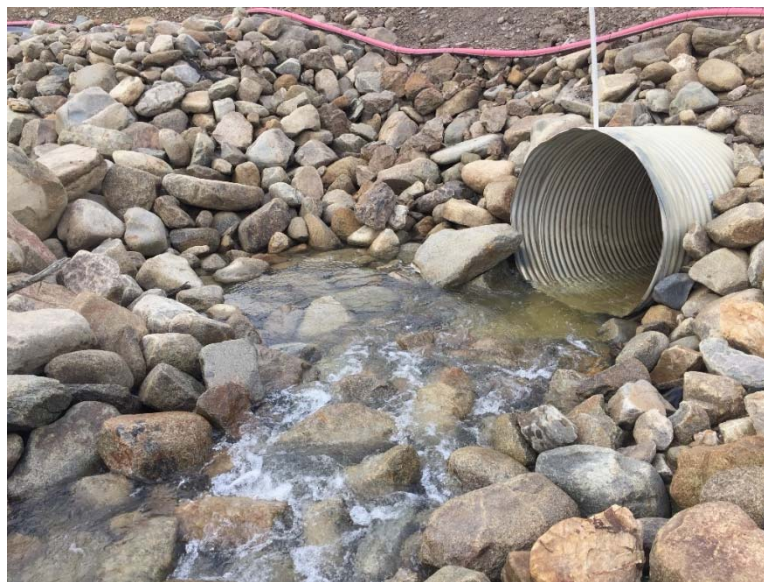
1. The condition of this culvert appears to be the same compared to the previous years inspections (Figures 3 and 4). No water was observed flowing through the culvert in the 2018 and 2019 inspections but a steady flow was observed for this inspection (Figure 5). No concerns noted.

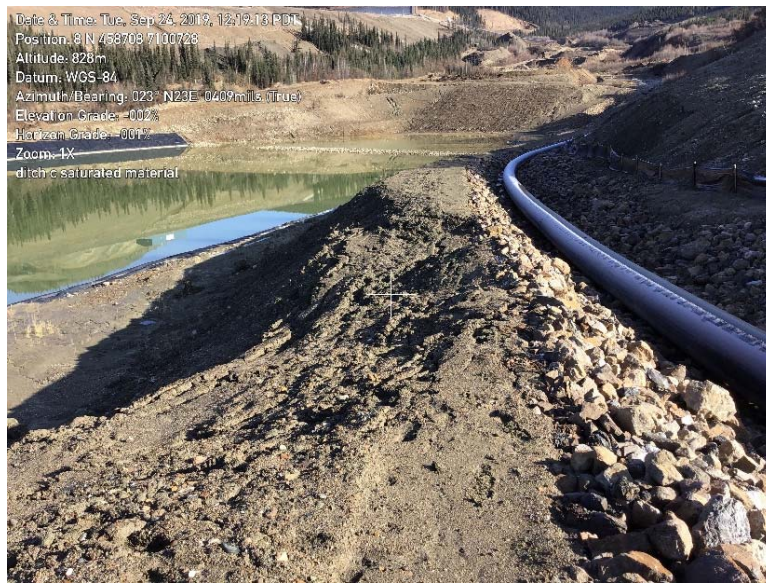
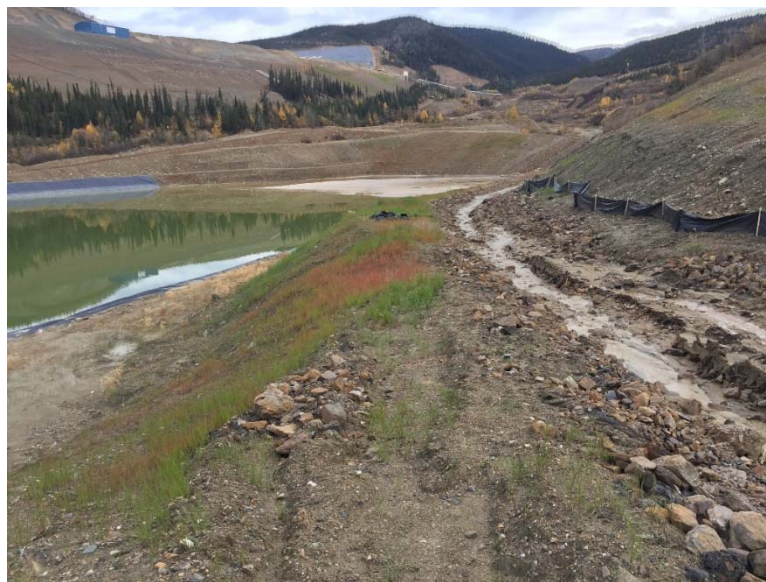
1. Some saturated material and erosion was noted on the slope of the southwest corner of the Control Pond over the width of the narrow access road in 2019 (Figure 6) and does not appear to have been completely rectified as of this inspection (Figure 7). Water flowing down Ditch A may be leaking into the fill in this area. There was some flow into this area from a culvert crossing a former construction access road, which was observed in 2019 (Figure 8) and still present as of this inspection (Figure 9). This area will be included in the Ditch A remediation effort which was observed to be underway in other areas during the site inspection. This would include lining and armoring Ditch A.

Figure 6: LDSP – Erosion on the Southwest slope 2019

Figure 7: LDSP – Erosion on the Southwest slope 2020

1. Address erosion occurring on the southwest slope of the pond. This is likely due to water infiltration from Ditch A or the adjacent culvert outlet. This section of ditch may require further armoring or installation of a liner to properly direct water away from the Control Pond slope.

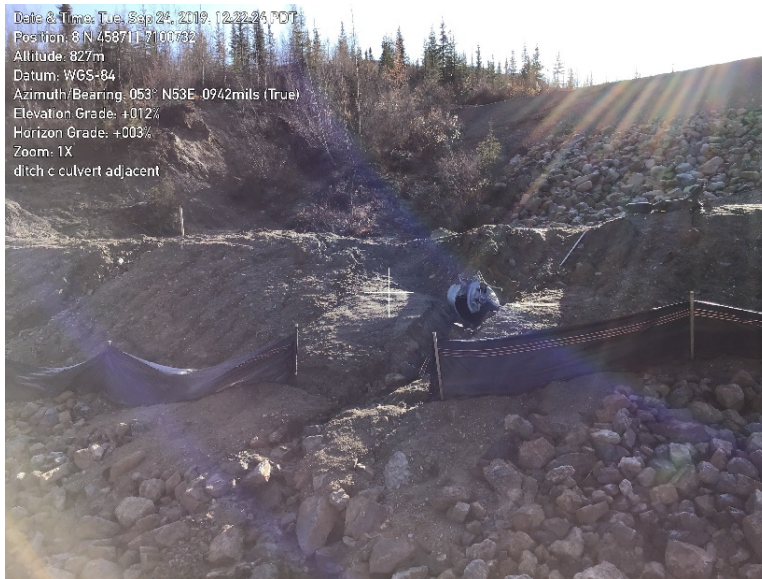
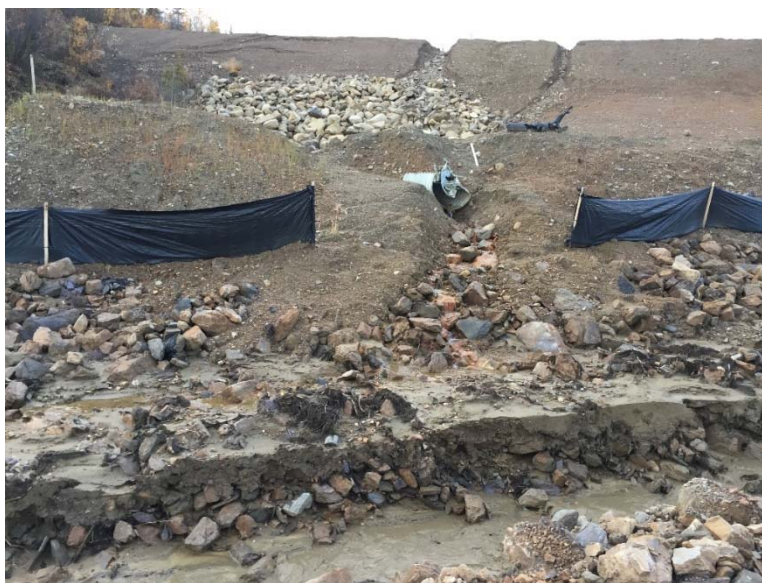
Figure 8: LDPS – Some flow from adjacent culvert 2019

Figure 9: LDPS – Some flow from adjacent culvert 2020

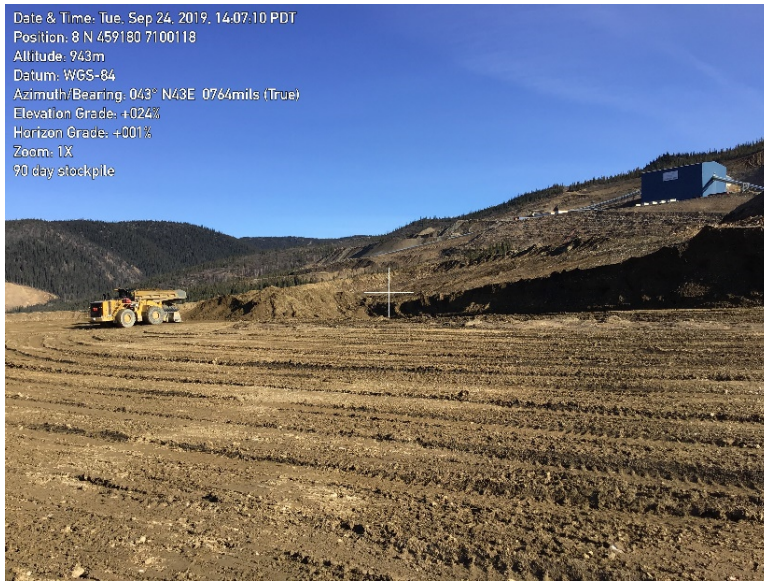
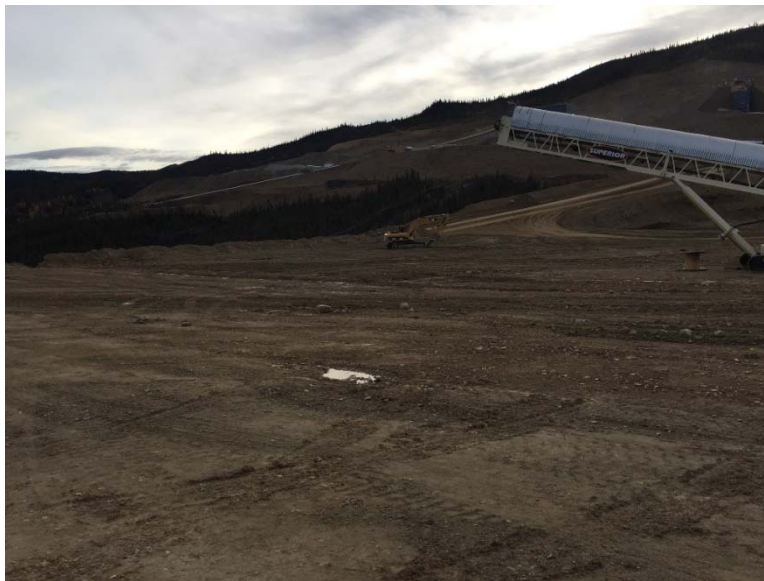
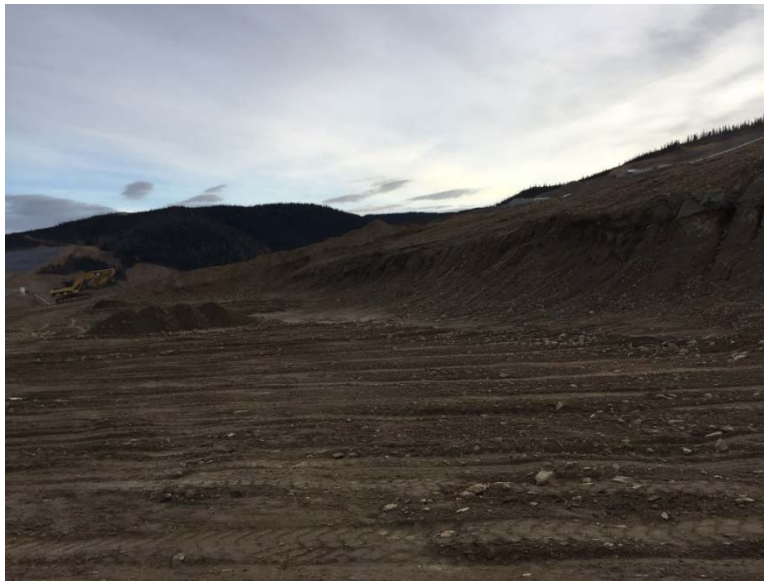
1. The Secondary Stockpile (also known as the 90 Day Stockpile) was under construction in 2019 (Figure 10) and was completed by the time of this inspection (Figure 11). Some over-steepened cut slopes were observed in the 2019 inspection (photos unavailable) however they appear to have been addressed as of this inspection (Figure 12).

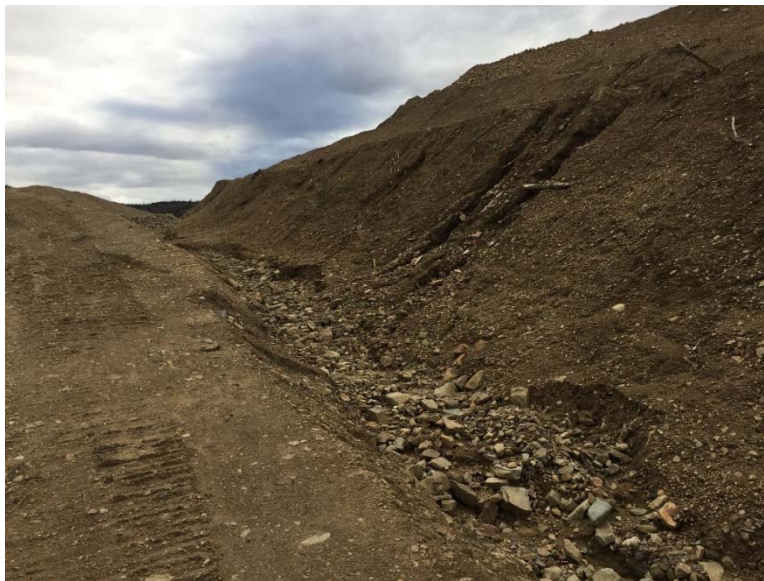
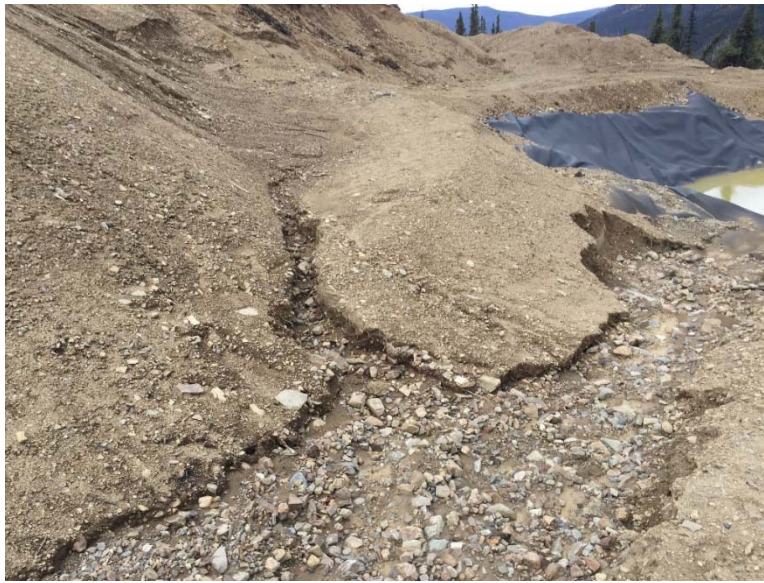
1. A perimeter interception ditch extends around the downhill toe of the Secondary Stockpile area (Figure 13 and Figure 14). The construction of this ditch is not yet complete, as it is currently un-lined with no rock armoring, and is founded on native soils, and over-steepened and sloughing in places.

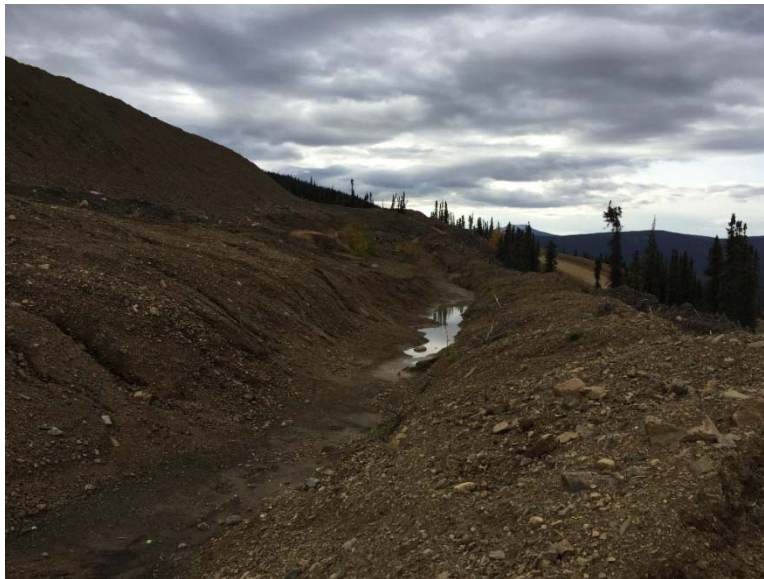
2. In one location some pooling of water has occurred as it appears that the final grade has not been completed (Figure 15).

Figure 15: Pooling water in perimeter ditch

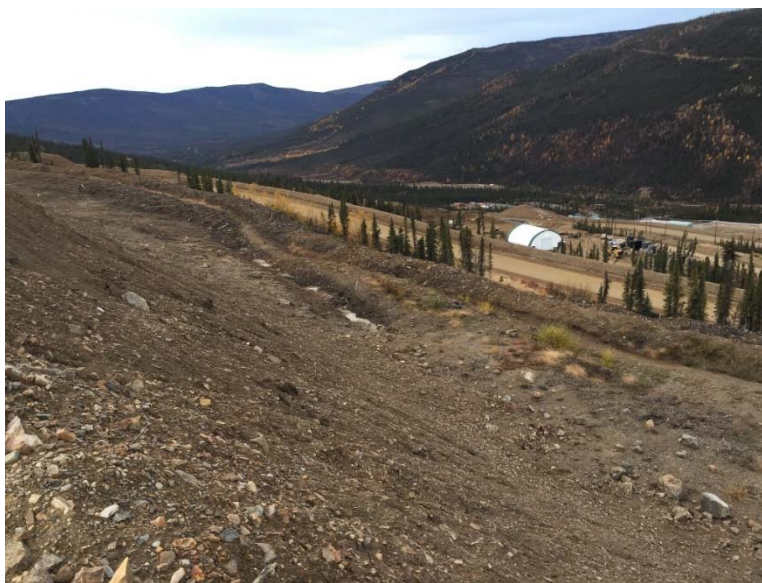
3. The outlet of one side of the perimeter ditch does not currently tie into the collection sump (Figures 16).

Figure 16: Unconnected Ditch Section

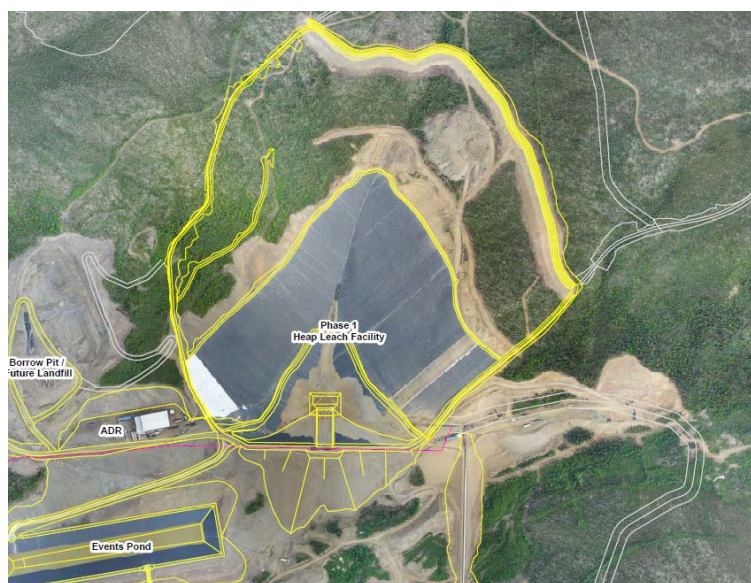
The Heap Leach Facility (HLF) is currently operational. In 2019 the Phase 1A expansion had been constructed as shown in Figure 17. By the time of the 2020 inspection the Phase 1B expansion was largely complete with placement of overliner drain fill and PLS collection piping ongoing as shown in Figure 18.

Figure 17: Heap Leach Facility Overview 2019

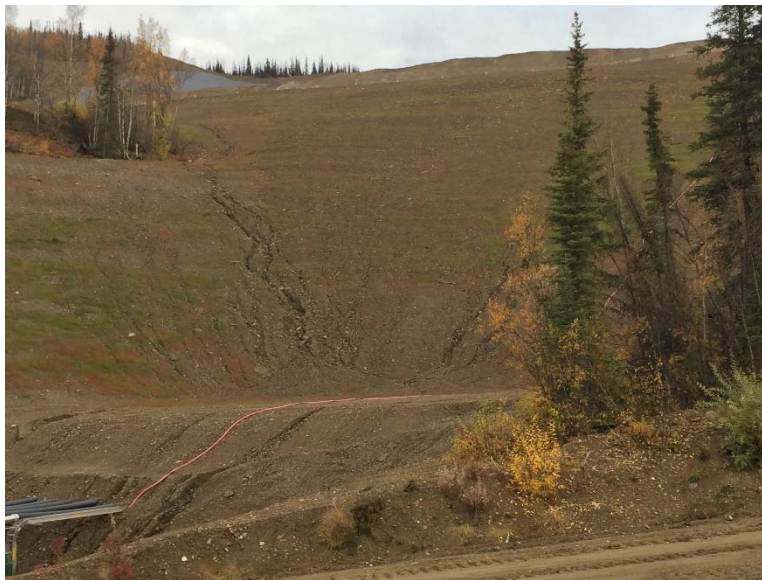
1. Some scouring and rilling noted along the toe slope below the HLF and above the un-named stockpile area. See Figure 19 below for details.

Figure 19: Scouring and rilling along toe slope of HLF

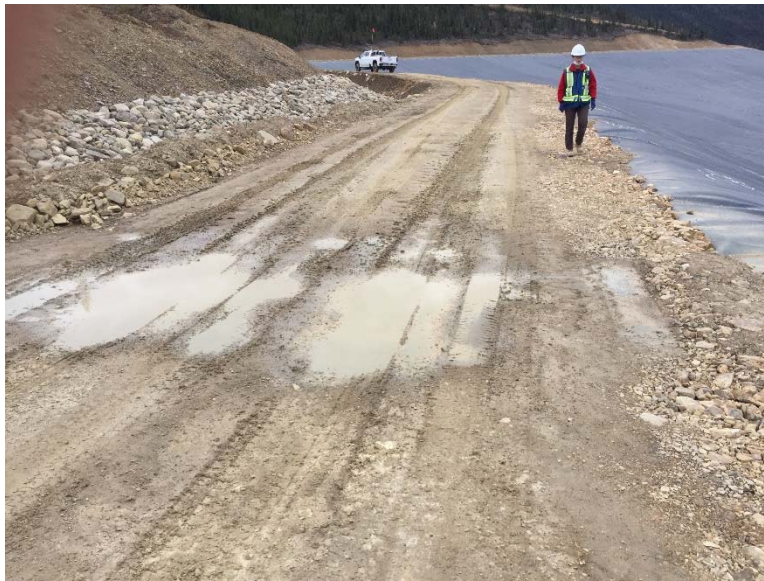
1. Noted sections of pooling water and or soft/deflecting areas on temporary access road above Phase 1B of the HLF. See Figures 20 – 22.

Figure 20: Pooling water above Phase 1B of the HLF

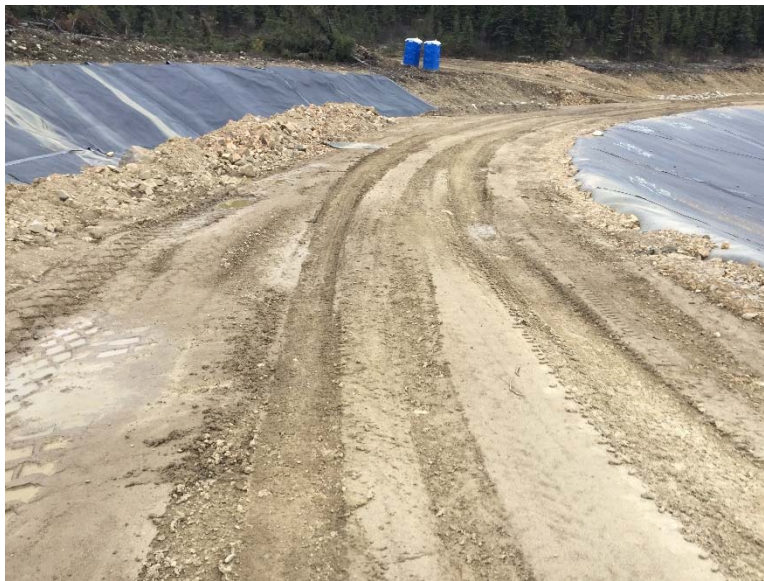
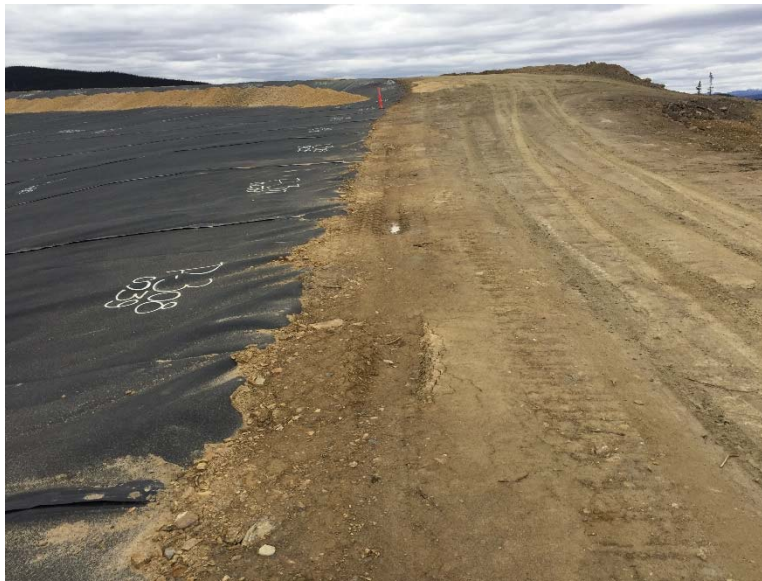
Figure 21: Soft road sections above Phase 1B of the HLF

Figure 22: Soft road sections above Phase 1B of the HLF

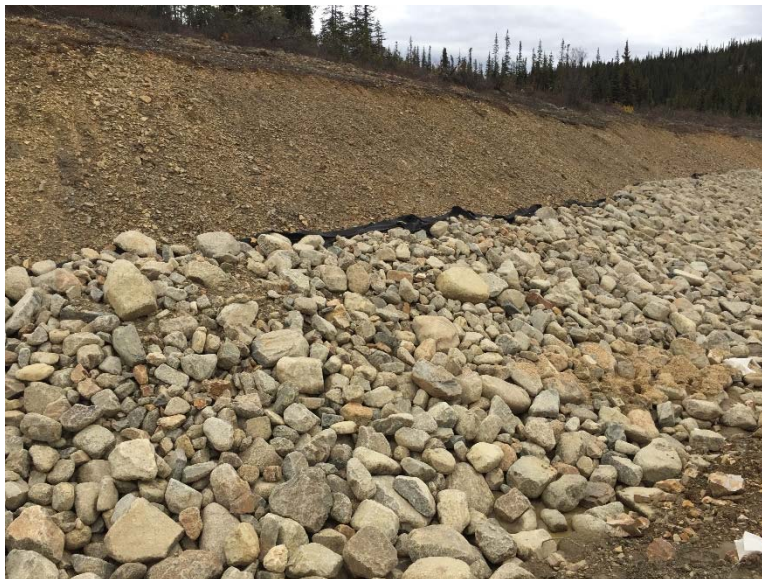
1. The phase 1B interception ditch appears to have been recently constructed. Rock armoring appears to be class 25kg to 50kg, and approximately 100mm to 150mm thick. Geotextile was visible in several locations (Figure 23).

Figure 23: Typical Phase 1B Ditch

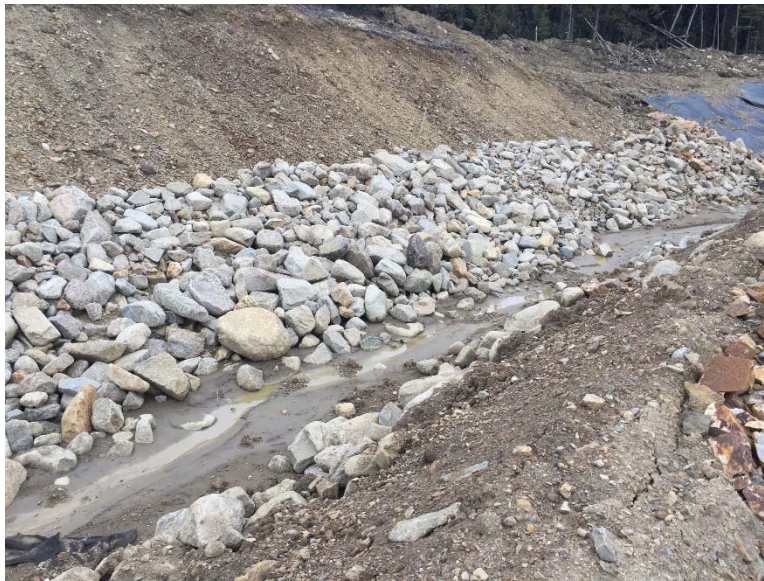
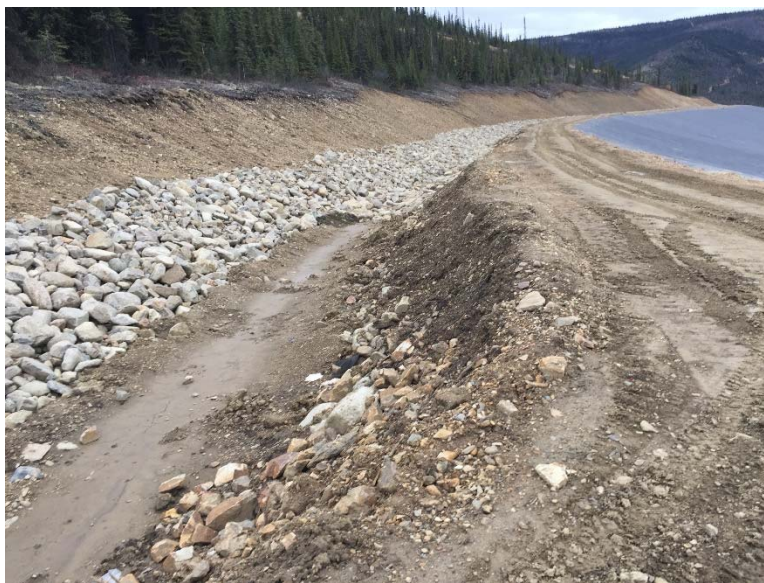
2. The interceptor ditch has collected silt/material in some sections, indicating scour and/or erosion on the uphill cut slope and/or sloughing from the access road. (Figure 24, 25)

Figure 24: Material deposited in HLF Phase 1B Interceptor Ditch

Figure 25: Material deposited in HLF Phase 1B Interceptor Ditch

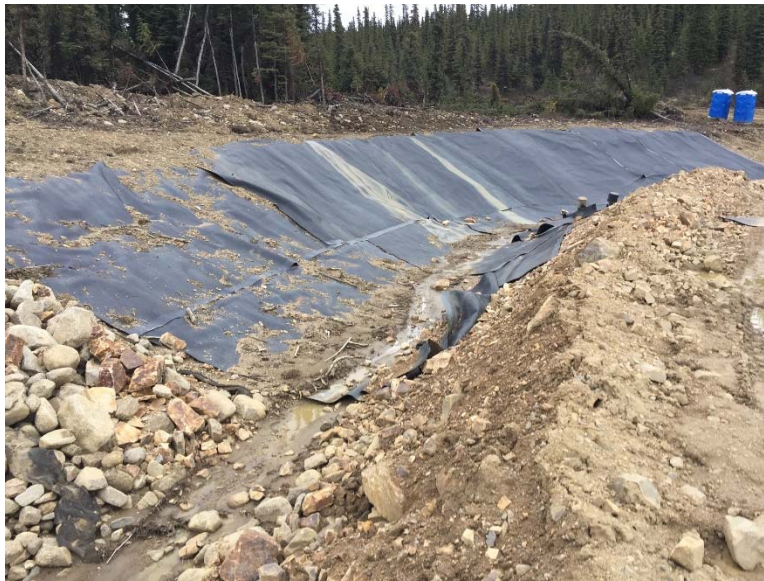
3. A section of the interceptor ditch along the North edge of the HLF appeared to be unfinished, with geotextile installed but no rock armoring (Figure 26).

Figure 26: Unfinished section of Interceptor Ditch

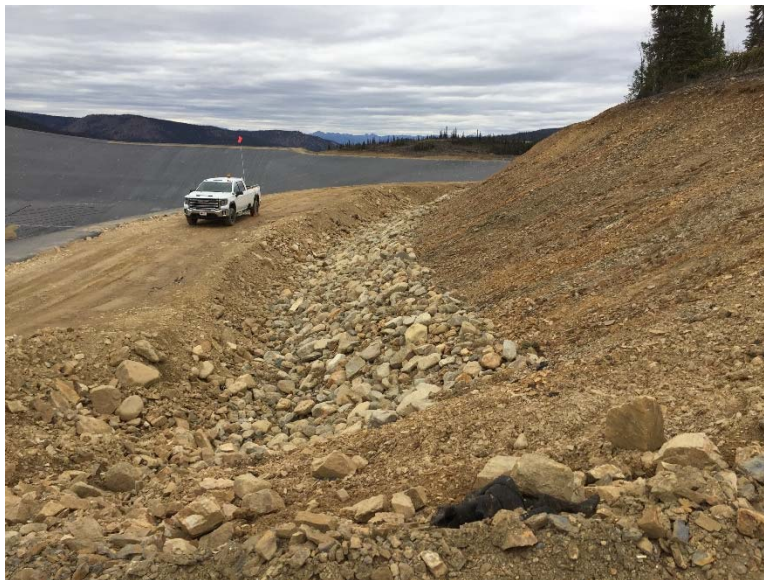
4. Based on visual inspection it did not appear that the Phase 1B Interceptor Ditch was properly graded from the ditch origin (East) to the discharge point (West). This could lead to pooling water forming above the HLF and lead to slope stability issues. See Figure 27 for a view from the ditch origin above the East edge of the Phase 1B HLF expansion.

Figure 27: Phase 1B Interception Ditch sloping

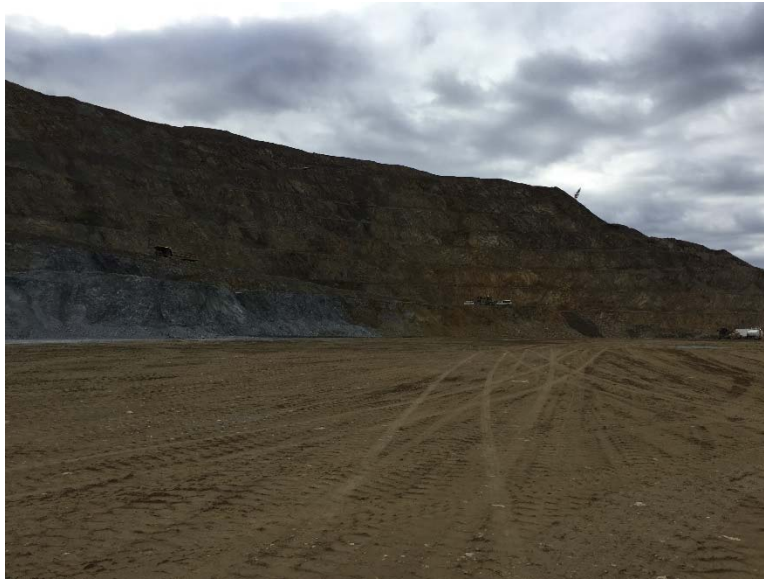
1. The pit walls appear stable, and constructed in competent rock. See Figure 28 below for details.

Figure 28: Pit Walls

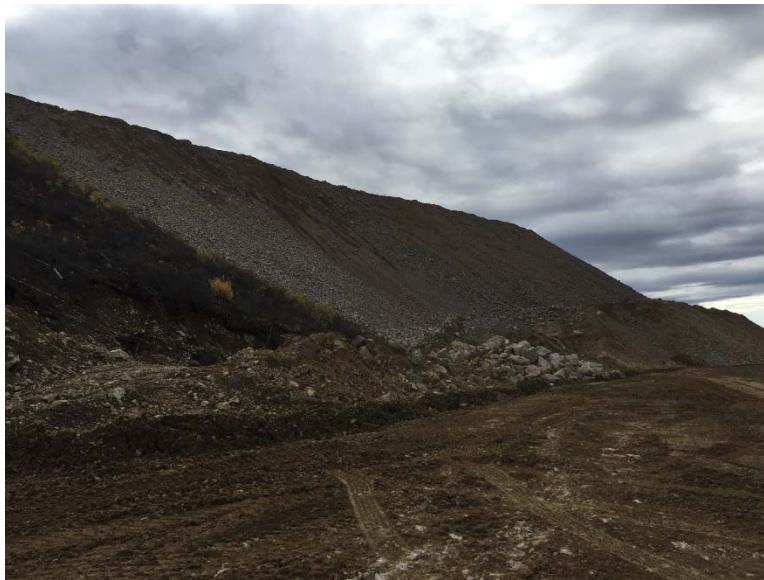
1. Platinum Gulch Dump is currently operational, and the side slopes appear to be stable. See Figure 29 below.

Figure 29: Dump Fill Slope

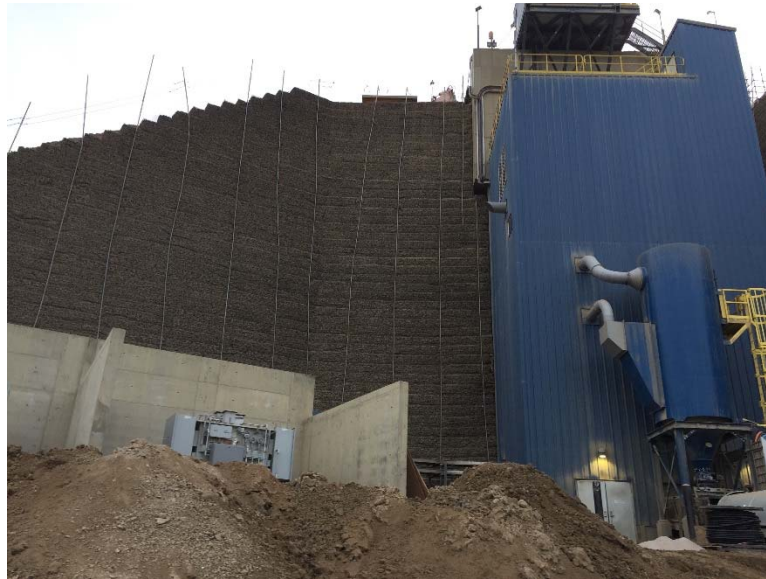
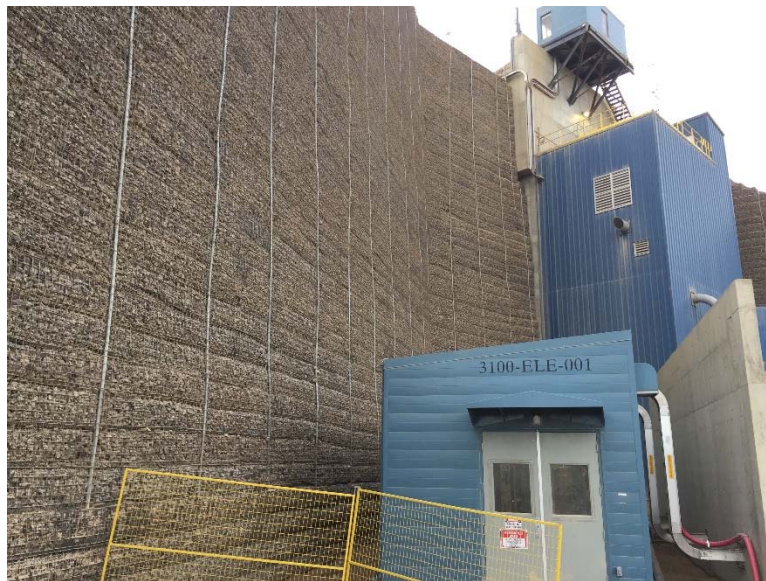
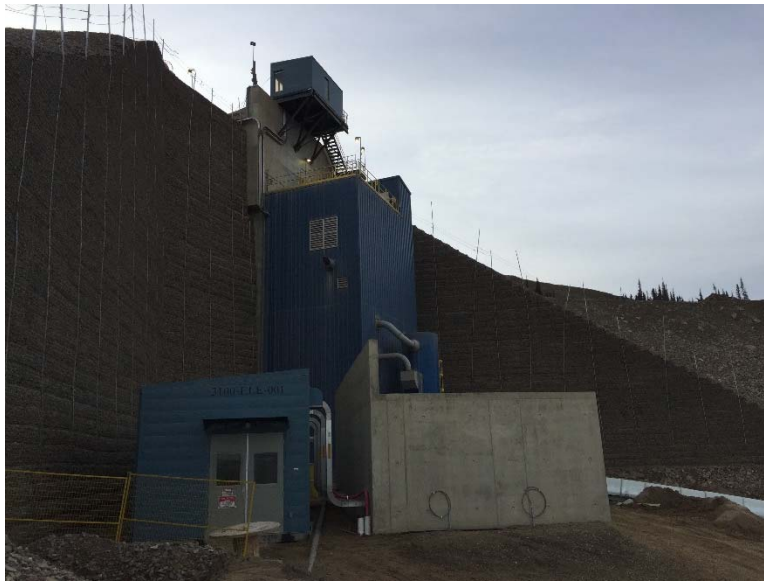
1. No apparent damage or deterioration was noted during the inspection of the Primary Crusher MSE wall (Figure 30 - 32). No changes were visually identified from the 2019 inspection.

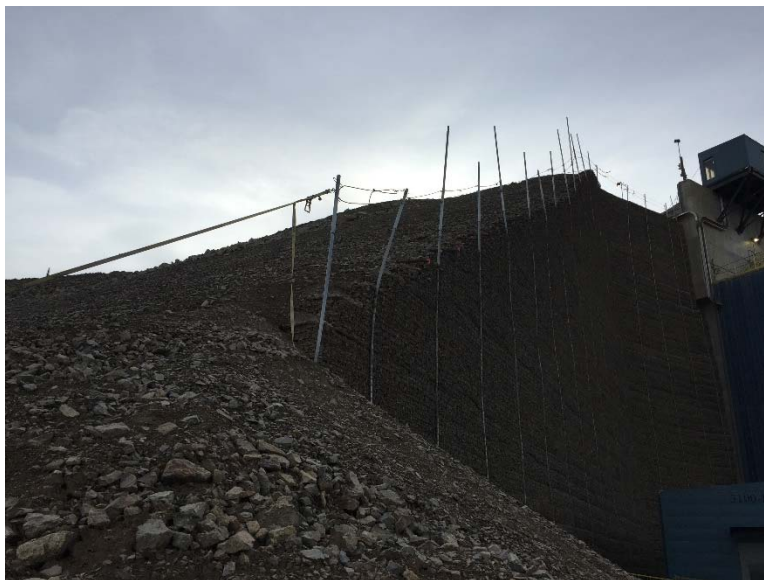
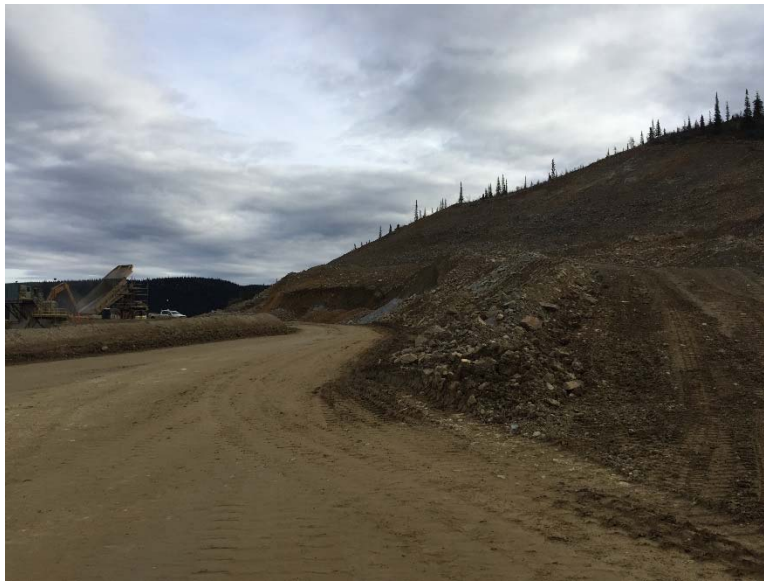
1. Cut and fill slopes appear to be acceptable, no stability or erosion issues noted. (Figures 33 and 34).

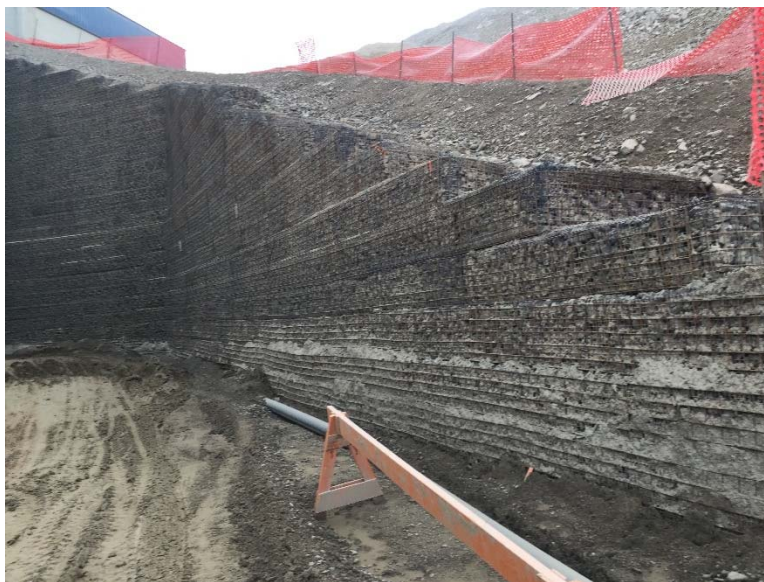
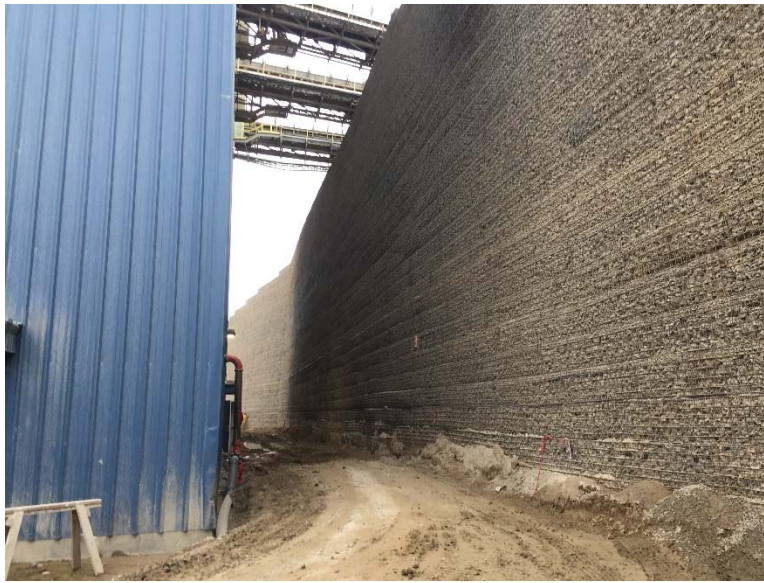
1. No apparent damage or deterioration was noted during the inspection of the Secondary/Tertiary Crusher MSE wall (Figure 35 – 36). No changes were visually identified from the 2019 inspection.

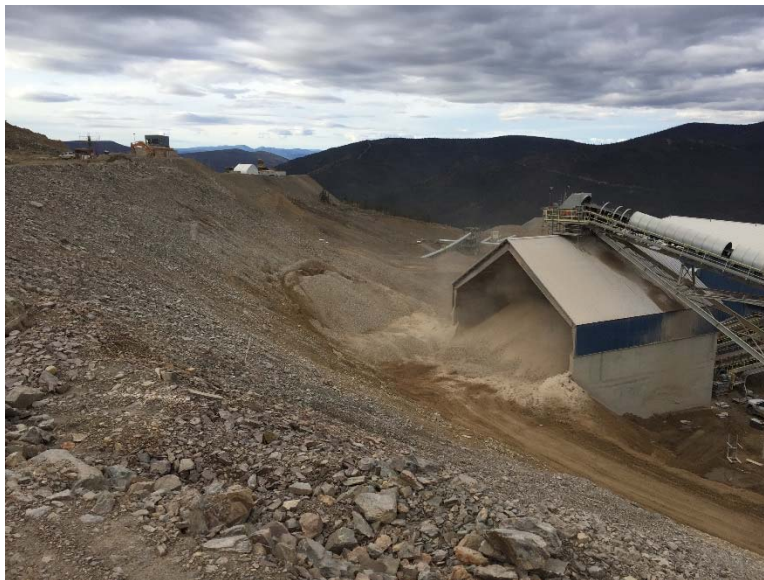
1. Observed locations behind the secondary crusher showed no signs of stability or erosion issues (Figure 37). Some outcrops of rippable rock visible.

Figure 37: Cut slopes above Secondary/Tertiary Crusher

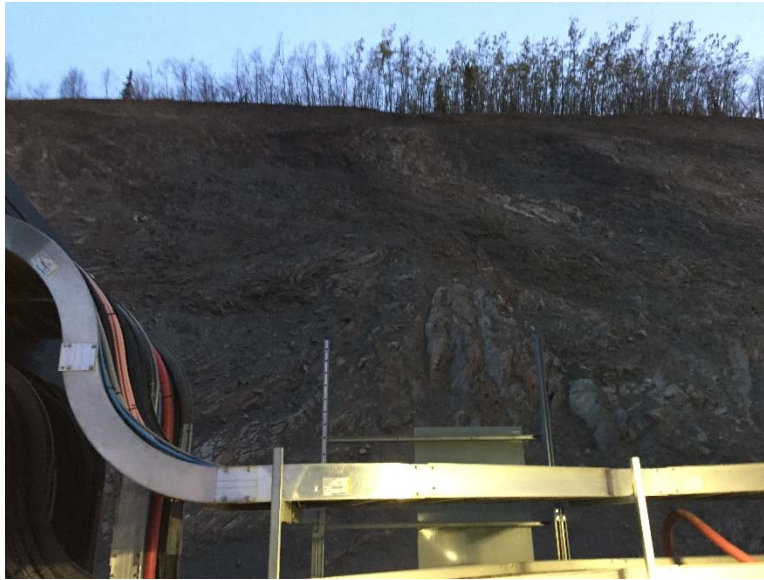
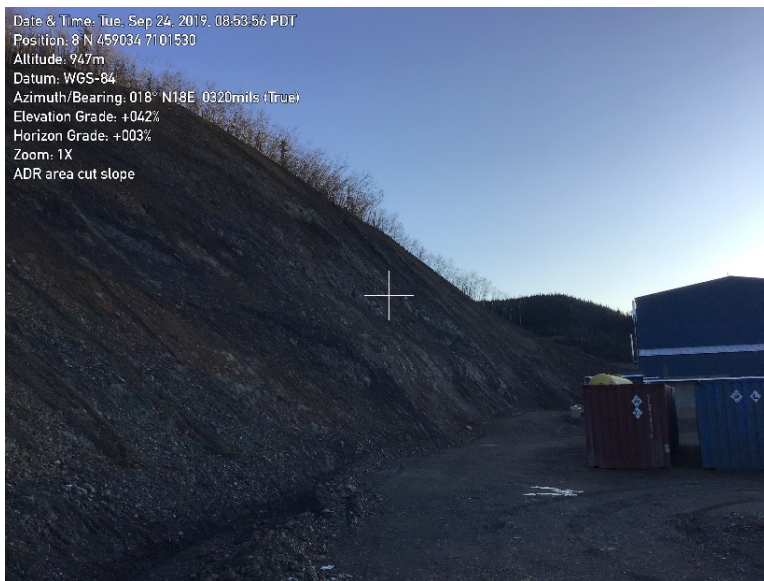
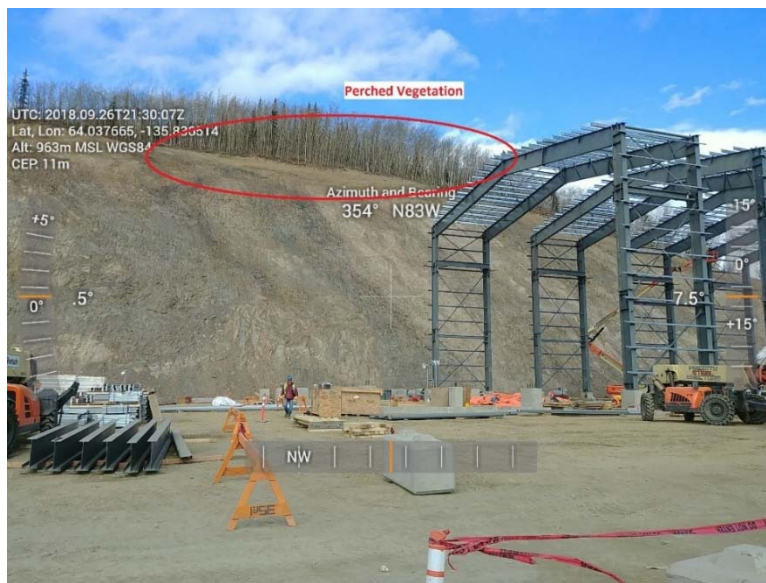
1. Cut slopes behind the ADR area appear to be competent rock, and currently stable though some unraveling and rilling were noted (Figure 38). Minor accumulation of small debris was noted at the toe of the slope, collecting in the ditch, and was observed in the 2018 and 2019 inspections (Figures 39 and 40).

Figure 38: Slopes behind ADR (2020) with unraveling and rilling

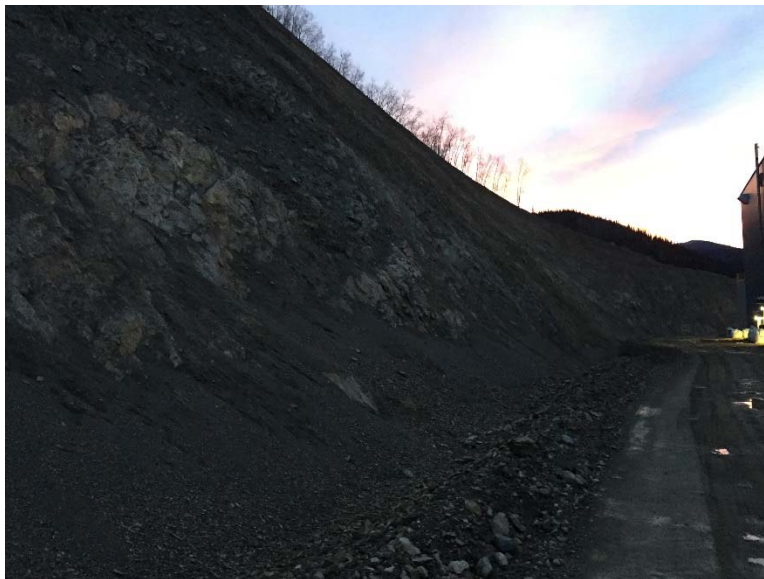
1. There is a small V ditch, referred to here as the North Toe Ditch (Figure 41), with sides close to 1:1 cut at the base of a large steep slope which is cut into bedrock; the ditch is not armored and contains loose gravel and fines, although there are no apparent scouring issues. There is also a culvert which has been installed along the ditch alignment.

Figure 41: Typical North Toe Ditch cross section

1. Review engineering requirements for the North Toe Ditch to confirm ditch size, and need for rock armoring. Toe ditch is currently tied into the roadside ditch, which should also be reviewed for engineering requirements. Recommend reviewing hydraulic design of both ditches to determine what is necessary.

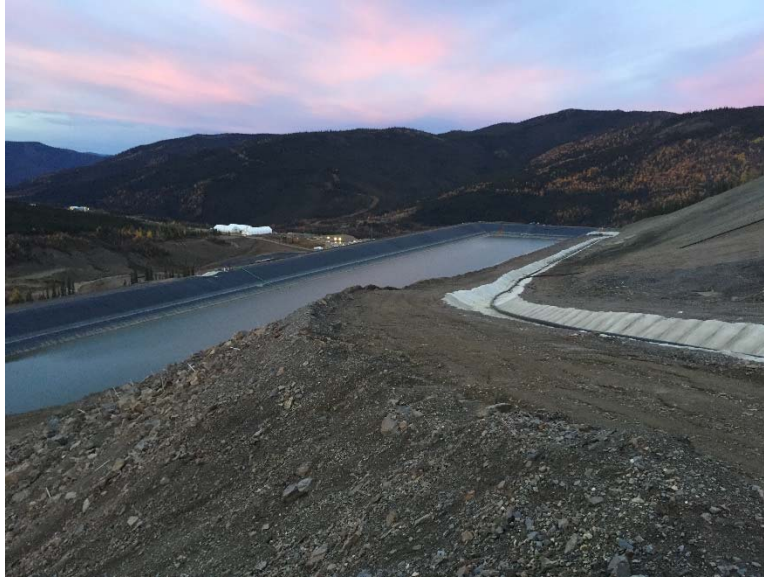
1. The events pond was constructed between the 2018 and 2019 inspections, with hillslope unraveling noted in the 2019 inspection.

Figure 42: Overall view of event pond

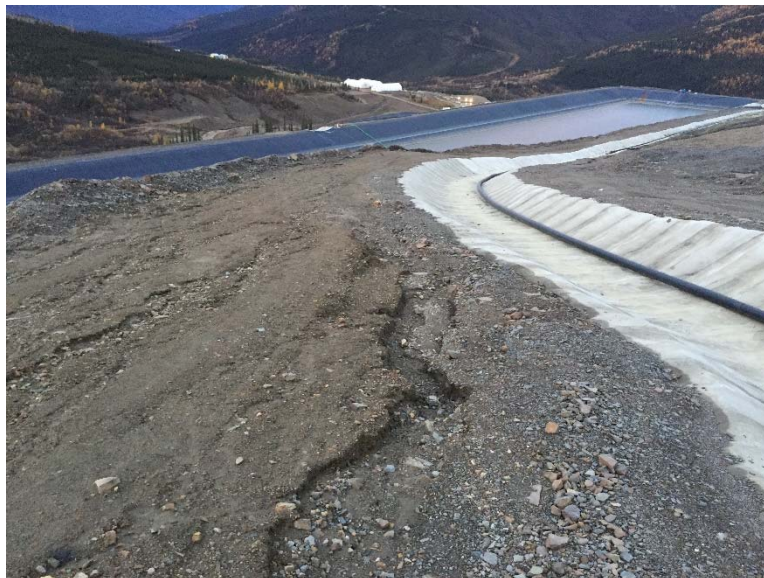
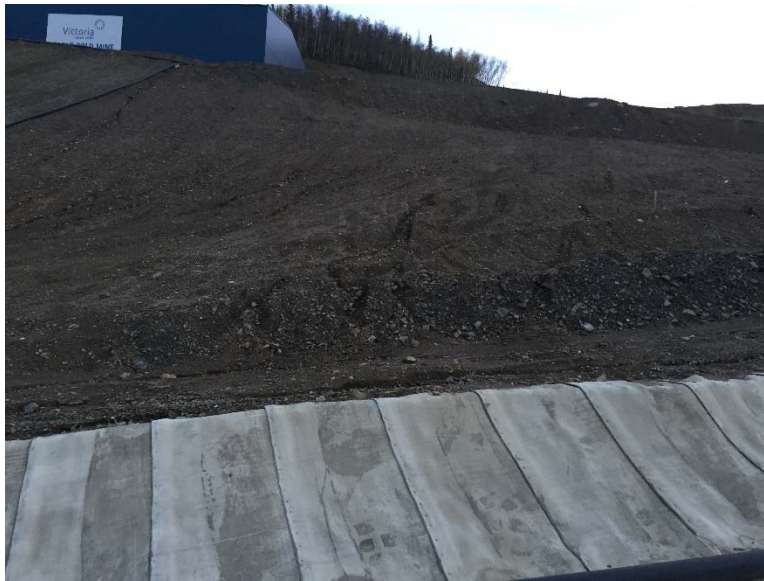
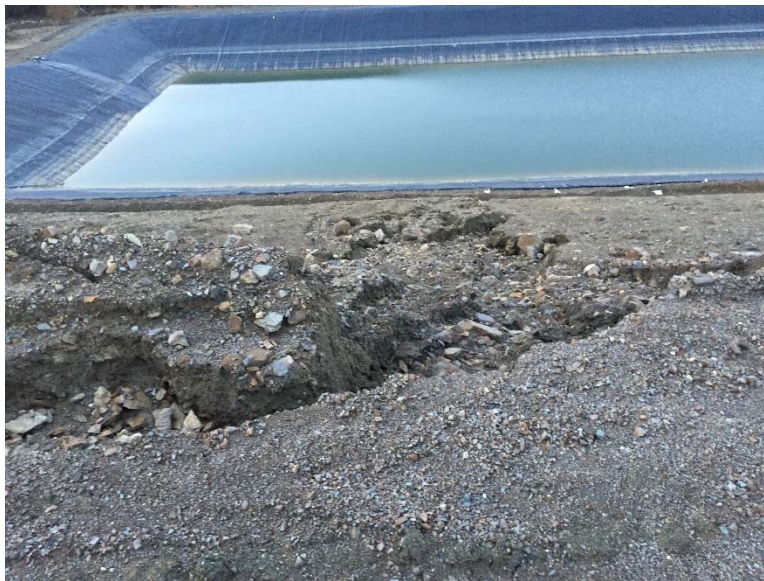
2. Rill erosion and scour channels on the cut slopes above the event pond and the heap leach spillway were noted in this inspection as shown in Figures 43 – 45.

Figure 43: Rill erosion below HLF spillway

Figure 44: Rill erosion above HLF spillway

Figure 45: Scoured channel above Event Pond
