Allnorth Information		VICTORIA GOLD CORP.	
Project #:	2002684	Client Project #:	
Document #:	201215	Client Document #:	
Document Rev. #:	1	Client Doc. Rev.#:	
Prepared By:	Spencer Bergin, EIT	Client Contact:	Richard Tuohey
Reviewed By:	Don Williams, P.Eng.

Document Description
Annual Physical Stability Assessment Report – Victoria Gold – Eagle Gold Project
<p>Project Description:</p> <p>Visual inspection of the following structures: Open Pit, Platinum Gulch Dump, Lower Dublin South (Control) Pond, Secondary Crusher, Primary Crusher, Secondary Stockpile, Adsorption, Desorption and Recovery Plant, Heap Leach Facility, Events Pond, Ditches A, B, and C, Former Nuway Crusher Pad, Orica Laydown, Various Un-named Stockpiles.</p>

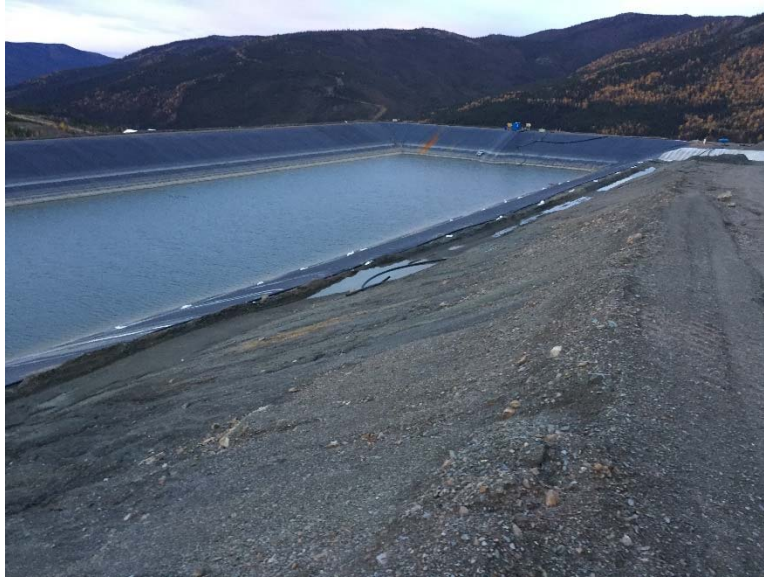
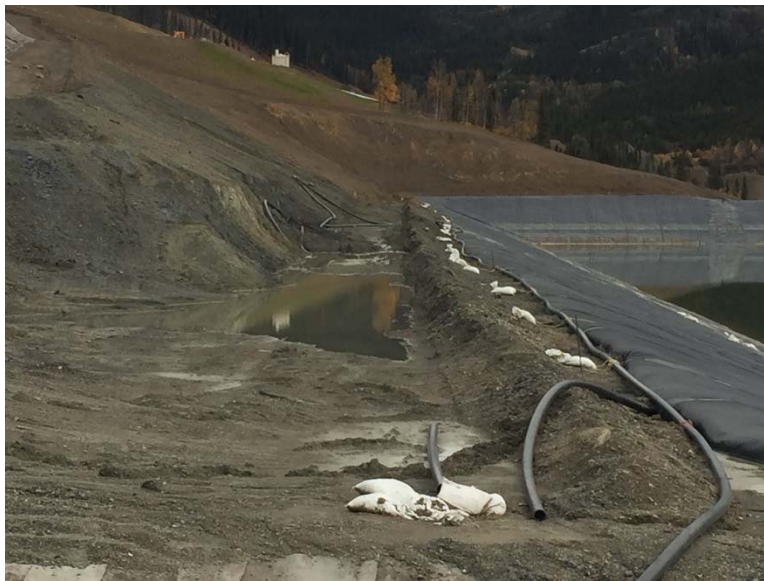
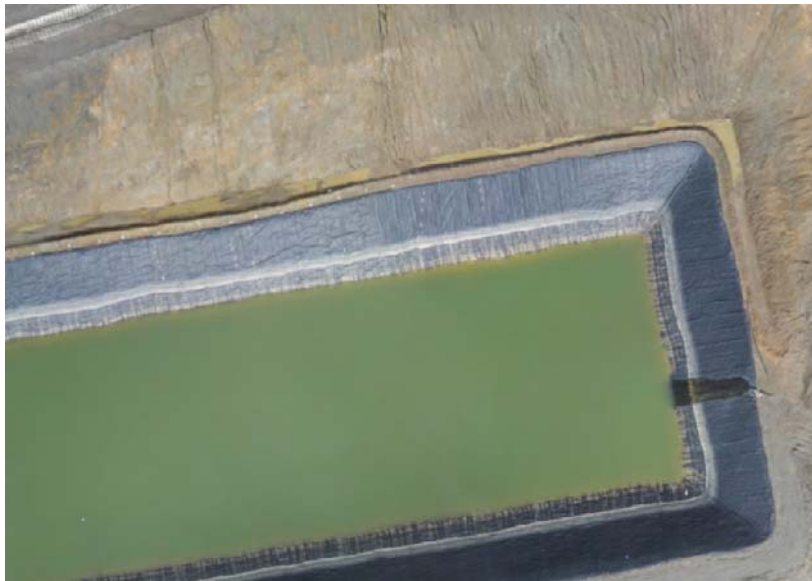
1. Pooling water was noted in various locations along the North side of the event pond as shown in Figures 46 – 48.

Figure 46: Pooling water above Event Pond

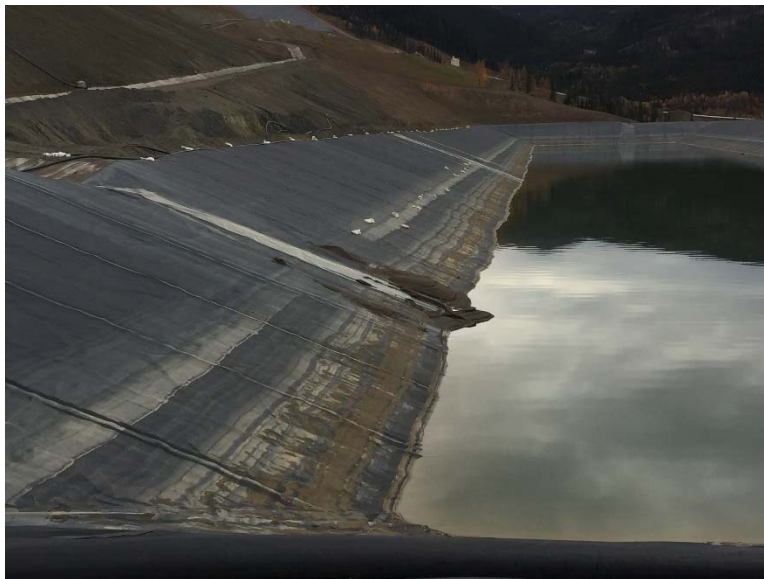
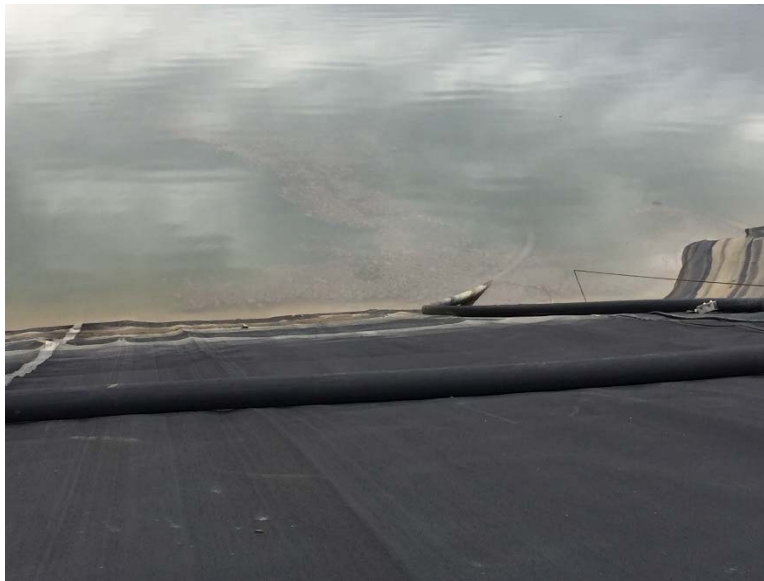
1. Silt build-up was noted at the discharge of the heap leach spillway into the event pond as shown in Figure 49. Material accumulation on the bottom of the pond was also observed from above as shown in Figure 50.

Figure 49: Silt build-up at HLF Spillway discharge

Figure 50: Material build-up on Event Pond bottom

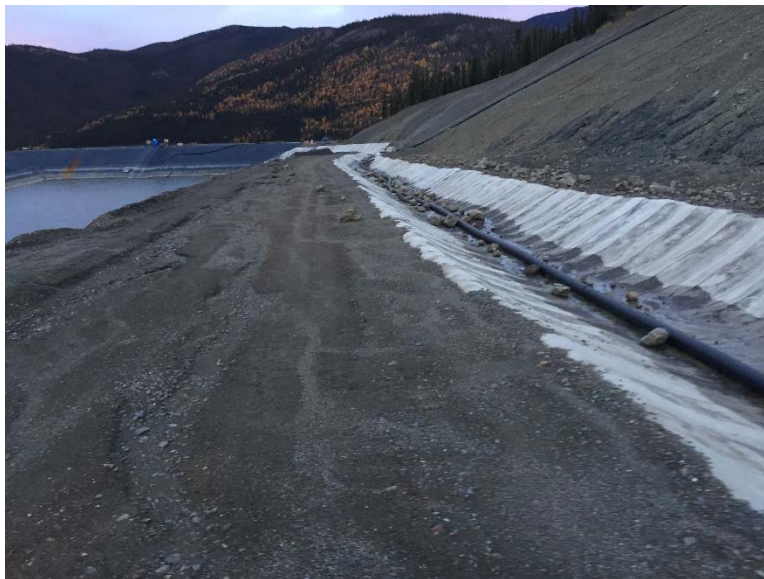
1. As noted in Section 11.1 scouring was observed upslope and downslope of the heap leach spillway. Material has begun to accumulate in the spillway as shown in Figure 51. The spillway is constructed with a concrete-filled fabric liner and appears stable.

Figure 51: Slopes from heap leach spillway

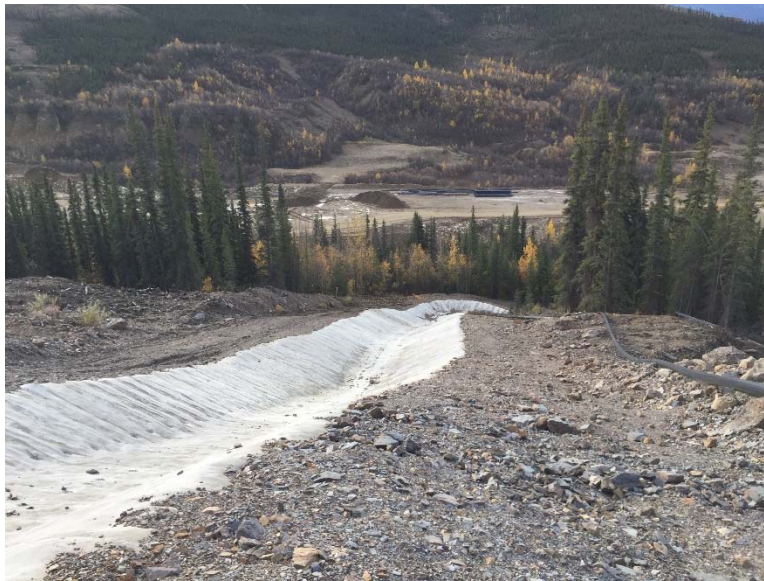
1. The emergency spillway is in place, constructed of similar material as the HLF spillway, and appears stable (Figure 52). The spillway is directed downslope towards Dublin Gulch. No concerns at this time.

Figure 52: Events Pond Emergency spillway

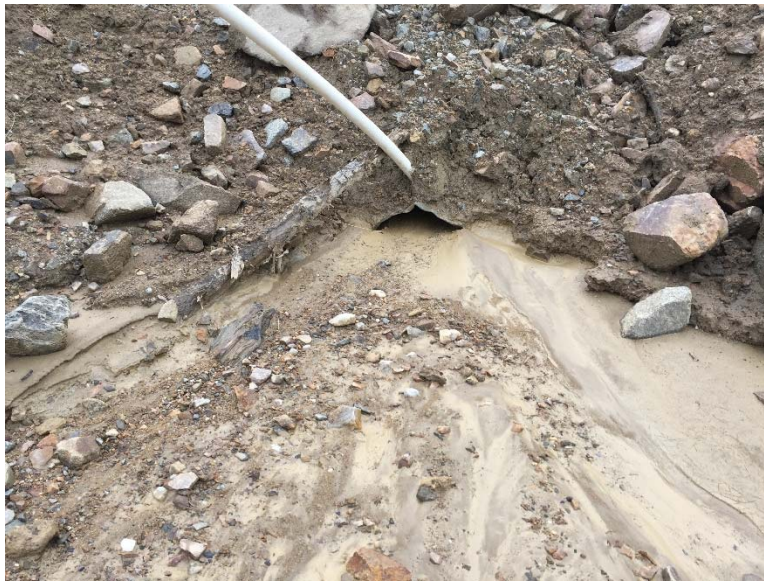
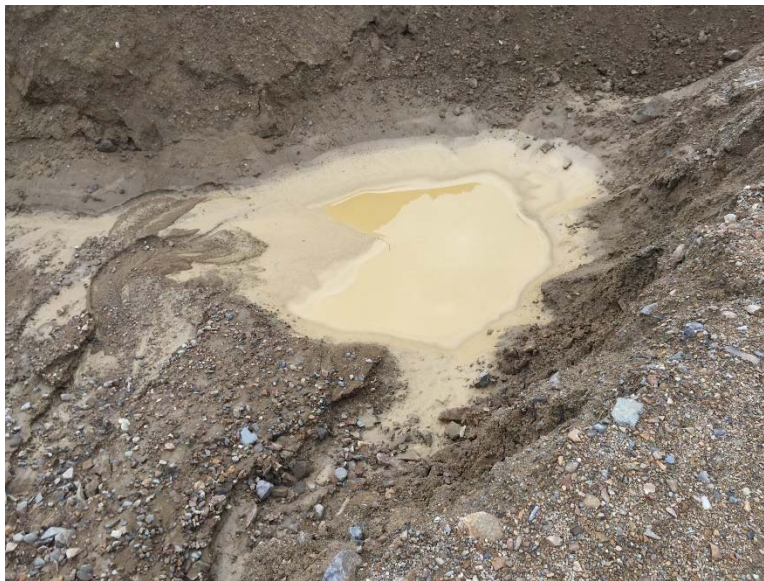
2. A culvert for a tie-in ditch from the Secondary Stockpile perimeter ditch was observed to be blocked with sediment/material just before the connection to Ditch A. The culvert outlet and inlet (buried) can be seen in Figures 56 and 57 respectively.

Figure 56: Secondary Stockpile drainage ditch culvert blocked (outlet)

Figure 57: Secondary Stockpile drainage ditch culvert blocked (inlet)

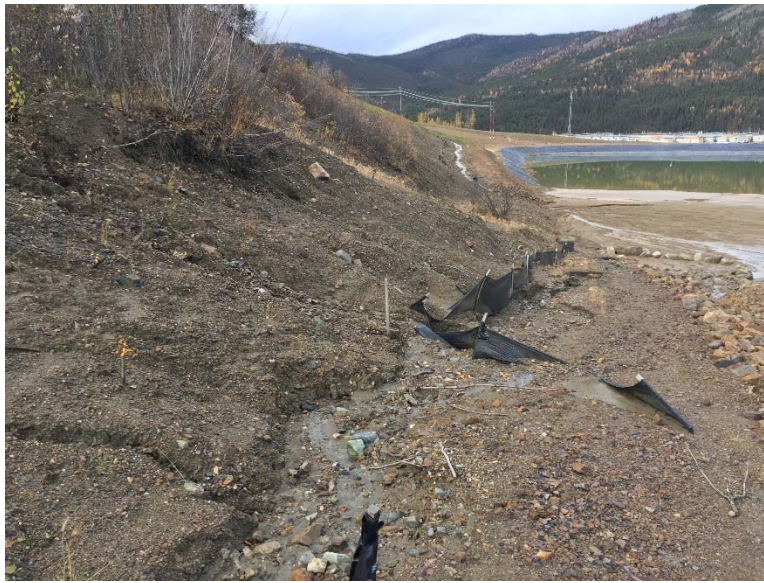
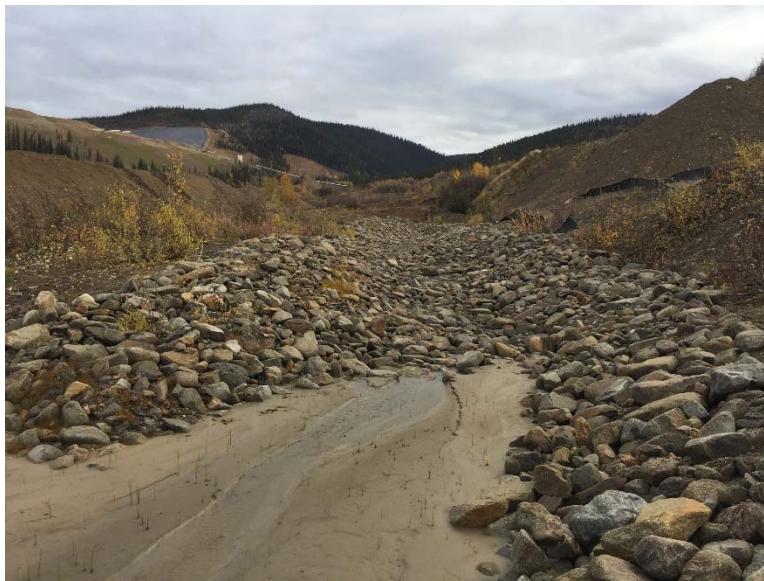
1. Ditch B begins at a small watercourse known as Suttles Gulch. The ditch flows West towards the Control Pond. The ditch is armored with approximately class 25kg rock. Some slope instability was noted near the control pond, with erosion carrying sediment down the cut slope (Figure 58). Site representatives are already aware of this issue, and sediment is being actively managed using silt fencing (Figure 59).

Figure 58: Erosion on South cut slope above Ditch B

Figure 59: Silt fencing constructed in areas of erosion on cut slopes

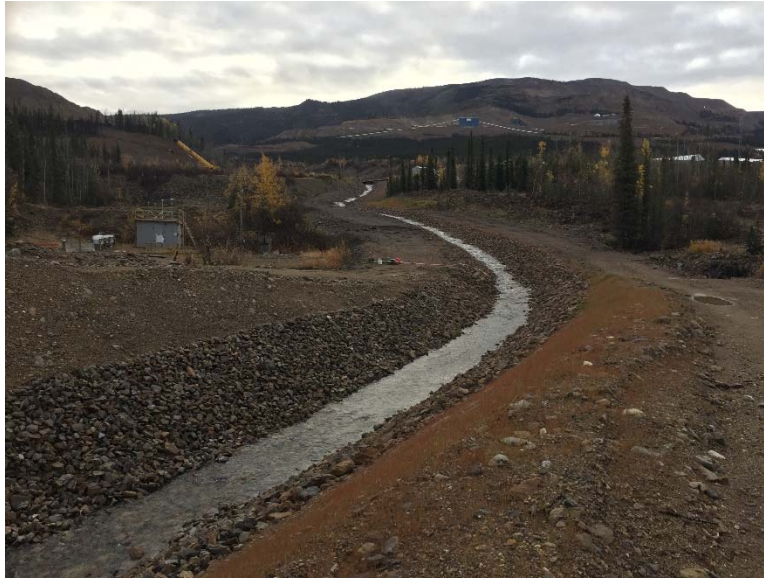
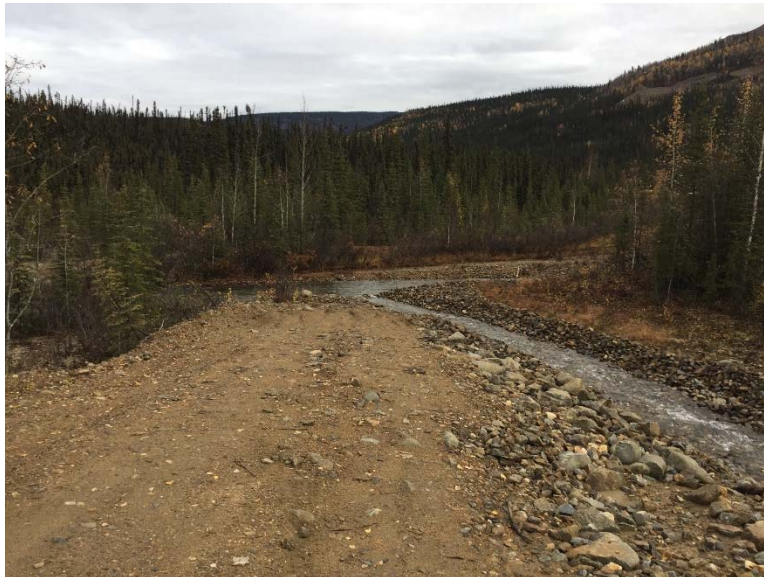
1. Diversion Ditch C (Figure 60) begins at the 1500mm outlet culvert for the Control Pond and terminates in Haggart Creek (Figure 61). This ditch acts as both an emergency spillway if the Control Pond is filled over capacity or a conveyance channel for water released from the control pond through the low level outlet. The ditch is armored with approximately class 10kg rock, and liner is visible in several locations. The ditch crosses several roads via culverts.

Figure 60: Ditch C typical section

Figure 61: Ditch C Outfall to Haggart Creek

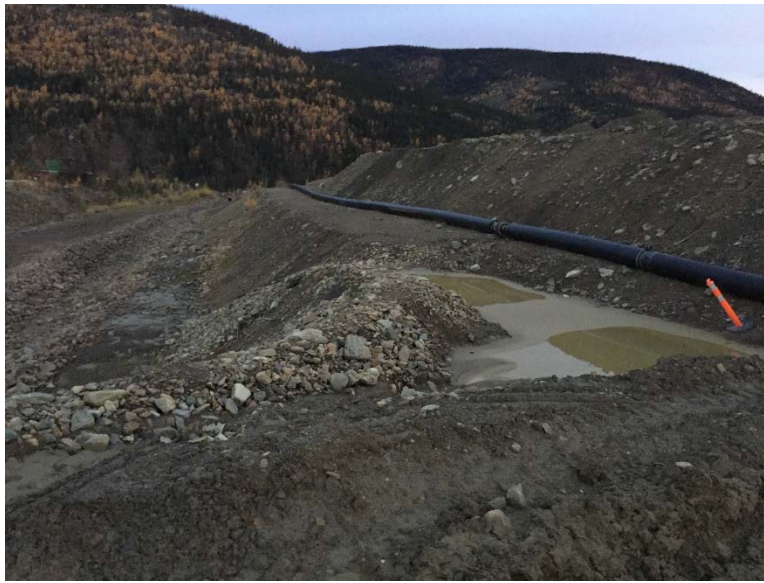
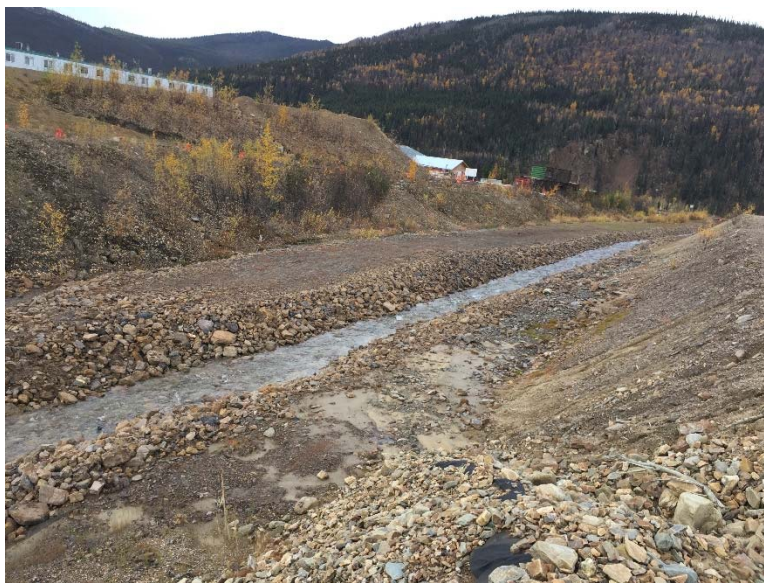
2. Pooling water and sedimentation was observed on the North side of Ditch C immediately West of the culvert from the LDSP spillway to Ditch C (Figure 62). There appeared to be a lined ditch that provided a path for the pooled water to flow down to Ditch C though the discharge of this ditch was not controlled (Figure 63)

Figure 62: Pooled water above Ditch C

Figure 63: Pooled water ditch discharge into Ditch C

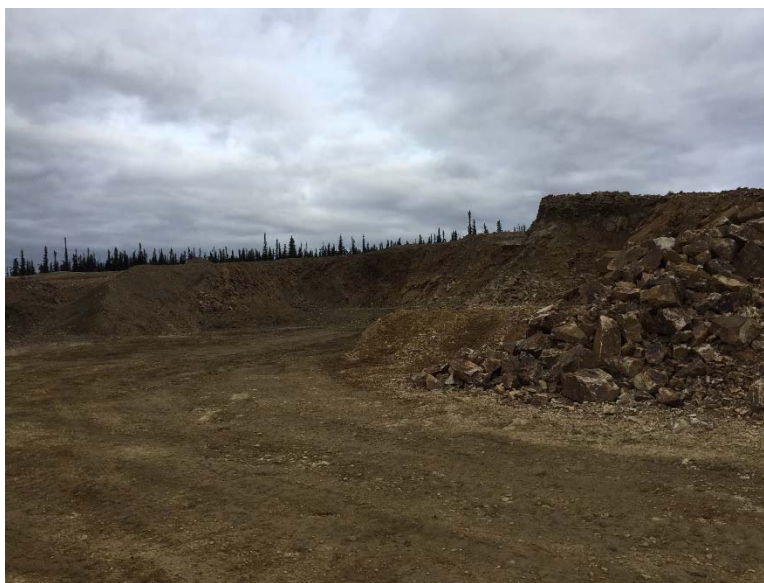
1. This area is not currently being used, but a VGC representative indicated that it is within the Phase 3 footprint of the HLF and will eventually be regraded in preparation for ongoing HLF development. Observed some over steepened slopes (Figure 64), with material collecting at the toe of these slopes.

Figure 64: Over steepened slopes

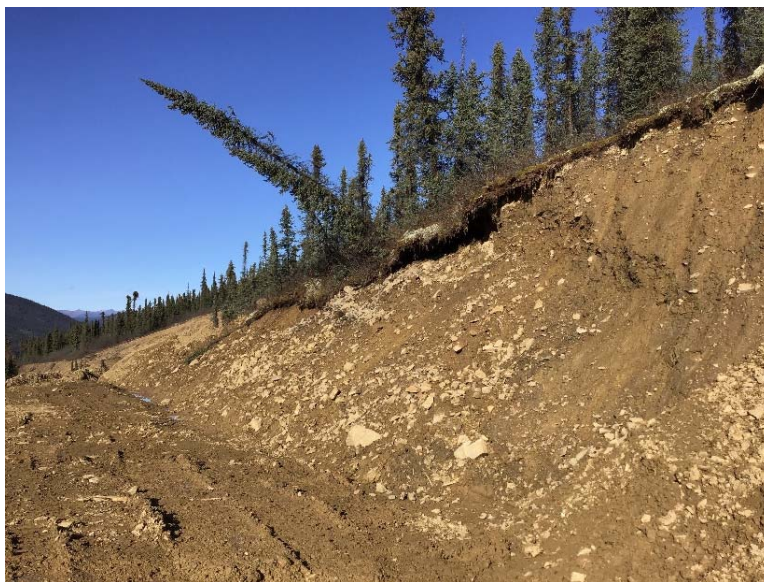
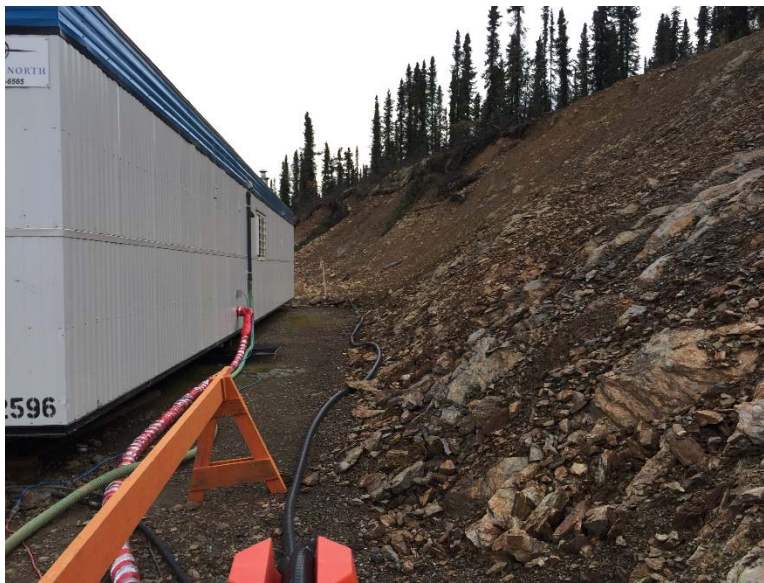
1. One section of cut slope was noted as being over-steepened in the 2019 inspection (Figure 65). This appears to have been since rectified as slopes appeared acceptable during this years inspection (Figure 66).

Figure 65: Section of over-steepened slope (2019)

Figure 66: Section of corrected slope (2020)

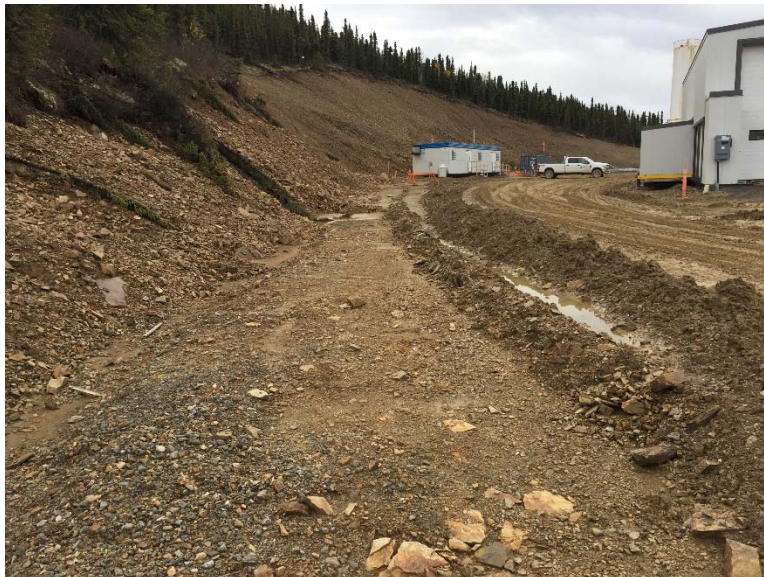
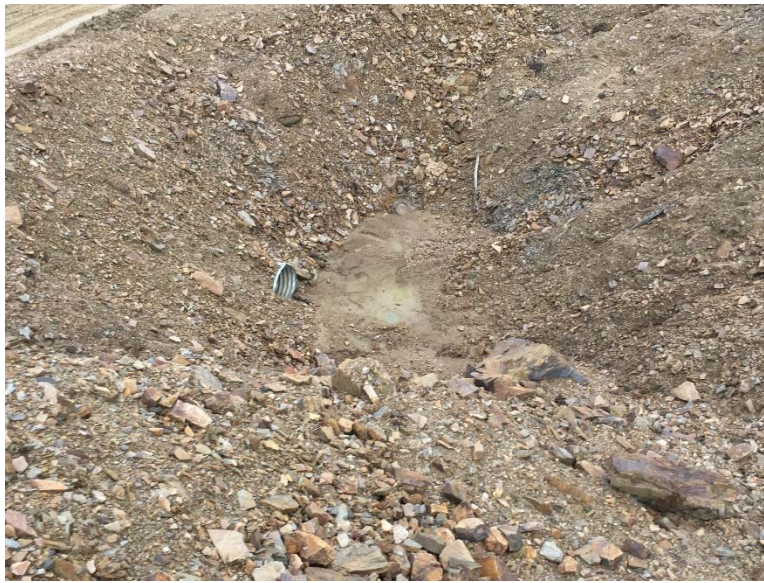
2. An unlined, unarmored ditch from the portable structures (Figure 67) appears to have been constructed since the previous inspection. The ditch appears interrupted in places but flow generally leads to the Orica sump (Figure 68) before discharging to the woods.

Figure 67: Orica perimeter ditch

Figure 68: Orica sump

1. Monitor perimeter sump for flow interruptions/blockages and consider re-trenching if pooled water observed.

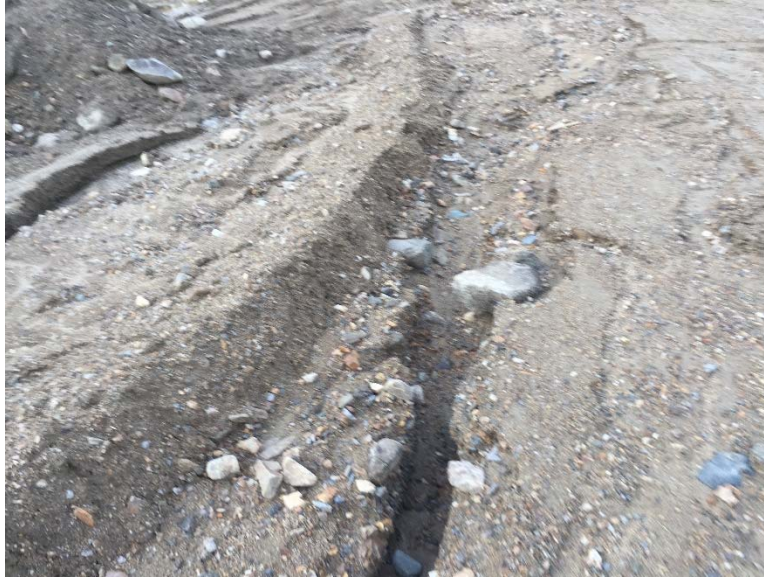
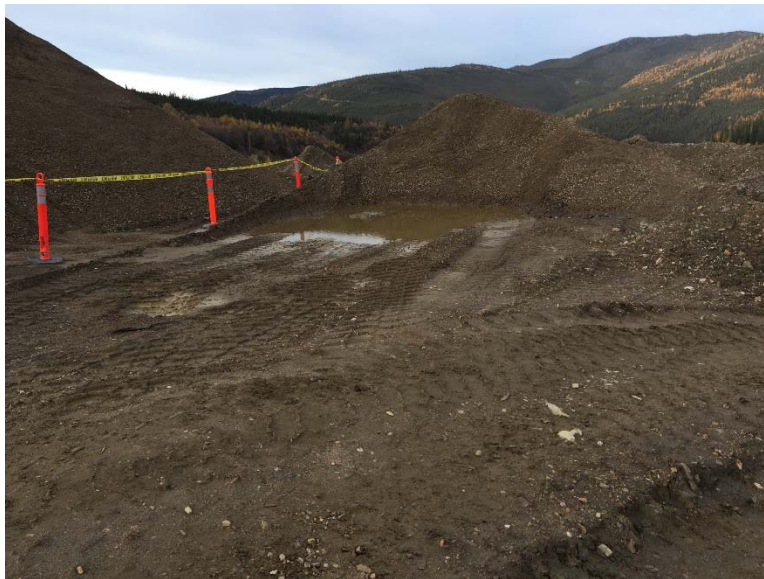
1. There are some minor water management issues in the area, with rainfall run-off flowing down and around the stockpiles as apparent from the small gully that formed at the base (Figure 70). Some ponding water is present in the laydown areas (Figure 71).

Figure 70: Small gully forming adjacent to stockpiles

Figure 71: Poned area adjacent to stockpiles
