Allnorth Information		VICTORIA GOLD CORP.	
Project #:	2102059	Client Project #:	
Document #:	211208	Client Document #:	
Document Rev. #:	0	Client Doc. Rev.#:	
Prepared By:	Spencer Bergin, EIT	Client Contact:	Richard Tuohey
Reviewed By:	Don Williams, P.Eng.

Annual Physical Stability Assessment Report – Victoria Gold – Eagle Gold Project

Visual inspection of the following structures: Open Pit, Platinum Gulch Dump, Eagle Pup Dump, Lower Dublin South (Control) Pond, Primary Crusher, Secondary & Tertiary Crushers, Secondary Stockpile, Adsorption, Desorption and Recovery (ADR) Plant, Heap Leach Facility, Heap Leach Overburden Stockpile, Event Pond, Ditches A, B, and C, Truck Shop, Orica Laydown, Various Un-named Stockpiles.

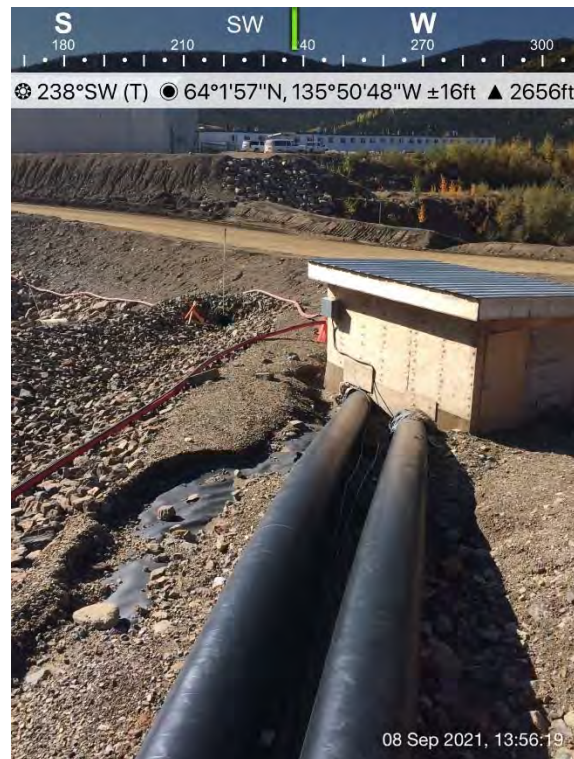
Some minor erosion was noticed above the shed which houses the junction of pipes and is adjacent to the rip-rapped groundwater diversion ditch (Figure 1), no other items noted. There is an outlet sump and weir which were constructed between the 2018 and 2019 inspections; no issues noted (Figure 2).

**Figure 1: LDSP – Erosion adjacent to Shed and Diversion Ditch**

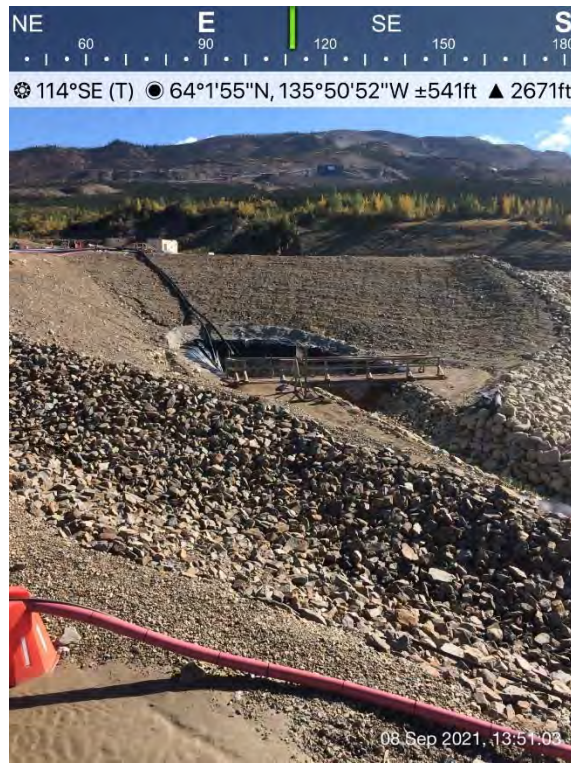
**Figure 2: LDSP – Outlet Sump and Weir**

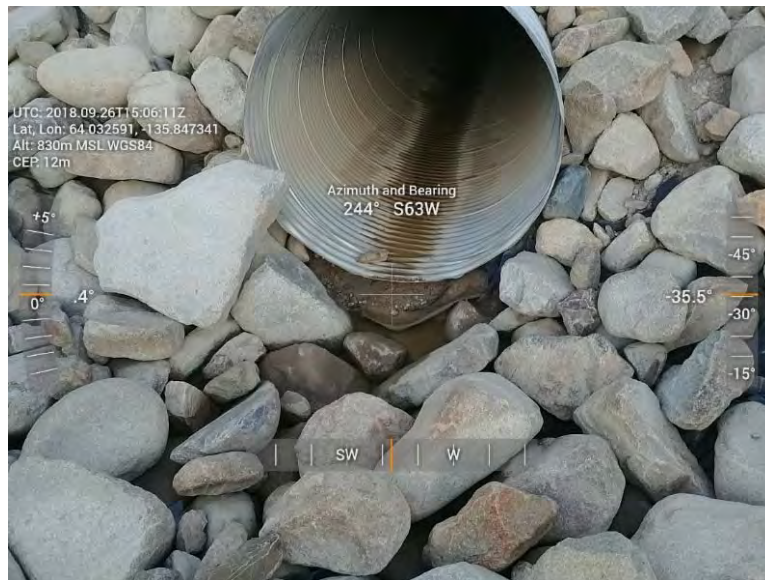
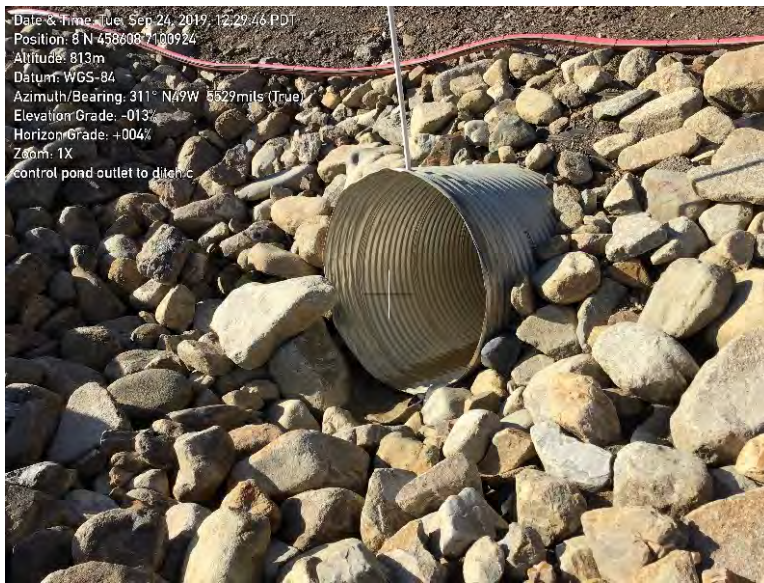
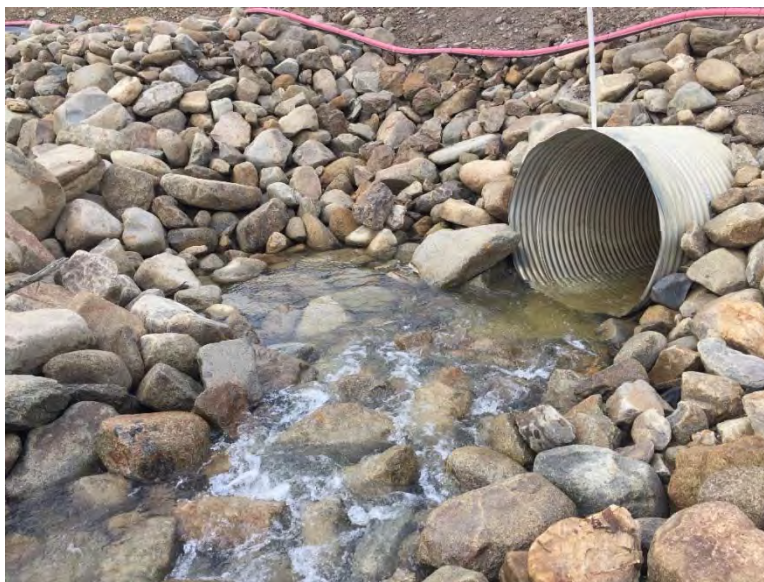
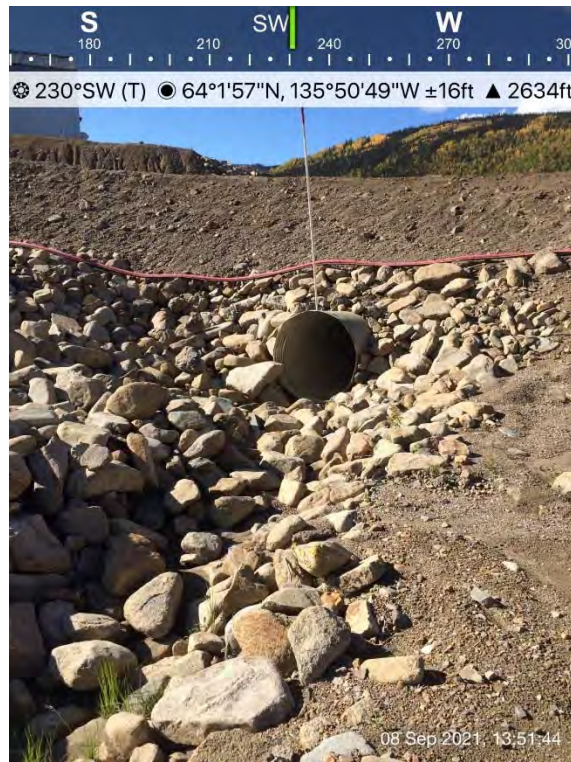
1. The condition of this culvert appears to be the same compared to the previous years inspections (Figure 3, Figure 4, Figure 5). No water was observed flowing through the culvert in the 2018 and 2019 and 2021 inspections (Figure 6). No concerns noted.

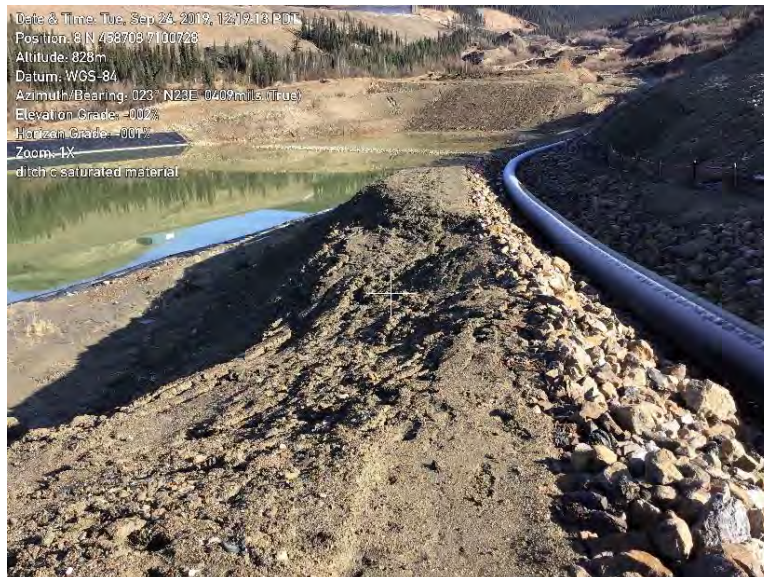
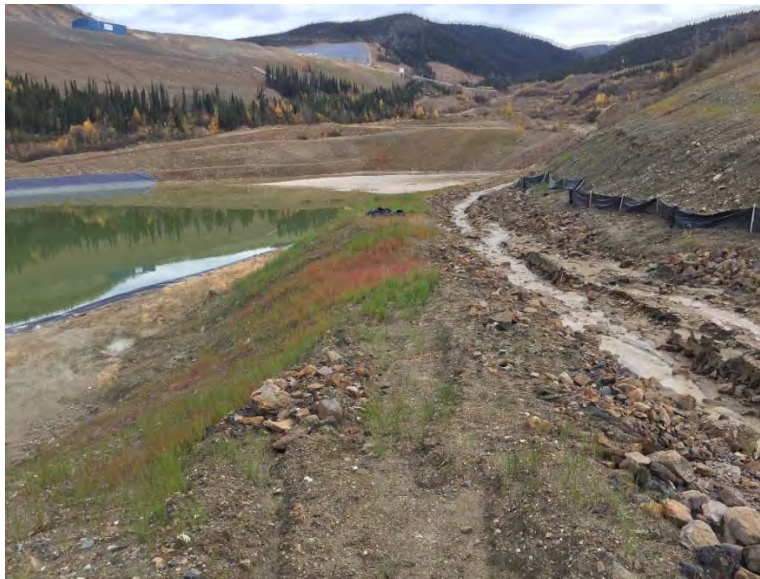
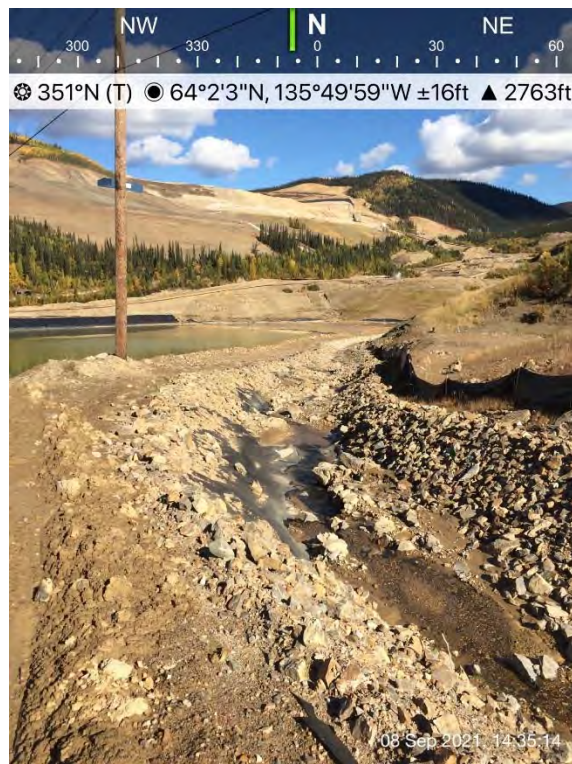
1. Some saturated material and erosion was noted on the slope of the southwest corner of the Control Pond over the width of the narrow access road in 2019 and 2020 (Figure 7, Figure 8) but this erosion was rectified with the completion of Ditch A between the 2020 and 2021 inspections (Figure 9).

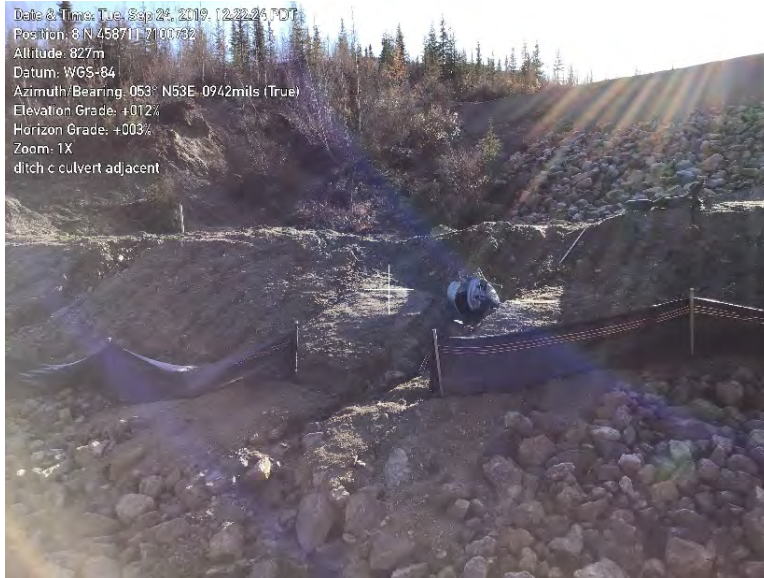
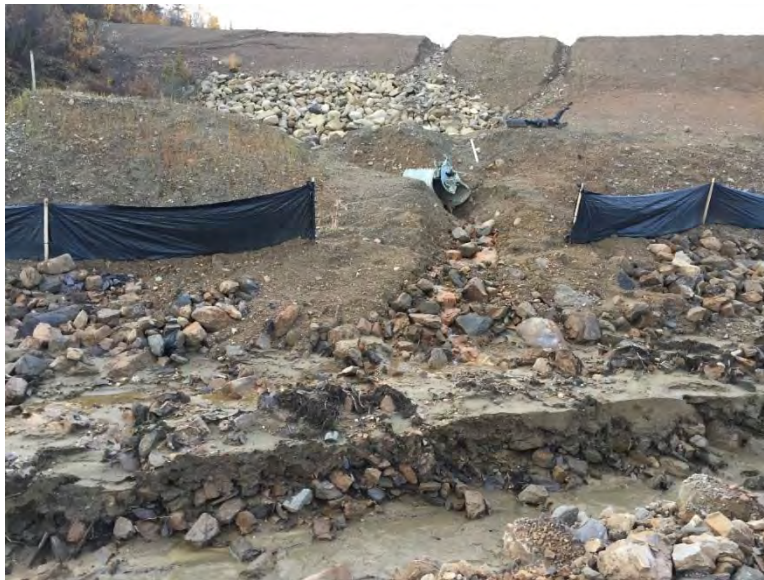
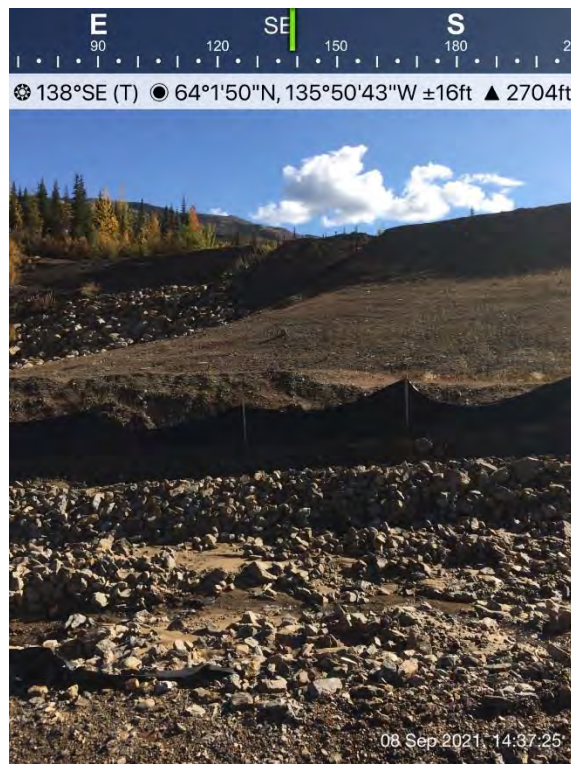
2. There was some flow into Ditch A on the Southwest corner of the LDSP from a culvert crossing a former construction access road, which was observed in 2019 and 2020 (Figure 10, Figure 11) and still present as of this inspection (Figure 12).

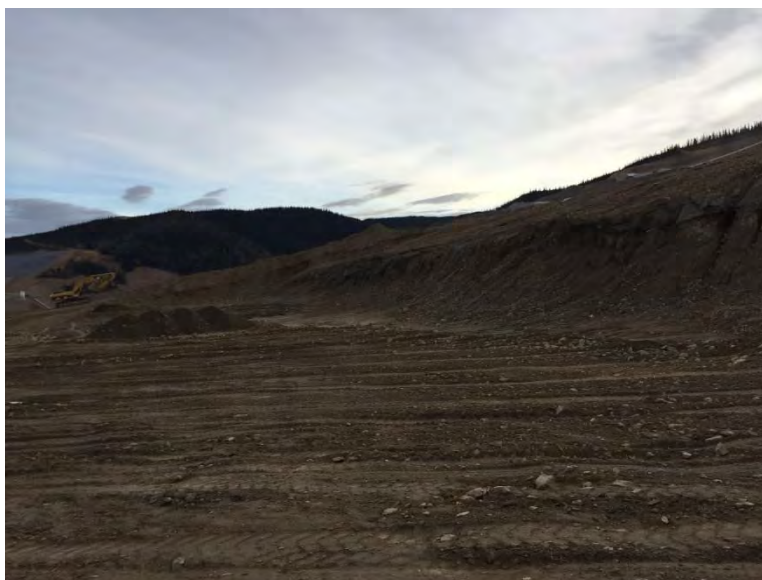
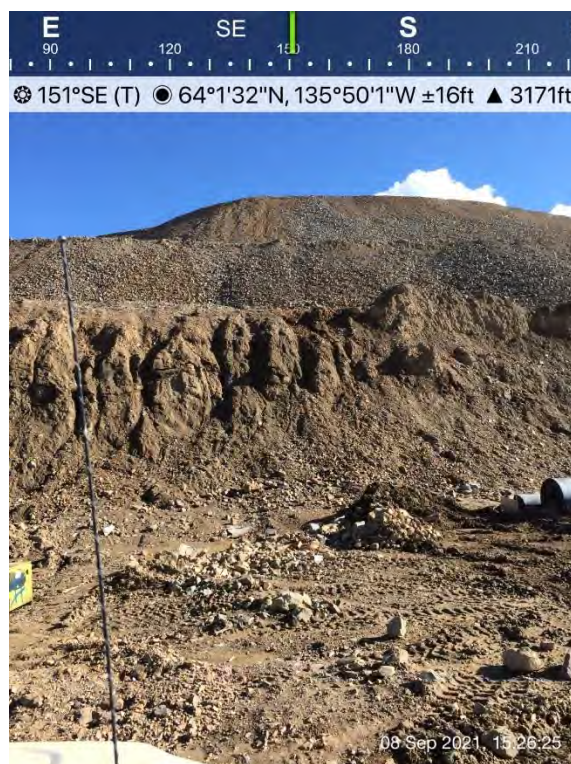
1. The Secondary Stockpile (also known as the 90 Day Stockpile) was completed in 2020 (Figure 13). Some over-steepened cut slopes were observed on this inspection where the slopes had begun to collapse/erode and material was collecting at the base of the slope (Figure 14).

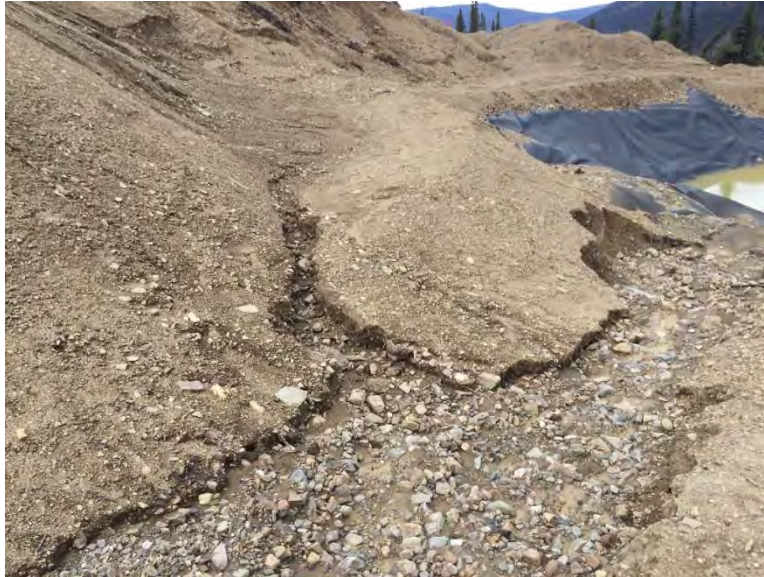
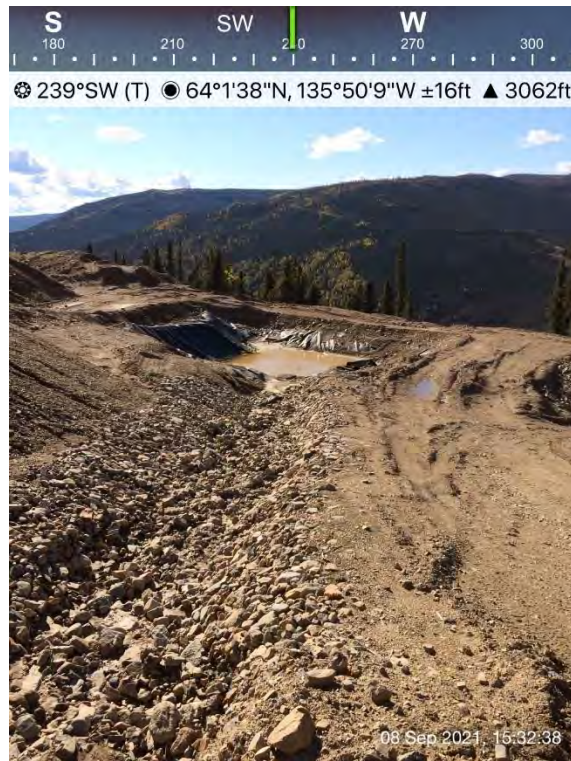
1. A perimeter interception ditch extends around the downhill toe of the Secondary Stockpile area. The construction of this ditch was not complete in 2020 but has since had rock armoring installed (Figure 15, Figure 16). Issues noted in the 2020 inspection including over-steepened and sloughing slopes on the interception ditch appear to have since been addressed.

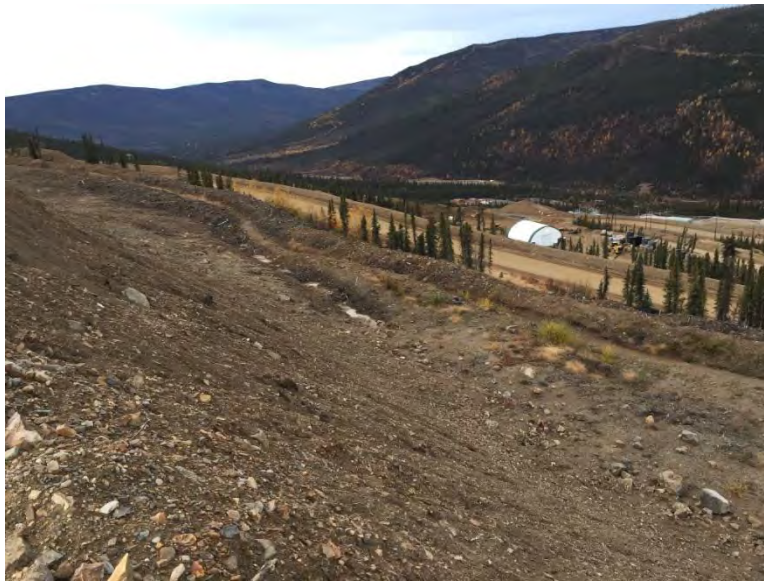
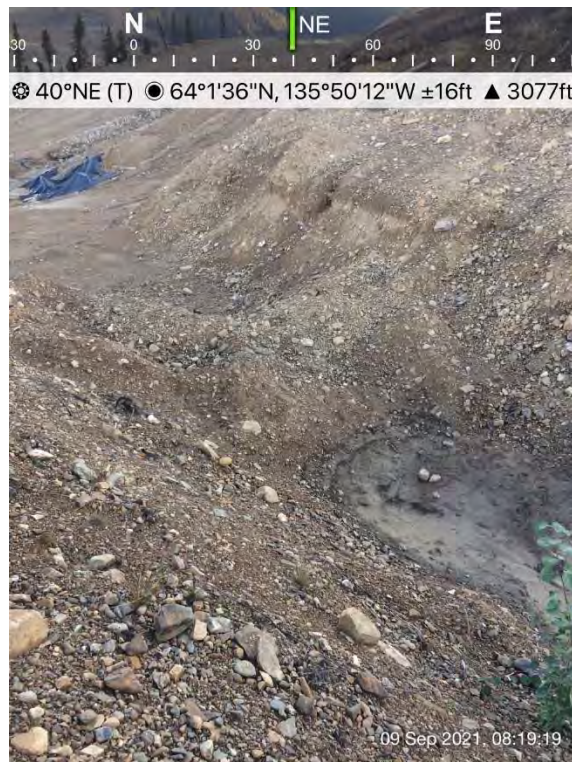
2. The outlet of one side of the perimeter ditch does not currently tie into the collection sump, this was observed in 2020 as well. (Figure 17, Figure 18).

1. Monitor perimeter sump for flow interruptions/blockages and consider re-trenching if pooled water observed.

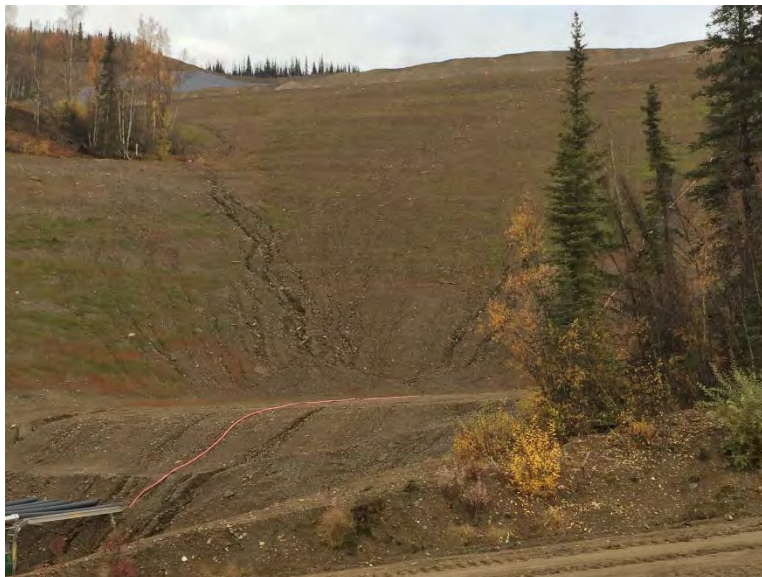
1. Some scouring and rilling was noted along the toe slope below the HLF and above the unnamed stockpile area and HLF Underdrain Monitoring Vault in the 2020 inspection (Figure 22). The slope has since been seeded and there appears to be less scouring of material off the toe slope (Figure 23).

**Figure 22: Scouring and rilling along toe slope of HLF (2020)**

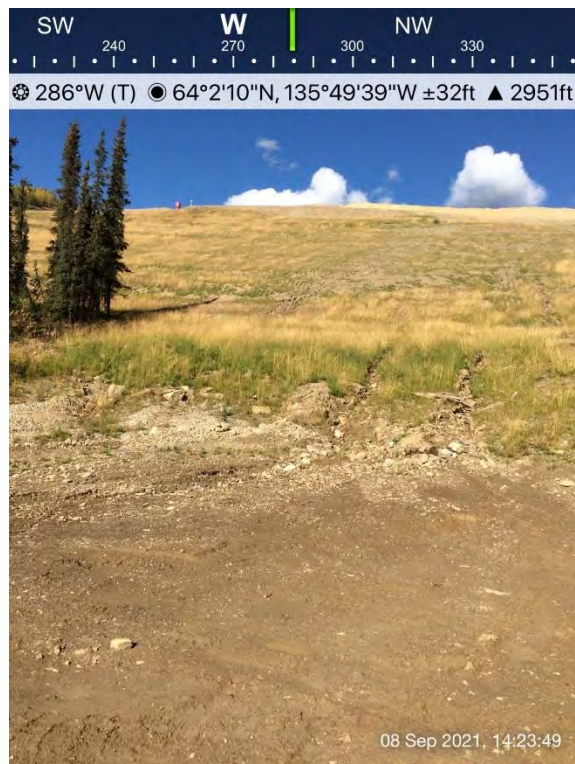
**Figure 23: Seeded grass on toe slope of HLF (2021)**

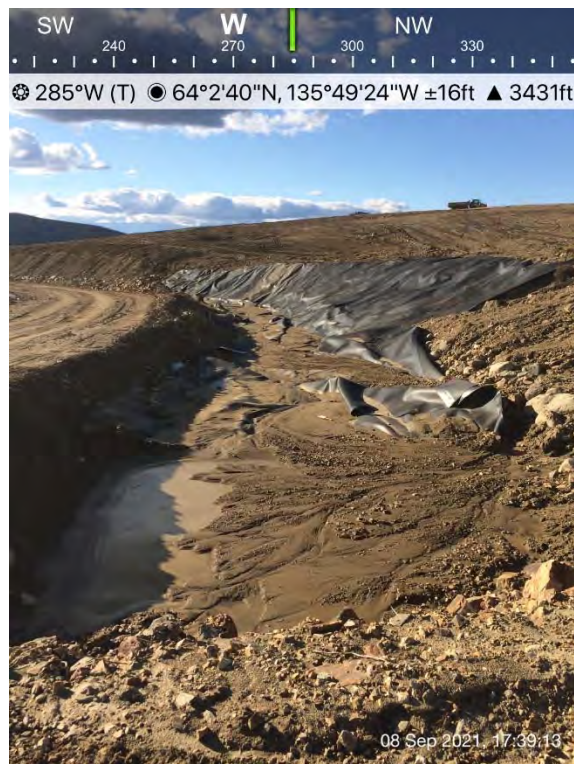
1. The phase 1B interception ditch was constructed before the 2020 inspection. The interceptor ditch has collected silt/material in some sections, indicating scour and/or erosion on the uphill cut slope and/or sloughing from the access road (Figure 24). The same section with material collection appears unfinished, with geotextile installed but no rock armoring present.

**Figure 24: Material deposited in HLF Phase 1B Interceptor Ditch**

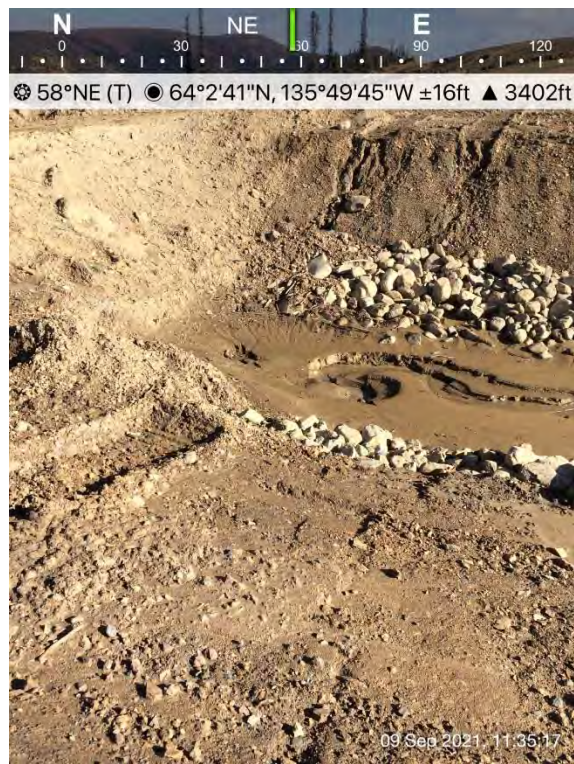
2. In addition to the material build-up shown in Figure 24 the West end of the interception ditch has material build-up at the drain pipe away from the HLF; the drain pipe was buried under silt and was not visible (Figure 25).

**Figure 25: Phase 1B Interception Ditch buried drain pipe**

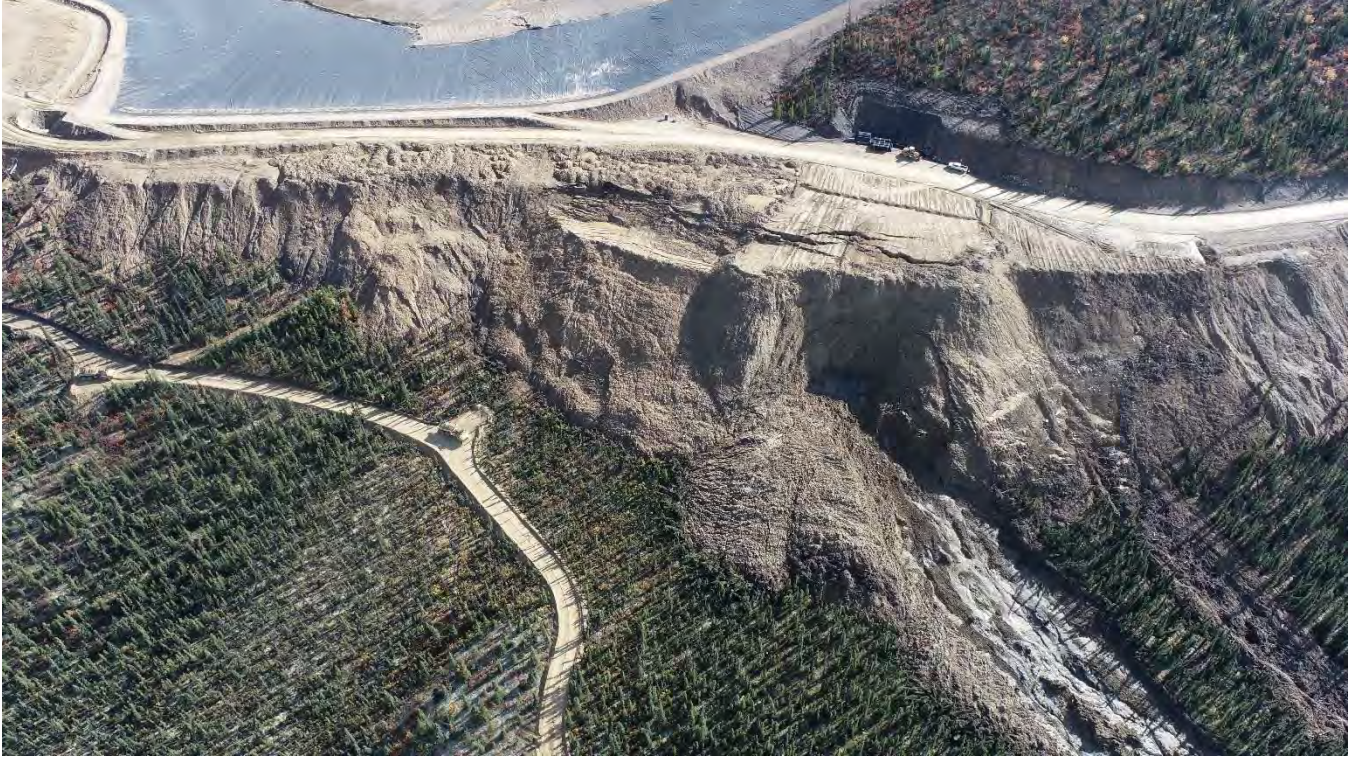
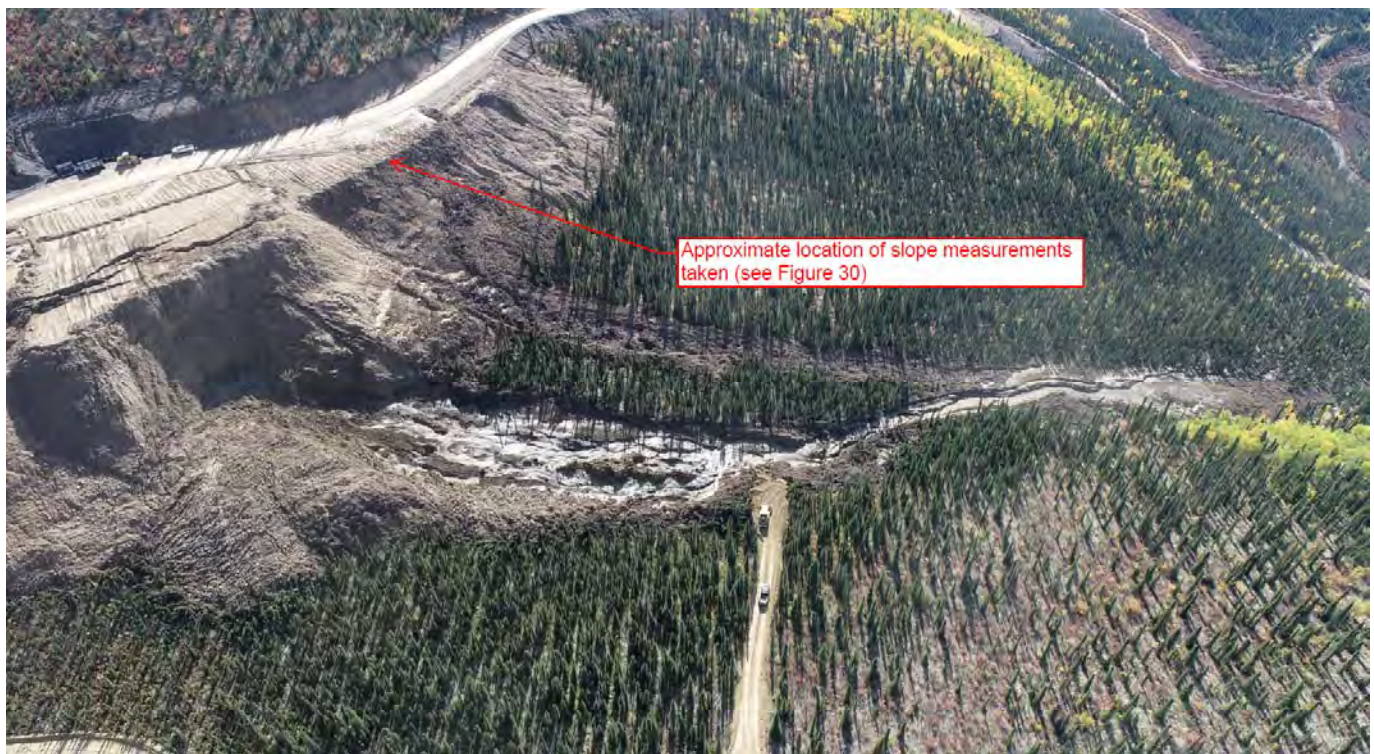
1. Overburden from clearing and grading of the HLF expansions has been placed along the North-West back slope of the HLF. Site representatives stated that the HLF overburden pile had shifted and partially collapsed some time in the late summer, roughly 4 – 5 weeks prior to the 2021 inspection (Figure 28, Figure 29).

**Figure 28: HLF Overburden Stockpile collapse – plan view**

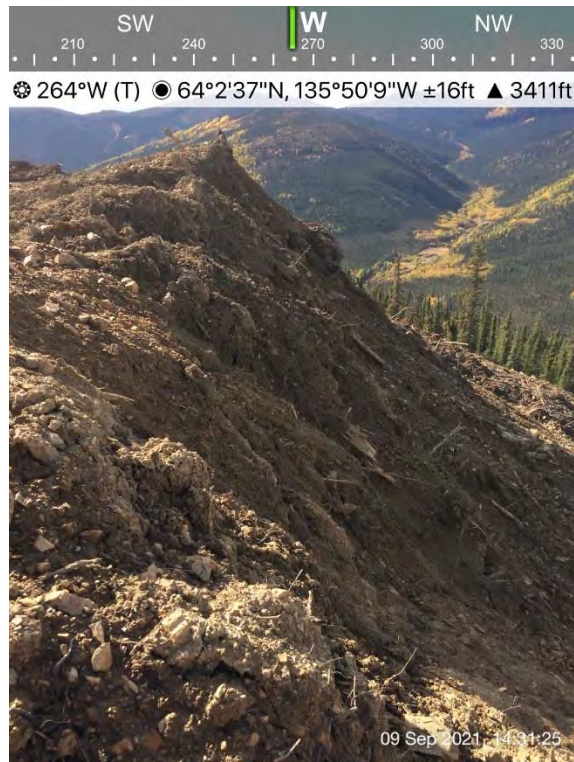
2. The slope of an uncollapsed section of the overburden pile was roughly measured with a meter stick and a smart phone protractor application to be between 40 and 50 degrees from horizontal at the location shown in Figure 30.

**Figure 30: HLF Overburden Stockpile slope**

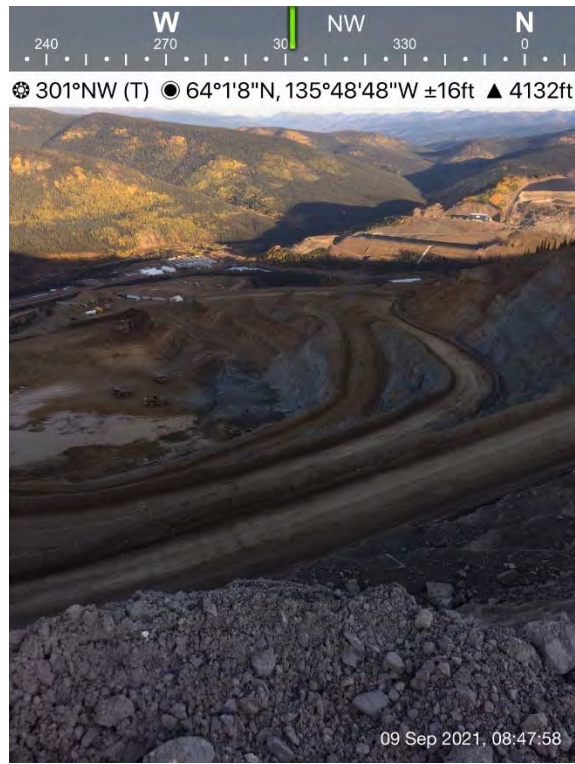
1. The pit walls appear stable, and constructed in competent rock (Figure 31).

**Figure 31: Phase 1 Pit Walls**

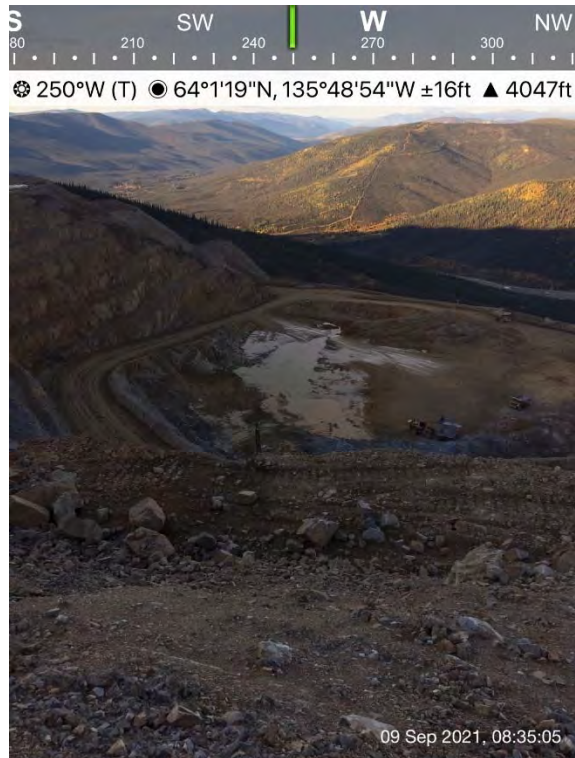
2. There is a section at the base of the pit where water collects and is unable to drain, resulting in pooled water (Figure 32).

**Figure 32: Phase 1 Pit pooled water**

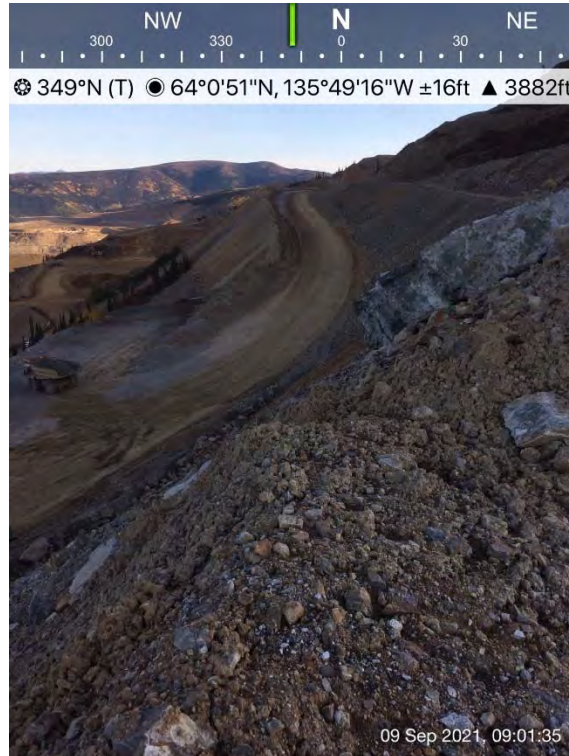
1. Platinum Gulch Dump is currently operational, and the side slopes appear to be stable. See Figure 33 below.

**Figure 33: Platinum Gulch Dump Fill Slope**

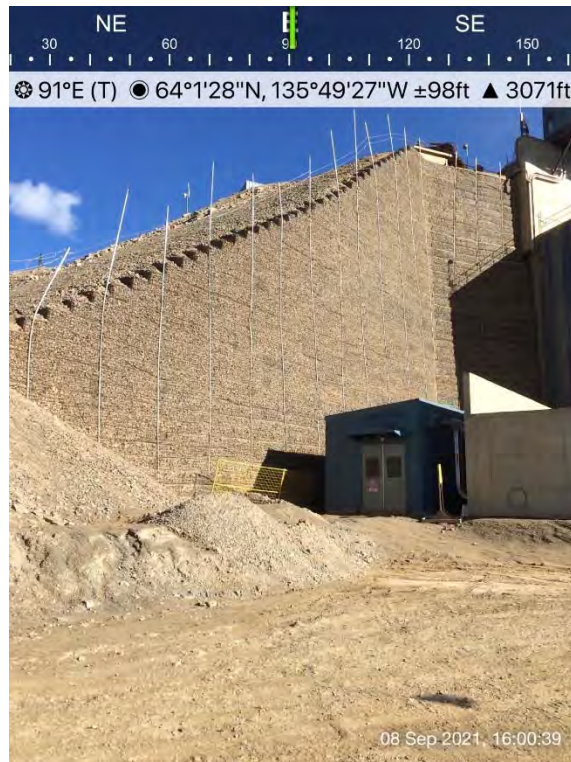
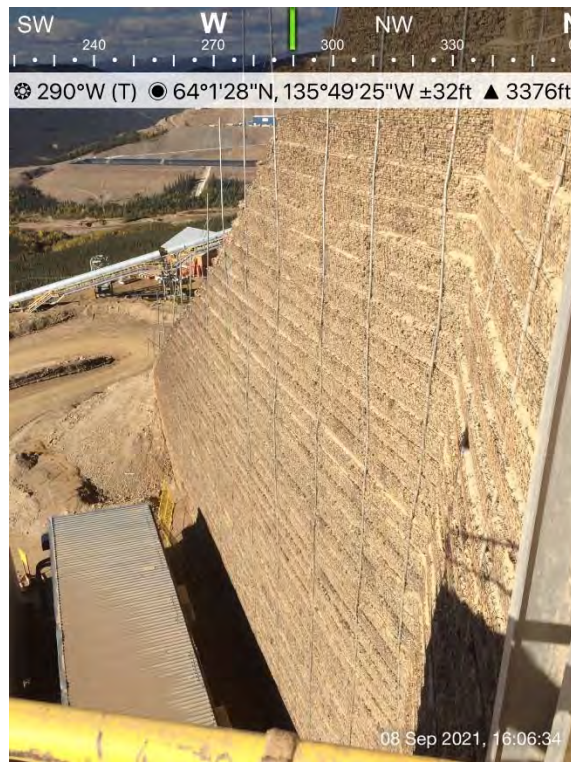
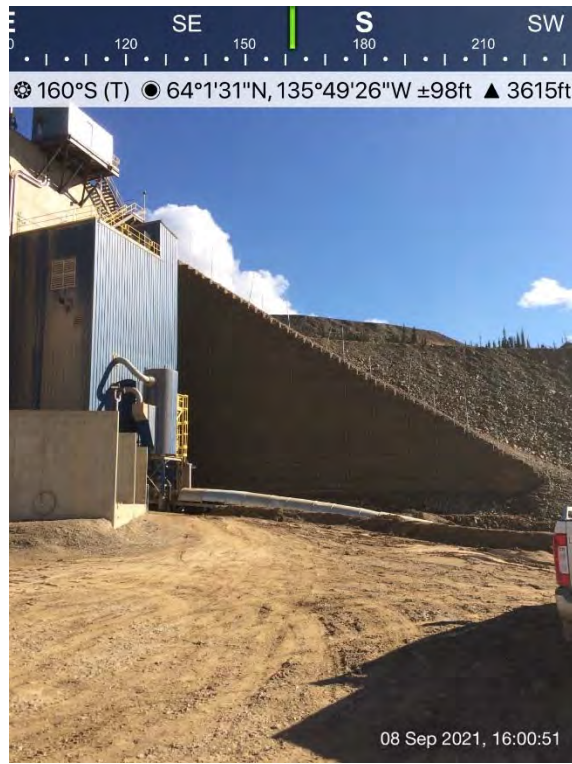
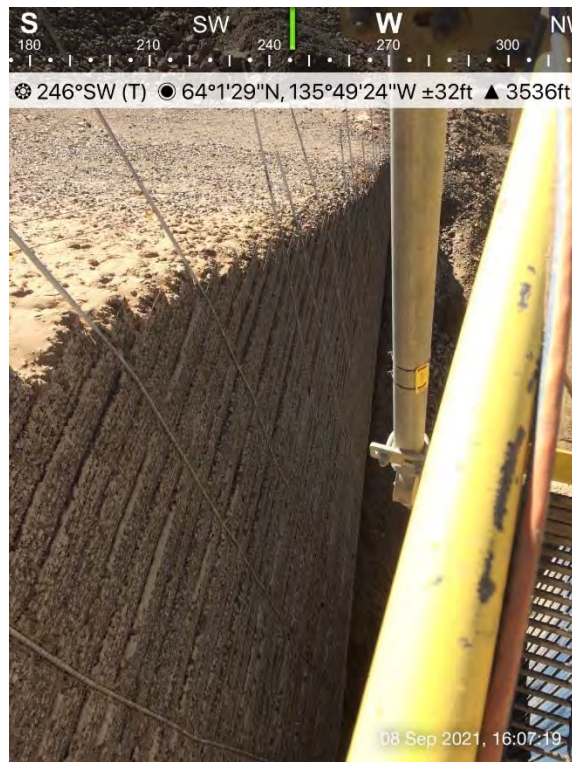
1. No apparent damage or deterioration was noted during the inspection of the Primary Crusher MSE wall (Figure 35 - Figure 38). No changes were visually identified from the 2020 inspection.

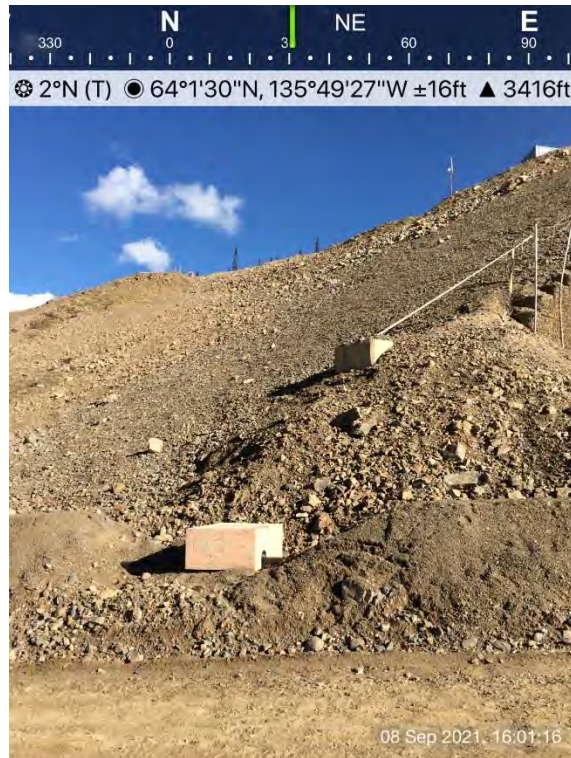
1. Cut and fill slopes appear to be acceptable, no stability or erosion issues noted. (Figure 39).

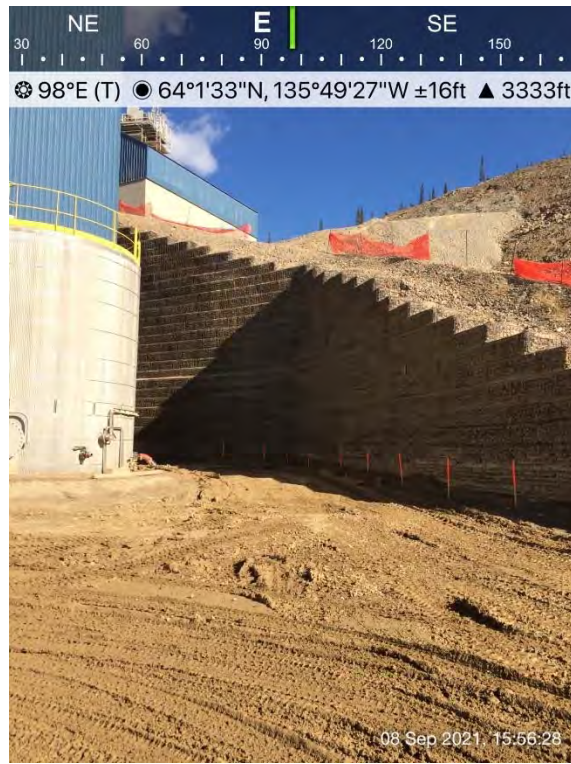
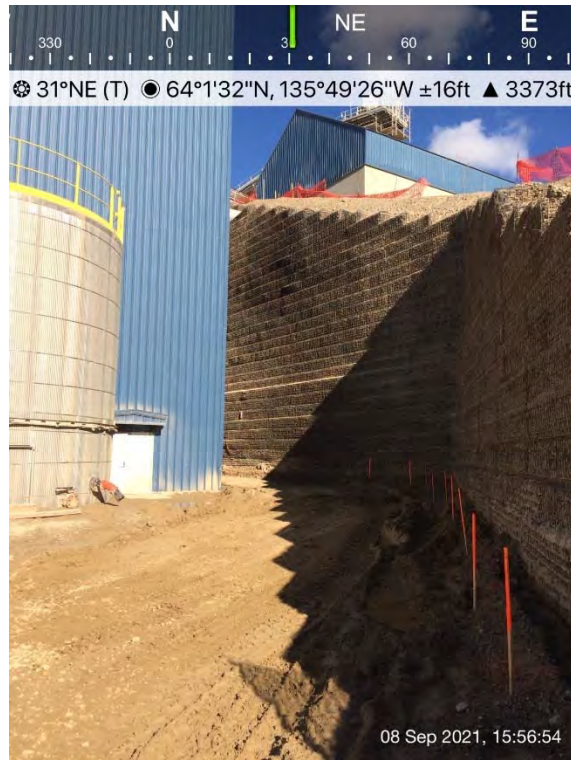
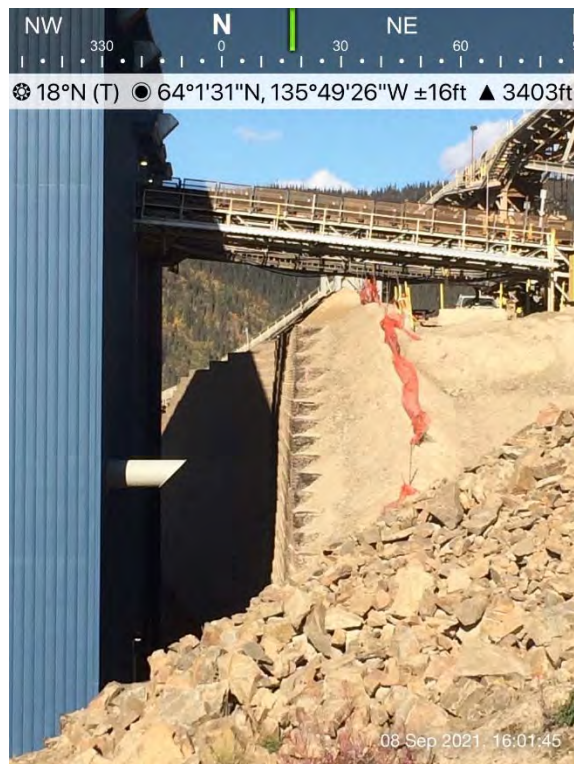
1. No apparent damage or deterioration was noted during the inspection of the Secondary/Tertiary Crusher MSE wall (Figure 40 - Figure 42). No changes were visually identified from the 2020 inspection.

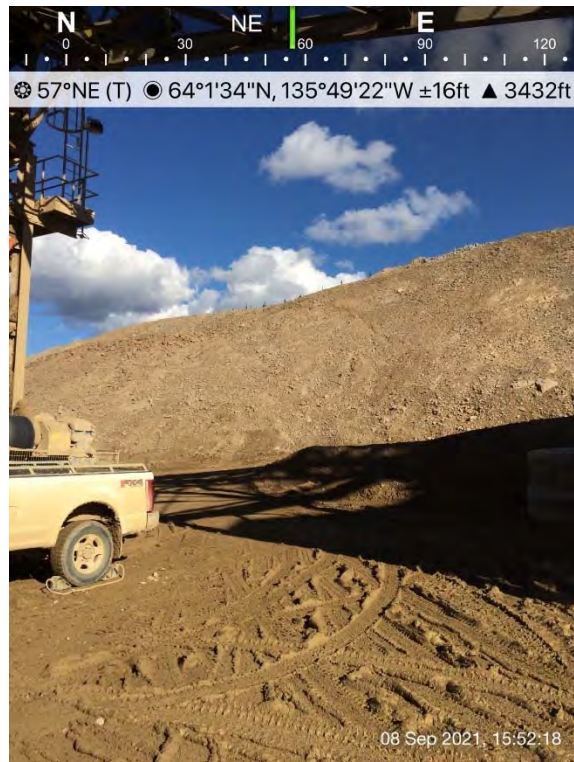
1. Observed locations behind the secondary crusher showed no signs of stability or erosion issues (Figure 43). Some outcrops of rippable rock visible.

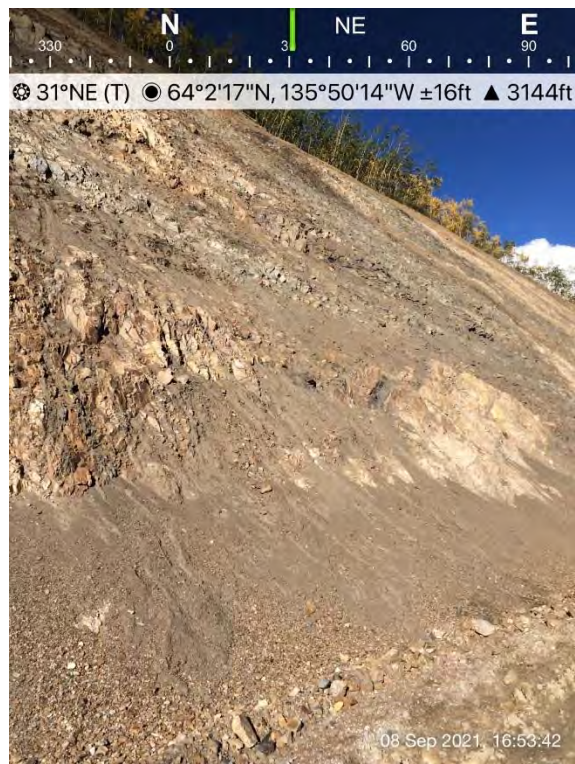
1. Cut slopes behind the ADR area appear to be competent rock, with some minor rilling and unraveling (Figure 44)

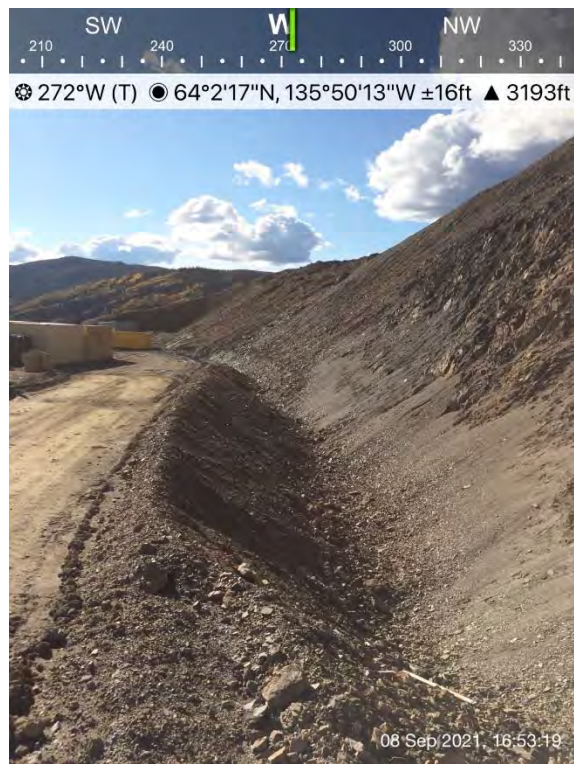
1. There is a small V ditch, referred to here as the North Toe Ditch (Figure 45), with sides close to 1:1 cut at the base of a large steep slope which is cut into bedrock; the ditch is not armored and contains loose gravel and fines, although there are no apparent scouring issues. There is also a culvert which has been installed along the ditch alignment.

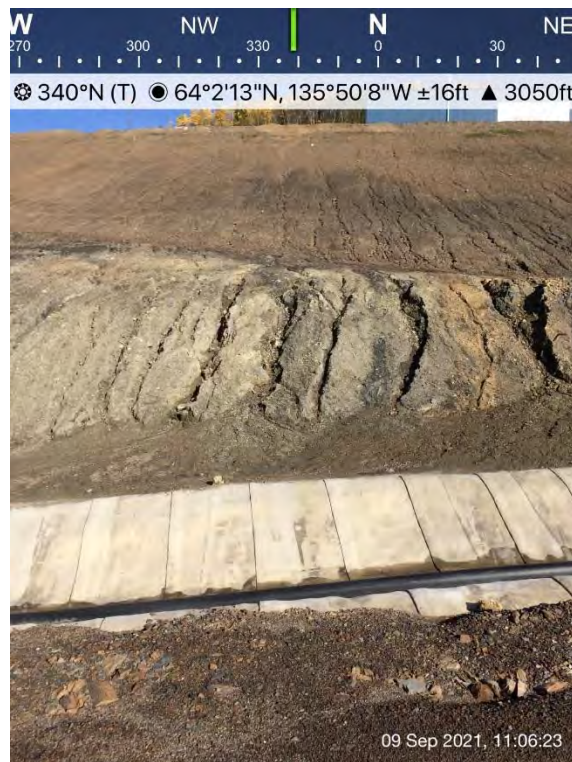
2. Rill erosion and scour channels on the cut slopes above the event pond and the heap leach spillway were noted in this inspection as shown in Figure 47.

**Figure 47: Rill erosion above HLF spillway**

1. Monitor minor erosion of cut slopes and maintain as required.
2. Monitor pooling water above the North side of the Event Pond and regrade area to prevent pool formation or install a water handling system (sump pumps, etc.).
3. Monitor material deposits on HLF spillway and Event Pond to ensure the spillway and pond designs are not compromised through either blockage of flow or reduced pond capacity.
4. Repair excavator damage to HLF spillway liner.
5. Clear crushed material out of Event Pond spillway mouth. If equipment access is needed for the South-East corner of the pond consider constructing additional road accesses as appropriate.

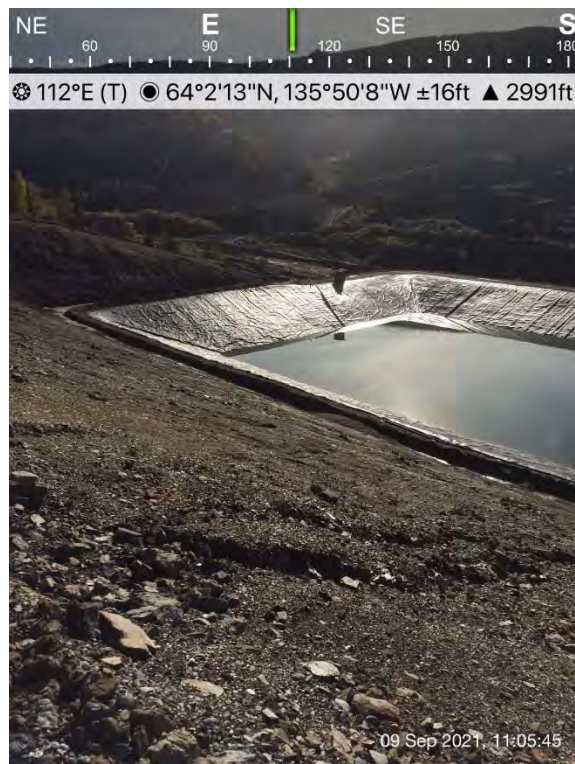
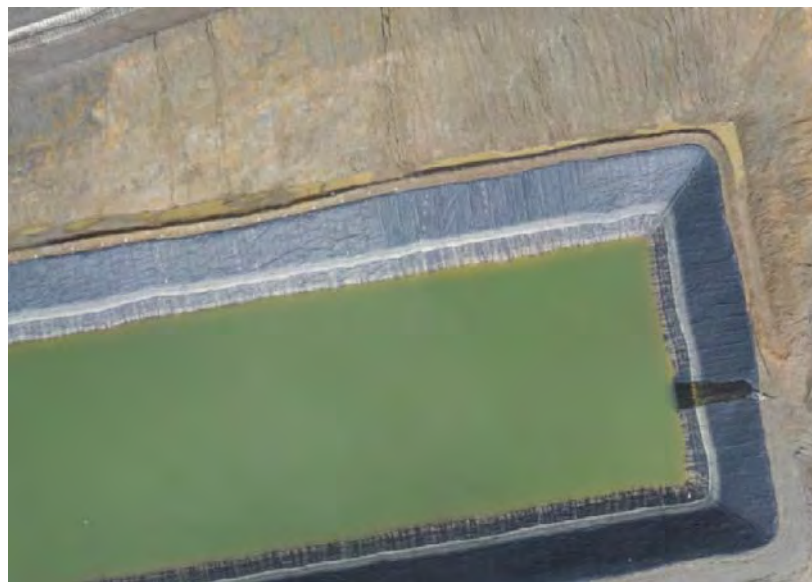
1. Pooling water appeared to be forming above the North-East corner of the Event Pond at the time of this inspection (Figure 48). Pooling water had also been noted in this location on the 2020 inspection (Figure 49).

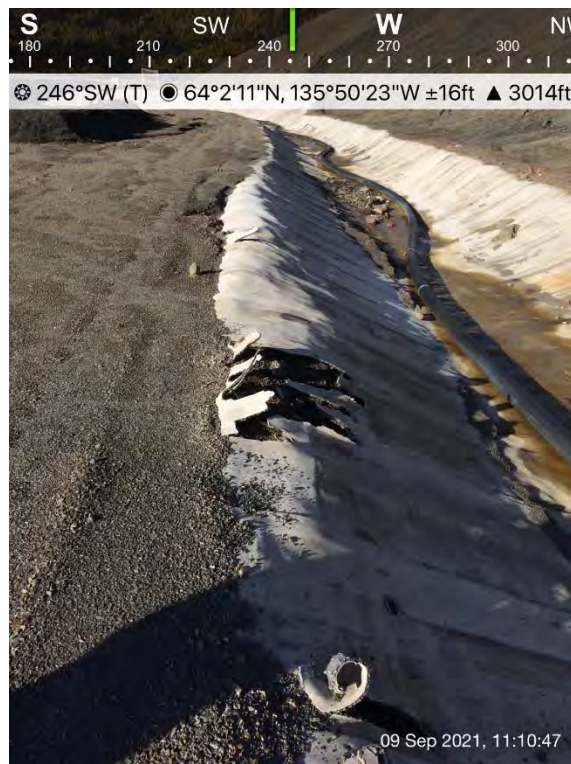
1. As noted in Section 13.1 scouring was observed upslope and downslope of the heap leach spillway, with material being deposited within the spillway. There is also damage to the spillway liner in sections; site representative reported that this was from an excavator clearing the spillway of snow during winter operations (Figure 50).

**Figure 50: Heap leach spillway damage**

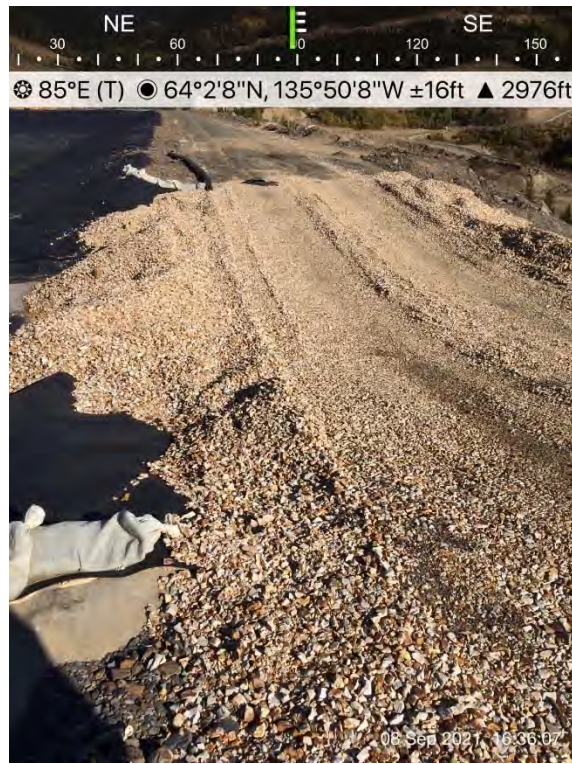
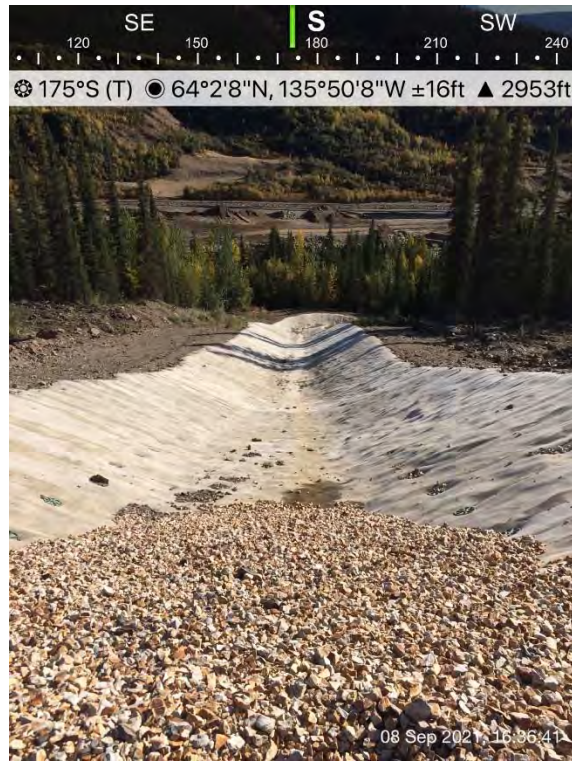
1. The emergency spillway has been temporarily blocked by crushed material by site to provide equipment access to the South-East corner of the pond as there is no other easy equipment access to that area of the pond and crush needed to be placed to prevent damage to the spillway liner (Figure 51, Figure 52).

**Figure 51: Events Pond Emergency spillway crush blockage**
