Allnorth Information		VICTORIA GOLD CORP.	
Project #:	2102059	Client Project #:	
Document #:	211208	Client Document #:	
Document Rev. #:	0	Client Doc. Rev.#:	
Prepared By:	Spencer Bergin, EIT	Client Contact:	Richard Tuohey
Reviewed By:	Don Williams, P.Eng.

Annual Physical Stability Assessment Report – Victoria Gold – Eagle Gold Project

Visual inspection of the following structures: Open Pit, Platinum Gulch Dump, Eagle Pup Dump, Lower Dublin South (Control) Pond, Primary Crusher, Secondary & Tertiary Crushers, Secondary Stockpile, Adsorption, Desorption and Recovery (ADR) Plant, Heap Leach Facility, Heap Leach Overburden Stockpile, Event Pond, Ditches A, B, and C, Truck Shop, Orica Laydown, Various Un-named Stockpiles.

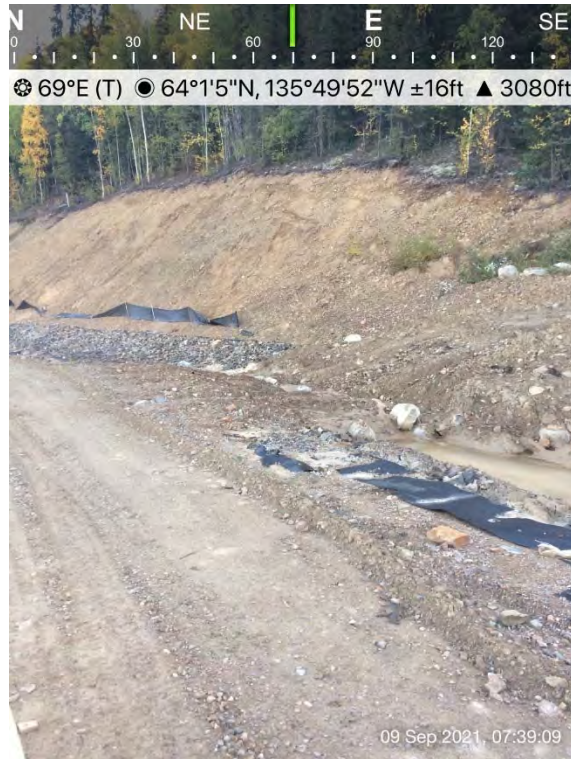
1. Ditch A carries flow from the Platinum Gulch Dump down to the Control Pond. The ditch was mostly completed at the time of the 2020 inspection and has since been finished. A section of the ditch below the Platinum Gulch Dump has been filled with material to provide a temporary vehicle access across the ditch below the dump (Figure 53).

**Figure 53: Ditch A material blockage**

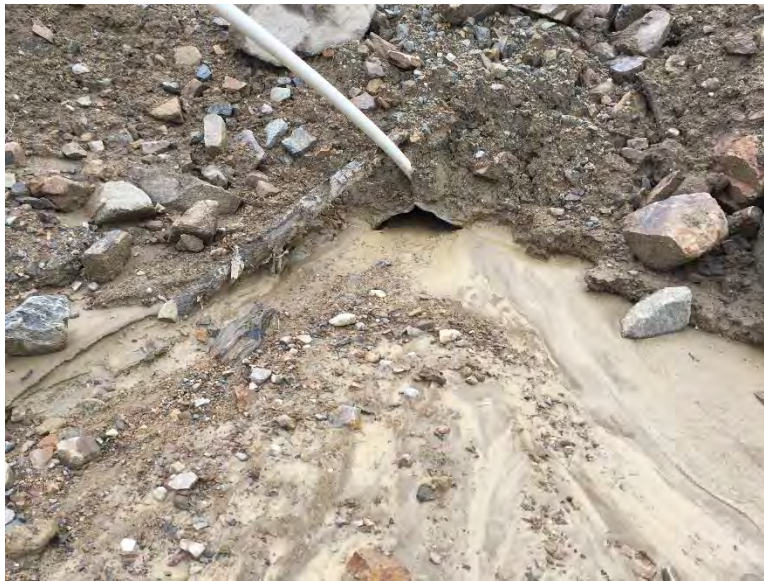
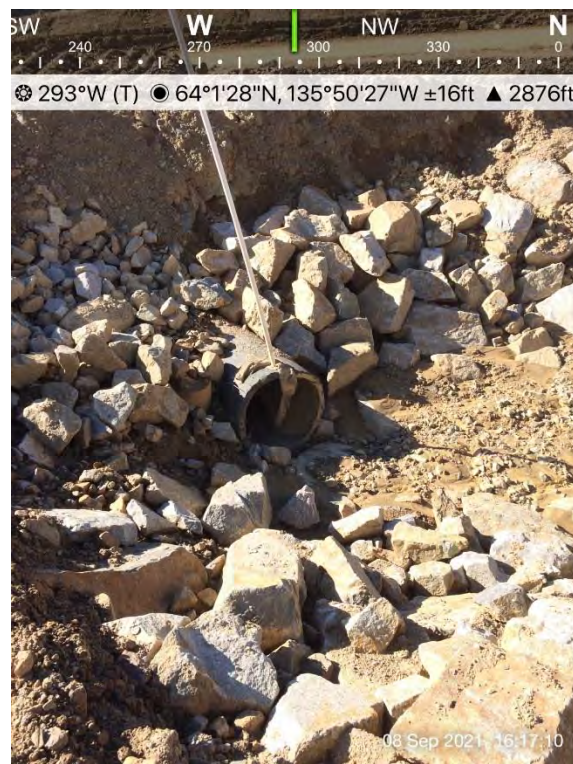
2. A culvert for a tie-in ditch from the Secondary Stockpile perimeter ditch was observed to be blocked with sediment/material in the 2020 inspection (Figure 54). The sump was dug out and the culvert uncovered and replaced since the previous inspection (Figure 55).

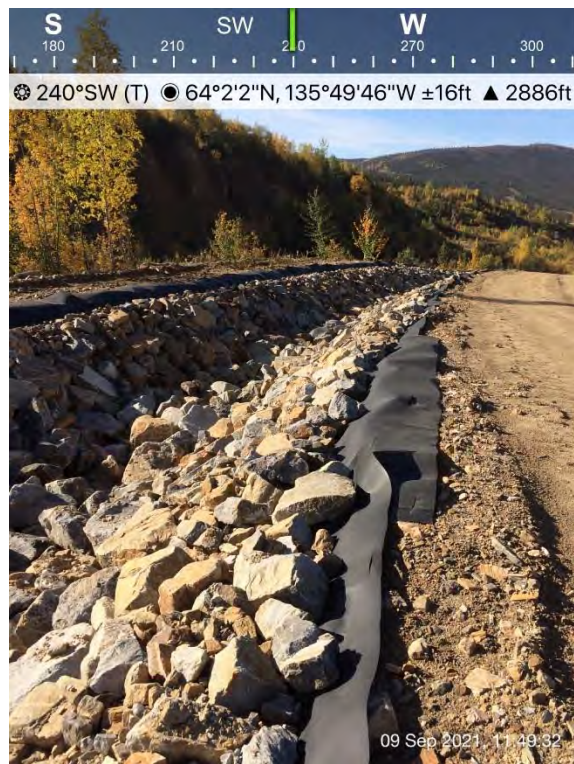
1. Ditch B was unfinished during the 2020 inspection but has since been extended and completed. No issues noted during this inspection (Figure 56).

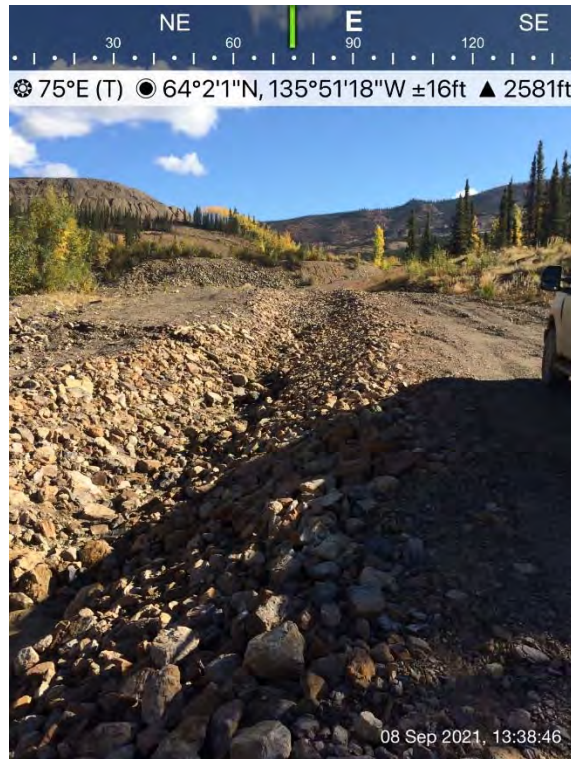
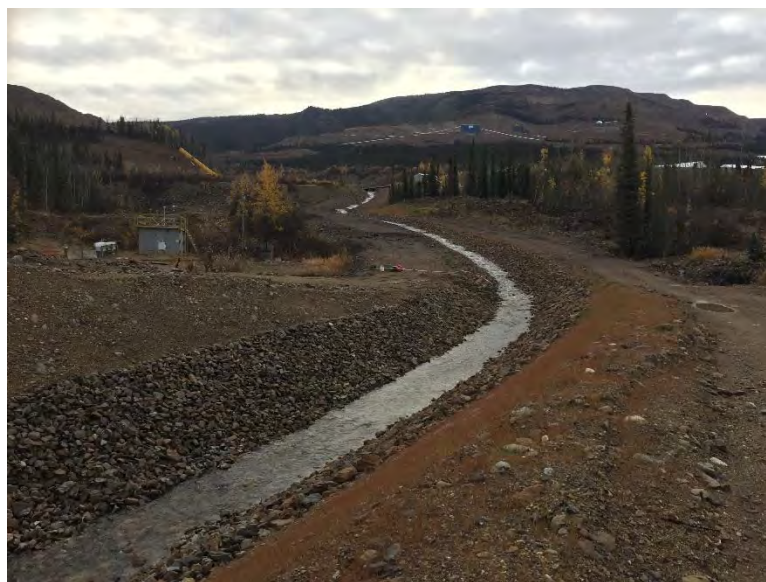
1. Diversion Ditch C begins at the 1500mm outlet culvert for the Control Pond and terminates in Haggart Creek. This ditch acts as both an emergency spillway if the Control Pond is filled over capacity or a conveyance channel for water released from the control pond through the low level outlet. There was no flow visible in the ditch during this inspection (Figure 57) as opposed to a steady flow during the 2020 inspection (Figure 58).

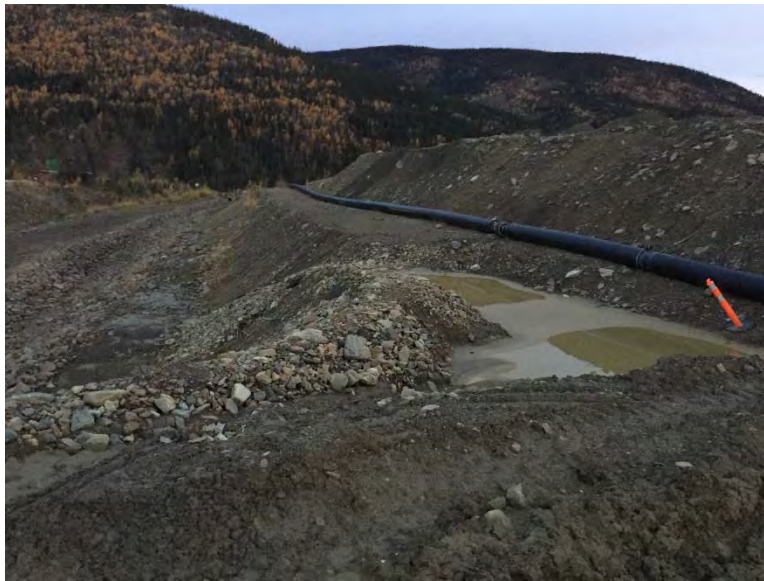
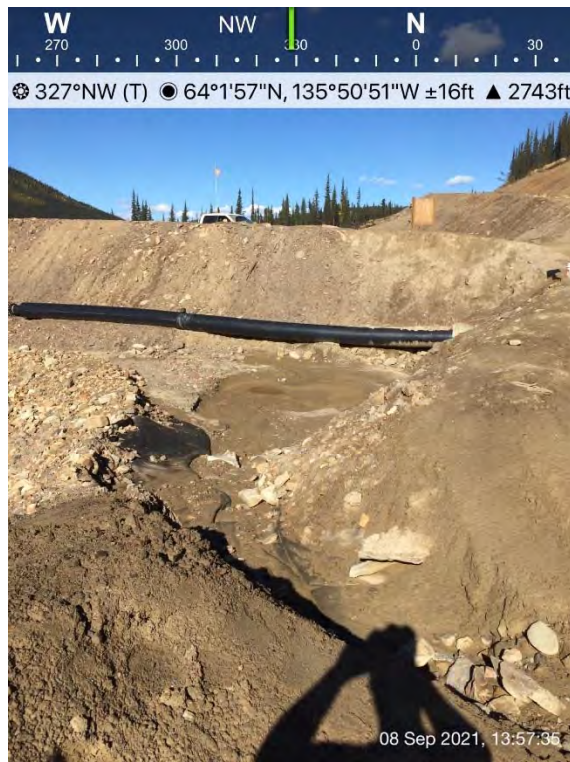
2. Pooling water and sedimentation was observed in the 2020 inspection on the North side of Ditch C immediately West of the culvert from the LDSP spillway to Ditch C (Figure 59). The area was dried out during the 2021 inspection with pooled sediment present (Figure 60).

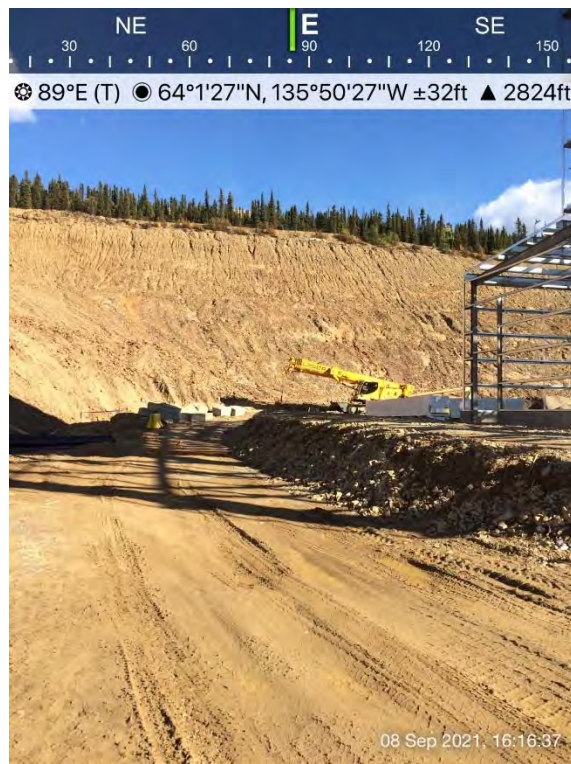
1. The truck shop was under construction at the time of this inspection. The grade had been cleared and the steel frame of the structure had been erected. Some rilling was present on the cut slope behind the truck shop (Figure 61)

**Figure 61: Truck Shop cut slopes**

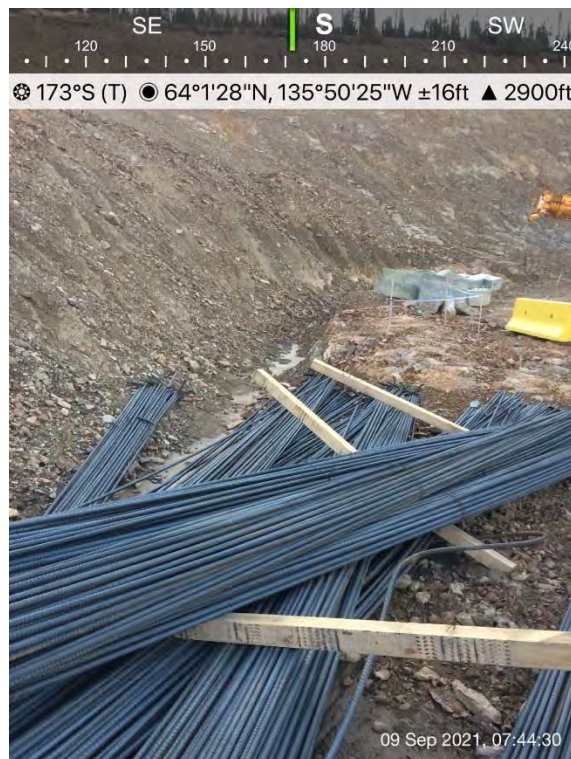
2. A drain ditch had been cut around the base of the cut slope and tied into Ditch A. In one section of the drain ditch rebar had been placed for storage, obstructing the ditch (Figure 62).

**Figure 62: Drain ditch rebar blockage**

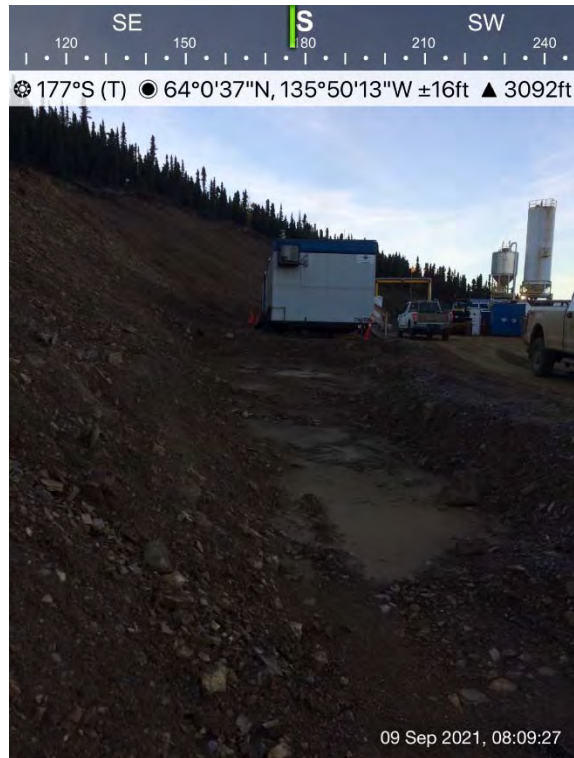
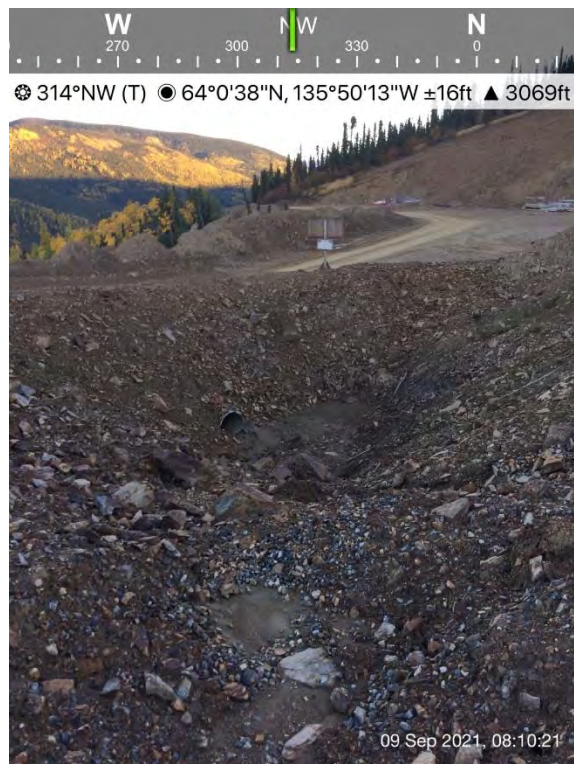
1. An unlined, unarmored ditch from the portable structures of the laydown has pools of sediment (Figure 63) but the overall grade of the ditch continues to flow to the sump (Figure 64) uninterrupted. No issues noted.

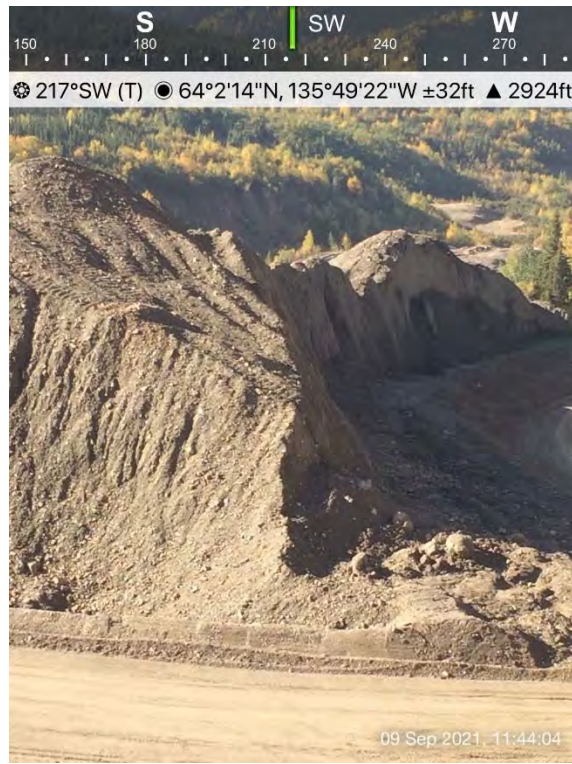
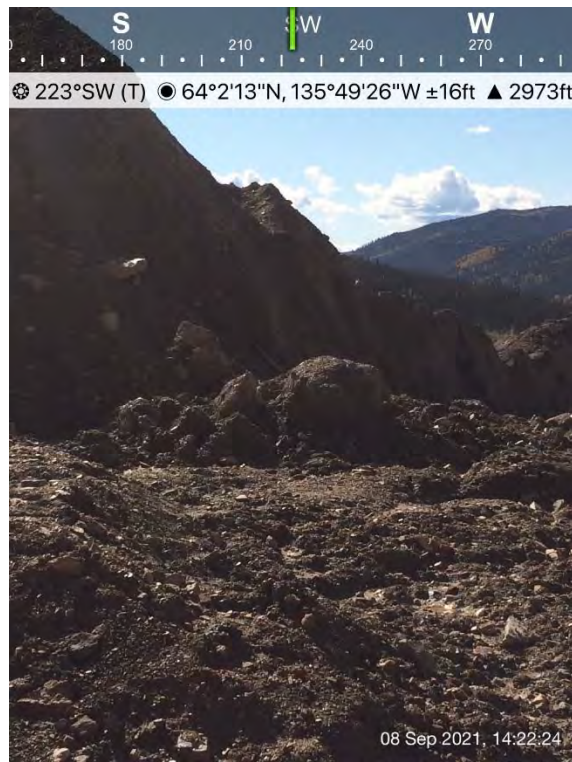
**Figure 65: Some stockpiles with steep side slopes**

**Figure 66: Additional stockpiles with steep side slopes**
