Allnorth Information		VICTORIA GOLD CORP.	
Project #:	2202179	Client Project #:	
Document #:	221207	Client Document #:	
Document Rev. #:	1	Client Doc. Rev.#:	
Prepared By:	Spencer Bergin, EIT	Client Contact:	Reanna Roberts
Reviewed By:	Don Williams, P.Eng.

Annual Physical Stability Assessment Report – Victoria Gold – Eagle Gold Project

Visual inspection of the following structures: Open Pit, Platinum Gulch Dump, Eagle Pup Dump, Lower Dublin South (Control) Pond, Primary Crusher, Secondary & Tertiary Crushers, Secondary Stockpile, Adsorption, Desorption and Recovery (ADR) Plant, Heap Leach Facility, Heap Leach Overburden Stockpile, Event Pond, Emergency Pond, Ditches A, B, and C, Heavy Duty Truck Shop, Warehouse Pad, Water Treatment Plant, Orica Laydown, Various Un-named Stockpiles.

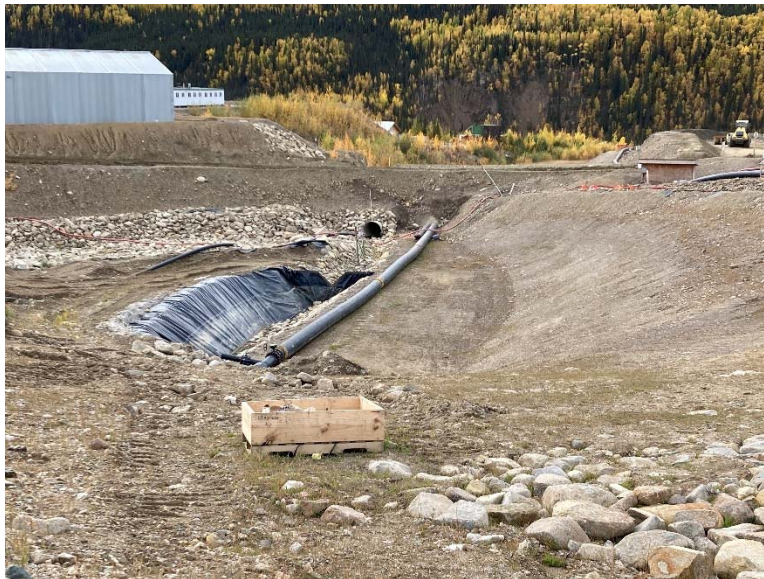
The low level outlet conveyance channel from the Lower Dublin South Pond (LDSP) is currently not in use, as water is being pumped direct from the LDSP to the end of Ditch C when water levels are high enough to warrant it. Once the Water Treatment Plant is operational flows may be diverted there instead. Currently the channel is dry and unused (Figure 1).

**Figure 1: LDSP – Low Level Outlet Conveyance Channel**

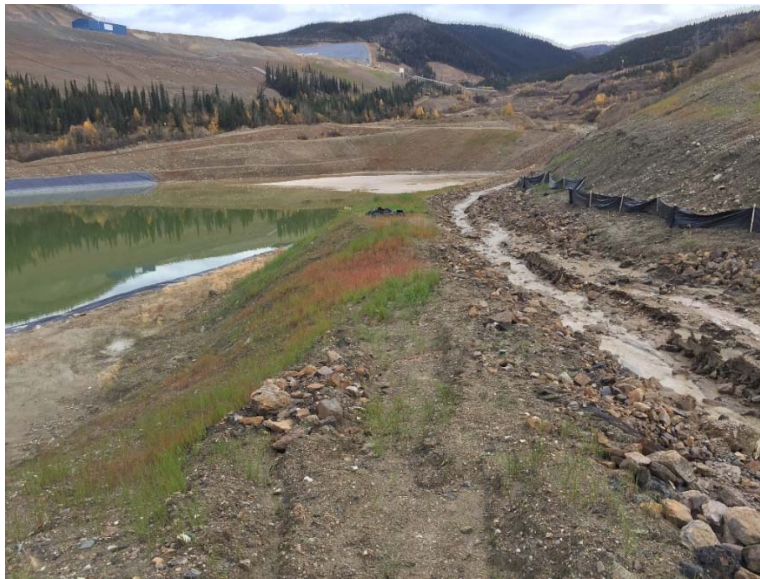
1. Some saturated material and erosion was noted on the slope of the southwest corner of the Control Pond over the width of the narrow access road in 2019 and 2020 (Figure 2,) but this erosion was rectified with the completion of Ditch A between the 2020 and 2021 inspections (Figure 3). The area is showing signs of cracking as of the 2022 inspection (Figure 4).

**Figure 2: LDSP – Erosion on the Southwest slope 2020**

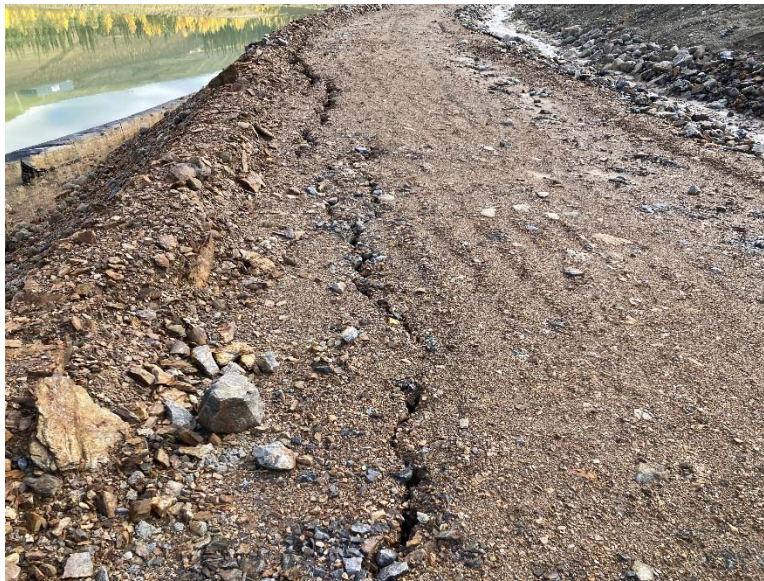
**Figure 4: LDSP – Cracking on the Southwest slope 2022**

1. Monitor cut slopes above Ditch A for further erosion, sloughing and cracking.

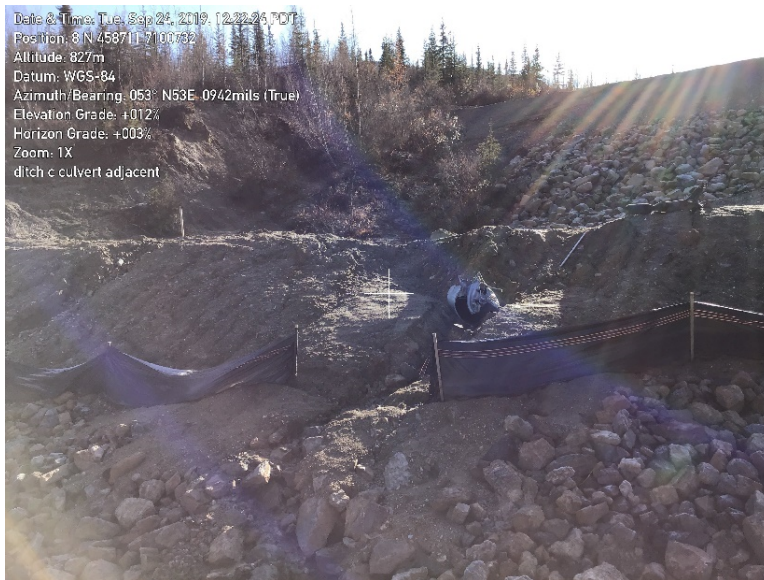
2. There was some flow into Ditch A on the Southwest corner of the LDSP from a culvert crossing a former construction access road, which was observed in 2019, 2020 and 2021 (Figure 5, Figure 6, Figure 7) and still present as of this inspection (Figure 8). Liner was installed under the culvert outlet at the time of this inspection to alleviate erosion (Figure 8).

**Figure 5: LDSP – Some flow from adjacent culvert 2019**

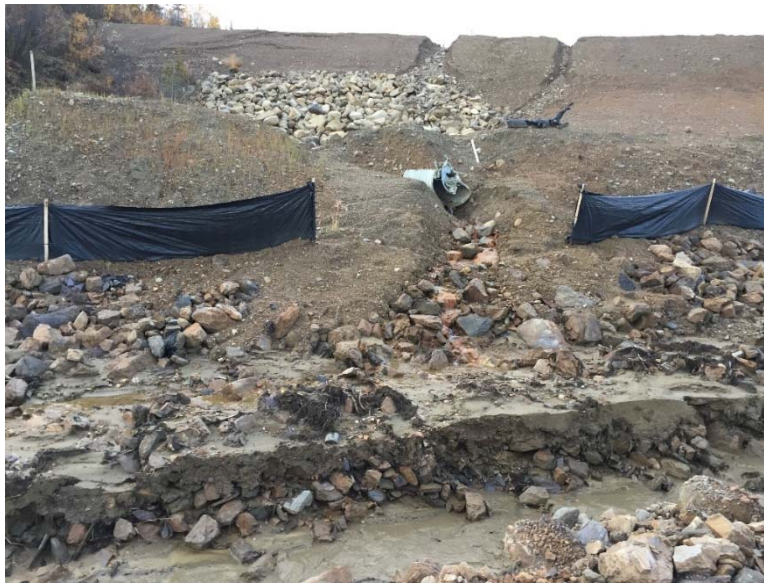
**Figure 6: LDSP – Some flow from adjacent culvert 2020**

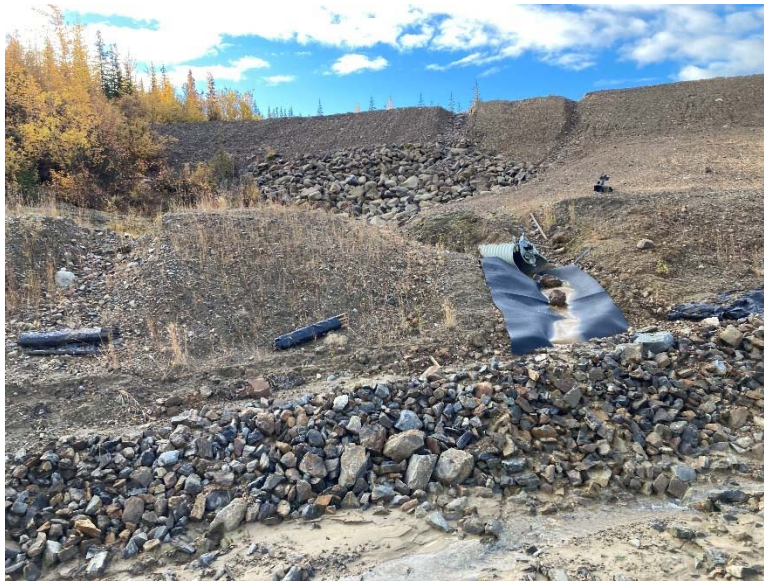
**Figure 8: LDSP – Some flow from adjacent culvert 2022**

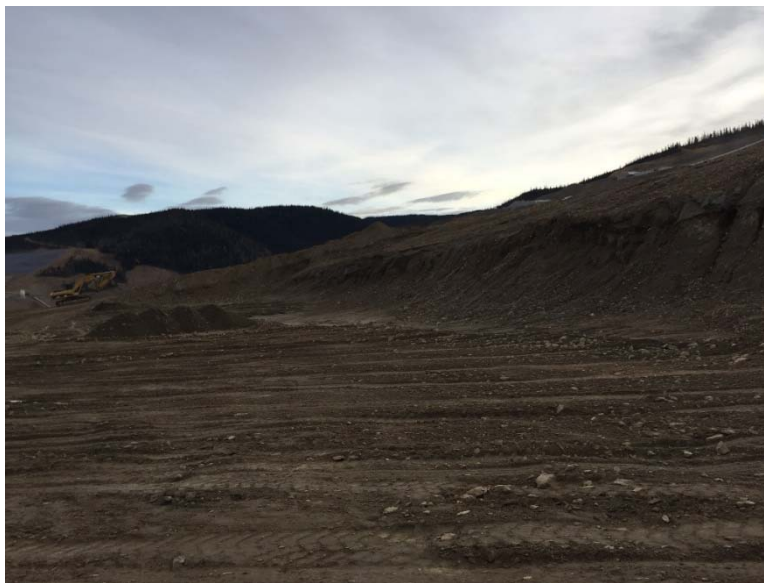
1. The Secondary Stockpile (also known as the 90 Day Stockpile) was completed in 2020 (Figure 9). Some over-steepened cut slopes were observed during the 2021 inspection where the slopes had begun to collapse/erode and material was collecting at the base of the slope (Figure 10). This was also the case during this years inspection (Figure 11).

**Figure 9: Secondary Stockpile Cut Slopes 2020**

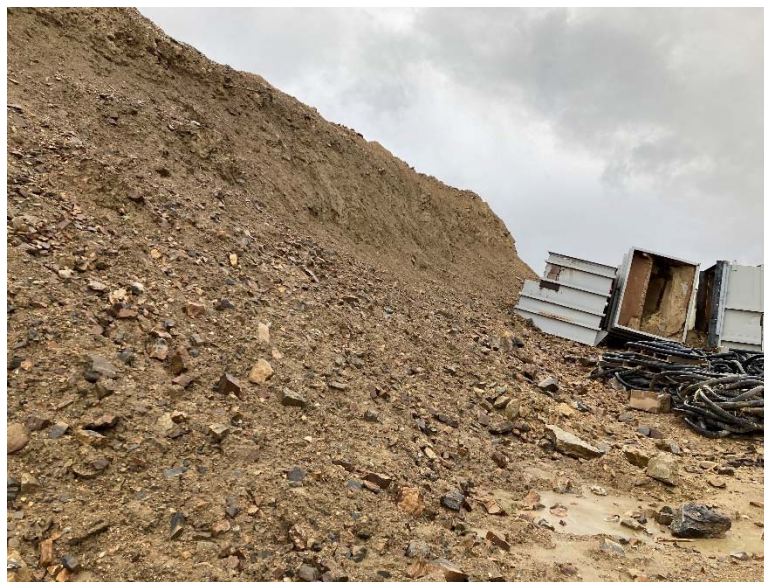
**Figure 11: Secondary Stockpile Cut Slopes 2022**

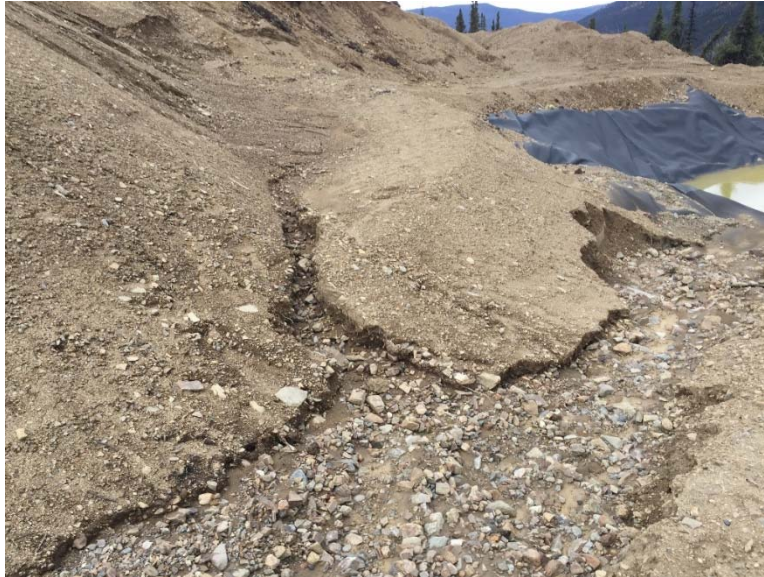
1. A perimeter interception ditch extends around the downhill toe of the Secondary Stockpile area. The construction of this ditch was not complete in 2020 but has since had rock armoring installed (Figure 12, Figure 13). Issues noted in the 2020 inspection including over-steepened and sloughing slopes on the interception ditch appear to have since been addressed. The ditch appears in good condition as of this years inspection (Figure 14).

**Figure 12: Perimeter Ditching 2020**

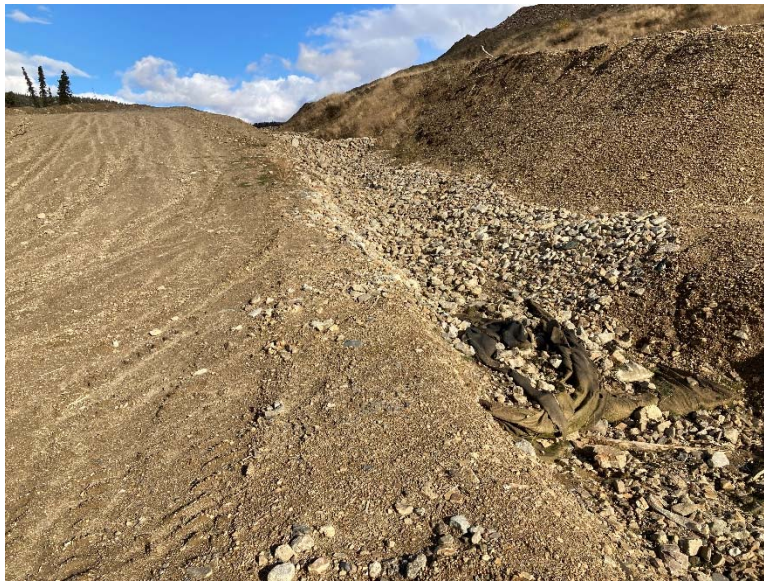
**Figure 14: Perimeter Ditching 2022**

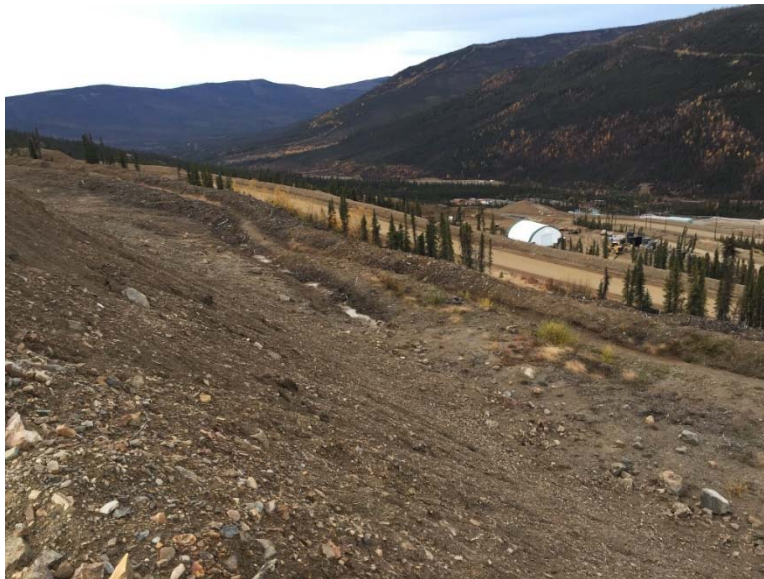
2. The outlet of one side of the perimeter ditch does not currently tie into the collection sump, this was observed in 2020 as well. (Figure 15, Figure 16, Figure 17).

**Figure 15: Unconnected Ditch Section 2020**

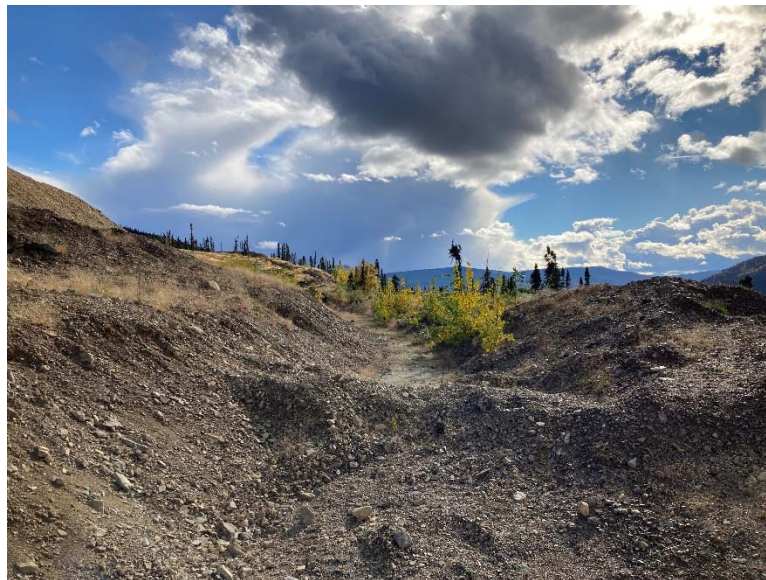
**Figure 17: Unconnected Ditch Section 2022**

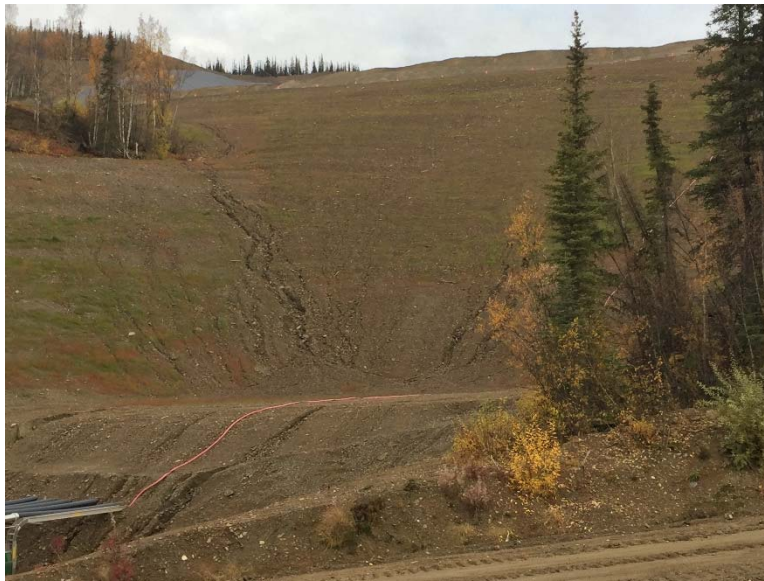
1. Some scouring and rilling was noted along the toe slope below the HLF and above the unnamed stockpile area and HLF Underdrain Monitoring Vault in the 2020 inspection (Figure 22). The slope has since been seeded and there appears to be less scouring of material off the toe slope as inspected in 2021 (Figure 23) and 2022 (Figure 24).

**Figure 22: Scouring and rilling along toe slope of HLF (2020)**

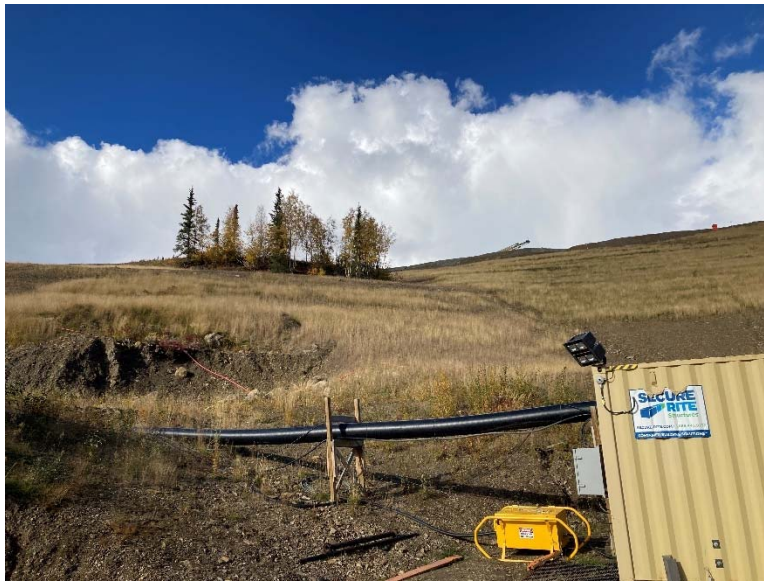
**Figure 24: Seeded grass on toe slope of HLF (2022)**

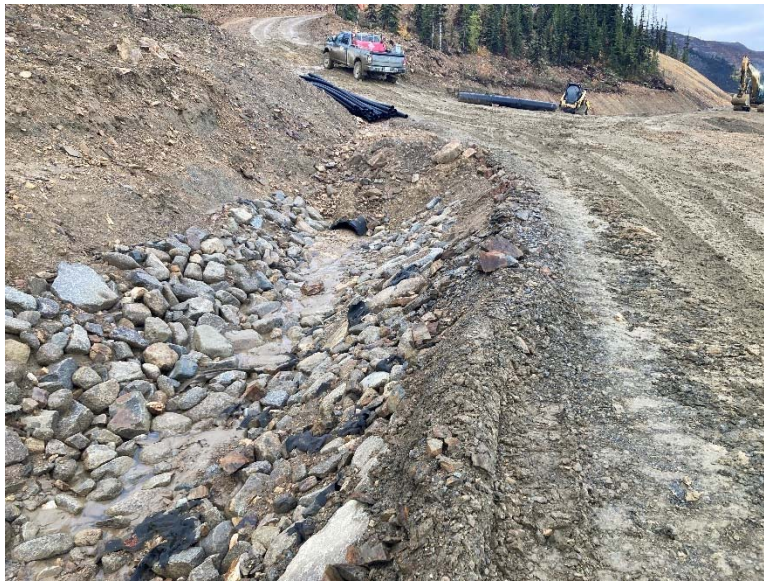
1. The HLF interception ditch was constructed before the 2022 inspection. The interception ditch has collected silt/material in some sections, almost blocking culverts in some areas (Figure 25).

**Figure 25: Material deposited in HLF Interception Ditch (2022)**

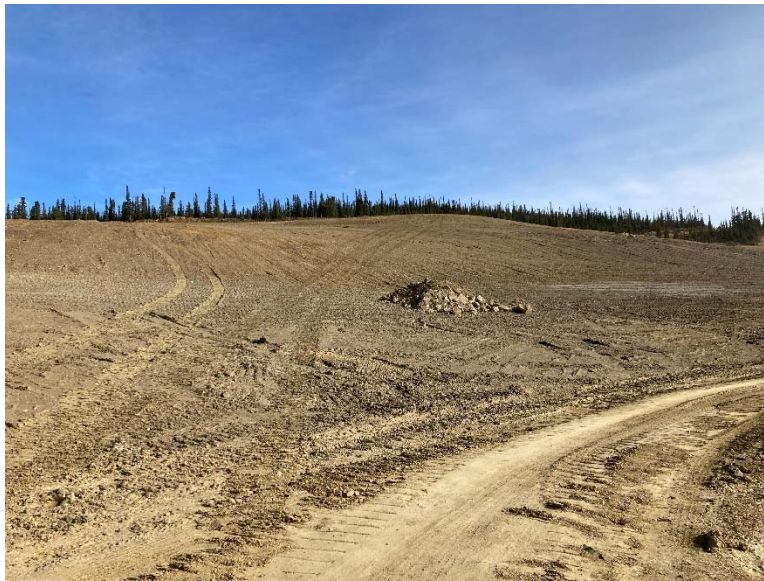
1. The Phase 2 of the HLF was mostly cleared at the time of inspection with grading nearly finished as well (Figure 26). No issues noted for the cleared area.

**Figure 26: Phase 2 graded area**

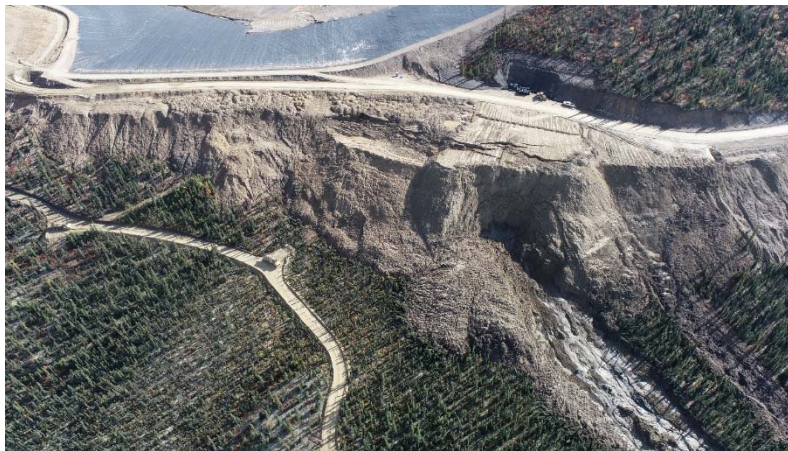
1. Overburden from clearing and grading of the HLF expansions has been placed along the North-West back slope of the HLF. Site representatives stated that the HLF overburden pile had shifted and partially collapsed some time in the late summer of 2021, roughly 4 – 5 weeks prior to the 2021 inspection (Figure 27). Since the 2021 inspection the collapsed area has been re-sloped (Figure 28). Some minor cracking was noted on the re-sloped surface (Figure 29). The area had also been seeded with grass by helicopter and the grass was starting to sprout at the time of this inspection.

**Figure 27: HLF Overburden Stockpile collapse – plan view 2021**

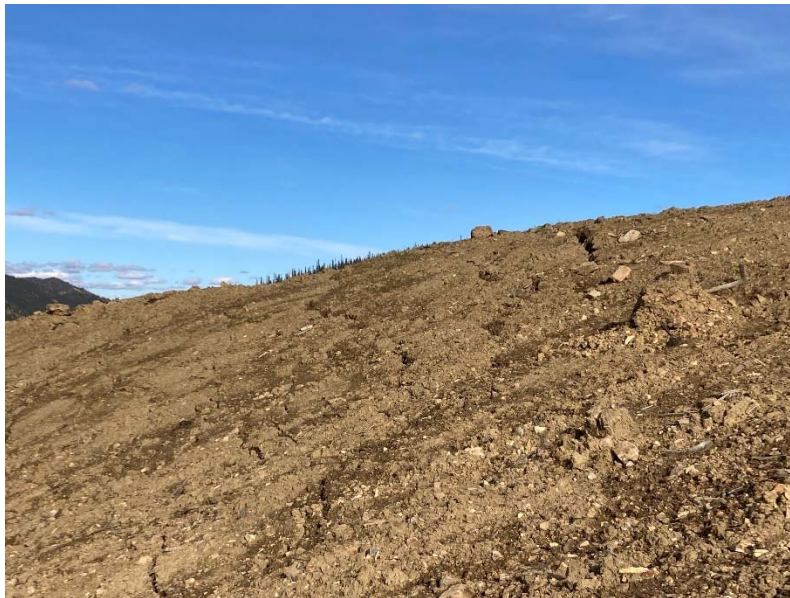
**Figure 29: HLF Overburden Stockpile collapse – slope cracking 2022**

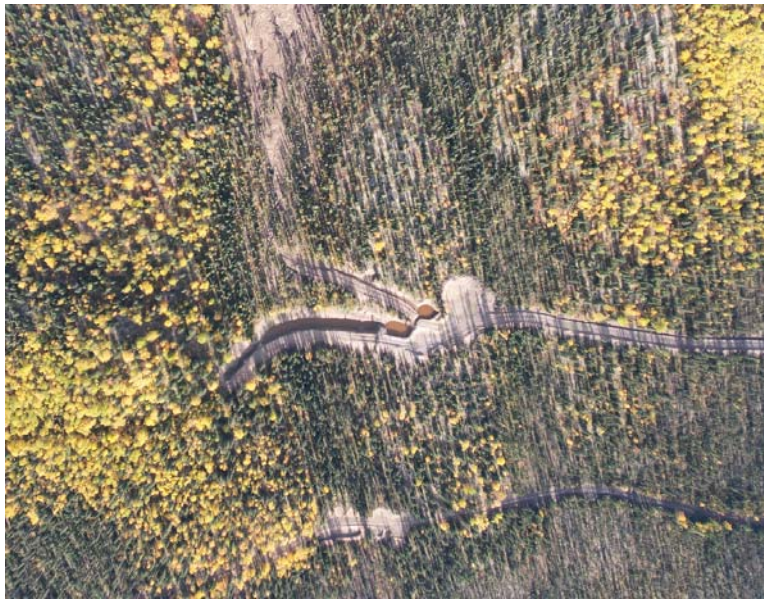
2. Sumps have been constructed downslope from the overburden collapse to collect silt run-off from the collapse (Figure 30). The sumps are holding water and appear soundly constructed (Figure 31)

**Figure 30: HLF Overburden sump system 2022**

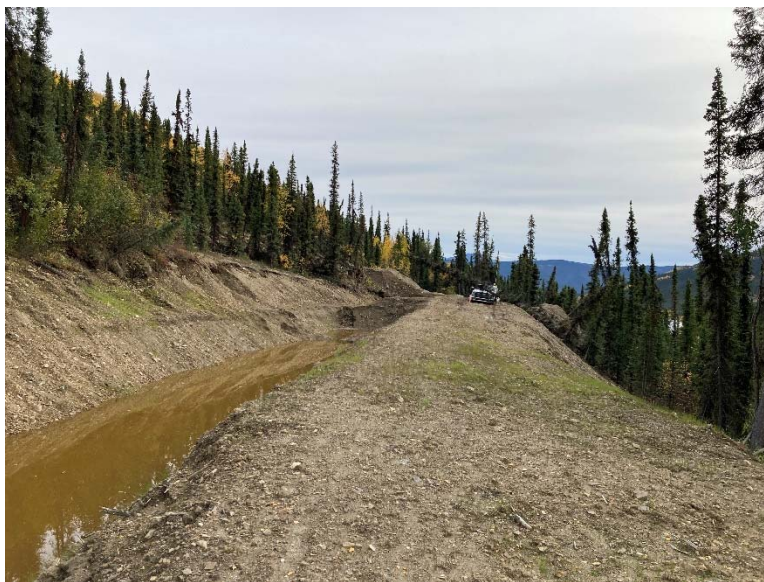
**Figure 31: HLF Overburden sump system 2022**

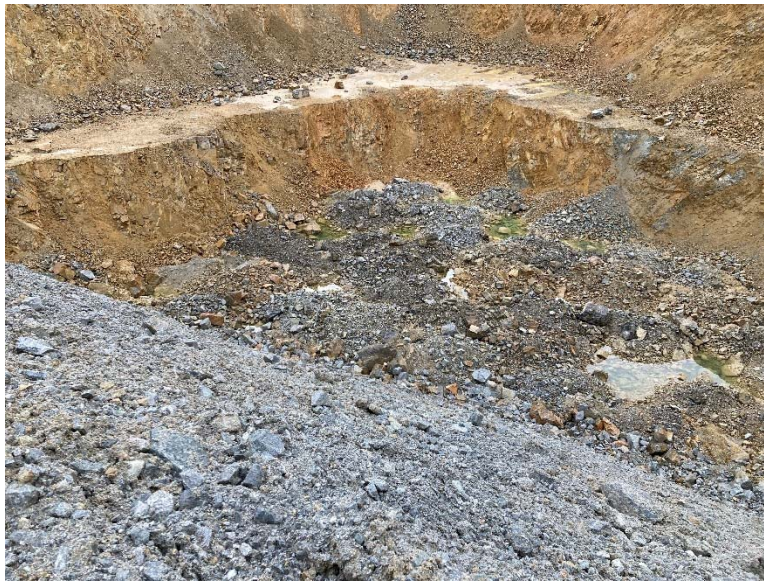
2. There is a section at the base of the pit where water collects and is unable to drain, resulting in pooled water (Figure 34).

**Figure 34: Phase 1 Pit pooled water**

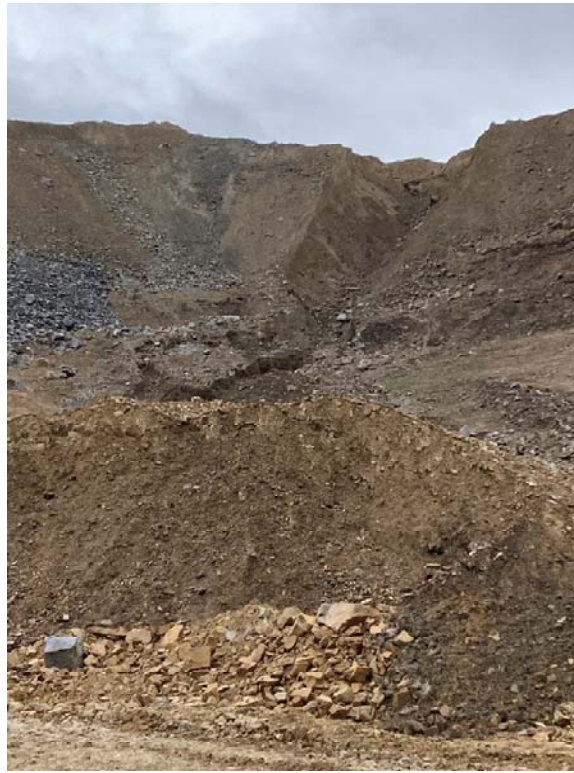
**Figure 36: Open Pit Erosion – From Base**

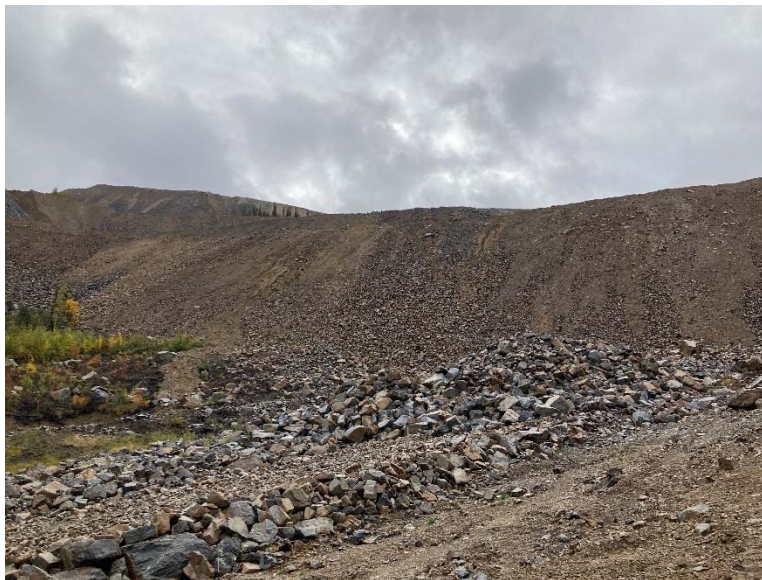
1. Platinum Gulch Dump is currently operational, and the side slopes generally appear to be stable. See Figure 37 and Figure 38 below.

**Figure 37: Platinum Gulch Dump (Base)**

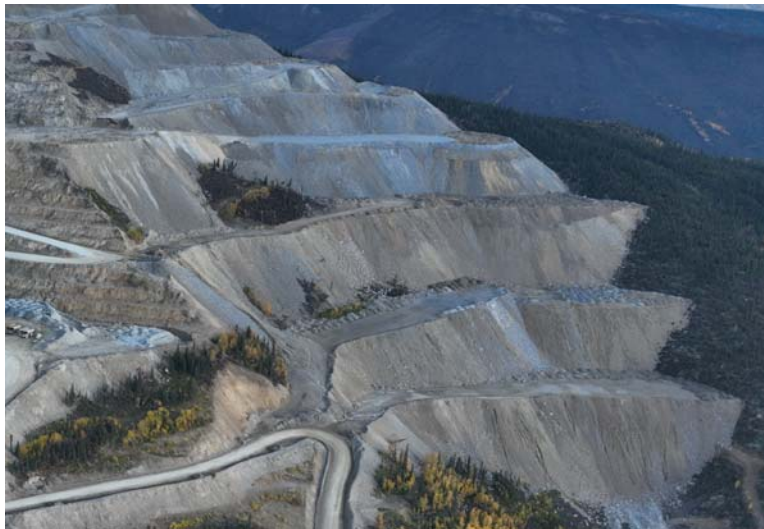
**Figure 38: Platinum Gulch Dump (Aerial View)**

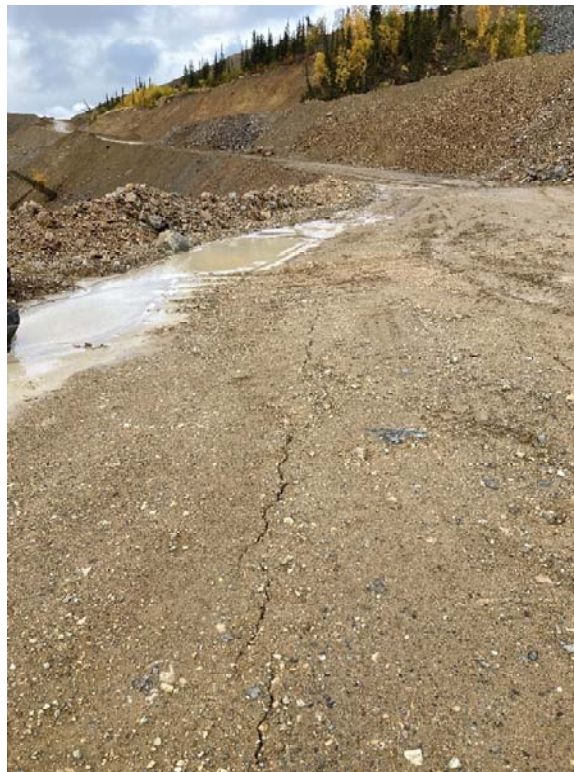
2. Some sections of pooling water and cracking were noted on the first level of the dump (Figure 39, Figure 40).

**Figure 39: Platinum Gulch Dump Water Pooling**

1. Monitor pooled water and cracking on first bench.

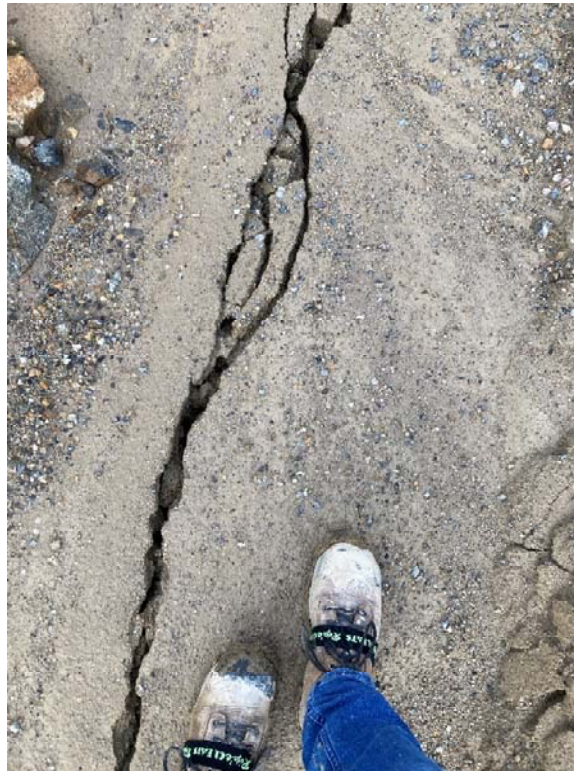
**Figure 40: Platinum Gulch Dump Cracking**

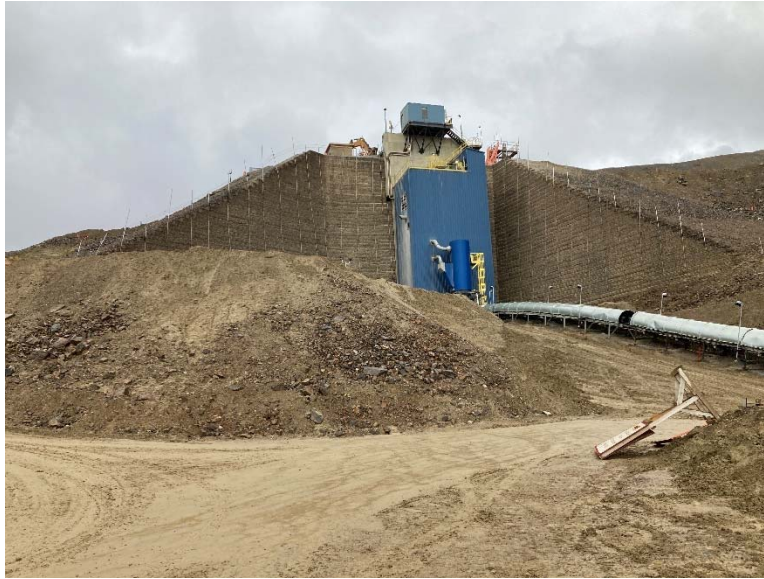
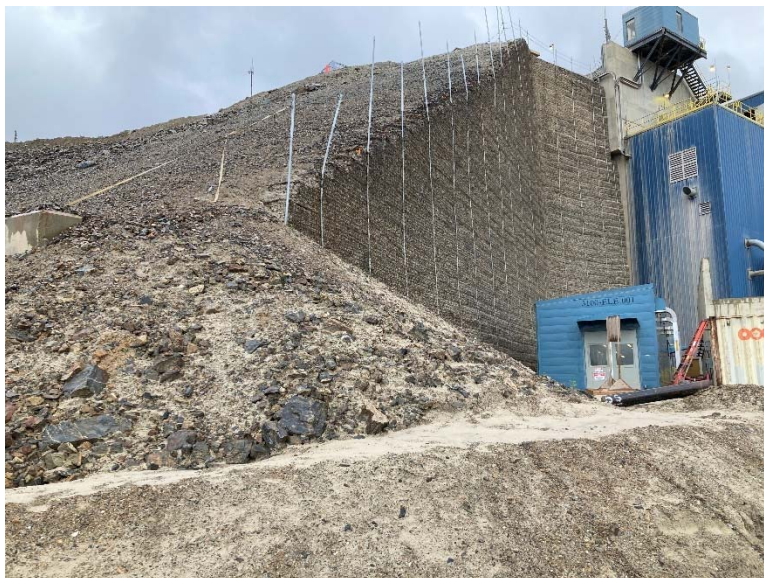
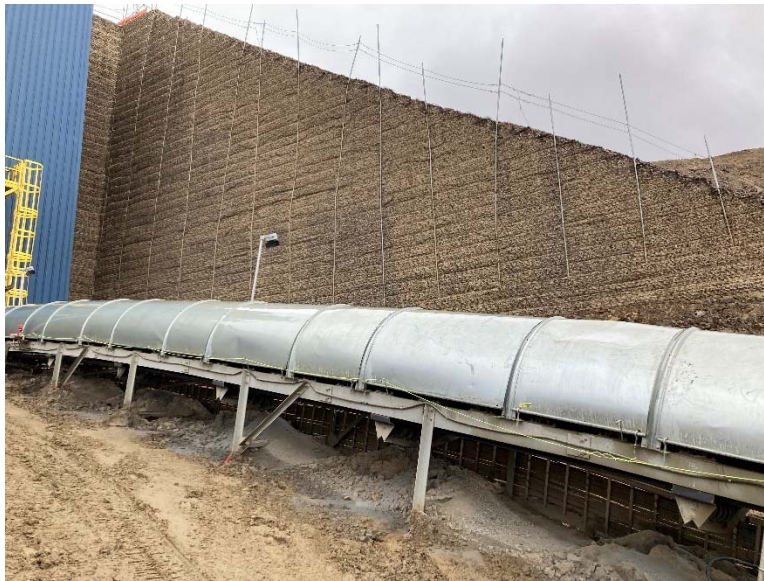
1. No apparent damage or deterioration was noted during the inspection of the Primary Crusher MSE wall (Figure 43 - Figure 45). No changes were visually identified from the 2021 inspection.

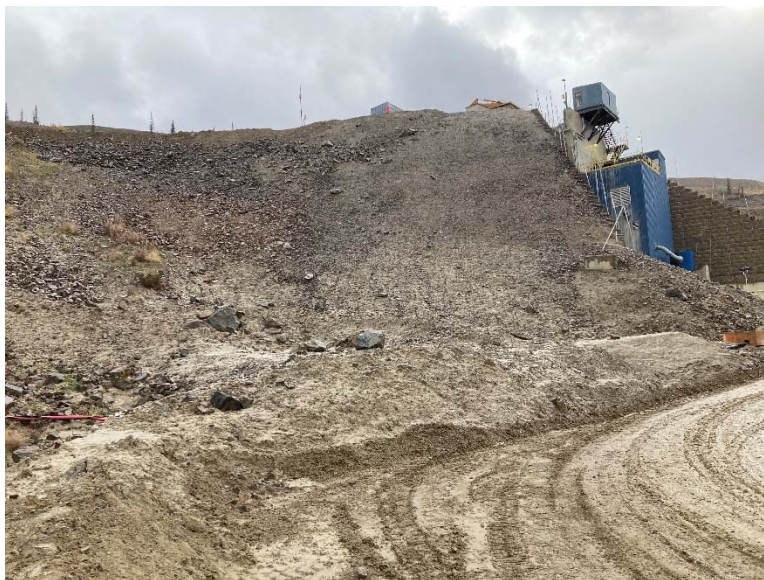
1. Cut and fill slopes appear to be acceptable, no stability or erosion issues noted. (Figure 46).

**Figure 46: North-West fill slopes**

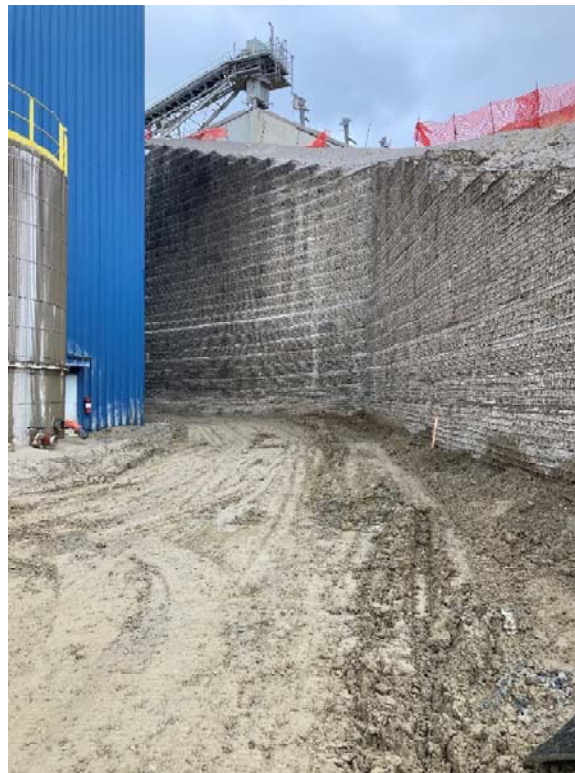
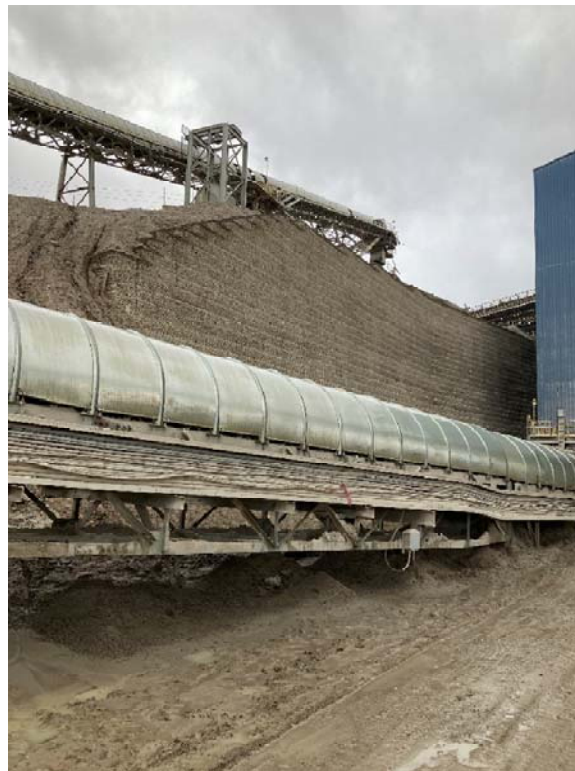
1. No apparent damage or deterioration was noted during the inspection of the Secondary/Tertiary Crusher MSE wall (Figure 47, Figure 48). No changes were visually identified from the 2021 inspection.

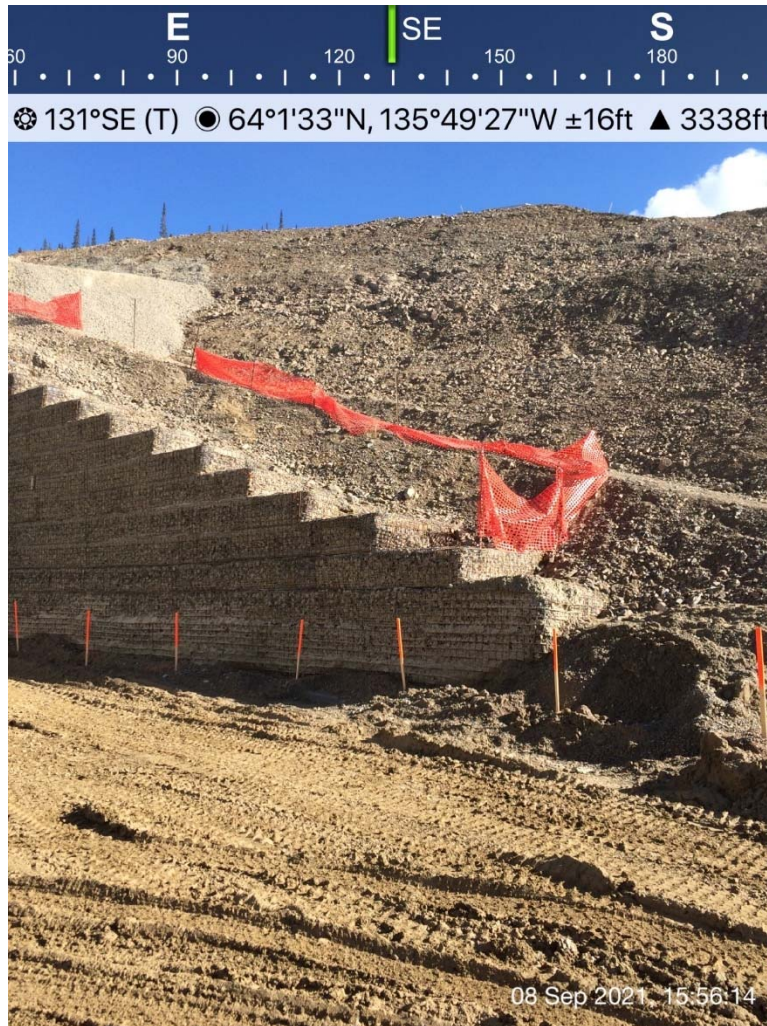
1. There has been an accumulation of fine sediment on the South slope above the MSE wall, likely from dust coming off the crusher transfer conveyor. Photos taken during the 2021 inspection (Figure 49) show a relatively clear slope, photos taken during the 2022 inspection show the silt build-up since the previous inspection (Figure 50, Figure 51).

**Figure 49: Cut slopes above Secondary/Tertiary Crusher 2021**

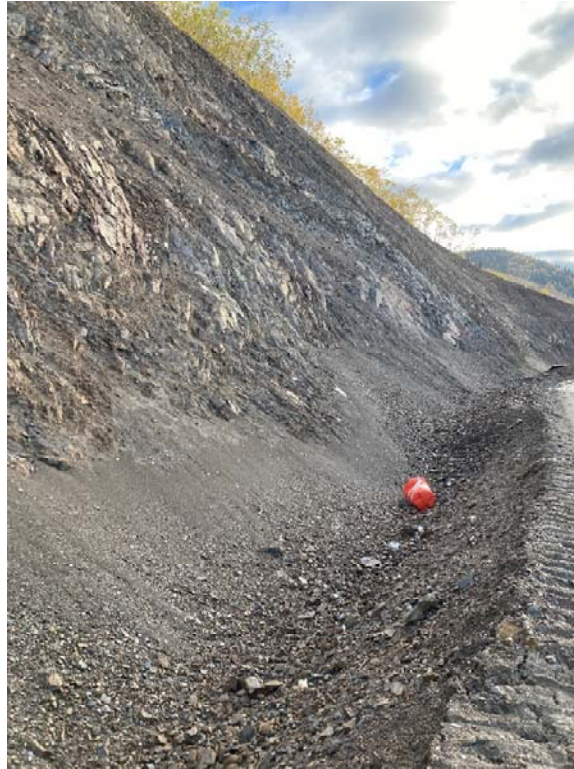
1. Cut slopes behind the ADR area appear to be competent rock, with some minor rilling and unraveling (Figure 52)

**Figure 52: Slopes behind ADR (2022)**

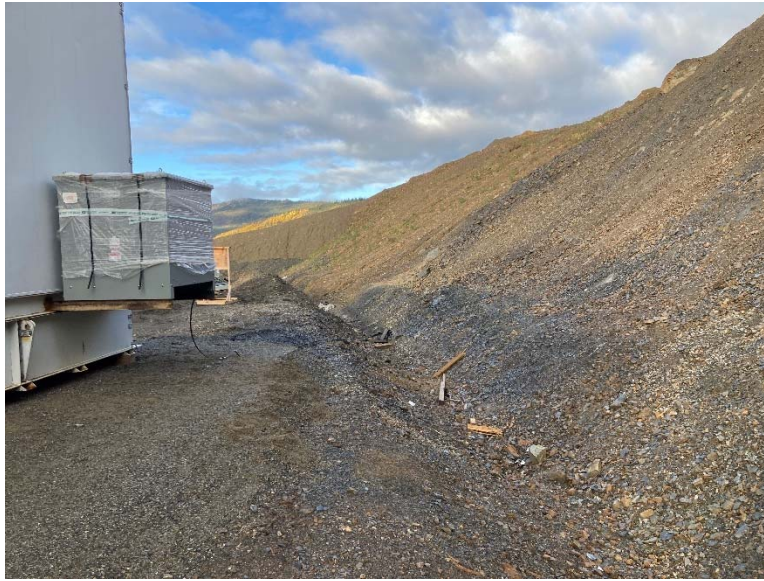
1. There is a small V ditch, referred to here as the North Toe Ditch (Figure 53), with sides close to 1:1 cut at the base of a large steep slope which is cut into bedrock; the ditch is not armored and contains loose gravel and fines, although there are no apparent scouring issues. There is also a culvert which has been installed along the ditch alignment.

**Figure 53: Typical North Toe Ditch cross section**

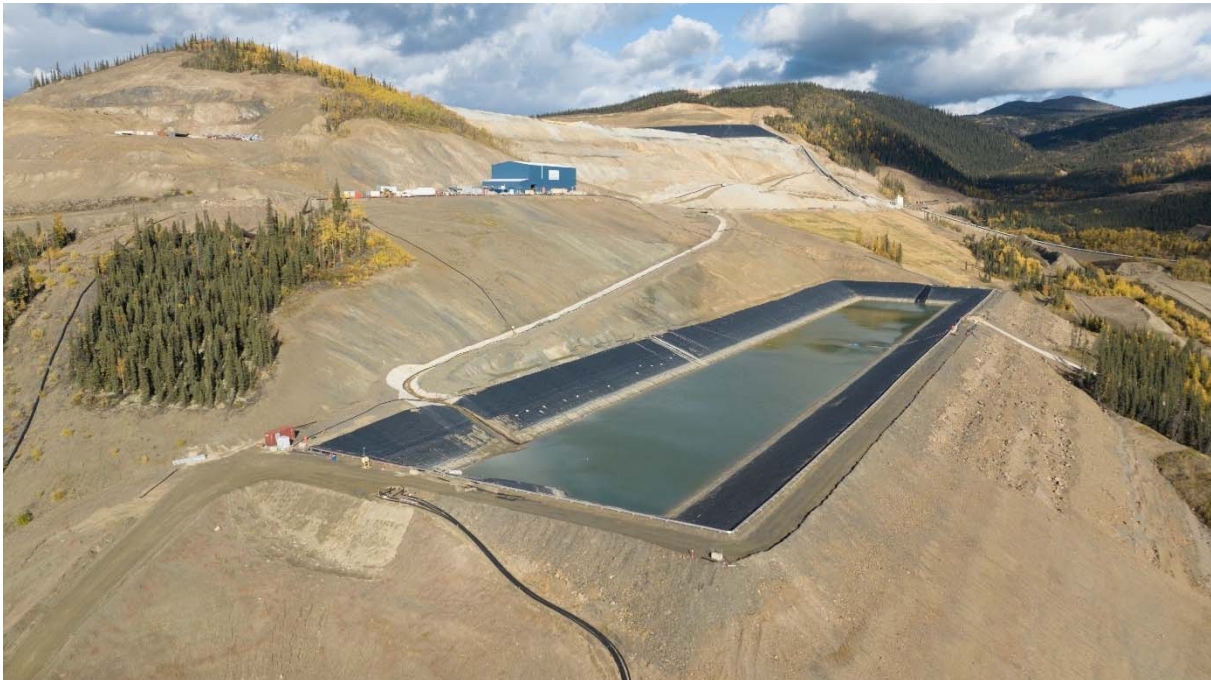
1. The event pond was constructed between the 2018 and 2019 inspections, with hillslope unraveling noted in the 2019 inspection.

**Figure 54: Overall view of event pond**

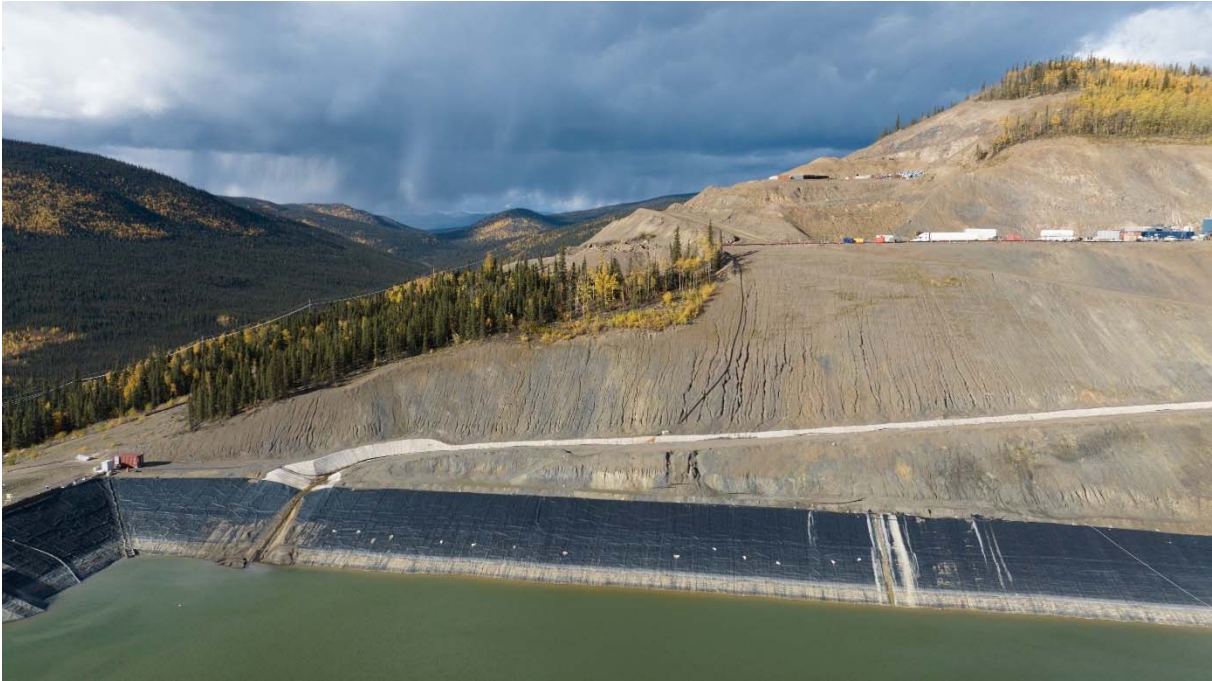
2. Rill erosion and scour channels on the cut slopes above the event pond and the heap leach spillway were noted in this inspection as shown in Figure 55.

**Figure 55: Rill erosion above HLF spillway**

1. Monitor minor erosion of cut slopes and maintain as required.
2. Monitor pooling water above the North side of the Event Pond and regrade area to prevent pool formation or install a water handling system (sump pumps, etc.).
3. Monitor material deposits on HLF spillway and Event Pond to ensure the spillway and pond designs are not compromised through either blockage of flow or reduced pond capacity.
4. Repair excavator damage to HLF spillway liner.

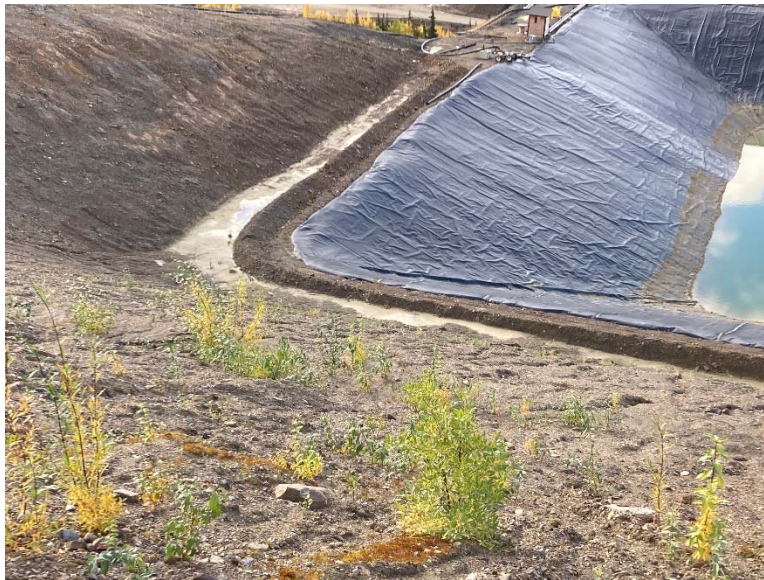
1. Pooling water appeared to be forming above the North-East corner of the Event Pond at the time of this inspection (Figure 56). Pooling water had also been noted in this location on the 2021 and 2020 inspections (Figure 57, Figure 58).

**Figure 56: Pooling water above Event Pond 2022**

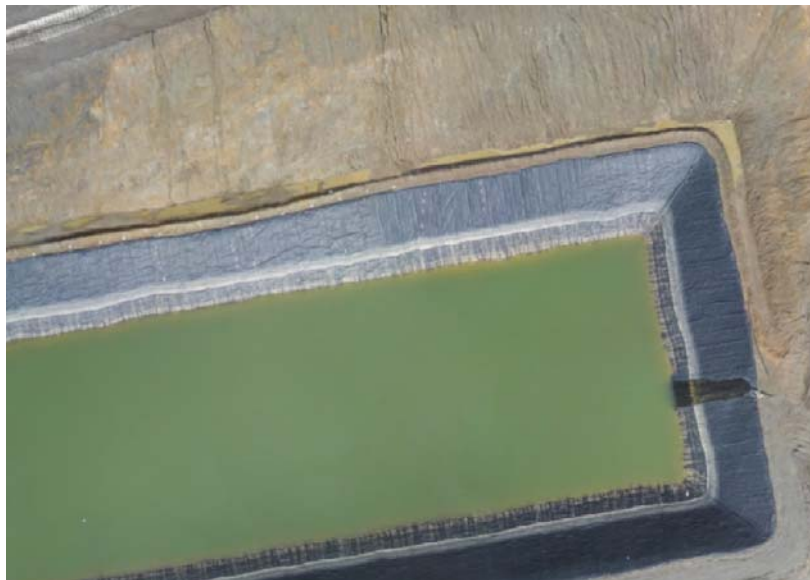
**Figure 58: Pooling water above Event Pond 2020**

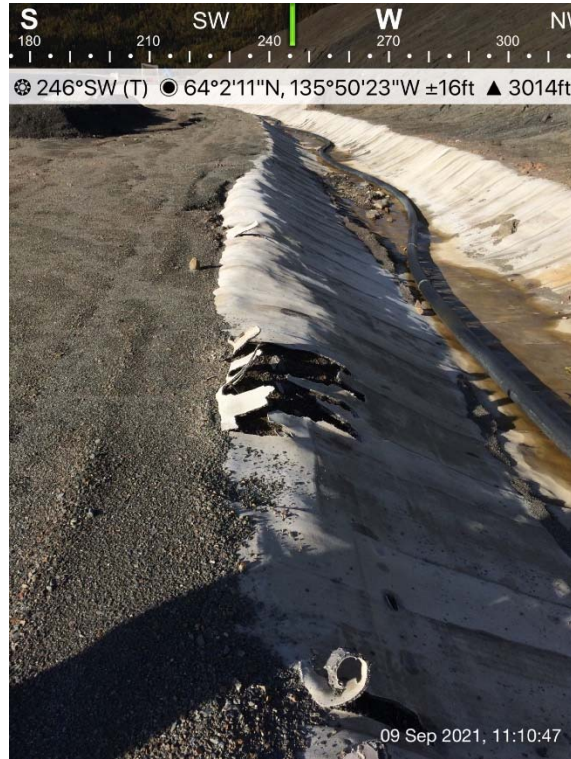
1. As noted in Section 13.1 scouring was observed upslope and downslope of the heap leach spillway, with material being deposited within the spillway. There is also damage to the spillway liner in sections; site representative reported that this was from an excavator clearing the spillway of snow during winter operations. This was noted in the 2021 inspection (Figure 59). At

**Figure 59: Heap leach spillway damage (2021)**

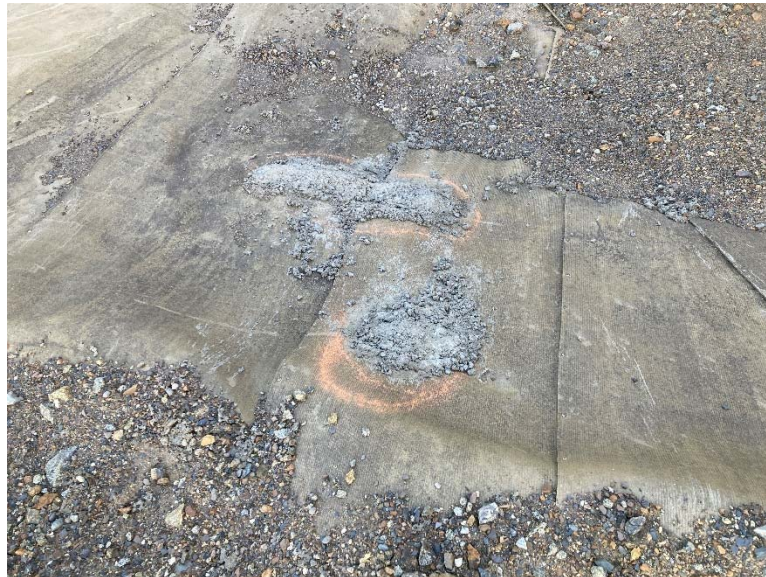
the time of this inspection some of the damage had been repaired (Figure 60) but there were still damaged sections that had not been repaired (Figure 61).

**Figure 60: Heap leach spillway repairs (2022)**

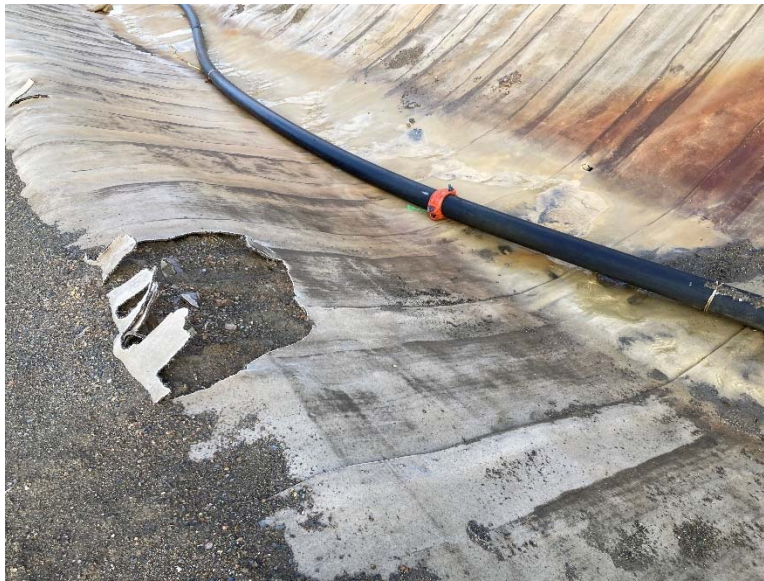
**Figure 61: Heap leach spillway damage (2022)**

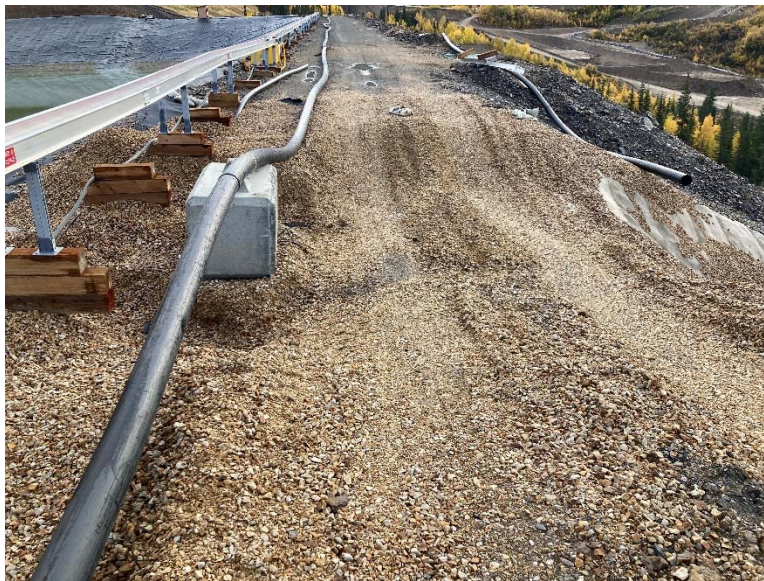
1. The emergency spillway has been temporarily blocked by crushed material by site to provide equipment access to the South-East corner of the pond as there is no other easy equipment access to that area of the pond and crush needed to be placed to prevent damage to the spillway liner (Figure 62).

**Figure 62: Events Pond Emergency spillway crush blockage**
