Allnorth Information		VICTORIA GOLD CORP.	
Project #:	2202179	Client Project #:	
Document #:	221207	Client Document #:	
Document Rev. #:	1	Client Doc. Rev.#:	
Prepared By:	Spencer Bergin, EIT	Client Contact:	Reanna Roberts
Reviewed By:	Don Williams, P.Eng.

Annual Physical Stability Assessment Report – Victoria Gold – Eagle Gold Project

Visual inspection of the following structures: Open Pit, Platinum Gulch Dump, Eagle Pup Dump, Lower Dublin South (Control) Pond, Primary Crusher, Secondary & Tertiary Crushers, Secondary Stockpile, Adsorption, Desorption and Recovery (ADR) Plant, Heap Leach Facility, Heap Leach Overburden Stockpile, Event Pond, Emergency Pond, Ditches A, B, and C, Heavy Duty Truck Shop, Warehouse Pad, Water Treatment Plant, Orica Laydown, Various Un-named Stockpiles.

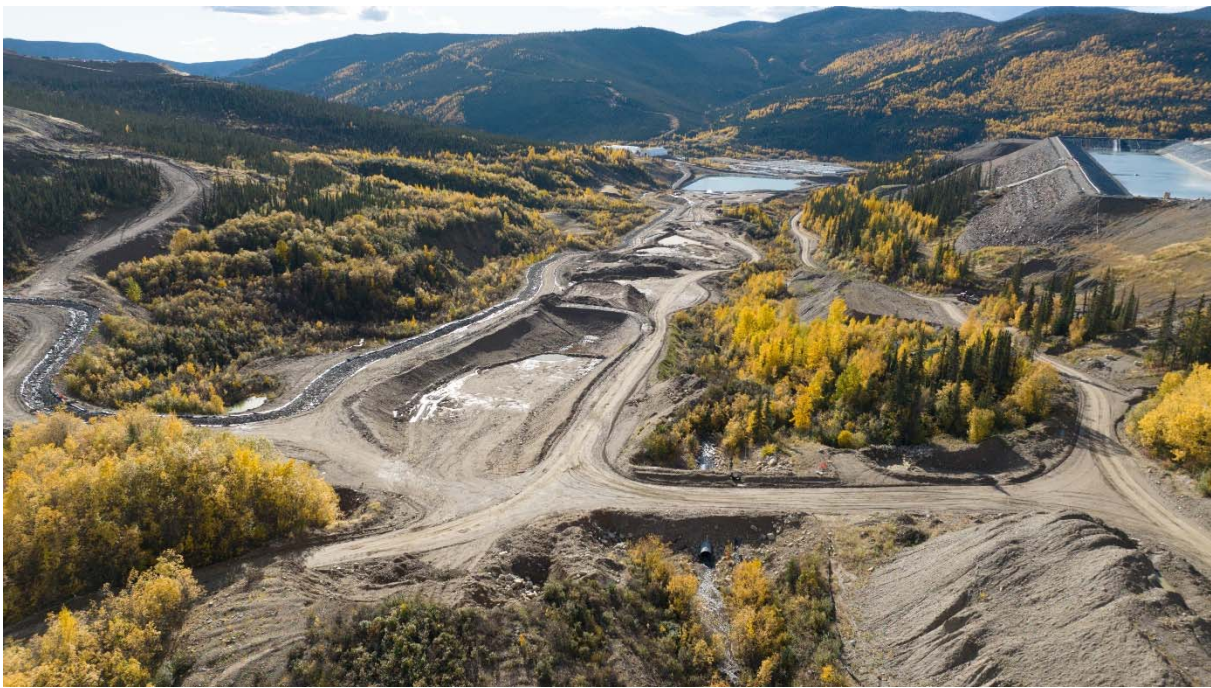
1. Between the 2021 and 2022 inspections an emergency pond was partially constructed to the East of the LDSP. At the time of this inspection the earthworks were mostly complete, lining had not been installed (Figure 63, Figure 64).

**Figure 63: Emergency Pond (Aerial view)**

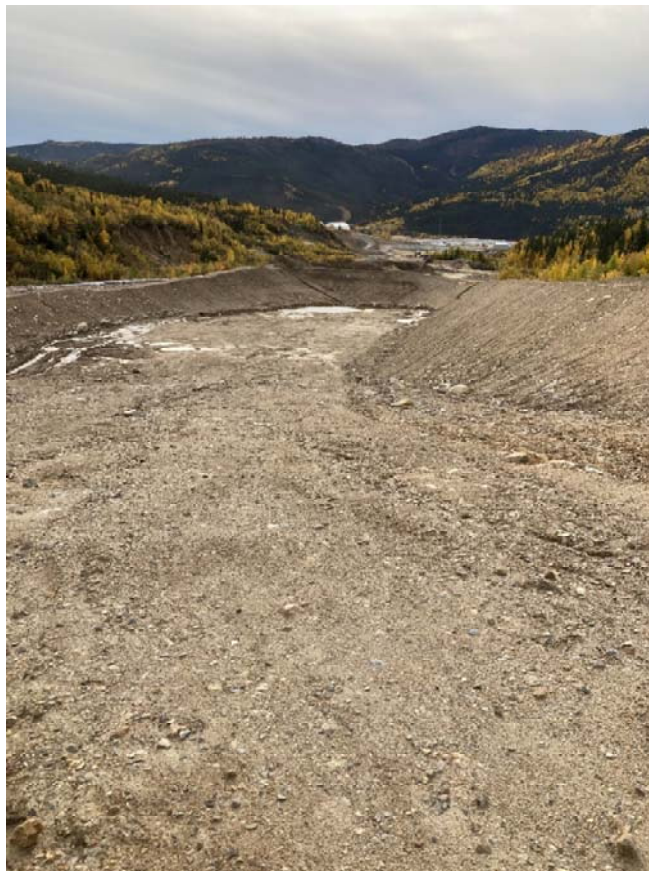
**Figure 64: Emergency Pond**

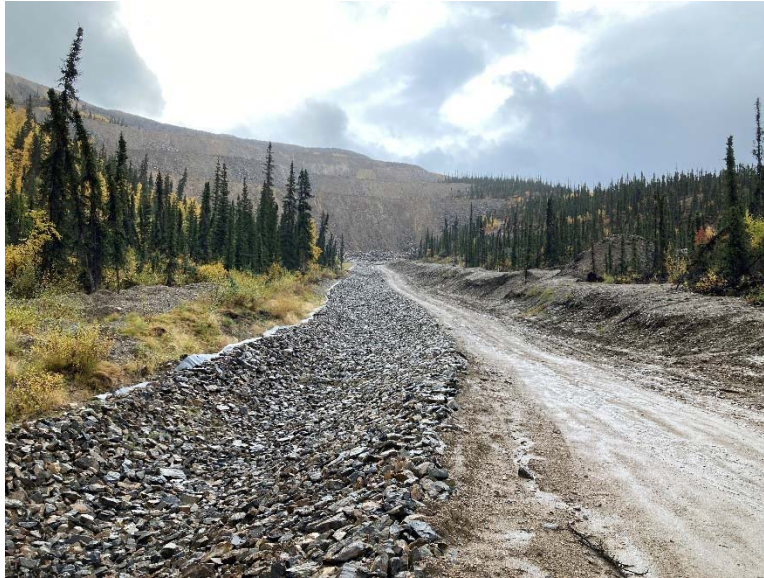
1. Ditch A carries flow from the Platinum Gulch Dump down to the Control Pond (Figure 65). The ditch was completed at the time of the 2021 inspection.

**Figure 65: Ditch A (Base of Platinum Gulch Dump)**

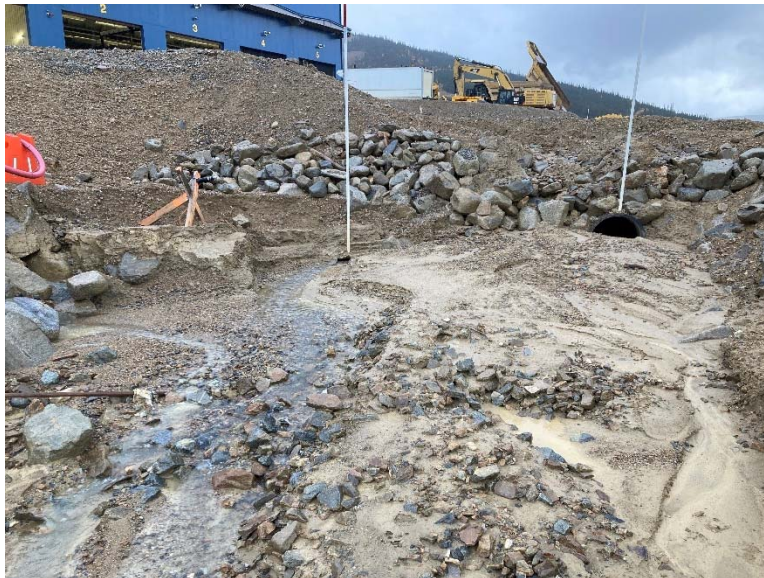
2. A culvert for a road crossing near the new Truck shop was observed to be almost completely buried (Figure 66). The secondary culvert was also partially submerged in material.

**Figure 66: Ditch A culvert blocked**

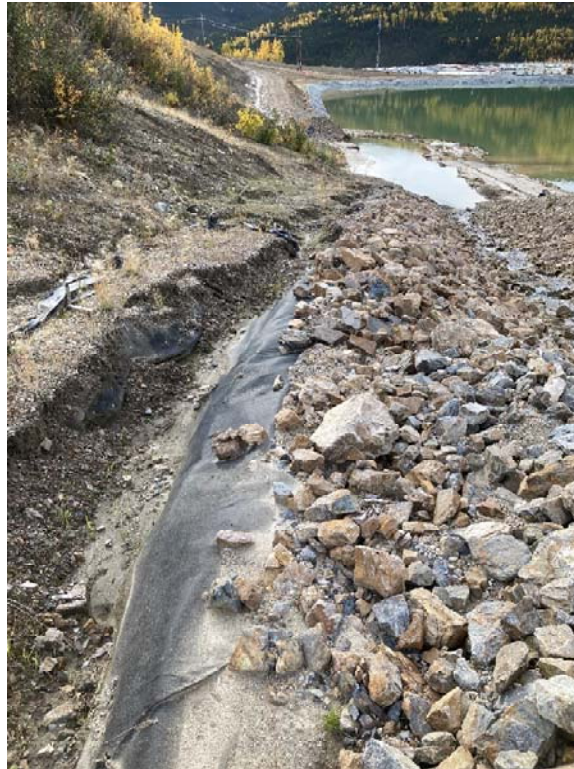
1. Ditch B was completed by the time of the 2021 inspection. Erosion was observed to have created a channel next to Ditch B near the outlet into the LDSP (Figure 67).

**Figure 67: Ditch B Erosion (view towards LDSP)**

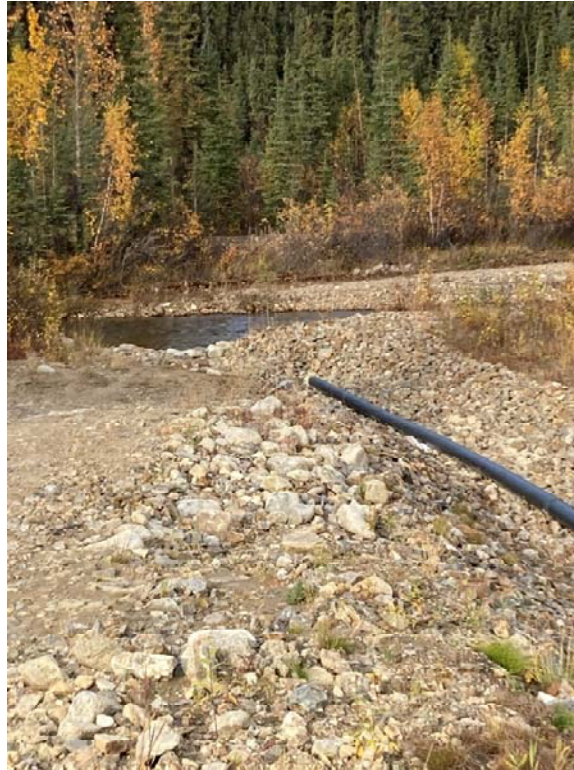
1. Diversion Ditch C begins at the 1500mm outlet culvert for the Control Pond and terminates in Haggart Creek. This ditch acts as both an emergency spillway if the Control Pond is filled over capacity or a conveyance channel for water released from the control pond through the low level outlet. At this point Ditch C is not in use as water from the LDSP is being pumped direct to the outlet of Ditch C at Haggart Creek when LDSP water levels are high enough (Figure 68, Figure 69). Once the Water Treatment Plant is operational this water will be diverted for treatment before discharge.

**Figure 68: Ditch C Outlet (LDSP Pipeline Discharge)**

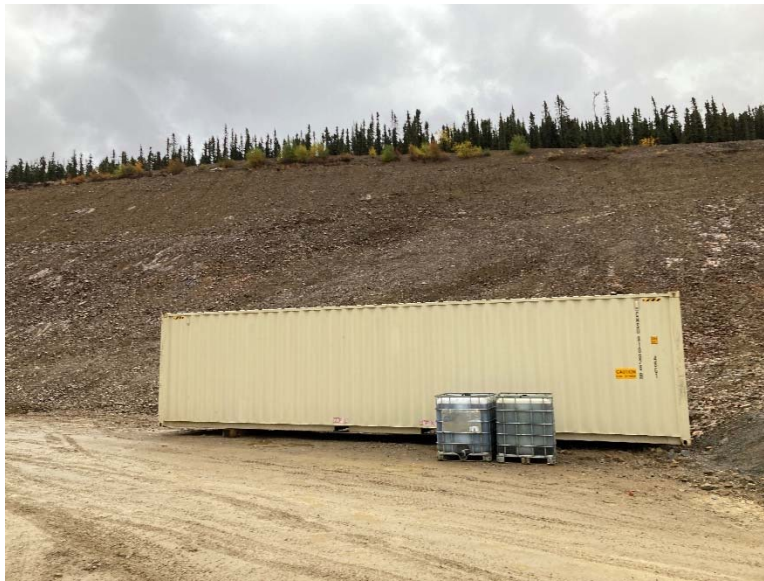
1. The heavy duty truck shop was under construction during the 2021 inspection and completed at the time of this inspection. Some minor rilling was present on the cut slope behind the truck shop (Figure 70).

**Figure 70: Truck Shop cut slopes**

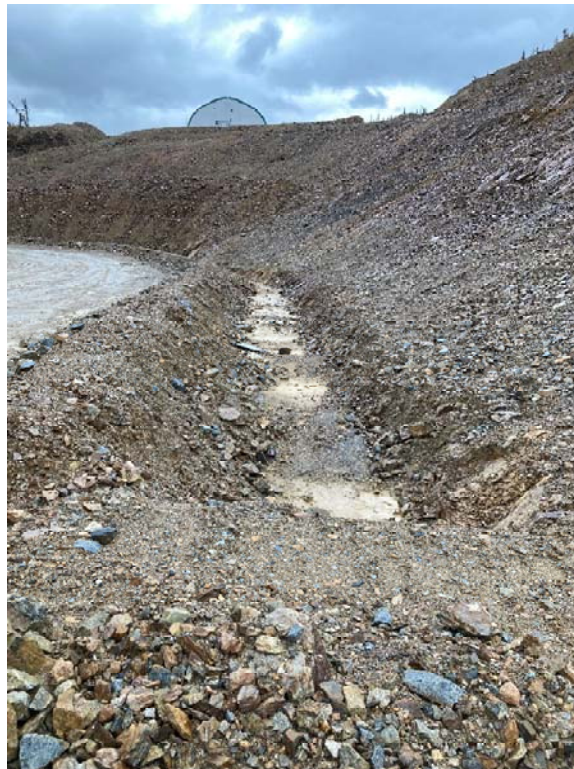
2. A drain ditch had been cut around the base of the cut slope (Figure 71) but it does not tie into any other ditching, as it is blocked with material (Figure 72).

**Figure 71: Truck Shop Drain Ditch**

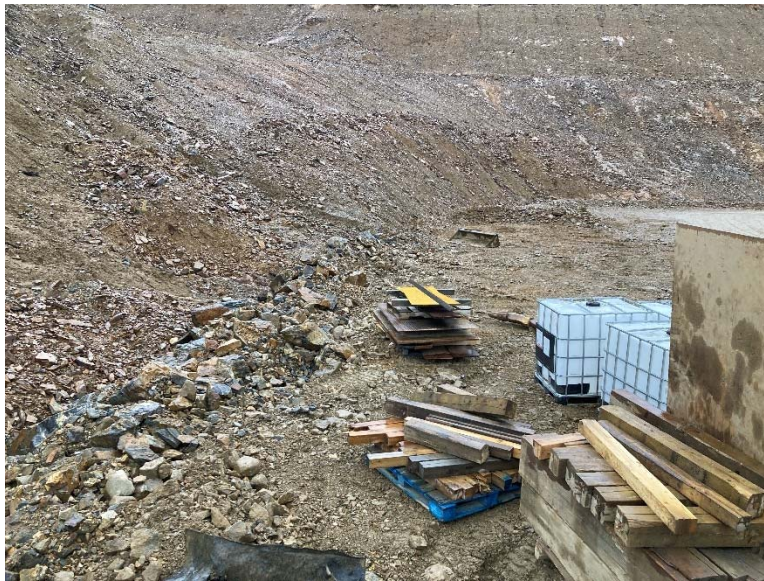
**Figure 72: Truck Shop Drain Ditch Blockage**

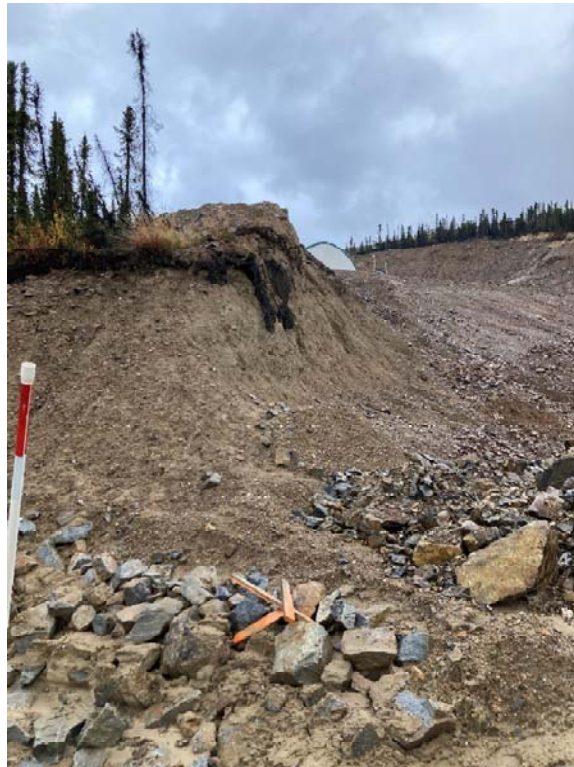
3. There is a section of over-steepened cut slope near the North-West corner of the truck shop pad. Material can be seen collecting at the base of the over steepened slope (Figure 73).

**Figure 73: Over Steepened Slope – Truck Shop**

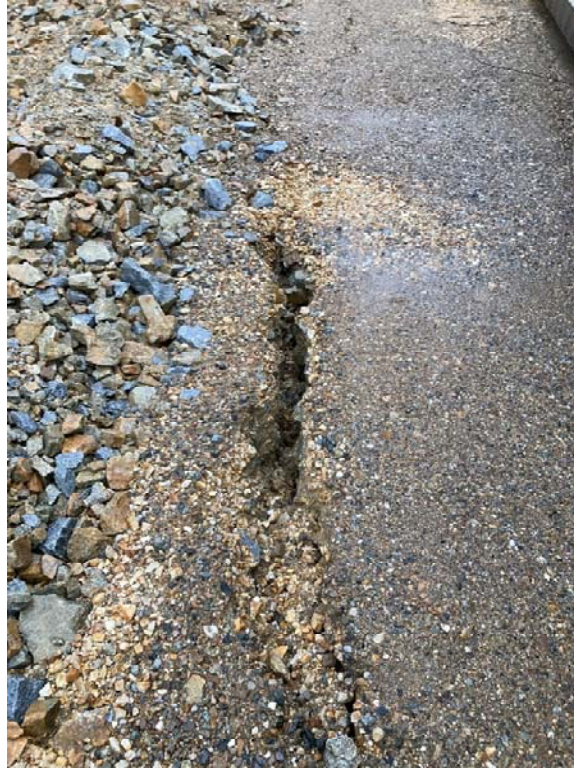
1. The warehouse pad is located South of the camp and mine admin areas. Cracking was observed at the crest of the slope off the warehouse pad as shown in Figure 74 and Figure 75.

**Figure 74: Cracking – Warehouse Pad**

1. Monitor cracking behind the warehouse pad. Come up with a solution to re-work slope below warehouse pad to eliminate cracking issue.

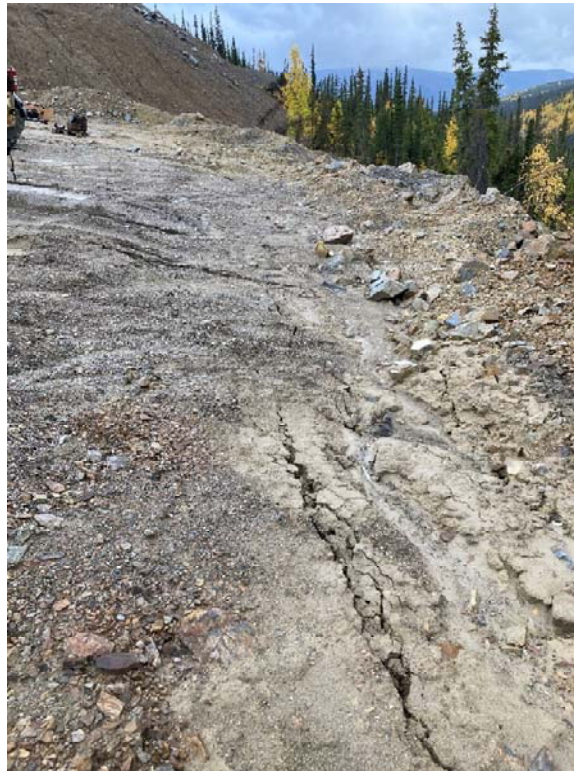
**Figure 75: Cracking – Warehouse Pad**

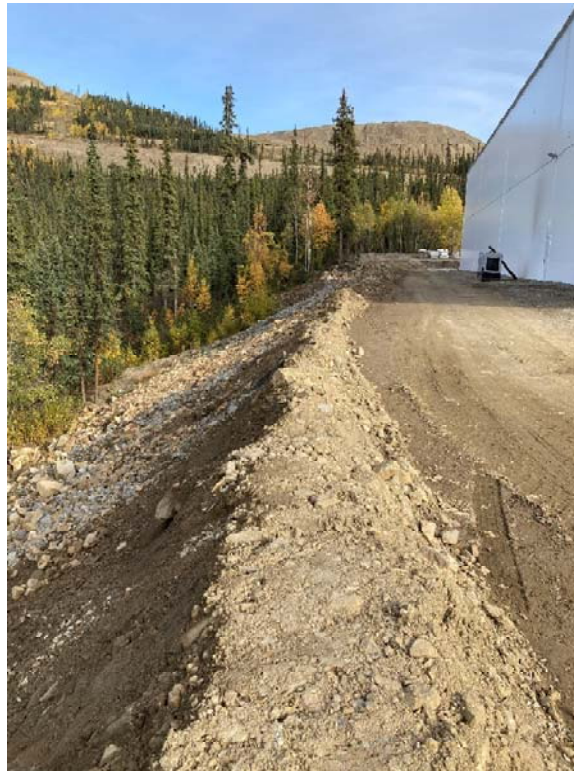
1. A water treatment plant was under construction at the time of this inspection, adjacent to Ditch C. Slopes surrounding the water treatment plant pad appear stable (Figure 76).

**Figure 76: Water Treatment Plant Slopes**

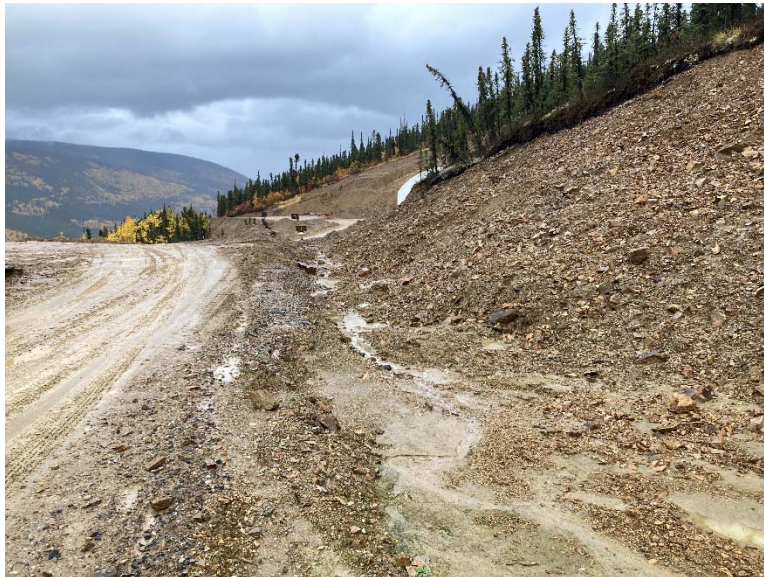
1. An unlined, unarmored ditch from the portable structures of the laydown has pools of sediment (Figure 77) but the overall grade of the ditch continues to flow to the sump (Figure 78) uninterrupted.

**Figure 77: Orica ditch sediment build-up**

1. Monitor perimeter sump for flow interruptions/blockages and consider re-trenching if pooled water observed.
2. Consider re-sloping area behind Orica site trailer to prevent further sediment build-up, remove existing build-up.

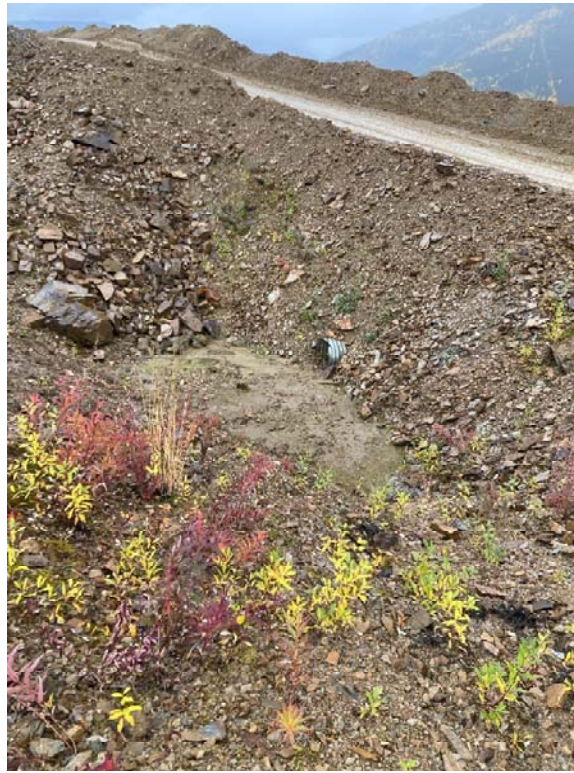
**Figure 78: Orica ditch sump & drain culvert**

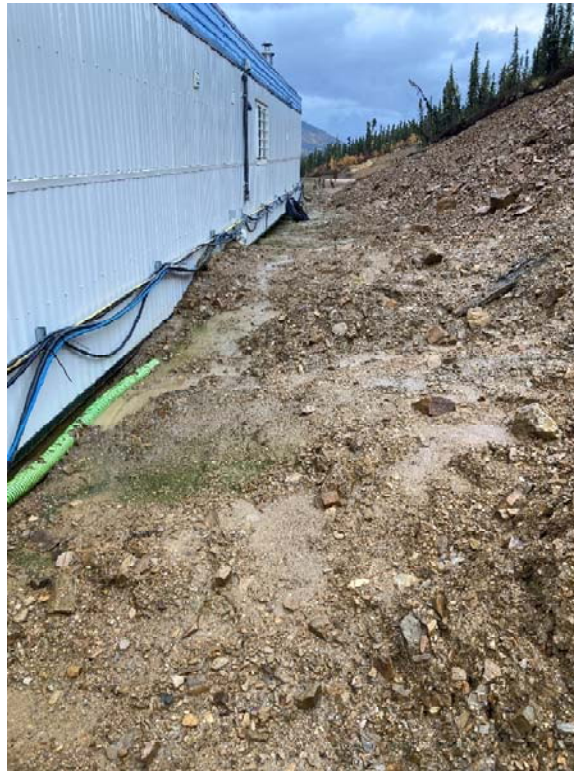
**Figure 79: Orica site trailer sediment build-up**

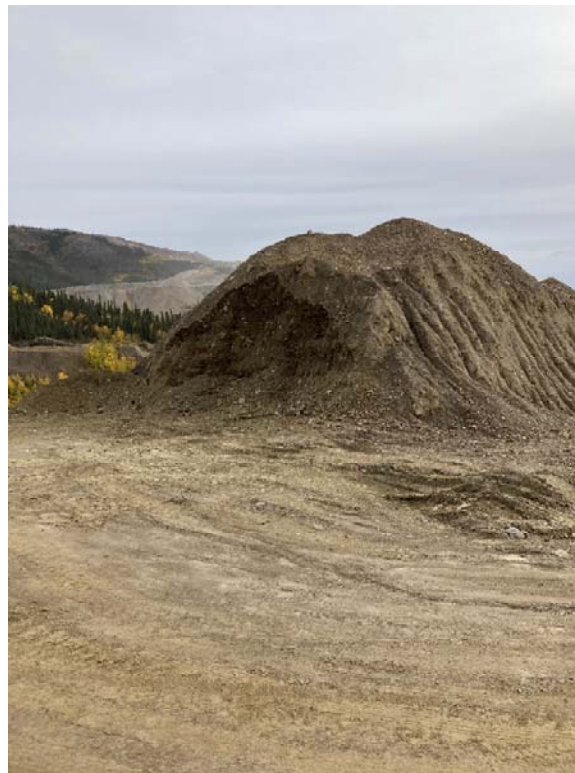
**Figure 80: Some stockpiles with steep side slopes**

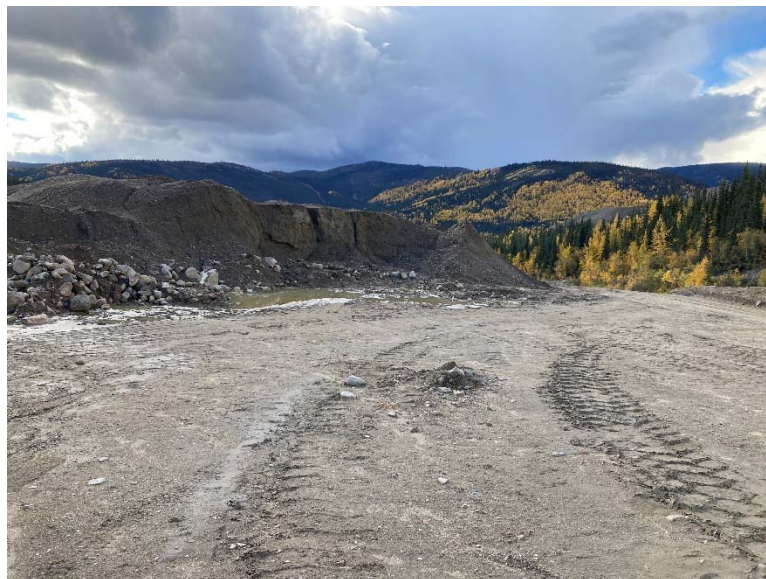
**Figure 81: Additional stockpiles with steep side slopes**
