Allnorth Information		VICTORIA GOLD CORP.	
Project #:	2302851	Client Project #:	
Document #:	2302851-800-001	Client Document #:	
Document Rev. #:	0	Client Doc. Rev.#:	
Prepared By:	Spencer Bergin, P.Eng.	Client Contact:	Hugh Coyle
Reviewed By:	Don Williams, P.Eng.

Annual Physical Stability Assessment Report – Victoria Gold – Eagle Gold Project

Visual inspection of the following structures: Open Pit, Platinum Gulch Dump, Eagle Pup Dump, Lower Dublin South (Control) Pond, Primary Crusher, Secondary & Tertiary Crushers, Secondary Stockpile, Adsorption, Desorption and Recovery (ADR) Plant, Heap Leach Facility, Heap Leach Overburden Stockpile, Event Pond, Emergency Pond, Ditches A, B, and C, Heavy Duty Truck Shop, Warehouse Pad, Water Treatment Plant, Orica Laydown, Various Un-named Stockpiles.

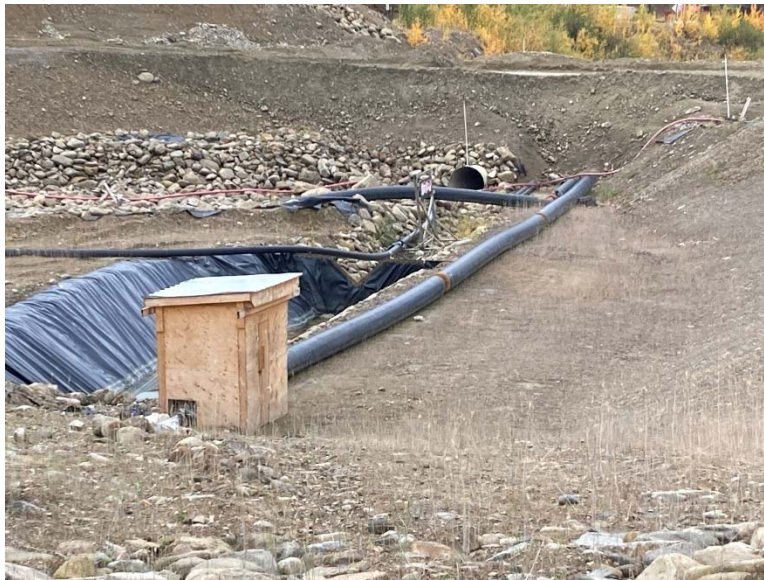
Figure 1: LDSP – Low Level Outlet Conveyance Channel

The low level outlet conveyance channel from the Lower Dublin South Pond (LDSP) is currently not in use, as water is being pumped direct from the LDSP to the Water Treatment Plant. Currently the channel is dry and unused (Figure 1).

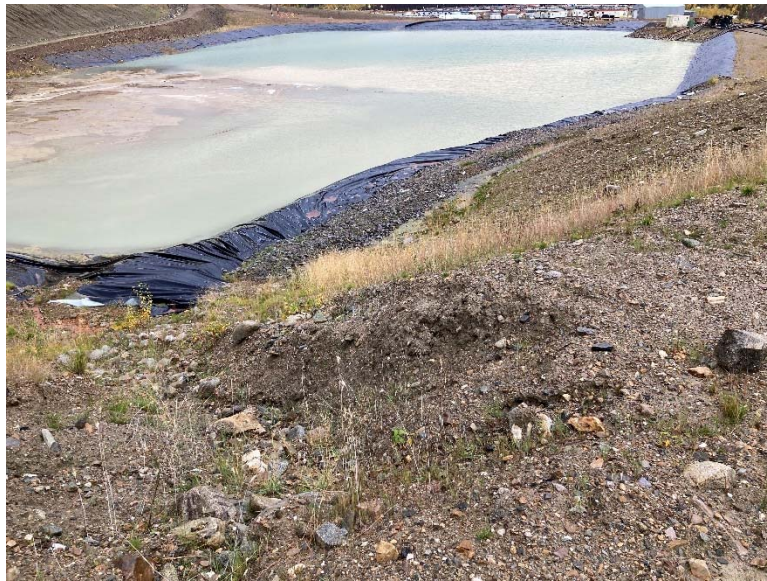
**Figure 6: Erosion above the LDSP**

3. There was an area above the North-East corner of the LDSP where erosion had worn a channel into the cut slope (Figure 6). Some material appeared to have been washed out over the liner and into the pond further downstream from the initial cut (Figure 7).

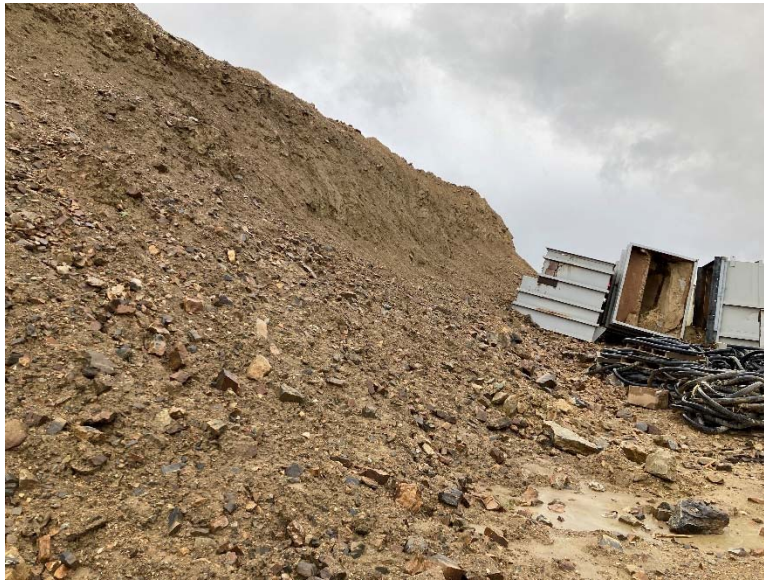
**Figure 8: Secondary Stockpile Cut Slopes 2022**

1. The Secondary Stockpile (also known as the 90 Day Stockpile) was completed in 2020. Some over-steepened cut slopes were observed during the 2021 inspection where the slopes had begun to slough/erode and material was collecting at the base of the slope, and this was also the case during the 2022 inspection (Figure 8). Since the previous inspection a ditch was cut behind the stockpile laydown area and partially lined with rock. The cut slopes above the ditch were over-steepened (Figure 9) and there were areas where material was sloughing out of the slope (Figure 10).

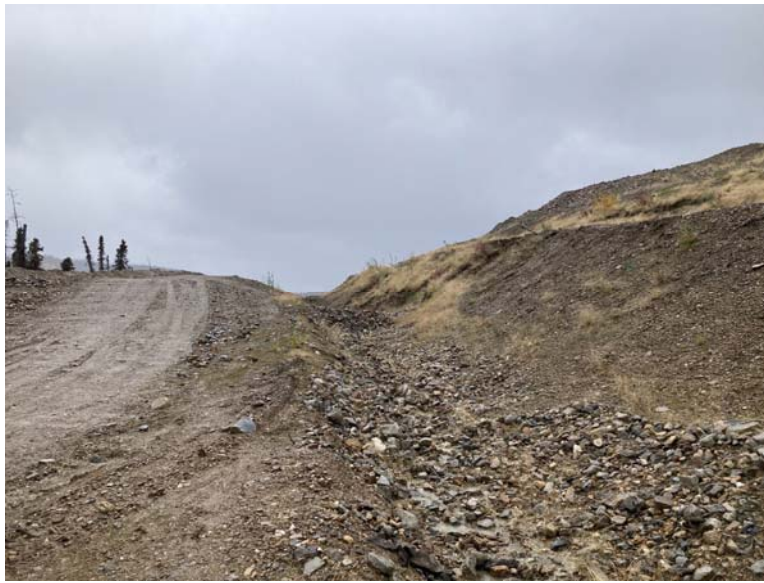
**Figure 11: Perimeter Ditching 2023**

1. A perimeter interception ditch extends around the downhill toe of the Secondary Stockpile area. Issues noted in the 2020 inspection including over-steepened and sloughing slopes on the interception ditch appear to have since been addressed. The ditch appears in good condition as of this years inspection (Figure 11).

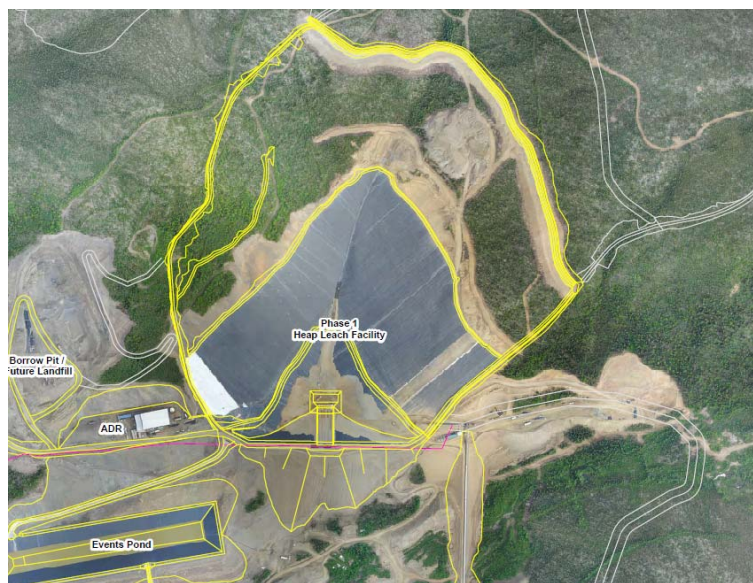
**Figure 14: Heap Leach Facility Overview 2019**

1. The Heap Leach Facility (HLF) is currently operational. In 2019 the Phase 1A expansion had been constructed as shown in Figure 14. By the time of the 2020 inspection the Phase 1B expansion was largely complete as shown in Figure 15. During the 2021 inspection land was being cleared and graded for the Phase 2 expansion as shown in Figure 16, and for the 2022 inspection liner was installed on part of the cleared area (Figure 17). The Phase 2 expansion was complete as of this years inspection (Figure 18).

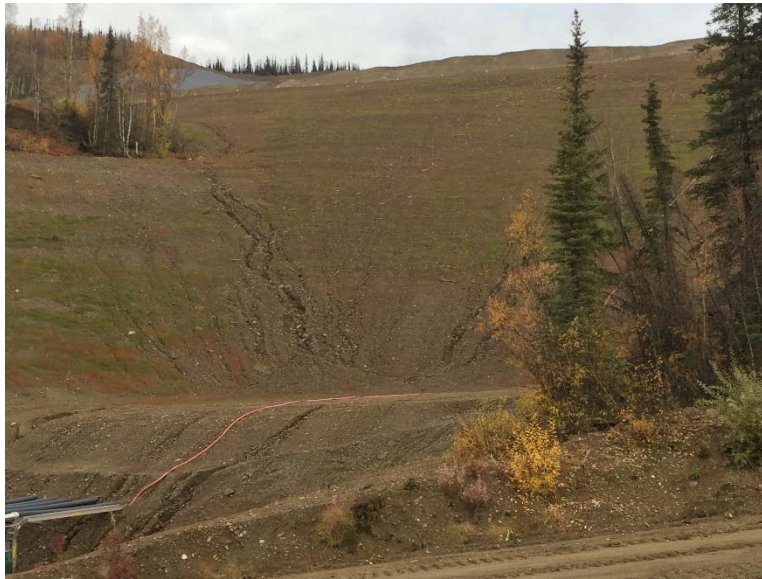
**Figure 19: Rilling along toe slope of HLF (2020)**

1. Some rilling was noted along the toe slope below the HLF and above the un-named stockpile area and HLF Underdrain Monitoring Vault in the 2020 inspection (Figure 19). The slope has since been seeded and there appears to be less erosion of material off the toe slope as inspected in 2021 and 2022 (Figure 20). Some erosion was noted in the less seeded area of the toe slope adjacent to the event pond spillway (Figure 21).

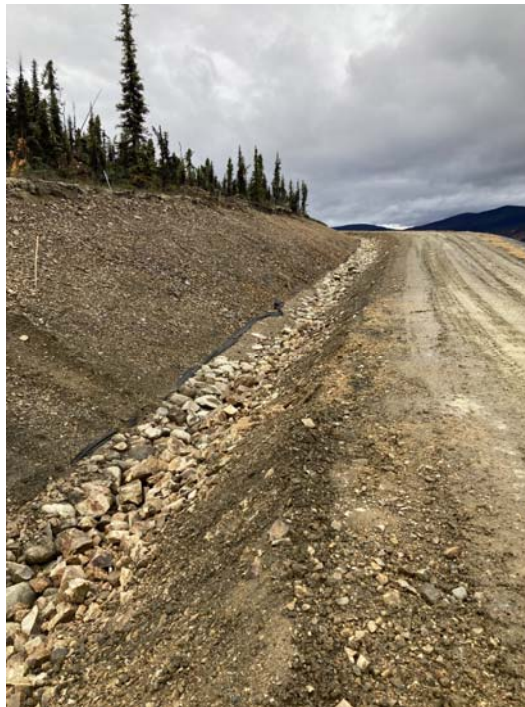
**Figure 22: HLF Interception Ditch (2023)**

1. The HLF interception ditch was constructed before the 2023 inspection. The ditch appears to be in good condition (Figure 22).

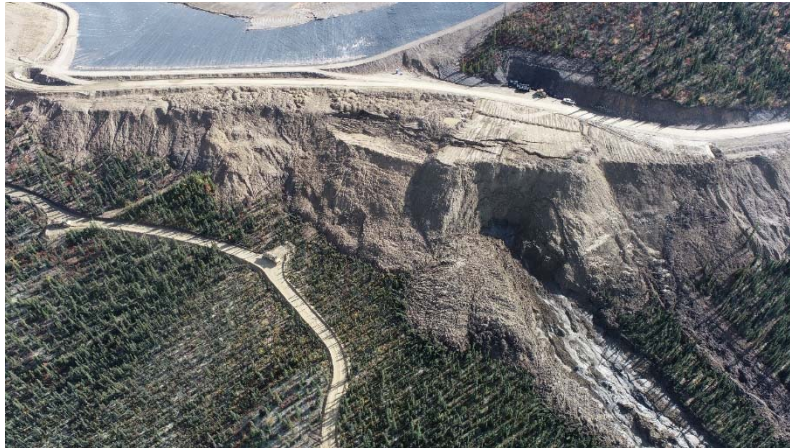
**Figure 23: HLF Overburden Stockpile collapse – plan view 2021**

shifted and partially collapsed some time in the late summer of 2021, roughly 4 – 5 weeks prior to the 2021 inspection (Figure 23). Since the 2021 inspection the collapsed area has been re-sloped (Figure 24, Figure 25). Some minor cracking was noted on the re-sloped surface (Figure 26). The area had also been seeded with grass by helicopter and the grass was starting to sprout at the time of this inspection.

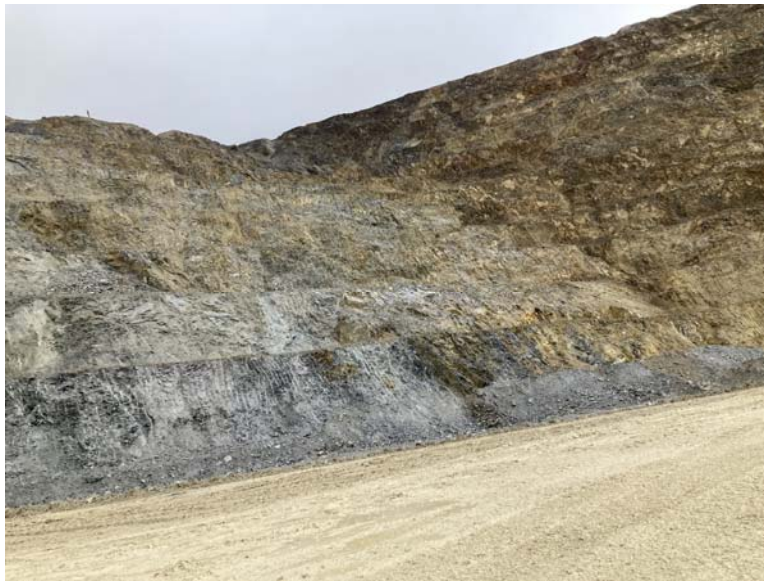
**Figure 27: Open Pit Walls**

1. The pit walls appear stable, and largely constructed in competent rock (Figure 27). There are some areas where localized sloughing and rockfall had occurred (Figure 28).

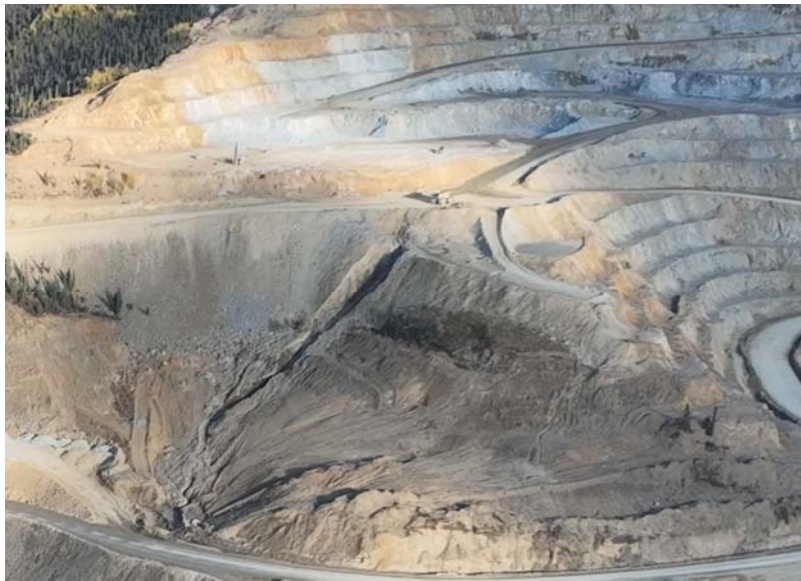
**Figure 29: Open Pit Erosion – Aerial View 2022**

2. There is a section between the open pit and the eagle pup dump where run-off had eroded a cut into the slope above the primary crusher access road prior to the 2022 inspection (Figure 29). The cut is still present but appears to have partially collapsed in on itself (Figure 30).

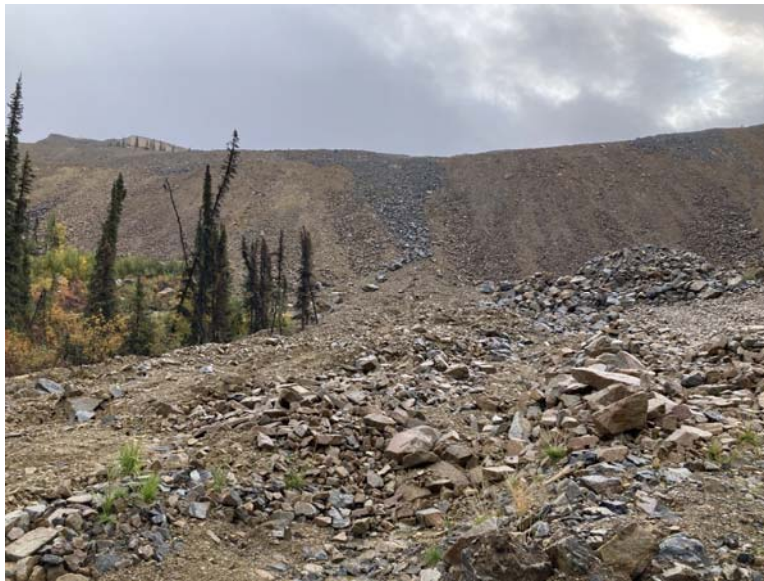
**Figure 31: Platinum Gulch Dump (Base)**

1. Waste rock deposition in the Platinum Gulch Dump is considered complete, and the side slopes generally appear to be stable. See Figure 31 and Figure 32 below.

2. Some sections of pooling water and cracking were noted on the first level of the dump in 2022 (Figure 33, Figure 34). In the spring of 2023 this area experienced surficial erosion of finer grained material from the crest of the bench (Figure 35, photo provided by site, photo dated May 20<sup>th</sup> 2023) but the affected area was repaired by the time of this inspection (Figure 31, Figure 32)

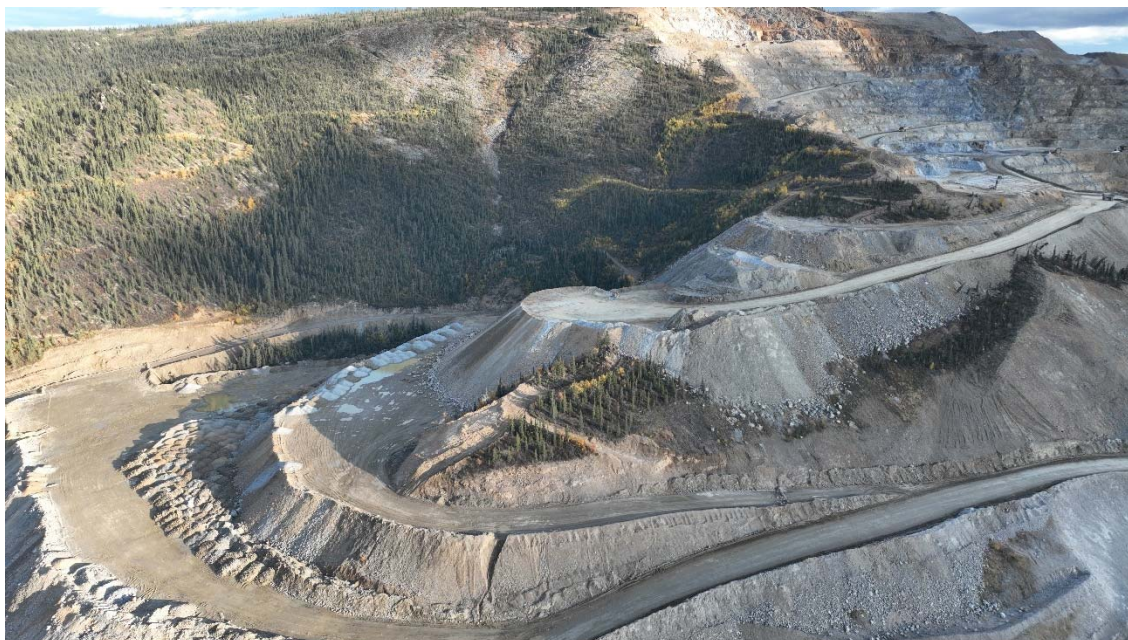
**Figure 36: Eagle Pup Dump 2022 (Aerial View)**

1. The Eagle Pup Dump was under construction during the 2021 inspection, with drain rock being placed at the base of the slope. Aerial photos of the dump from 2022 and 2023 can be seen in Figure 36 and Figure 37.

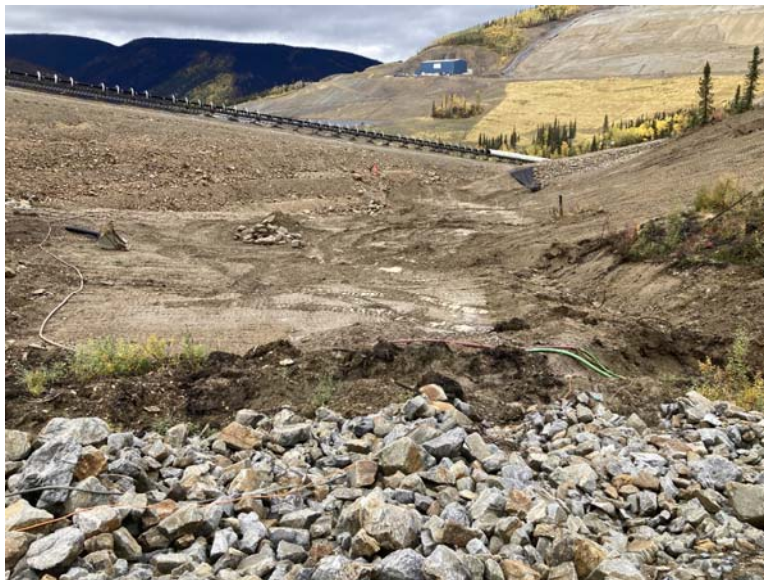
**Figure 38: Eagle Pup Dump Rock Drain**

2. Construction of the rock drain at the base of the Eagle Pup Dump continued at the time of this inspection. Ultimately, the drain will connect to Ditch B via an existing culvert that is present within the fill slope of the overland conveyor (the culvert mouth location is flagged in Figure 38). Flows currently passing through the rock drain follow the exiting topography to Ditch B.

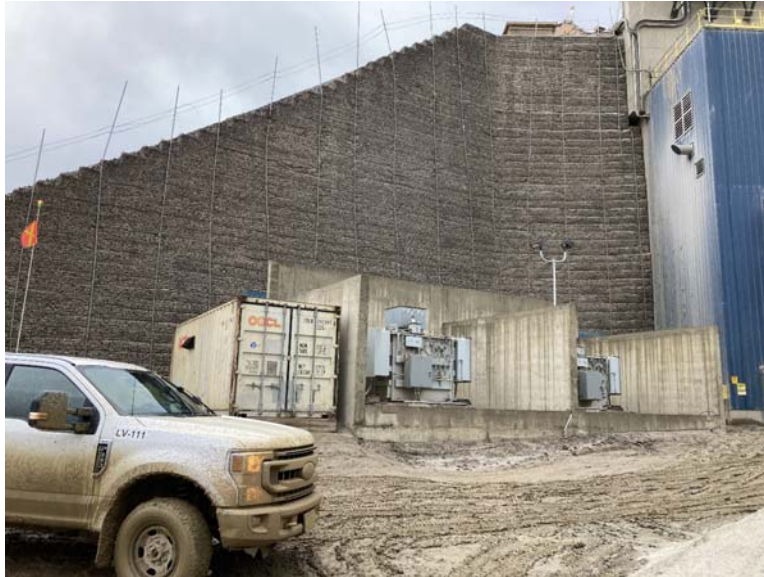
**Figure 39: Primary Crusher North-West Wall**

1. No apparent damage or deterioration was noted during the inspection of the Primary Crusher MSE wall (Figure 39, Figure 40). No changes were visually identified from the 2022 inspection.

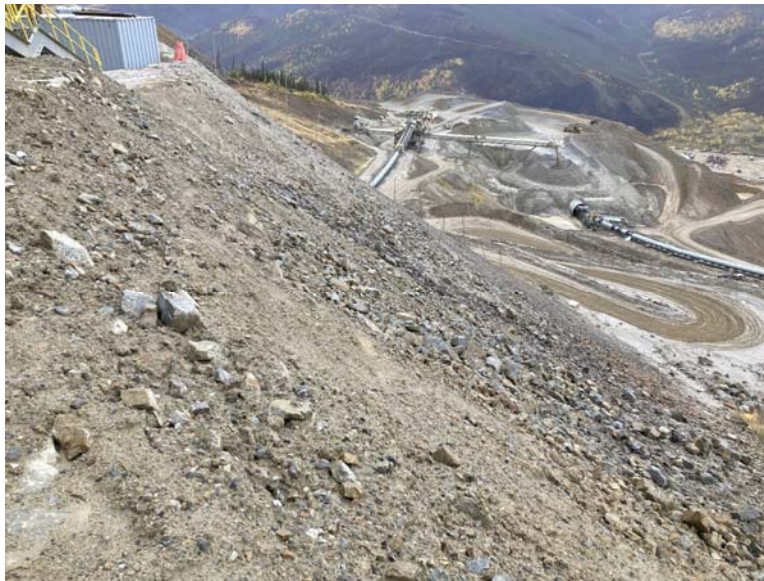
**Figure 41: North-West fill slopes**

1. Cut and fill slopes appear to be acceptable, no stability or erosion issues noted. (Figure 41).

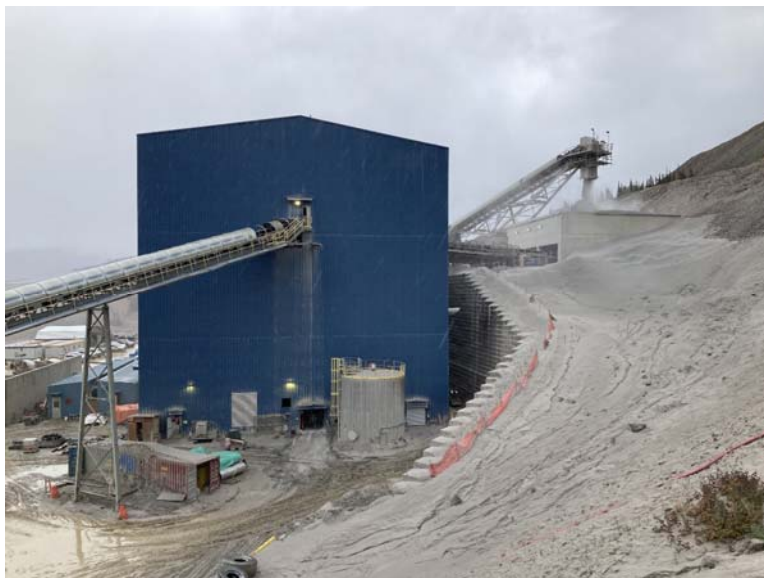
**Figure 42: South side of MSE wall**

1. No apparent damage or deterioration was noted during the inspection of the Secondary/Tertiary Crusher MSE wall (Figure 42). No changes were visually identified from the 2022 inspection.

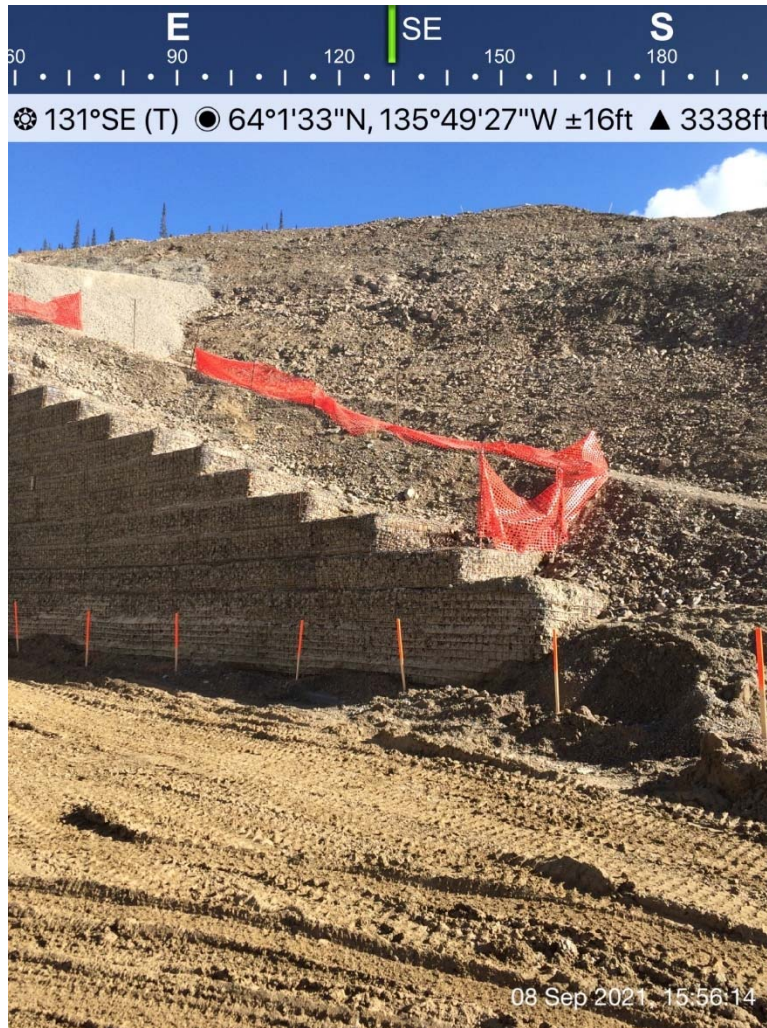
**Figure 43: Cut slopes above Secondary/Tertiary Crusher 2021**

1. There has been an accumulation of fine sediment on the South slope above the MSE wall, likely from dust coming off the crusher transfer conveyor. Photos taken during the 2021 inspection (Figure 43) show a relatively clear slope, photos taken during the 2022 inspection show the silt build-up since the previous inspection (Figure 44), and the build-up was still present as of this years inspection (Figure 45).

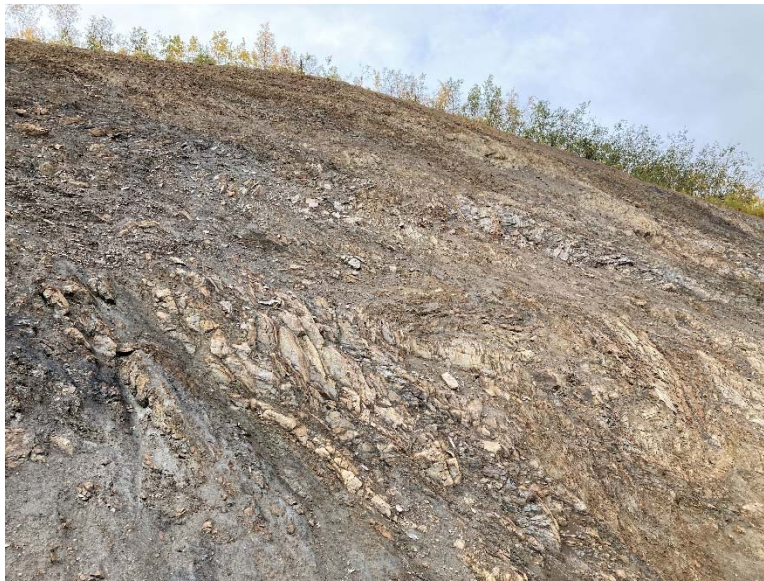
**Figure 46: Slopes behind ADR (2023)**

1. Cut slopes behind the ADR area appear to be competent rock, with some minor rilling and unraveling (Figure 46)

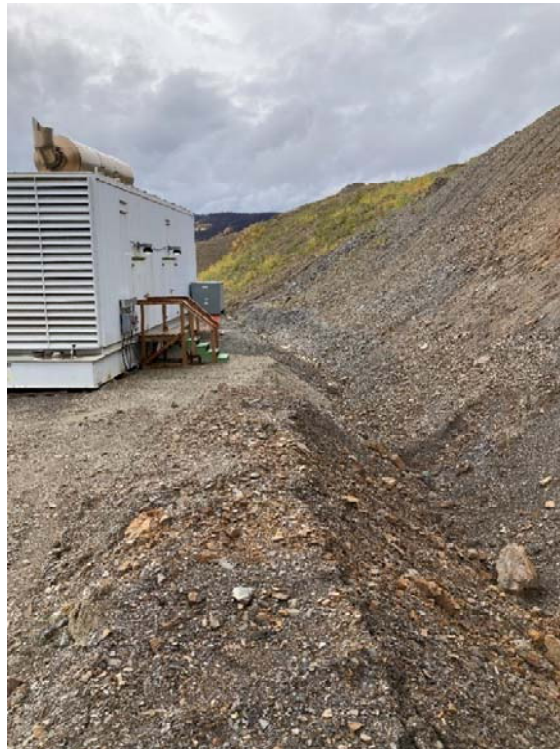
**Figure 47: Typical North Toe Ditch cross section**

1. There is a small V ditch, referred to here as the North Toe Ditch (Figure 47), with sides close to 1:1 cut at the base of a large steep slope which is cut into bedrock; the ditch is not armored and contains loose gravel and fines, although there are no apparent scouring issues. There is also a culvert which has been installed along the ditch alignment.

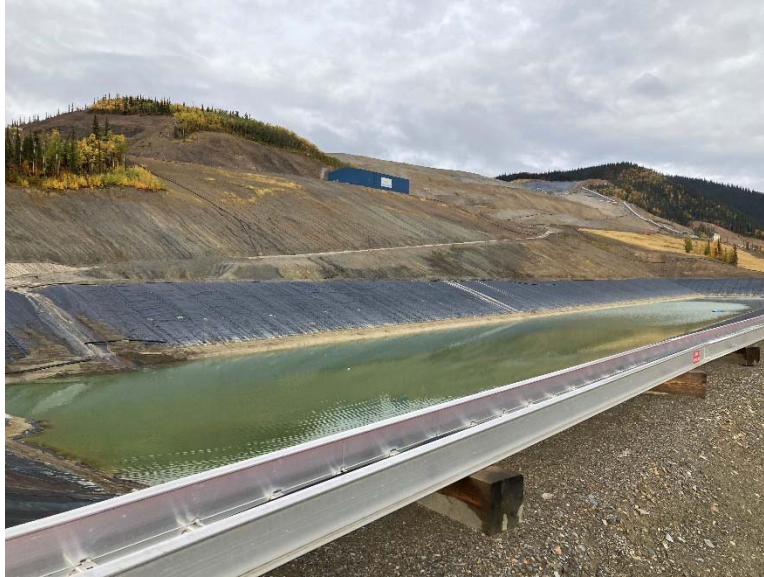
**Figure 48: Overall view of event pond**

1. The event pond was constructed between the 2018 and 2019 inspections, with hillslope unraveling noted in the 2019 inspection.

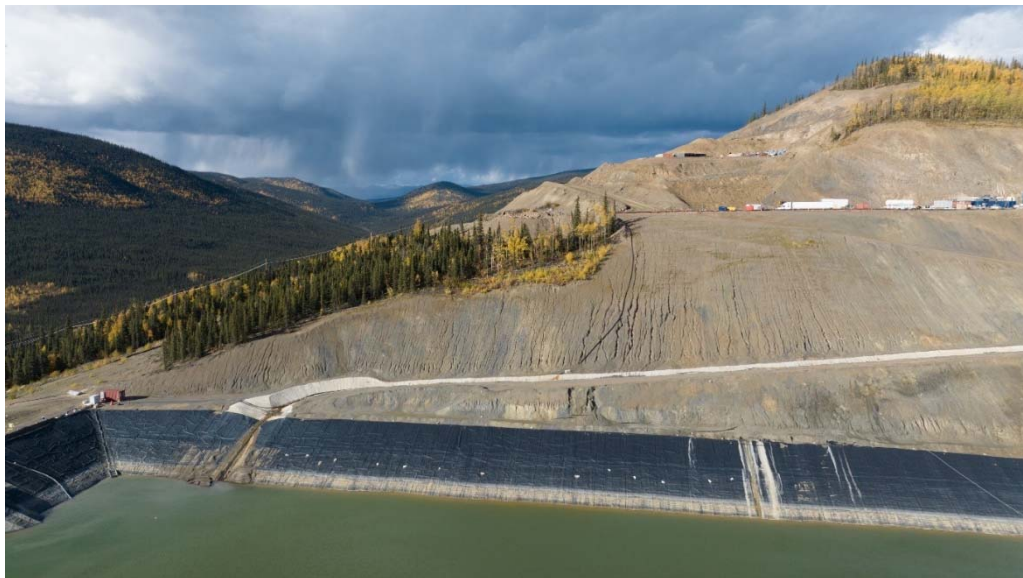
**Figure 49: Rill erosion above HLF spillway (2022)**

2. Rill erosion channels on the cut slopes above the event pond and the heap leach spillway were present in the previous inspection and noted in this inspection as shown in Figure 49 and Figure 50.

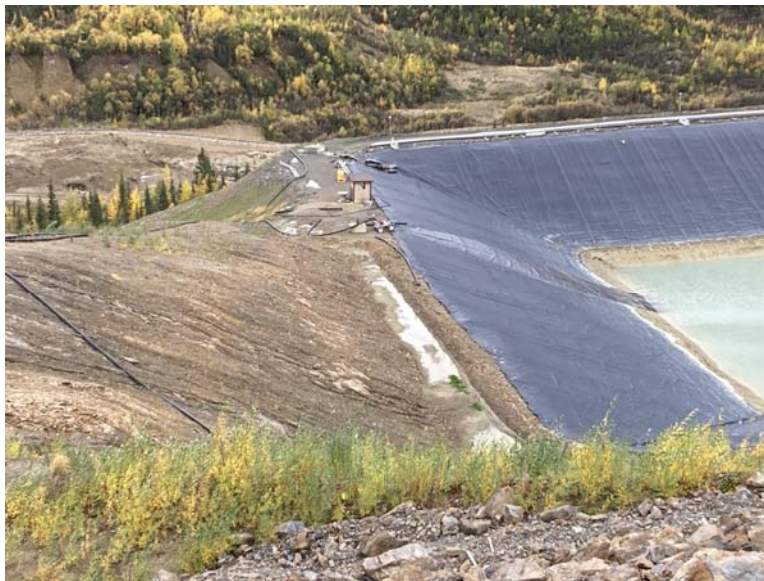
**Figure 51: Pooling water above Event Pond 2023**

1. Pooling water appeared to be forming above the North-East corner of the Event Pond at the time of this inspection (Figure 51). Pooling water had also been noted in this location on the 2022, 2021, and 2020 inspections (Figure 52, Figure 53, Figure 54).

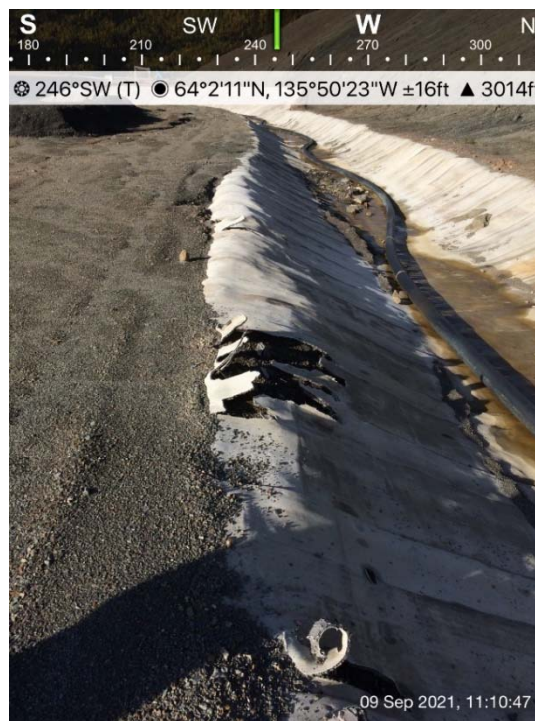
**Figure 55: Heap leach spillway damage (2021)**

1. As noted in Section 13.1 rilling was observed upslope and downslope of the heap leach spillway, with material being deposited within the spillway. There is also damage to the spillway liner in sections; site representative reported that this was from an excavator clearing the spillway of snow during winter operations. This was noted in the 2021 inspection (Figure 55). At the time of this inspection most of the damage had been repaired (Figure 56).

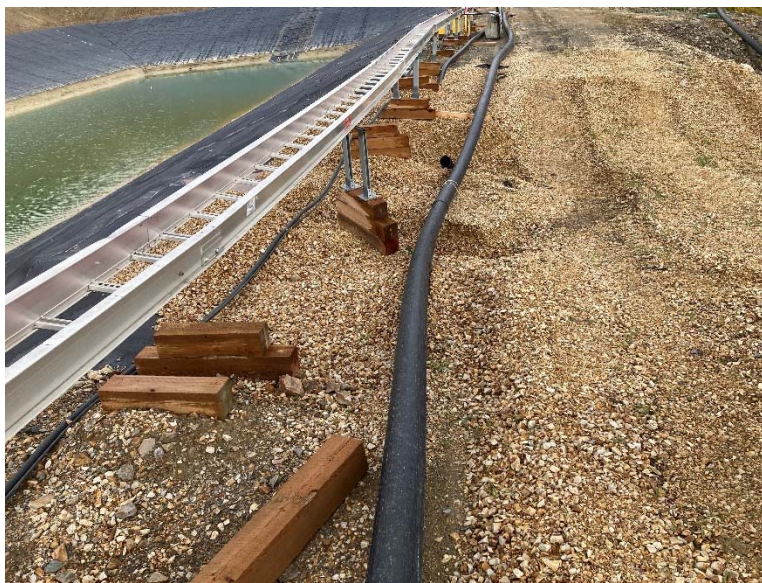
**Figure 57: Events Pond Emergency spillway crush blockage**

1. Crushed material was observed in the emergency spillway to provide equipment access to the South-East corner of the pond as there is no other easy equipment access to that area of the pond and crush needed to be placed to prevent damage to the spillway liner (Figure 57).

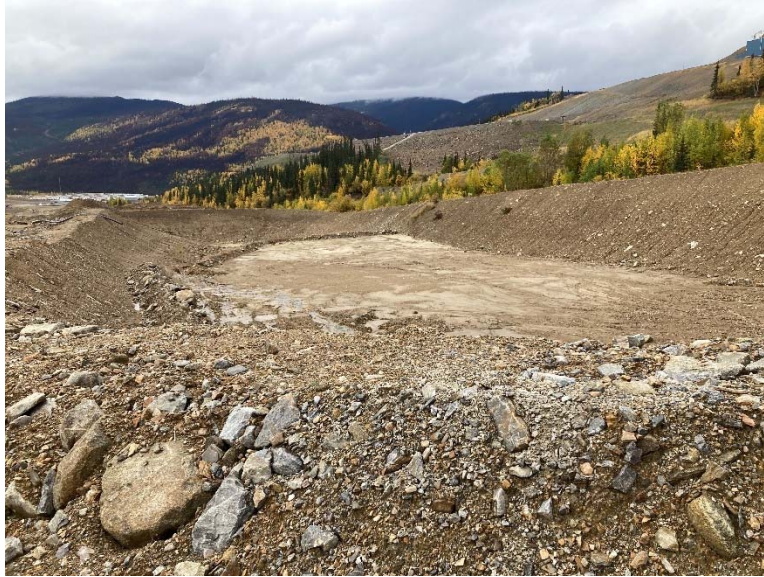
**Figure 58: Emergency Pond**

1. Between the 2021 and 2022 inspections an emergency pond was excavated to the East of the LDSP. At the time of this inspection the earthworks were mostly complete, however per the client there are no immediate plans to complete the structure (Figure 58, Figure 59).

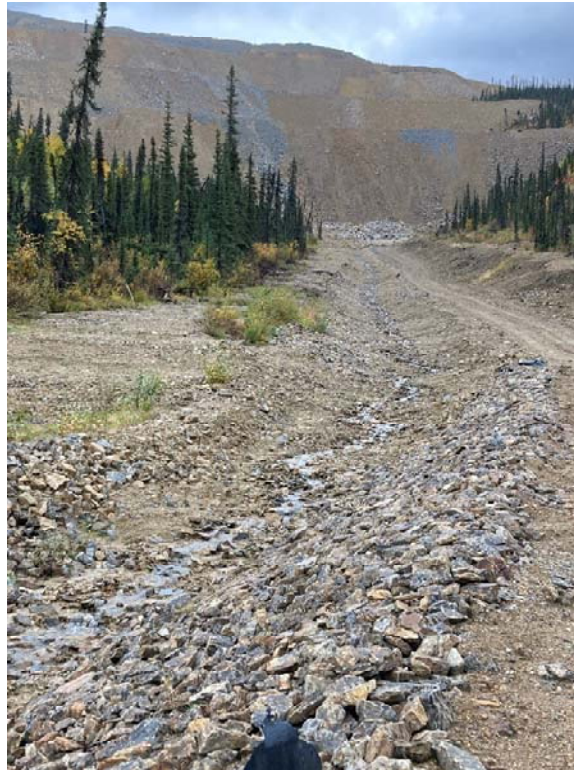
**Figure 60: Ditch A (Base of Platinum Gulch Dump)**

1. Ditch A carries flow from the Platinum Gulch Dump down to the Control Pond (Figure 60). The ditch was completed at the time of the 2021 inspection.

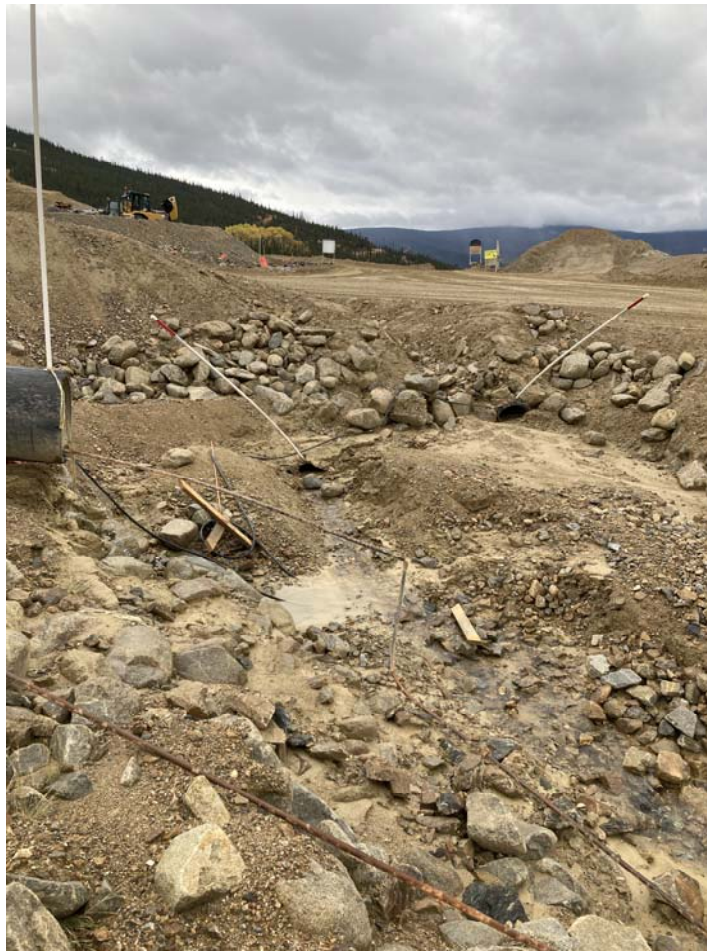
**Figure 61: Ditch A culvert blocked (2023)**

2. A culvert for a road crossing near the new Truck shop was observed to be almost completely buried. The secondary culvert was also partially submerged in material (Figure 61). This issue was also noted in the 2022 inspection (Figure 62).

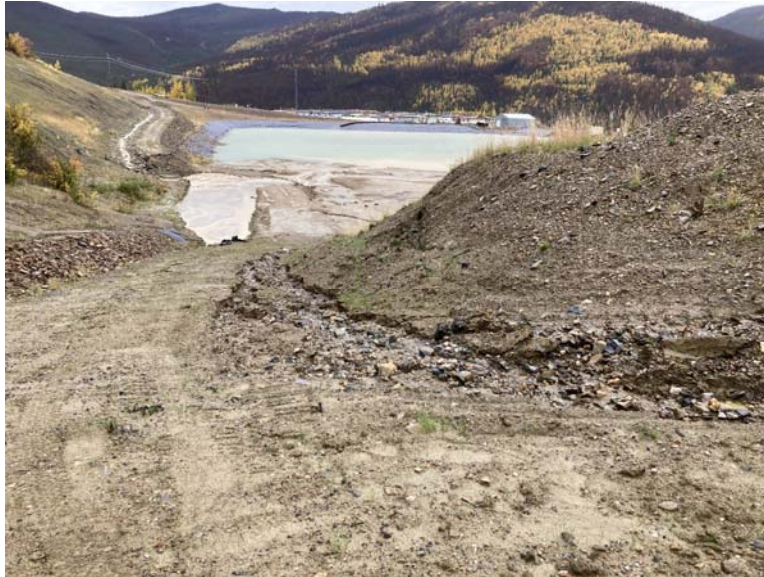
**Figure 63: Ditch B Erosion (view towards LDSP)**

1. Ditch B was completed by the time of the 2021 inspection. Erosion was observed to have created a channel next to Ditch B near the outlet into the LDSP (Figure 63).

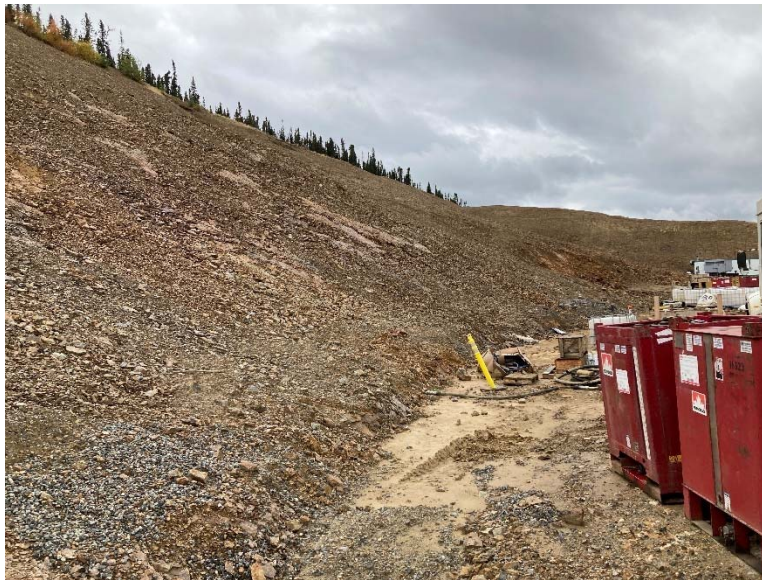
**Figure 65: Truck Shop cut slopes**

1. The heavy duty truck shop was under construction during the 2021 inspection and completed prior to the 2022 inspection. Some minor rilling was present on the cut slope behind the truck shop (Figure 65).

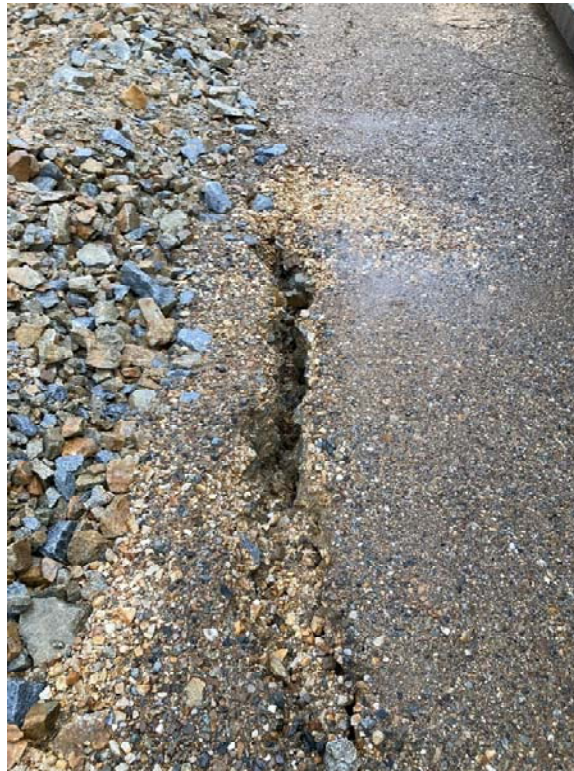
**Figure 67: Cracking – Warehouse Pad (2022)**

1. The warehouse pad is located South of the camp and mine admin areas. Cracking was observed at the crest of the slope off the warehouse pad during the 2022 inspection (Figure 67) and during this inspection (Figure 68).

1. Monitor cracking behind the warehouse pad. Come up with a solution to re-work slope below warehouse pad to eliminate cracking issue.

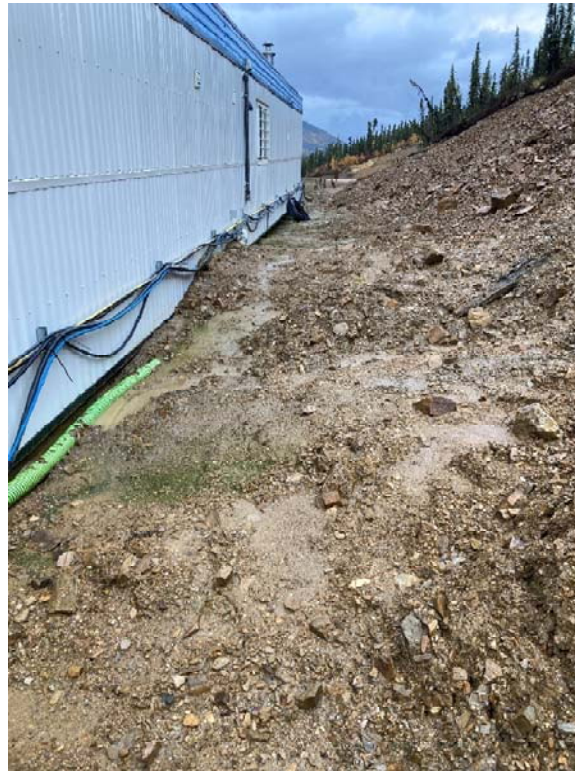
**Figure 72: Orica site trailer sediment build-up (2022)**

2. Between the 2021 and 2022 inspections sediment and material accumulated behind the Orica site trailer from the cut slope behind it (Figure 72). The trailer has since been moved South to a new location where it does not back against a cut slope (Figure 73). The area where the trailer formerly sat has been re-graded (Figure 74).

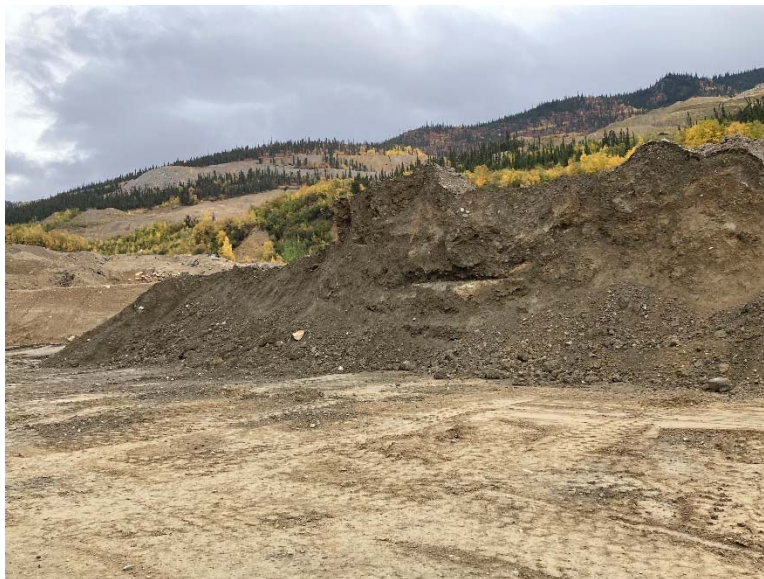
**Figure 75: Some stockpiles with steep side slopes**

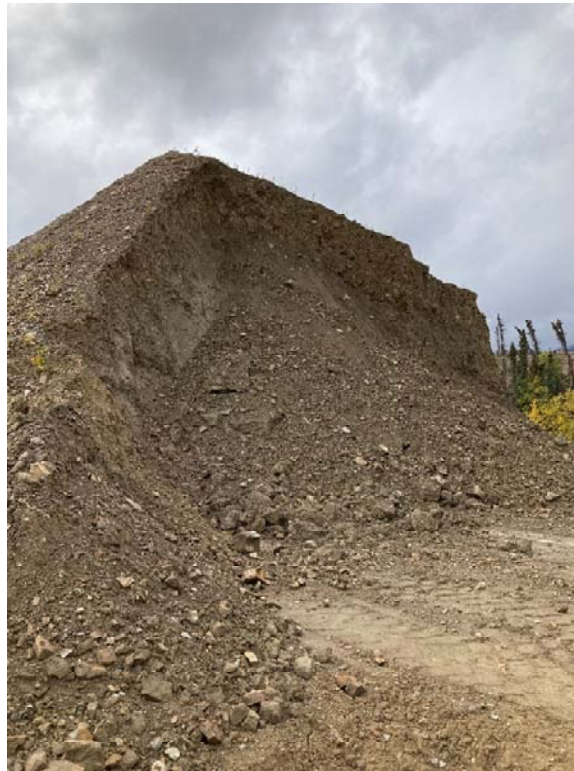
**Figure 76: Additional stockpiles with steep side slopes**
