Date: March 13, 2020
To: File
From: Richard Tuohey – Technical Services Superintendent Eagle Gold Project
Subject: 2019 Engineer of Record Summary Report for the Eagle Zone Open Pit

Date: March 13, 2020
To: File
From: Richard Tuohey – Technical Services Superintendent Eagle Gold Project
Subject: 2019 Engineer of Record Summary Report for the Platinum Gulch Waste Rock Storage Area (PG WRSA)

Re: Eagle Gold Heap Leach Facility – Annual Inspection

BGC Engineering Inc. (BGC) was retained by Strata Gold Corporation's (SGC) to carry out an annual geotechnical inspection of the Heap Leach Facility (HLF) at the Eagle Gold Mine located in Yukon Territory, Canada. SGC is a directly held, wholly owned subsidiary of Victoria Gold Corporation. The general site layout of the HLF is shown on Figure A1 in Appendix A.

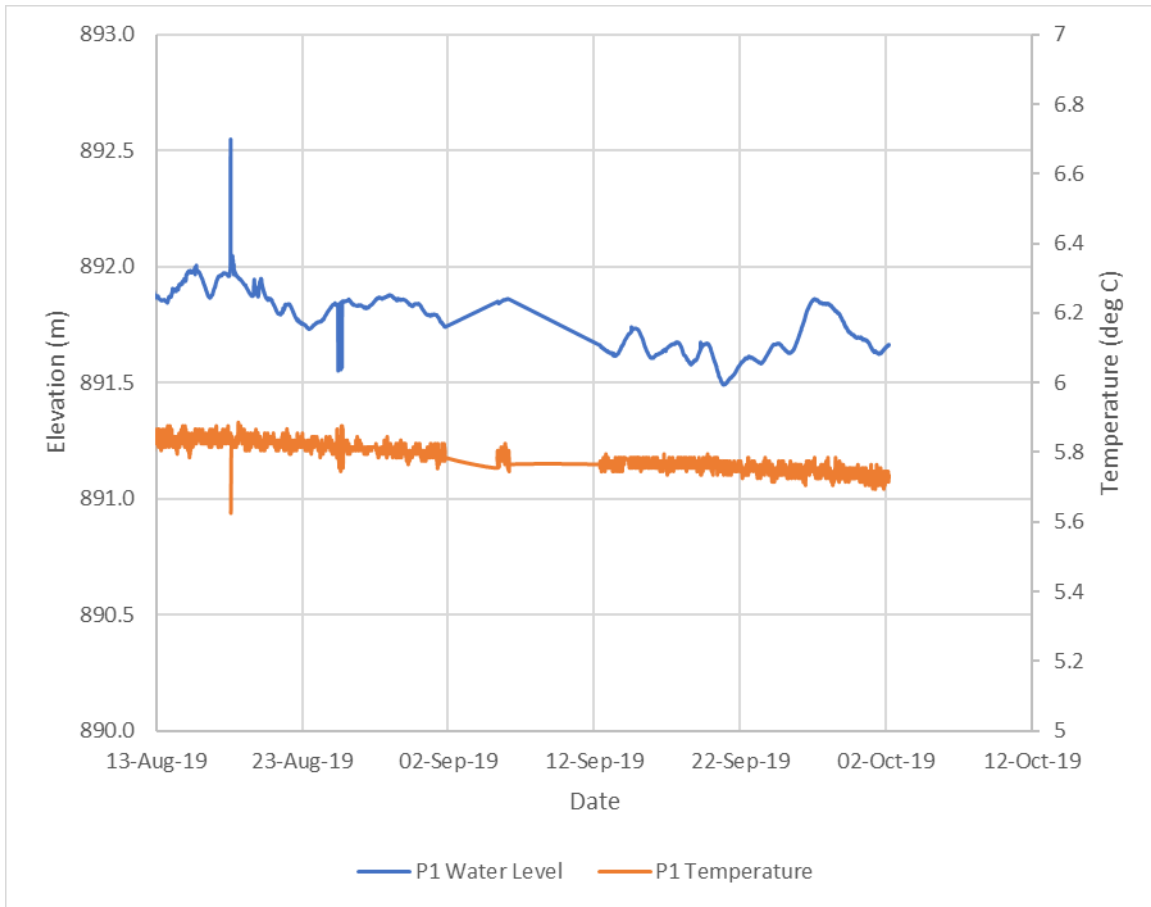
Figure 3-1. Piezometer P1 readings.

foundation bedrock and Piezometers P2 and P3 were installed in the dam fill just above the western and eastern underdrains, respectively. Piezometers P2 and P3 have been reportedly dry since installation. The water level in P1 reflects groundwater in the fractured and weathered bedrock foundation. The well log for P1 indicates a bedrock contact elevation of about 899.5 m. The water level readings since mid-August for P1 are presented in Figure 3-1 and reflect a general downward trend.

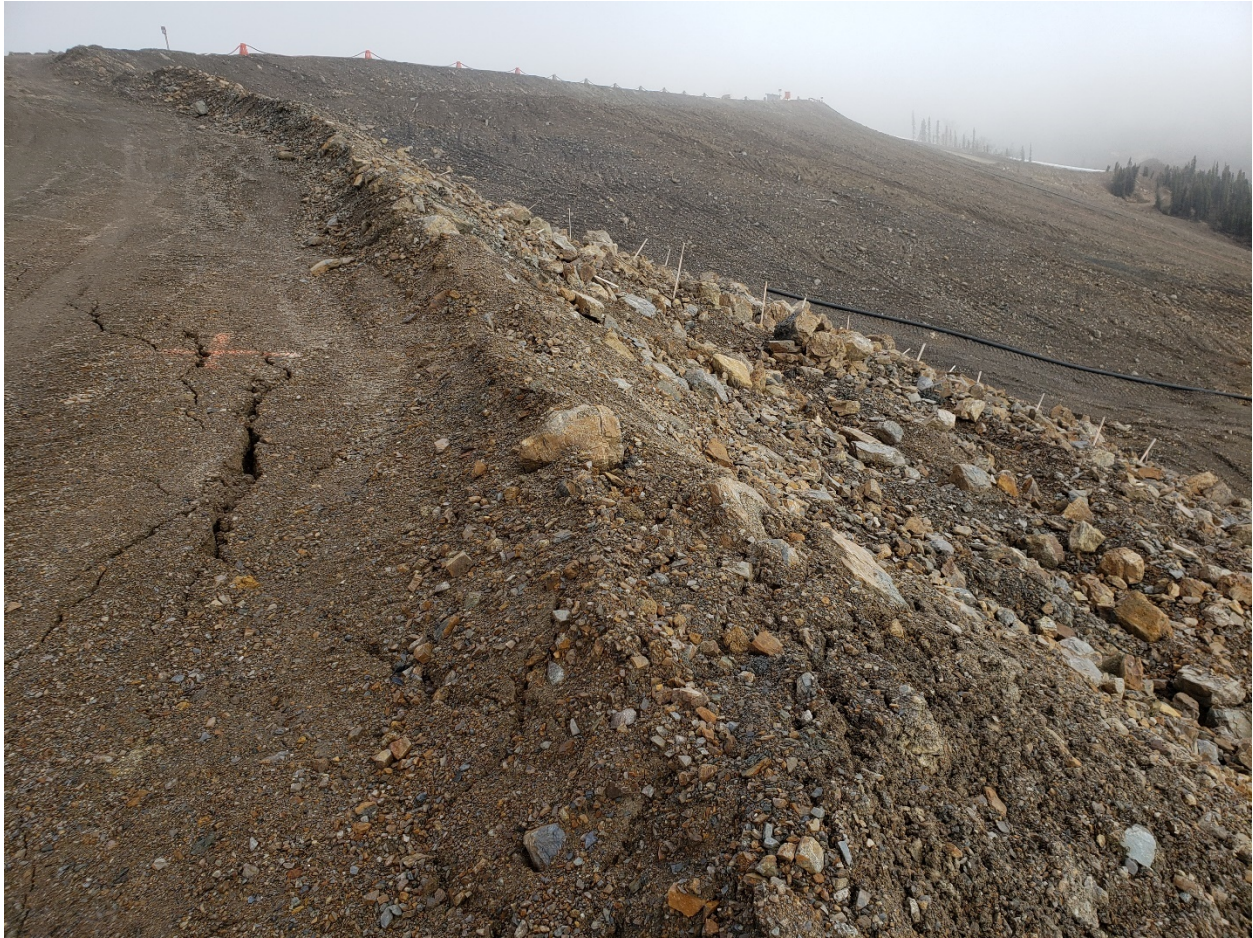
Photo 3. Upper portion of HLF spillway access road.

Moderate cracking was observed on the HLF spillway access road (Photo 3). These cracks were not apparent in June 2019 during routine construction inspection by BGC personnel. The cracks are up to 2 cm wide and about 10 m long. The cracks do not pose a threat to the HLF embankment but could affect the access road and possibly the HLF spillway if not mitigated. BGC recommends mitigation of this area by excavating a trench along the toe of the access road fill down to

competent frost-free material and placing imported fill (structural or rock fill) into the trench and onto at least the bottom half of the access road slope to form a buttress. BGC can provide engineering guidance and oversight for the work. SGC should document this work and report back to BGC and this area should be monitored during routine HLF inspections by SGC personnel.

As discussed in Section 3.1.2, BGC recommends remediation of two areas that require minor earthworks and engineering review. This work should be completed as soon as practicable and prior to winter includes 1) HLF upper spillway access road slope, and 2) Event Pond access road adjacent to emergency spillway outfall.

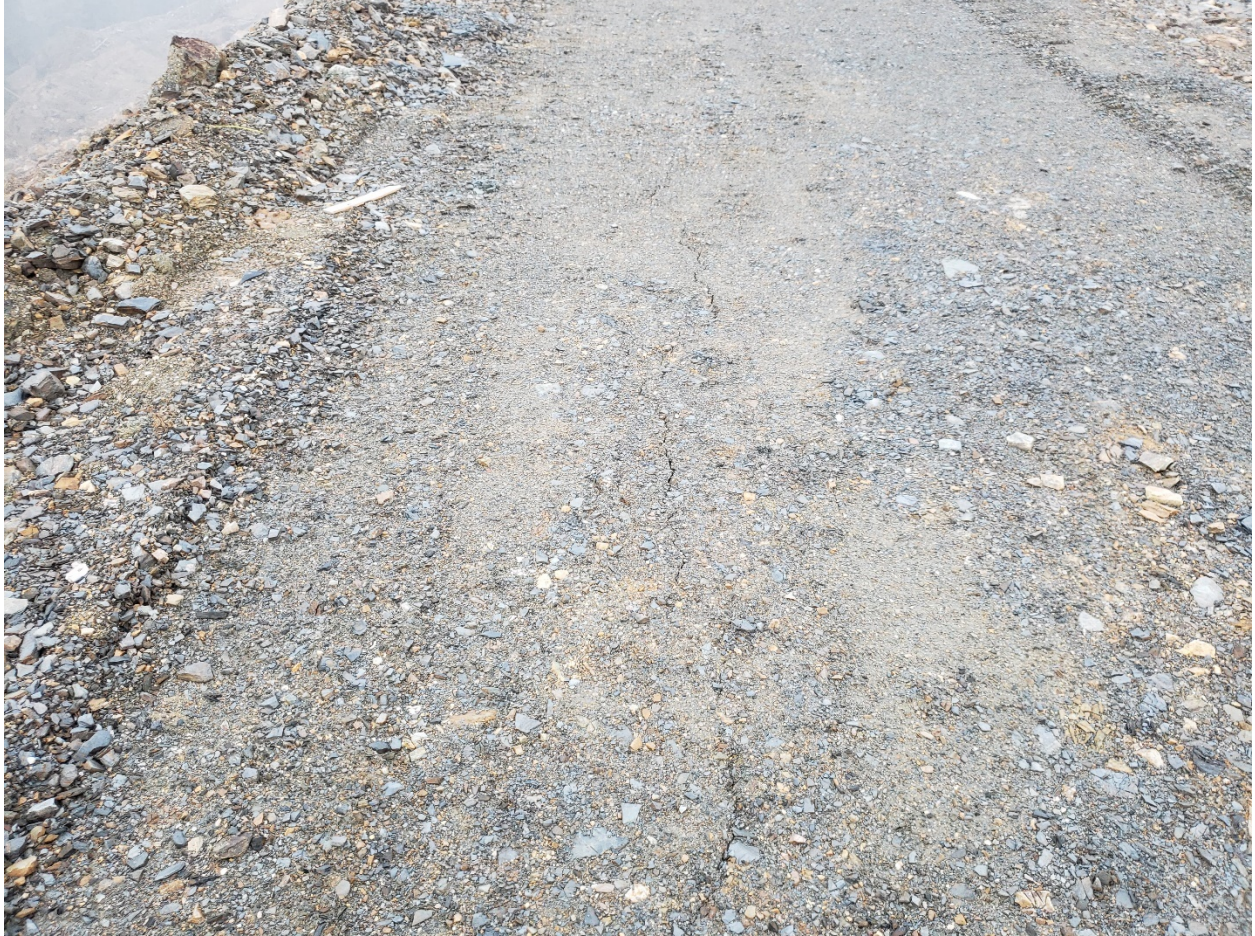
Photo 6. Event Pond south embankment crest looking west.

Minor cracking was observed along the crest of the south embankment of the Event Pond (Photo 6). This was compared to construction records (BGC, September 2019) it appears the crack were first observed by BGC personnel in June 2019. The cracks do not appear to have expanded in width or length over that time period. BGC recommends continued monitoring of these cracks.

Action Required
Cracking	<input type="checkbox"/> not apparent	<input checked="" type="checkbox"/> apparent	Notes: <u>Minor cracking along the south embankment crest, about 3mm wide and up to 10m long</u>		N
Settlement/Uneven	<input checked="" type="checkbox"/> not apparent	<input type="checkbox"/> apparent	Notes: _____		N
Erosion	<input checked="" type="checkbox"/> not apparent	<input type="checkbox"/> apparent	Notes: _____		N
Sinkholes	<input checked="" type="checkbox"/> not apparent	<input type="checkbox"/> apparent	Notes: _____		N
Other Movement	<input checked="" type="checkbox"/> not apparent	<input type="checkbox"/> apparent	Notes: _____		N
Crest Vegetation	<input checked="" type="checkbox"/> not apparent	<input type="checkbox"/> apparent	<input type="checkbox"/> sparse <input type="checkbox"/> moderate <input type="checkbox"/> heavy		N
Comments:	<u>Cracking on crest has not expanded in width or length since first noted by BGC construction personnel in June 2019</u>				Y

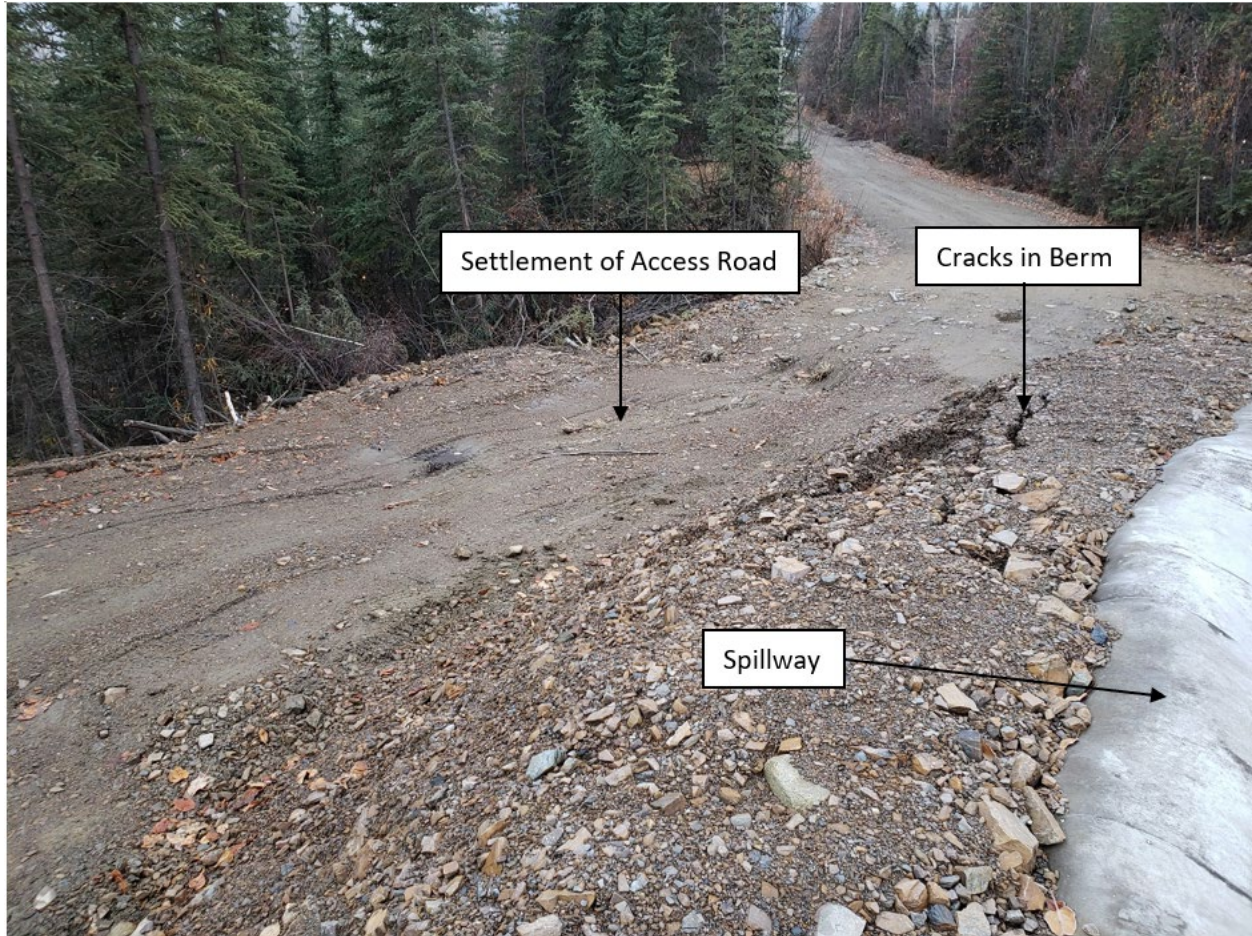
Photo 8. Berm and access road adjacent to bottom portion of Event Pond spillway.

Minor cracking and settlement was observed along the Event Pond access road adjacent to the emergency spillway outfall (Photo 8). The affected area is located well outside the toe limits of the Event Pond embankment but could affect the access road and emergency spillway outfall. BGC recommends placement of additional fill to bring the area back to design grade. SGC should document this work and report back to BGC and this area should be monitored during routine HLF inspections by SGC personnel.

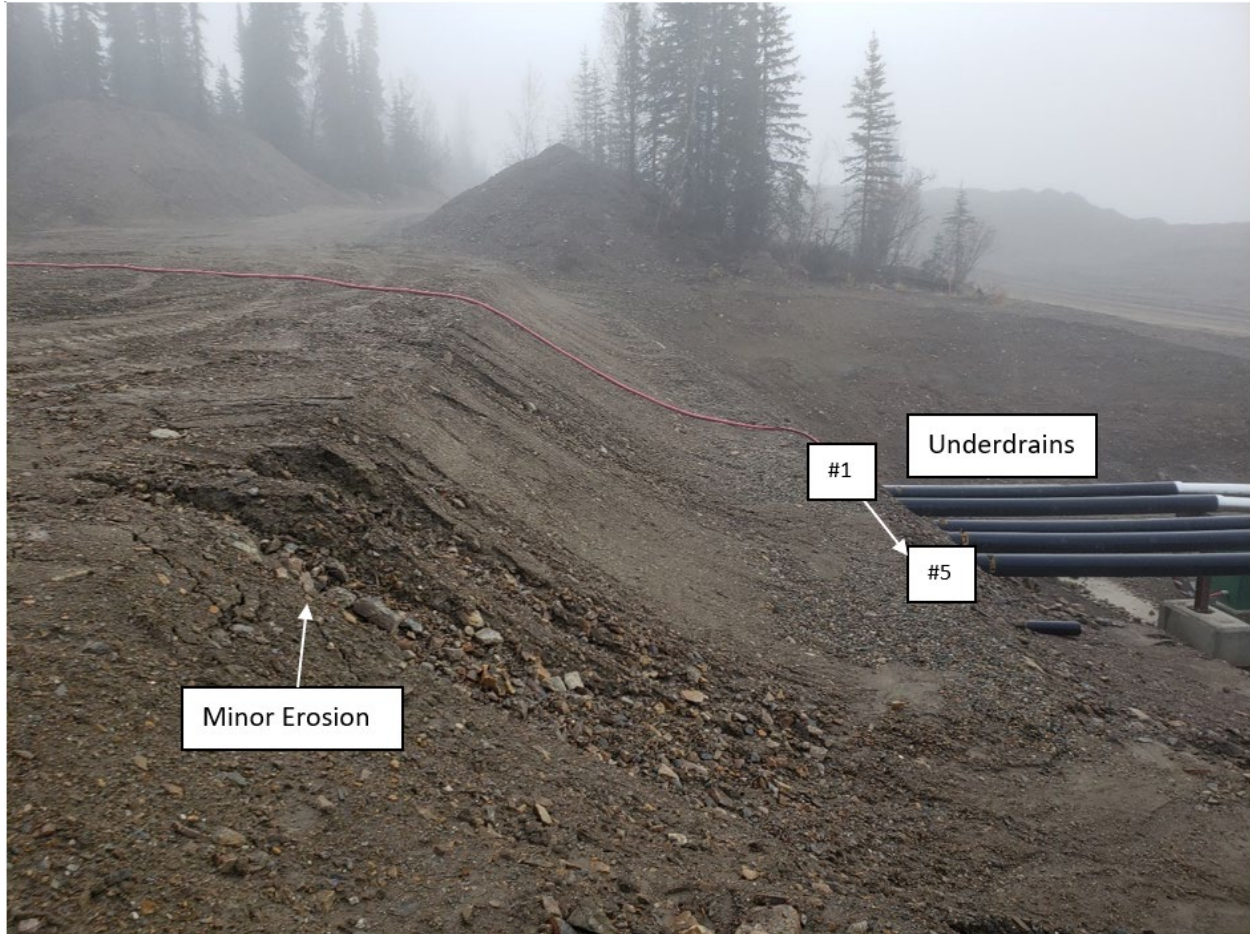
Photo 11. HLF underdrain outlet between dam and monitoring vault looking east.

At the time of the visual inspection, water was not being discharged to the environment from the HLF underdrain flows but was being pumped back into the process circuit. Flows were apparent in underdrains #1, 2 and 5 which collect seepage under the Phase 1 HLF. No discharge was observed from underdrains #3 and 4, which are blank pipes installed in reserve for future phases of the HLF. The underdrain pipes are numbered from east to west (Figure A2 and Photo 11).

Some unevenness, most likely caused by vehicle traffic, was visible on the dam’s crest near the PLS risers, with ponding apparent (Photo 13). A few minor surface erosion gullies (Photo 11), which appear to be caused by rainfall runoff, were observed on the downstream slope of the underdrain containment area. BGC recommends that SGC place additional coarse fill on the dam crest to limit ponding and construct a small berm along the crest of the underdrain containment area to direct surface water flows to the west edge of the monitoring vault area.

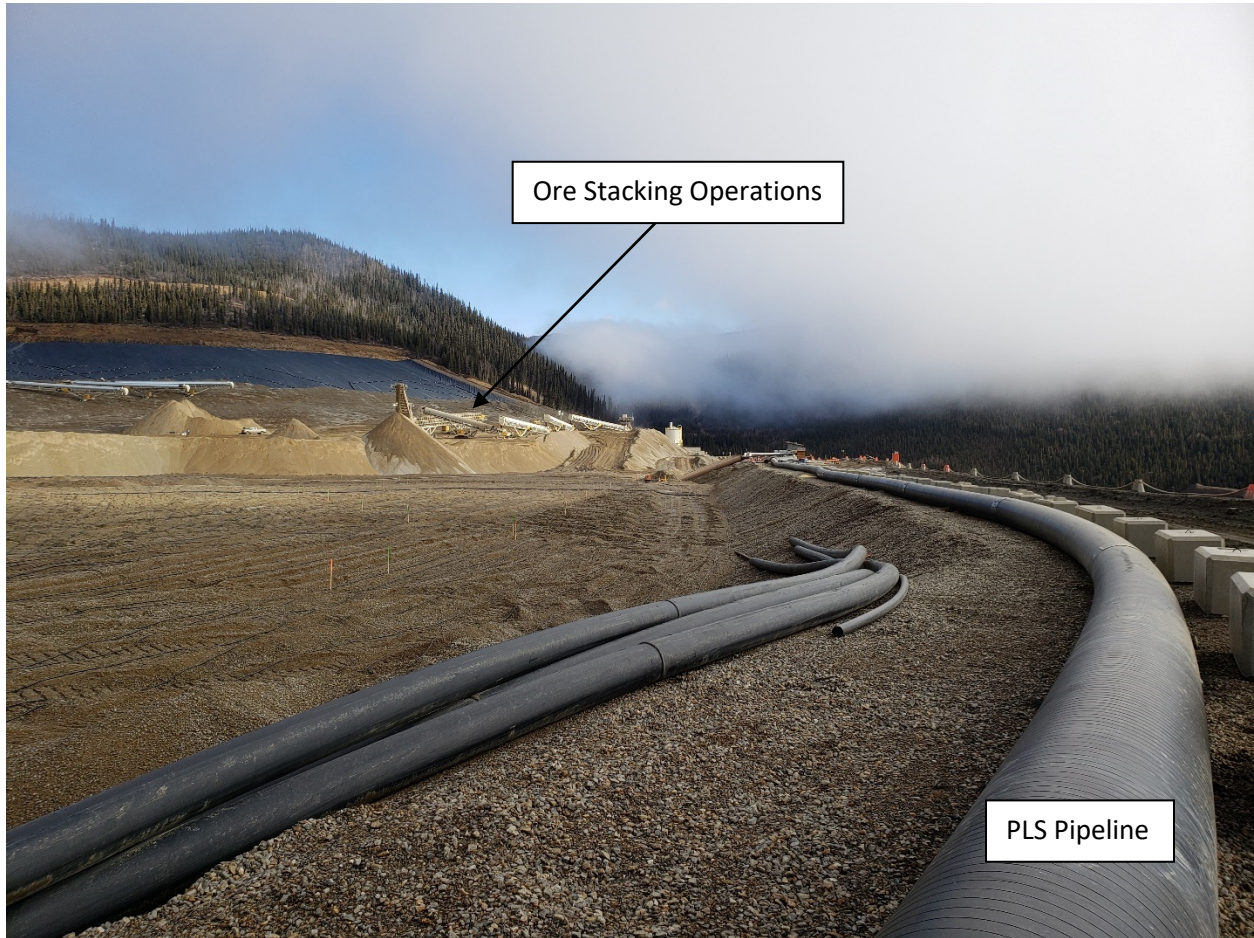
Photo 19. HLF Phase 1 Pad looking east from dam crest.

Based on discussions with SGC personnel, BGC understands the PLS pipeline, which is currently positioned on the HLF dam crest (Photo 19), will be repositioned down onto the ore at elevation 937.5 m in order to provide better containment and protection of the dam in case of a spill. BGC also understands that the ROM ore ramp placed near the western HLF dam abutment (Photo 21) will be regraded to provide more space between the fill and the spillway culvert entrance. BGC recommends a minimum 5 m setback to ensure free flow into the culverts. A 10 m setback is required between the dam crest and the ore pile toe per the construction documents (BGC, January 8, 2018).
