Allnorth Information		VICTORIA GOLD CORP.	
Project #:	<b>19-PG-0305</b>	Client Project #:	
Document #:	<b>191029</b>	Client Document #:	
Document Rev. #:	<b>0</b>	Client Doc. Rev.#:	
Prepared By:	Jordan Smith, EIT	Client Contact:	Richard Tuohey
Reviewed By:	Don Williams, P.Eng.

Annual Physical Stability Assessment Report – Victoria Gold – Eagle Gold Project

Visual inspection of the following structures: Open Pit, Platinum Gulch Dump, Lower Dublin South (Control) Pond, Secondary Crusher, Primary Crusher, 90 Day Stockpile, Adsorption, Desorption and Recovery Plant, Heap Leach Facility, Event Pond, Ditch A, B, and C, Former Nuway Crusher Pad, Orica Laydown, Various Un-named Stockpiles.

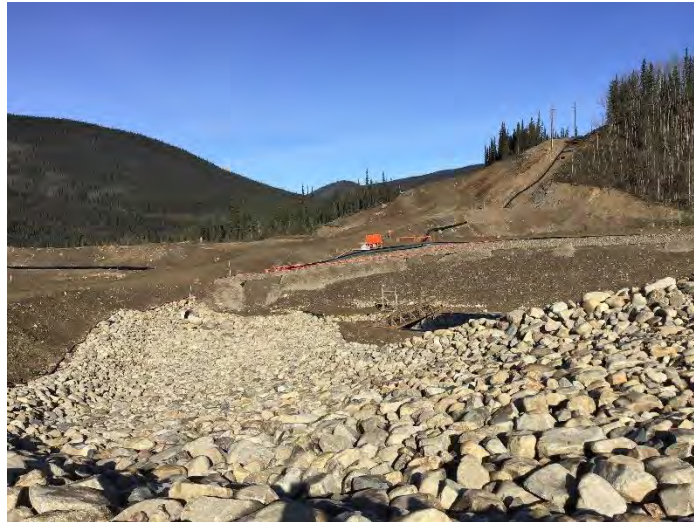
**Figure 1: LDSP – Spillway**

No issues to note in the spillway (Figure 1). There is an outlet sump and weir which have been constructed since the previous inspection (Figure 2).

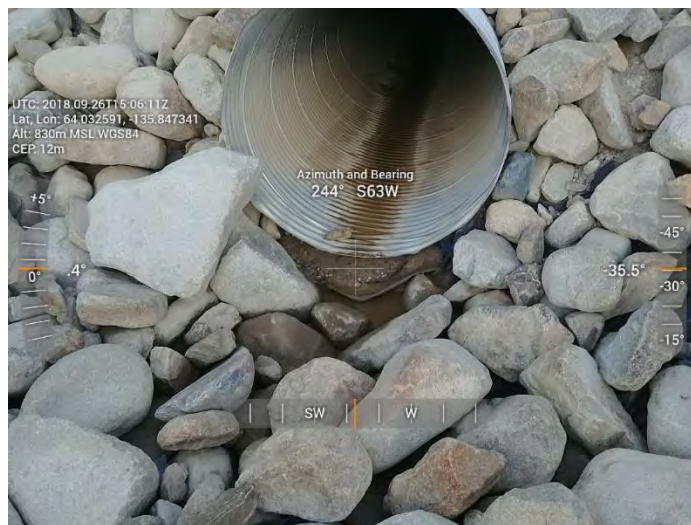
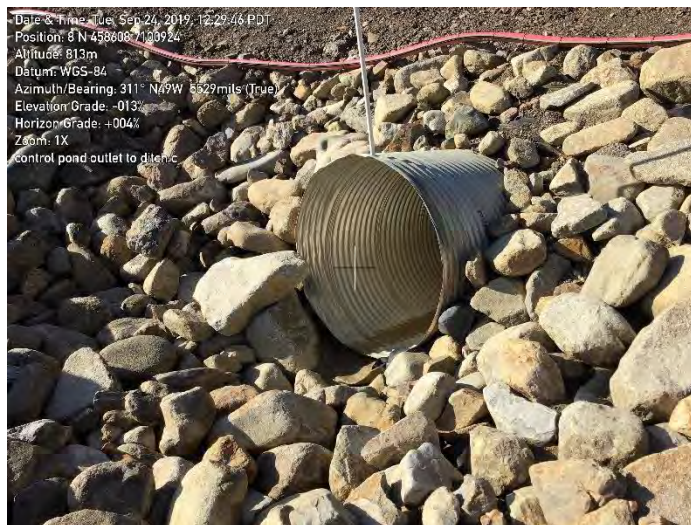
1. The condition of this culvert appears to be similar to the previous year's inspection (Figure 3). No water was observed flowing through the culvert. The 2018 inspection noted some standing water below the riprap, but above the geotextile. This water was not passing through the 1500mm culvert; therefore, it is likely that the water is left from rainfall runoff that cannot pass quickly through the granular subgrade of the culvert. No concerns at this time.

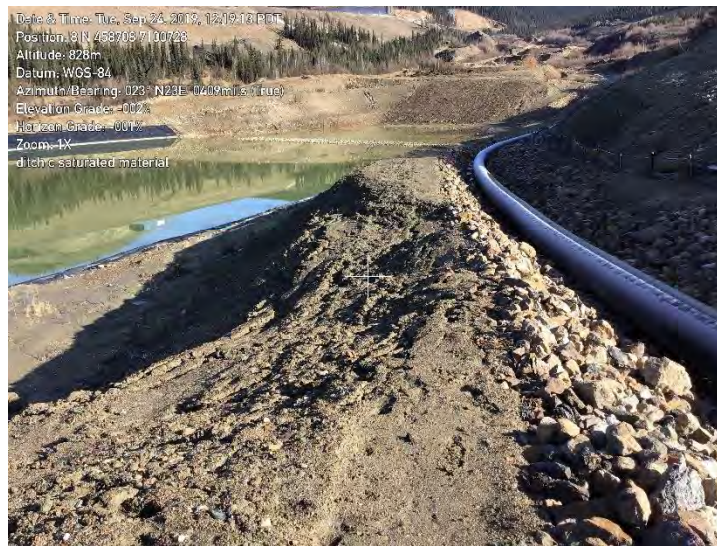
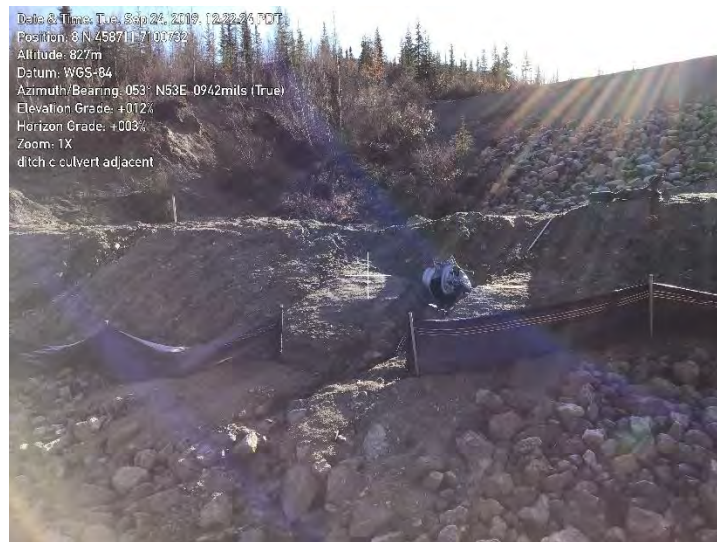
1. Some saturated material and erosion was noted on the slope of the southwest corner of the Control Pond over the width of the narrow access road (Figure 5). Water flowing down Ditch A may be leaking into the fill in this area. There was some flow into this area from a culvert crossing a former construction access road.

1. Address erosion occurring on the southwest slope of the pond. This is likely due to water infiltration from Ditch A or the adjacent culvert outlet. This section of ditch may require further armoring or installation of a liner to properly direct water away from the Control Pond slope.

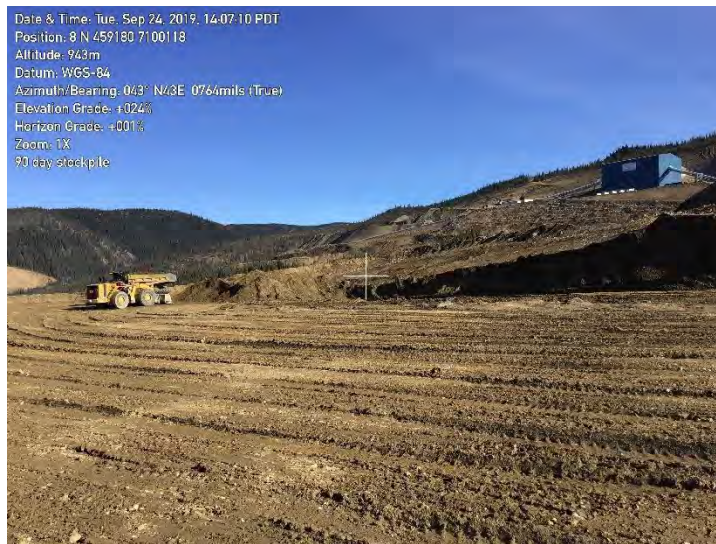
**Figure 7: 90 Day Stockpile under construction**

1. The 90 Day Stockpile is currently under construction (Figure 7). During the time of inspection, some over-steepened cut slopes were observed, however they are currently being cut back with material being hauled to a stockpile in another area of the mine site.

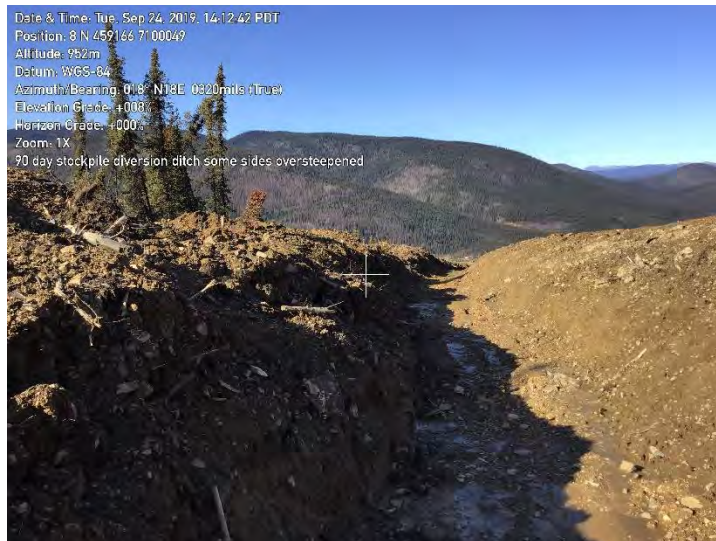
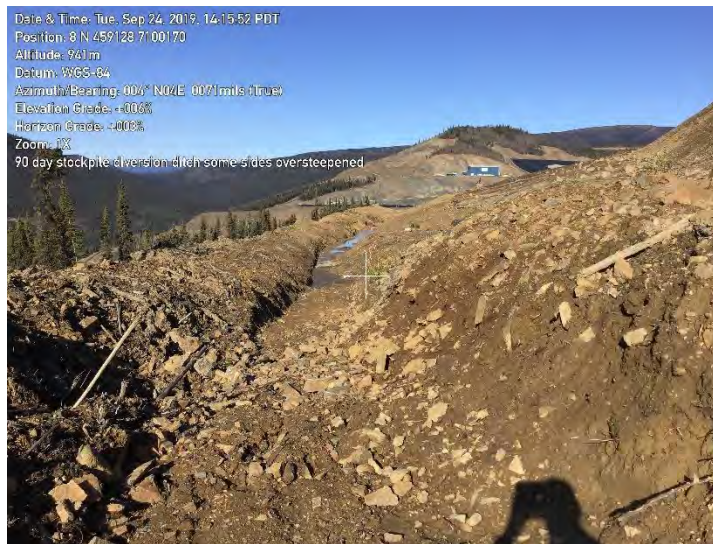
1. A perimeter interception ditch extends around the downhill toe of the 90 Day Stockpile area (Figure 8 and Figure 9). The construction of this ditch is not yet complete, as it is currently unlined with no rock armoring, and is founded on native soils, and over-steepened and sloughing in places.

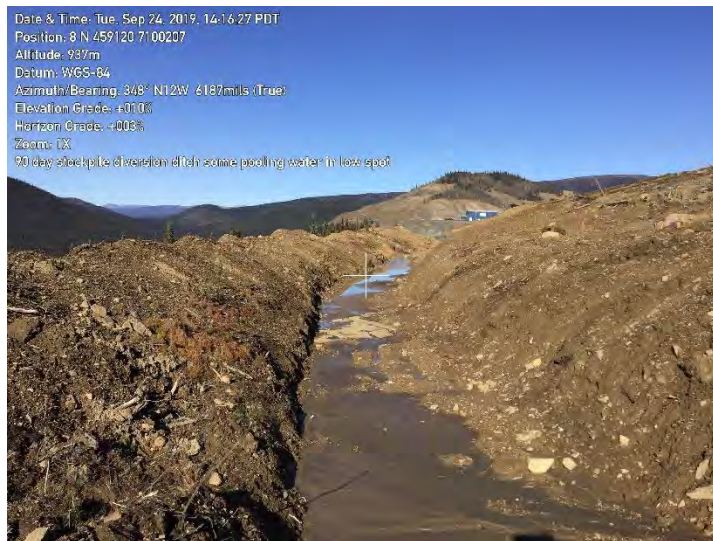
**Figure 10: Pooling water in perimeter ditch**

2. In one location some pooling of water has occurred as it appears that the final grade has not been completed (Figure 10).

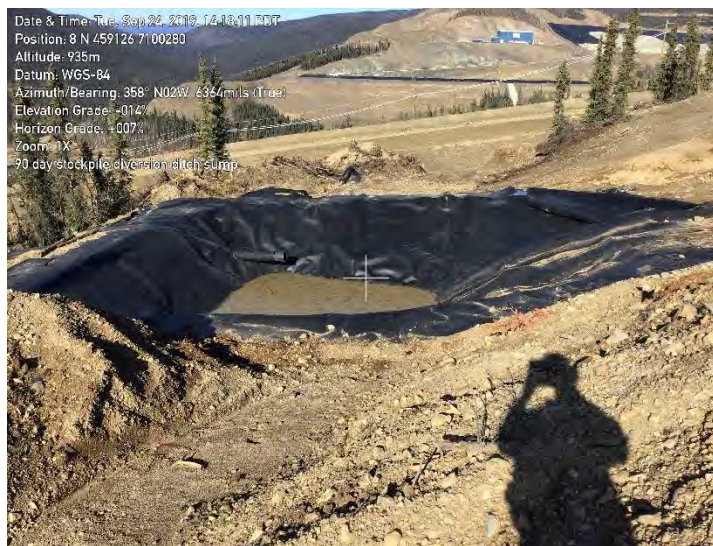
**Figure 11: Collection Sump**

3. The outlet of one side of the perimeter ditch does not currently tie into the collection sump (Figure 11), such that a large flow of runoff could be directed down towards the access road until the tie in is completed. Site representatives indicated that this ditch will eventually be tied into the collection sump.

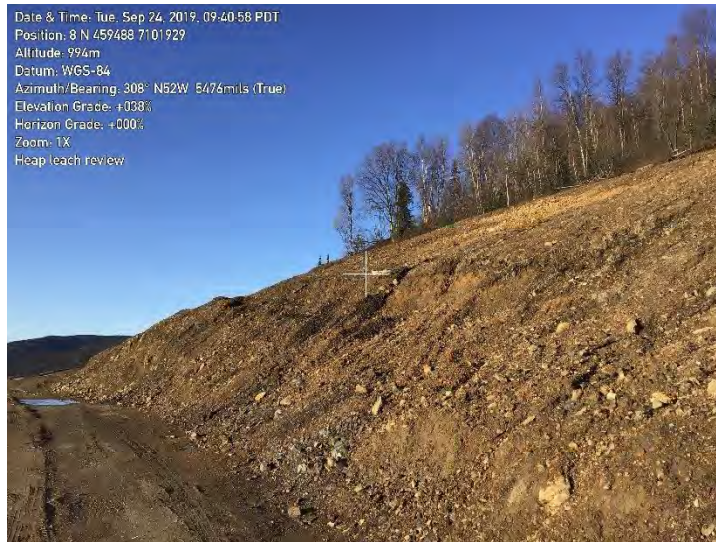
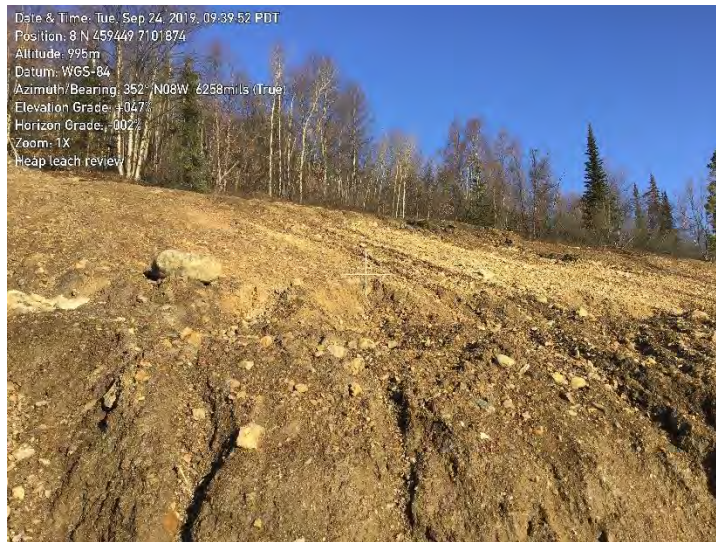
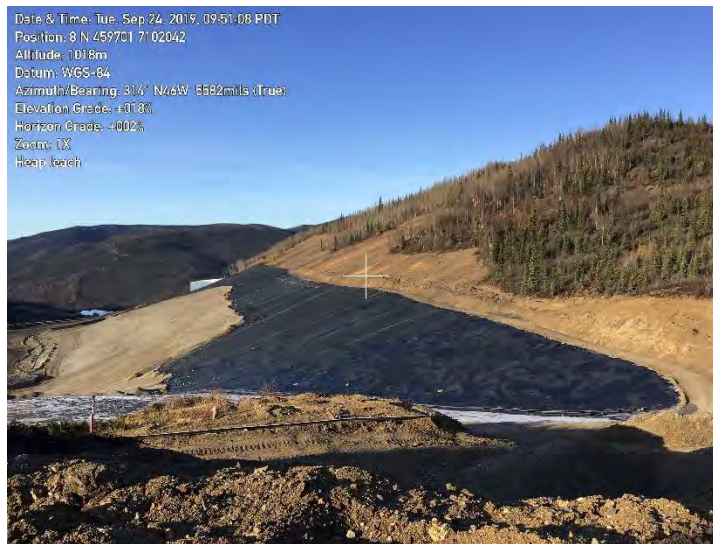
1. Some minor erosion issues noted along the cut slopes adjacent to the upper access road (Figure 13 and Figure 14). Small amount of material is collecting at the toe of the cut slope. In locations measured, slopes are cut back to less than a 50% grade. Minor sloughing noted along the length of the bench above the HLF pad, as shown below in Figure 15. Site representatives indicated that these slopes will be further cut back during the Phase 1B HLF expansion.

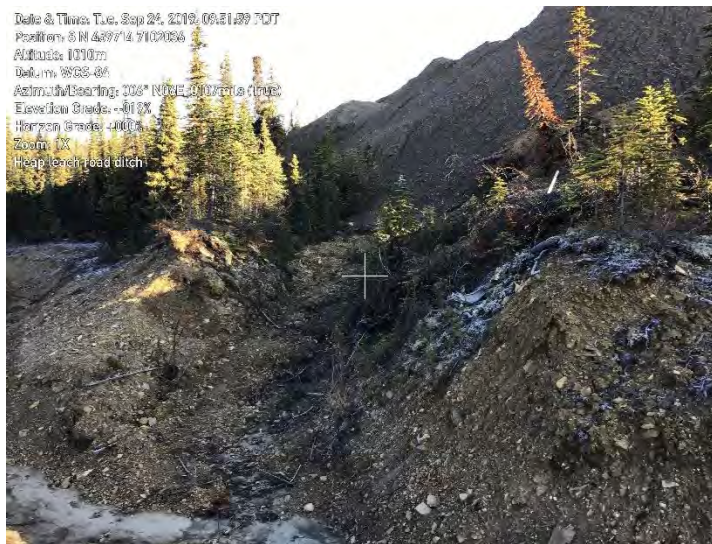
**Figure 17: Stockpile adjacent to access road**

2. The upper overburden stockpile is located adjacent to the HLF access road / upper bench. Some erosion on the sides of the stockpile has occurred (Figure 17) and material being carried down the slope was noted. This temporary stockpile appears to be over-steepened in places. Site representatives indicated that this stockpile will be moved during Phase 1B pad expansion.

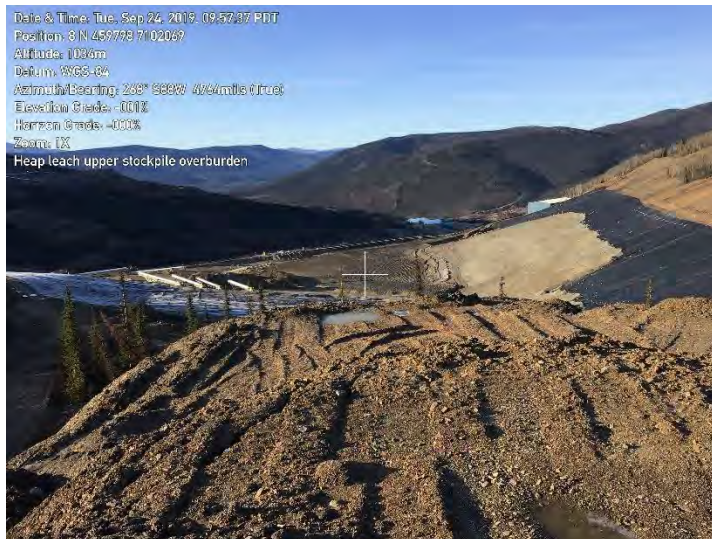
**Figure 18: Top of stockpile**

3. Some ponded water was noted on top of the stockpile, likely from recent rainfall. (Figure 18).

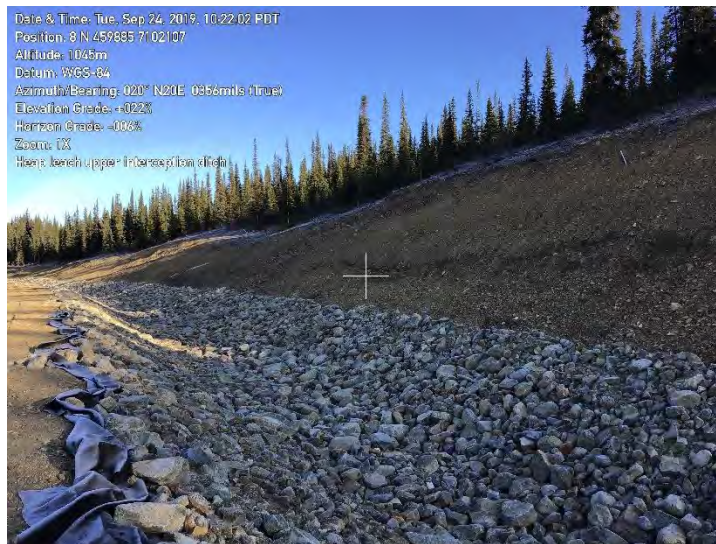
**Figure 19: Typical Phase 1 Ditch**

1. The phase 1 interception ditch appears to have been constructed in a sound manner and is stable (Figure 19). Rock armoring appears to be class 25kg to 50kg, and approximately 100mm to 150mm thick. Geotextile was visible in several locations.

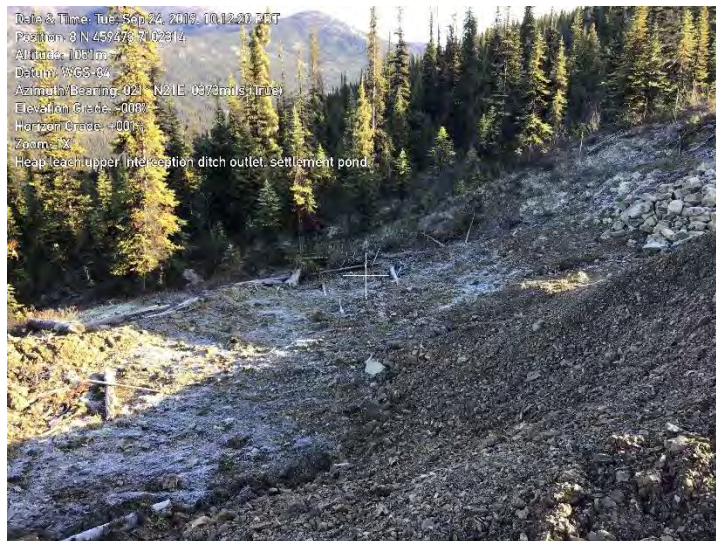
**Figure 20: Outlet of HLF Phase 1 Interceptor Ditch**

2. The interceptor ditch west end appears incomplete and outfalls to an un-vegetated area that slopes into the surrounding forest (Figure 20).

4. Review requirements of the Phase 1 Interception ditch outfall. Currently the ditch terminates at the top of an un-vegetated slope, and would be more stable with an armored exfiltration outfall/sediment sump.
5. Monitor road settlement around 0+650 of the interceptor ditch alignment. Currently this section requires some additional fill to facilitate truck traffic. Additional settlement could impact the functionality of the interception ditch. Additional settlement or failure is unlikely to impact other infrastructure, due to adequate setback from the toe of the slope.

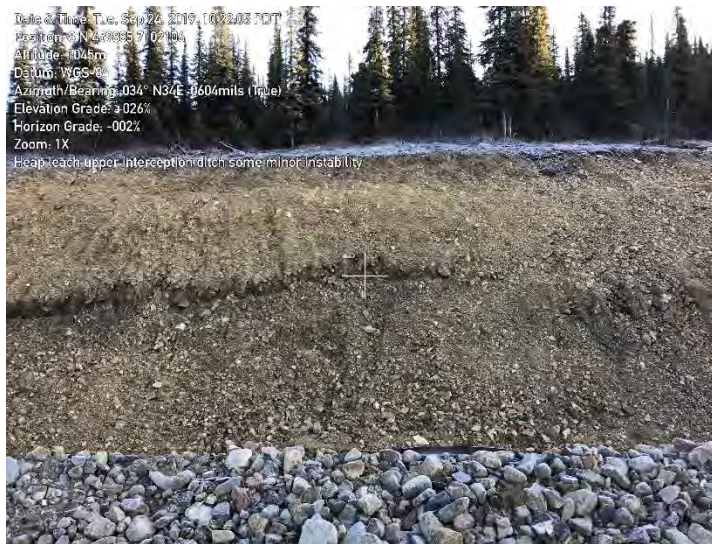
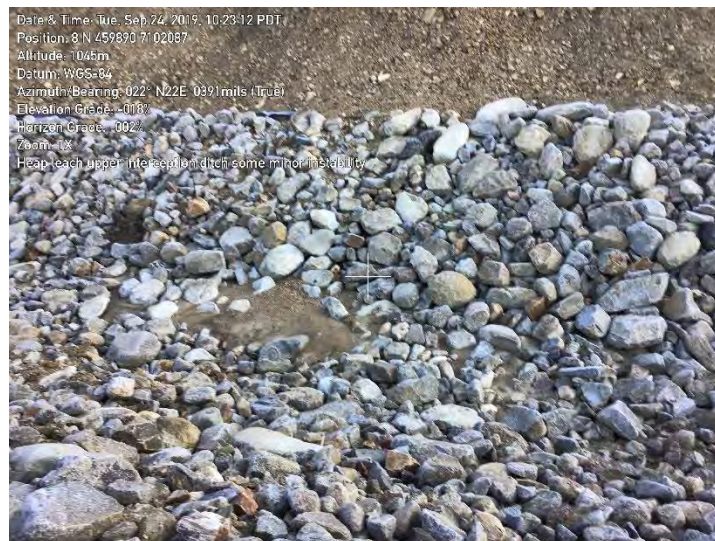
3. Some minor scour and slope instability was noted on the uphill cut slope adjacent to the ditch (Figure 21). Some material has been deposited into the ditch (Figure 22).

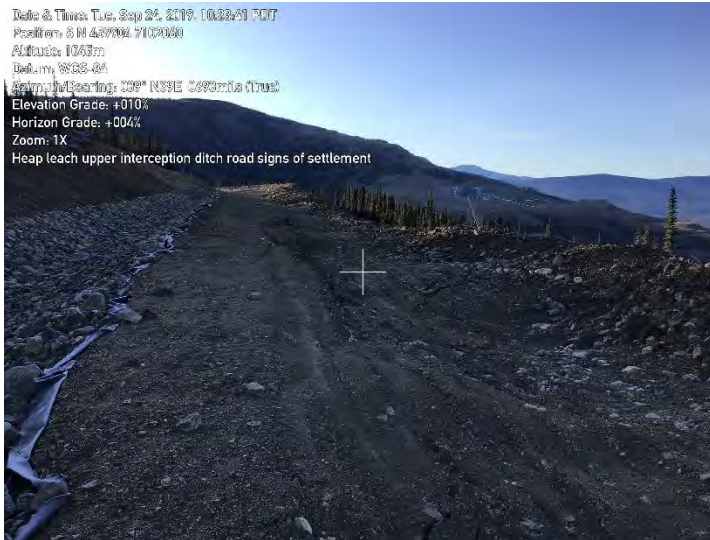
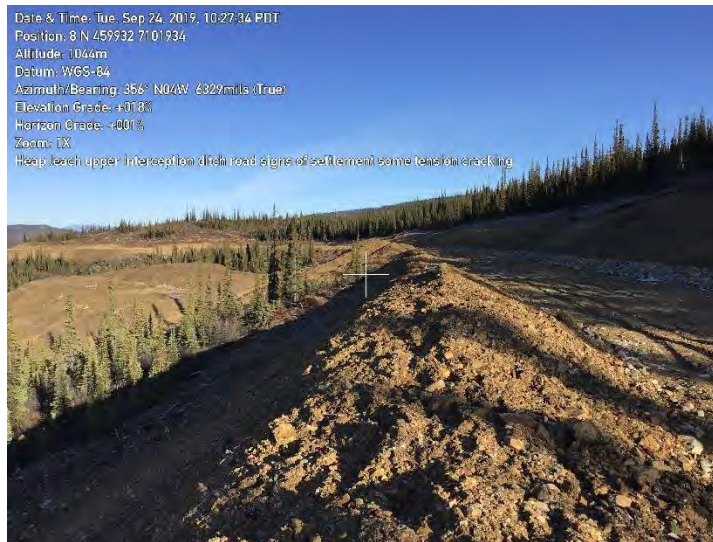
4. Settlement and movement was noted in one section of the temporary access road, which extends along the south and down gradient side of the ditch (approximate 0+650 along the ditch alignment) (Figure 23). Tension cracking in the soil is present. This is likely due to settlement after road construction, which occurred during winter and likely incorporated snow/ice when building up the fill section. Movement or failure of the fill section could impact the functionality of the interception ditch, however, fill slopes were measured to be less than 50%, and the consequences of further movement are likely low, as there is moderate setback from the toe of the downhill slope to the closest access road (Figure 24). This deteriorated temporary road only accesses a short section of the interception ditch.

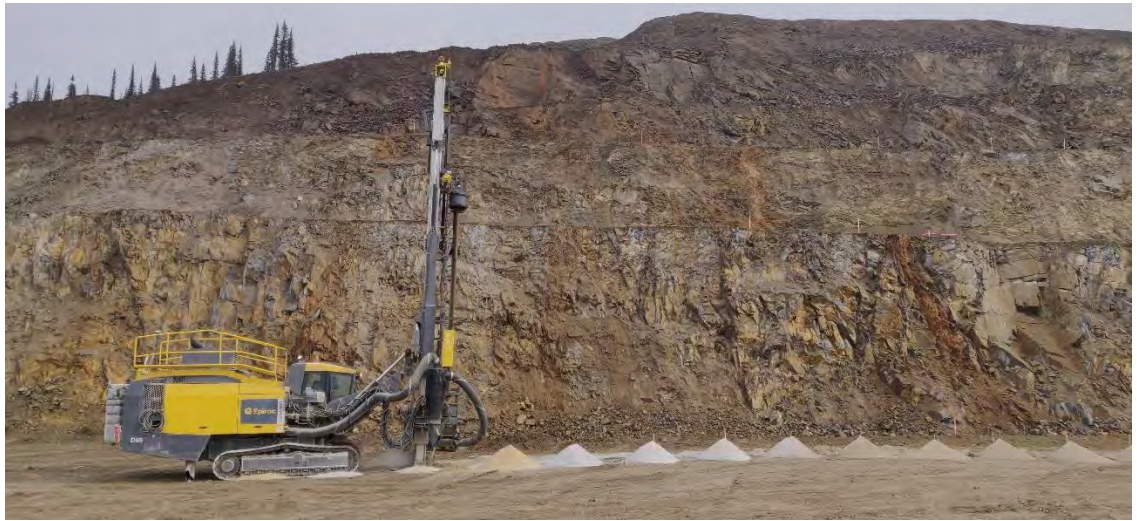
**Figure 25: Pit Walls**

1. The pit walls appear stable, and constructed in competent rock. Figure 25 below was provided by Victoria Gold, and reviewed by Allnorth.

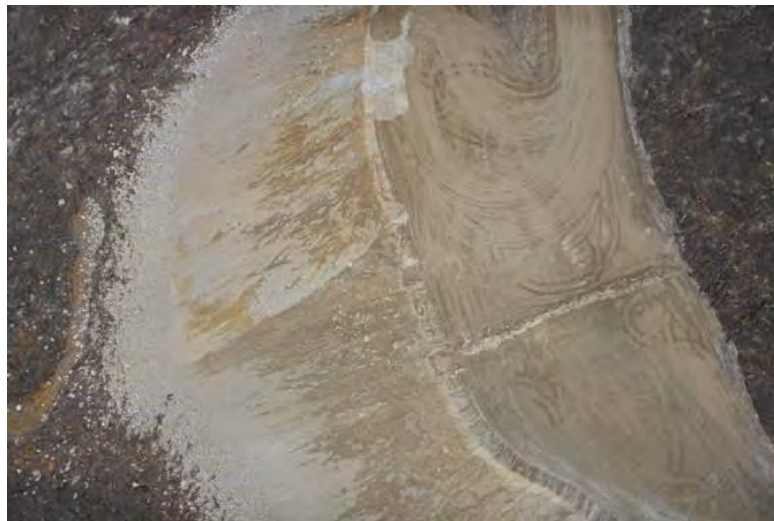
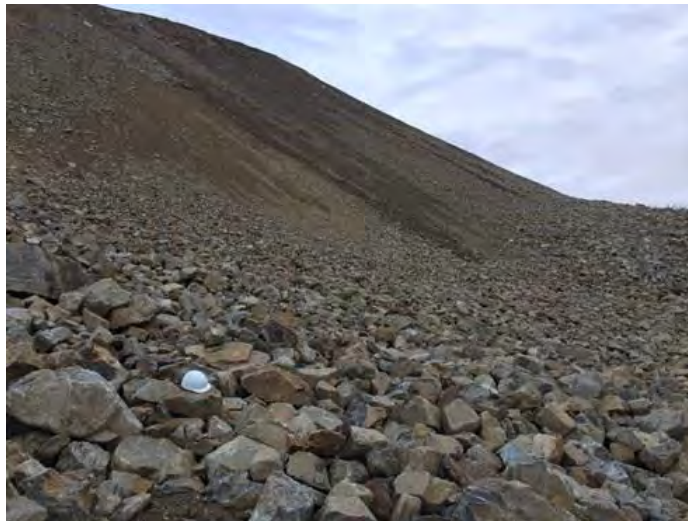
1. Platinum Gulch Dump is currently operational, and the side slopes appear to be stable. Figure 26 and 27 below were provided by Victoria Gold, and reviewed by Allnorth.

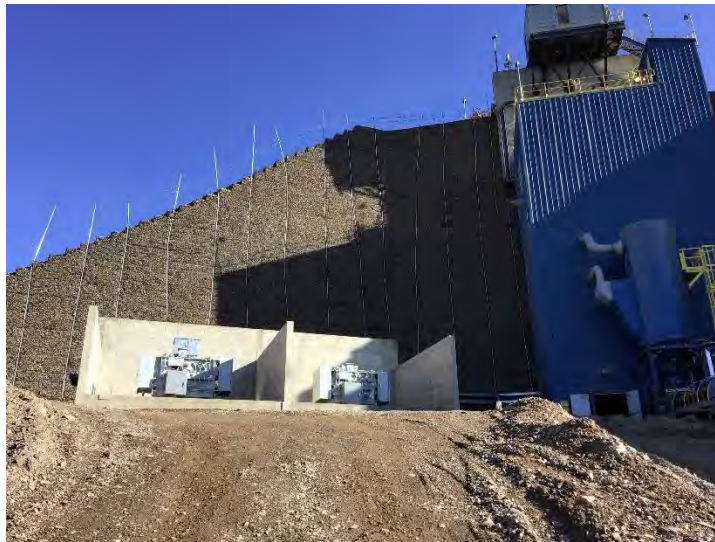
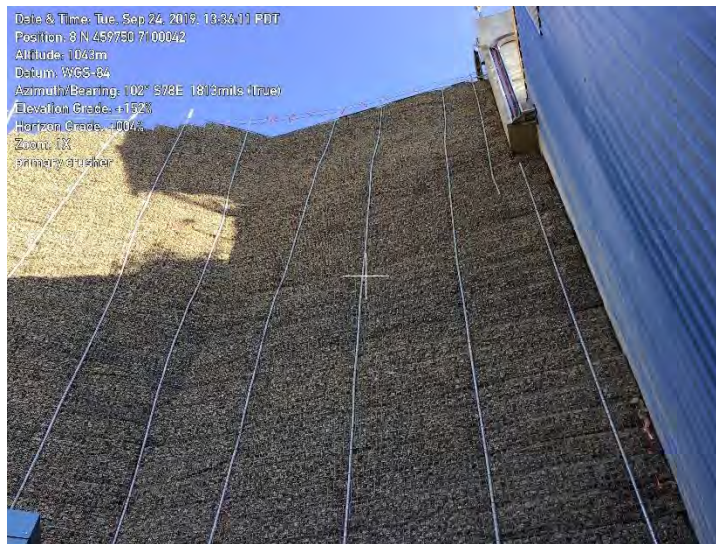
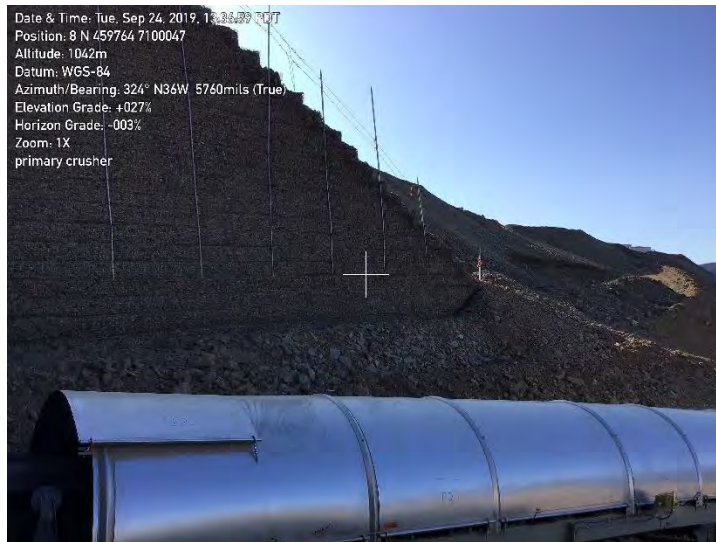
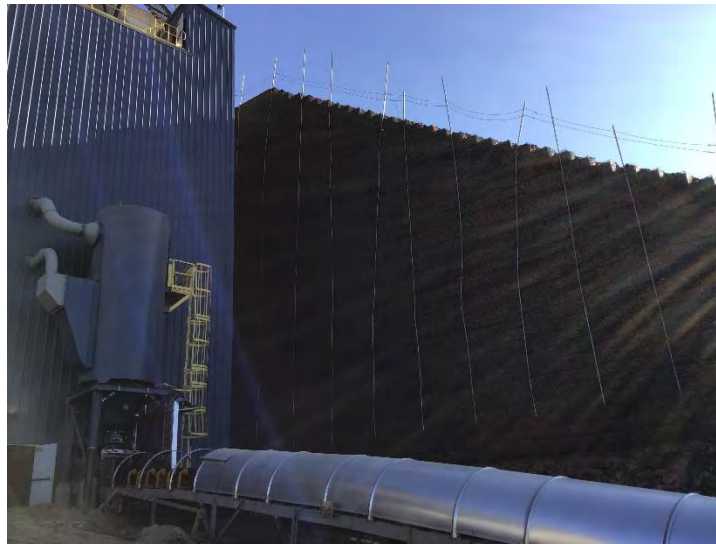
1. No apparent damage or deterioration was noted during the inspection of the Primary Crusher MSE wall (Figure 28, Figure 29, Figure 30 and Figure 31). Most of the construction in this area was completed after the previous inspection in 2018, and no baseline data is available for comparison. The structure is now complete and operational.

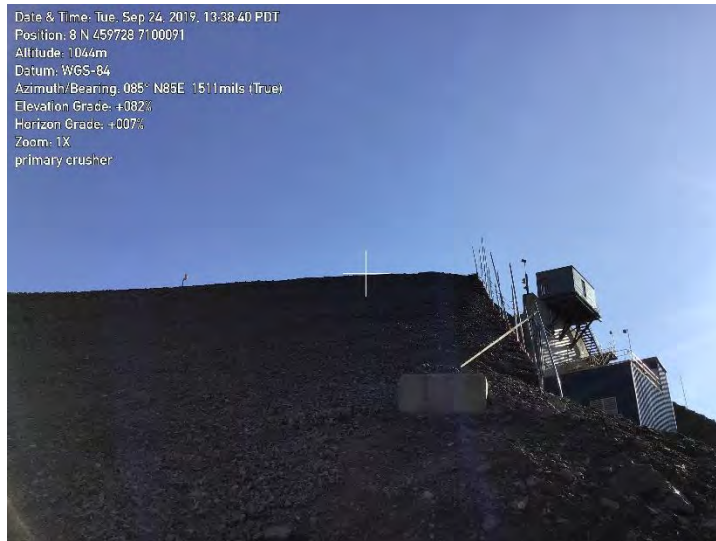
**Figure 32: Southeast Face**

1. Measured fill slopes appear to be acceptable, and meet recommended guidelines. Fill slopes at the side of the MSE wall were measured to be approximately 1.5:1 (Figure 32).

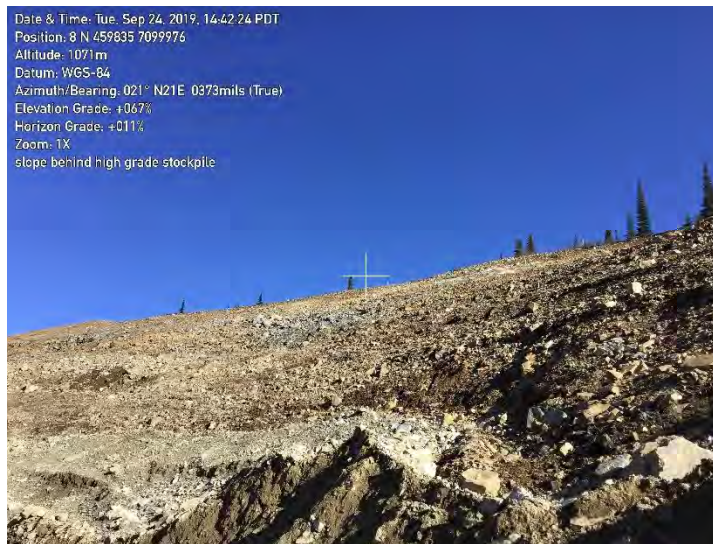
**Figure 33: Cut slope and small ore stockpile behind primary crusher**

2. Cut slopes behind the Primary Crusher were measured to be approximately 50%, and within recommended guidelines (Figure 33). A small ore stockpile is located in this area.

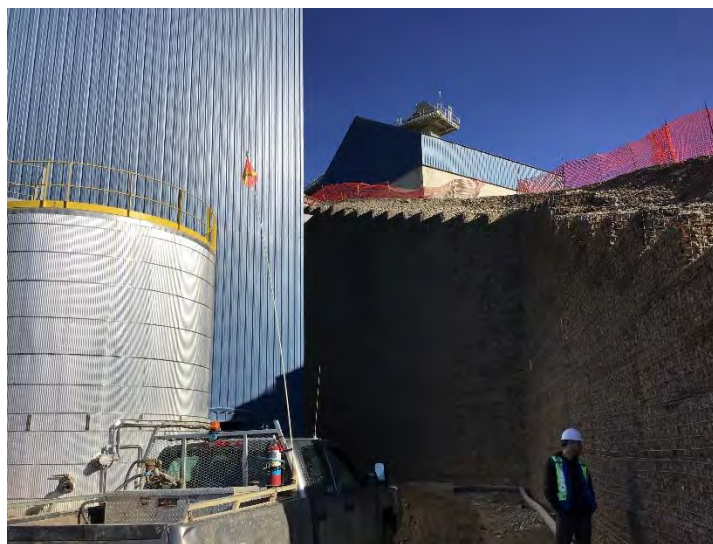
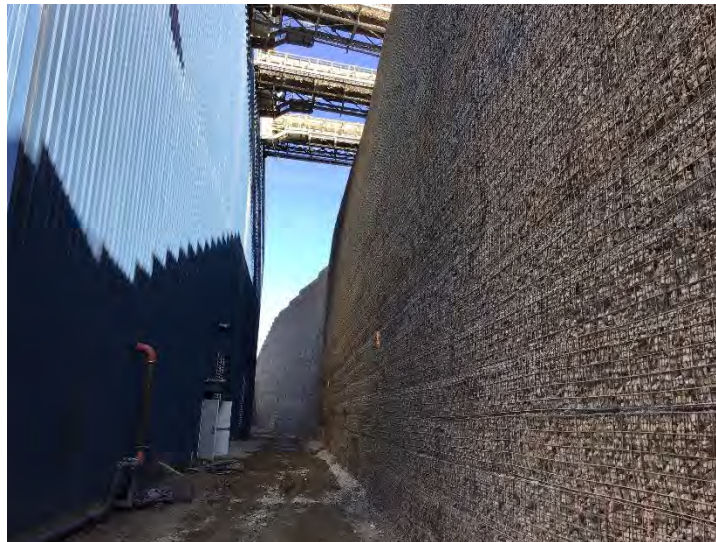
1. No apparent damage or deterioration was noted during the inspection (Figure 34). Much of the construction in this area has been completed since the previous inspection in 2018, and little baseline data is available for comparison. The structure is complete and operational. Survey benchmarks were present on the face of the wall (Figure 35).

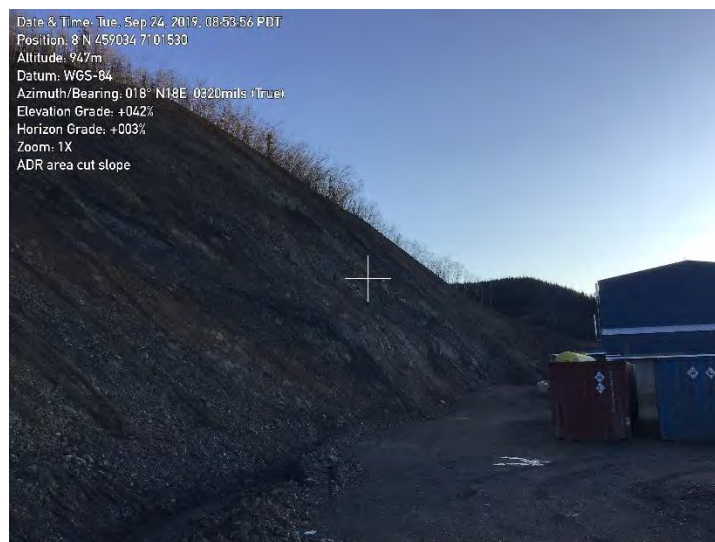
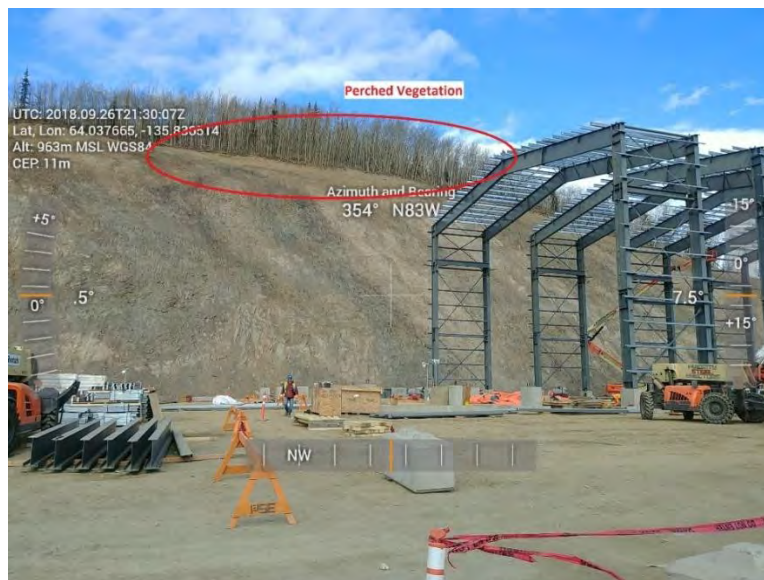
1. Cut slopes behind the ADR area appear to be competent rock, and currently stable (Figure 36). Minor accumulation of small debris was noted at the toe of the slope, collecting in the ditch. Minor debris accumulation was also noted in the 2018 inspection. Condition of the slopes appears similar to the 2018 inspection (Figure 37).

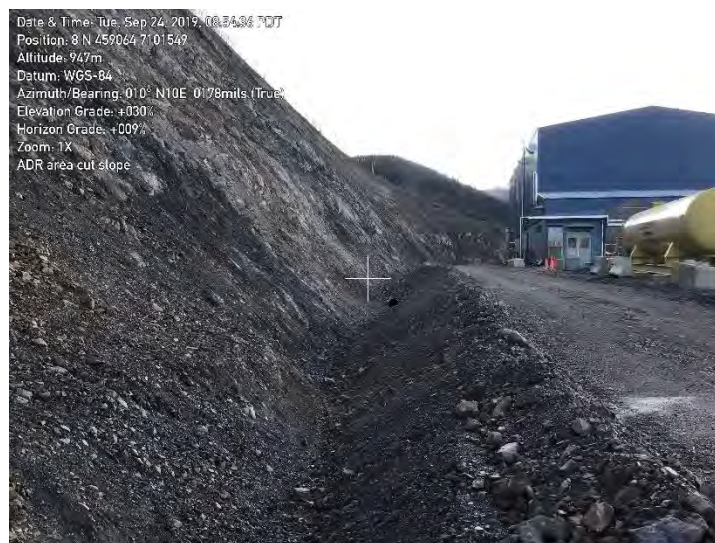
**Figure 38: Typical North Toe Ditch cross section**

1. There is a small V ditch, referred to here as the North Toe Ditch, with sides close to 1:1 cut at the base of a large steep slope which is cut into bedrock; the ditch is not armored and contains loose gravel and fines, although there are no apparent scouring issues. There is also a culvert which has been installed along the ditch alignment, possibly to widen the laydown area.

1. Review engineering requirements for the North Toe Ditch to confirm ditch size, and need for rock armoring. Toe ditch is currently tied into the roadside ditch, which should also be reviewed for engineering requirements. Recommend reviewing hydraulic design of both ditches to determine what is necessary.

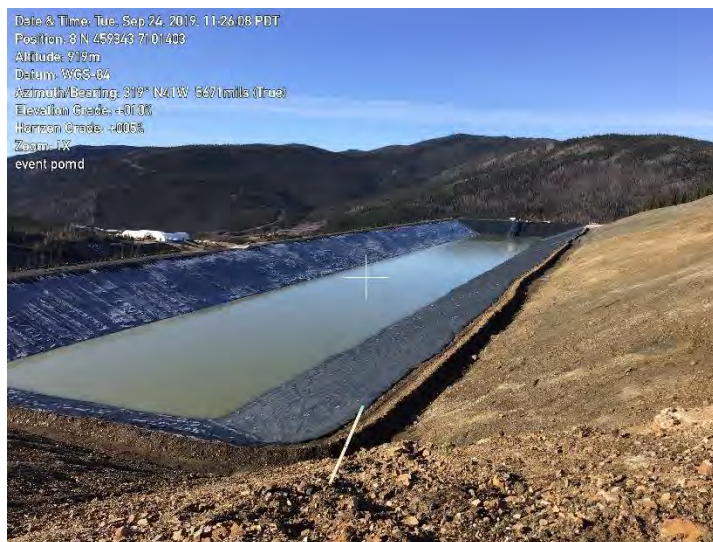
**Figure 40: Overall view of event pond**

1. The event pond was constructed since the previous inspection in 2018. Measured fill slopes are within recommended guidelines (2:1 slopes).

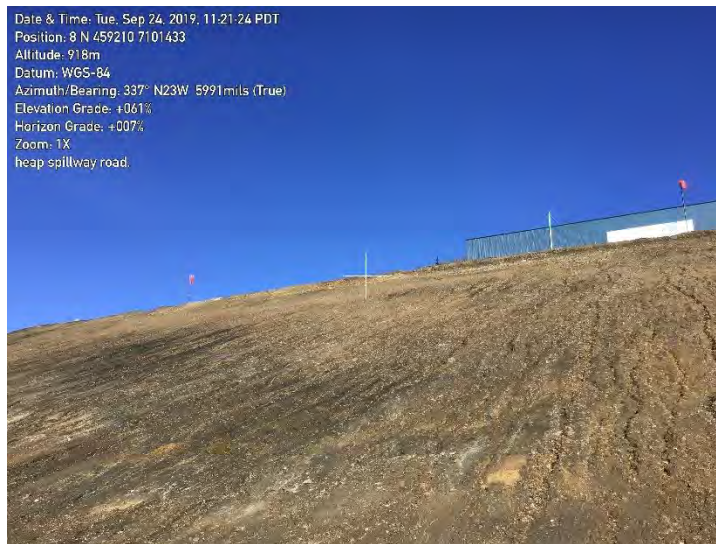
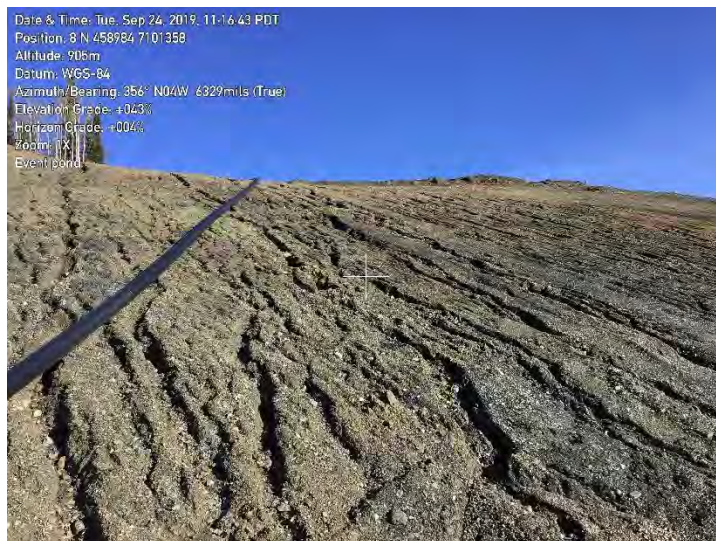
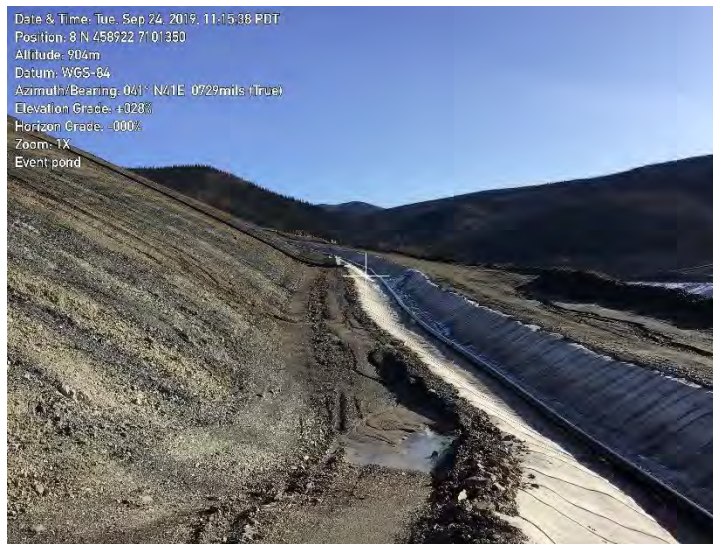
1. Some minor scouring of the cut slopes along the heap leach spillway bench/access was noted. Some material has accumulated on the bench and into the spillway (Figure 41, Figure 42 and Figure 43). The spillway is constructed with a concrete-filled fabric liner and appears stable.

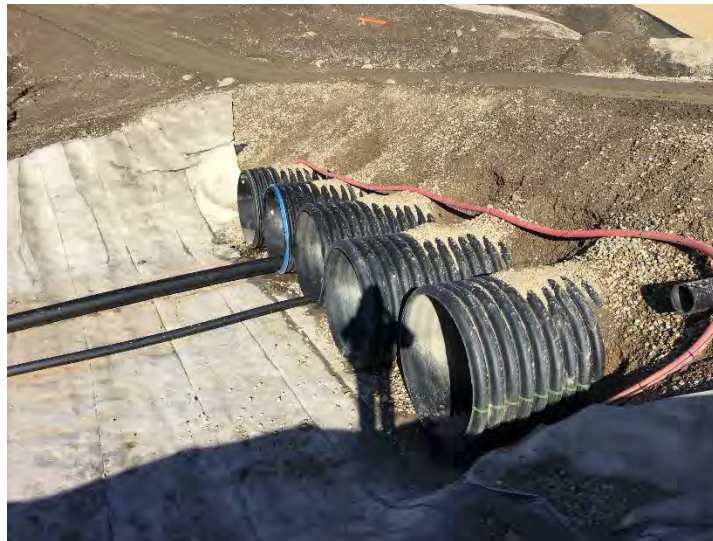
**Figure 44: Culverts installed under HLF embankment access road crossing**

2. Five plastic culverts have been installed under the embankment access road at the head of the HLF spillway (Figure 44). Minor sloughing is occurring from the fill overlying the culvert outlets. Otherwise the engineered structure appears stable

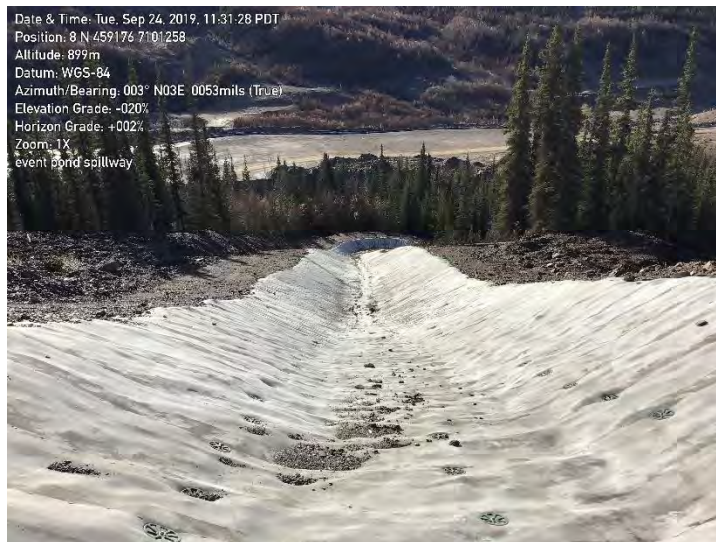
**Figure 45: Events Pond Emergency spillway**

1. The emergency spillway is in place, constructed of similar material as the HLF spillway, and appears stable (Figure 45). The spillway is directed downslope towards Dublin Gulch. No concerns at this time.

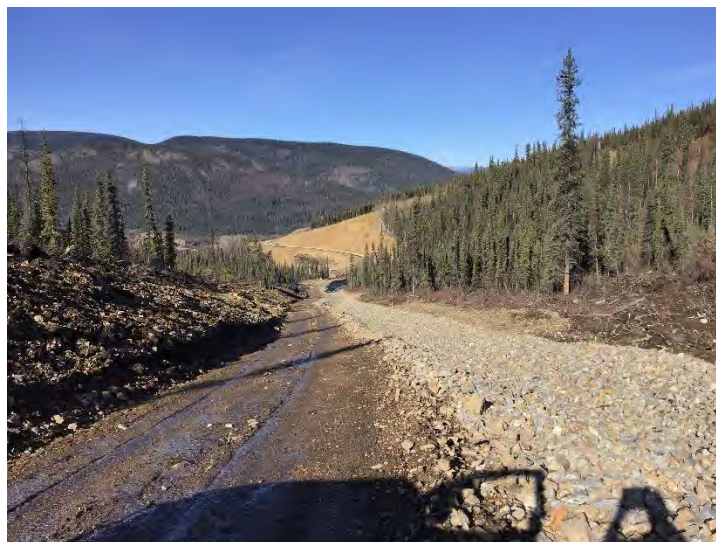
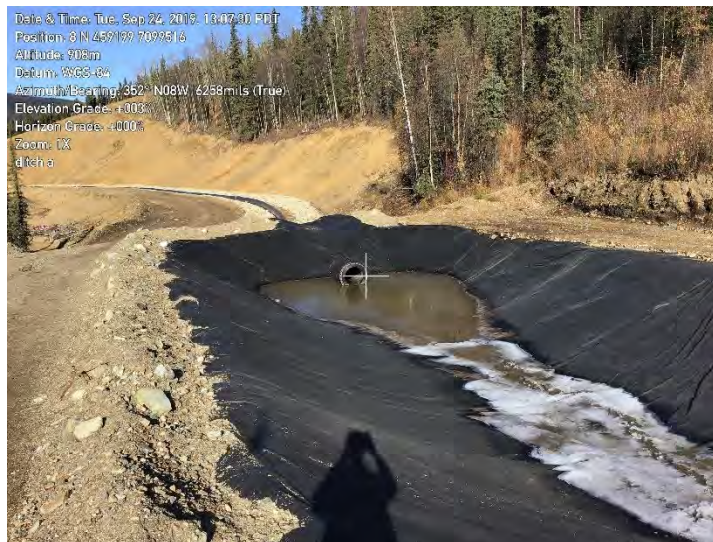
1. Ditch A carries flow from Platinum Gulch down to the Control Pond. The ditch is armored with approximately 50kg rock, and appears to be un-lined for the majority of it's length. The ditch flows into a lined collection sump several hundred meters down from it's initial point of collection (Figure 46 and Figure 47). Water collects in the sump and flows through a 36" HDPE pipe for the remainder of it's length. An overflow weir is present at the sump over the collection pipe, which would direct flow into the ditch during higher water level events. During the time of inspection, the ditch was mostly dry downstream from the collection sump, with all of the visible flow handled by the 36" HDPE pipe.

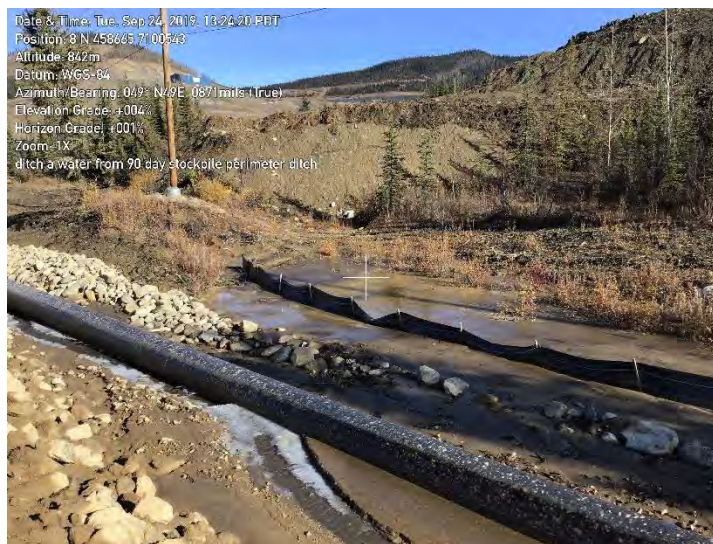
**Figure 48: Debris and flow from thawing permafrost terrain and the 90-day stockpile area**

2. Sediment flow into the ditch was noted near the truck shops. Site representative indicated that this took place over the previous week following heavy rains. As per the site representative, this flow is coming primarily from thawing permafrost uphill from the ditch, and may also have received flow from the 90-day stockpile perimeter ditch outlet, which as noted in Section 4, is still under construction. Future plans include construction of a ditch/pipe structure to carry water from the 90-day stockpile sump to Ditch A in a controlled manner. Site conditions have been too wet and unstable in the permafrost terrain to complete this work, and are planned for the winter season.

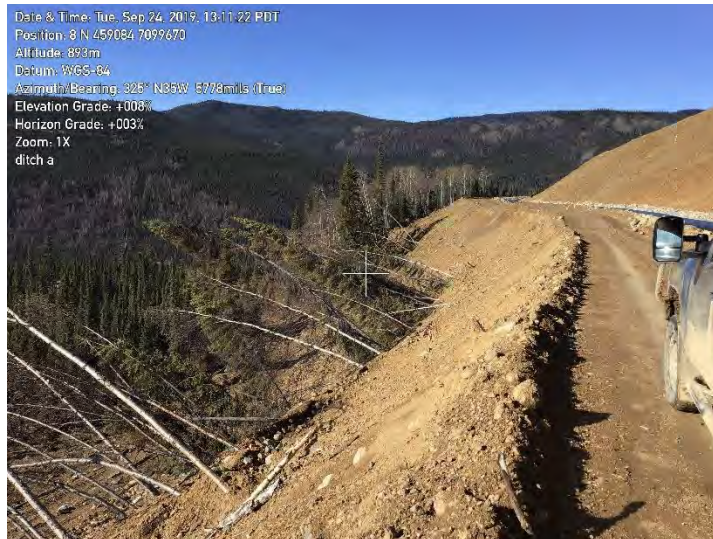
**Figure 49: Trees in fill subgrade**

- Fill along portions of the access road adjacent to Ditch A appears to have been pushed onto trees and debris in the subgrade (Figure 49).

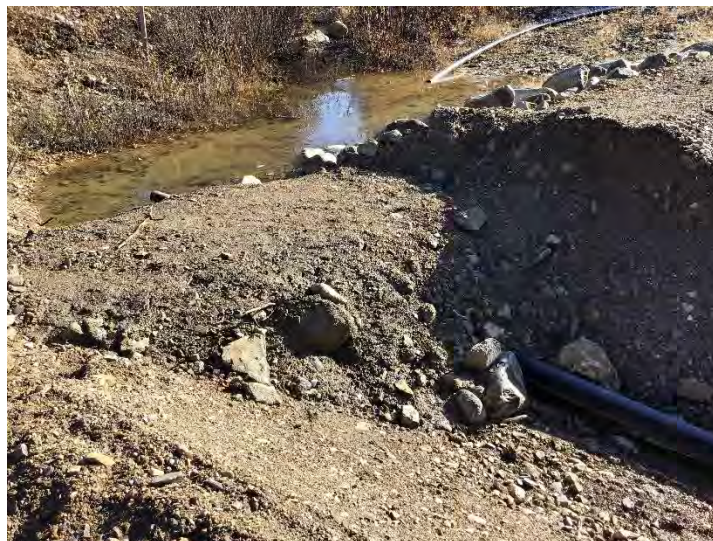
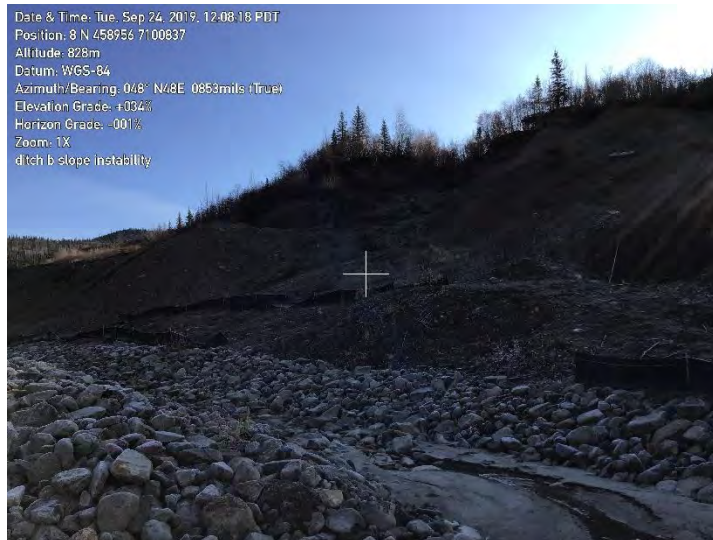
- Ditch B begins at a small watercourse known as Suttles Gulch. A small stream, known as Eagle Creek, is currently captured by a small berm and then directed into Ditch B under the berm via a small diameter HDPE pipe (Figure 50). The ditch flows West towards the Control Pond. The ditch is armored with approximately class 25kg rock. Some slope instability was noted near the control pond, with erosion carrying sediment down the cut slope. Site representatives are already aware of this issue, and sediment is being actively managed using silt fencing (Figure 51).

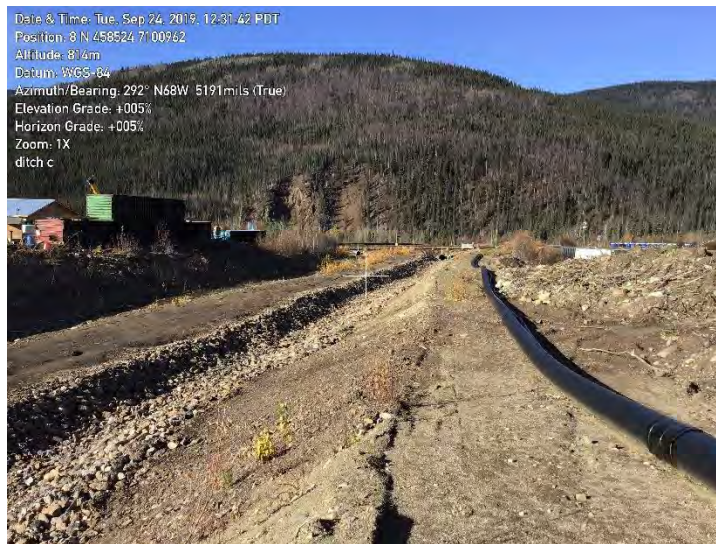
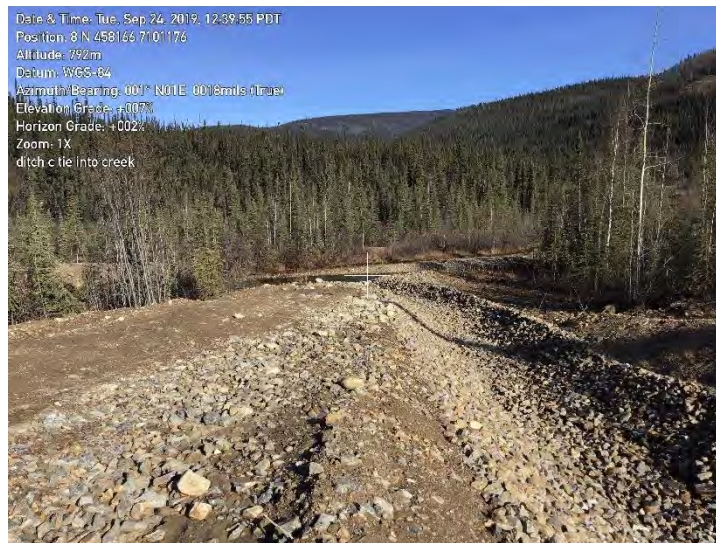
1. Diversion ditch C begins at the 1500mm outlet culvert for the Control Pond (Figure 52), and terminates in Haggart Creek (Figure 53 and Figure 54). This ditch acts as both an emergency spillway if the Control Pond is filled over capacity or a conveyance channel for water released from the control pond through the low level outlet. The ditch is armored with approximately class 10kg rock, and liner is visible in several locations. The ditch has several road crossings which are spanned by culverts. No issues identified at the time of inspection.
