Allnorth Information		VICTORIA GOLD CORP.	
Project #:	<b>19-PG-0305</b>	Client Project #:	
Document #:	<b>191029</b>	Client Document #:	
Document Rev. #:	<b>0</b>	Client Doc. Rev.#:	
Prepared By:	Jordan Smith, EIT	Client Contact:	Richard Tuohey
Reviewed By:	Don Williams, P.Eng.

Annual Physical Stability Assessment Report – Victoria Gold – Eagle Gold Project

Visual inspection of the following structures: Open Pit, Platinum Gulch Dump, Lower Dublin South (Control) Pond, Secondary Crusher, Primary Crusher, 90 Day Stockpile, Adsorption, Desorption and Recovery Plant, Heap Leach Facility, Event Pond, Ditch A, B, and C, Former Nuway Crusher Pad, Orica Laydown, Various Un-named Stockpiles.

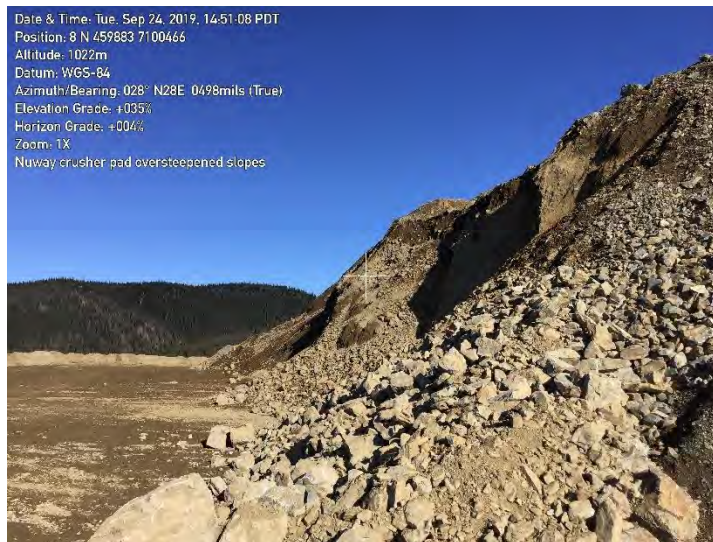
**Figure 55: Over steepened slopes**

1. This area is not currently being used, but the site representative indicated that it may be used in the future as a stockpiling area. Observed some over steepened slopes (Figure 55), with material collecting at the toe of these slopes.

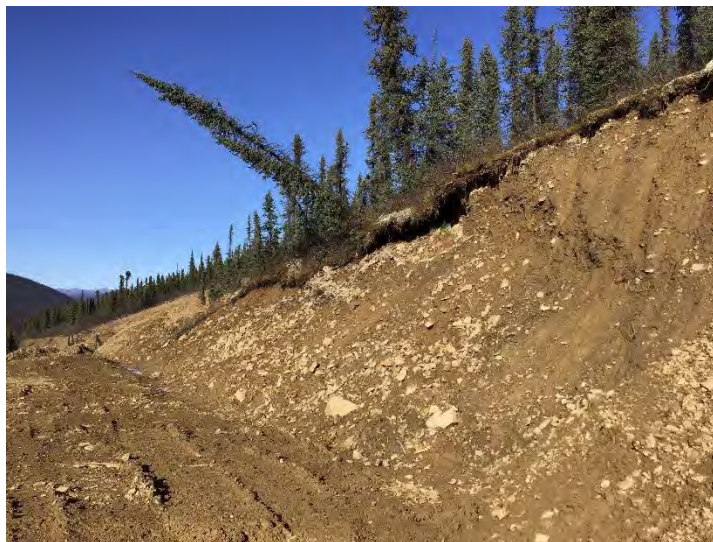
**Figure 56: Section of over-steepened slope**

1. One section of cut slope has been over-steepened while expanding the laydown (Figure 56). Sloughing of material and some undercutting present. Site representative indicated that this area will be addressed prior to placing new buildings in their final location

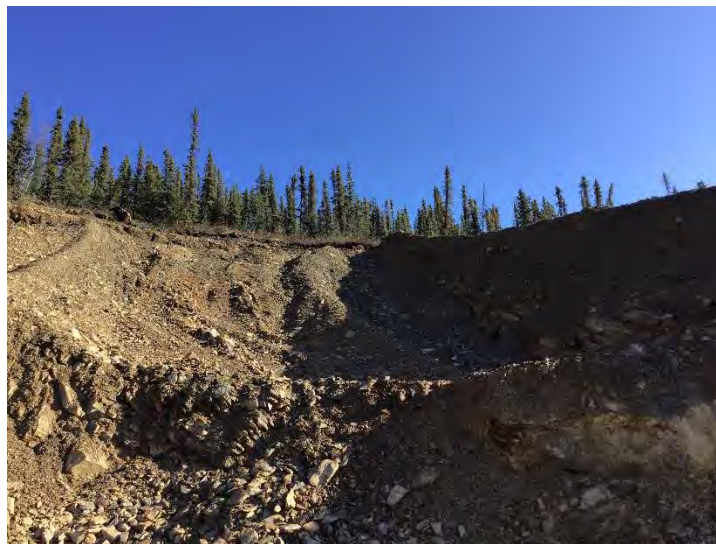
**Figure 57: Sediment control sump**

2. Lower section of the laydown appears to have some wet material on the slope. Some water is ponding around the base of the slope in a sediment control sump apparently installed in this area to manage runoff (Figure 57). No visible water flow is evident. Water may be percolating through the subsurface at the base of the slope. The remainder of the cut slopes appear to be competent material.

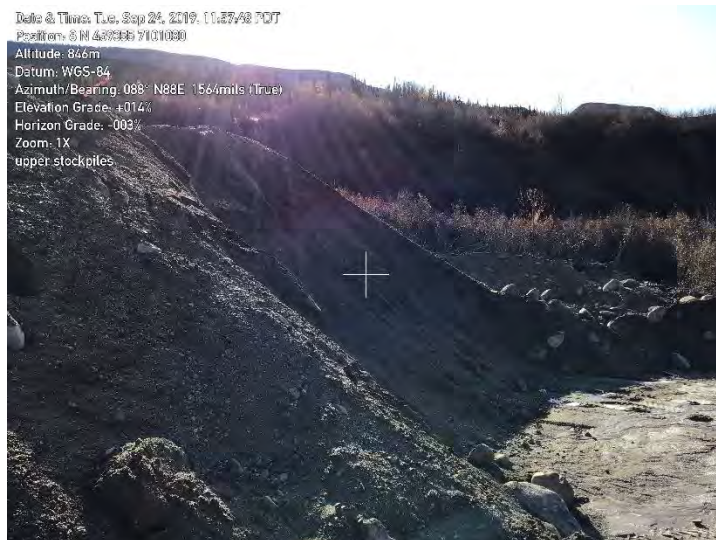
**Figure 58: Some stockpiles with steep side slopes**

1. Several un-named overburden stockpiles have been placed to the south of the HLF and Event Pond (Figure 58). Some of the stockpiles have over-steepened sides, but there is little risk to other infrastructure. The area is currently mostly un-used.

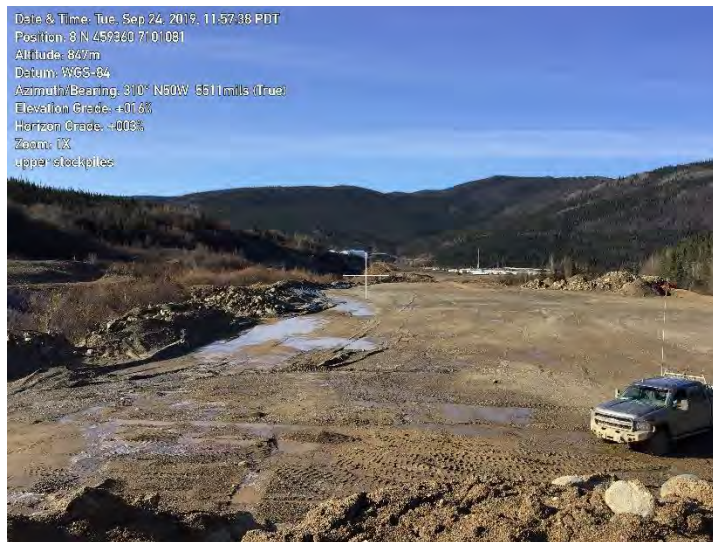
**Figure 60: Ponding downhill of stockpiles**

appears to be trenched out towards the Control Pond, although there is ponding water in this area (Figure 60).

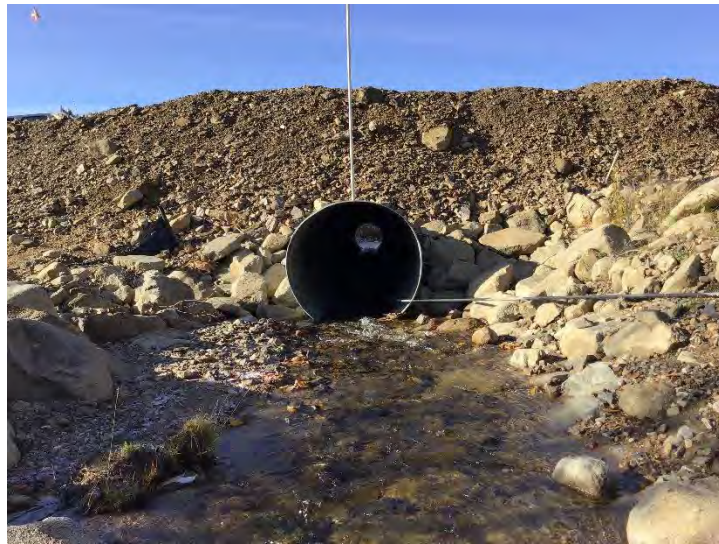
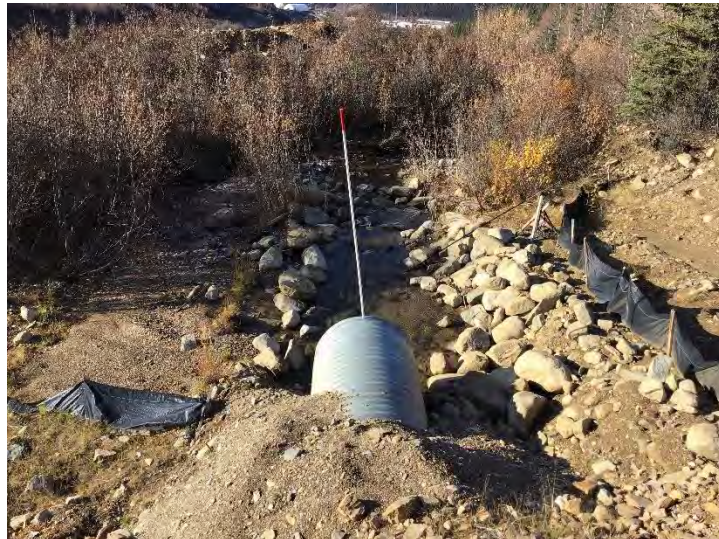
1. The culvert crossing in this area was found to be in good condition. Riprap armoring at the inlet and outlet appears to be functioning well, with no signs of scour observed (Figure 61 and Figure 62).
