## **EAGLE GOLD PROJECT**

WATER LICENCE QZ14-041-01

QUARTZ MINING LICENSE QML-0011

2019 ANNUAL REPORT

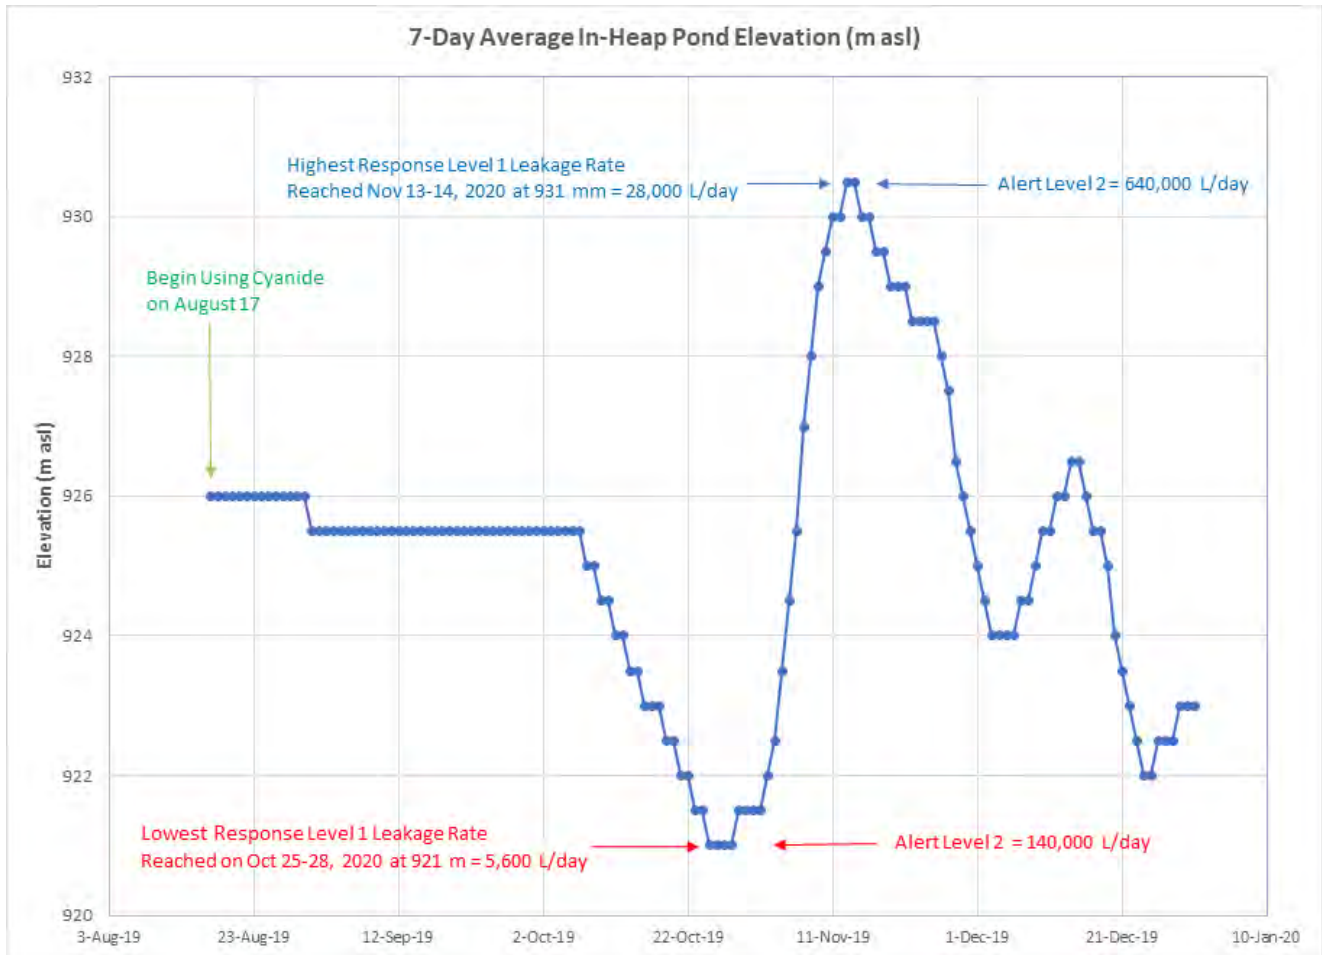
Figure 2.6-1: 2019 LDRS Leakage Recovery Rates and Response (Alert) Levels Associated with In-Heap Pond Levels

In general, these rates were below Alert Level 1 (AL1) leakage rates (Figure 2.6-1), which are the expected leakage rates based on design criteria and reflect the as-built conditions. The AL1 is based on a small defect leakage rate, which is intended to represent the leakage rate expected from geomembranes installed with strict construction quality assurance. As depicted in Figure 2.6-1, AL rates vary with the pond level since the hydraulic head dictates the rate of leakage through a hole or seam defect.

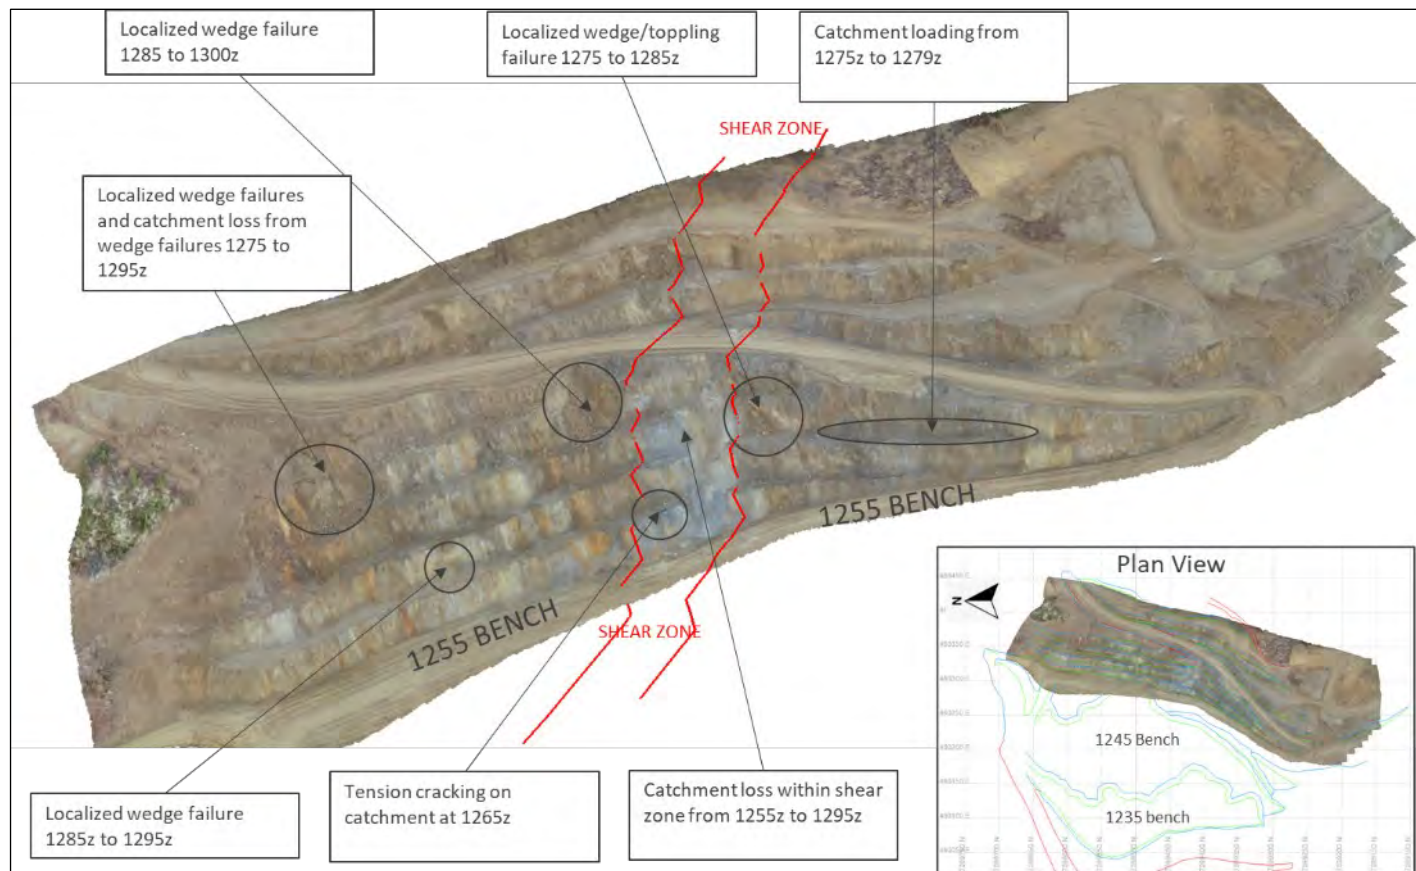
Figure 4.1-3: Eagle Pit Phase 1 - Localized Wedge Failures Relative to Shear Zone

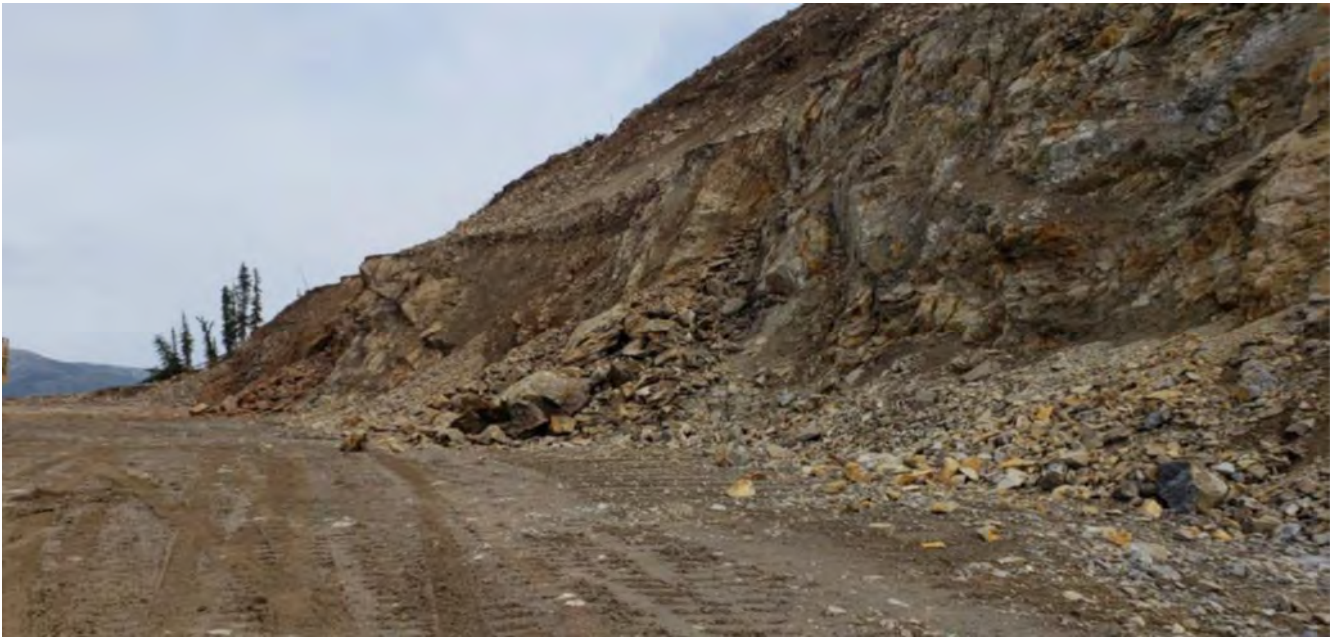
**Photo 4.1-1: Localized Wedge Failures on the 1285 Bench - June 9, 2019**

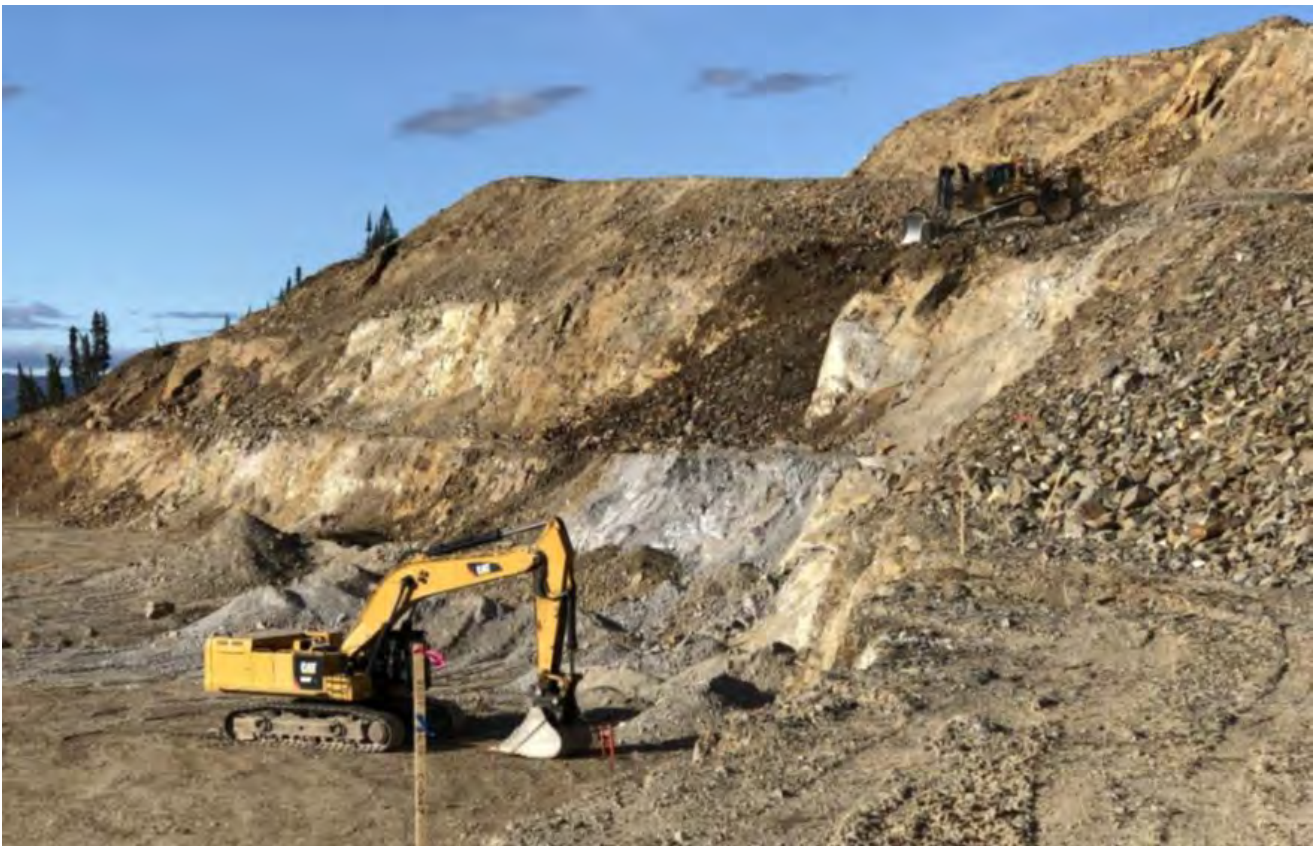
**Photo 4.1-2: Remediation Activities on Localized Wedge Failures on the 1275 and 1285 Benches - June 18, 2019**

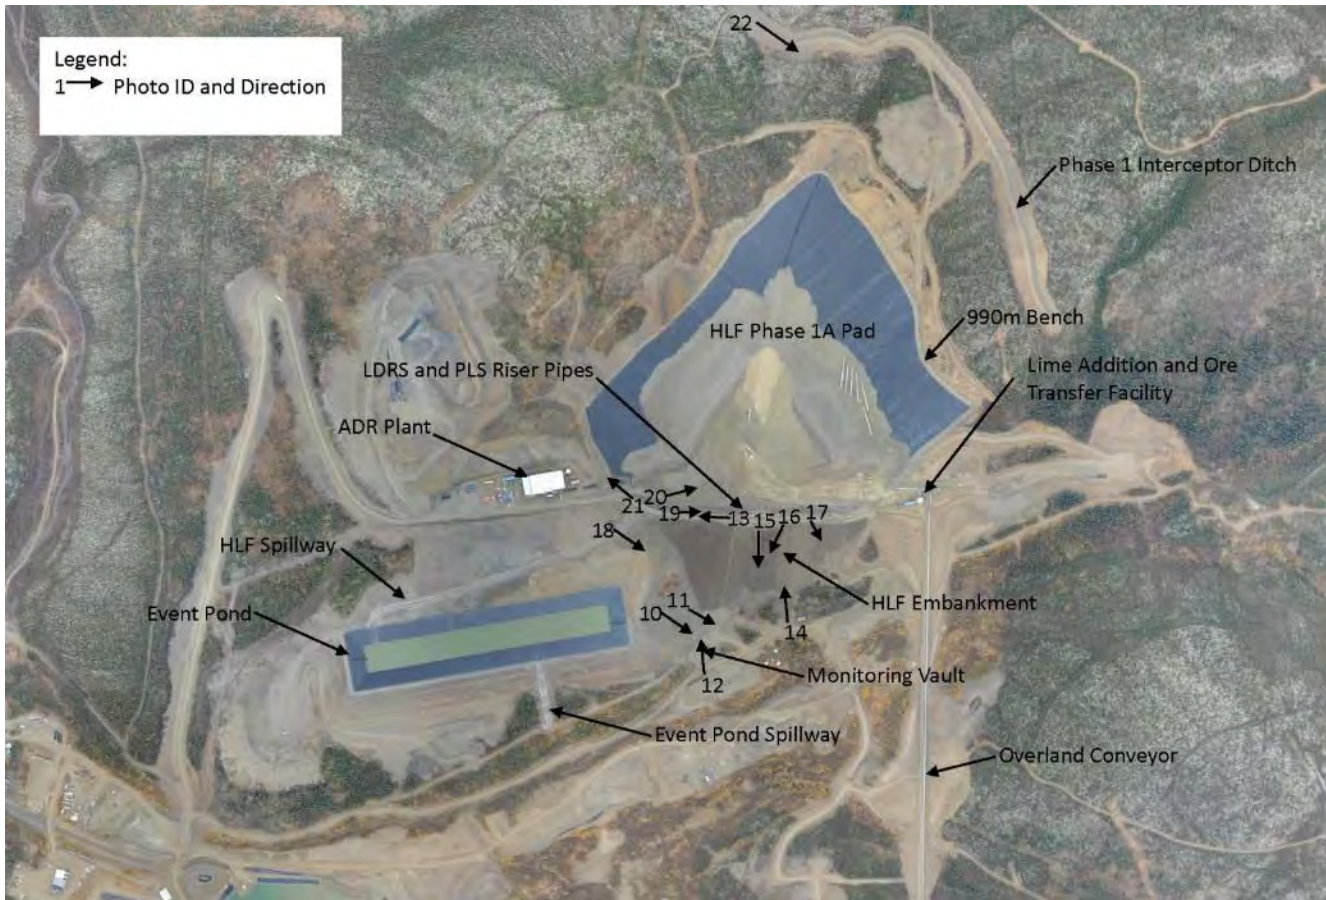
**Figure 4.3-3: Inspection Photo Map for HLF**

At the time of the visual inspection, water was not being discharged to the environment from the HLF underdrain flows but was being pumped back into the process circuit. Flows were apparent in underdrains #1, 2 and 5 which collect seepage under the Phase 1 HLF. No discharge was observed from underdrains #3 and 4, which are blank pipes installed in reserve for future phases of the HLF. The underdrain pipes are numbered from east to west (Figure 4.3-3 and see Photo 11 in Appendix B).

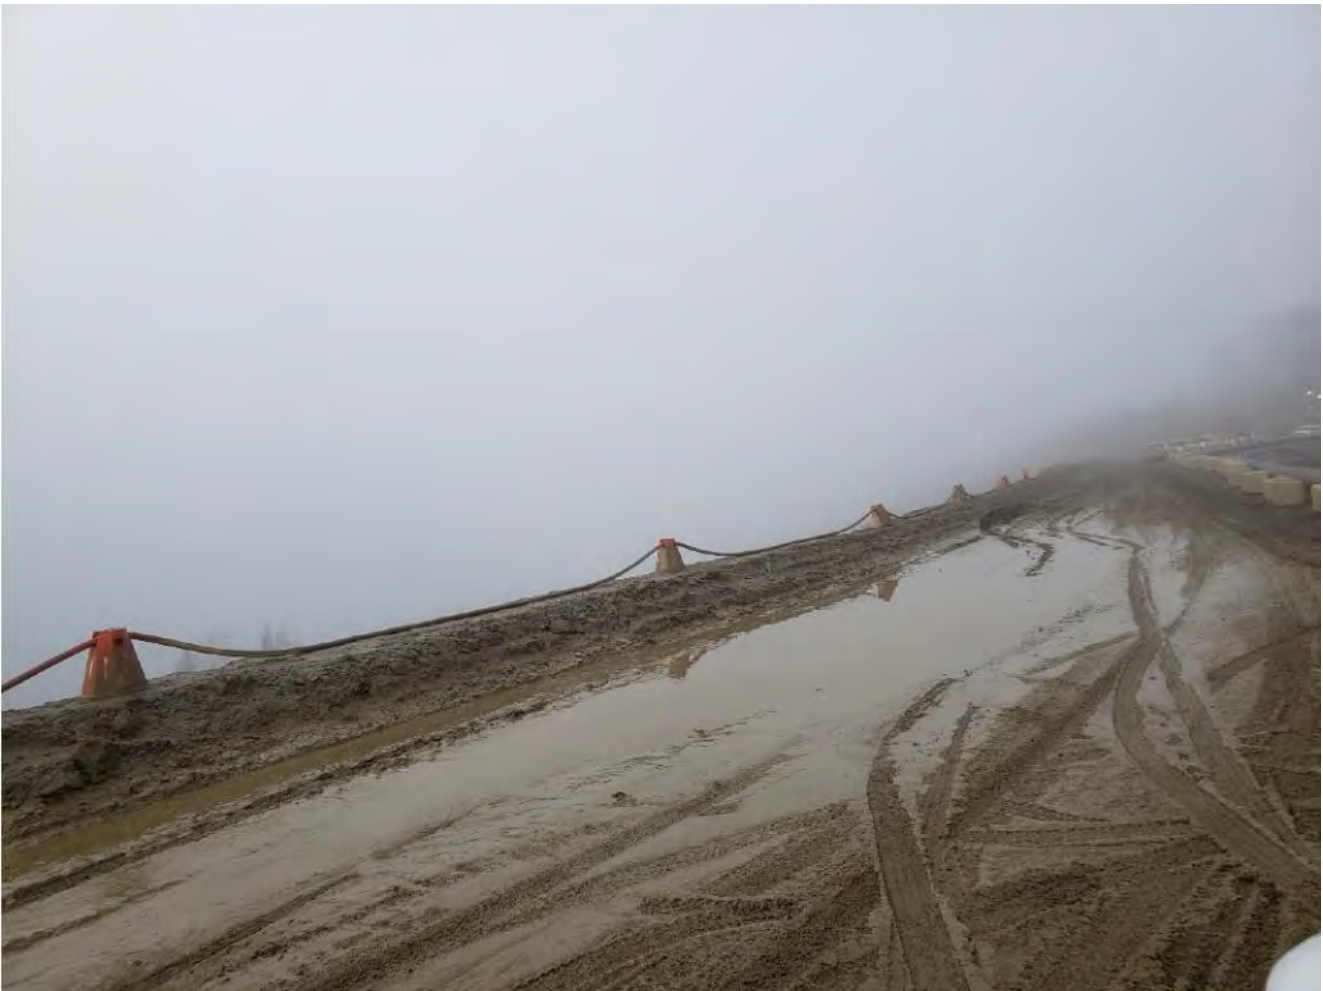
Some unevenness, most likely caused by vehicle traffic, was visible on the dam's crest near the PLS risers, with ponding apparent (Photo 4.3-1 - Photo 13 in Appendix B). A few minor surface erosion gullies (Photo 4.3-2 - Photo 11 in Appendix B), which appear to be caused by rainfall runoff, were observed on the downstream slope of the underdrain containment area. The EOR recommended (see Table 4.3-2) that additional coarse fill be placed on the dam crest to limit ponding. The additional fill was placed after the inspection and the area is being monitored. The EOR also recommended that a small berm be constructed along the crest of the underdrain containment area to direct surface water flows to the west edge of the monitoring vault area. This area is being monitored and will be re-evaluated after freshet 2020.

**Photo 4.3-1: HLF Dam Crest Looking West**

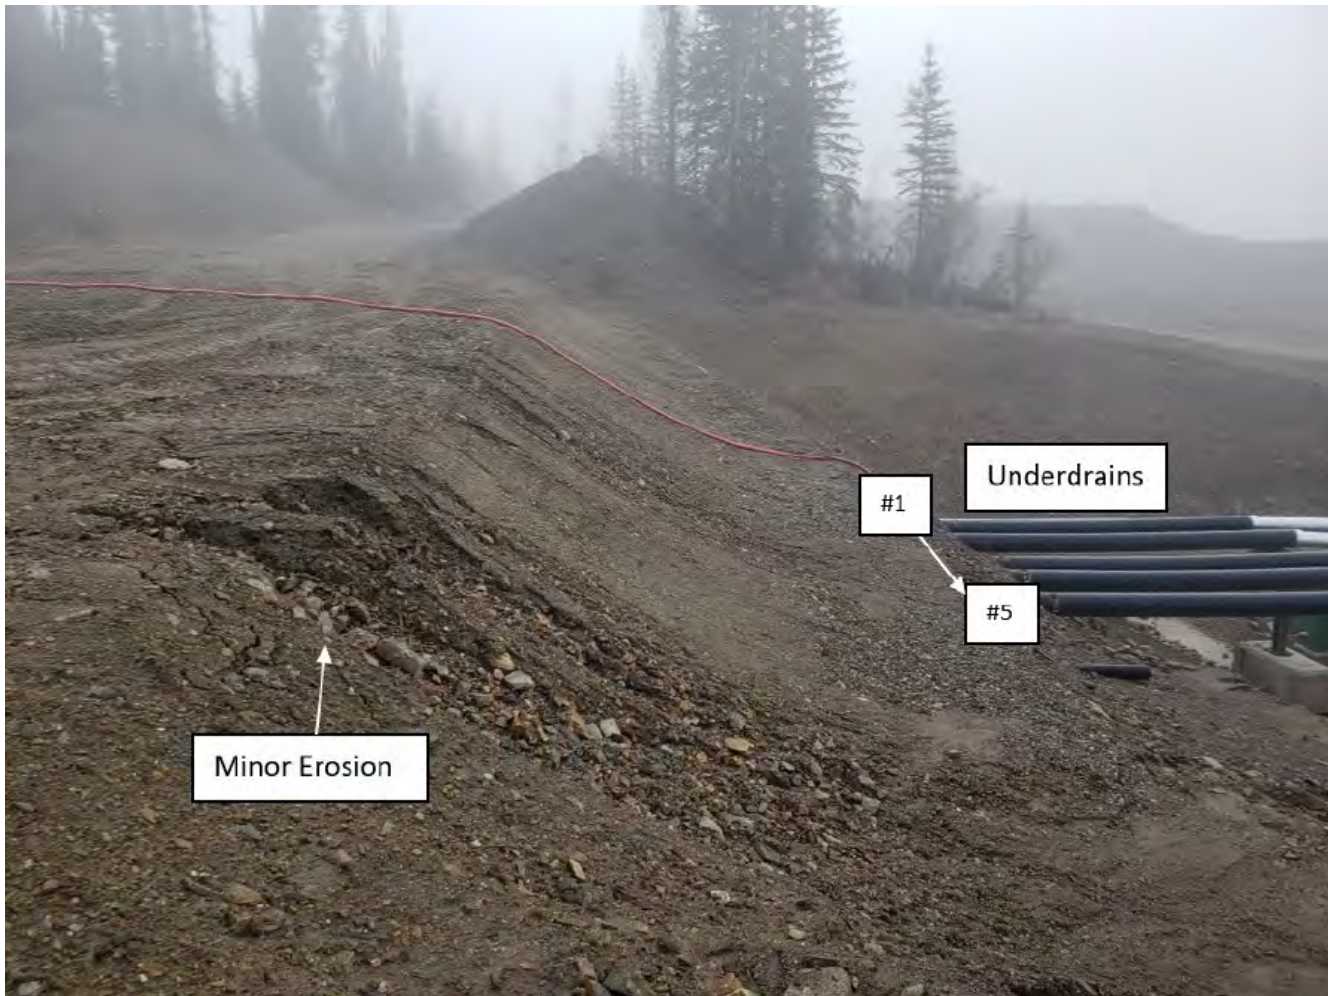
**Photo 4.3-2: HLF Underdrain Outlet Between Dam and Monitoring Vault Looking East**

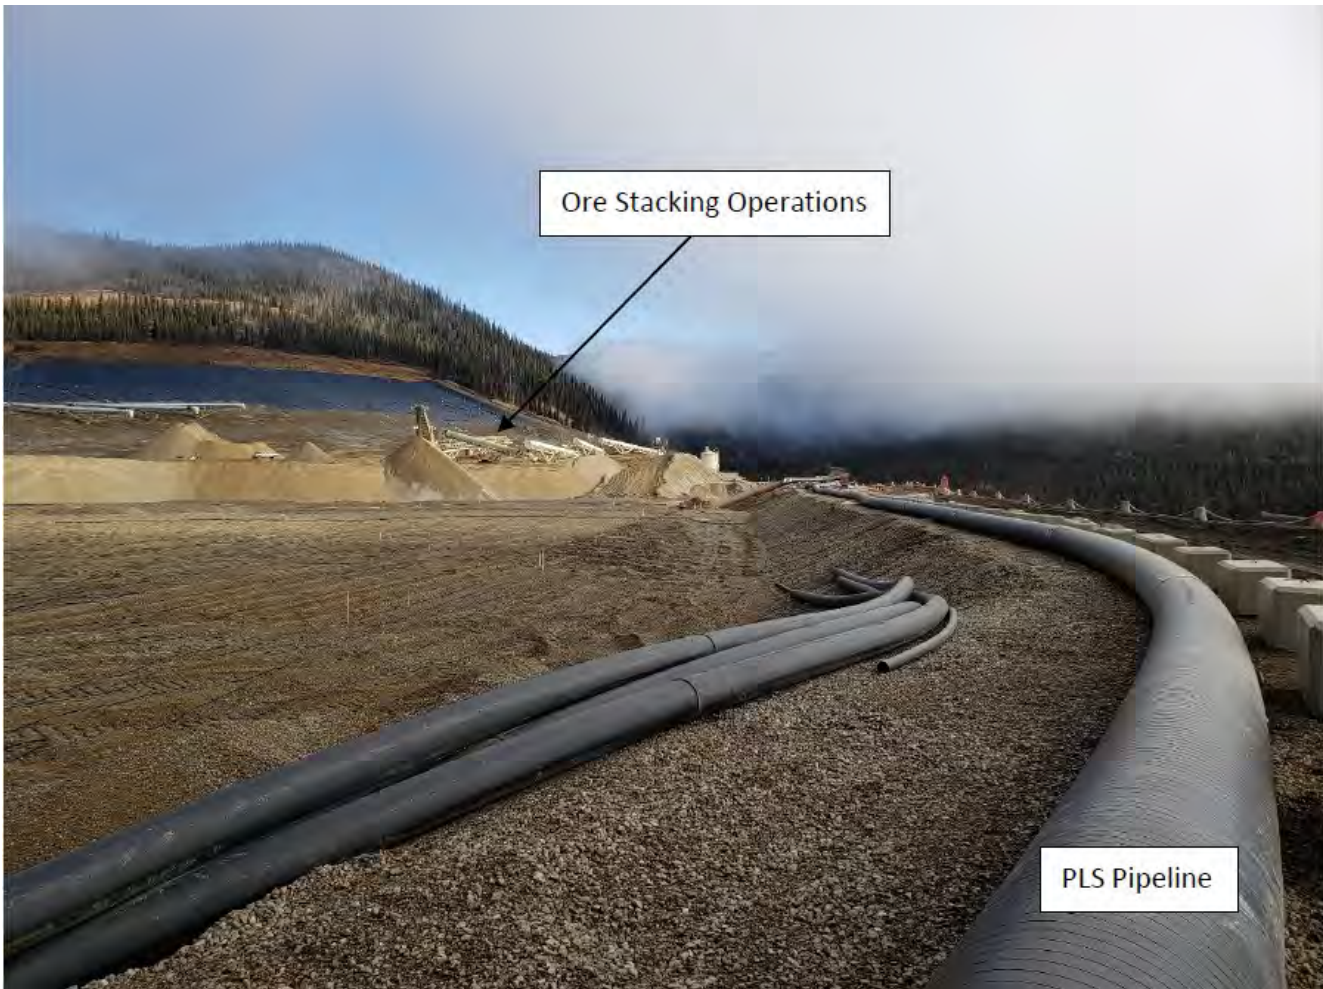
**Photo 4.3-3: HLF Phase 1 Pad Looking East from Dam Crest**

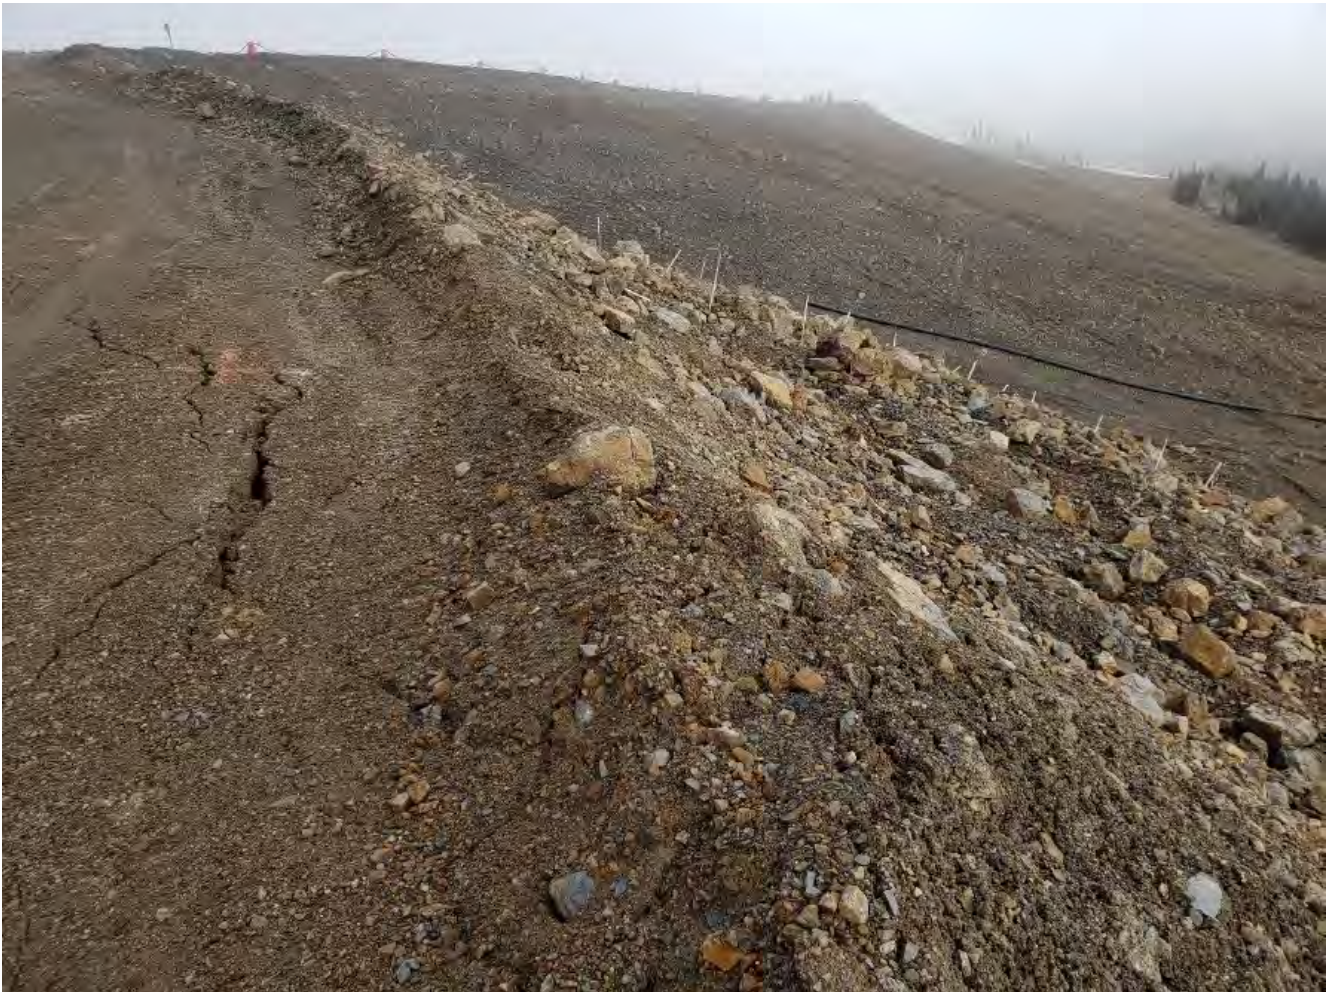
**Photo 4.3-4: Upper Portion of HLF Spillway Access Road**

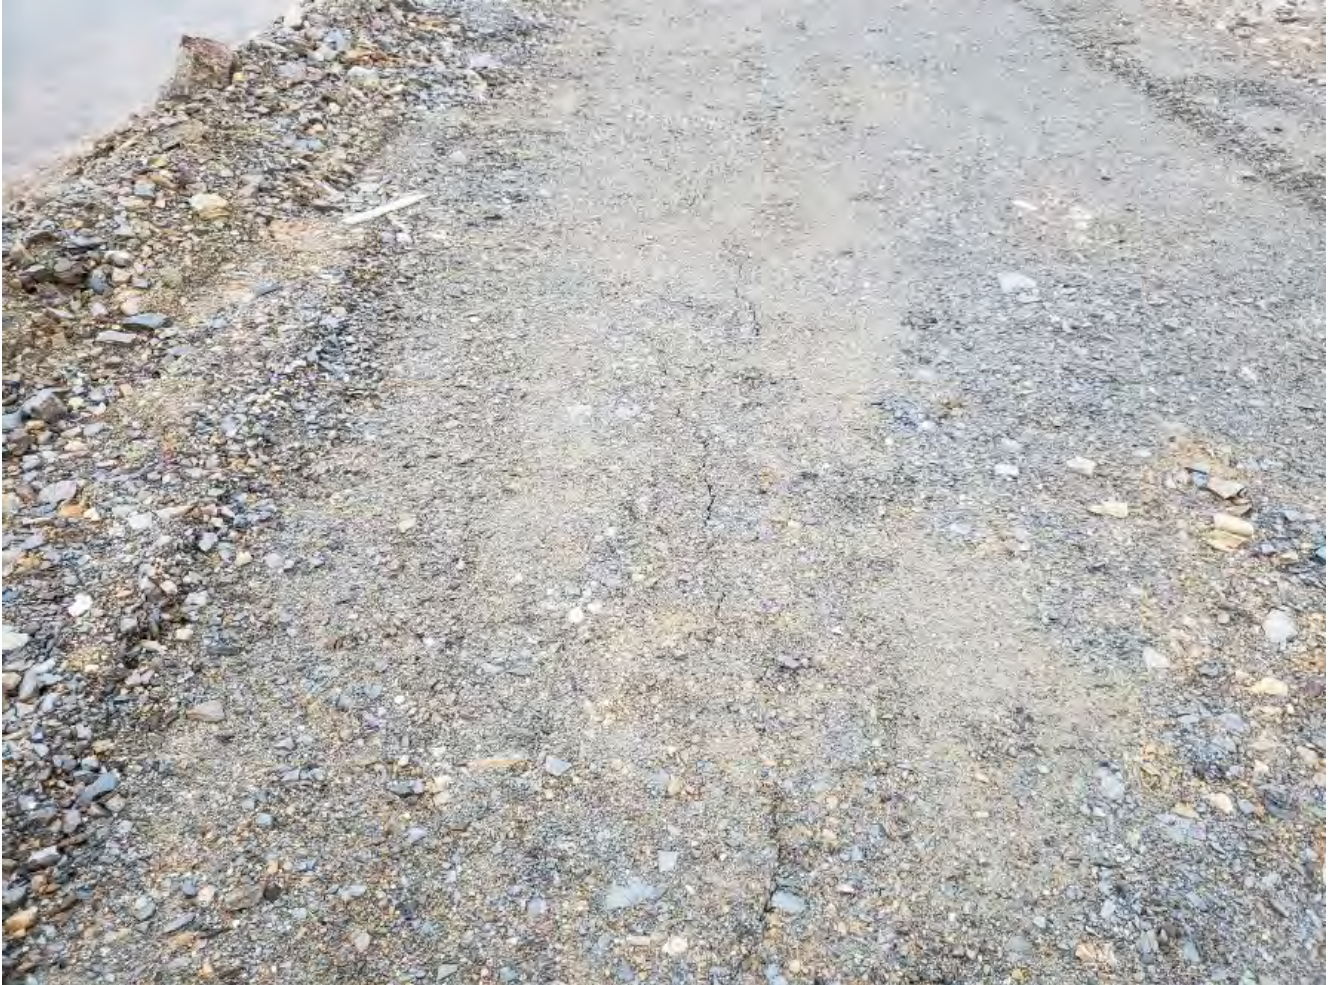
**Photo 4.3-5: Event Pond South Embankment Crest Looking West**

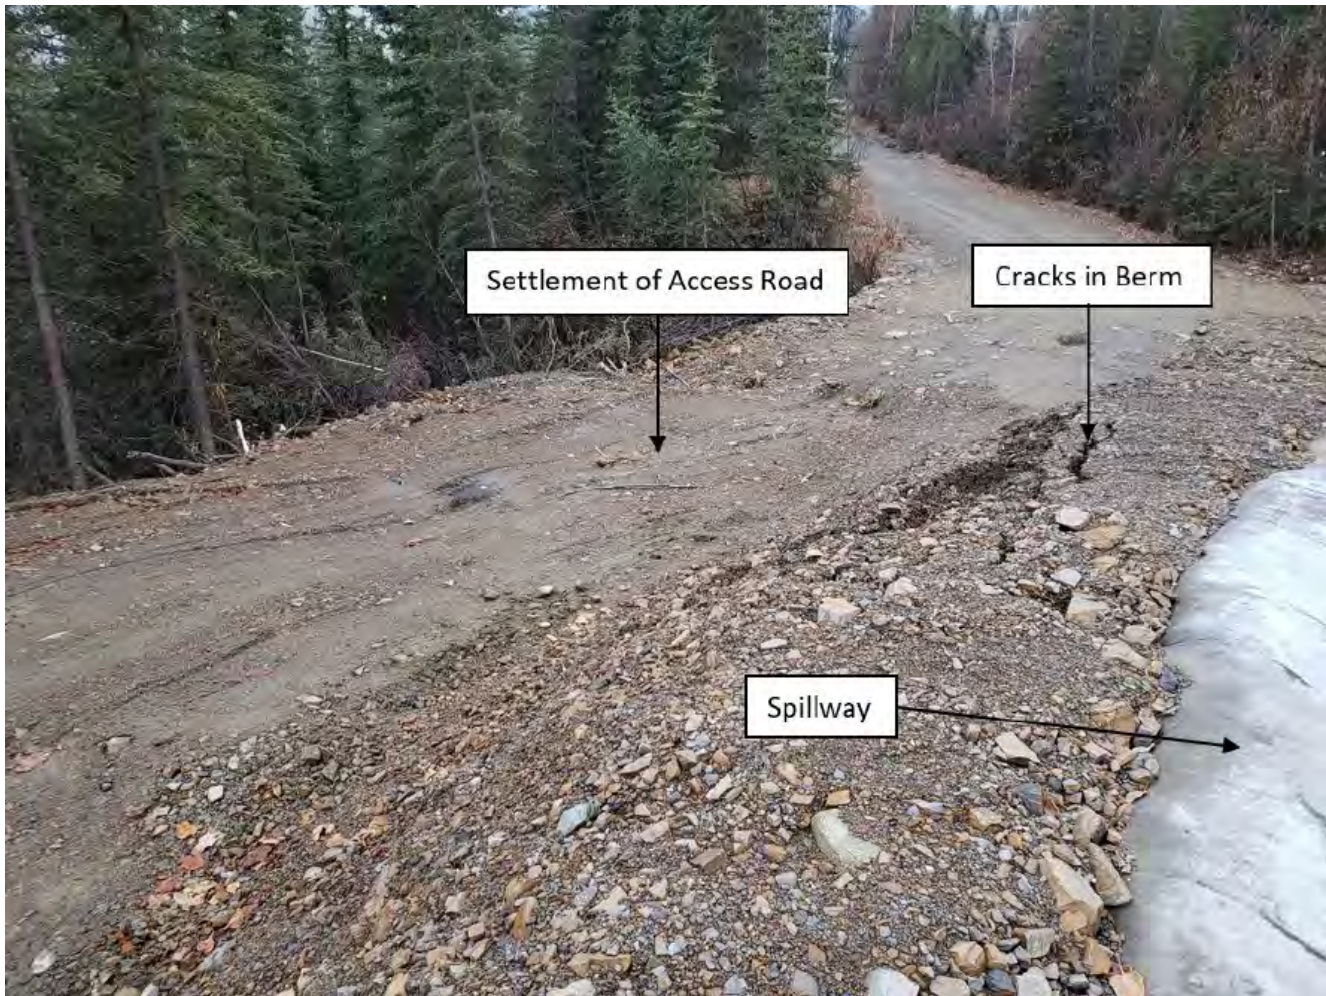
**Photo 4.3-6: Berm and Access Road Adjacent to Bottom Portion of Event Pond Spillway**
