**Re: 2010 Annual Physical Inspection , Quartz Mining Licence QML-0009
 Bellekeno Mine, Yukon**

ALEXCO KENO HILL MINING CORP.
QUARTZ MINING LICENCE QML-0009
2011 ANNUAL PHYSICAL INSPECTION
BELLEKENO MINE SITE
KENO HILL SILVER DISTRICT
YUKON

2011 ANNUAL PHYSICAL INSPECTION
SURFACE STRUCTURES

Subject: 2011 Annual Inspection – Surface Engineered Earth Structures
Bellekeno Minesite, Keno City, Yukon

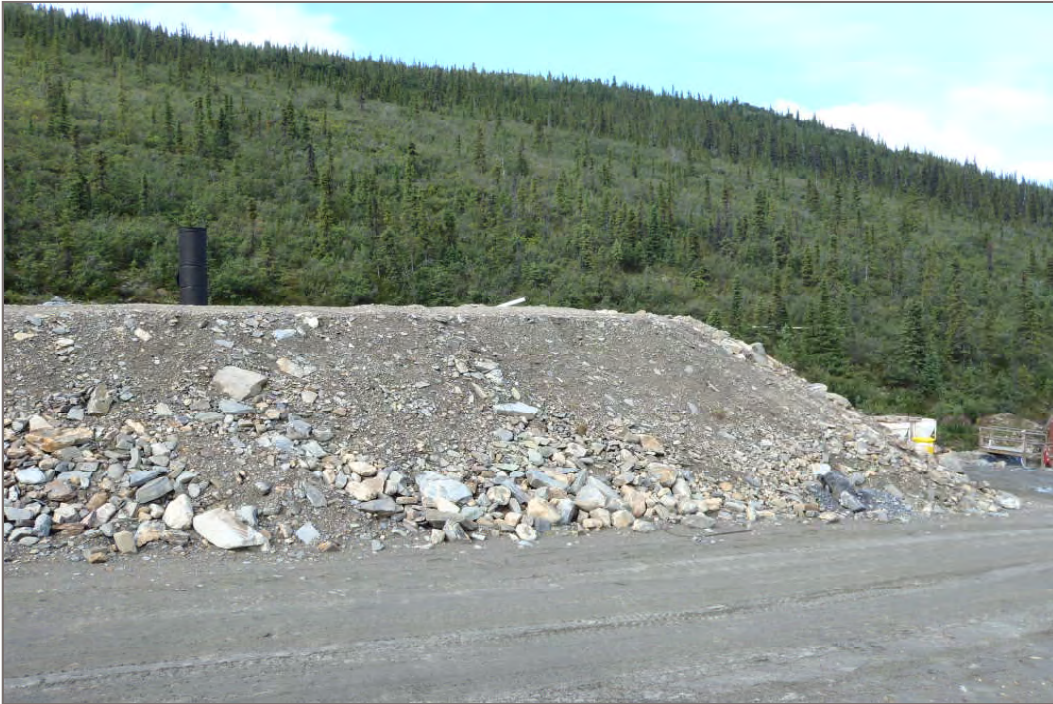
The PAG Waste Storage Facility is located south of the Bellekeno Mine portal, the location is shown on Figure 1. The perimeter berms of the facility appeared intact with no visible signs of instability or erosion (Photo 1). The vertical geotextile wrapped extraction culvert, waste piles, and completed liner system appeared stable (Photo 2).

Photo 1: PAG Waste Storage Facility perimeter berm
(Facing northwest – July 28, 2011)

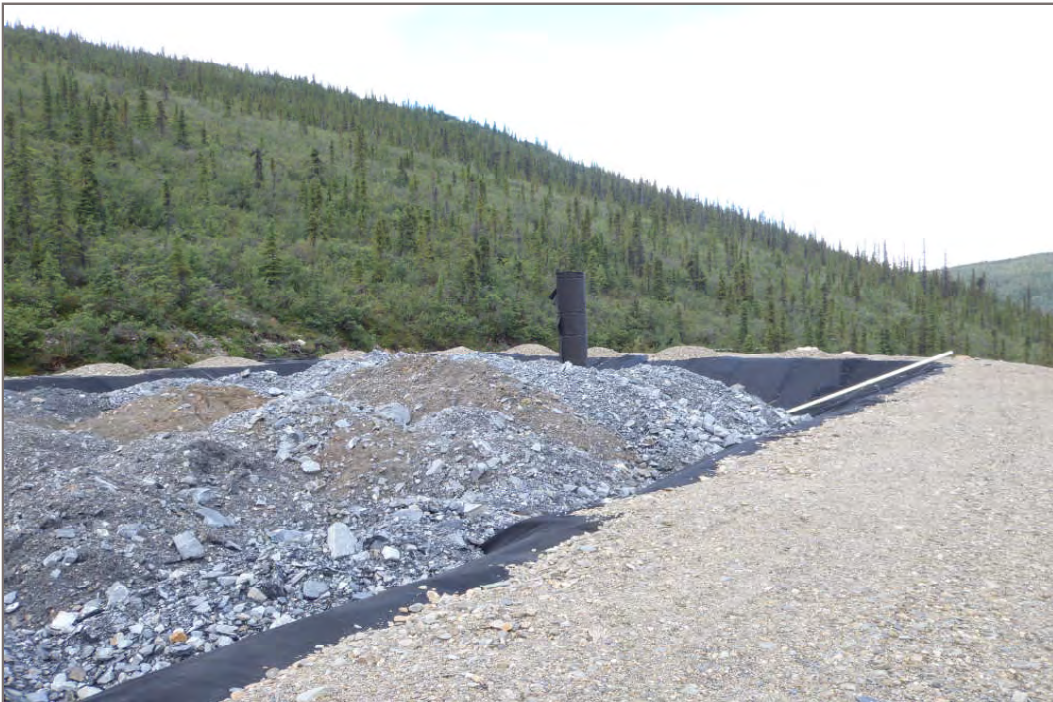
Photo 2: Geotextile wrapped vertical culvert, waste piles, completed portion of liner system
(Facing north – July 28, 2011)

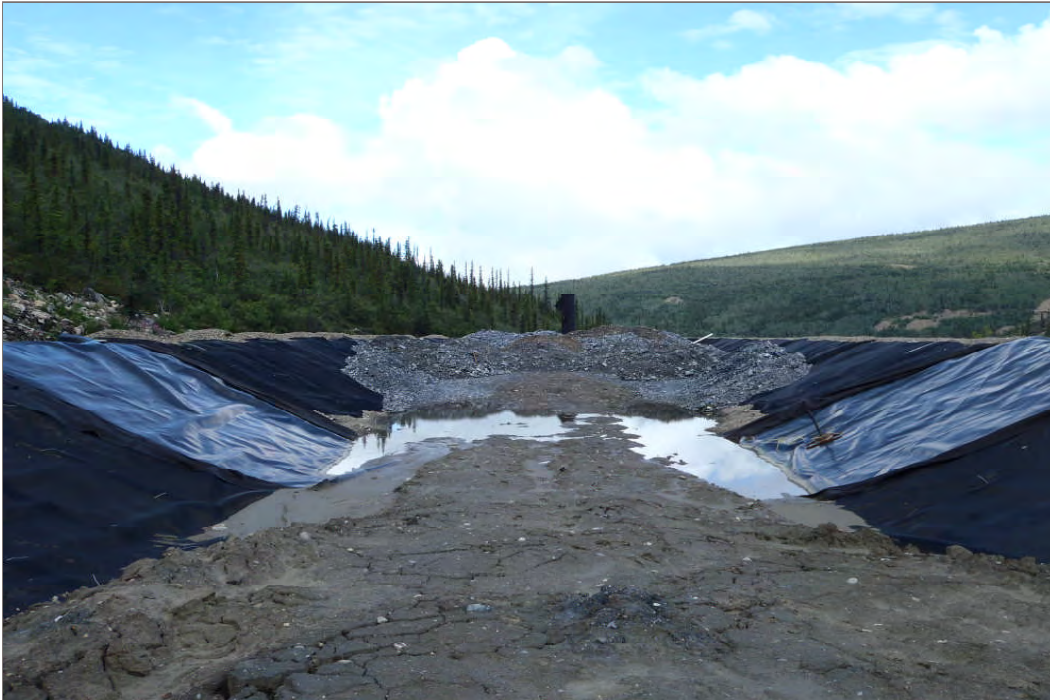
At the time of the inspection construction of the PAG Waste Storage Facility was only partially completed (Photo 3). The material being stored within the facility appeared to be properly contained; construction of the facility should be completed to reduce the risk of uncontrolled release and allow for additional storage capacity.

Photo 3: Partially completed PAG Waste Storage Facility
(Facing north – July 28, 2011)

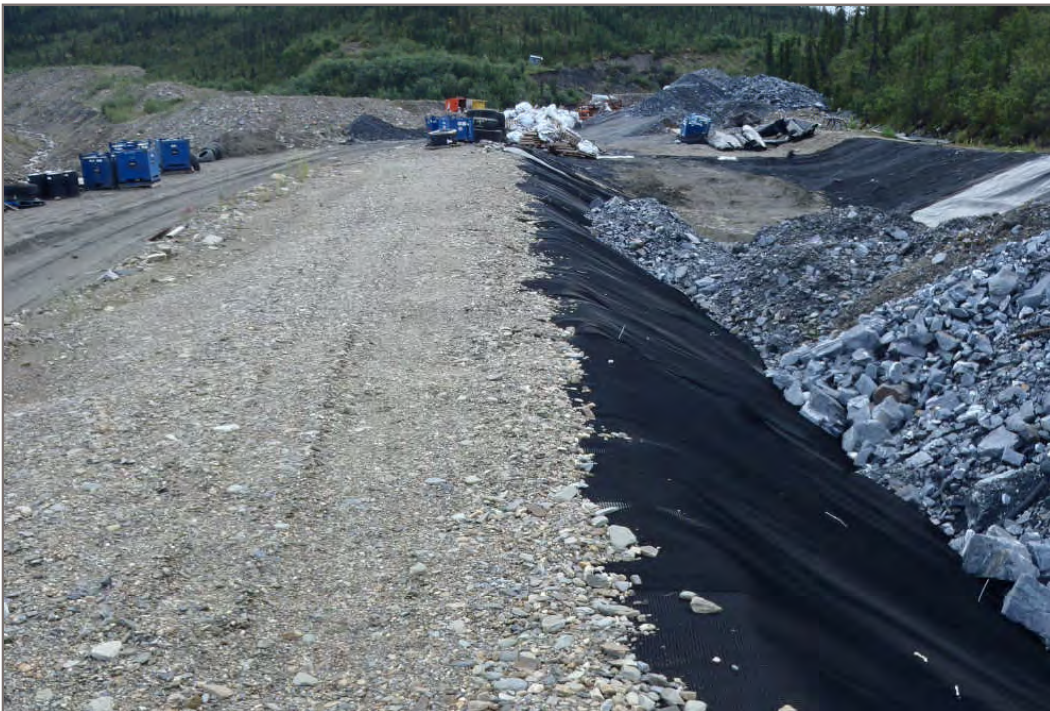
Within the completed portion of the facility (northern half) the liner anchoring trench along the east berm appeared finished (Photo 4). Elsewhere, loose material was piled on top of the berm to hold the liner in place (Photo 5). The liner anchoring trench should be finished for the remainder of the completed facility (north and west berms).

Photo 4: Liner anchoring trench along east berm
(Facing south – July 28, 2011)

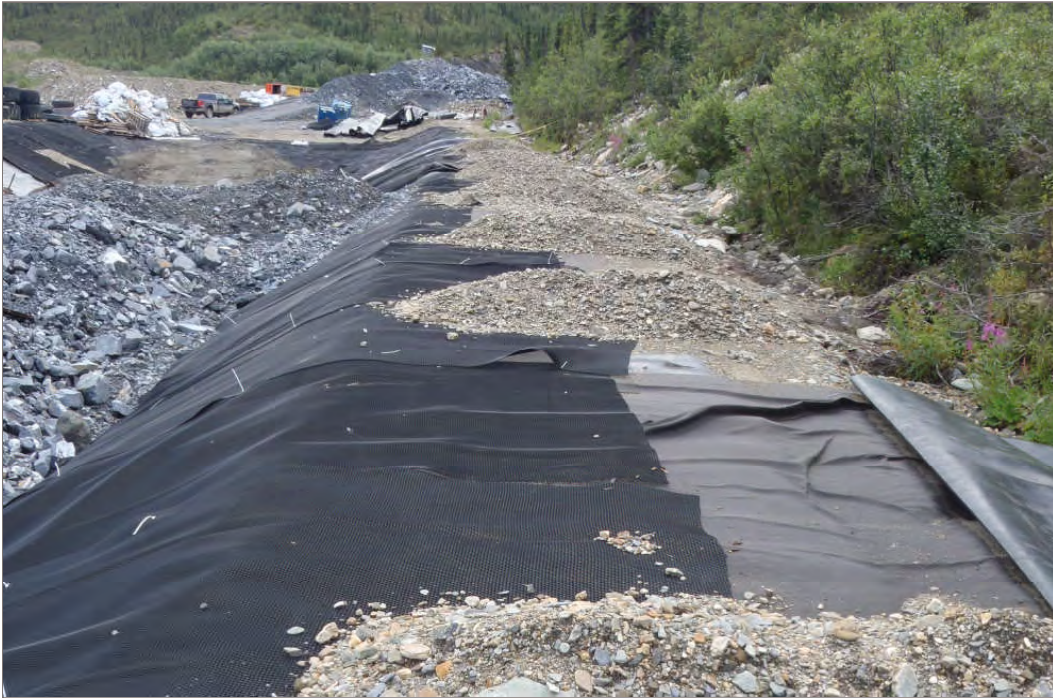
Photo 5: Loose material piled on top of west berm to hold liner in place
(Facing south – July 28, 2011)

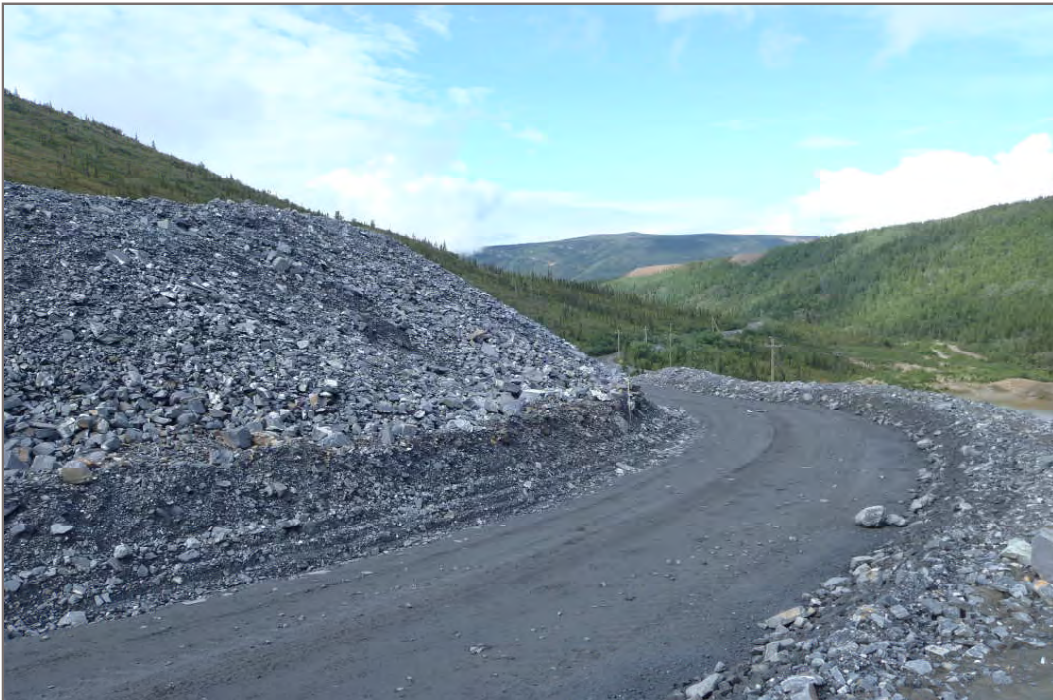
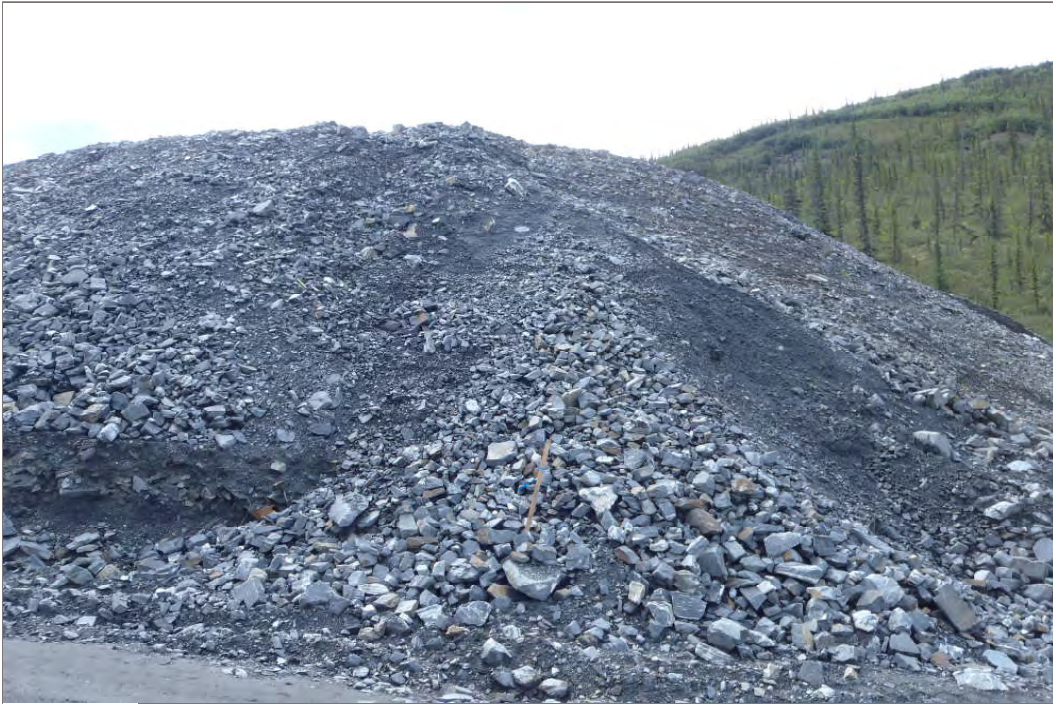
The waste rock pile is located along the Bellekeno Mine haul road, north of the portal. The location is shown on Figure 1. The pile and sideslopes appeared stable at the time of the inspection (Photos 6 and 7). No remedial action is recommended for the waste rock pile at this time.

Photo 6: Bellekeno Mine haul road and waste rock pile
(Facing west – July 28, 2011)

Photo 7: Waste rock pile
(Facing south – July 28, 2011)

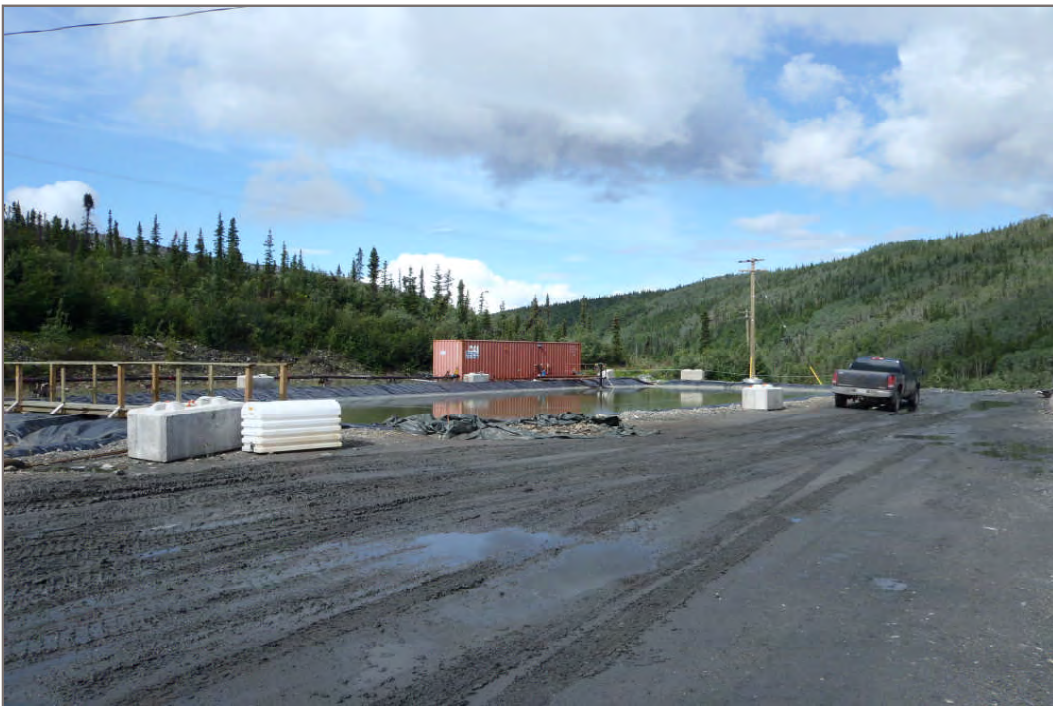
The Bellekeno 625 water treatment pond is located east of the Bellekeno Mine haul road where it passes the waste rock pile. The location is shown on Figure 1. The pond and surrounding structures (vehicle barriers, walkways, and piping) appeared stable at the time of the inspection (Photo 8). The liner system appeared intact and no liner tension or bulging was observed (Photo 9). The pond berms and liner anchoring trenches appeared intact (Photo 10). No remedial action is recommended for the Bellekeno 625 water treatment pond at this time.

Photo 8: Bellekeno 625 water treatment pond and surrounding structures
(Facing north – July 28, 2011)

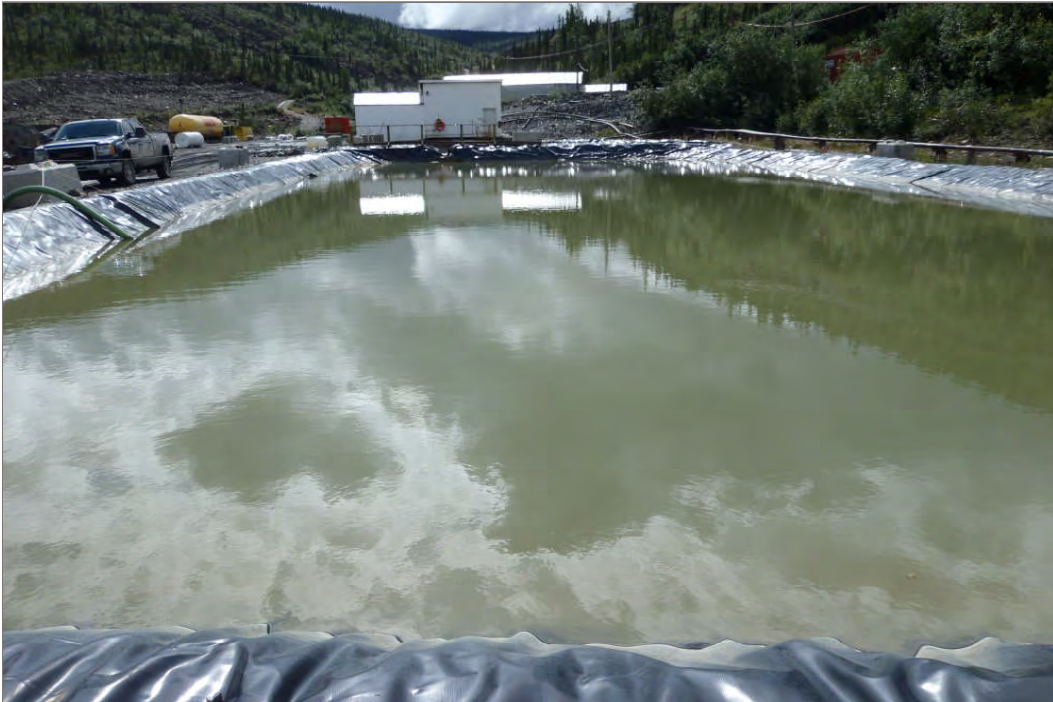
Photo 9: Bellekeno 625 water treatment pond liner system
(Facing south – July 28, 2011)

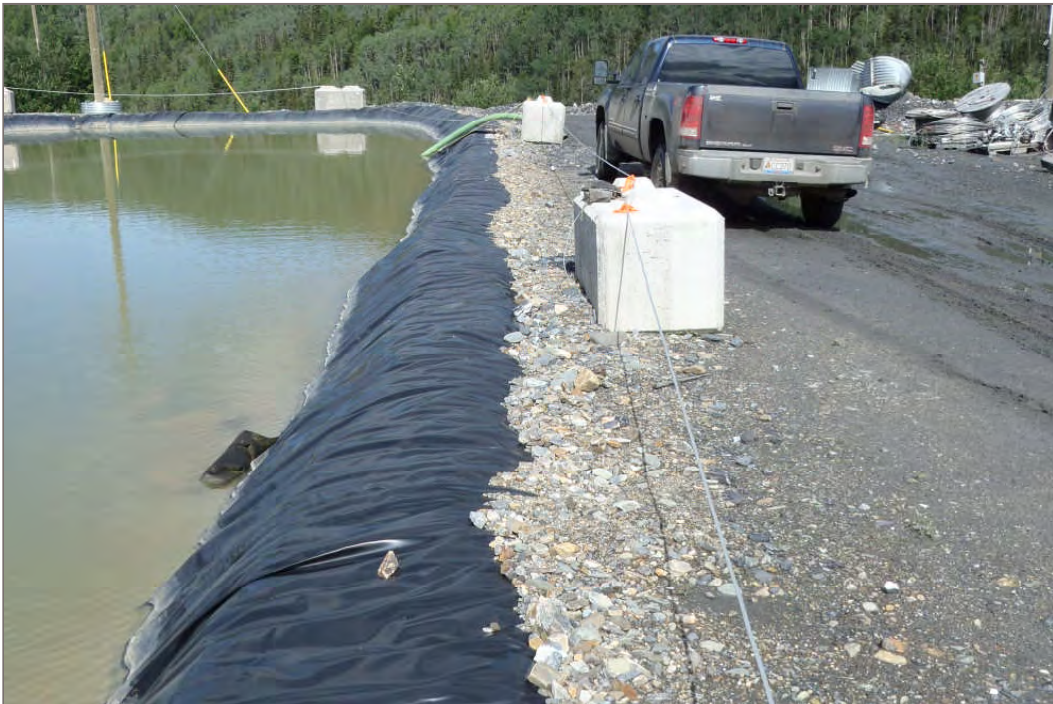
Photo 10: Liner anchoring trench and berm
(Facing north – July 28, 2011)

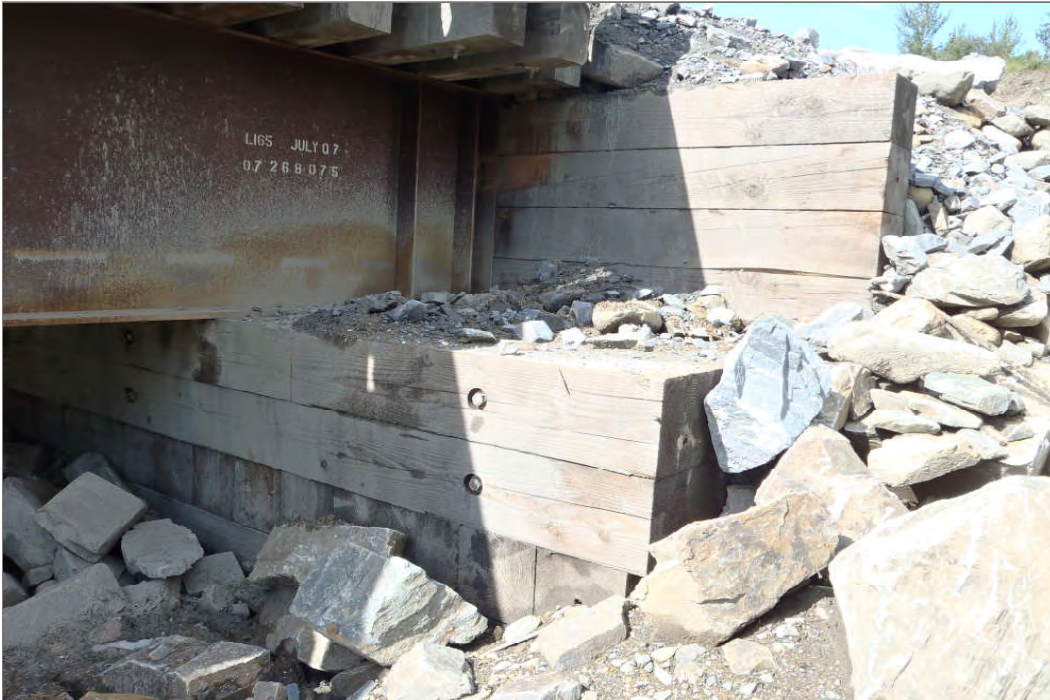
The Lightning Creek bridge is located on the Bellekeno Mine haul road near Keno City. The location is shown on Figure 1. The bridge abutments are constructed of earth filled timber cribbing and no indications of movement were observed at the time of the inspection (Photo 11).

Photo 11: Lightning Creek bridge, north abutment
(Facing west – July 28, 2011)

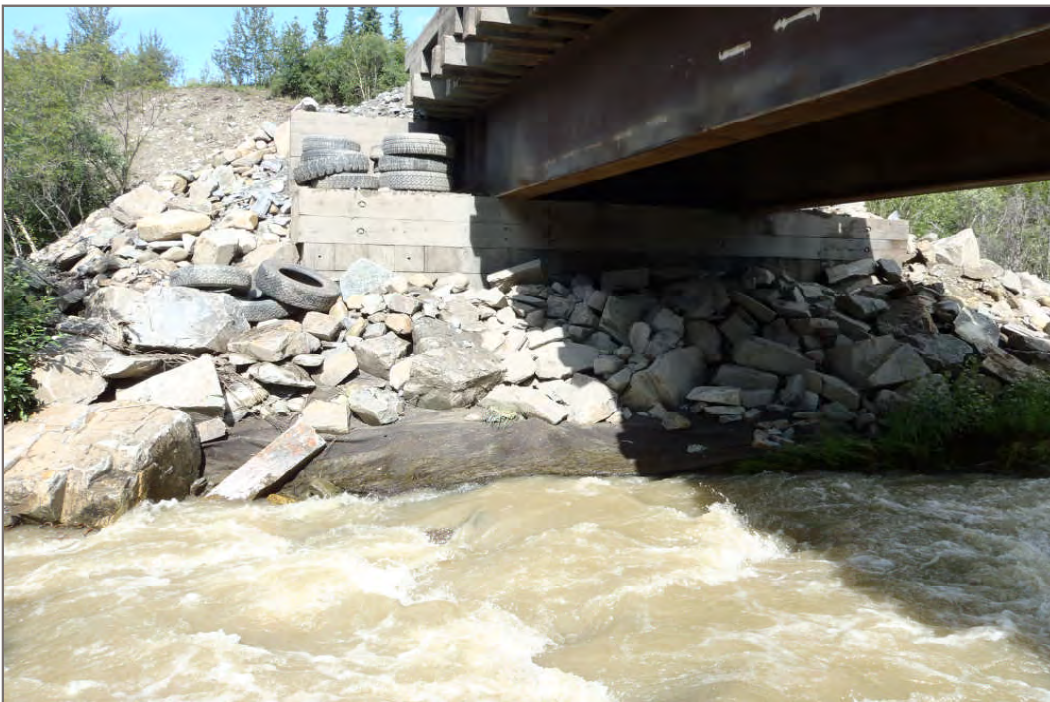
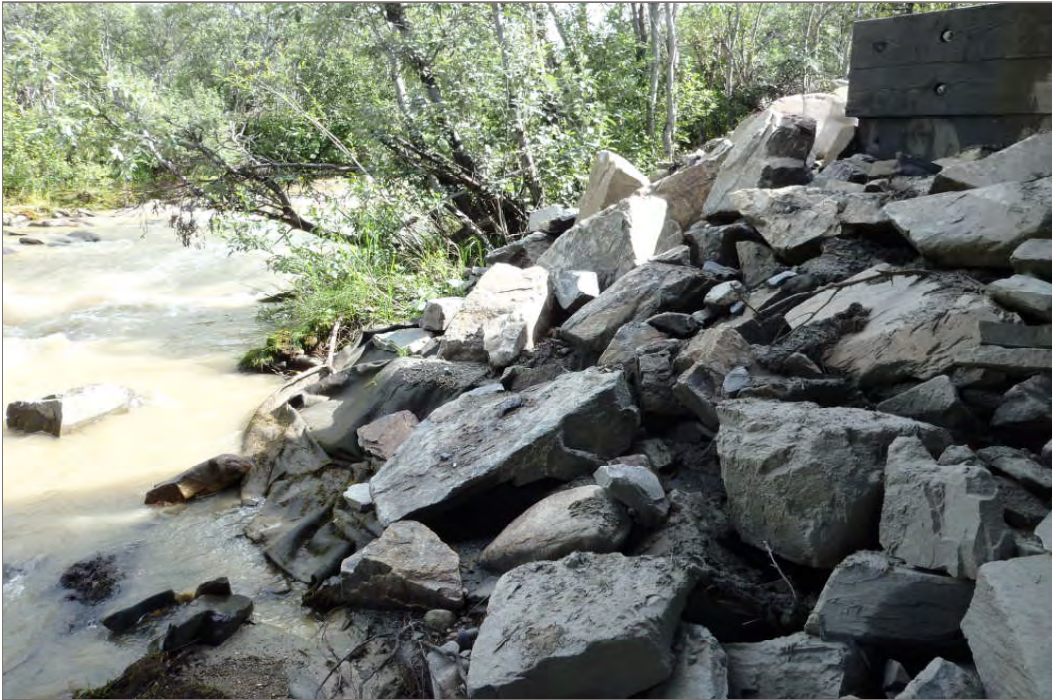
Riprap placed along both banks of Lightning Creek to protect the abutments from scour does not adequately cover the underlying geotextile near the creek’s edge (Photos 12 and 13). The geotextile

beneath the riprap was exposed immediately above the water line at the time of the inspection on both the north and south banks. Additional riprap should be placed on both creek banks to cover the exposed geotextile. This work should be completed when the water level in the creek is low.

Photo 12: Exposed geotextile on north bank of Lightning Creek requiring additional
riprap placement
(Facing north – July 28, 2011)

Photo 13: Exposed geotextile on south bank of Lightning Creek requiring additional riprap placement
(Facing east – July 28, 2011)

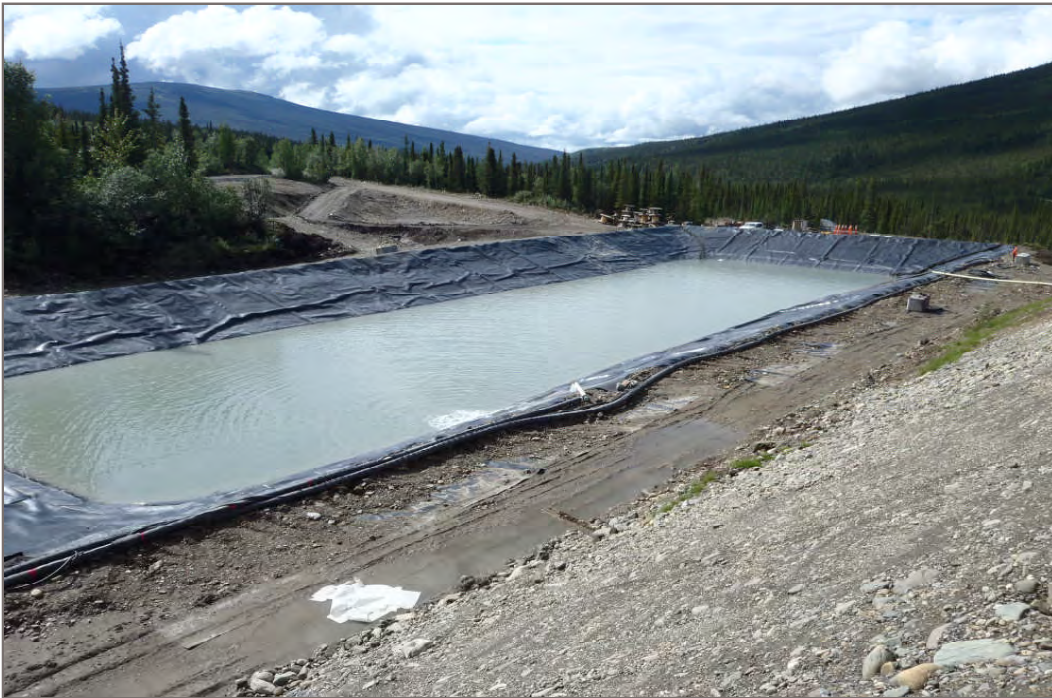
The mill water storage pond is located at the Bellekeno Mill Site approximately 1 km west of Keno City. The location is shown on Figure 1. No visible seepage was observed and the pond berms appeared stable at the time of the inspection (Photo 14). The liner system appeared intact with no loose seams, liner tension, or liner bulging observed (Photo 15).

Photo 14: Mill water storage pond and berms appeared stable
(Facing west – July 28, 2011)

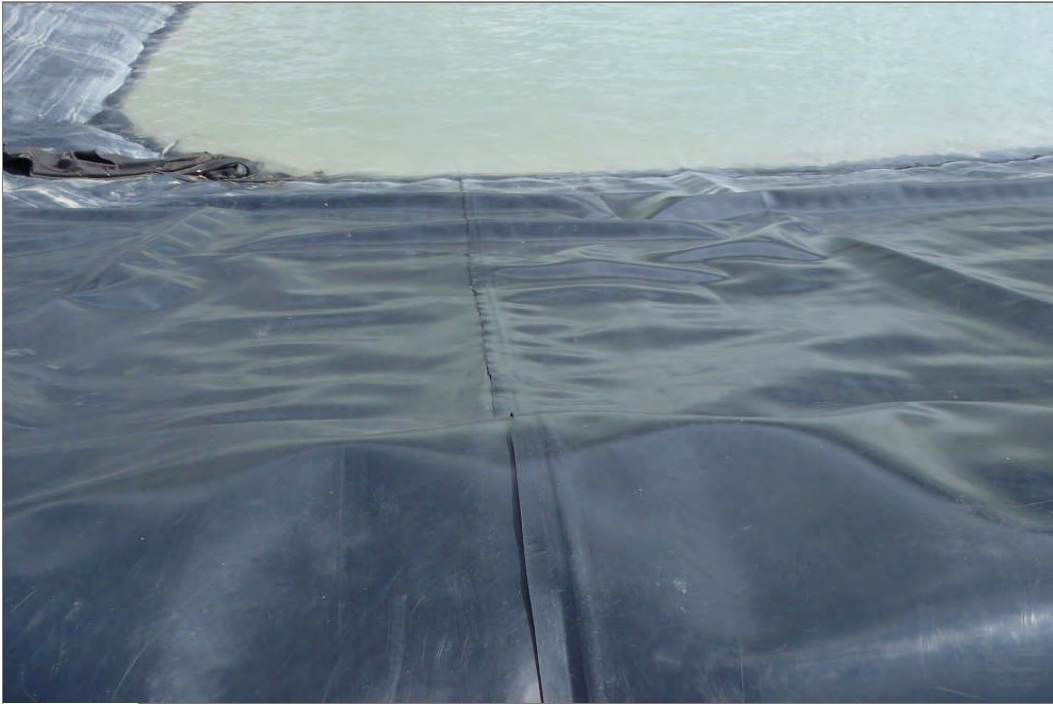
Photo 15: Typical seam in liner of mill water storage pond
(Facing east – July 28, 2011)

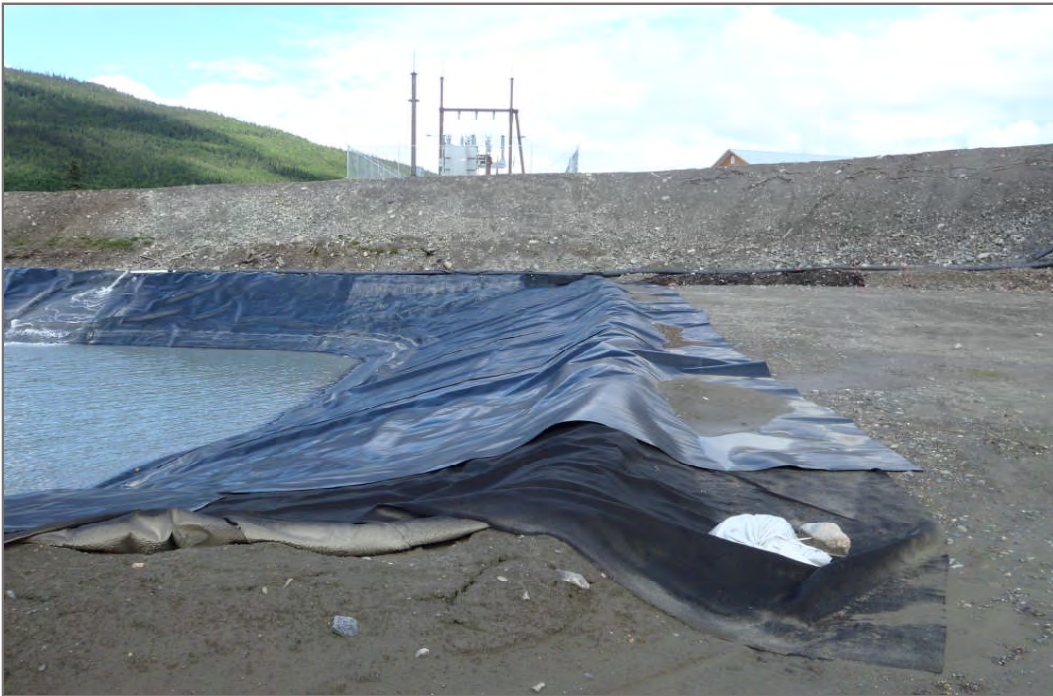
The liner anchoring trench for the east end of the pond was not completed at the time of the inspection (Photo 16). The liner anchoring trench should be completed for the entire facility to limit the risk of damage to the liner from high winds.

Photo 16: Incomplete liner anchoring trench at east end of mill water storage pond
(Facing north – July 28, 2011)

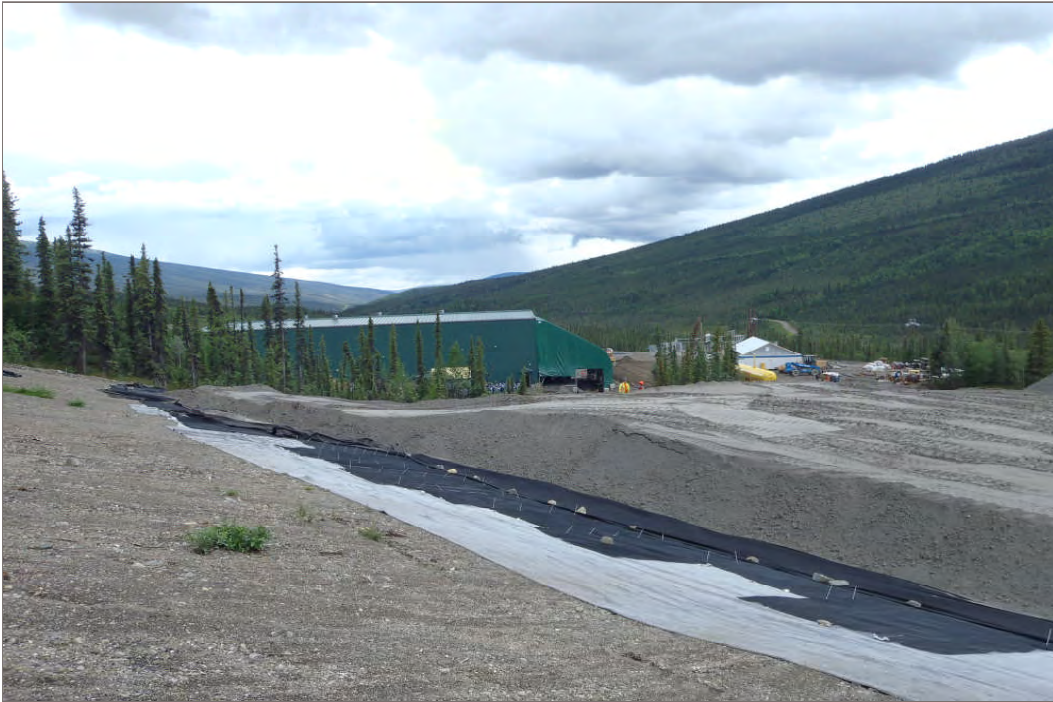
The dry stacked tailings facility (DSTF) is located at the Bellekeno Mill Site approximately 1 km west of Keno City. The location is shown on Figure 1. Construction of the DSTF was ongoing at the time of the inspection. The gravel drainage blanket, geosynthetic clay liner, geonet, and geotextile placed to date appeared intact under the placed tailings (Photo 17).

Photo 17: Gravel drainage blanket, geosynthetic clay liner, geonet, geotextile, and tailings placed within the DSTF (Facing south – July 28, 2011)

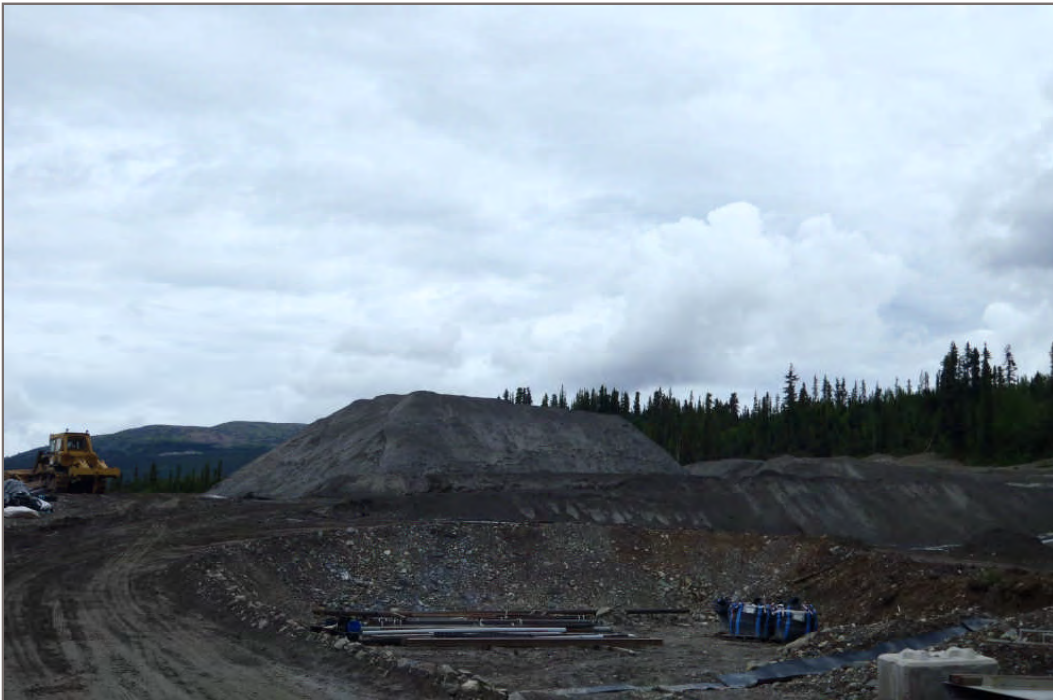
The tailings appear to have been placed in accordance with the design with the exception of the tallest portion of the existing pile (Photo 18). The crest elevation is higher than the design elevation; the pile should be reshaped to the design dimensions.

Photo 18: Existing pile crest exceeds design elevation; the pile should be reshaped to design dimensions (Facing north – July 28, 2011)

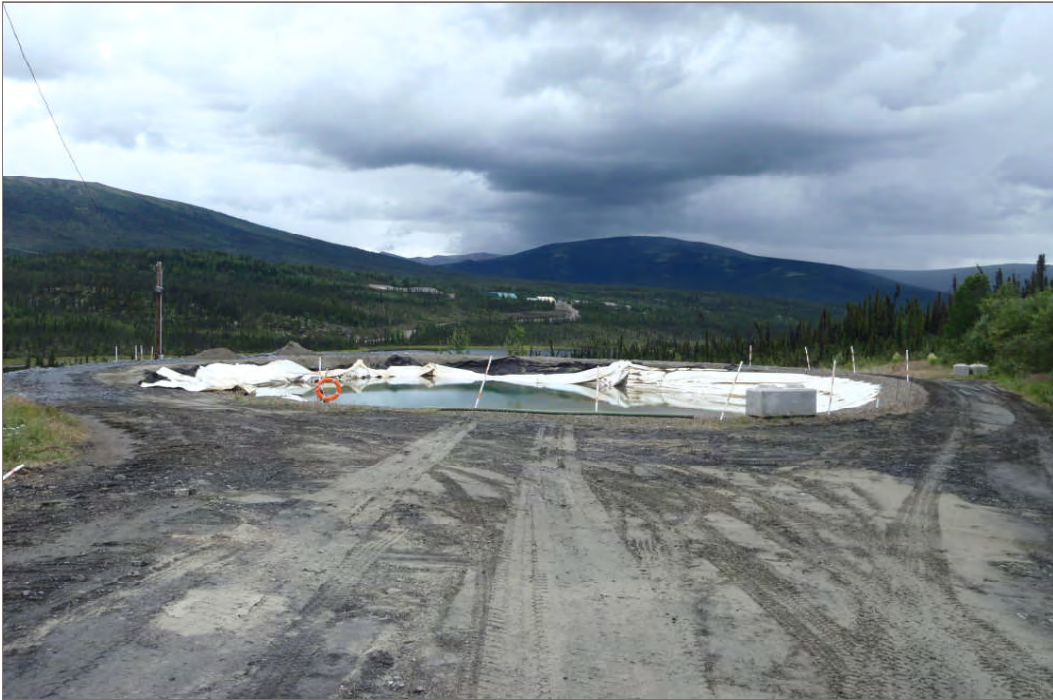
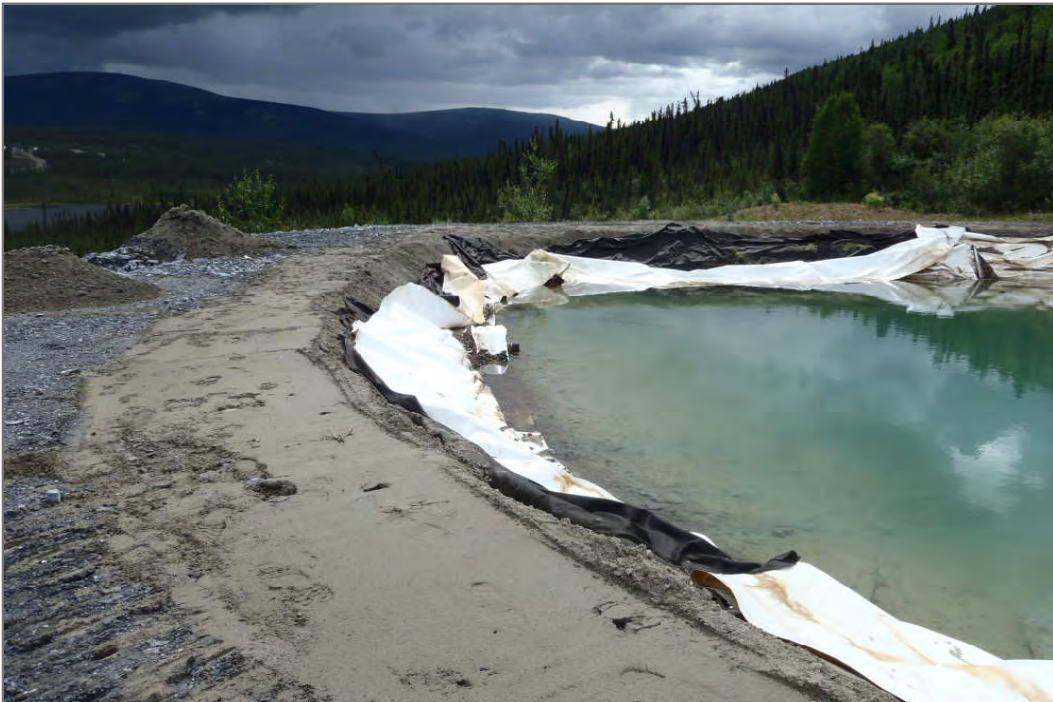
The Galkeno 900 water treatment pond is located off of the Silver Trail Highway at the north end of Christal Lake. The location is shown on Figure 1. No visible seepage was observed and the pond berms appeared stable at the time of the inspection. The liner system was not anchored properly along the south and east berms of the pond resulting in the liner falling into the pond (Photos 19 and 20). The liner system should be pulled up and held in place with a proper liner anchoring trench. This work should be completed as soon as possible to reduce the risk of damage to the liner system and berms.

Photo 19: Galkeno 900 water treatment pond liner falling into pond
(Facing south – July 28, 2011)

Photo 20: Exposed berm and liner system falling into pond
(Facing south – July 28, 2011)
