December 9, 2013

ISSUED FOR USE
EBA FILE: W14103290

Subject: 2013 Annual Inspection – Surface Engineered Earth Structures
Bellekeno Mine, Keno City, YT

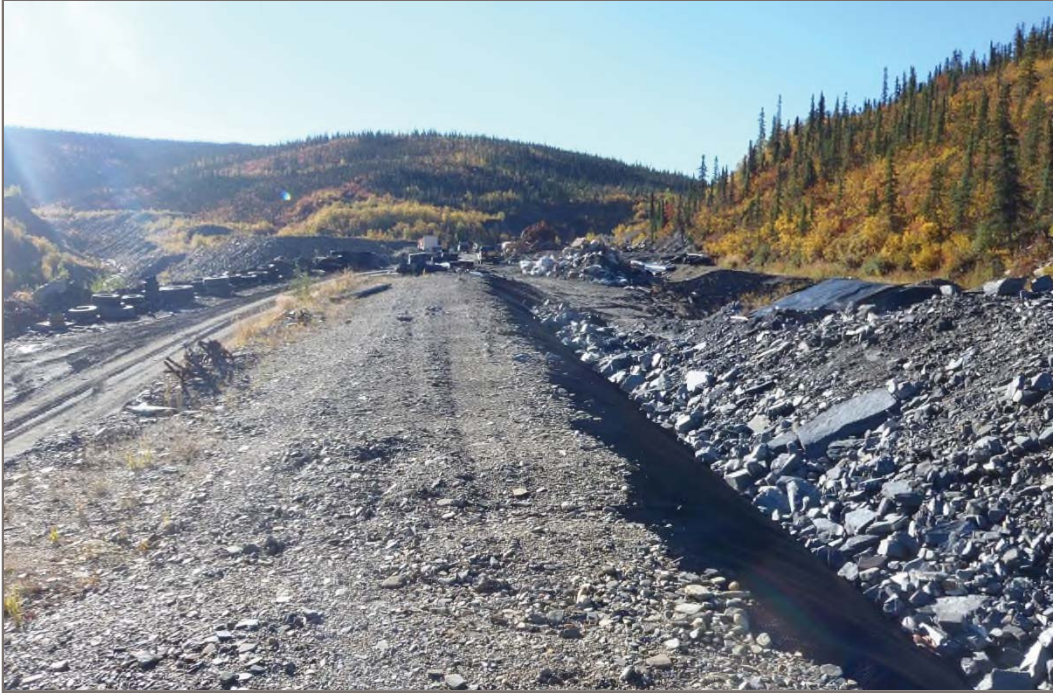
The PAG waste storage facility is located immediately south of the Bellekeno portal, as shown on Figure 1. The perimeter berms of the facility appeared intact with no visible signs of instability (Photo 1). Waste in the facility is being stored in accordance with the design (Photo 2).

Photo 1: PAG Waste Storage Facility
Perimeter berm
Facing south – September 10, 2013

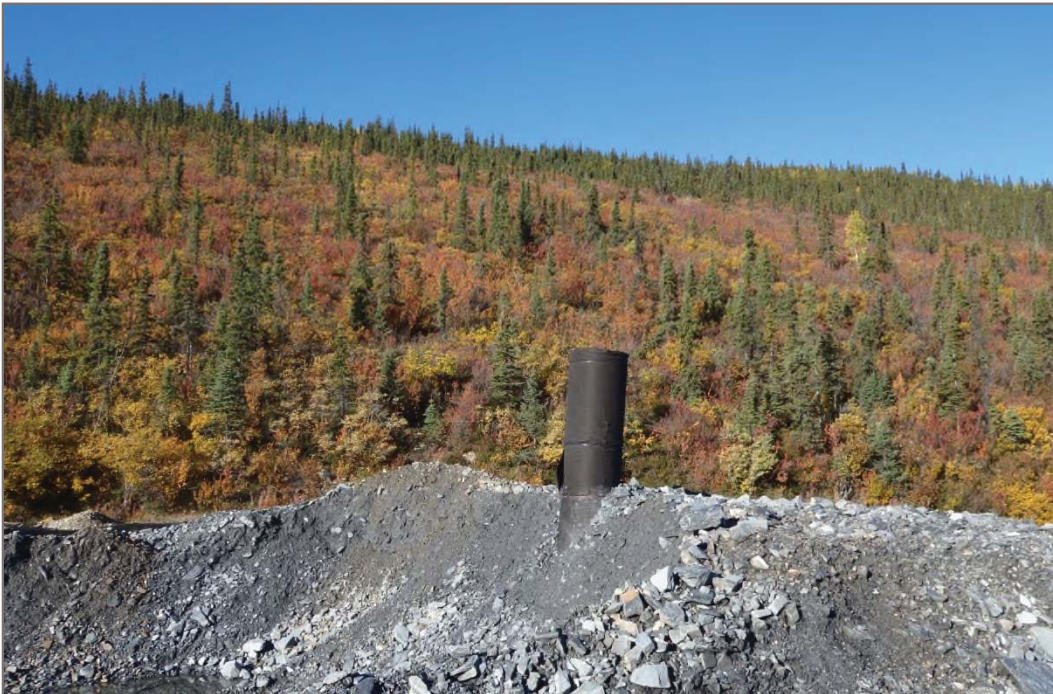
Photo 2: PAG Waste Storage Facility
Material stored in facility
Facing north – September 10, 2013

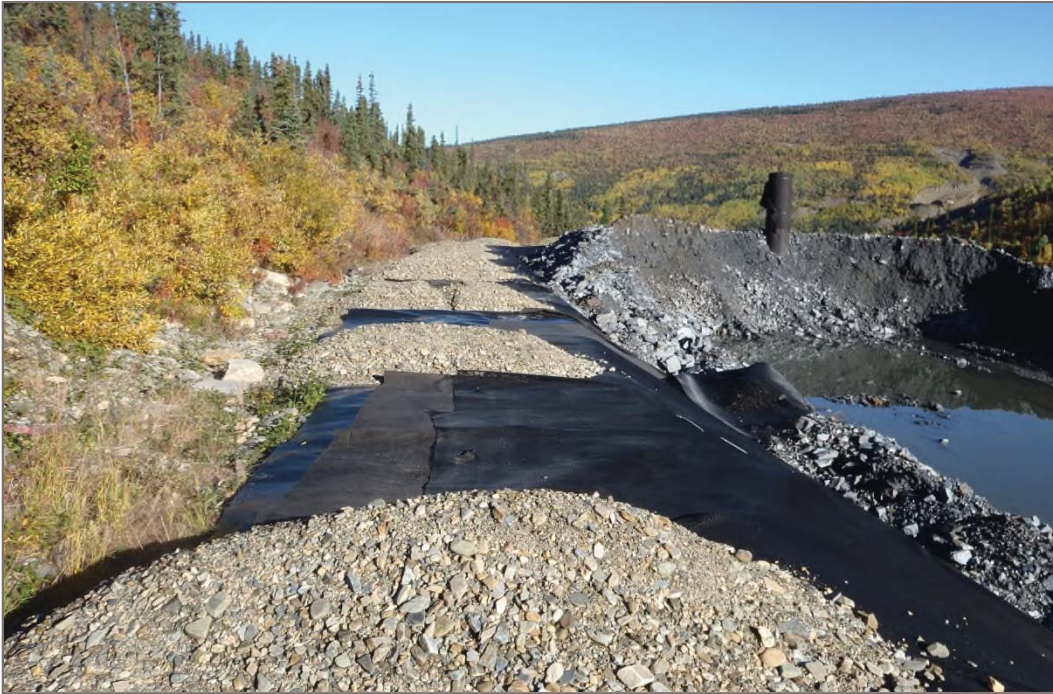
The north and west anchor trenches are incomplete and should be excavated to properly anchor the liner. Currently piles of loose material anchor the liner in place (Photo 3).

Photo 3: PAG Waste Storage Facility
Liner not properly anchored around north and west perimeter
Facing north – September 10, 2013

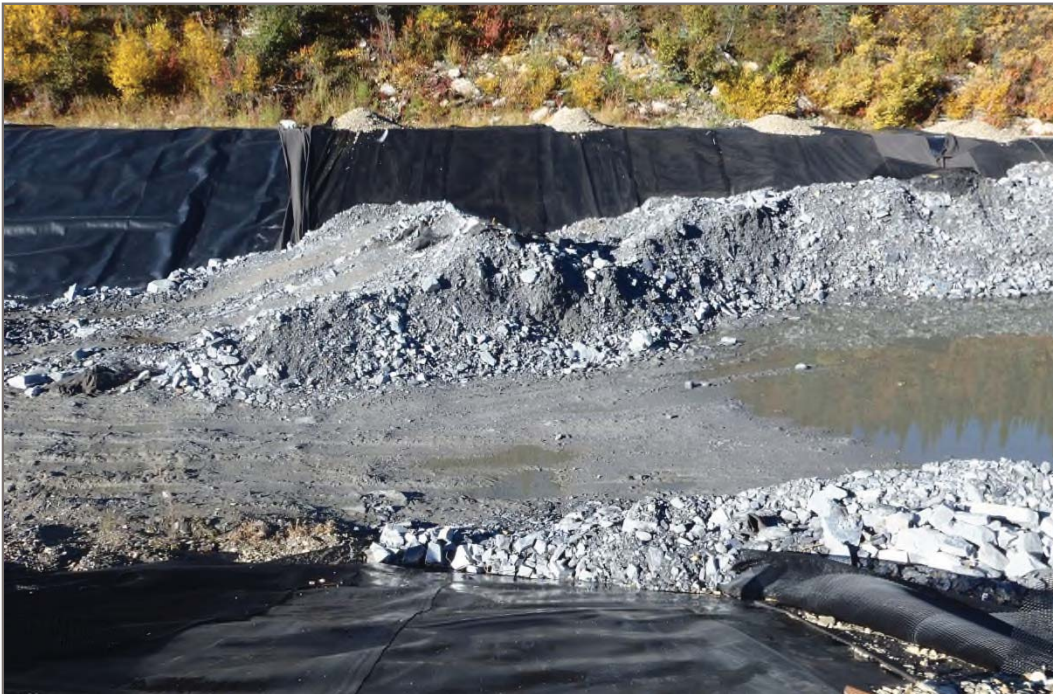
The liner has been placed throughout the facility but the protective geotextile and geonet materials have only been placed in the north half of the facility. Some of the waste rock currently being stored in the facility extends beyond the limits of the protective geotextile and geonet (Photo 4). Sharp angular waste material in direct contact with the liner increases the likelihood of damage and punching failures. The protective geotextile and geonet should be installed over the remainder of the exposed liner.

Photo 4: PAG Waste Storage Facility
Angular waste material in direct contact with liner
Facing west – September 10, 2013

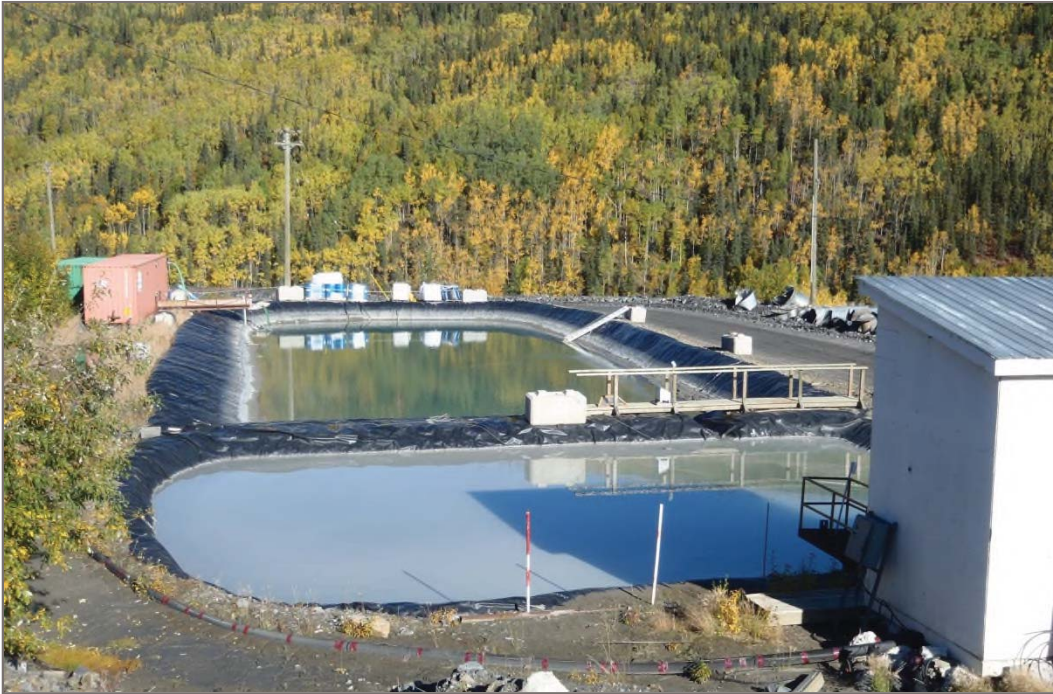
The Bellekeno 625 water treatment ponds are located northeast of the Bellekeno portal, as shown on Figure 1. The ponds and surrounding structures (vehicle barriers, walkways, and piping) appeared stable at the time of inspection (Photo 5). The facility consists of two water treatment ponds and was operating at the time of the inspection. The water level in the primary pond was at the spillway invert with a freeboard of approximately 0.5 m below the crest of the perimeter berm (Photo 6). The water level in the secondary pond was approximately 1.5 m below the crest of the perimeter berm and 1.0 m below the emergency spillway invert (Photo 7).

Photo 5: Bellekeno 625 Water Treatment Ponds
Photograph showing condition of facility
Facing north – September 10, 2013

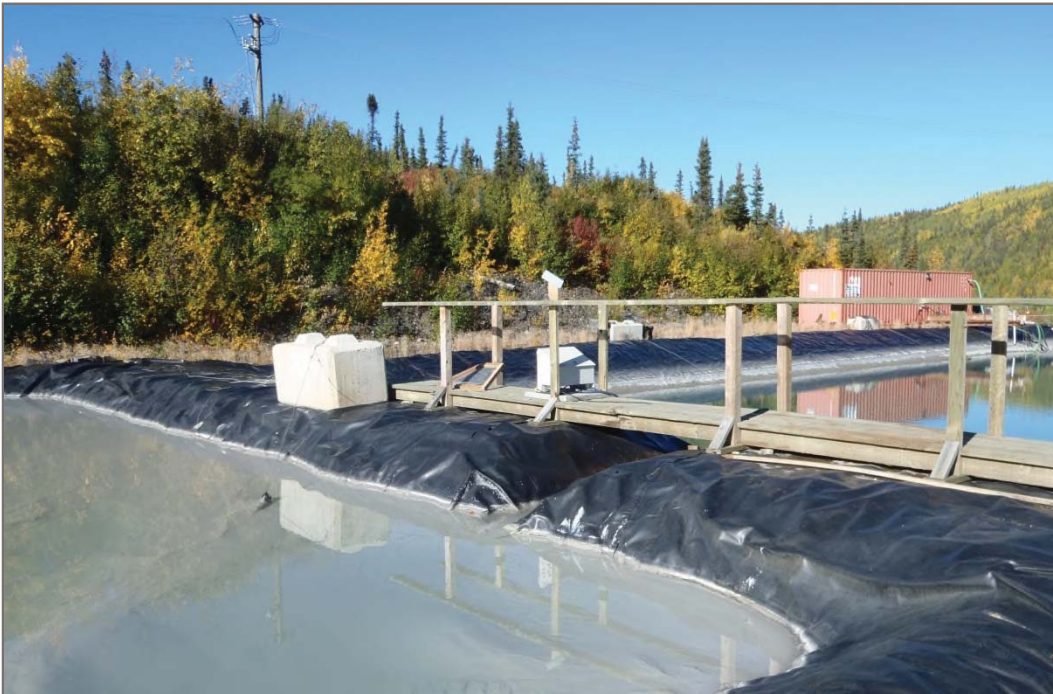
Photo 6: Bellekeno 625 Water Treatment Ponds
Approximately 0.5 m freeboard in pond one
Facing west – September 10, 2013

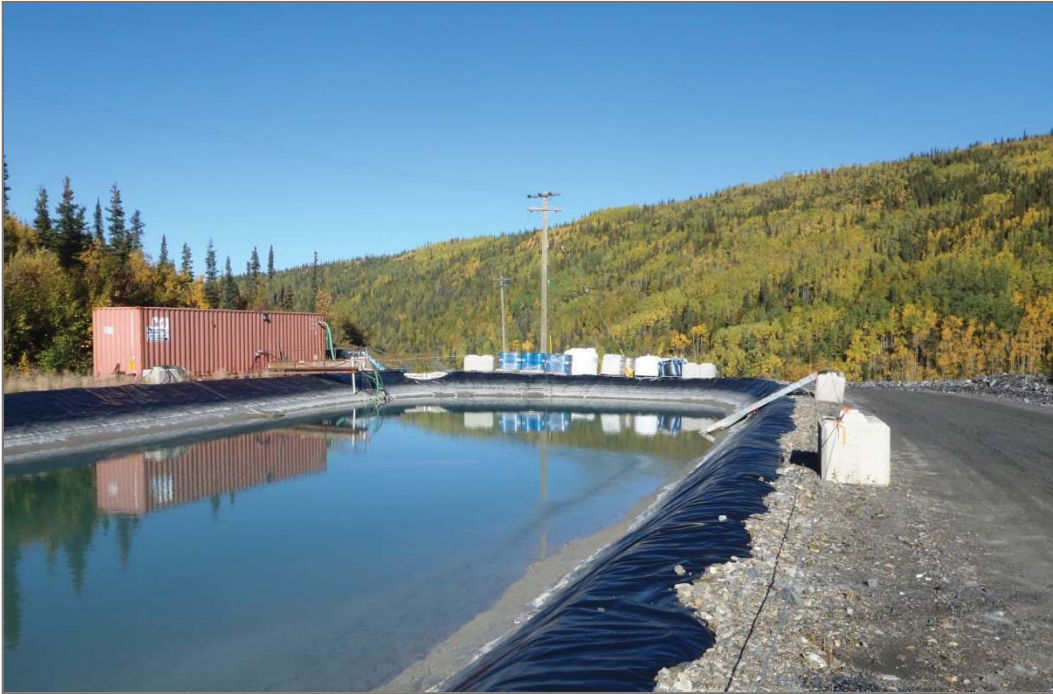
Photo 7: Bellekeno 625 Water Treatment Ponds
Approximately 1.5 m freeboard in pond two
Facing north – September 10, 2013

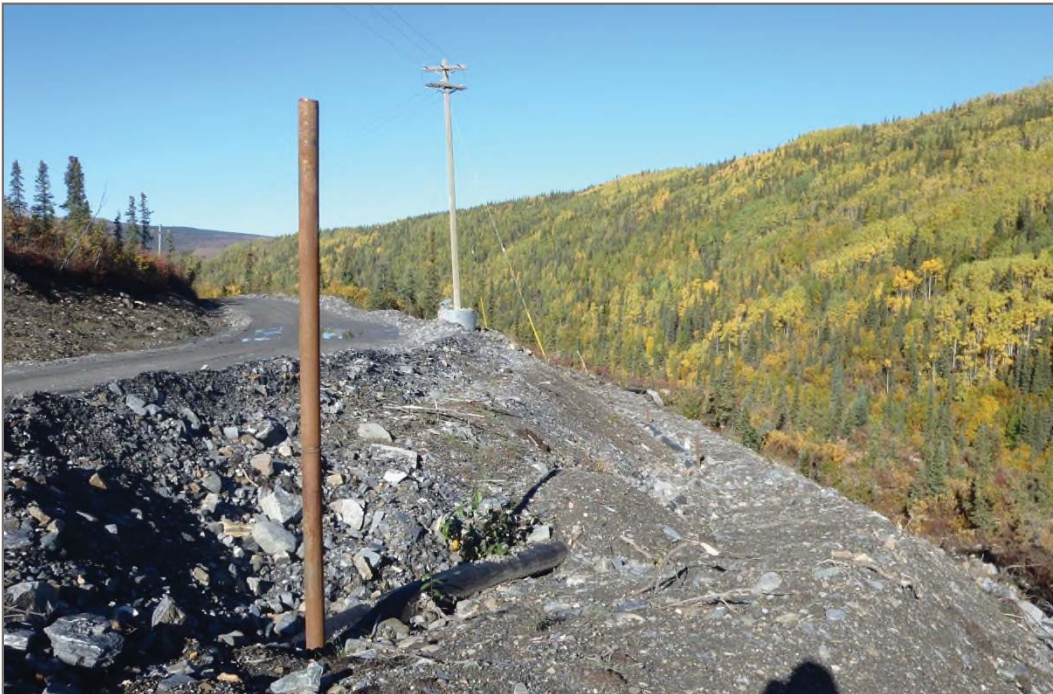
At the time of the inspection water was being discharged from the secondary pond downslope of the facility. The partially buried discharge line appeared stable and intact (Photo 8). Erosion protection in the form of rip-rap should be placed immediately below the discharge point to protect the natural slope (Photo 9).

Photo 8: Bellekeno 625 Water Treatment Ponds
Partially buried discharge line
Facing west – September 10, 2013

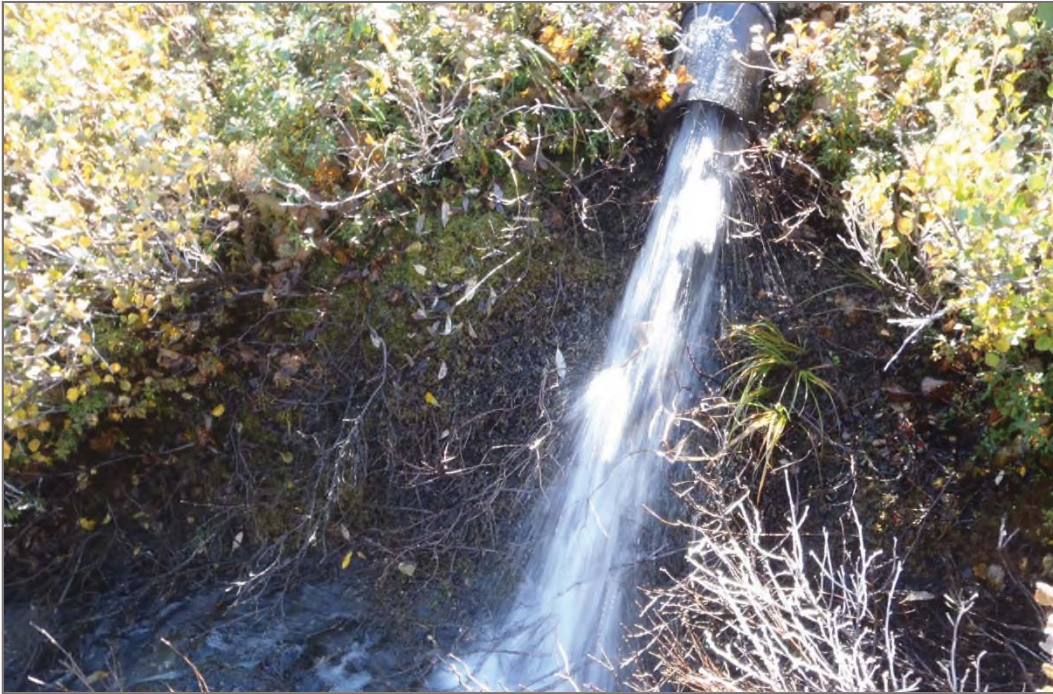
Photo 9: Bellekeno 625 Water Treatment Ponds
Discharge point requiring rip-rap armouring for erosion protection
Facing south – September 10, 2013

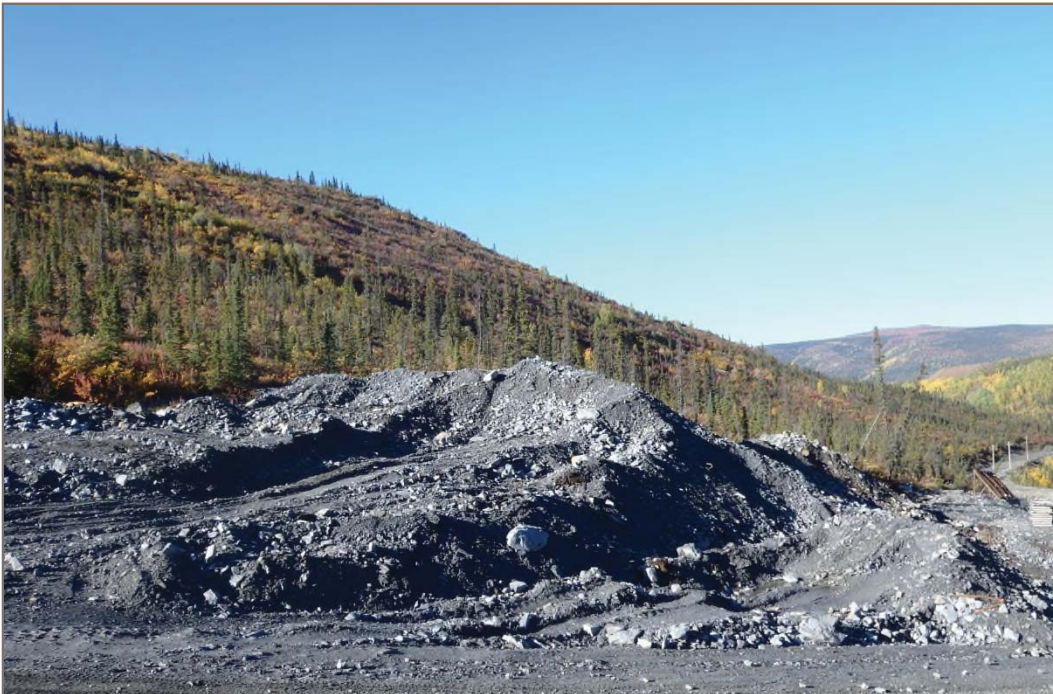
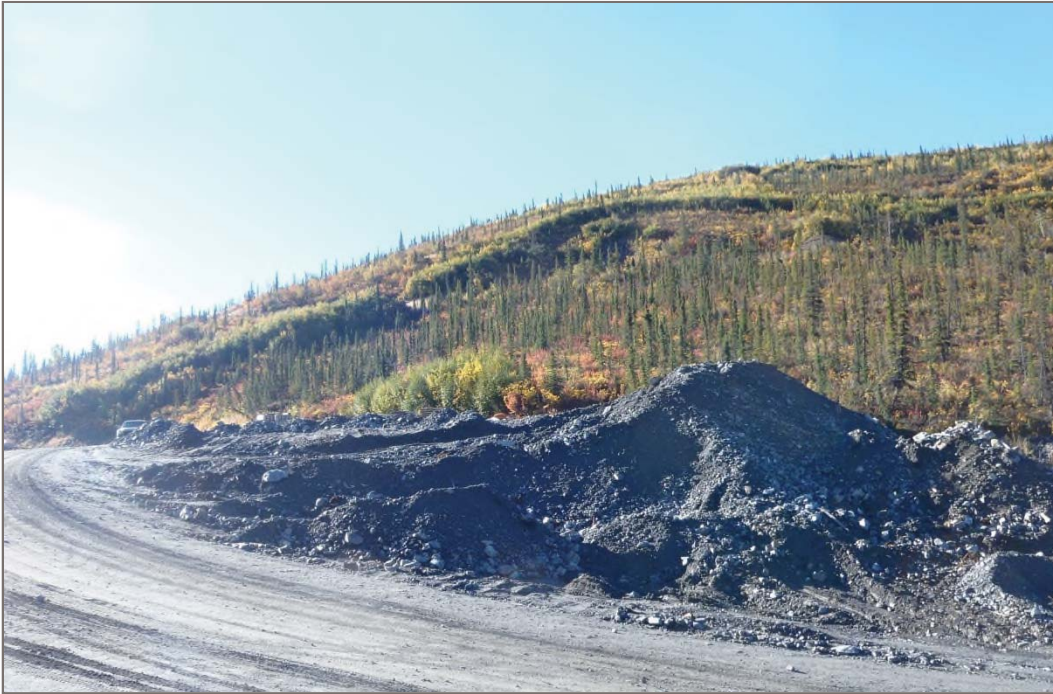
The Bellekeno waste rock pile is located beside the Bellekeno Road north of the Bellekeno portal, as shown on Figure 1. The waste rock pile has decreased in overall size from previous inspections because of ongoing construction activities around the property (Photos 10 and 11). The pile and side slopes appeared stable at the time of the inspection (Photo 12). No remedial action is recommended for the Bellekeno waste rock pile.

Photo 10: Bellekeno Waste Rock Pile
Overview of waste rock pile
Facing west – September 10, 2013

Photo 11: Bellekeno Waste Rock Pile
Overview of waste rock pile
Facing south – September 10, 2013

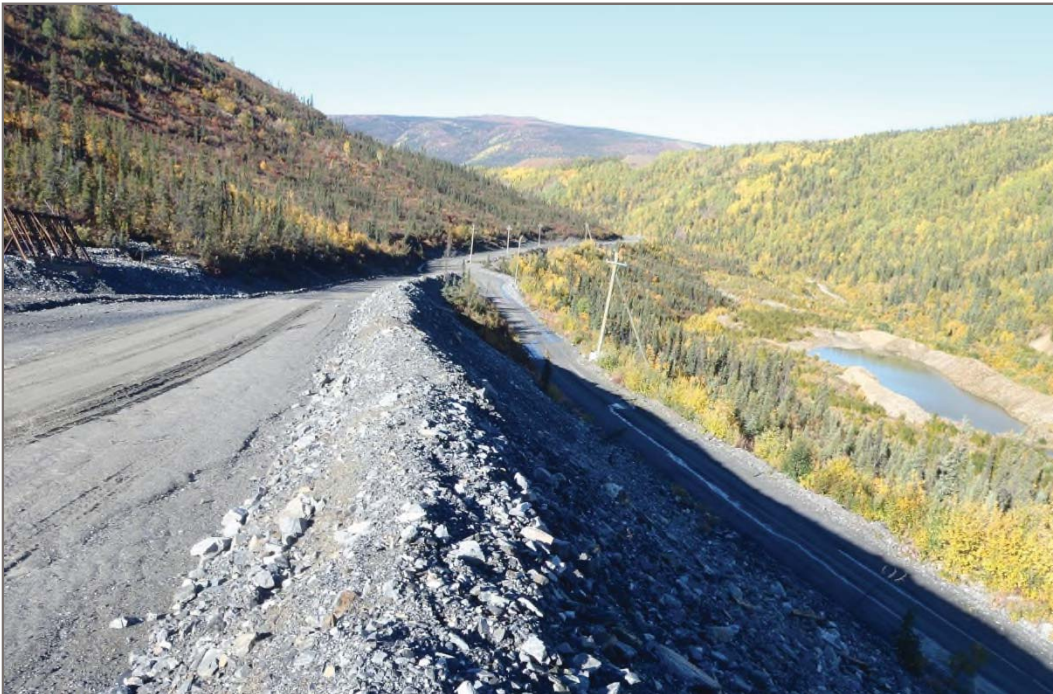
Photo 12: Bellekeno Waste Rock Pile
Stable pile sideslopes
Facing west – September 10, 2013

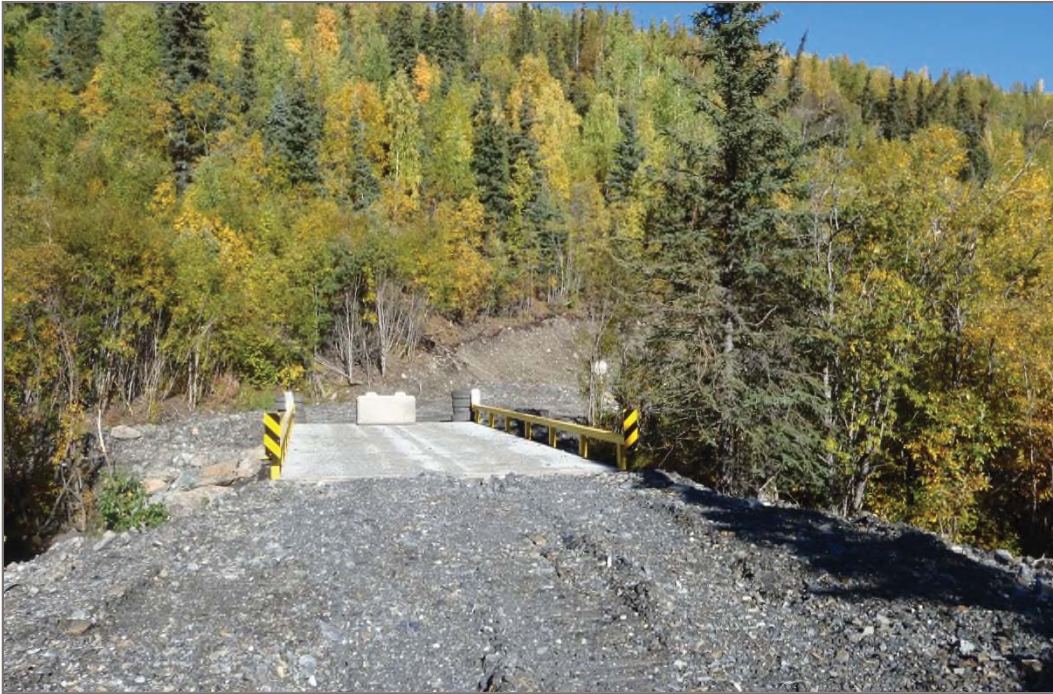
The Onek Road Lightning Creek Bridge is located east of Keno City, as shown on Figure 1. The bridge was recently constructed and was not in service at the time of the inspection. It is a single span steel structure approximately 6 m in length (Photo 13) founded on compacted earth fill and adjustable wooden timber abutments (Photo 14). The abutments appeared stable at the time of the inspection.

Photo 13: Lightning Creek Bridge Abutments (Onek Road)
Lightning Creek Bridge on the Onek Road
Facing north – September 10, 2013

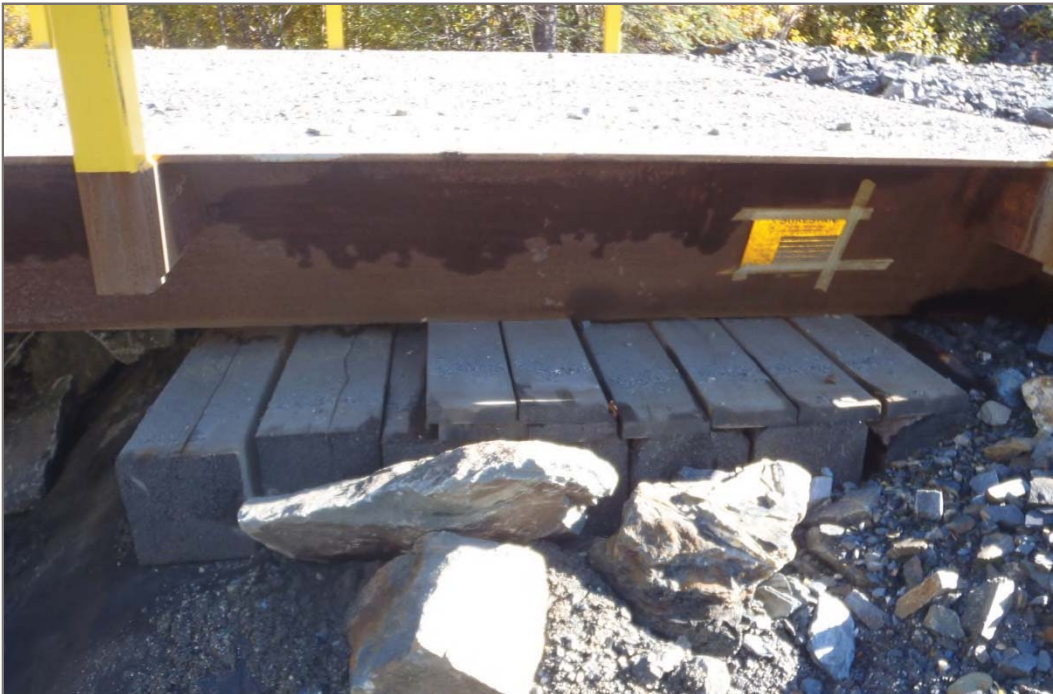
Photo 14: Lightning Creek Bridge Abutments (Onek Road)
Compacted earth fill and wooden timber bridge abutments
Facing east – September 10, 2013

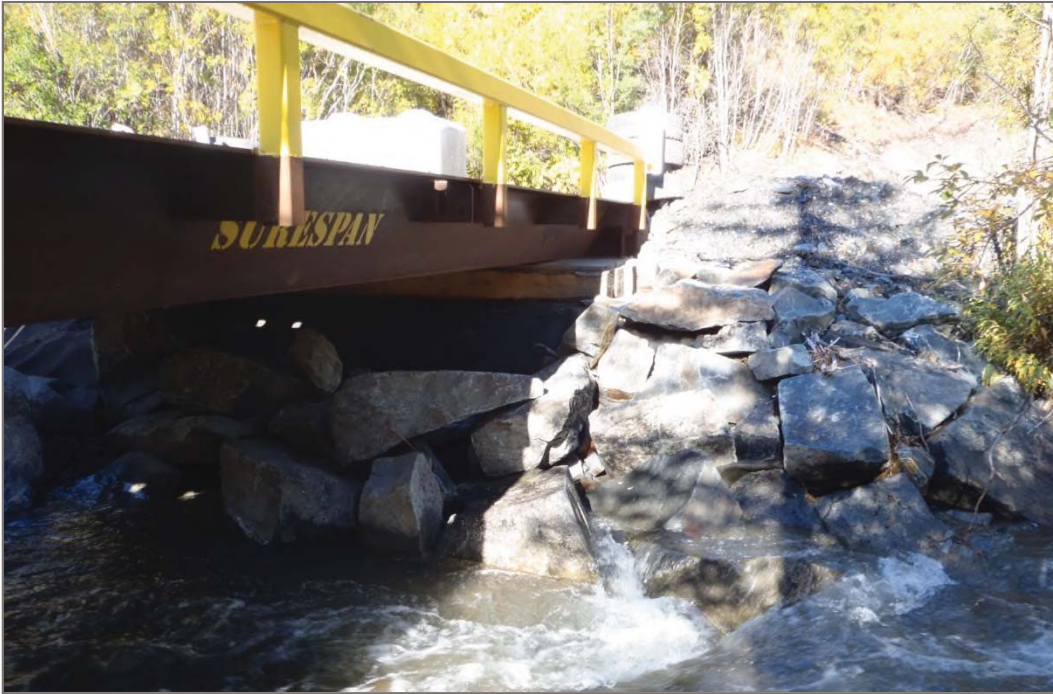
The earth fill abutments are guarded from erosion by rip-rap placed after construction. The rip-rap placed protecting both bridge abutments appears satisfactory (Photo 15). No remedial action is recommended for the Lightning Creek Bridge on the Onek Road.

Photo 15: Lightning Creek Bridge Abutments (Onek Road)
Rip-rap armoring providing erosion protection for bridge abutments
Facing north – September 10, 2013

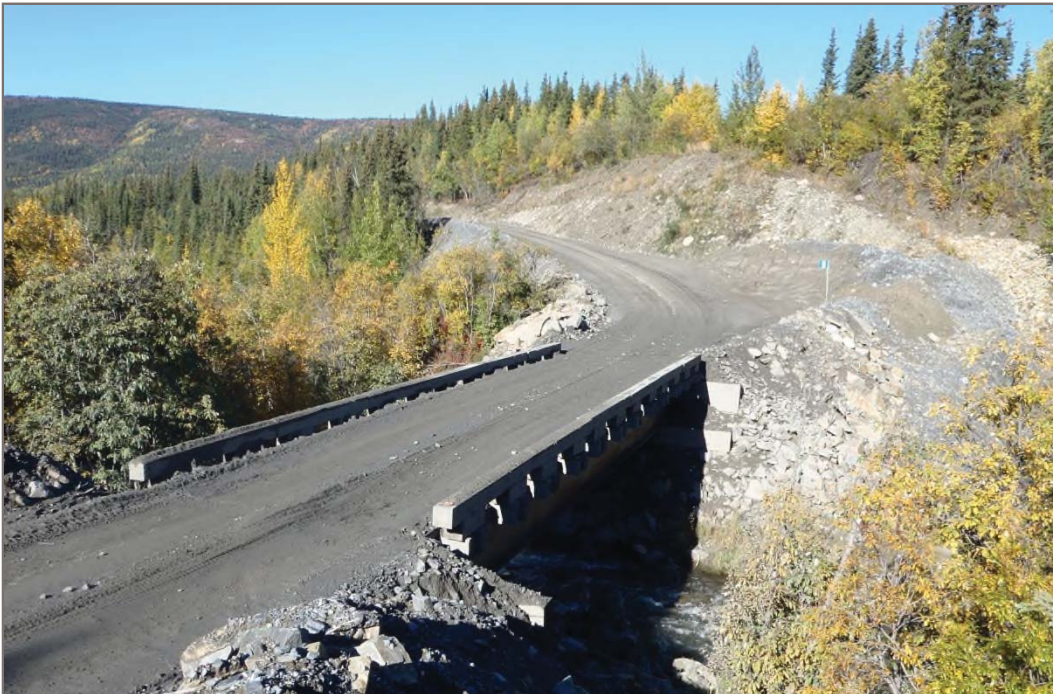
The Bellekeno Road Lightning Creek Bridge is located southwest of Keno City, as shown on Figure 1. The bridge was in service at the time of the inspection. It is a single span steel structure approximately 9 m in length (Photo 16) founded on earth filled timber cribbing abutments (Photo 17). The abutments appeared stable at the time of inspection.

Photo 16: Lightning Creek Bridge Abutments (Bellekeno Road)
Lightning Creek Bridge on the Bellekeno Road
Facing west – September 10, 2013

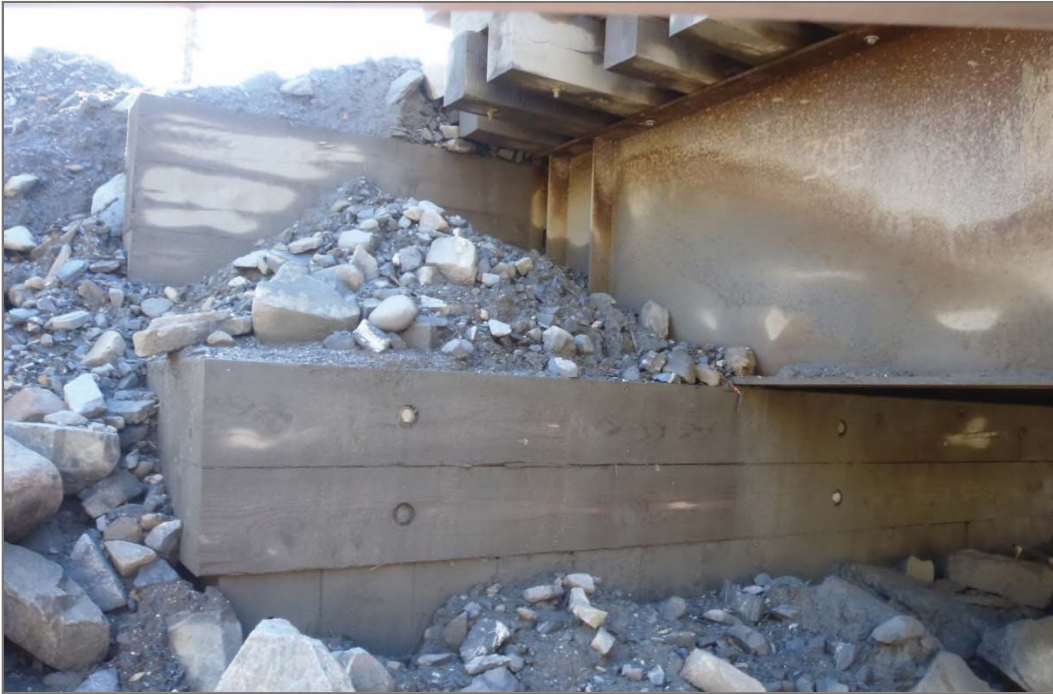
Photo 17: Lightning Creek Bridge Abutments (Bellekeno Road)
Earth filled timber cribbing bridge abutments
Facing east – September 10, 2013

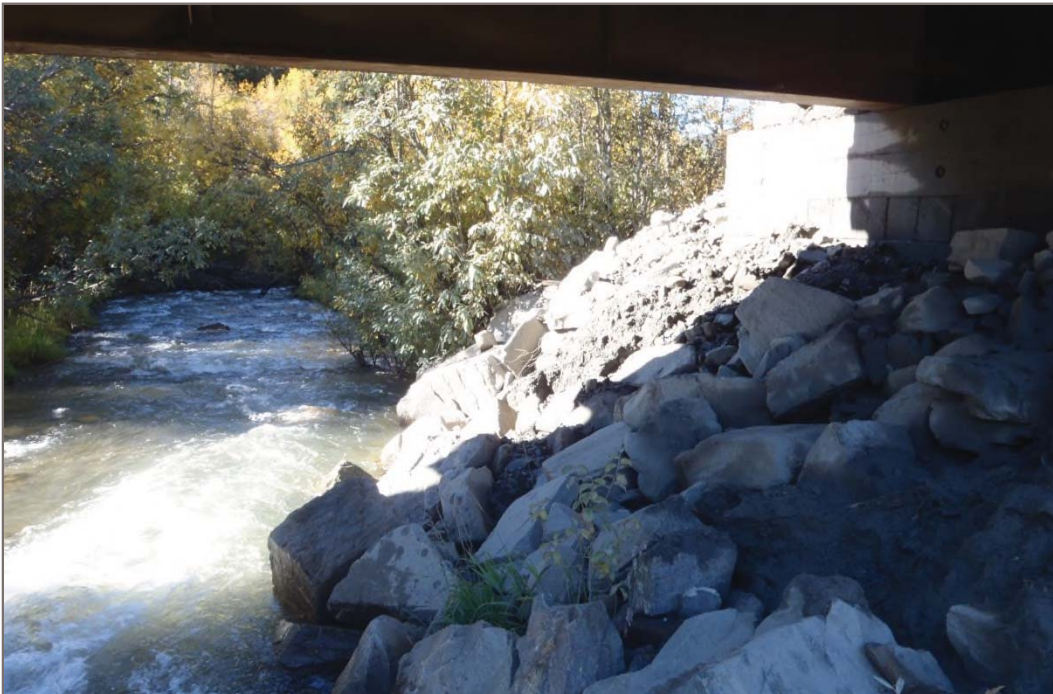
The earth fill abutments are guarded from erosion by rip-rap placed after construction. The rip-rap protection for both abutments appears satisfactory (Photo 18). No remedial action is recommended for the Lightning Creek Bridge on the Bellekeno Road.

Photo 18: Lightning Creek Bridge Abutments (Bellekeno Road)
Rip-rap armoring providing erosion protection for bridge abutments
Facing south – September 10, 2013

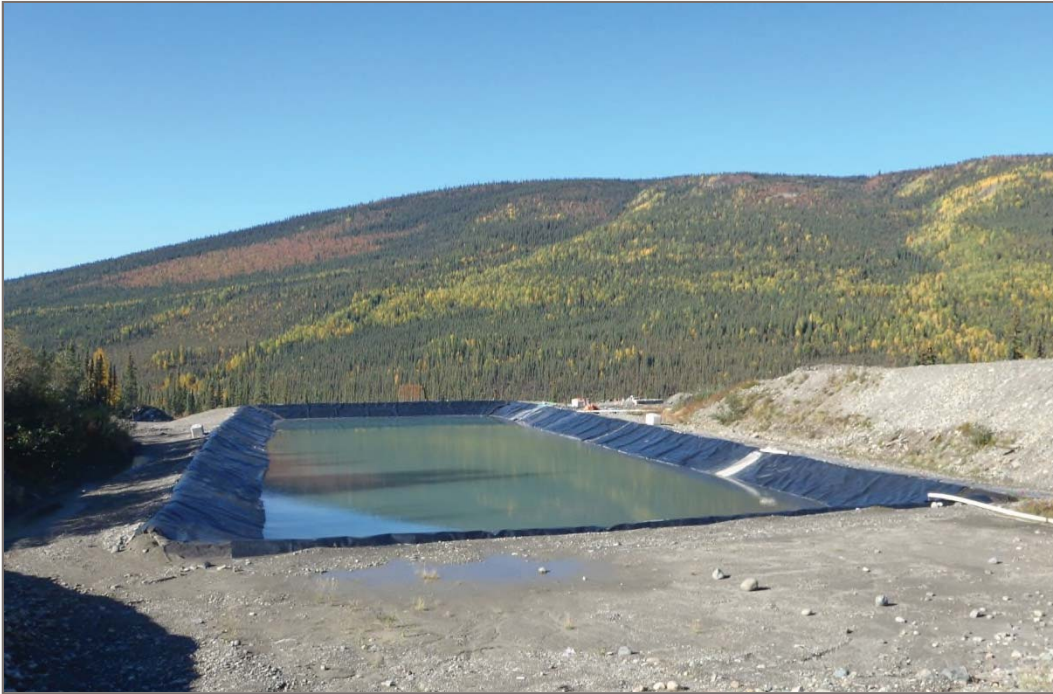
The mill water storage pond is located at the Keno Hill District Mill Site approximately 1 km west of Keno City, as shown on Figure 1. The pond was operating at the time of the inspection with a water level approximately 2 m below the perimeter berm crest (Photo 19). The perimeter berm appeared stable at the time of inspection and no loose seems, excessive tension or bulging was observed in the liner (Photo 20).

Photo 19: Mill Water Storage Pond
Approximately 2.0 m of freeboard in mill water storage pond
Facing west – September 10, 2013

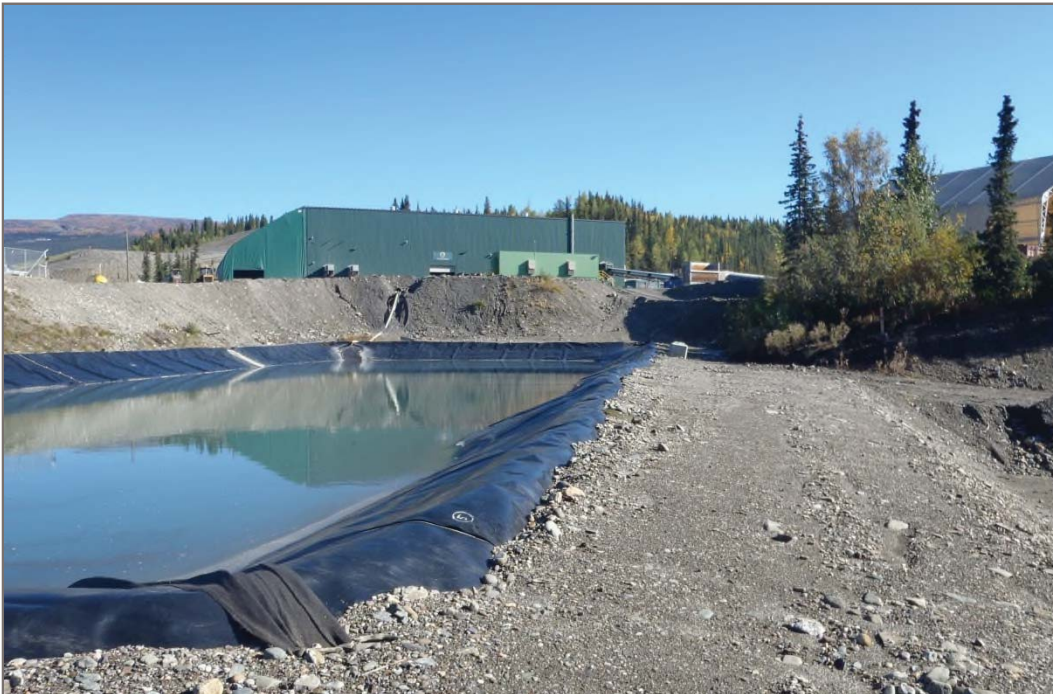
Photo 20: Mill Water Storage Pond
Stable perimeter berm
Facing east – September 10, 2013

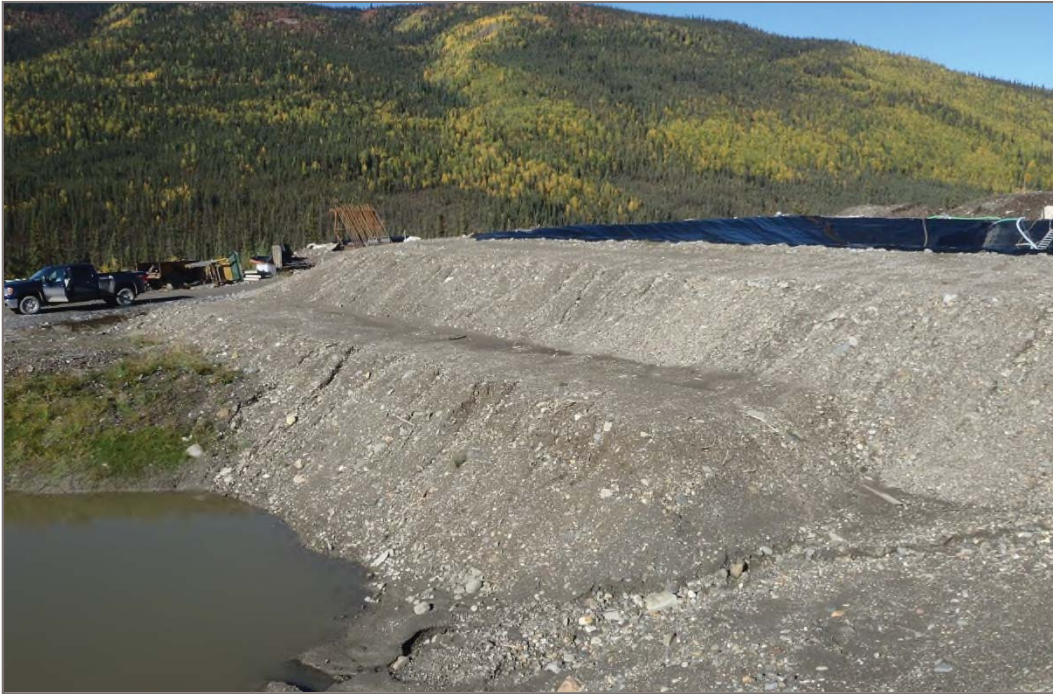
Photo 21: Mill Water Storage Pond
Minor erosion observed on exterior of perimeter berm on south and west sides
Facing west – September 10, 2013

Some minor erosion was noted during the inspection along the exterior berm in the south and west portion of the pond (Photo 21). This area should be monitored closely for signs of increased erosion and armoured with rip-rap or vegetation if erosion continues.

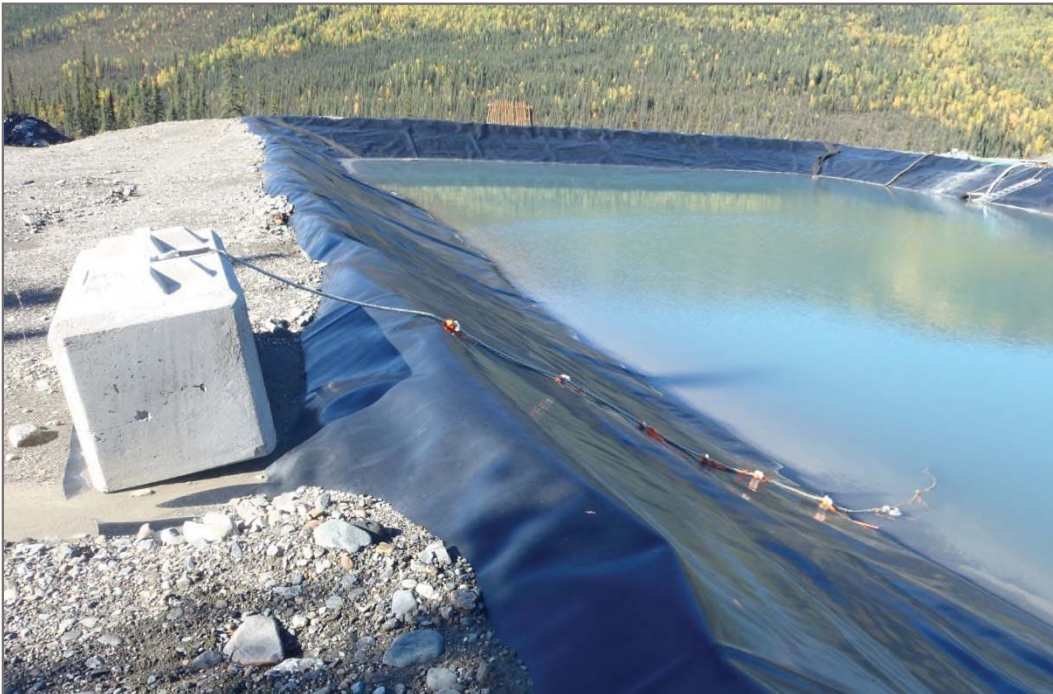
In response to previous safety recommendations, ropes have been installed in several locations around the perimeter of the pond to help personnel climb out of the pond should they fall in (Photo 22).

Photo 22: Mill Water Storage Pond
Safety rope for exiting pond
Facing west – September 10, 2013

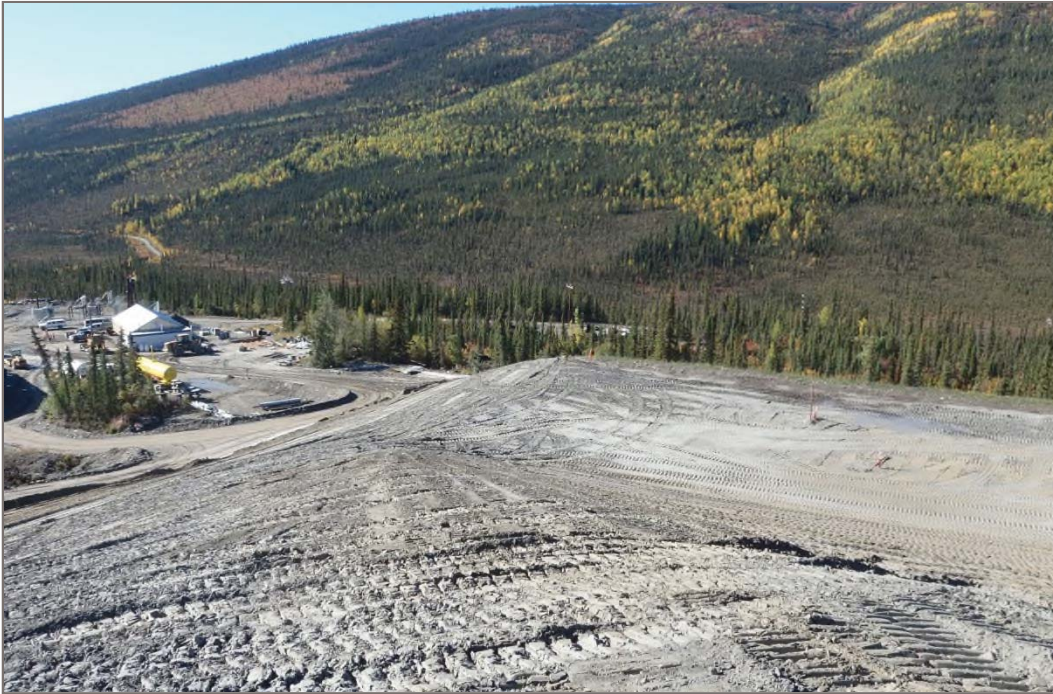
The dry stacked tailings facility (DSTF) is located at the Keno Hill District Mill Site approximately 1 km west of Keno City, as shown on Figure 1. Construction and operation of the DSTF was ongoing at the time of the inspection with work being focussed on contouring the sideslopes (Photo 23).

Photo 23: Dry Stacked Tailings Facility
Contouring of facility to design grades
Facing west – September 10, 2013

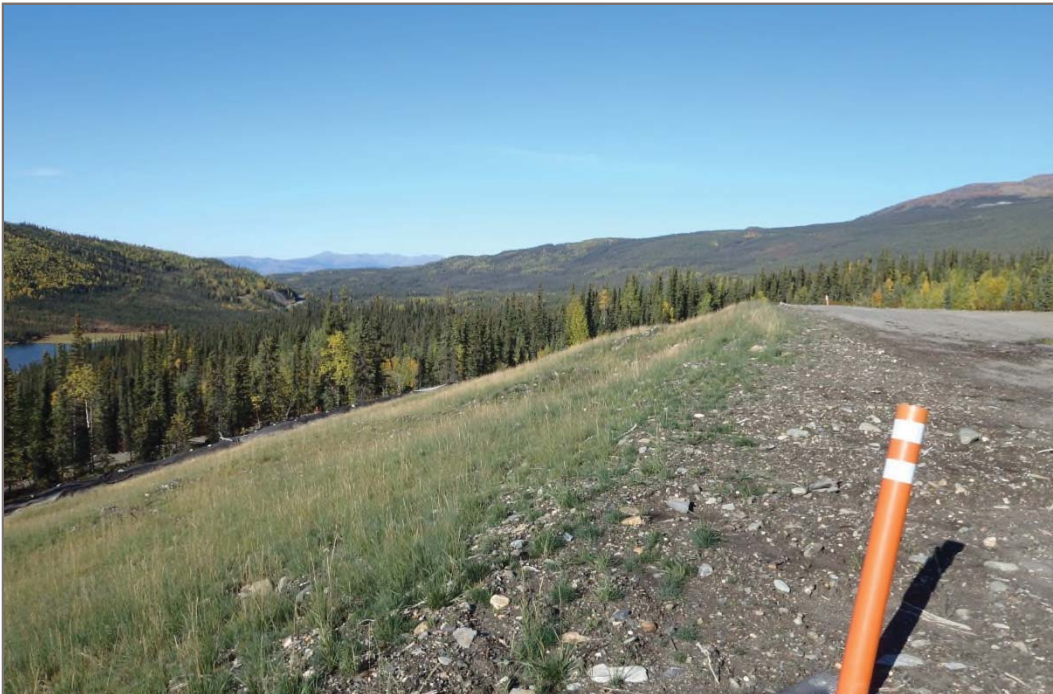
Construction of the lower tailings bench is complete to the design dimensions and elevations. Progressive reclamation of the facility is underway with revegetation of the western face of the lower bench (Photo 24).

Photo 24: Dry Stacked Tailings Facility
Vegetation on western slope of lower tailings bench
Facing north – September 10, 2013

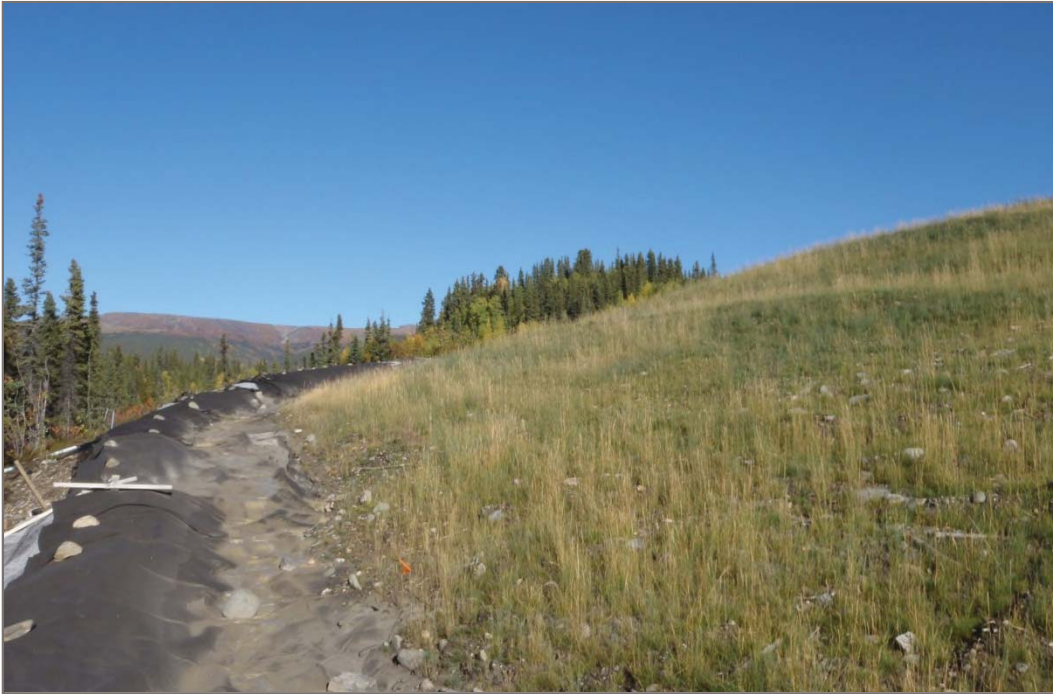
The foundation elements of the DSTF (gravel drainage blanket, geosynthetic clay liner, geonet, and geotextile) placed to date appeared properly installed and intact at the time of the inspection. The perimeter berms and surface water collection structures appeared stable and functional (Photo 25).

Photo 25: Dry Stacked Tailings Facility
Perimeter berm and surface water collection system
Facing north – September 10, 2013

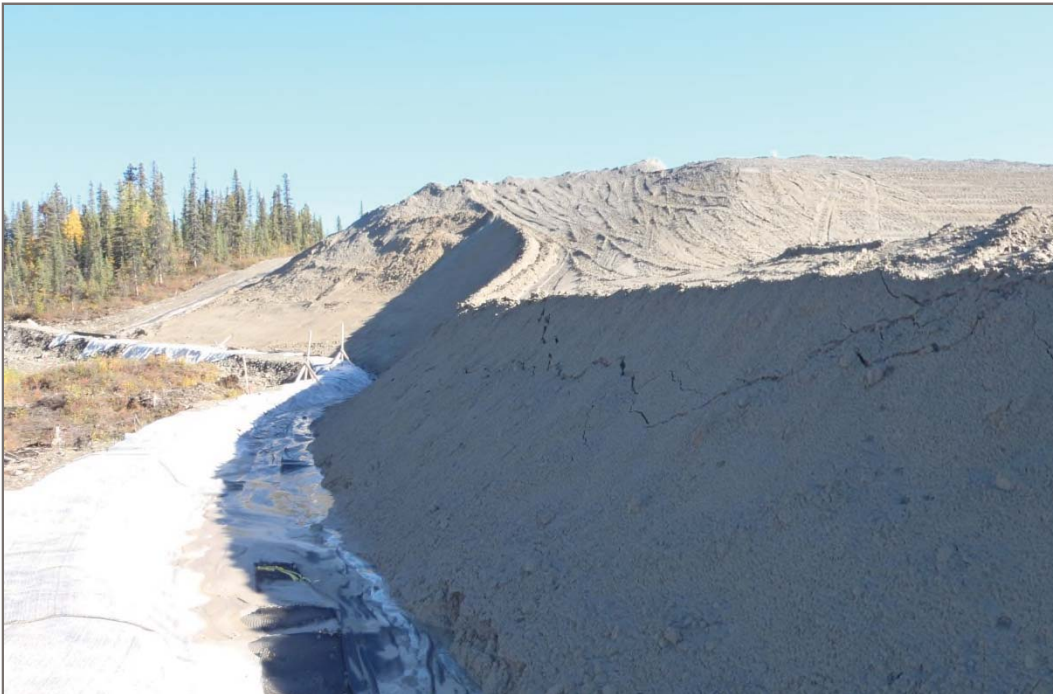
Some minor tension cracking was observed near the top of the placed tailings on the north slope of the DSTF (Photo 26). This is likely due to the natural drying of placed tailings and should not impact the performance of the facility.

Photo 26: Dry Stacked Tailings Facility
Minor tension cracking on north side of facility
Facing east – September 10, 2013

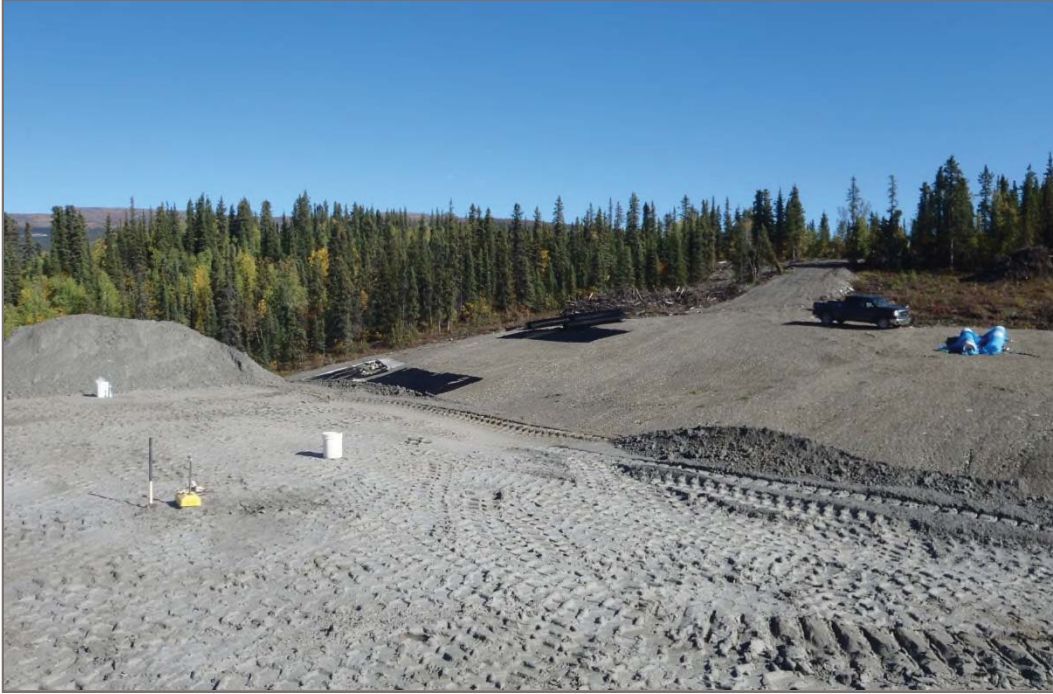
Ongoing routine DSTF instrumentation monitoring and compaction testing (Photo 27) indicates there is no lateral movement of the frozen foundation soils and that compaction of the placed tailings to date is adequate. In general, construction and performance of the DSTF has been consistent with the design to date. No remedial action is recommended for the DSTF.

Photo 27: Dry Stacked Tailings Facility
Compaction testing at the dry stacked tailings facility
Facing north – September 10, 2013
