Alexco Resource Corp.
3 – 151 Industrial Road
Whitehorse, YT Y1A 2V3

ISSUED FOR USE – REVISION I

FILE: W14103450-01

Subject: 2014 Annual Inspection – Surface Engineered Earth Structures
Bellekeno Mine, Keno City, YT

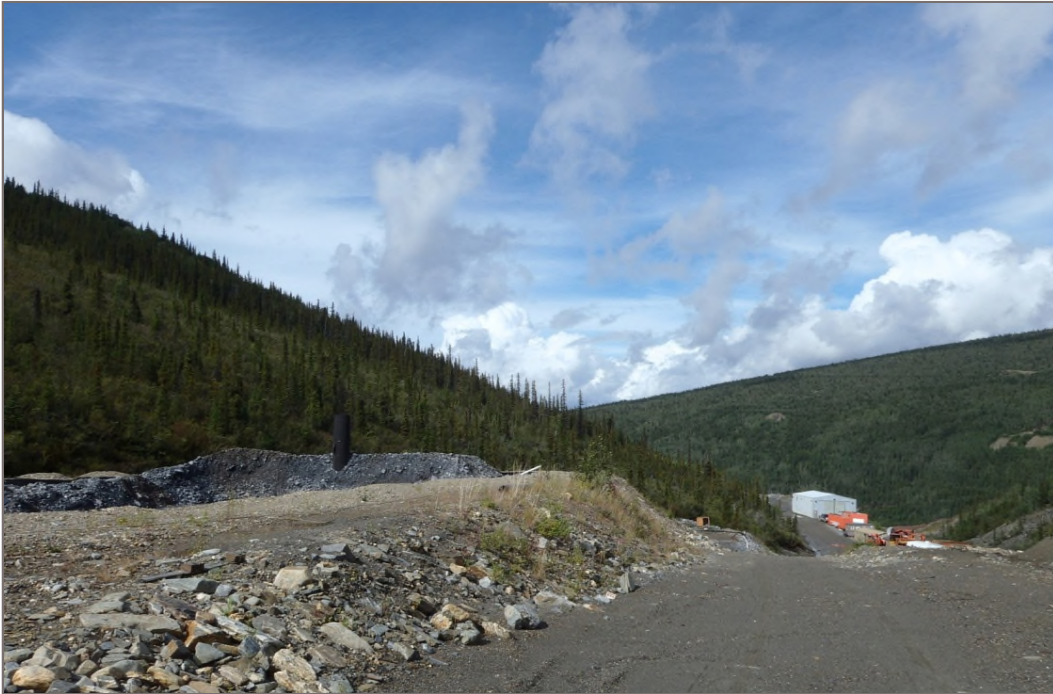
The PAG waste storage facility is located south of the existing Bellekeno portal, as shown on Figure 1. At the time of the inspection the facility perimeter berms appeared intact (Photo 1) with no visible signs of instability (tension cracks, erosion rills, slumps, etc.). The facility was impounding some surface water (Photo 2). This is likely a result of the laydown area immediately south (upslope) of the facility being generally graded toward the entrance (Photo 3). To reduce the amount of surface runoff water captured by the facility, the upslope laydown area can be regraded to drain away from the facility entrance or a diversion berm can be constructed to direct surface runoff around the entrance to the facility. This work can be completed during regular facility maintenance and is not a facility stability concern.

Photo 1: PAG Waste Storage Facility
Facility berms and sideslopes
Facing north – August 12, 2014

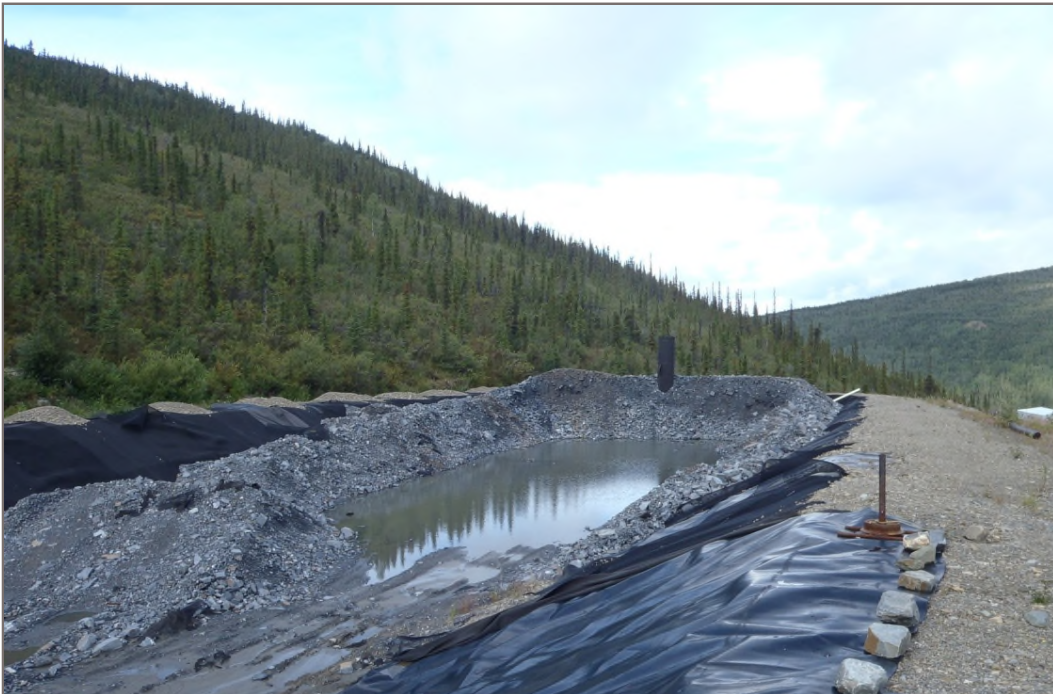
Photo 2: PAG Waste Storage Facility
Surface water in facility
Facing north – August 12, 2014

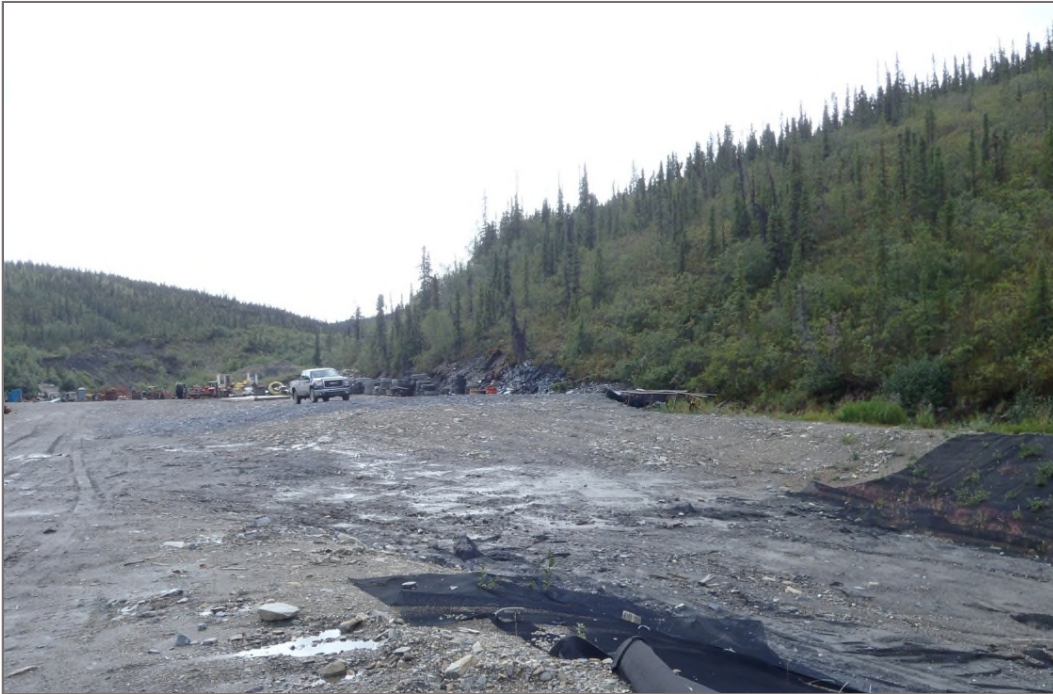
Photo 3: PAG Waste Storage Facility
Laydown area graded toward facility entrance
Facing south – August 12, 2014

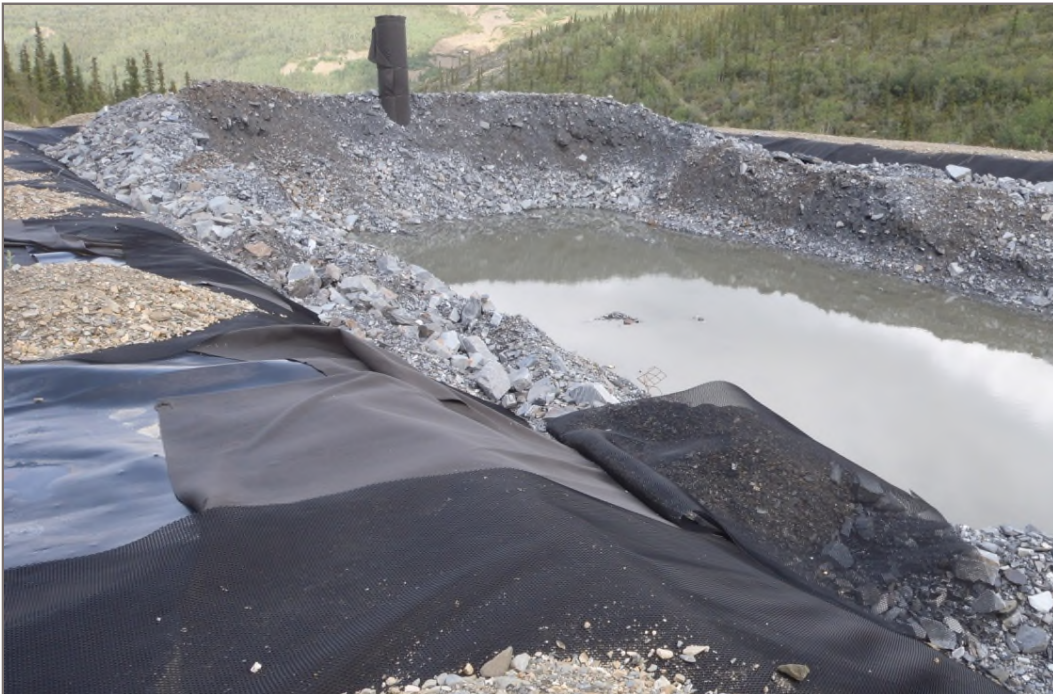
The north and west liner anchor trenches along the berm crests remain incomplete. For several years a recommendation to complete the trenching to adequately anchor the liner system has been made. The liner components have now been displaced by wind, due to insufficient anchoring (Photo 4). The liner system should be properly anchored before wind rips the material.

Photo 4: PAG Waste Storage Facility
Liner components displaced due to wind
Facing east – August 12, 2014

Structure	Remedial Recommendations (Stability)	Remedial Recommendations (Maintenance)
PAG Waste Storage Facility	<ul style="list-style-type: none"> Re-align liner system components and complete proper anchor trenching along north and west sides of facility. 	<ul style="list-style-type: none"> Regrade laydown above entrance to facility or construct diversion berm to limit the capture of surface water runoff. Complete placement of protective geotextile and geonet materials in southern portion of facility or remove waste rock stored in direct contact with exposed liner to limit risk of punctures.
Bellekeno 625 Water Treatment Ponds	<ul style="list-style-type: none"> Armour discharge location with rip-rap to protect hillside. 	<ul style="list-style-type: none"> Monitor sediment accumulation outside perimeter berm in southwest corner of primary pond and excavate as required to prevent surface water from entering pond.

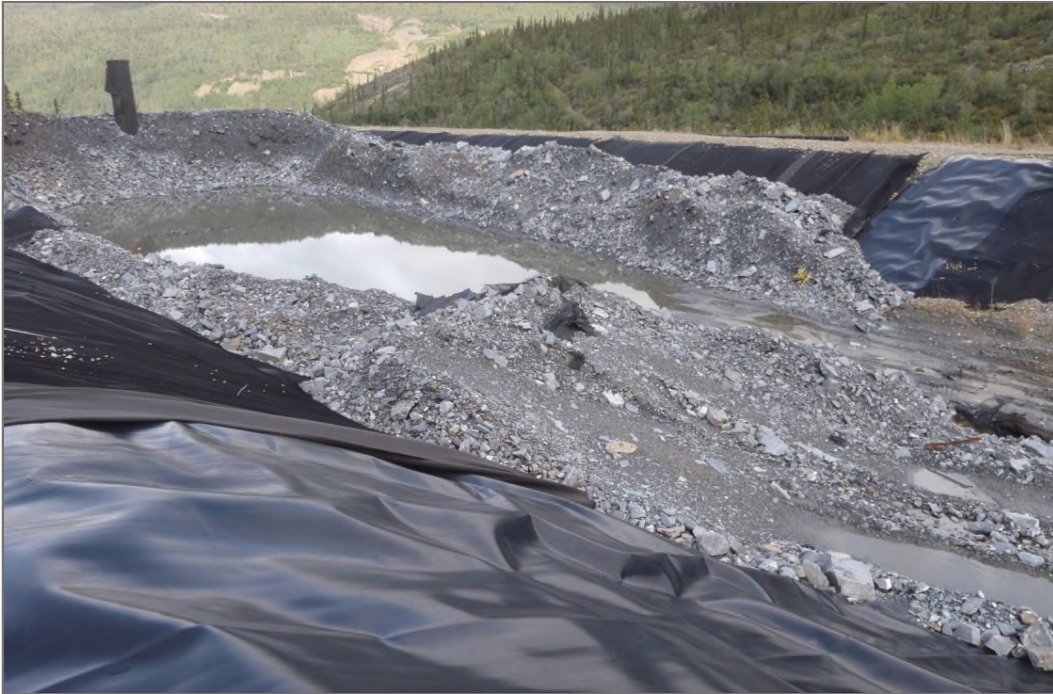
As noted in previous years, the protective geotextile and geonet materials have only been placed in the north half of the facility. Some waste rock currently being stored in the facility extends beyond this protection and is in direct contact with the liner (Photo 5). Large angular waste rock has the potential to puncture the liner and should be carefully relocated to the north (protected) end of the facility prior to the placement of additional material in the south end of the facility. Ultimately, the geotextile and geonet materials should be installed throughout the entire facility as was intended in the original facility design.

Photo 5: PAG Waste Storage Facility
Angular waste rock in direct contact with liner
Facing east – August 12, 2014

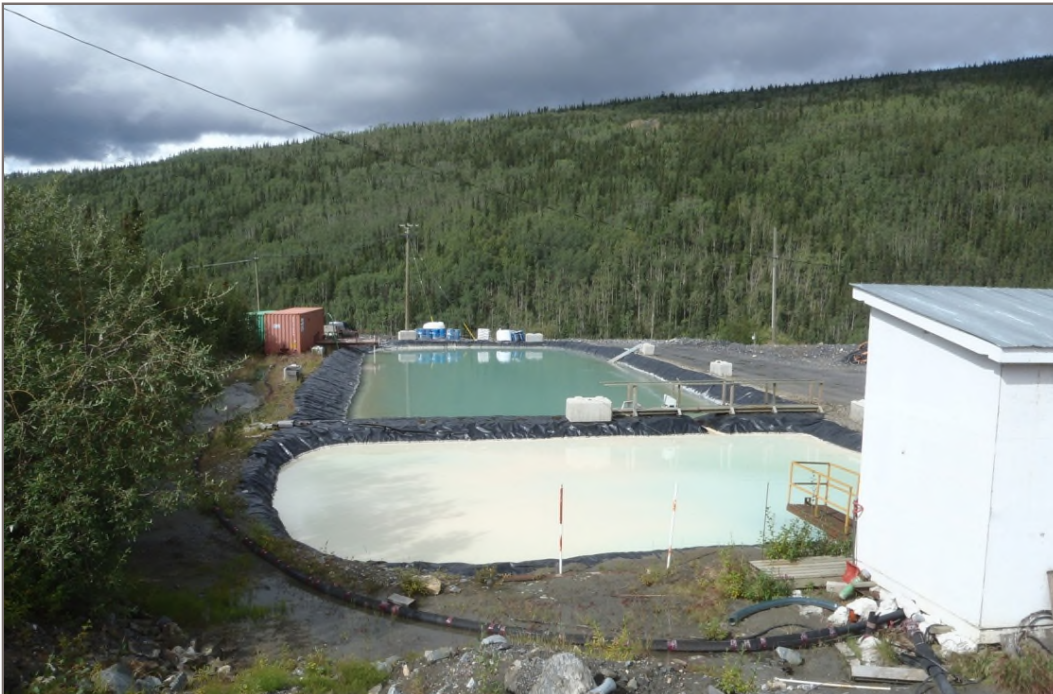
Photo 6: Bellekeno 625 Water Treatment Ponds
Facility overview
Facing north – August 12, 2014

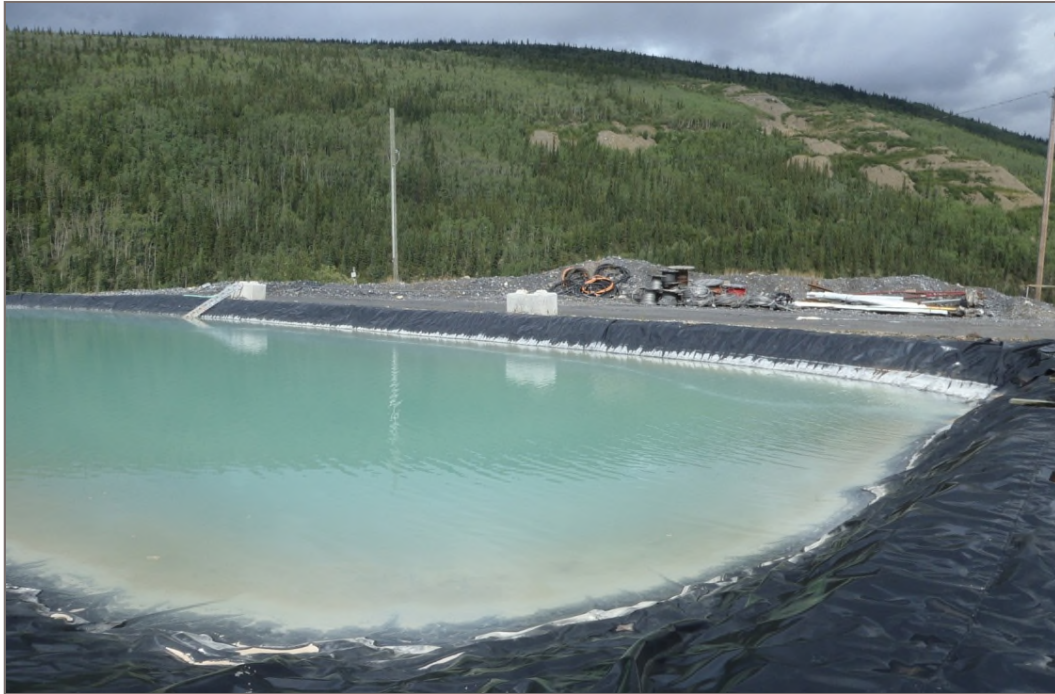
Photo 7: Bellekeno 625 Water Treatment Ponds
Intact perimeter berms and liners
Facing east – August 12, 2014

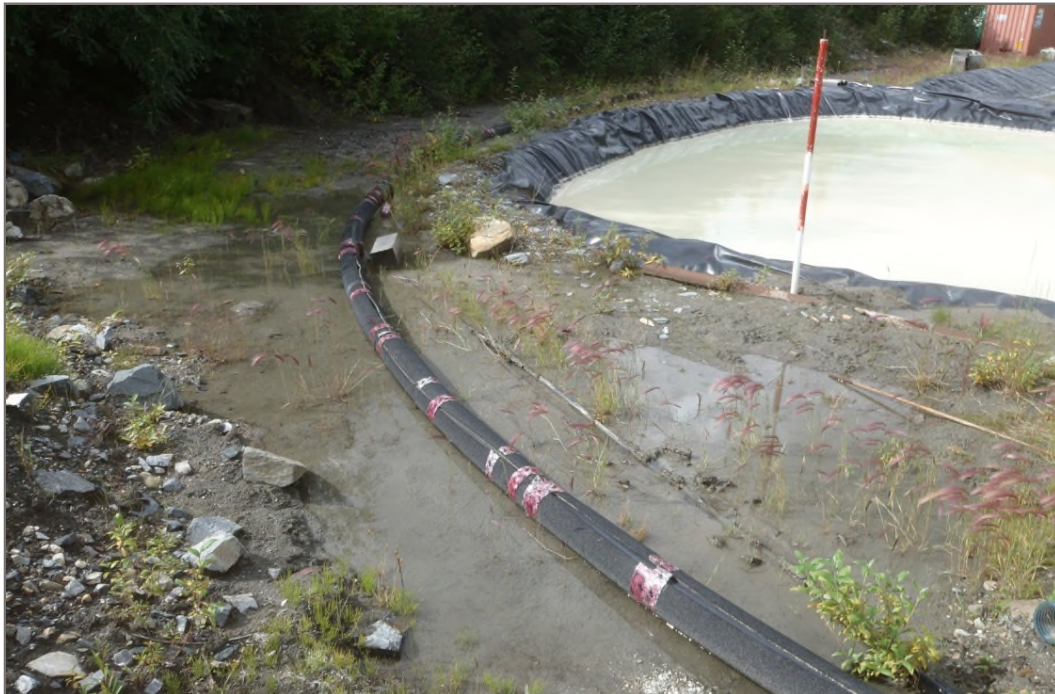
The Bellekeno 625 water treatment ponds are located about 750 m north of the Bellekeno portal, as shown on Figure 1. The facility consists of two water treatment ponds that were both operating at the time of the inspection (Photo 6). The perimeter berms and liners appeared intact at the time of the inspection (Photo 7). Surface water runoff transporting fine grained soil has been accumulating outside the southwest corner of the primary treatment pond (Photo 8). Fines in this area should be monitored and removed as part of facility maintenance to prevent accumulation to the point of allowing surface runoff water to enter the treatment pond. If sediment transport and accumulation continues to be an issue in this area, a diversion structure should be constructed upgradient of the facility.

Photo 8: Bellekeno 625 Water Treatment Ponds
Surface water and sediment accumulation outside southwest corner of primary pond
Facing west – August 12, 2014

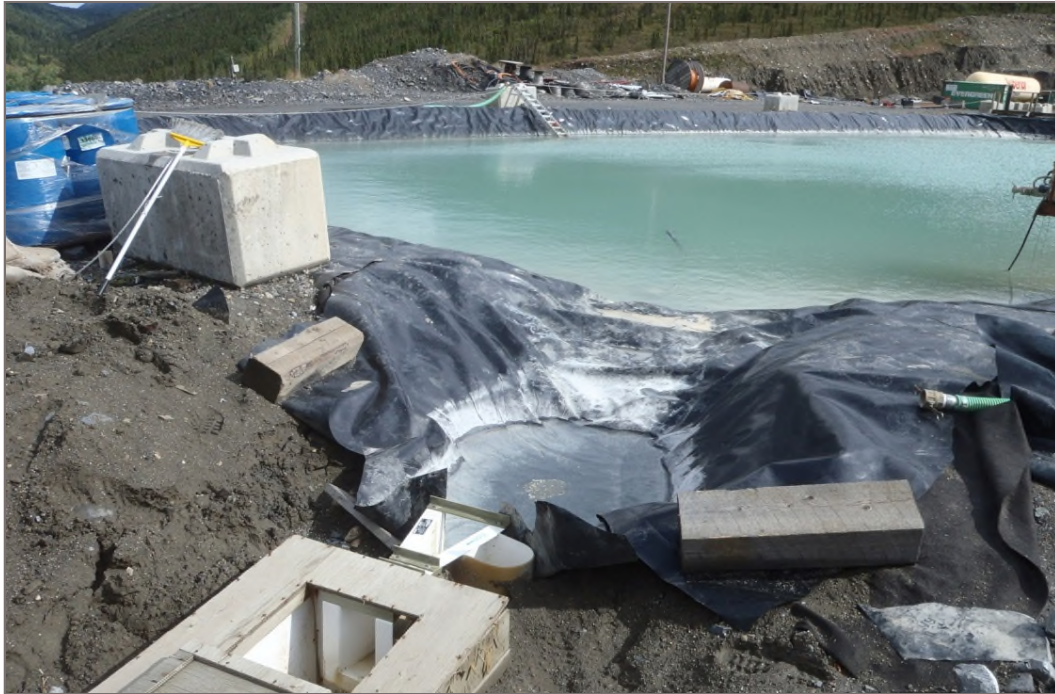
The primary treatment pond had a freeboard of about 0.5 m below the perimeter berm crest at the time of the inspection. Water in the secondary pond was about 0.1 m below the discharge invert elevation and the pond had a freeboard of about 1.0 m below the perimeter berm crest (Photo 9). The discharge line appeared intact at the time of the inspection. Consistent with recommendations made in previous years, rip-rap armouring is required at the discharge location (Photo 10) to limit damage to the natural hillside.

Photo 9: Bellekeno 625 Water Treatment Ponds
Freeboard in secondary pond at outlet location
Facing east – August 12, 2014

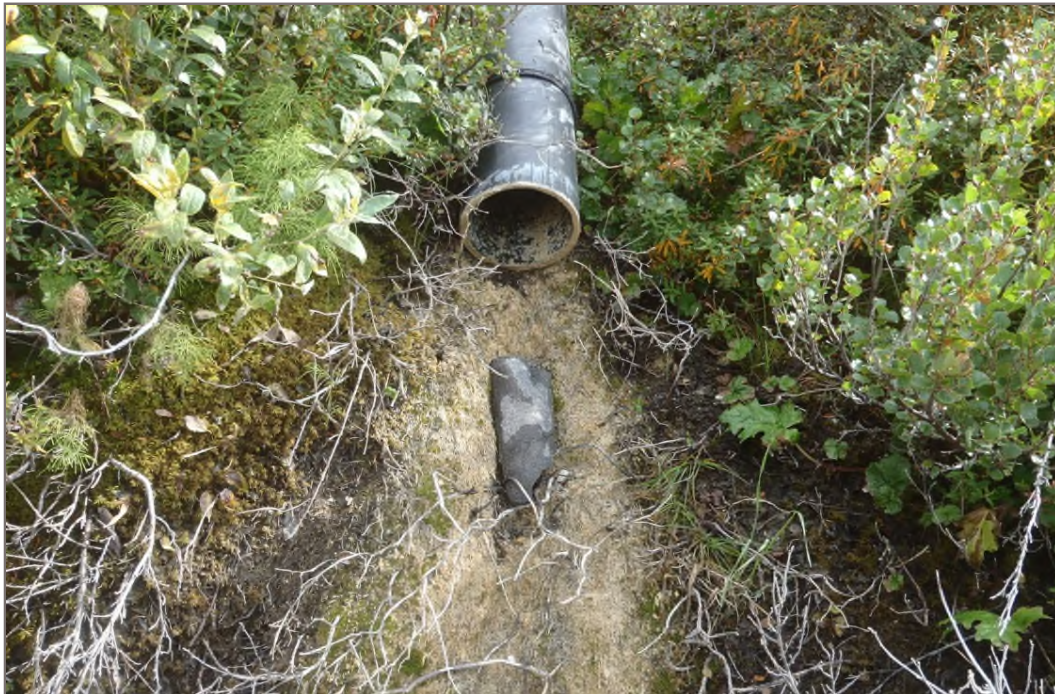
Photo 10: Bellekeno 625 Water Treatment Ponds
Discharge location
Facing south – August 12, 2014

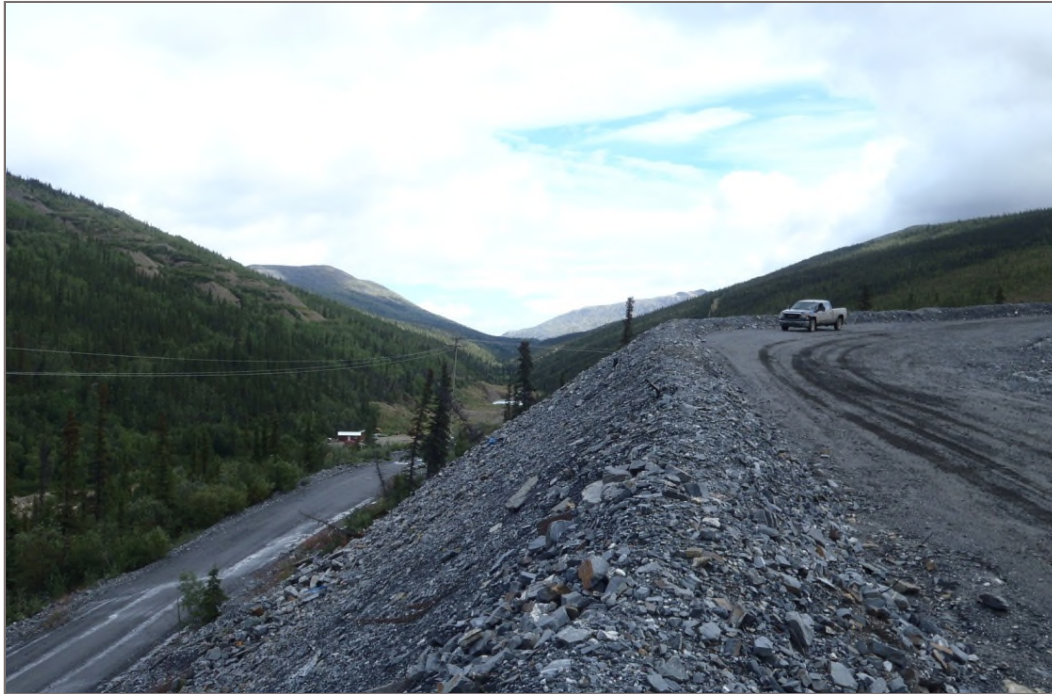
Photo 11: Bellekeno Waste Rock Pile
Intact sideslopes
Facing east – August 12, 2014

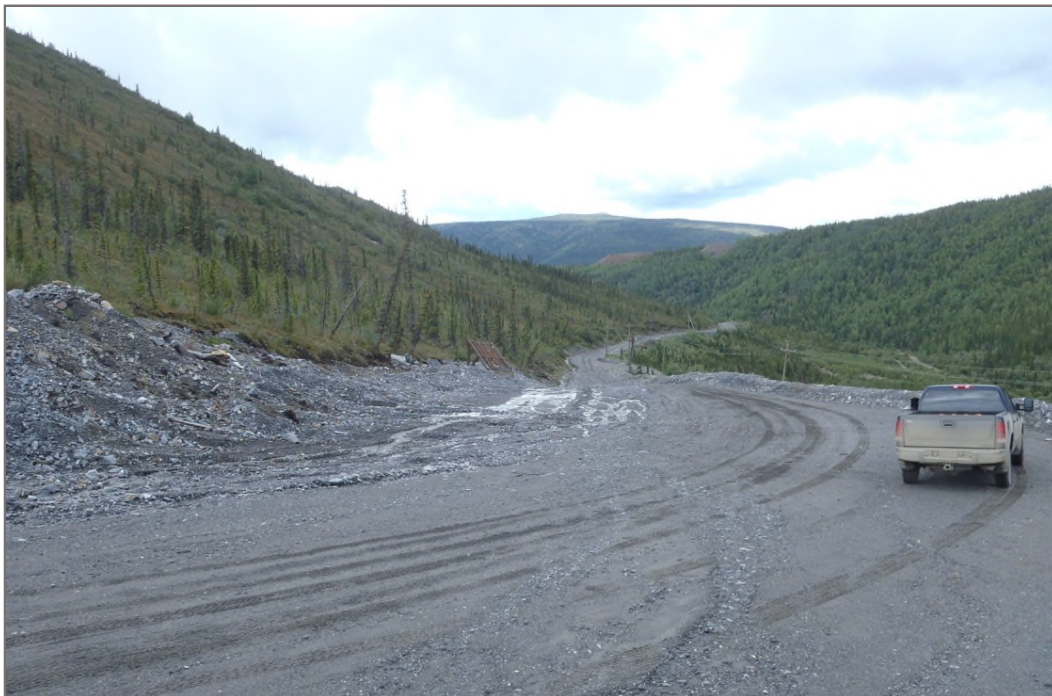
The Bellekeno waste rock pile forms a portion of the Bellekeno Haul Road and is located north of the Bellekeno portal, as shown on Figure 1. At the time of the inspection the waste rock pile sideslopes appeared intact and stable (Photo 11). South of the Bellekeno waste rock pile, ditching exists along the upslope side of the Bellekeno Haul Road to control surface water runoff. The ditching ends as the road passes through the waste rock pile and the surface water fans out across the roadway (Photo 12). During regular maintenance operations, the ditching should be continued on the upslope side of the Bellekeno Haul Road through the waste rock pile to prevent erosion damage to the road surface and waste rock pile sideslopes.

Photo 12: Bellekeno Waste Rock Pile
Surface water and erosion on roadway
Facing west – August 12, 2014

Bellekeno Waste Rock Pile	<ul style="list-style-type: none"> No stability related remedial action required. 	<ul style="list-style-type: none"> Continue ditch on upslope side of the Bellekeno Haul Road through the Bellekeno waste rock pile section to control surface water runoff and limit erosion to road surface and waste rock pile sideslopes.
Lightning Creek Bridge Abutments (Onek Road)	<ul style="list-style-type: none"> No stability related remedial action required. 	<ul style="list-style-type: none"> No maintenance related remedial action required.
Lightning Creek Bridge Abutments (Bellekeno Haul Road)	<ul style="list-style-type: none"> No stability related remedial action required. 	<ul style="list-style-type: none"> No maintenance related remedial action required.
Mill Water Storage Pond	<ul style="list-style-type: none"> No stability related remedial action required. 	<ul style="list-style-type: none"> Consider adding bales of hay to the DSTF surface water collection system to control runoff velocity and limit the volume of sediment deposited in the pond.

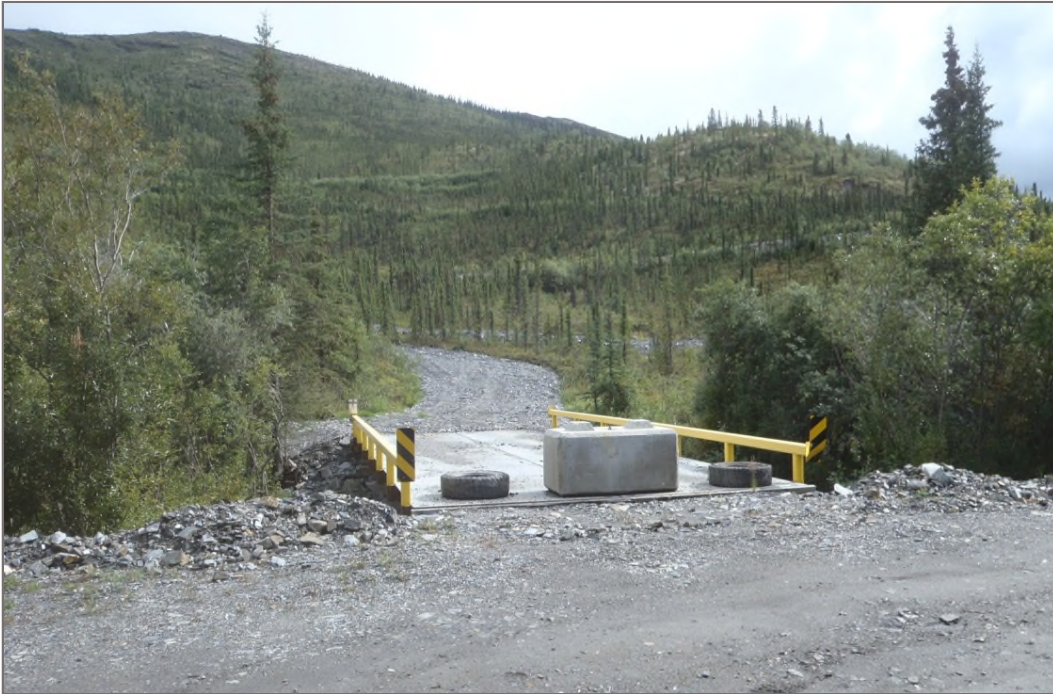
Photo 13: Lightning Creek Bridge Abutments (Onek Road)
Bridge overview
Facing south – August 12, 2014

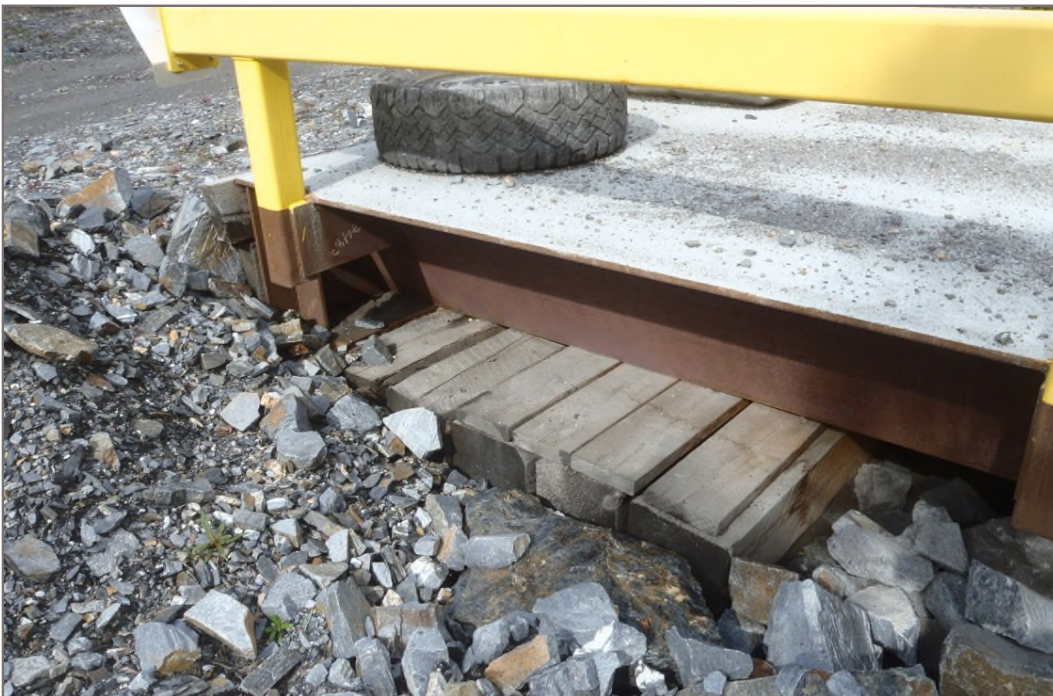
Photo 14: Lightning Creek Bridge Abutments (Onek Road)
Stable timber bridge abutments
Facing west – August 12, 2014

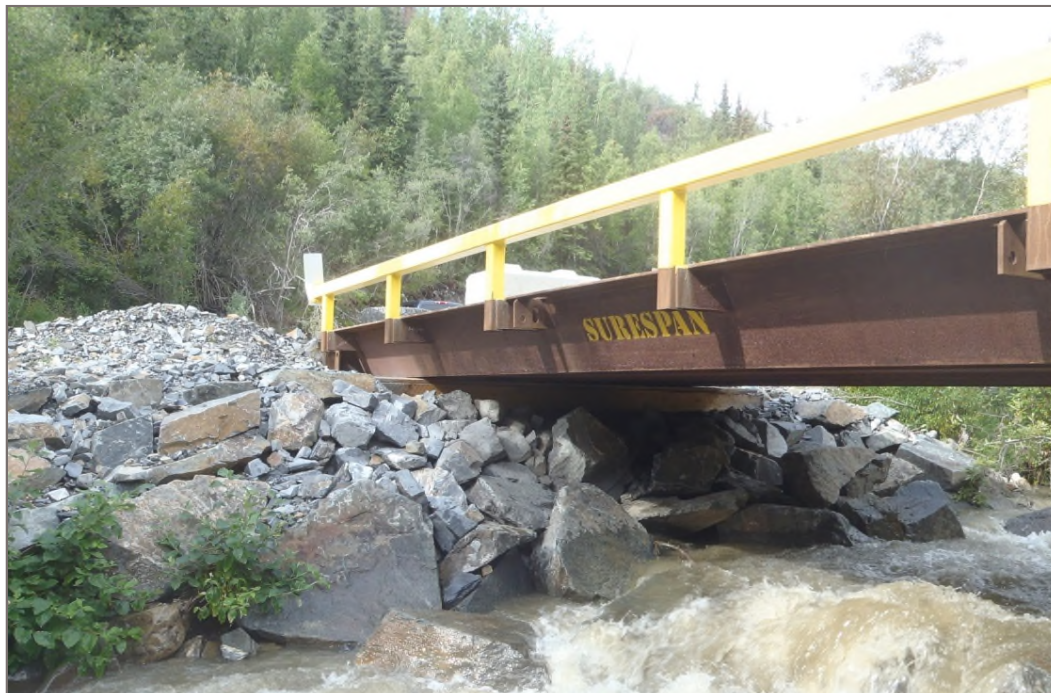
Photo 15: Lightning Creek Bridge Abutments (Onek Road)
Rip-rap armouring bridge abutments
Facing north – August 12, 2014

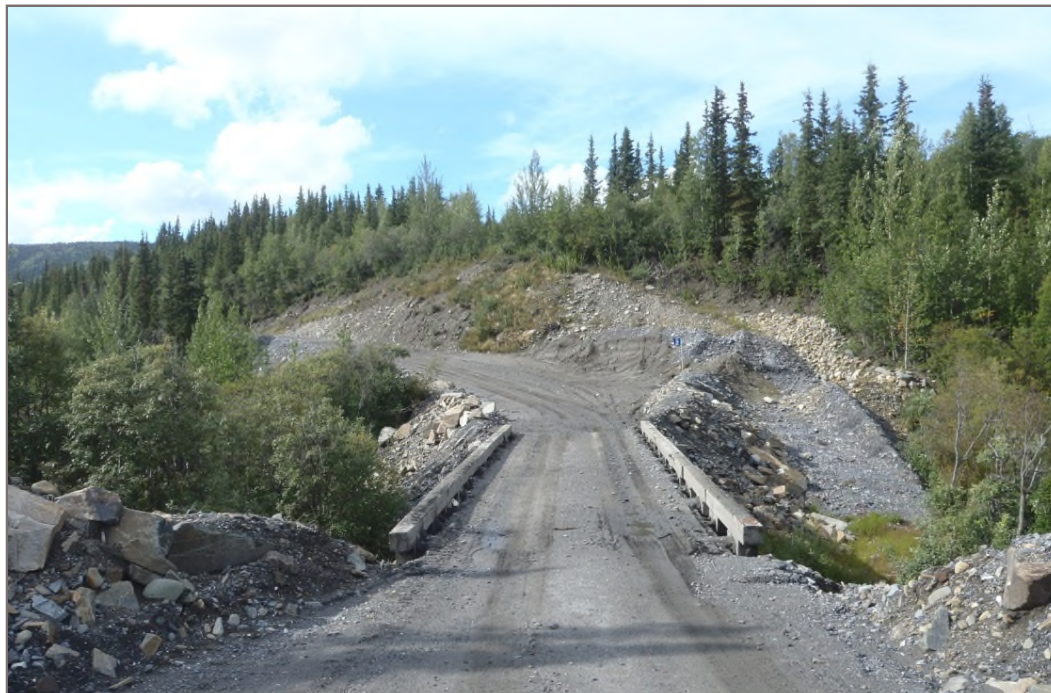
The Lightning Creek bridge on the Bellekeno Haul Road is located southwest of Keno City, as shown on Figure 1. The bridge was in service at the time of the inspection. The bridge is a single span steel bridge with a 18 mm wooden deck (Photo 16) founded on earth filled timber cribbing abutments (Photo 17). The abutments are sufficiently protected from erosion by rip-rap armouring (Photo 18). No remedial action is required for the Lightning Creek bridge on the Bellekeno Haul Road at this time.

Photo 16: Lightning Creek Bridge Abutments (Bellekeno Haul Road)
Bridge overview
Facing west – August 12, 2014

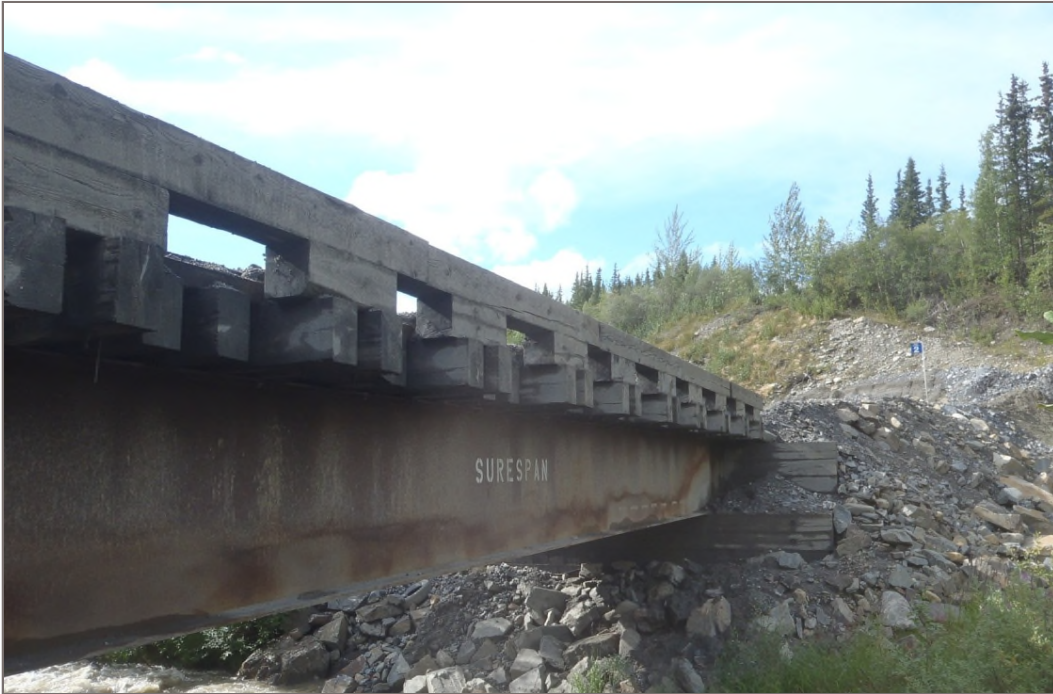
Photo 17: Lightning Creek Bridge Abutments (Bellekeno Haul Road)
Stable earth filled timber abutments
Facing west – August 12, 2014

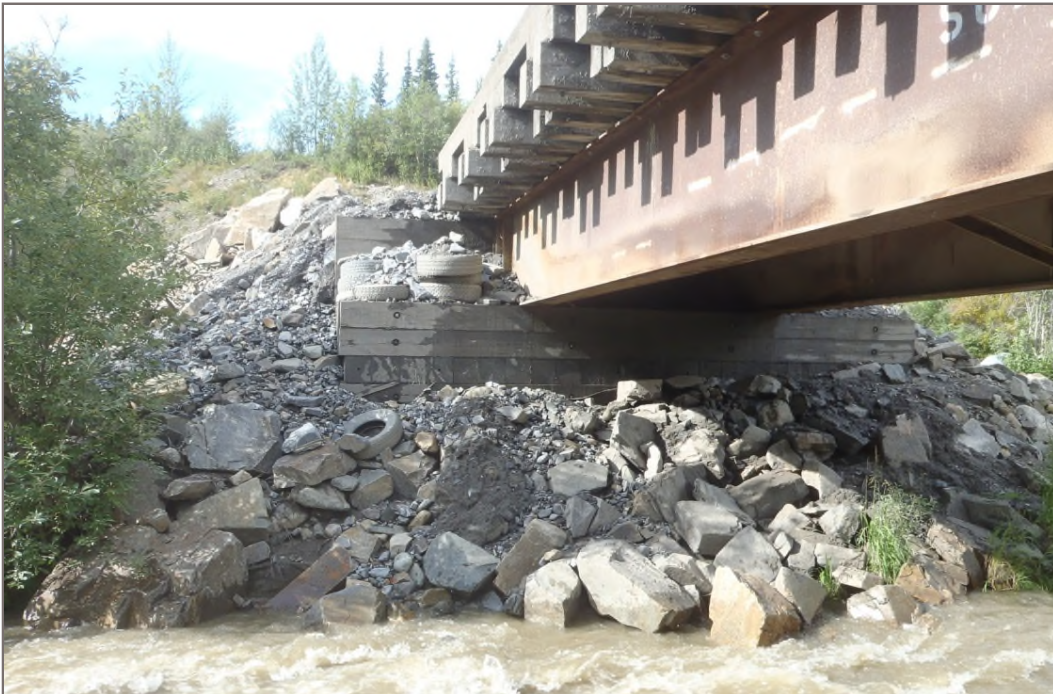
Photo 18: Lightning Creek Bridge Abutments (Bellekeno Haul Road)
Rip-rap armouring bridge abutments
Facing west – August 12, 2014

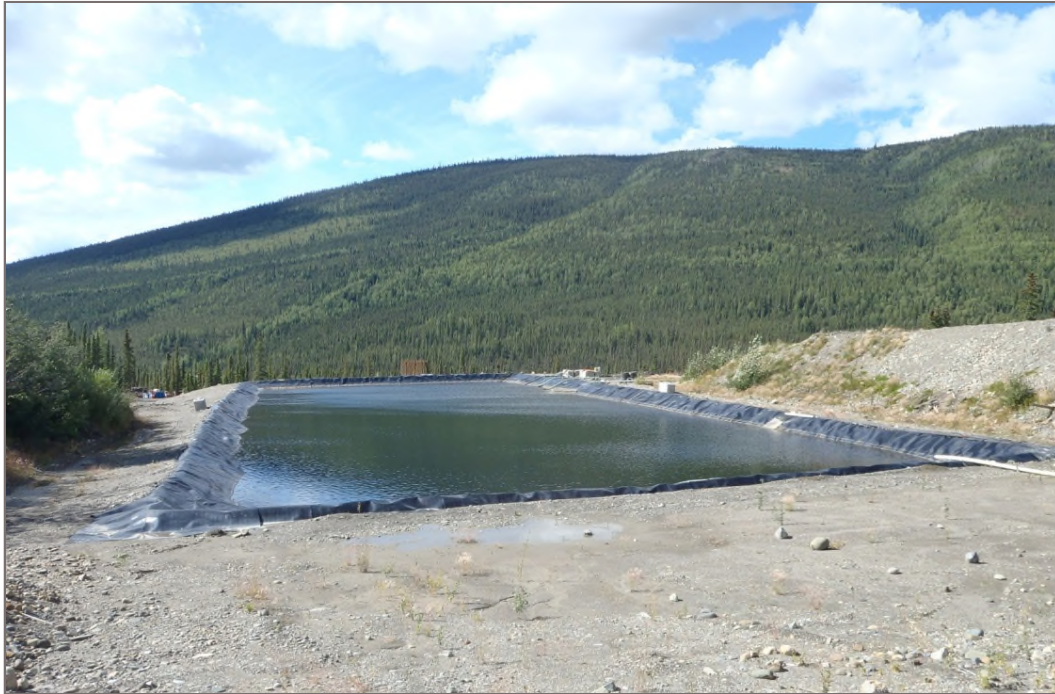
Photo 19: Mill Water Storage Pond
Water level in pond
Facing west – August 13, 2014

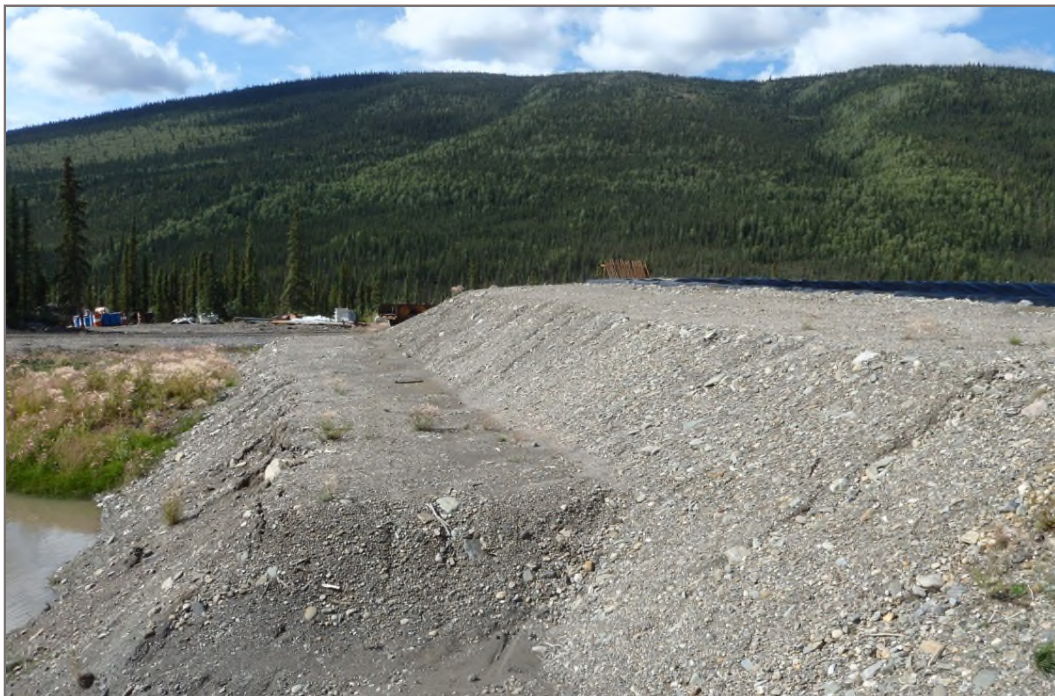
Following up on observations made during the annual inspection last year, no additional erosion was noted along the exterior berm in the southwest portion of the pond (Photo 20).

Photo 20: Mill Water Storage Pond
Stable berm sideslope
Facing west – August 13, 2014

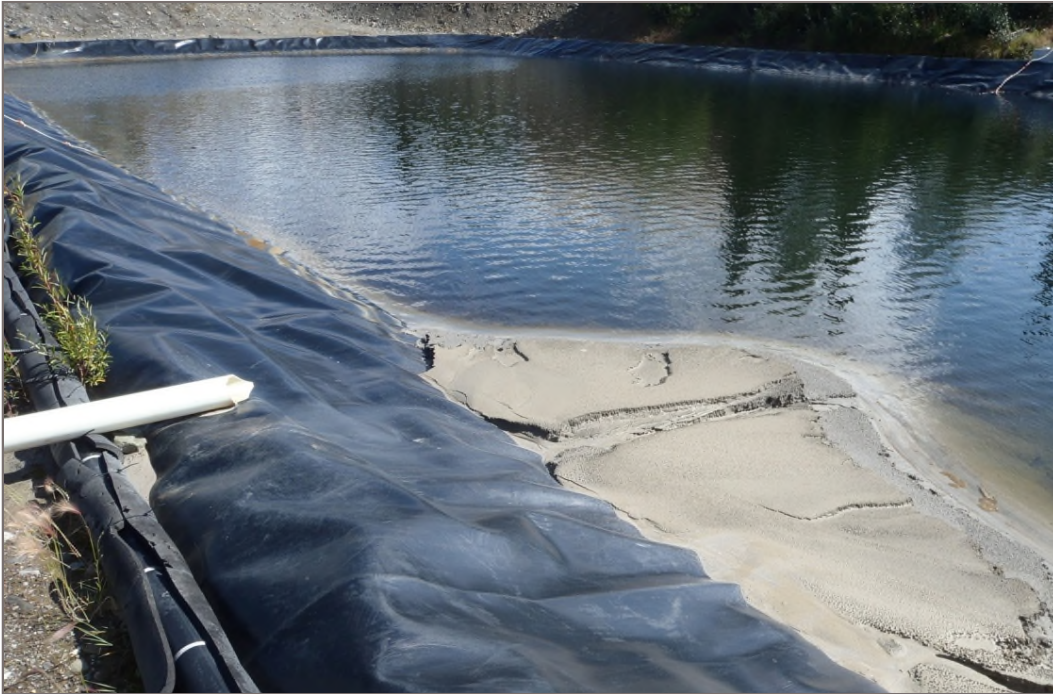
The surface water collection system below the DSTF collects runoff water and conveys it to the mill water pond for storage. Sediment collected in this system is also transported into the pond and has been depositing near the inlet (Photo 21). Additional bales of hay can be installed in the DSTF surface water collection system to control runoff velocity and limit the volume of sediment deposited in the mill water storage pond.

Photo 21: Mill Water Storage Pond
Sediment deposited at inlet from DSTF surface water collection system
Facing east – August 13, 2014

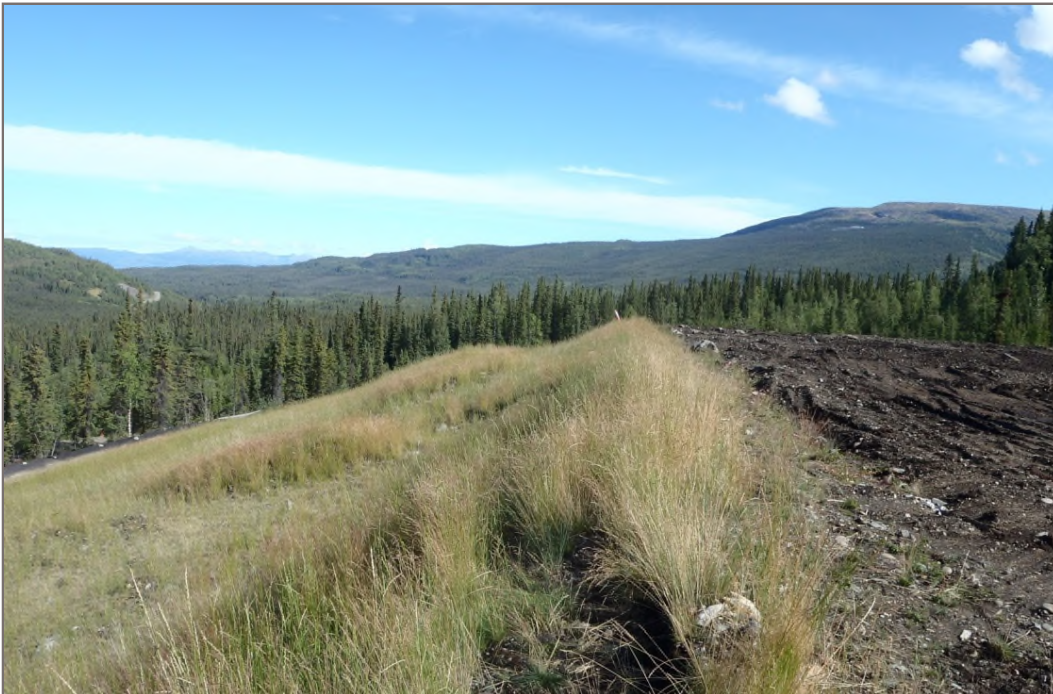
Photo 22: Dry Stacked Tailings Facility
Grass on front face of lower bench
Facing north – August 13, 2014

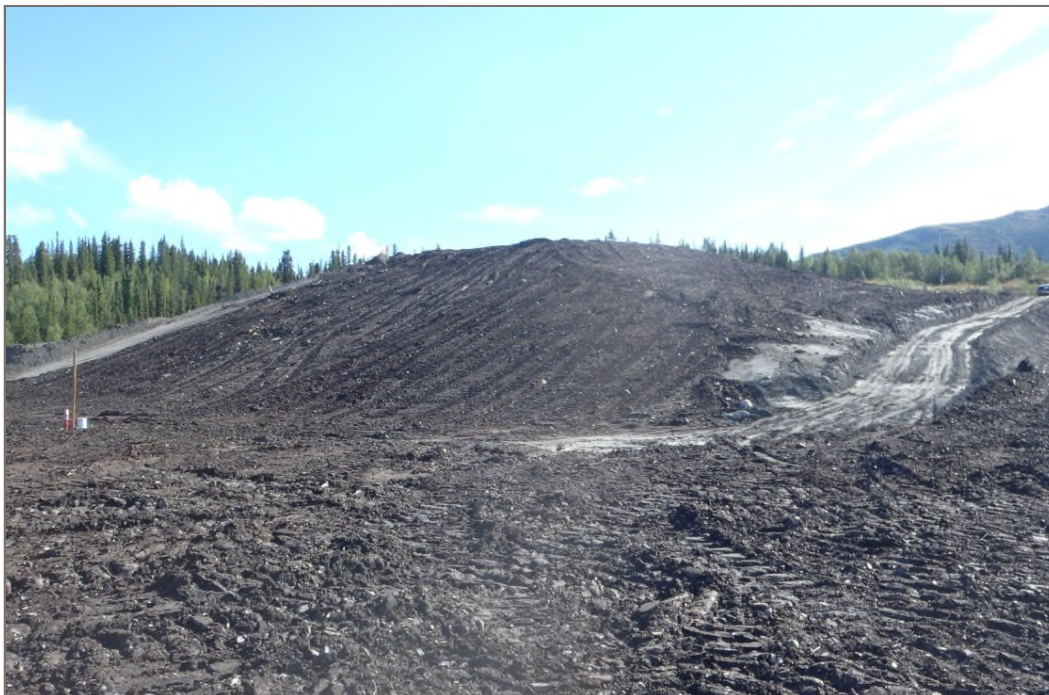
Photo 23: Dry Stacked Tailings Facility
Progressive reclamation of upper bench (cover and seed mixture applied)
Facing east – August 13, 2014

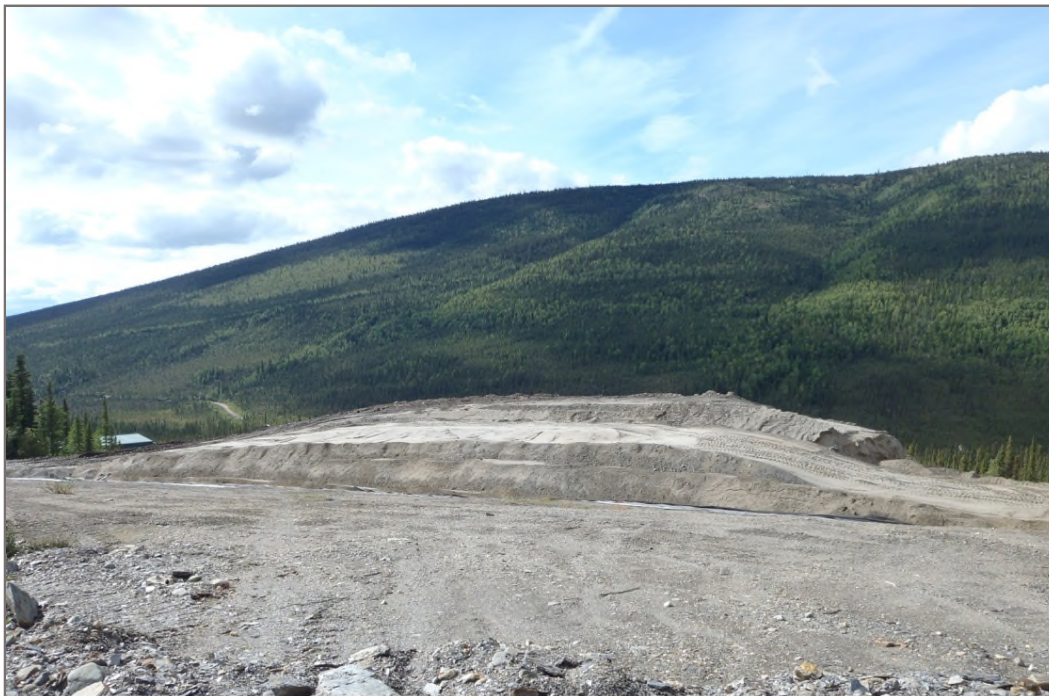
The dry stacked tailings facility (DSTF) is located at the Keno Hill District Mill Site, approximately 1 km west of Keno City, as shown on Figure 1. No additional tailings have been placed in the DSTF since the 2013 annual inspection because milling operations have stopped. Regrading of tailings placed within the DSTF to date was completed and progressive reclamation was underway at the time of the inspection. The front face of the lower bench has been covered, seeded, and grass has been established (Photo 22). Most of the tailings placed to date were covered and seeded at the time of the inspection (Photo 23), except for the very top of the facility where tailings placement will resume when milling operations begin again (Photo 24).

Photo 24: Dry Stacked Tailings Facility
Top of facility where tailings placement will continue
Facing west – August 13, 2014

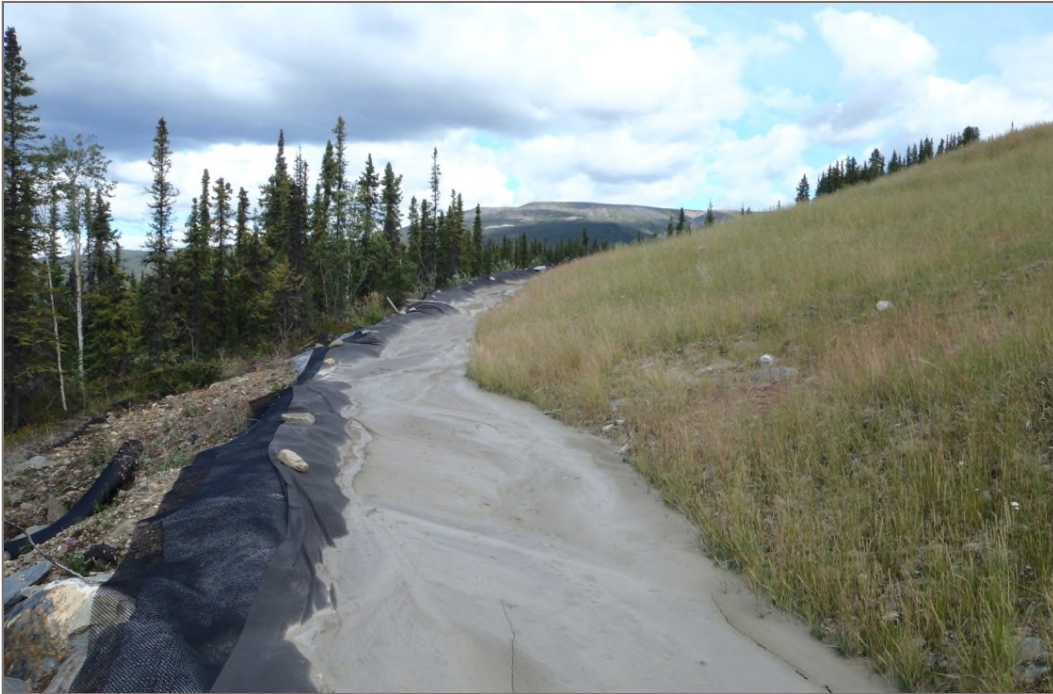
The DSTF sideslopes, liner system, and surface water runoff collection system appeared intact at the time of the inspection. The surface water runoff collection system was observed to contain tailings transported by surface water runoff (Photo 25). Tailings within the collection system should be mucked out and transported to the active portion of the facility to limit the potential for overtopping of the collection system during future surface water runoff events. In general, construction and performance of the DSTF has been consistent with the design to date.

Photo 25: Dry Stacked Tailings Facility
Tailings in the surface water runoff collection system
Facing north – August 13, 2014

Dry Stacked Tailings Facility	<ul style="list-style-type: none"> Muck out tailings in the surface water runoff collection system to limit the potential for overtopping of the collection system during future surface water runoff events. Repair slope indicator casing in BH30 or advance replacement borehole during future geotechnical drill investigation if salvage of the existing installation is not possible. Advance replacement borehole for malfunctioning ground temperature cable in BH40 during future geotechnical drill investigation. 	<ul style="list-style-type: none"> Continue regular instrumentation readings to monitor DSTF foundation conditions.

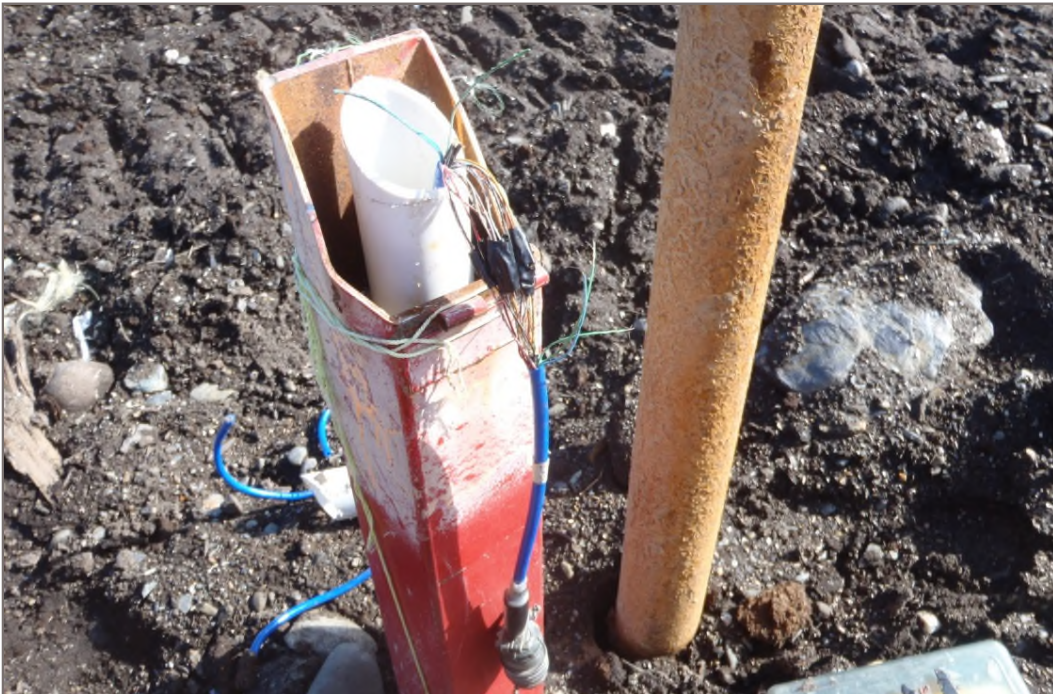
The ground temperature cable installed in BH40, through the placed tailings and into the foundation soils below the DSTF, has not returned proper readings since May 2013. During the site inspection a new connector was spliced onto the cable lead in an attempt to repair the cable (Photo 26). The repair was ineffective, leading us to believe the damage is within the buried portion of the cable and thus not repairable. The next time a geotechnical drill program is conducted near the DSTF, a borehole should be advanced through the placed tailings to install a replacement cable for the malfunctioning one in BH40.

Photo 26: Dry Stacked Tailings Facility
Attempted repair of the ground temperature cable in BH40
Facing north – August 13, 2014
