Alexco Resource Corp.
3 – 151 Industrial Road
Whitehorse, YT Y1A 2V3

ISSUED FOR USE – REVISION I

FILE: W14103450-01

Subject: 2014 Annual Inspection – Surface Engineered Earth Structures
Bellekeno Mine, Keno City, YT

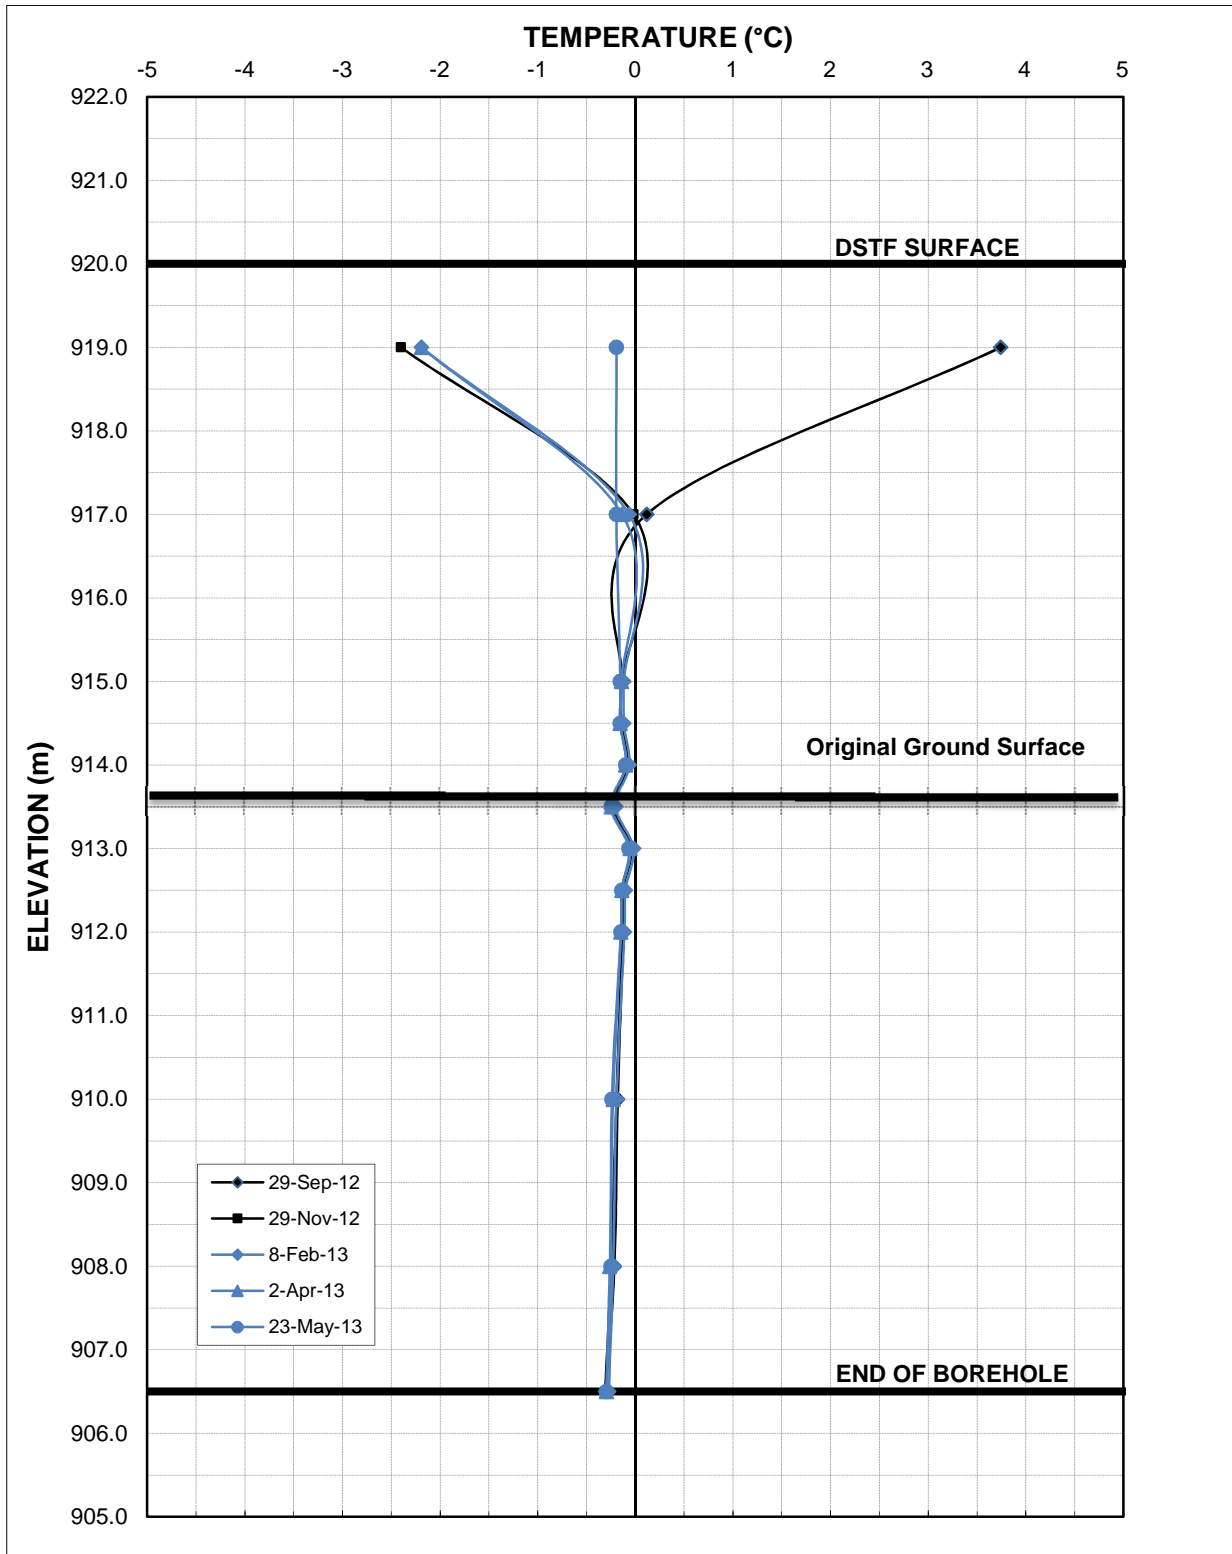
Ground Temperature Profile
Keno Hill District Mill Site Borehole BH40
 Figure T7

The ground temperature cable installed in BH40, through the placed tailings and into the foundation soils below the DSTF, has not returned proper readings since May 2013. During the site inspection a new connector was spliced onto the cable lead in an attempt to repair the cable (Photo 26). The repair was ineffective, leading us to believe the damage is within the buried portion of the cable and thus not repairable. The next time a geotechnical drill program is conducted near the DSTF, a borehole should be advanced through the placed tailings to install a replacement cable for the malfunctioning one in BH40.
