Subject: 2015 Annual Inspection – Surface Engineered Earth Structures
Bellekeno Mine, Keno City, YT

ISSUED FOR USE
FILE: W14103659-01

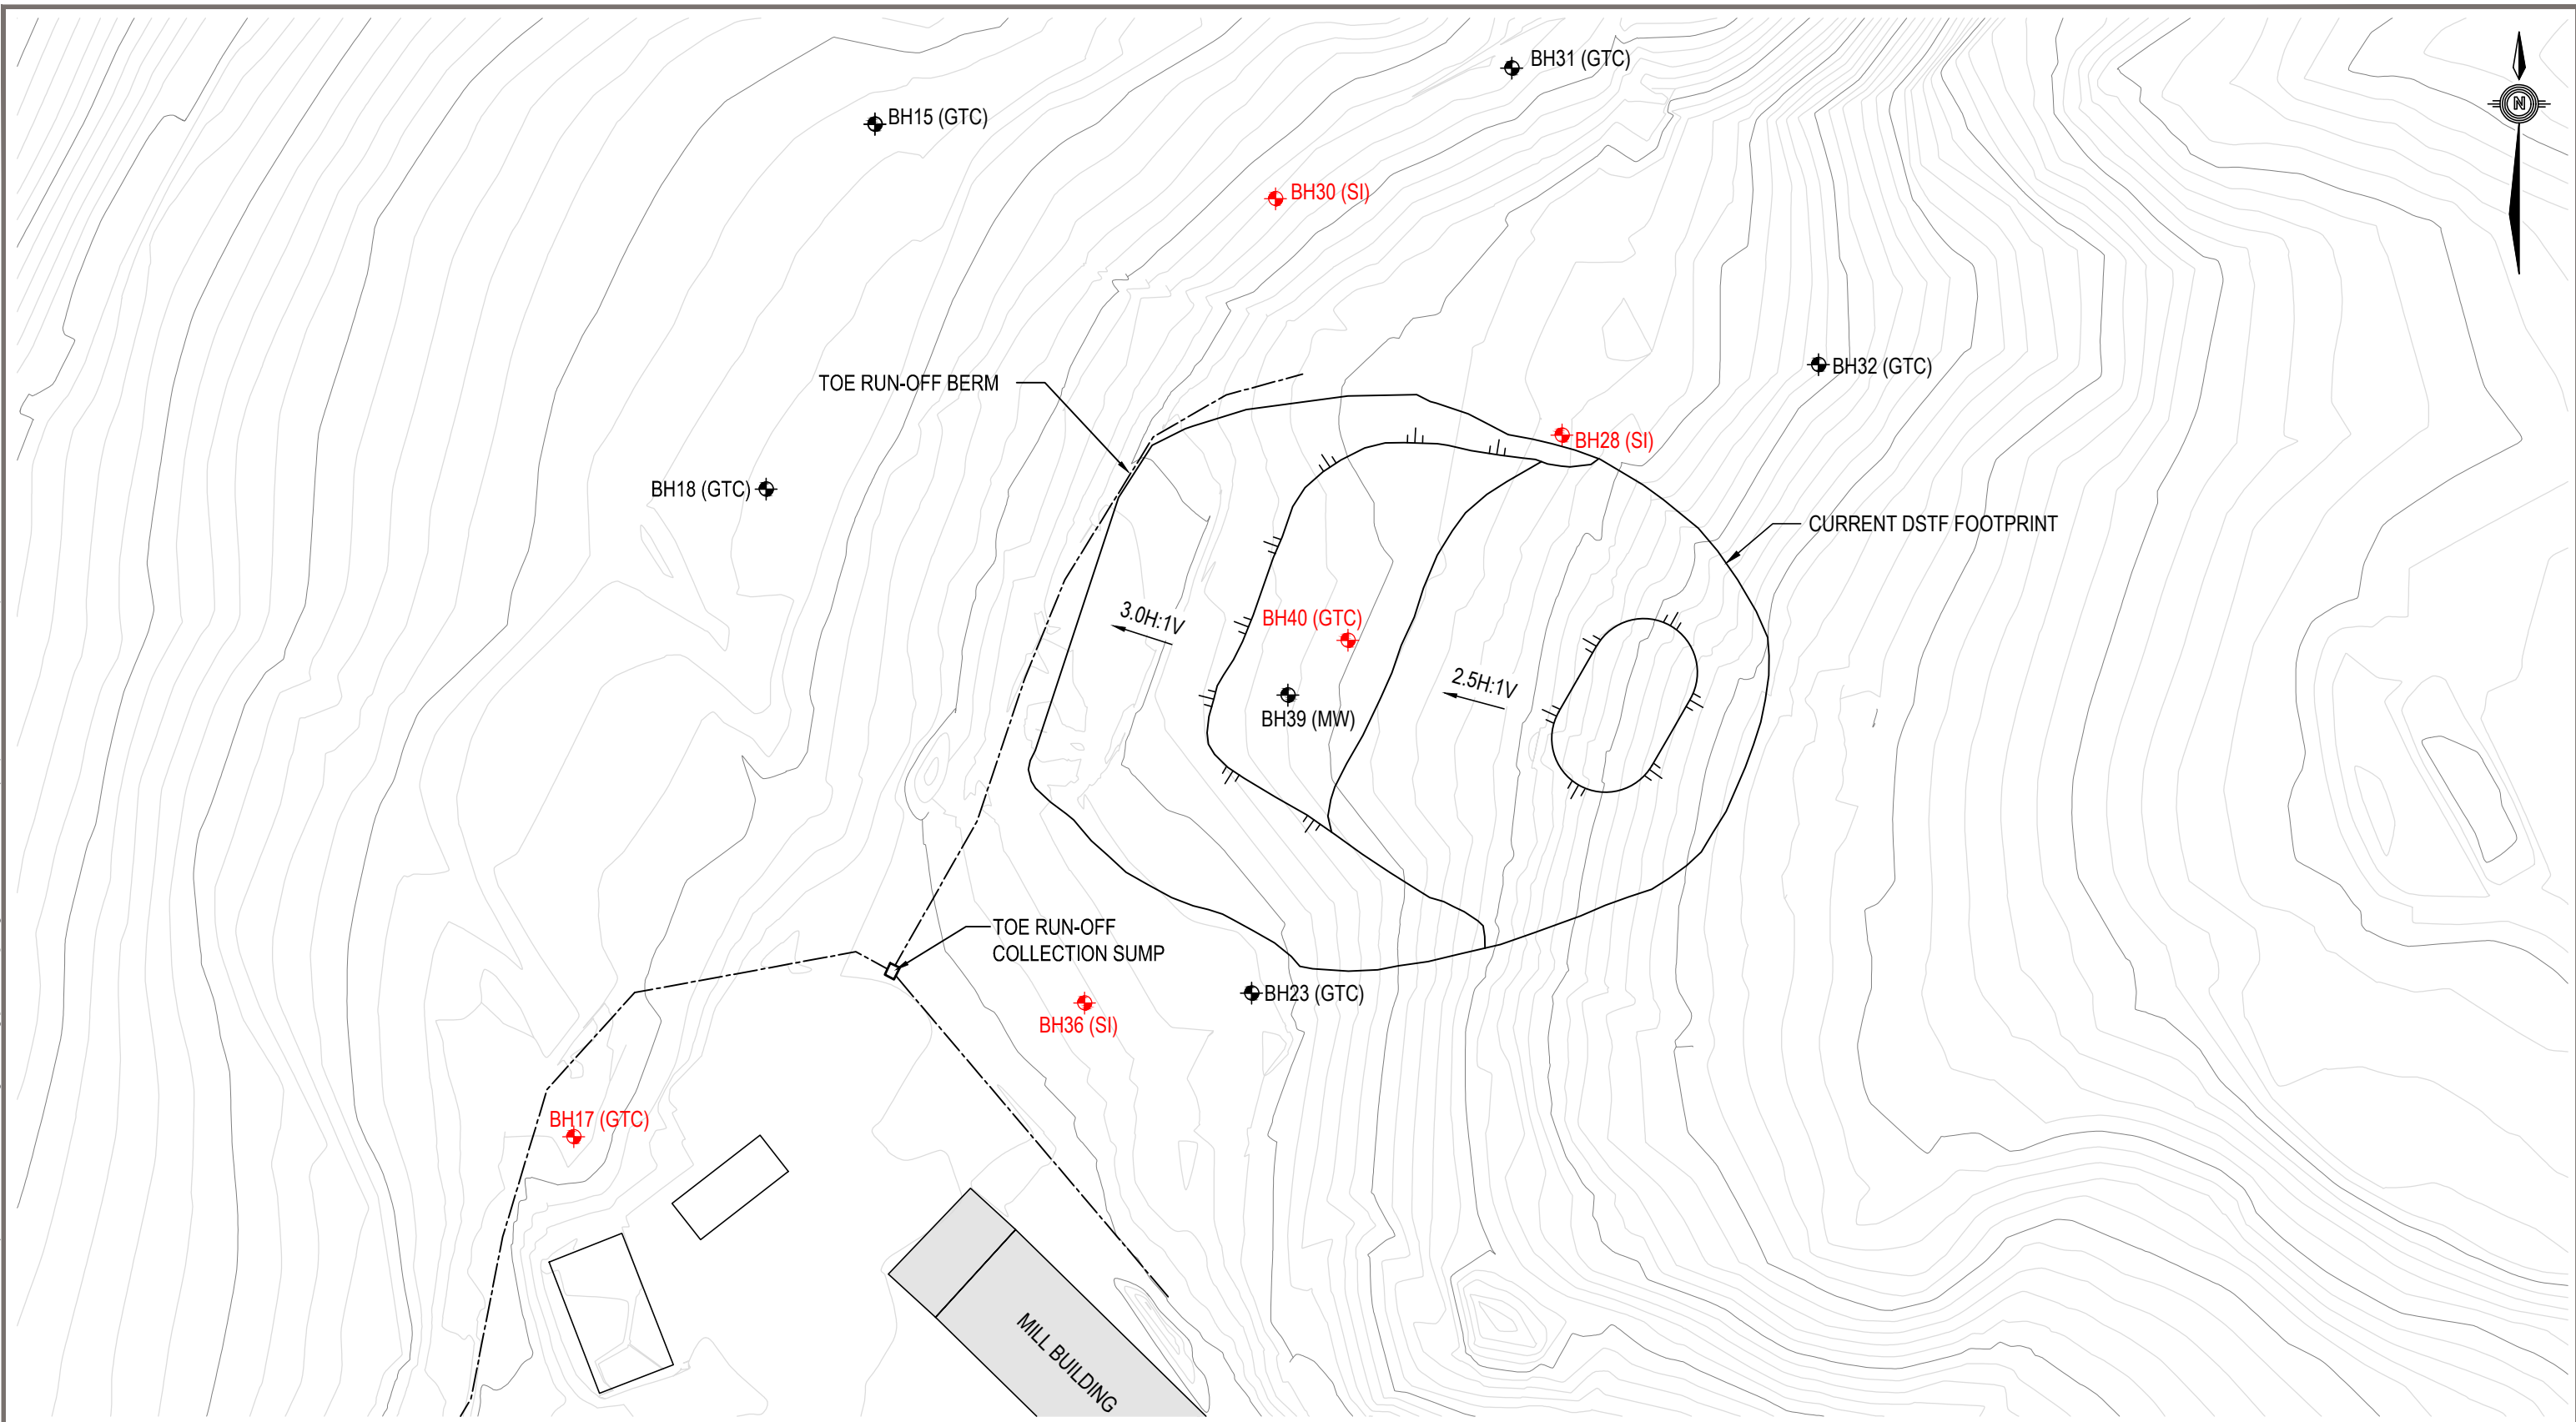
Figure 2

INSTRUMENTATION SHOWN IN RED HAS BEEN DAMAGED.

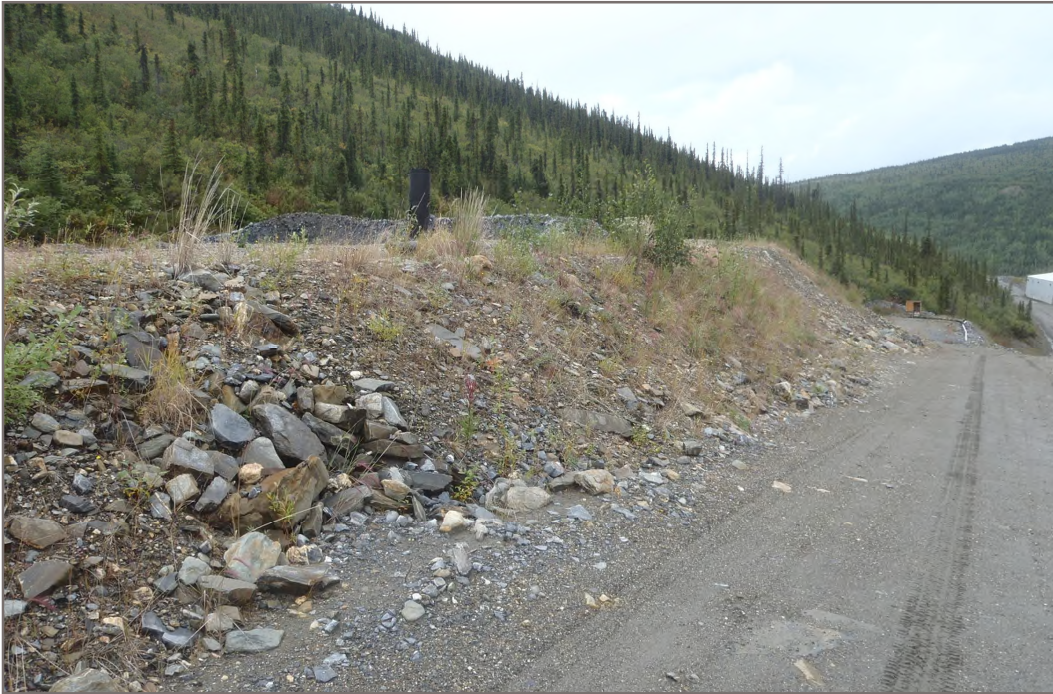
The perimeter berms are intact with no visible signs of instability (Photo 1). The north and west anchor trenches along the berm crests remain incomplete (Photo 2) and the liner components have been displaced by wind as a result of improper anchoring (Photo 3). The protective geonet and geotextile components of the liner system have only been installed in the north half of the facility to date and some rock currently being stored in the southern portion of the facility is in direct contact with the geosynthetic liner. Angular waste rock can puncture the geosynthetic liner causing a breach in facility containment. The installation of the liner system should be completed as per the original facility design prior to the placement of additional material in the facility.

Photo 1: PAG Waste Storage Facility
Stable facility berms and sideslopes
Facing North - August 10, 2015

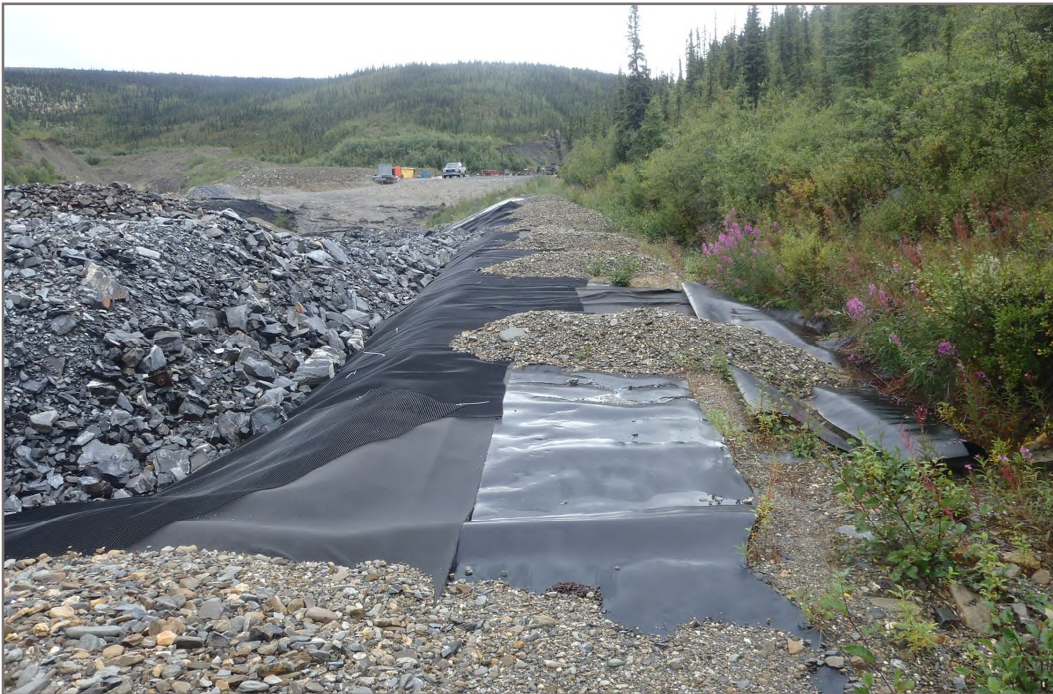
Photo 2: PAG Waste Storage Facility
Incomplete anchor trench on north and west side of facility
Facing South - August 10, 2015

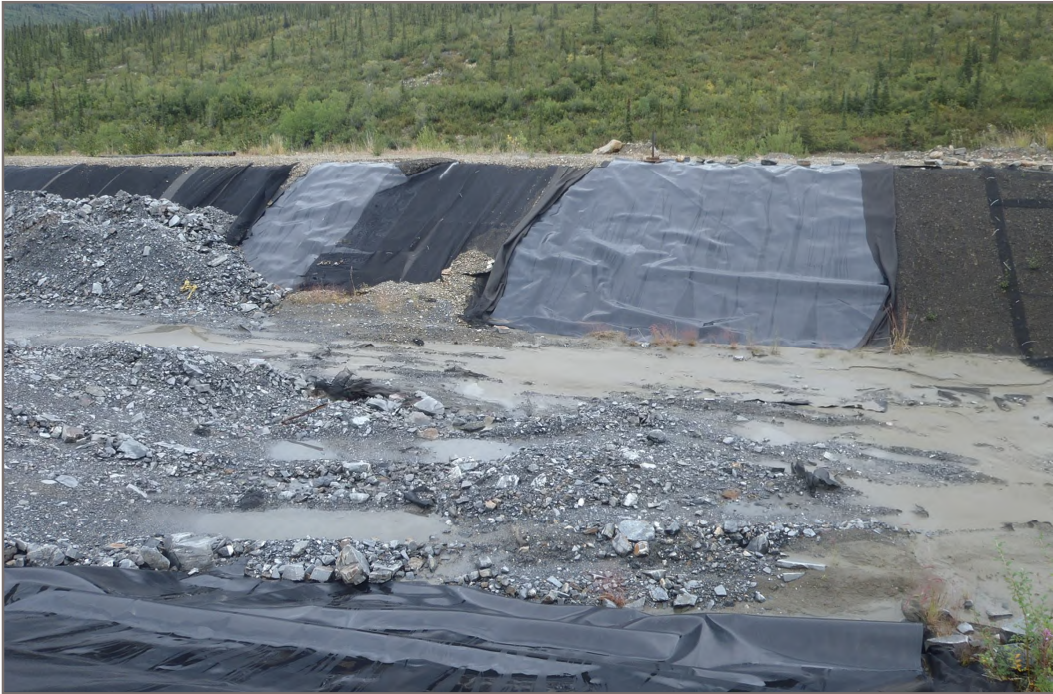
Photo 3: PAG Waste Storage Facility
Liner components displaced due to wind
Facing East - August 10, 2015

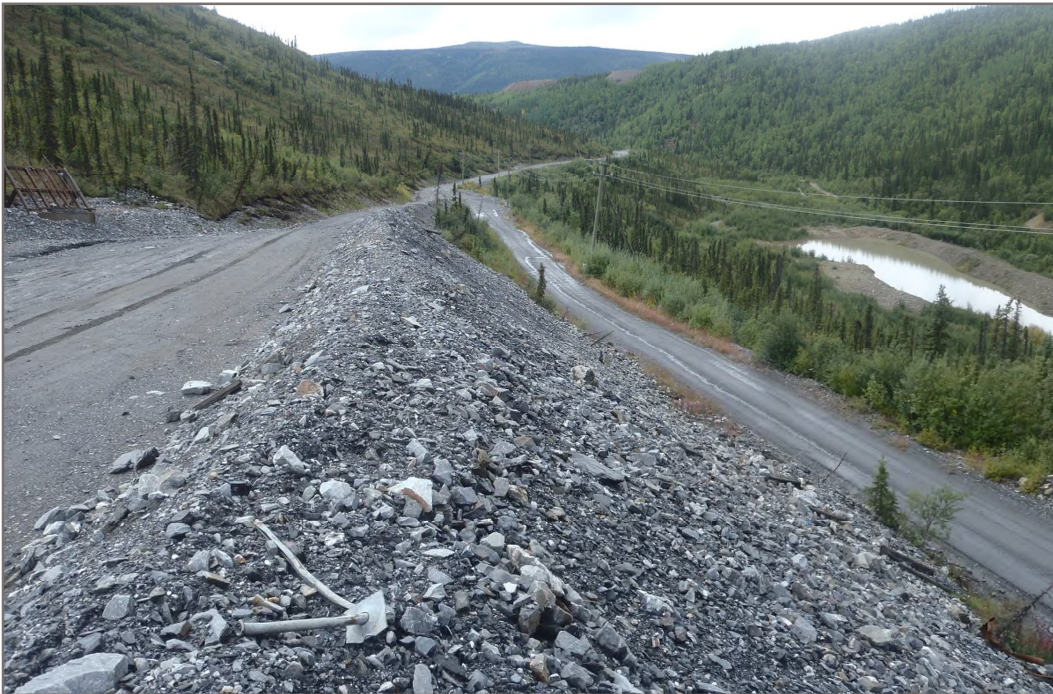
Photo 4: Bellekeno Waste Rock Pile
Stable waste rock pile sideslope
Facing West - August 10, 2015

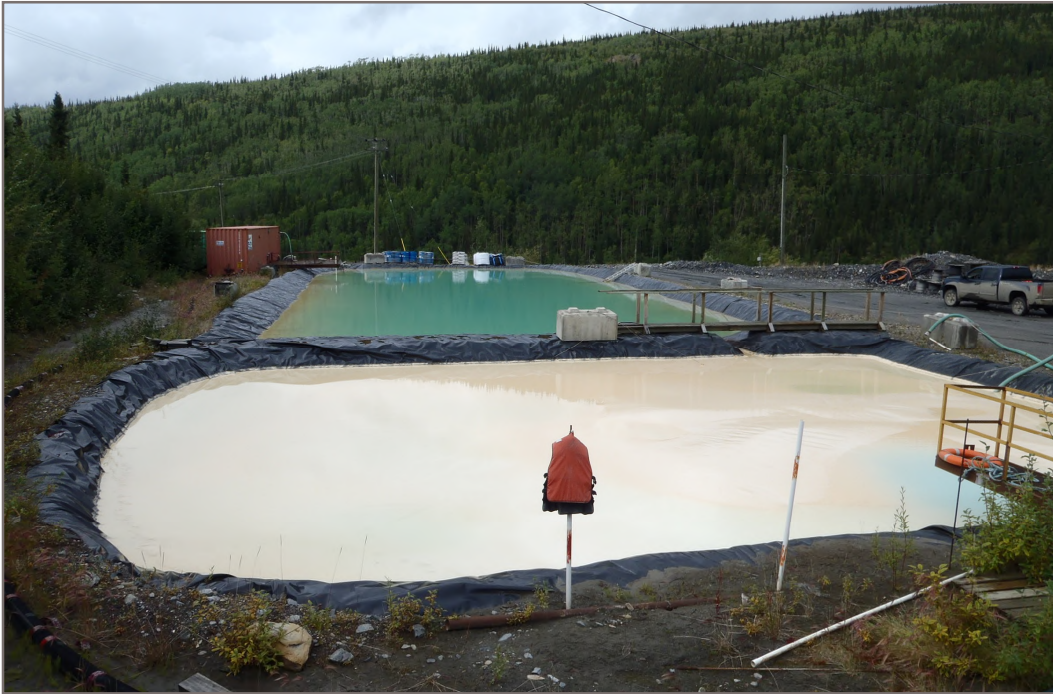
Photo 5: Bellekeno 625 Water Treatment Ponds
Facility overview
Facing North - August 10, 2015

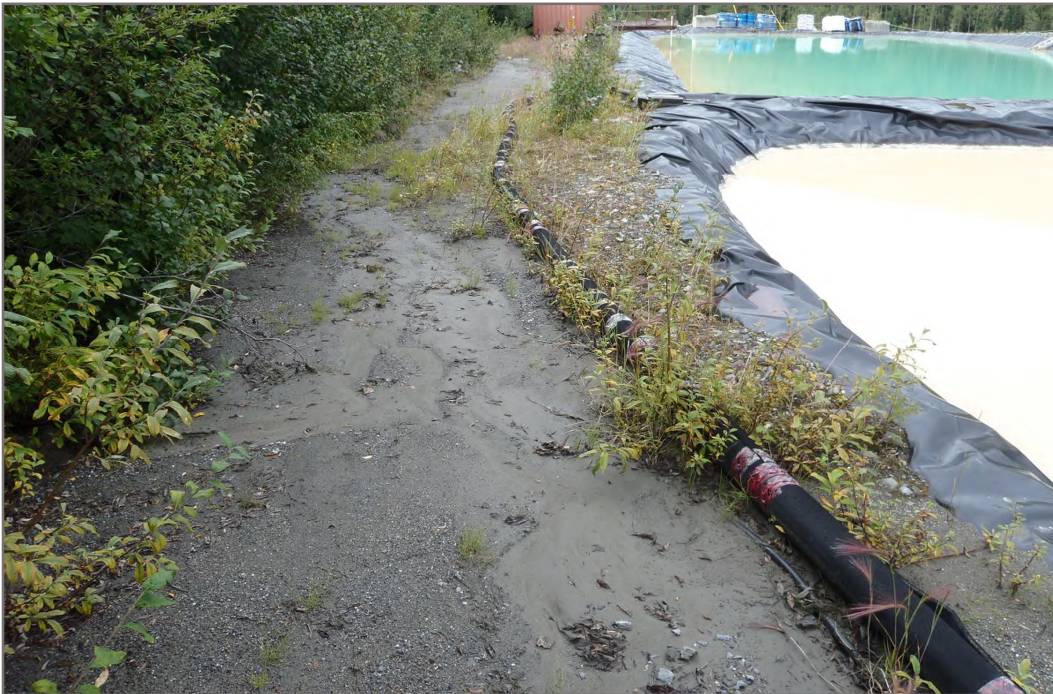
Photo 6: Bellekeno 625 Water Treatment Ponds
Sediment deposited outside southwest corner of facility
Facing North - August 10, 2015

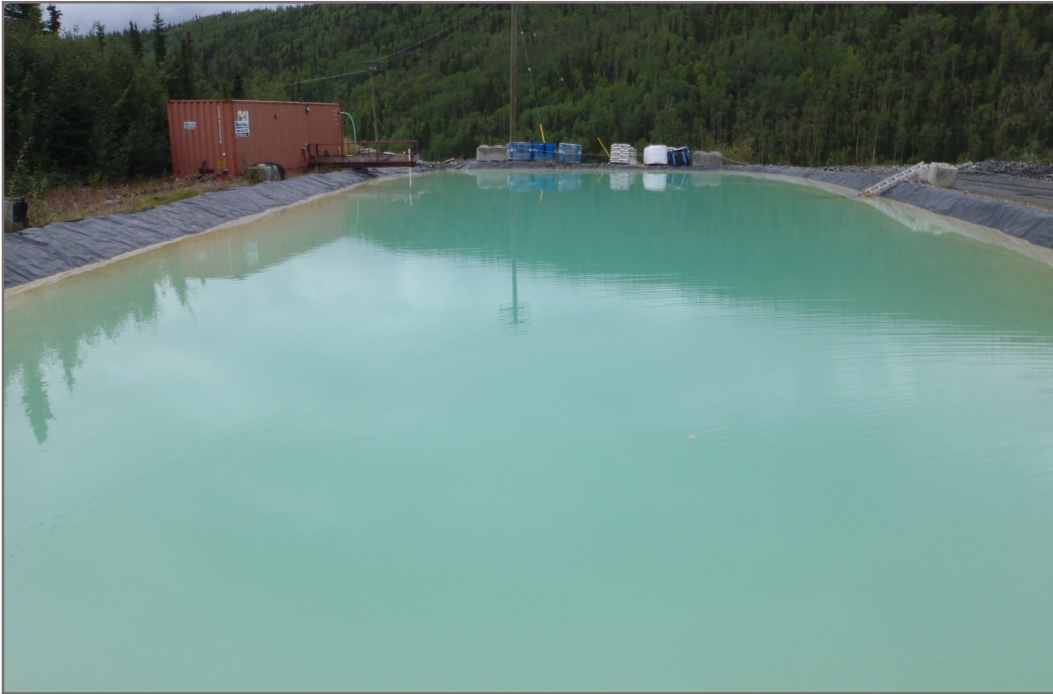
The primary treatment pond was operating at the discharge invert elevation with a freeboard of 0.5 m below perimeter berm crest at the time of the inspection. The secondary pond was also operating at the discharge elevation. Freeboard in the secondary pond ranges from about 0.5 m at the south end to about 0.3 m at the north end. Diminished freeboard could be the result of settlement of the north end of the facility (Photo 7). No signs of settlement were observed during the inspection but a survey should be completed prior to winter to determine if settlement has occurred and establish a base case for future survey monitoring.

Photo 7: Bellekeno 625 Water Treatment Ponds
Reduced freeboard at north end of secondary pond
Facing North - August 10, 2015

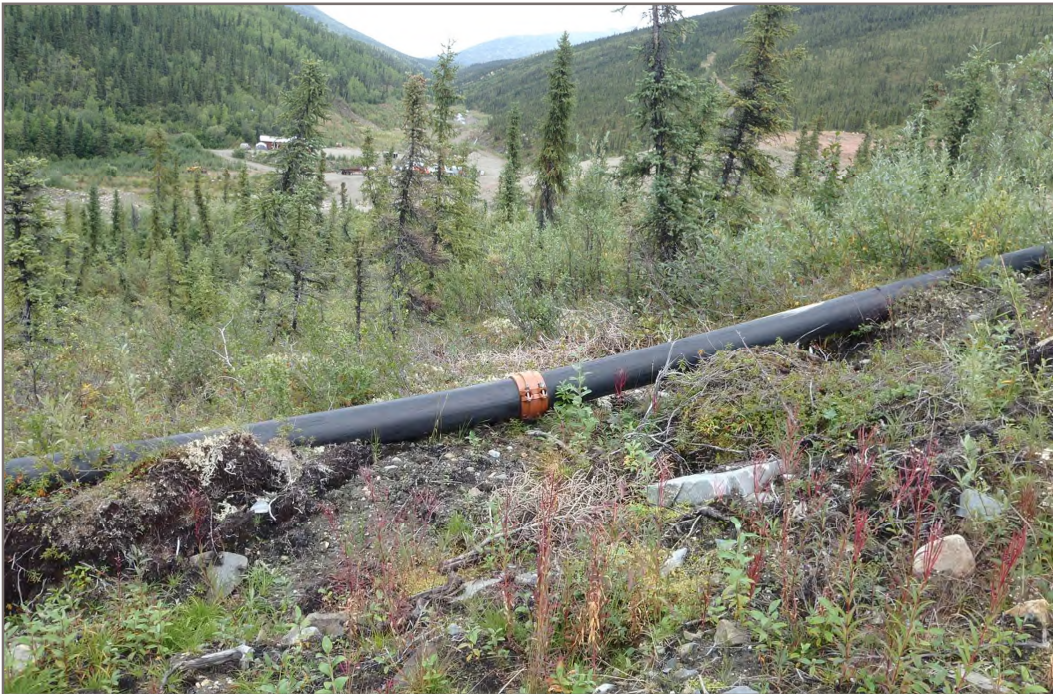
The discharge line appeared intact at the time of the inspection but had a noticeable deflection at one of the joints resulting from supporting material eroding away from beneath the pipe (Photo 8). The discharge line should be monitored and supported with additional fill if necessary to minimize distress to the pipe.

Photo 8: Bellekeno 625 Water Treatment Ponds
Bend in discharge pipe at coupler
Facing East - August 10, 2015

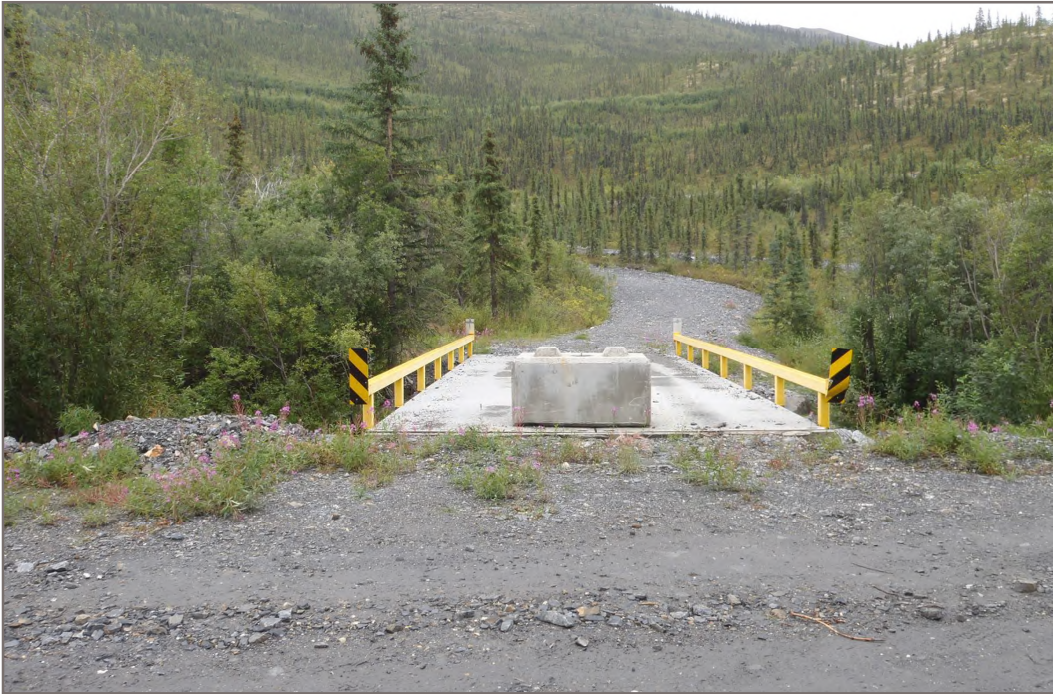
Photo 9: Lightning Creek Bridge Abutments (Onek Road)
Bridge overview
Facing South - August 10, 2015

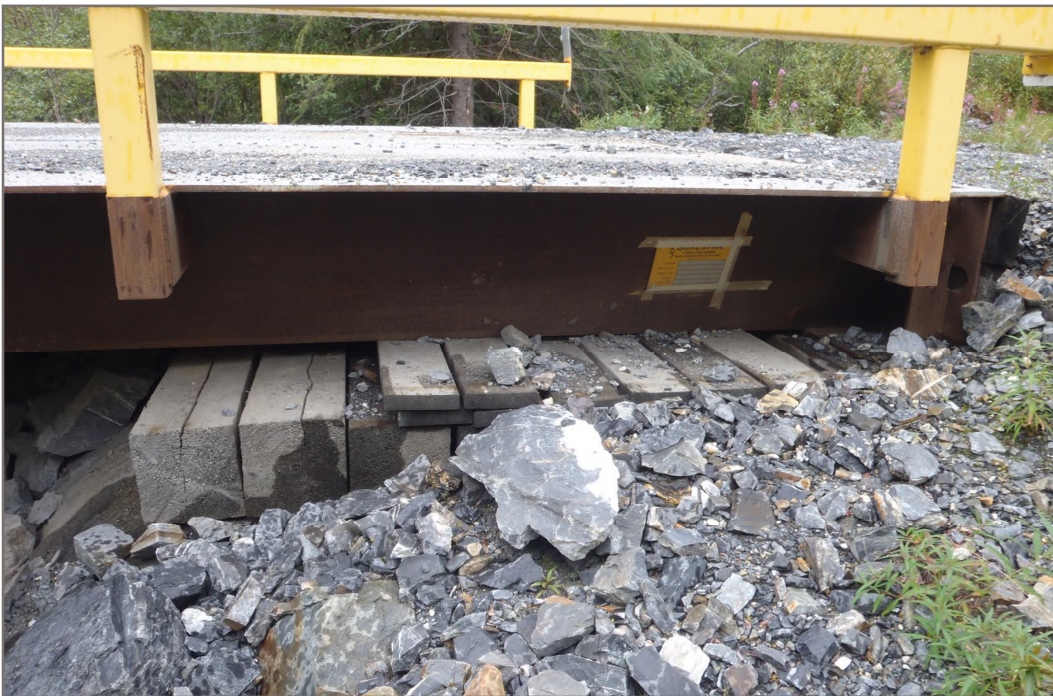
Photo 10: Lightning Creek Bridge Abutments (Onek Road)
South bridge abutment
Facing East - August 10, 2015

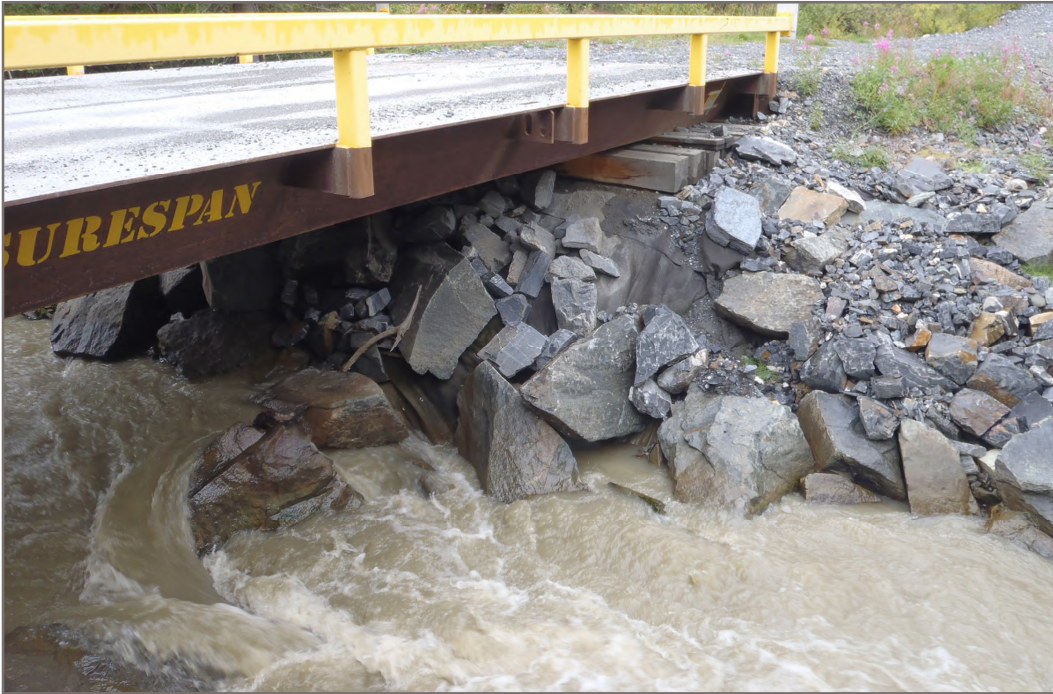
The Lightning Creek bridge on the Onek Road is located east of Keno City, as shown on Figure 1. The bridge is a single span steel structure (Photo 9) founded on earth filled timber cribbing abutments. The abutments appeared stable at the time of the inspection (Photo 10). Some of the rip-rap armouring the south abutment on the downstream side of the bridge has been displaced exposing the underlying geotextile (Photo 11). The rip-rap should be replaced as part of ongoing site maintenance to prevent erosion, and the abutment should be monitored for settlement.

Photo 11: Lightning Creek Bridge Abutments (Onek Road)
Displaced rip-rap on downstream side of south abutment
Facing South - August 10, 2015

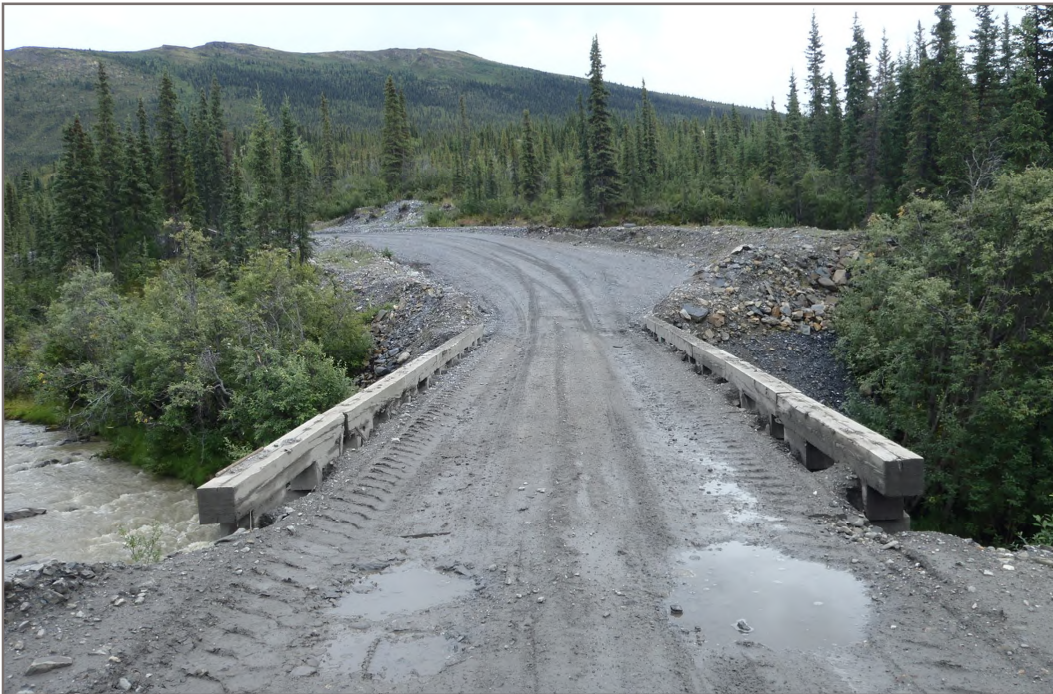
Photo 12: Lightning Creek Bridge Abutments (Bellekeno Haul Road)
Bridge overview
Facing South - August 10, 2015

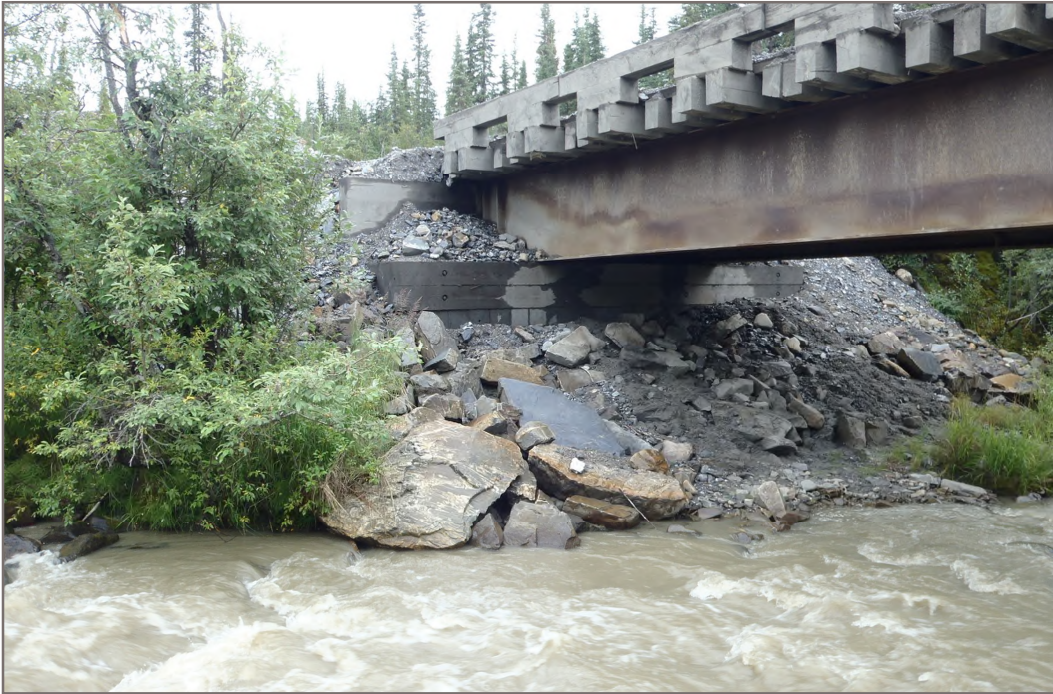
Photo 13: Lightning Creek Bridge Abutments (Bellekeno Haul Road)
Stable abutment and sufficient rip-rap armouring
Facing South - August 10, 2015

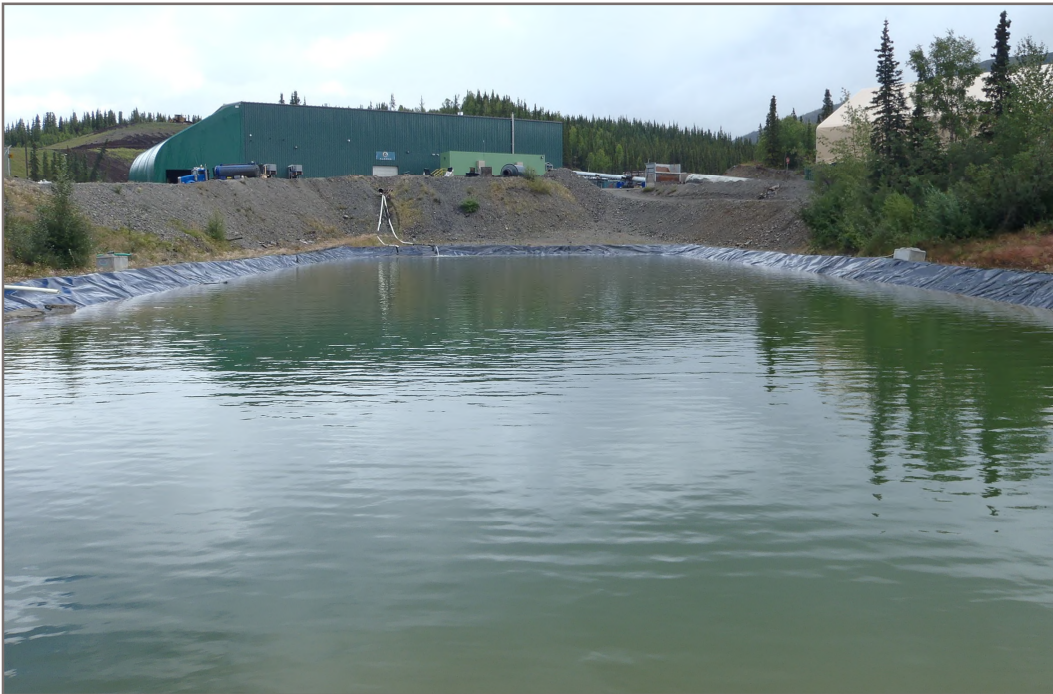
Photo 14: Mill Water Storage Pond
Water level in pond
Facing East - August 11, 2015

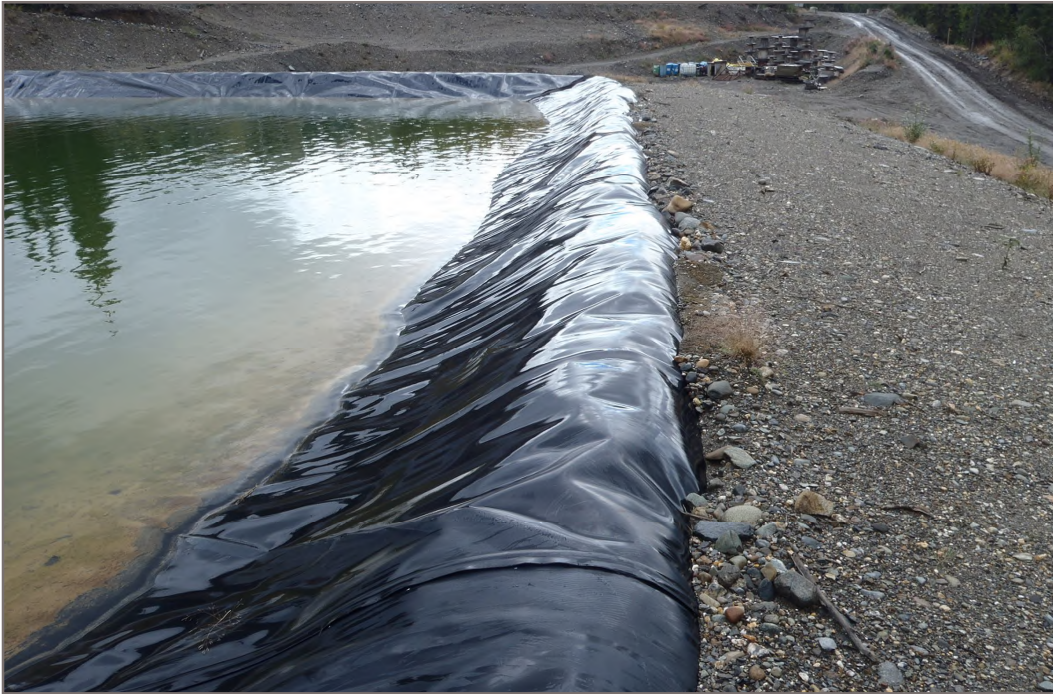
Photo 15: Mill Water Storage Pond
Stable perimeter berm and intact liner
Facing South - August 11, 2015

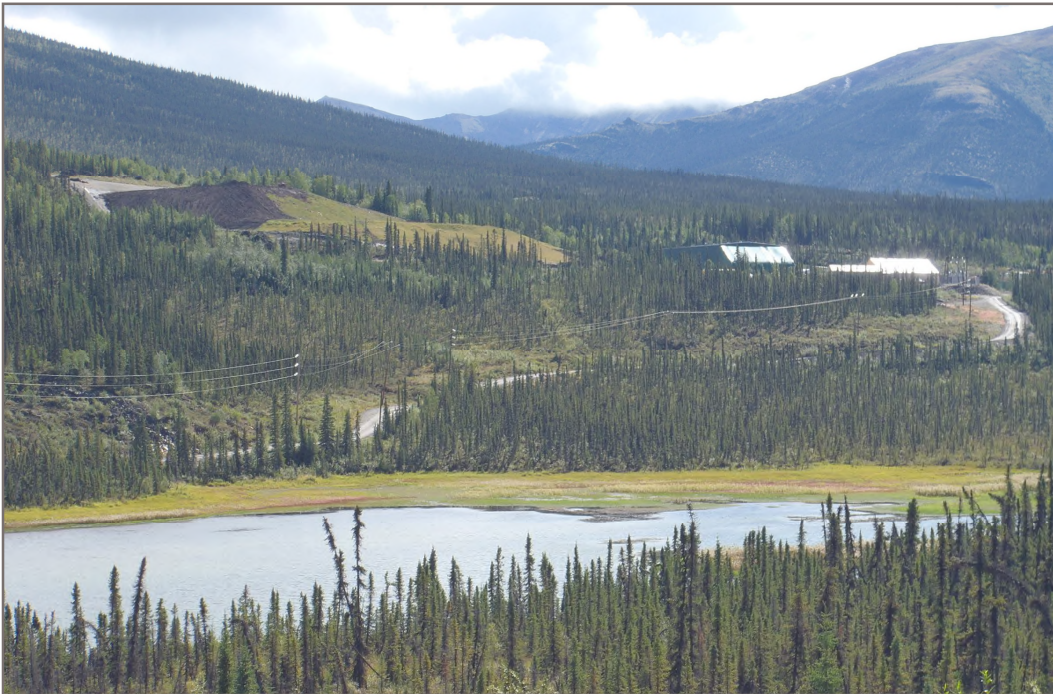
Photo 16: Dry Stacked Tailings Facility
Regraded and covered tailings facility
Facing East - August 11, 2015

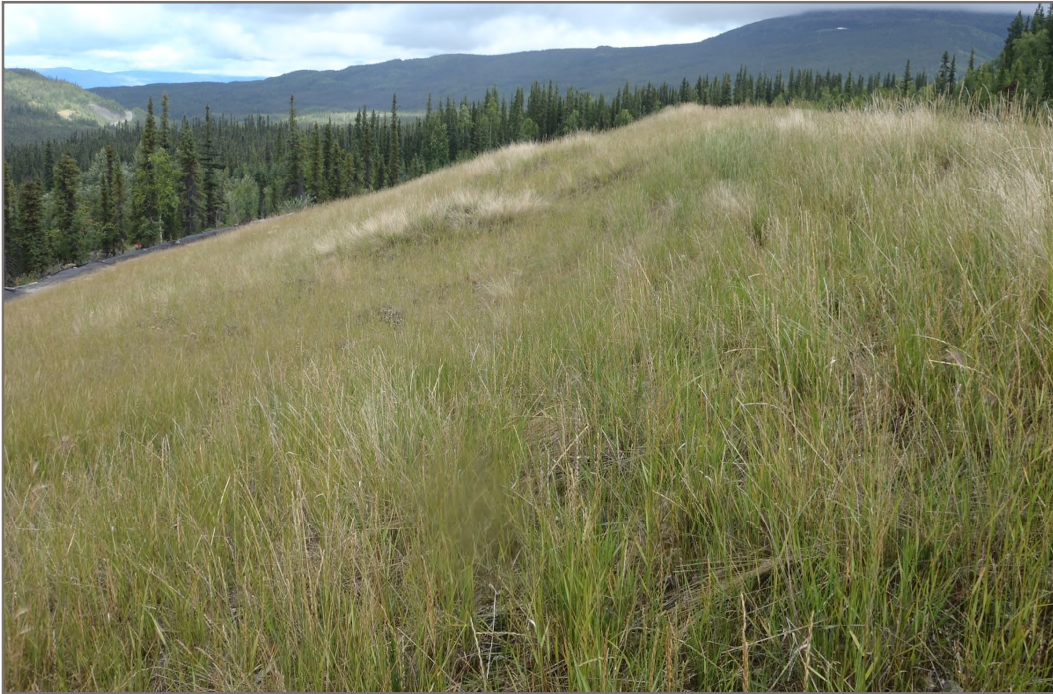
Photo 17: Dry Stacked Tailings Facility
Surface of DSTF supporting vegetation
Facing North - August 11, 2015

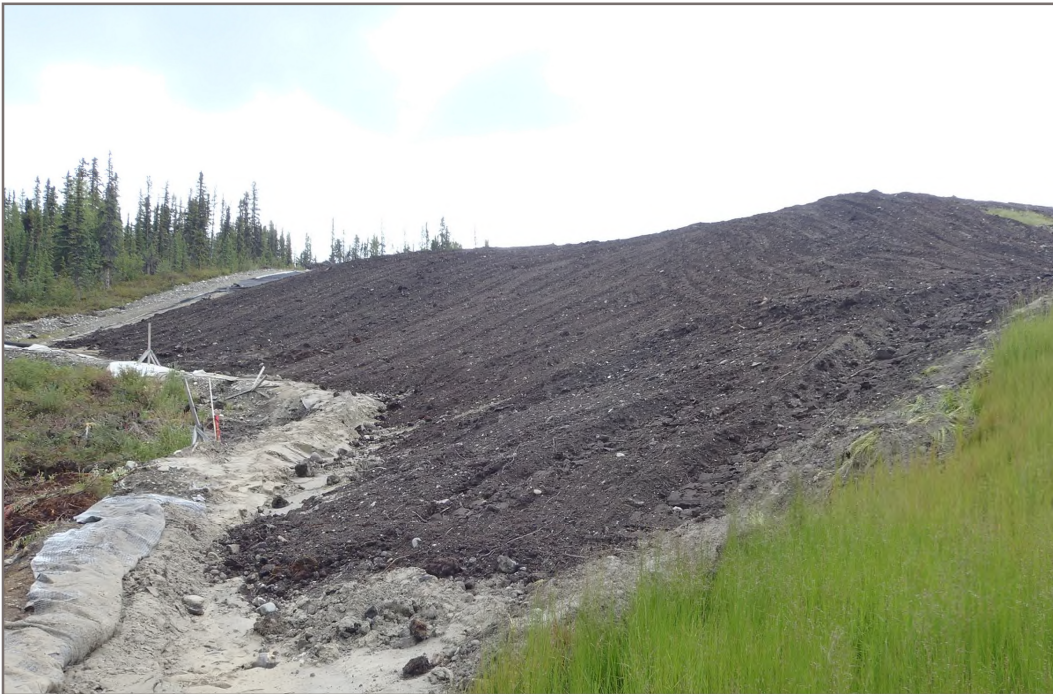
Photo 18: Dry Stacked Tailings Facility
Surface of DSTF covered with growth medium
Facing South - August 11, 2015

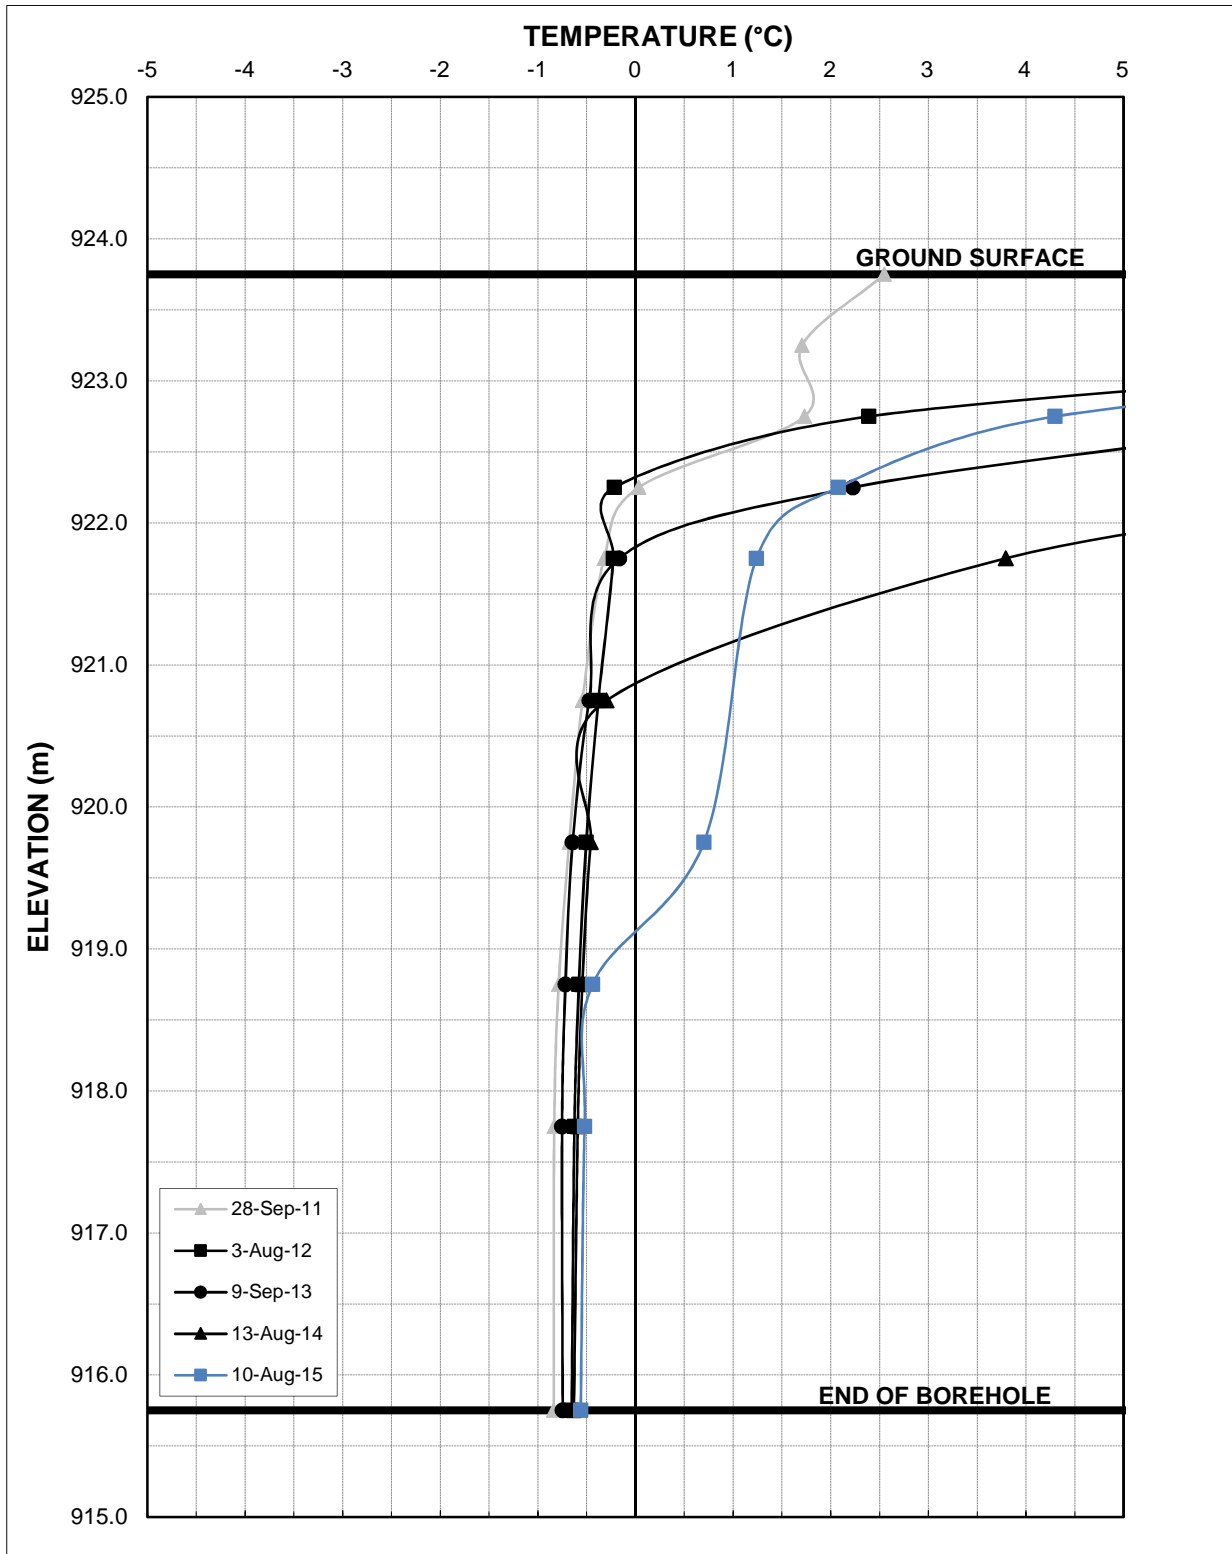
Ground Temperature Profile
Keno Hill District Mill Site Borehole BH32
Figure T6

Updated ground temperature readings were collected from five of the six ground temperature cables installed in natural soils adjacent to the DSTF during the inspection. Readings were not collected from BH17 as the protective steel casing has been damaged, wedging the instrument connector within the protective casing. The protective casing should be repaired or removed to allow for continued instrumentation reading. As indicated on the updated ground temperature profiles included in Appendix B, the slight warming trend observed in previous years has continued. The warming trend appears to be more significant in areas of recent disturbance, such as BH32,

indicating it may be the result of disturbance to the insulating vegetative cover during instrumentation installation. Continued regular instrumentation readings are recommended to monitor ground temperature conditions.

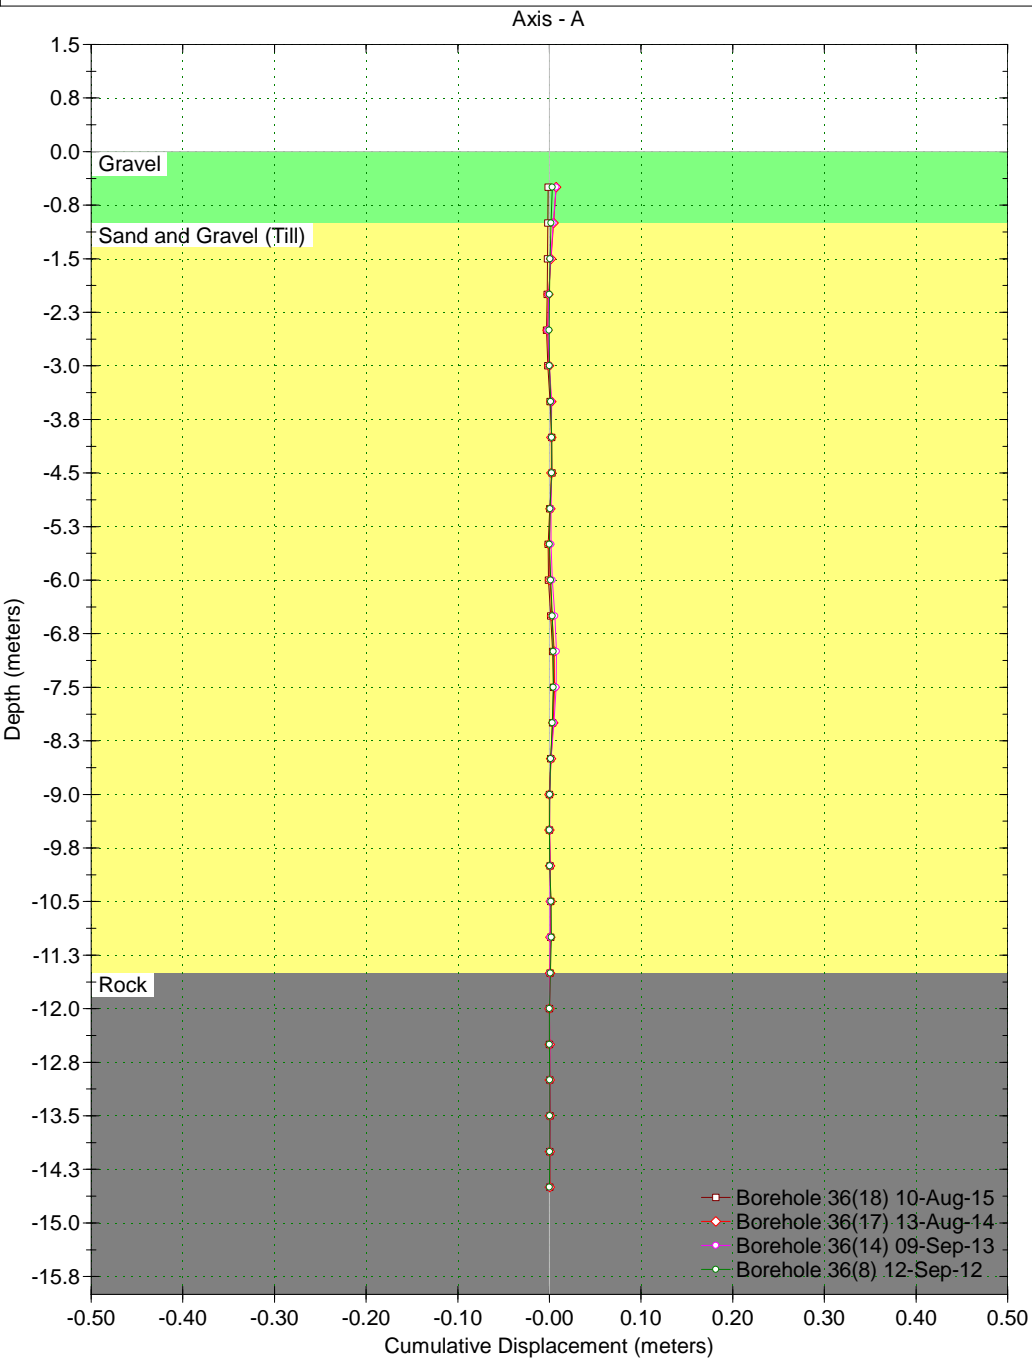
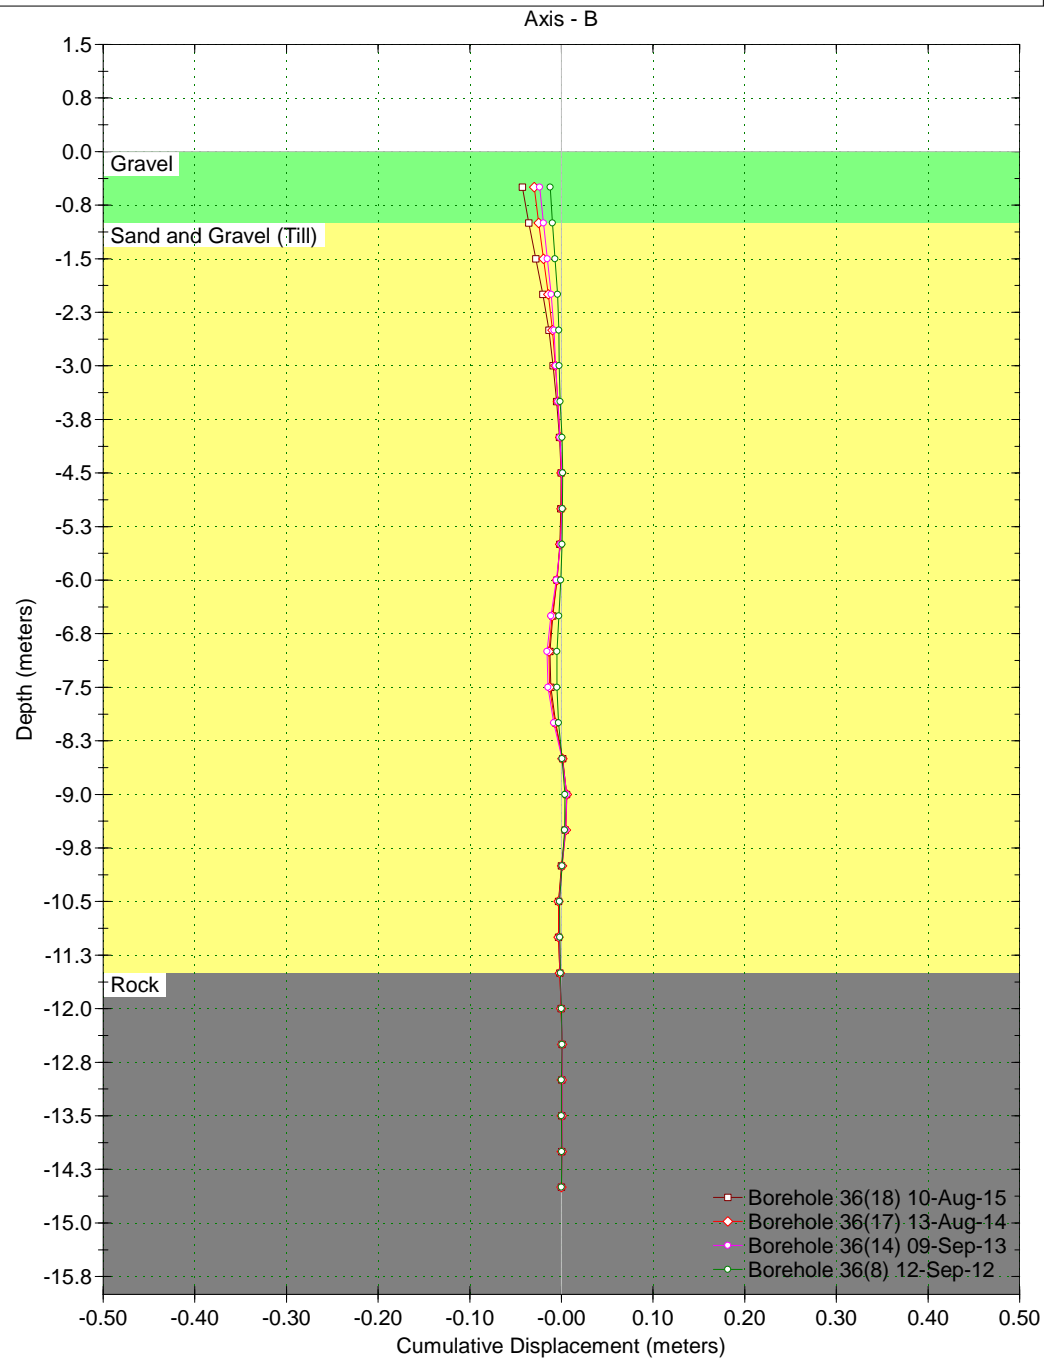
Borehole : BH36
Project : Keno
Location : DSTF
Northing : 7086872
Easting : 483931
Collar :

An updated lateral movement profile developed from readings collected from the slope indicator installed in BH36 in natural soils adjacent to the DSTF is included in Appendix C. No significant lateral movement of the foundation soils has been observed in the slope indicator results to date.
