November 7, 2017

Alexco Resource Corp.  
3 – 151 Industrial Road  
Whitehorse, YT Y1A 2V3

**Subject:** 2017 Annual Geotechnical Inspection – Surface Engineered Earth Structures  
Bellekeno Mine, Keno City, YT

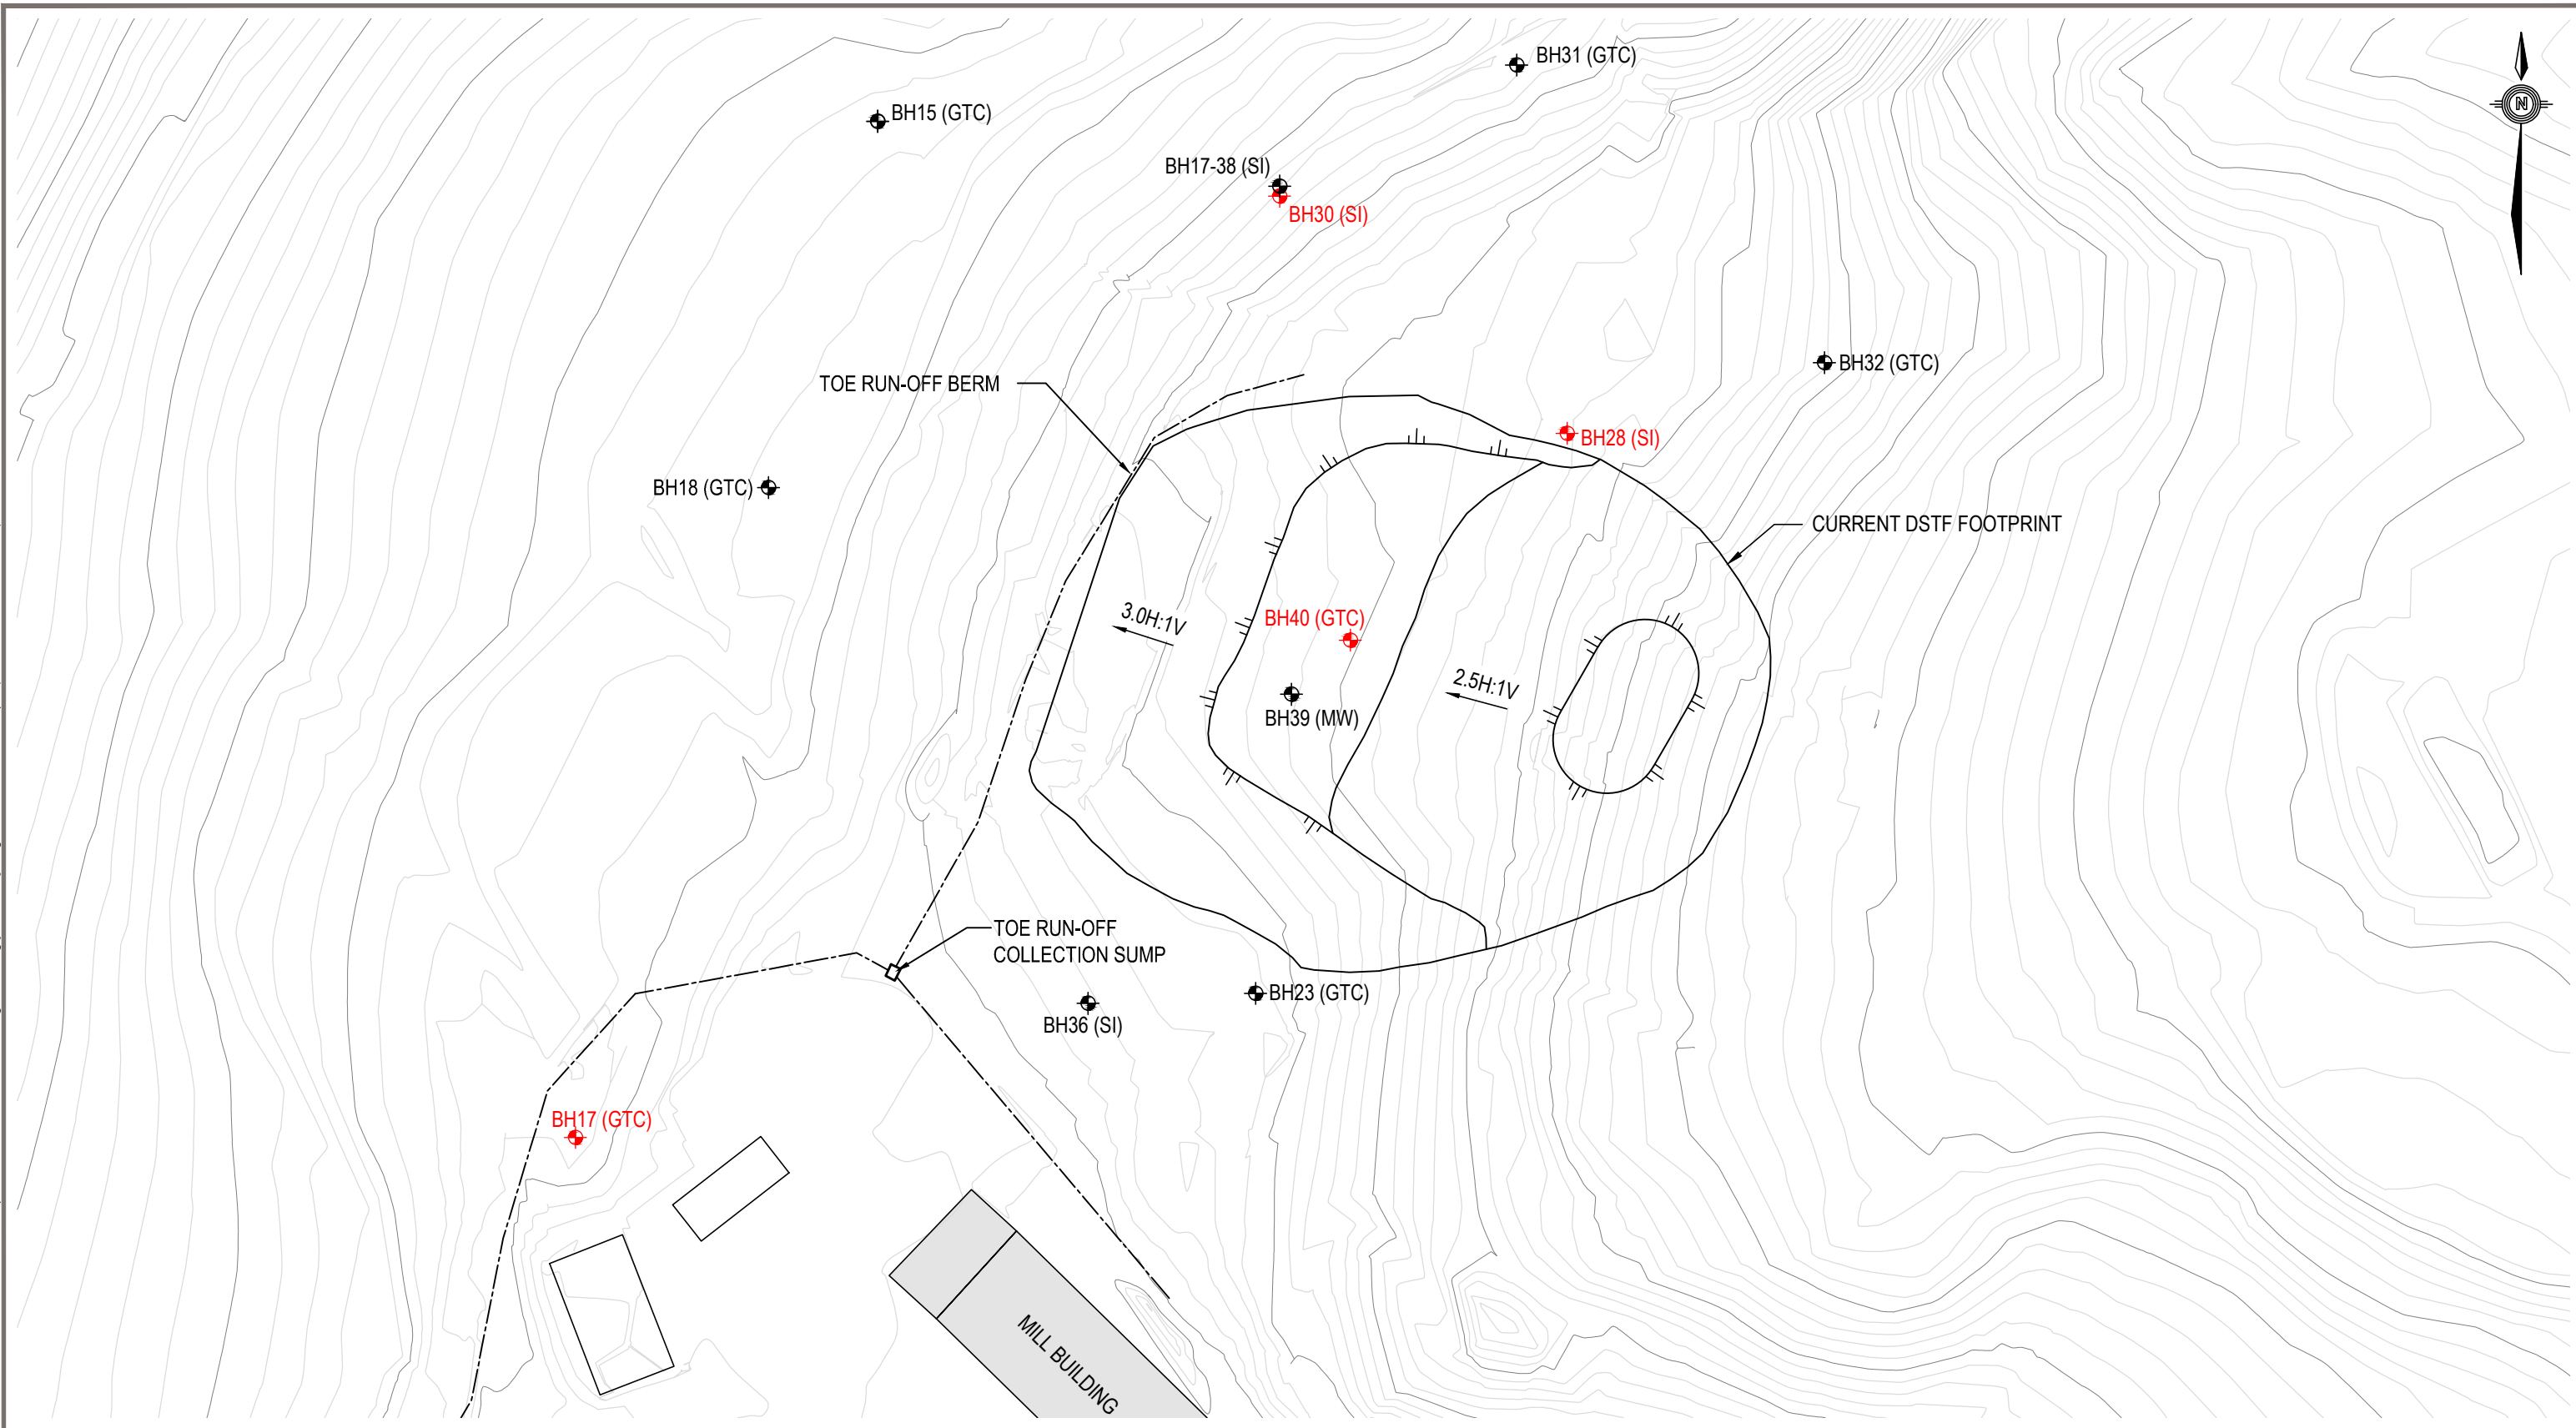
<b>2017 ANNUAL INSPECTION BELLEKENO MINE SITE - KENO CITY, YUKON</b>				
<b>SITE PLAN SHOWING BOREHOLE AND INSTRUMENTATION LOCATIONS</b>				
PROJECT NO. ENG.WARC03301-01	DWN CB	CKD TP	REV 0	<b>Figure 2</b>
OFFICE EBA-WHSE	DATE August 31, 2017

It should be noted that some critical instrumentation located within and adjacent to the DSTF is in need of repair and/or replacement.

Updated ground temperature readings were collected from five of the six ground temperature cables installed in natural soils adjacent to the DSTF during the inspection. Readings were not collected from BH17 as the protective steel casing has been damaged, and the instrument connector is wedged out of inside the casing. The protective casing should be repaired or removed to allow for continued instrumentation reading.

The ground temperature cable installed in BH40, through the tailings and into the foundation soils below the DSTF has been damaged and requires replacement. This is a critical installation needed to confirm design assumptions and provide ongoing temperature monitoring.

**NOTE**  
INSTRUMENTATION SHOWN IN RED HAS BEEN DAMAGED.

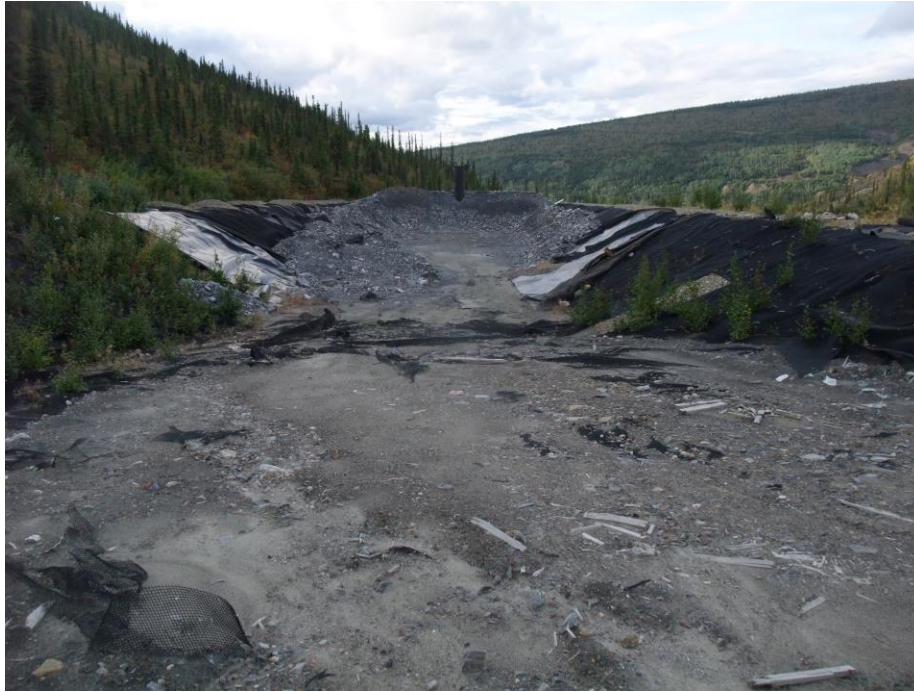
The PAG waste storage facility is located south of the Bellekeno portal, as shown on Figure 1. The facility has not been used since mining operations were suspended in winter 2013, but currently contains some volume of PAG waste rock. At the time of inspection, the perimeter berms appeared intact with no visible sign of instability.

The client also requested revisions to the “standard” design drawing for future PAG storage sites to reflect their experience in water monitoring at the present sites (Photo 1).

**Photo 1:** PAG Waste Storage Facility  
Facing North – August 24, 2017

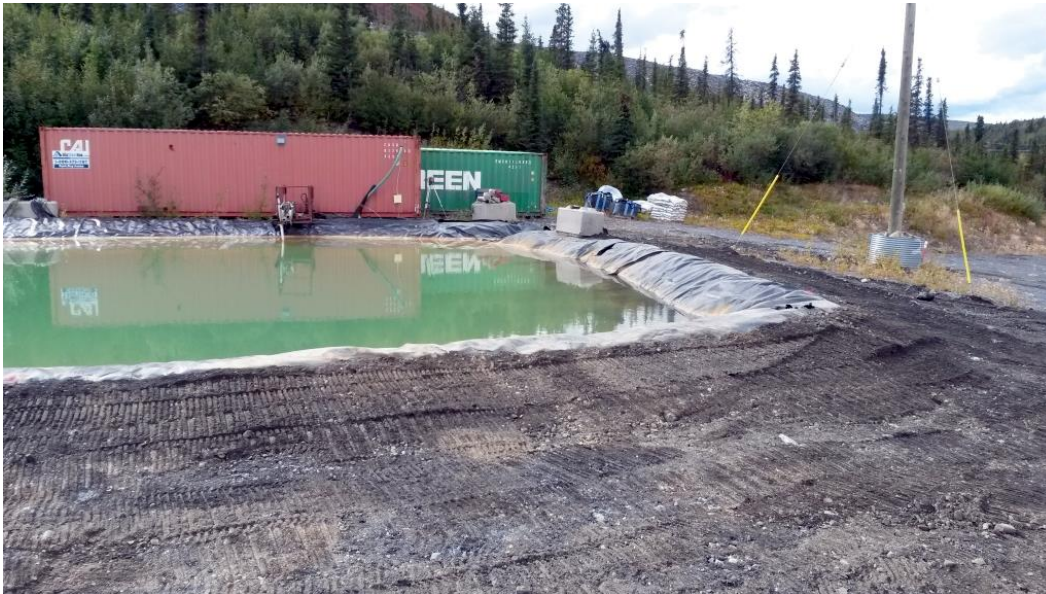
The Bellekeno 625 water treatment ponds are located north of the Bellekeno portal, as shown on Figure 1. The facility consists of two water treatment ponds that were both operating at the time of inspection. The primary treatment pond was operating at the discharge invert elevation with a freeboard of 0.5 m below the perimeter berm crest at the time of inspection. The secondary pond was also operating at the discharge elevation, with a freeboard of 0.5 m in the south end. The north end was in the process of being raised to the recommended minimum 0.5 m freeboard elevation during the inspection. After the inspection was conducted, Alexco provided photos showing the north perimeter berm raised to the final grade, with the liner installed and perimeter berm compacted (Photos 2).

**Photo 2:** Bellekeno 625 Water Treatment Ponds  
North Perimeter Berm  
Facing South – August 24, 2017

As recommended in the 2016 annual geotechnical inspection report, elevation surveys to monitor for settlement at the north end of the pond should be completed monthly during the snow free seasons. At the end of the discharge pipe at the 625 treatment pond, water is being discharged onto the natural soils without any protection from erosion (Photo 3). The current flow conditions of the discharge were low, but continuous monitoring should take place. If the rate of erosion increases, rip-rap armouring should be installed.

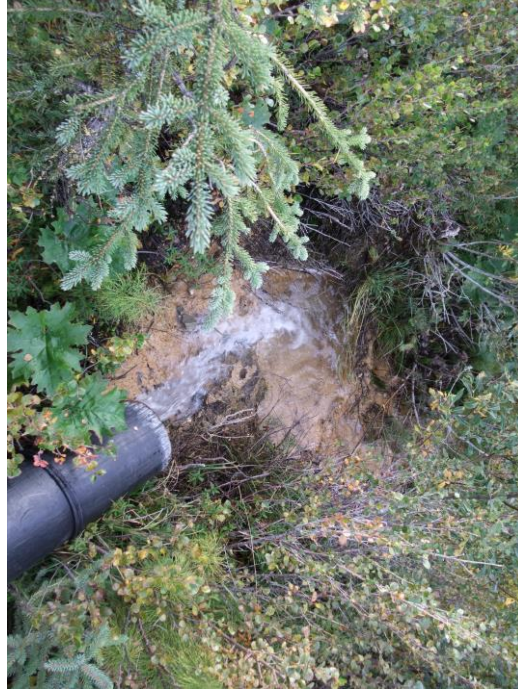
**Photo 3:** Bellekeno 625 Water Treatment Ponds  
Water Discharge  
August 24, 2017

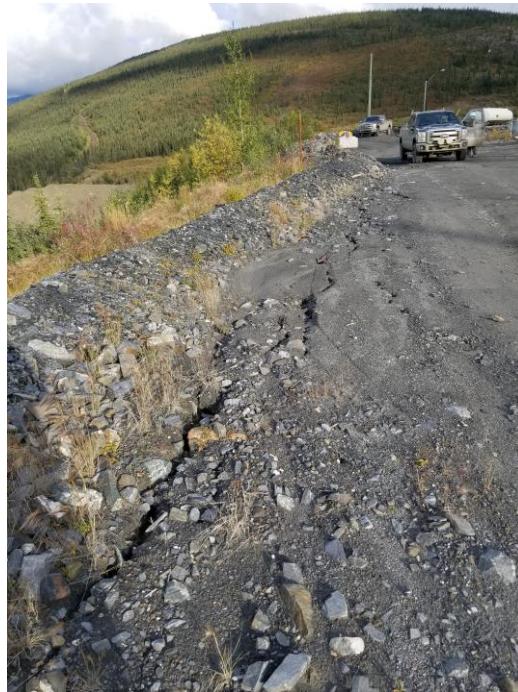
Tension cracks were observed on the access road north of 625 (Photo 4). The cracks should be filled and the ground surface re-compacted to prevent water infiltration and further erosion.

**Photo 4:** Bellekeno 625 Water Treatment Ponds  
Access Road Tension Cracks  
August 24, 2017

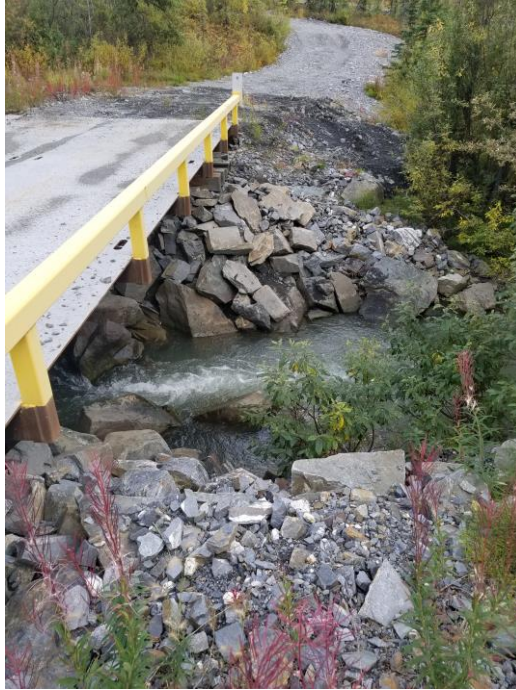
The Lightning Creek Bridge on the Onek Road is located east of Keno City, as shown on Figure 1. The bridge is a single span steel structure founded on earth filled timber cribbing abutments. The abutments appeared stable at the time of the inspection and are sufficiently protected from erosion by rip-rap armouring (Photo 5). No remedial action is required for the Lightning Creek Bridge on the Onek road at this time.

**Photo 5:** Lightning Creek Abutments  
Onek Road  
August 24, 2017

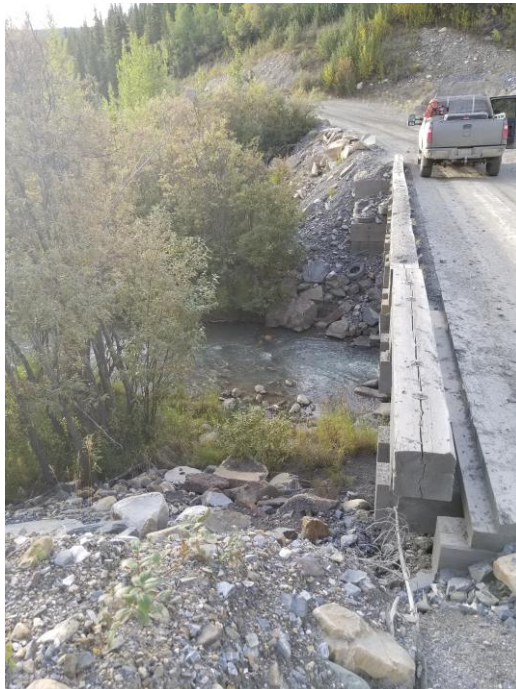
The Lightning Creek Bridge on the Bellekeno Haul Road is located southwest of Keno City, as shown on Figure 1. The bridge is a single span steel structure with a wooden deck founded on earth filled timber cribbing abutments. The abutments appeared stable at the time of the inspection and are sufficiently protected from erosion by rip-rap armouring (Photo 6). No remedial action is required for the Lightning Creek Bridge on the Bellekeno Haul Road at this time.

**Photo 6:** Lightning Creek Abutments  
Bellekeno Haul Road  
August 24, 2017

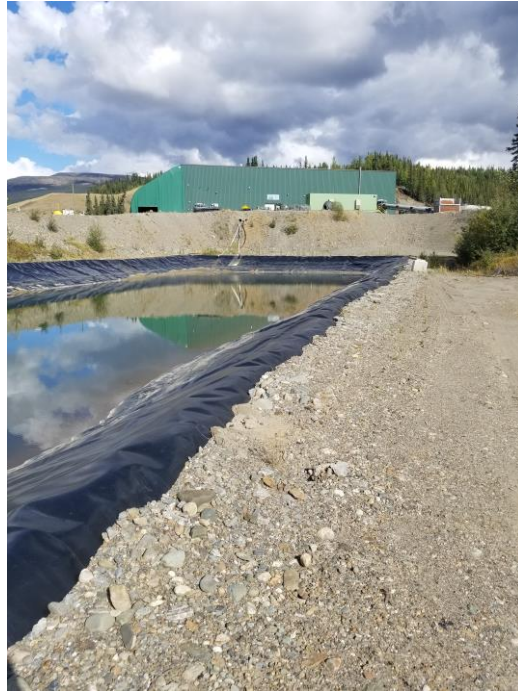
The mill water storage pond is located at the Keno Hill District Mill Site, west of Keno City, as shown on Figure 1. At the time of the inspection the pond was not operating but contained some water, with a freeboard of about 2 m below the perimeter berm crest (Photo 7). The perimeter berms and pond liner appeared intact with no visible signs of instability. No remedial action is required for the mill water storage pond at this time.

**Photo 7:** Mill Water Storage Pond  
August 24, 2017

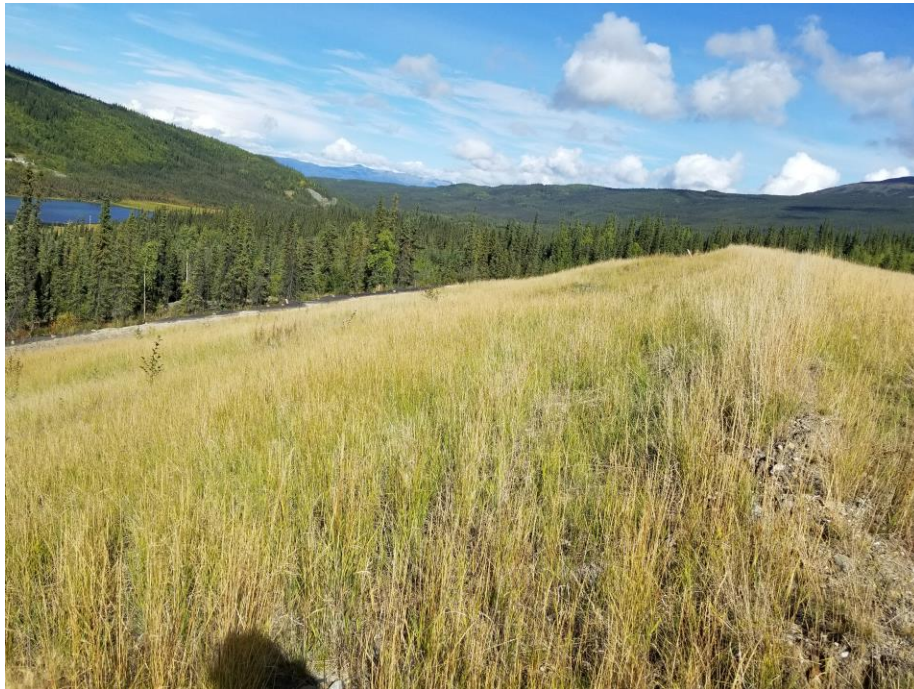
**Photo 8:** DSTF Progressive Reclamation  
August 24, 2017

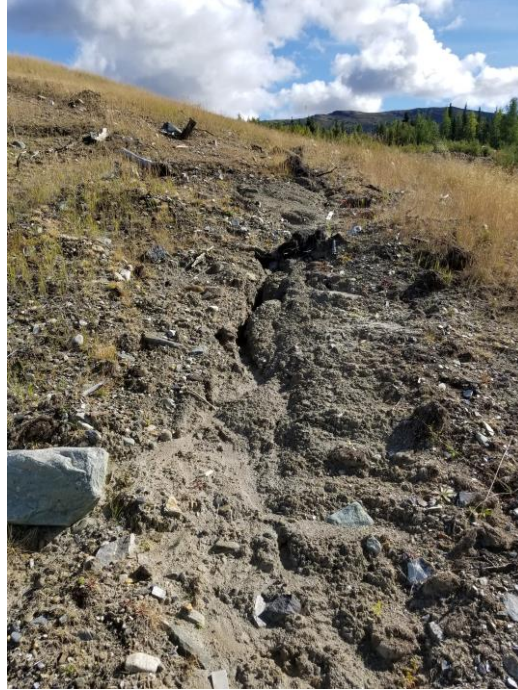
The dry stacked tailings facility (DSTF) is located at the Keno Hill District Mill Site west of Keno City, as shown on Figure 1. No tailings have been placed in the DSTF since mining operations were suspended in winter 2013. The tailings placed to date have been regraded, covered with organic growth medium, and seeded as part of progressive reclamation activities (Photo 8). At the top of the DSTF near the south end, there was visible erosion and deposition of tailings from weathering (Photo 9). Arrangements should be made to fill the eroded area to prevent further erosion.

**Photo 9:** DSTF  
Visible Erosion and Deposition  
August 24, 2017

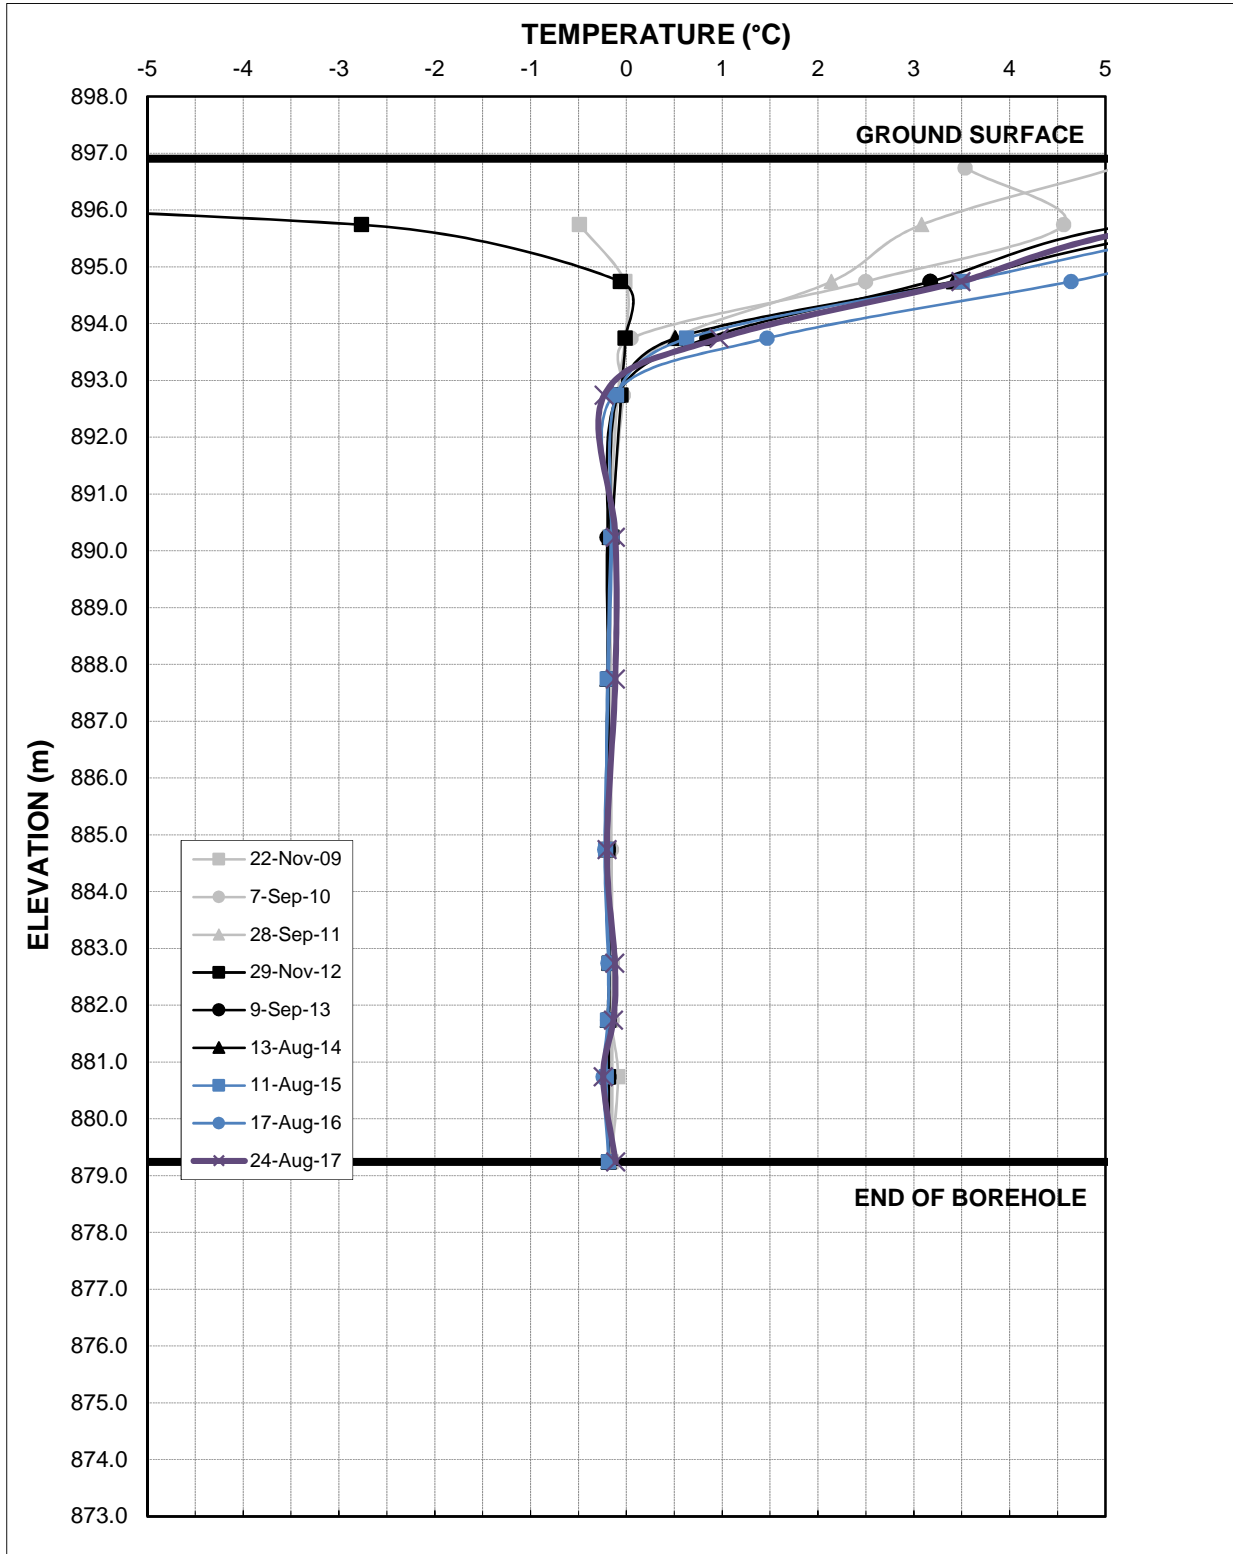
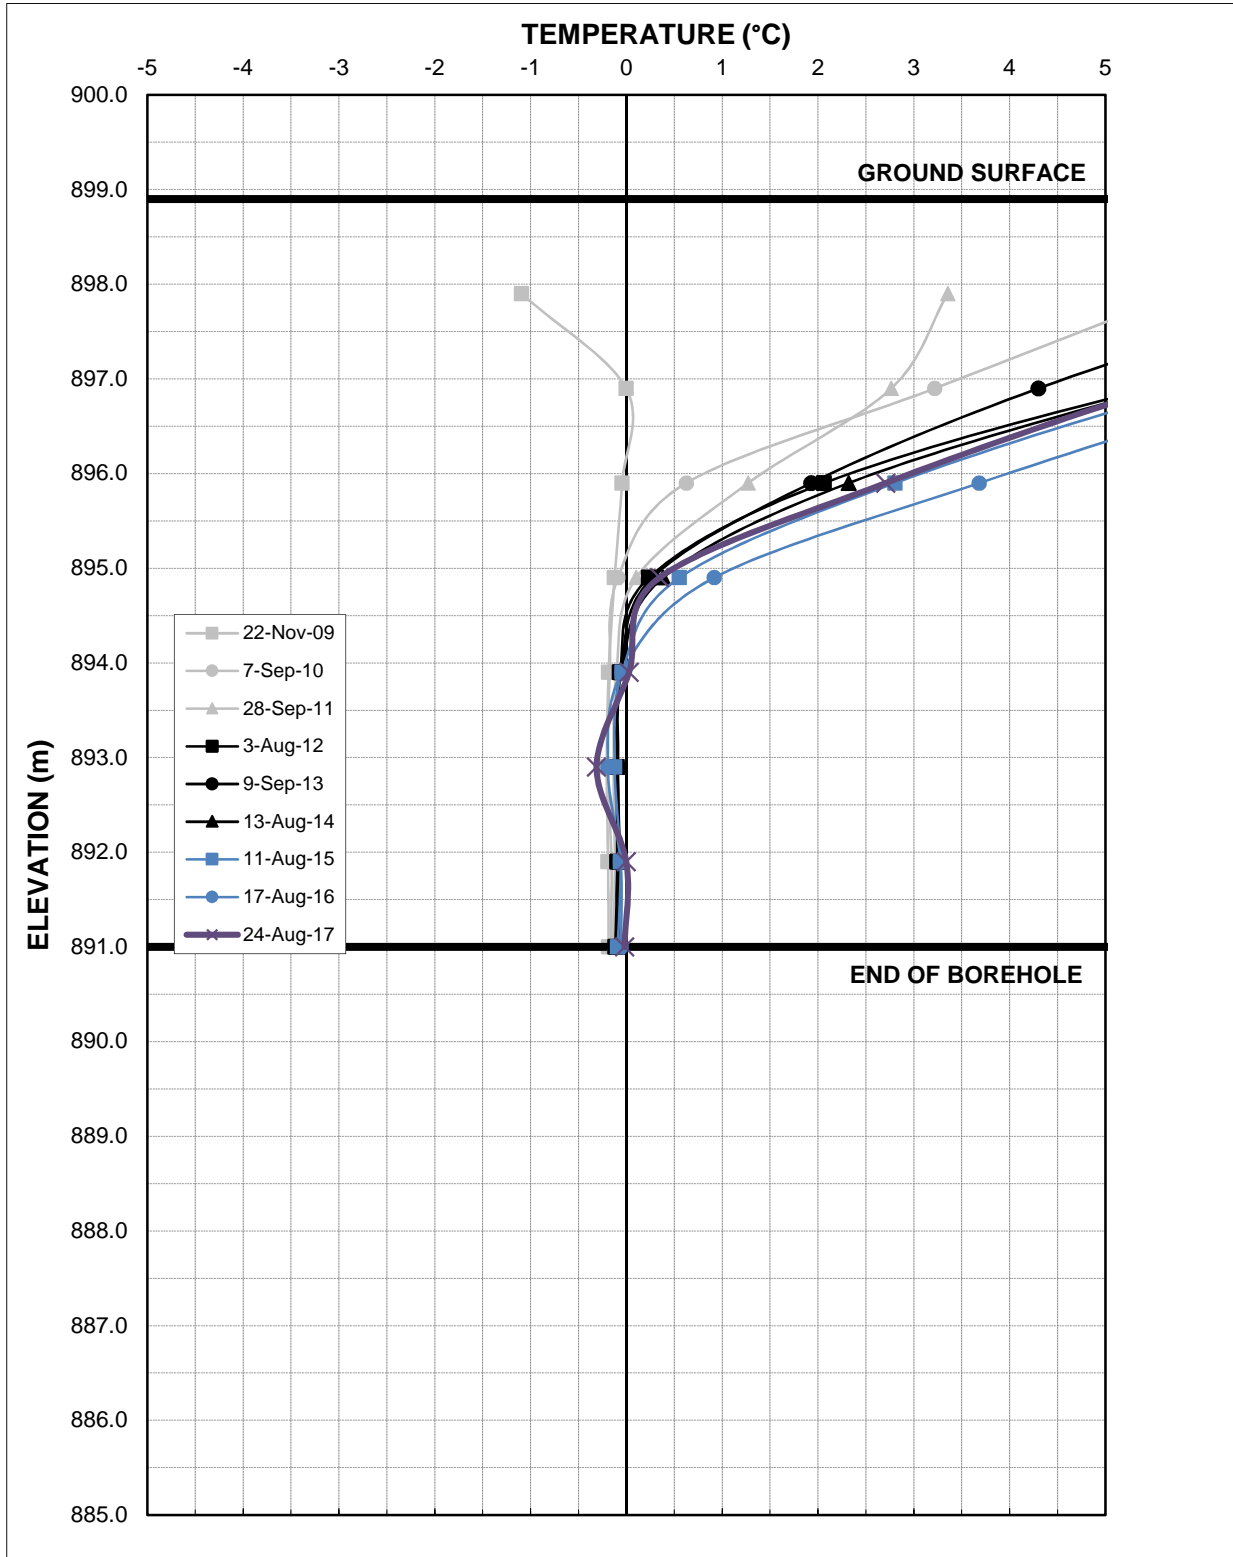
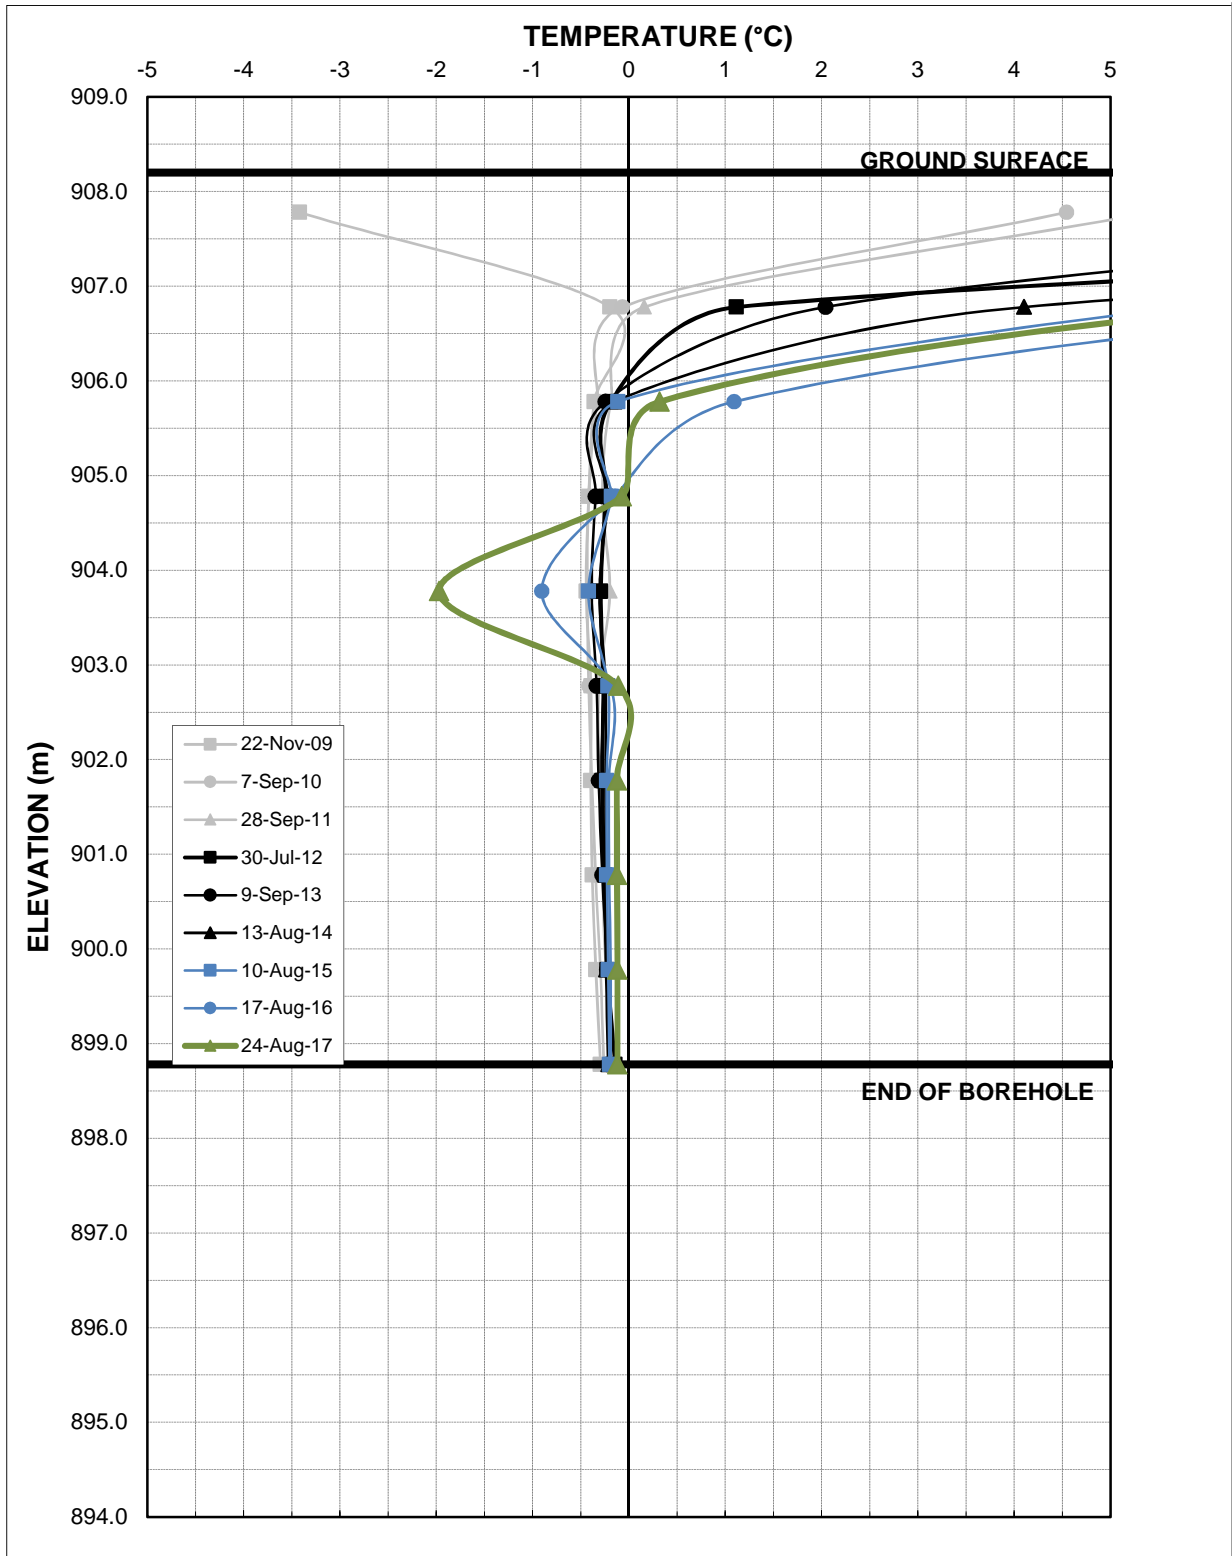
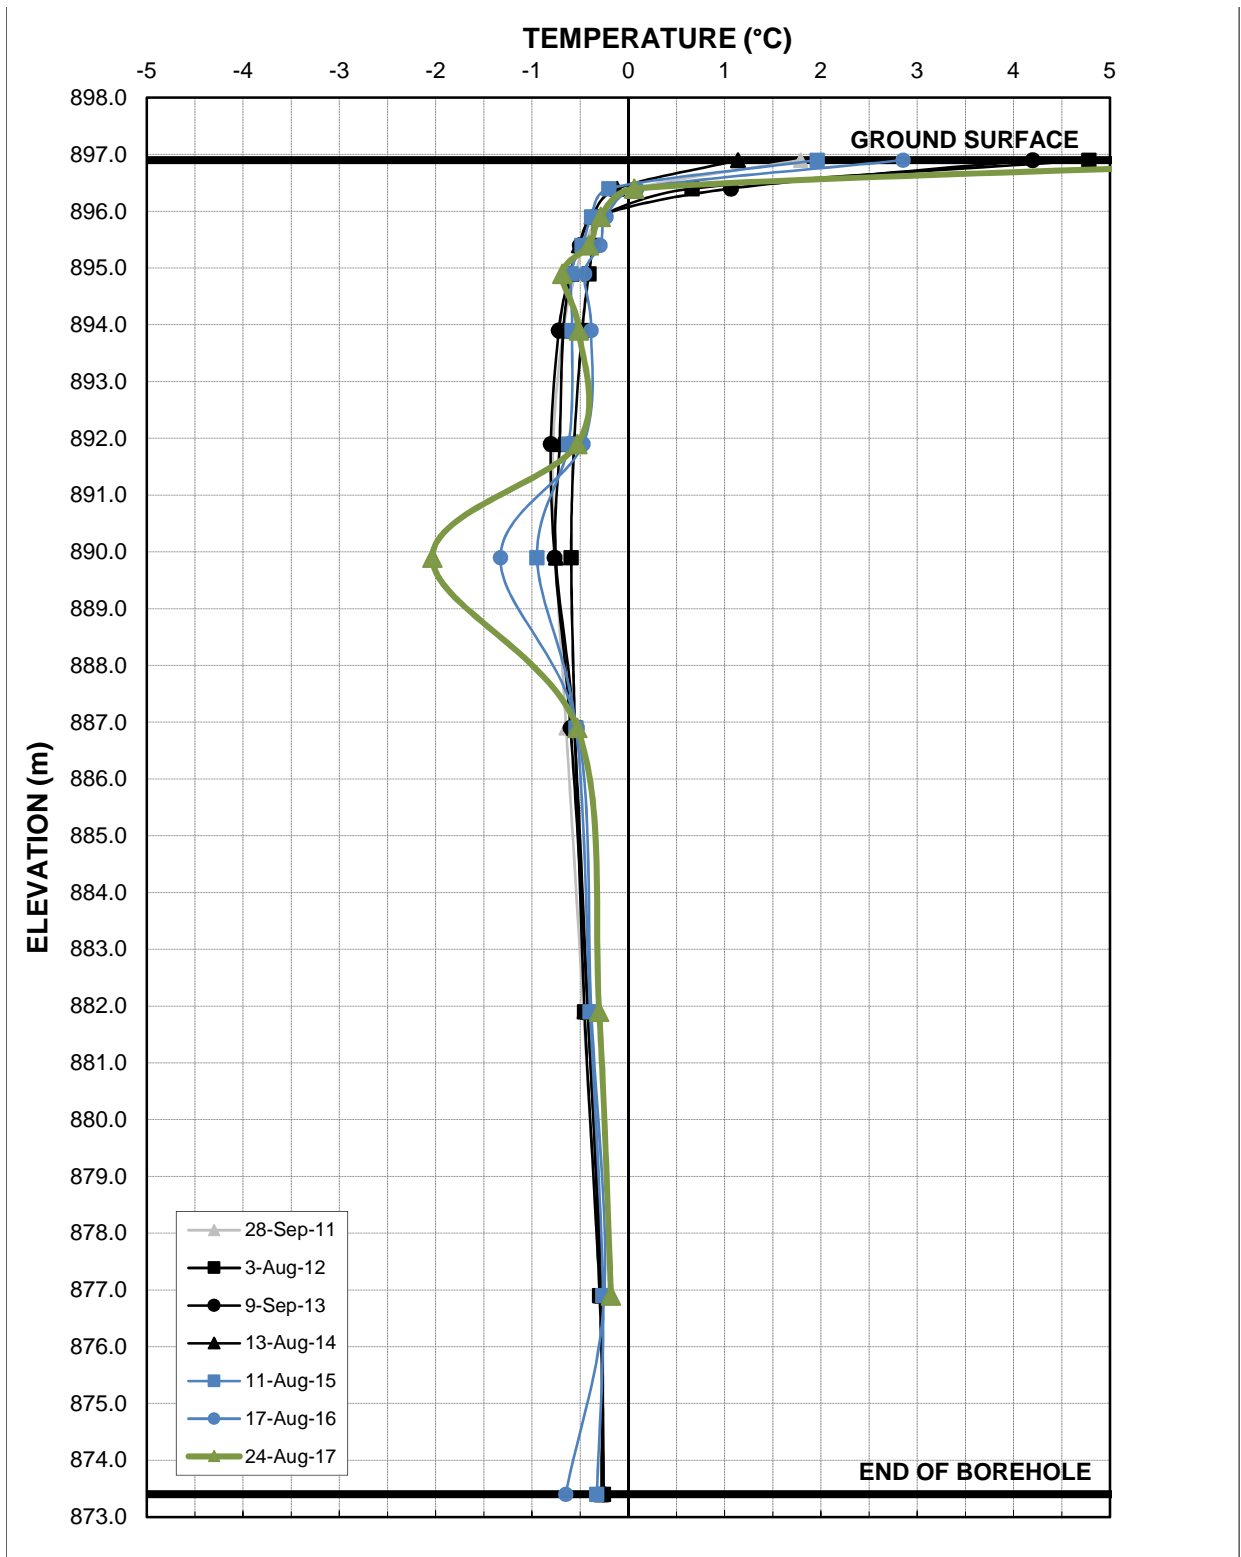
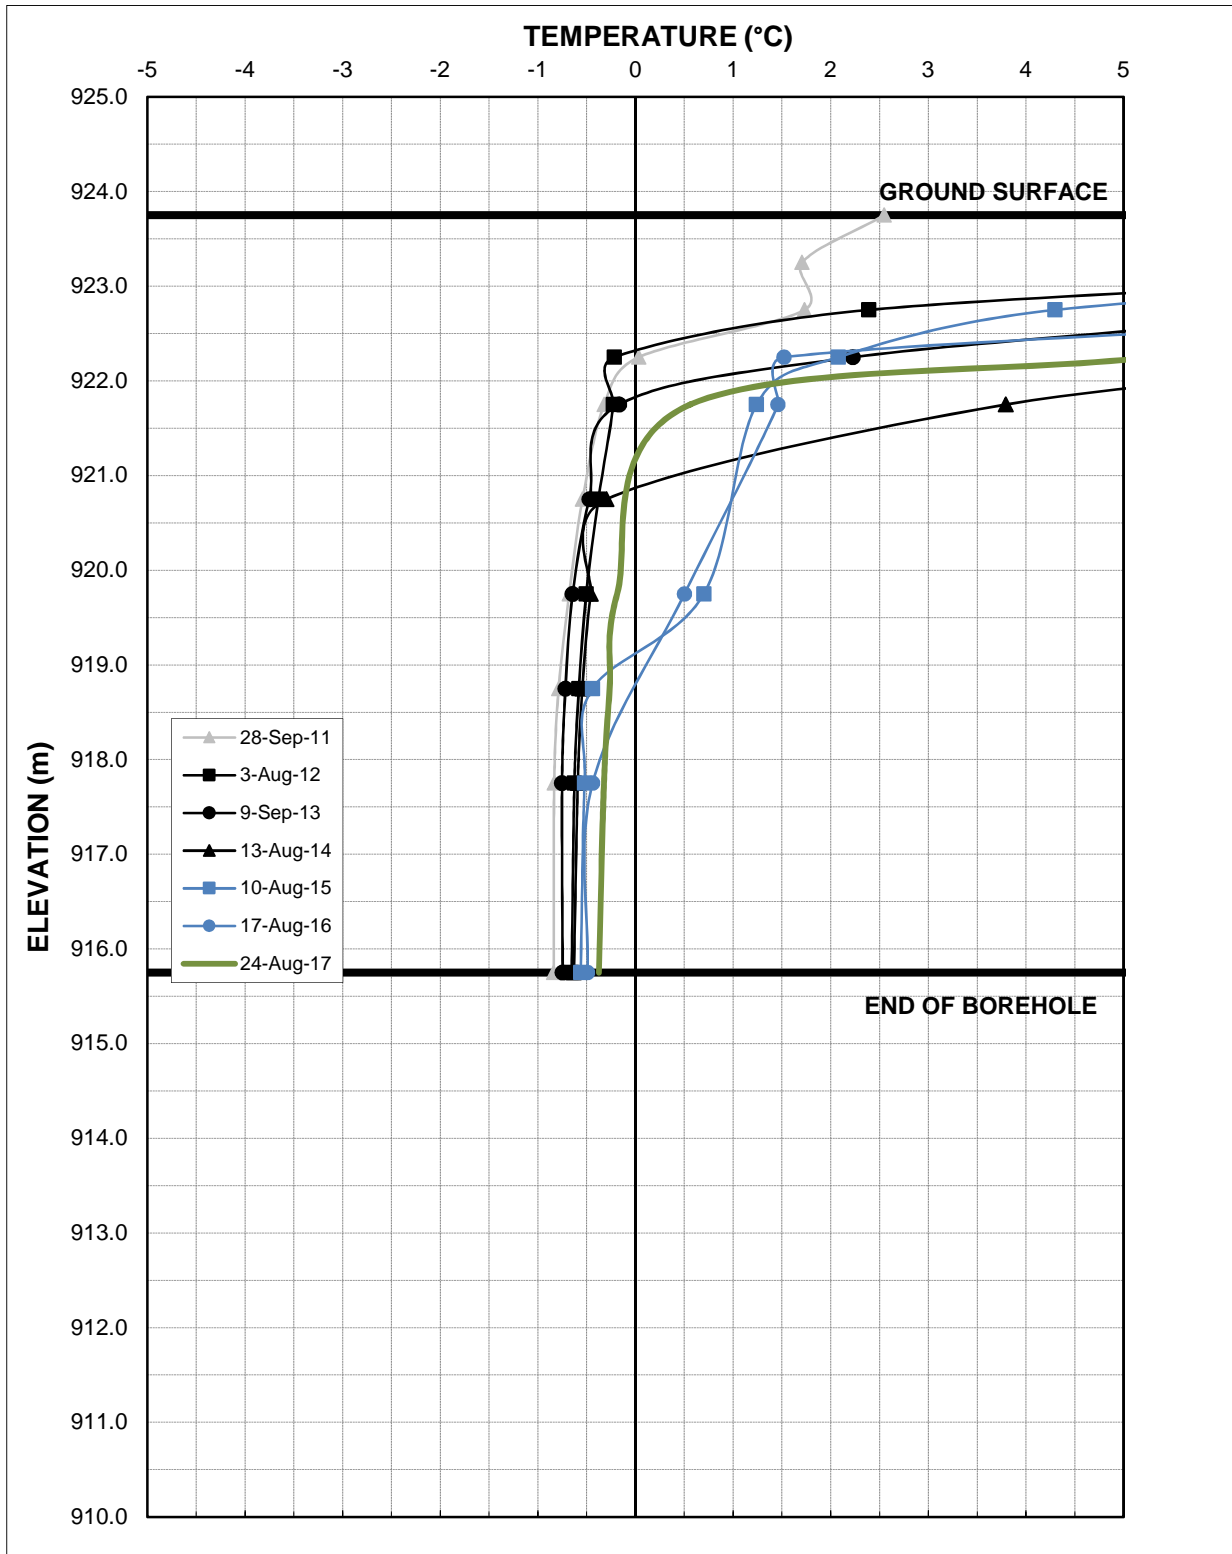
As indicated on the updated ground temperature profiles included in Appendix B, the slight near surface warming trend observed in previous years has continued. Continued regular instrumentation readings are recommended to monitor ground temperature conditions.

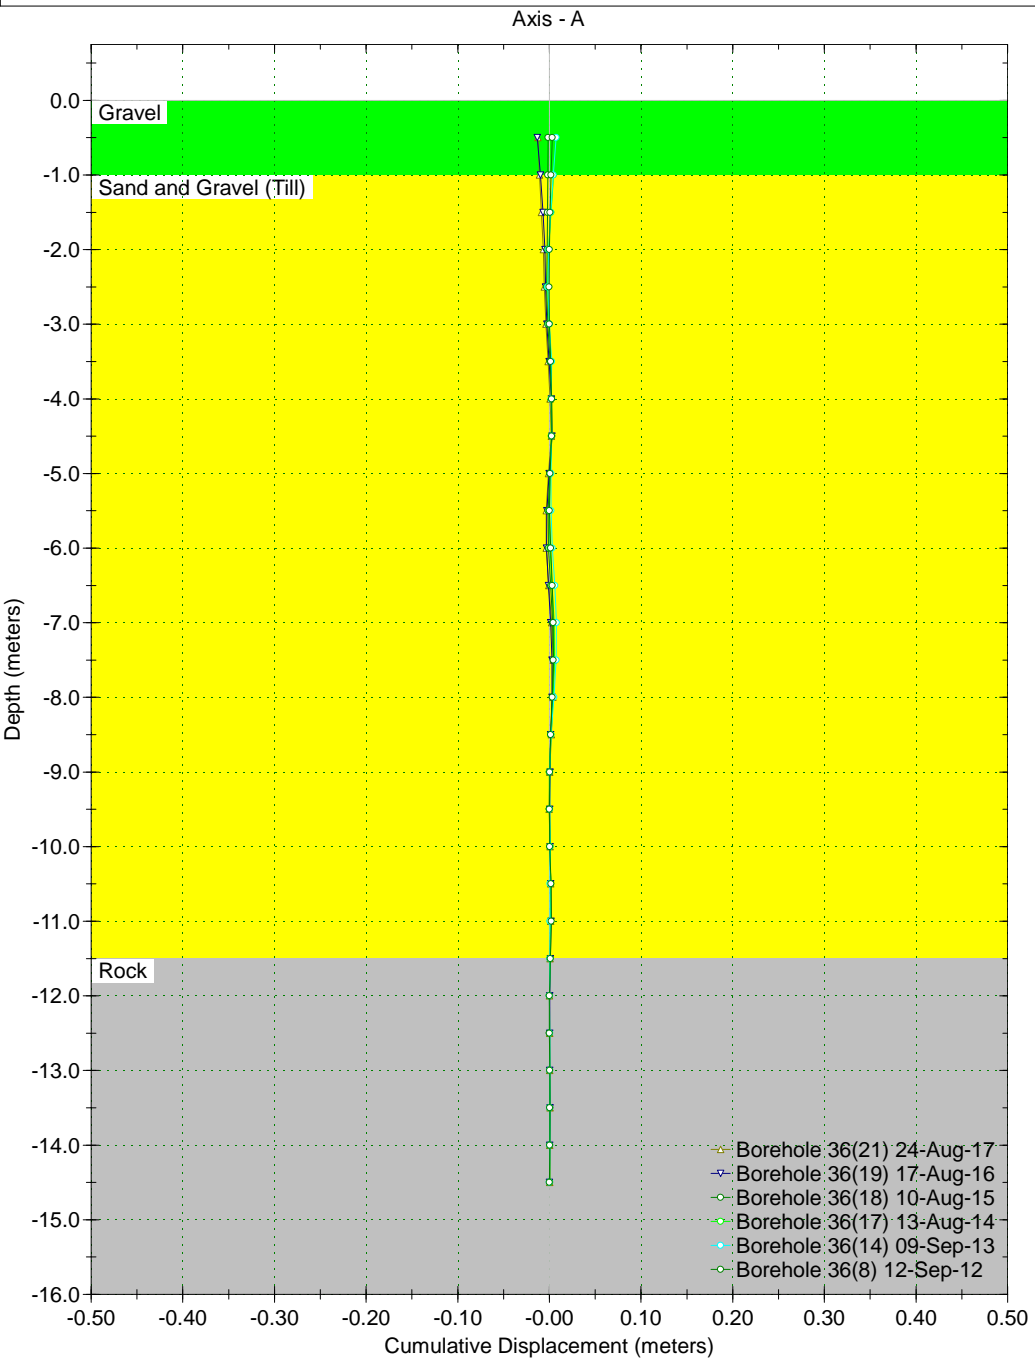
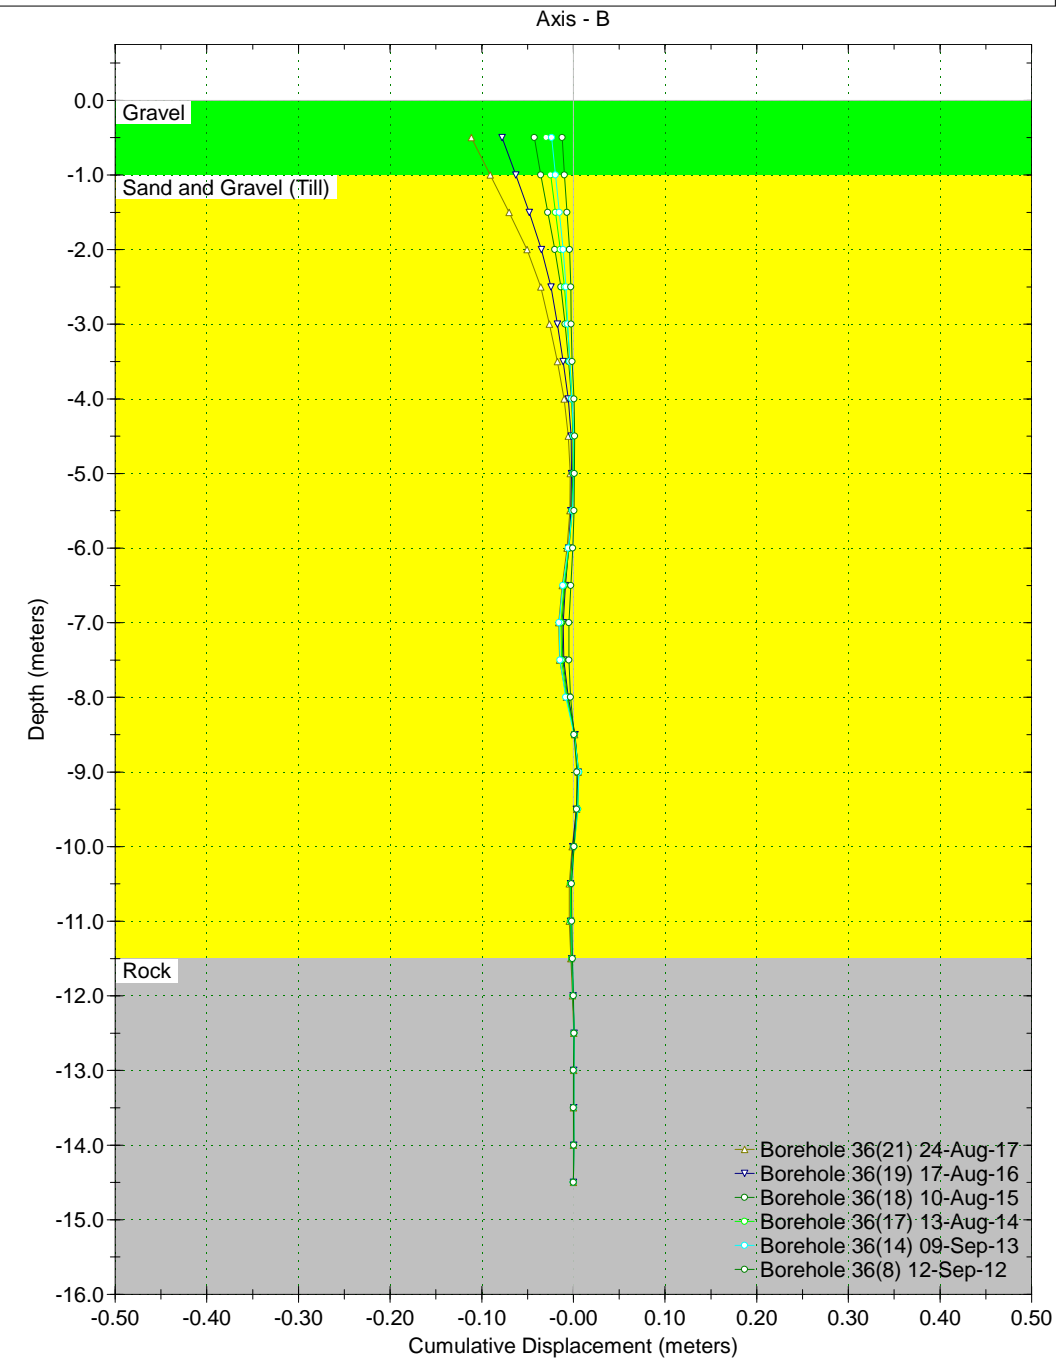
Borehole : Borehole 36  
 Project : Keno Hill District Mill  
 Location : DSTF  
 Northing : 7086872  
 Easting : 483931  
 Collar :

An updated lateral movement profile developed from readings collected from the slope indicator installed in BH36 in natural soils adjacent to the DSTF is included in Appendix C.
