October 30, 2018

Alexco Resource Corp.
3 – 151 Industrial Road
Whitehorse, YT Y1A 2V3

Subject: 2018 Annual Geotechnical Inspection – Earth Structures
Bellekeno Mine, Keno City, YT

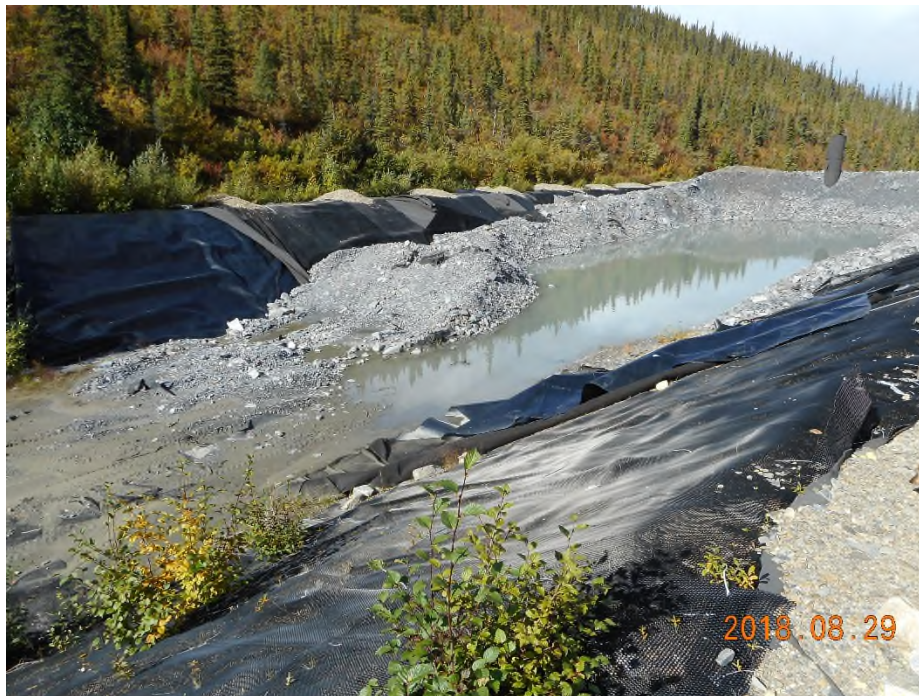
The PAG waste storage facility is located south of the Bellekeno portal, as shown on Figure 1. The facility has not been used since mining operations were suspended in winter 2013, but currently contains some volume of PAG waste rock and some surface runoff water. At the time of inspection, the perimeter berms appeared intact with no visible sign of instability.

Photo 1: View of PAG waste storage cell south of Bellekeno portal

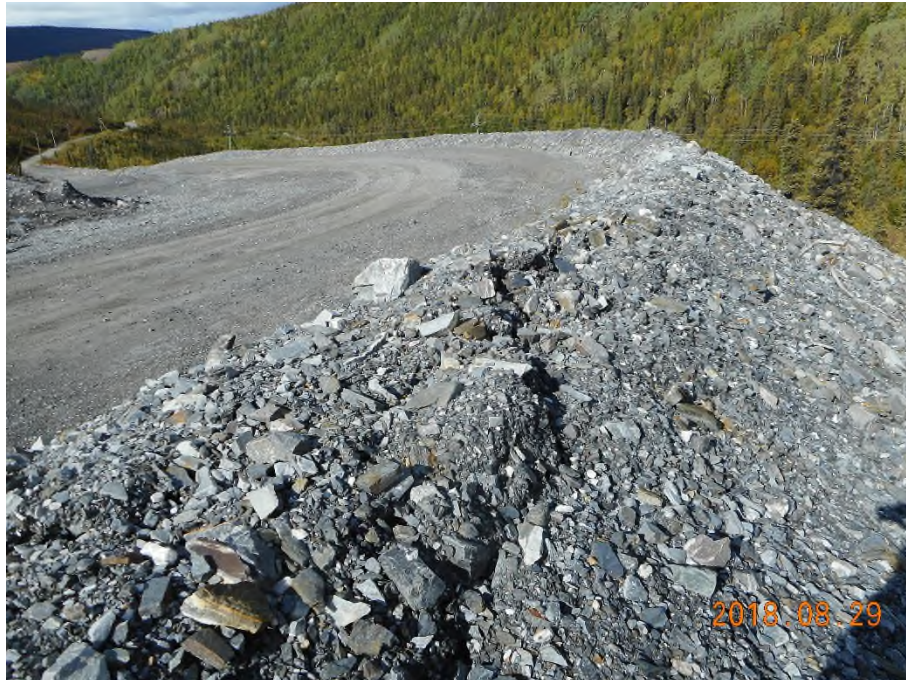
The Bellekeno waste rock pile forms a portion of the Bellekeno Haul Road and is located north of the Bellekeno portal, as shown on Figure 1. At the time of the inspection the sideslopes of the waste rock pile appeared to be intact and stable. One minor tension crack was observed (see Photo 2) but no remedial action is required at this time.

Photo 2: Bellekeno waste rock dump used as foundation for access road

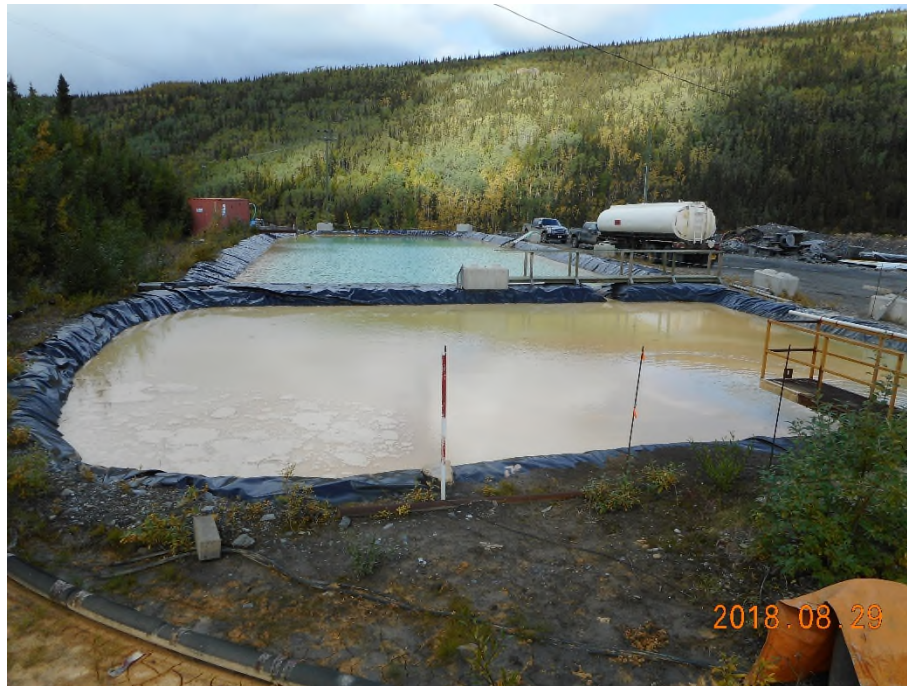
The Bellekeno 625 water treatment ponds are located north of the Bellekeno 625 portal, as shown on Figure 1. The facility consists of two water treatment ponds that were both operating at the time of inspection. The primary treatment pond was operating at the discharge invert elevation with a freeboard of 0.5 m below the perimeter berm crest at the time of inspection. The secondary pond was also operating at the discharge elevation, with a freeboard of 0.5 m in the south end. Treated water discharges through an HDPE pipe onto the hillside above Lightning Creek. Photo 3 shows the two ponds at the time of the inspection.

Photo 3: Bellekeno 625 water treatment ponds – discharge is from the far end of the facility

As recommended in previous annual geotechnical inspection reports, elevation surveys to monitor for settlement at the north end of the pond should be completed monthly during the snow free seasons, and observed settlement must be repaired by adding fill under the liner at the north end of the ponds to maintain the design freeboard.

The pipe from the treated water pond discharges directly onto the natural soils above Lightning Creek without any protection from erosion. At the time of the inspection the flow from the discharge pipe was low, but regular monitoring should be completed. If any signs of erosion are observed, rip-rap armouring must be installed.

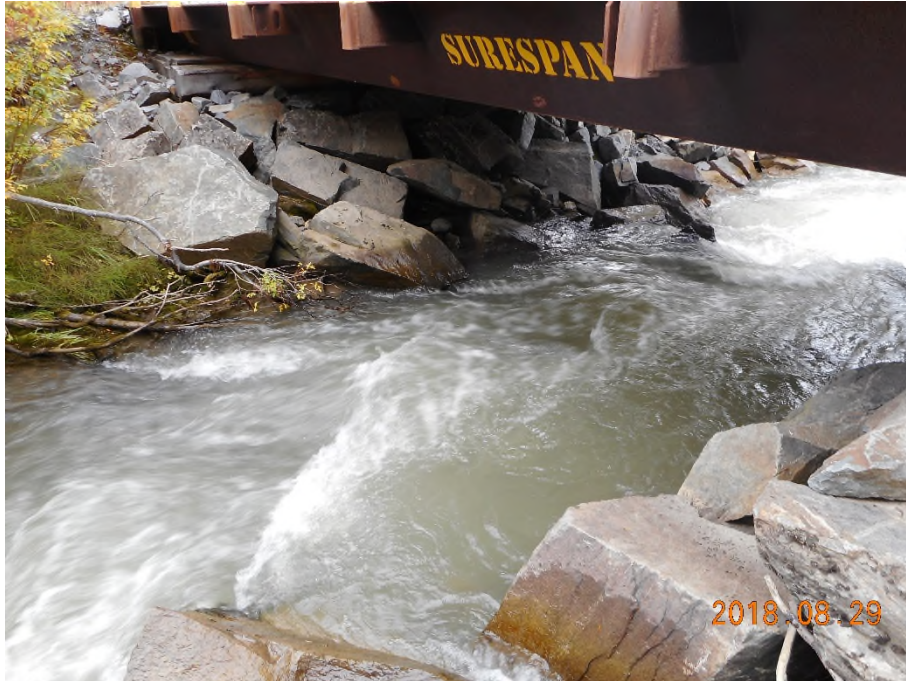
The Lightning Creek Bridge on the Onek Road is located east of Keno City, as shown on Figure 1. The bridge is a single span steel structure founded on earth filled timber cribbing abutments. The abutments were stable at the time of the inspection and are sufficiently protected from erosion by rip-rap armouring (Photo 4). No remedial action is required for the Lightning Creek Bridge on the Onek road at this time.

Photo 4: Well armoured bridge abutments at Lightning Creek crossing by the Onek road.

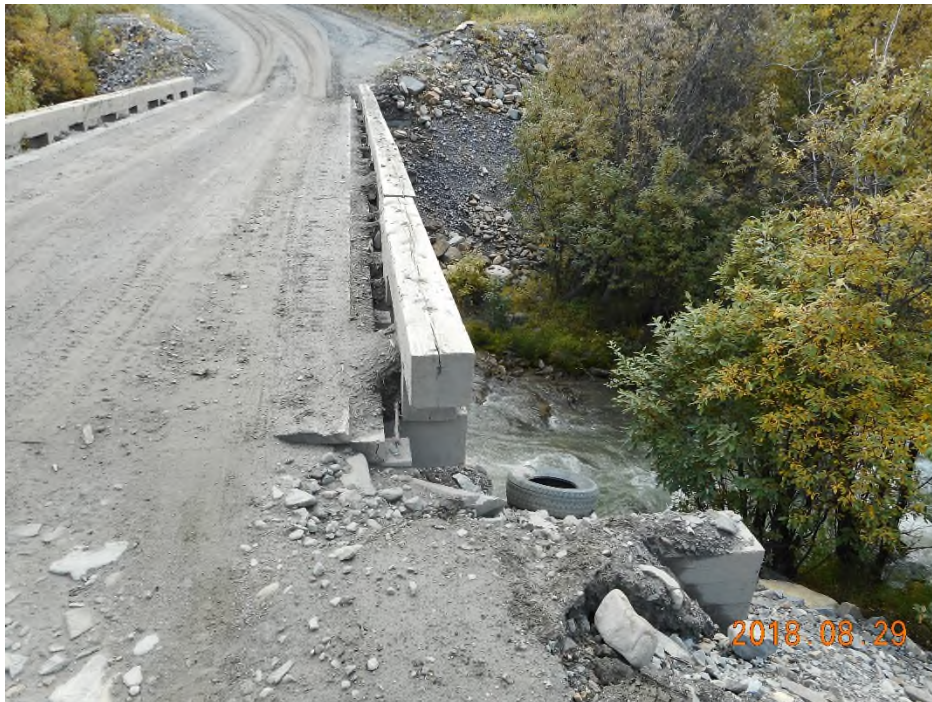
The Lightning Creek Bridge on the Bellekeno Haul Road is located southwest of Keno City, as shown on Figure 1. The bridge is a single span steel structure with a wooden deck founded on earth filled timber cribbing abutments. The abutments were stable at the time of the inspection and are sufficiently protected by rip-rap armouring from erosion by Lightning Creek. Although the bases of the abutments are well protected, the approaches need some maintenance to protect the ends of the bridge deck from erosion (see Figure 5). It is recommended that some coarse rockfill be placed at both ends of the approaches, along with a short section of safety berm to maintain stability. If coarse rockfill is used for the safety berm, surface drainage would not be impeded, but must be channeled so that the berm is not eroded away or undercut.

Photo 5: Bellekeno Haul Road bridge crossing Lightning Creek – erosion protection is required at the ends of the approaches to the bridge to protect the abutments and the bridge deck

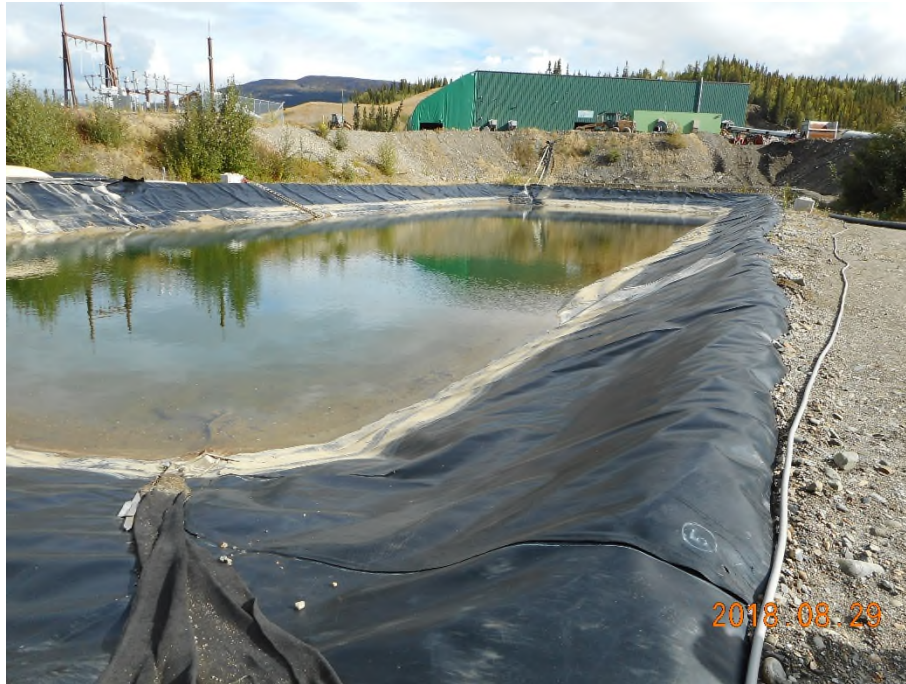
The two mill water storage ponds are located at the Keno Hill District Mill Site, west of Keno City, as shown on Figure 1. At the time of the inspection the mill was not operating, but both ponds contained some water, with a freeboard of about 2 m below the perimeter berm crest (Photo 6). The perimeter berms and pond liner appeared intact with no visible signs of instability. No remedial action is required for the mill water storage ponds at this time.

Photo 6: One of the mill water ponds at the Mill Site – stable berms and sideslopes.
