November 26, 2019

Alexco Resource Corp.
3 – 151 Industrial Road
Whitehorse, YT
Y1A 2V3

Subject: 2019 Annual Geotechnical Inspection – Mining Related Structures
Bellekeno Mine – Keno City, YT

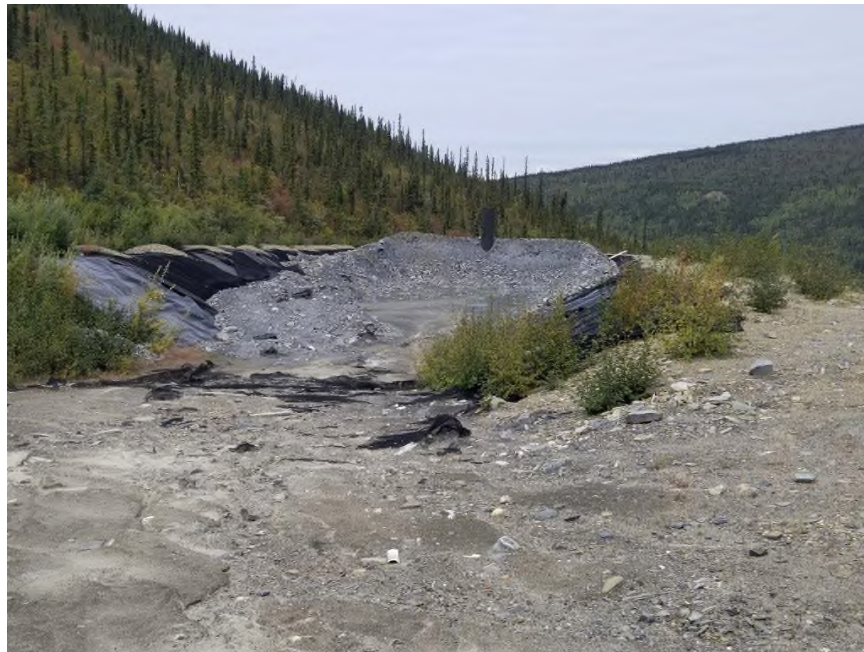
The PAG waste storage facility is located south of the Bellekeno portal, as shown on Figure 1. The facility has not been used since mining operations were suspended in 2013, but currently contains some volume of PAG waste rock. At the time of the inspection, the perimeter berms appeared intact with no visible sign of instability (Photo 1).

Photo 1 - Bellekeno PAG Storage Facility (August 20/19)

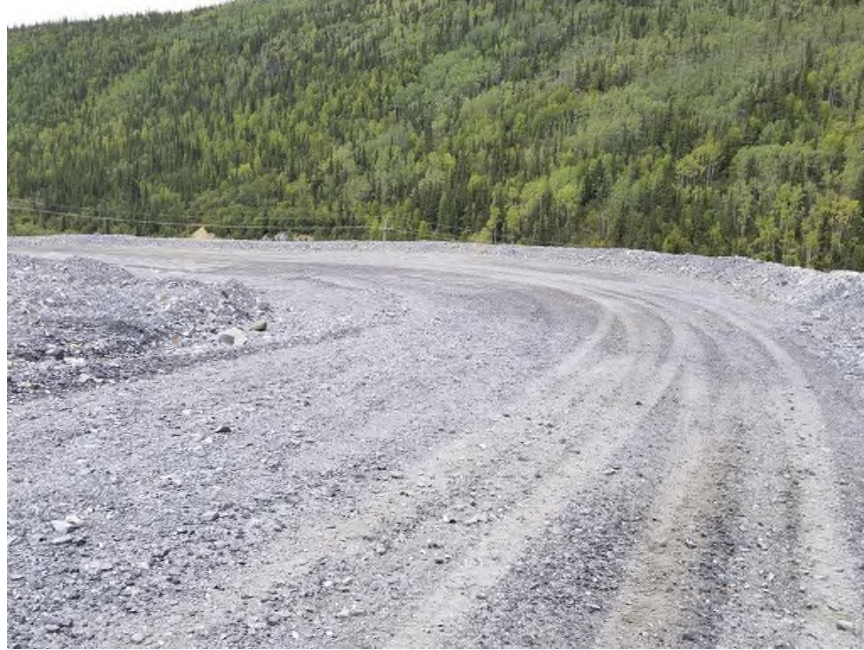
The Bellekeno waste rock pile forms a portion of the Bellekeno Haul Road and is located north of the Bellekeno portal, as shown on Figure 1. At the time of the inspection the side slopes of the waste rock pile appeared to be intact and stable. No remedial action is required.

Photo 2 – Bellekeno Road Waste Rock Pile (August 20/19)

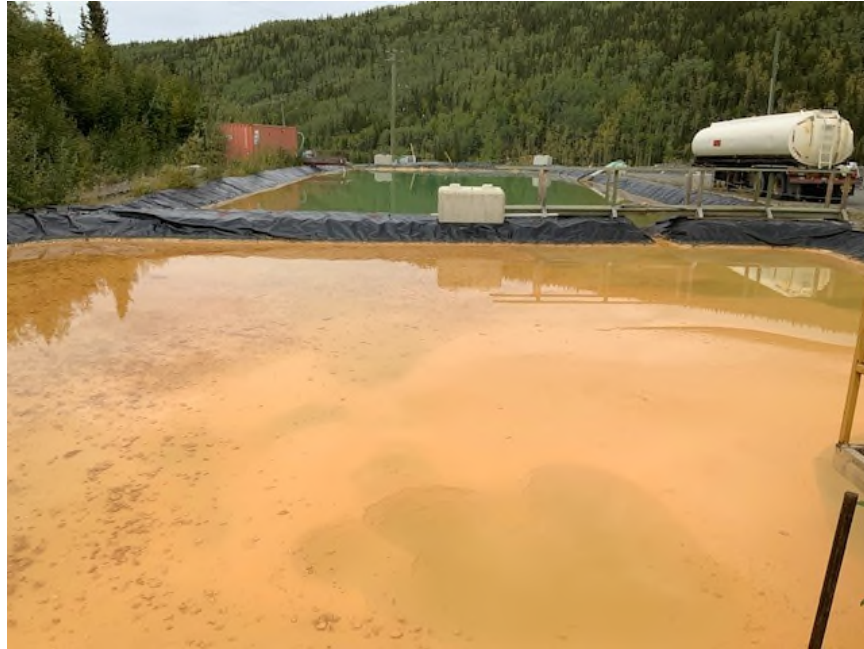
The Bellekeno 625 water treatment ponds are located north of the Bellekeno 625 portal, as shown on Figure 1. The facility consists of two water treatment ponds that were both operating at the time of inspection. The primary treatment pond was operating at the discharge invert elevation with a freeboard of 0.5 m below the perimeter berm crest at the time of the inspection. The secondary pond was also operating at the discharge elevation, with a freeboard of 0.5 m in the south end. Treated water discharges through an HDPE pipe onto the hillside above Lightning creek. A small rip in the liner was identified at the south end crest of the secondary pond. The rip appeared to be caused by equipment operating around the pond but should be monitored and repaired if conditions worsen.

Photo 3 - Bellekeno 625 Water Treatment Ponds (August 20/19)

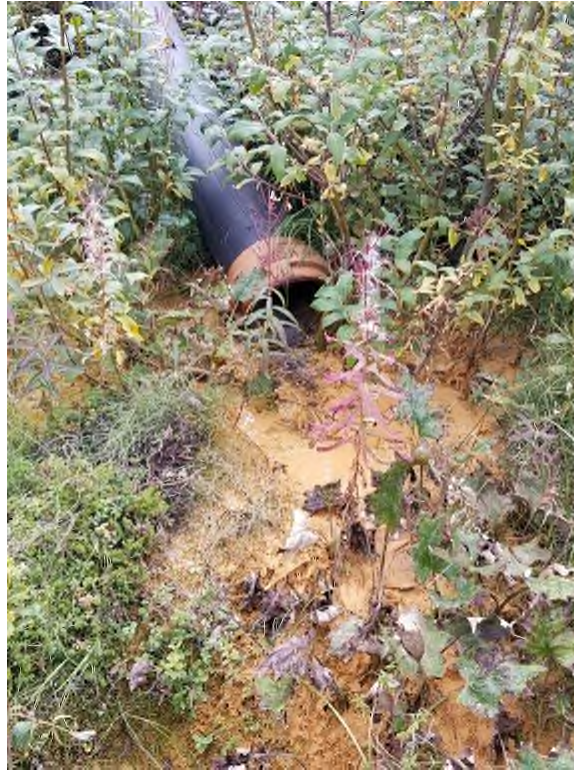
The pipe from the treated water pond discharges directly onto the natural soils above Lightning Creek without any protection from erosion (Photo 4). At the time of the inspection the discharge pipe was unhooked at a coupler upstream from the previous discharge location. The discharge rate was low, but regular monitoring should be completed. If any signs of erosion are observed, riprap armouring must be installed.

Photo 4 - Bellekeno 625 Water Treatment Ponds, Discharge Location (August 20/19)

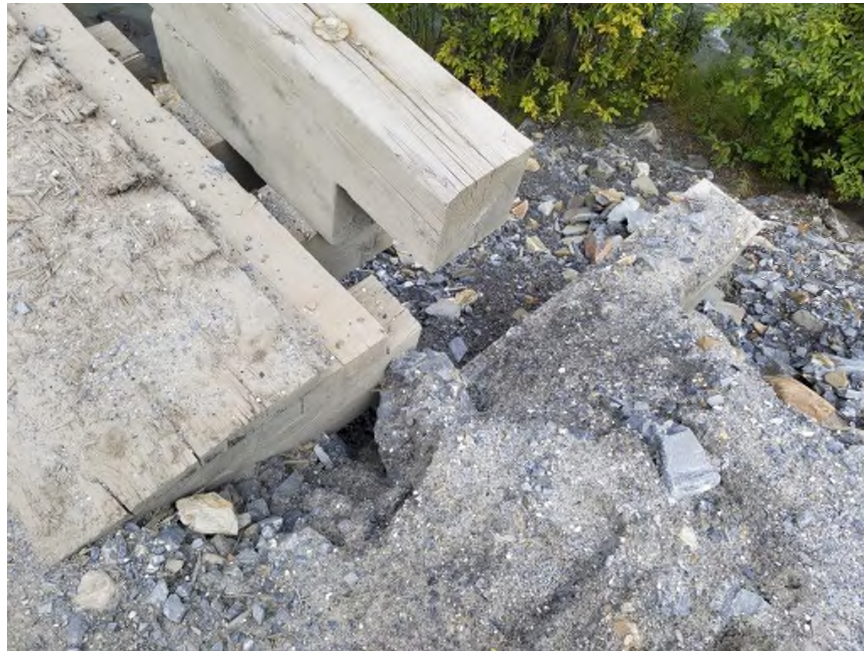
The Lightning Creek Bridge on the Bellekeno Haul Road is located southwest of Keno City, as shown on Figure 1. The bridge is a single span steel structure with wooden deck founded on earth filled timber cribbed abutments. The abutments were stable at the time of the inspection and are sufficiently protected by riprap armouring from erosion of Lightning Creek. Although the bases of the abutments are well protected, the approaches have undergone erosion and are starting to become undermined by washout (Photo 5). It is recommended that the eroded areas be backfilled with coarse rock and the berms built up to maintain stability. If coarse rock is used for the safety berm, surface drainage would not be impeded, but must be directed so that the berm is not eroded away.

Photo 5 - Bellekeno Haul Road, Approach Erosion (August 20/19)

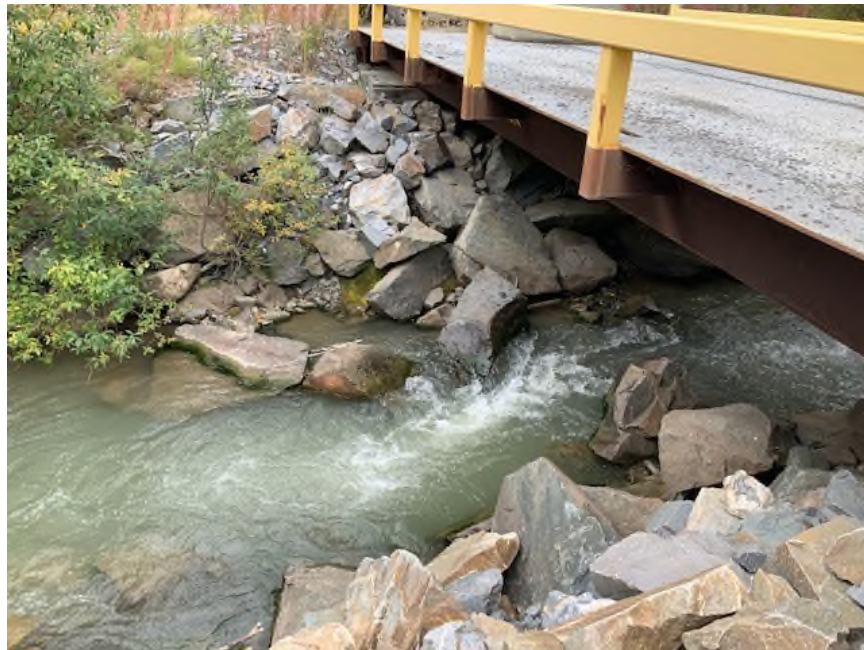
The Lightning Creek Bridge on the Onek Road is located east of Keno City, as shown on Figure 1. The bridge is a single span steel structure founded on earth filled timber cribbing abutments. The abutments were stable at the time of the inspection and are sufficiently protected from erosion by riprap. No remedial action is required for the Lightning Creek Bridge on the Onek Road at this time.

Photo 6 - Lightning Creek Bridge Abutments, Onek Road (August 20/19)

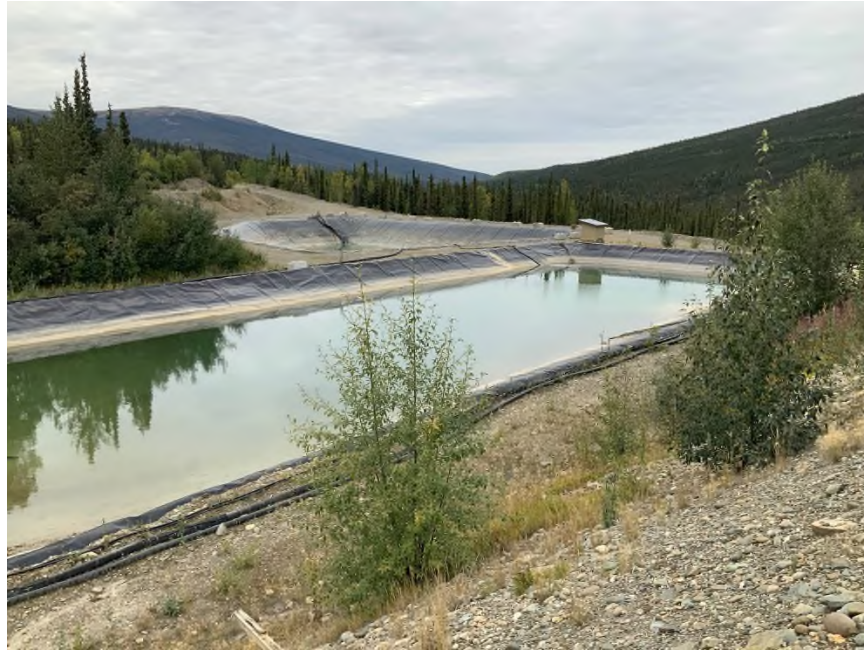
The two mill water storage ponds are located at the Keno Hill District Mill Site, west of Keno City, as shown on Figure 1. At the time of the inspection the mill was not operating, but both ponds contained some water, with a freeboard of about 2 m below the perimeter berms in the older pond, and an estimated 6 m of freeboard in the newer pond.

Photo 7 - Mill Water Storage Ponds (August 20/19)

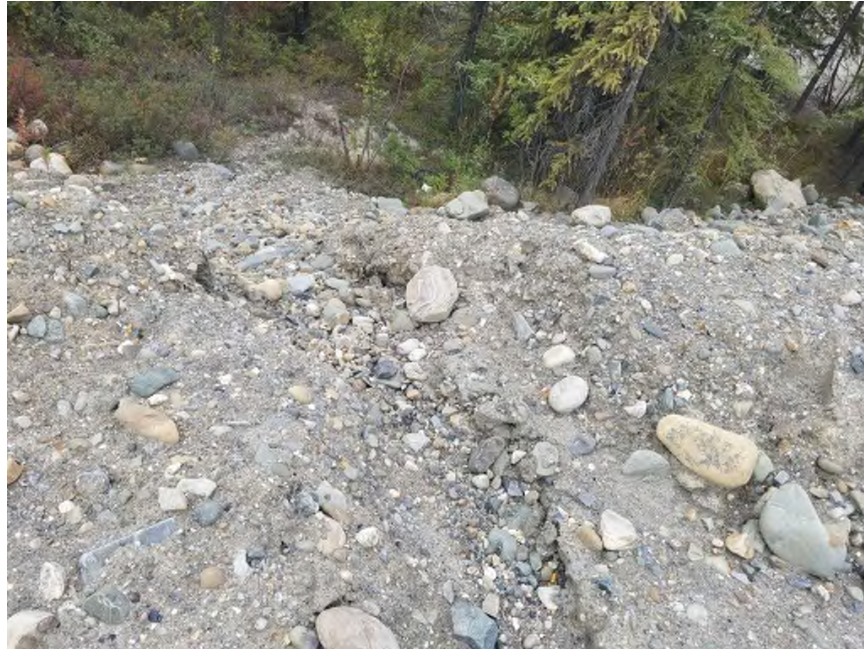
The access road on the west side of the ponds have shown signs of erosion in three areas (Photo 8). The berms on the road should be restored to direct drainage away and reduce further erosion.

Photo 8 - Mill Storage Ponds, Access Road Erosion (August 2019)

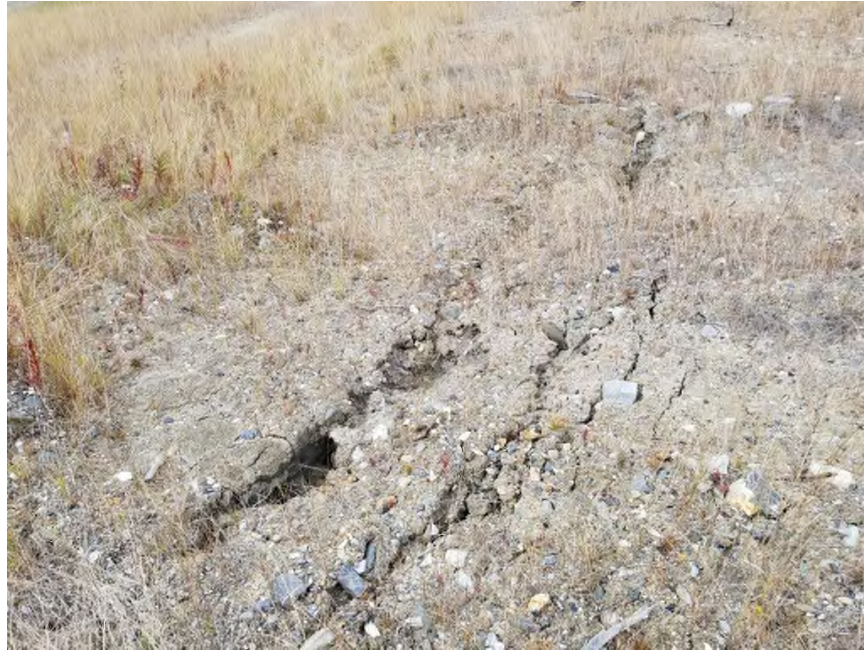
The dry stacked tailings facility (DSTF) is located at the Keno Hill District Mill Site west of Keno City, as shown on Figure 1. No tailings have been placed on the DSTF since mining operations were suspended in 2013. The tailings placed to date have been regraded, covered with organic materials and glacial till, then seeded as part of the progressive reclamation activities. On the south east side of the DSTF, a deep circular slope instability was identified on surface that extended approximately 25 m long (Photo 9 and 10). The approximate location of the instability is shown on Figure 1. This instability must be repaired to prevent water or snow from flowing into the opening and accelerating further movement. To repair the instability, the DSTF should be excavated down to the extent of the failure and backfilled with compacted materials. Special care should be taken to ensure that surface drainage is restored to keep runoff and rain/snowmelt water away from this area.

Photo 9 - DSTF Circular Instability (August 20/19)

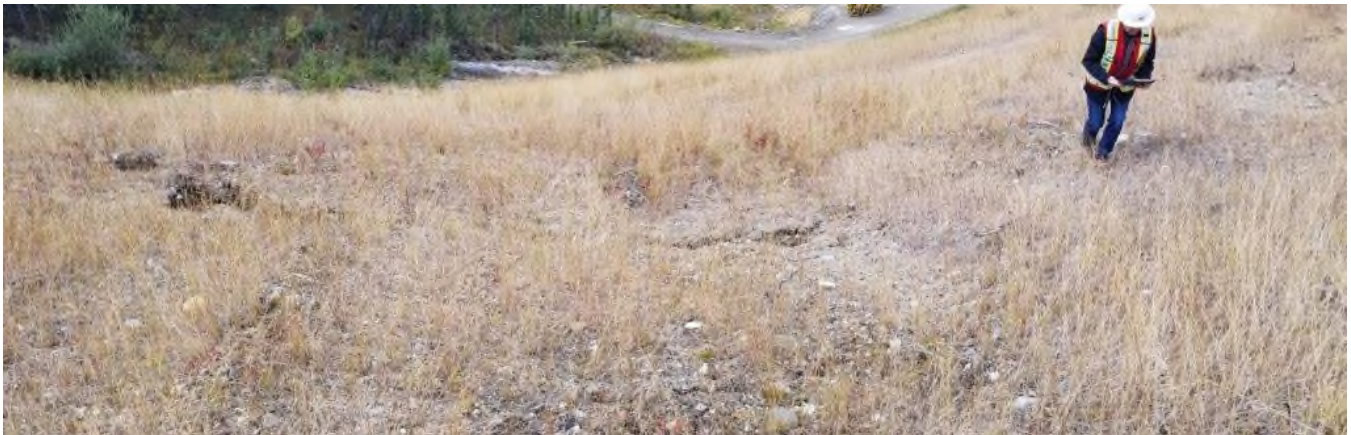
Photo 10 - DSTF Circular Instability (August 20/19)

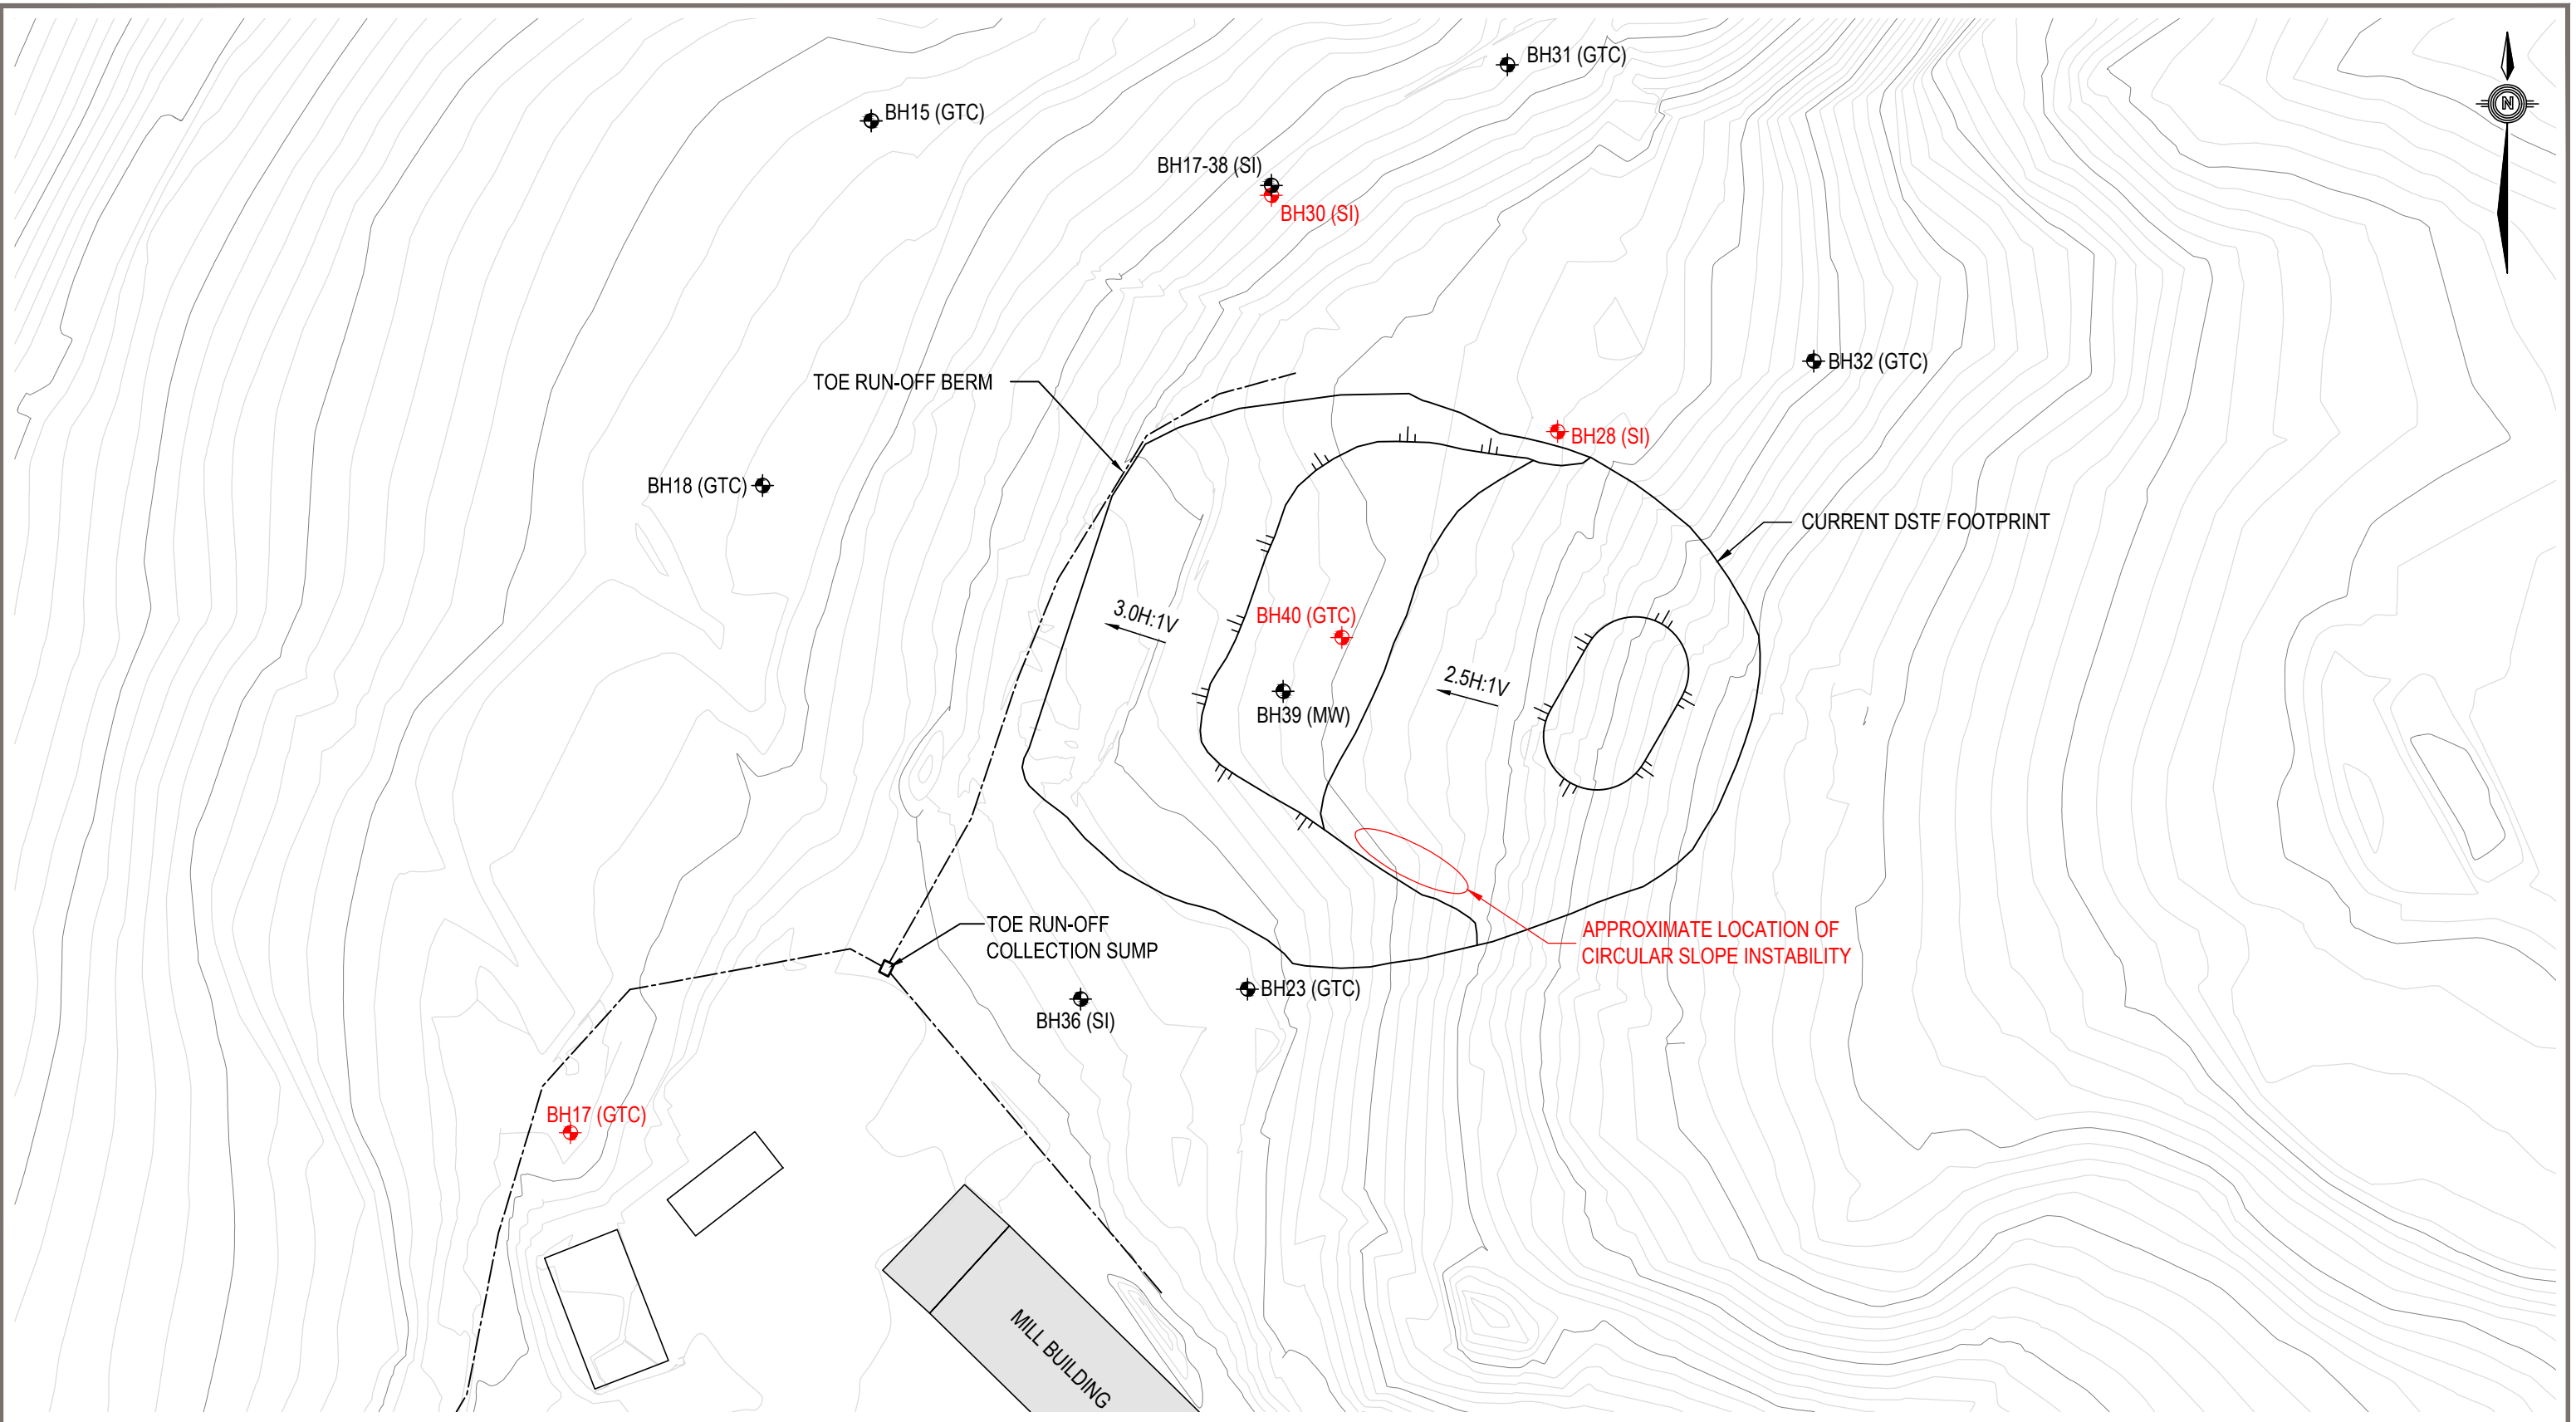
Figure 2

It should be noted that some critical instrumentation located within and adjacent to the DSTF is in need of repair and/or replacement.

The ground temperature cable installed in BH40, which extends through the tailings and into the foundation soils below to DSTF has been damaged and requires replacement. This is a critical installation needed to confirm design assumptions and provide ongoing temperature monitoring. Access to BH15 and BH18 has overgrown with vegetation over the years and should be cleared to allow access for future monitoring.

NOTE
INSTRUMENTATION SHOWN IN RED HAS BEEN DAMAGED.

Dry Stacked Tailings Facility	<ul style="list-style-type: none"> ▪ Repair or remove casing at BH17 to allow for continuous ground temperature mentoring; ▪ Install a new ground temperature cable to replace damaged cable at BH40; ▪ Purge and clean BH38 and preserve using liquid suitable for use in permafrost conditions (silicone oil); ▪ Replace the slope indicator located at BH28; and ▪ Repair the circular slope instability identified on the south east side. 	<ul style="list-style-type: none"> ▪ Continue regular instrumentation readings to monitor DSTF foundation conditions; ▪ Restore marker posts on top of DSTF (mainly BH40 and BH37); and ▪ Trim vegetation for future access to BH15 and BH18.

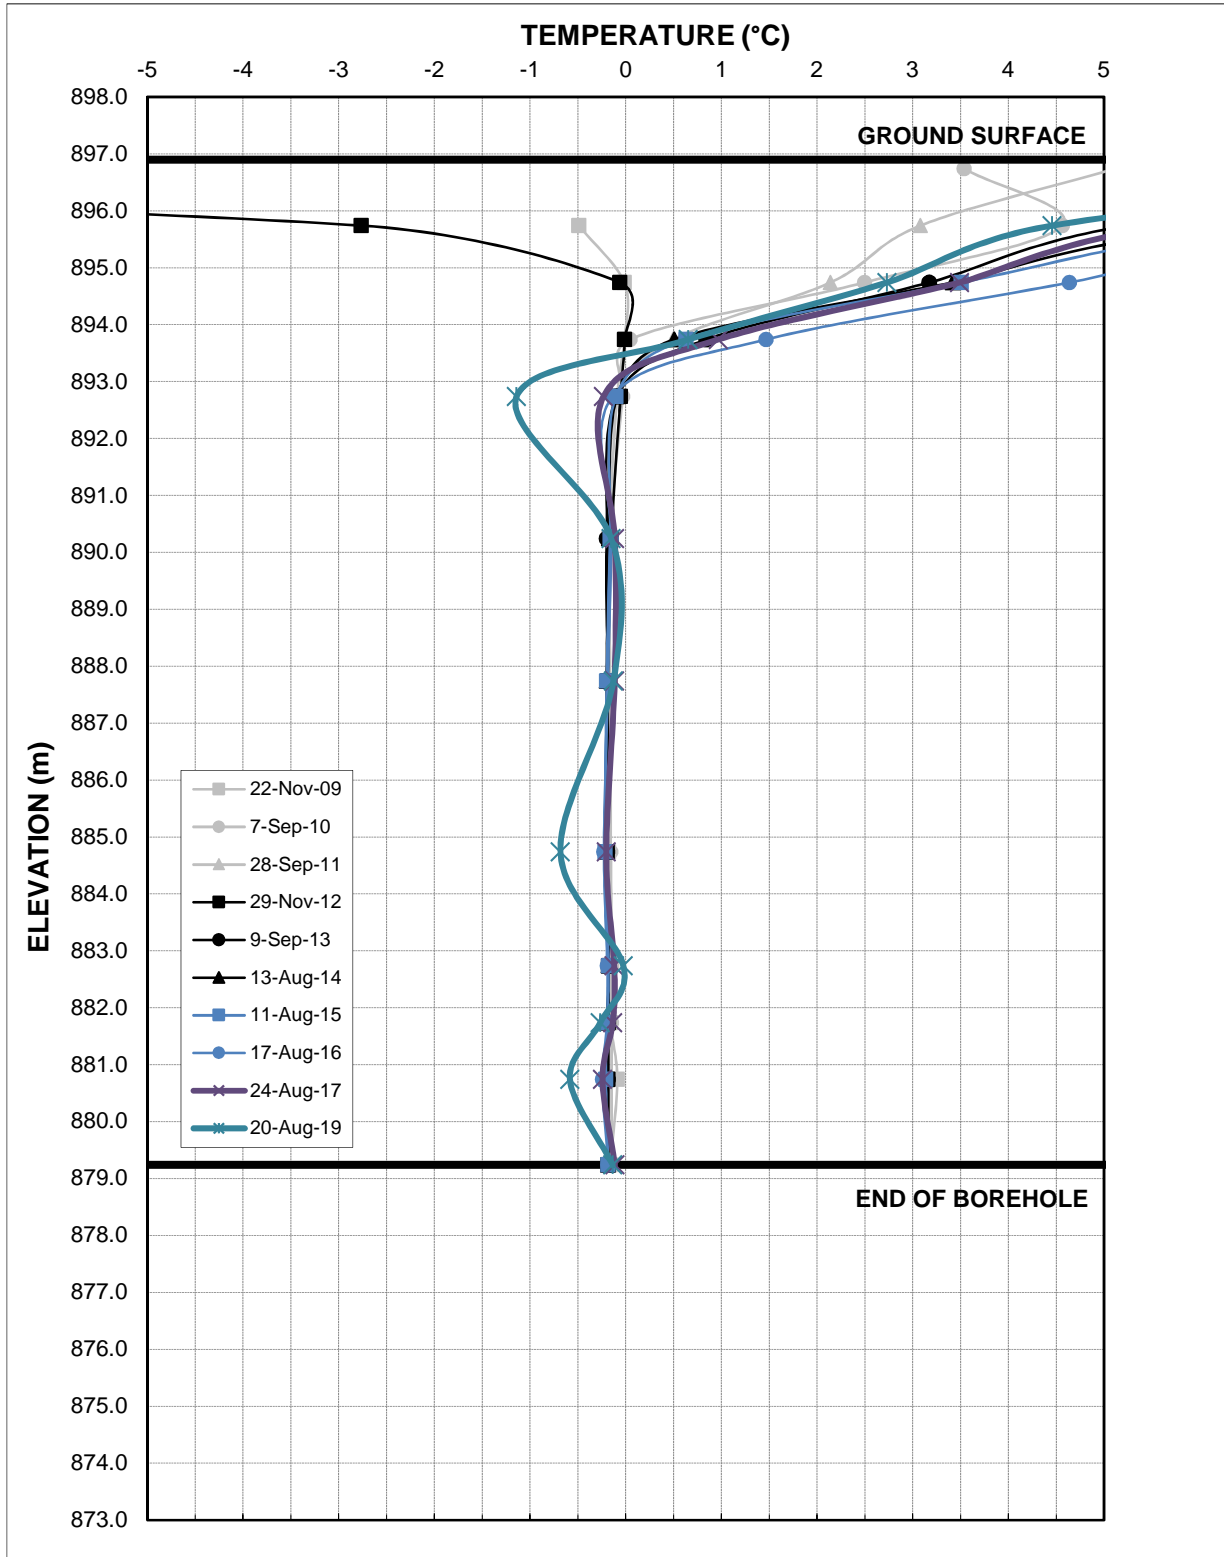
Ground Temperature Profile
Keno Hill District Mill Site Borehole BH15
Figure T1

As indicated on the updated ground temperature profiles included in Appendix B, the ground temperatures near surface have stabilized. Ground temperature at depth have indicated that ground temperature has decreased over the last few years. Continued regular instrumentation readings are recommended to monitor ground temperature conditions.

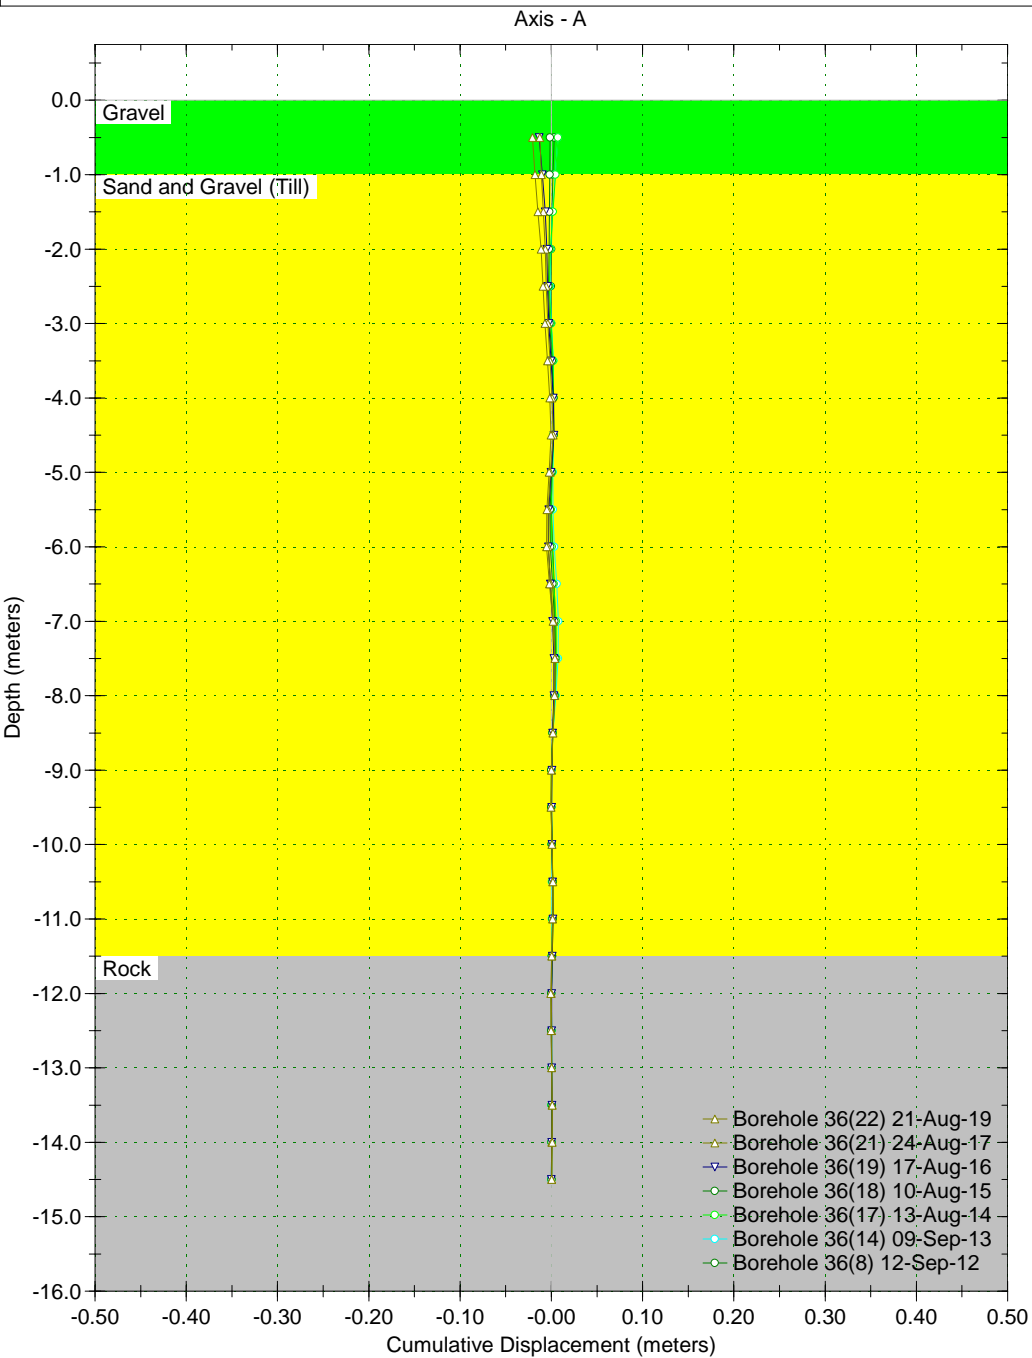
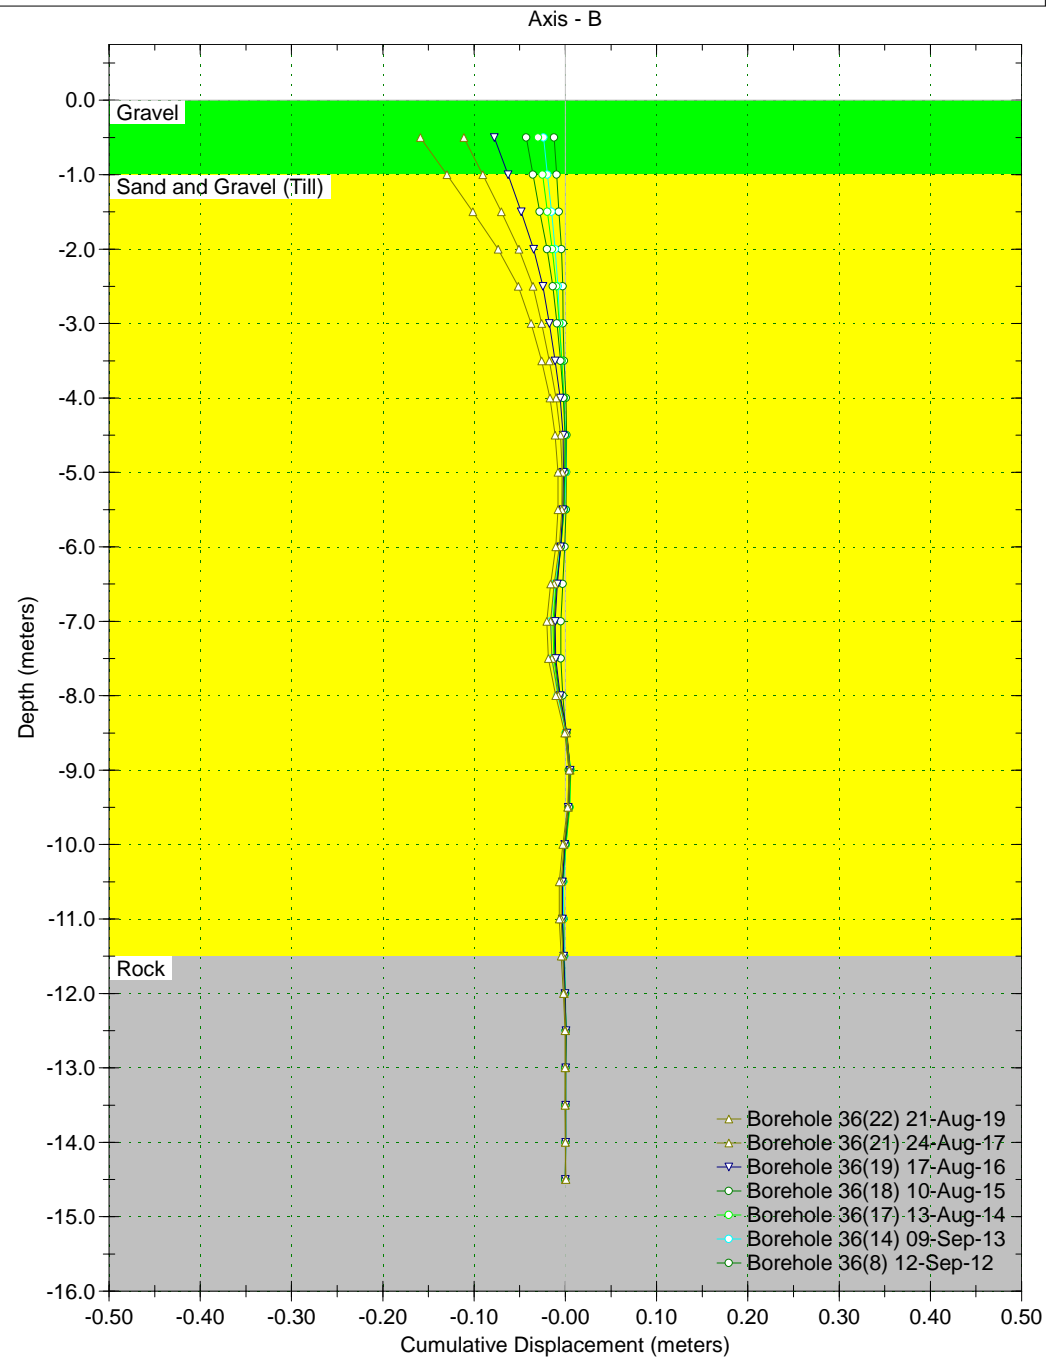
Borehole : Borehole 36
Project : Keno Hill District Mill
Location : DSTF
Northing : 7086872
Easting : 483931
Collar :

An updated lateral movement profile developed from readings collected from the slope indicators installed in BH36 and BH38 in natural soils adjacent to the DSTF is included in Appendix C. Lateral movement that ranged from 50 mm to 80 mm at the top of the casing was identified in BH38.

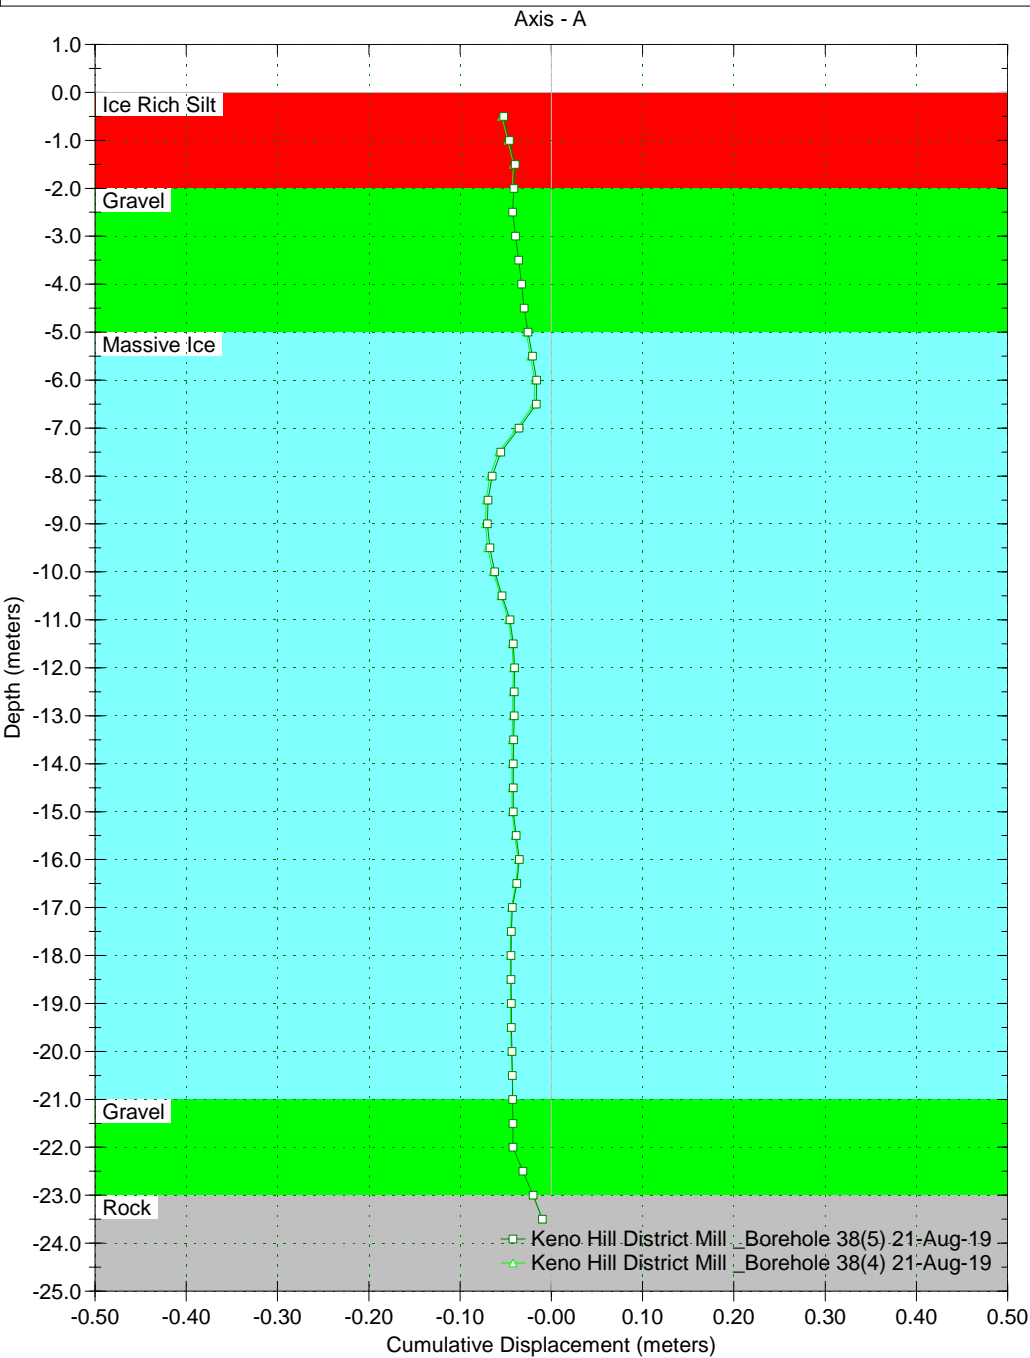
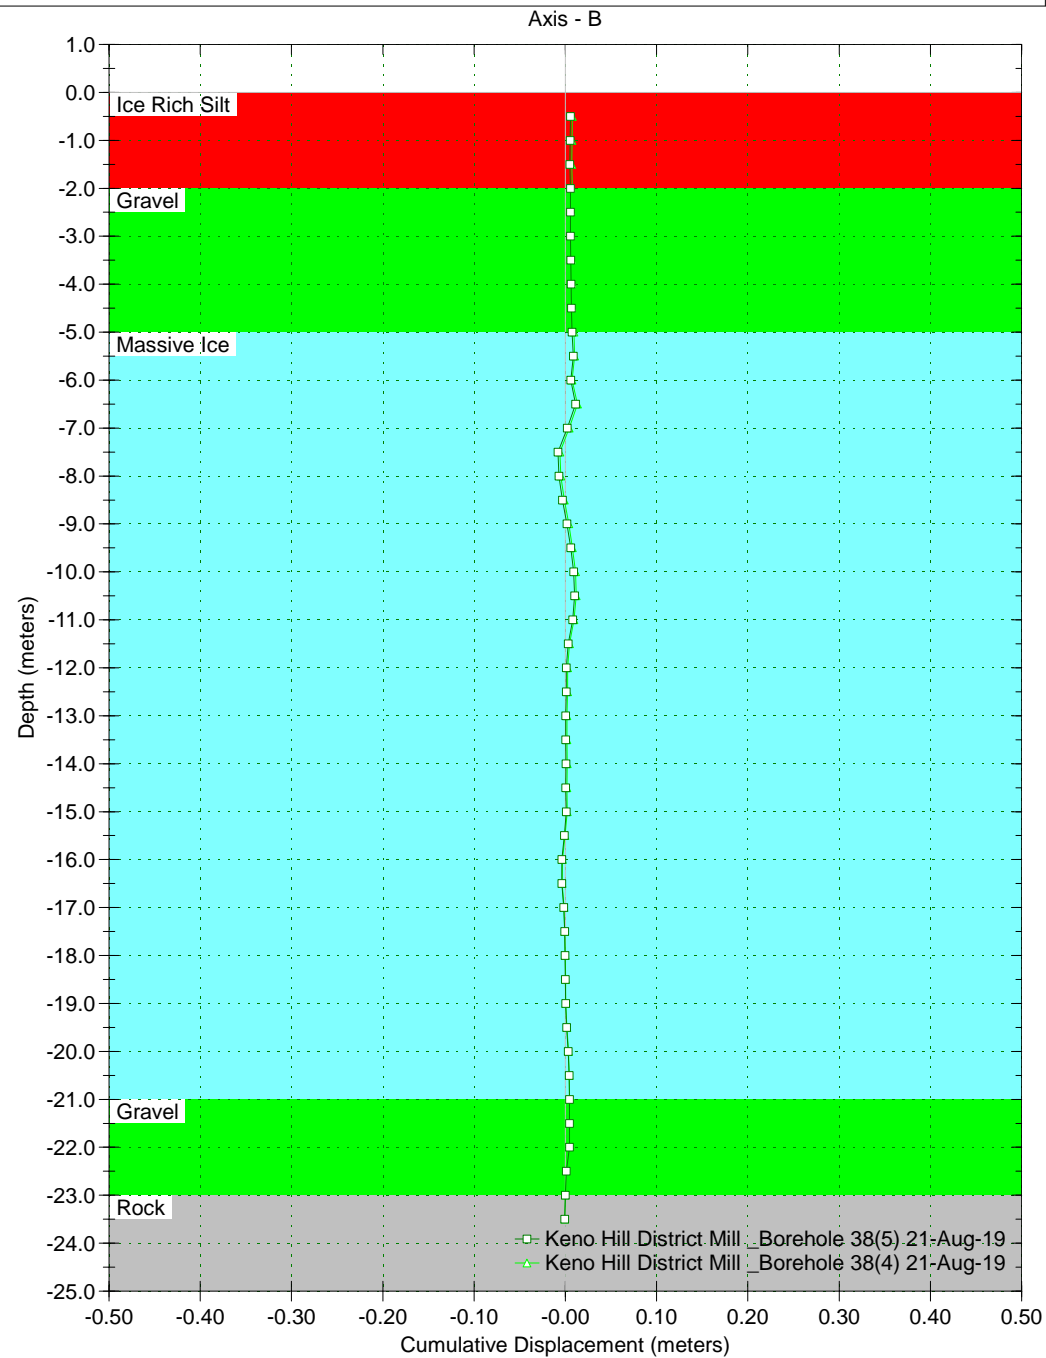
Borehole : Borehole 38
Project : Keno Hill District Mill
Location : DSTF
Northing : 7087034
Easting : 483969
Collar :

Ice accumulated at the bottom two metres of BH38 and should be cleaned out and preserved using liquid suitable for use in permafrost conditions. The slope indicator located at BH28 was blocked approximately 3.7 m below the top of the instrument. This instrument has been non-operational for several years and should be replaced.
