November 17, 2020

ISSUED FOR USE  
FILE: 704-ENG.WARC03869-01  
Via Email: lbroughton@alexcoresource.com

**Subject:** 2020 Annual Geotechnical Inspection – Mining Related Structures  
Bellekeno Mine – Keno City, YT

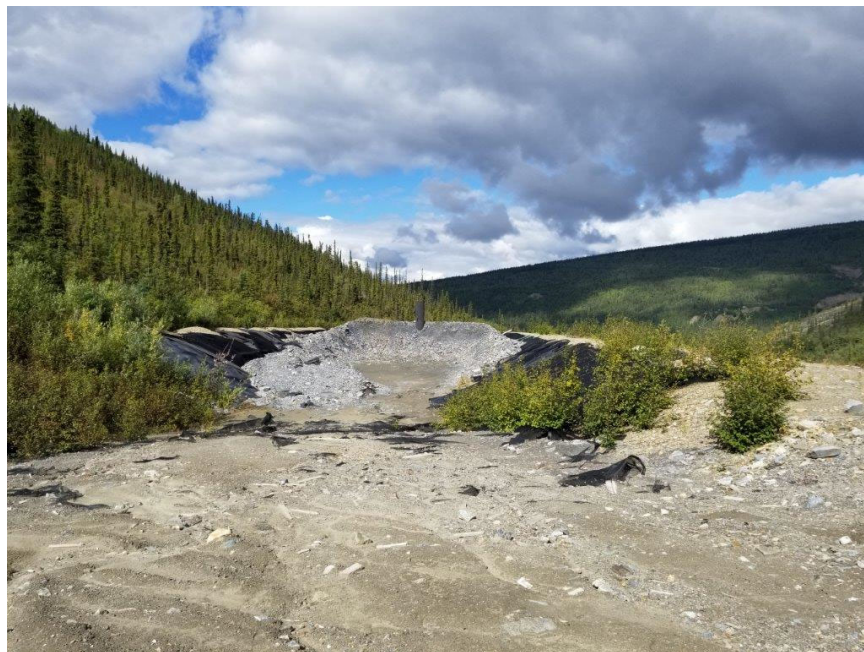
The PAG waste storage facility is located south of the Bellekeno portal, as shown on Figure 1. The facility has not been used since mining operations were suspended in 2013, but currently contains some volume of waste rock. At the time of the inspection, the perimeter berms appeared intact with no visible sign of instability (Photo 1). No remedial action is required.

**Photo 1 - Bellekeno PAG Storage Facility (August 18/20)**

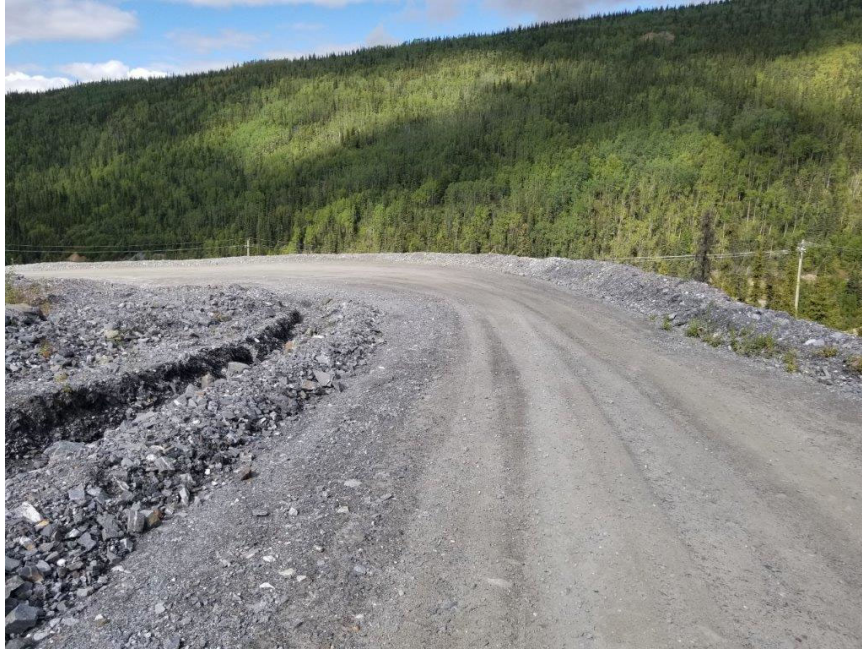
The Bellekeno waste rock pile forms a portion of the Bellekeno Haul Road and is located north of the Bellekeno portal, as shown on Figure 1. At the time of the inspection the side slopes of the waste rock pile appeared to be intact and stable. No remedial action is required.

**Photo 2 – Bellekeno Road Waste Rock Pile/Haul Road (August 18/20)**

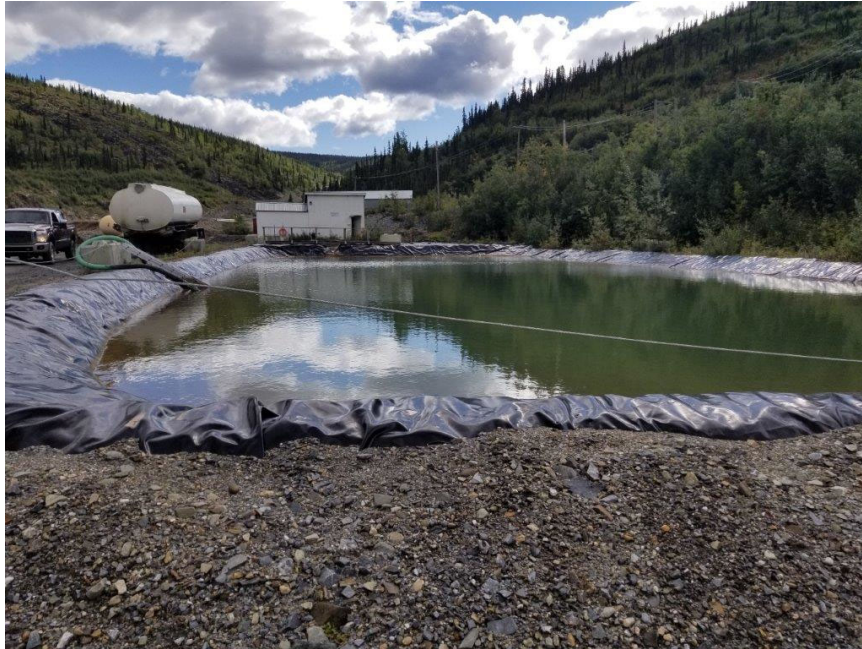
The Bellekeno 625 water treatment ponds are located north of the Bellekeno 625 portal, as shown on Figure 1. The facility consists of two water treatment ponds that were both operating at the time of inspection. The primary treatment pond was operating at the discharge invert elevation with a freeboard of 0.5 m below the perimeter berm crest at the time of the inspection. The secondary pond was also operating at the discharge elevation, with a freeboard of 0.5 m in the south end. Treated water discharges through an HDPE pipe onto the hillside above Lightning Creek. A small rip in the liner was identified at the south end crest of the secondary pond, above and outside the water pond. The rip appeared to be caused by equipment operating around the pond and should be monitored and repaired if conditions worsen and it could potentially affect pond water containment.

**Photo 3 - Bellekeno 625 Water Treatment Ponds (August 18/20)**

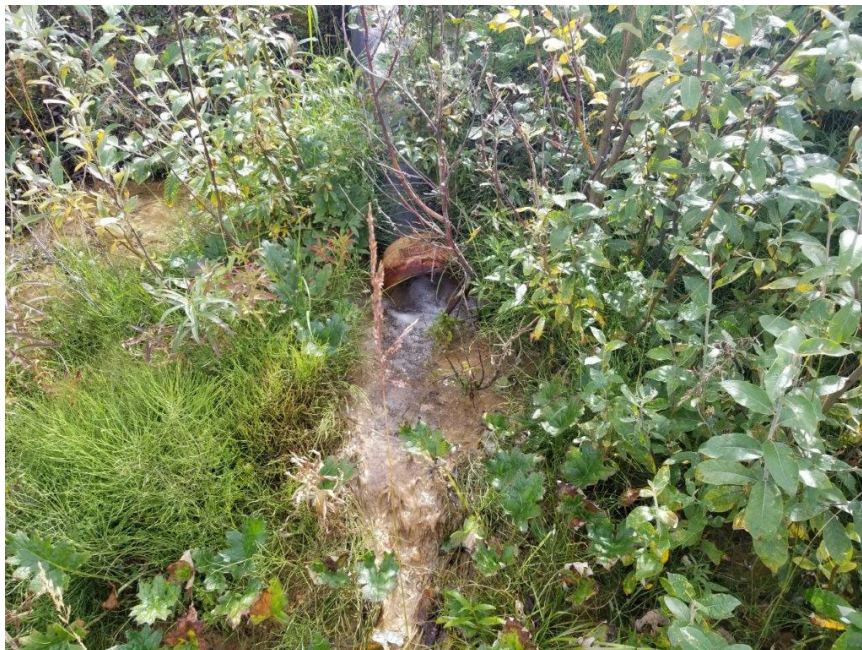
The pipe from the treated water pond discharges directly onto the natural soils above Lightning Creek without any protection from erosion. The discharge pipe was still unhooked at a coupler upstream from the original discharge location. The outlet of the pipe has subsided into the ground and only the top half of the pipe was exposed, and the ground was starting to erode. The pipe should be elevated or moved so that the outlet is unobstructed. If further erosion takes place, riprap armoring must be installed.

**Photo 4 - Bellekeno 625 Water Treatment Ponds, Discharge Location (August 18/20)**

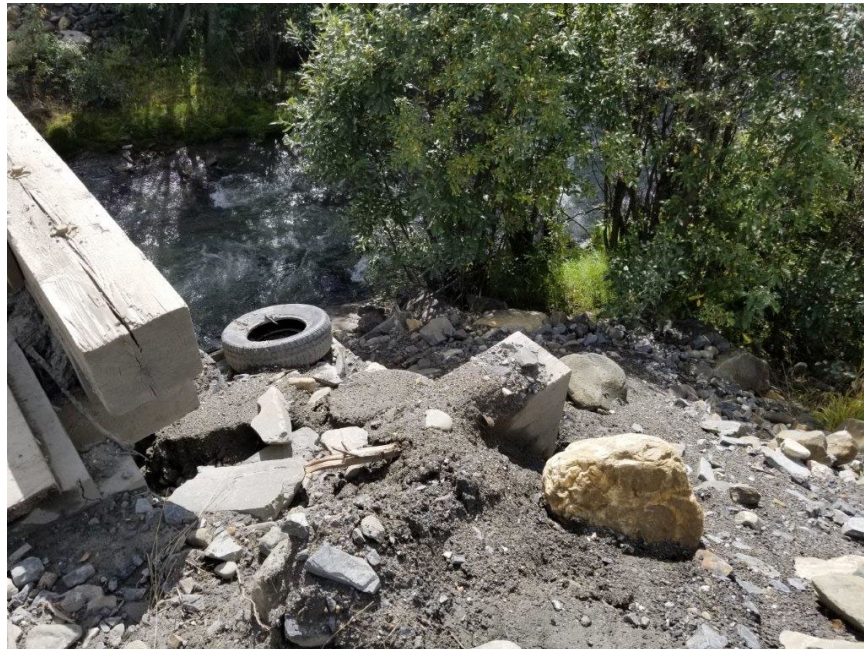
As identified in the previous year's inspection, the approaches and safety berms have undergone erosion and are starting to become undermined by washout. It is recommended that the eroded areas be backfilled with coarse rock and the berms built up to maintain stability. Debris (tires, etc.) accumulated on the downslope side should be removed before backfilling. If coarse rock is used for the safety berm surface drainage would not be impeded, but it must be directed so that the berm is not eroded away.

**Photo 5 - Bellekeno Haul Road, Approach Erosion (August 08/20)**

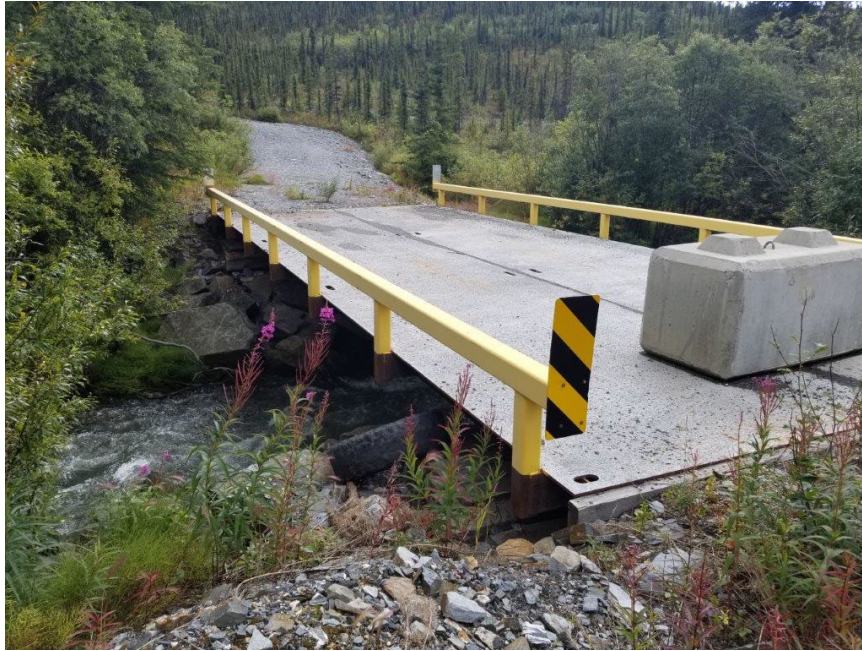
The Lightning Creek Bridge on the Onek Road is located east of Keno City, as shown on Figure 1. The bridge is a single span steel structure founded on earth filled timber cribbing abutments. The abutments were stable at the time of the inspection and are sufficiently protected from erosion by riprap, as shown in Photo 6 below. No remedial action is required for the Lightning Creek Bridge on the Onek Road at this time.

**Photo 6 - Lightning Creek Bridge Abutments, Onek Road (August 18/20)**

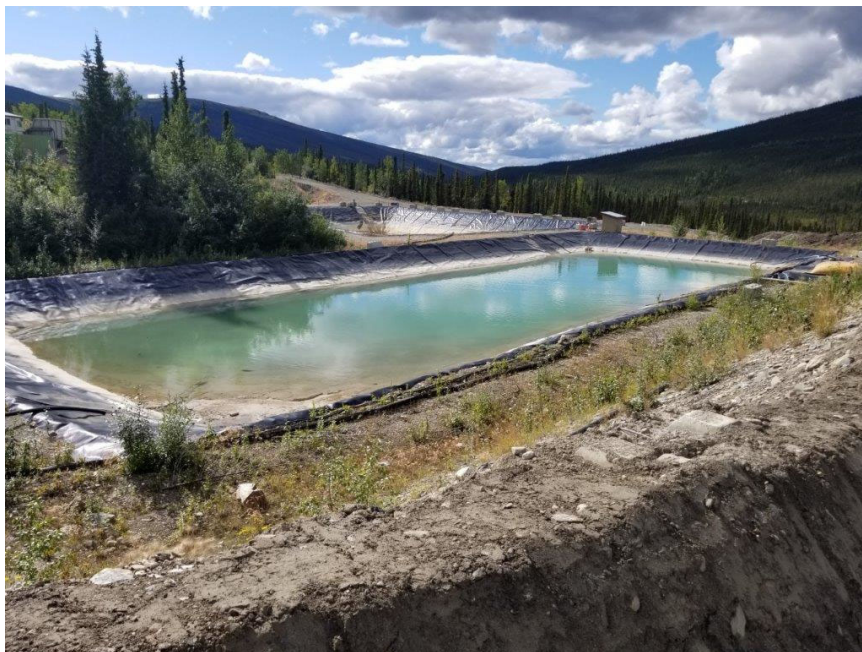
The two mill water storage ponds are located at the Keno Hill District Mill Site, west of Keno City, as shown on Figure 1. At the time of the inspection the mill was not operating, but both ponds contained some water, with a freeboard of about 2 m below the perimeter berms in the older pond, and an estimated 6 m of freeboard in the newer pond. No remedial action is required for these ponds.

**Photo 7 - Mill Water Storage Ponds (August 18/20)**

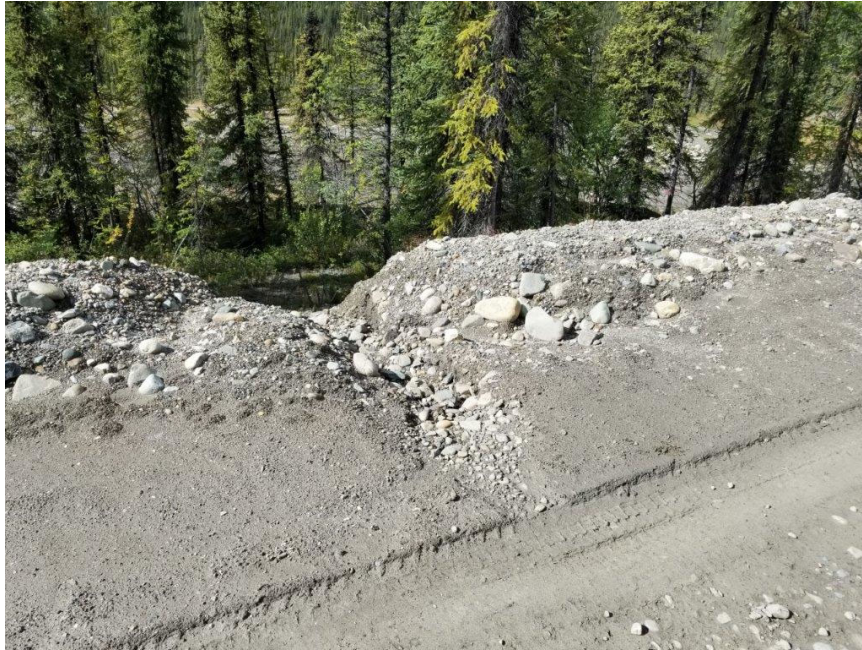
The access road on the west side of the ponds has shown signs of erosion in three areas. The berms on the road should be restored to direct drainage away and reduce further erosion, and the safety berms should be restored. If necessary, surface drainage should be directed in a controlled manner to a riprap protected half-culvert down the slope.

**Photo 8 - Mill Storage Ponds, Access Road Erosion (August 18/20)**

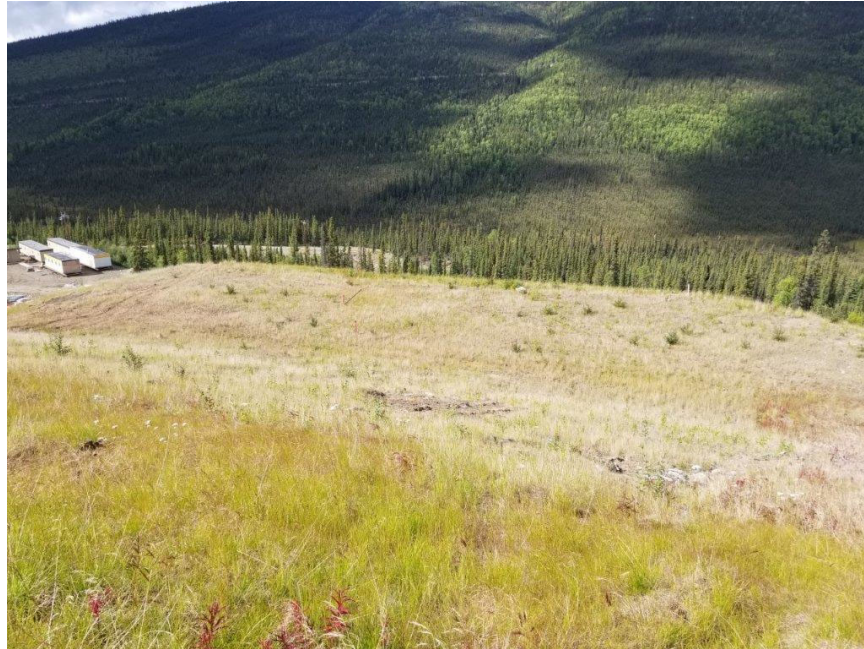
Several tension cracks on the DSTF surface that were observed last year have been repaired by shallow excavation, backfilled with the excavated material capped with glacial till, and then compacted with the backhoe bucket. The location of the cracks is shown on Figure 1. All of these locations should continue to be monitored and repaired as necessary over the year so that the potential for water ingress into the DSTF is reduced. Ideally, the repairs should be capped higher than the surrounding terrain to keep surface runoff water away.

**Photo 9 – DSTF Surface Showing some Repaired Tension Cracks (August 18/20)**

It is recommended that the locations of all these tension cracks be mapped, and new locations (if any), along with associated photographs, be added to an annual survey and submitted to the geotechnical engineer. The annual survey should be done in the spring, prior to any repairs.

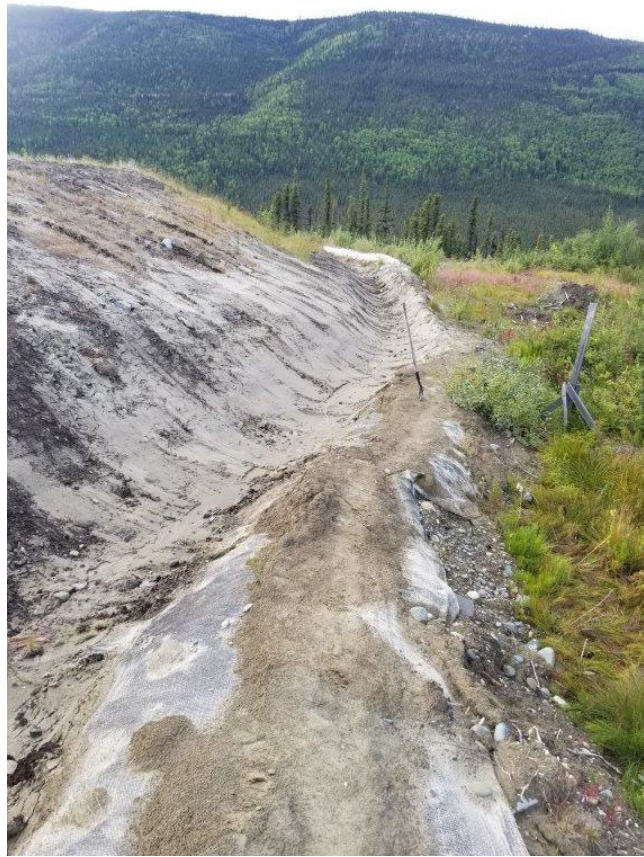
The diversion ditch around the side and base of the DSTF was cleaned out, but in the process the slope of the DSTF was locally increased. This area should be monitored for stability and erosion, and then repaired as required. The placement of riprap armouring in the ditch would assist in slowing runoff water velocity and minimizing future erosion/transport of tailings down the ditch.

**Photo 10 - DSTF Diversion Ditch (August 18/20)**

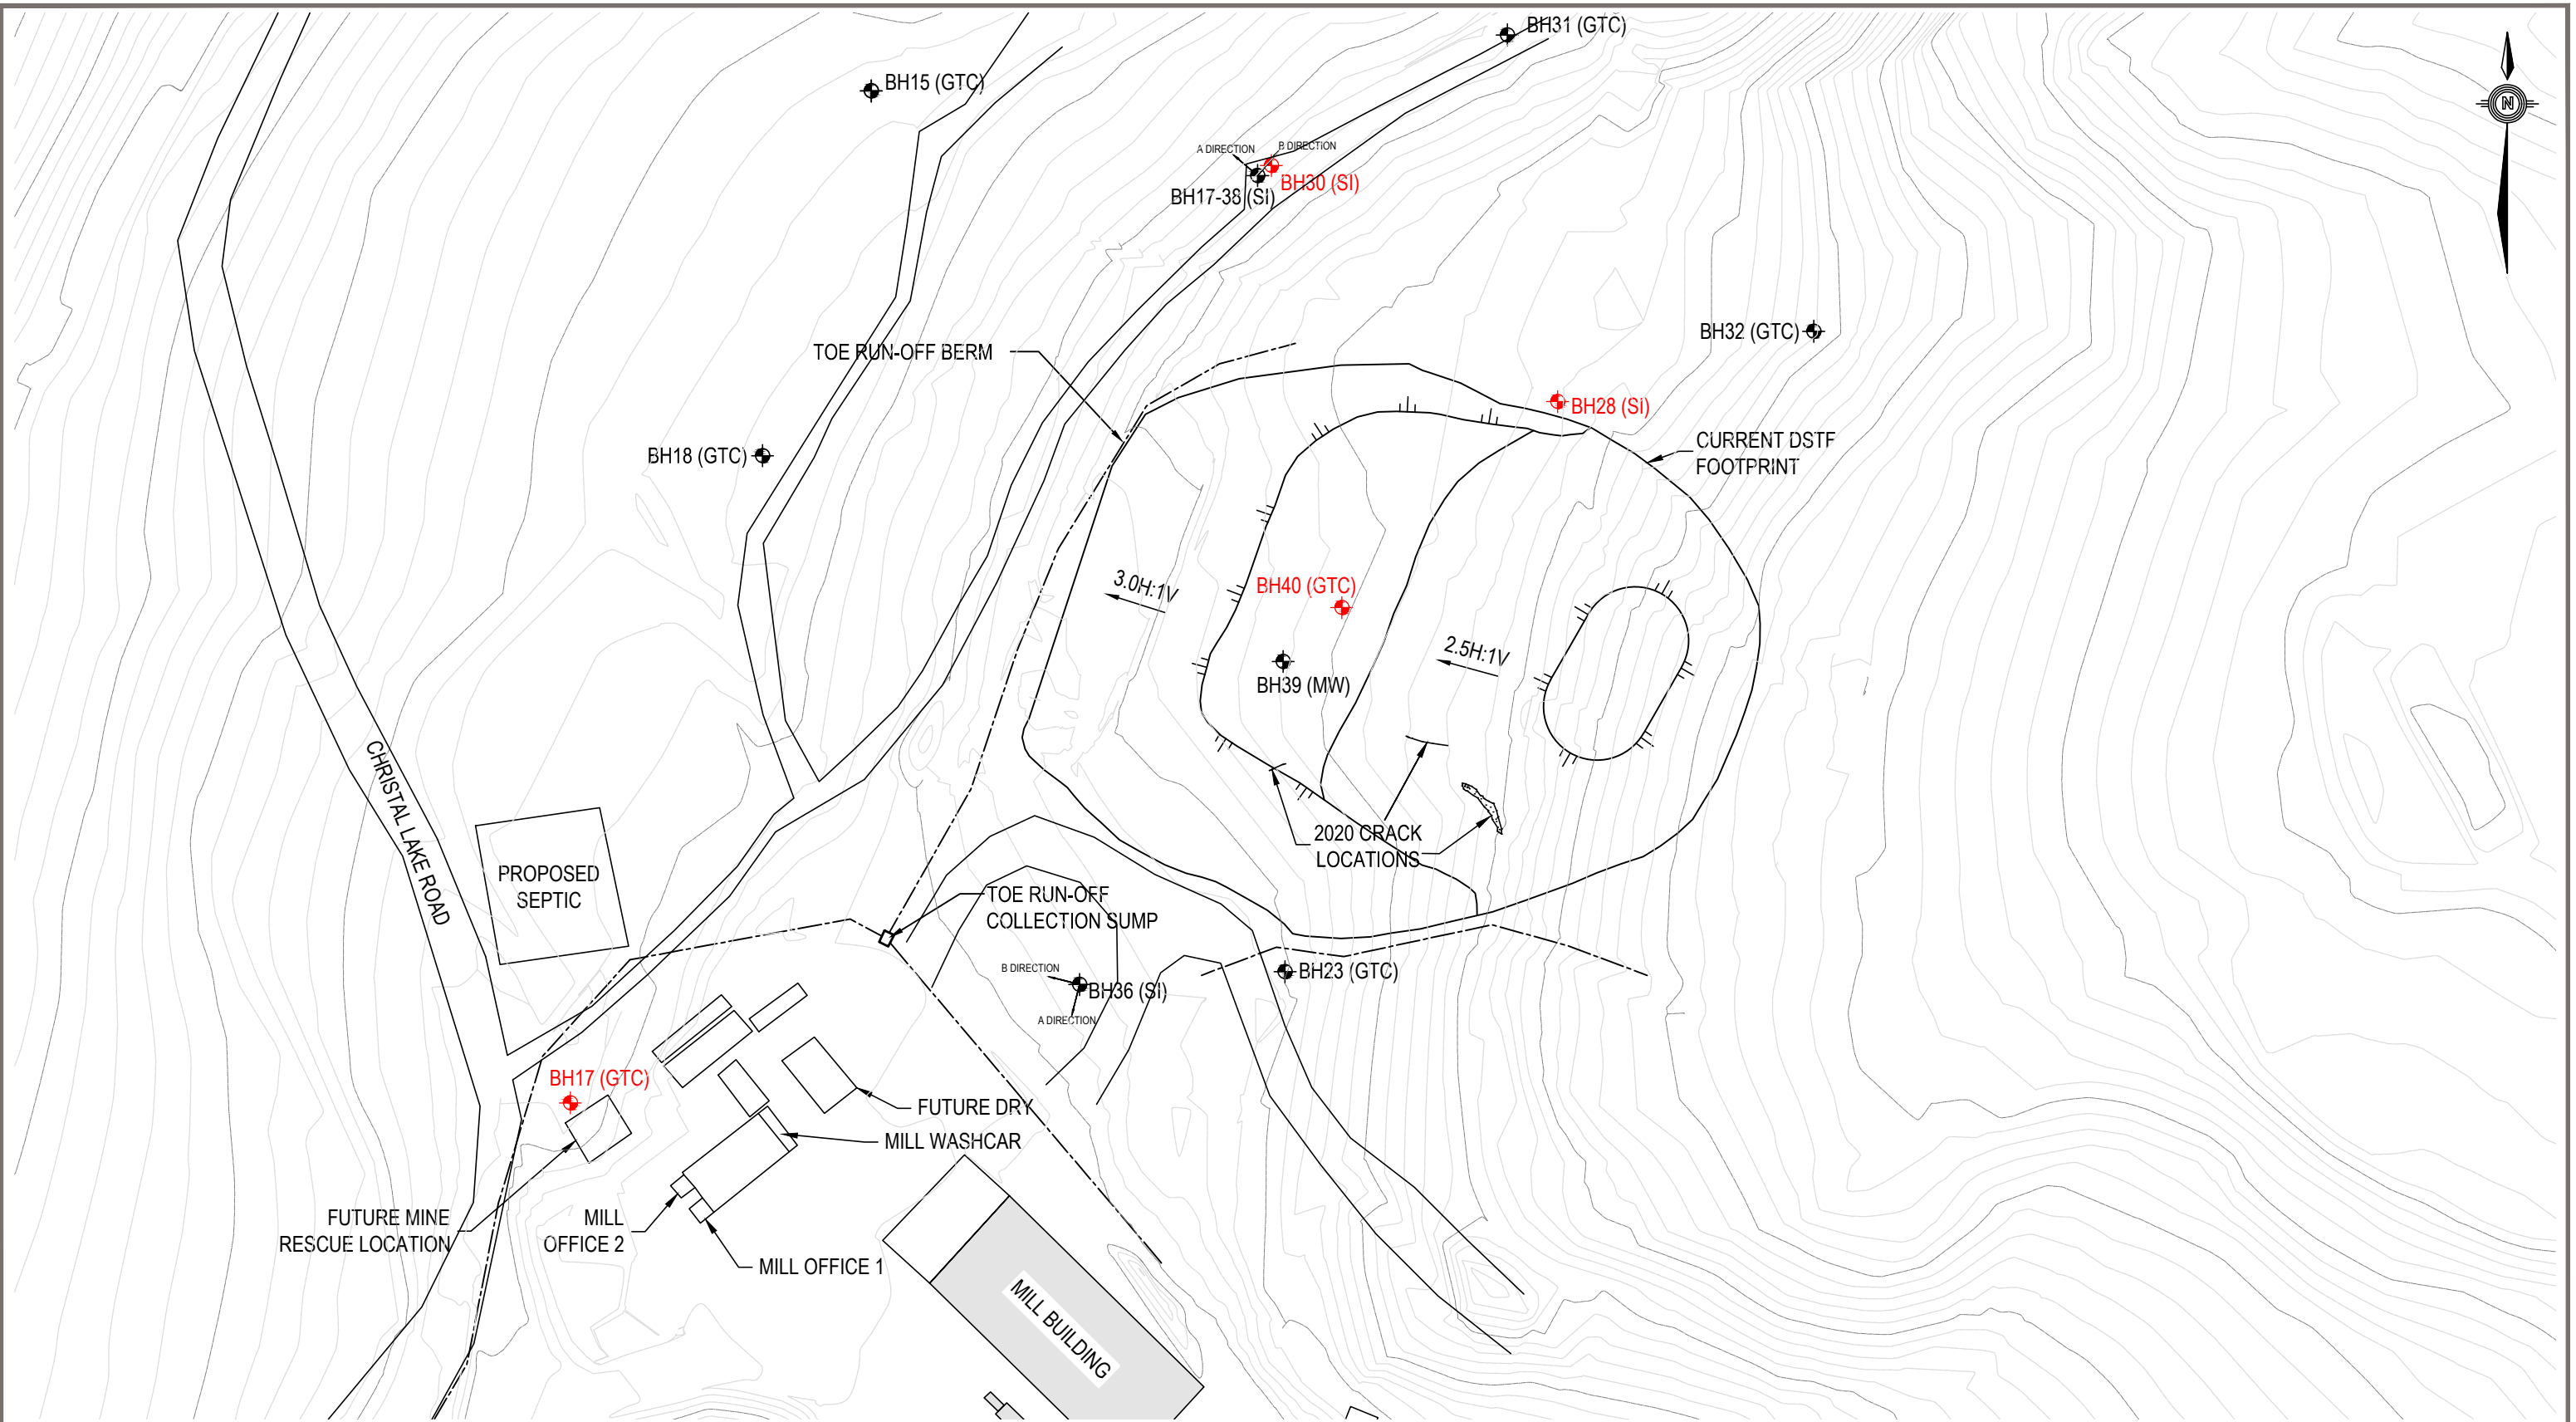
<b>2020 AKHM ANNUAL INSPECTION BELLEKENO MINE SITE - KENO CITY, YUKON</b>				
<b>SITE PLAN SHOWING BOREHOLE AND INSTRUMENTATION LOCATIONS</b>				
PROJECT NO. ENG.WARC03869-01	DWN TP	CKD JRT	REV 0	<b>Figure 2</b>
OFFICE EBA-WHSE	DATE August 24, 2020

It should be noted that some critical instrumentation located within and adjacent to the DSTF is in need of repair and/or replacement. As further described below, the ground temperature cable in the centre of the DSTF (BH40) is the most critical of these installations and must be replaced as soon as a drill is available.

**NOTE**  
 INSTRUMENTATION SHOWN IN RED HAS BEEN DAMAGED OR DESTROYED AND IS NOT READABLE. SOME OF THESE NEED TO BE REPAIRED AND/OR REPLACED. SEE ACCOMPANYING REPORT TEXT.

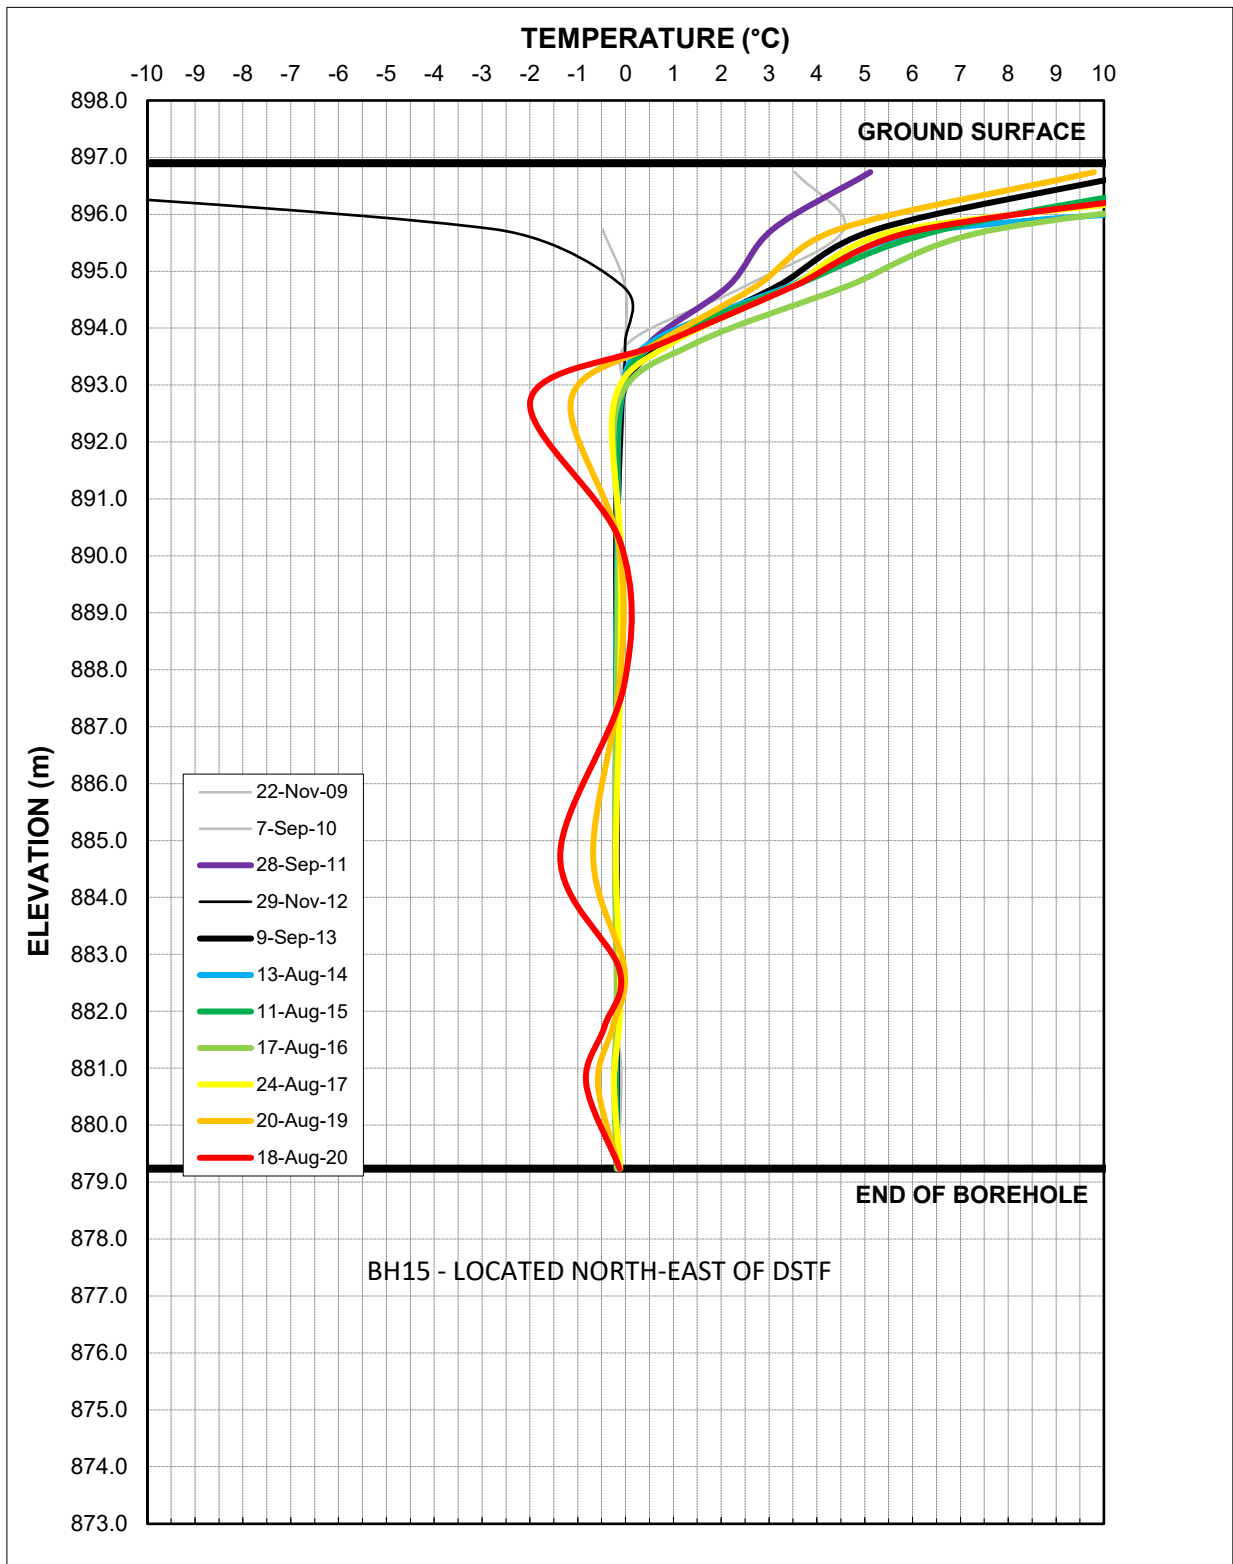
**Ground Temperature Profile**  
**Keno Hill District Mill Site Borehole BH15**  
**Figure T1**

As indicated on the updated ground temperature profiles included in Appendix B, the ground temperatures near surface have stabilized. Ground temperature at depth have indicated that ground temperature has decreased over the last few years. Some of the beads on ground temperature cables indicating temperatures less than  $-3^{\circ}\text{C}$  may

Access to BH15 and BH18 has overgrown with vegetation over the years and should be cleared to allow access for future monitoring.

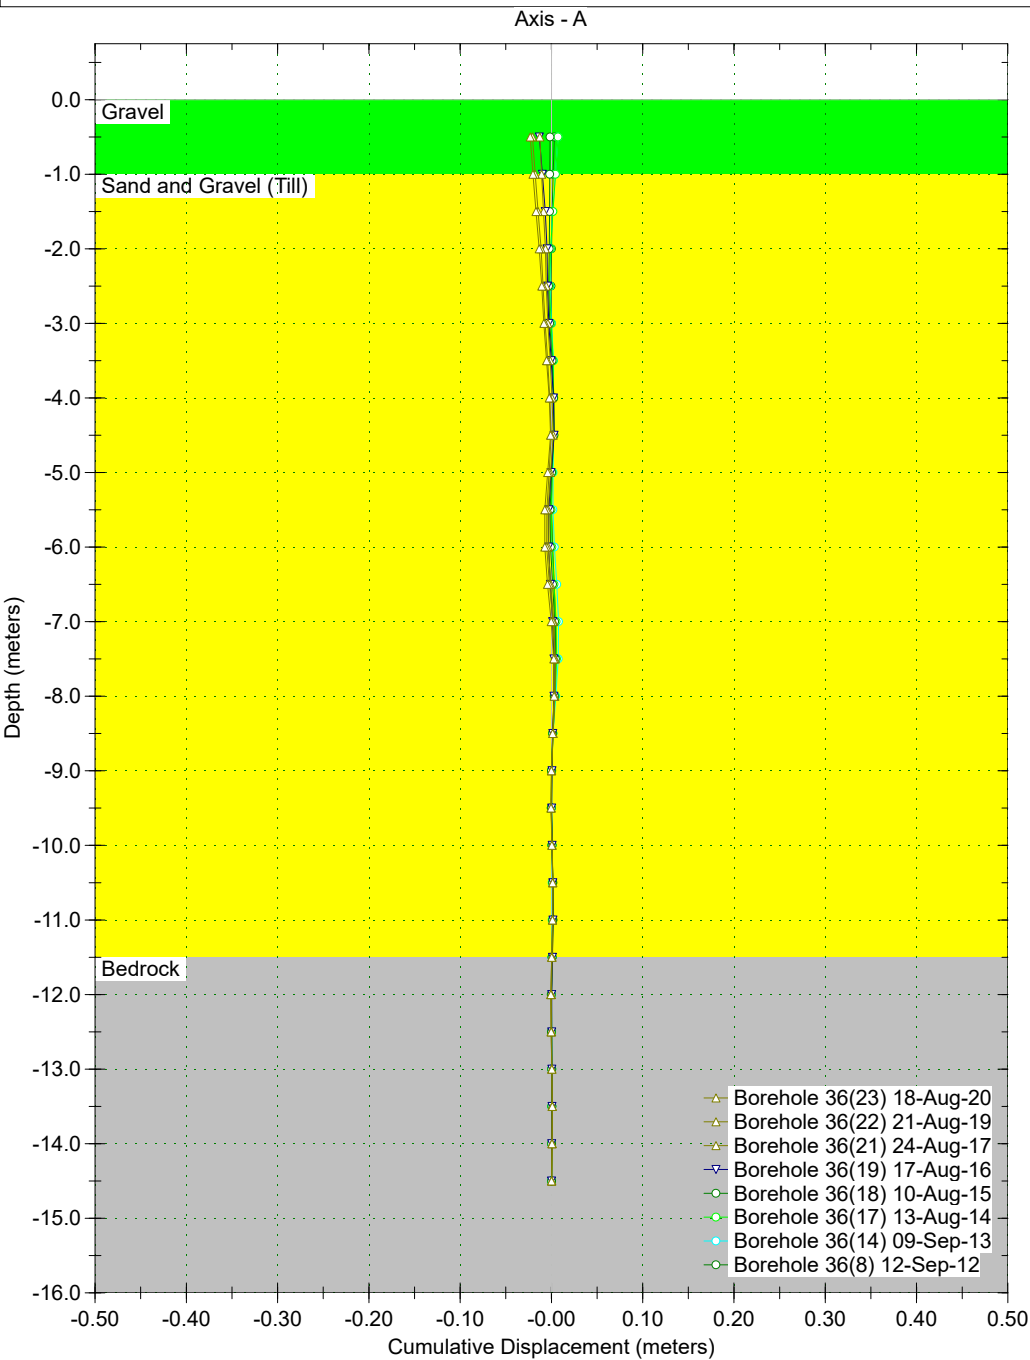
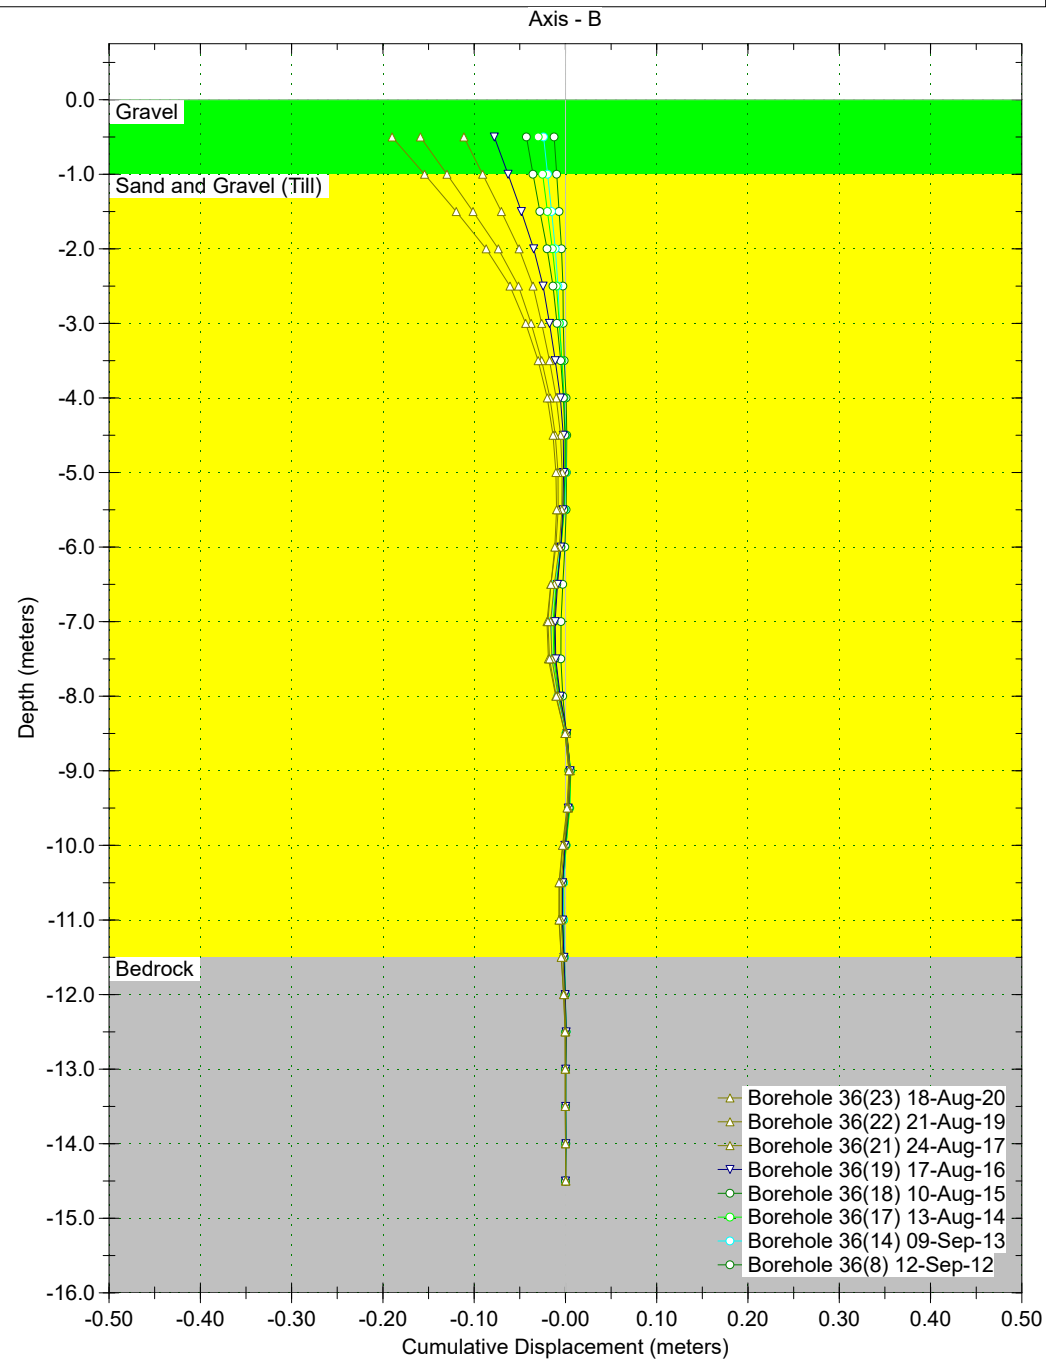
Borehole : Borehole 36  
Project : Keno Hill District Mill  
Location : DSTF  
Northing : 7086872  
Easting : 483931  
Collar : 908.1

BH36 has also shown approximately 0.2 m of lateral displacement starting about 4 m below surface along the B-axis of the slope indicator (strike direction of the DSTF) since it was originally installed. Alexco has excavated an area to the north west of the slope indicator to use as a laydown area. The movement identified in BH36 is in the direction of the laydown, and the displacement is considered as “creep” (or relaxing) of the soil towards the excavation. The movement is not a concern at this time, but annual monitoring should continue.

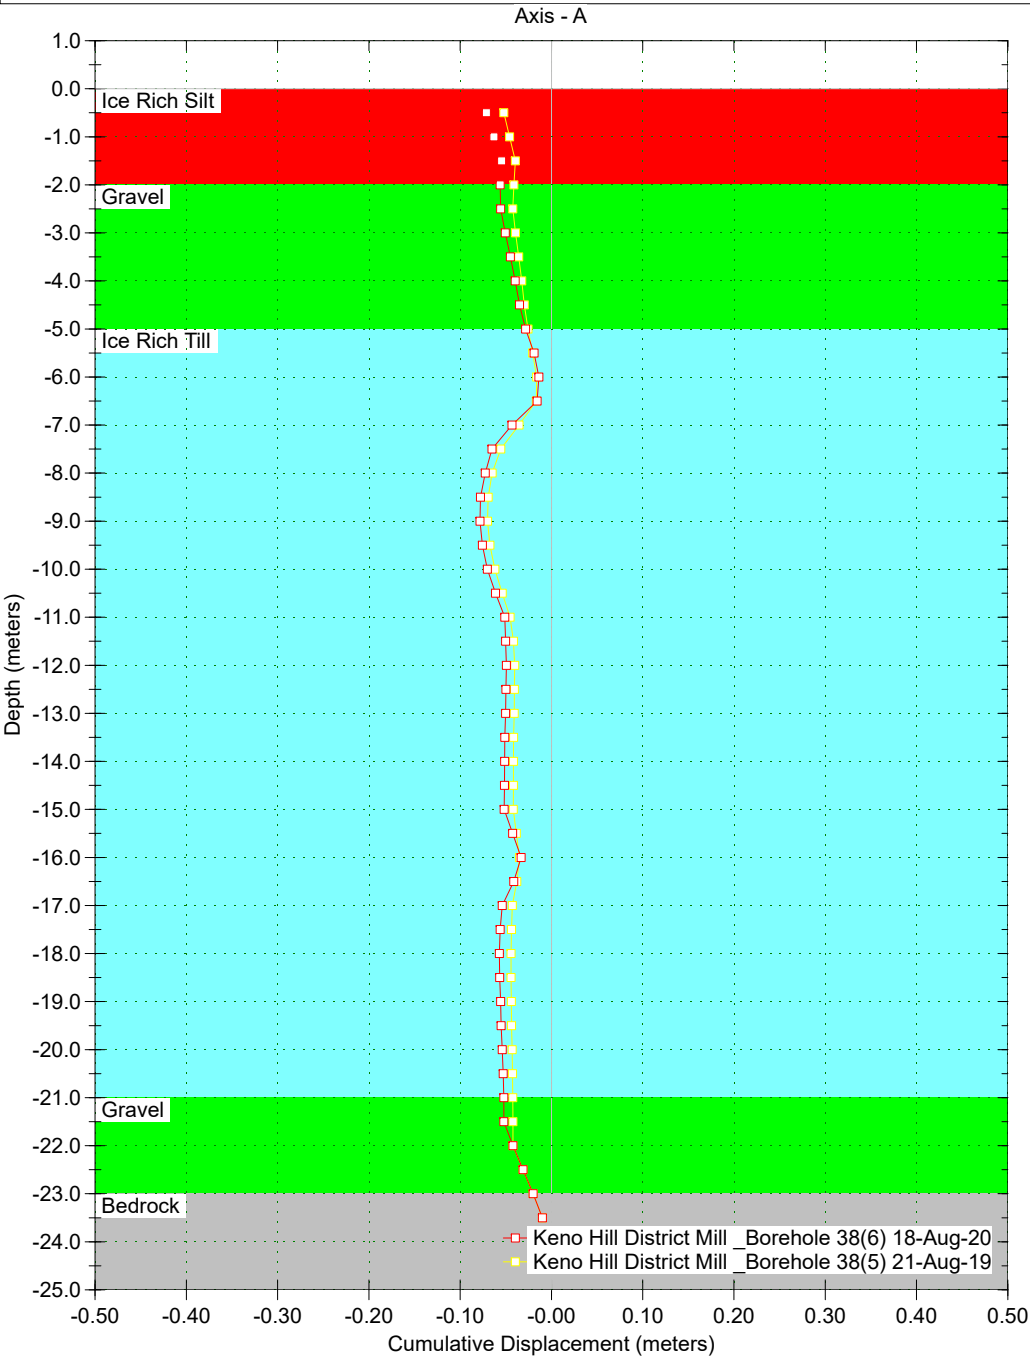
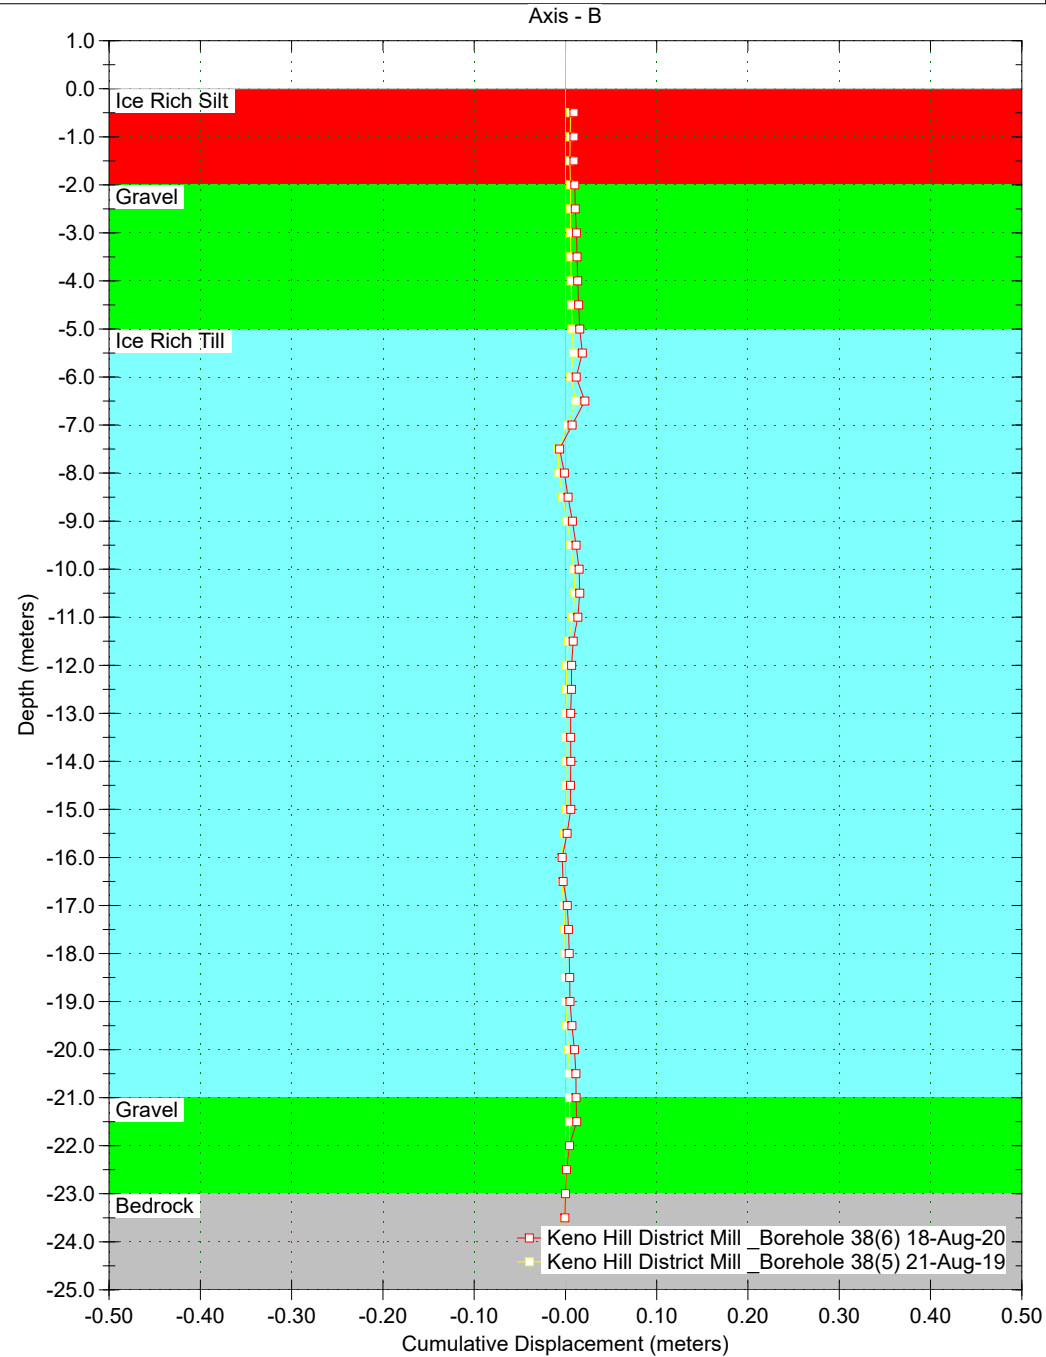
Borehole : Borehole 38  
 Project : Keno Hill District Mill  
 Location : DSTF  
 Northing : 7087034  
 Easting : 483969  
 Collar : 907.6

An updated lateral movement profile developed from readings collected from the slope indicators installed in BH36 and BH38 in natural soils adjacent to the DSTF is included in Appendix C. Lateral movement that ranged from 50 mm to 80 mm was identified in BH38. Tetra Tech does not consider this movement to be of concern at this time, but annual monitoring should continue.

Ice accumulated at the bottom two metres of BH38 and should be cleaned out and preserved using liquid suitable for use in permafrost conditions. The slope indicator located at BH28 is blocked and was not recorded. This instrument has been non-operational for several years and should be replaced.
