November 30, 2021

Alexco Keno Hill Mining Corp.  
Suite 1225 – 555 Burrard St.  
Vancouver. BC  
V7X 1M9

**Subject:** 2021 Annual Geotechnical Inspection – Mining Related Structures  
Bellekeno Mine – Keno City, YT

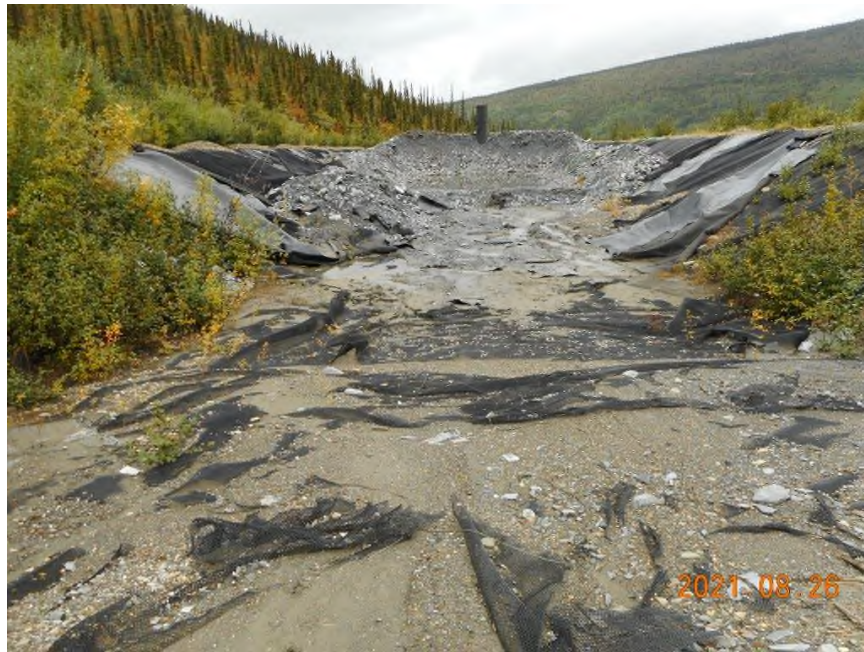
The PAG waste storage facility is located south of the Bellekeno portal, as shown on Figure 1. The facility has not been used since mining operations were suspended in 2013, but currently contains some volume of waste rock. At the time of the inspection, the perimeter berms appeared intact with no visible sign of instability. Some water was accumulated in the base of the storage facility and the entrance was in rough shape. If the PAG is extended beyond the access berm, the berm, liner, and underlay should be replaced and repaired. It is understood that this PAG material will eventually be moved back underground.

Photo 1: Bellekeno PAG Storage Facility (August 26/21)

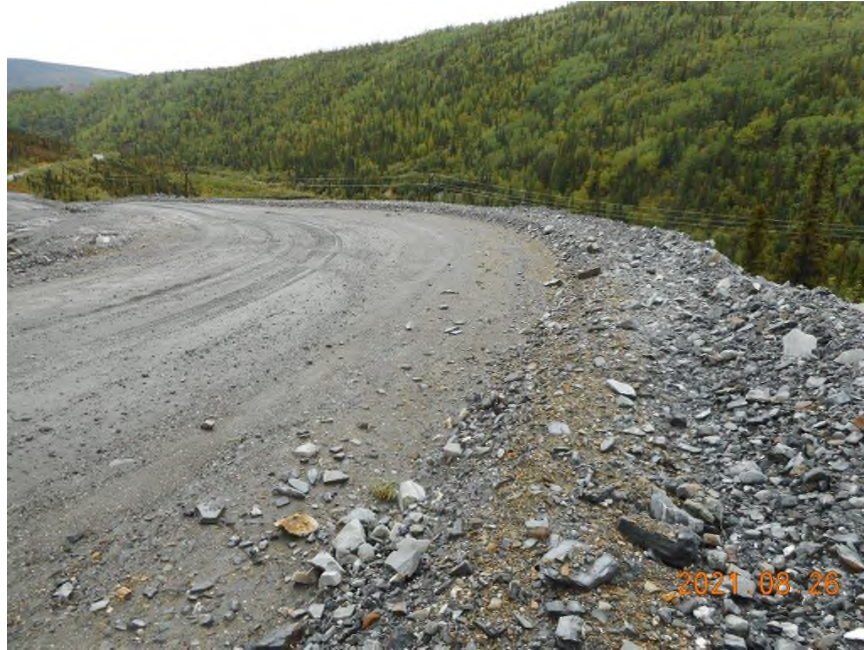
The Bellekeno waste rock pile forms a portion of the Bellekeno Haul Road and is located north of the Bellekeno portal, as shown on Figure 1. At the time of the inspection the side slopes of the waste rock pile appeared to be intact and stable. No remedial action is required.

Photo 2: Bellekeno Road Waste Rock Pile/Haul Road (August 26/21)

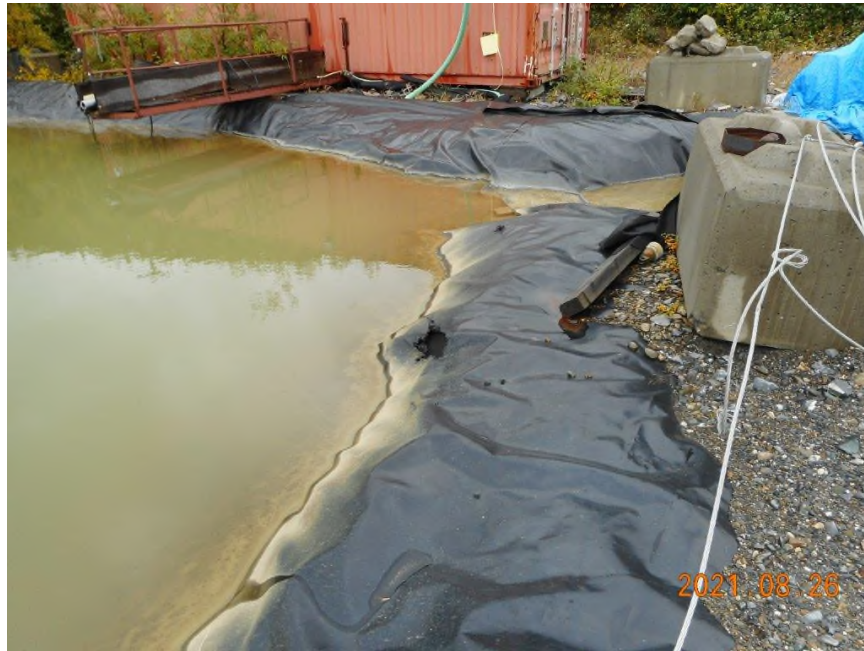
A small rip in the liner was identified at the end of the secondary pond, above the water and near pond outlet. The rip should be repaired.

Photo 3: Small Rip in Liner at Bellekeno 625 Water Treatment Ponds (August 26/21)

| Structure | Stability Recommendations | Maintenance Recommendations |
|--|---|--|
| Bellekeno 625 Water Treatment Ponds | <ul style="list-style-type: none"> <li>▪ None</li> </ul> | <ul style="list-style-type: none"> <li>▪ Repair rip near secondary pond outlet;</li> <li>▪ Discharge line unhooked at coupler. Lift or move discharge hose to clear outlet. Monitor erosion and place riprap if required.</li> </ul> |

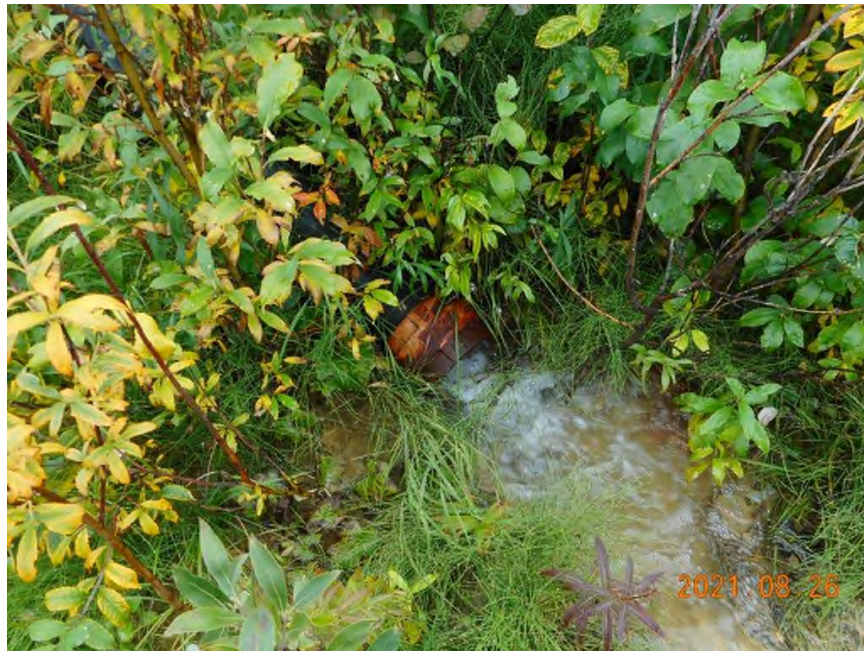
The pipe from the treated water pond discharges directly onto the natural soils above Lightning Creek without any protection from erosion. The discharge pipe was still unhooked at a coupler upstream from the original discharge location. The outlet of the pipe has subsided into the ground and only the top half of the pipe was exposed, and the ground was starting to erode. The pipe should be elevated or moved so that the outlet is unobstructed. If further erosion takes place, riprap armoring must be installed.

Photo 4: Bellekeno 625 Water Treatment Ponds, Discharge Location (August 26/21)

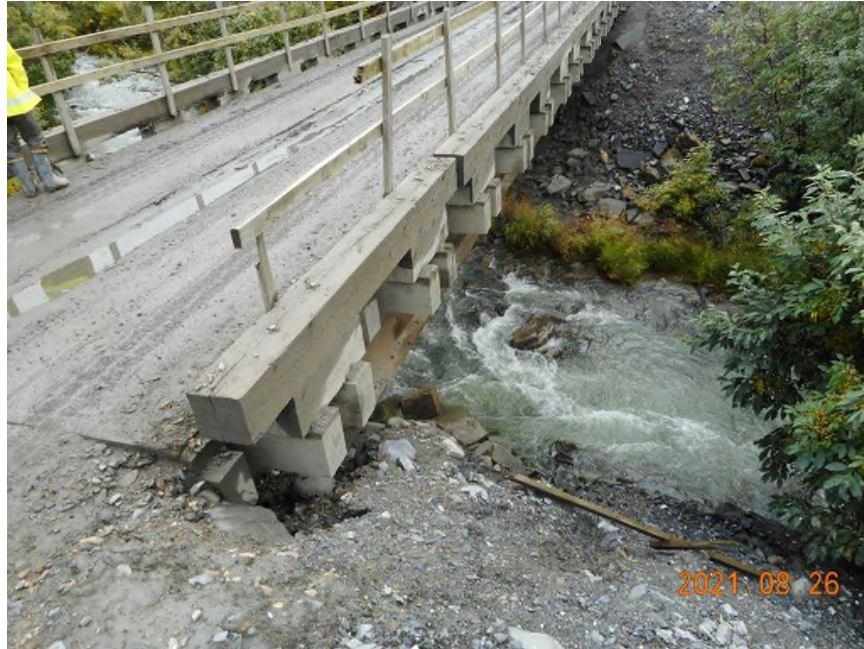
Minor erosion was identified near the bridge abutment as shown in Photo 5. This erosion should be backfilled with coarse rock and the berms built up to maintain stability. The abutments should be monitored for future erosion.

Photo 5: Bellekeno Haul Road, Approach Erosion (August 26/21)

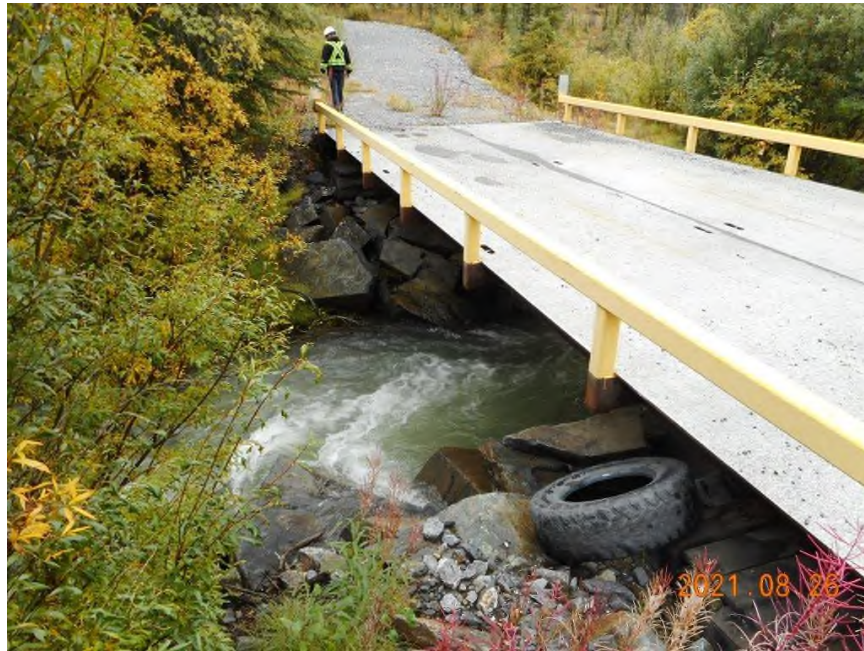
The Lightning Creek Bridge on the Onek Road is located east of Keno City, as shown on Figure 1. The bridge is a single span steel structure founded on earth filled timber cribbing abutments. The abutments were stable at the time of the inspection and are sufficiently protected from erosion by riprap. No remedial action is required for the Lightning Creek Bridge on the Onek Road at this time.

Photo 6: Lightning Creek Bridge Abutments, Onek Road (August 26/21)

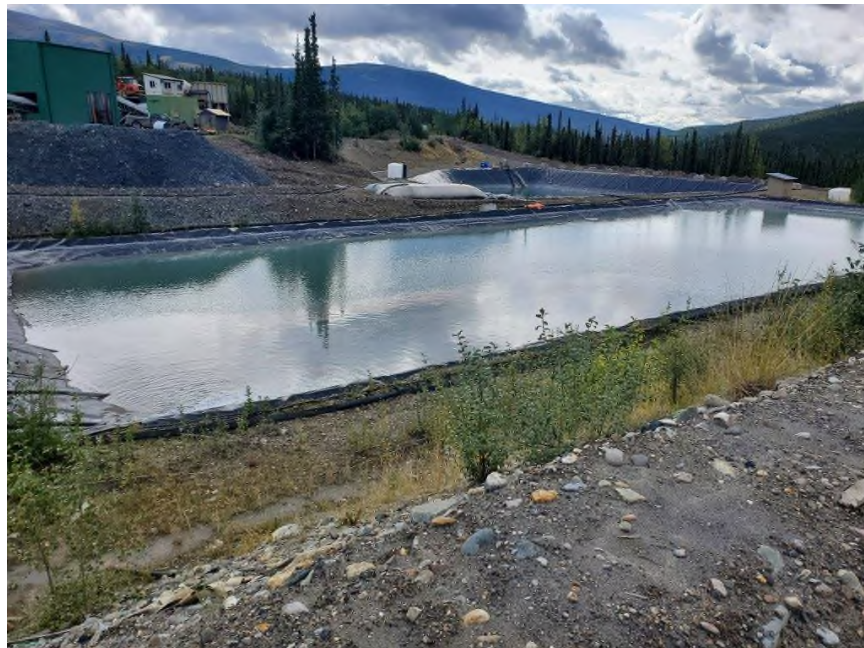
The two mill water storage ponds are located at the Keno Hill District Mill Site, west of Keno City, as shown on Figure 1. At the time of the inspection the mill was operating, and both ponds contained some water with a freeboard of about 1.2 m below the perimeter berms in the older pond, and an estimated 2.4 m of freeboard in the newer pond. No remedial action is required for these ponds.

Photo 7: Mill Water Storage Pond (August 26/21)

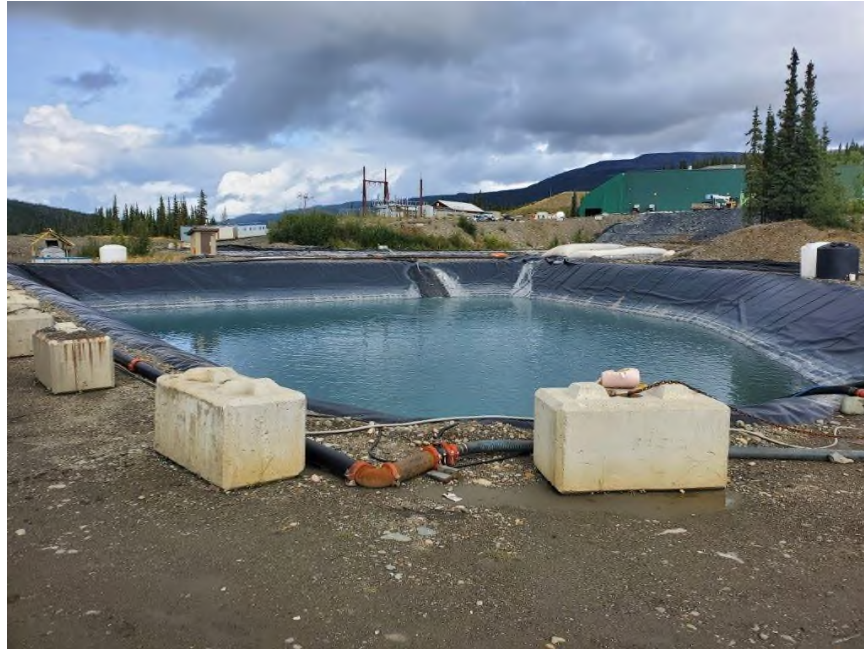
Photo 8: Mill Water Storage Pond (August 26/21)

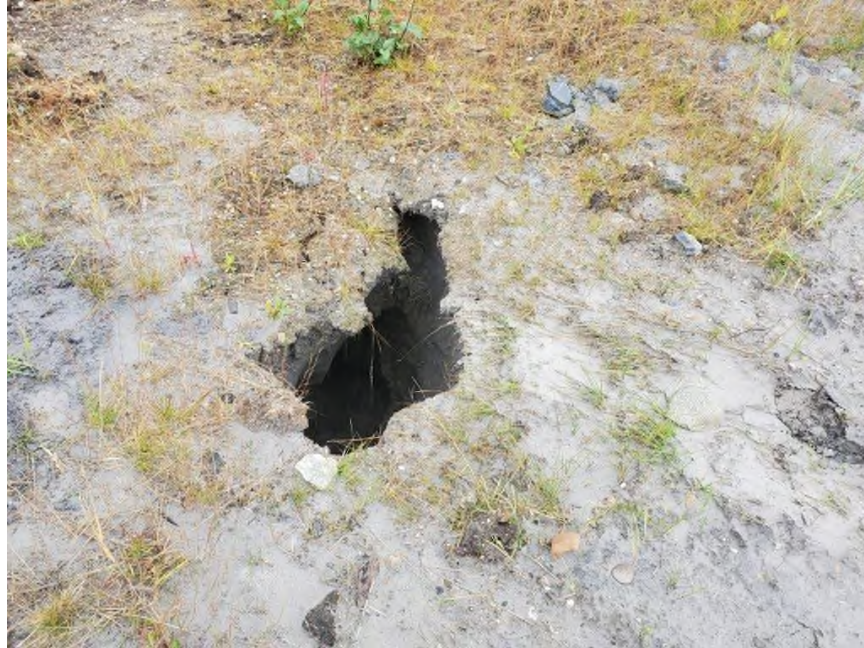
- A “sinkhole” and blow out (Photo 9 and Photo 10) were identified on the north end of the DSTF;
- Where the new tailings were placed, precipitation caused some tailings to erode (Photo 11) and accumulate in the runoff collection ditch;
- A shallow rotational failure (Photo 12) was identified on the north end of the DSTF, which has filled the runoff collection ditch; and
- A tension crack on the surface of the DSTF was observed near the approximate location of a tension crack identified in previous inspections.

Photo 9: DSTF Sinkhole (August 26/21)

The approximate location of all instabilities identified during the inspection are shown on Figure 2. The runoff berm should be cleaned out of tailings and other material from the shallow failure. The erosion gullies should be repaired, and the tailings should either be reclaimed or temporarily covered to reduce future erosion. The sinkhole, blow out, shallow failure, and tension cracks should be excavated to competent ground (no deeper than 2.5 m or to the liner), backfilled with excavated soil, and compacted with a backhoe bucket. The replaced material should be sloped no steeper than 3H:1V.

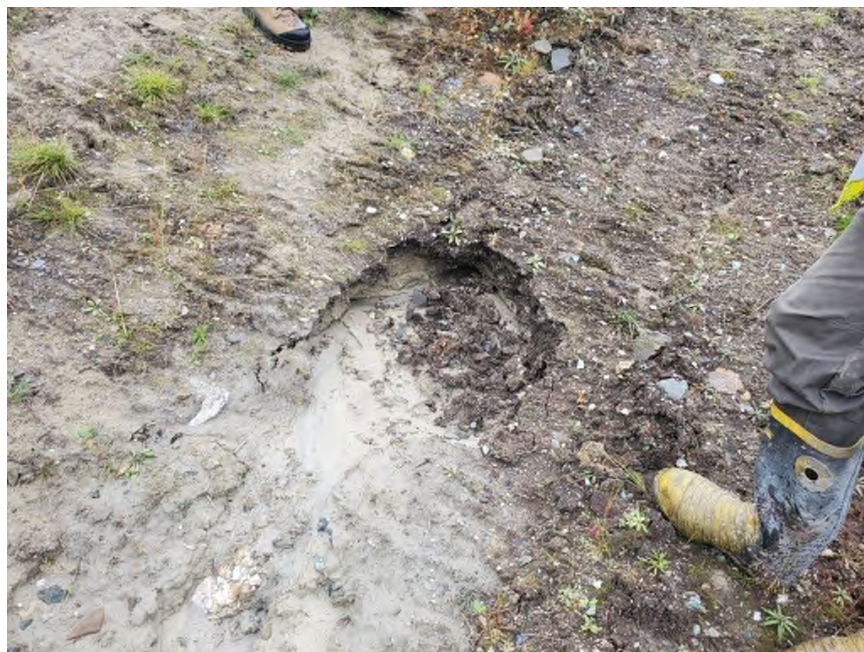
Photo 10: DSTF Blow-Out (August 26/21)

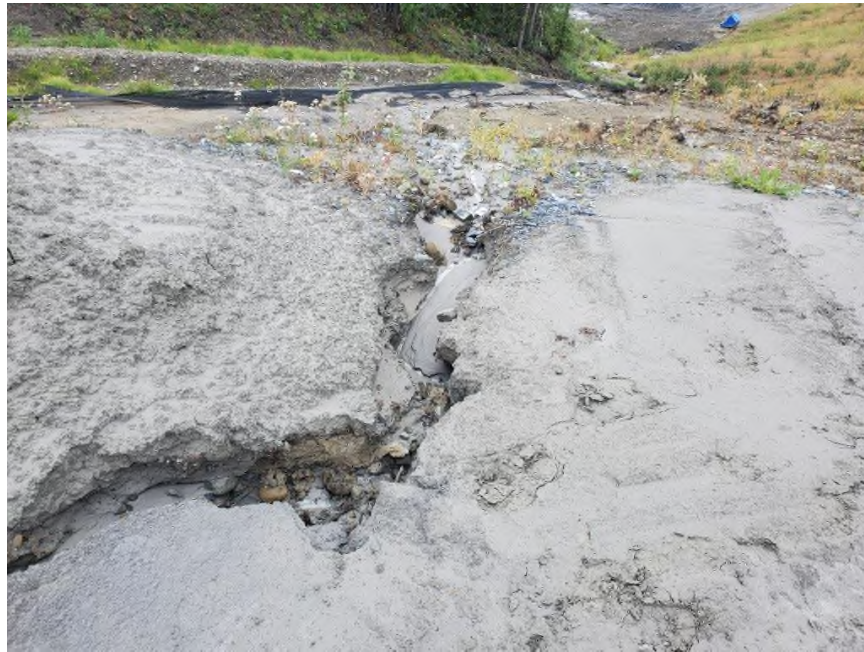
Photo 11: DSTF Tailings Erosion (August 26/21)

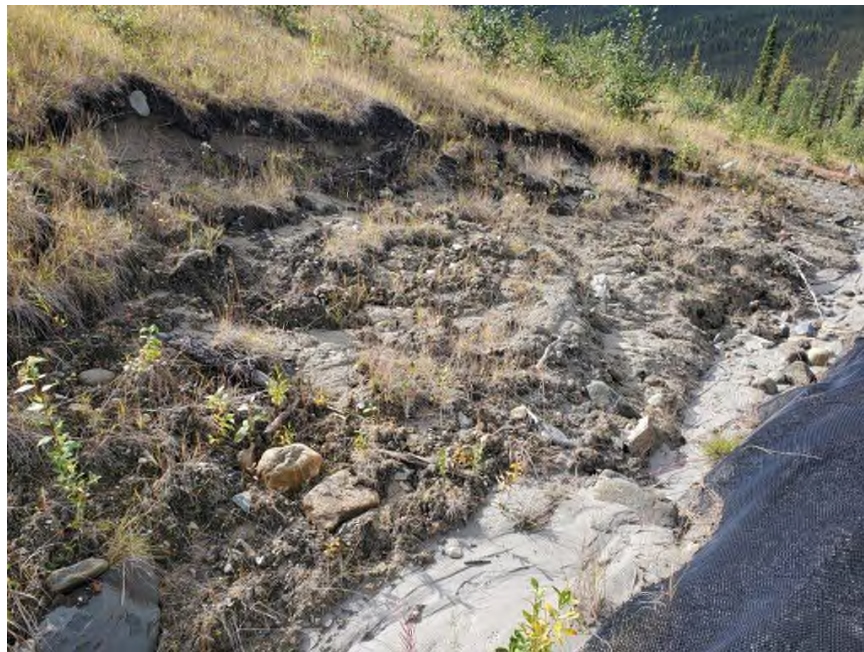
Photo 12: DSTF Shallow Failure into Runoff Collection Ditch (August 26/21)

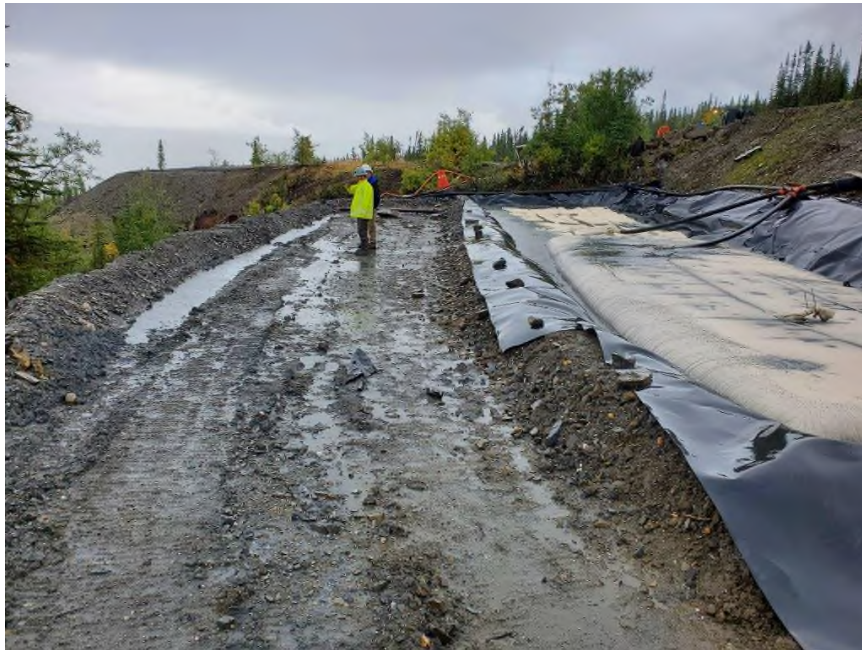
A lined pad was constructed below the water treatment plant at Alexco's Birmingham property to support a sludge containment bag. The water treatment plant was currently in operation at the time of the inspection, and no instabilities were noted. No remedial action is required for the facility.

Photo 13: Birmingham Mine (August 26/21)

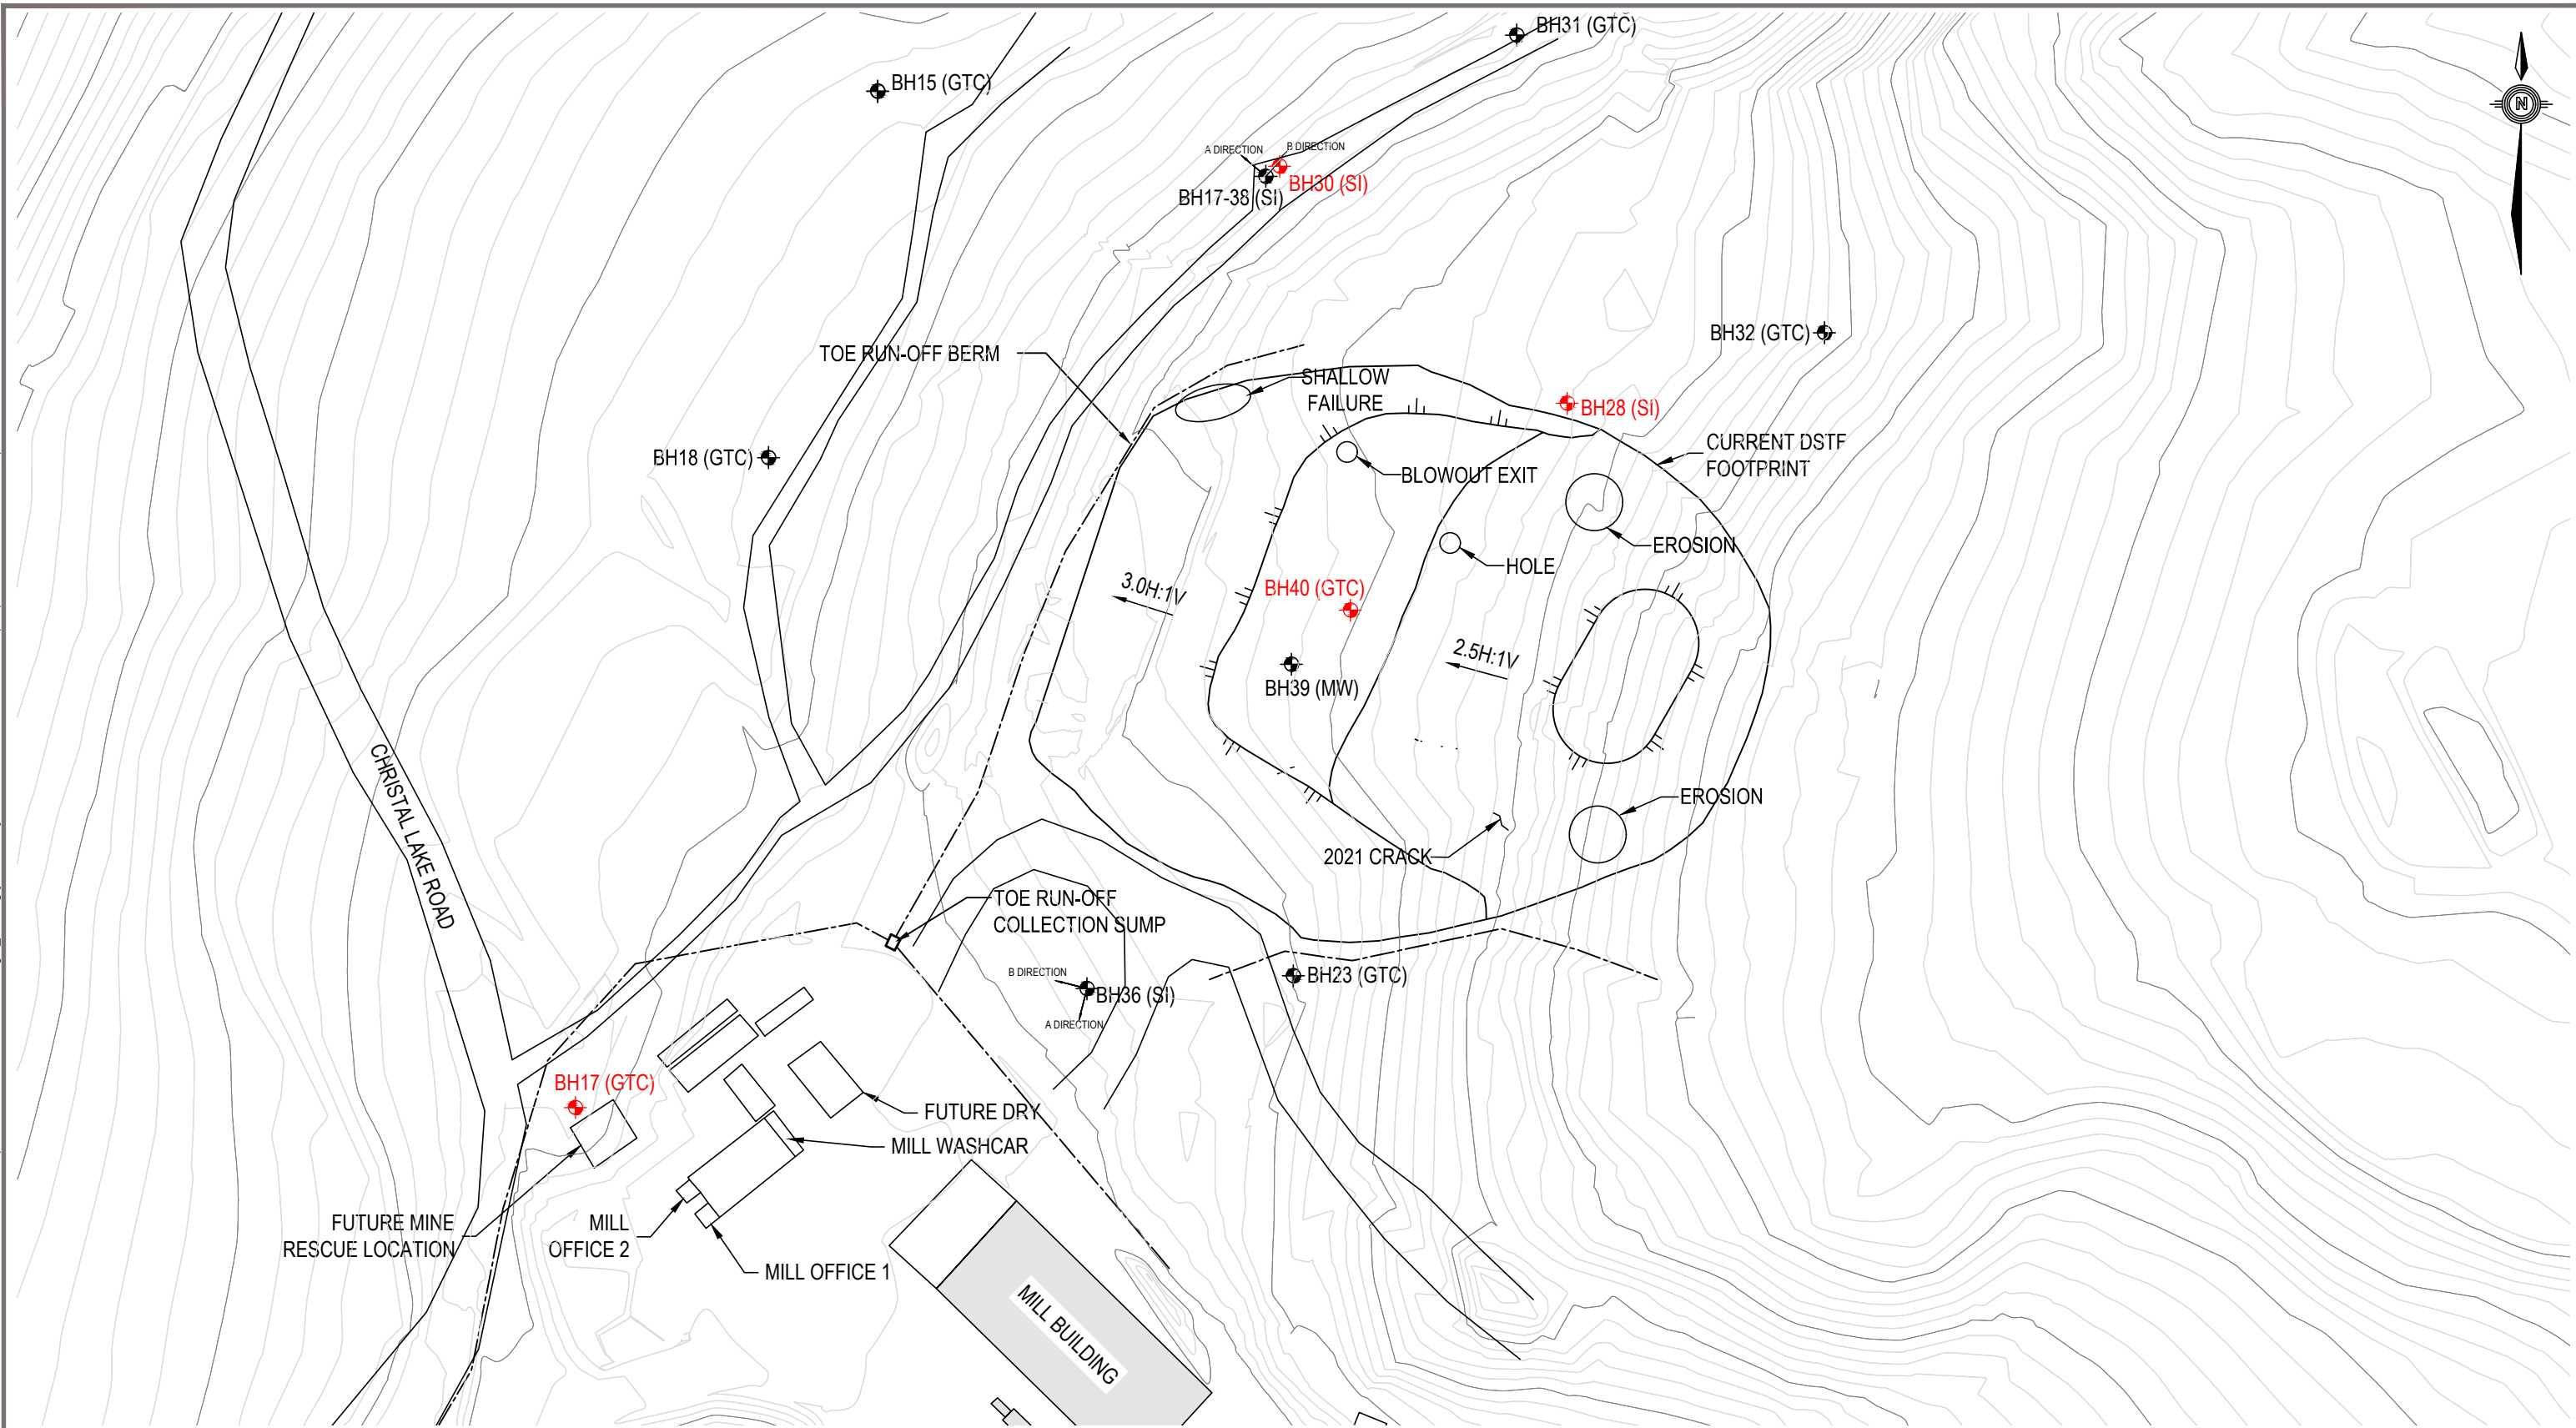
It should be noted that some critical instrumentation located within and adjacent to the DSTF is in need of repair and/or replacement. As further described below, the ground temperature cable in the centre of the DSTF (BH40) is the most critical of these installations and must be replaced as soon as possible.

The ground temperature cable installed in BH40, which extends through the tailings and into the foundation soils below to DSTF has been damaged and requires replacement. This is a critical installation needed to confirm design assumptions and provide ongoing temperature monitoring.

INSTRUMENTATION SHOWN IN RED HAS BEEN DAMAGED OR DESTROYED AND IS NOT READABLE. SOME OF THESE NEED TO BE REPAIRED AND/OR REPLACED. SEE ACCOMPANYING REPORT TEXT.

| Structure | Stability Recommendations | Maintenance Recommendations |
|--|---|--|
| Dry Stacked Tailings Facility | <ul style="list-style-type: none"> <li>▪ Repair or remove casing at BH17 to allow for ground temperature monitoring;</li> <li>▪ Install a new ground temperature cable to replace damaged cable at BH40;</li> <li>▪ Purge and clean BH38 and preserve using liquid suitable for use in permafrost conditions (silicone oil); and</li> <li>▪ Replace the slope indicator located at BH28.</li> </ul> | <ul style="list-style-type: none"> <li>▪ Repair sink hole and blow out;</li> <li>▪ Clean out runoff berm of tailings and repair erosion gullies;</li> <li>▪ Repair shallow failure;</li> <li>▪ Repair tension crack;</li> <li>▪ Reclaim or cover fresh tailings to reduce erosion;</li> <li>▪ Annual spring survey and photographs of instabilities, prior to repairs;</li> <li>▪ Continue annual instrumentation readings to monitor DSTF foundation conditions; and</li> <li>▪ Trim vegetation for future access to BH15, BH18, and BH32.</li> </ul> |
