2023 Annual Geotechnical Inspection Mining Related Earth Structures

PRESENTED TO

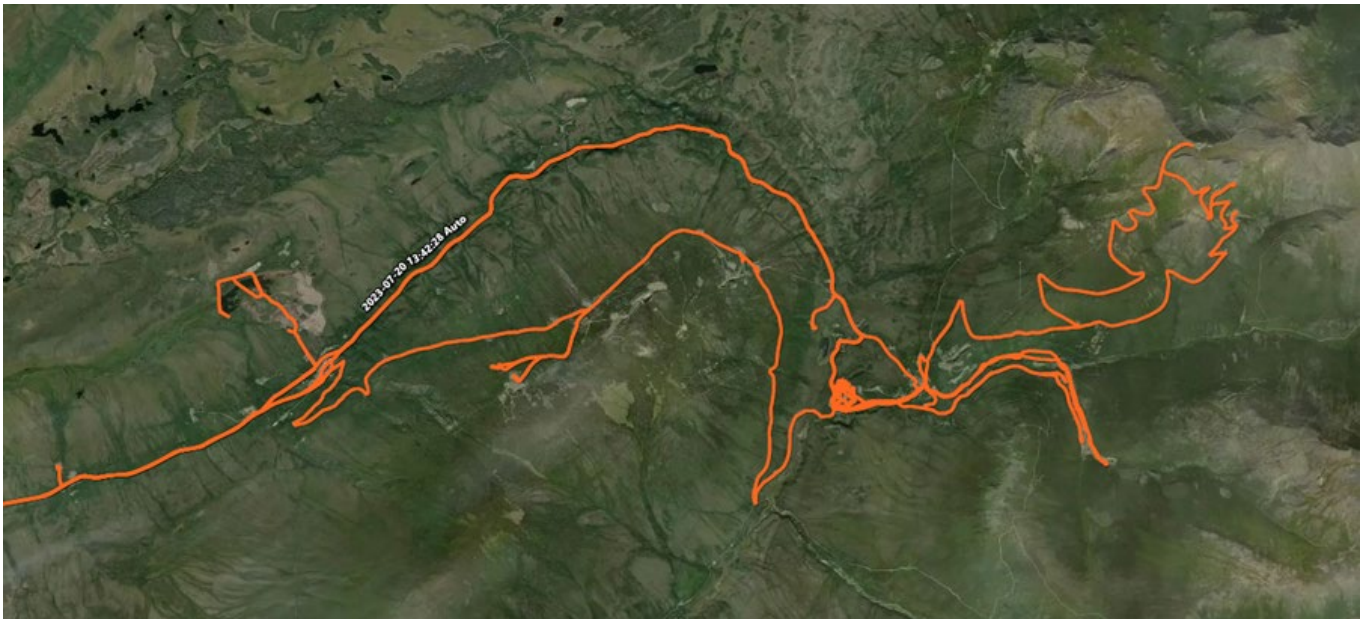
Figure 1: GPS tracklog of Mr. MacIntyre between July 20 and July 22, 2023.

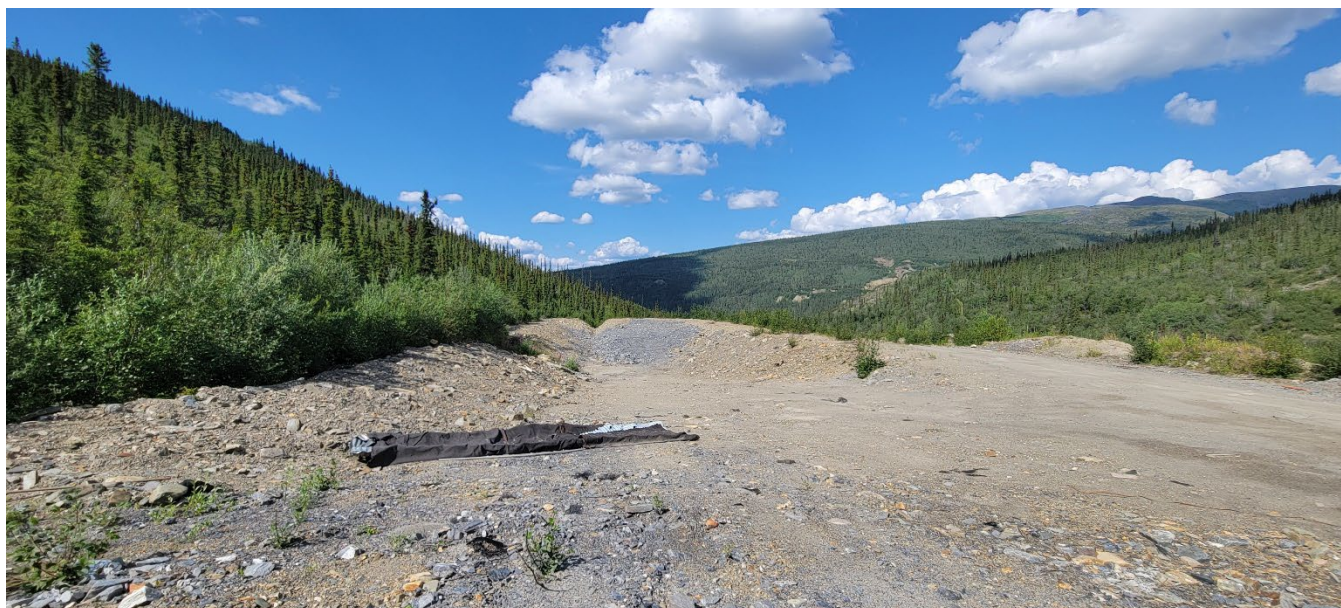
Photo 1: Bellekeno PAG Storage Facility, facing north (I. MacIntyre, July 20, 2023)

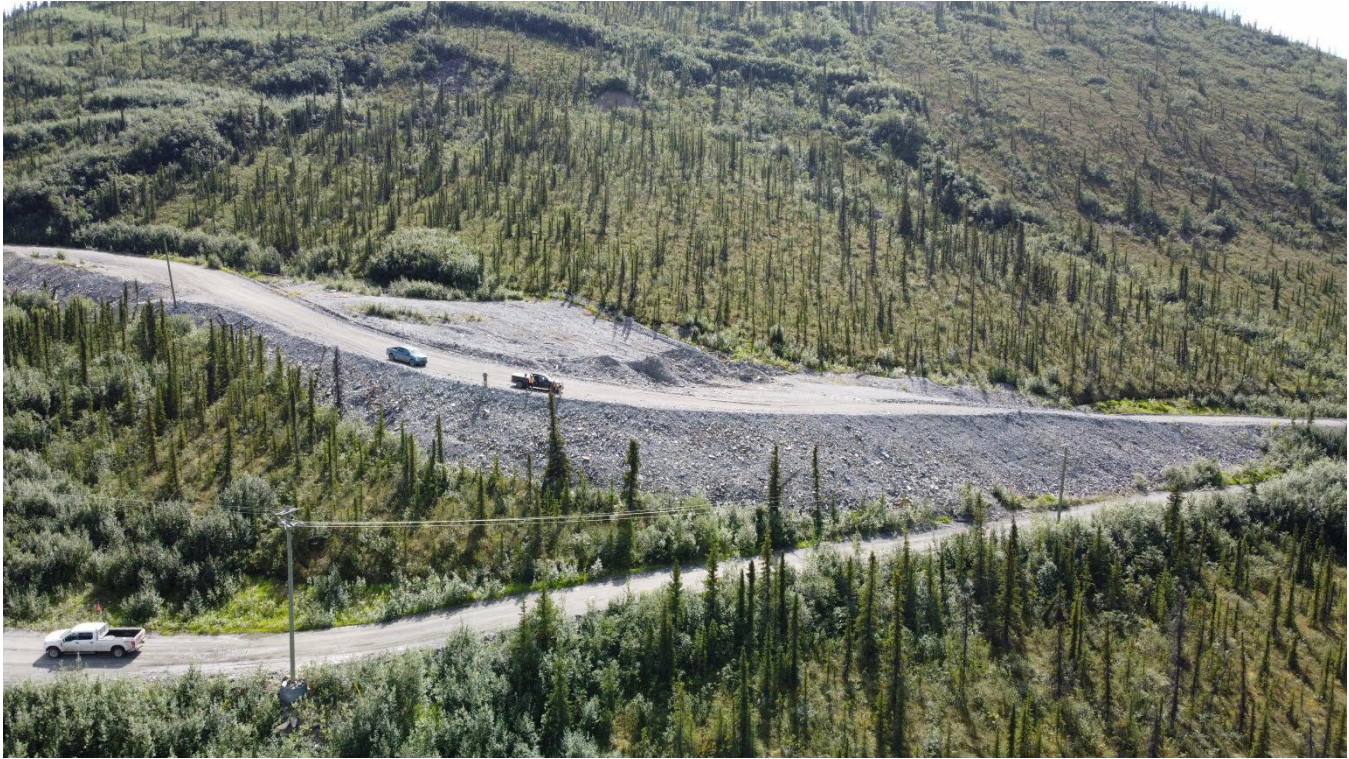
Photo 2: Bellekeno Road Waste Rock Pile, facing southwest (I. MacIntyre, July 20, 2023)

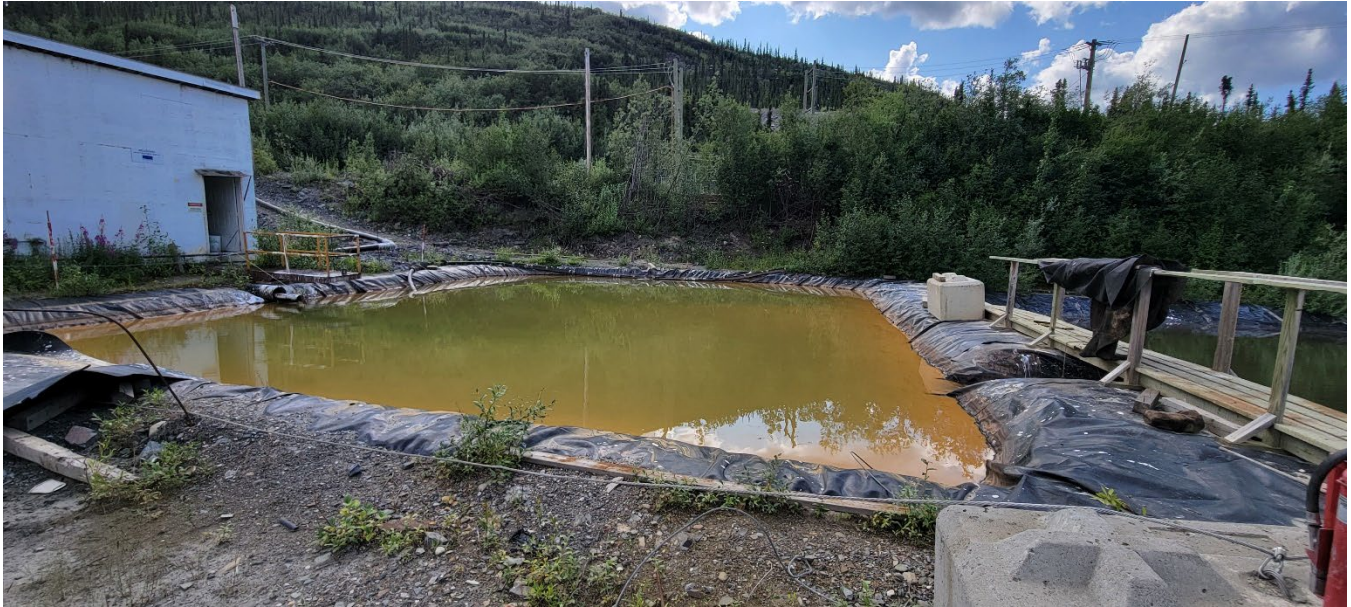
Photo 3: Bellekeno 625 Water Treatment Ponds, facing southwest (I. MacIntyre, July 20, 2023)

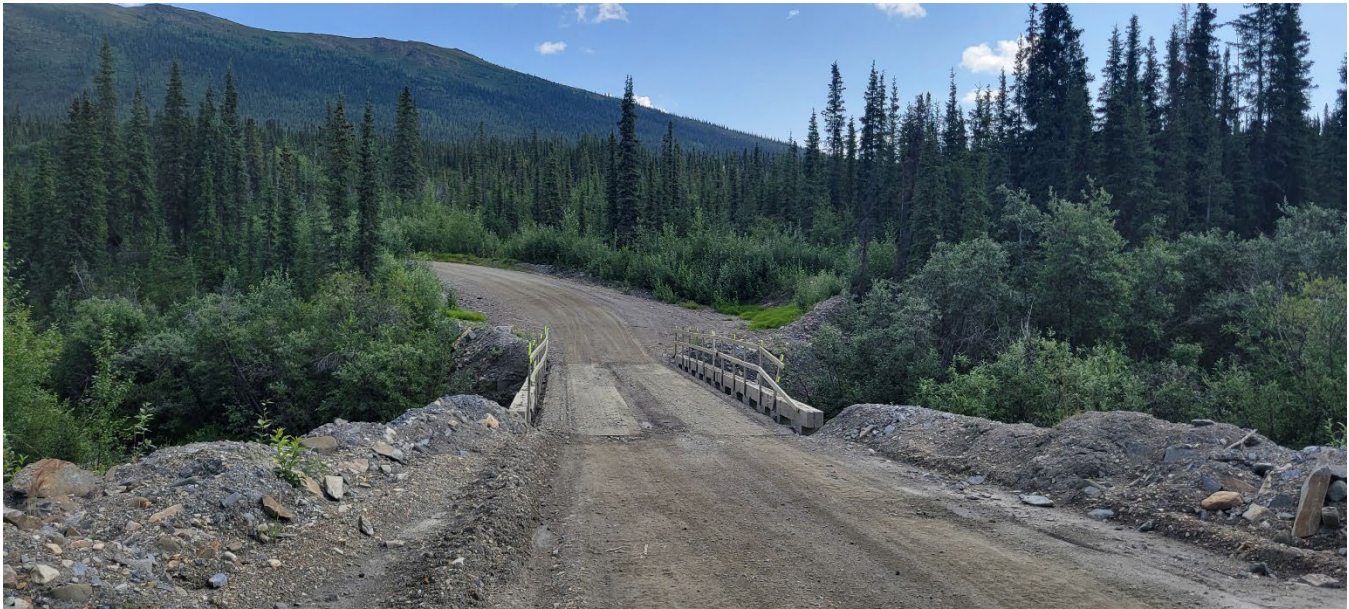
Photo 6: Lightning Creek Bridge – Bellekeno Haul Road (I. MacIntyre, July 30, 2023)

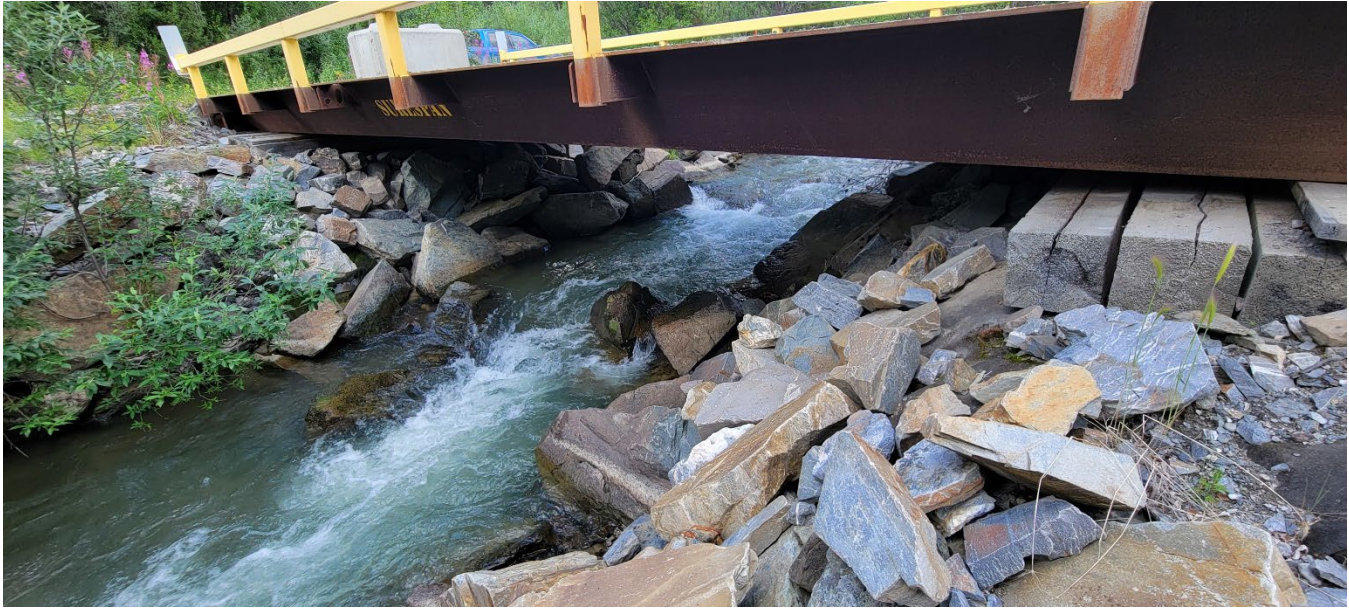
Photo 8: Lightning Creek Bridge – Onek Road (I. MacIntyre, July 20, 2023)

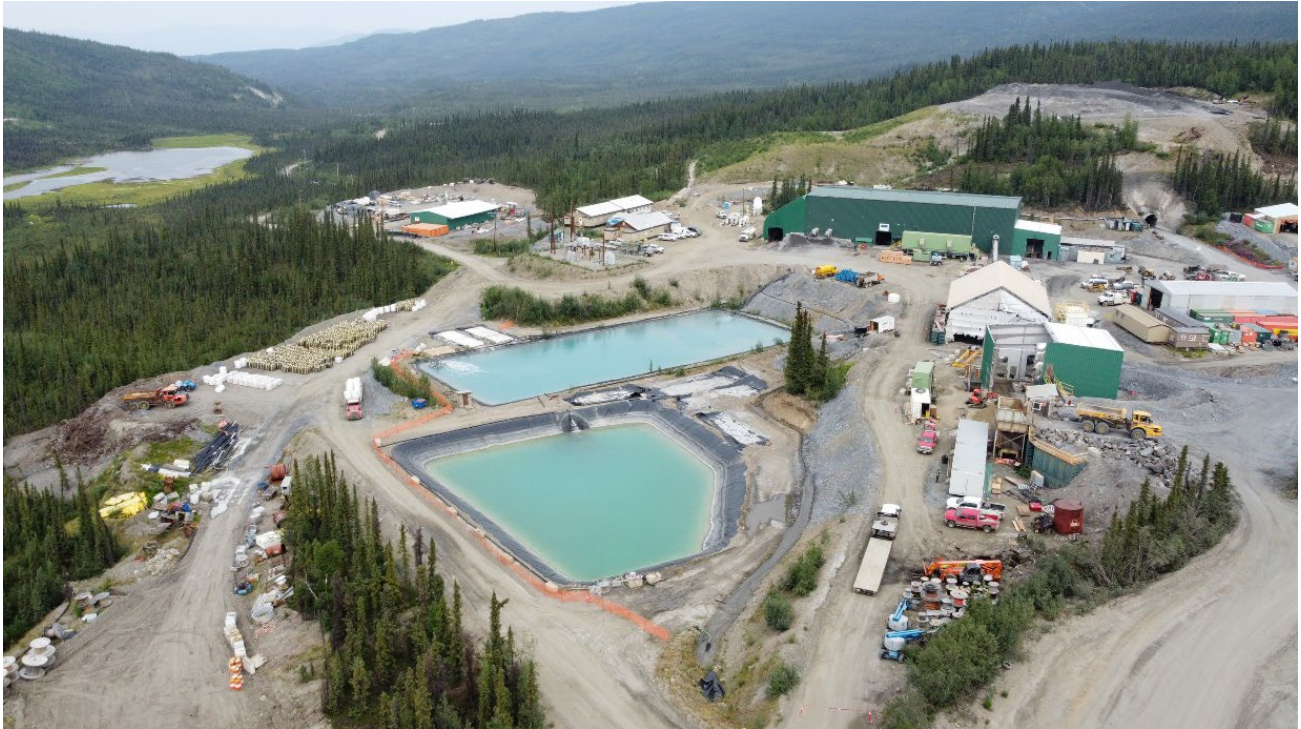
Photo 9: Fill and Mill Water Treatment Plant ponds, background and foreground, respectively. – aerial view facing north (I. MacIntyre, July 20, 2023)

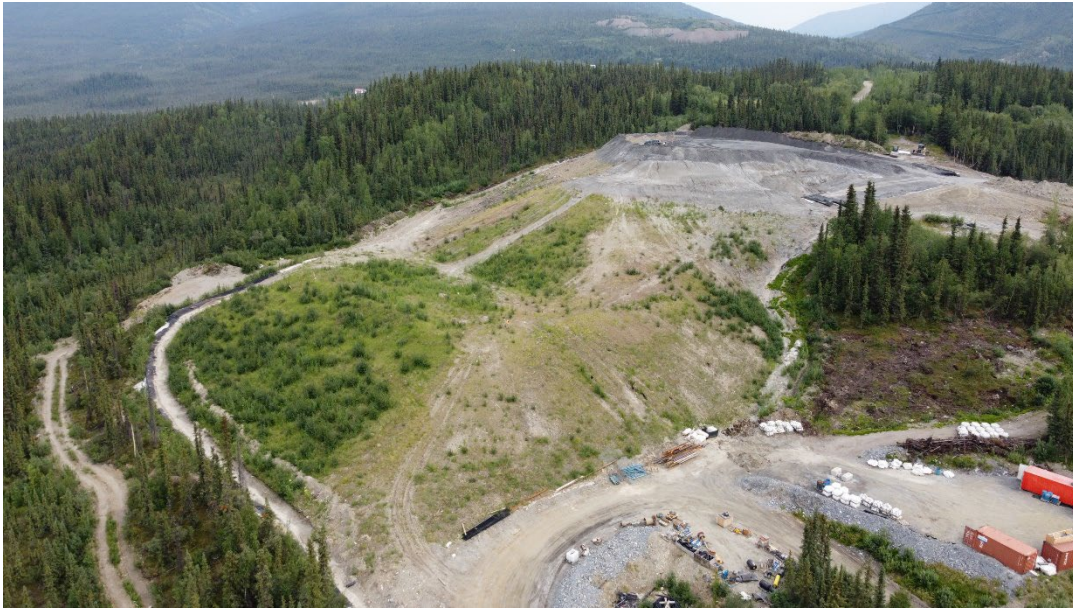
**Photo 13: DSTF Phase 1 – aerial view facing northeast. Areas of erosion visible in foreground slope.
(I. MacIntyre, July 22, 2023)**

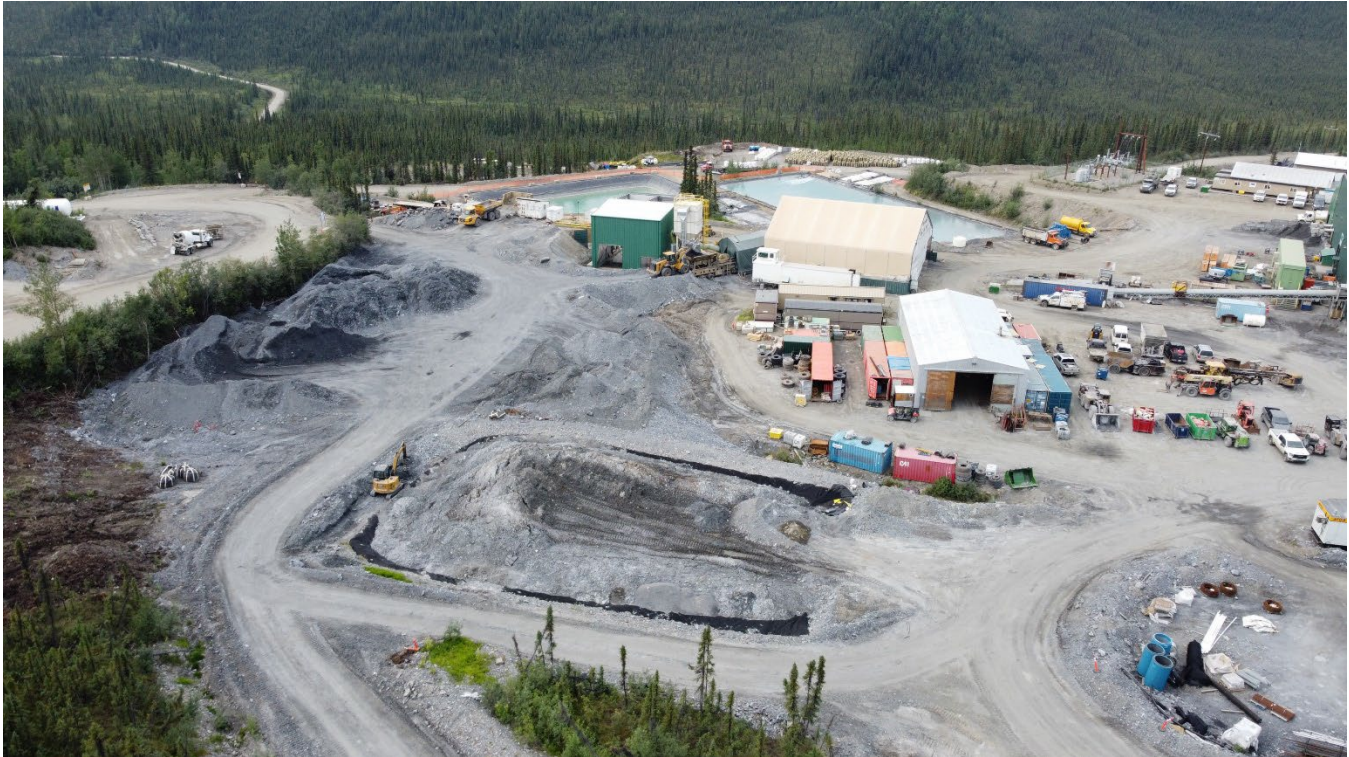
Photo 21: Flame and Moth PAG waste storage facility, aerial view facing west. (I. MacIntyre, July 20, 2023)

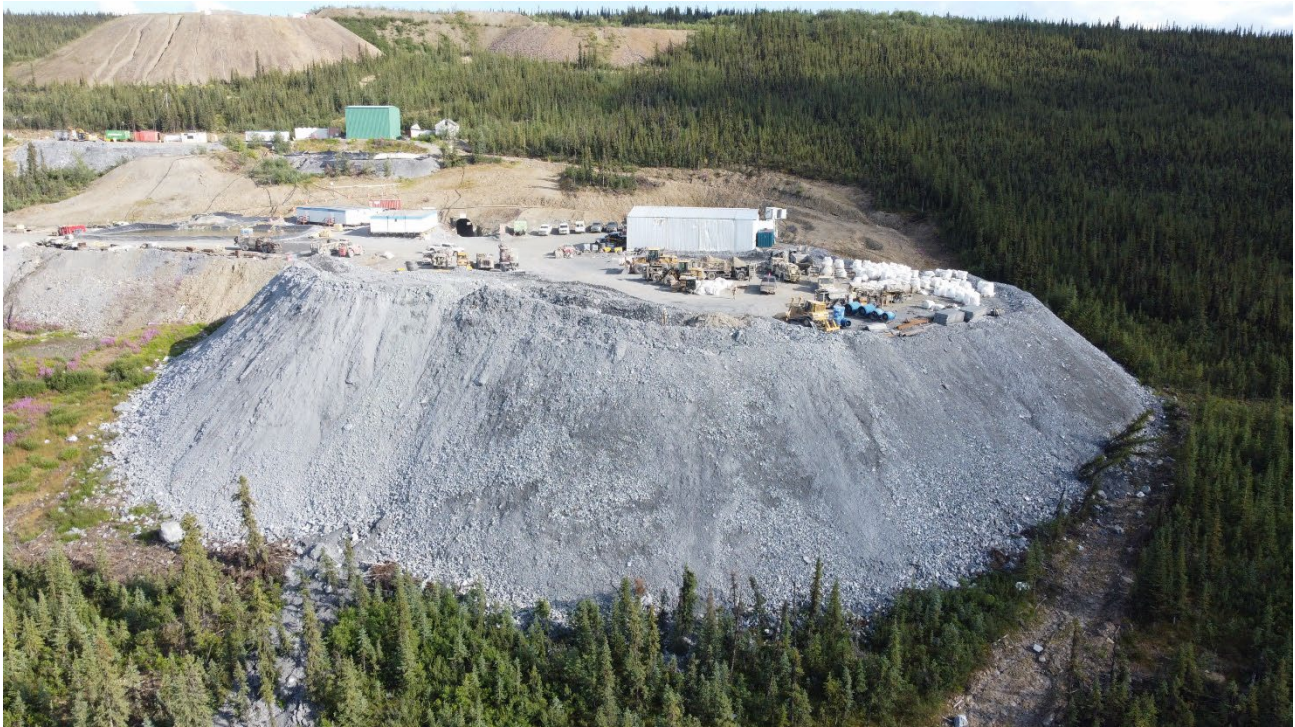
Photo 22: Birmingham NAML waste dump, aerial view facing south. Sloughed material visible in lower left. (I. MacIntyre, July 20, 2023)

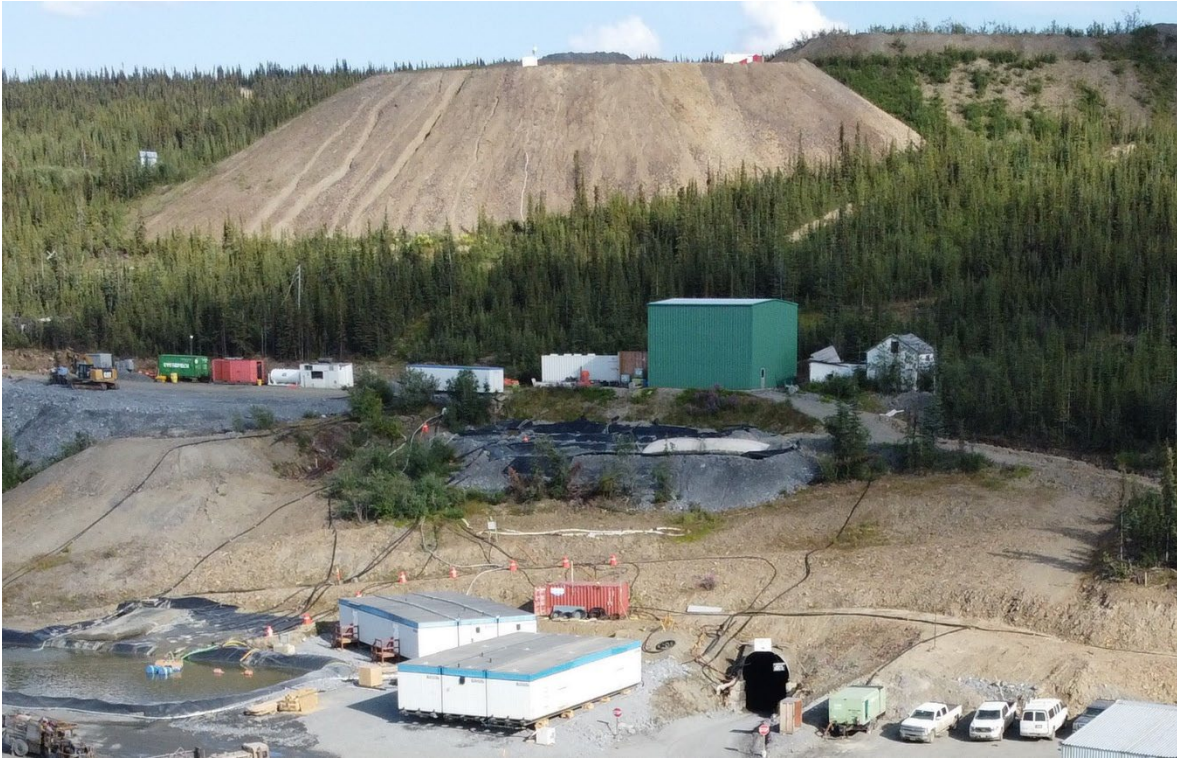
Photo 23: Bermingham Mine Sludge Waste Containment Facility – buried organics and trees visible in foreground. (I. MacIntyre, July 20, 2023)

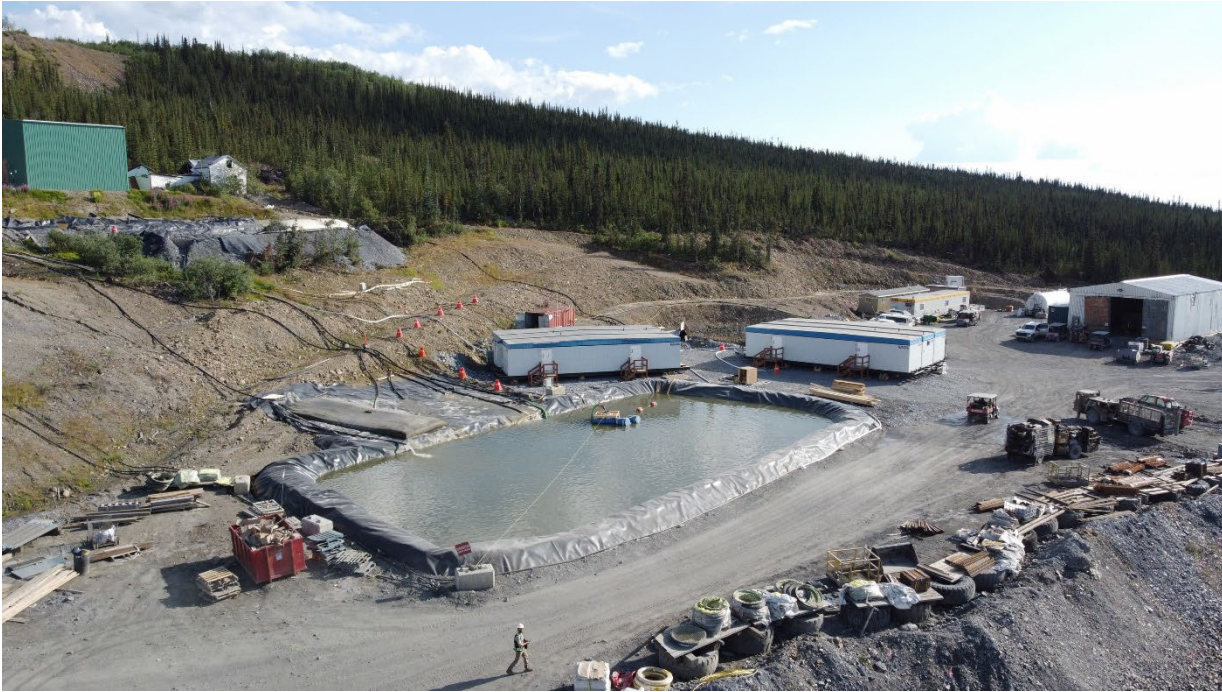
Photo 24: An aerial view of the Bermingham storage pond (I. MacIntyre, July 20, 2023)

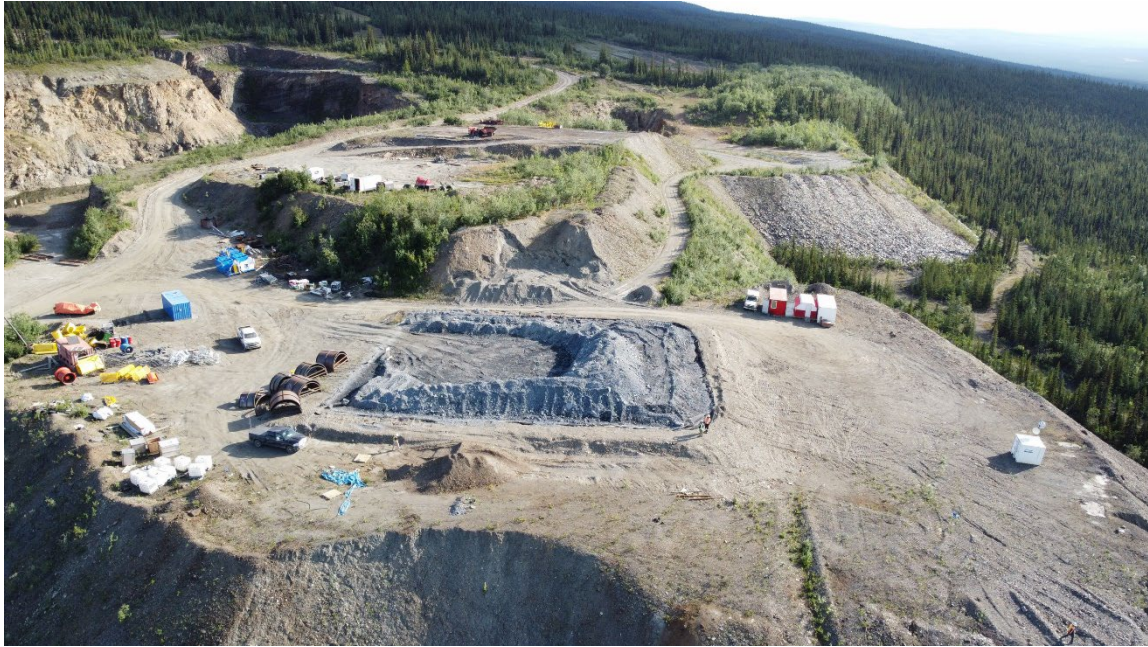
Photo 25: Bermingham PAG waste storage facility, aerial view (P. Johnson, August 30, 2022)
