**Re: 2012 Annual Physical Inspection , Quartz Mining Licence QML-0009
 Bellekeno Mine, Yukon**

ALEXCO KENO HILL MINING CORP.
QUARTZ MINING LICENCE QML-0009
2012 ANNUAL PHYSICAL INSPECTION
BELLEKENO MINE SITE
KENO HILL SILVER DISTRICT
YUKON

2012 ANNUAL PHYSICAL INSPECTION
SURFACE STRUCTURES

Subject: 2012 Annual Inspection – Surface Engineered Earth Structures
Bellekeno Minesite, Keno City, Yukon

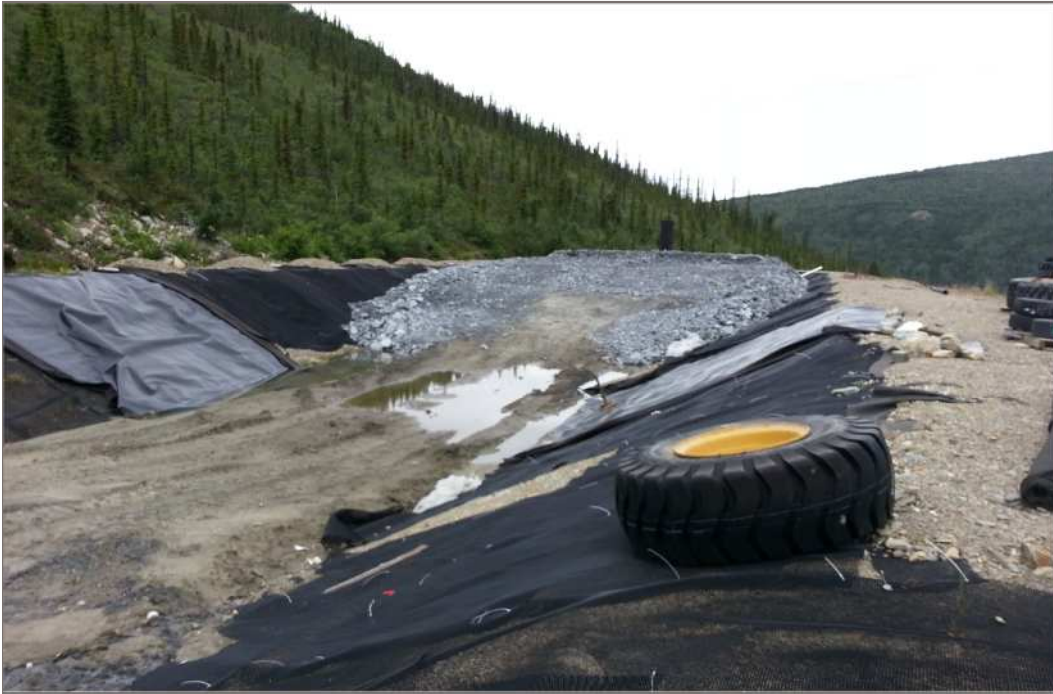
The PAG Waste Storage Facility is located south of the Bellekeno Mine portal, as shown on Figure 1. The perimeter berms of the facility appeared intact with no visible signs of instability or erosion (Photos 1 and 2). The vertical geotextile wrapped extraction culvert, waste piles, and completed liner system appeared stable (Photo 3).

Photo 1: PAG Waste Storage Facility
Completed and partially completed sections of liner.
July 13, 2012

The storage facility has not been completed and little work has been done since the 2011 Inspection to bring it nearer to completion. While the material being stored within the facility appeared to be properly contained; construction of the facility should be completed to reduce the risk of uncontrolled release and allow for additional storage capacity.

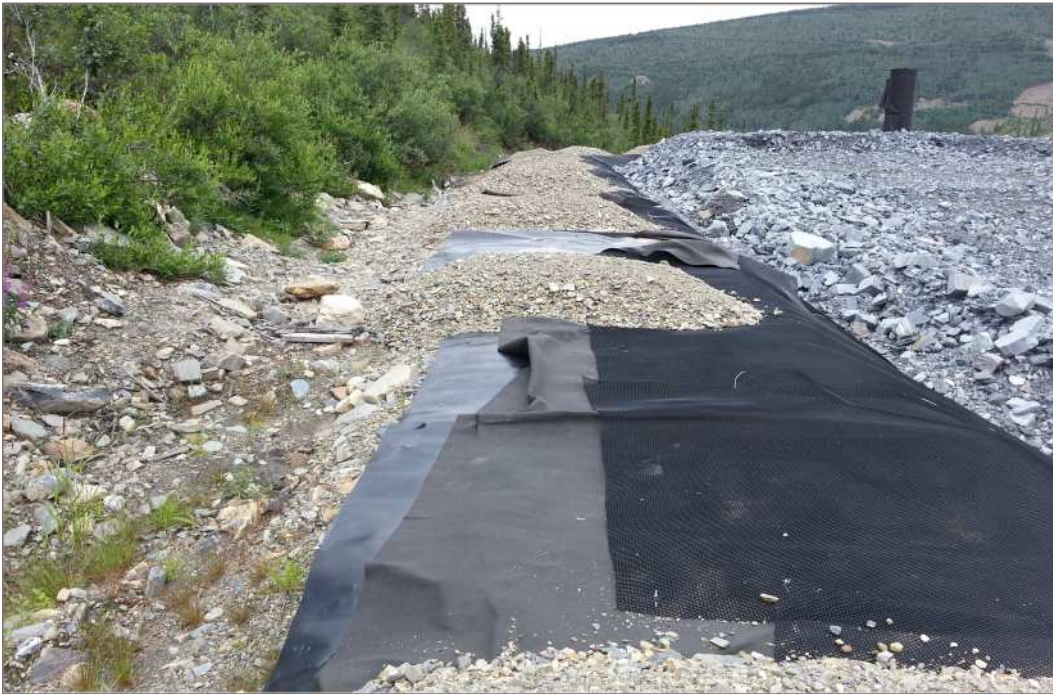
Photo 2: PAG Waste Storage Facility
Liner not adequately anchored along west berm
July 13, 2012

Within the completed portion of the facility (northern half) the liner anchoring trench along the east berm appeared finished. Elsewhere, loose material was piled on top of the berm to hold the liner in place (Photo 4). The liner anchoring trench should be finished for the remainder of the completed facility (north and west berms).

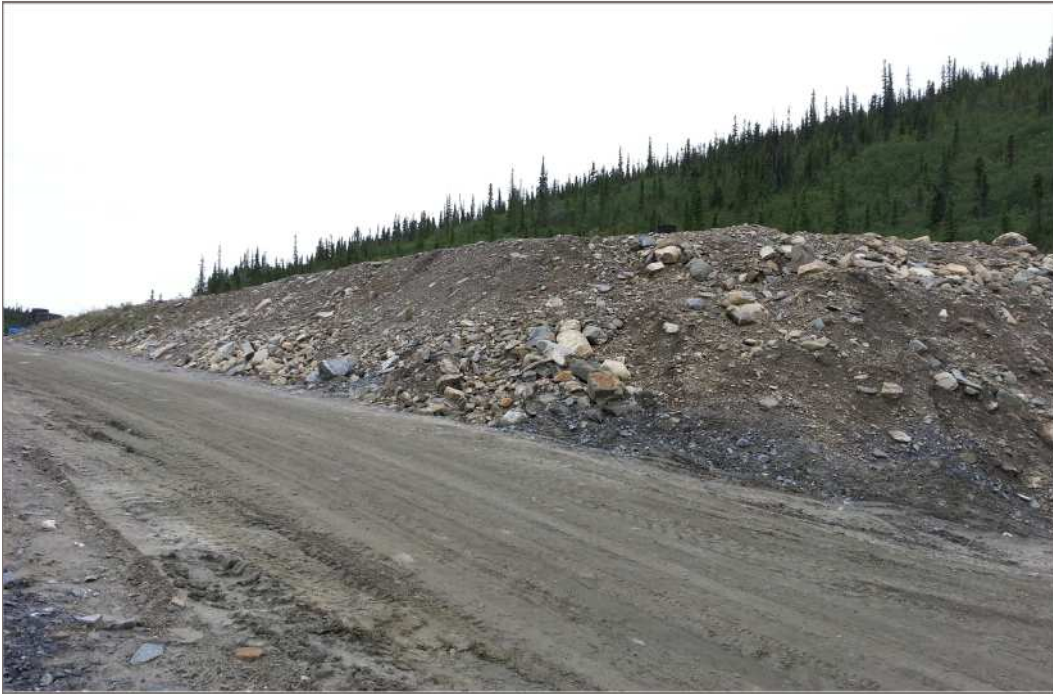
Photo 3: PAG Waste Storage Facility
East perimeter berm
July 13, 2012

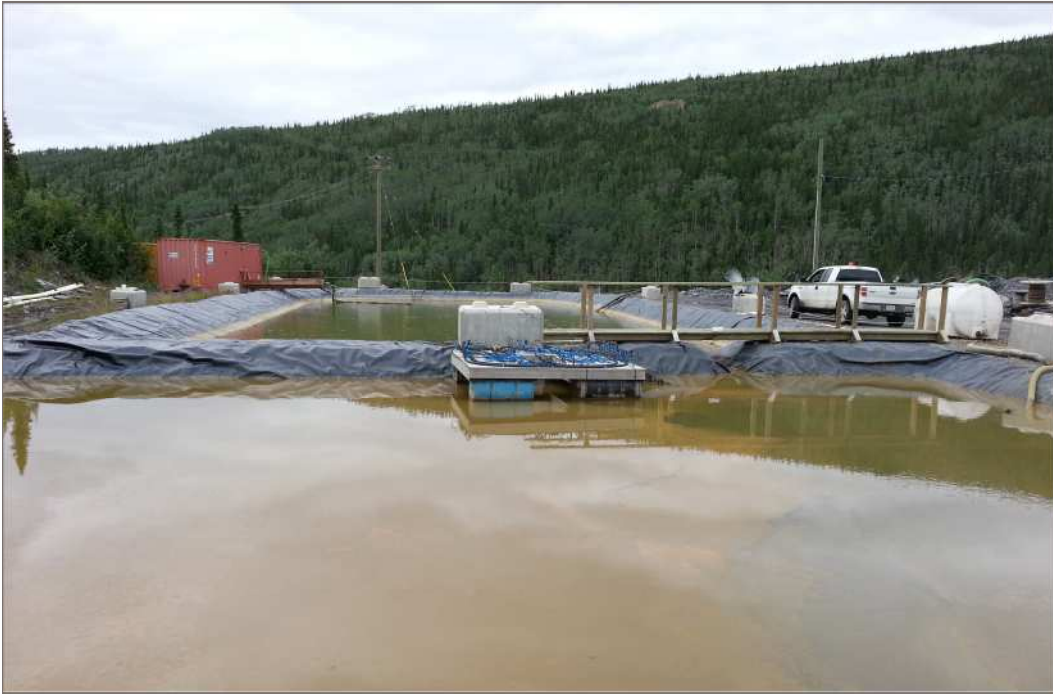
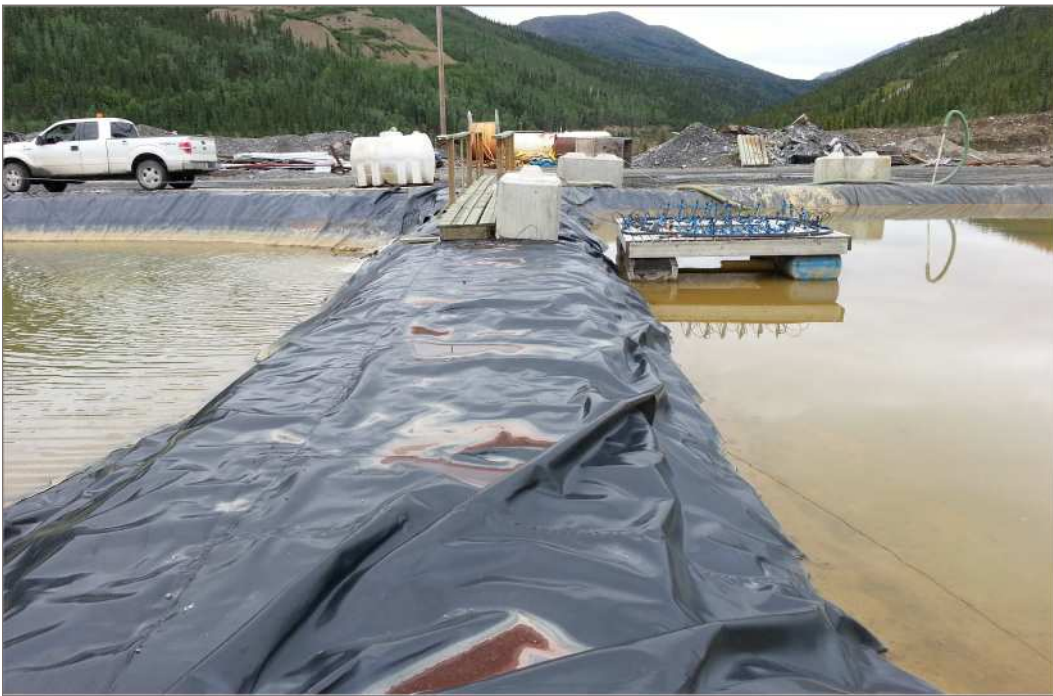
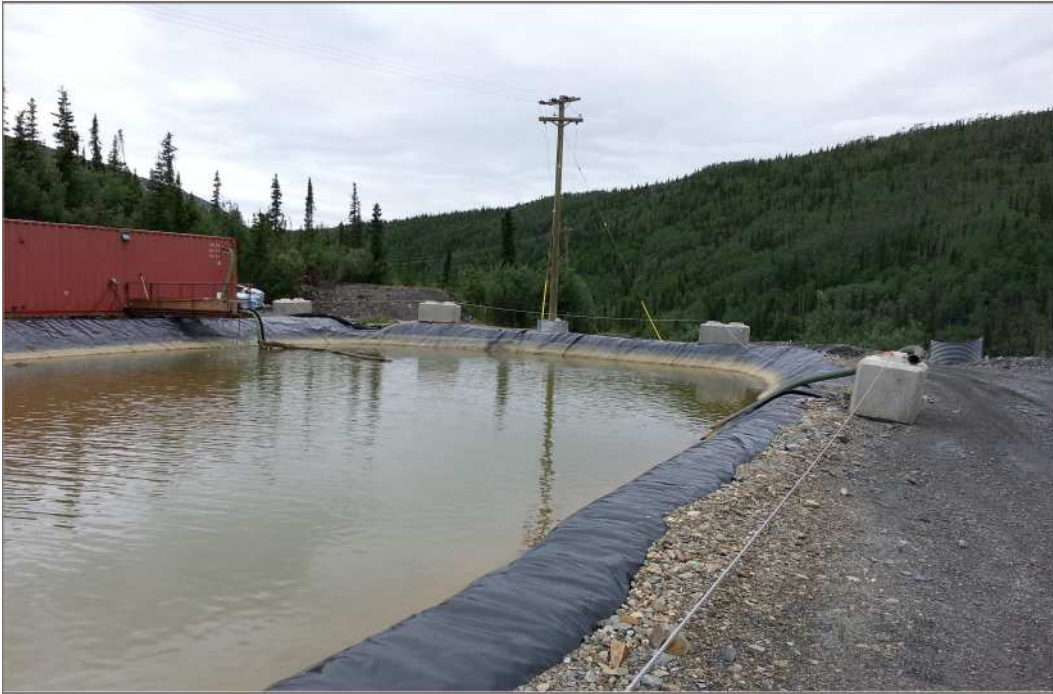
The Bellekeno 625 water treatment pond is located east of the Bellekeno Mine haul road where it passes the waste rock pile. The location is shown on Figure 1. The pond and surrounding structures (vehicle barriers, walkways, and piping) appeared stable at the time of the inspection. The liner system appeared intact and no liner tension or bulging was observed. The pond berms and liner anchoring trenches appeared intact and stable. No remedial action is recommended for the Bellekeno 625 water treatment pond at this time (Photos 5 through 7).

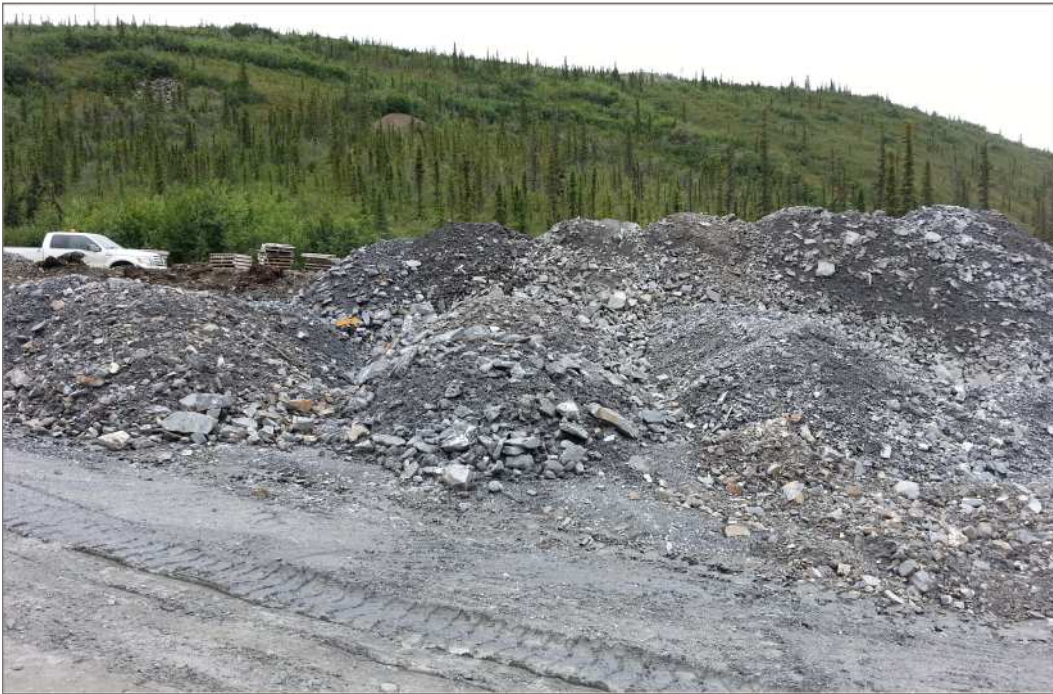
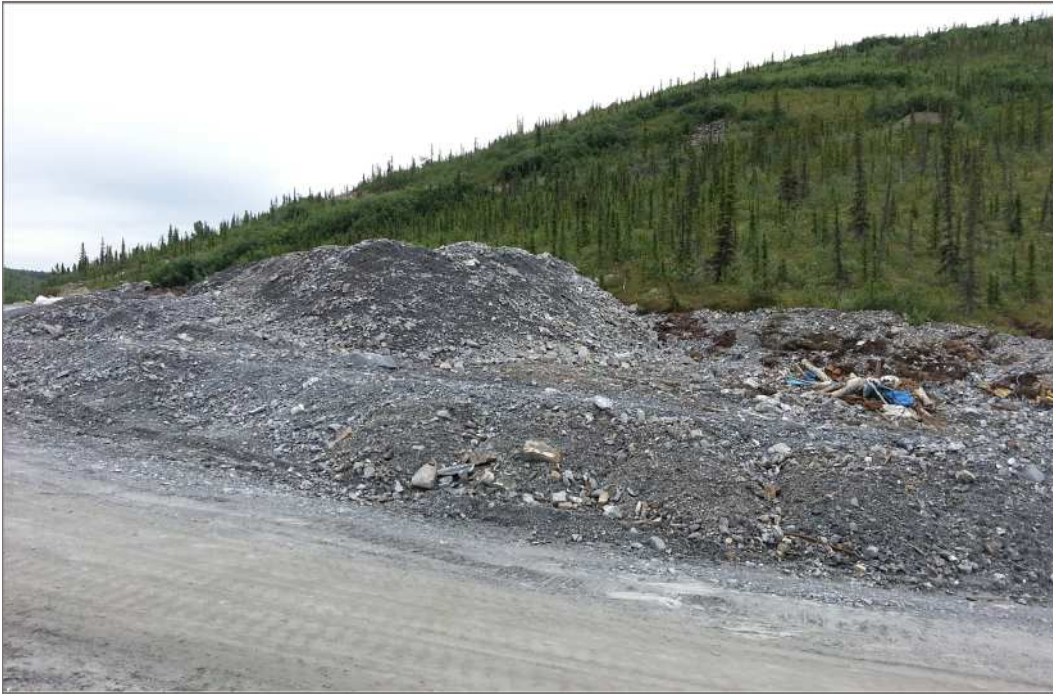
The waste rock pile is located along the Bellekeno Mine haul road, north of the portal. The location is shown on Figure 1. The pile and side slopes appeared stable at the time of the inspection (Photos 8 and 9). No remedial action is recommended for the waste rock pile at this time.

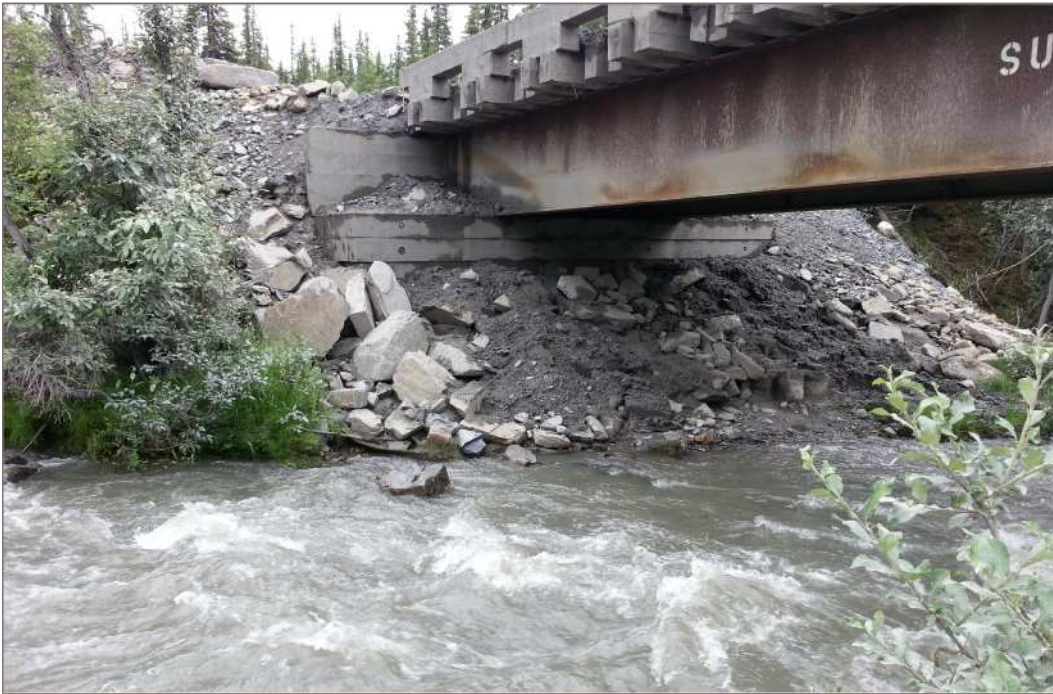
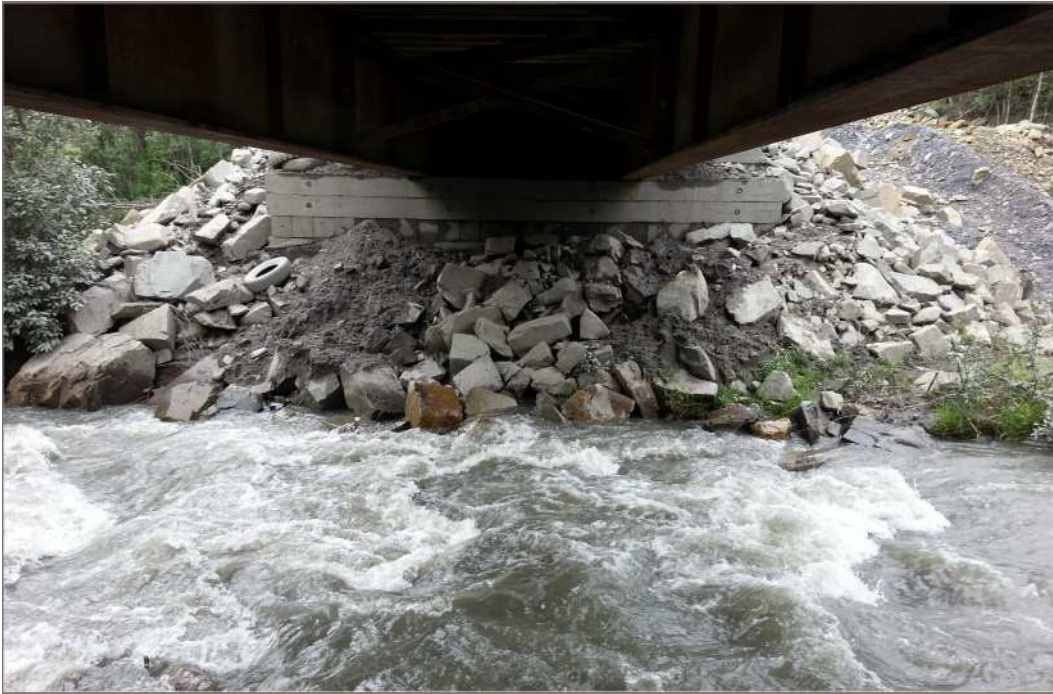
The Lightning Creek Bridge is located on the Bellekeno Mine haul road near Keno City. The location is shown on Figure 1. The bridge abutments are constructed of earth filled timber cribbing and no indications of movement or instability were observed at the time of the inspection (Photos 10 and 11).

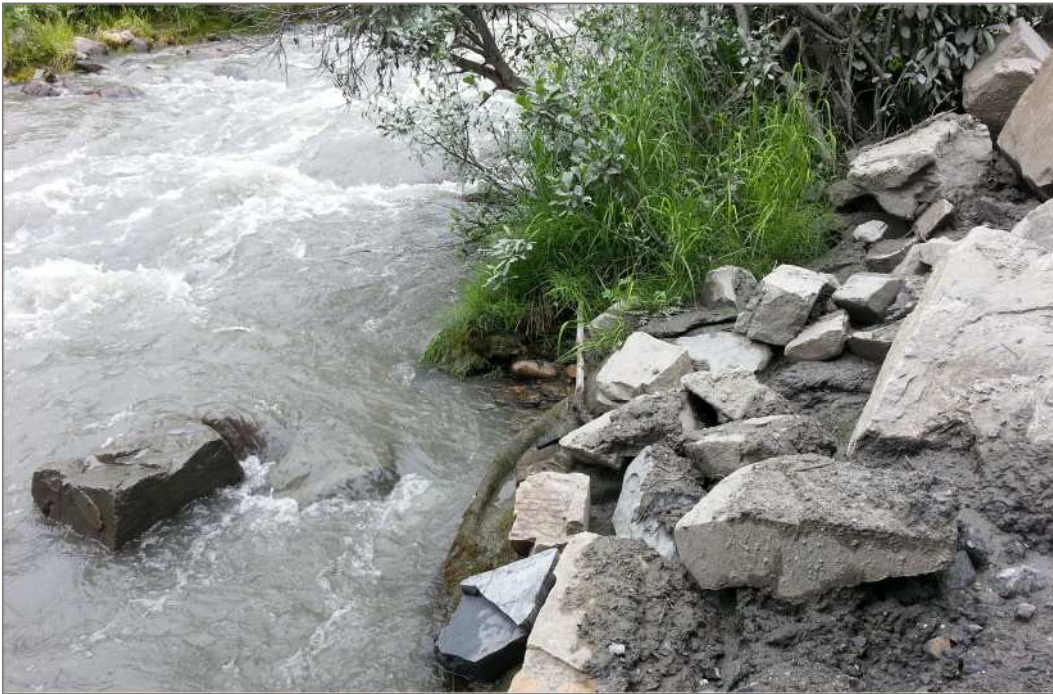
The geotextile that had been exposed immediately above the water line at the time of the inspection in 2011 has been adequately covered in additional rip rap material. However, riprap placed along the east

bank of Lightning Creek to protect the abutments from scour does not adequately cover the underlying geotextile near the creek's edge (Photo 12). Additional riprap should be placed as an added precaution.

Photo 12: Lightning Creek Bridge Abutments
Exposed geotextile on East Abutment
July 13, 2012

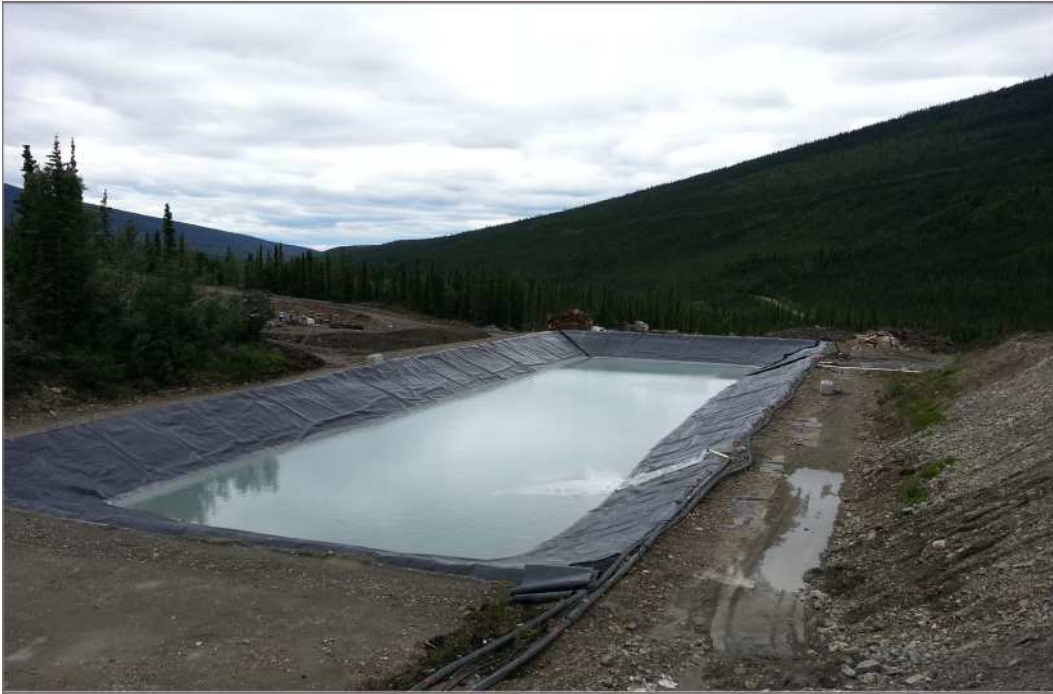
Photo 13: Mill Water Storage Pond
July 13, 2012

The mill water storage pond is located at the Bellekeno Mill Site approximately 1 km west of Keno City. The location is shown on Figure 1. No visible seepage was observed and the pond berms appeared stable at the time of the inspection. The liner system appeared intact with no loose seams, liner tension, or liner bulging observed (Photos 13 and 14).

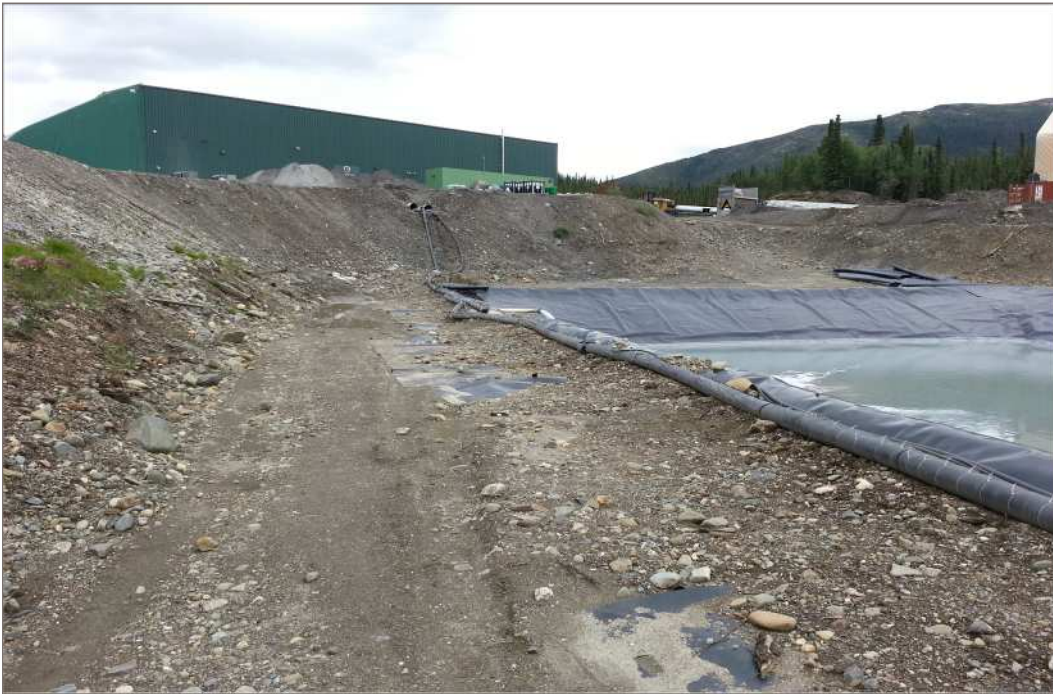
Photo 14: Mill Water Storage Pond
Exposed liner along pond berm
July 13, 2012

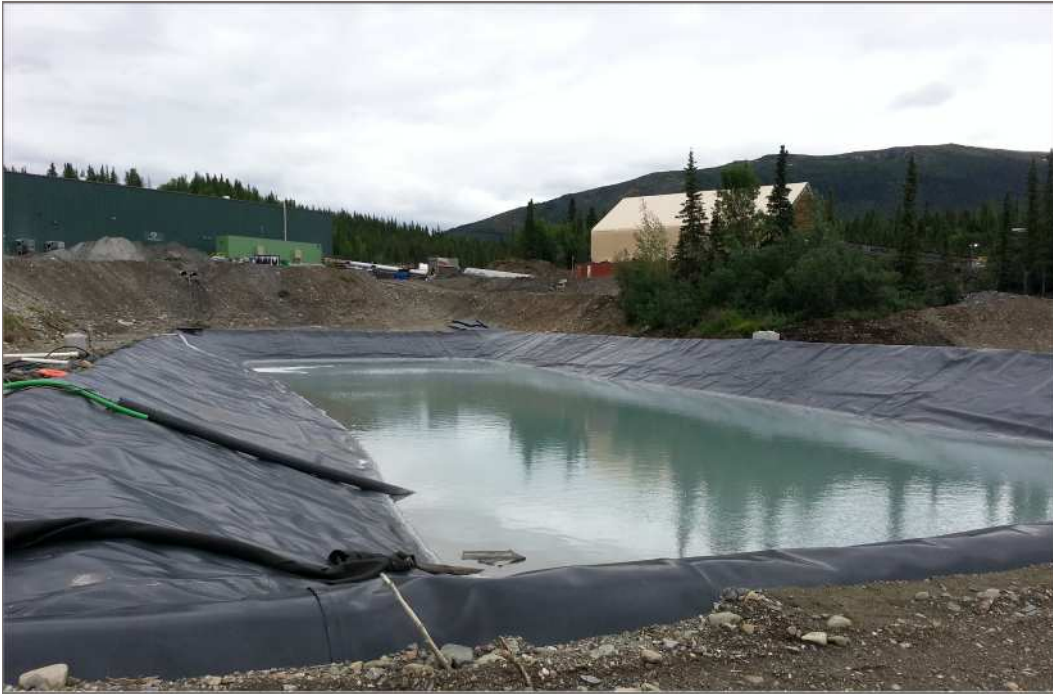
Photo 15: Mill Water Storage Pond
July 13, 2012

The liner anchoring trench for the North West side of the pond is not completed and is exposed along the entire length of the pond (Photo 15). To reduce the potential of damage due to high winds, it is recommended that the liner be properly anchored and buried.

From a safety standpoint, it is also recommended that ropes or ladders be laid into the pond along its length. As the pond does not freeze in the winter, if a worker falls into the water they will be able to exit the high slopes more easily.

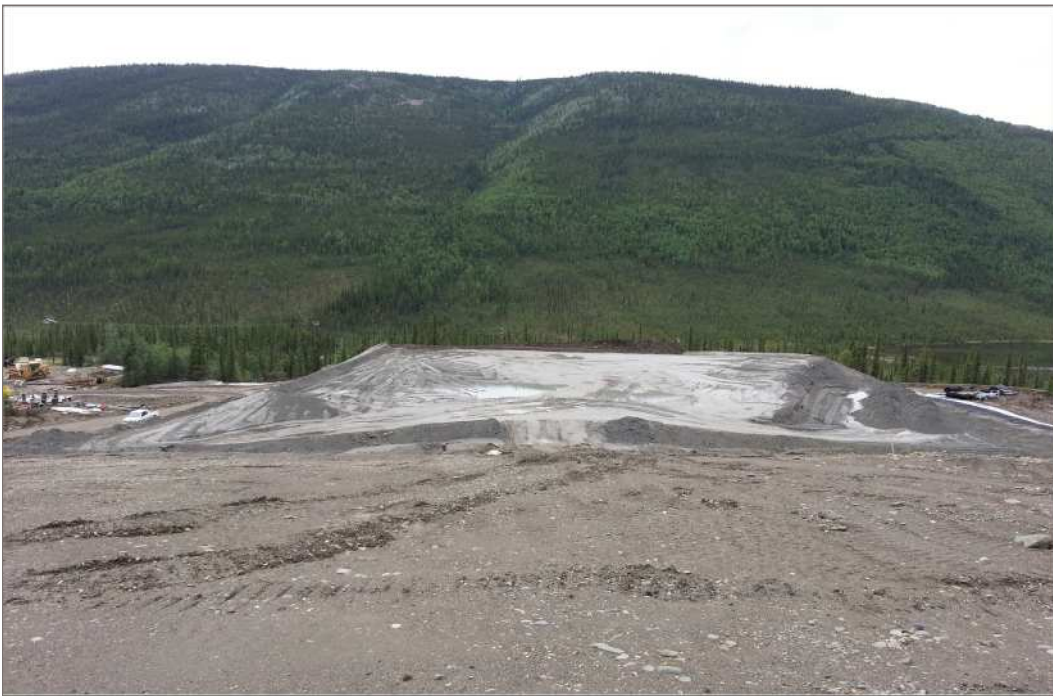
The tailings appear to have been placed in accordance with the design with the lower bench being mostly completed to date (Photo 16). The crest elevation has been brought back down to its final design elevation in accordance with the 2011 inspection recommendations. This has allowed the placement of cover material to begin over the west facing slope (Photo 17).

Photo 16: DSTF Lower Bench
Facing west
July 13, 2012

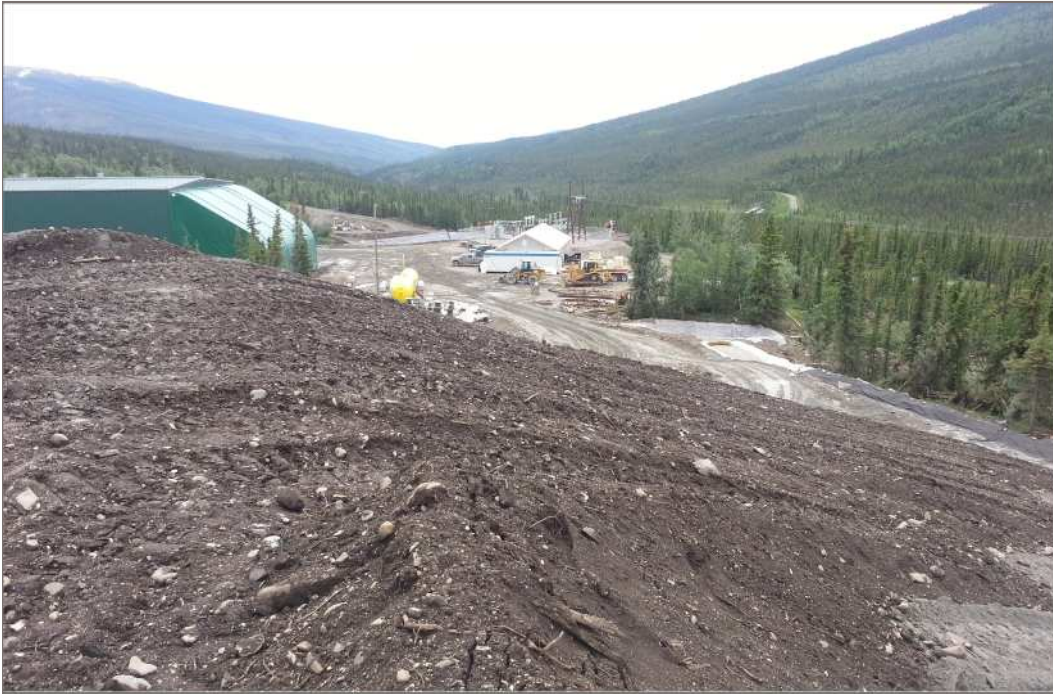
Photo 17: DSTF Lower Bench
Early stages of cover placement
July 13, 2012

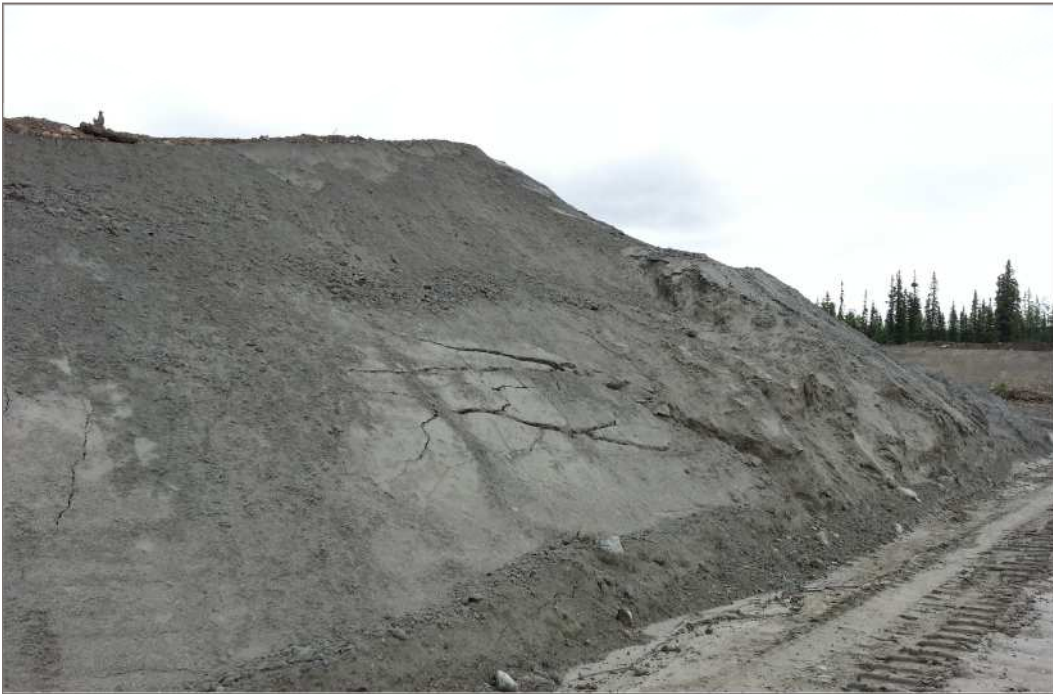
Minor cracking along the south slope face and adjacent to the haul road was observed at the time of the inspection (Photo 18). This is likely due to the combination of loose placement of material along the slope surface and heavy rainfall in the weeks leading up to the inspection. It is recommended that the affected areas be pulled back in benches and re-worked.

Photo 18: DSTF Lower Bench
Cracking on south slope along haul road
July 13, 2012
