TECHNICAL MEMO

TO: Katherine Penney
C: Vanessa Benwood
FROM: Justin Pigage, EIT
DATE: February 16, 2012
MEMO NO.: 008
EBA FILE: W14101696

SUBJECT: DSTF Instrumentation and Construction Monitoring
Keno Hill District Mill Site

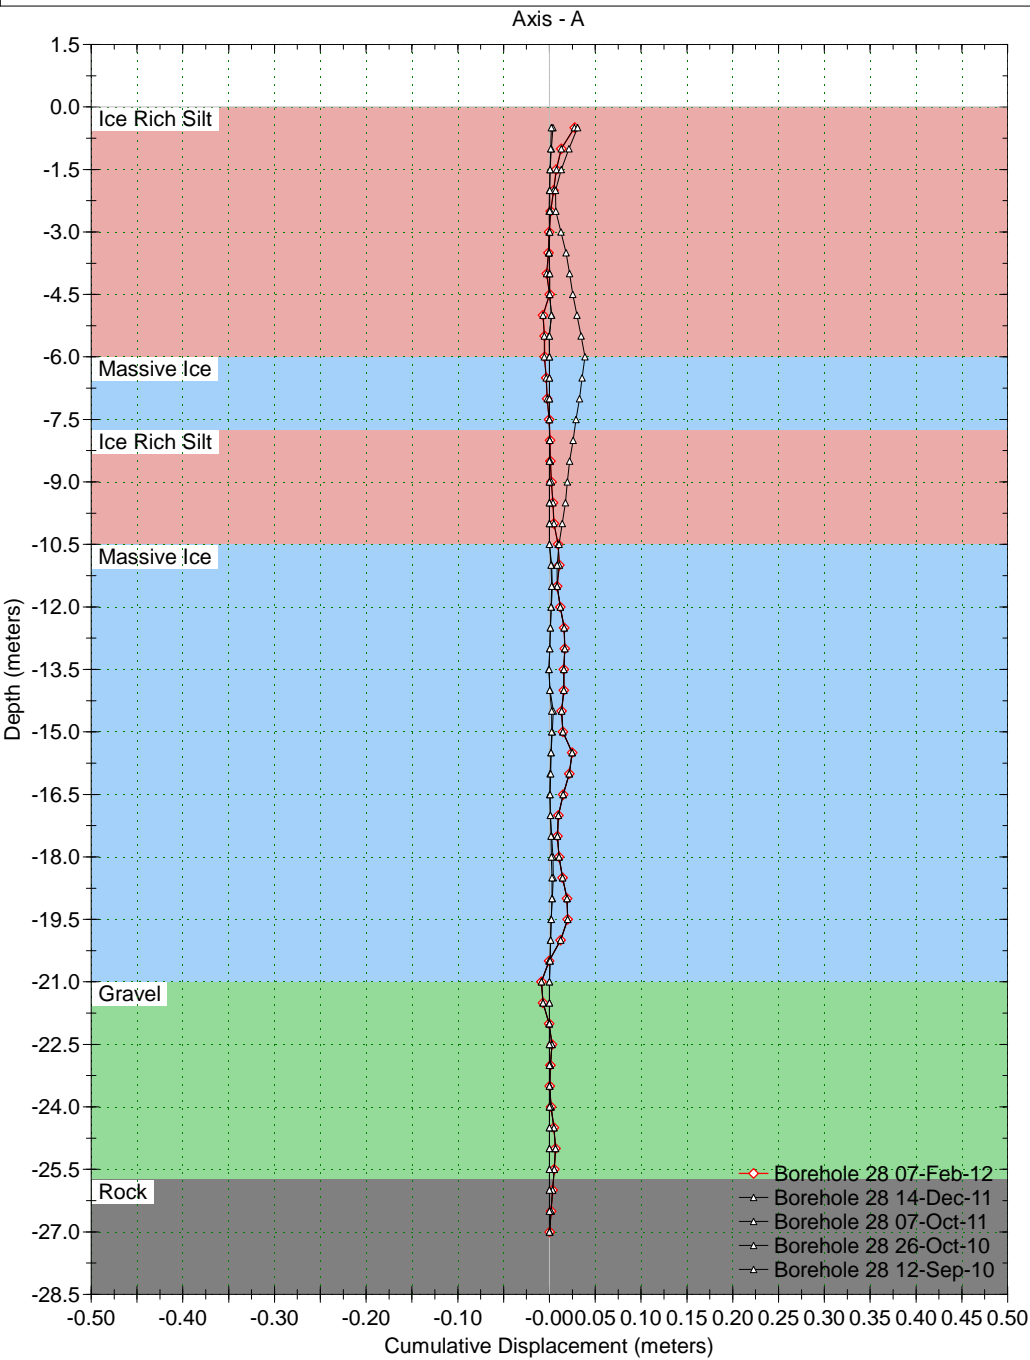
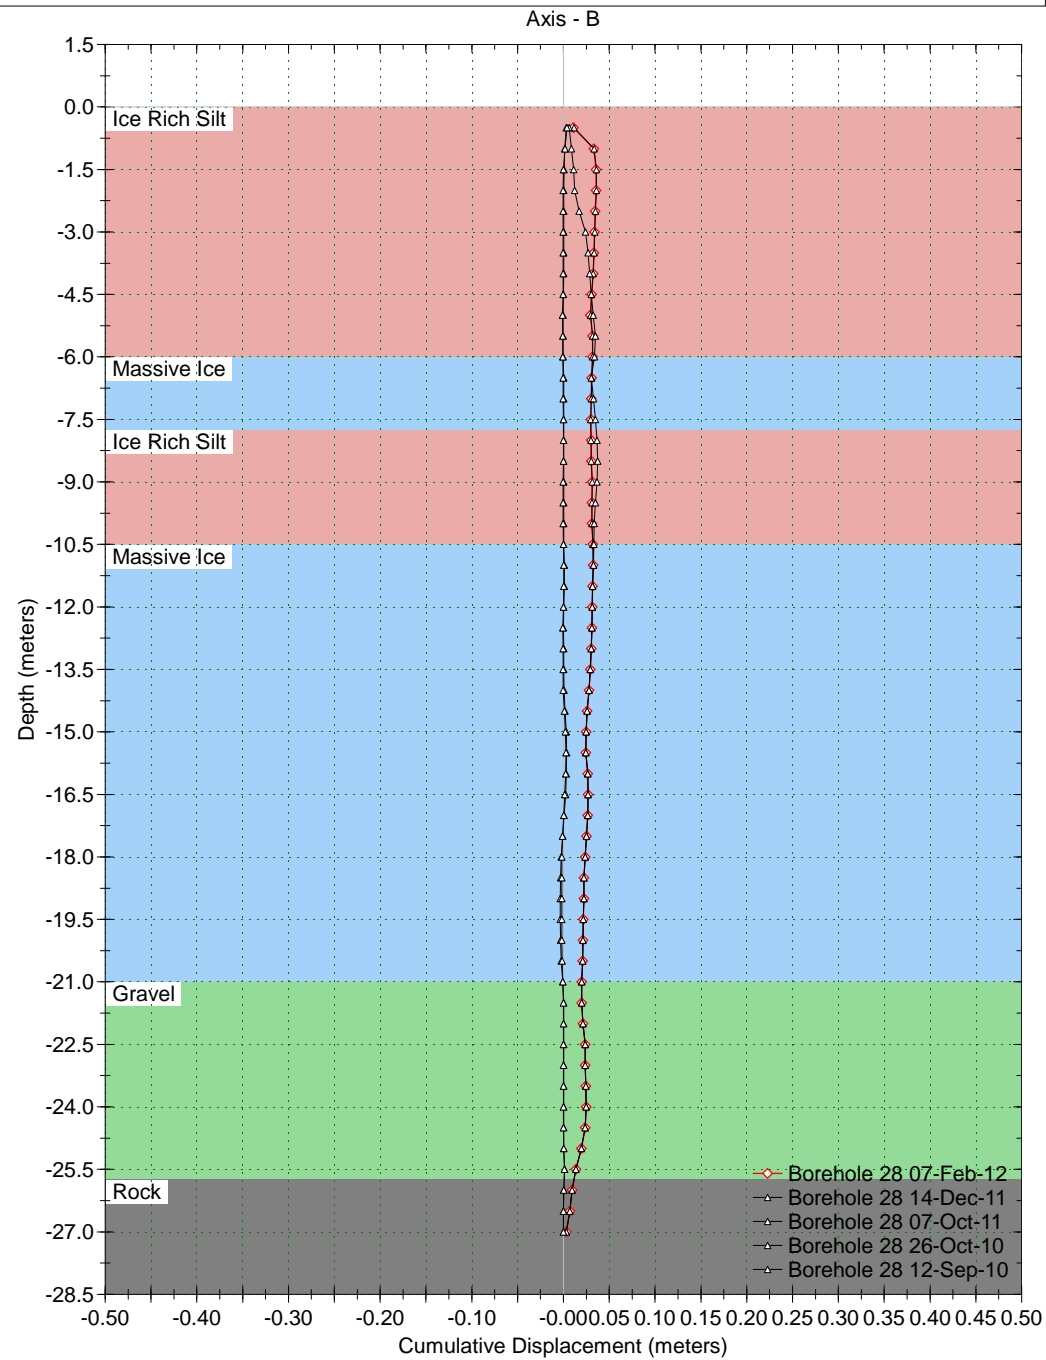
Only a partial set of SI readings were collected from BH28 during the site visit because water had entered the installation and the SI pipe was frozen / closed at a depth of approximately 11 m. The source of the water is unknown at this time. During a future site inspection, when weather conditions are more favourable, the installation should be steamed out and monitored for water accumulation on a daily basis. If water continues to accumulate in the installation, a brine solution that will remain unfrozen below 0°C may be required within the SI pipe to allow for data collection.

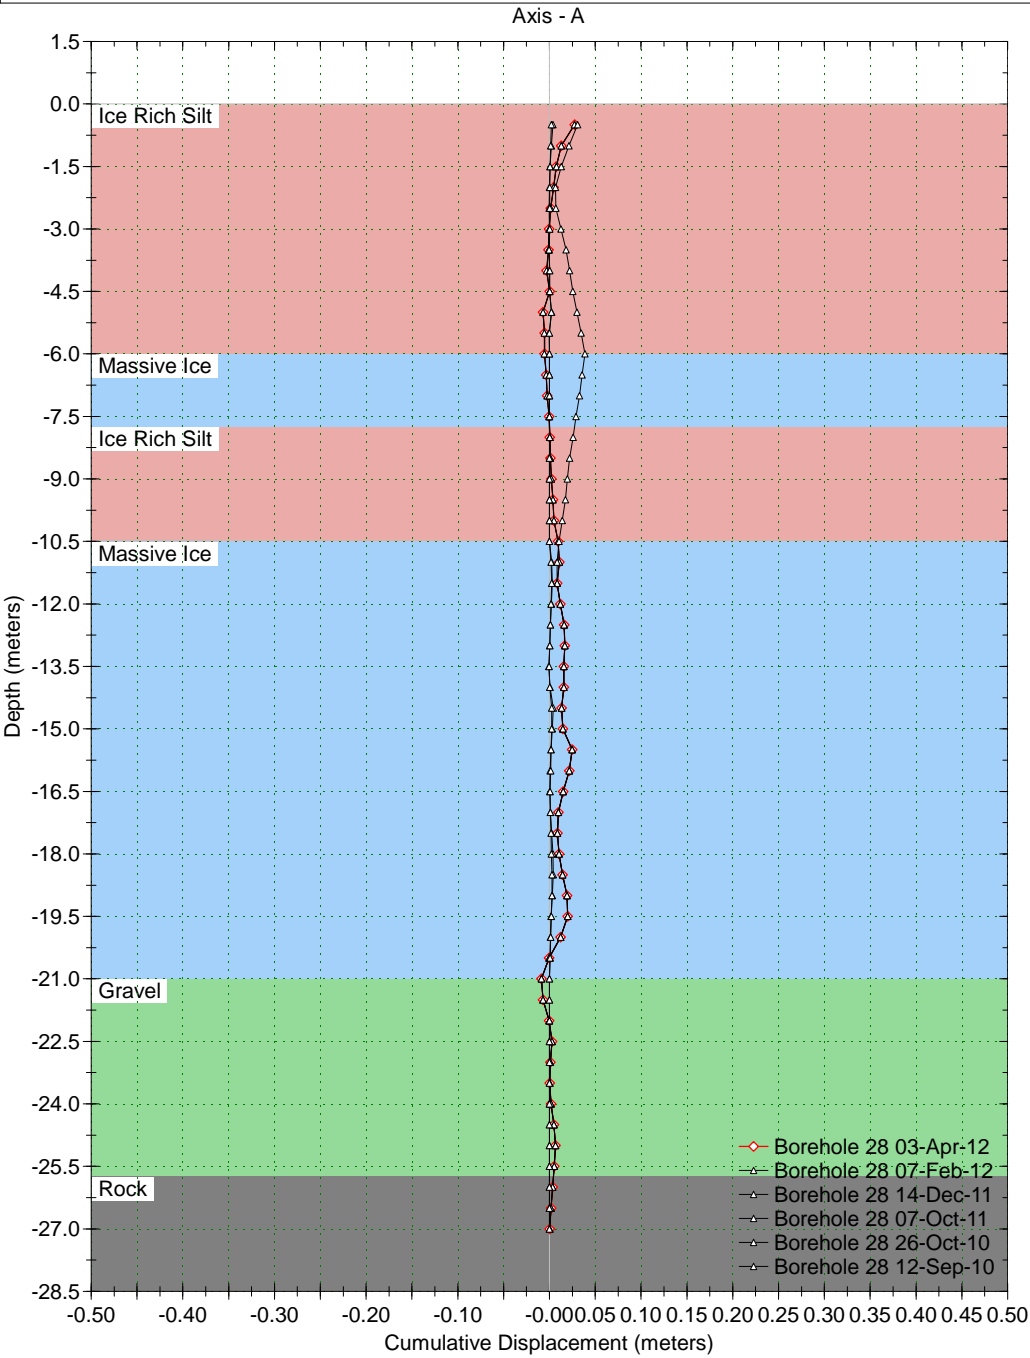
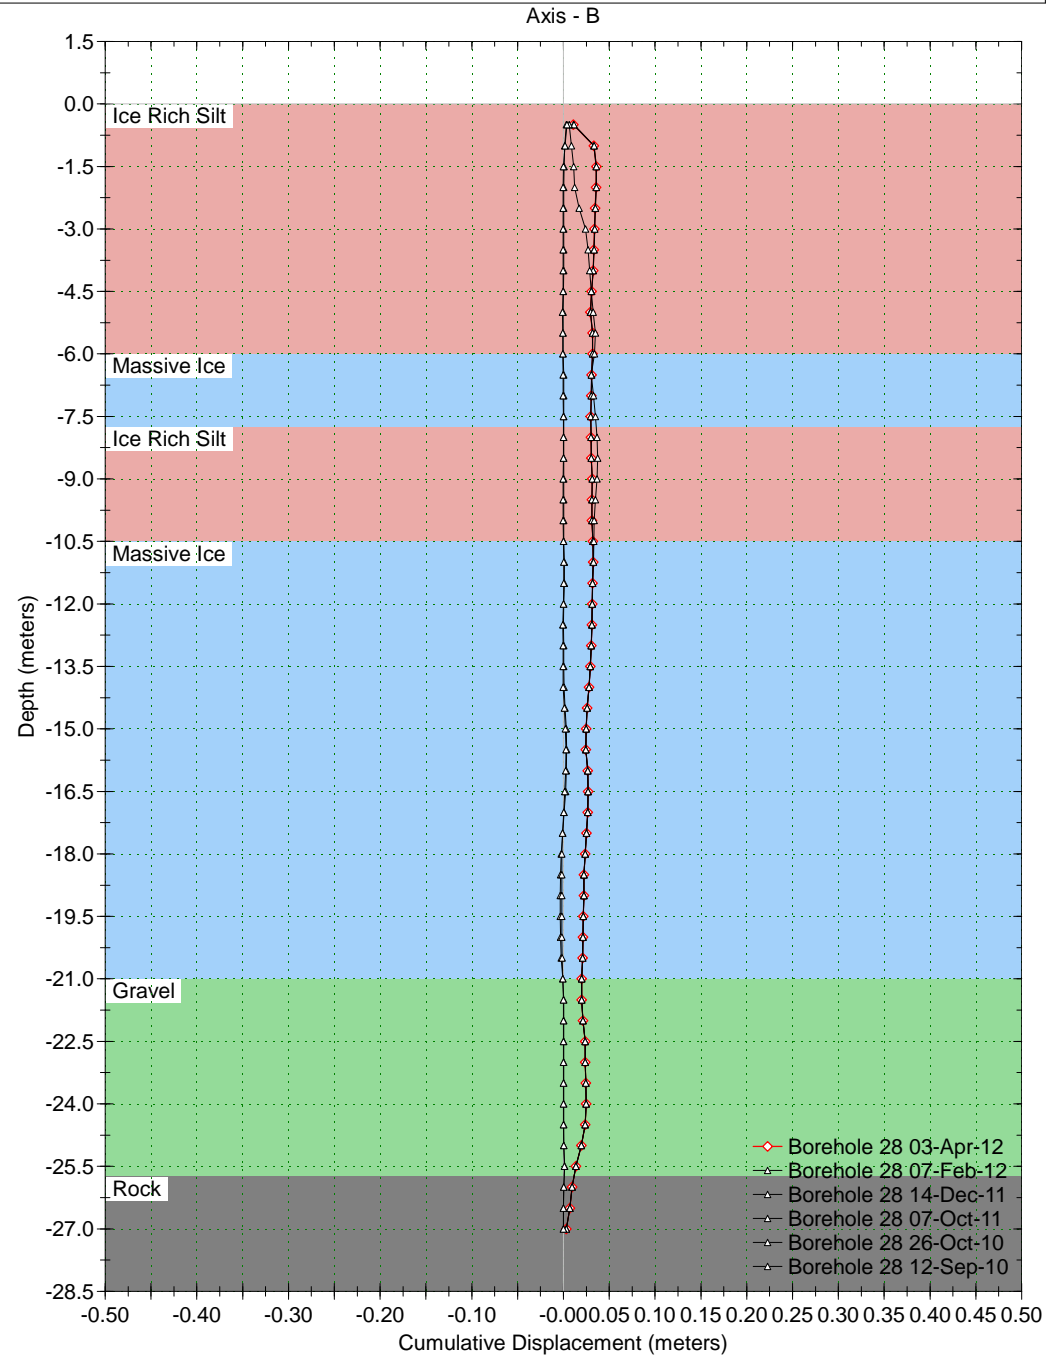
Only a partial set of SI readings were collected from BH28 during the site visit. Ice continues to block the SI pipe at a depth of 11 m. When weather conditions are more favourable, the installation should be steamed out and monitored for water accumulation on a daily basis. If water continues to accumulate in the installation, a brine solution that will remain unfrozen below 0°C may be required within the SI pipe to allow for data collection.

As discussed in the February 2012 report, repair of the SI installation in BH28 is not yet complete. The condition of the installation will be re-assessed when the weather on site improves allowing for further investigation.

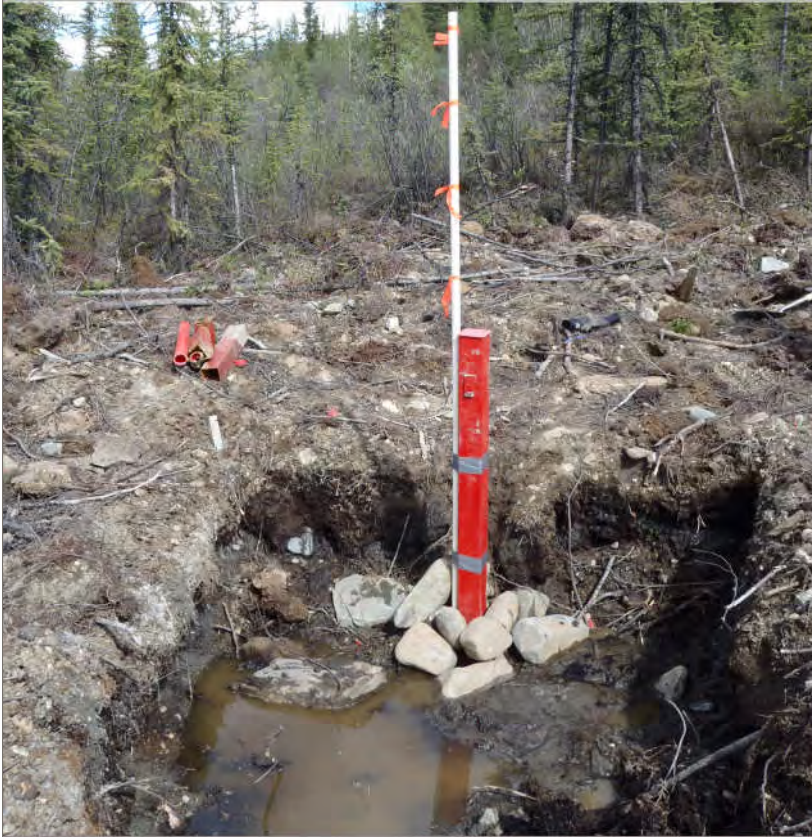
While on site, EBA personnel completed repairs to the SI pipe at surface and the protective casing of BH28. The damaged casing was removed and replaced. The repaired surface installation is shown in the attached Photo 1.

Accumulation of surface water around the BH28 was observed and may be contributing to the ice blockage within the installation. EBA recommends the surrounding area be backfilled to discourage surface water accumulation.

Photo 1: Repaired SI Installation – BH28.
May 30, 2012.

Although the surface section of BH28 is repaired, EBA recommends the installation be steamed, cleared of water, and monitored for further accumulation. If water continues to accumulate in the installation, a brine solution that will remain unfrozen below 0°C may be required within the SI pipe to allow for proper data collection.
