Re: Notification of Spill at Bellekeno 625 Treatment Pond Decant, Oct 11, 2012

Alexco Keno Hill Mining, Bellekeno Minesite

Spill Report Form

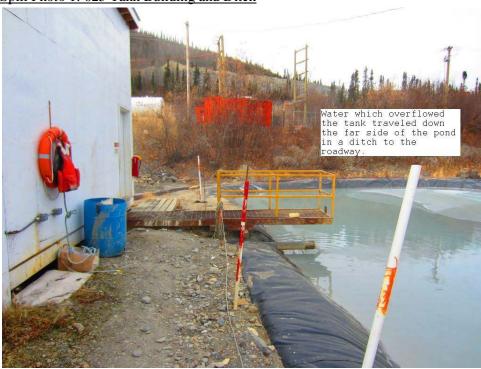
Spill Photo 1: 625 Tank Building and Ditch

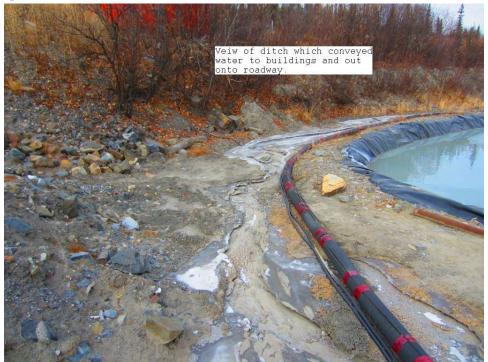
Spill Photo 2: 625 Pond Ditch

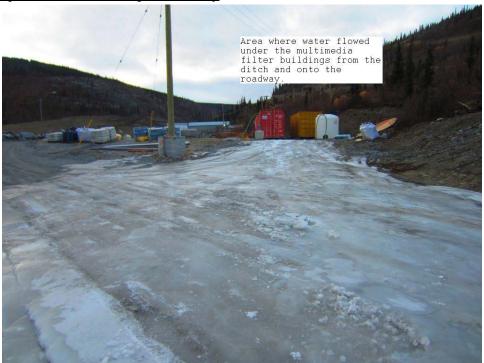
Alexco Keno Hill Mining Corp. 200 Granville Street Suite 1150 Vancouver, BC V6C 1S4 www.alexcoresource.com Spill Photo 3: 625 Ramp to Roadway

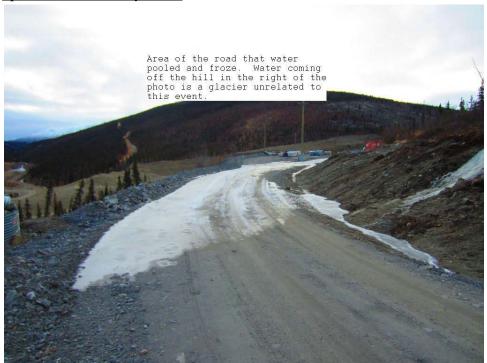
Spill Photo 4: Roadway to 625

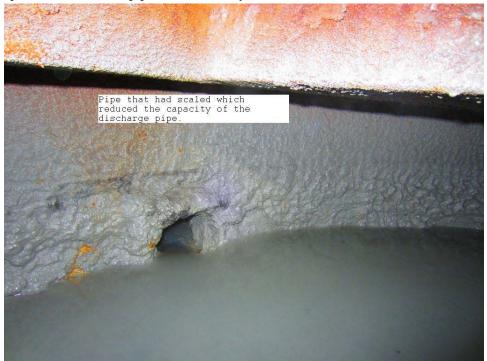
The care and maintenance manager was notified and a small submersible pump was immediately installed to pump from the mix tank into the settling pond, effectively ceasing discharge from the tank. Tank levels were lowered, and upon inspection scaling of the discharge line was found to be the cause of the overflow. A steam cleaner was used to remove scaling and flow improved, however a submersible pump was left in place until the following day to allow for further cleaning and inspection on October 12th.

Spill Photo 6: Scaled pipe within Primary Mix Tank

| 1 | DATE OF SPILL: October 11,12 | TIME OF SPILL: 10:00 am | SPILL REPORT #: |
|---|---|--|---|
| 5 | CAUSE OF THE SPILL (E.G., BROKEN HOSE, VEHICLE ACCIDENT, EQUIPMENT FAILURE, POLICY AWARENESS) line scaled which caused water to overflow top of tank Incident Report #(if applicable) | | |

| 8 | ENVIRONMENTAL RISK (DESCRIBE DISTANCE TO NEAREST WATER BODY, SENSITIVE HABITAT, WAS IT A SPILL TO GROUND OR WATER ETC.): | | | | | |
|---|--|--|--|--|--|--|
| | The line which scaled over has been put on a preventative maintenance schedule which consists of daily inspections and monthly de-scaling activities. | | | | | |

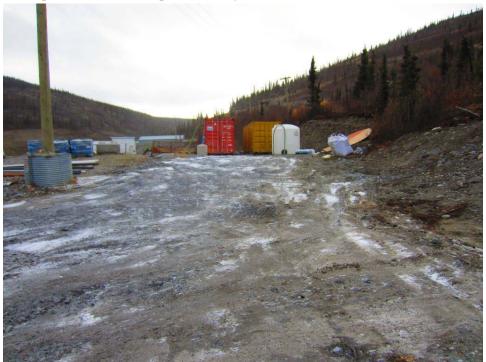
Cleanup Photo 1: 625 Ramp to Roadway

An excavator and dump truck were dispatched to the spill site the morning of October 13th to clear the spilled effluent. A total of four truckloads of frozen effluent were removed from the area of the ramp and roadway adjacent to the treatment plant buildings and transported to the valley tailings facility.

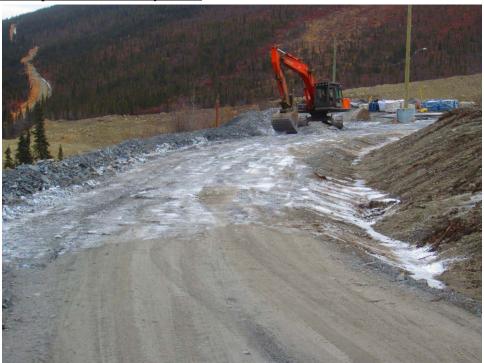
Cleanup Photo 2: Roadway to 625

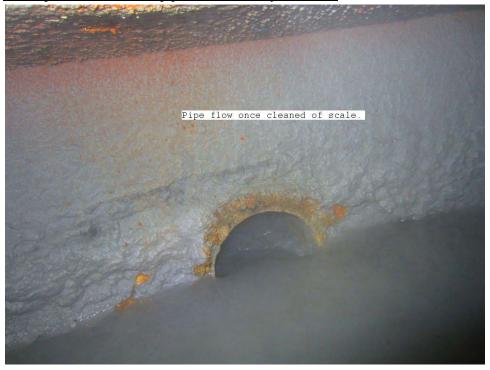
Cleanup Photo 3: Cleaned pipe within Primary mix Tank

On October 12th the tank level was further lowered to allow access to the discharge pipe from inside the tank. Upon further cleaning of the pipe, the mine effluent was observed to flow unrestricted with at least 8-10 inches of freeboard in the tank.
