Keno Hill Environmental Audit – 2023 Hecla Mining Co.

Project No. 107840-01

October 19, 2023

Ausenco Sustainability Inc.
2237 2nd Avenue, Suite 230
Whitehorse, YT Y1A 0K7
T: 867.456.4865
ausenco.com

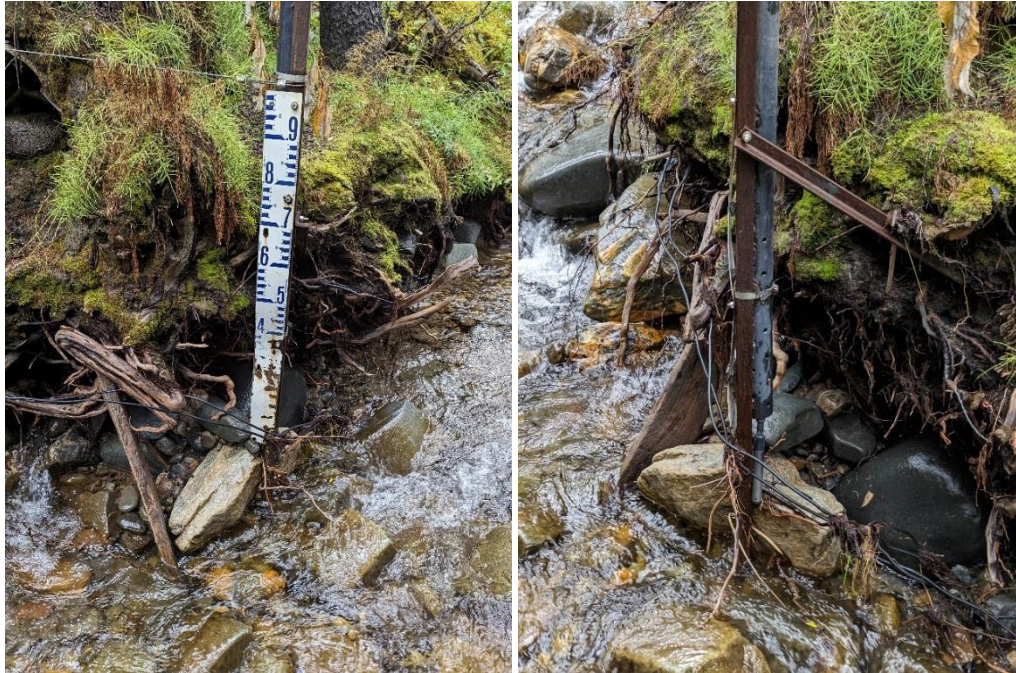
The following continuous flow monitoring stations were visited during the field audit: KV-6, KV-7, KV-21, KV-41, and KV-64. It should be noted that site KV-64 is a sample site under the ERDC Water License, not a AKHM monitoring station. It was determined that each of these station locations was appropriate based on desktop review of permits and monitoring reports. Furthermore, field equipment such as loggers and staff gauges were inspected at each station for adequacy of physical installation and flow capture. It was determined that each of these stations was installed at an appropriate location to capture flow and the physical installation was done correctly and robust enough to withstand changes in stream conditions and seasonal variation. It was documented that the staff gauge and levellogger at site KV-64 were not operating as they should, as the levellogger was located above the water mark and the staff gauge was damaged so that accurate readings cannot be obtained (**Figure 1**). The Ensero field technician reported that a recent flood on Flat Creek had scoured the creek bed resulting in the active water level of the creek to drop and the levellogger to be stranded above the water line. It was assumed that rocks washing down the creek during the flood had damaged the staff gauge.

Figure 1 Damaged staff gauge and improperly installed data logger at Monitoring Station KV-64.

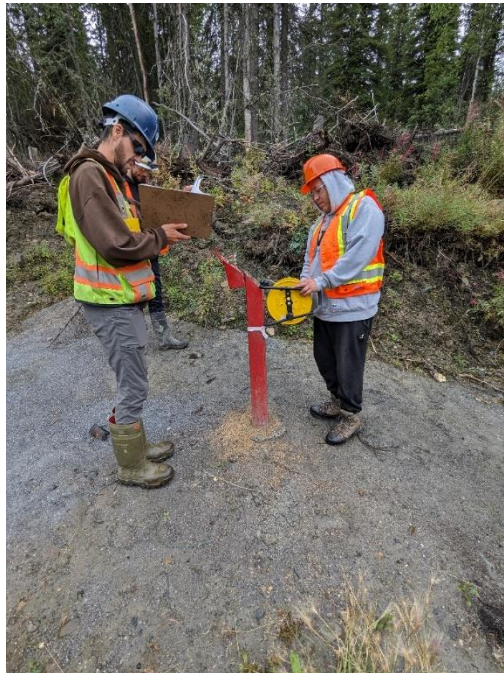
As part of the onsite audit, groundwater wells were sounded for depth to confirm their integrity (**Figure 2**). Depth to bottom measurements collected during the audit were compared to historical records of depth to bottom observations. A review of well logs, well development records, and previous sampling events including development, field parameter monitoring, and laboratory results were evaluated to confirm that the installations are functioning as designed. Based on results of the onsite audit, sites KV-85D, KV-123, and BH39 had significantly different depths compared to those reported in the historical records (**Figure 3**). All other sites that were monitored had depths within 10% of the historical records. An investigation is required to determine why the depths are significantly different and the sites should be monitored to determine if the depths are changing over time.

Figure 2 Ensero field technician and Na-Cho Nyäk Dun First Nation member sounding groundwater well.

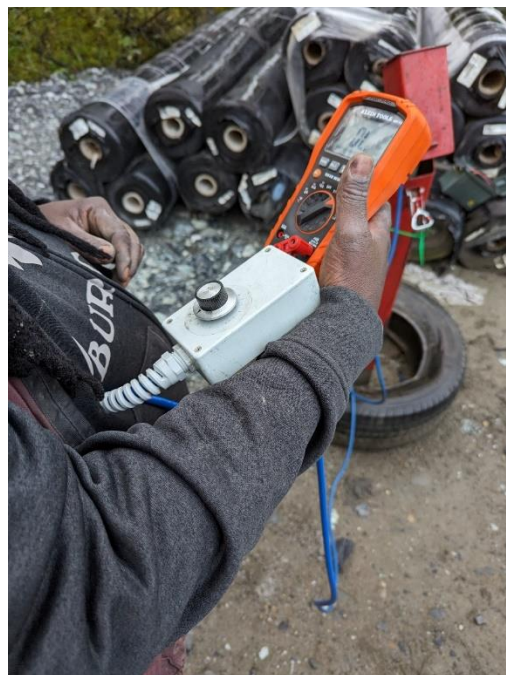
On August 17th, Devon Yacura was accompanied by Michael Rae and Arthur Mokwena to each of the six boreholes to obtain the temperature data (**Figure 3**). A total of 16 readings are collected at each monitoring station. The real-time readings are recorded in kilo-ohms, which are ultimately converted to Celsius using computer software. All 16 readings were obtained for each of the six monitoring stations during the field trip. It appeared that sensor #9 for borehole BH22-09 was malfunctioning, as the data output value was not consistent with the values for the other 15 sensors. However, this may have been a one-off error as the historical data for that sensor appears to be correct. Moving forward, the data for this sensor should be monitored closely to observe whether it continues to be inconsistent with the remaining 15 sensors. It appeared that all six boreholes were operating as intended and recording meaningful data (**Table 4**).

Figure 3 Mine Technician collecting real-time readings from the Ground Temperature Probes.

Cable ID	Status	Comments
BH 22-01	Functioning	Cap won't close. PVC sticking up. PVC filled with water/oil mixture.
BH 22-05	Functioning	Good condition
BH 22-06	Functioning	Base of casing is loose
BH 22-07	Functioning	Good condition
BH 22-09	Functioning	Sensor #9 appears to be malfunctioning
BH 22-40B	Functioning	Good condition

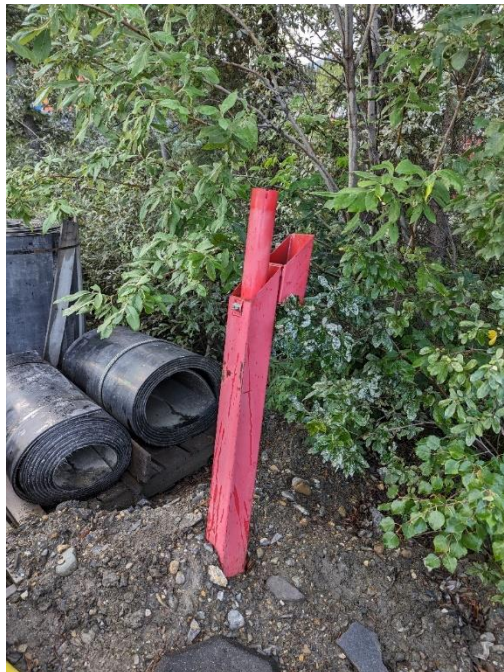
No slope inclinometer data was obtained from BH36 during the audit (**Table 5**). Onsite staff members had limited knowledge of the slope inclinometers and were not able to comment on the current status of the monitoring stations.

Figure 4 Slope inclinometer station, BH36.

Cable ID	Functioning (Yes/No)	Comments
BH36	No	TetraTech attempted to collect data from this instrument in August 2022 but was unsuccessful due to equipment issues.
BH38	No	As of 2021, the monitoring equipment is not accessible.
BH28	No	This instrument has been non-operational for several years and needs to be replaced.

- The slope inclinometers are not functioning as intended or unable to obtain data. The geotechnical inspection report for 2023 should be addressing this aspect to determine whether additional/replacement stations are warranted.
- Two of the groundwater wells (KV-85D and KV-123) were unable to get to the depths required in the groundwater monitoring plan. Efforts should be made to determine whether the repairs are possible and if not these stations should be replaced unless a qualified professional determines otherwise.

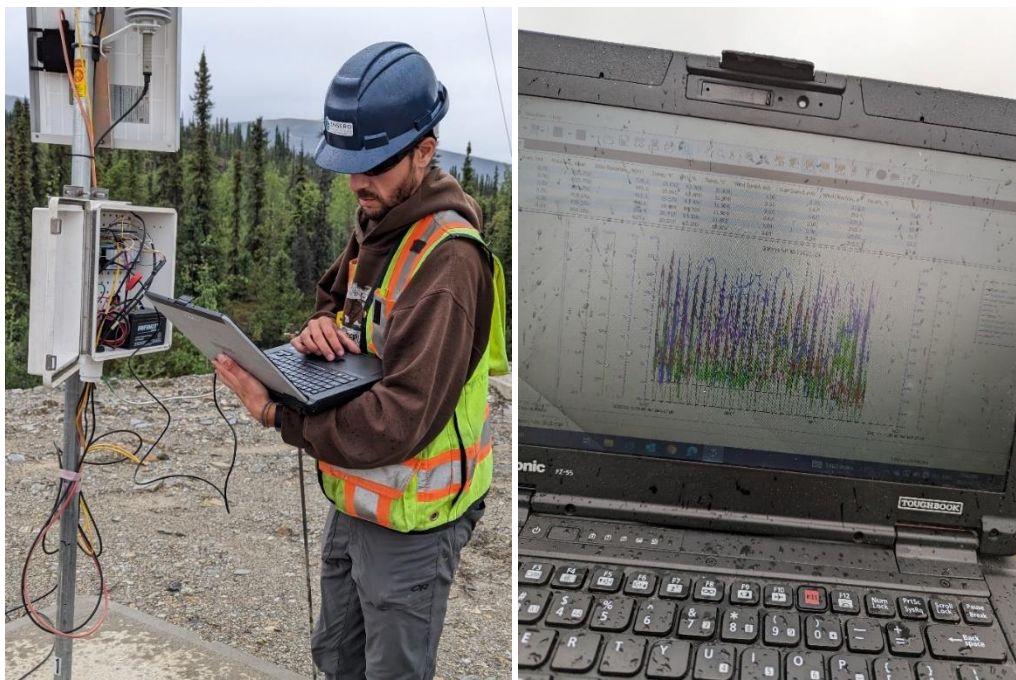
Each of the meteorological stations were visited during the audit to inspect the operational status of the monitoring equipment and instruments (**Figure 5**). Data was downloaded from each of the meteorological stations to show that the instruments are operating and collecting data as intended.

Figure 5 Ensero field technician downloading data from Calumet weather station on August 16th, 2023.
