**Ketza River Mine**  
**Environmental Liability Assessment**  
**FINAL Report**

*Prepared for:*  
**DIAND Contaminants / Waste Program, Whitehorse**

*Prepared by:*  
**Gartner Lee Limited**

*May, 2002*

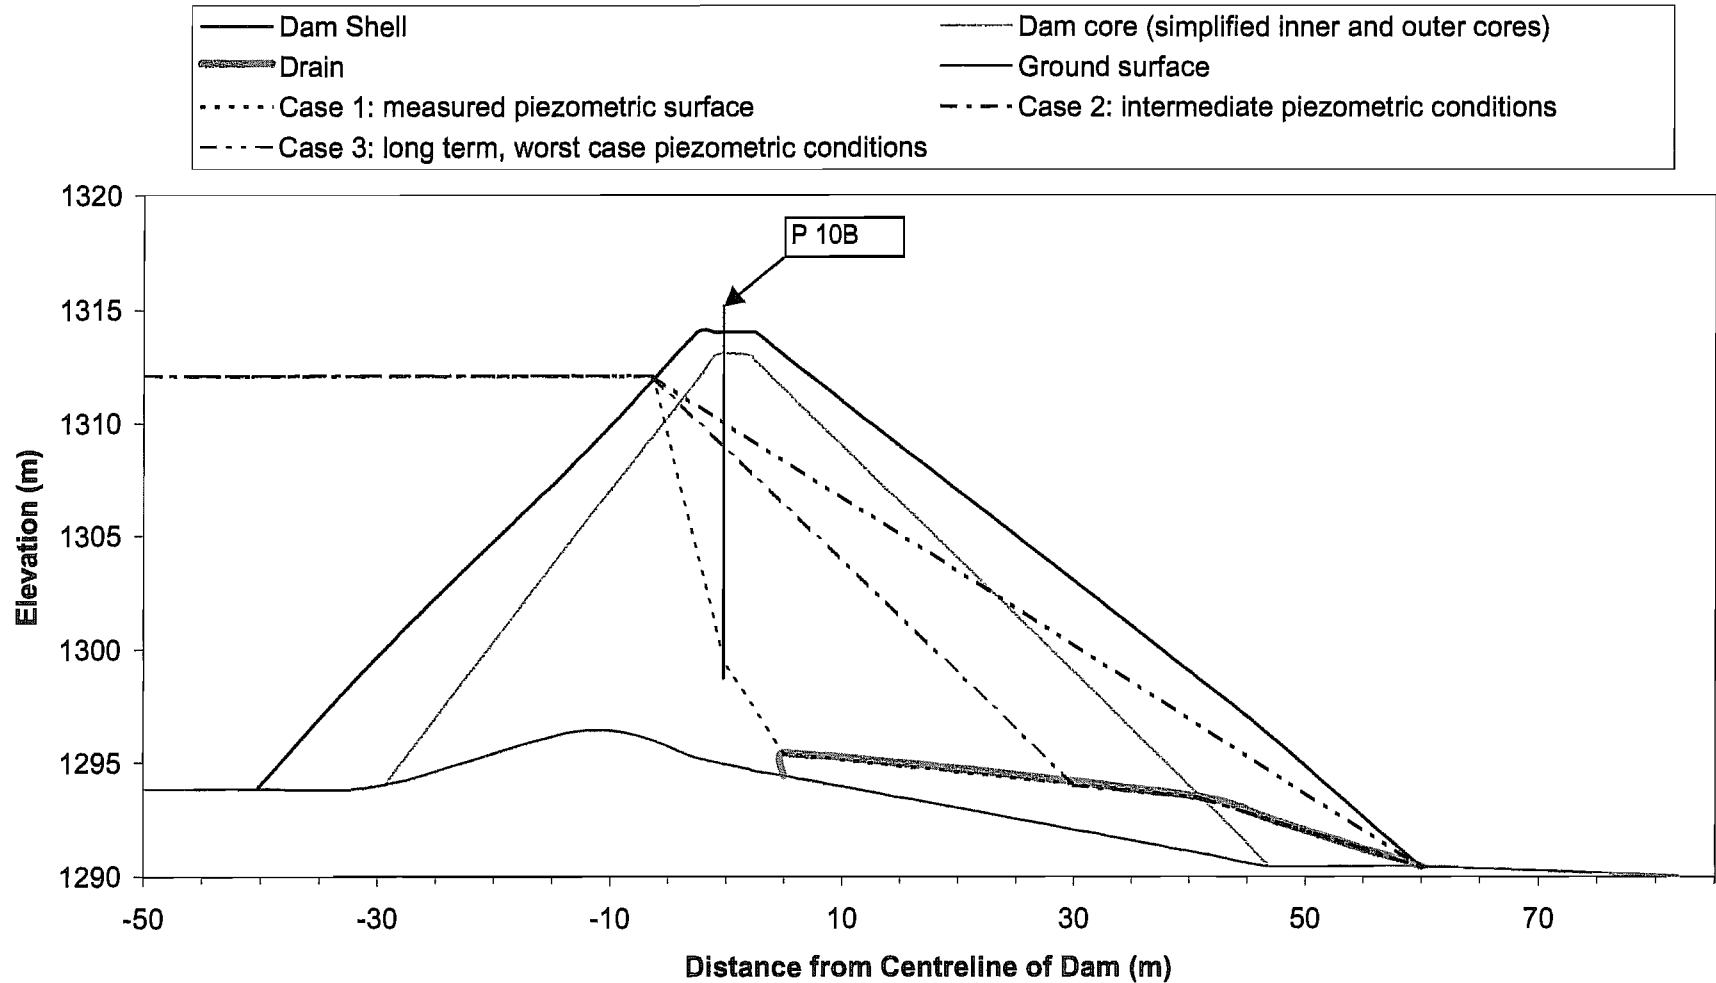
**Figure 4.2**  
**North Dam Piezometric Cases**

As such, three potential piezometric cases, as shown on Figure 4.2, are reviewed within the following stability analyses.

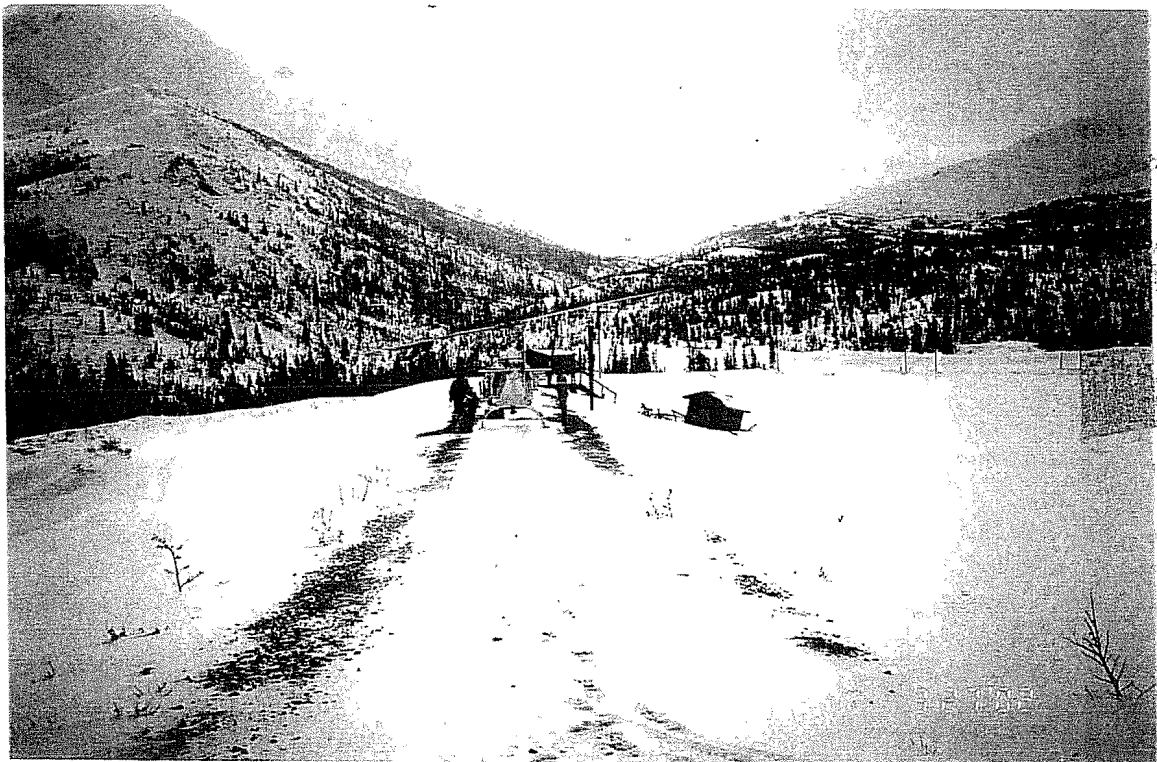
deformation other than minor rutting due to vehicle traffic. No signs of standing water were noted on the crest.

**Photograph 2. View along crest of north dam.**

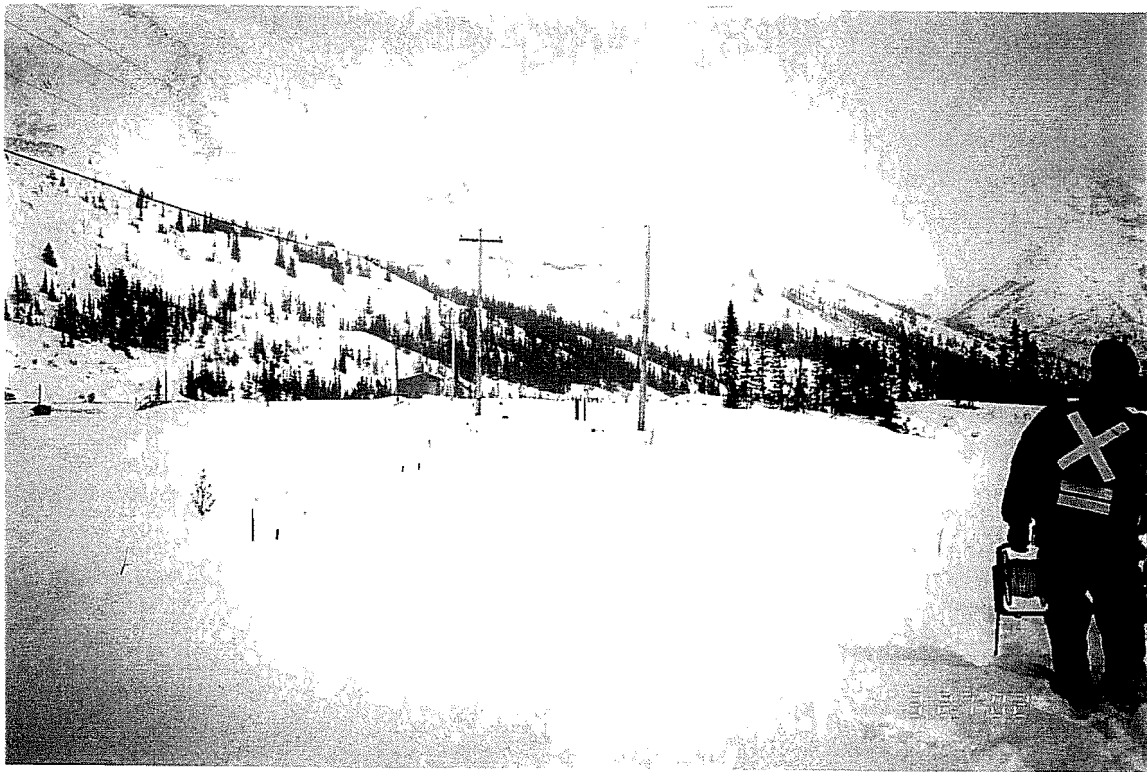
The South Dam is approximately 15 m high above native grade in the area and the crest width varies from 5 to 6 m. No signs of cracking, settlement and/or standing water were noted on the crest.

**Photograph 5 Crest of south dam.**

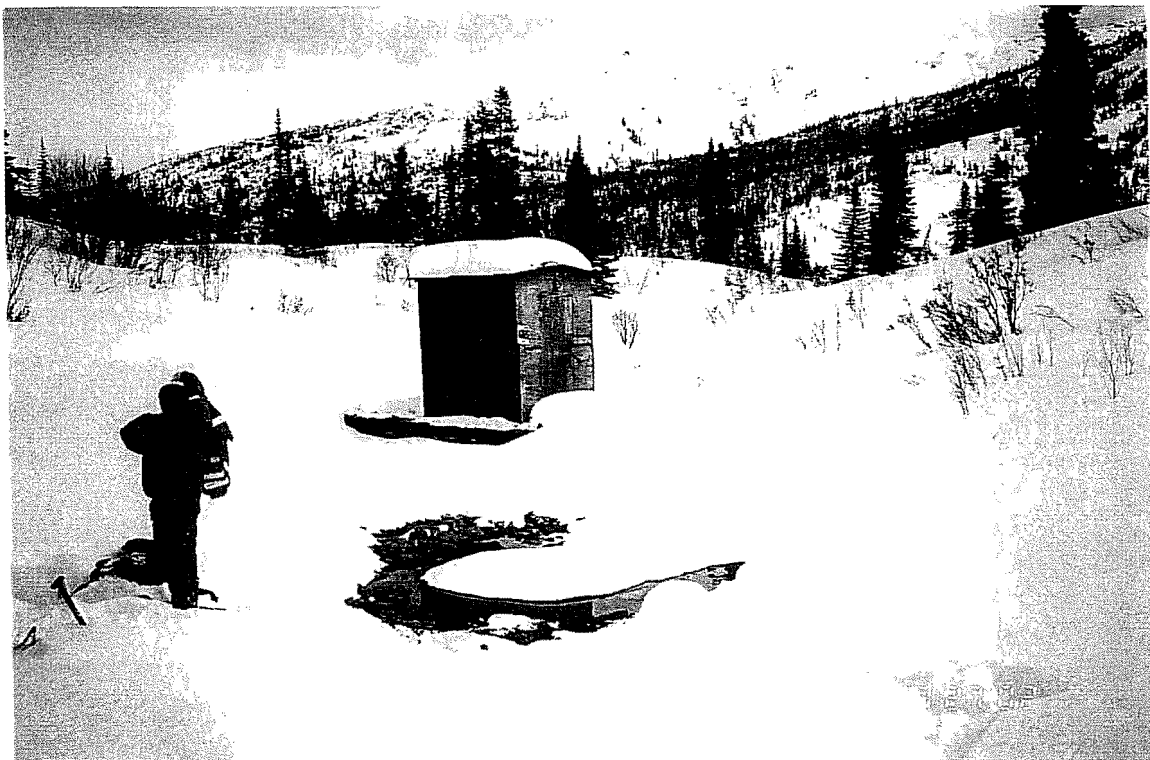
The downstream side of the South Dam has an intermediate berm that is situated approximately 3.5 to 4 m below the top crest. The slope angle was measured at 19.5° to 21.5° or approximately 2.75H:1V that is slightly flatter than the design side slope. The downstream slope had a consistent grade with no signs of bulging, cracking or settlement. Seepage was noted just beyond the toe of the dam. The seepage was

**Photograph 6. Site KA-5, toe of south dam.**

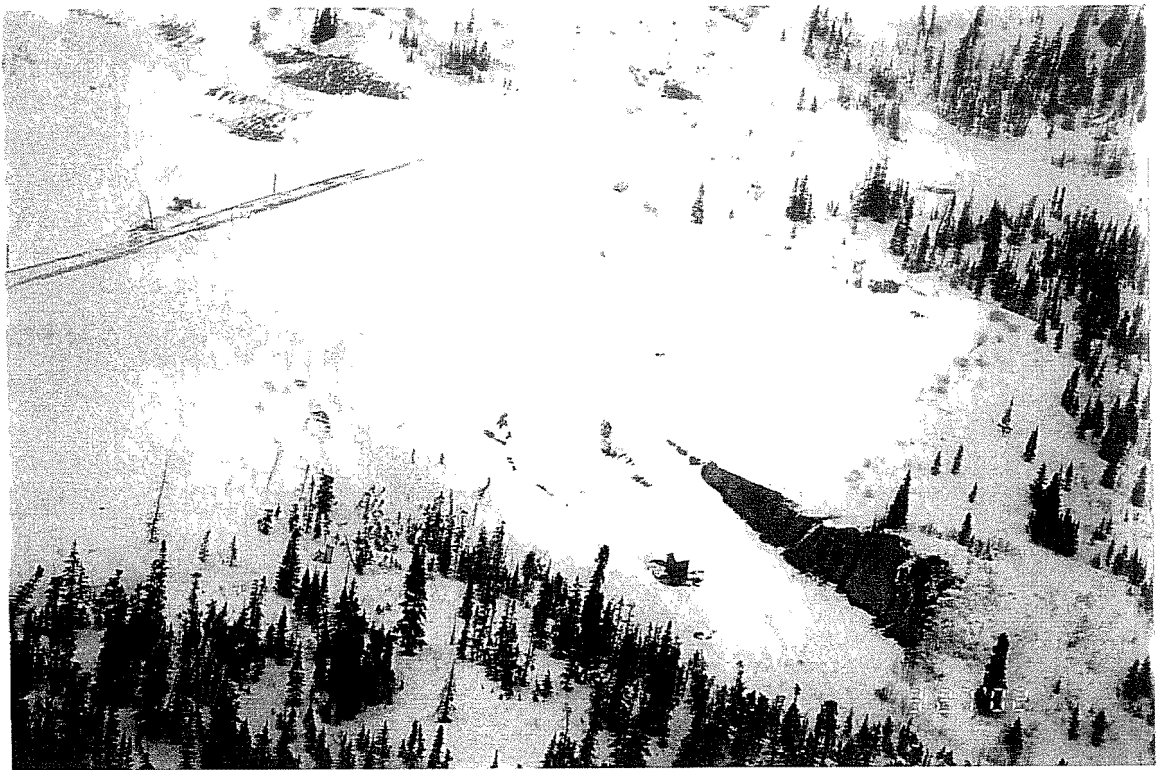
The downstream side slope angle was measured at 20° to 21°, approximately 2.6H:1V that corresponds to the design side slope. The downstream slope had a consistent grade with no signs of bulging, cracking or settlement. Some minor erosional gullies, less than 0.5 m deep, were noted on the face; these small gullies are the result of the concentration of surface run-off. Seepage was noted from approximately three different point sources near the toe of the dam. The seepage was clear with no sign of entrained sediment. The granular material at the seepage location was unconsolidated and saturated (loose and difficult to walk-on without sinking in). This 'soft' area at the toe, previously noted in almost all other previous inspection reports, measured approximately 8 m long by 4 m wide. Seepage then drained into a small pond located adjacent to a pump house.

On a visual basis, the dam appears to be stable under the current static conditions with no significant concerns regarding settlement, deformation or cracking. The main issue with the dam appears to be the seepage discharge and the associated soft area near the toe of the dam. The soft area may be due to loose or liquefiable soils and/or artesian pressures within this area. The design cross-section for this dam notes that a granular blanket drain was placed under the downstream side of the dam. This drain was connected to the downstream shell, and hence, any seepage through this dam, should be collected within this element of the dam.

**Photograph 7. Overview of north dam, note seepage from toe.**

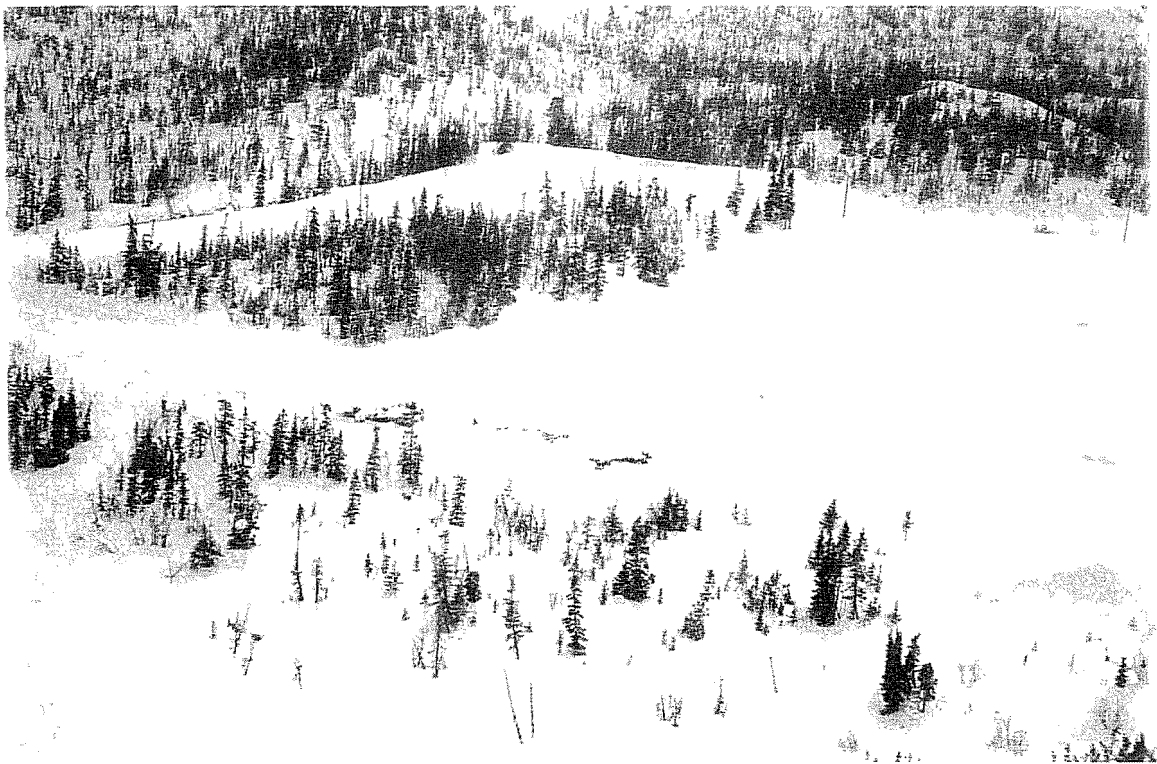
The Lower Subsidiary Creek diversion channel was inspected and found to be in generally good condition. The bottom width generally was in accordance with the design width of 1.0 m, but in some areas, it was reduced to approximately 0.7 m. Some minor cracking and small slumps were noted on the backslope, indicating marginal stability for portions of the ditch. Several significant erosion gullies were noted on the downhill side of the ditch. These were formed as a result of channel blockage (slump failure or ice) and the seepage water exiting from the channel section. This diversion ditch water was then directed into the tailings pond. These erosional gullies, approximately 0.5 to 0.7 m deep, should be backfilled and graded over so that concentration of surface run-off is not exacerbated.

**Photograph 8. Lower subsidiary creek diversion. Note drifting across ditch to left of drum cache.**
