**Government of Yukon
Water Resources Branch
Ketza River Mine
2007 Geotechnical Inspections**

UMA Project No.: 6029 010 00 (4.12.4)

February 2008

**Re: Yukon Sites – 2007 Geotechnical Inspections
 Ketza River Mine**

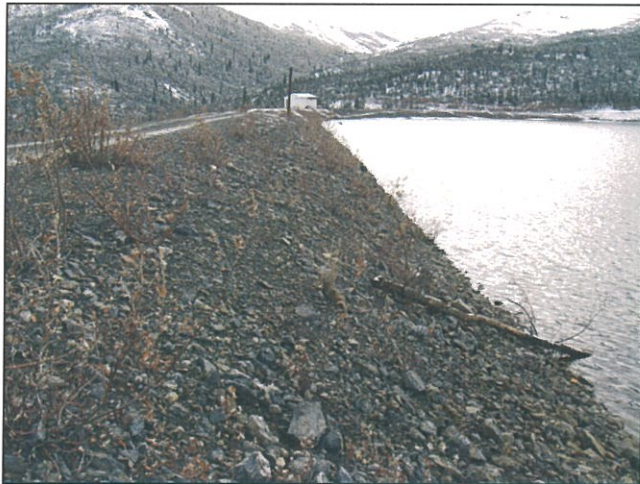
Figure 04 Upstream Side of North Dam

At the time of our inspection, the water level in the tailings pond was estimated to be 2 to 2.5 m below the tailings dam crest level (Figure 04). A staff gauge in the tailings pond read 7 inches. At the current water level, small exposures of tailings beaches were noted along the upstream side of the tailings dams, in particular the South Dam (Figure 05). It was estimated that the water level was approximately 1 m below the invert of the spillway that separates the North and South Tailings Dams. This is approximately the same water elevation reported in the September 2005 inspection by SRK Consulting and probably 0.3 to 0.6 m lower than reported by EBA in their June 26 inspection of this year. It is our understanding that when necessary, tailings pond levels are lowered through pumping via the intake and pumphouse situated on the southwest side of the pond (Figure 06). Water from the pumphouse is discharged via a 150 mm line to the Cache Creek Diversion Channel (Figure 07). The pump was not in operation at the time of our October inspection.

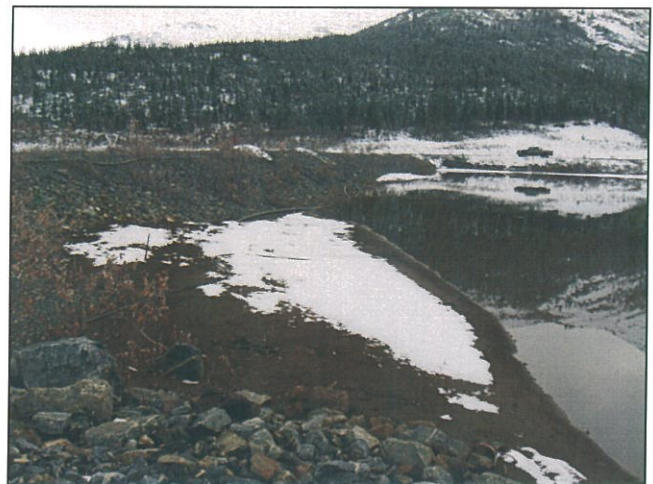
Figure 05 Exposed Tailings Behind South Dam

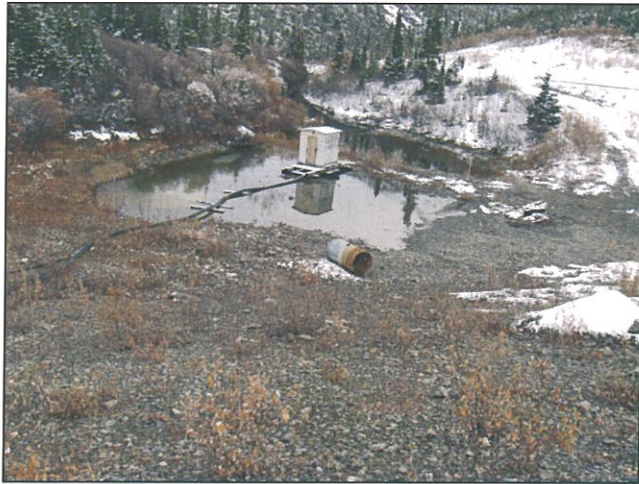
Figure 08 Pumphouse S1

It is also our understanding that at one time, water from the tailings pond was circulated back to the mill via the abandoned pumphouse just north of the spillway. Seepage water was collected in ponds downstream of the North and South Dams and pumped back over the dams back into the tailings pond via Pumphouses N1, S1 and S2 (Figure 08). None of the pumps are currently operational.

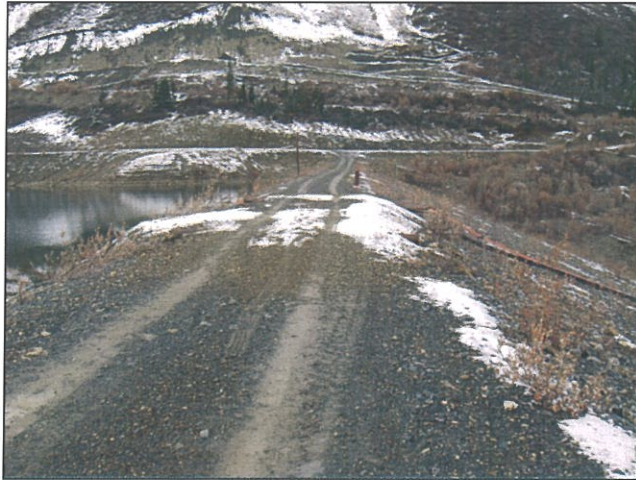
Figure 12 North Dam Crest

The dam crest is in generally good condition with no visible tension cracks or tilting. A minor depression of the crest (less than 0.2 m) was noted in the vicinity of Piezometer Nest 11 in the North Dam (Figure 12) and also from the spillway to Piezometer Nest 12 on the South Dam. It appears that the crest was recently surveyed (evidenced by paint marks along the edge), which could provide confirmation of these visual observations. The observation of crest depressions on the South Dam is also supported by apparent settlement of the protective casing at Piezometer P96-12B&C (Figure 13).

- Cut saplings on upstream and downstream dam slopes.
- Survey dam crest and identify any areas below design elevation. Fill low areas as required.
- Repair riprap at the downstream segment of the Cache Creek Diversion.

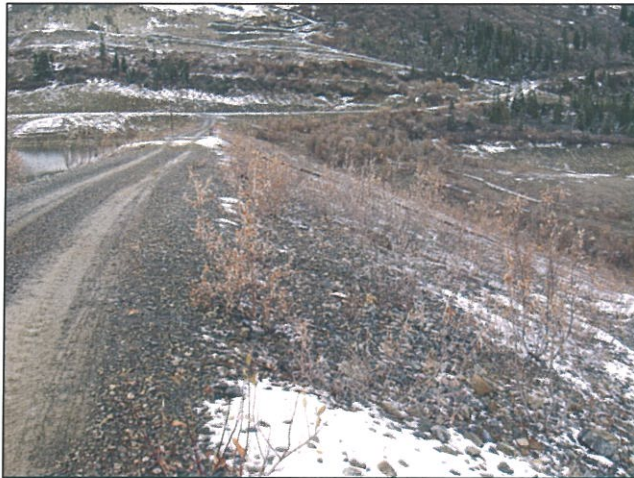
The dam slopes are in good condition with no visible signs of bulging or erosion. Vegetative cover is sparse although saplings up to 25 mm in calliper have become established on the upstream and downstream slopes of both dams as seen on Figures 14 and 15.

Figure 14 Saplings on North Dam Slopes

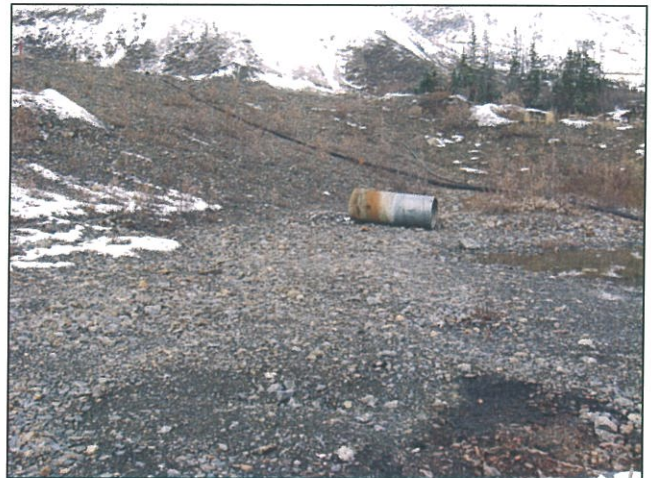
Figure 15 Saplings on D/S Slope of South Dam

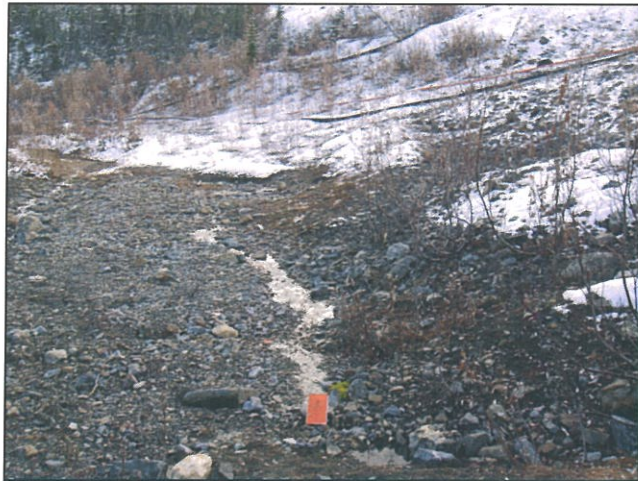
Seepage was noted at the toe of the North Dam at several locations along a stretch of about 20 m (Figure 16). Water from these seeps collects into a common drainage channel that runs into the collection pond at Pumphouse N1 (Figure 17). Some fine grained soil has accumulated at the bottom of the drainage channel just upstream of the V notch weir. Although the source of these fines could not be determined they may be from surface erosion of the silty soil beyond the toe since the water seeping from the toe of the dam was clear. The ground is also very soft in the area of the seeps with quicking conditions evident. The soft zone extends up the face of the dam by approximately 1 m. Although seepage was not observed at the toe of the South Dam, water accumulating at the surface of the granular drainage blanket and flow downstream of the pumphouse clearly indicates that seepage losses similar to the North Dam are occurring.

Figure 16 Seepage at Toe of North Dam

- Construct downstream toe berm at the North Dam (planned for summer 2008).
- Evaluate the hydraulic capacity and erosion potential for the spillway. Repair/upgrade as required.
- Repair weirs downstream of the North Dam to allow flow measurements to be made.
- Install piezometers near the toe of the North Dam where the toe berm is to be constructed. The piezometers are required to confirm design objectives with respect to seepage are met and to confirm groundwater levels used in previous slope stability analysis.
- Consider an emergency spillway to the Cache Creek Diversion at the downstream end of the Lower Creek Subsidiary Diversion in the event that the culverts are blocked.

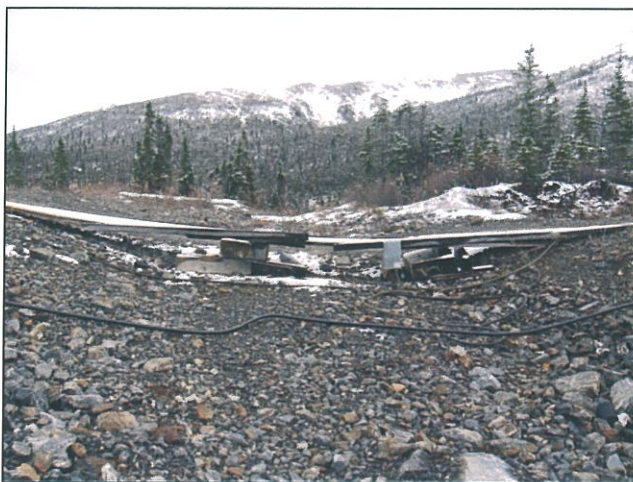
Figure 18 Spillway (view D/S)

The spillway located between the North and South Dams is in good condition (Figure 18). As previously noted by others, the granular material across the spillway channel, in particular on the downstream side of the dam centreline is made up of material with a D_{50} less than 75 mm (SRK, 2005). Previous reports have raised a concern with respect to the ability of the spillway to convey large flows without experiencing significant erosion. Although the spillway is located within natural high ground between the two dams, erosion of the spillway channel material could cause weakening of the structure. A small sink hole in the downstream face of the South Dam was noted, however, this feature is related to extraction of a timber utility pole at this location (Photo 19).

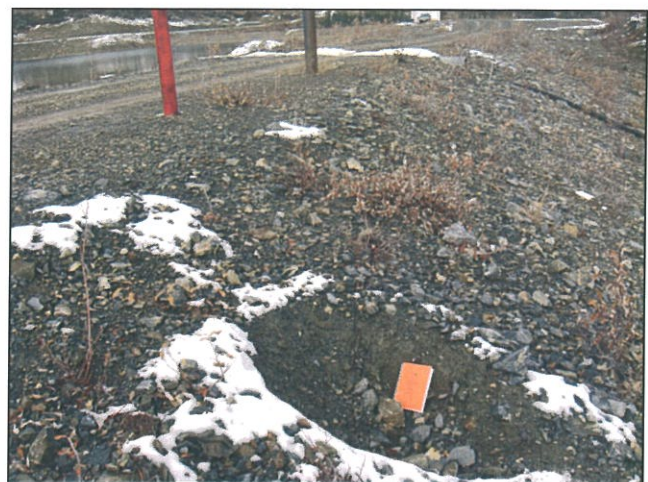
Figure 19 Sinkhole in South Dam

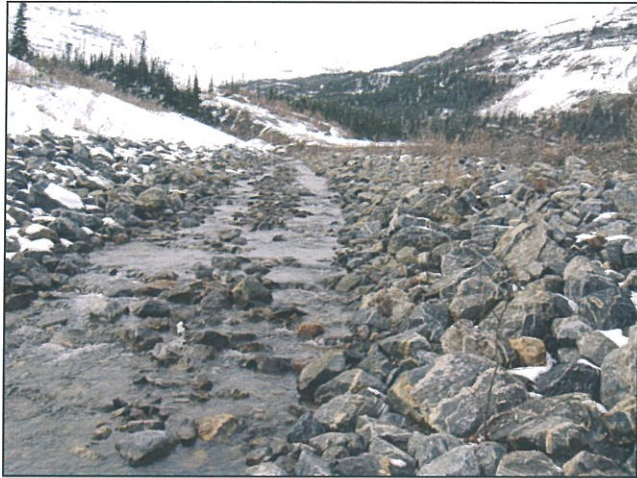
Figure 20 Middle Segment of Cache Cr. Div.

The upstream and middle segments of the Cache Creek Diversion are in good condition (Figure 20). The riprap armouring is stable and no down-cutting of the channel is evident. The far end of the downstream segment (east of the South Dam centreline) is considerably steeper with evidence of ongoing ravelling of riprap along the bank (Figure 21 and 22). Down-cutting of the bedrock through which the channel is founded at the confluence with the drainage channel from the South Dam seepage pond is also evident (Figure 23). The narrow channel width and steep banks of the downstream channel segment makes it more prone to blockages from bank instabilities or ravelling of riprap from the banks.

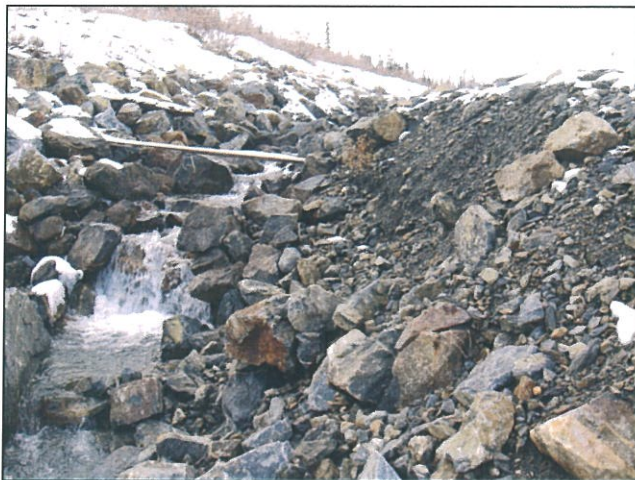
Figure 22 Ravelling of Riprapped Bank

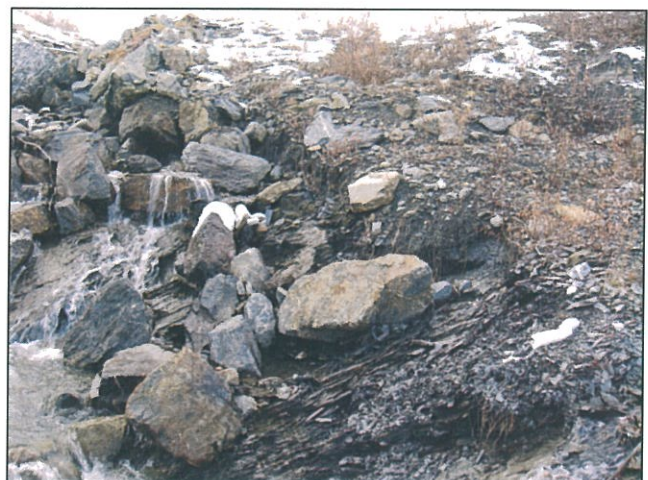
Figure 23 Bedrock Down-Cutting

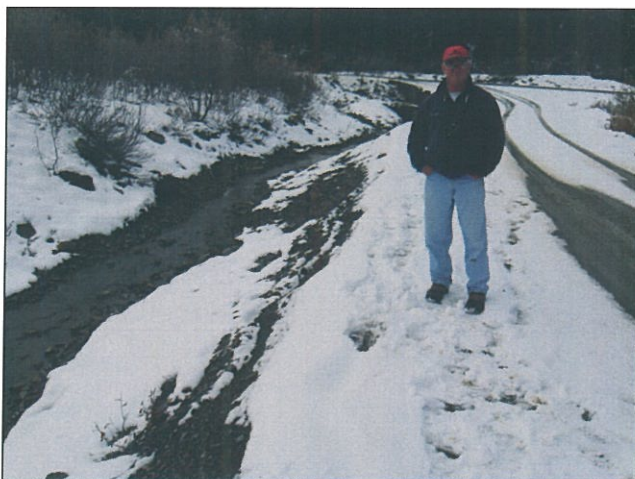
The Lower Subsidiary Creek Diversion is in generally good condition along its length from the mine site access road to its confluence with the Cache Creek Diversion. The 600 mm diameter culvert at the downstream end of the channel is in good condition with no blockages (Figure 24). Based on observations at a weir just upstream of the culvert, the flow is estimated to be in the order of 1 l/sec (Figure 25). Tension cracks and minor slumping of the channel bank about 60 m downstream of the mine

Figure 26 Minor Bank Slumping

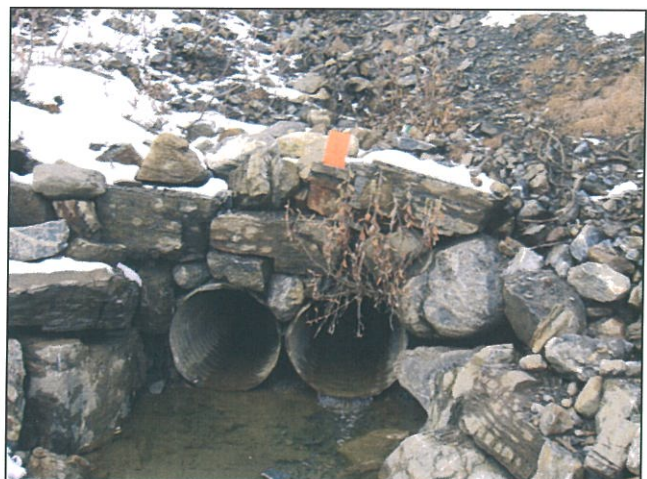
Figure 27 Culverts at Upstream End of Channel

access road was noted (Figure 26). Similar observations were made at the road crossing where the channel banks are about 2.5 m high with slopes of about 1 horizontal to 1 vertical (1H:1V). The two 600 mm diameter culverts at the road crossing are in good condition (Figure 27).

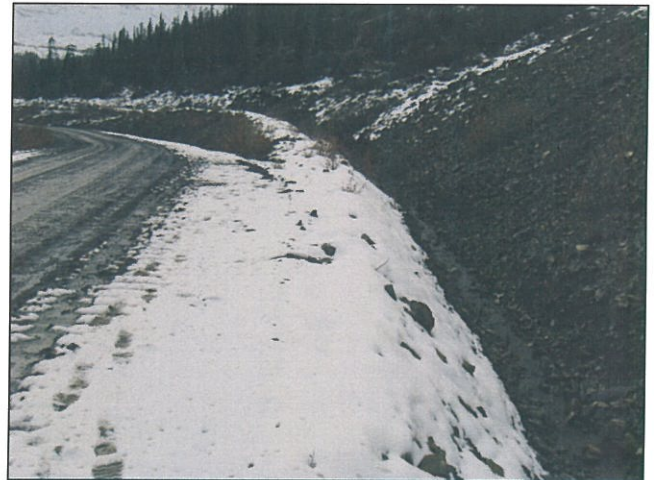
Figure 29 D/S Segment of Interceptor Ditch

The Northwest Interceptor Ditch intercepts and conveys surface water run-off from higher ground to the northwest around the tailings pond. It runs along the northwest side of the mine access road with a high point (drainage divide) about halfway along the edge of the pond. From this point water either runs southwest feeding into the Lower Subsidiary Creek Diversion or northeast along the edge of the road away from the tailings impoundment. The ditch has a bottom width of about 2 m southwest of the drainage divide with sideslopes of about 2H:1V (Figure 28). Northeast of the divide, the channel is V-shaped with steeper slopes estimated to be about 1H:1V (Figure 29).

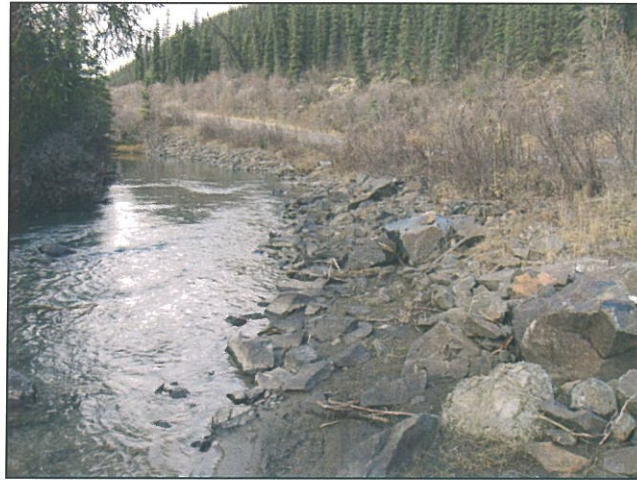
Figure 31 Riprap at Location A

Located on a gentle outside bend, the riprap along this 75 m long segment is in good condition with no evidence of bank erosion (Figure 31). The bank is about 2 m high. Riprap size is up to 900mm with an estimated D_{50} of 300mm.

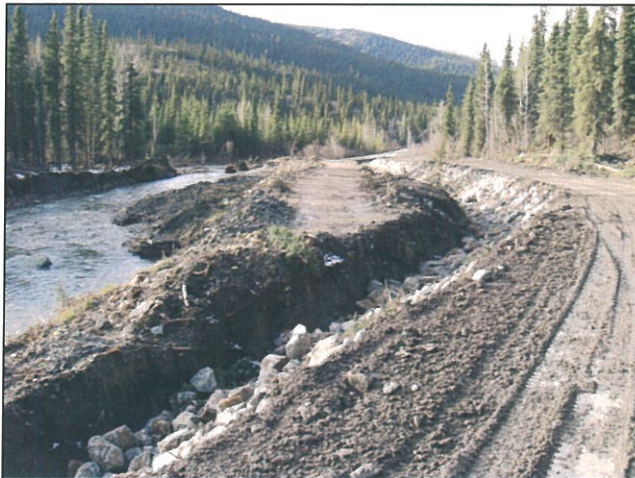
Location B is at a section of the road that washed out in the spring of 2007 and has since been repaired (Figure 32). Riprap has been placed along the new road alignment leaving the old road bed exposed within the channel where it is being actively eroded (Figure 33). The riprap is in good condition with no evidence of erosion of the new road bed. Some undercutting of the riprap should be expected as the old road bed erodes unless it has been keyed into the channel bottom. The bank is about 3 m high. Riprap size is up to 750 mm with an estimated D_{50} of 250 mm.

Figure 32 Road Washout at Location B

Although outside of the TMA, it is recommended that the erosion protection measures along the mine access road also be inspected on a regular basis and maintained as required. In particular, attention should be given to the upstream end of the riprap installed at Location H where scouring is considered likely to occur. Location B should also be closely monitored to determine if additional armouring is required once the old roadbed between the repaired section and the river has eroded.

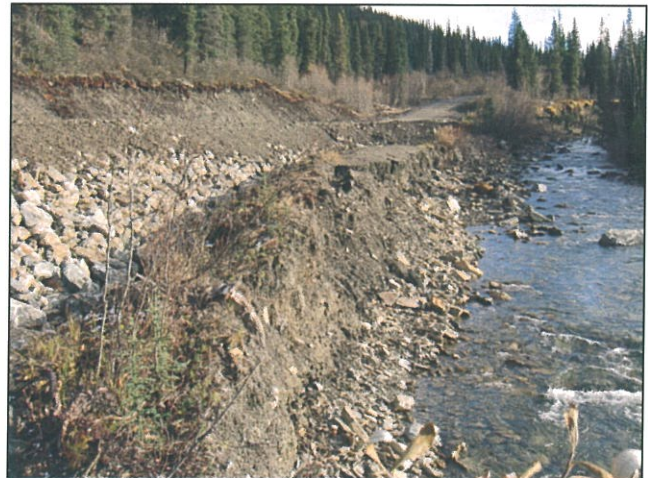
Figure 33 Erosion of Old Roadbed

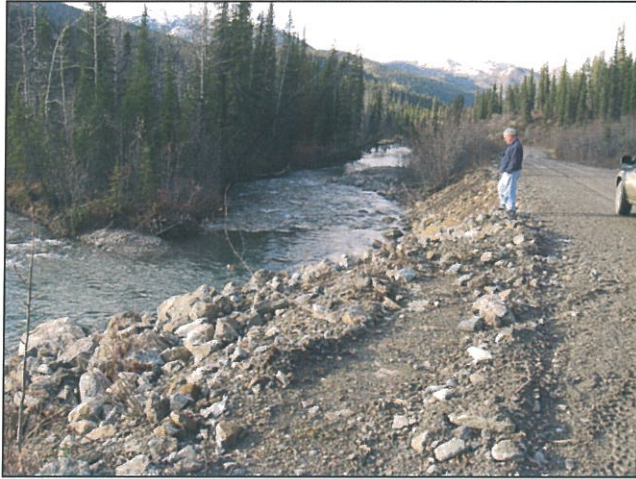
Figure 34 View D/S at Location C

Location C is a 15 m long section of riprap at a sharp outside bend of the river channel (Figure 34). The bank is about 2 m high with the riprap in good condition with no evidence of active bank erosion (Figure 35). Riprap size is up to 800 mm with an estimated D_{50} of 250 mm.

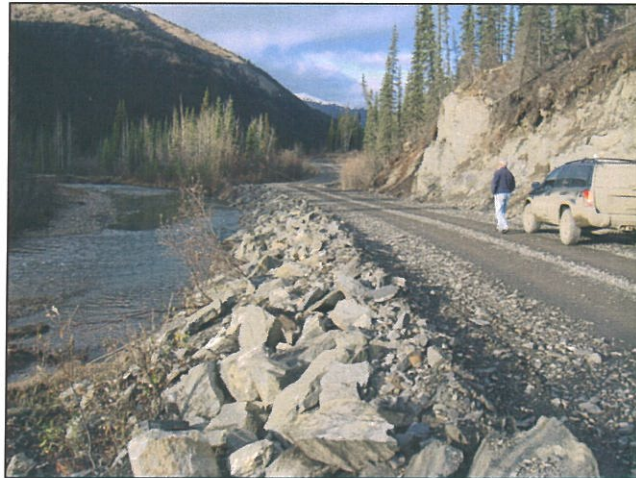
Figure 37 View D/S at Location E

Location E is about 50 m long along a gentle outside bend in the channel where the road is flanked on the east side by bedrock (Figure 37). The riprap is in good condition with no evidence of active erosion. The bank is about 1.5 m high. Riprap size is up to 1,500 mm with an estimated D_{50} of 450 mm. Many of the riprap pieces are flat.

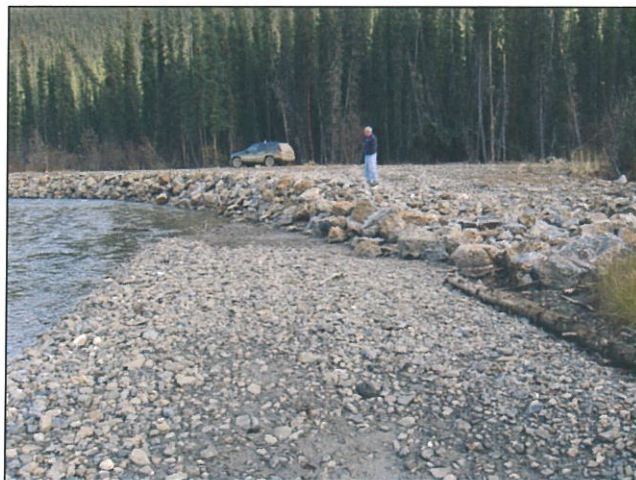
Figure 38 View D/S at Location F

Location F is about 50 m long along a moderate outside bend in the channel (Figure 38). The riprap is in good condition with no evidence of active erosion. The bank is about 2 m high (Figure 39). Riprap size is up to 1,000 mm with an estimated D_{50} of 450 mm. Many of the riprap pieces are flat.

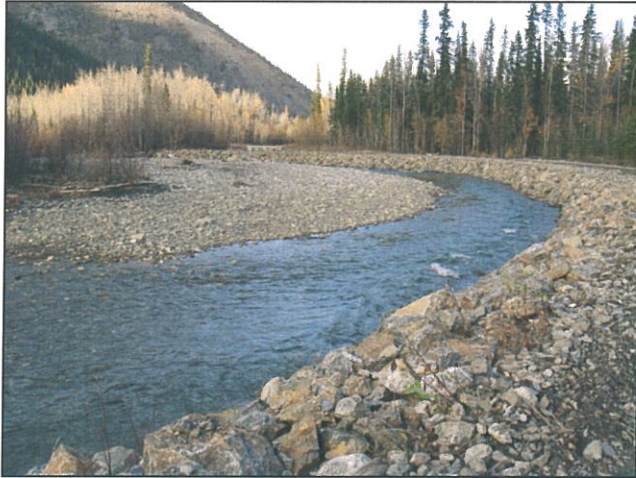
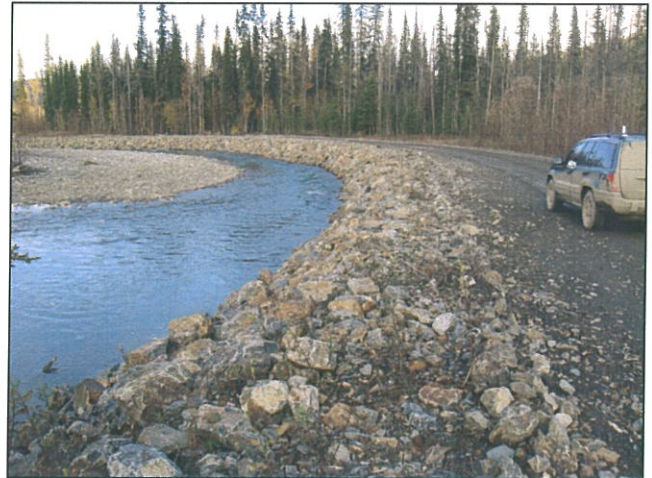
Location G is along a gentle outside bend in the channel where the riprap extends for well over 100 m (Figure 40 and 41). The riprap is in good condition with no evidence of active erosion. The bank is about 2 m high. Riprap size is up to 900 mm with an estimated D_{50} of 450 mm.

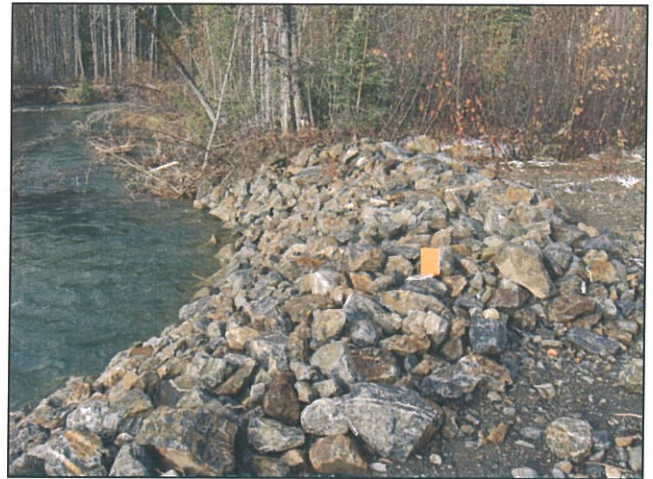
Figure 47 D/S Transition at Location H

Location H is the farthest downstream point just before the road and creek channel diverge. It is located on the outside bend of a channel meander where armouring has been recently placed for a distance of about 100m (Figure 42 and 43). A 400 mm diameter culvert crosses the road from a recently excavated drainage ditch on the opposite side of the road (Figure 44 and 45). Although there was no water flowing in the ditch at the time of our inspection, the bottom 1/3rd of the culvert is blocked with sand from previous flows. The bank is about 2 m high. Riprap size is up to 900 mm with an estimated D_{50} of 300 mm. The upstream transition of the armouring with the shoreline is abrupt which may result in scouring towards the road during high flow events (Figure 46). The downstream transition appears adequate (Figure 47).
