Government of Yukon, Water Resources Branch

Ketza Mine North Tailings Dam Toe Berm Assessment

AECOM

December, 2009

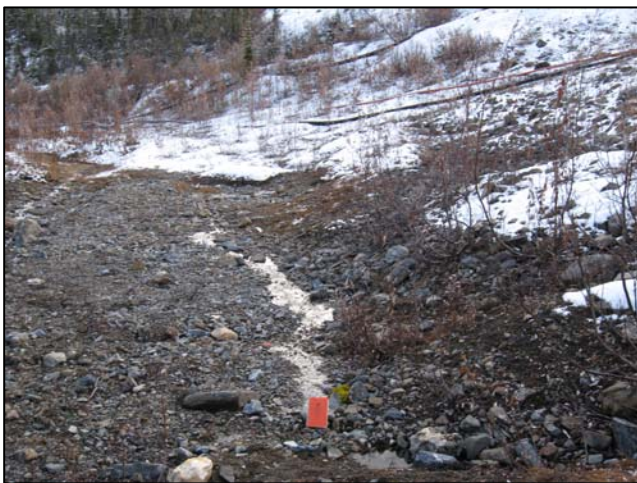
The tailings management area (TMA) consists of the tailings impoundment created by the north and south tailings dams, and diversion ditches to route Cache Creek around the tailings pond as illustrated on Figure 02. The north and south dams are separated by a spillway. Seepage was previously observed at the toe of the north dam at several locations along a stretch of about 20 m (Figure 03). Water from these seeps collected into a common drainage channel that runs into the collection pond at Pumphouse N1 (Figure 04). The ground was observed to be very soft in the area of the seeps with quicking conditions evident. The soft zone extended up the face of the dam by approximately 1 m.

Fig 03 Seepage at Toe of North Dam (2007)

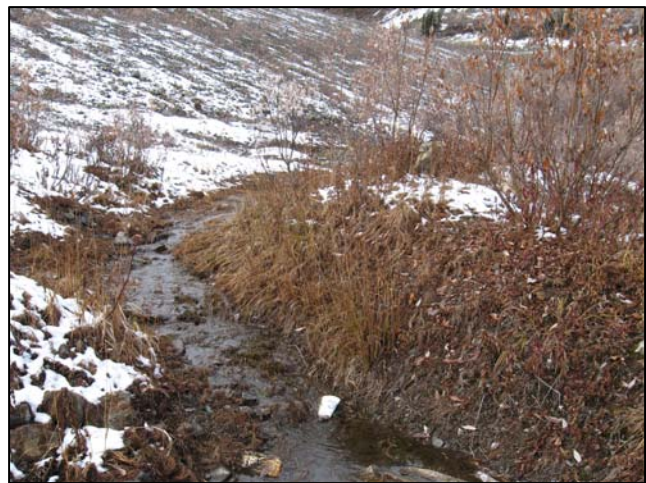
Fig 04 Drainage at Toe of N Dam (2007)

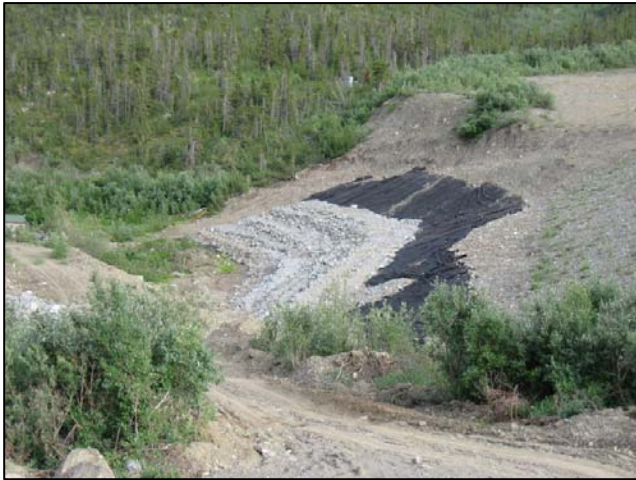
In general, the berm appears to be in agreement with the design drawings although it was constructed with a series of 2 or 3 benches rather than a uniform slope (Figure 05). The berm material consists of rock fill placed on a non-woven geotextile. The saplings observed on the downstream face of the dam in 2007 have been removed. It is our understanding that the geotextile was originally placed to a higher elevation on the downstream face of the dam due to a misunderstanding as to the design elevation for the top of berm. A small amount of rock fill was also placed to a higher elevation as seen on Figure 06. Based on survey shots taken at approximately the section lines provided (Sections 2 and 3) and one intermediate shot, the top of the berm ranges in elevation from 1294.7 to 1295.2 compared to the design elevation of 1294.5 m. The north end of the berm at the access road to the seepage pond is at about elevation 1297.6 m. The top bench is in the order of 4 to 5 m wide. The benches below vary in width and height but the average slope was determined to be from 3H:1V to 3.2H:1V (compared with the design slope of 2.5H:1V). The berm surface is somewhat uneven, likely as a consequence of winter construction.

Fig 05 View S at Toe Berm From Access Rd

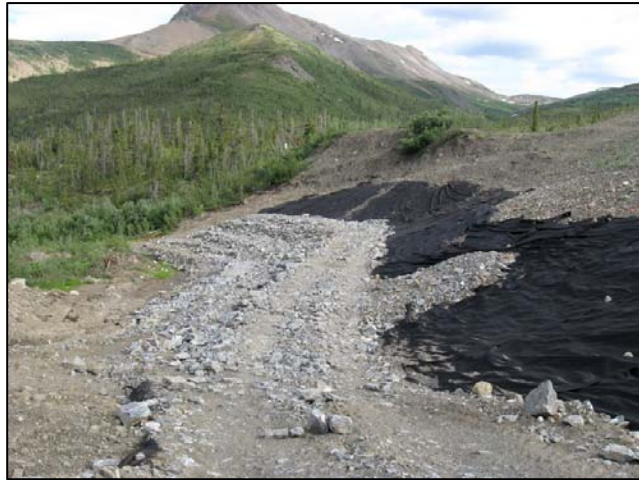
Fig 06 View S at Toe Berm From WP 162

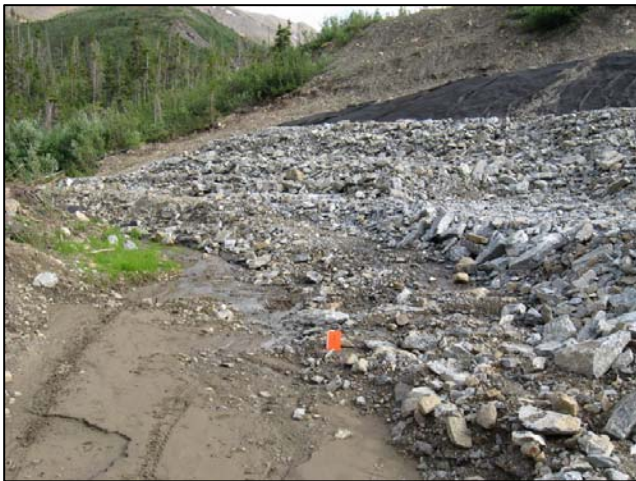
Seepage is occurring at the toe of the berm at a location approximately coincident (in a north south perspective) to the seepage zone previously identified (Figure 07 and 08). The seepage water was clear with individual seeps estimated to be flowing at rates in the order of 0.2 l/sec. The seepage water meanders across the gravel at the toe of the berm where it is collected by a channel directed to the seepage pond. This is the same channel where seepage water previously was routed through a non-functional weir and broken steel pipe as noted in 2007. Flow at the pipe was estimated to be in the order of 0.6 l/sec. The seeps were generally along the edge of the fill where it terminates on gravel. There was no visible seepage farther up on the berm or beneath the geotextile where small inspection cuts were made. It appears that a small amount of fine grained soil from the toe area has eroded from surface runoff and accumulated in the drainage channel and seepage pond. The gravel is soft in the area of the seeps, a condition similar to observations made in 2007.

Fig 07 View S at Toe Seepage From WP 164

Overall, the north tailings dam toe berm appears to have been constructed in general agreement with the original (EBA) design, although some segregation has been observed in local areas. Seepage at the toe of the berm is not unexpected and provides an indication that the material overall is allowing seepage water to freely drain. However, the piezometer in the downstream face of the dam recommended in AECOM's 2007 prior to berm construction was not installed. The intent of the piezometer was to confirm the design assumptions with respect to groundwater (piezometric) levels across the dam used in previous slope stability analysis and assess any impact on groundwater levels from berm construction. Installation of at least one piezometer should still be considered to supplement the existing network of piezometers used to monitor the performance of the dam.

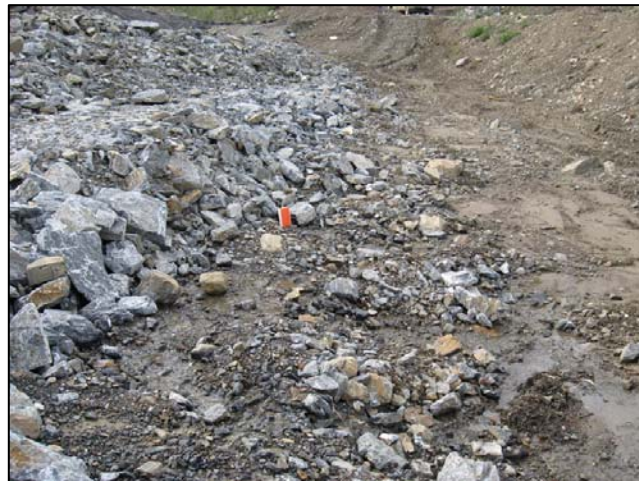
Fig 08 View N at Toe Seepage From WP 166

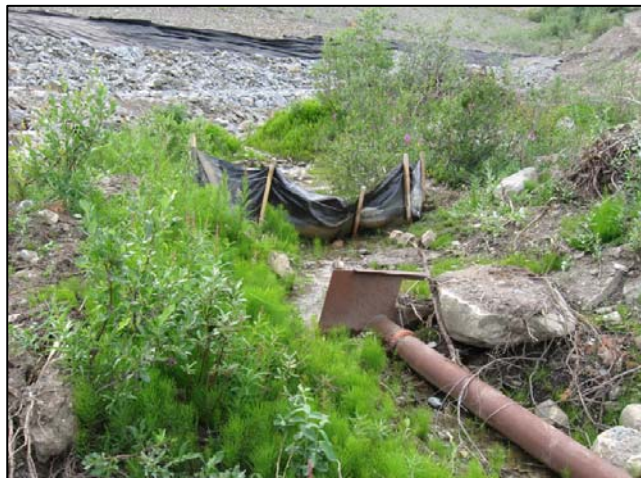
Fig 09 Seepage Channel and Weir Pipe

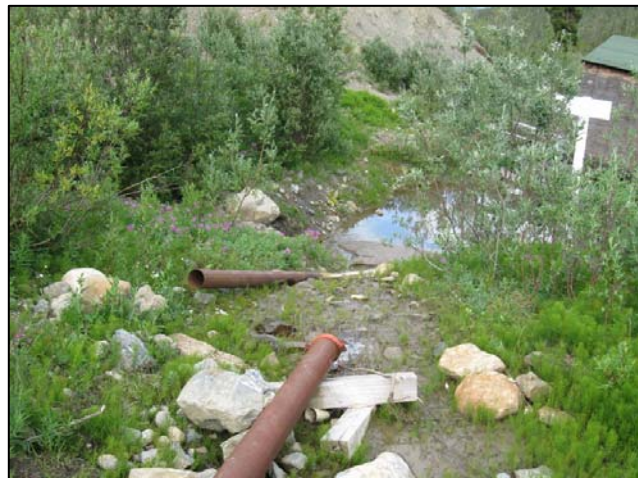
Fig 10 Pipe Outlet at Seepage Pond

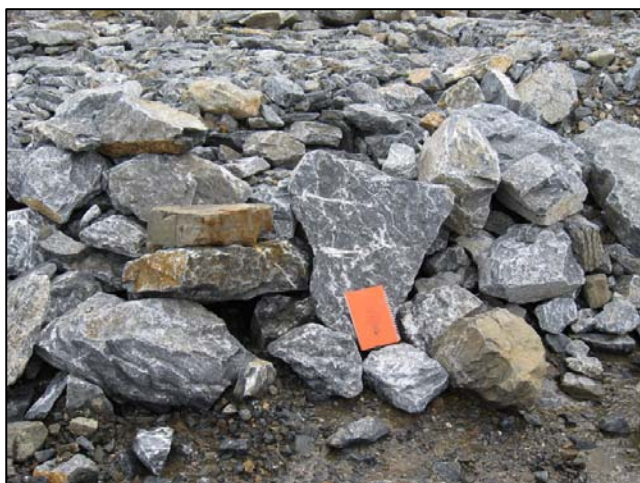
The grading of the rock fill is somewhat variable, with some areas containing appreciable fines, most notably along the lower bench. The variability can be seen in Figures 11 and 12 taken along the toe of the berm at WPs 258 and 259 respectively. The variability can also be seen in the photos attached to this report in Appendix A. The areas with finer grained material are intermittent however and likely reflective of variability in the processing (blending) of material.

Fig 11 Rock Fill at Toe at WP 258

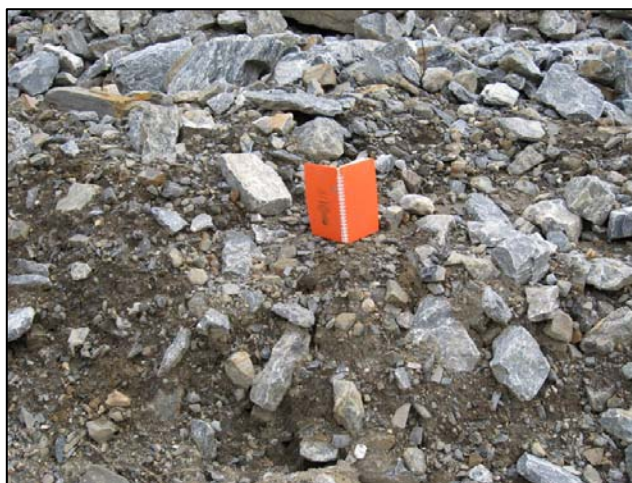
Fig 12 Rock Fill at Toe at WP 259
