**Ketza River Mine Site – Phase 1  
Environmental Site Investigation**

**Ross River Dena Council and  
DIAND Contaminants/Waste Program**

**Gartner Lee Limited  
Mehling Environmental Management Inc.  
BGC Engineering Inc.  
Sheila C. Greer**

*March, 2001*

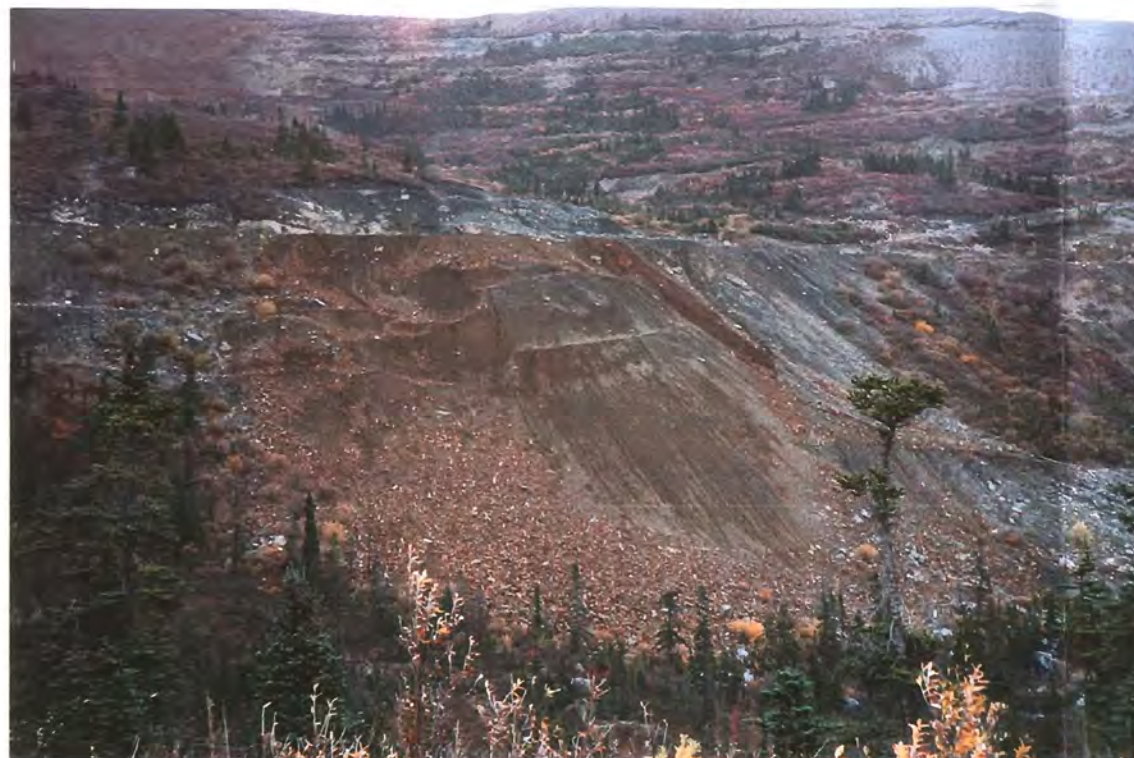
Photo 2: Waste rock dump below portal 1430.

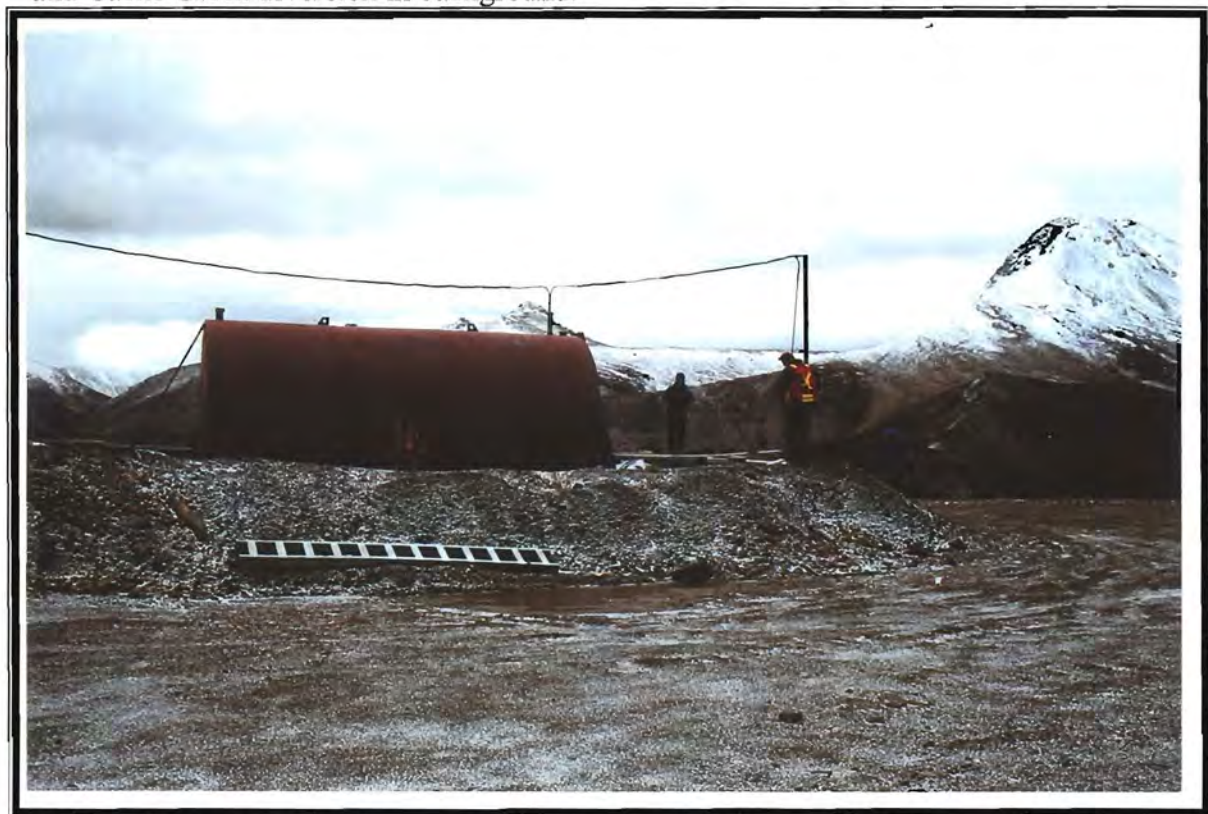
4. Other areas of hydrocarbon staining were observed around the site including:
  - 1510 AST (soil sample contained LEPH and HEPH concentrations > YCSR IL)

Photo 5: AST at 1510 portal used for fuelling underground equipment.

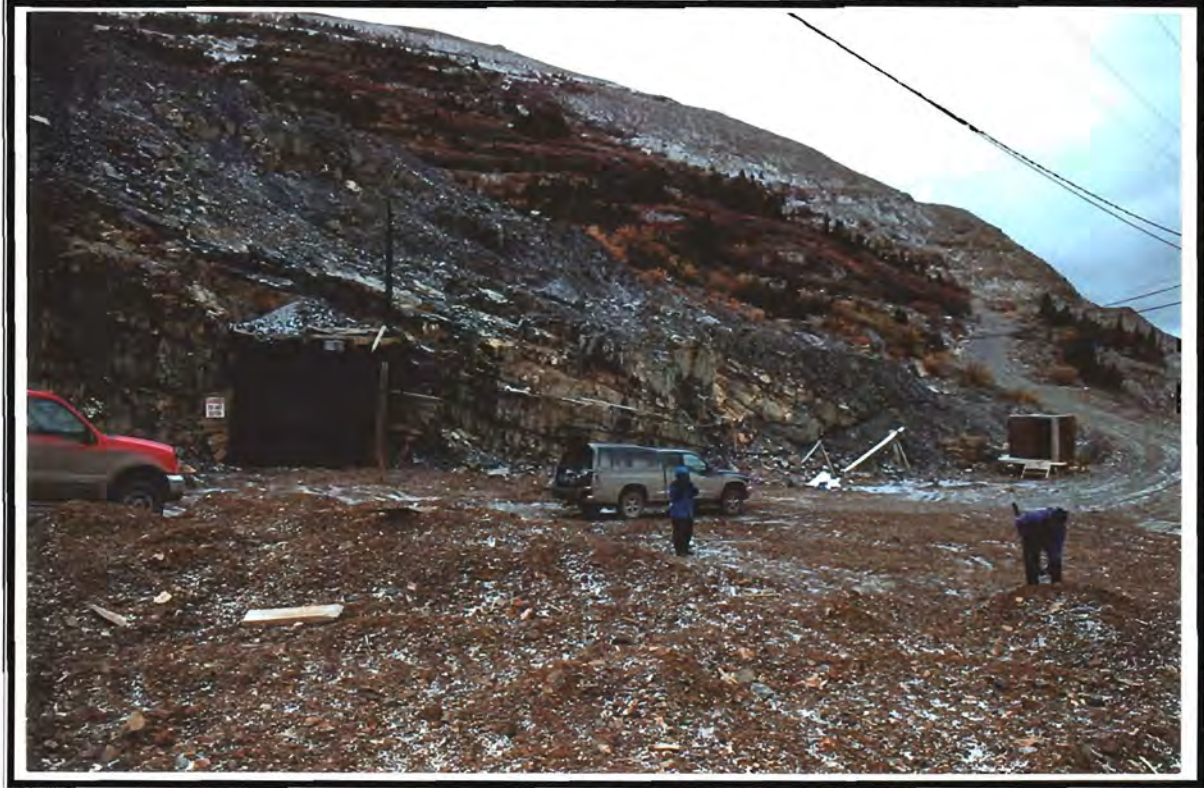
4. The 1430 and 1510 adits are poorly sealed. The seals do not adequately prevent public exposure to safety hazards in the underground mine.
5. The status of the 1550 backfill raise to the surface is unknown. If the raise is open and accessible, then it represents a public safety hazard.

Photo 6: 1430 adit.

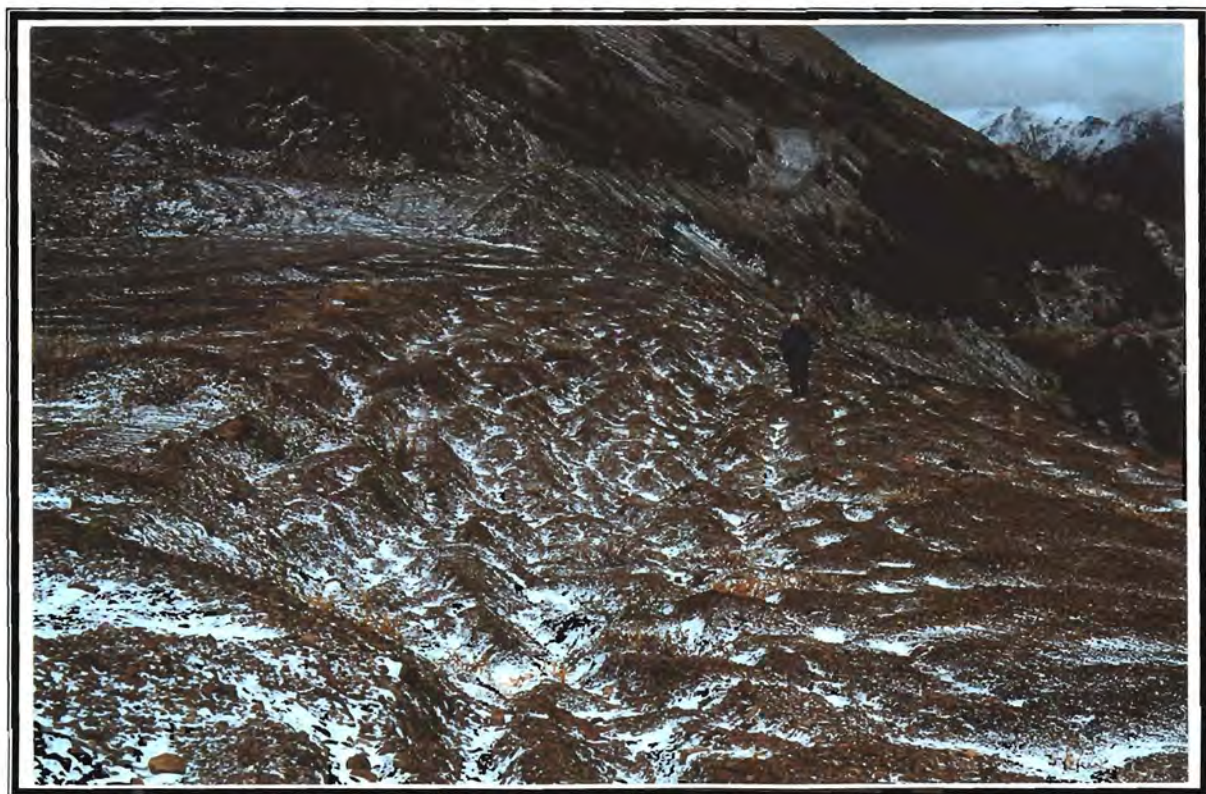
Photo 9: Slumping of waste rock dump at Ridge Pit.

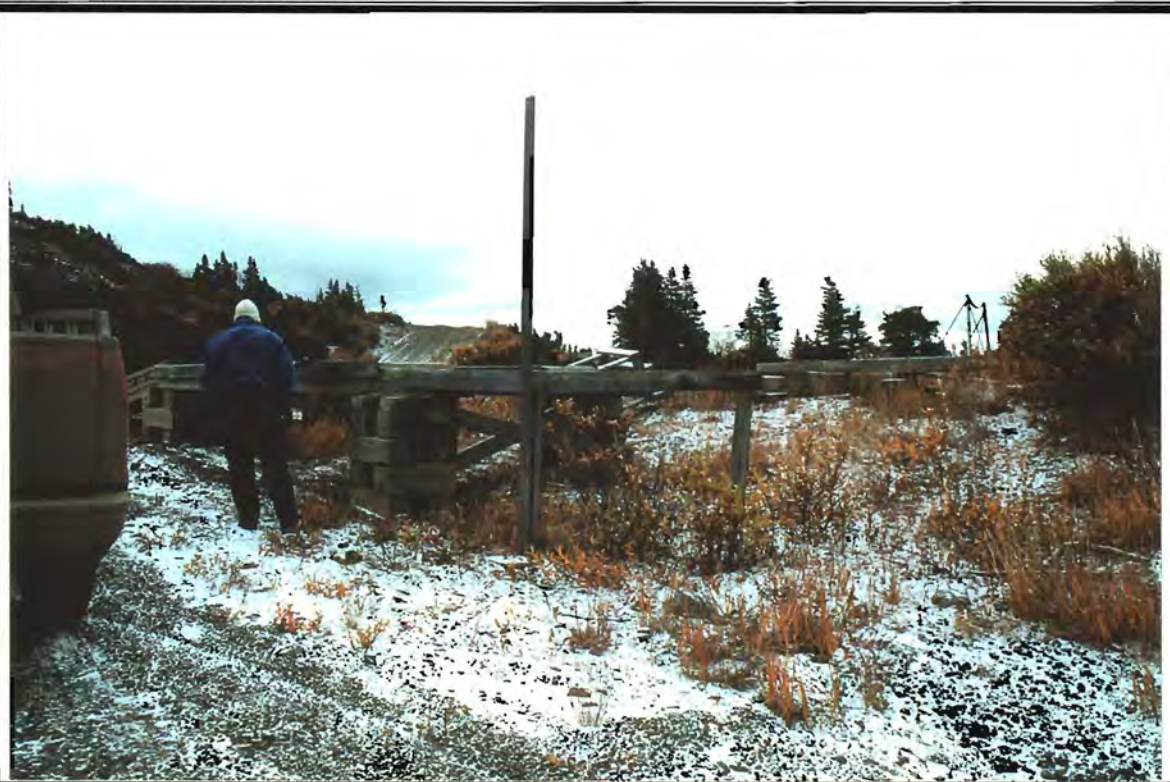
Photo 13: Grease ramp at exploration camp, some surface hydrocarbon staining in right foreground.

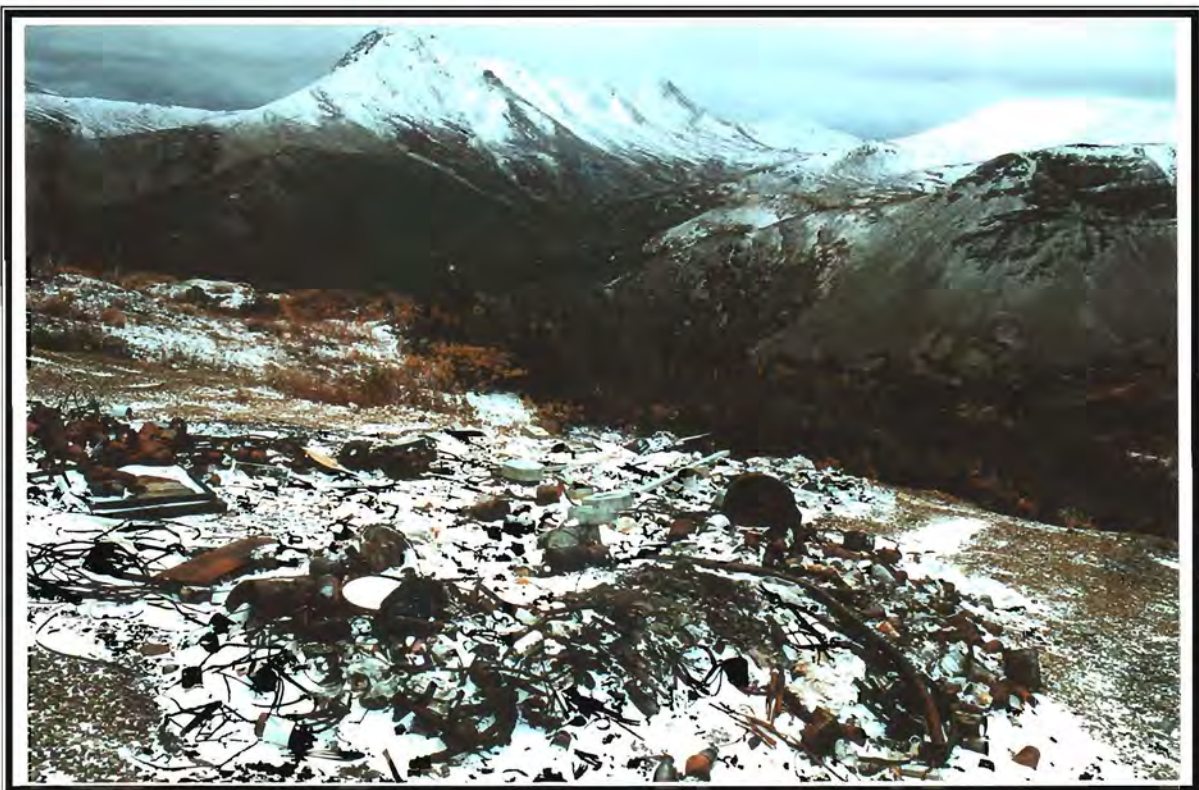
Photo 15: Burnt debris on upper surface of landfill.

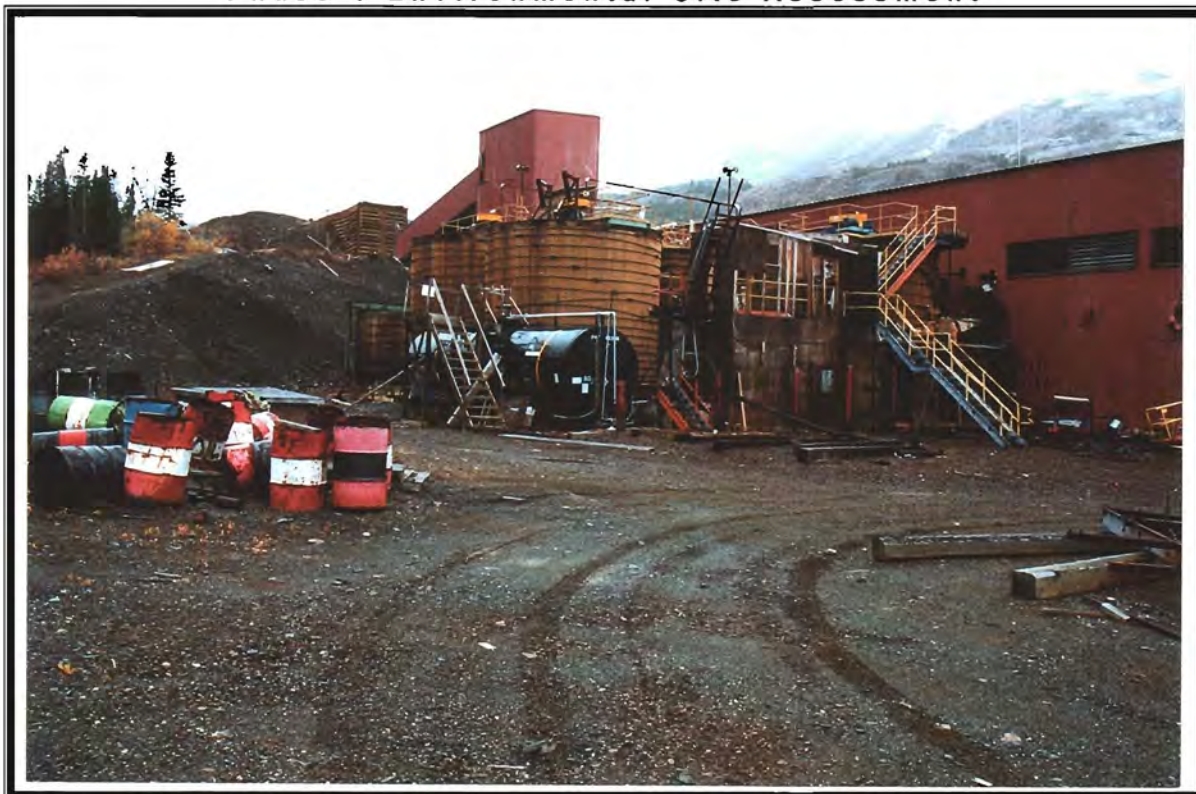
Photo 19: Cyanide leach vats and former location of water treatment plant in foreground. Note SO<sub>2</sub> railcar.

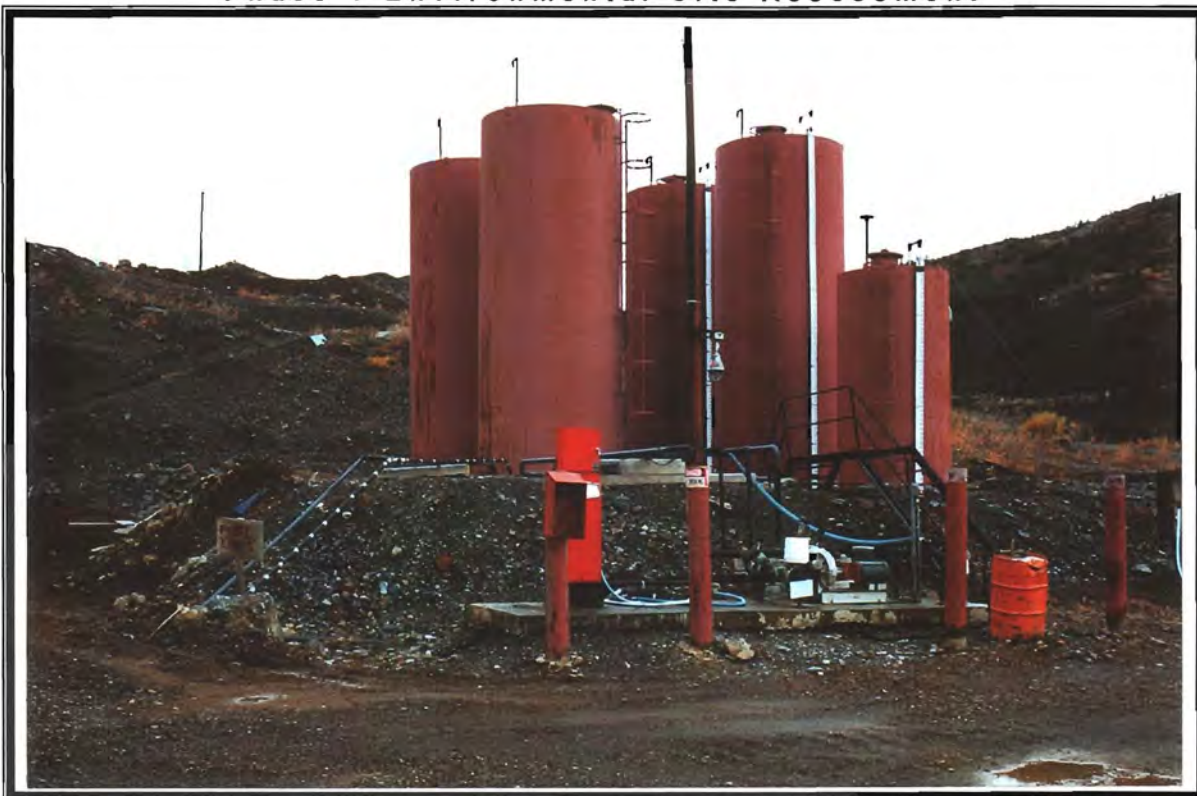
Photo 21: Tank farm and fueling island. Note drum of gasoline.

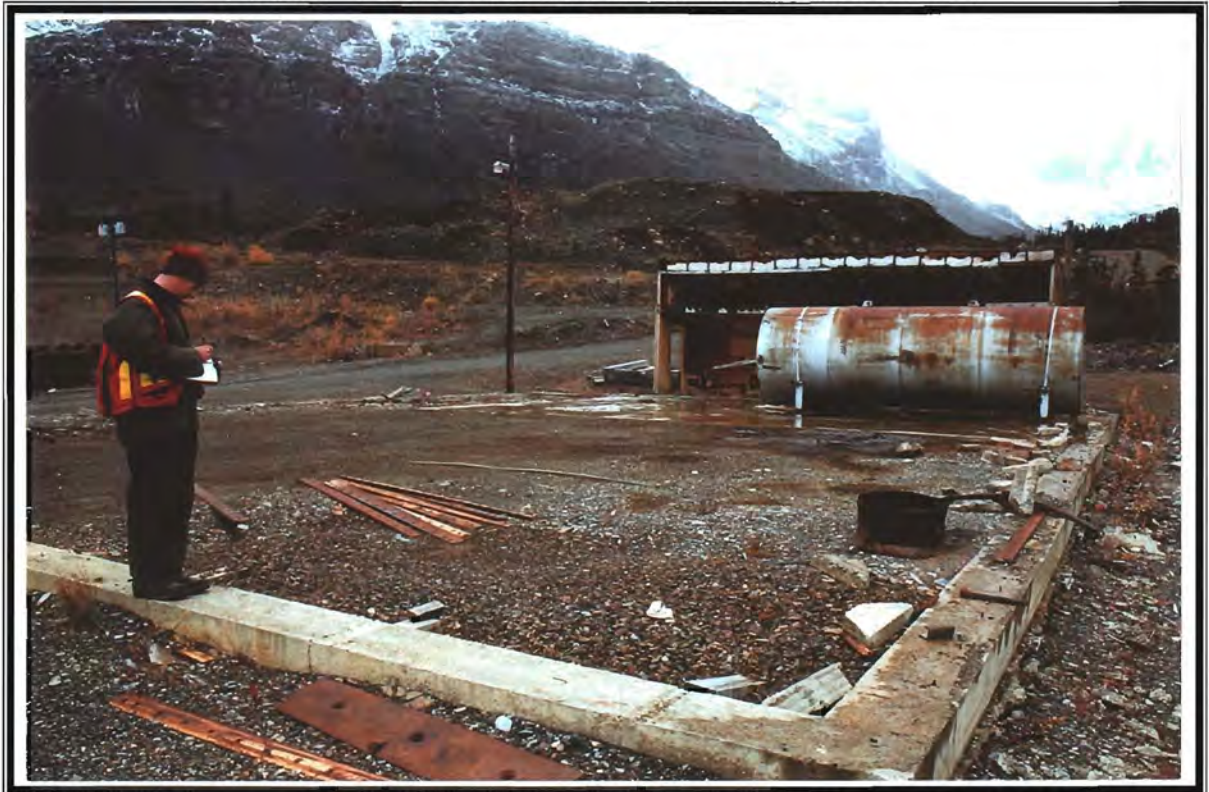
Photo 25: Foundation of road maintenance contractor's Quonset hut. Note heavy hydrocarbon staining of soil in front of gasoline tank. Ore stockpile in background.

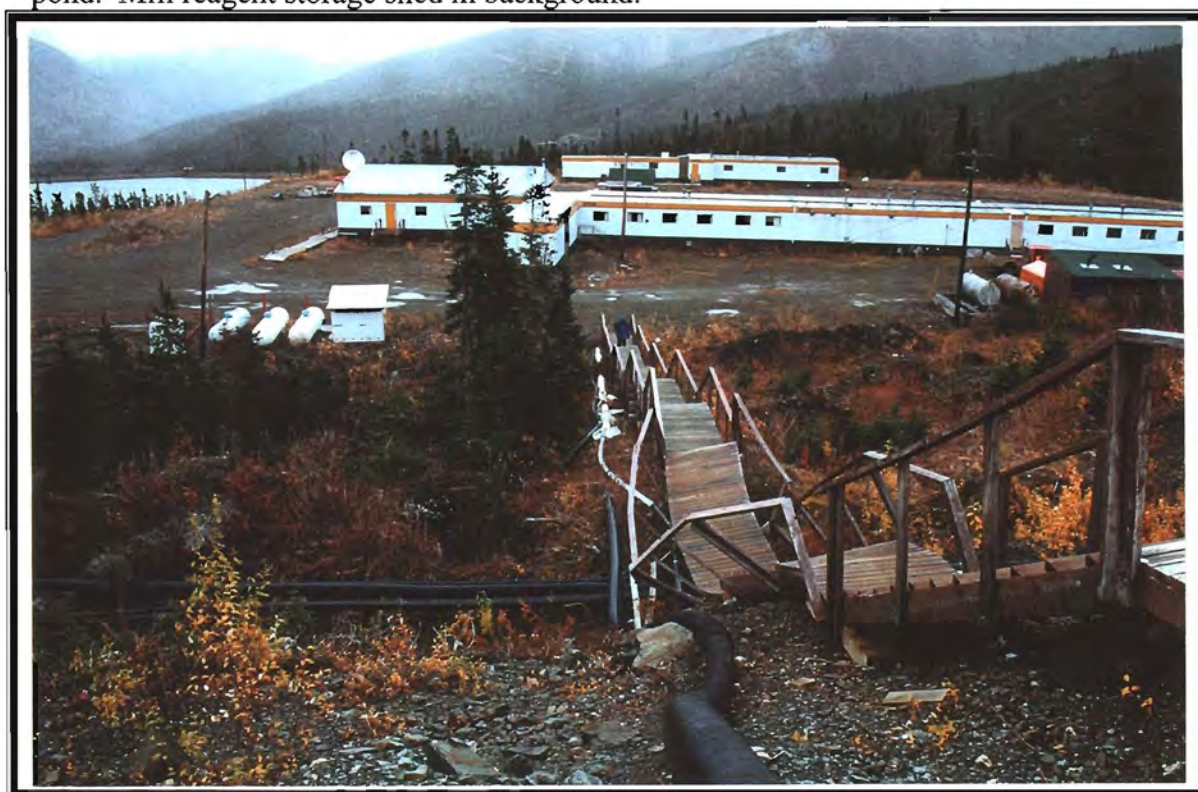
Two samples collected from an area of observed soil staining in front of the ancillary buildings contained HEPH concentrations greater than the YCSR Industrial Standard (IL). The sample collected from behind the camp generator ASTs (sample "Camp Diesel Intake") contained 1.5% LEPH, exceeding the YCSR Industrial Standard for LEPH. This high concentration of light extractable petroleum hydrocarbon is likely related to the spill in 1992 of 40,000 L of diesel fuel.

Photo 28: Remainder of accommodation/office complex, camp generator shed to right of photo. Note test pits in foreground from diesel spill.

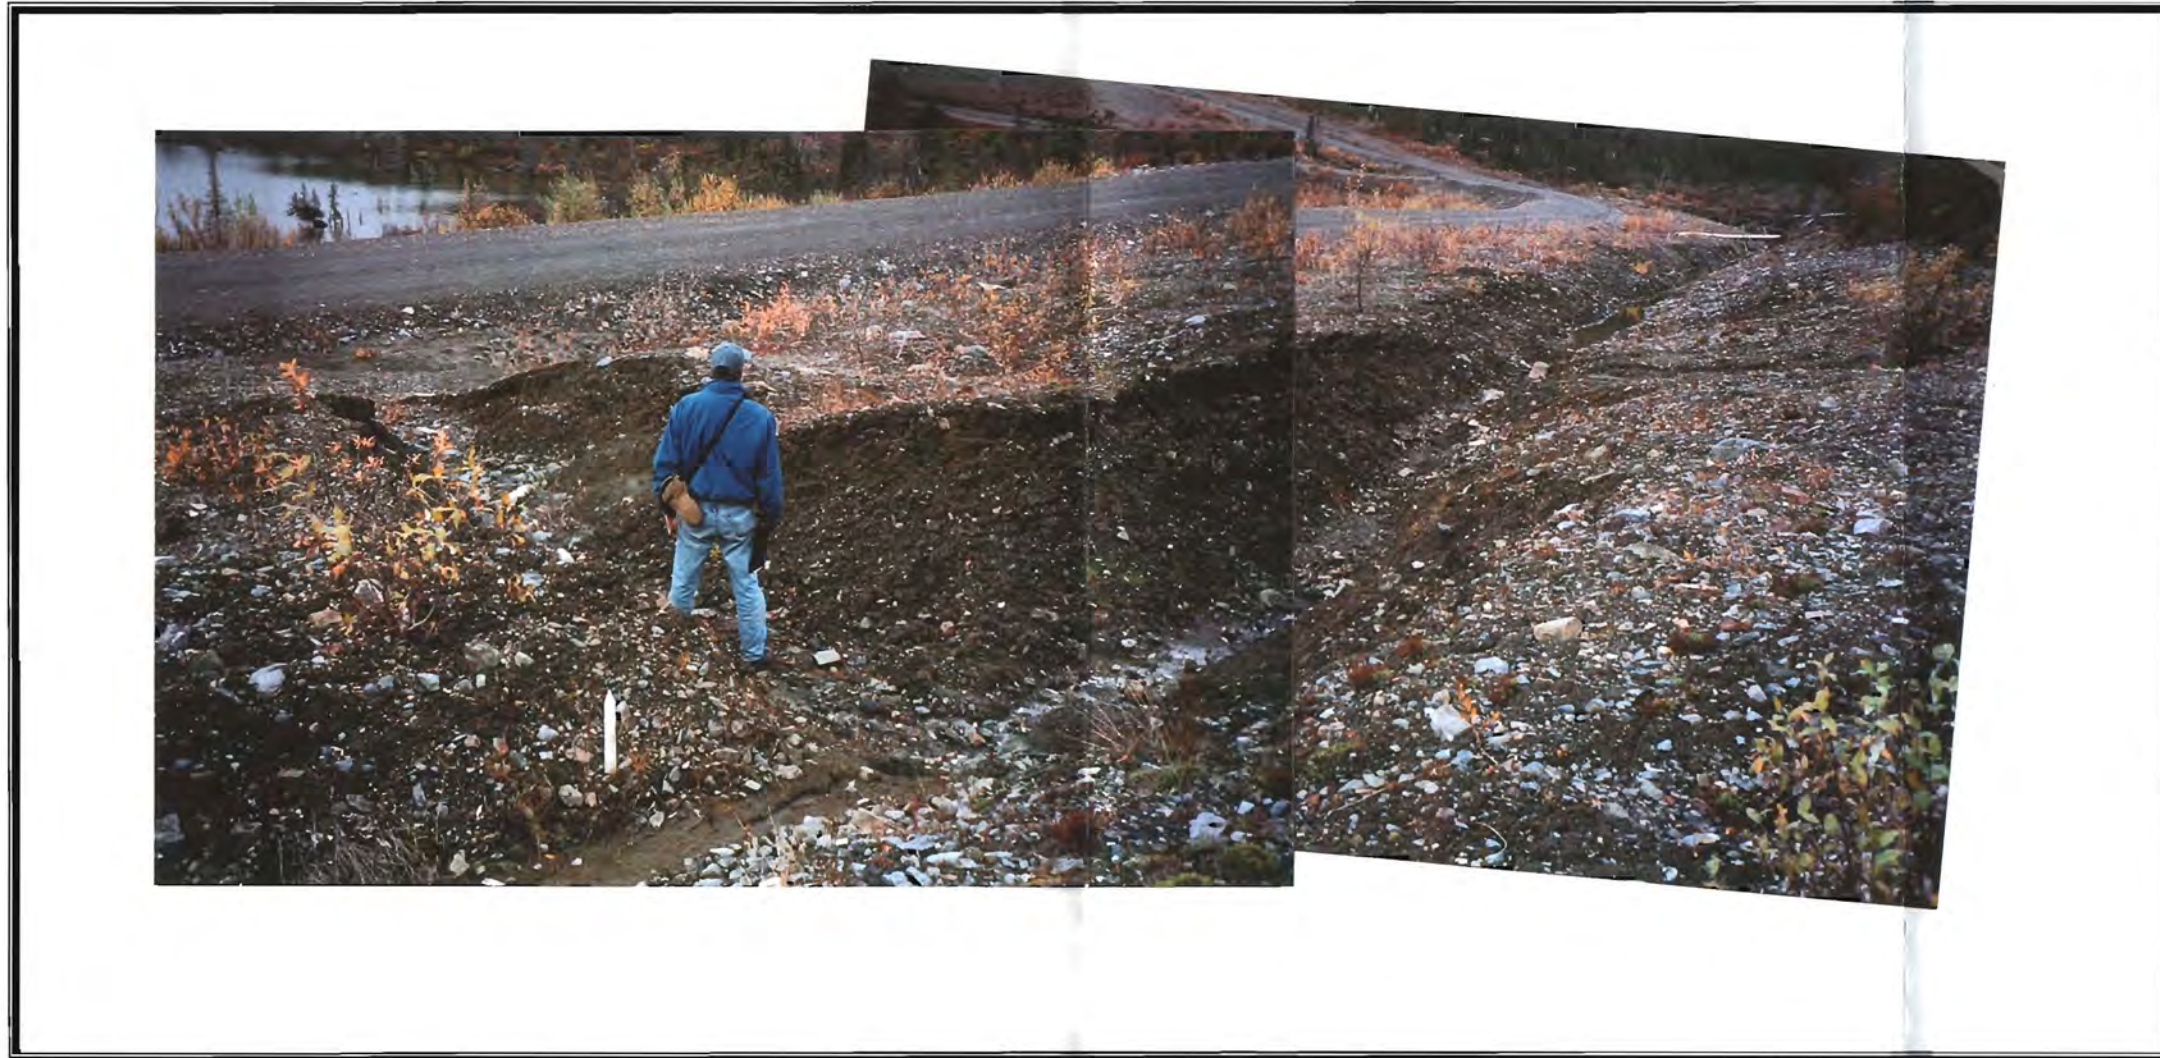
- Piping failure of the Northwest Interceptor Ditch.
  - Slumping and blockage of the Northwest Interceptor Ditch.
  - Erosion evidence of overtopping (blockage) of the Lower Subsidiary Creek Diversion.

Photo 31: Erosion, failure and pounded water flowing towards failure in northwest diversion ditch.

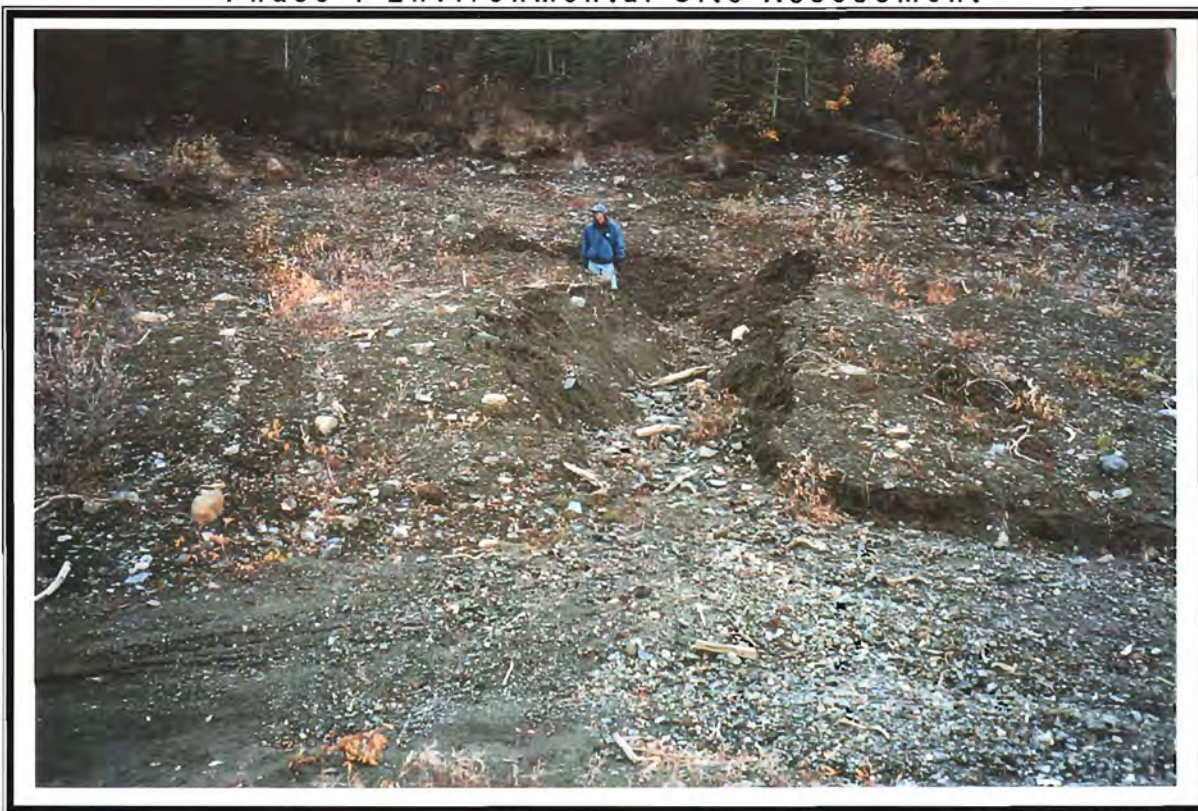
Photo 32: Failure and erosion of northwest diversion ditch.

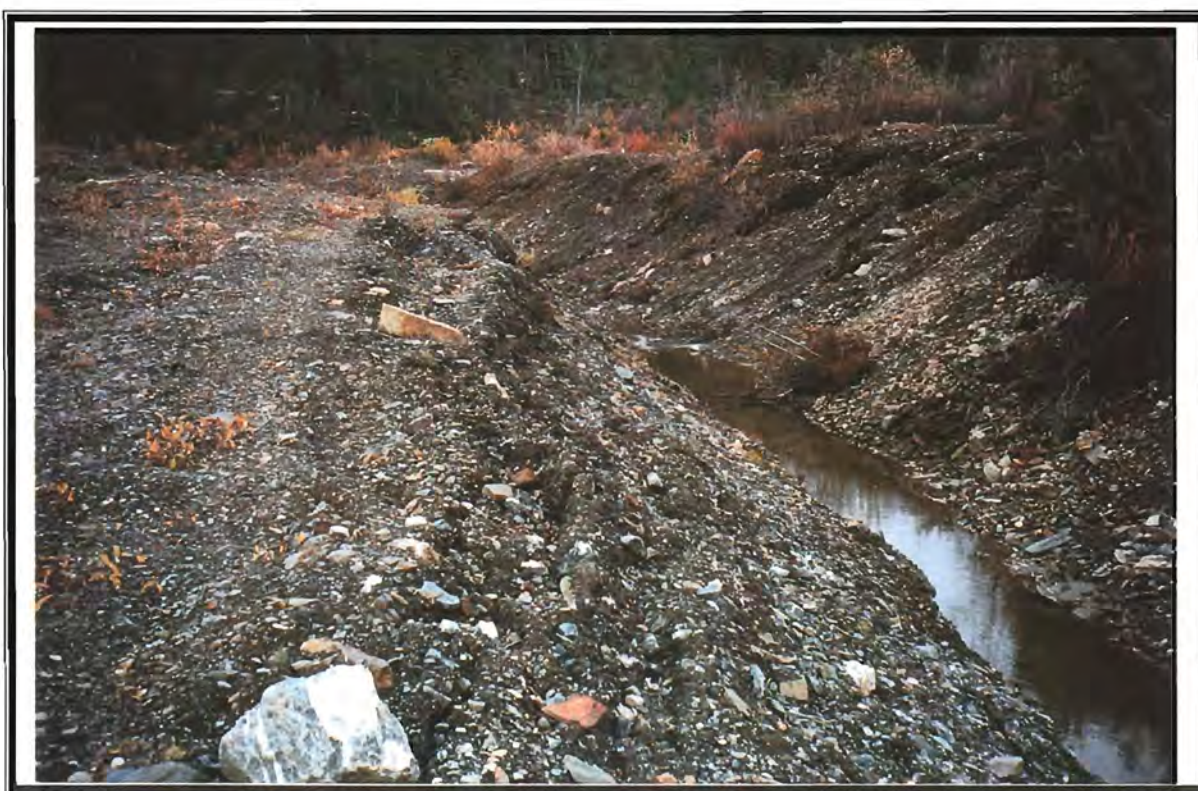
Photo 33: Ditch near confluence/Subsidiary Creek. Note failures and ponding, need for maintenance.

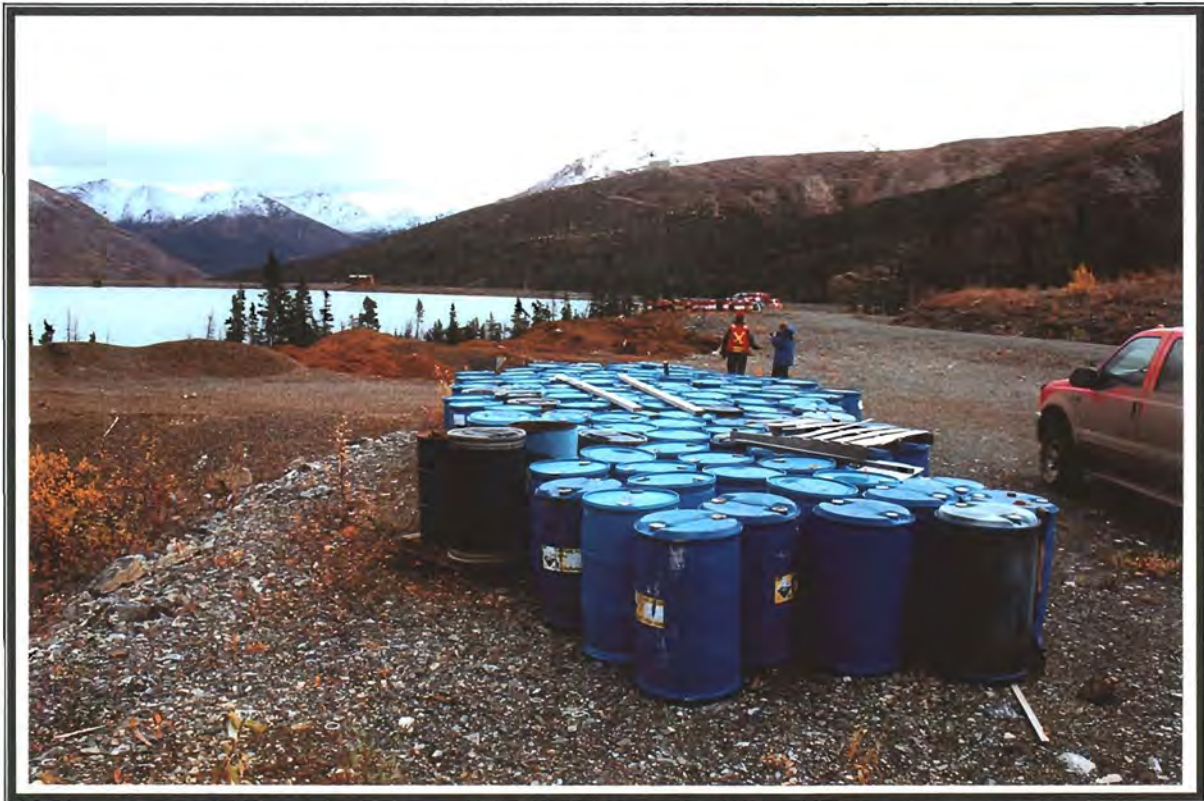
Photo 34: Sulphuric acid drums, some partially full. Coconut fiber and used oil drums in background. Tailings pond to left and Subsidiary Creek diversion to right of photo.

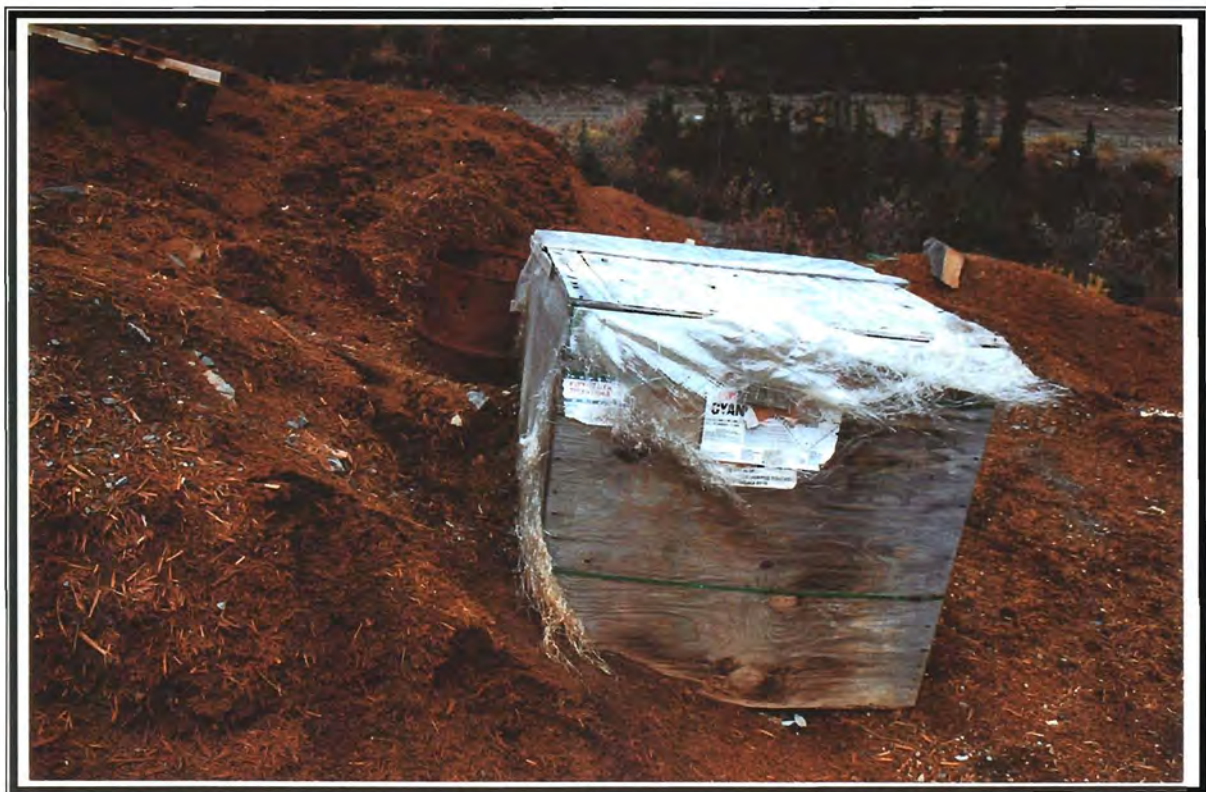
2. There are many hazardous and non-hazardous wastes and chemicals still on site, including sodium cyanide, acids and other reagents, which are not stored in a safe manner that minimizes hazards to the public.

Photo 37: Potentially full crate of Sodium Cyanide adjacent to tailings pond.

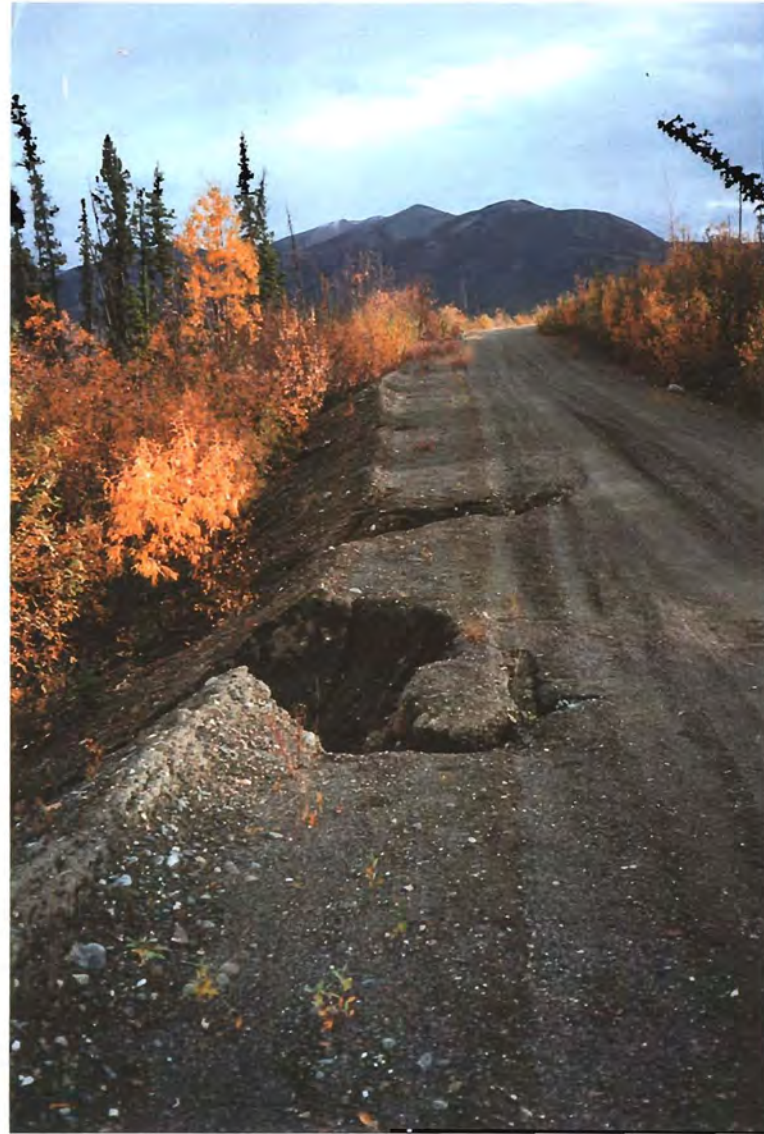
Photo 40: Erosion on access road

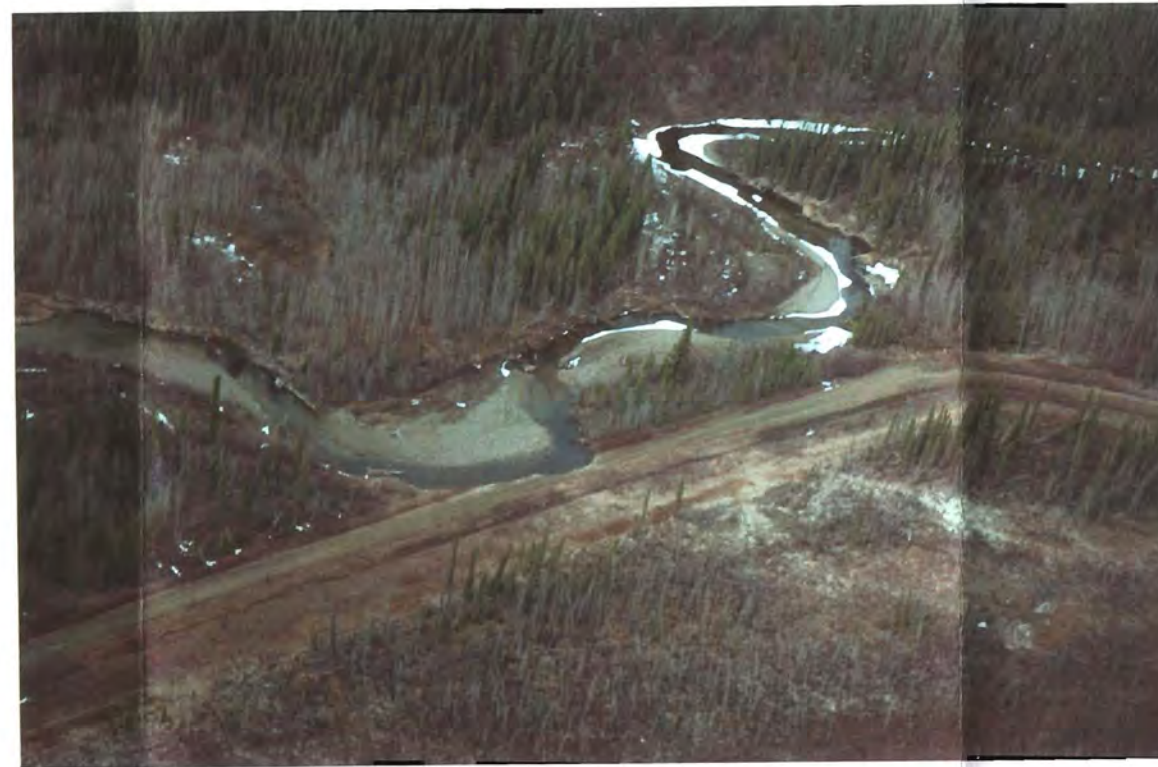
Photo 41: Ketza River washing  
out access road to mine
