KETZA RIVER MINE , MINING LAND USE  
WHITEHORSE, Y.T.

**REPORT  
ON  
1999 SITE INSPECTION**

Prepared for:  
NORTHERN AFFAIRS PROGRAM  
Calgary, Alberta

October 1999  
G1000

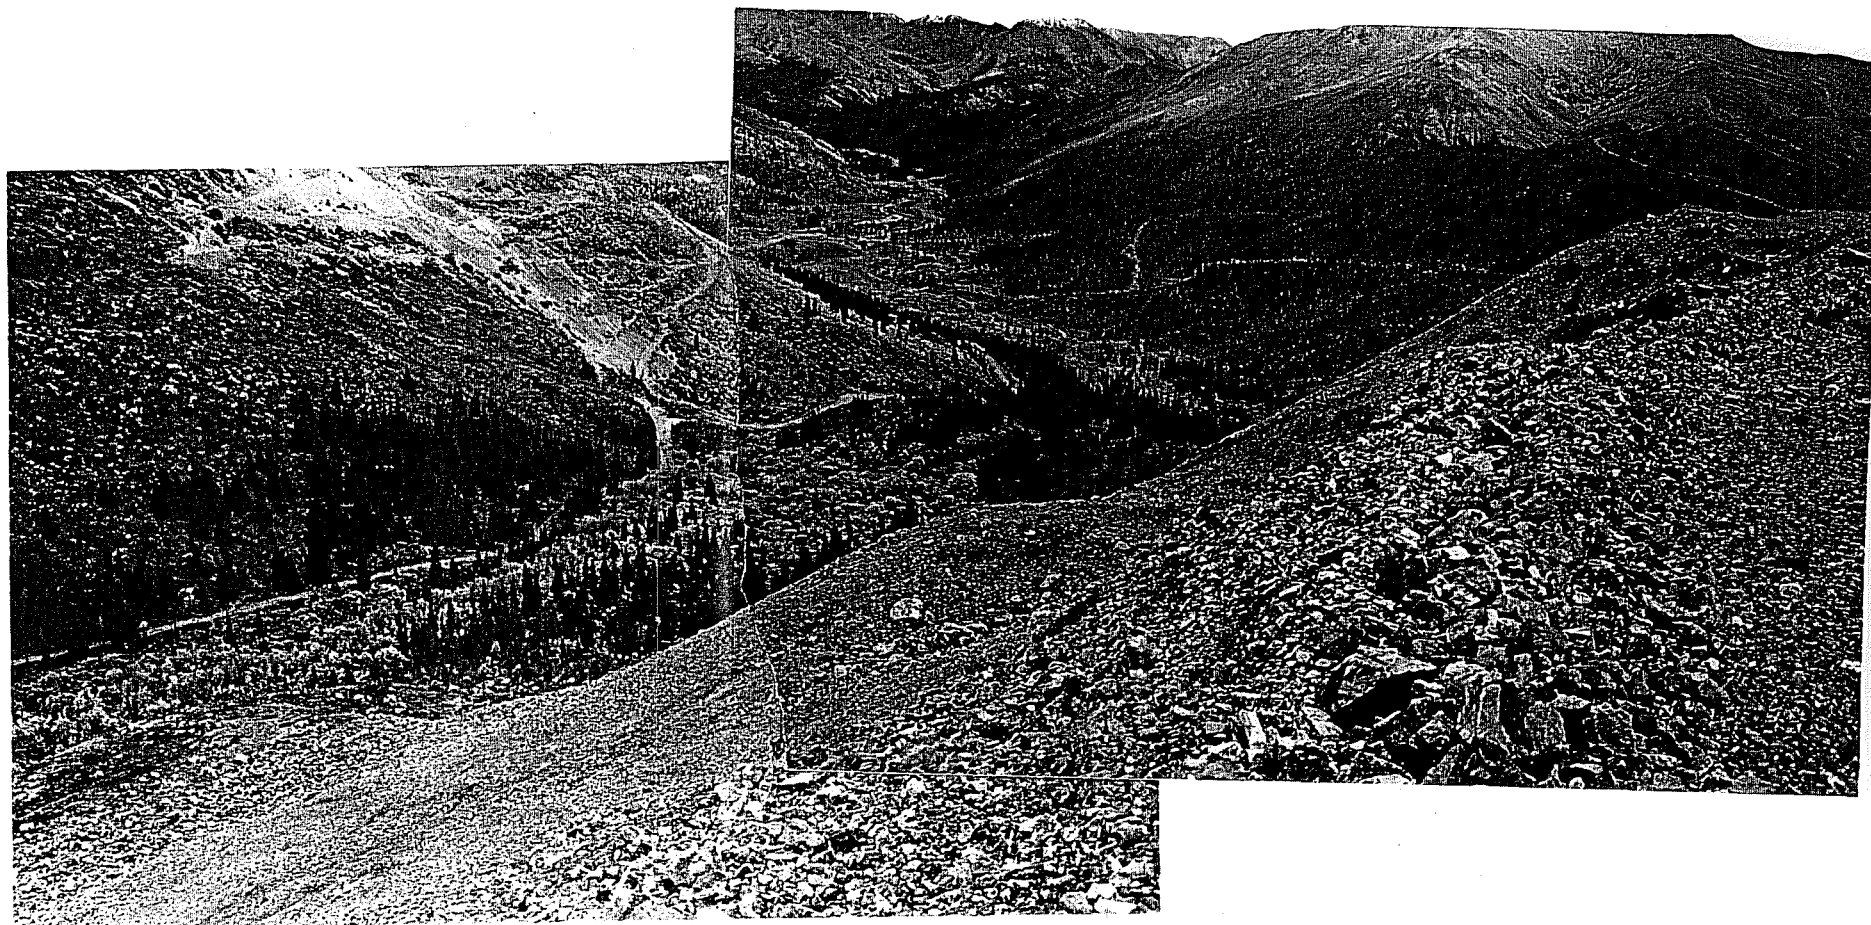
Similarly, most of the waste dump faces creep or slump at a very slow rate. Most prominent bulging, forming a two-step outer face configuration (Photo 1) occurs on the waste dump on the Peel Creek valley slope. A significant vertical displacement occurred over the period of the last decade and continuing movement is indicated by fresh cracks.

Photo 1: View of Peel Creek valley waste dump. Note two bulges; the surface of the upper bulge used to be at road level, shown on the right.

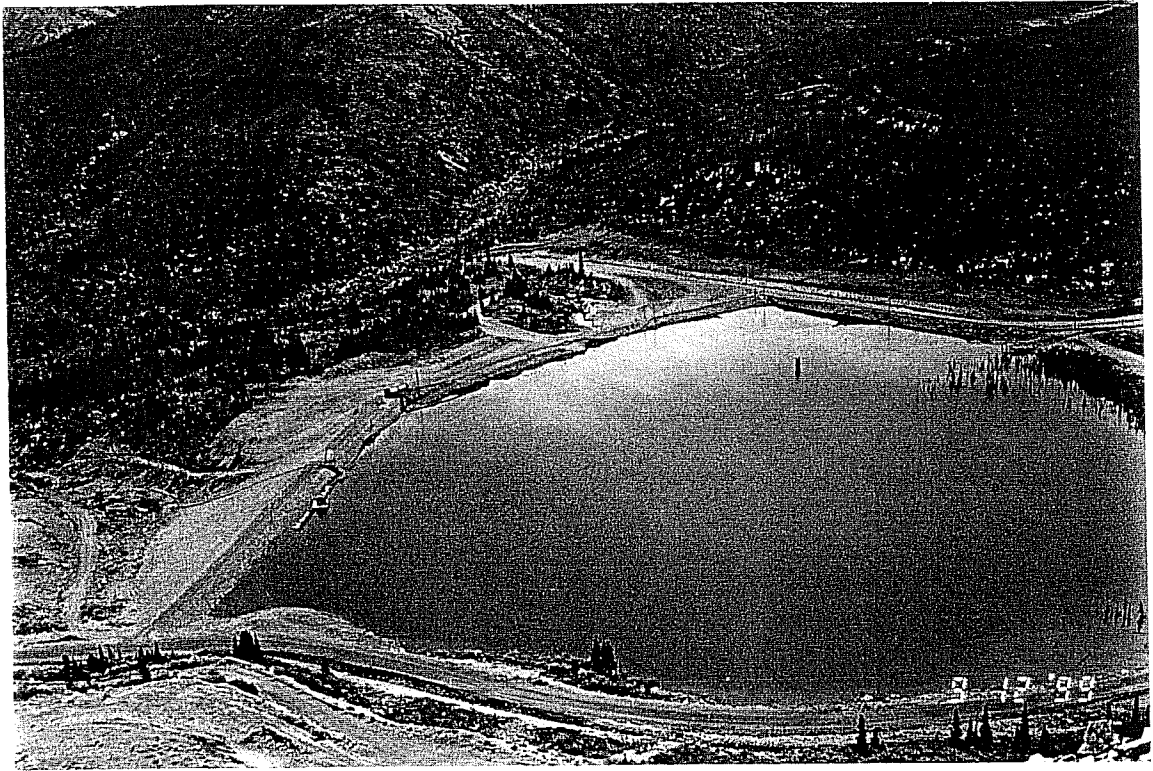
Almost all the tailings, previously forming beaches in front of both dams and along the Cache Creek diversion dyke, were submerged (Photo 2) at this time.

Photo 2: View of the tailings pond. Note that most of the previously exposed tailings are submerged.

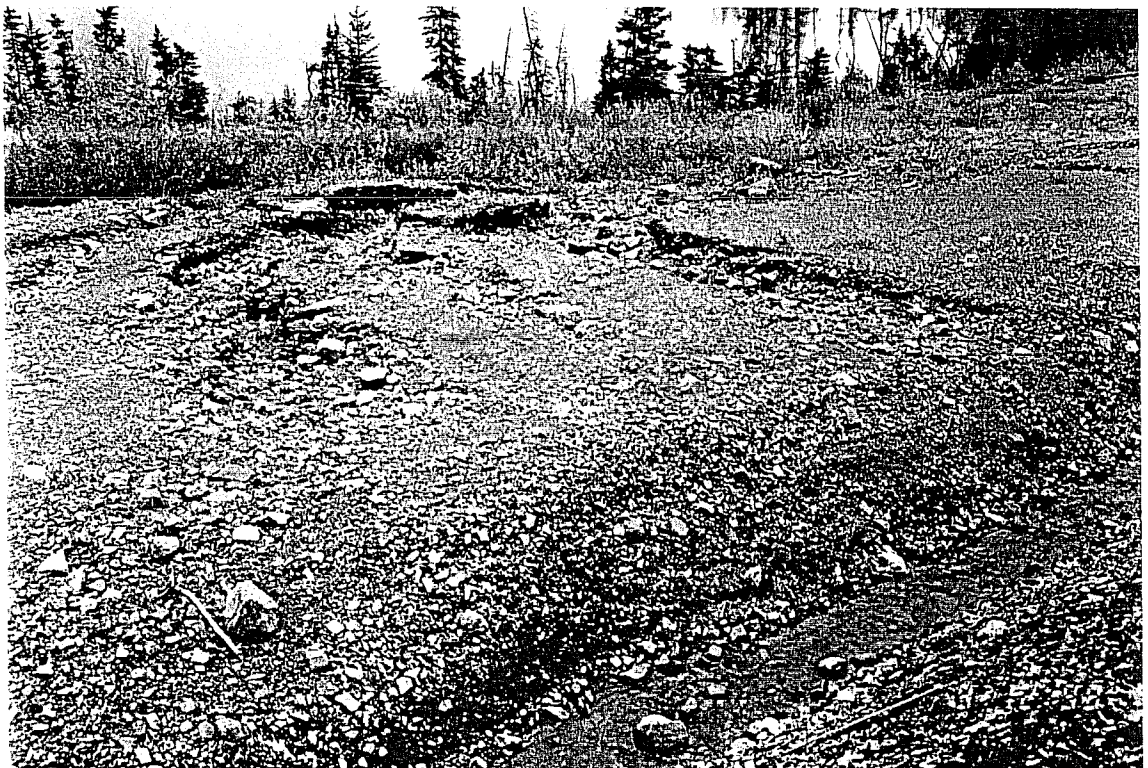
Our record indicates that the water level of the pond fluctuated between 1,309.6 m and 1,311.1 m in the past seven seasons. The estimated water level rise between 1998 and 1999 is almost one meter, which is unprecedented. Examination of the upstream pond perimeter indicated that the Subsidiary creek diversion ditch was overtopped during the freshet period, likely because the ditch was plugged with ice and water flowed across the road into the pond. A series of erosion rills cut into the road between the diversion ditch and the pond (Photo 3) supports this interpretation.

Photo 3: Erosion rills cut into the road indicate overflow from the Subsidiary Creek, likely during the spring break-up time.

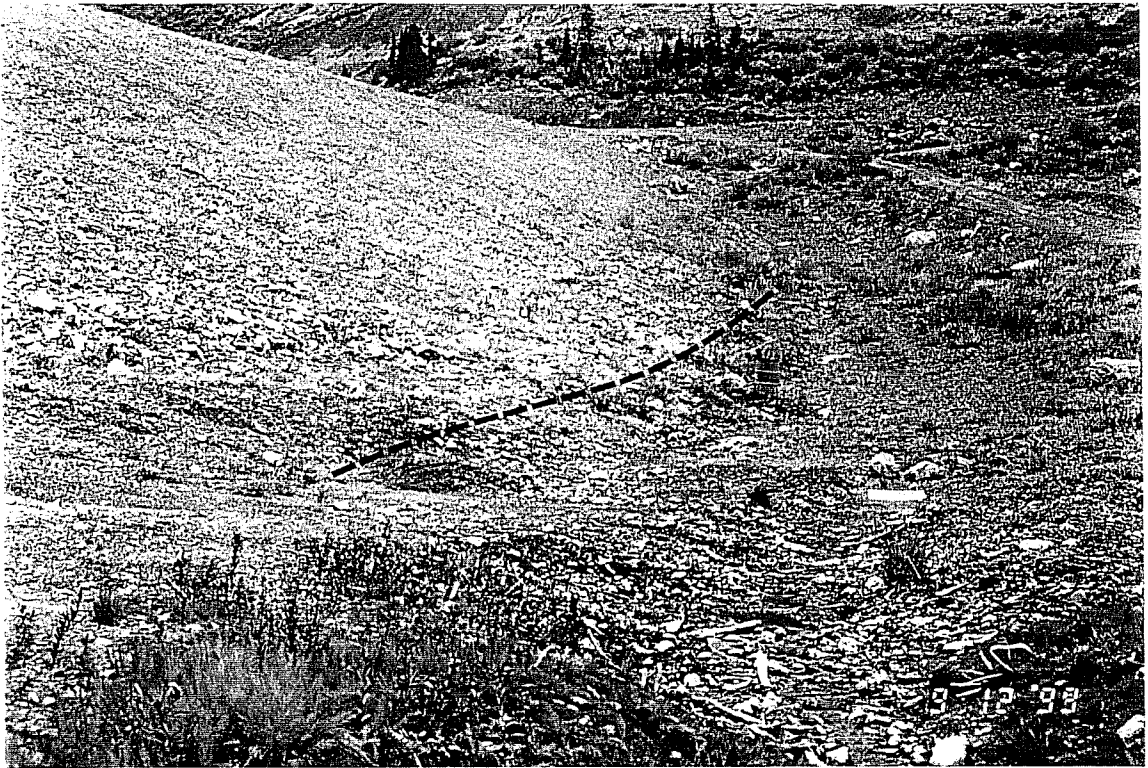
dam, heavy seeps occur along the toe at several locations (Photo 4) and also from the dam abutment (natural slope) to the south. Algae covers the bottom of the concentrated flow path. The ground and dam material in seepage zones is soft and quicks when exposed to vibration.

Photo 4: View of the north dam toe. The broken line indicates approximate extent of seeps.

Failure of the north dam toe may occur under current seepage/ground conditions or during the design seismic event. While a Factor of Safety slightly bigger than unity is indicated for static loading of the toe of the dam, a Factor of Safety lower than unity is indicated for the same area under dynamic loading. This analyses confirm that the long-term stability of the north dam requires design and construction of a toe berm. However,

The inspection confirms that seepage (and apparently the phreatic line within the dams) reflects changes in the pond water level. Previously undertaken stability analyses (see the 1998 report) indicate that the north dam requires design and construction of a toe berm to ensure its integrity. This issue is more important now since the pond water level is only about 2 m below the dam crests and approximately 1 m below the spillway invert.

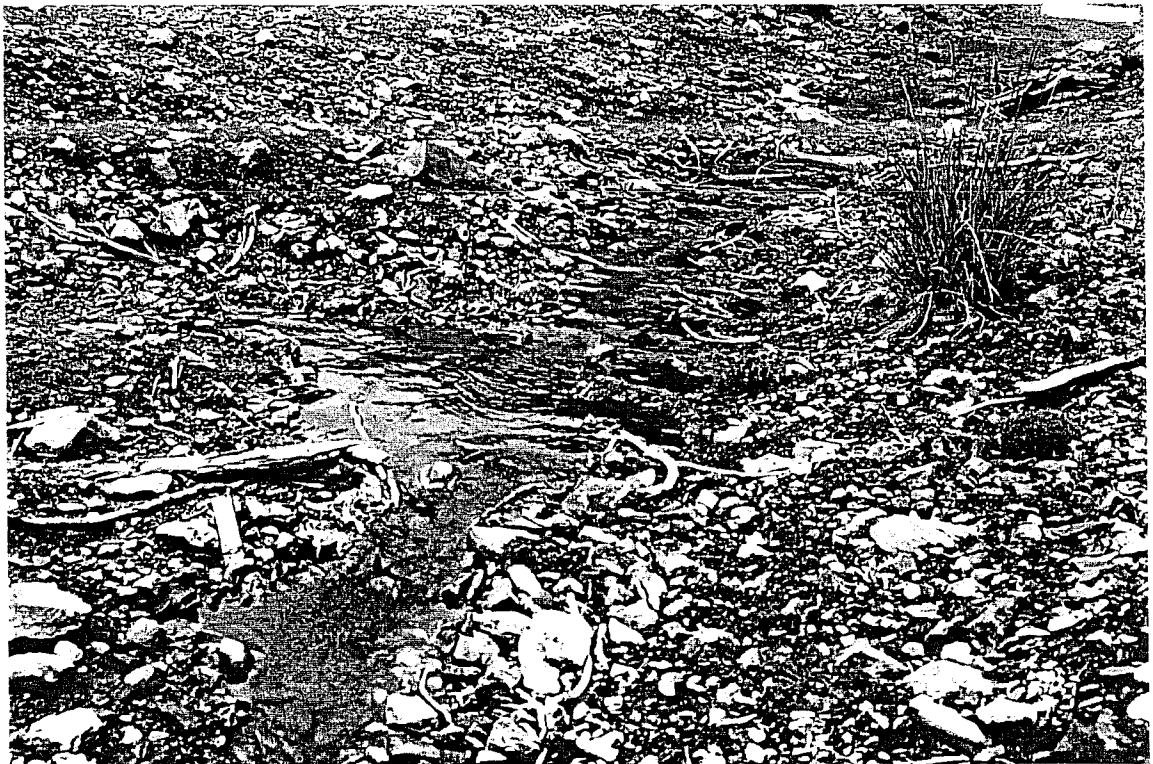
Photo 5: View of the seepage flow below the north dam toe. Note algae growing in the flow channel.

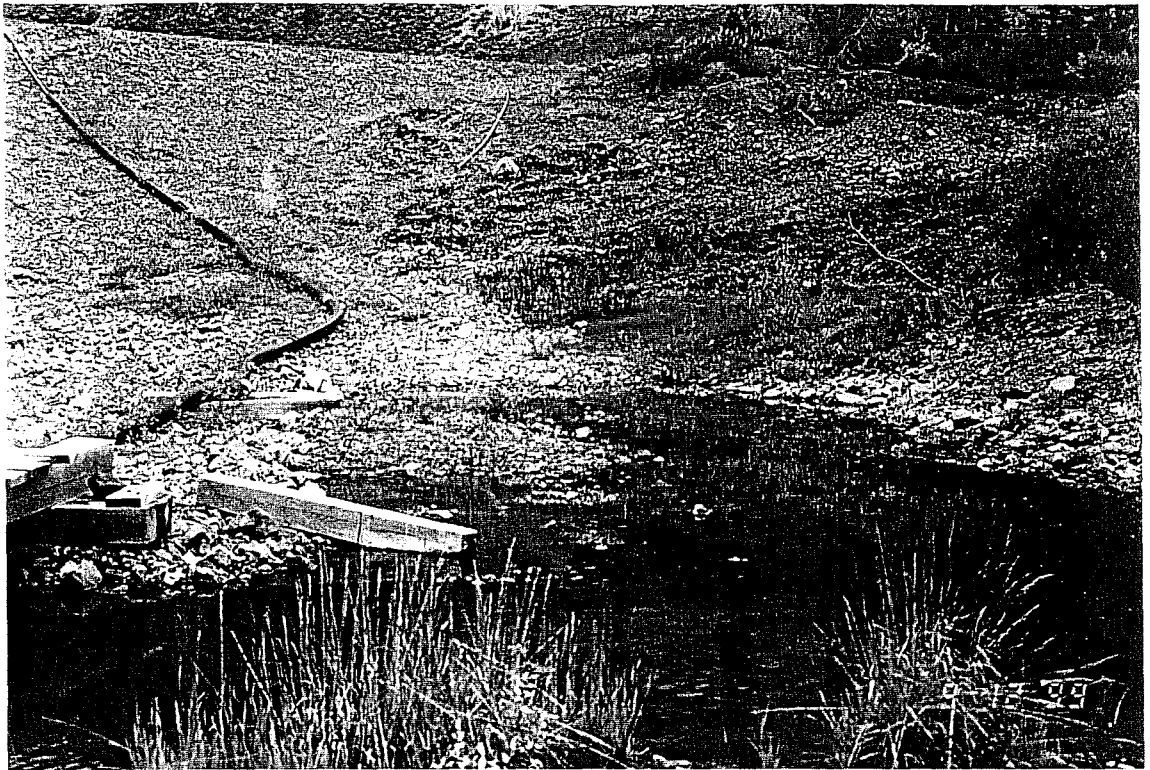
It is difficult to examine the toe of the south dam because this area is covered with a drainage blanket (Photo 6) and discharged flow downstream from the pumphouses indicates that significant seepage exists at this dam as well.

Photo 6: Ponded water below the toe of the south dam.

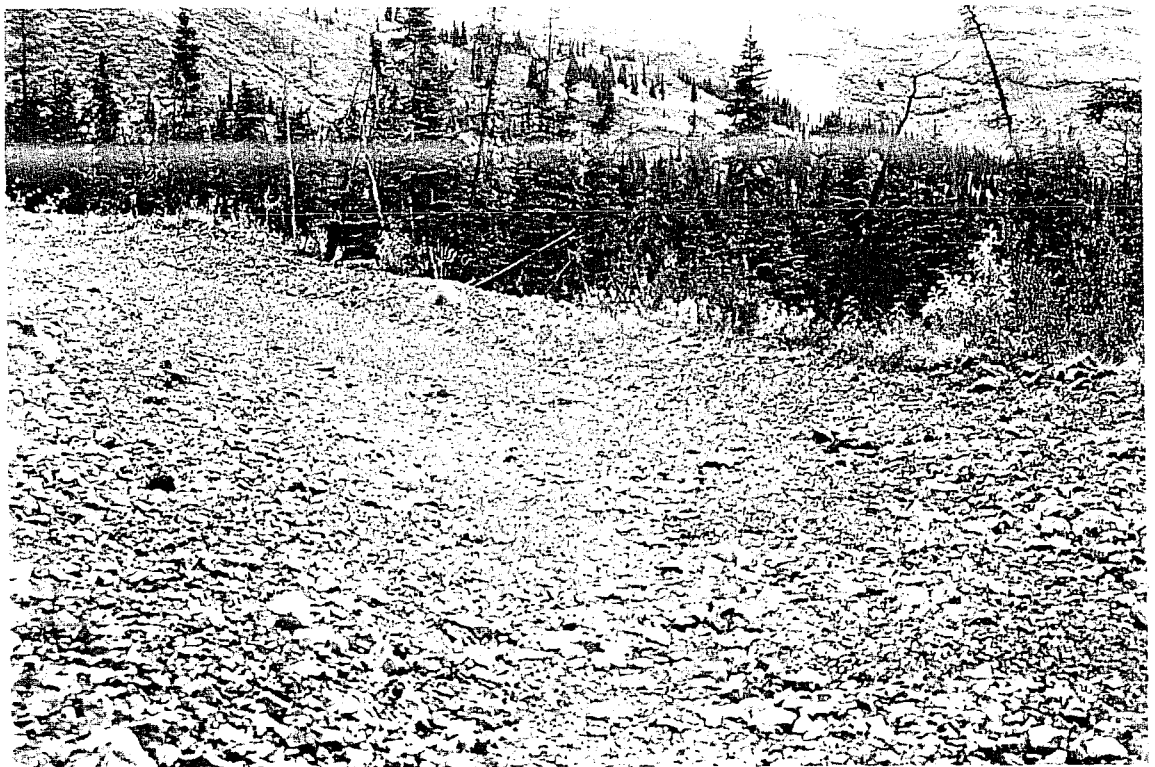
The existing emergency spillway (of an unknown capacity) may have to convey flows exceeding the remaining pond storage capacity. Should an uncontrolled discharge from Subsidiary creek occur, similar to this year's event, the overflow may happen during the year 2000 break-up. The impact of this flow would largely depend upon the actual volume of flow. The spillway is shallow and its armour is small-sized (Photo 7). It was not constructed for large flows. Larger flows may erode the rip-rap and may cut a new channel over the hillside in the spillway bend area.

Photo 7: View of the spillway, looking north. Note shallow depth of the channel and small size rip-rap at this location.

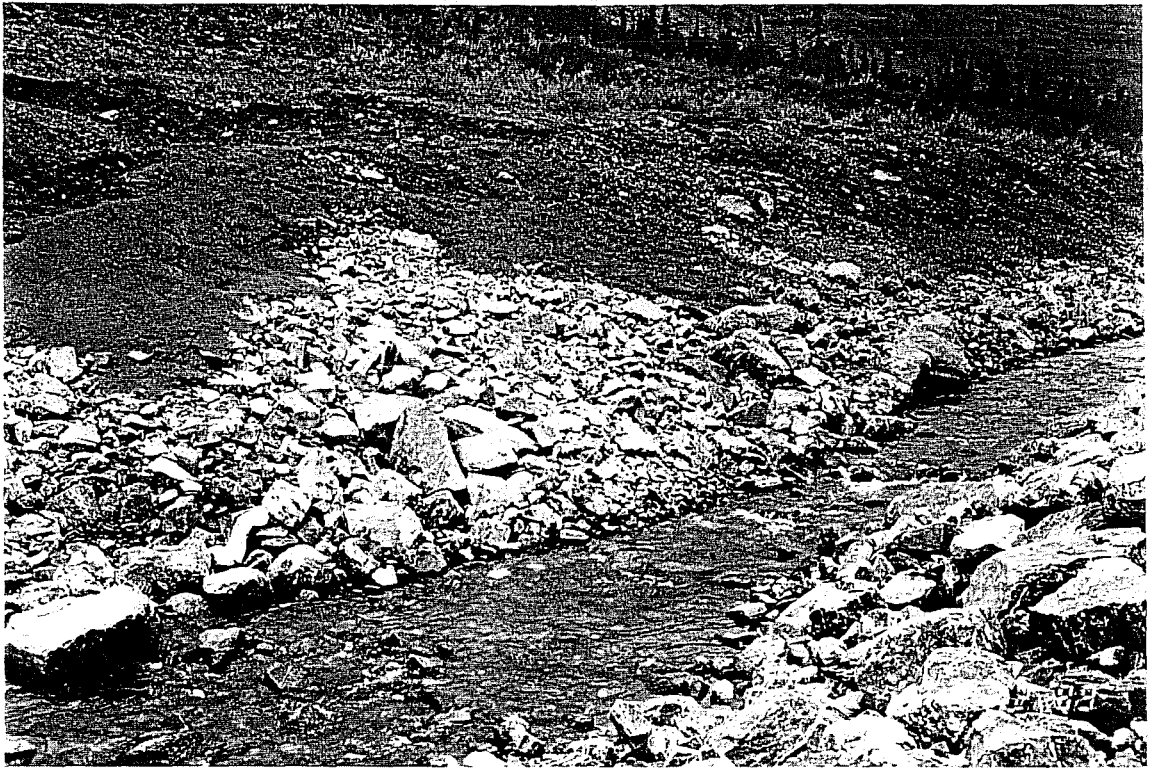
The downstream segment and the drop section (destroyed during the 1992 spring break-up and reconstructed the same year) continue to deteriorate. The slide on the south side of the channel retrogresses further uphill and its headscarp is bigger. The centre portion of the slump encroaches into the creek channel, narrowing the channel width (Photo 8). Both channel banks are also eroded further downstream (Photo 9). Cracks are evident, caused by oversteepening of channel slopes. Rip-rap ravel into the channel and during bigger flow stages is transported further downstream. It appears that both downcutting of the channel and retrogressive erosion are taking place.

Photo 8: Thawing of permafrost on the south side of the Cache Creek diversion continues, causing extensive sloughing. The centre segment of the slump encroaches into the channel.

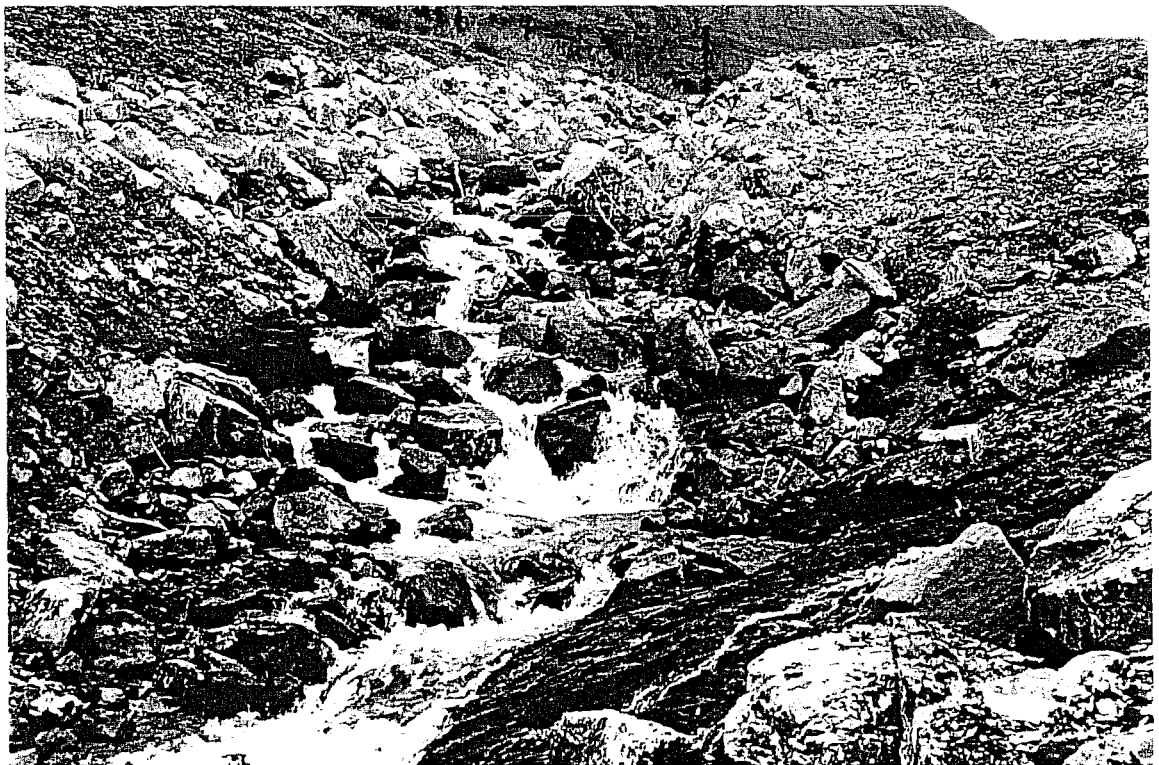
Photo 9: View of the so-called drop section. Both channel banks are undercut by erosion.
