September 30, 2011

ISSUED FOR USE
EBA FILE: W14101068.037

Subject: Mill & Camp Site – 2011 Annual Review, Minto Mine, YT

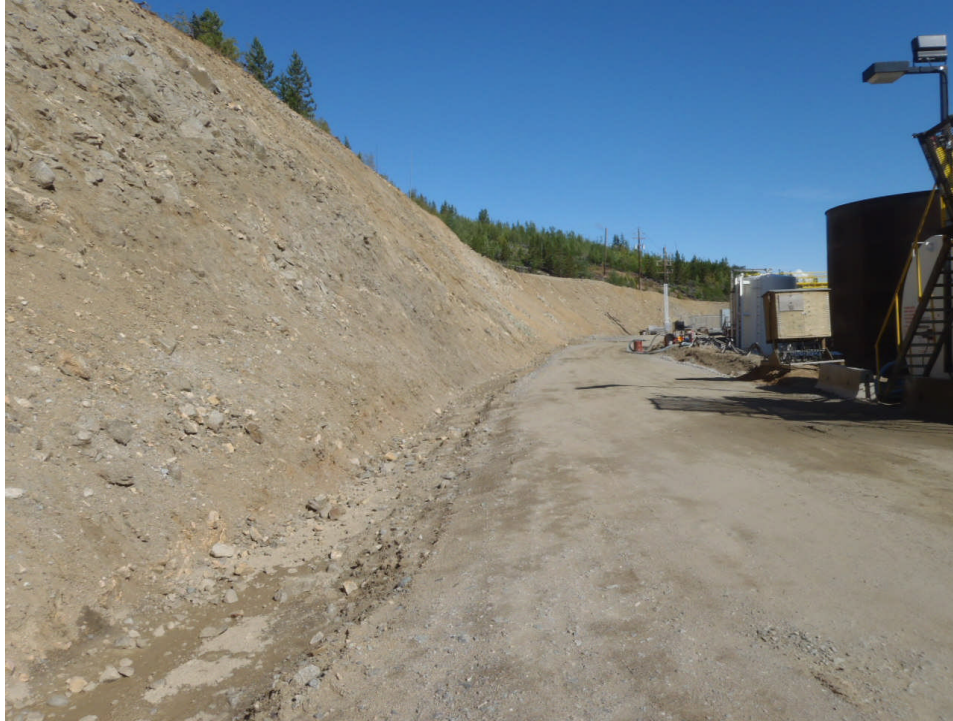
Photo 1

- The slopes above the fuel containment facility (Photo 1) and the main mill site (Photo 2) have not changed significantly since their original construction. Some eroded sand and gravel is present along the toe of the slope, with occasional pieces up to 200 mm.
- The slopes above the camp site and access road (below the camp site) are stable. Some eroded sand and gravel is present along the toe of the slope, with occasional pieces up to 50 mm in size. No other signs of instability, bulging or slumping, or potential sources of additional slough material were observed. Some minor erosion channels are present above the camp site. During EBA's August 2011 site visit it was noted that two large erosion channels on the slope below the camp above the access road are present. (Photos 3 and 4).

Backslope behind the Fuel Containment Cell. (August 25, 2011)

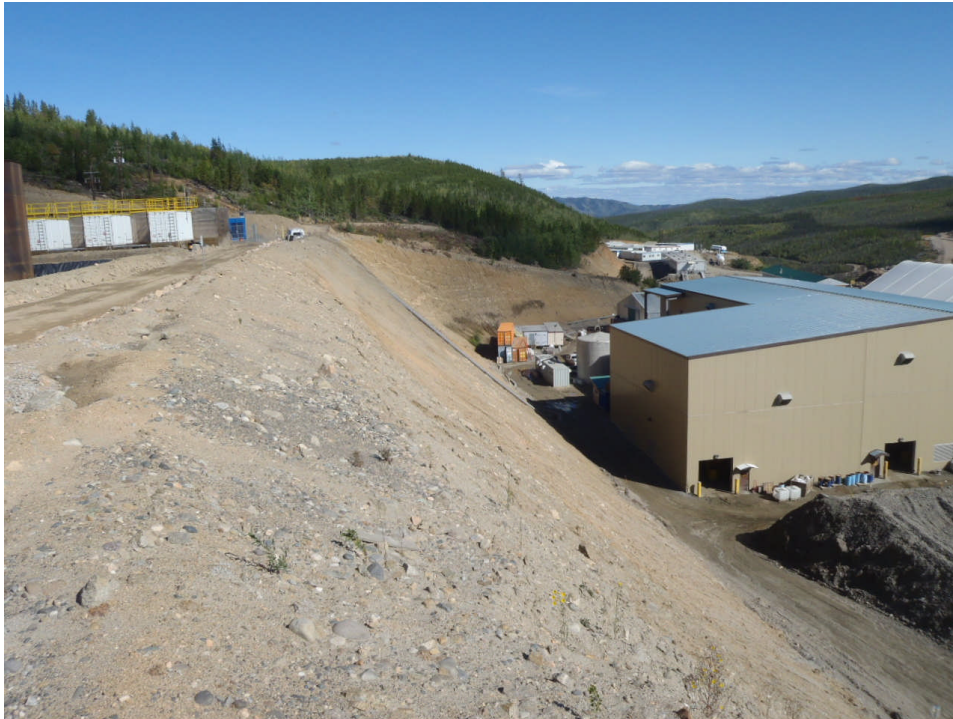
Photo 2

Backslope of the Mill Site. (August 25, 2011)

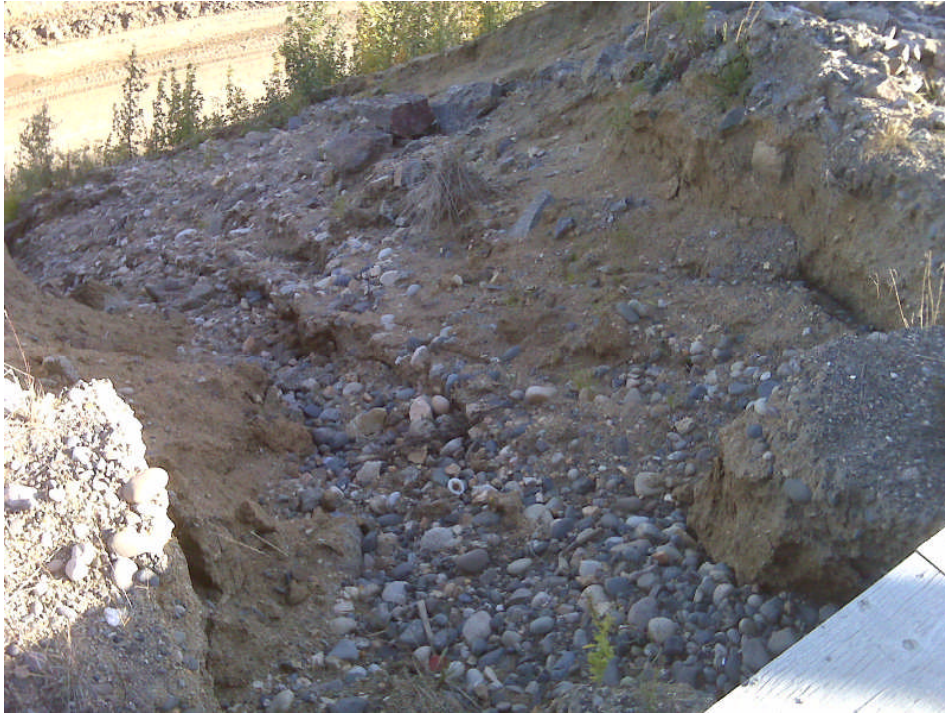
Photo 3

Large erosion channel (East side) along crest of Camp Pad slope above the Access Road. (August 25, 2011)

It is recommended that the erosion channels noted in two locations along the slope below the Camp Site and the two locations located along the northern edge of the Mill Valley Fill be regraded to promote runoff away from these areas to locations where the water can be collected and pumped back to the Area 1 Open Pit.

In the interim, to minimize slope erosion, these channels could be filled with rip rap material or a “half culvert” could be installed down the slopes with adequate outlet protection.

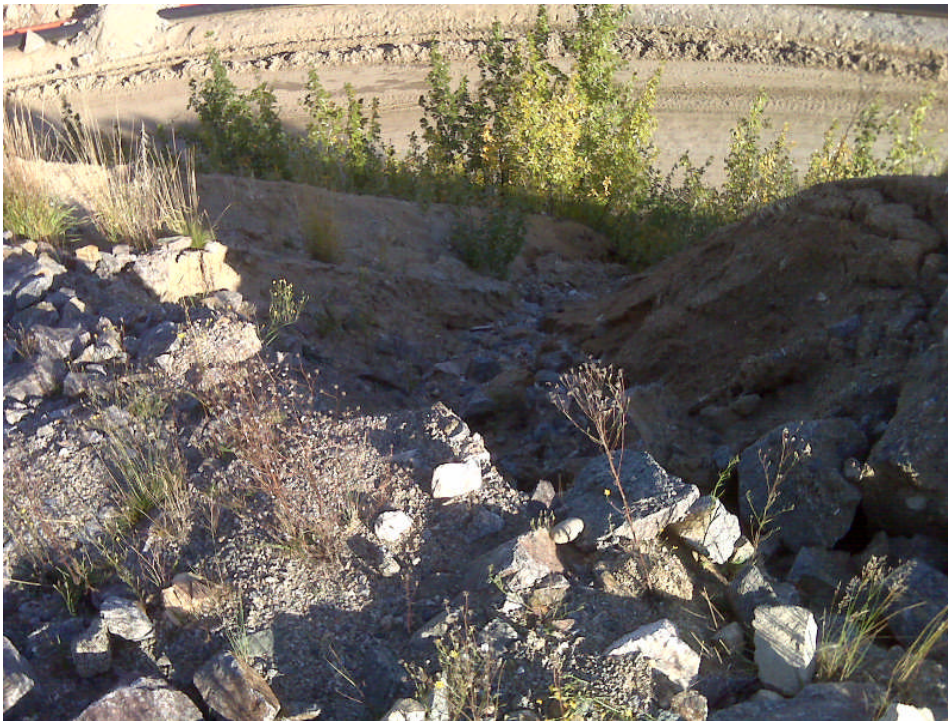
Photo 4

Large erosion channel (West side) along crest of Camp Pad slope above the Access Road. (August 25, 2011)

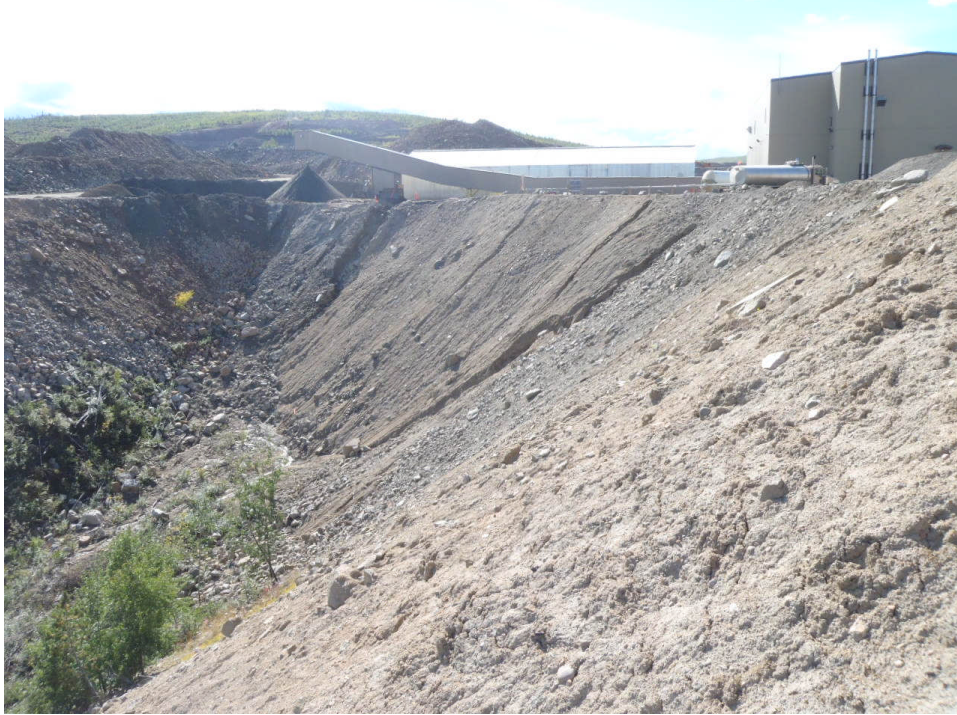
Photo 5

- The mill valley fill slope on the east side of the mill site appears stable. No signs of instability, tension cracks, bulging or slumping, were observed. Two erosion channels were noted along the slope closest to the Tailings Filter Building (Photo 5).
- No flow at the toe of the mill valley fill slope was observed. The rock drain installed at the bottom of the mill valley fill was not visible and it appears that some fill material has sloughed and covered it.
- The discharge path for the culvert from the Mill Water Pond is in satisfactory condition with large rip rap present.
- Safety berms are present in working areas.

Large erosion channels along the slope of the Mill Valley Fill. (August 25, 2011)
