October 18, 2011

ISSUED FOR USE
EBA FILE: WI4101068.037

Subject: Dry Stack Tailings Storage Facility – 2011 Annual Review
Minto Mine, YT

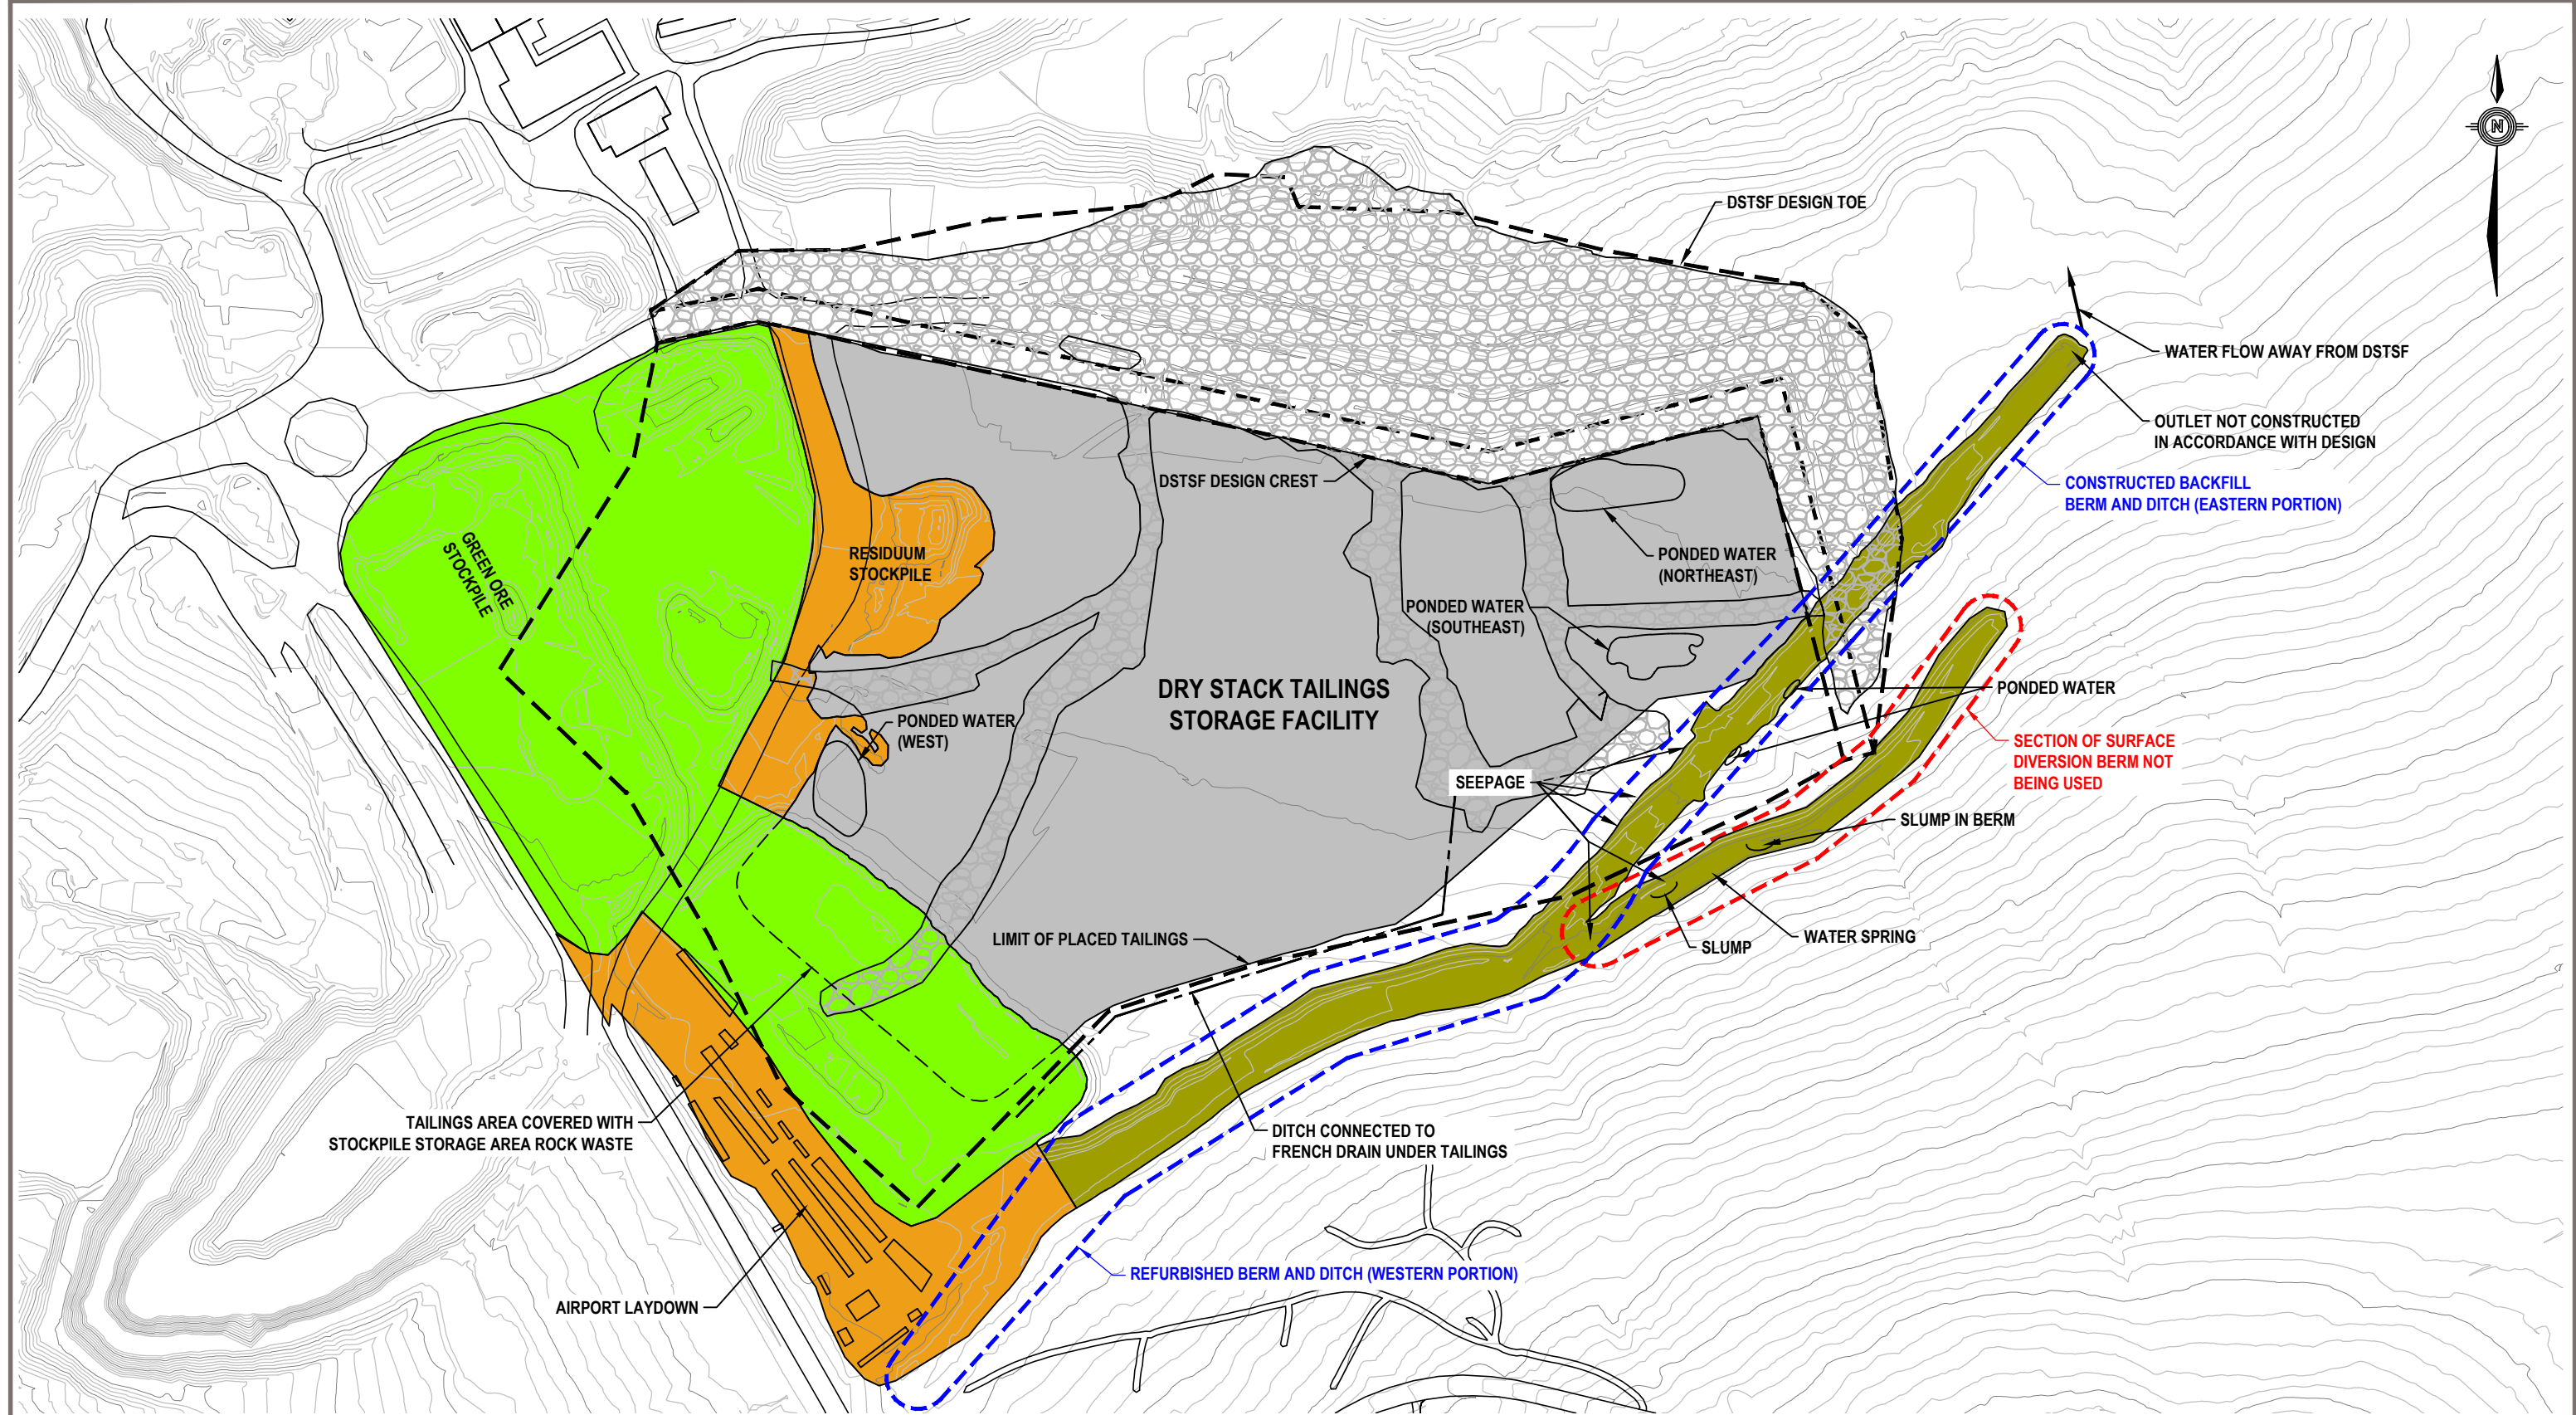
Figure 1 Site Plan with Observations

- As presented in Photos 1 through 3 and Figure 1, the components of the facility constructed at the time of the visit were the majority of the drainage blanket/starter bench, benches 1 through 7 of the waste rock shell and a surface diversion berm and ditch.

- Water ponded over the areas of tailings upstream of bench 7 was noted in three locations, the west portion, the northeast portion, and the southeast portion within the facility shown on Figure 1 (Photos 5, 6 and 7). In all three cases, the water was observed as murky. The ponded water in the west portion of the facility can be attributed to possibly run-on surface water and water flowing under the liner at various locations along the South Diversion Ditch. The ponded water in the northeast portion of the facility can be attributed to melting snow that was stockpiled in the area during the previous winter. The ponded water in the southeast portion of the facility can be attributed to surface water run-on from southeastern slope of the facility.

- The additional section of the berm constructed south of the eastern portion of berm with ditch (surrounded by the red dashed line on Figure 1) is performing much in the same manner as it was during the 2010 inspection; several high points in the ditch have caused water to pond on the uphill side of the berm. Seepage was noted at several points along the downhill side of the berm along this portion. This seepage water was noted ponding on the uphill side of the rockfill berm and seeping into the tailings area in several areas (Photos 11 and 12). Therefore, run-on water from this section still flows into the tailings area.

It is recommended that the surface diversion berm be rehabilitated to effectively capture water along the entire length of ditch. Minto has engaged EBA in providing a updated design (September 14th, 2011 Issued for Review EBA Technical Memo 013.06 titled “Upstream Water Management for the Mill Valley Fill Expansion and Dry Stack Tailings Storage Facility”) but the implementation is dependent on a lease boundary extension, which is pending. After rehabilitation, maintenance issues are expected and maintenance issues will need to be addressed throughout its use.

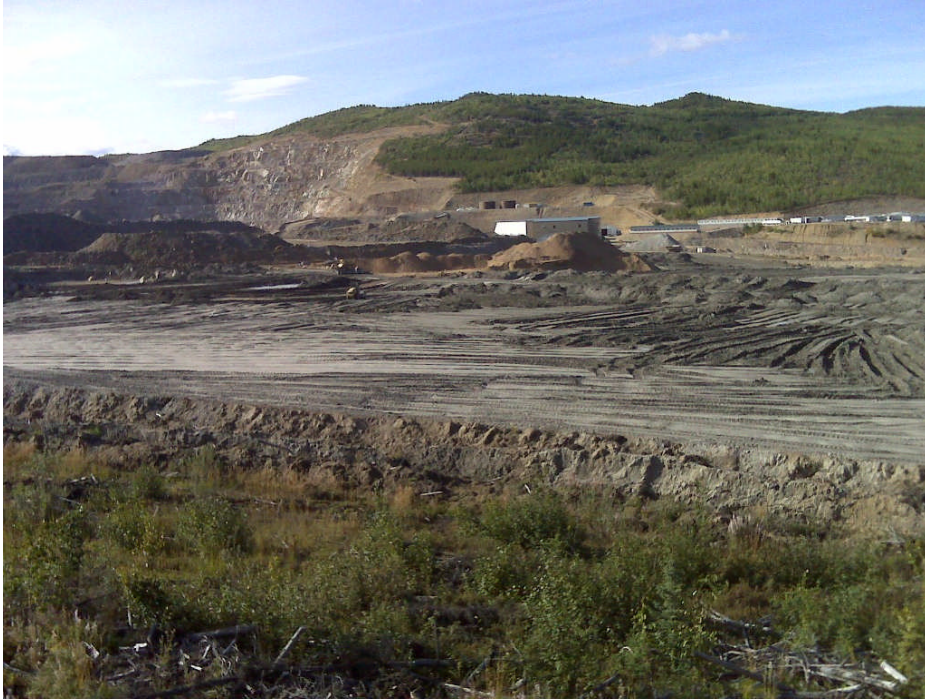
Photo 1

DSTSF Tailings Placement Aspect: Northwest (August 25, 2011)

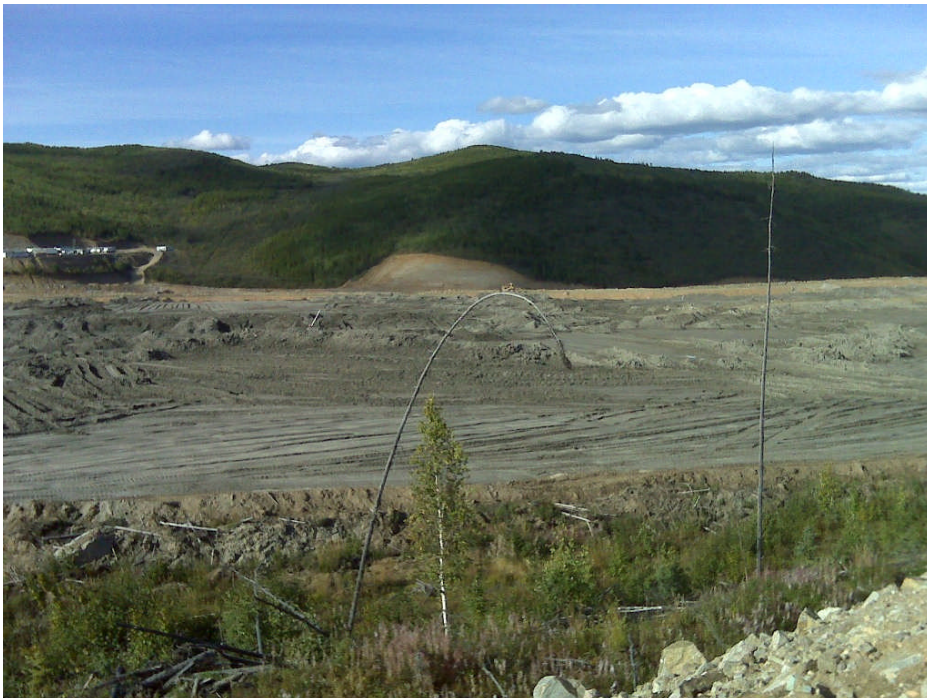
Photo 2

DSTSF Tailings Placement Aspect: North (August 25, 2011)

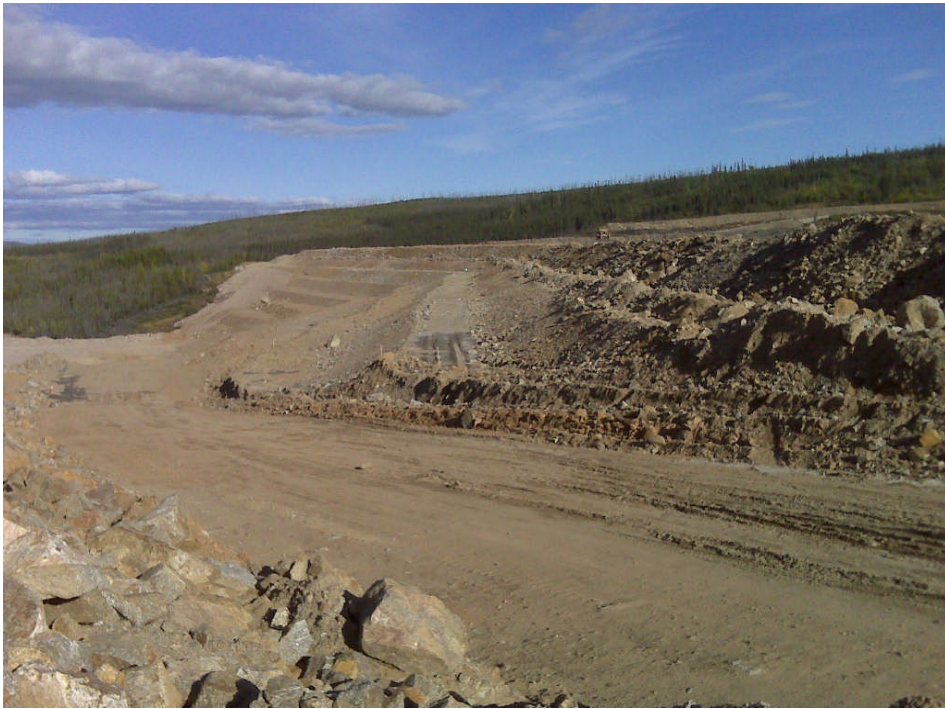
Photo 3
DSTS Front Face, Aspect: East (August 25, 2011)

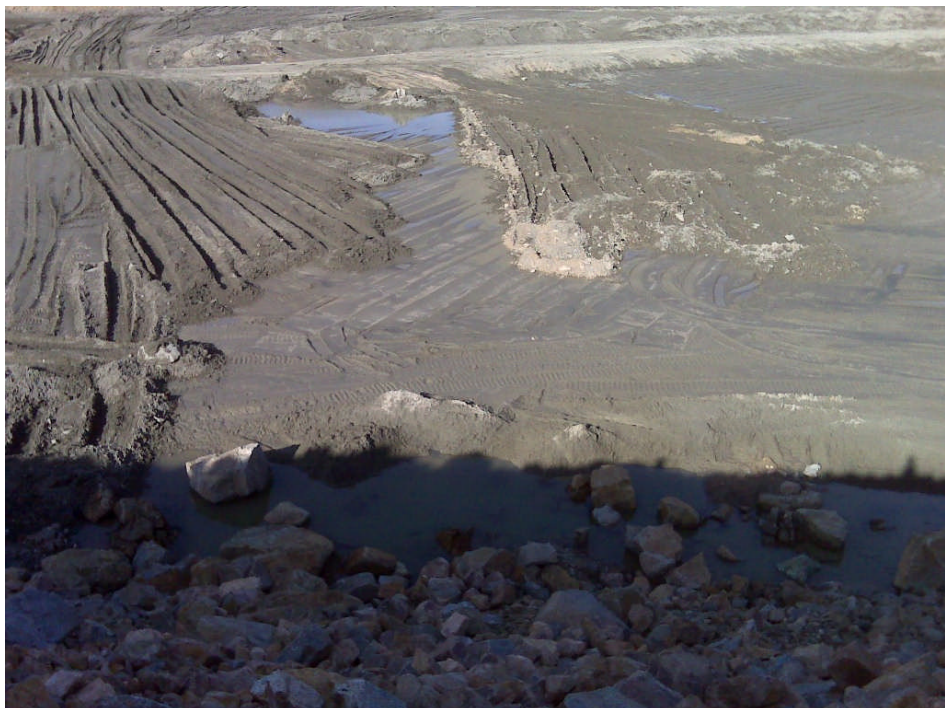
- Tailings placement covers roughly 95% of the facility. Typical placement and compaction practices are shown in Photo 4.
- The slopes of the waste rock shell benches appear consistent with original placement; no signs of slumping, bulging, or tension cracks were noted. No erosion was noted along the toe or external slopes of the facility.

Photo 4
Typical placement and compaction activities (August 25, 2011)

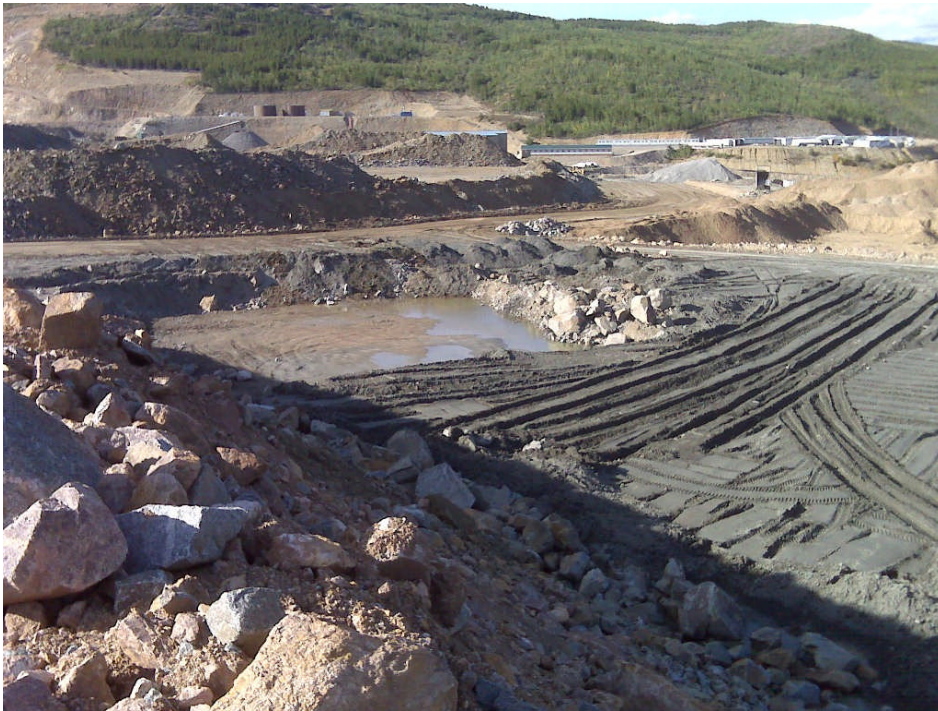
Photo 5

Ponded water in West portion of DSTSF Aspect: North (August 25, 2011)

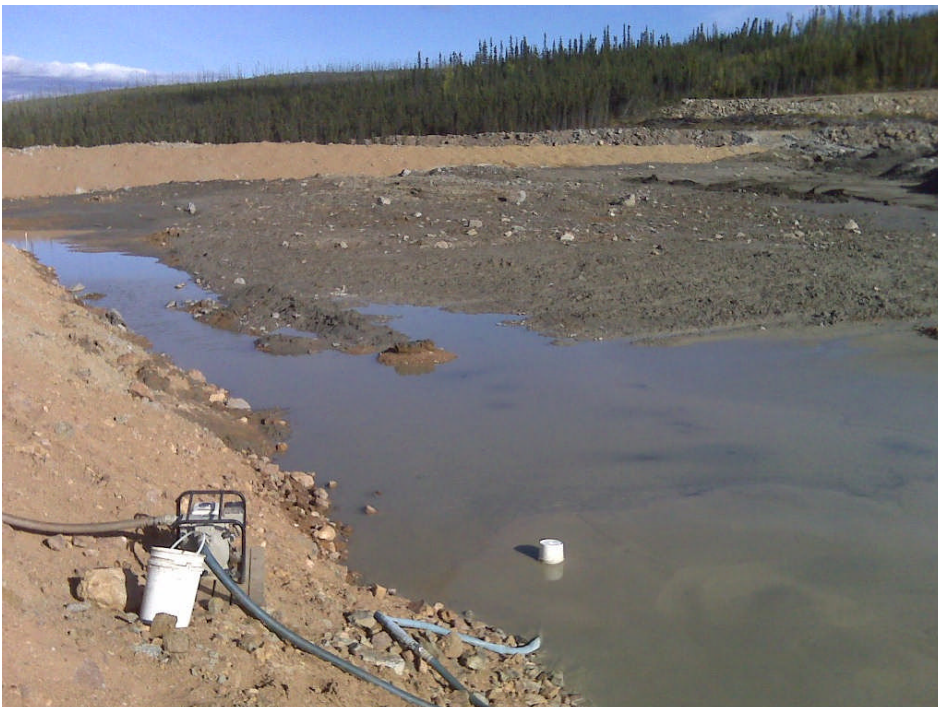
Photo 6

Ponded water in Northeast portion of DSTSF Aspect: East (August 25, 2011)

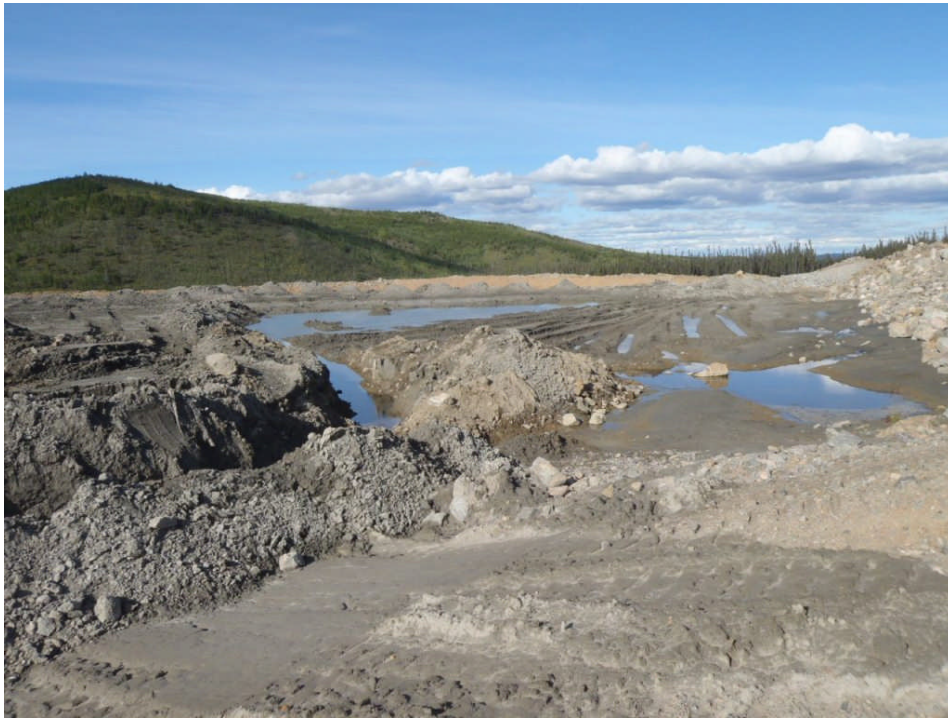
Photo 7

Ponded water in Southeast portion of DSTSF Aspect: Northeast (August 25, 2011)

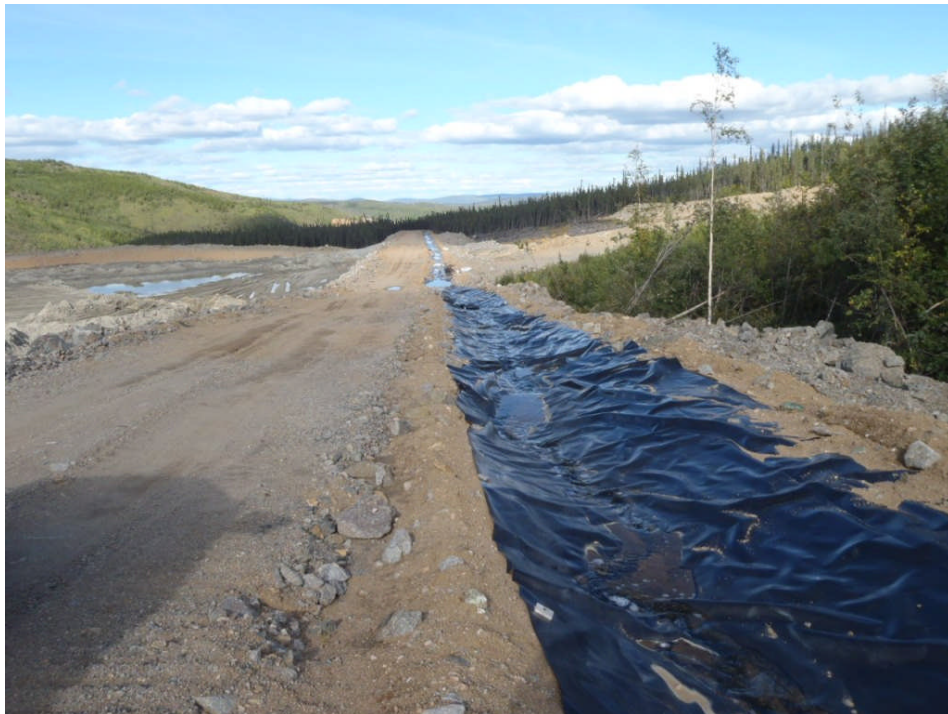
Photo 8

- The western portion of the Tailings Diversion Ditch constructed in 2008 was rehabilitated during the winter of 2010 in accordance with EBA's March 23, 2010 Issued for Use drawing TDD-01. The rehabilitation consisted of regrading the existing ditch to convey this water to a lined ditch to discharge on the east side of the facility. The lined ditch (eastern portion) was excavated into a constructed rockfill berm. The ditch constructed in the rockfill berm was lined with HDPE liner (Photo 8).

Tailings Diversion Ditch – Lined ditch portion Aspect: Northeast (August 25, 2011)

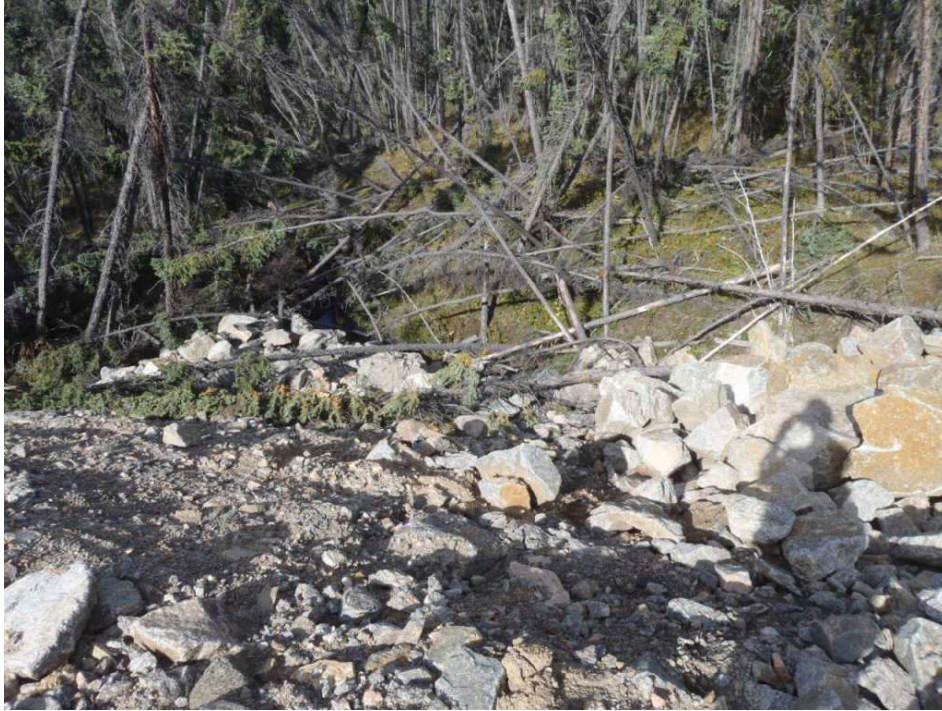
Photo 9

- At the time of the site visit, the western portion of the Tailings Diversion Ditch was working in accordance with the design intent of conveying water from the western portion of the southern slope to the discharge point east of the DSTSF. The discharge water was observed as clear and was flowing northeast, away from the DSTSF (Photo 9).

- The discharge point of the Tailings Diversion Ditch was not constructed in accordance with the March 23, 2010 Issued for Use drawing TDD-01. The discharge should flow into a lined stilling basin to dissipate the water flow energy and reduce the amount degradation to the natural subsurface. EBA has discussed these discharge requirements with Minto site staff during previous site visits. Minto should

Tailings Diversion Ditch outlet (August 25, 2011)

The discharge location of the lined ditch should be constructed in accordance with the September 14th, 2011 Issued for Review EBA Technical Memo 013.06 titled “Upstream Water Management for the Mill Valley Fill Expansion and Dry Stack Tailings Storage Facility”.

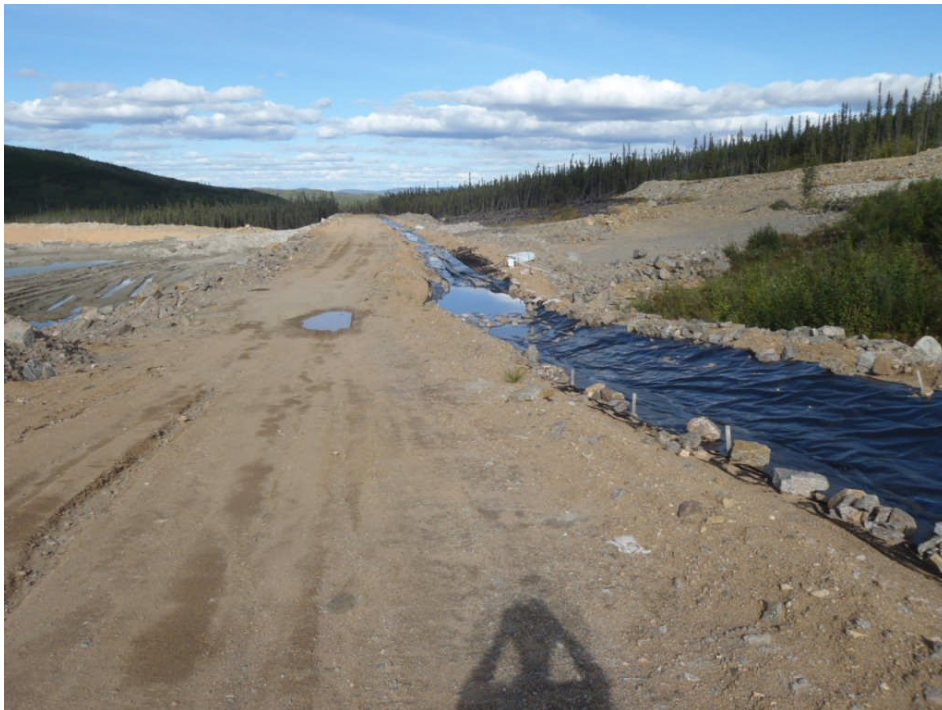
Photo 10

- The eastern portion of the ditch that has been constructed on top of the berm has slumped in several places (Photo 10). These slumps typically happen on the downhill side of the berm from areas of ponded water. There were also areas of seepage noted along this portion of the berm allowing the run-on water to flow into the tailings area.

Section of berm that has settled in area of ponded water upstream of berm Aspect: East (August 25, 2011)

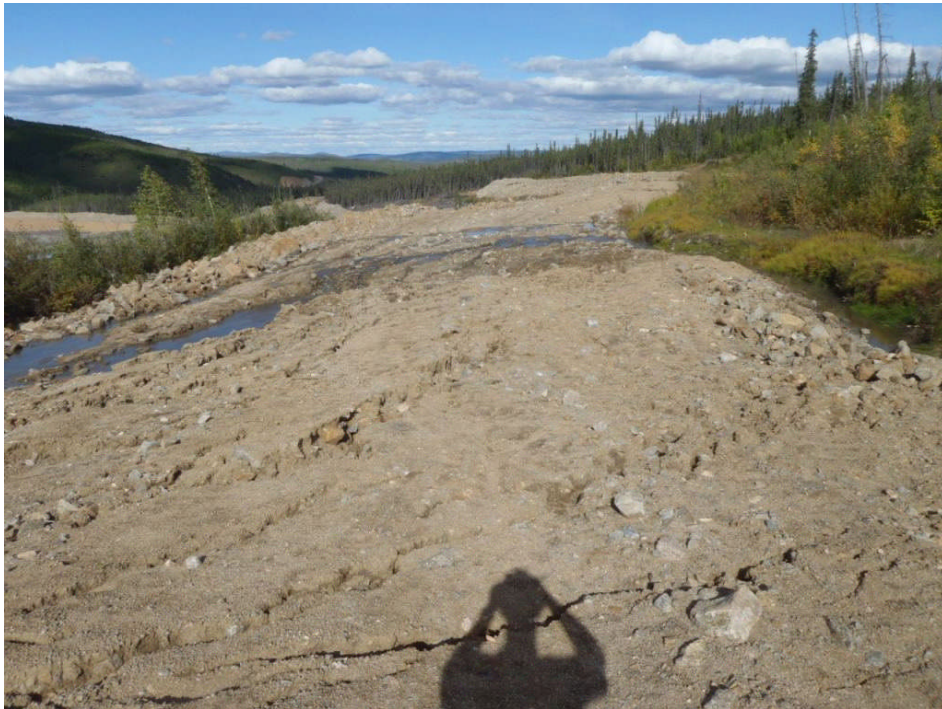
Photo 11

Ponded water, surface run-off and tension cracks along 2008 diversion berm Aspect: East (August 25, 2011)

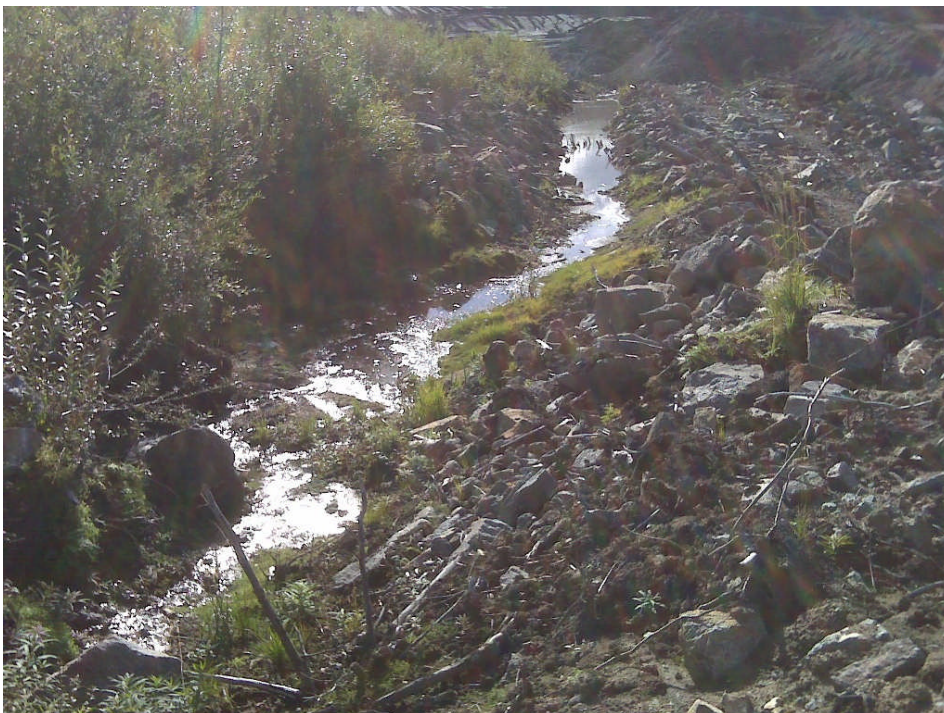
Photo 12

Water seepage downslope of eastern portion of berm from ponded water upslope of berm Aspect: West (August 25, 2011)
